Compton Bassett Chapel
A Historic Structure Report

Derek N. Anderson

HISP 710/711 HISP Final Project

May 2013

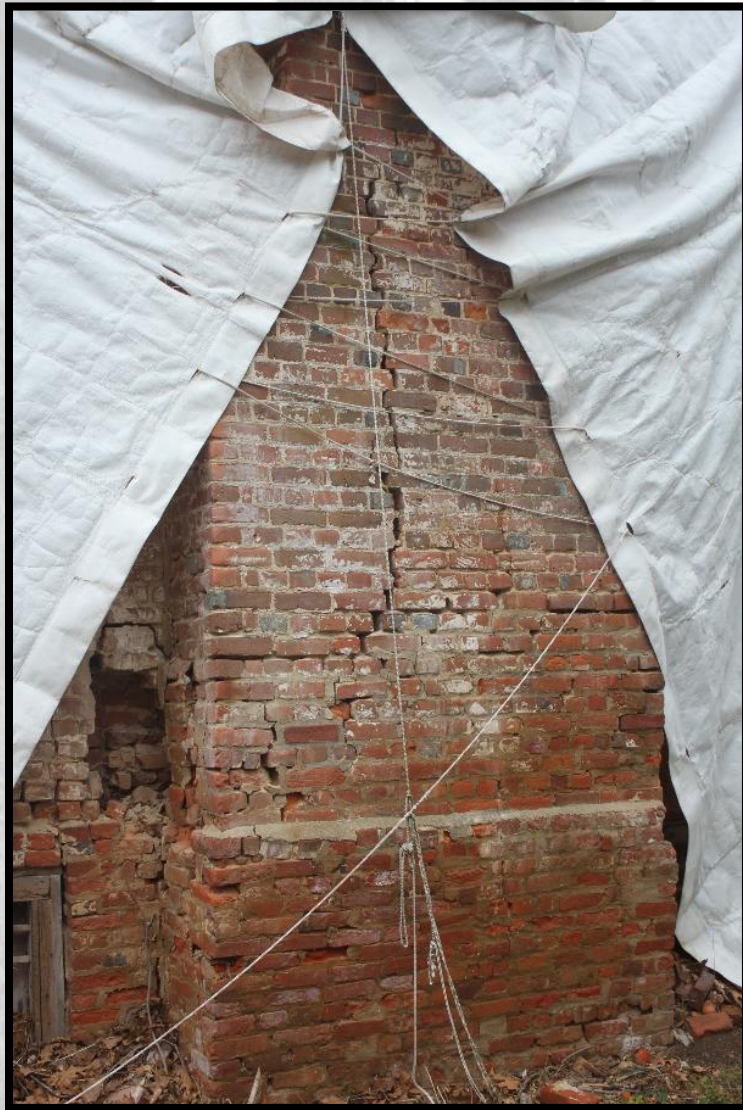
Structural Problems

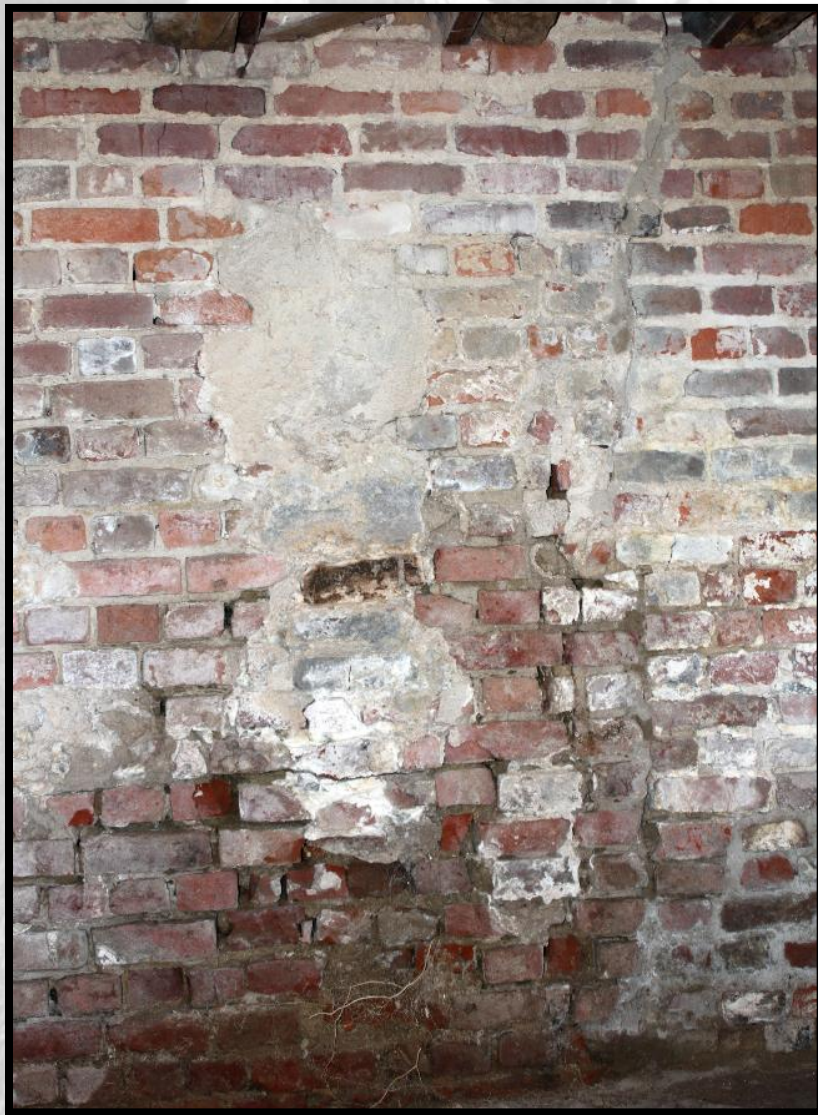
Spalling Masonry

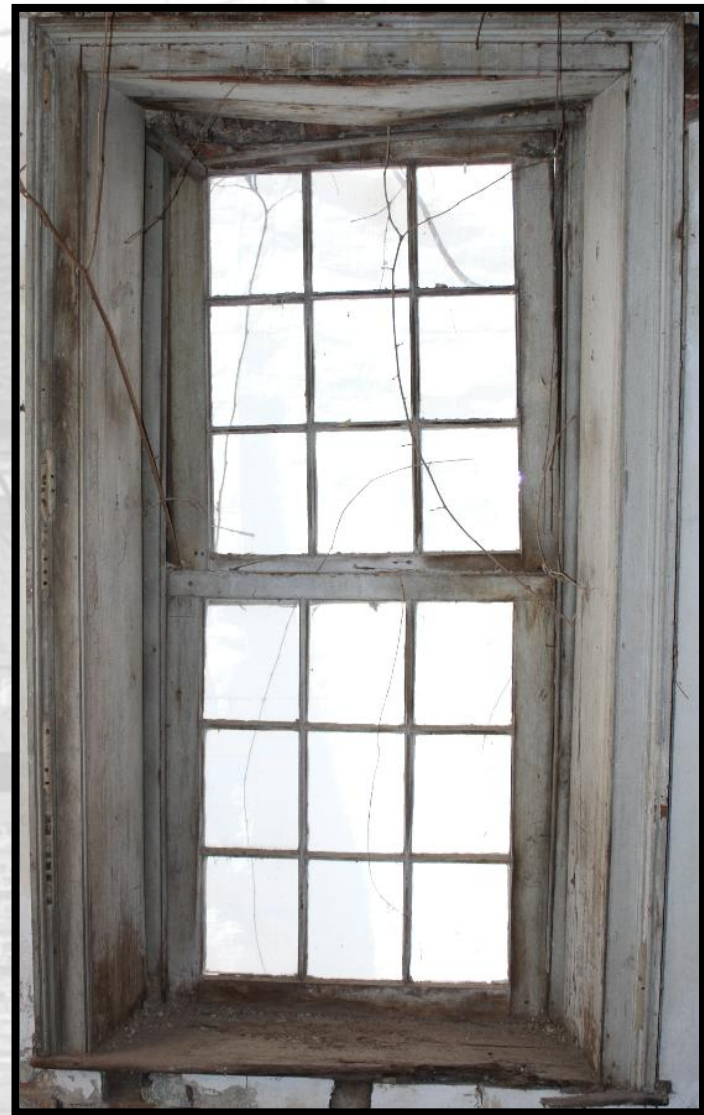
Deteriorating Windows

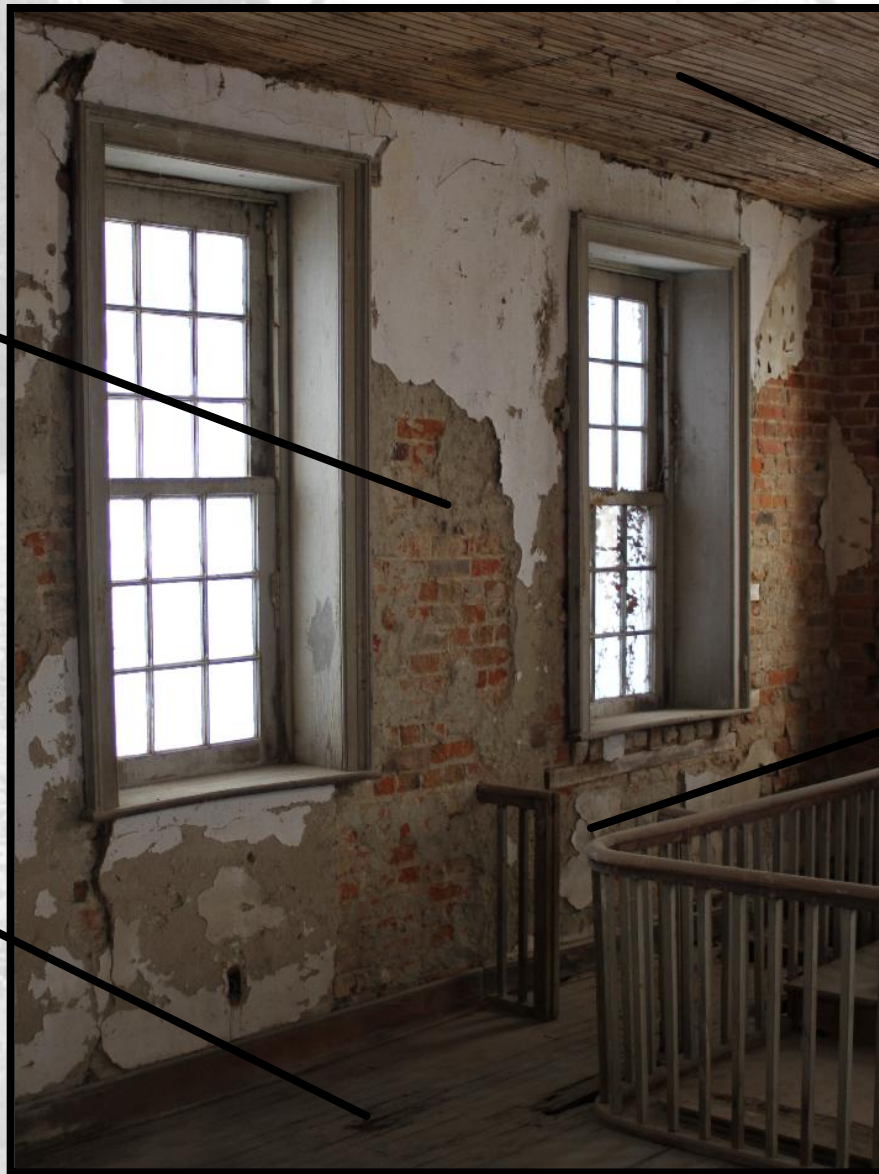
Deteriorating
Interior Masonry
Walls
