Title of Thesis: THE ST. FRANCIS DAM COLLAPSE AND  
ITS IMPACT ON THE CONSTRUCTION OF  
THE HOOVER DAM

Thomas M. McMullen, Master of Science, 2004

Thesis Directed By: Director of Project Management Program, Dr.  
John Cable, Civil Engineering

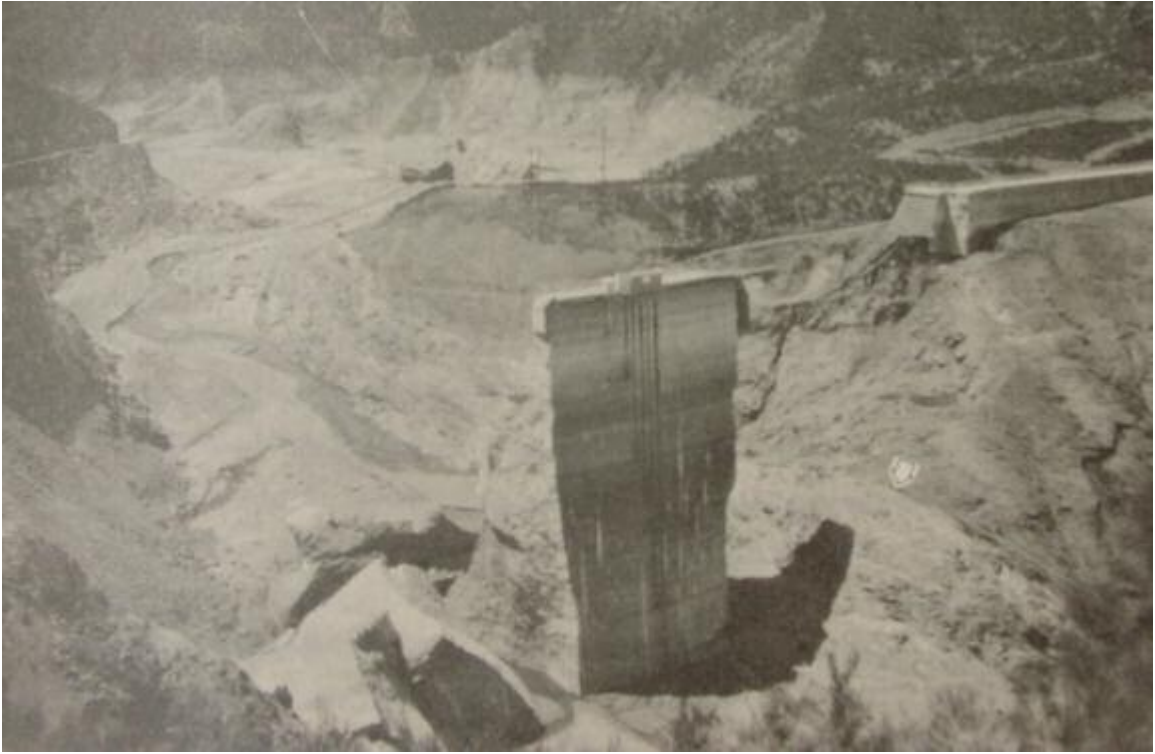
The site Mr. Mulholland selected for the future Dam was located on the old San Francisquito fault line which was easily visible in pictures taken to document the Dam's collapse (Plate 1, page 55).<sup>4</sup> Fault lines are indications of previous earth shifts and are typically the location of multiple soil conditions. For example, the nature of the spur of mountain against which the Dam abutted fluctuated so widely in composition that while no explosives were ever used to excavate for the Dam itself, roads leading to the Dam through the same mountain formation required extensive use of dynamite to prepare their path. Further, the canyon walls were so soft and fractured that blasting had not been necessary to prepare them prior to placement of concrete. Instead high-pressure hoses were used to sluice off the mountainsides and human labor armed with picks and gads were utilized to finish the job.<sup>5</sup> Geologists who examined the site after the disaster questioned Mr. Mulholland's site selection, and, as early as 1911, 11 years before Dam construction was started, Mr. Mulholland,

Plate 1 Fault line visible in picture taken after the St. Francis Dam collapse.

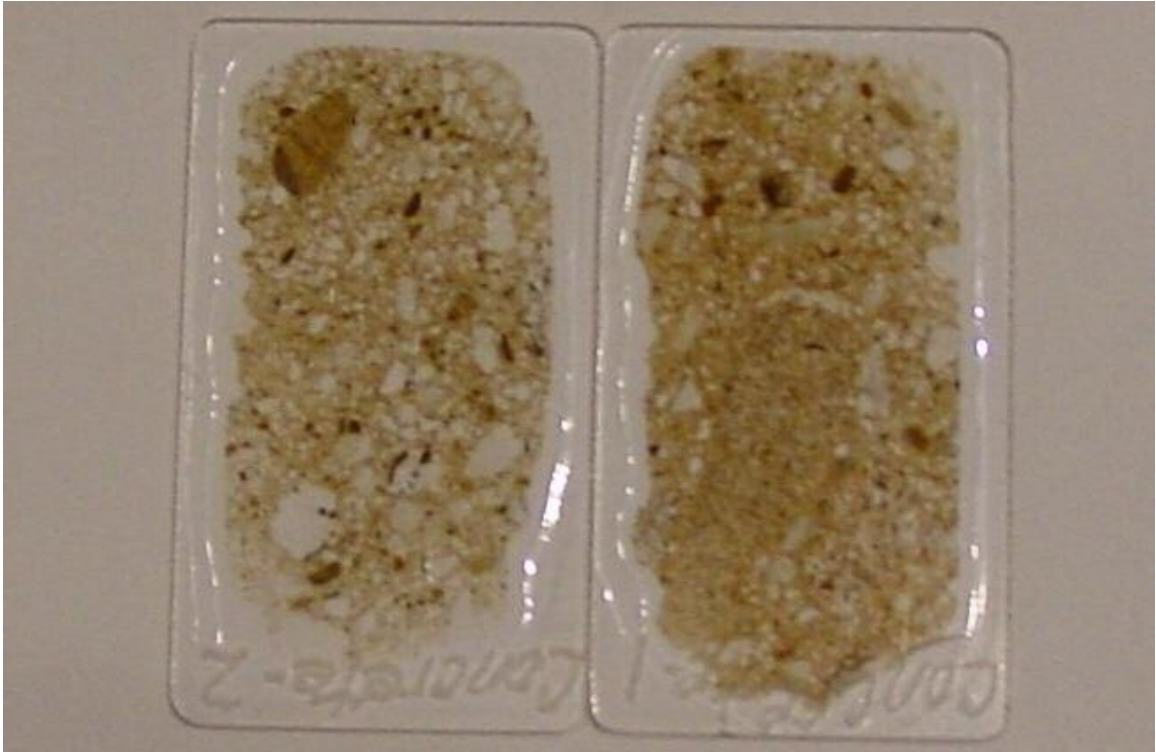
Plate 3 Prepared slides of concrete sample showing heterogeneous distribution of aggregate.

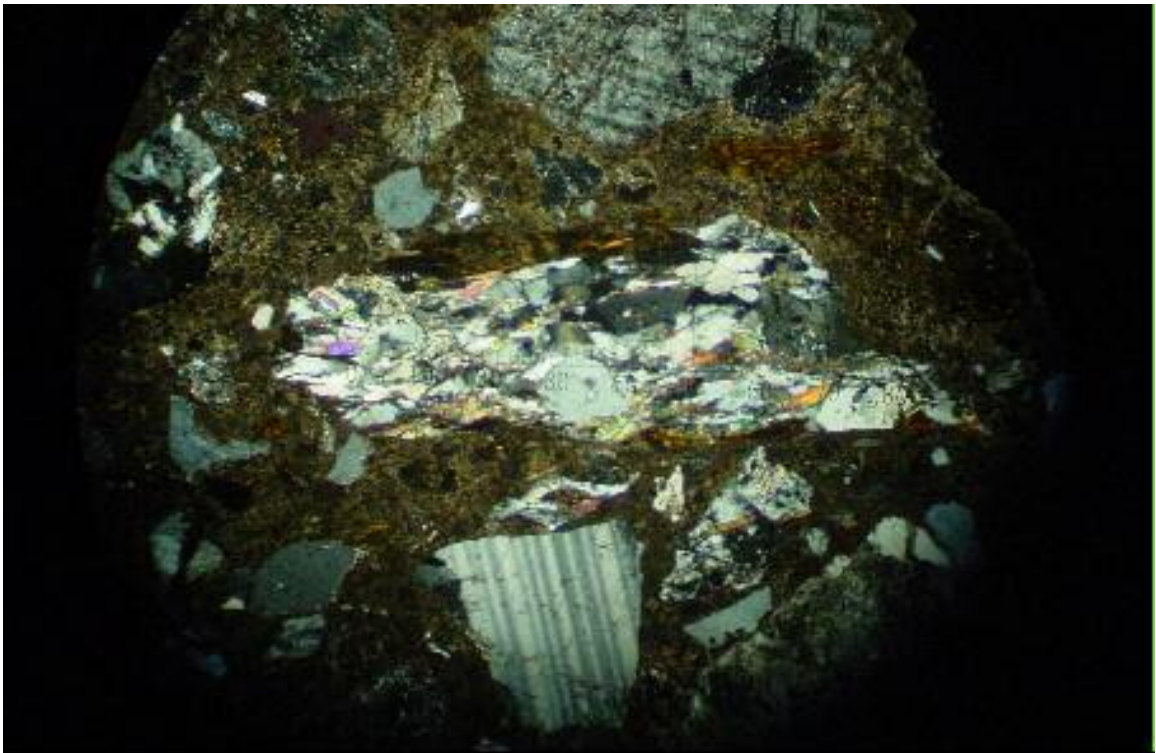
Plate 4 Prepared slide showing mica schist fragment magnified 10X.

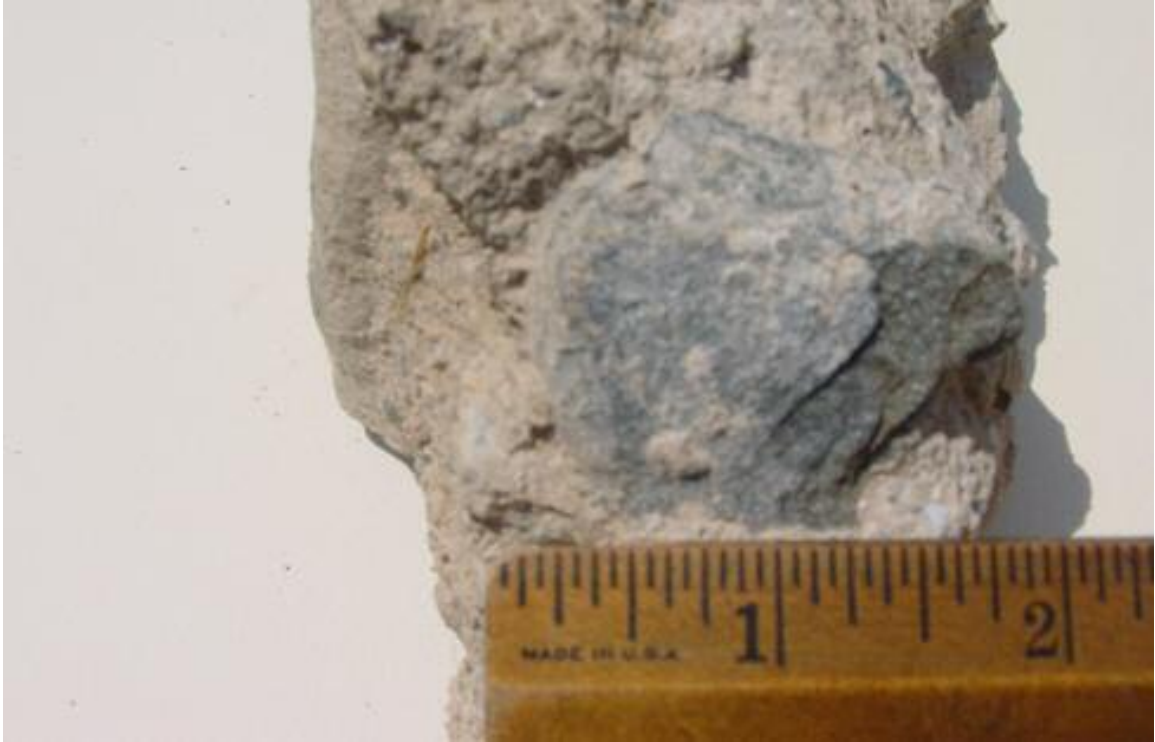
Plate 5 Mica schist aggregate visible in concrete sample from the St Francis Dam.

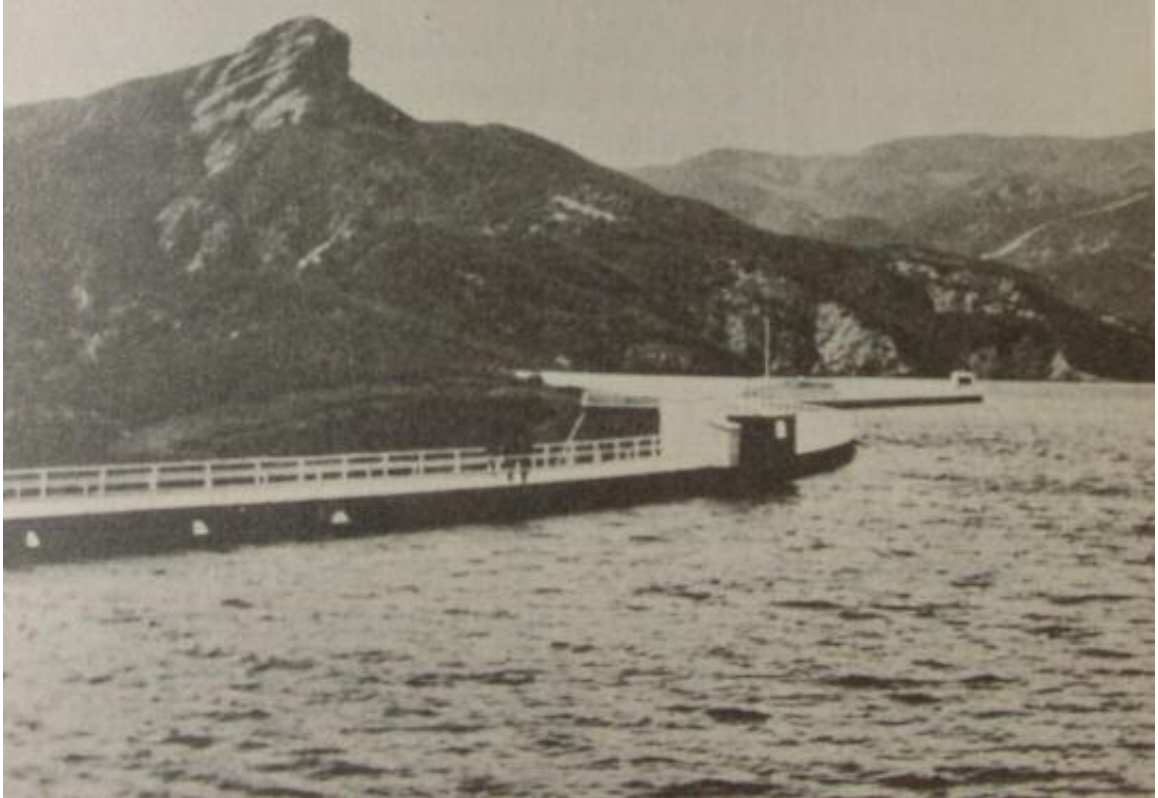
full with the waters at level of the outlet openings below the walkway (see Plate 9, page 59).<sup>37</sup> Another picture taken at the same time from the downstream side of the Dam shows the leak at the wing wall connection to the main structure with water spilling through the outlet openings on the eastern side of the Dam (see Plate 10, page 59).<sup>38</sup>

Plate 9 View of reservoir outlet openings at St. Francis Dam on March 12, 1928.

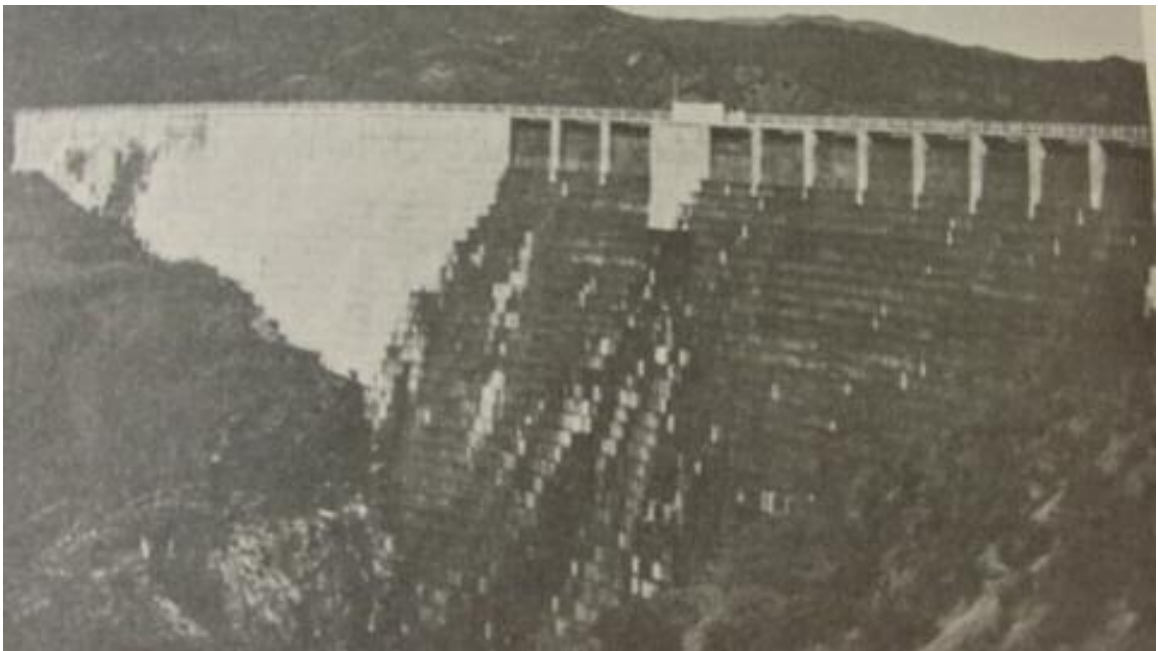
Plate 10 View from downstream side of St. Francis Dam on March 12, 1928.

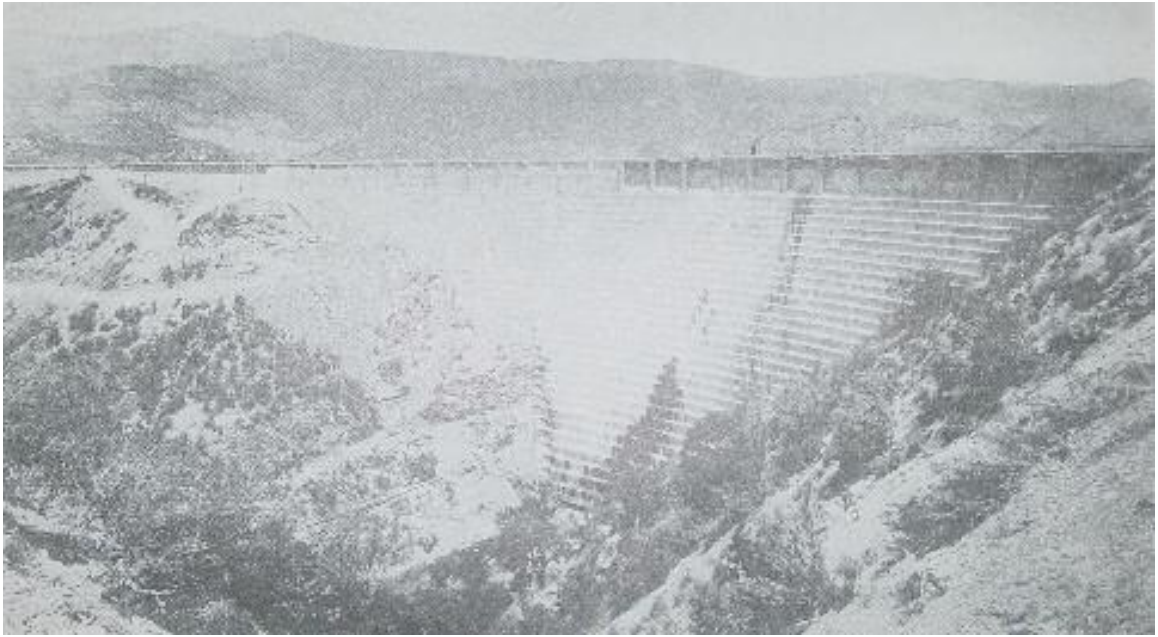
Both these cracks were also packed with oakum in an attempt to slow the leaks. It should be noted that, in general, the use of oakum and surface grouting is not a technique typically used in the construction of dams during this era.

Plate 16 Cracks visible in completed St. Francis Dam.

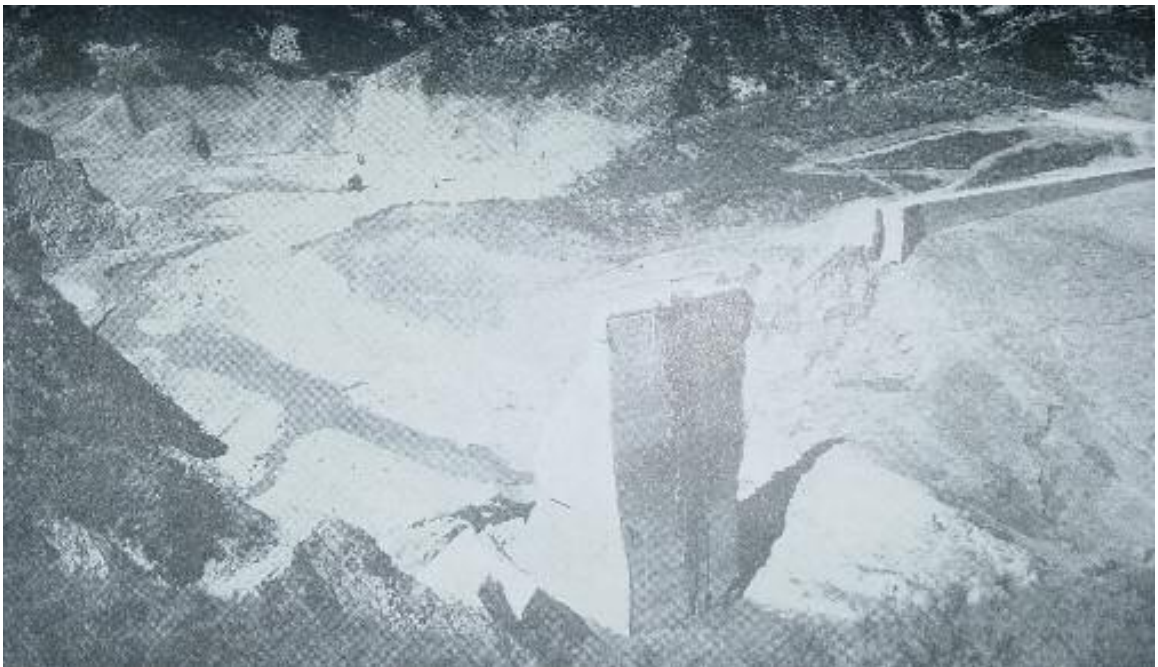
Plate 17 View from upstream side of St. Francis Dam after collapse.

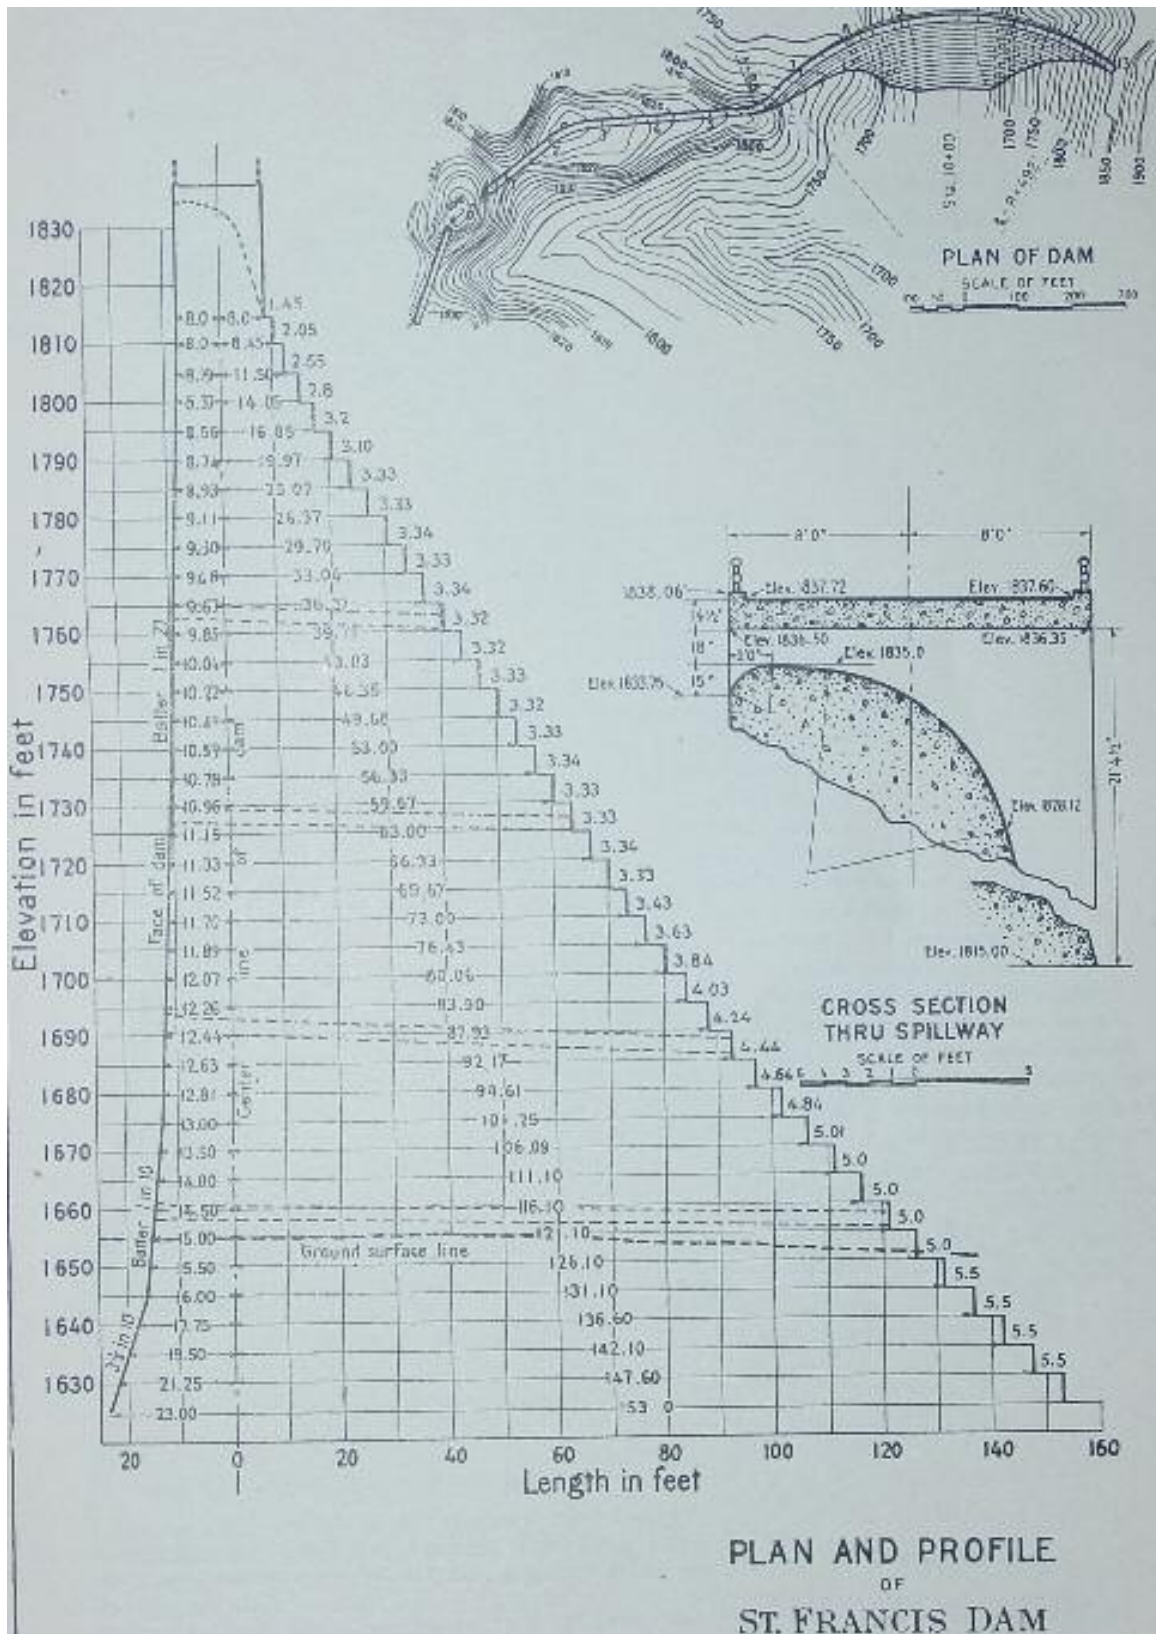
The foundation of the Dam is stated to have been excavated to an elevation of 1630 or 20 feet below streambed level.<sup>83</sup> The St. Francis Dam design, plan, and profile, included on page 29 of The Report (see Plate 19, page 65), shows the Dam foundation was to be 30 feet below streambed level or at elevation 1620. If bedrock conditions were found to be different from what had been planned, this modification to the plan would not have been a reason for concern, but the Report does not give any reason or explanation for the discrepancy in foundation depths. Likewise the Report states that under *portions* of the west abutment and about 25 feet from the upstream face, a cut-off trench about three feet wide and three feet deep was excavated. No mention is made as to why only portions and not the entire abutment was built into a cut-off trench.

Plate 19 Drawing of St. Francis Dam showing outlet tunnels.

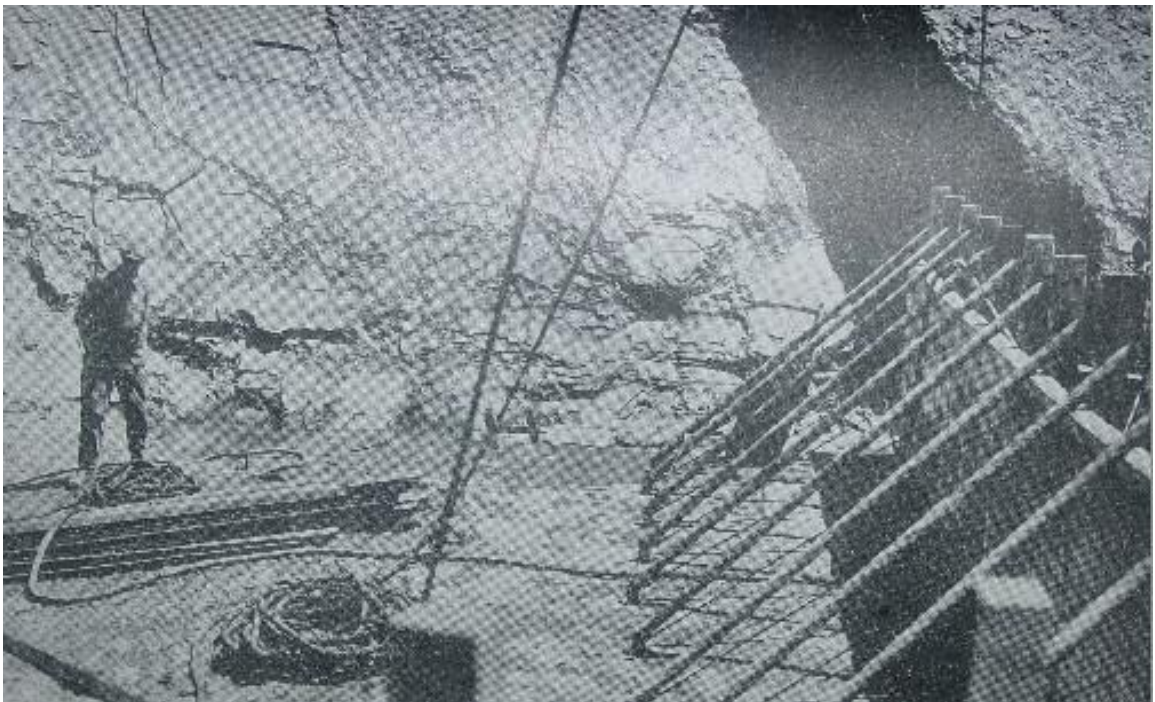
Plate 21 View of St. Francis Dam east abutment showing trenching up canyon wall.

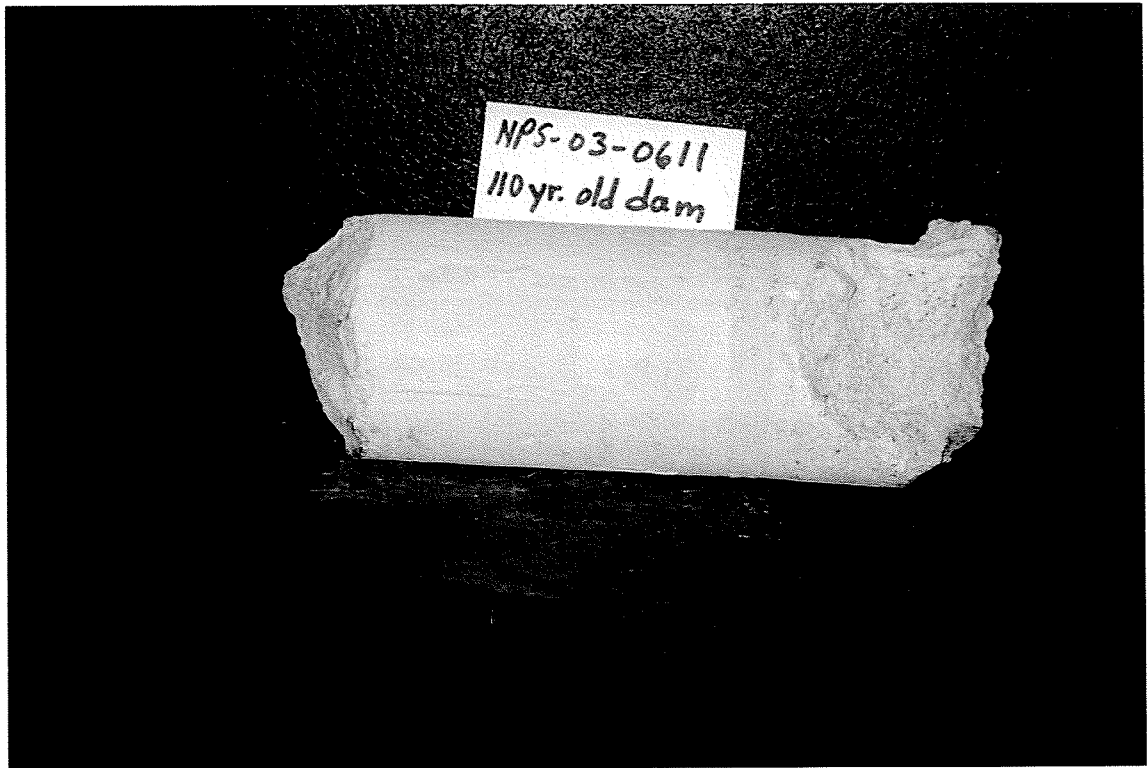
**Photo 1.** Core From 110 Year Old Dam: Concrete core sample as received. Note surface of core is covered with dried slurry resulting from the coring.

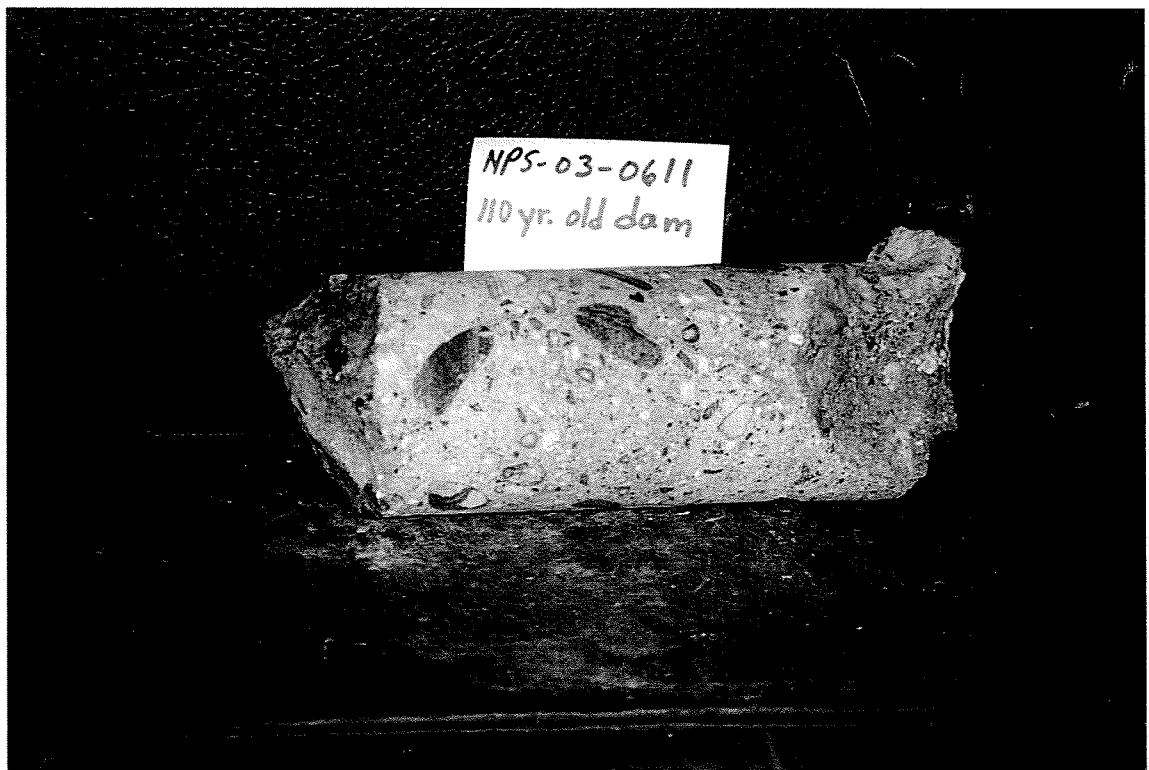
**Photo 2.** Core From 110 Year Old Dam: Concrete core sample as it appeared after it was washed off.

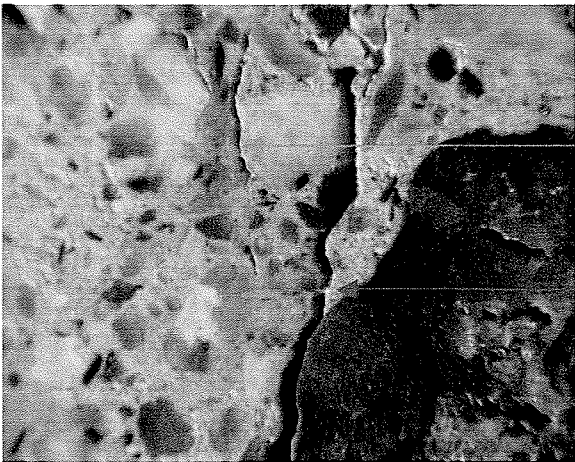
**Photo 3.** Microscopic photo taken through a stereoscopic microscope of a polished (lapped) portion of the examined concrete sample.

The concrete exhibited an extensive fracture oriented parallel to the core length. The photo shows a portion of the fracture (red arrow) extending through the cement paste and along a portion of the periphery of a coarse aggregate. The 2 green arrows point out microfractures adjacent to the main fracture.

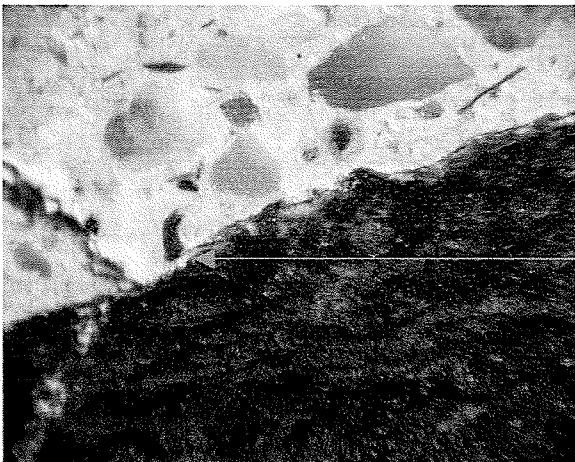
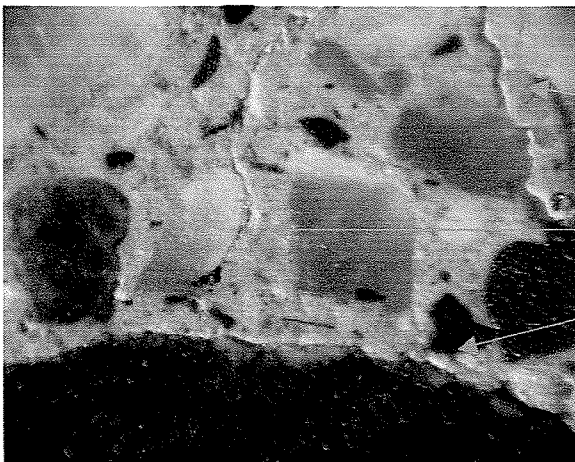
**Photos 4 & 5.** Microscopic photos taken through a stereoscopic microscope of a polished (lapped) portion of the examined concrete sample.

Photo 4 shows a microfracture within the cement paste and going along the periphery of a coarse aggregate. Photo 5 shows microfractures within the cement paste and along portions of the peripheries of a coarse aggregate and some fine aggregates.

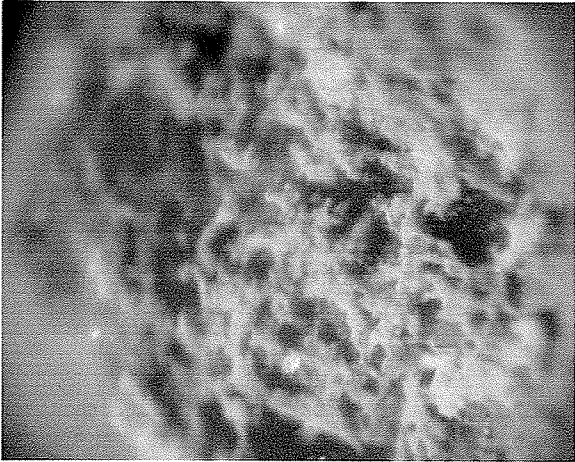
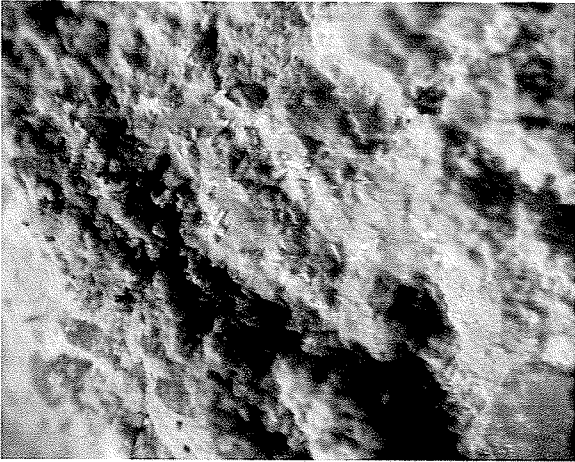
**Photos 6 & 7.** Microscopic photos taken through a stereoscopic microscope of freshly broken surfaces of the concrete core sample.
