Title of Document: CHARACTERIZATION OF DELAYED
ETTRINGITE FORMATION IN MARYLAND
BRIDGES

Micah Shalom Ceary, Ph.D., 2007

CHARACTERIZATION OF DELAYED ETTRINGITE FORMATION IN
MARYLAND BRIDGES

Dissertation submitted to the Faculty of the Graduate School of the
University of Maryland, College Park, in partial fulfillment
of the requirements for the degree of
Doctorate of Philosophy
2007

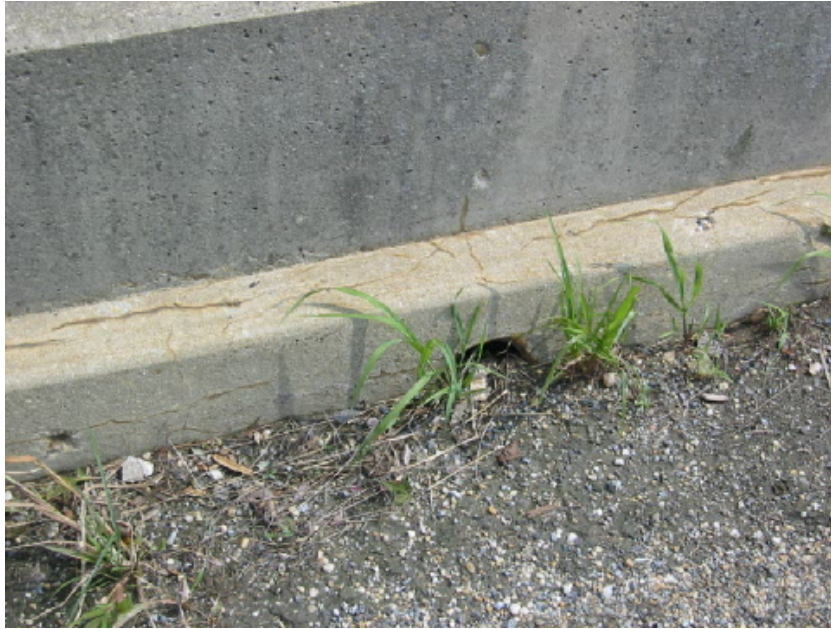
Figure 3.25: Typical Map Cracking (0800201 - MD 5 NB over Zekiah Swamp)

Testing was conducted on the inside face of the east parapet wall. The parapet wall exhibits minor map cracking in scattered locations around and on the curb, see Figures 3.25.

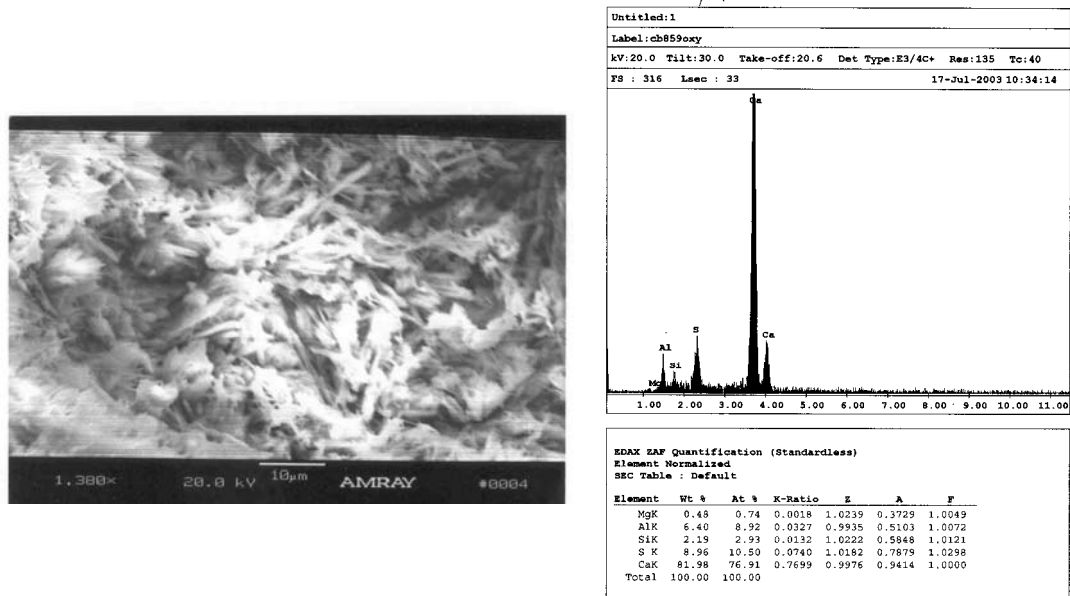
(a) Ettringite on the Surface

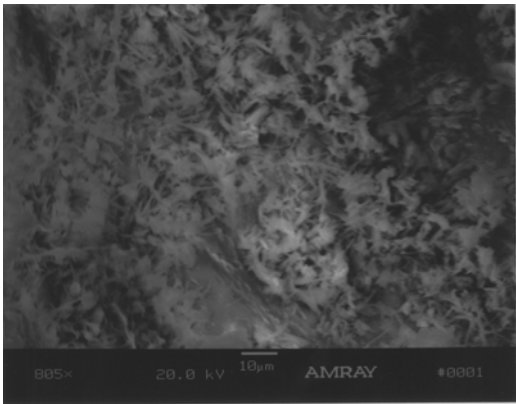
(a) Ettringite in Void

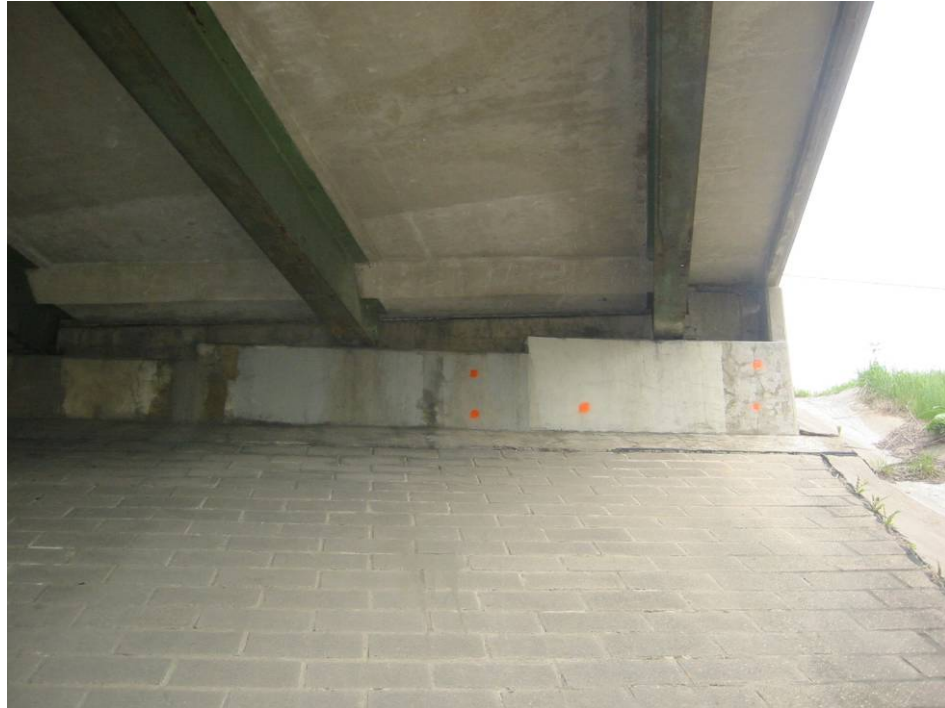
**Figure 6.34: Typical Localized Moist Map Cracking
(Cracking is on the Right Side of the Abutment)**

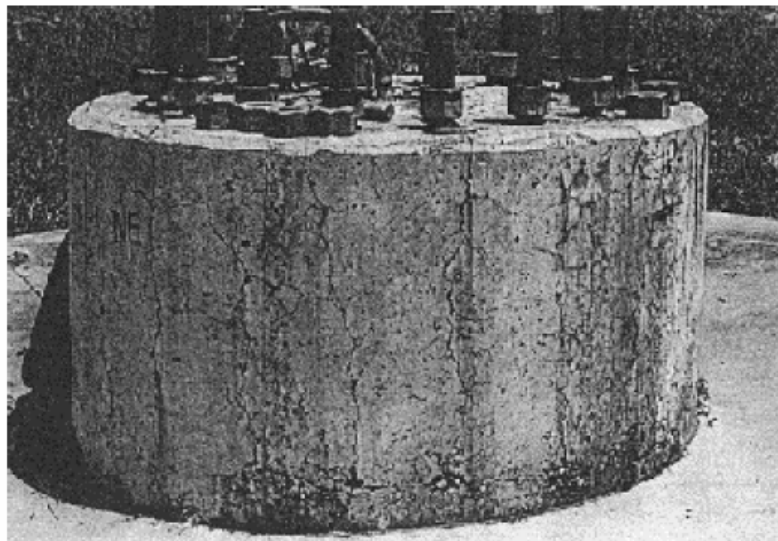
**Figure 7.2 - High Mast Pole Foundations with DEF Related Map Cracking
(Lawrence 1999)**
