# THE EFFECTS OF ENVIRONMENTAL STRESSES ON THE RELIABILITY OF FLEXIBLE AND STANDARD TERMINATION MULTILAYER CERAMIC CAPACITORS

Thesis submitted to the faculty of the Graduate School of the University of Maryland, College Park, in partial fulfillment of the requirements for the degree of Master of Science,

May 2009

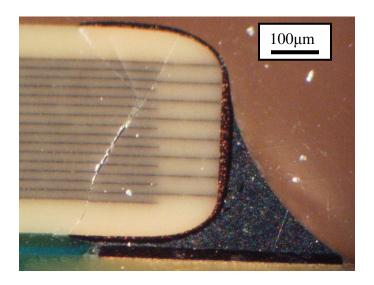
Flex cracks typically have the same origin. They start at the end of the termination on the board side of the capacitor and propagate up into the dielectric and electrode layers. Various factors, such as ceramic dielectric type, capacitor dimensions and the solder fillet shape can influence cracking of the capacitor. A photo of a flex crack is shown in Figure 3.

Figure 3: Flex crack in standard termination MLCC

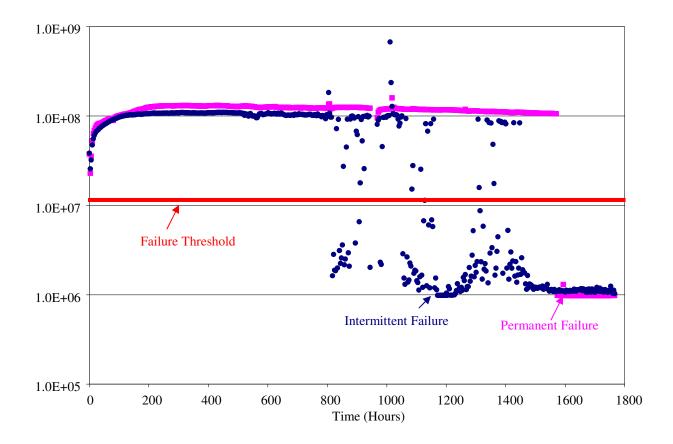
Throughout the testing there were some capacitors which experienced an intermittent failure, with a capacitor failing at one instance, but subsequently recovering. An example of a permanent and an intermittent failure for insulation resistance is shown in Figure 11. The behavior of insulation resistance for these capacitors is similar to that observed in the experiments reported by Nie et al [18] and Gu et al [19].

Figure 11: Examples of permanent and intermittent IR failures

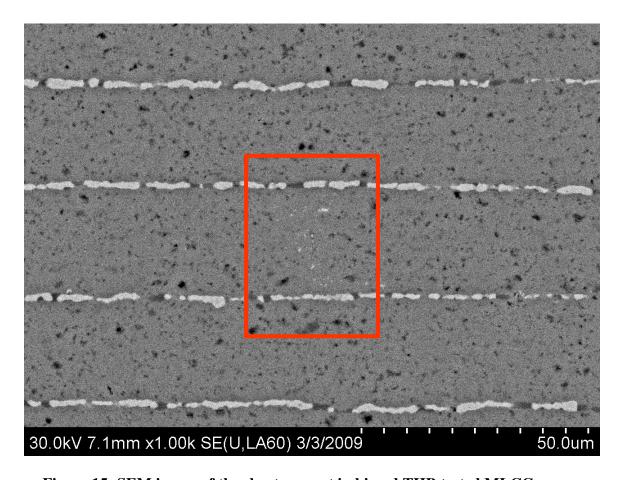
Scanning electron microscopy (SEM) was used to examine the area of the short. It was found that the short consisted of metal which had penetrated into voids present in the ceramic between the 2<sup>nd</sup> and 3<sup>rd</sup> electrodes from the bottom of the capacitor. This metal was only present in one area of the capacitor and was not found in any of the voids in the surroundings ceramic. A SEM image, showing the short (in the red box) and the surrounding dielectric with no metal in the voids, is shown in Figure 15.

Figure 15: SEM image of the short present in biased THB tested MLCC

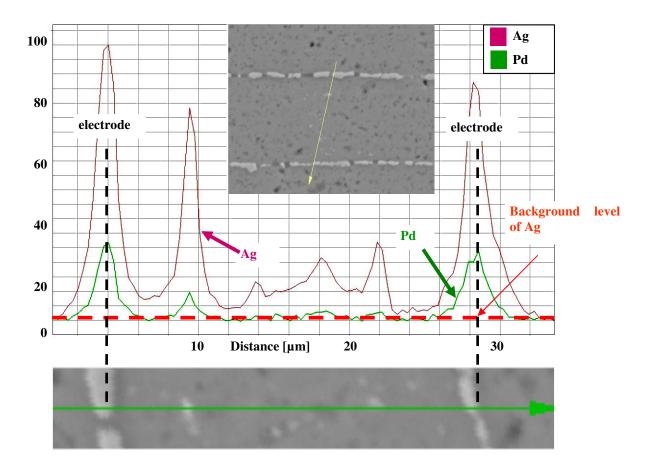
Energy dispersive spectroscopy (EDS) was used to determine the material compositions of the metallic shorts. It was found that the shorts were caused by a migration of silver and palladium into voids in the dielectric. Given that palladium was also present in the voids, the metal is therefore coming from the electrodes and not the end termination. A line scan demonstrating the elevated levels of silver and palladium between the electrodes is shown in Figure 16.

Figure 16: EDS line scan of metallic short

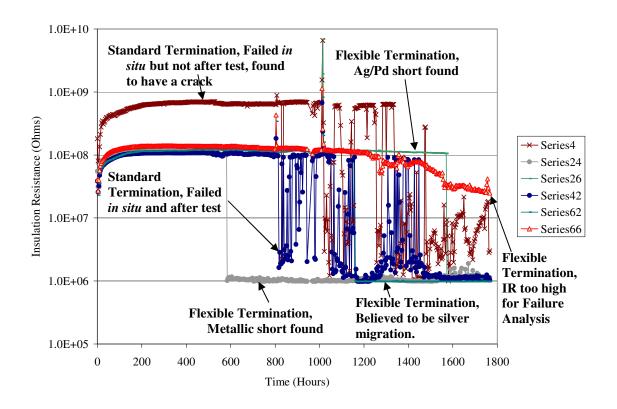
The standard termination capacitors experienced many intermittent failures with only one capacitor failing after removal from THB conditions. The standard termination MLCC which failed in situ but not after removal from THB conditions was found to have a crack present. It is believed that this crack allowed a path for moisture penetration which is the reason for the *in situ* failures. Once removed from THB conditions there was no longer moisture present in the crack and therefore there was not a conduction path. The failure mechanism of the other standard termination MLCC could not be determined since the resistance was too high for cross sectioning while monitoring resistance. It is believed that it is caused by silver and palladium migration, given that it also had a 50V bias applied. The capacitor also had a similar data trend with many intermittent failures, but the insulation resistance finally settling at 1 MOhm, the value of the series resistor. A graph showing the insulation resistance over time for the failed biased capacitors in the THB test can be found in Figure 17. It should be noted that the peaks occurring at approximately 800 and 1000 hours were due to chamber problems, and are not indicative of the true nature of the capacitors.

Figure 17: IR over time for the failed biased THB tested capacitors

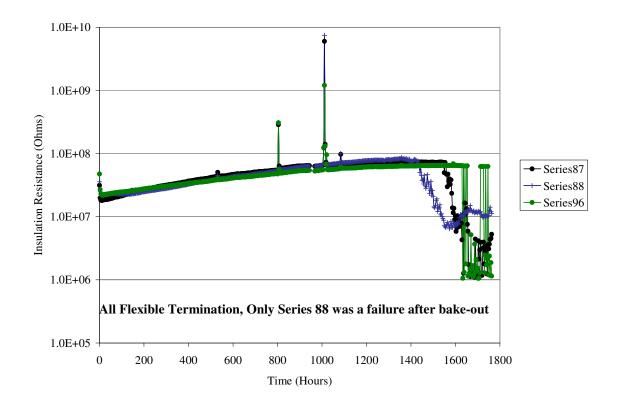
The failed unbiased MLCCs had a different trend from the biased MLCCs. Around 1400 hours in THB conditions the failed capacitors were found to start experiencing a slow degradation. The insulation resistance gradually dropped to and below the failure threshold. Only one capacitor ever reached the value of the series resistor (1 MOhm) and this was an intermittent failure. Only one of the failed unbiased capacitors was a failure after removal from the chambers. Due to the gradual reduction of insulation resistance, it is believed that there is a degradation of the ceramic dielectric occurring which is leading to failure of the MLCCs. Currently there is not a failure analysis method which can conclusively say degradation of the ceramic has occurred, therefore this is only speculation from the data trends. The IR over time for the three failed unbiased capacitors

is shown in Figure 18. It should be noted that the peaks occurring at approximately 800 and 1000 hours were due to chamber problems, and are not indicative of the true nature of the capacitors.

Figure 18: IR over time for the failed unbiased MLCCs in the THB test

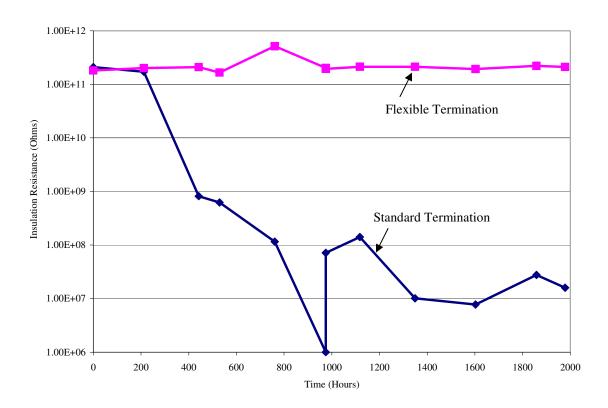
termination capacitors experiencing degradation and failing, while the flexible termination capacitors where not experiencing any changes. At completion of testing it was found that there were 18 MLCCs which failed at one or more instances which had a standard termination, compared with one failure in the flexible termination MLCCs. The flexible termination MLCC failed for dissipation factor and recovered on a subsequent measurement. An example of the degradation in insulation resistance for a standard and flexible termination MLCCs is shown in Figure 19.

Figure 19: Insulation resistance over time for a standard and flexible termination  ${\bf MLCC}$

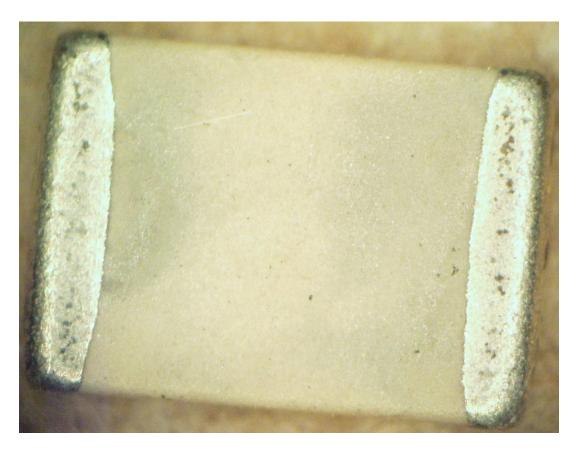
In testing it was noticed that the standard termination capacitors were experiencing a discoloration which was occurring in the dielectric around the end terminations. This discoloration can be seen in Figure 21.

Figure 21: Image of standard termination MLCC with staining present in the dielectric

In the standard termination capacitors the end termination is comprised of silver which is against the dielectric without a barrier layer. Unlike the flexible termination capacitors, the termination contains pure silver without any polymer. It is believed that the discoloration is due to a bulk diffusion of this silver from the end termination into the

dielectric of the capacitor. This silver is also believed to be the cause of the low insulation resistance in the standard termination capacitors.

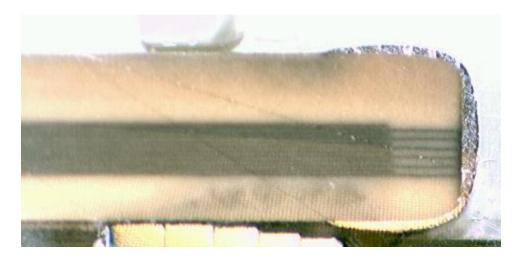
A cross section showed that the discoloration was also permeating into the dielectric in the area of the electrodes. An image of this cross section is shown in Figure 22.

Figure 22: Propagation of stain into the ceramic dielectric of a standard termination MLCC

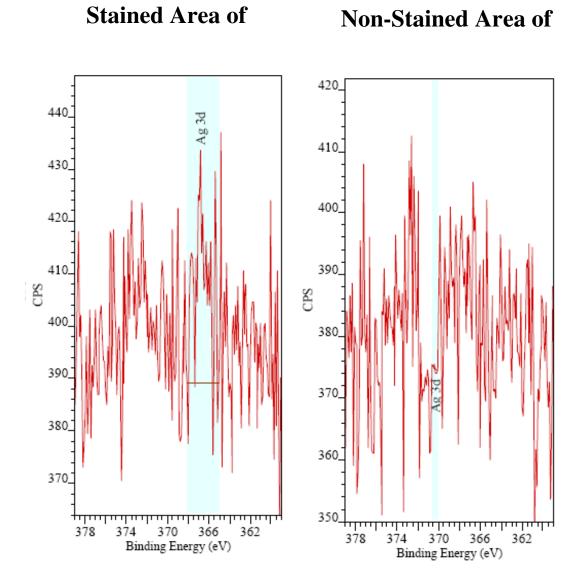
XPS was completed on the surface of the capacitor, and also in a region after extensive sputtering was completed on the surface of the MLCC. The discolored area was found to have silver which was not present in non-discolored areas. The differences between the amounts of silver were determined using a high resolution scan. These results are shown in Figure 23. Please note that the axes are not on the same scale (CPS = Counts per Second).

Figure 23: Silver amounts in stained and non-stained area of MLCC

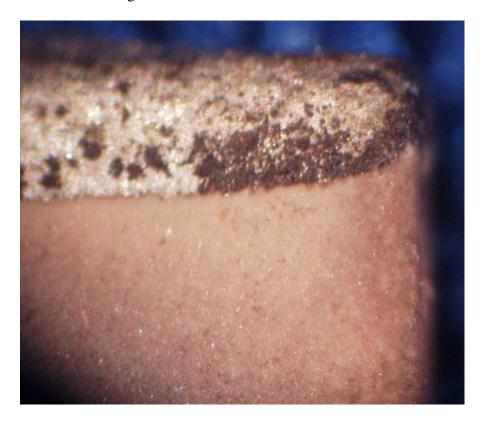
There was a growth appearing on the end terminations of the flexible termination capacitors which was not present on the standard termination capacitors. This growth was impeding measurement of the capacitor on the equipment and was not electrically conductive. An optical image of this growth can be seen in Figure 24, and a SEM image can be seen in Figure 25.

Figure 24: Optical image of growth on flexible terminations

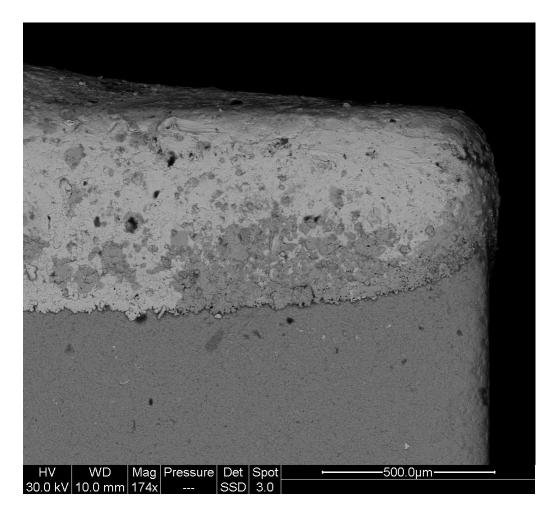
Figure 25: SEM image of growth on flexible terminations

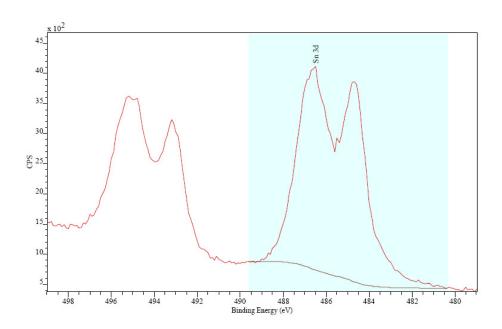
XPS was used to analyze the material and it was found to be caused by tin oxide. The metallization coating the standard and flexible terminations is the same, both nickel coated with tin, however this problem is solely on the flexible termination capacitors, which indicates that the silver filled polymer is having some effect on the tin coating of the end termination. The XPS results for an area without the oxidation (pure tin) are shown in Figure 26, while the results for the oxidized tin are shown in Figure 27.

Figure 27: XPS results for oxidized tin on the flexible terminations
