# Drainage Solutions

Institute of Applied Agriculture, University of Maryland

Prince George's County Department of Parks and Recreation

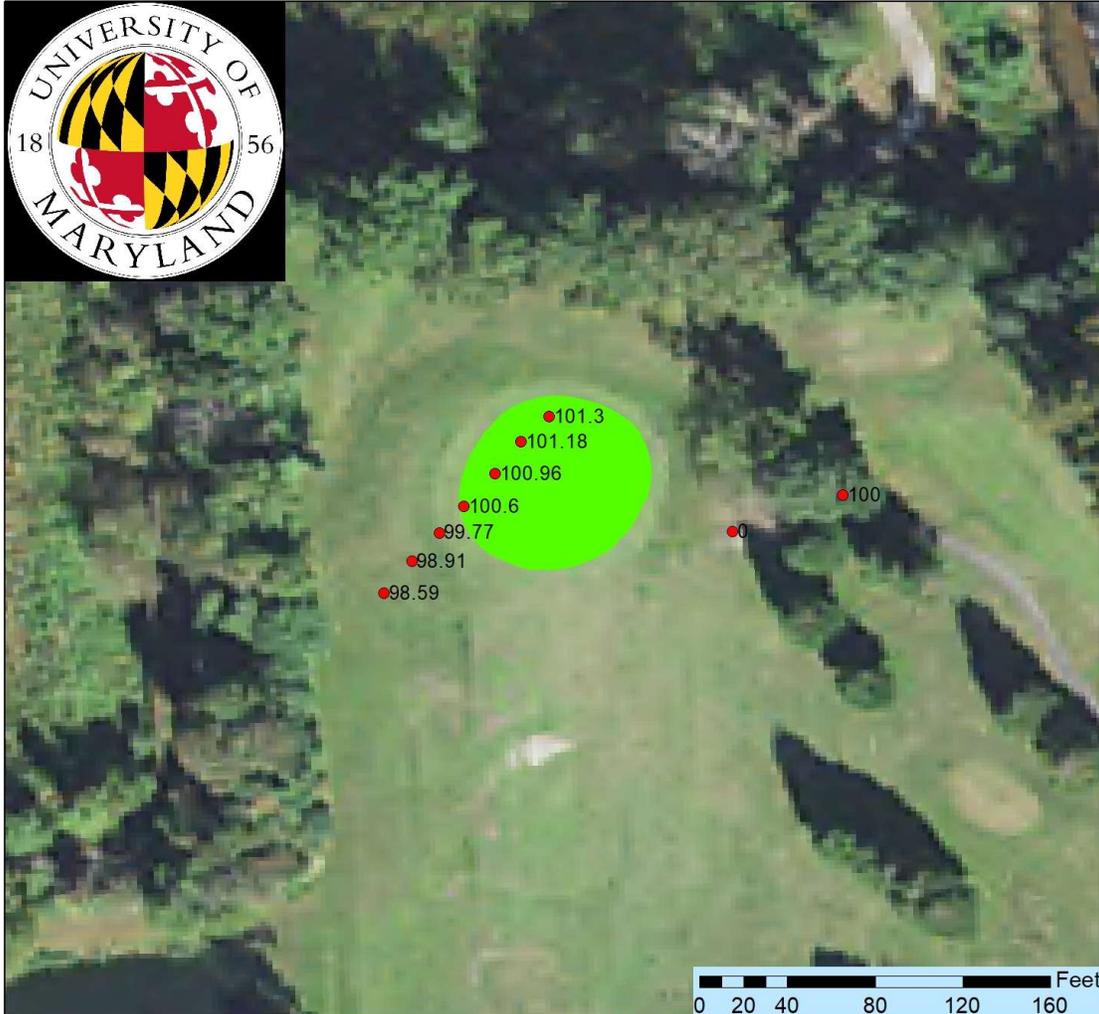
**Paint Branch: Number 3 Green**

Paint Branch Hole 3 Elevation and Slope				
1	2	3	4	5
				Elev
STA	BS	HI	FS	Profile
BM	3.28			100.00
		103.28		
0+00			1.98	101.30
0+18			2.10	101.18
0+36			2.32	100.96
0+54			2.68	100.60
0+72			3.51	99.77
0+90			4.37	98.91
1+08			4.69	98.59
BM			3.28	
Existing Slope		0.0251	3%

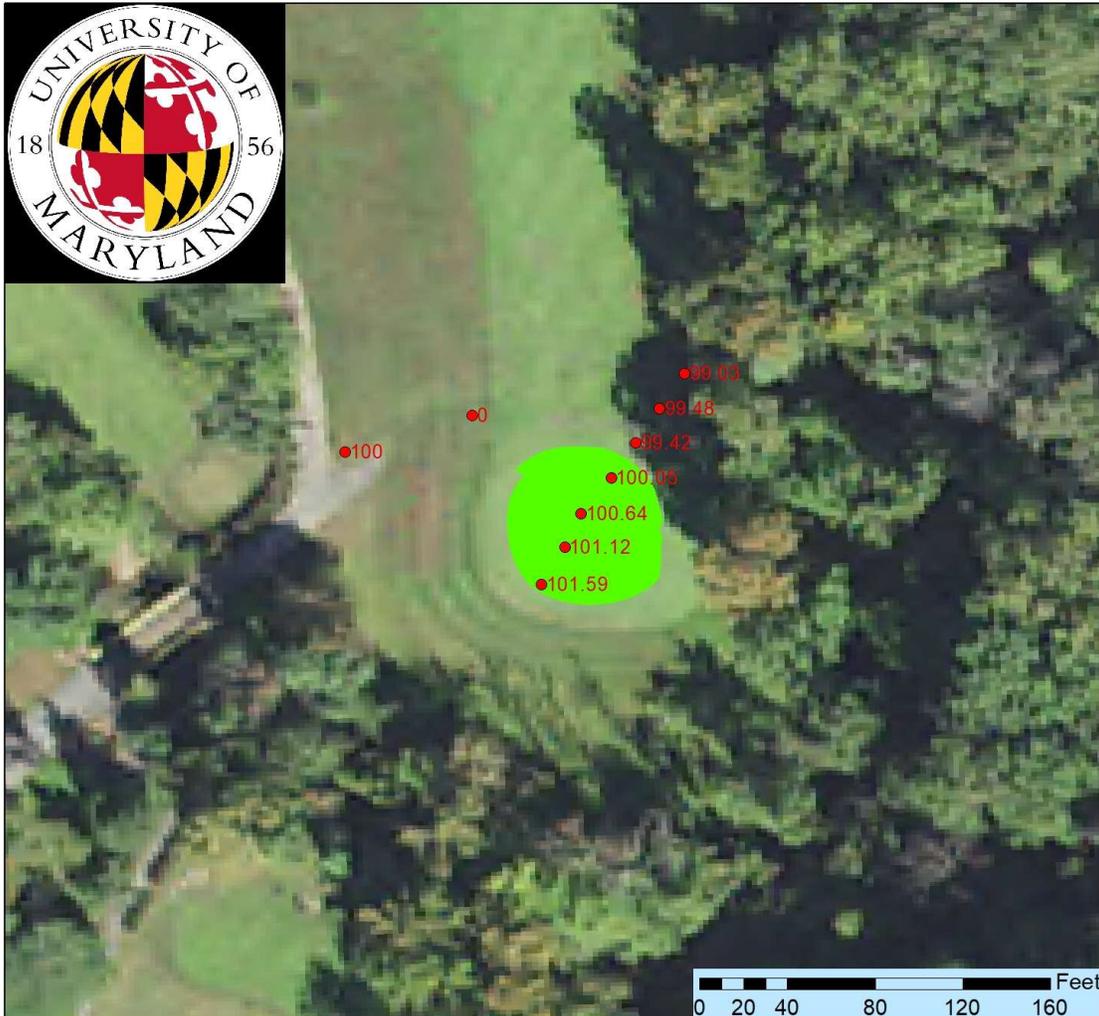
**Paint Branch: Number 6 Green**

Paint Branch Hole 6 Elevation and Slope				
1	2	3	4	5
				Elev
STA	BS	HI	FS	Profile
BM	4.43			100.00
		104.43		
0+00			2.84	101.59
0+18			3.31	101.12
0+36			3.79	100.64
0+54			4.38	100.05
0+72			5.01	99.42
0+90			4.95	99.48
1+08			5.40	99.03
BM			4.43	
Existing Slope		0.023704	2%

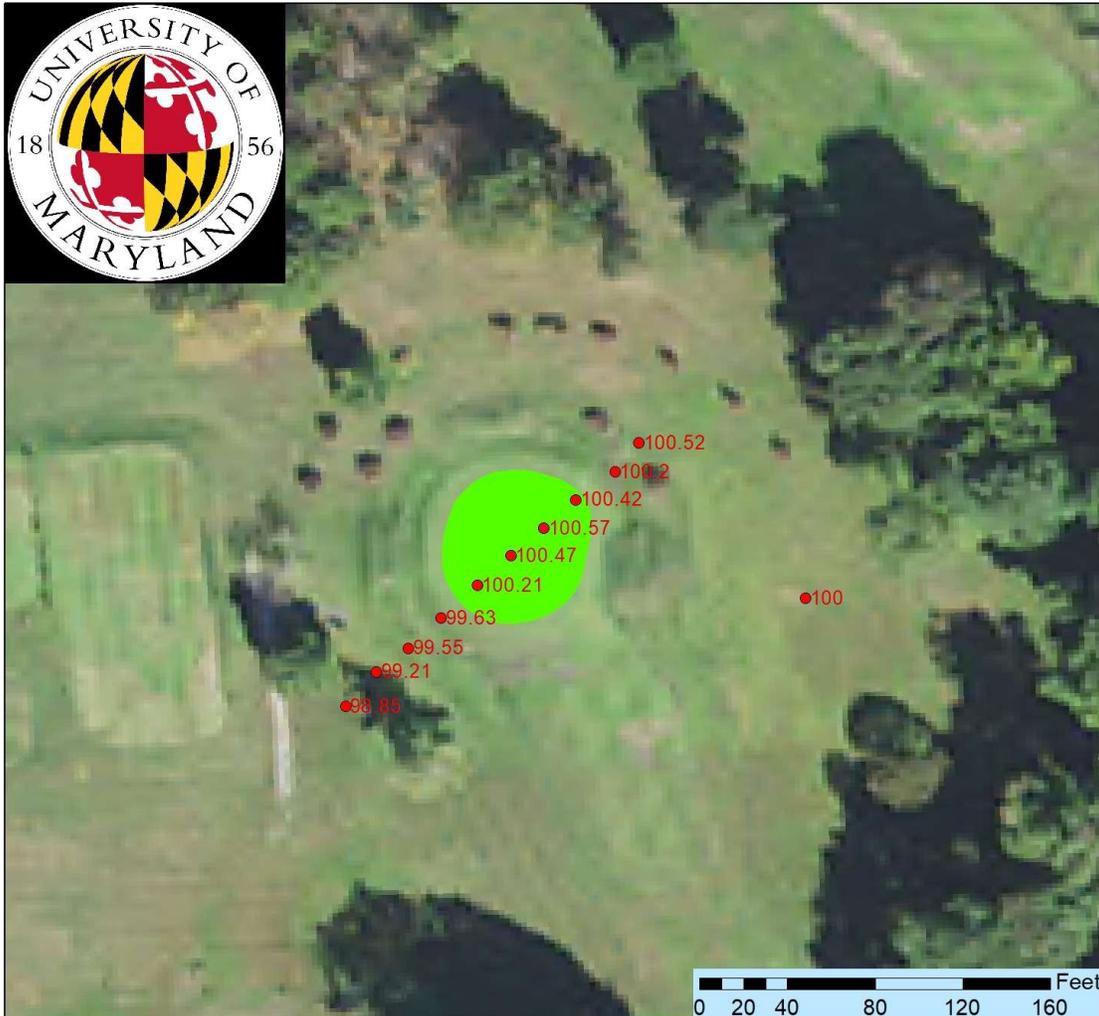
**Paint Branch: Number 8 Green**

Paint Branch Hole 8 Elevation and Slope				
1	2	3	4	5
				Elev
STA	BS	HI	FS	Profile
BM	4.32			100.00
		104.32		
0+00			3.80	100.52
0+18			4.12	100.20
0+36			3.90	100.42
0+54			3.75	100.57
0+72			3.85	100.47
0+90			4.11	100.21
1+08			4.69	99.63
1+26			4.77	99.55
1+44			5.11	99.21
1+62			5.47	98.85
BM			4.32	
Existing Slope		0.01031	1%
