Title of Document: HISTORIC STRUCTURE INVESTIGATION:
THE COLLINS HOUSE, BLOOMFIELD,
NEW JERSEY

Francesca Evans, Master of Historic
Preservation, 2022

The Collins House in the Township of Bloomfield, New Jersey, is in the process of being rehabilitated with the intent for the building to become one of the visitor centers along the state-wide Morris Canal Greenway. Despite the building's National Register Nomination form and a cultural resources survey carried out in 1982, there is a lack of detailed documentation of the Collins House to guide future interpretation of the site and ensure that character defining features are preserved and retained.

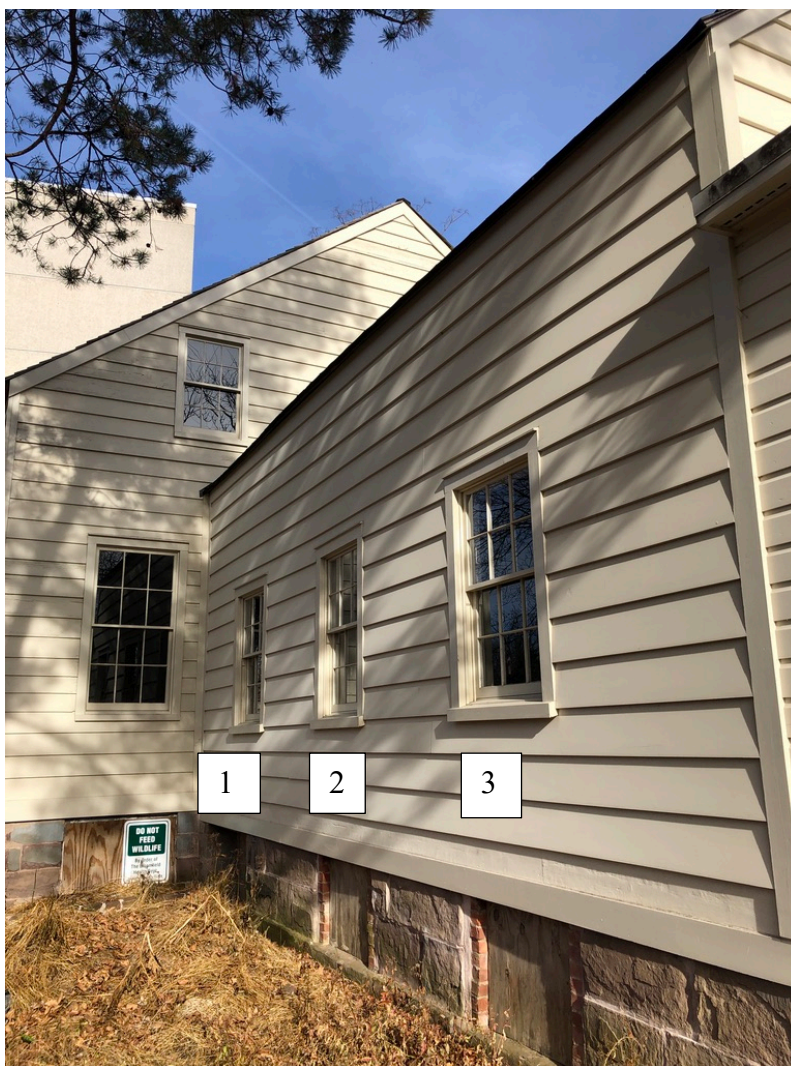
Figure 21. West elevation of Phase One. The numbers under each window represent in which bay that opening is located. This report argues that the original entry was in the first bay shown in the far left of the image. (Source: Francesca Evans, 2022).

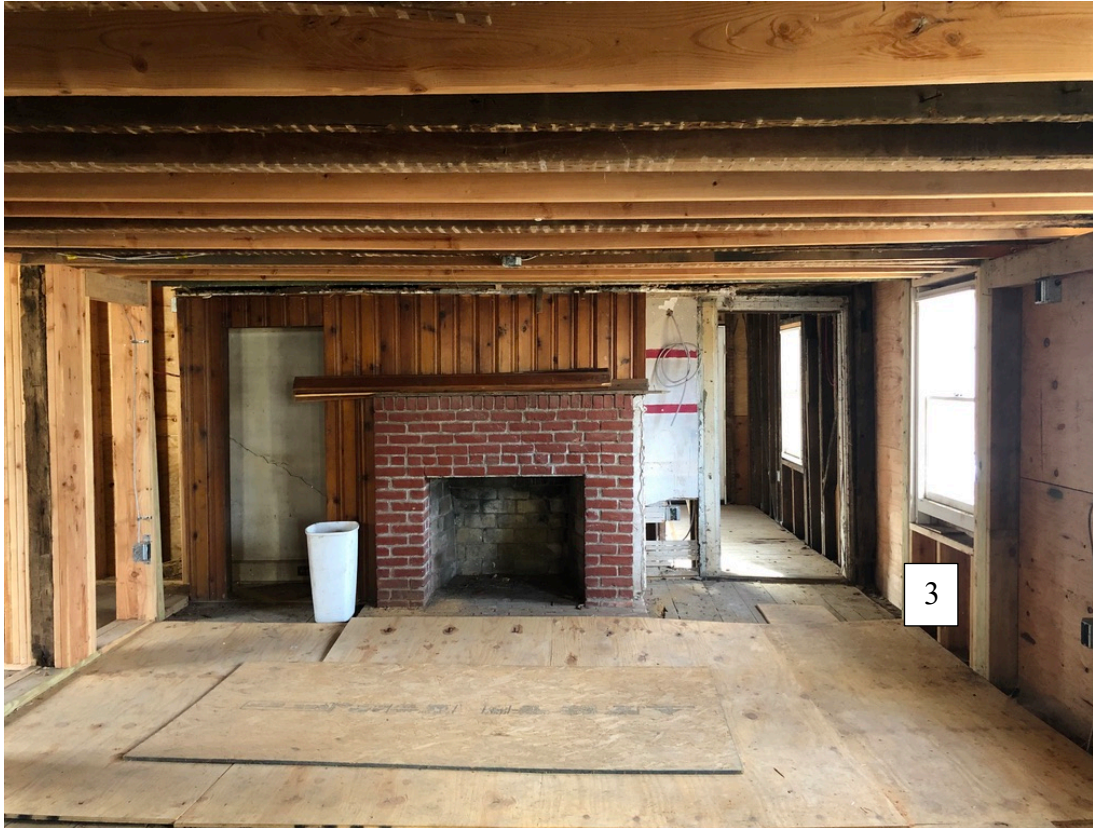
Figure 22. Phase One facing south. The National Register nomination posits that the original entry was in the third bay, labeled in the above image. However, its proximity to the main heat source of the room would make bay three an odd place for an entry door.

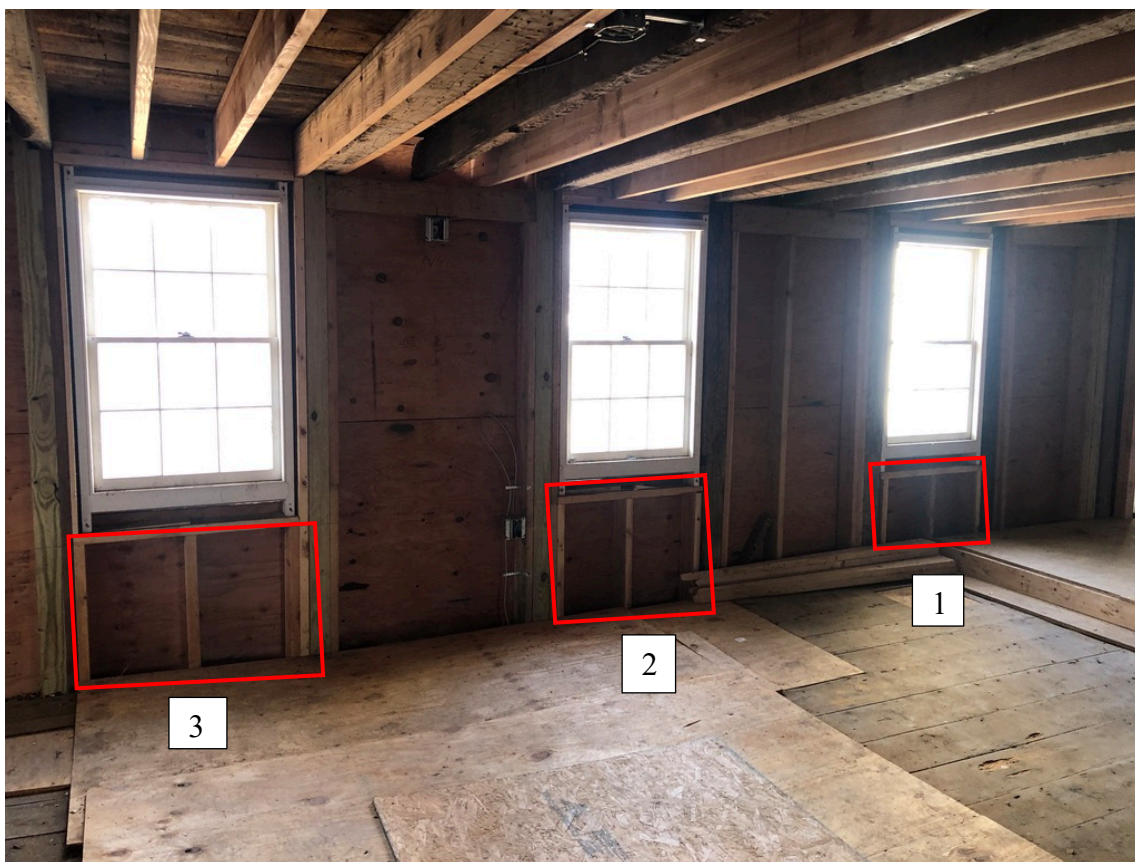
Figure 23. Facing West: Anchor-bents and additional structural supports from the stabilization of the building. Prior to the rehabilitation, nogging was found in bays one and two while none was found in bay three, leading the National Register nomination authors to suggest that bay three contained the original entry. (Source: Francesca Evans, 2022)

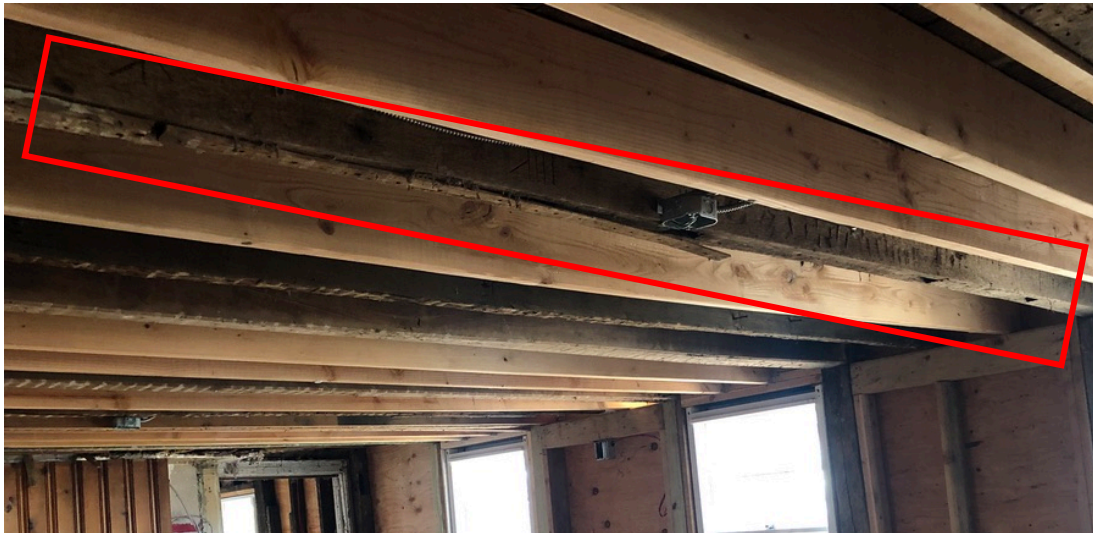
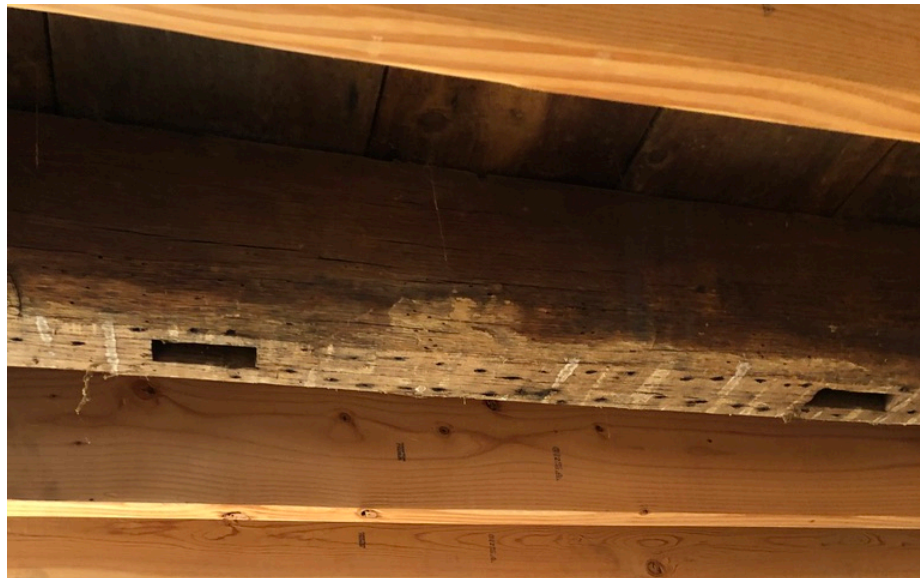
Figure 24. The top image depicts the beam with empty mortises (several of which are obscured by an old strip of lath) outlined in red. The lower image is a close-up of two of the five empty mortises located across the length of the beam. (Source: Francesca Evans, 2022)

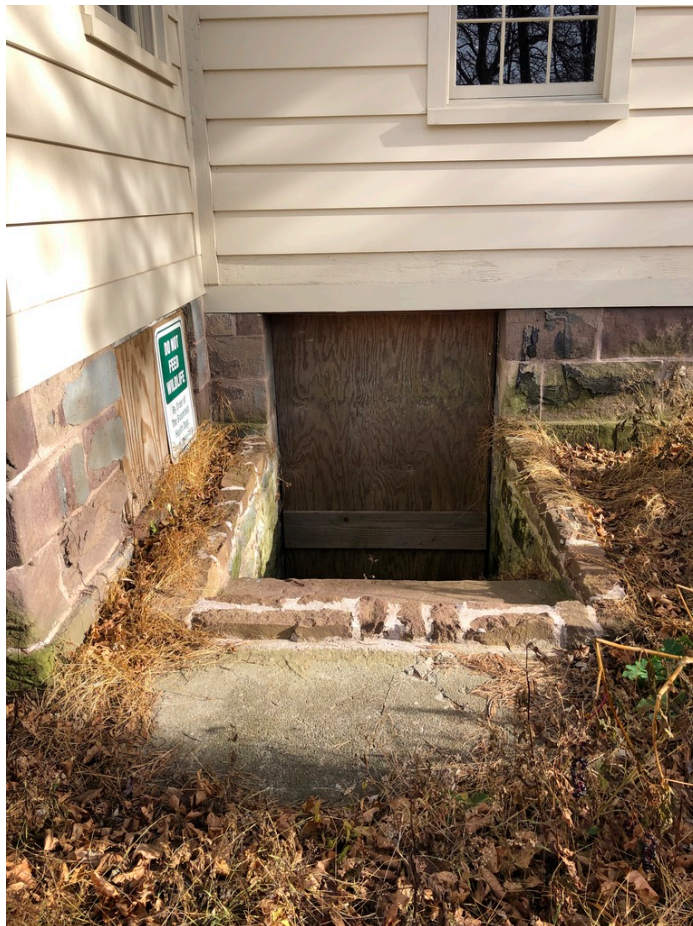
Figure 26. Bulkhead leading to the cellar of the original dwelling located in the first bay of the west façade. Note how it is unaligned with the first story window. (Source: Francesca Evans, 2022)

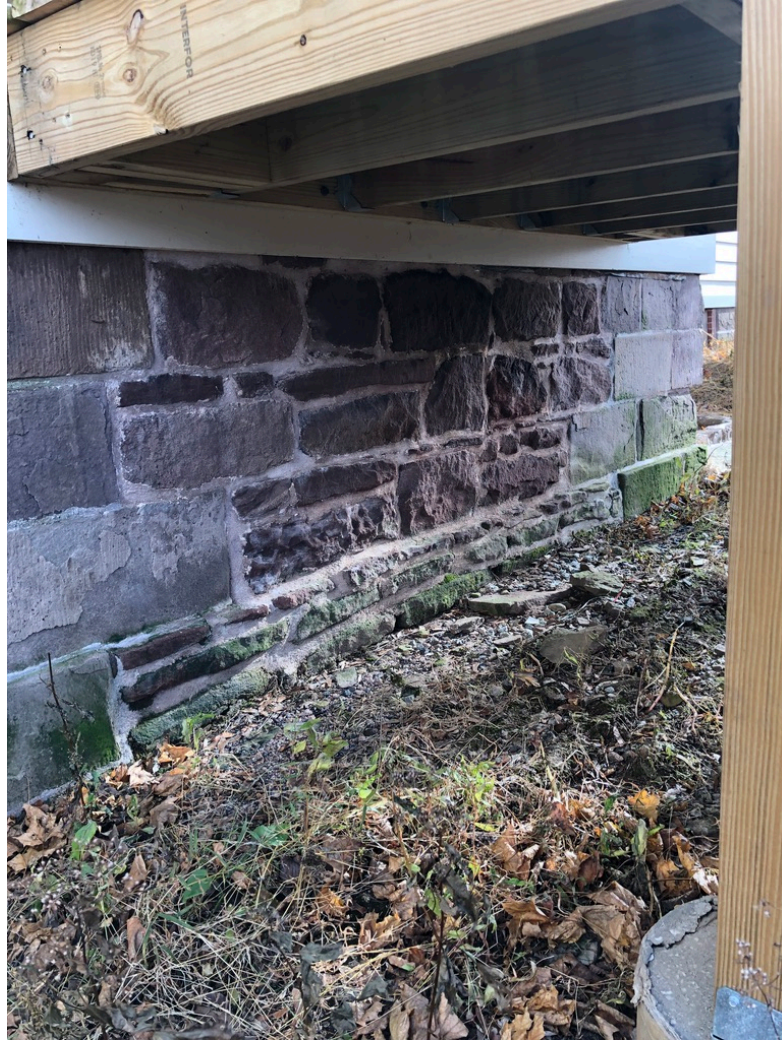
Figure 34. Evidence in the foundation of the location and size of the original front step when this section of the house was constructed. (Source: Francesca Evans, 2022)

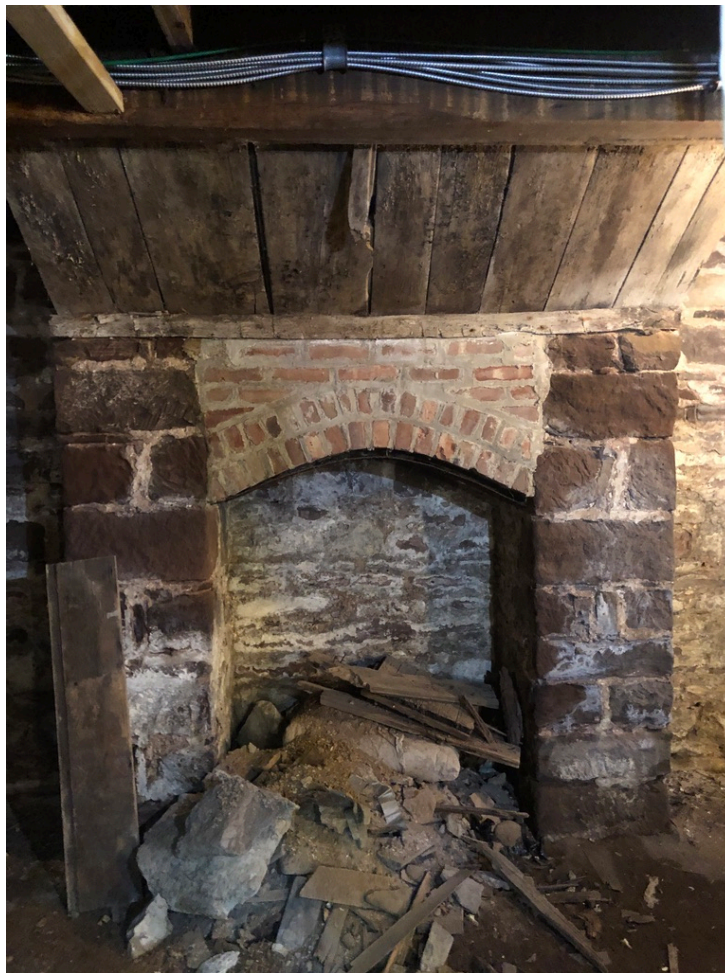
Figure 35. Lower supports for the fireplace in the west parlor. Note the brick segmental arch which was added later. (Source: Francesca Evans, 2022)

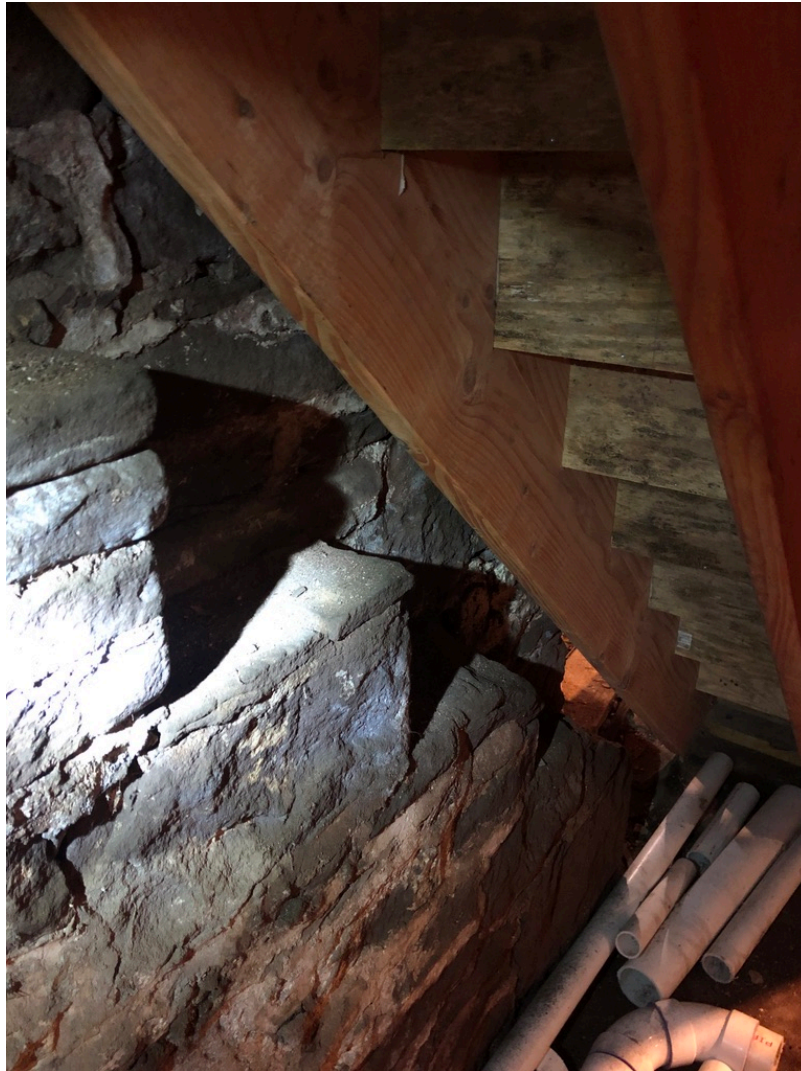
Figure 36. This stepped ledge in the southern wall of the Phase Two cellar indicates where an earlier staircase was located. (Source: Francesca Evans, 2022)

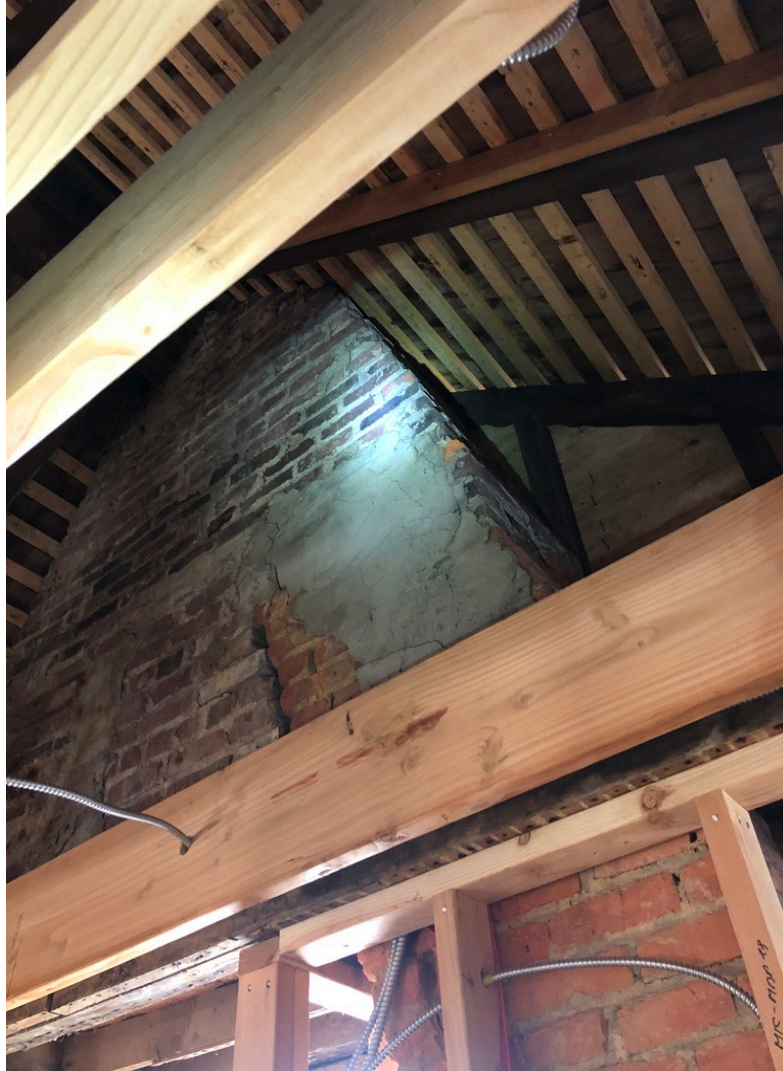
Figure 40. Evidence of repairs made to the double chimney. (Source: Francesca Evans, 2022)

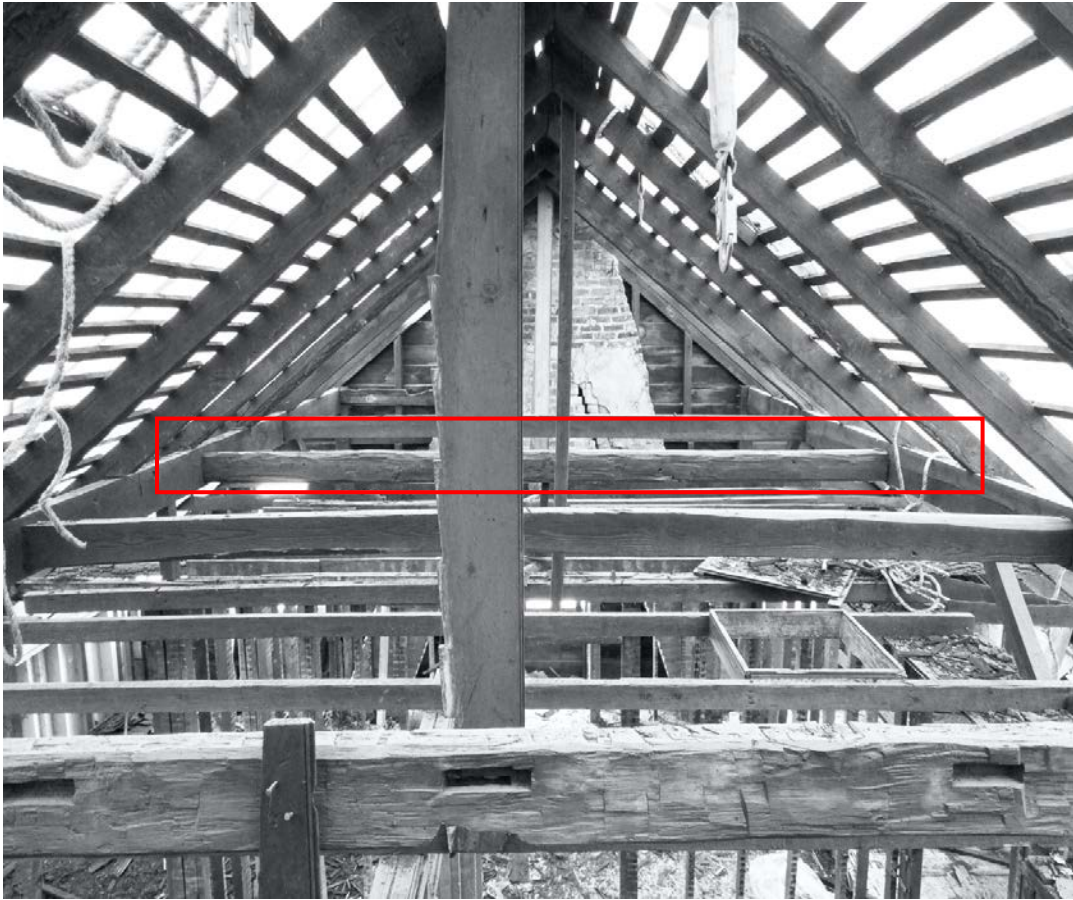
Figure 41. Empty mortises in the collar beam in the southern end of the attic. The other hand-hewn beam in the north end (outlined in red) also has empty mortises on the side and bottom of the beam. (Source: Rich Rockwell)

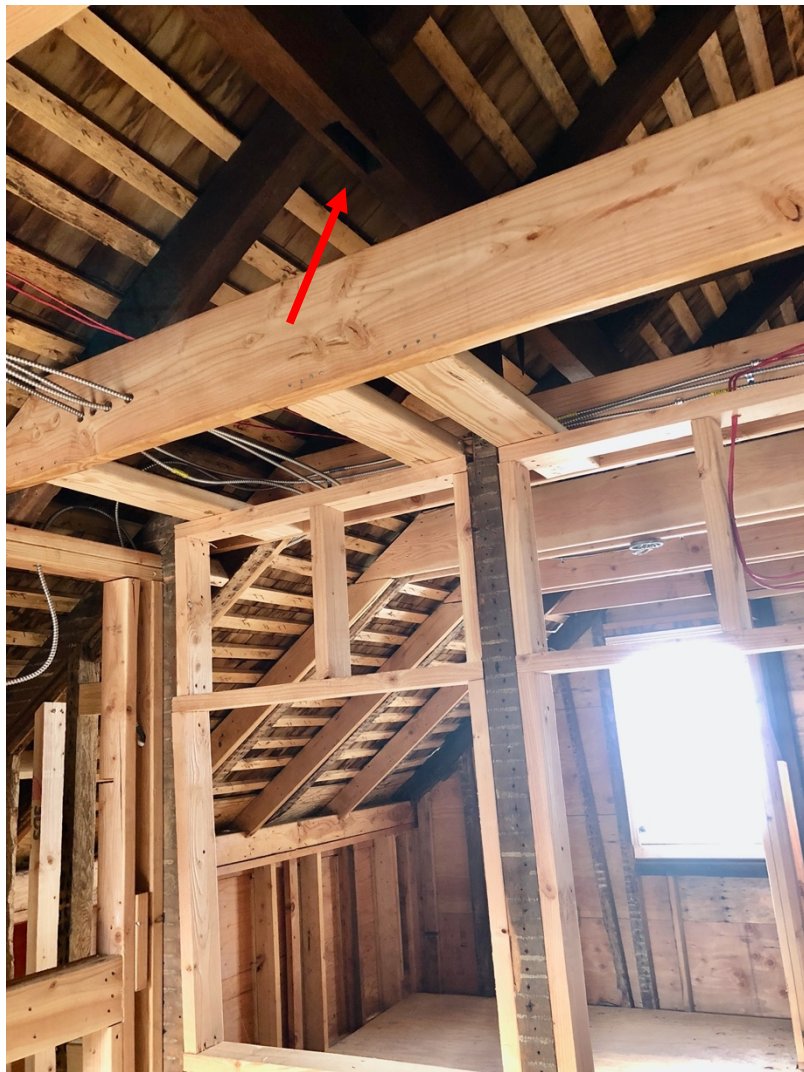
Figure 42. One of three empty mortises in the purlin on the west side of the roof. The post, reinforced on either side by new lumber, is mortised into the purlin, providing evidence that similar posts would have been in the three empty mortises, effectively dividing the half-story space. (Source: Francesca Evans, 2022)

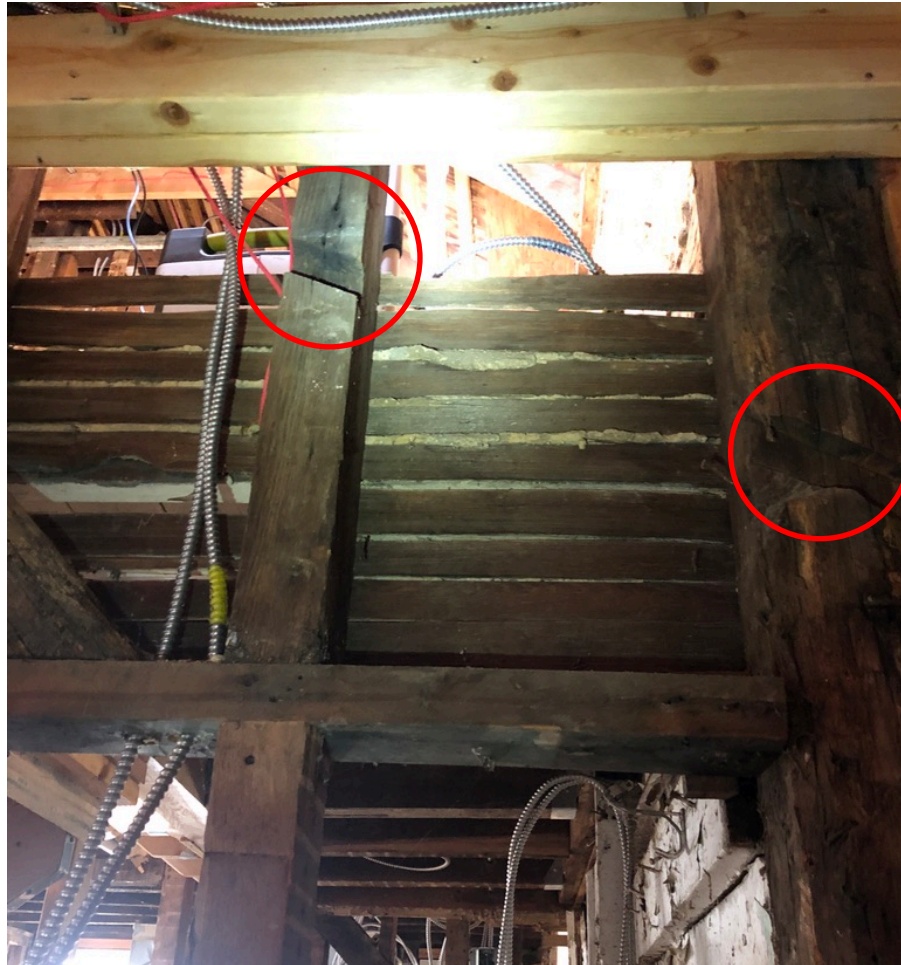
Figure 53. Evidence of a no longer extant “let-in” brace in the Phase Four addition appended to the original dwelling, which provides physical evidence that this section was constructed using balloon framing techniques. (Source: Francesca Evans, 2022)

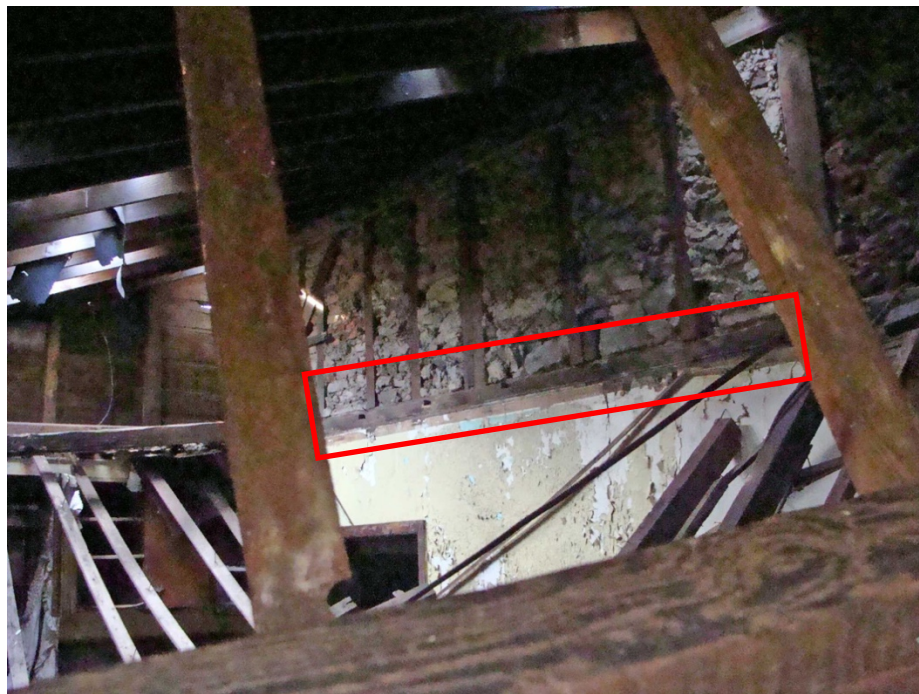
Figure 55. Image taken prior to any stabilization or rehabilitation efforts. Note the plastered wall, pockets in the ledger board (in red), and extant ceiling joists in place (in the far left of the photograph) and those resting on the wall. (Source: Rich Rockwell)

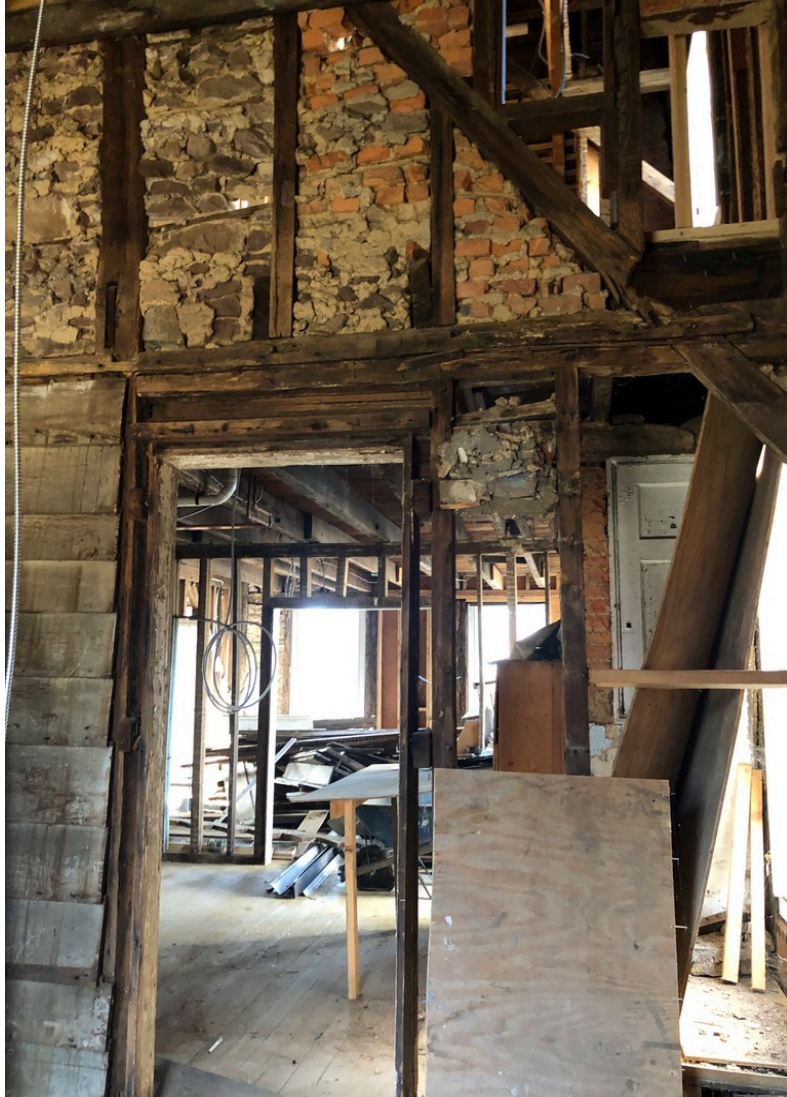
Figure 56. Doorway leading into the Phase Two addition from the Phase Four addition. This doorway was once a window, prior to the construction of the Phase Four addition. A floor plan in the 1982 cultural resources survey shows no opening in this location, while the 2015 National Register nomination does show an opening here (although there is no indication that it is a doorway). It is unclear when the window was converted into a doorway—it could have been before the wall was plastered over or sometime after the cultural resources survey was completed in 1982. (Source: Francesca Evans, 2022)
