Title of Final Project: JOHN TYLER'S WOOD BURN:  
A PRESERVATION PLAN

William Valentine White IV, Master of Historic  
Preservation, 2023.

JOHN TYLER'S WOODBURN: A PRESERVATION PLAN

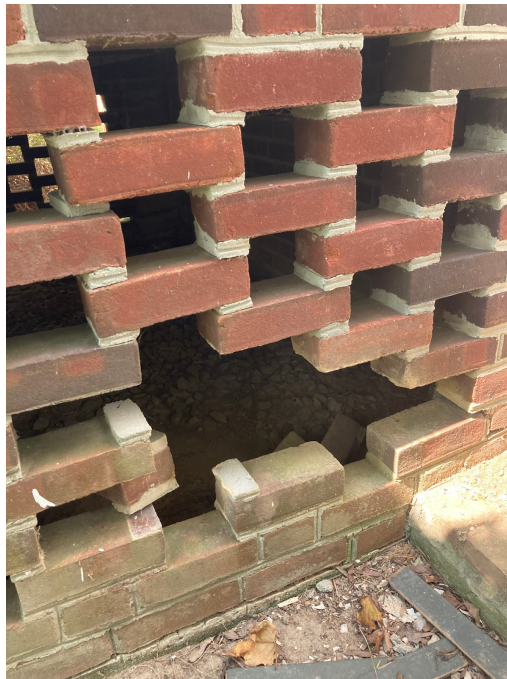
Figure 4.9. Damaged brick latticework on front porch  
(Photos by author, 2022).

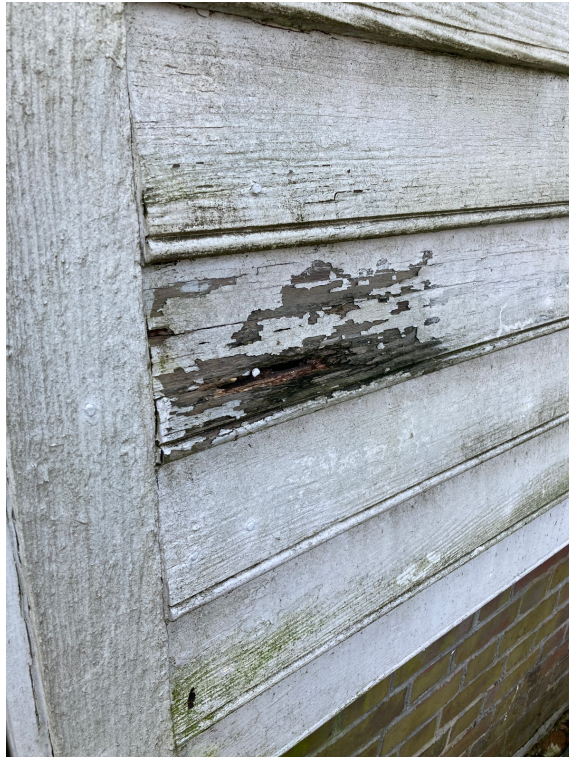
Figure 4.10 - Damage on weatherboarding  
(Photo by author, 2022).

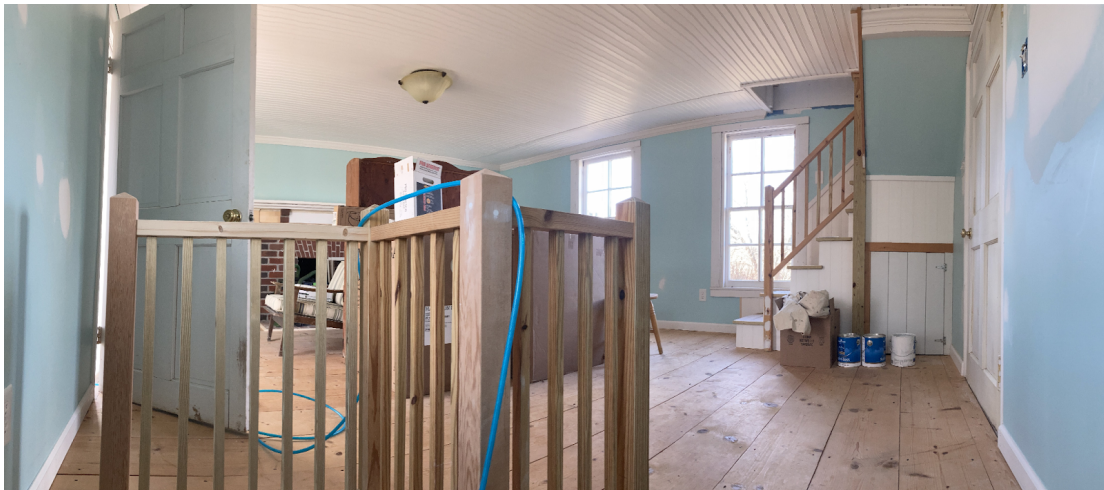
Figure 4.13. Kitchen Remodeling  
(Photo by author, 2022).
