Title of Document: EVALUATION OF SKEWED SIMPLE SPAN
TRANSVERSELY POST-TENSIONED
ADJACENT PRECAST CONCRETE SLAB
BRIDGES

Timothy Levi Briner, Master of Science in Civil
Engineering, 2012

Thesis submitted to the Faculty of the Graduate School of the
University of Maryland, College Park, in partial fulfillment
of the requirements for the degree of
Master of Science
2012

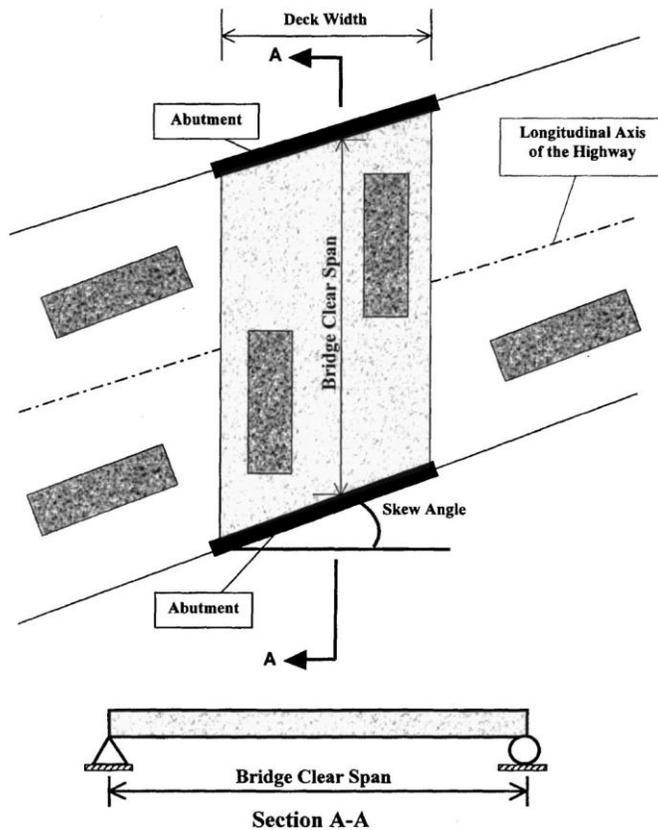
Figure 1-1: Description of a Skew Angle Using a Skewed Bridge over a Highway (Menassa et al., 2007).

Non-skewed bridges, also known as straight, normal, or right bridges, are built with the longitudinal axis of the roadway normal to the abutment. Similar to the AASHTO LRFD Bridge Design Specifications (2012), the skew angle of a bridge is defined as the angle between the longitudinal axis of the bridge and the normal to the abutment, or equivalently as the angle between the abutment and the normal to the longitudinal axis of the bridge as shown in Figure 1-1. With such a definition, a non-skewed bridge has a skew angle of 0° . Skewed bridges are often built due to geometric restrictions, such as obstacles, complex intersections, rough terrain, or space limitations (Huang et al., 2004, and Menassa et al., 2007).

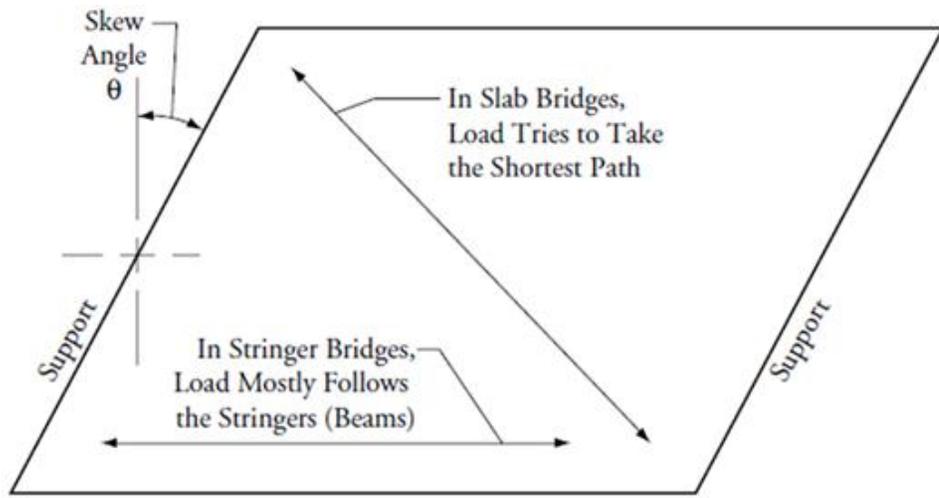
Figure 1-2: Load Path on a Skewed Bridge (Precast/Prestressed Concrete Institute, 2003).

than traveling along the longitudinal girders (see Figure 1-2) which reduces the longitudinal bending moments but increases the shear in the obtuse corners (Precast/Prestressed Concrete Institute, 2003).

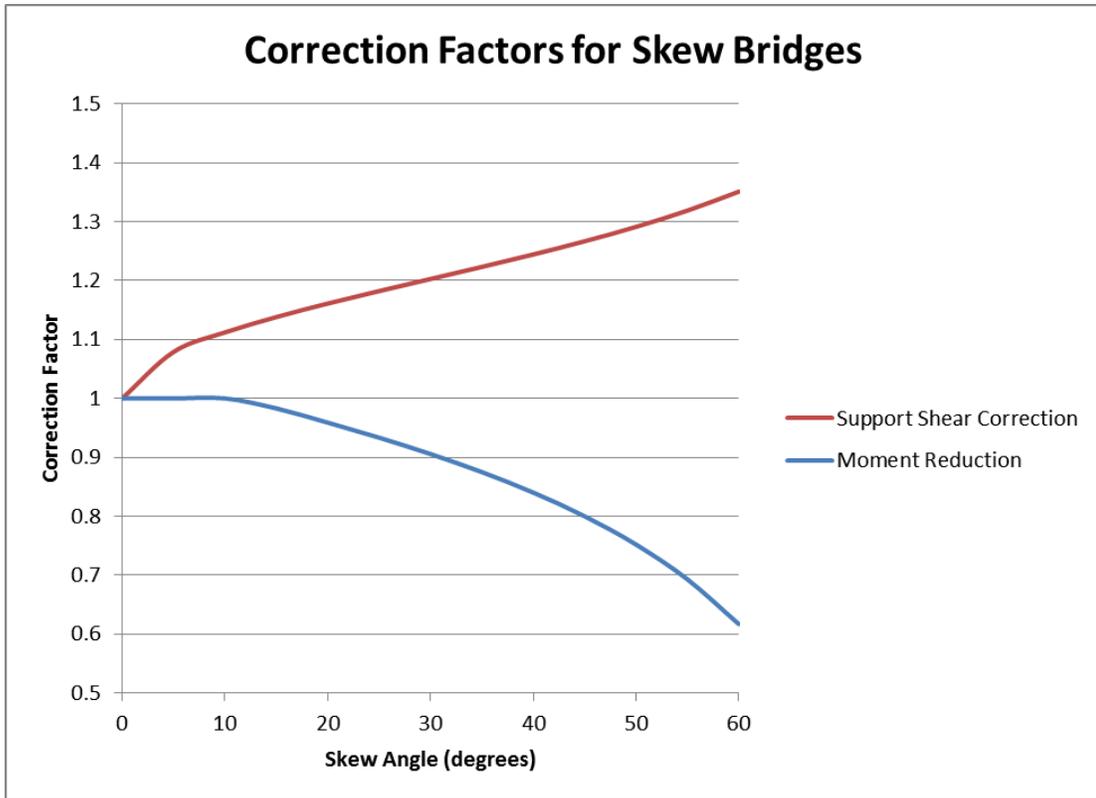
Figure 1-3: Corrections for Load Distribution Factors for Concrete Box Beams Used in Multi-Beam Bridges on Skewed Supports Based on $L = 40$ ft. and $d = 20$ in.

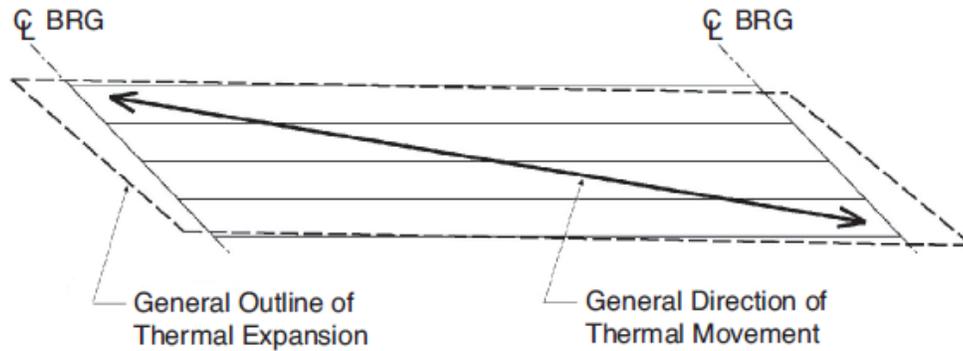
Figure 1-4: General Effect of Thermal Expansion on a Skewed Bridge (CL BRG = Centerline Bearing) (Coletti et al., 2011).

bridges. This causes the thermal movement of a skewed bridge to be asymmetrical, with the movement centered on a line between the acute corners of the skewed bridge as shown in Figure 1-4 (Coletti et al., 2011). Similar effects occur due to thermal contraction and shrinkage of the concrete (Precast/Prestressed Concrete Institute, 2003).

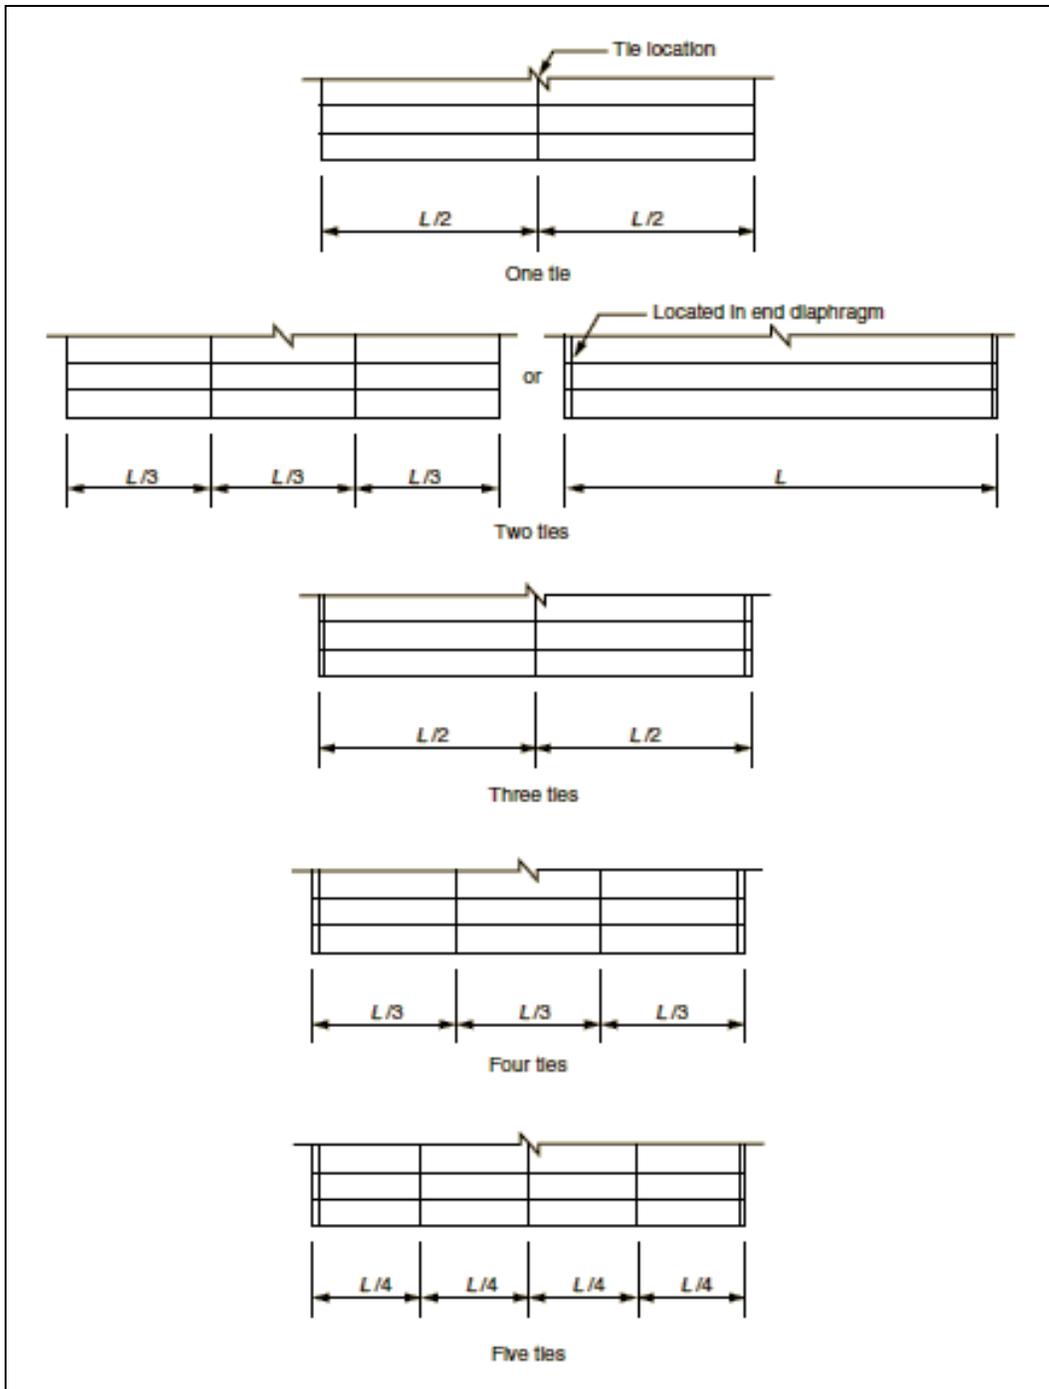
Figure 2-1: Common Transverse Post-Tensioning Tendon Locations Based on the Number of Ties (Russell, 2011). (Note: L = Length of Span)

As with the other transverse tendon specifications, the number and location of the tendons also varies from state to state. States require anywhere from one to ten transverse post-tensioning tendons with between two and four being most common. The tendons can be arranged in a variety of ways that include a regular discretization of the bridge span (i.e. locating tendons at the midspan, third points, quarter points, etc.) or specified distances (i.e. eleven feet apart). Figure 2-1 shows common ways to locate tendons depending on the number of tendons being used.

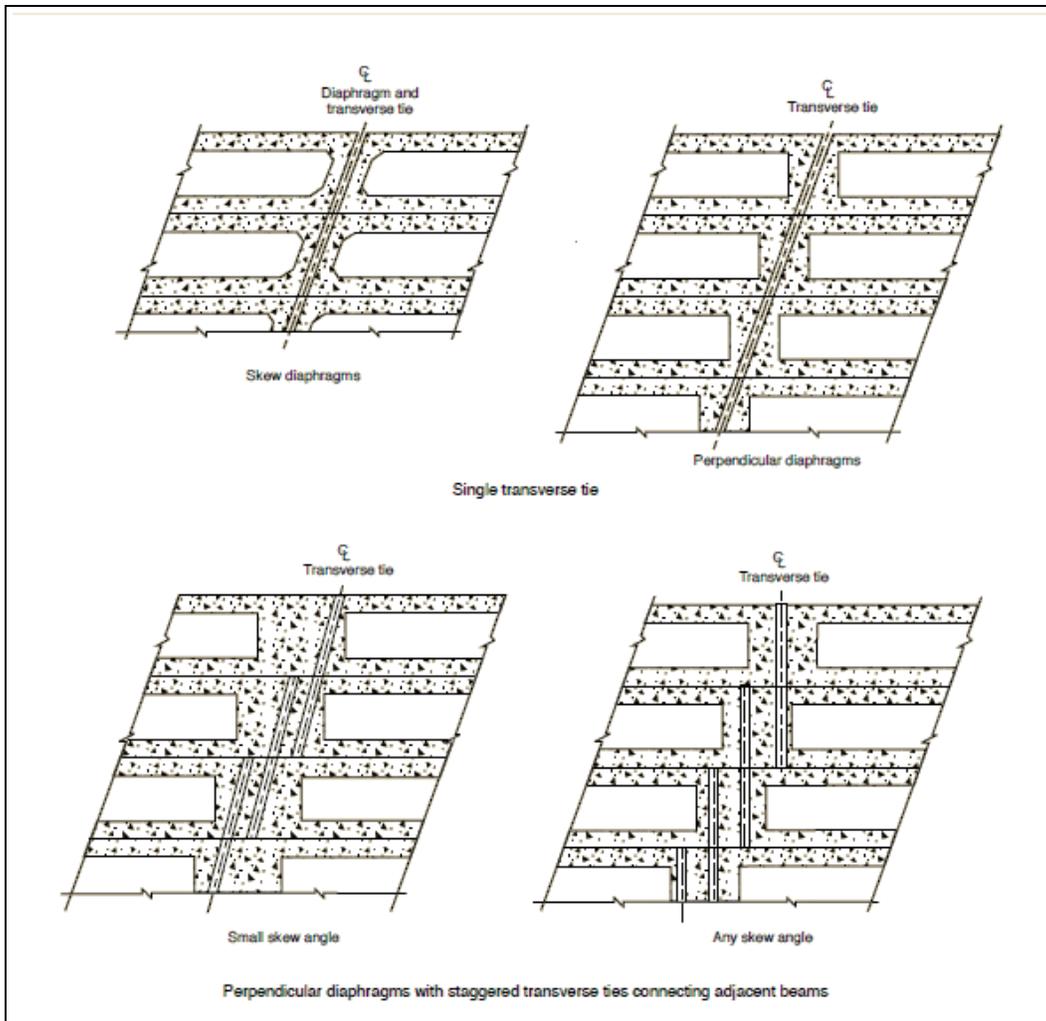
Figure 2-2: Transverse Tendon Orientation and Diaphragm Construction Possibilities (Russell, 2011).

The transverse tendons will transfer the applied loads to the connected concrete beams in different ways depending on their orientation. The tendons can either remain normal to the beams and staggered throughout the cross-section of a skewed bridge, or they can be placed parallel to the bridge's skew angle. A staggered orientation is often easier to install but it connects the beams at different relative distances along the beams. Though more difficult to install, tendons with a skewed orientation connect the beams at their same relative points thus making the bridge deformation behave more similarly to a normal bridge. Figure 2-2 shows the possible transverse tendon orientations and the corresponding possible diaphragm construction possibilities for box beams or voided slabs.

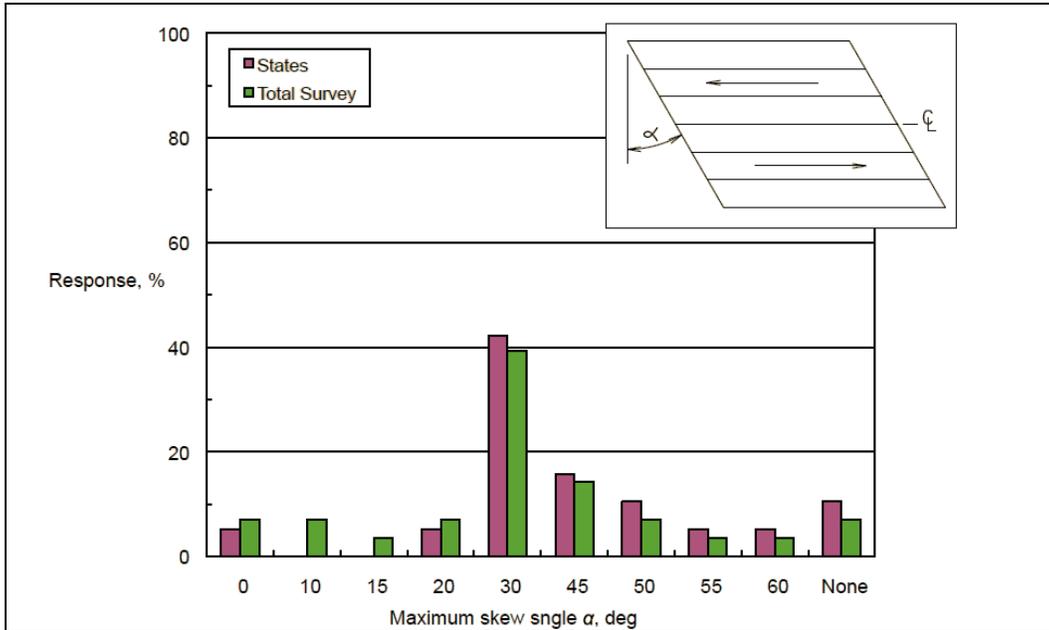
Figure 2-3: Alternate Survey Results for Maximum Skew Angle Specification (Russell, 2011).

30°. Again, there is a wide variation in different states' practices as confirmed by a similar survey's findings shown in Figure 2-3. A summary of the skew specifications survey is shown in Table 2-1.

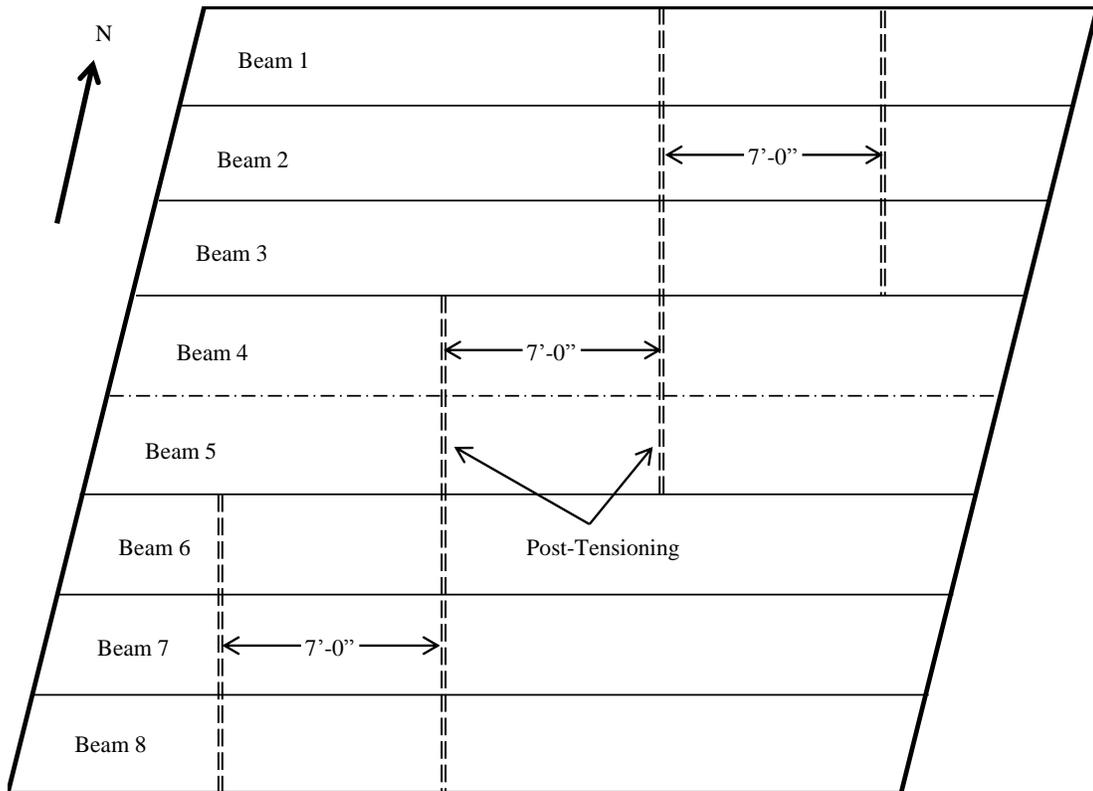
Figure 3-1: Locations of the Post-Tensioning Tie-Rods on the Knoxville Bridge.

The slabs were transversely post-tensioned using four 1" diameter tie rods tensioned to 80 kips. The tie rods were staggered and placed normal to the beams in 2.5" diameter holes precast in the slabs. Two tie rods were placed at approximately the third-points of the bridge 7' apart, each integrating five beams (one integrating beams one through five; the other integrating beams four through eight). Two more tie rods were placed 7' from the third-point tie rods towards the acute corners of the bridge, each integrating three beams (one integrating beams one through three; the other integrating beams six through eight). See Figure 3-1 for a schematic of the post-tensioning placement.

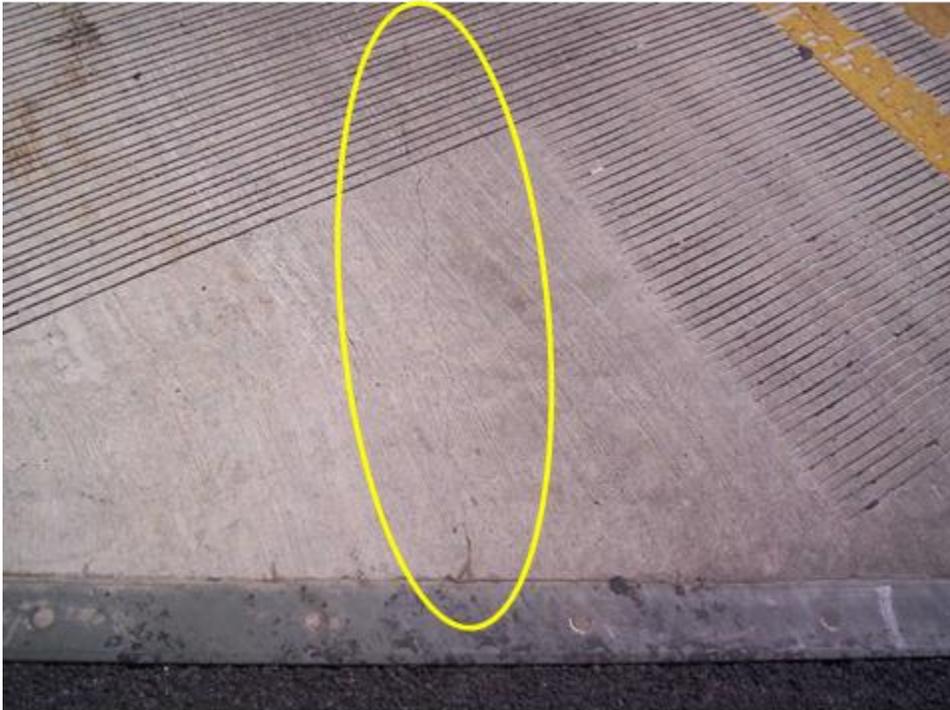
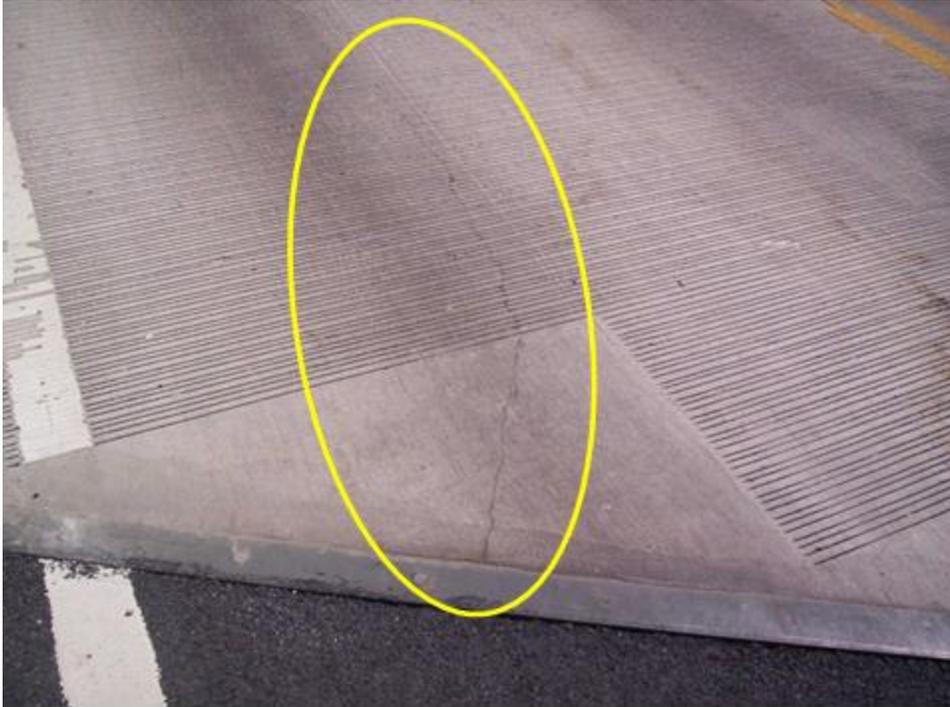
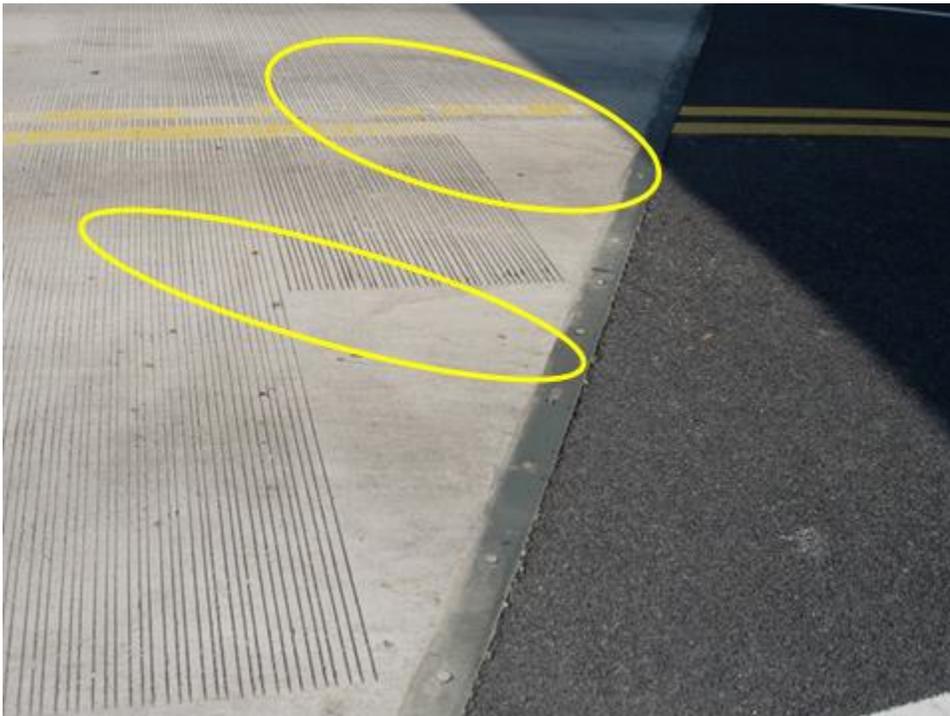
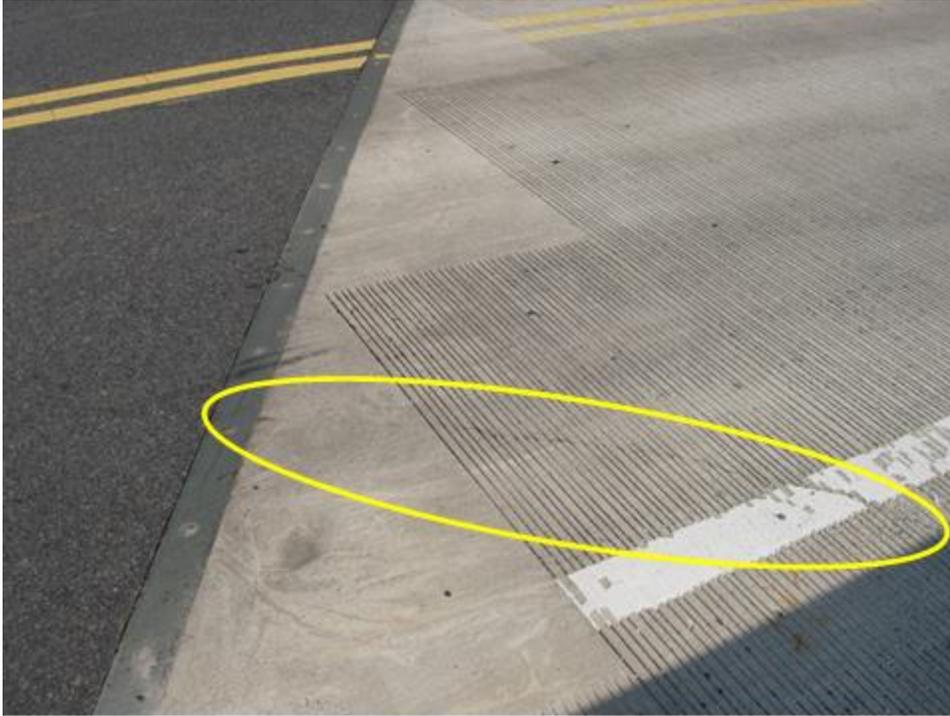
Figure 3-2: Longitudinal Crack on the Top Surface of the Knoxville Bridge.

Figure 3-3: Longitudinal Crack on the Top Surface of the Knoxville Bridge.

Figure 3-4: Longitudinal Cracks on the Top Surface of the Knoxville Bridge.

Figure 3-5: Longitudinal Crack on the Top Surface of the Knoxville Bridge.

The longitudinal cracking on the top surface of the Knoxville bridge can be seen circled in yellow in Figures 3-2 to 3-5. A clear pattern emerges when viewing the cracks – the cracks initiate perpendicular to the abutment, travel a couple of feet, then reorient to travel parallel to the bridge beams and seem to follow the shear keys between the slabs. Figures 3-6 and 3-7 show that no leakage was occurring on the underside of the bridge, indicating that the longitudinal reflective cracks on the top surface were probably not yet full depth and not affecting the steel reinforcement and

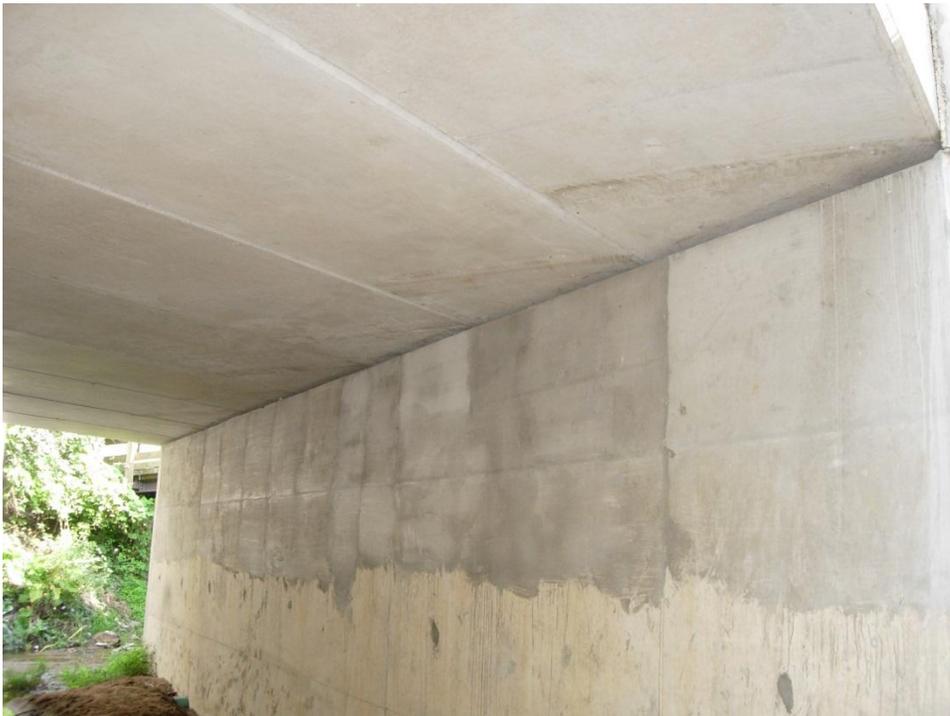
Figure 3-6: View of the Bottom Surface and the East Abutment of the Knoxville Bridge.

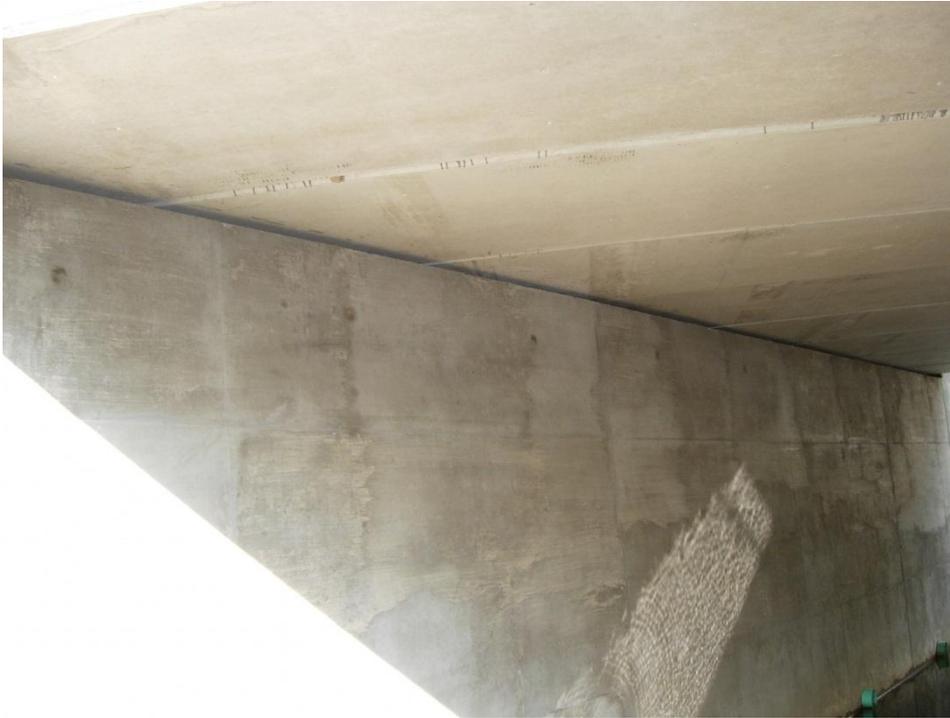
Figure 3-7: View of the Bottom Surface and West Abutment of the Knoxville Bridge.

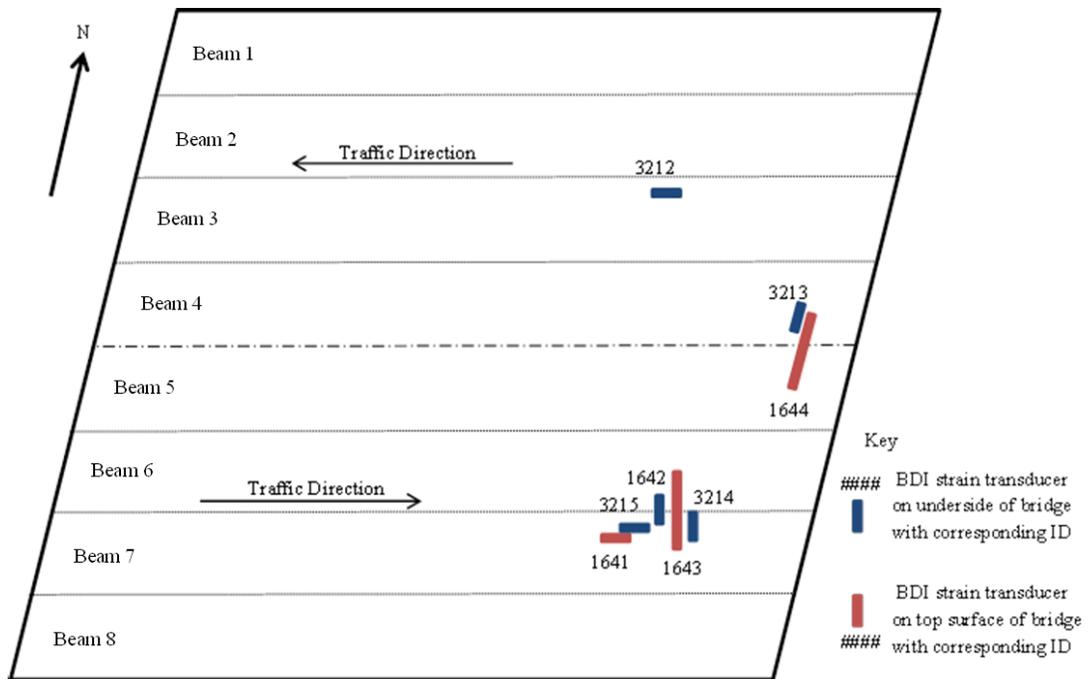
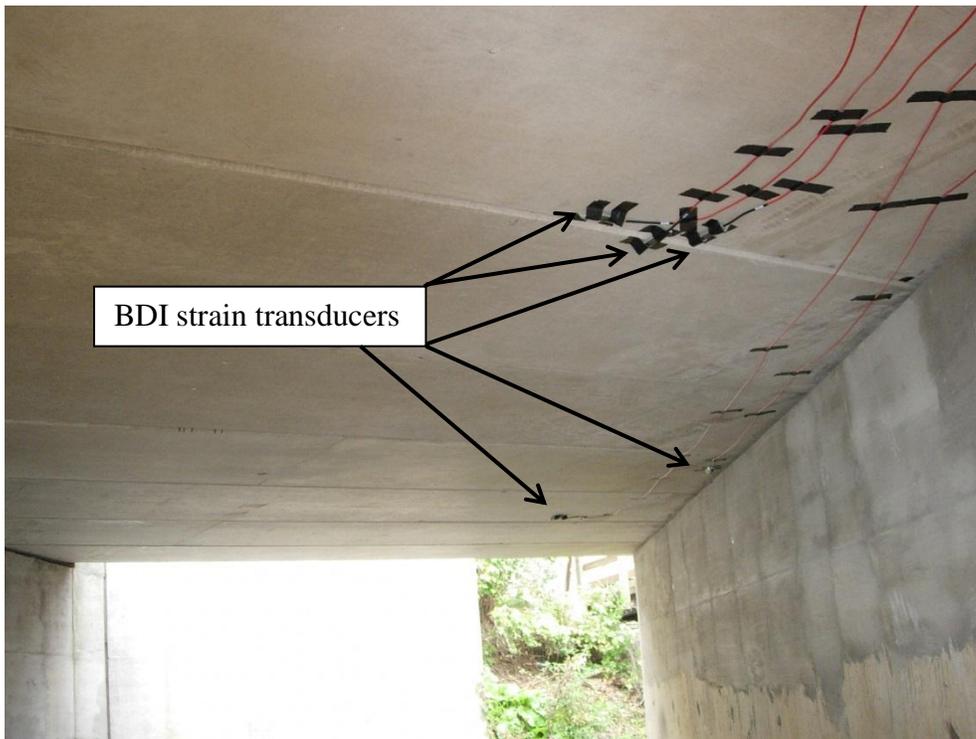
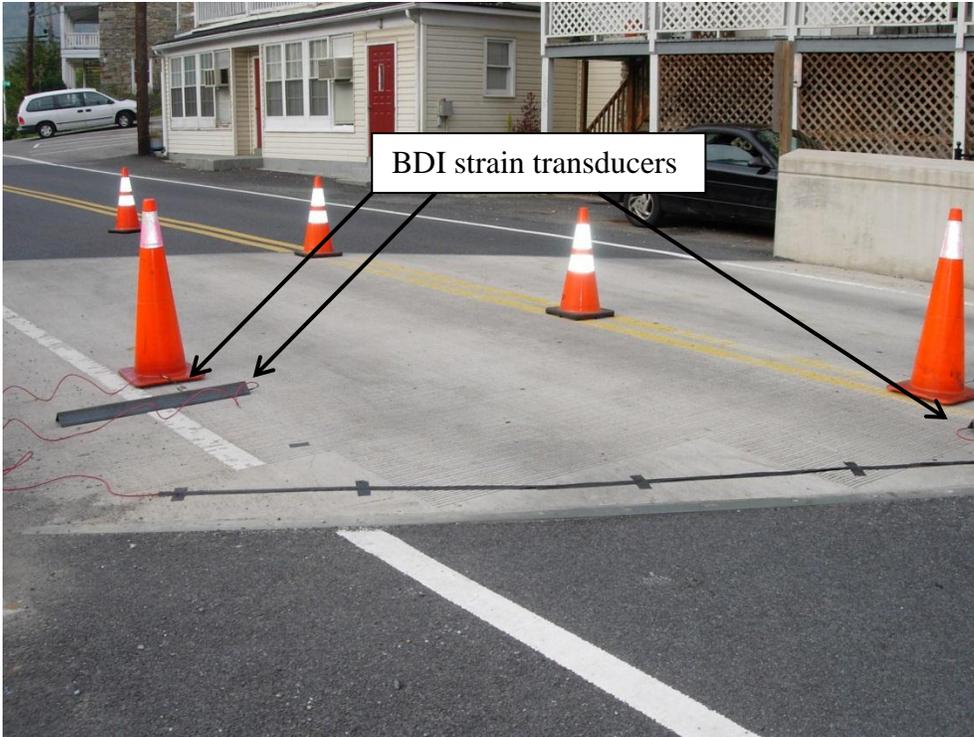
Figure 3-8: Strain Gauge Locations on the Knoxville Bridge.

Figure 3-9: Location of BDI Sensors on the Bottom Surface of the Knoxville Bridge.

Figure 3-10: Location of BDI Sensors on the Top Surface of the Knoxville Bridge.

The strain gauge locations were selected based on three important criteria: first, the necessary locations to characterize the bridge behavior; second, the locations of the longitudinal cracks in the bridge; and third, the ease of accessing similar points on the underside of the bridge. The cracks on the top surface of the bridge that corresponded in location with accessible area on the underside of the bridge were chosen for the sensor locations. One BDI sensor was placed on the top surface of the bridge parallel to the abutment across a crack near where the abutment supported the beams (#1644) with a corresponding sensor on the bottom surface of the beams (#3213). Two more BDI sensor were placed on the top surface of the bridge, one normal to the beams across another longitudinal crack (#1643) and one close by but parallel to the beams (#1641), with two more sensors placed approximately in the corresponding positions on the underside of the bridge (#3214 and #3215, respectively). The last two BDI sensors were placed on the underside of the bridge, one normal and across beams 6 and 7 and the other parallel to the beams on beam 3. A gauge location schematic and photos of the strain gauges on the bridge are shown in Figures 3-8 to 3-10.

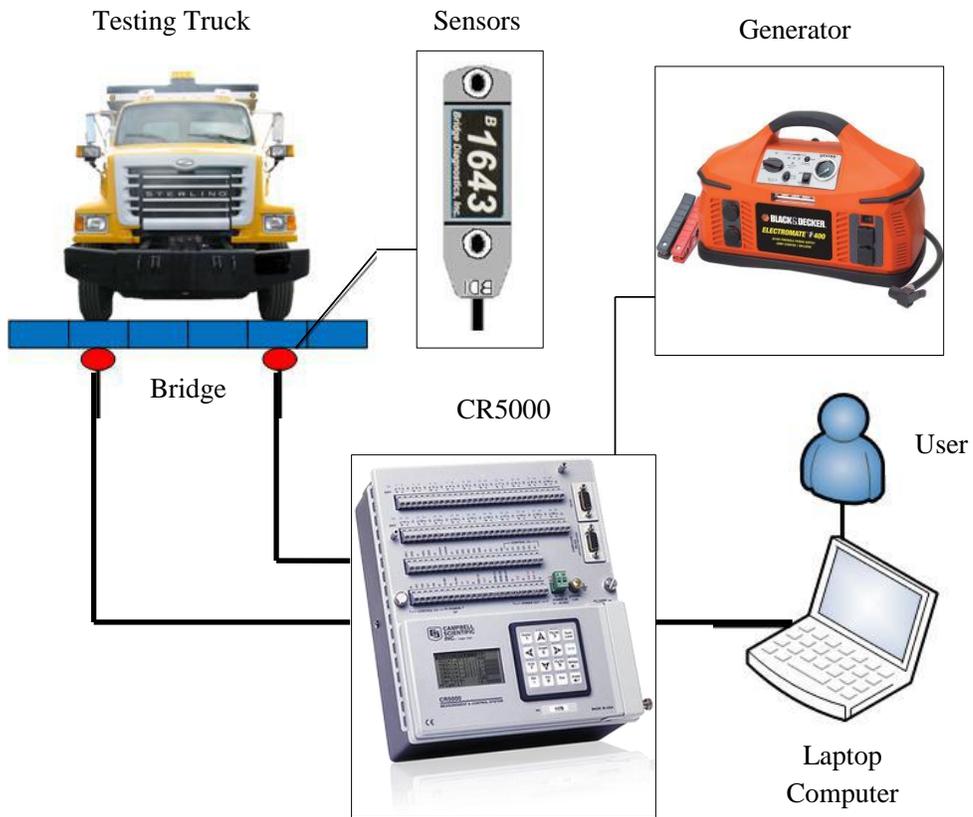
Figure 3-11: Data Acquisition Network (Jeong, 2009).

The instrumentation setup for the live load test consisted of multiple components. Eight prefabricated BDI sensors were connected to the Campbell Scientific CR5000 data logger. The CR5000 was powered by a small generator and connected to a laptop computer which was running the PC9000 software. The connections from the sensors to the data logger were correctly made on the same day as the field test and checked using a multi-meter and preliminary test runs. The data was recorded to the CR5000 and transferred using the PC9000 to the computer. A schematic of the data acquisition network and a photo of it during operation are shown in Figures 3-11 and 3-12; further descriptions of each component of the system are provided in the following section.

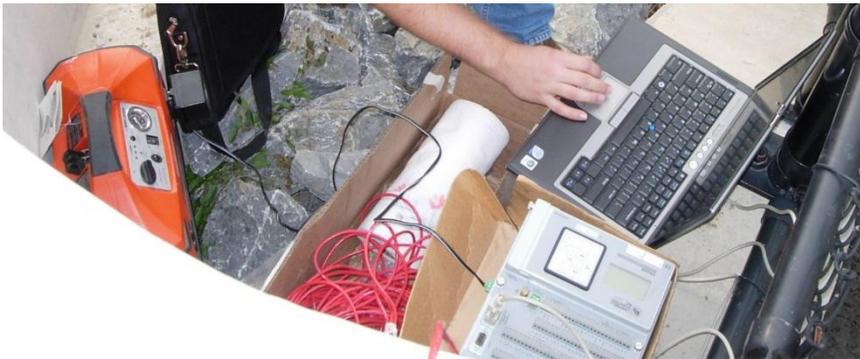
Figure 3-12: Data Acquisition System Monitoring the Strain Gauges During the Live Load Test.

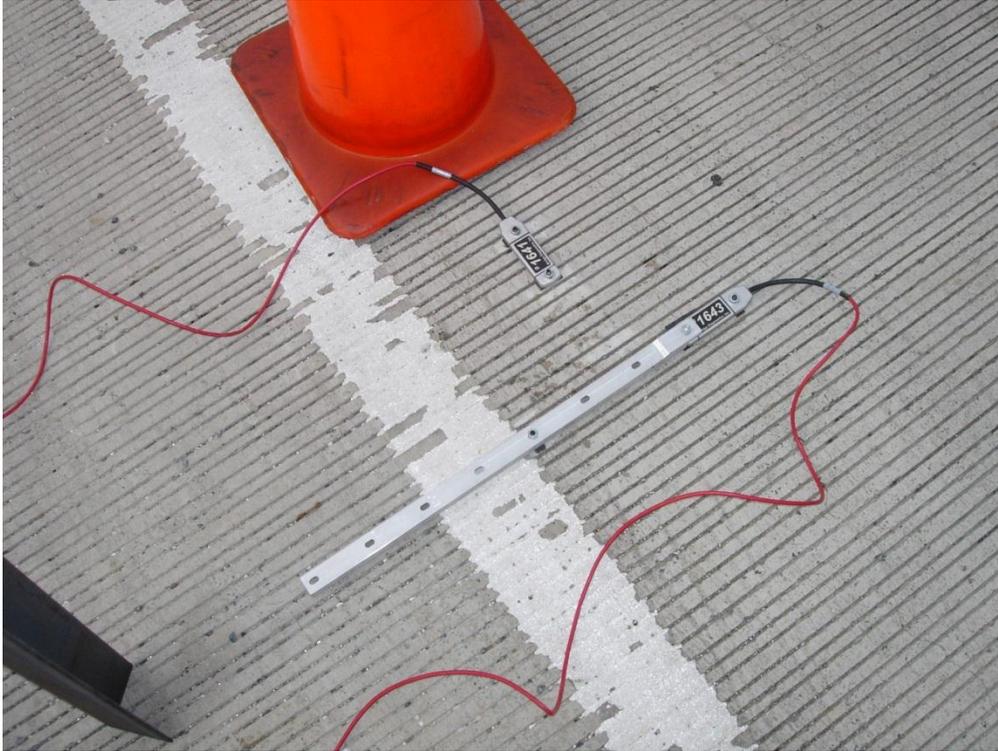
Figure 3-17: Two BDI Strain Transducers Installed on the Top Surface of the Bridge (BDI #1643 with an Extension Bar, BDI #1641 without an Extension Bar).

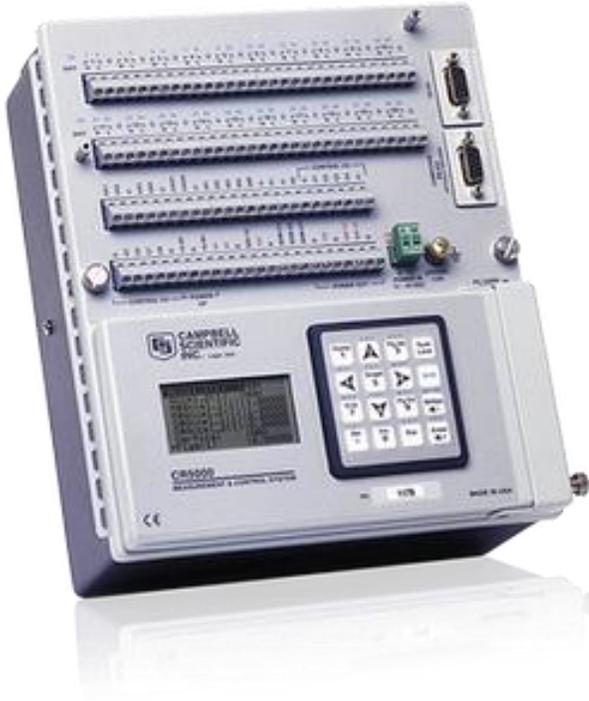
Figure 3-18: Campbell Scientific CR5000 Data Logger.

For the live load field testing, the Campbell Scientific CR5000 Measurement and Control System was used to record the data obtained from the BDI strain transducers. The CR5000 is a rugged, high performance data acquisition system that can be used as an excitation source for sensors as well as recording data at a maximum rate of 5000 Hz (5000 measurements per second). It has twenty differential individually configured inputs that can be used for a wide variety of different sensor types, including strain gauges. See Figure 3-18 for a photo of the CR5000.

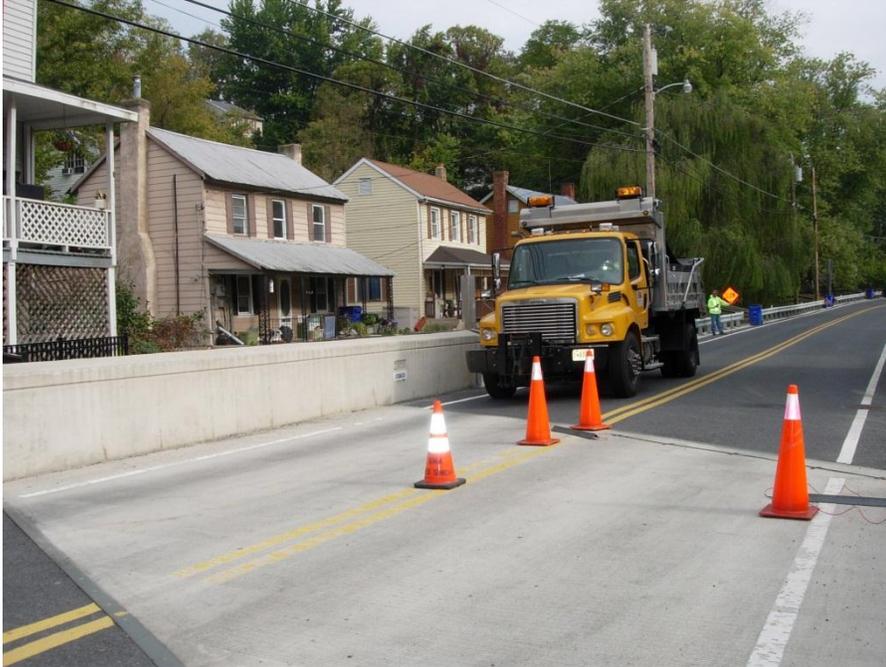
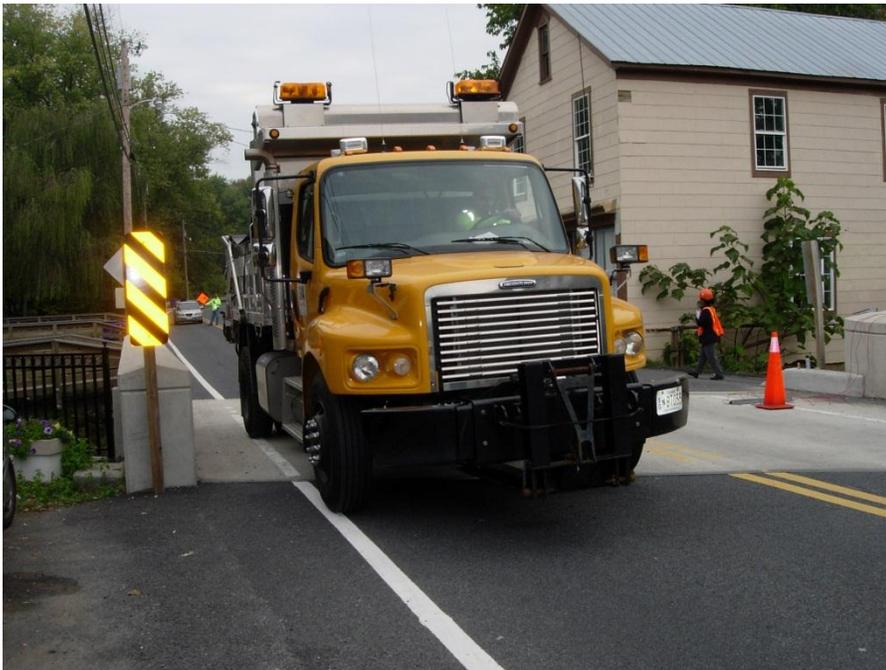
Figure 3-19: Test Vehicle Provided by MDSHA Traveling Westbound across Knoxville Bridge.

Figure 3-20: Test Vehicle Provided by MDSHA Traveling Westbound across Knoxville Bridge.

The pre-weighted test vehicle was a two-axle dump truck provided by MDSHA and weighing 26,420 pounds. It weighed 5,200 pounds in each front wheel and 8,010 pounds in each rear tandem. The driver was instructed to drive across the bridge a total of eight times (four times in each direction) at varying speeds to obtain live-load strain data for the bridge. See Figures 3-19 and 3-20 for photos of the test vehicle.

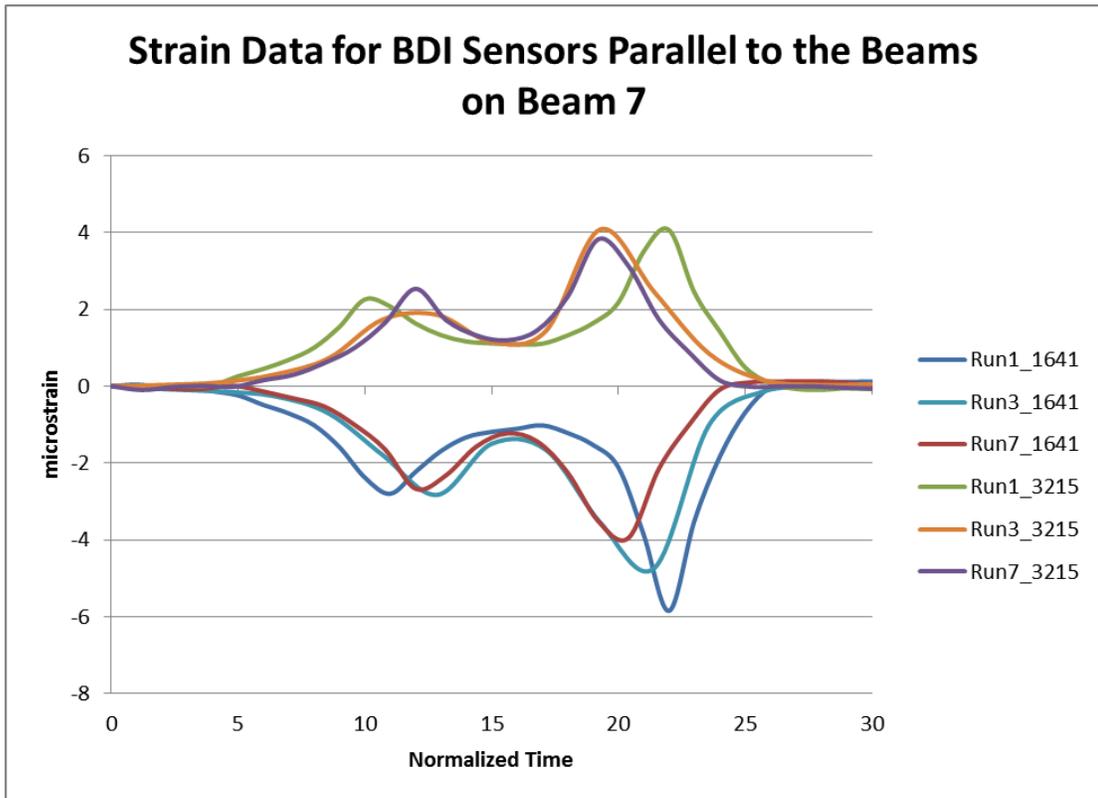
Figure 3-21: Strain Data for BDI Sensors #1641 and #3215 from Runs 1, 3, and 7.

The strain data was also plotted to view significant similarities or differences. The strain data from BDI sensors #1641 and #3215 located parallel to the beams on the top and bottom of beam 7, respectively, is shown in Figure 3-21. As can be seen, the data from the two respective runs in the same direction show both similar shapes and similar magnitudes with opposite signs (positive vs. negative) corresponding to the tension and compression that the bottom and top of the bridge, respectively, was experiencing during the live-load testing as expected.

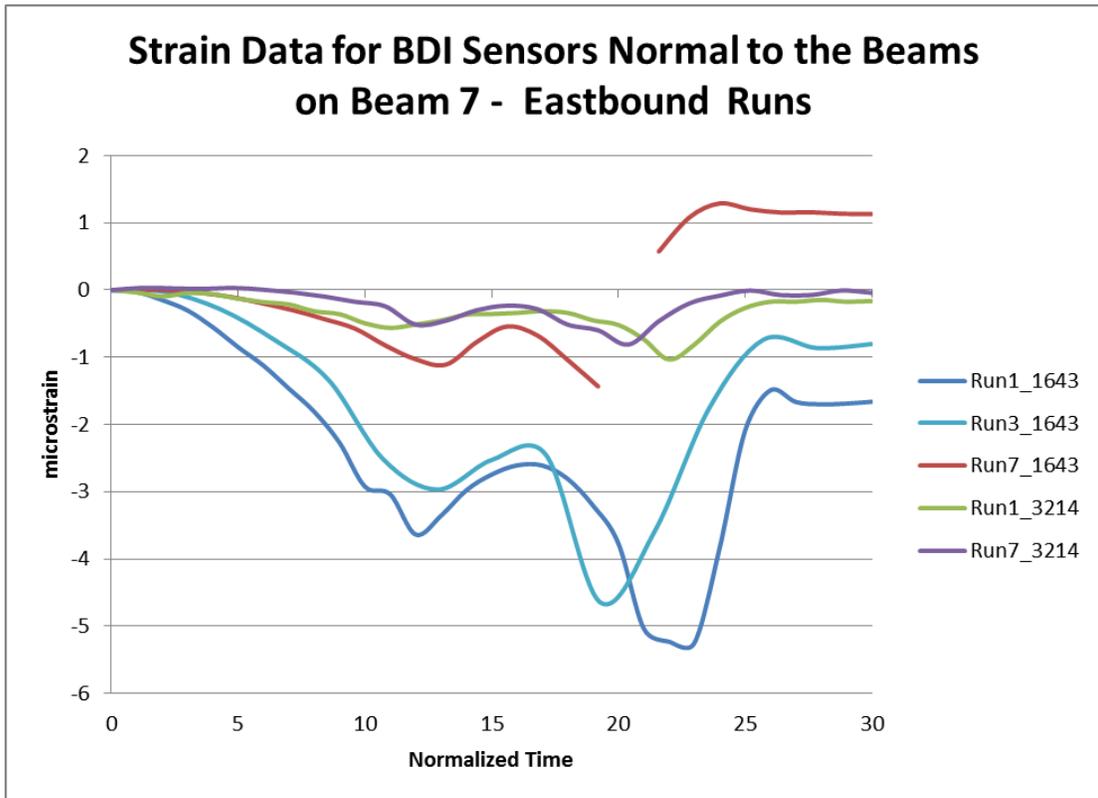
Figure 3-22: Strain Data for BDI Sensors #1643 and #3214 from Runs 1, 3, and 7.

shown in Figure 3-22. As can be seen, the data from the runs in the same direction show similar shapes with all of the magnitudes in the same direction as expected. However, there are some discrepancies in the magnitude of some of the records, notably by the same sensor (BDI #1643). This may be explained by its location on the top surface of the bridge across a crack and very close to where the test truck made its run. It is important to note the absence of a return to the initial strain value in the data from both runs and the lack of some data from run 7 (removed because of an obvious error, possibly caused by the truck coming in contact with a portion of the sensors protective cover). Taking these into consideration, the data is not nearly as conflicting as it may first seem and seems in more agreement with the data from run 3.

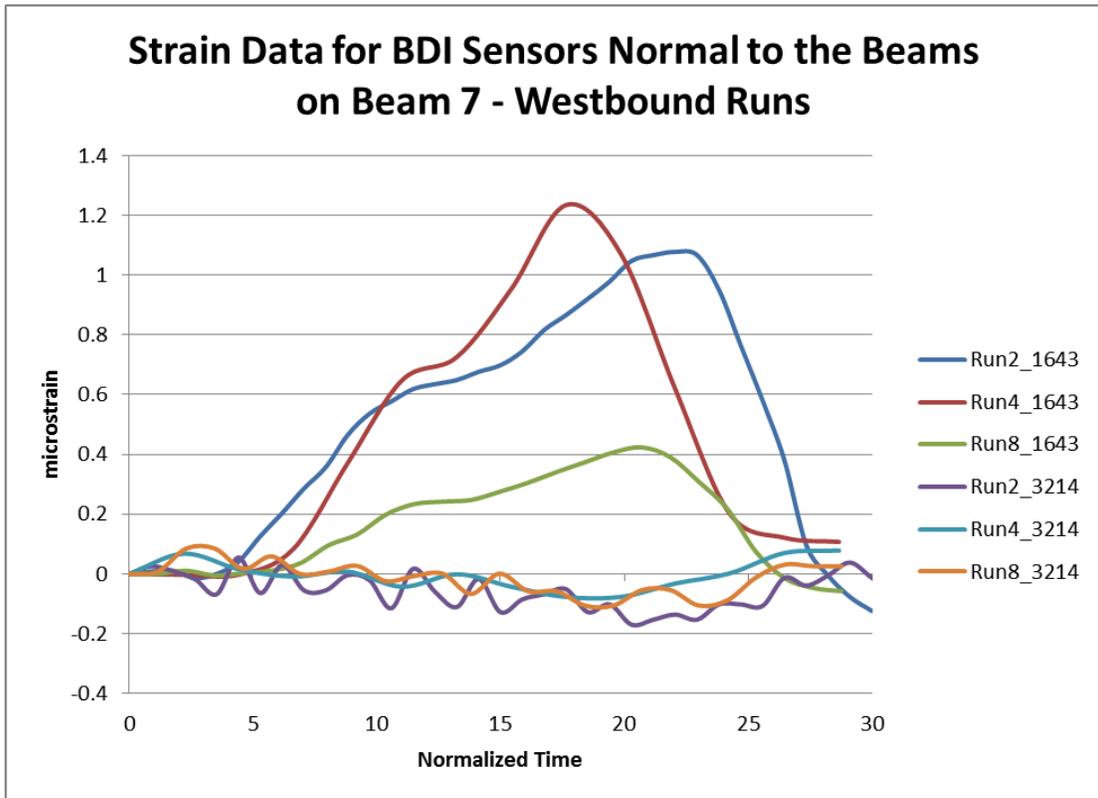
Figure 3-23: Strain Data for BDI Sensors #1643 and #3214 from Runs 2, 4, and 8.

The strain data from BDI sensors #1643 and #3214 located perpendicular to the beams on the top and bottom of beam 7, respectively, for the westbound runs is shown in Figure 3-23. As can be seen, the data from the runs in the same direction show similar shapes for each corresponding sensor. However, again, there are some discrepancies in the magnitude of some of the records by the same sensor (BDI #1643). This may again be explained by its location on the top surface of the bridge across a crack. It is important to note that while strain gauge on the top surface of the bridge (BDI #1643) recorded compression in the transverse direction when the test truck made the eastbound runs, it recorded tension in the transverse direction when the test truck made the westbound runs, possibly contributing to the cracking of the concrete overlay.

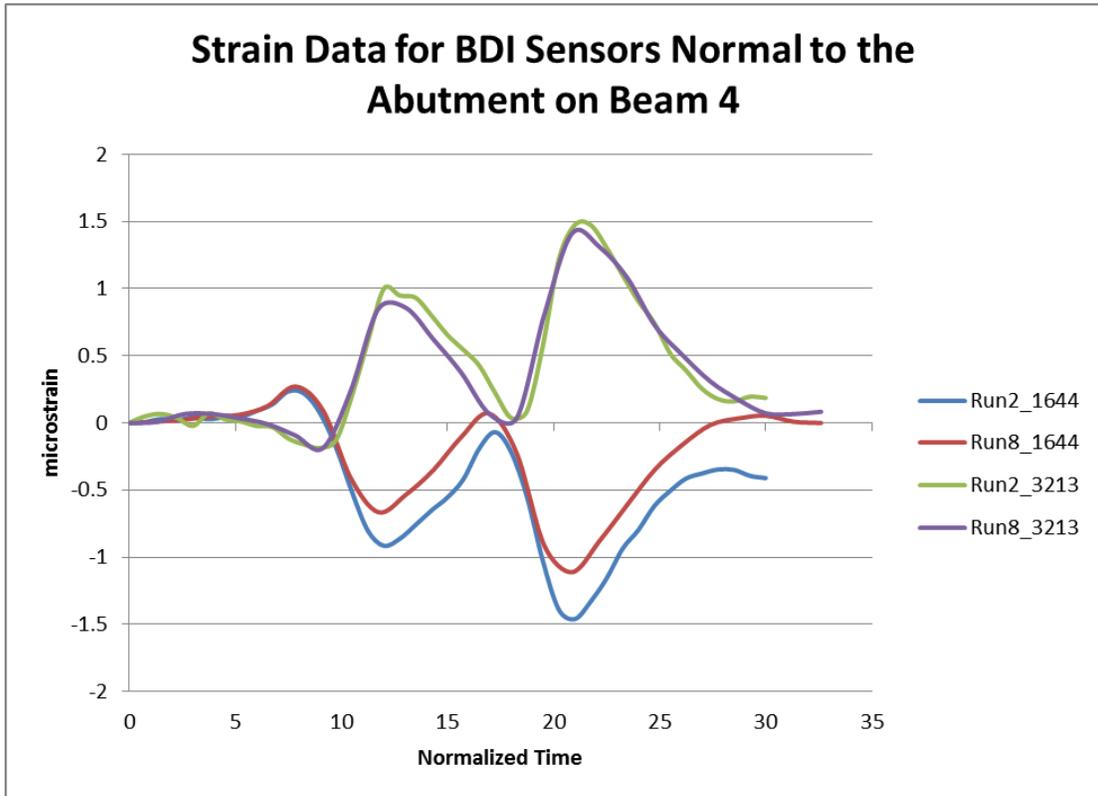
Figure 3-24: Strain Data for BDI Sensors #1644 and #3213 from Runs 2 and 8.

The strain data from BDI sensors #1644 and #3213 located parallel to the abutment on the top and bottom of beam 4, respectively, is shown in Figure 3-24. As can be seen, the data from the two respective runs in the same direction show similar shapes and similar magnitudes in the same direction as expected.
