Title of Document: EVALUATION OF SKEWED SIMPLE SPAN
TRANSVERSELY POST-TENSIONED
ADJACENT PRECAST CONCRETE SLAB
BRIDGES

Timothy Levi Briner, Master of Science in Civil
Engineering, 2012

Thesis submitted to the Faculty of the Graduate School of the
University of Maryland, College Park, in partial fulfillment
of the requirements for the degree of
Master of Science
2012

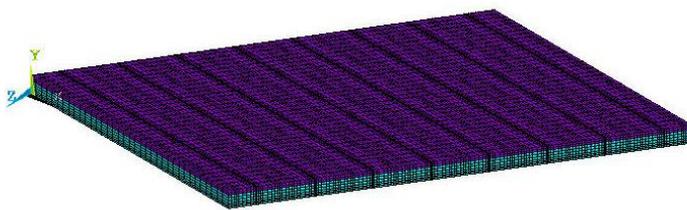
Figure 4-1: Finite Element Model of the Knoxville, MD, Bridge.

A finite element model (FEM) of the Knoxville bridge was created and refined using the field test results to analyze possible causes of the longitudinal cracking found in the deck of the bridge (see Figure 4-1). Though other analysis methods have been used, such as grillage analysis or analytical methods, finite element analysis has proven to be both robust and accurate for refined analyses. Finite element analysis enables detailed forces and stress and strain distributions to be found in complicated structures while still allowing flexibility in analyzing specific material characteristics (Jeong, 2009). The strain data from the finite element model was compared to the strain data from the field test, following which the model was refined until close enough results were found. ANSYS version 10.0 was used to create this model. The model details are described in the following section.

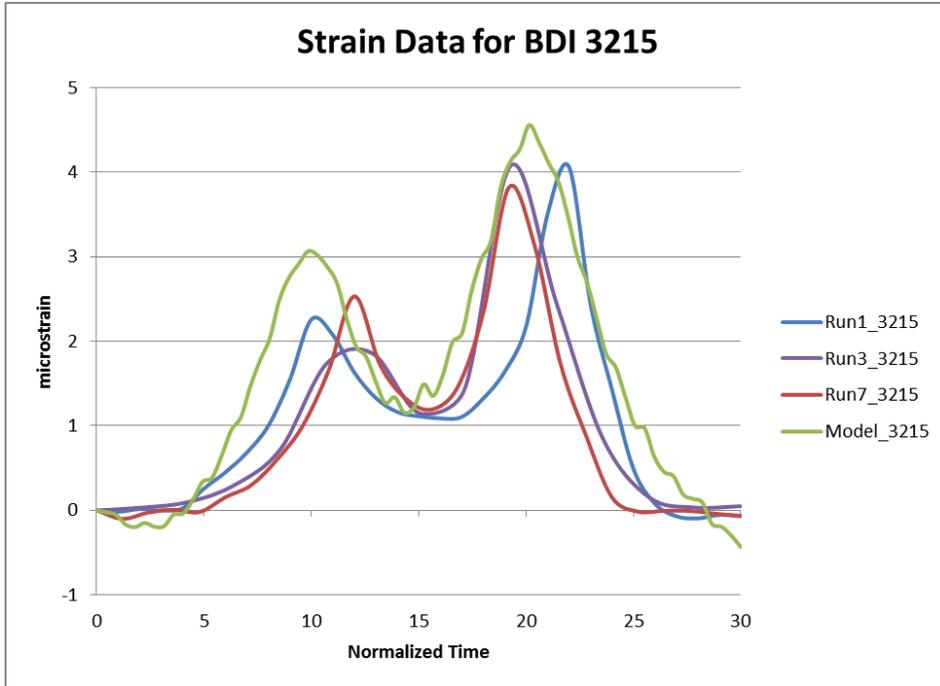
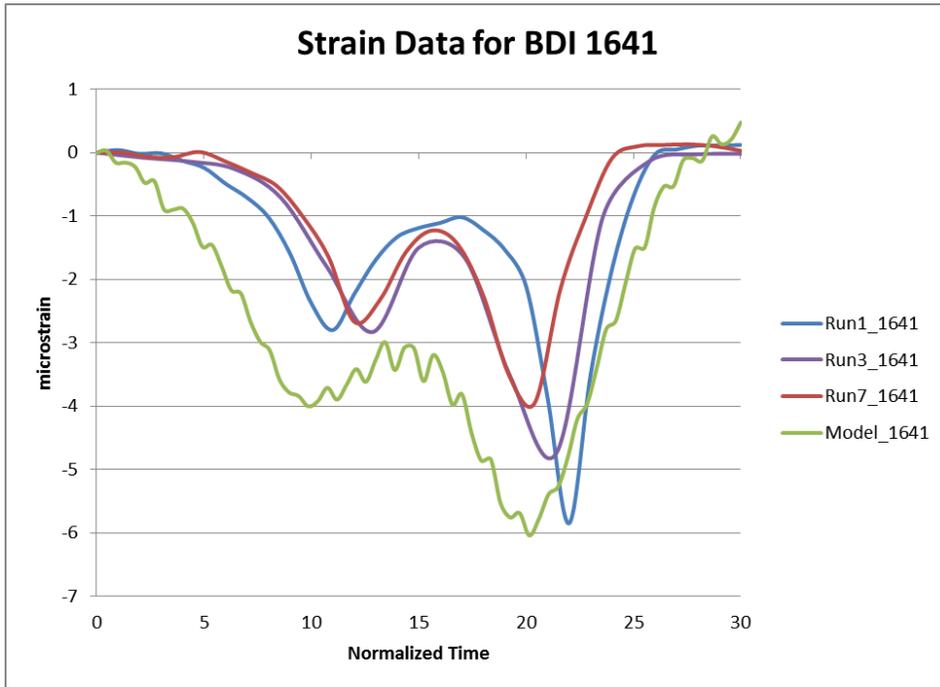
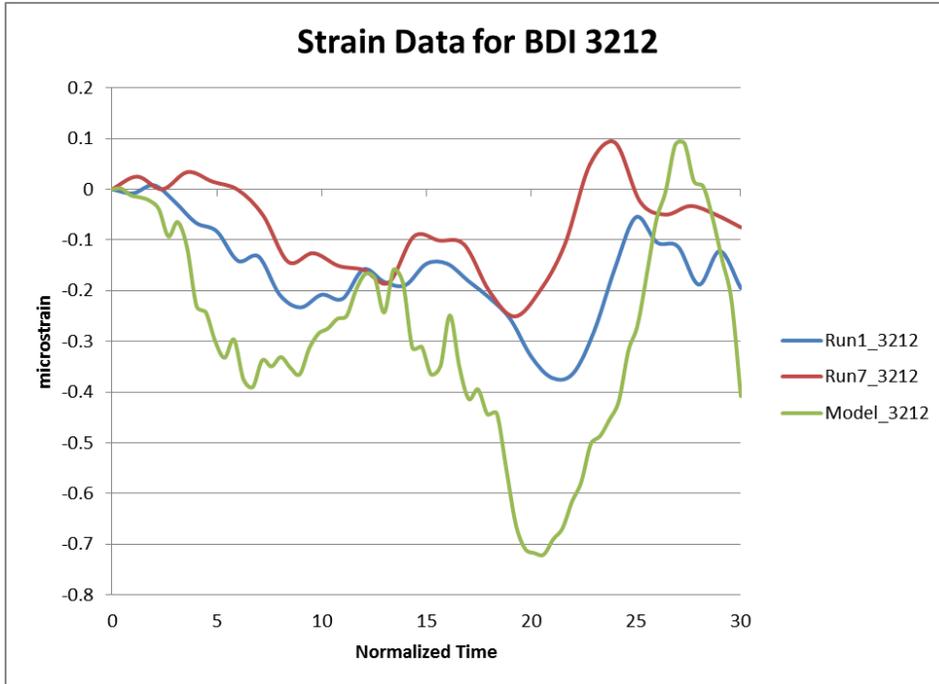
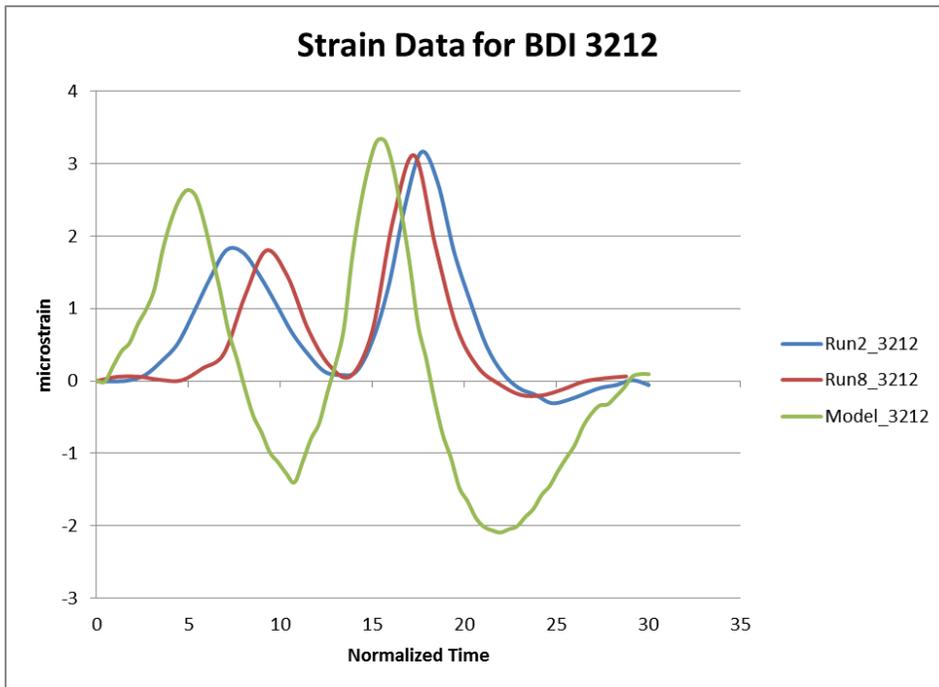
Figure 4-6: BDI Strain Transducer #3215 - Placed Parallel to the Slabs on the Bottom Surface of Beam 7.

Figure 4-7: BDI Strain Transducer #1641 - Placed Parallel to the Slabs on the Top Surface of Beam 7.

Figure 4-8: BDI Strain Transducer #3212 - Placed Parallel to the Slabs on the Bottom Surface of Beam 3.

Figure 4-9: Field Test Data Based on BDI Strain Transducer #3212 - Placed Parallel to the Slabs on the Bottom Surface of Beam 3 Near the East Side of the Bridge; Model Data Based on an Equivalent Position on Beam 6 Near the West Side of the Bridge.

(see Figures 4-6 and 4-7). The data show logical strain directions (tensile on the bottom surface of the beam and compressive on the top surface) and similar trends and maximum values of strain, with the bottom surface undergoing approximately 4 microstrain longitudinally in tension and the top surface undergoing approximately 6 microstrain longitudinally in compression. The model results for the sensor placed parallel to the slabs on the bottom surface of beam 3 do not seem to correspond as well with the field test results because of the minimal amount of strain that beam 3 undergoes due to the loading on the opposite side of the bridge, but the model result does show a similar trend and only differs by a little more than 0.3 microstrain (see Figure 4-8). When the corresponding point on the opposite side of the bridge was examined in the model and compared with the data obtained from runs 2 and 8 (when the testing truck was traveling westbound on beams 2 and 3, directly over the strain gauge), both the trends and the maximum peaks (3 microstrain longitudinally in tension) match well, confirming that the finite element model is a reasonably accurate model for the Knoxville bridge (see Figure 4-9).

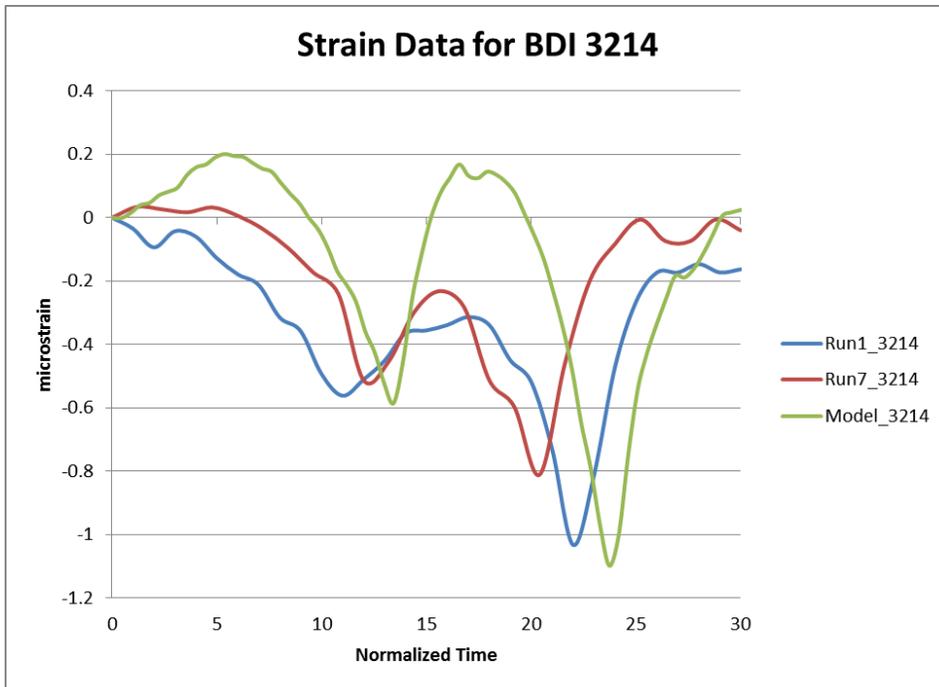
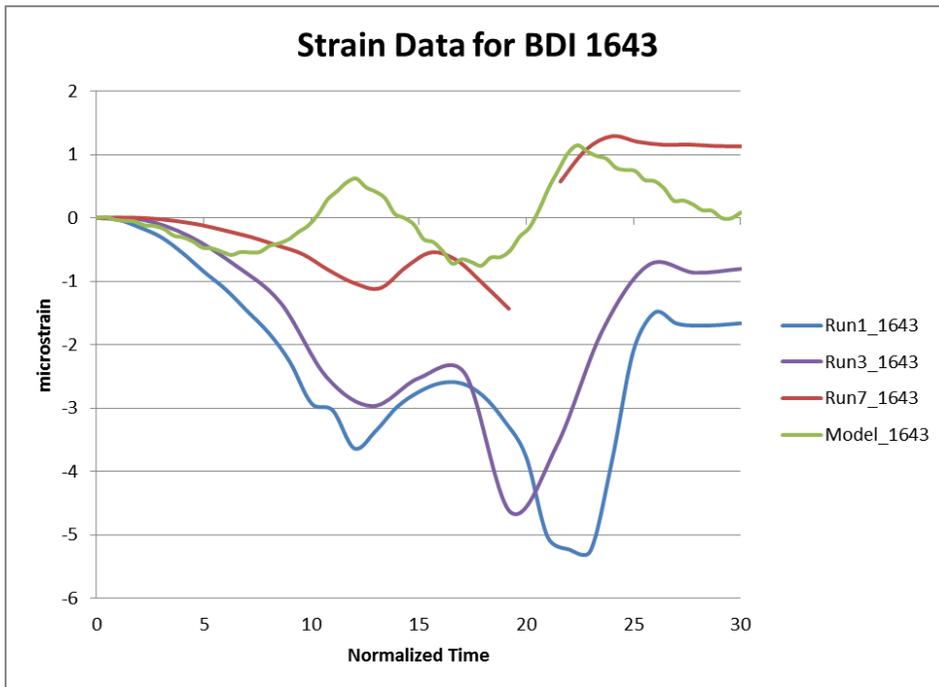
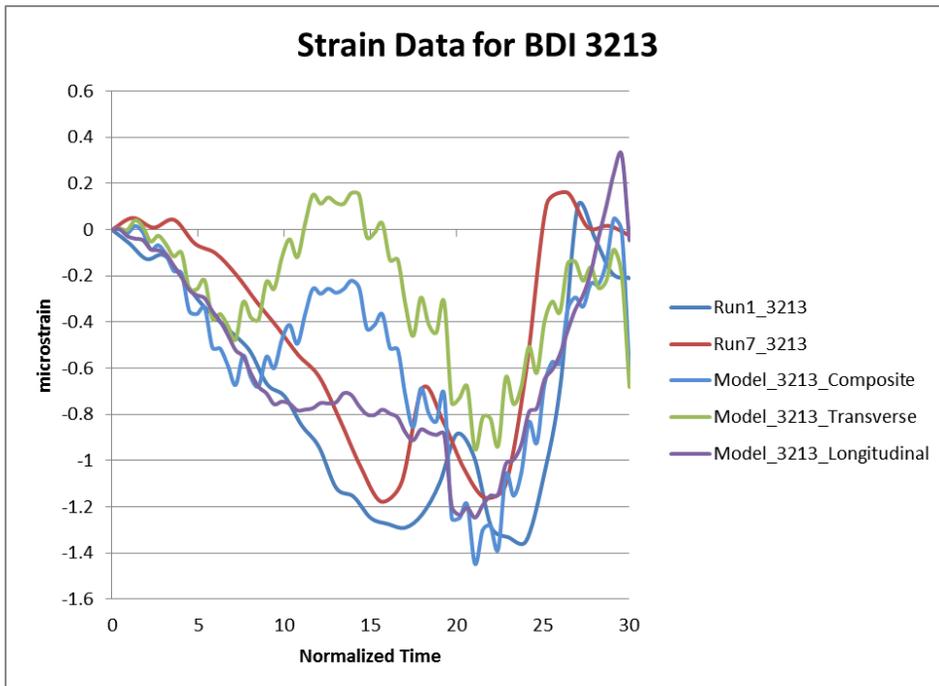
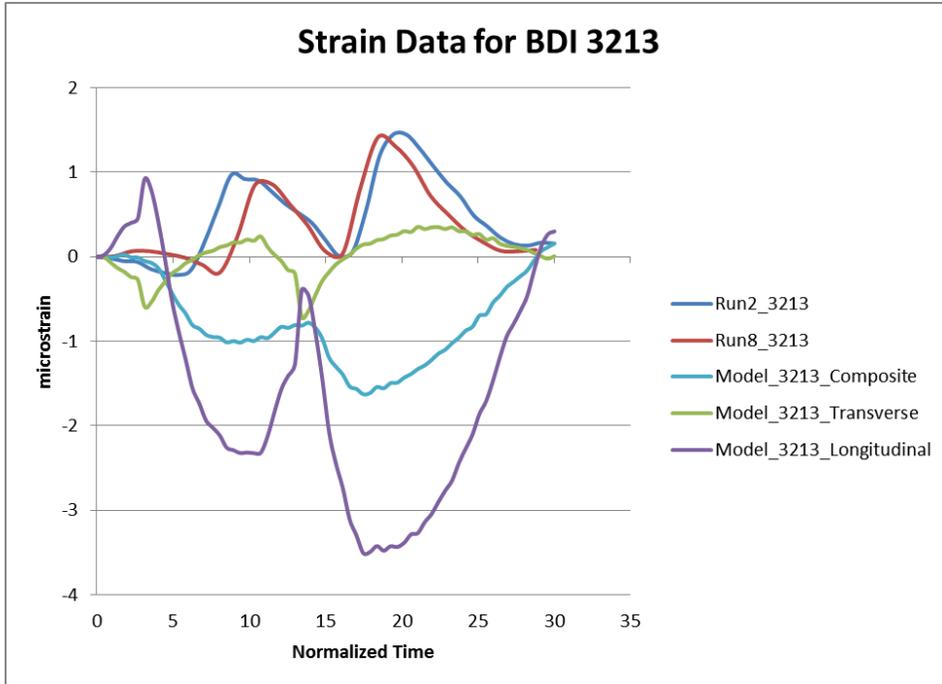
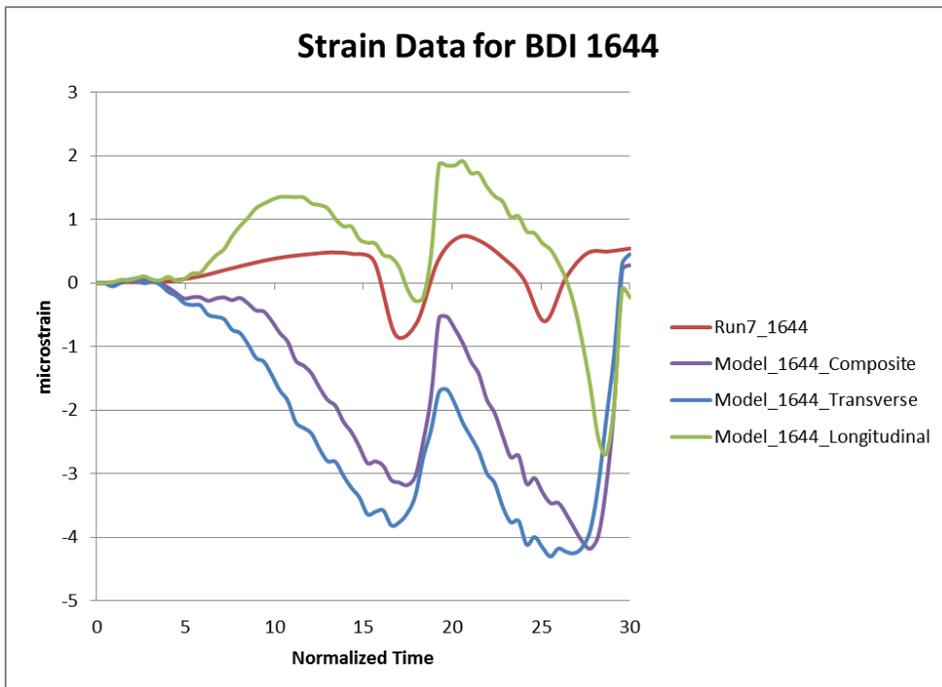
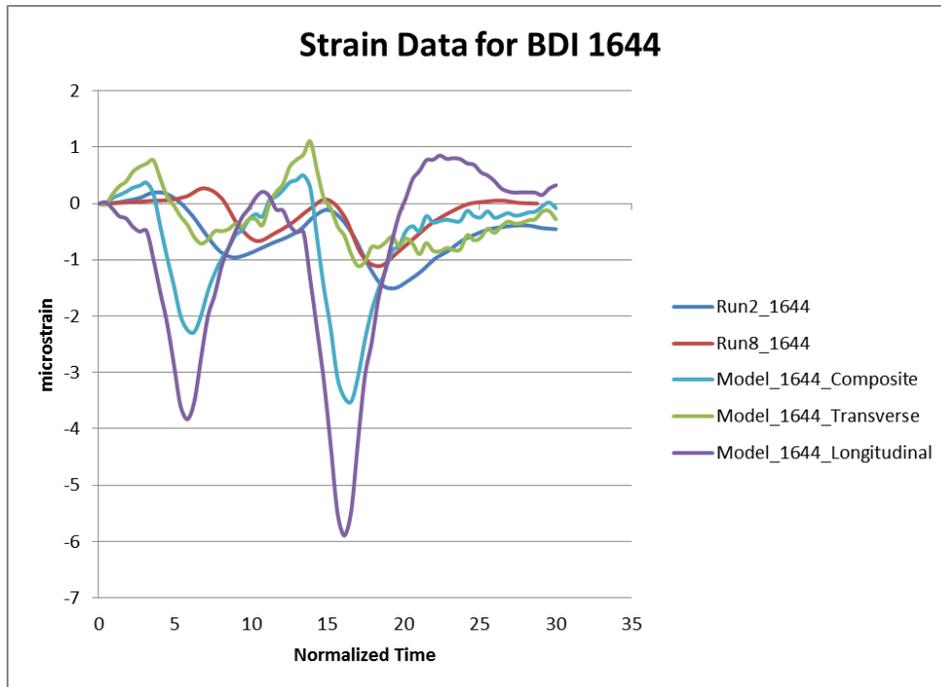
Figure 4-10: BDI Strain Transducer #3214 - Placed Normal to the Slabs on the Bottom Surface of Beam 2.

Figure 4-11: BDI Strain Transducer #1643 - Placed Normal to the Slabs on the Top Surface across a Crack between Beams 6 and 7; Model Data Based on an Approximately Equivalent Position on Beam 7.

Figure 4-12: BDI Strain Transducer #3213 - Placed Normal to the Abutment on the Bottom Surface of Beam 4.

Figure 4-13: Field Test Data Based on BDI Strain Transducer 3213 - Placed Normal to the Abutment on the Bottom Surface of Beam 4 Near the East Side of the Bridge; Model Data Based on an Equivalent Position on Beam 5 Near the West Side of the Bridge.

Figure 4-14: BDI Strain Transducer #1644 - Placed Normal to the Abutment on the Top Surface across a Crack between Beams 4 and 5; Model Data Based on an Approximately Equivalent Position on Beam 5.

Figure 4-15: Field Test Data Based on BDI Strain Transducer #1644 - Placed Normal to the Abutment on the Top Surface across a Crack between Beams 4 and 5 Near the East Side of the Bridge; Model Data Based on an Equivalent Position on Beam 4 Near the West Side of the Bridge.

For further comparison and confirmation, the field test strain data obtained from the strain transducers placed normal to the precast concrete slabs was compared with the finite element model results. The model results for the strain gauge placed on the bottom surface of beam 2 (BDI #3214) matched well with the field test data, with both a similar trend and peak, with a maximum value of about 1 microstrain transversely in compression (see Figure 4-10). The model results for BDI #1643 which was placed on beams 6 and 7 across a crack that was present between the slabs did not correspond well with the field test results (see Figure 4-11). This may be because the strain gauge in the field was calculating strain across the two beams whereas only one node in the finite element model (i.e. only a point on beam 7) could be analyzed to determine the strain it was undergoing. An additional contribution may be that the finite element model did not directly consider cracking or the consequences of it because of insufficient data about the cracks in the test bridge.

eastbound case, the longitudinal strain from the model shows similarities to the field test data; and for the westbound case, the transverse strain from the model shows similarities to the field test data. These discrepancies may be in part due to the orientation difficulties. For the strain gauge on the top surface, the differences may be compounded because that sensor was placed across a crack between beams 4 and 5, whereas the strain data from the model could only be calculated from one point on beam 5. Significantly, the transverse stress results from the model generally were closest to the field test results and thus were primarily used in the finite element model stress analyses for both this bridge and the parametric study.

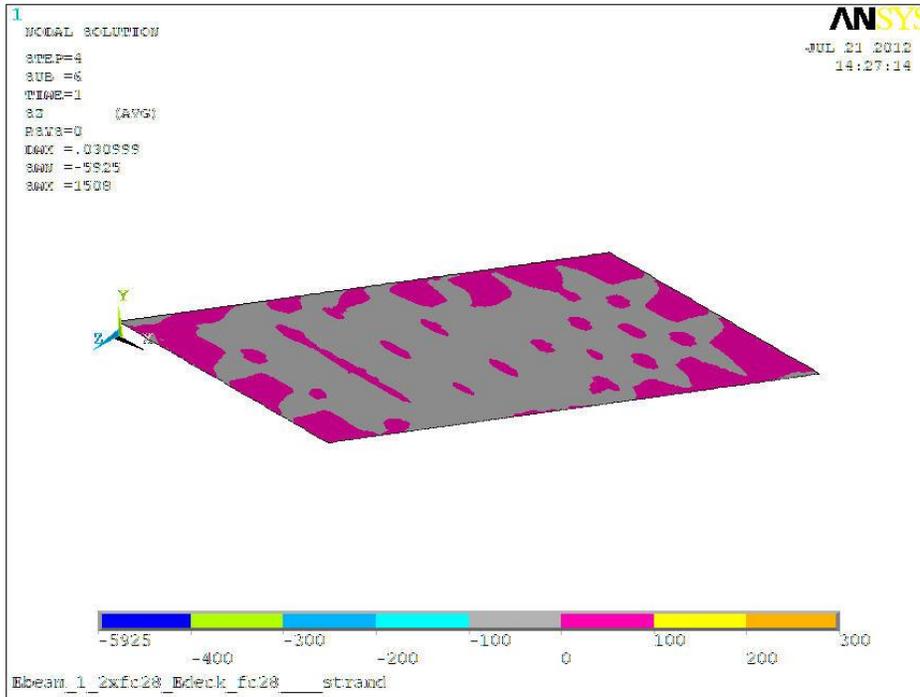
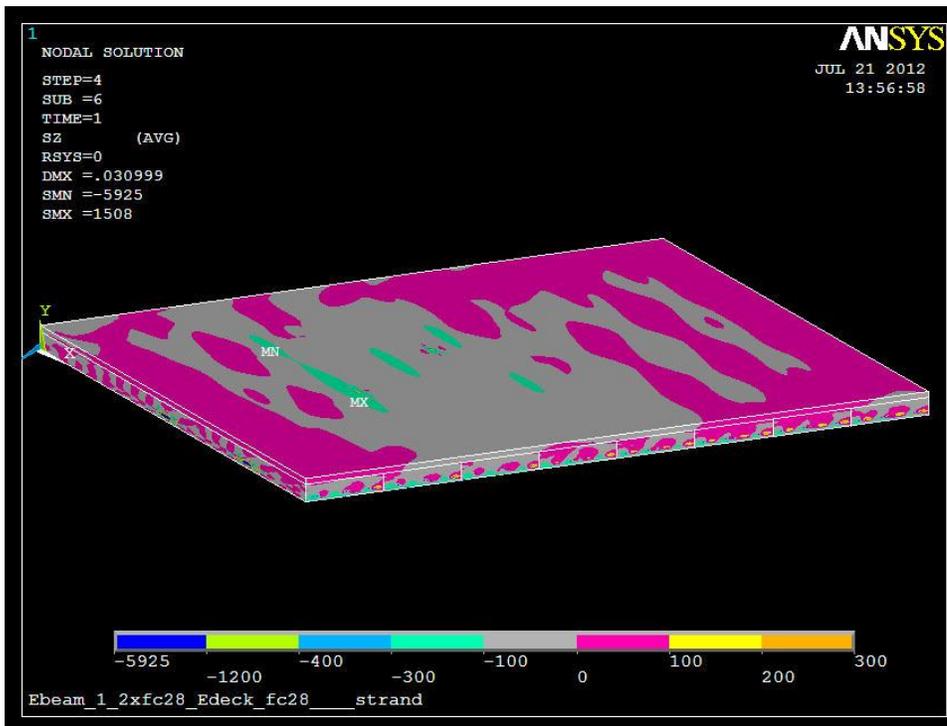
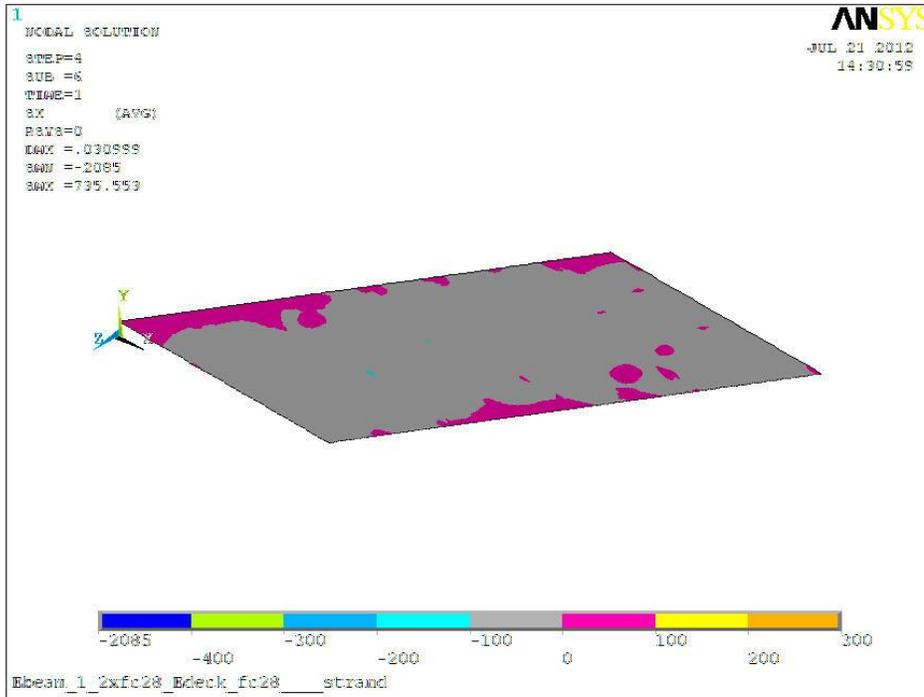
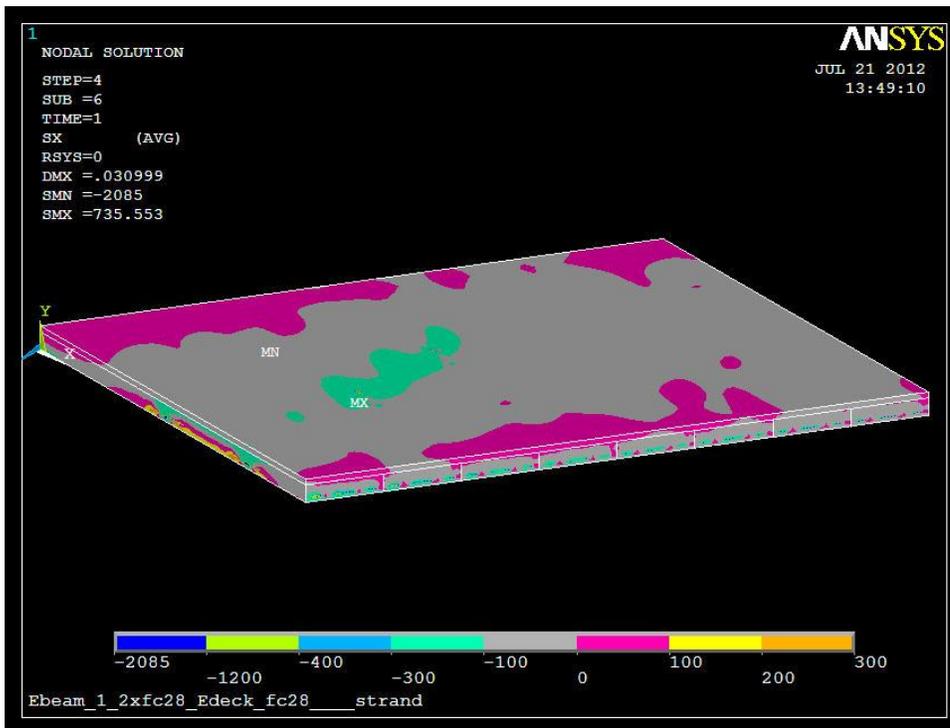
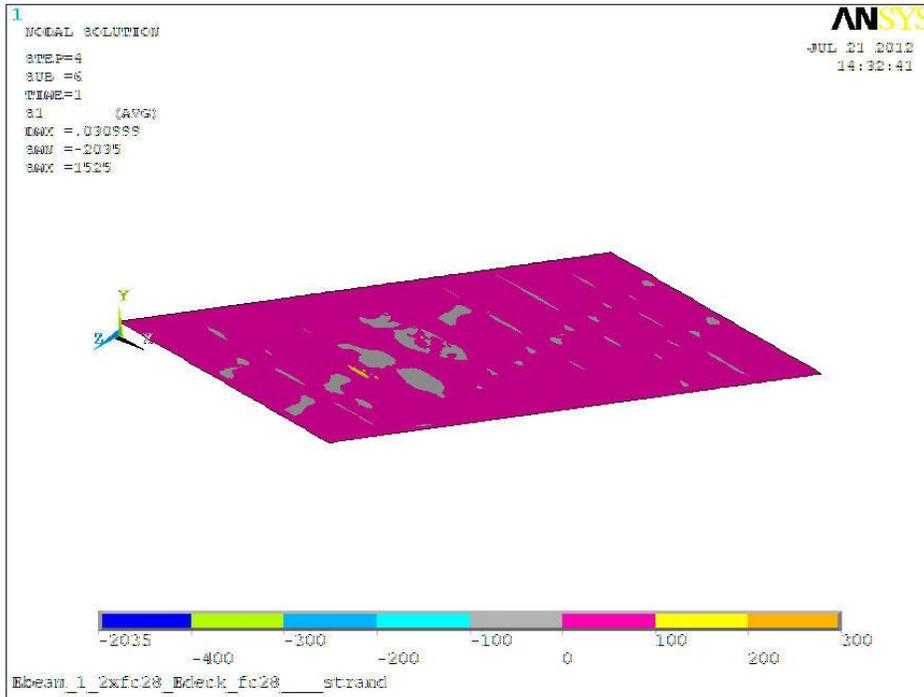
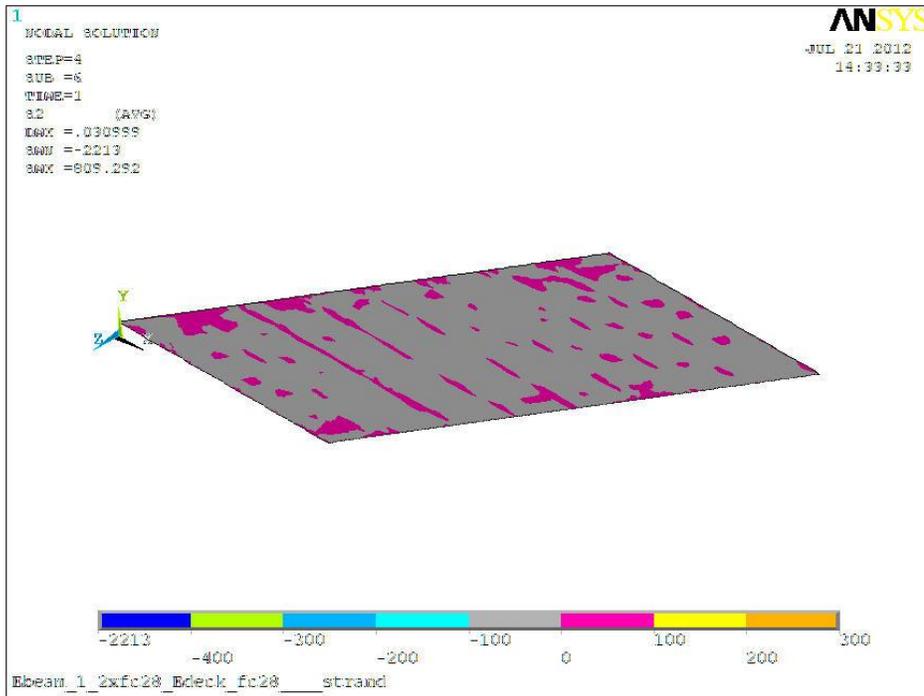
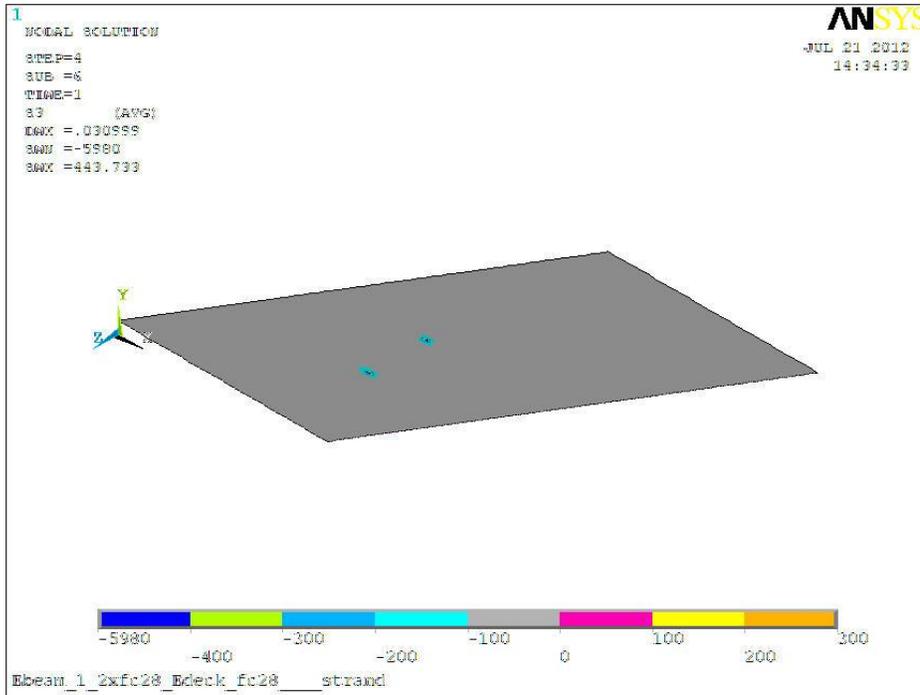
Figure 4-16: Transverse Stress at the Beam-Overlay Interface.

Figure 4-17: Transverse Stress at the Top Surface.

Figure 4-18: Longitudinal Stress at the Beam-Overlay Interface.

Figure 4-19: Longitudinal Stress at the Top Surface.

Figure 4-20: First Principal Stress at the Beam-Overlay Interface.

Figure 4-21: Second Principal Stress at the Beam-Overlay Interface.

Figure 4-22: Third Principal Stress at the Beam-Overlay Interface.

The model that was created was then run with a static H-20 truck loading (a truck applying 8,000 pounds beneath the front axle and 32,000 pounds beneath the rear axle) on beams 6 and 7. The stress distribution at the beam-overlay interface and the top surface was then analyzed to examine if any conclusions could be reached as to why the top surface of the concrete overlay was cracking. The stress displayed in the following figures has units of pounds per square inch (psi). Generally, the greatest tensile stresses exist near the abutments and on the opposite side of the bridge from the loading (see Figures 4-16 to 4-22). The tensile stresses between the beams (along the shear key) are evident from the transverse, first principal, and second principal stresses.

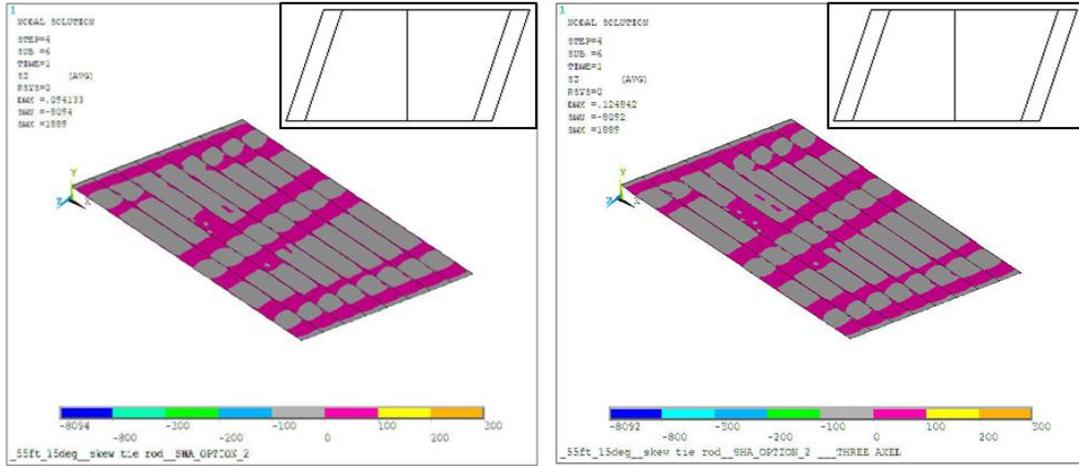
Figure 5-21: Transverse Stress Present at Slab-Deck Interface of a Fifty-Five Foot, Thirty Degree Skewed Bridge. (On the left, H-20 (two axle) load; on the right, HS-20 (three axle) load.)

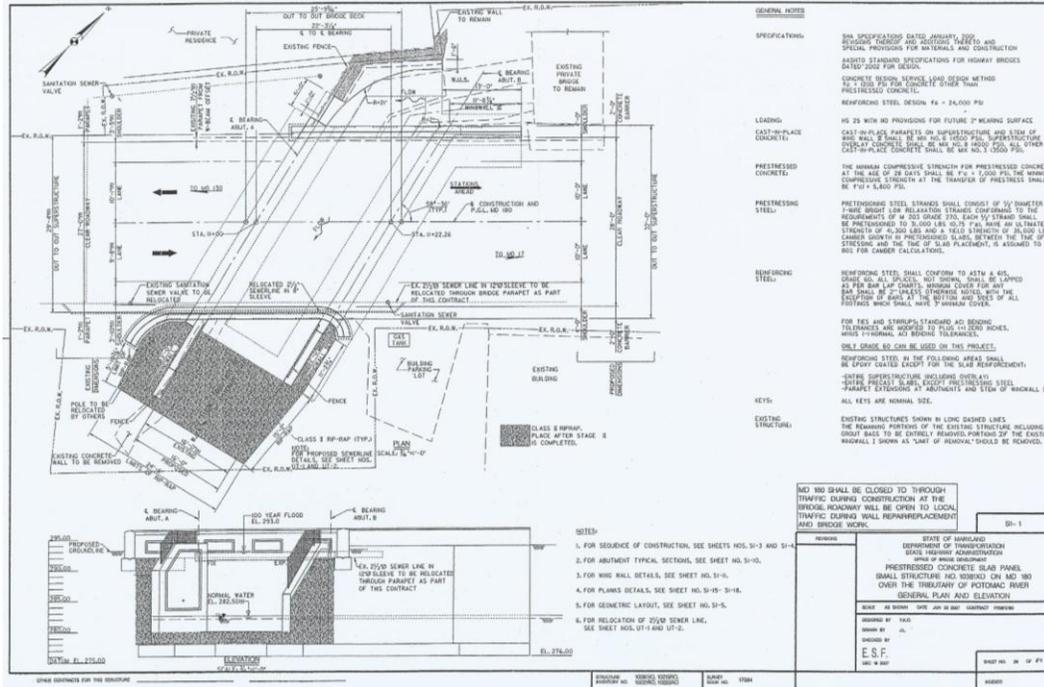
Figure B-1: General Plan and Elevation View of the Knoxville Bridge.

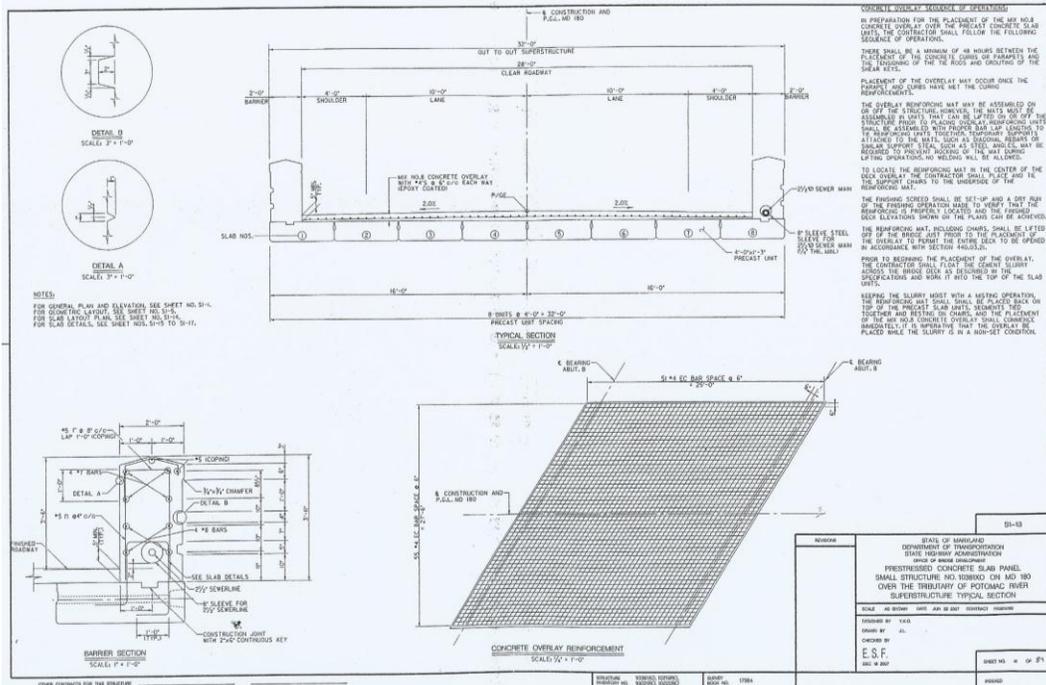
Figure B-5: Knoxville Bridge Superstructure Typical Section.

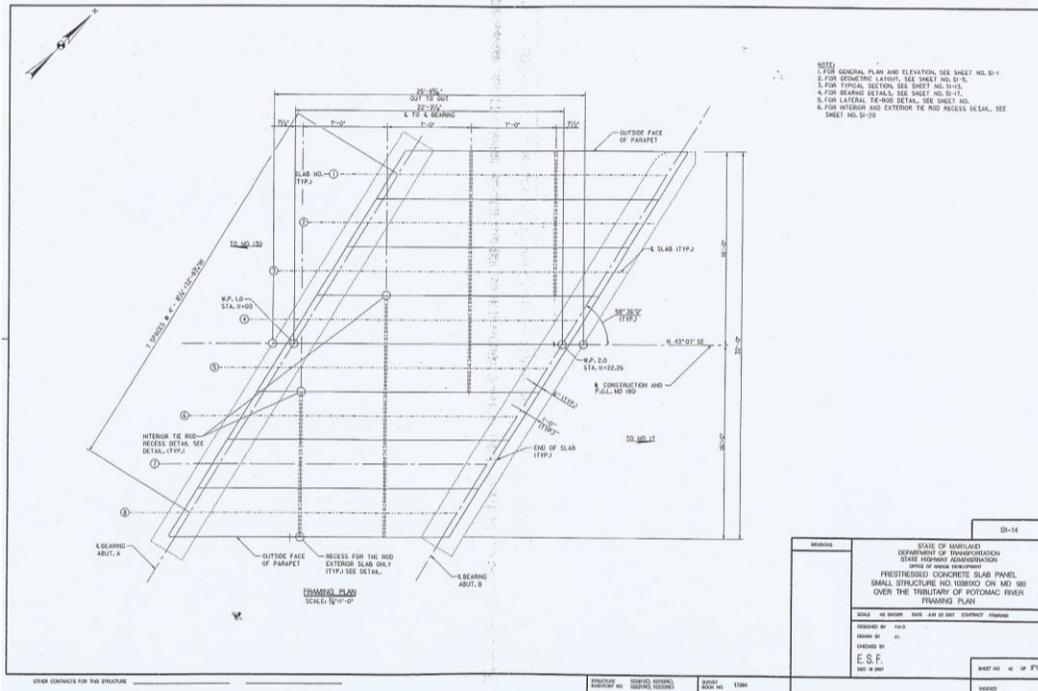
Figure B-6: Knoxville Bridge Framing Plan.

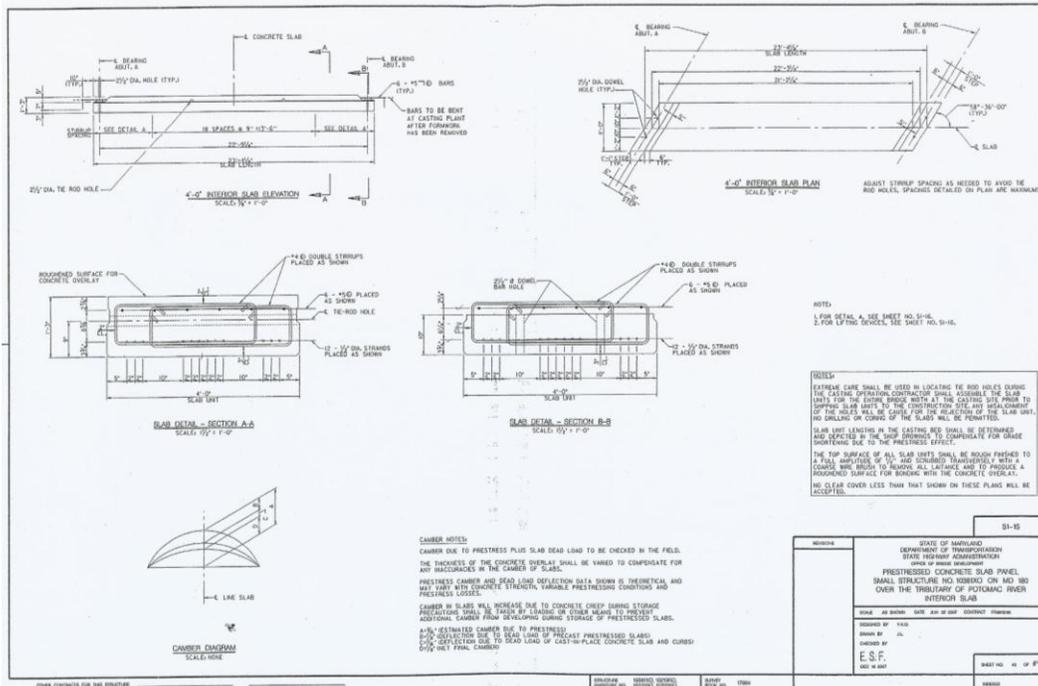
Figure B-7: Slab Details of the Knoxville Bridge.
