CORROSION RESISTANCE OF WEATHERING STEELS

Kyungha Park

Thesis submitted to the Faculty of the Graduate School of the  
University of Maryland, College Park in partial fulfillment  
of the requirements for the degree of  
Master of Science  
2004

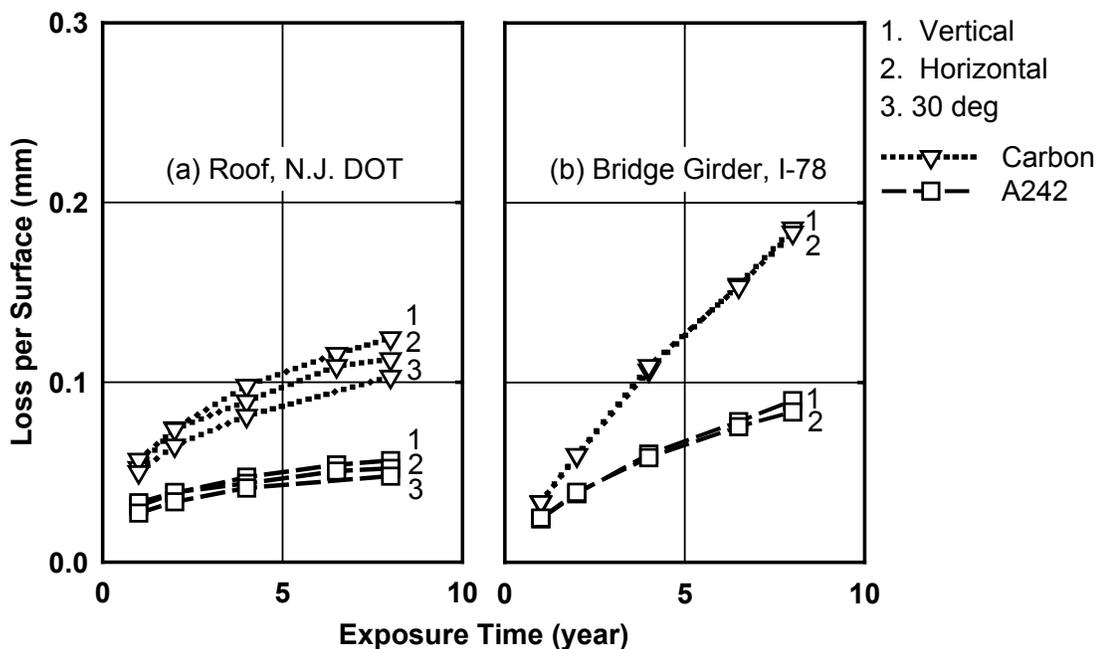
FIG. 2.1. Effect of exposure angle on corrosion of steels in Newark, N.J., industrial atmosphere (Cosaboom 1979)

Cosaboom et al. (1979) explained that “the site was selected to expose the specimens to what were considered the most corrosive atmospheric conditions.” 30-deg specimens, which were close to the latitude of the site, were corroded less than horizontal and vertical specimens because they washed and dried within a short time after the rainfall, as shown in Fig. 2.1(a) Roof, N.J. DOT.

On the other hand, Fig. 2.1(b) Bridge Girder, I-78 shows that the difference between corrosion at the vertical and horizontal conditions at the bridge-mounted specimens is very small because these specimens were mounted on an interior beam located at the center-span of a bridge girder on I-78. According to Cosaboom et al. (1979), the bridge was opened to traffic after several years, and was found to be free from salt spray or exhaust fumes. Nevertheless, in comparison to the A242 steel specimens, carbon steel corroded more on the bridge than when it was located on the roof. According to Cosaboom et al. (1979), “carbon steel is highly sensitive to atmospheric conditions.”

The experiments of Cosaboom et al. (1979), Zoccola (1976), and the worldwide data shows that weathering steel, A242 and A588 steels, corroded less than carbon steel in rural, industrial, and marine environments. In addition, the specimens facing south at 30-deg corroded less than vertical and horizontal specimens as shown in Fig. 2.1 (Cosaboom et al. 1979) and Fig. 2.3 to 2.8 from the worldwide data.

As generally expected, vertical specimens on the roof from Cosaboom et al. (1979) were less corroded than horizontal and 30-deg specimens under bald exposure. However, Zoccola (1976) did not confirm this expectation because the corrosion rates of horizontal specimens in both cases were higher than those of vertical specimens. Since there was a traffic way below the bridge, salt spray was kicked up by the traffic and accumulated more densely on the horizontal specimens than on the vertical specimens, owing to presence of water in the drainage. Nevertheless, microclimate conditions affecting the corrosion of steel might be studied as further research.

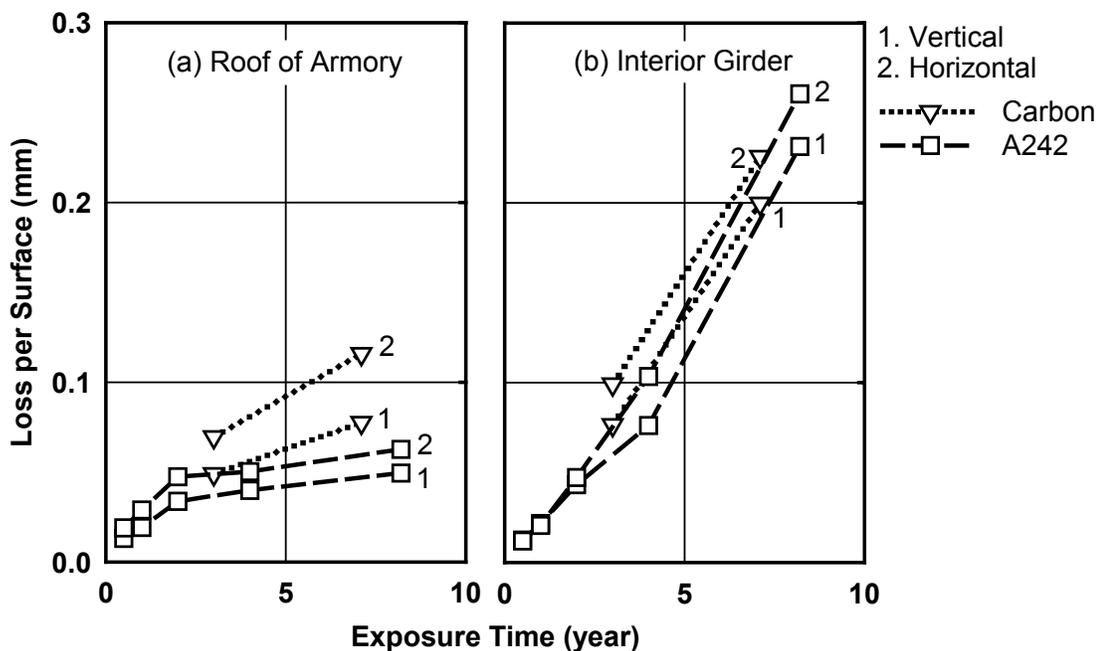
FIG. 2.2. Effect of exposure angle on corrosion of steels in Detroit, Mich. (Zoccola 1976)

The horizontal specimens corroded more than the vertical specimens, unpredictably contrary to the test by Cosaboom et al. (1979) reported in section 2.1. Zoccola (1976) described how the test site was subjected to accumulated road dirt and salts on steel surfaces. There was a high retaining wall along the shoulder of the highway beneath the low-level service bridges and tunnel-like conditions in the underpass next to the wall. For this reason,

road spray, dirt and salts were carried by the air blast created by the heavy traffic on the expressway, and easily contaminated the horizontal specimen. The prolonged wetness caused by deposits, chlorides, and sulfates in close contact with the steel accelerates corrosion.

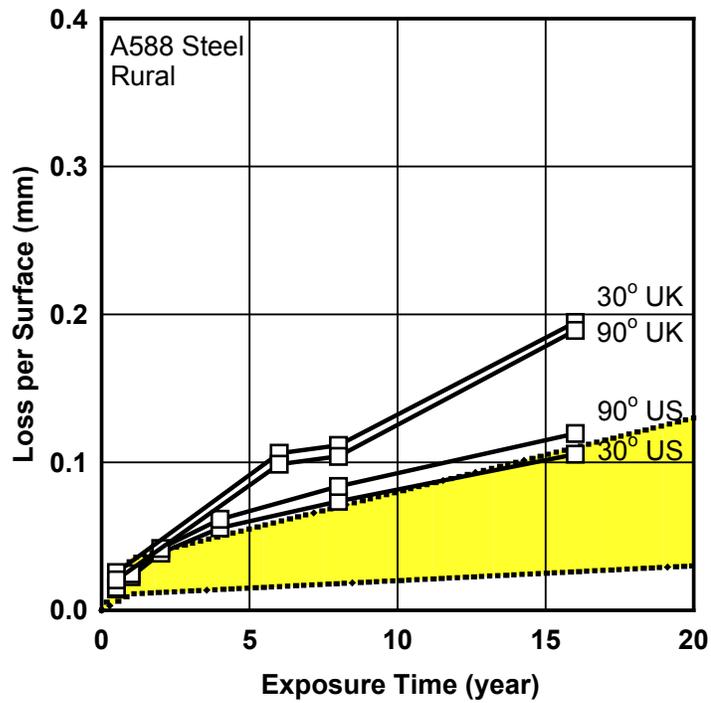
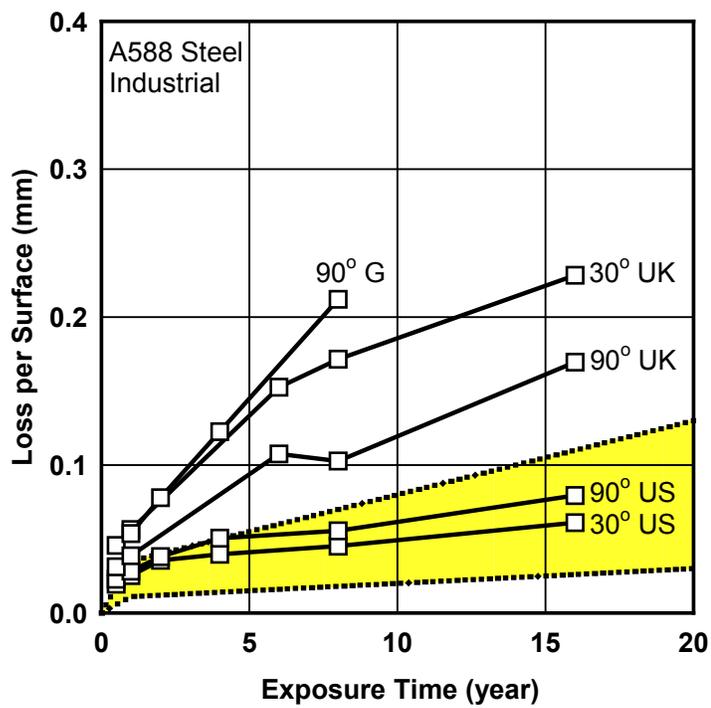
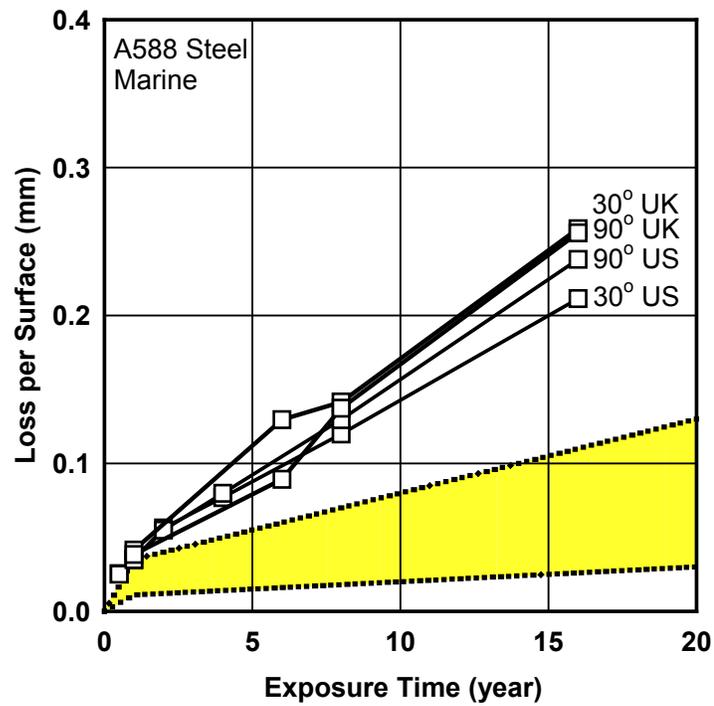
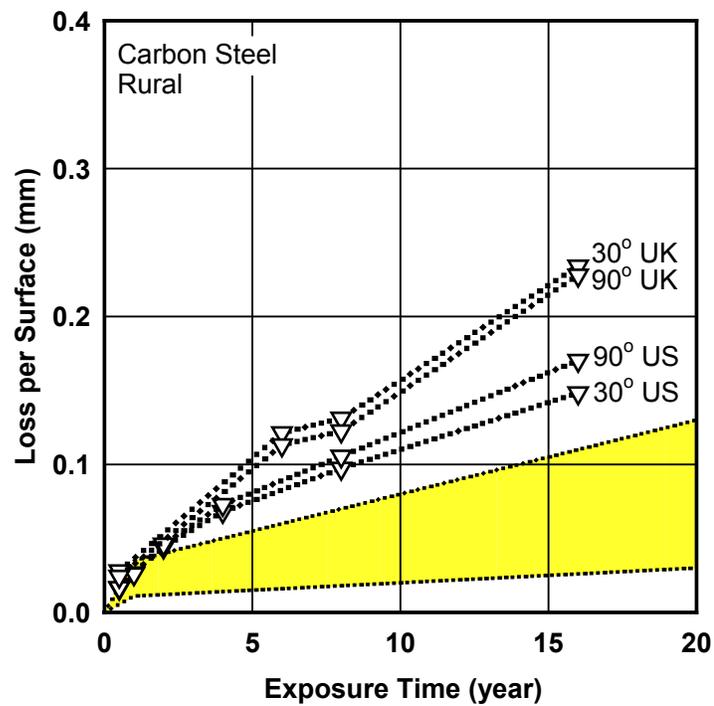
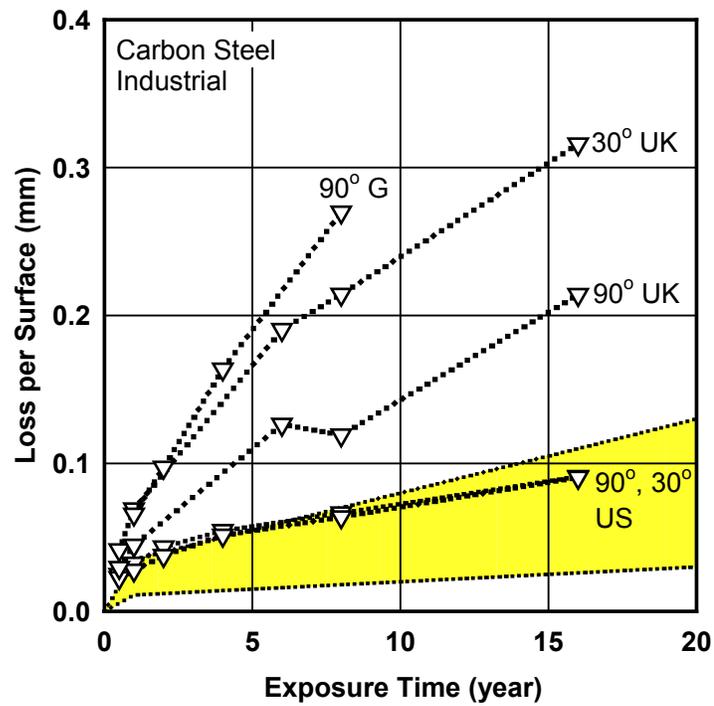
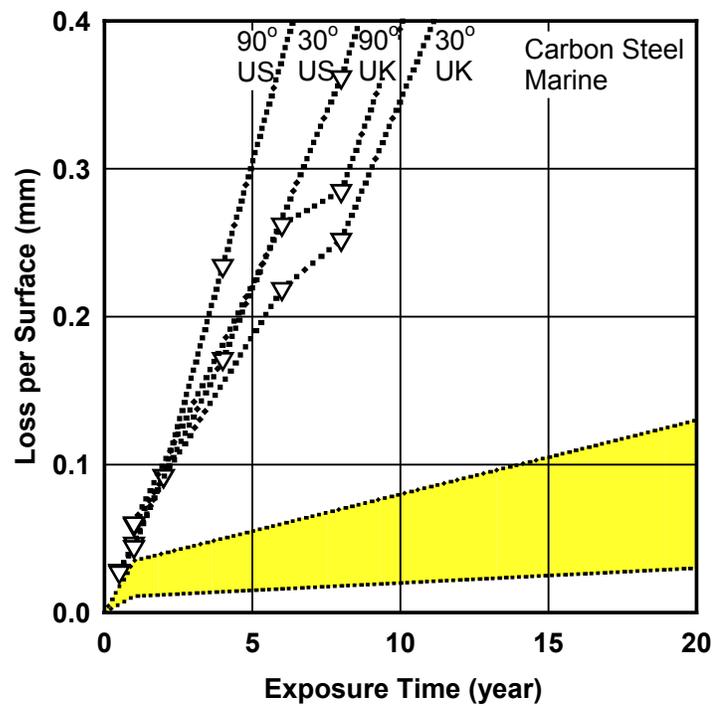
FIG. 2.3. A588 steel in rural environments

FIG. 2.4. A588 steel in industrial environments

FIG. 2.5. A588 steel in marine environments

FIG. 2.6. Carbon steel in rural environments

FIG. 2.7. Carbon steel in industrial environments

FIG. 2.8. Carbon steel in marine environments

The results of the study are presented as thickness loss curves in Figs. 2.3 to 2.8 organized by type of environment and type of steel. Each figure compares a 30 deg angle of exposure with a 90 deg angle of exposure, taking the average of the data for thickness loss curves, in three countries: US, UK, and Germany. Since the United Kingdom extends from 50 to 60 deg latitude, 90 deg specimens were corroded less than 30 deg in all three rural, industrial, and marine environments. The United Kingdom is located between the North Atlantic Ocean and the North Sea, where prevailing southwest winds over the North Atlantic, picking up a lot of moisture. Therefore, more corrosion thickness loss per surface occurs on the specimens in UK than in the US.

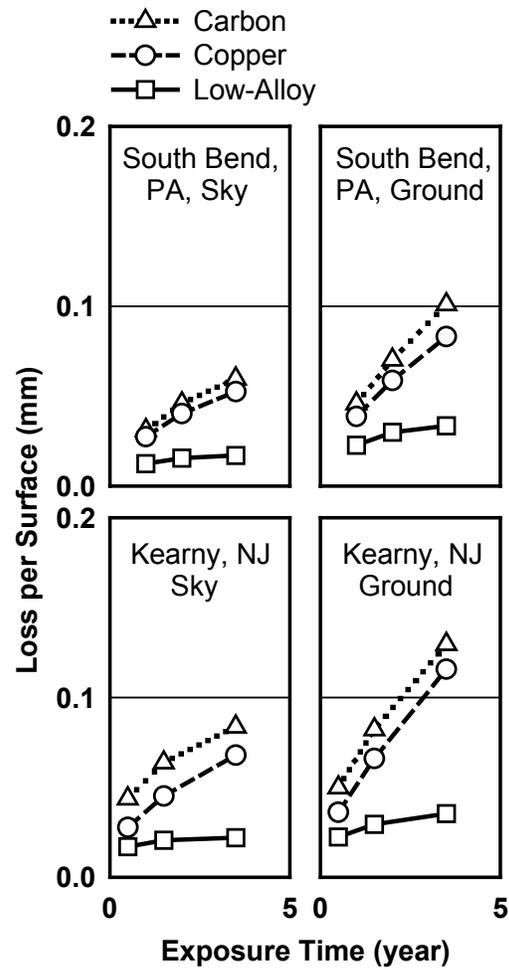
**FIG. 3.1. Effect of skyward versus groundward exposure on corrosion of steels in the rural atmosphere of South Bend, PA, and the industrial atmosphere of Kearny, NJ (Larrabee 1944)**

The weathering steel panels performed with lower corrosion rate than other copper and carbon steels in the experiments of Larrabee (1944) and Zoccola (1976), as generally expected: the corrosion rate of the skyward specimens was lower than that of the groundward ones (Fig. 3.1 and Fig. 3.2(b)). The specimens, especially carbon and copper steels, corroded more in industrial Kearny, NJ, than in rural South Bend, PA. The thickness losses per surface of low-alloy steel in both rural and industrial atmospheres slowly increased; however, that of copper or carbon steel apparently grew especially at industrial Kearny, NJ, as seen in Fig 3.1.

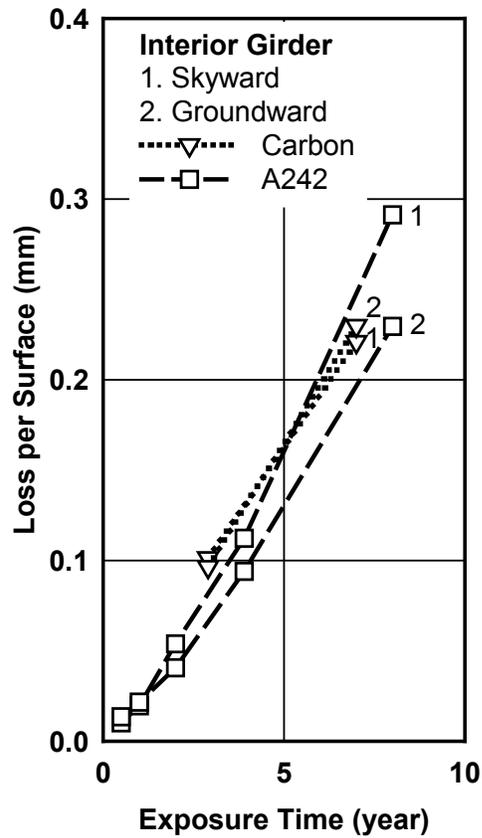
FIG. 3.2(a). Effect of sheltering skyward versus groundward exposure on corrosion of steels horizontally exposed to the Detroit, Mich., industrial atmosphere (Zoccola 1976)

On the other hand, the result of the corrosion rates in Fig. 3.2(a) Interior Girder was not clear: The thickness loss per surface on the skyward and

groundward specimens of carbon steel was very similar to each other. The corrosion rate of A242 steel on the skyward surface was even higher than on the groundward surface because the interior girder was located in the sheltered area where there was a high-concrete retaining wall on one side and abutments on the other side. As mentioned before in section 3.2, the location of the specimen could be considered as a significant factor in preventing further corrosion.

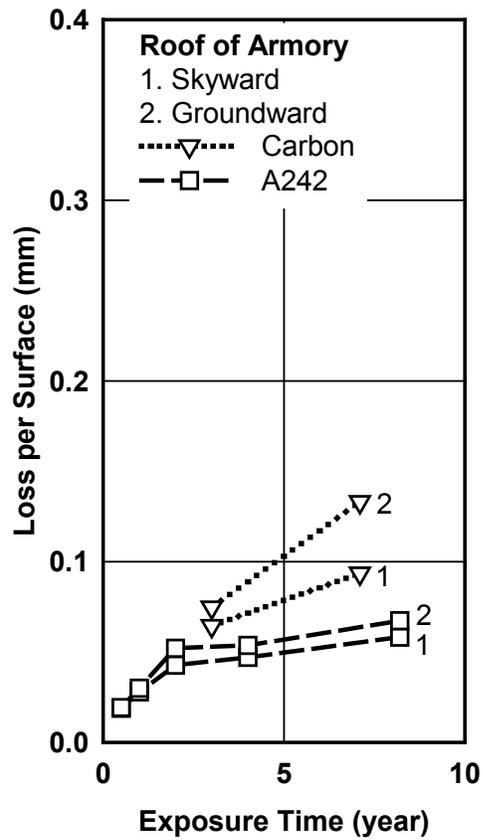
**FIG. 3.2(b). Effect of sheltering skyward versus groundward exposure on corrosion of steels horizontally exposed to the Detroit, Mich., industrial atmosphere (Zoccola 1976)**

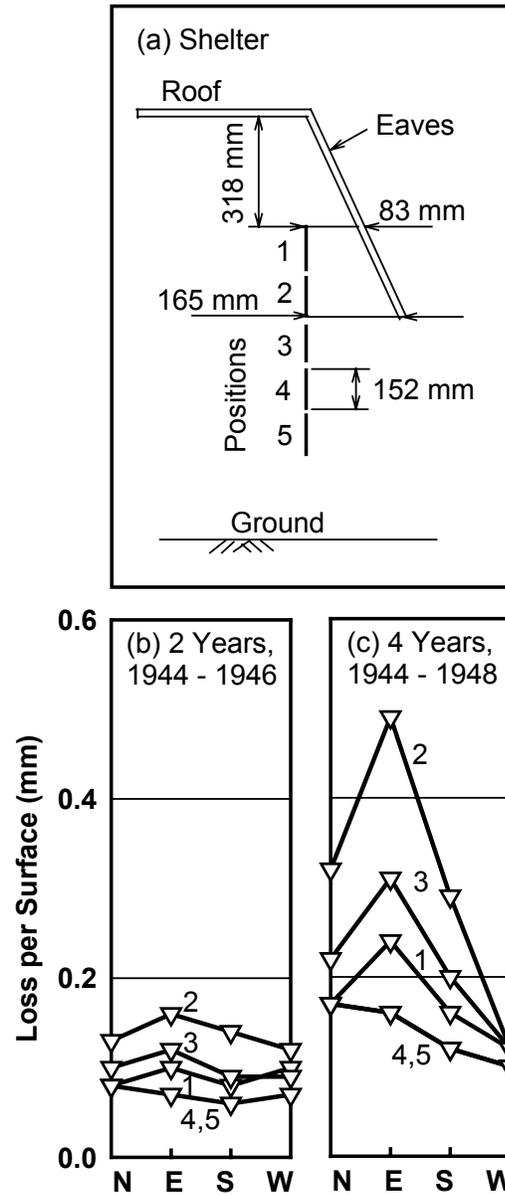
FIG. 4.1. Effect of sheltering on corrosion steel exposed to the Kure Beach, NC, marine atmosphere (Larrabee 1966)

In the Larrabee (1966) experiment, groups of five specimens each were vertically exposed as shown in Fig. 4.1 (a). Specimens 1 and 2 were entirely sheltered and specimen 3 was partially sheltered. Baldly exposed specimens 4 and 5 were hit by wind, rain, and sunshine. The sheltered test racks were located in semi-rural South Bend, PA, and in marine Kure Beach, NC. The corrosion results at both sites are summarized in Table 4.1. The two bottom specimens facing south or west received more sunlight than did those higher specimens facing north: the longer exposure to sunlight seems to have resulted in a more protective rust layer on the bottom specimens. The corrosion rates of specimens 4 and 5 were obviously lower than those of the other three specimens. Specimens 2 and 3 were, on the other hand, more severely corroded due to prolonged wet periods under the shelter. Specimen 1 was in good condition, being sheltered from both water and sunshine.

The four-year data for carbon steel was plotted differently for the marine atmosphere, Kure Beach, NC in Fig. 4.1 (c) and Table 4.1. More seawater spray and deposits by hurricane-force winds led to extreme corrosion of the specimens facing east, contrary to the specimens facing west, which received the least amount of seawater spray during the first few months of the test period. Additionally, the rain washed the salt sprays from the rust of the bottom specimens, 4 and 5. They were the least corroded (Larrabee 1966).

Larrabee (1966): the use of sheltered racks gave us an idea of which locations may prevent corrosion. Perfectly sheltered specimen 1 was less corroded than specimens 2 and 3. Specimens 2 and 3 were severely penetrated by corrosion because of prolonged wet periods under the shelter. Additionally, the corrosion rates of specimens 4 and 5 were obviously lower than other specimens, as mentioned by Larrabee (1966).

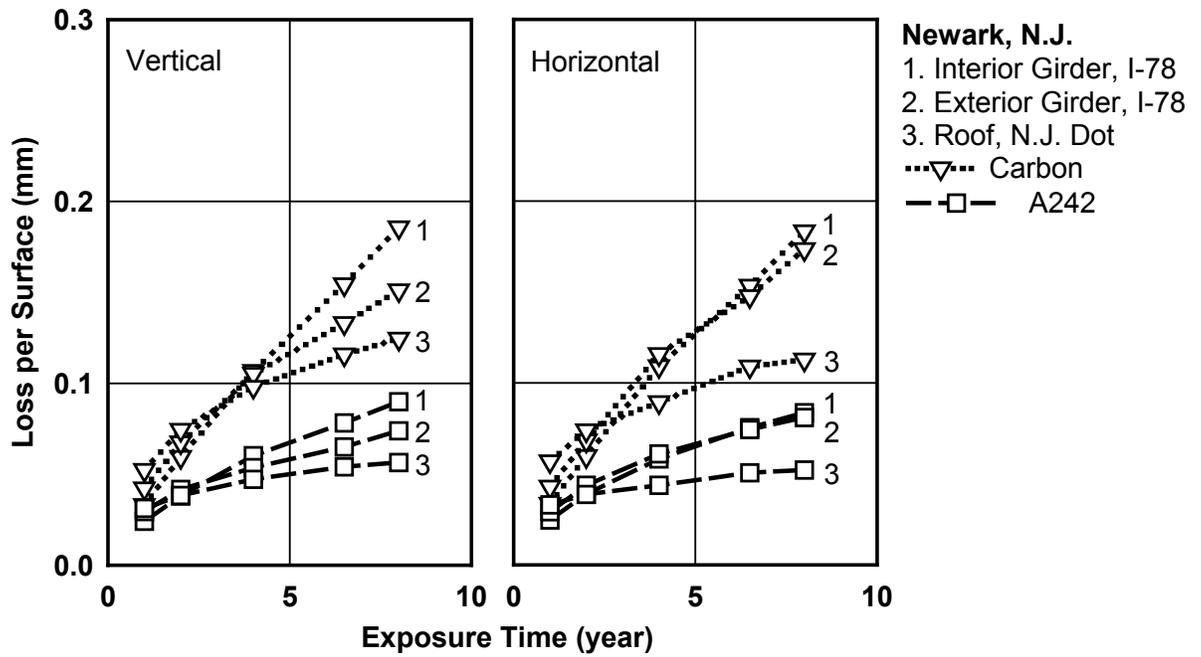
FIG. 4.2. Effect of sheltering on corrosion of steels exposed to the Newark, NJ, industrial atmosphere (Cosaboom 1979)

The data from Cosaboom et al. (1979) provided corrosion data for A242 and carbon steels in industrial Newark, NJ. The specimens were mounted vertically and horizontally on the interior and exterior girders of Bridge No. 9 on Interstate I-78, Section 5V, and on the roof of a nearby two-story building

occupied by the New Jersey Department of Transportation. There was a 6.5-year gap after construction until the bridge was opened and exposure of the weathering steel specimens began; therefore, there was no traffic either on or below the bridge during time that the bridge was closed. Vertical and horizontal specimens were used to imitate a web or a flange of the girder. In both vertical and horizontal cases, the bridge-sheltered specimens lost up to 65 percent more thickness of A242 and carbon steels than those baldly exposed on the building roof. Moreover, the vertical specimens corroded more on the interior girders than the exterior girders, while the horizontal specimens corroded almost the same on interior and exterior girders.

The corrosion loss per surface at mid-span of an interior girder was not different than corrosion loss per surface near the abutment because the bridge had been newly constructed and the test had been delayed for the initial 6.5 years without any traffic. As a result, there was no salt-contaminated water and accumulated debris near the abutments (Cosaboom et al. 1976).

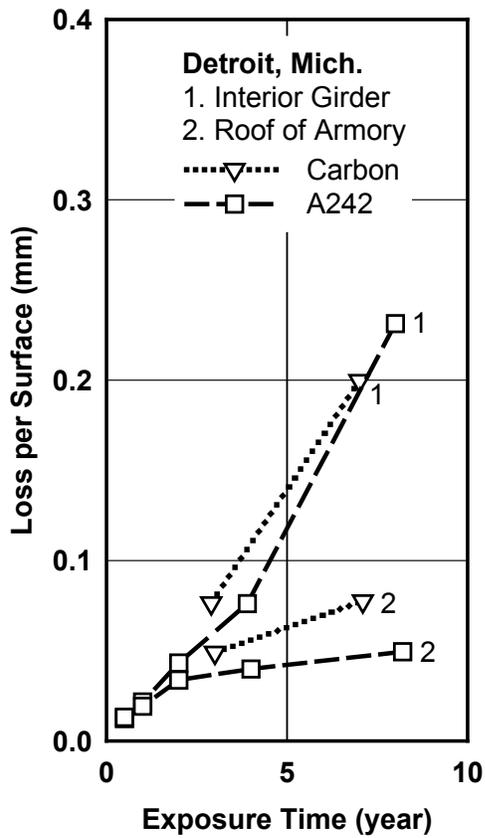
FIG. 4.3. Effect of sheltering on corrosion of steels exposed to the Detroit, Mich, industrial atmosphere (Zoccola 1976)

Zoccola examined the corrosion test with A242 and carbon steels in Detroit, Mich. The vertical specimens were attached on an interior girder of Eight-Mile Road over US highway 10 and the roof of the National Guard Armory, near the bridge. The bridge was opened to traffic in 1964; the freeway below, in 1965. Corrosion specimens were exposed in the tunnel-like underpass of the westbound service bridge above the southbound lanes of the expressway. (More detailed test information was mentioned in Chapter 3.)

A242 and carbon steels in Fig. 4.3 were both two times more corroded on sheltered interior girders than on open exposures. The A242 steel was less corroded than the carbon steel on the roof of the Armory, while there was poor behavior of A242 steel on an interior girder. It can be argued that this expressway demonstrated a major problem for weathering steel corrosion exposed to traffic fumes, road salt, and dirt which caused the specimens to develop heavy, flaky rust and a significant accumulation of deposits.

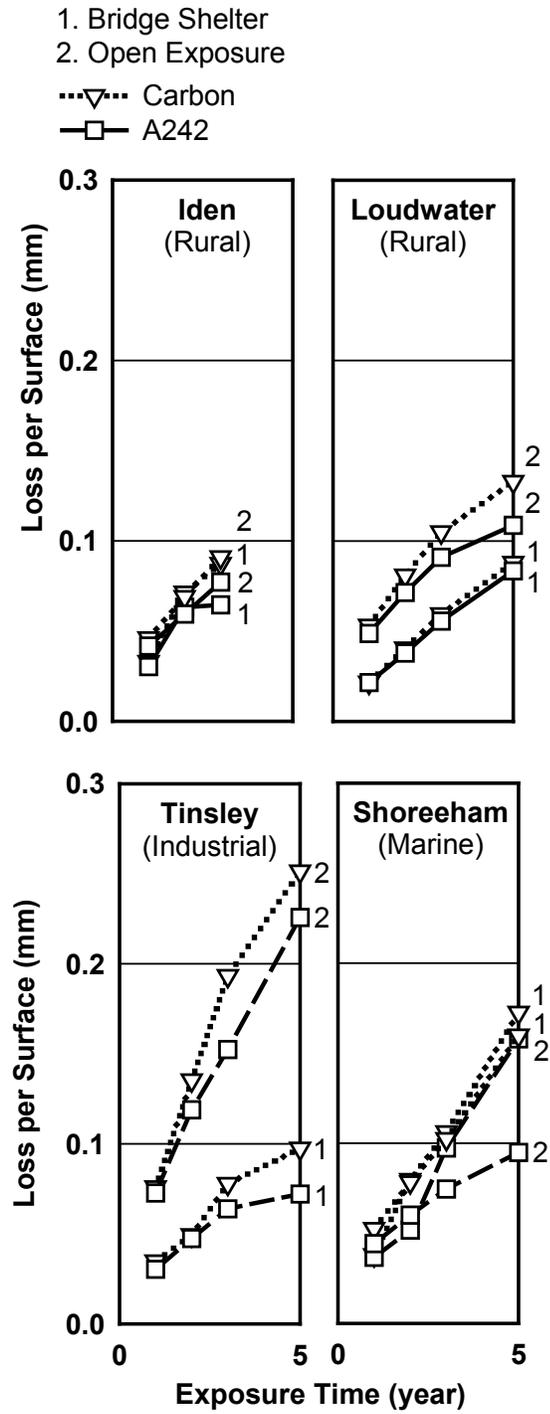
FIG. 4.4. Effect of sheltering corrosion on steels exposed at four British sites (Mckenzie 1978)

Duplicate specimens of each steel were removed from each exposure position annually for periods of up to five years. After derusting, corrosion rates were established by weight loss over the exposure period. The specimens were examined for pitting and in some cases measurements of pit depths. Environment conditions are shown in Table 4.2.

- **Comparison of open exposure and bridge sheltering:** “the corrosion time curves for Tinsley, Loudwater, Eastney and Iden are shown in Fig. 4.3. It is clear from these that the corrosion rates measured beneath a bridge can differ considerably from those measured in open exposure. At Tinsley and Loudwater, bridge sheltered corrosion rates for both steels were much lower than in open exposure over the period of the test. At the marine site however the opposite was found, indicating the particularly adverse effect of chlorides under sheltered conditions. At Iden, open exposure and bridge-sheltered rates were similar. There were also differences between the shapes of the corrosion time curves in open and bridge-sheltered exposure. In particular, at Loudwater, there was very little sign of a reduction in corrosion rate with time under bridge sheltering so that, for Cor-Ten B, the corrosion rate over the last two years of the test was higher than in open exposure.” (Mckenzie 1978, pp. 4–5)

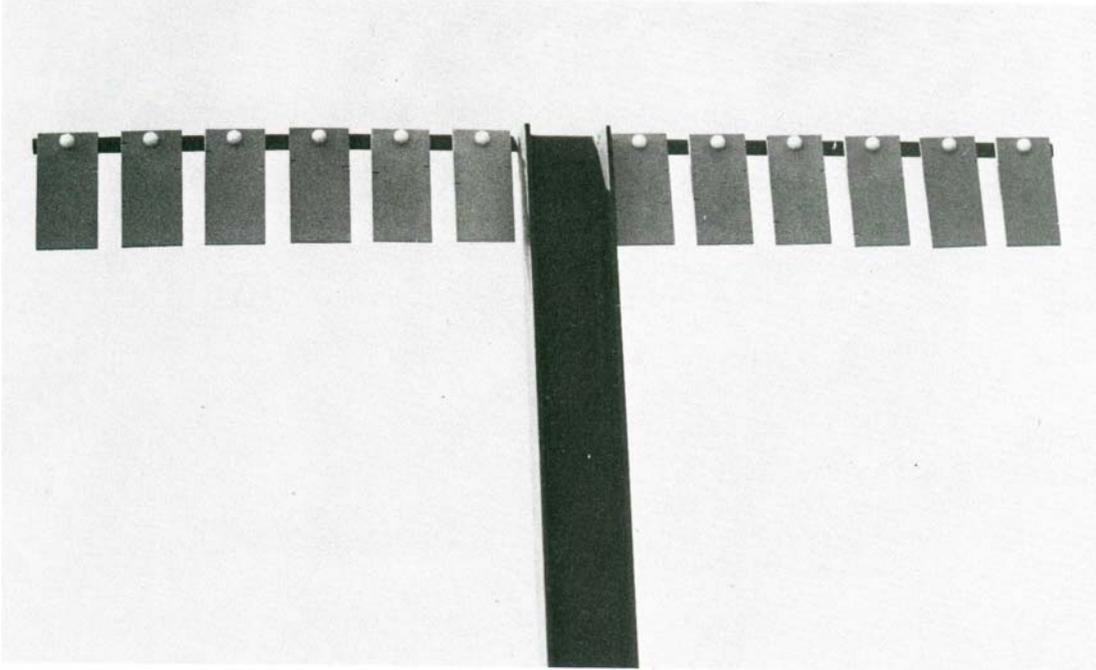
**FIG. 4.5. Open exposure test specimens (McKenzie 1978)**

McKenzie (1978) concluded the corrosion rates were as follows (actual test sites are shown in Fig. 4.5 and Fig. 4.6):

- **Open exposure:** “the special mild steel corrosion rates and the Cor-Ten B rates are shown Fig. 4.2. Cor-Ten B corroded at a generally lower rate than the special mild steel and although there were signs of a reduction in corrosion rate with time, at none of the sites could the corrosion rate be considered negligible.” (Mckenzie 1978, pp. 4–5)

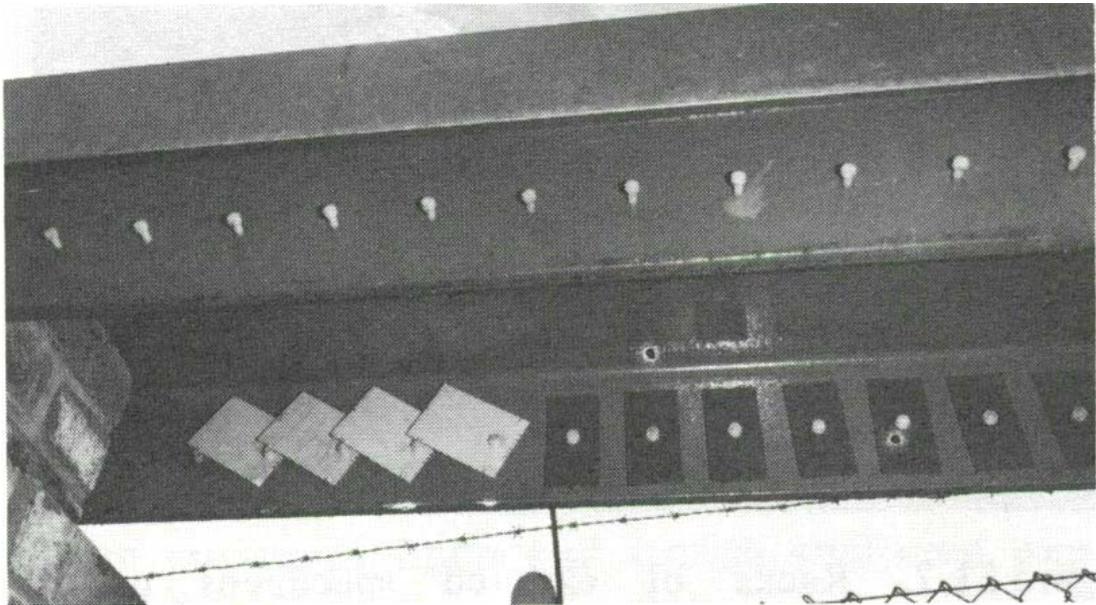
**FIG. 4.6. Girder sheltered test specimens (McKenzie 1978)**

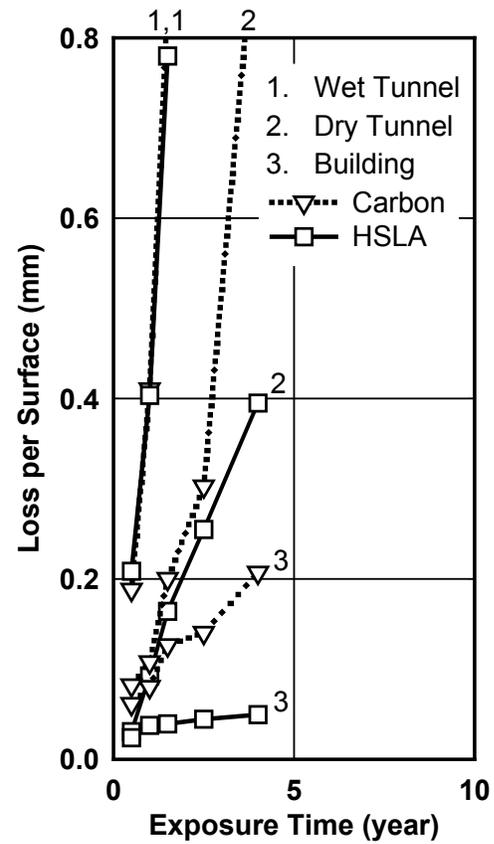
**FIG. 5.1. Effect of continuously moist conditions on corrosion of steels (Larrabee 1966)**

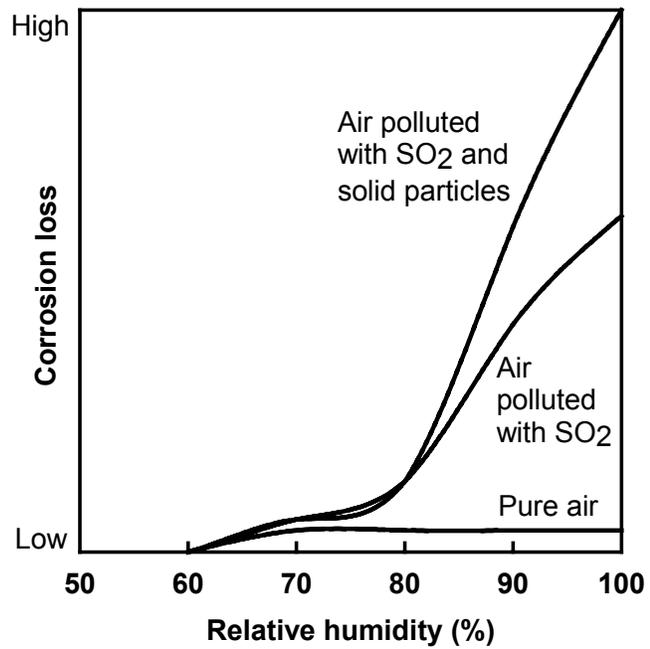
**FIG. 5. 2. Simplified diagram showing the effect of relative humidity and pollution on the corrosion of carbon steel (after Vernon)**

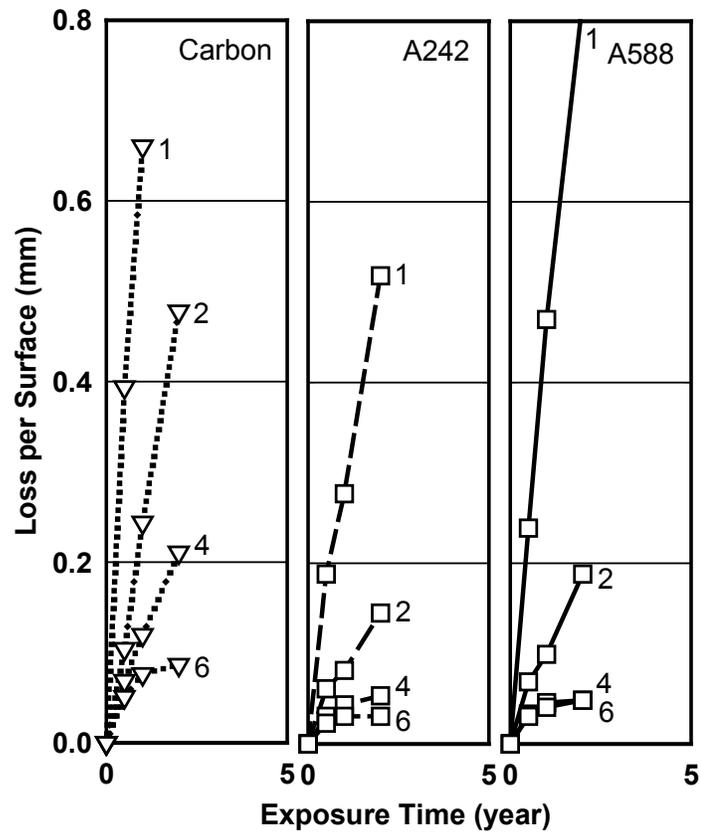
**FIG. 6.1. Corrosion penetration of carbon and weathering steels exposed to various chemical plant atmospheres (see Table 6.1) (Schmitt 1967)**

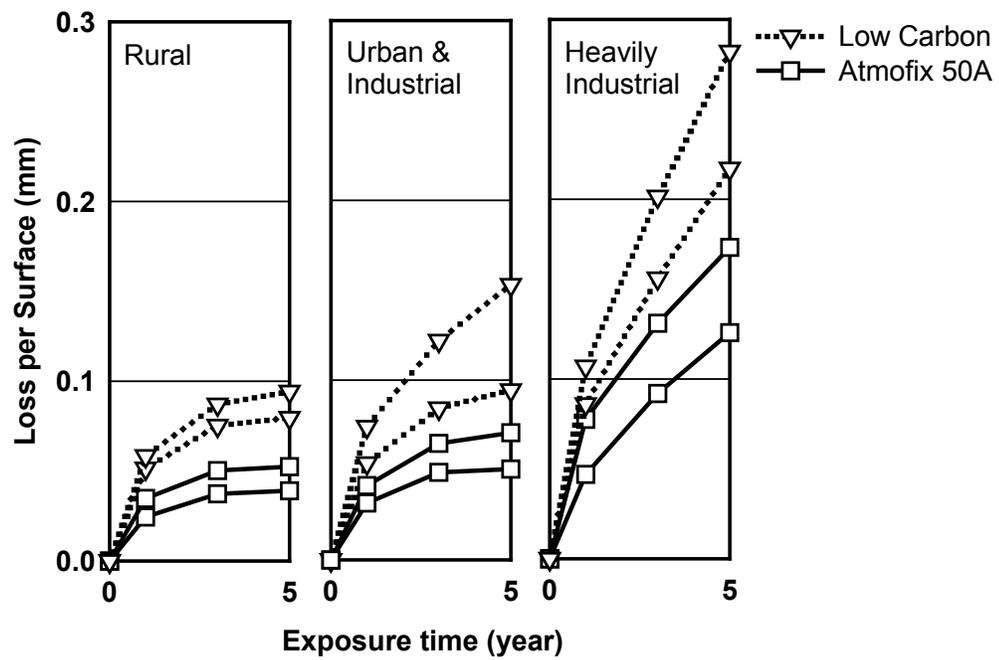
**FIG. 6.2.** Effect of sulfur dioxide content on corrosion of low carbon and weathering steels exposed to various atmospheres in Czechoslovakia (see Table 6.2) (Knotkova, Vlckova, and Honzak, 1982)

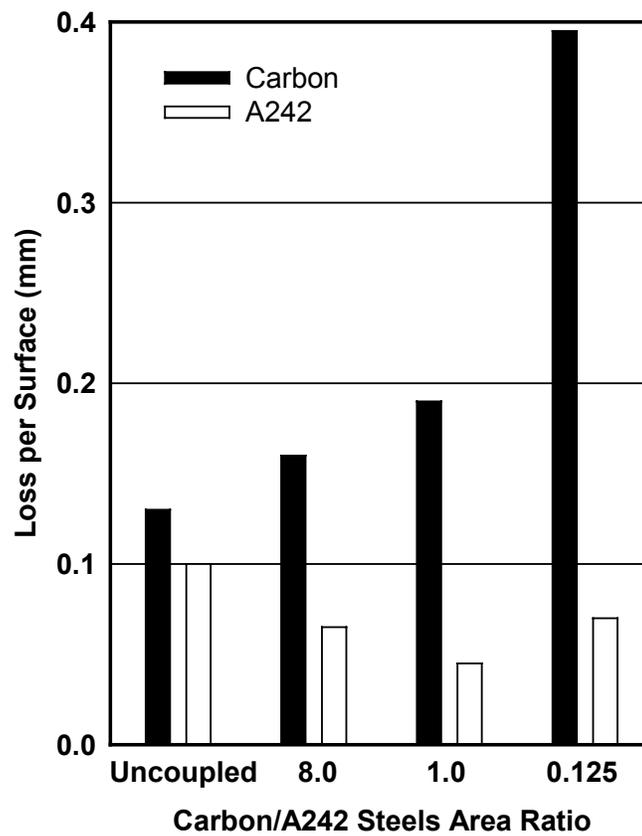
**FIG. 7.1. Corrosion thickness loss per surface of uncoupled and coupled steels after 6 months in seawater (Ellis and LaQue, 1951)**

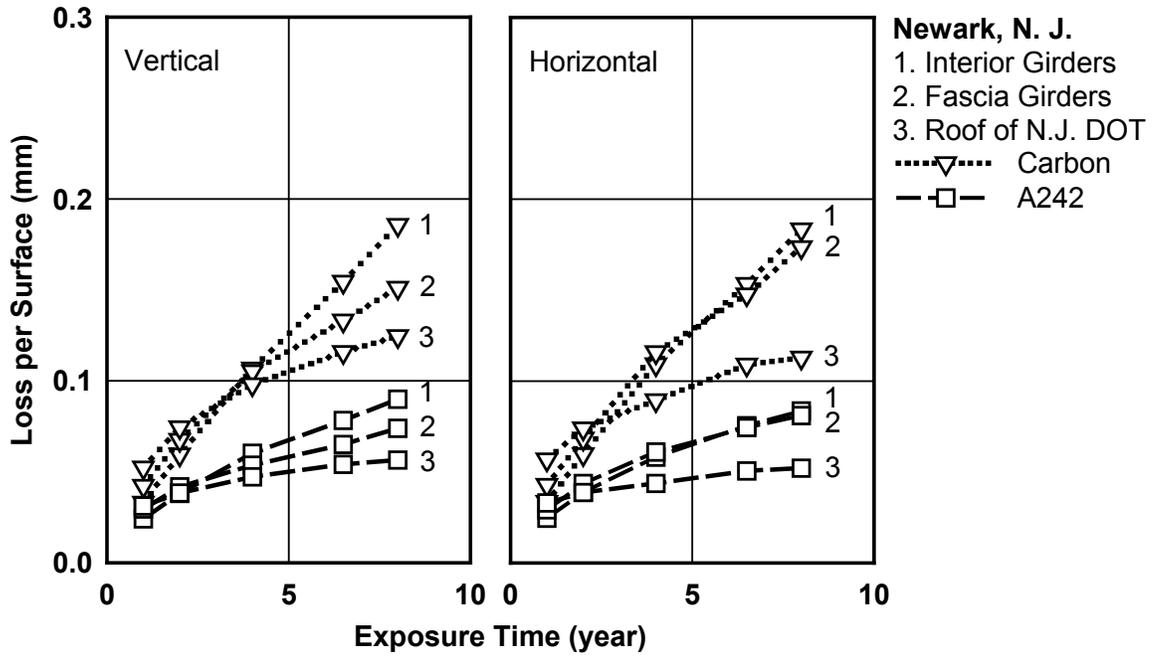
FIG. 8.1. Effect of salt contamination on corrosion (Cosaboom 1979)

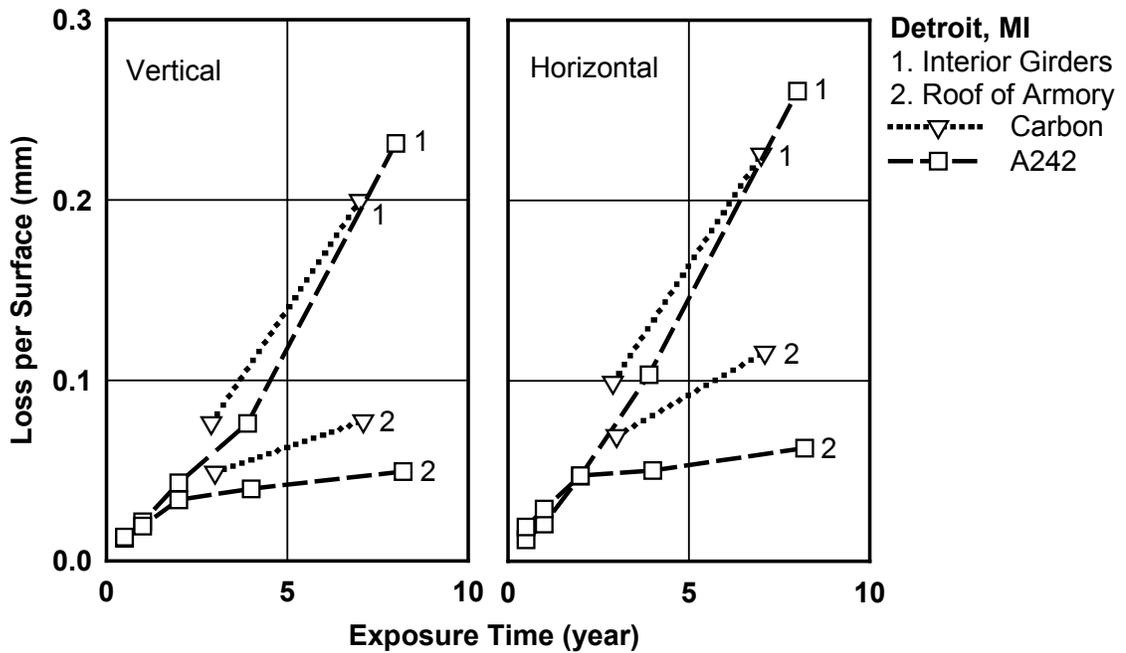
FIG. 8.2. Effect of salt contamination on corrosion (Zoccola 1976)

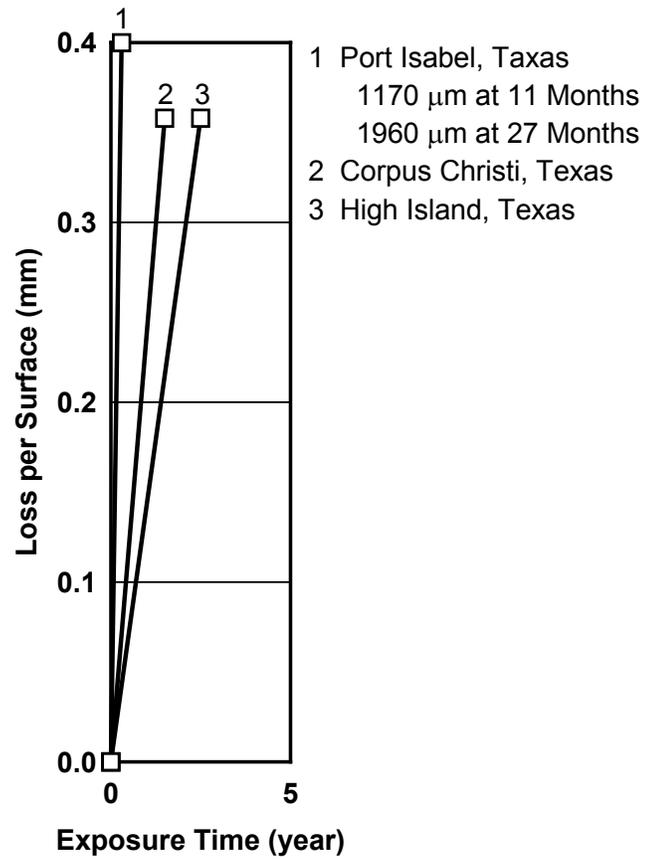
**FIG. 8.3. Effect of salt contamination on corrosion at Texas Gulf Coast atmosphere (Raska 1983)**

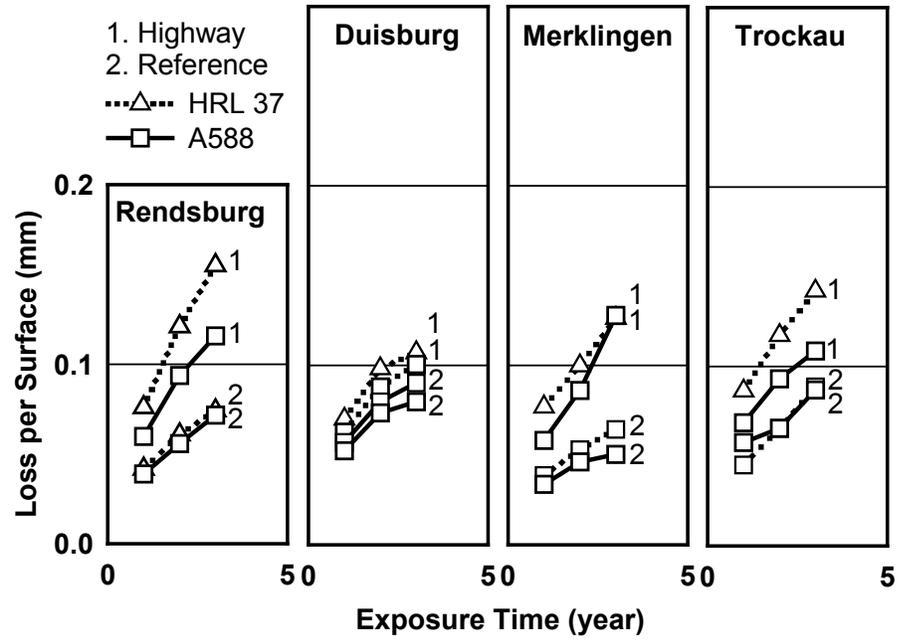
**FIG. 8.4. Effect of salt contamination on corrosion at various atmospheres in FRG (Hein 1981)**

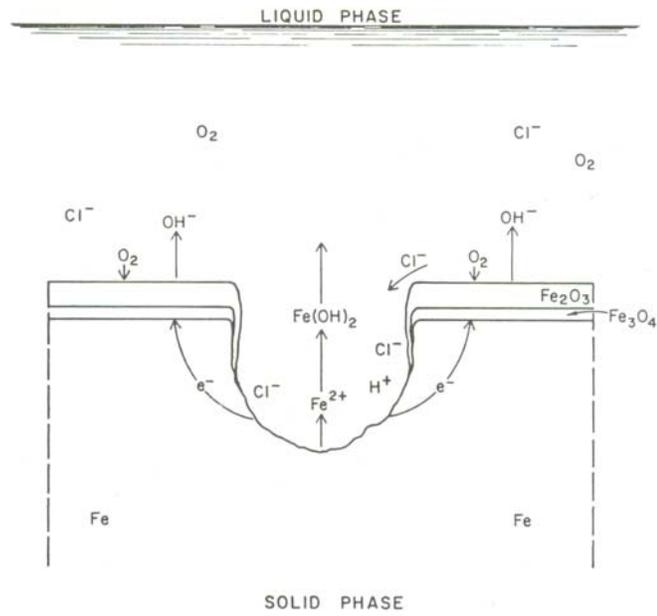
FIG. 9.1. Pitting of oxide covered steel (Wilhelm 1988)

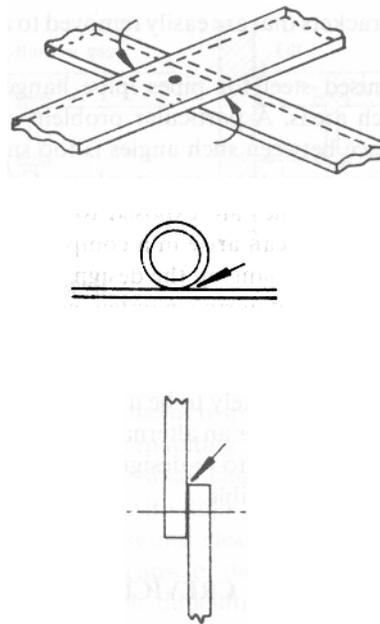
FIG. 9.2. Typical crevices situations (Chandler 1991)

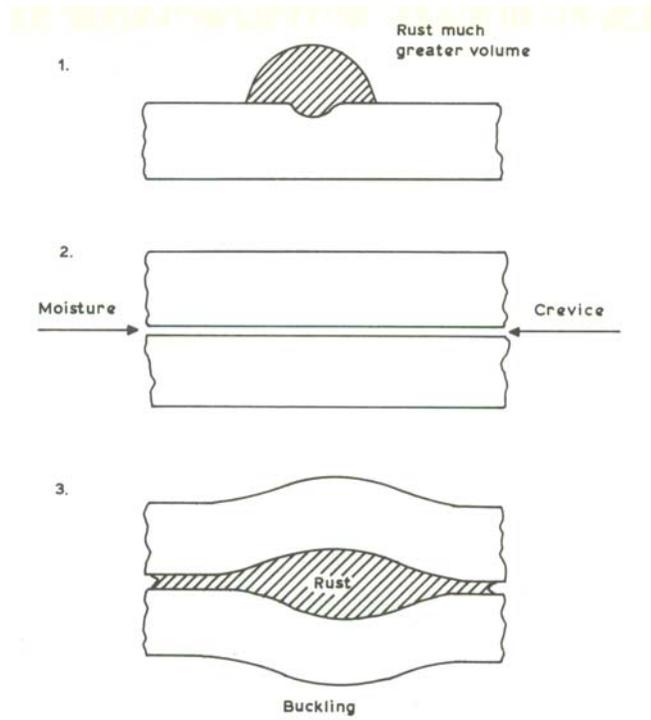
**FIG. 9.3. Rust formation in crevices (Chandler 1991)**

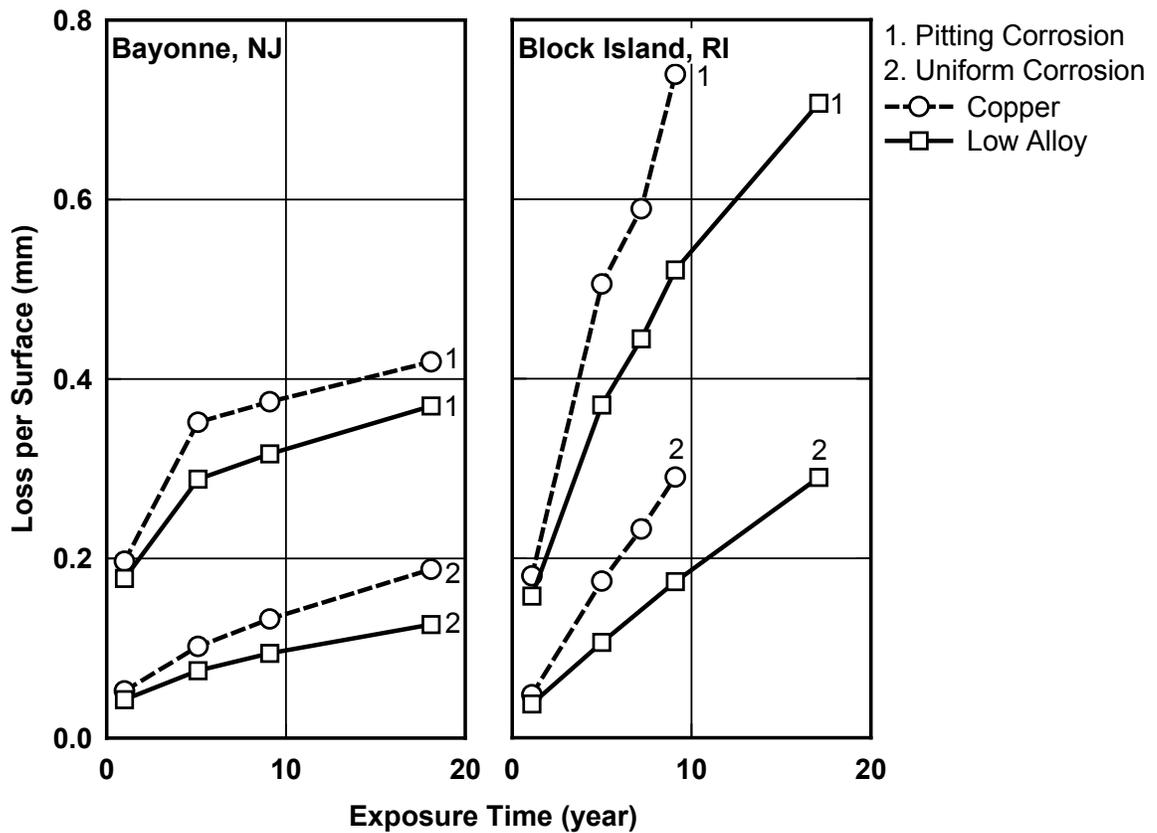
**FIG. 9.4. Comparison of pitting and uniform corrosion of copper steel and low-alloy steel exposed in industrial Bayonne, NJ, and marine Block Island, RI (Copson 1960)**
