Title of Document: THE EFFECT OF PACKAGE GEOMETRY  
ON MOISTURE-DRIVEN DEGRADATION  
OF POLYMER ALUMINUM CAPACITORS

Thesis submitted to the Faculty of the Graduate School of the  
University of Maryland, College Park, in partial fulfillment  
of the requirements for the degree of  
Master of Science  
2016

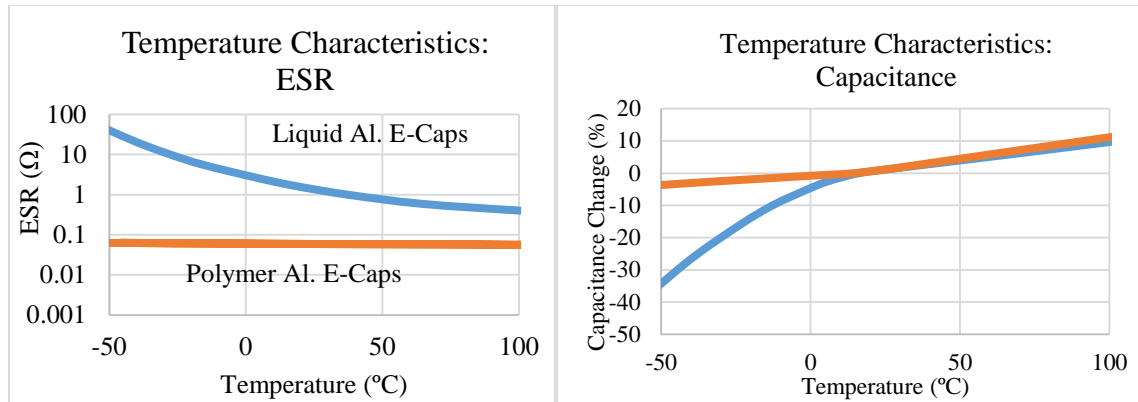
**Figure 4. Temperature Characteristics of Liquid and Polymer Aluminum Electrolytic Capacitors.**  
(Adapted from [9])

Temperature stability of polymer aluminum capacitors is also considered an advantage over their liquid electrolyte counterparts. The temperature-dependent electrical characteristics of liquid electrolytes result in capacitors with temperature-dependent electrical parameters. More specifically, liquid electrolytic capacitors show changes in capacitance and ESR over their rated temperature range. This is due to a decrease in conductivity of the liquid electrolyte and increase in viscosity in low temperatures, leading to increased ESR and decreased capacitance. Since the conductivity of the polymer PEDOT is constant over the capacitor's rated operating temperatures (-55°C to around 105°C), polymer aluminum capacitors show much more stable ESR over that temperature range, as seen in Figure 4 [9].

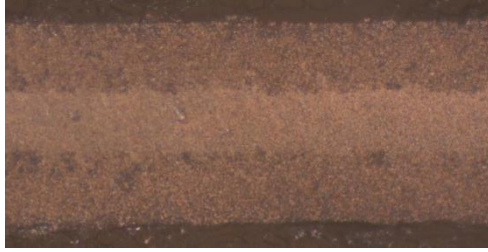
**Figure 7. Cross Section of Anode Foil with Oxide-Covered Etched Aluminum**

This process can result in increases of surface area of the aluminum foil of up to 150 times [8]. The next step in the manufacture of these capacitors is the formation of the dielectric layer composed of alumina on the etched aluminum anode. This is done by immersing the etched aluminum into a solution containing an ammonium salt of boric or phosphoric acid and applying a DC voltage to the aluminum. This results in an oxide formation with a thickness dependent on the DC voltage (or forming voltage) applied to the aluminum. The thickness achieved by the forming voltage is in the order of 1.3 to 1.5 nanometers per volt applied [17]. This method results in a dense, non-porous, barrier-type aluminum oxide. A schematic showing how the dielectric coats the highly etched aluminum anode is shown in **Figure 6**. An optical microscope image of what is represented in **Figure 6** is shown in **Figure 7**

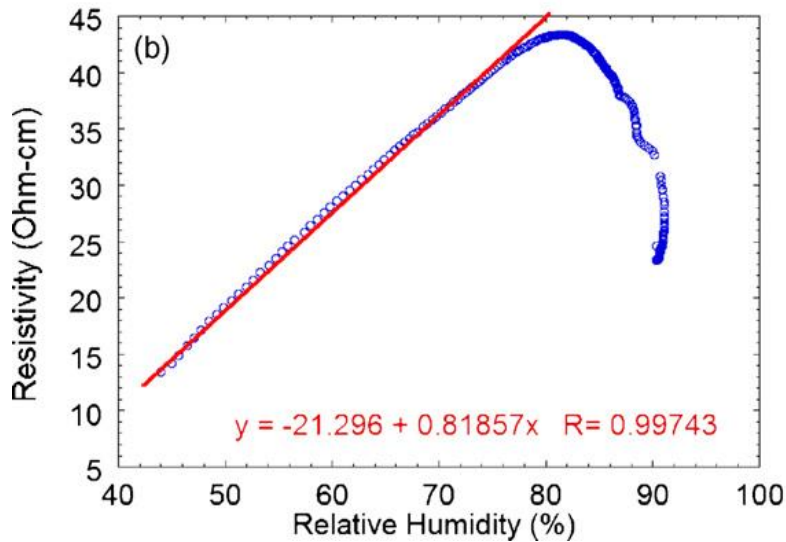
**Figure 9. Humidity-Dependent Resistivity of PEDOT-Based Humidity Sensor [22]**

Kus et al. performed a study titled “Electrical Characterization of PEDOT: PSS Beyond Humidity Saturation” in which a PEDOT: PSS humidity sensor was fabricated [22]. By subjecting the humidity sensor to varying relative humidity conditions, the authors were able to see reversible electrical properties of conductivity up to 80% relative humidity. As can be seen in **Figure 9**, the relationship between resistivity and relative humidity are linearly correlated up until a level of 80% relative humidity.

Up until 80% relative humidity, the increase in resistivity was attributed to the increase in distance between PEDOT chains in the polymer matrix as a result of an increase in the presence of water molecules. The larger distance between PEDOT chains makes the conducting mechanism of electron hopping more difficult, therefore increasing the resistance of the polymer. The sharp decrease in resistivity past 80% relative humidity is attributed to the formation of a meniscus layer of water upon saturation of the polymer, which dissolves PSS protons and atmospheric gases, thus leading to an increase in ionic conductivity past the 80% relative humidity saturation point.

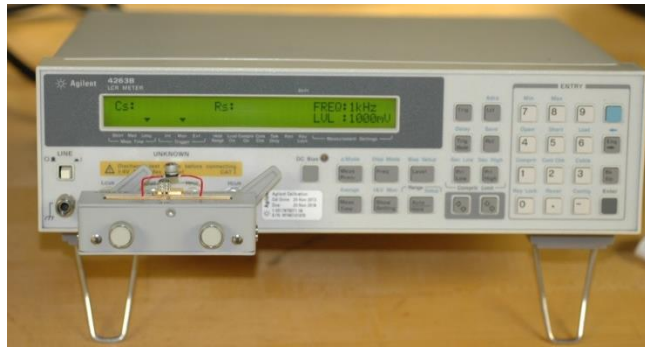
**Figure 10. Agilent 4263B LCR Meter with surface-mount polymer aluminum capacitor**

Various electrical parameters were monitored during the HAST and dry heat testing. Capacitance, equivalent series resistance, and dissipation factor were monitored with an Agilent 4263B LCR meter using an Agilent 16047E test fixture (Figure 10), leakage current was monitored with an Agilent 4155C semiconductor parameter analyzer (Figure 11) using an Agilent 16442A test fixture, and weight was monitored with a Mettler AE 100 Analytical Balance (Figure 12). AC measurements of capacitance and dissipation factor were taken with a 120 Hz 1 VAC signal, and equivalent series resistance measurements were taken with a 100 kHz 1 VAC signal. Leakage current measurements were taken by applying the rated DC voltage of the capacitors for 120 seconds, at which time the current was measured. All measurements were taken at room temperature, and all capacitors were allowed time to cool to room temperature after being removed from the HAST and dry heat environments.

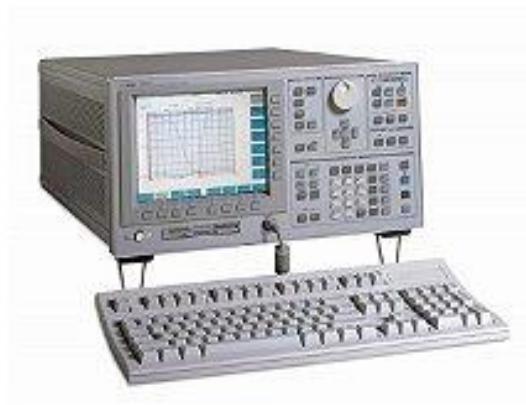
**Figure 11. 4155C Semiconductor Parameter Analyzer (from Keysight.com)**

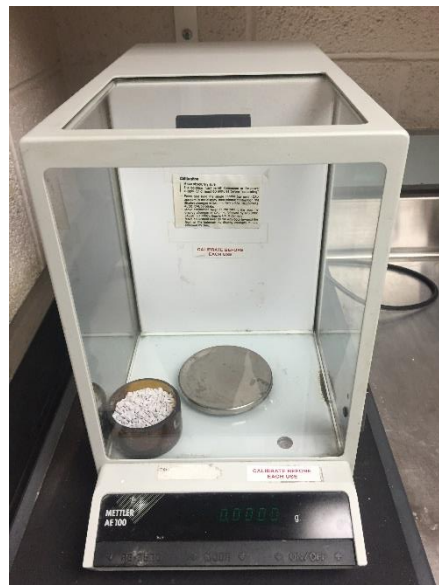
**Figure 12. Mettler AE100 Analytical Balance**

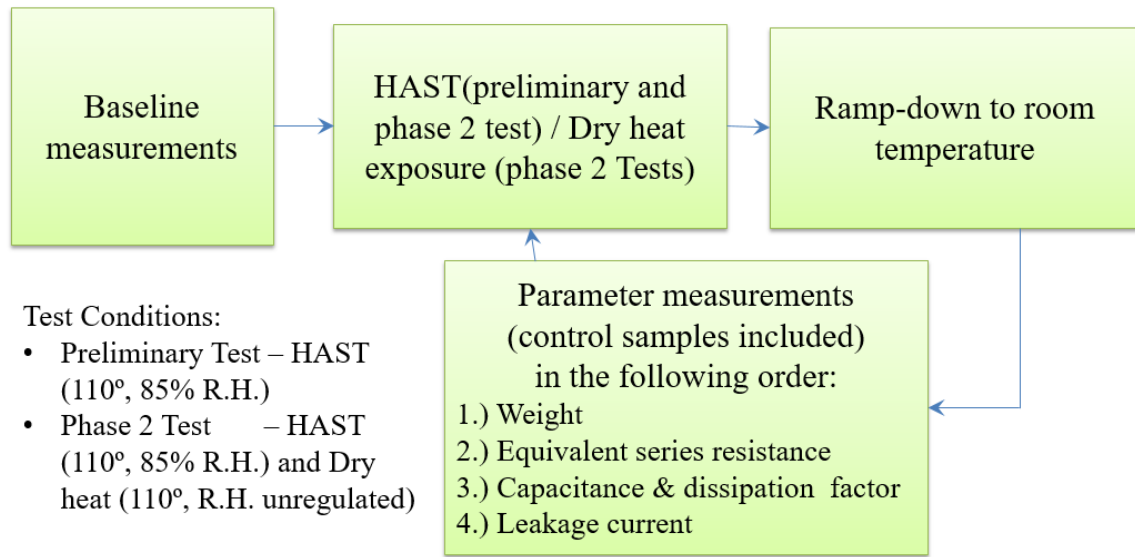
**Figure 13. Testing sequence flowchart**

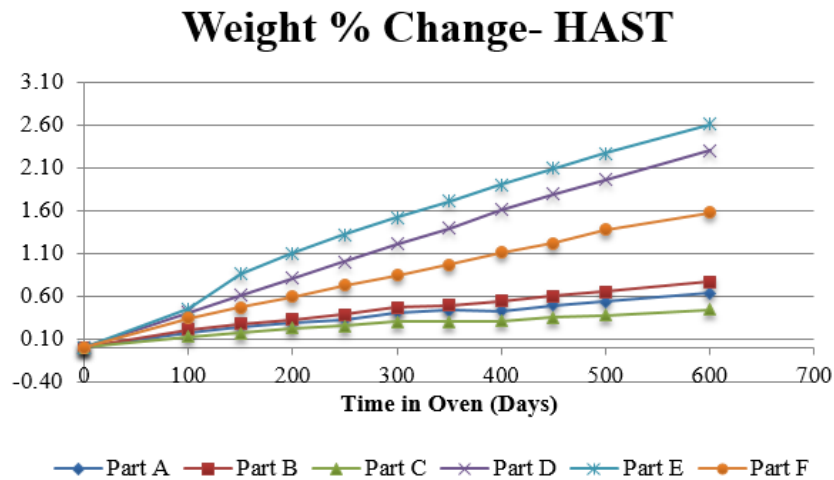
**Figure 15. Percent weight change for capacitors in Geometry-Based HAST test**

parameter measurements from the Geometry-Based HAST tests can be found in Appendix B. An example of the differences in degradation seen between parts from the same manufacturer, electrical ratings, and same capacitor series are seen in **Figure 16**. Furthermore, it can be seen that the rates of moisture uptake for these capacitors are also slightly different, depending on the capacitor sample. As seen on the results plots on Appendix B, and the results on **Figure 17**, capacitors D and E (both from manufacturer 2) both show considerably higher degradation rates than the rest of the capacitors tested in the Geometry-Based HAST tests. As seen in **Figure 15**, those two capacitors also experienced the highest % weight increase throughout testing.

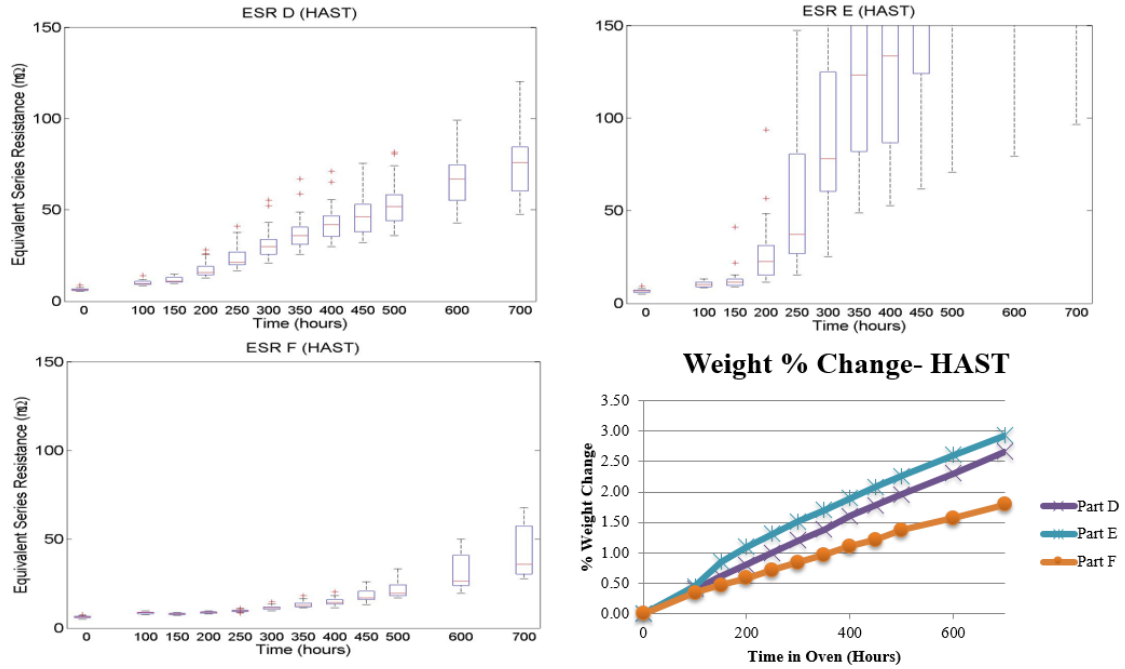
**Figure 16. Equivalent Series Resistance Results for Capacitors of the Same Series and Electrical Ratings**

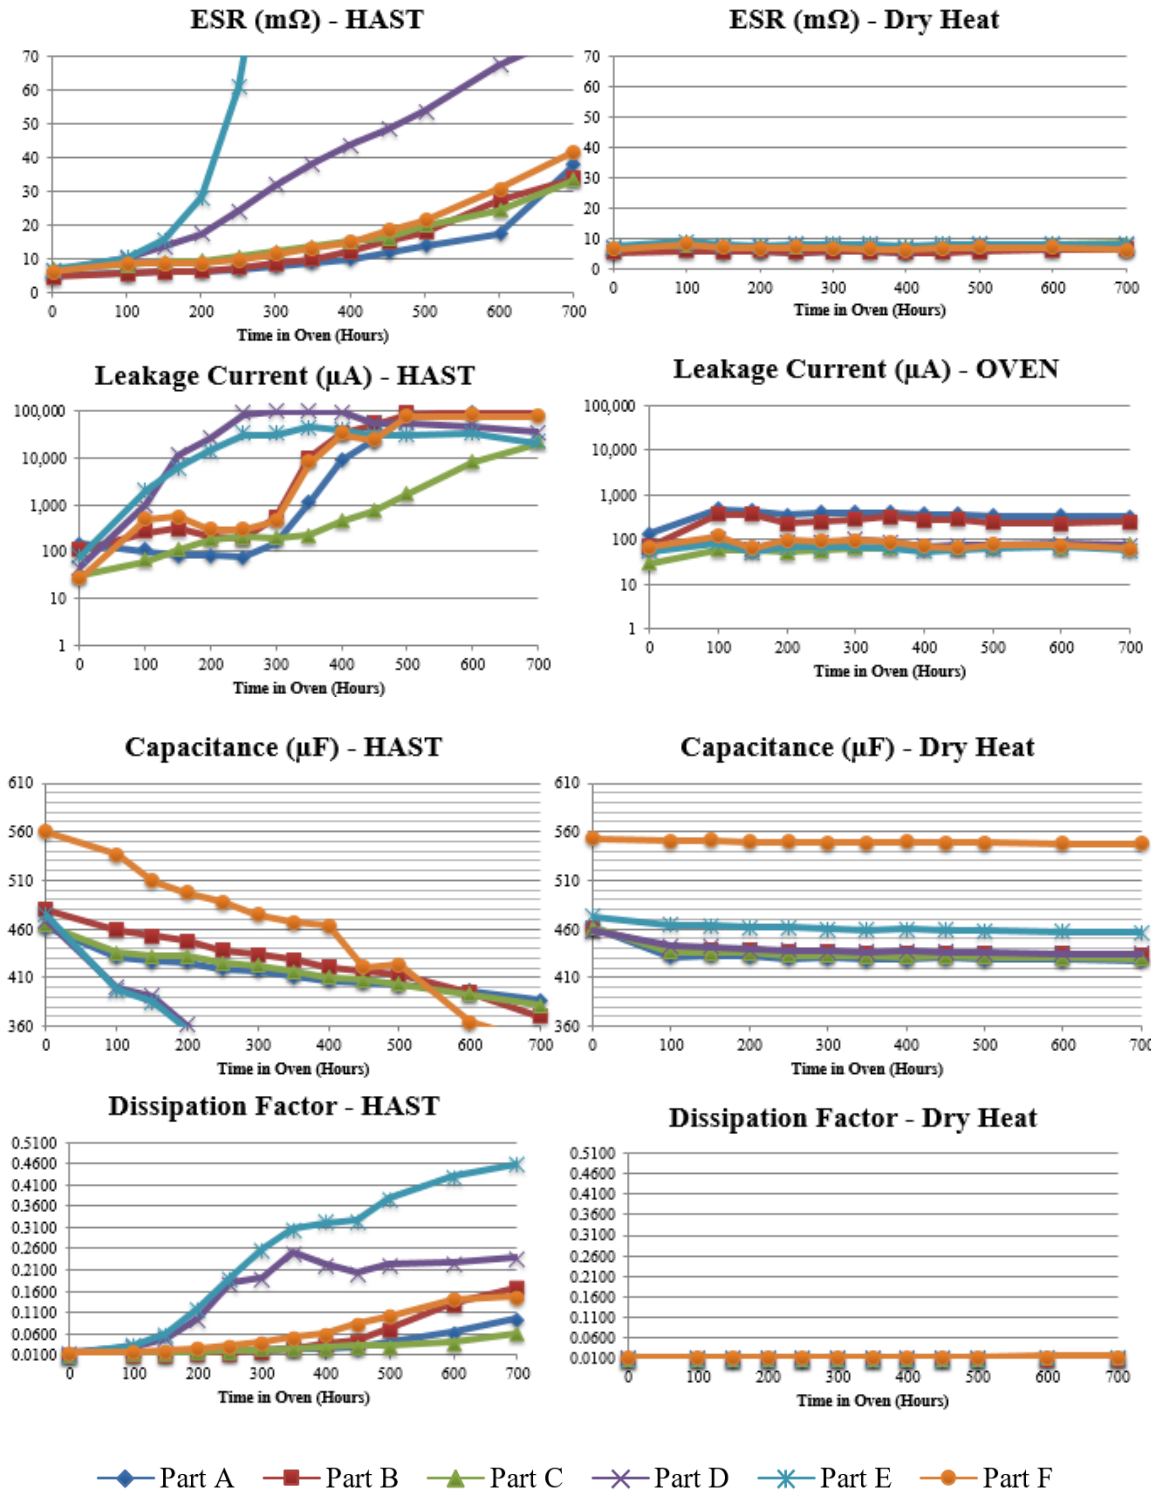
Figure 17. Results for HAST vs. Dry Heat testing

Dry heat testing (110°C, relative humidity unregulated) yielded almost no degradation in comparison to the degradation seen with HAST testing. Comparative result plots showing sample means for ESR and leakage current for the capacitors subjected to dry heat testing can be seen in **Figure 17**. Small changes in capacitance, leakage current, and ESR were seen in the first 100 hours of testing, but appeared to stabilize thereafter.

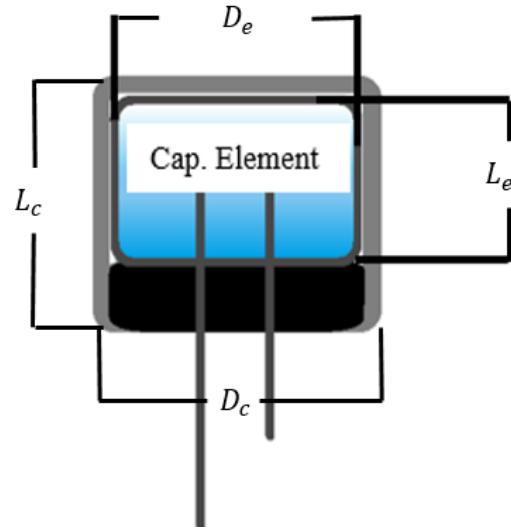
Figure 18. Representation of capacitor element dimensions

The aspect ratio of the capacitor is a parameter calculated from the geometry of the capacitor element inside the aluminum can. The capacitor element is comprised of the wound structure that includes the polymer PEDOT, paper separator, cathode and anode aluminum electrodes, and lead tabs. The aspect ratio of the polymer capacitors is calculated by dividing the length of the capacitor element ( $L_e$ ) by the capacitor element diameter ( $D_e$ ). The length and diameter of the capacitor element are illustrated in **Figure 18**. It should be noted that the aspect ratio is not a ratio of the length of the whole capacitor structure over the diameter of the capacitor structure, but is based on measurements of the capacitor element winding instead.

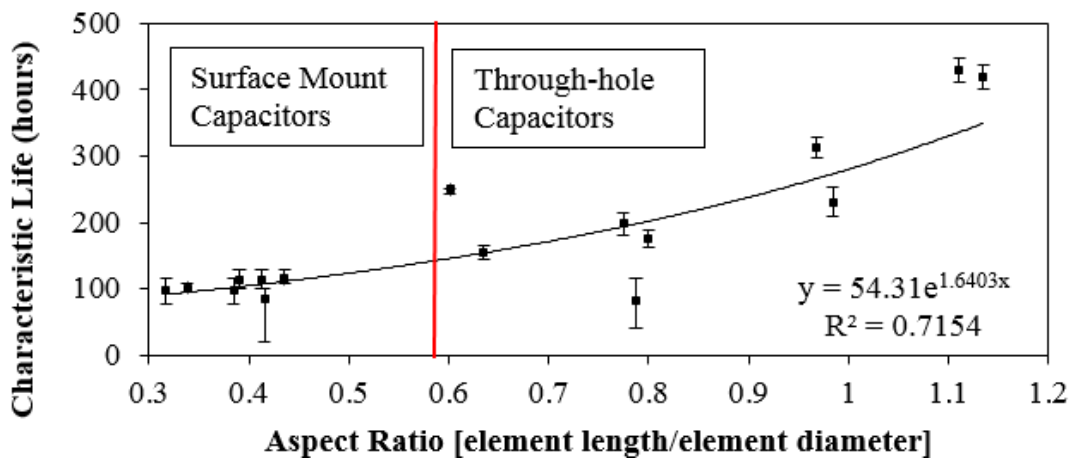
Figure 19. HAST Weibull Eta Values (Characteristic life) for Failures at Time of First Failure vs. Capacitor Aspect Ratio. Error bars represent Eta values with 90% confidence bounds.

A trend of increasing Weibull eta parameters with increasing aspect ratio emerges when plotting eta values versus aspect ratio for the Preliminary HAST test. This trend can be seen in Figure 19. It is noteworthy that the surface mount capacitors all have an aspect ratio that is less than  $\sim 0.62$ , while through-hole capacitors all have an aspect ratio that is larger than  $\sim 0.62$ . Each point on Figure 19 represents the Weibull eta parameter calculated from the failure times of 20 capacitors.

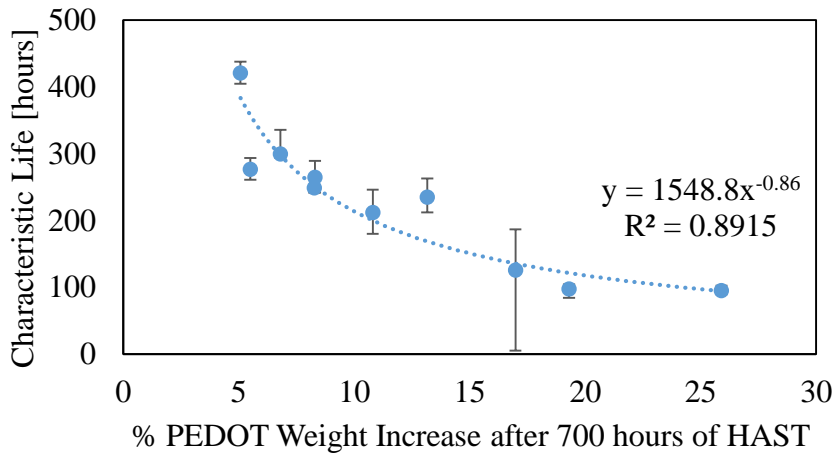
**Figure 23. Characteristic life (Weibull eta) for ESR failures versus the percent PEDOT weight increase after 700 hours of HAST**

This shows a correlation that is valid in capacitors between manufacturer 1 and manufacturer 2 capacitors, regardless of their seal quality. It can be seen that those capacitors that experienced the highest amounts of percent PEDOT weight increase saw the shortest times to failures.

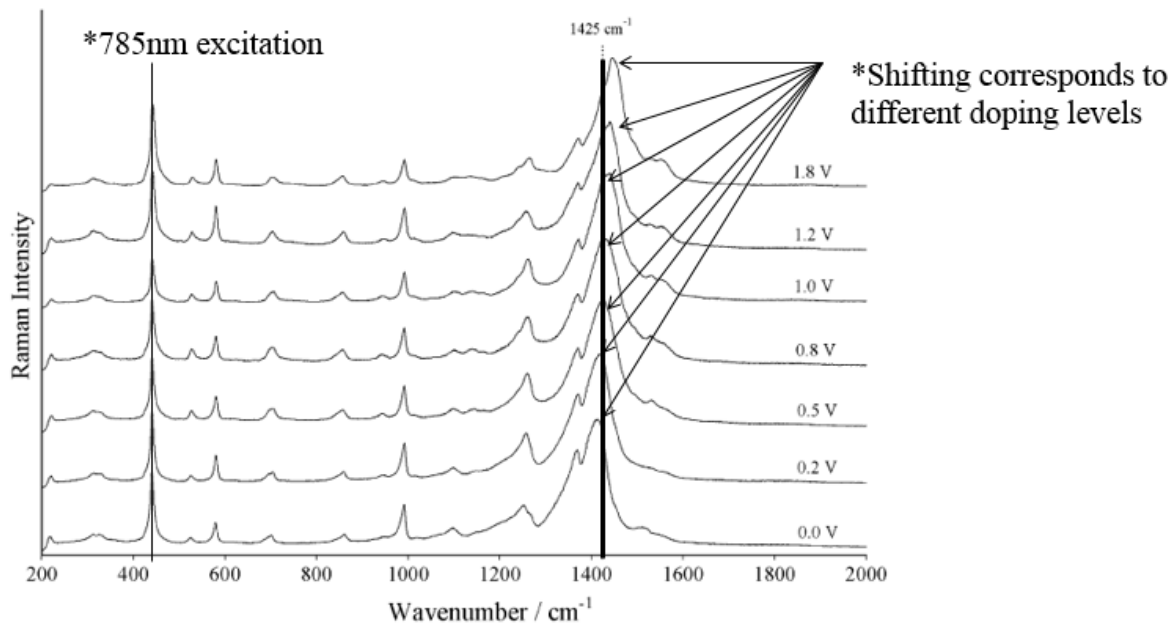
**Figure 25. Raman spectra of PEDOT doped electrochemically at different potentials [27]**

A Raman microscope amplifies the wavelength shifts of the inelastic scattered light and gives results in the format of a Raman spectrum/spectrograph. The Raman spectrum of the polymer PEDOT shows several peaks that are described by different vibrational modes. A study by Chiu et al. shows how the Raman spectrum of PEDOT changes with differences in doping levels. **Figure 24** shows the Raman spectrum of a neutral (de-doped) sample of PEDOT [27]. In the same study by Chiu et al., neutral PEDOT samples were electrochemically sulfate-doped at different doping levels, which was achieved by doping the polymer electrochemically at different potentials. The results for this can be seen in **Figure 25**.

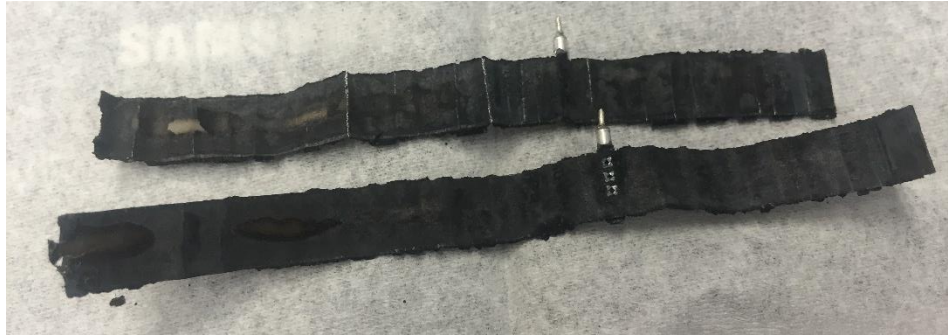
**Figure 26. Unrolled capacitor element of polymer aluminum capacitor after HAST exposure**

absorption. Capacitor samples were prepared by first removing the capacitor elements from the aluminum can, and then unrolling the capacitor elements as seen in **Figure 26**. This was done immediately prior to the Raman spectroscopy analysis to minimize any moisture absorption that could occur from the ambient conditions. Once the capacitor elements were unrolled, they were placed in the Raman microscope and analyzed.

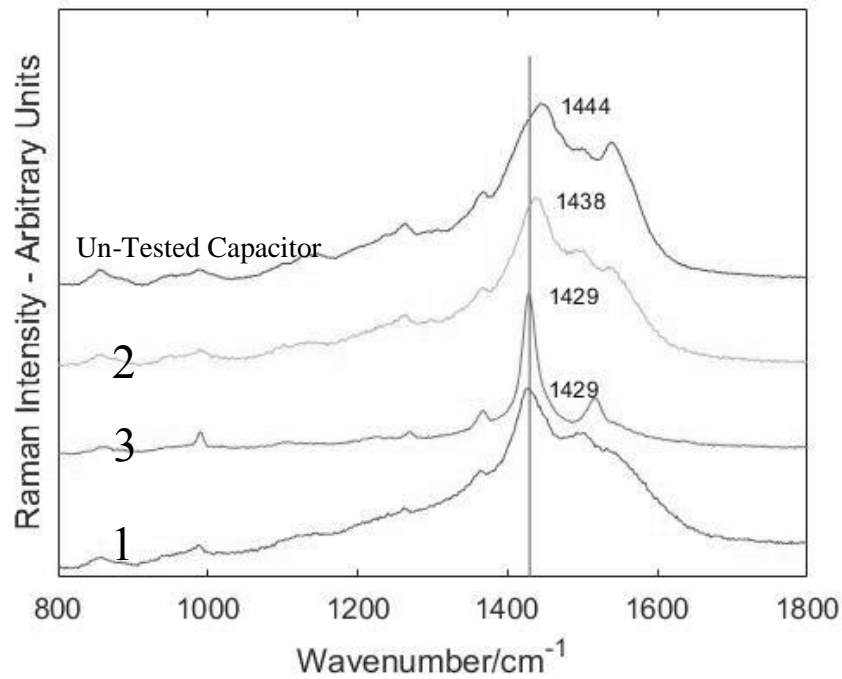
**Figure 29. Raman spectra of PEDOT at different capacitor locations**

A sample of Raman spectra taken at different locations of a failed capacitor is shown on Figure 29. It can be seen that along the top (location 1) and bottom (location 2) of the capacitor winding, the doping-related Raman peak is at around  $1429\text{ cm}^{-1}$ , while the center of the capacitor element shows a peak at  $1438\text{ cm}^{-1}$ . These results show that the polymer PEDOT is more de-doped along the top and bottom of the capacitor element than the center. The Raman spectrum of an untested and healthy capacitor is shown on the same figure, and the doping-associated peak is at  $1444\text{ cm}^{-1}$ . A healthy capacitor measured at the same locations shown on Figure 28 did not show large differences in doping levels like the ones seen in the failed capacitor. Repeated measurements along the 1 (top), 2(center) and 3(bottom, closest to seal) locations of a new capacitor and failed capacitor are shown in **Error! Reference source not found..**

While Fig. 28 shows example results from testing, repeated measurements were taken from 4 capacitors. A total of 5 measurements taken along the top, center, and bottom of the capacitor elements from a failed sample E manufacturer 2 capacitor, failed sample F manufacturer 2 capacitor, failed sample C manufacturer 1 capacitor, and healthy sample F manufacturer 2 capacitor. The results for the peak values are shown as boxplots in the following figures. It can be seen that the trend of higher peak values at the center of the capacitor are seen in both manufacturer 1 and manufacturer 2 capacitors.

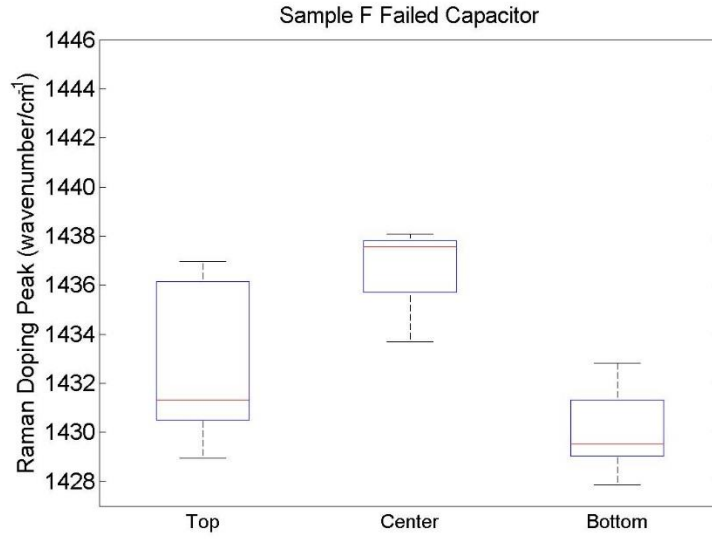
**Figure 32. Raman peak values for sample F manufacturer 2 failed capacitor**

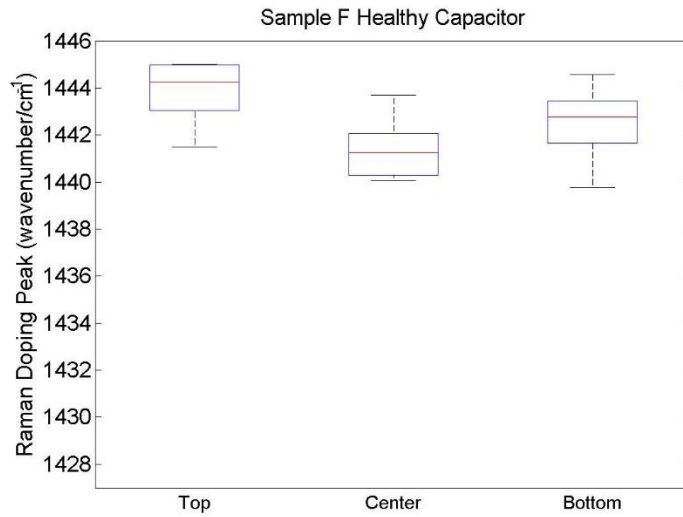
**Figure 33. Raman peak values for sample F manufacturer 2 healthy capacitor**
