Title of Document: HISTORIC STRUCTURE INVESTIGATION: THE  
PIPER HOUSE, ANTIETAM NATIONAL  
BATTLEFIELD, SHARPSBURG, MARYLAND

Thesis submitted to the Faculty of the Graduate School of the  
University of Maryland, College Park, in partial fulfillment  
of the requirements for the degree of  
Master of Historic  
Preservation  
2020

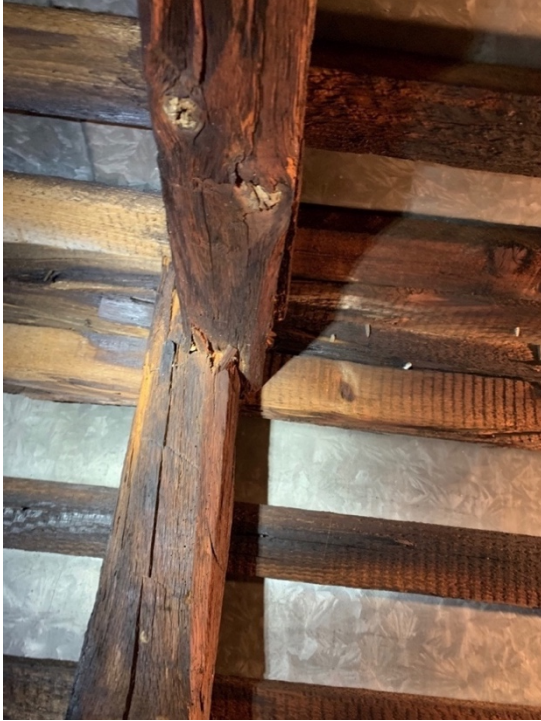
**Figure 9:** Detailed view of one of the rafter pairs. The rafters connect with a lap joint and are fastened with a wooden peg. The nailers have prominent band sawn marks and are replacements. *Grace Davenport, 2020.*

The roof nailers have been replaced. They are bandsawn, and do not exhibit the multiple generations of holes for shingle nails that would be expected. In addition, they are spaced to accommodate standard short shingles, rather than the long side-lapped shingles that are visible in the photographs. Whitewash appears on some of the nailers, suggesting that they may have been reused, while others are black and shiny, likely due to pine resin.

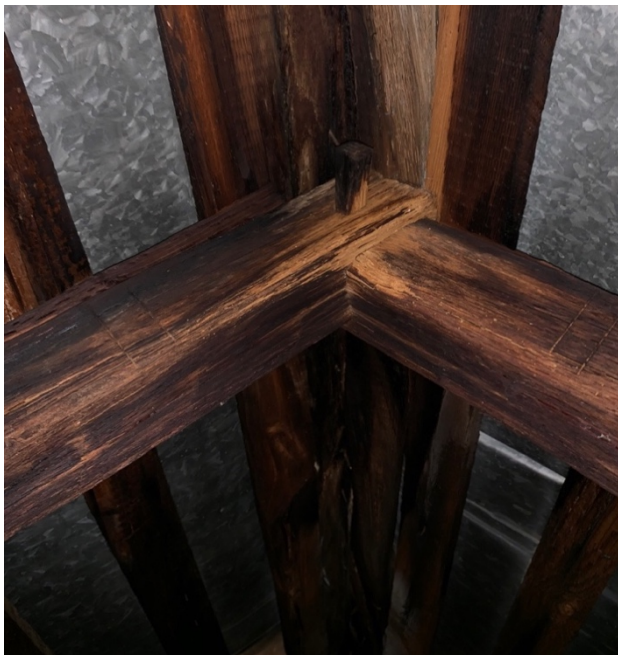
**Figure 10:** View of the rafter pair "II" showing the lap joint and wooden peg. *Grace Davenport, 2020.*

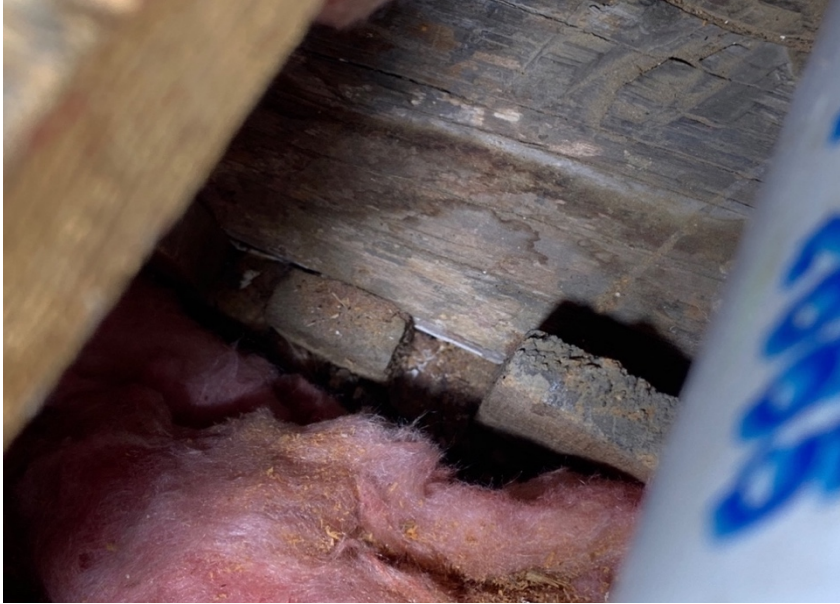
**Figure 11:** View of the top of the east wall log. The log shows whitewashing under where the lath was installed. Some plaster is also visible. *Grace Davenport, 2020.*

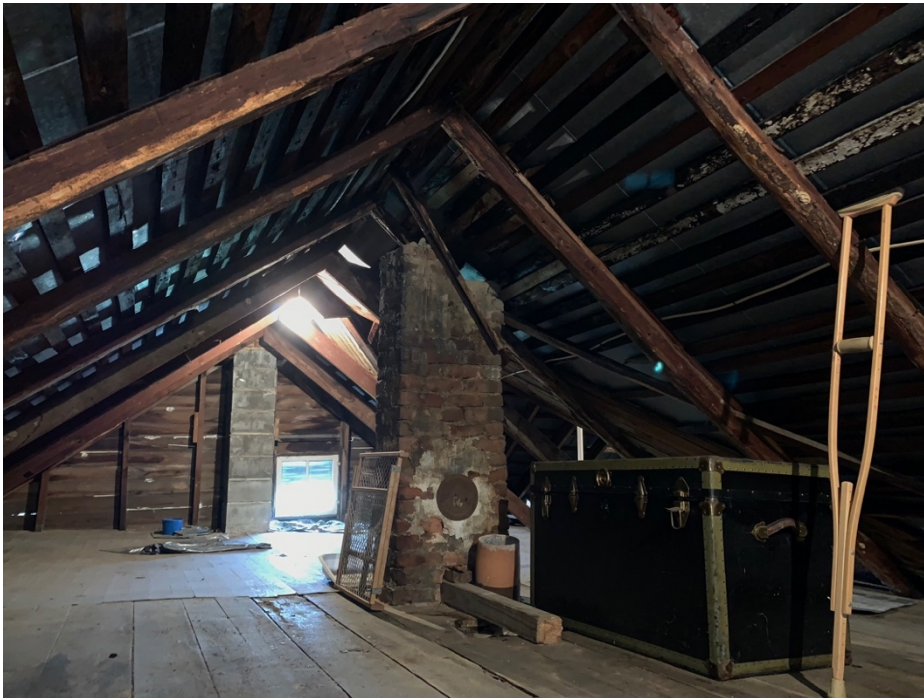
**Figure 12:** North view from Phase One attic to Phase Three attic. The original chimney stack is in the center with its support timber. The hole in the floorboards at the base of the chimney accommodated a wood stove pipe travelling up from the floor below. The round plate in the side of the chimney is where the stove pipe connected to release smoke outside. *Grace Davenport, 2019.*

first and second floors. This removal left the chimney stack unsupported. During the 1984-85 rehabilitation, a hole was cut in the base of the chimney stack, and a timber was inserted in order to support its weight (Figure 12). The chimney stack was removed above the roofline, likely during the 1980s rehabilitations, possibly to prevent further water damage. The irregularity of the bricks indicate they are handmade. They have been repointed several times in different places.

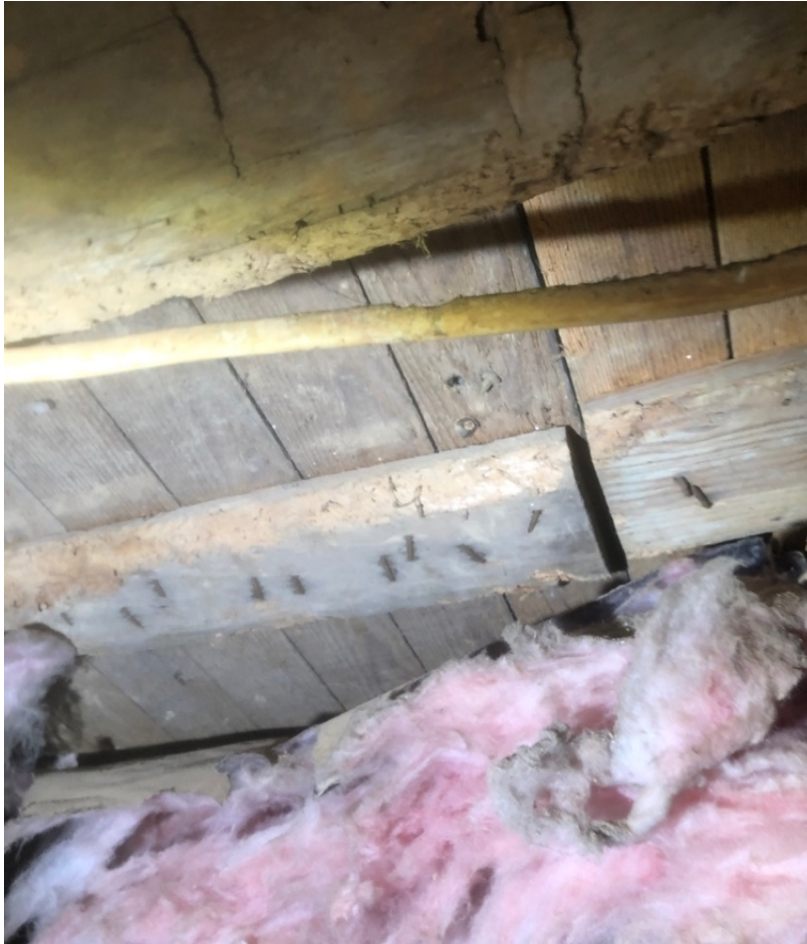
**Figure 16:** View from crawlspace looking up at the two hatch doors in the Phase Two addition. *Grace Davenport, 2020.*

Phase Two's foundation is constructed of stone, although it is currently missing and damaged in many places. The log joists that supported this addition are present, although they have been highly altered, likely in Phase Three. They run parallel with the log joists of Phase One and are similarly straightened with an adze on the top and bottom, their sides remaining rounded.

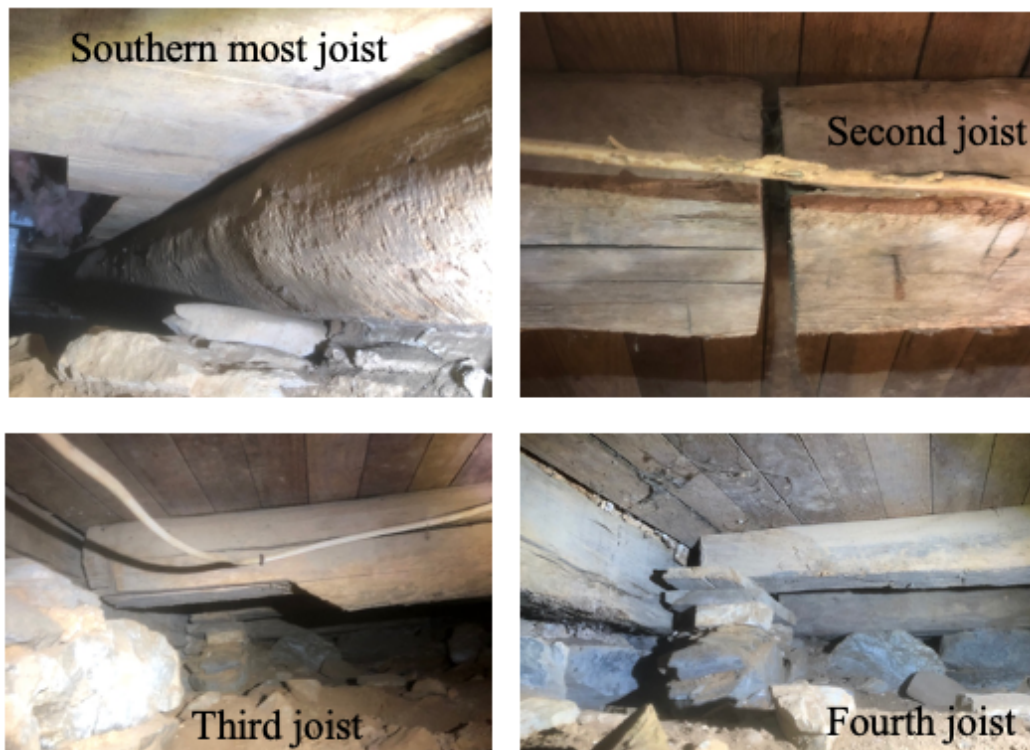
**Figure 20:** The four visible joists under Room 103. At the end of the fourth joist, vertical lath is visible coming down below the floorboards. *Grace Davenport, 2020.*

New finishes were installed in this addition at this time. The first floor received circular sawn vertical lath and plaster and a baseboard (Figure 20 & 27). The baseboard in Room 103 remains today. The second floor was finished with horizontal lath and plaster, and the windows were trimmed. Even though the first story is constructed of log and the second constructed of frame, the depth of the windows on both the first floor and the second floor are the same.

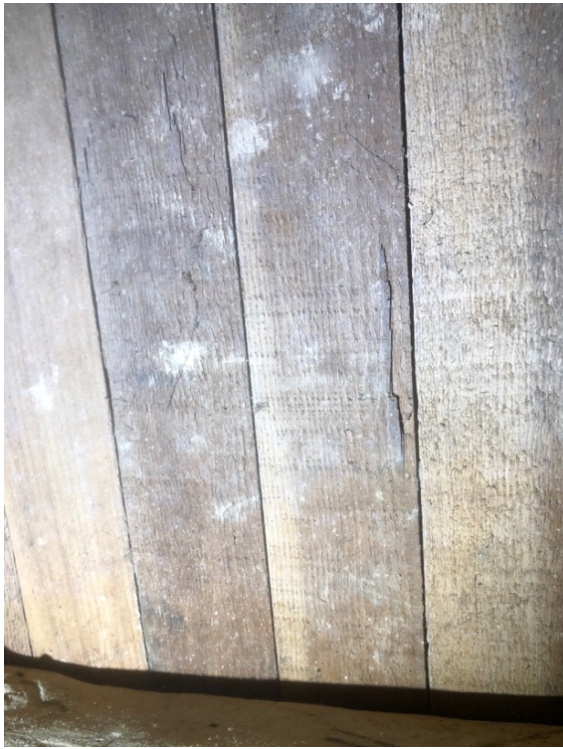
**Figure 21:** The underside of the floorboards in Room 103. *Grace Davenport, 2020.*

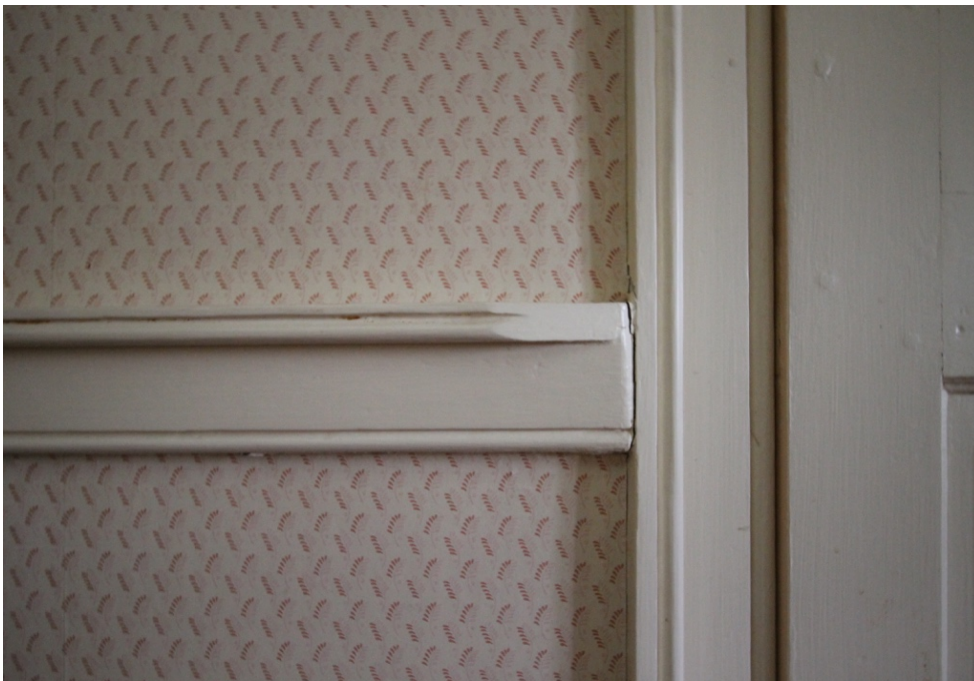
**Figure 22:** Chair rail decoratively beveled in Room 102 to accommodate a door into Room 103. *Grace Davenport, 2020.*

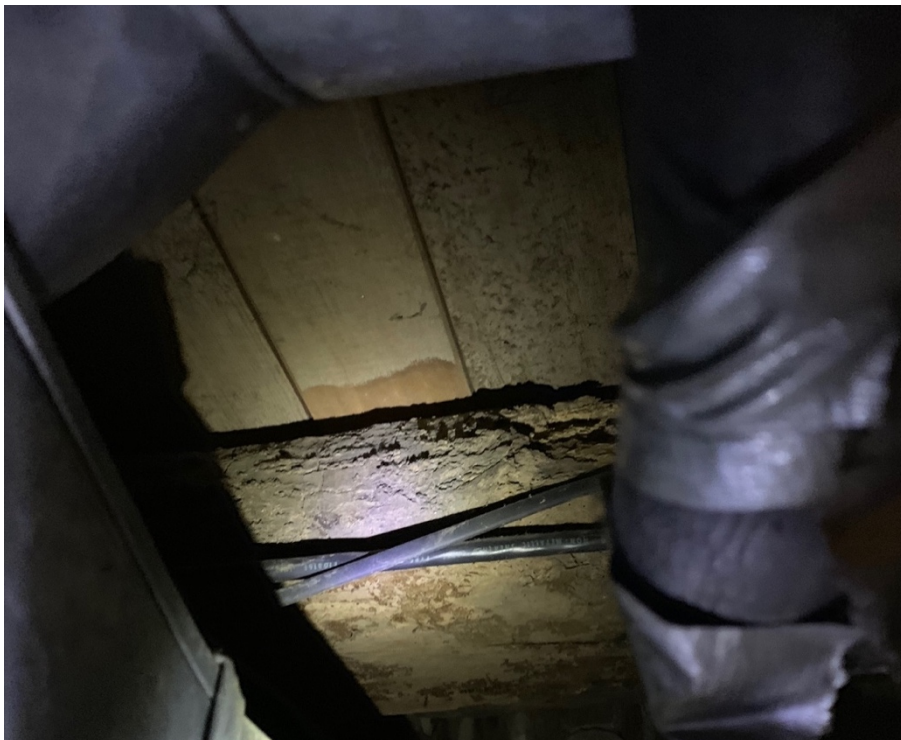
**Figure 24:** Northern Phase One log joist with new floorboards on top. *Grace Davenport, 2020.*

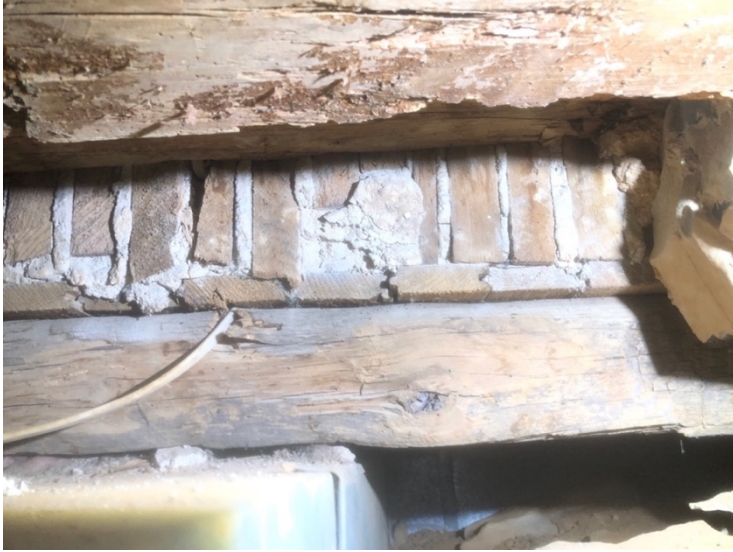
**Figure 27:** View looking north from the north end of Phase One cellar. Shown is the floorboards and vertical lath and plaster of Phase Three. At the top of the image is the northmost log joist of Phase One. In the bottom of the image, modern HVAC equipment is installed on top of the Phase One fireplace support. *Grace Davenport, 2020.*

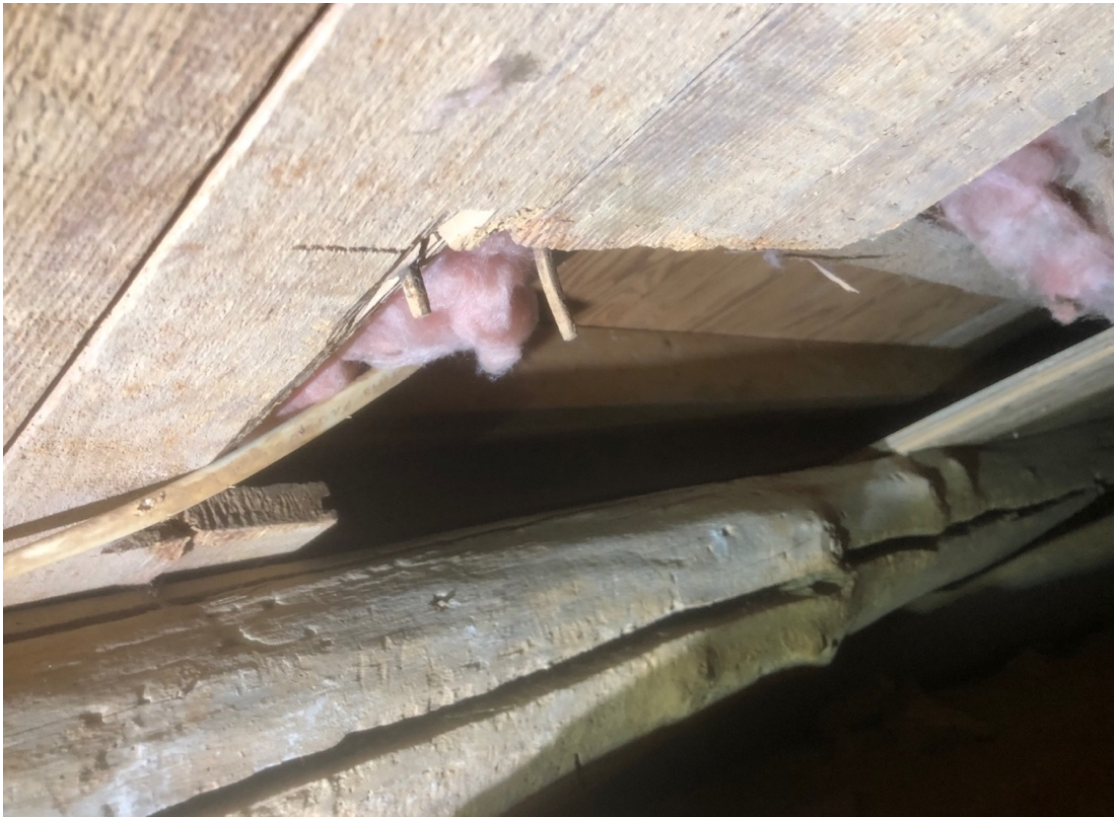
**Figure 34:** View looking up from the crawlspace to the plywood decking of Room 103. Two cut nails are visible, they both have blunt ends. The tongue and groove floorboards are also visible. Facing northeast. *Grace Davenport, 2020.*

There is evidence that suggests the floor level in Rooms 103 and 104 were raised in Phase Five instead of in Phase Four. A large hole was cut in the Phase Three floorboards of Room 103 to accommodate the installation of HVAC equipment. The hole and plywood decking that supports the current carpeted floor (Figure 34) are visible from the crawlspace. It is more likely that this plywood decking was installed to replace water damaged floorboards during the Phase Five rehabilitations.<sup>109</sup>

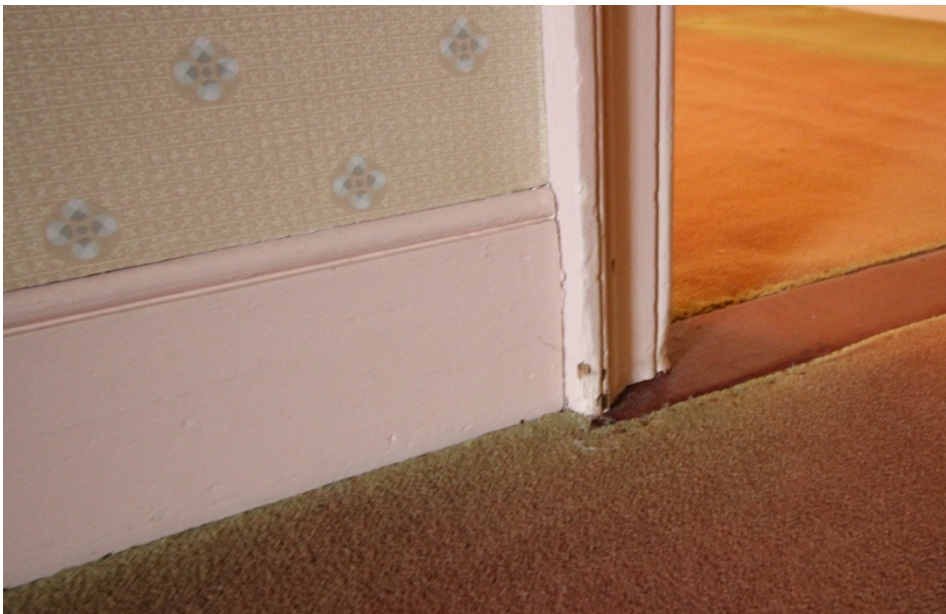
**PHASE ONE**  
**Baseboard**

- Room 101
- Room 102
- Room 201
- Room 202
- Both Stairways
- Some baseboards have been replaced with in kind material. The replacement material has a flatter top.

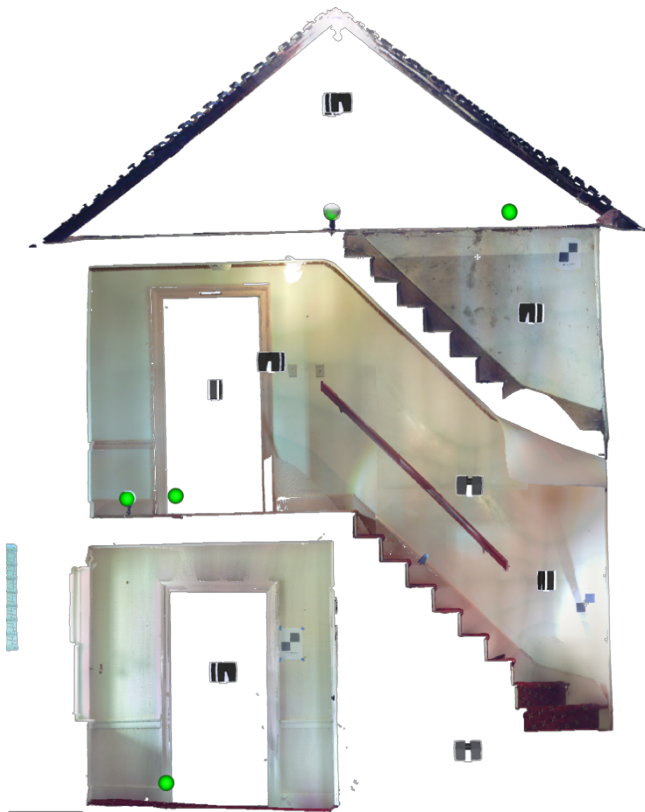
Phase One cross section – north side of frame partition wall and stair.

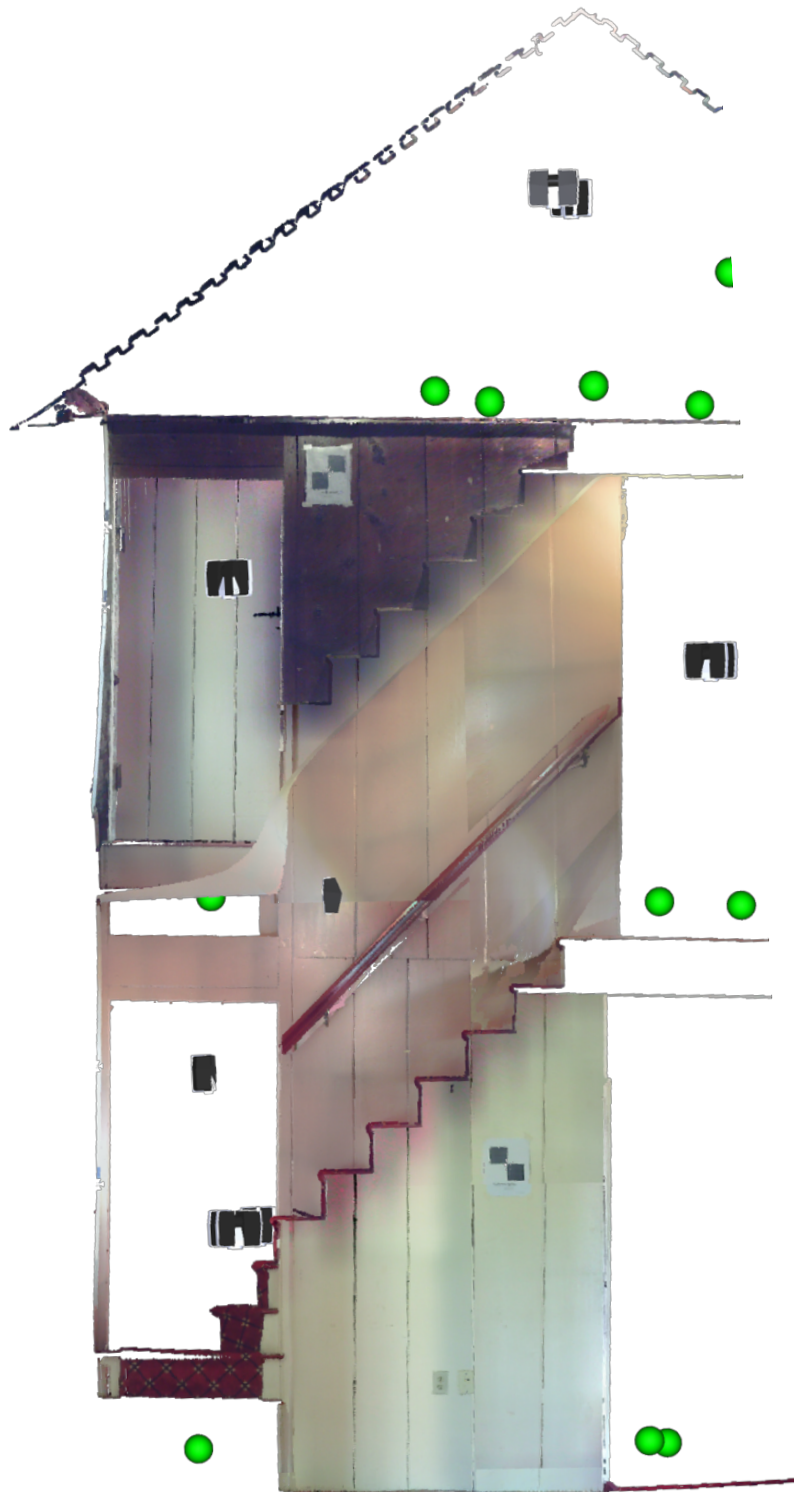
Phase One cross section – showing the beaded board stair partition as it is inserted between the two floors.
