Title of Document: HISTORIC STRUCTURE ASSESSMENT:  
JOSEPH R. POFFENBERGER HOUSE  
ANTIETAM NATIONAL BATTLEFIELD  
SHARPSBURG, MD

HISTORIC STRUCTURE ASSESSMENT:  
JOSEPH R. POFFENBERGER HOUSE  
ANTIETAM NATIONAL BATTLEFIELD  
SHARPSBURG, MD.

Dissertation submitted to the Faculty of the Graduate School of the  
University of Maryland, College Park, in partial fulfillment  
of the requirements for the degree of  
Master in Historic  
Preservation  
2020

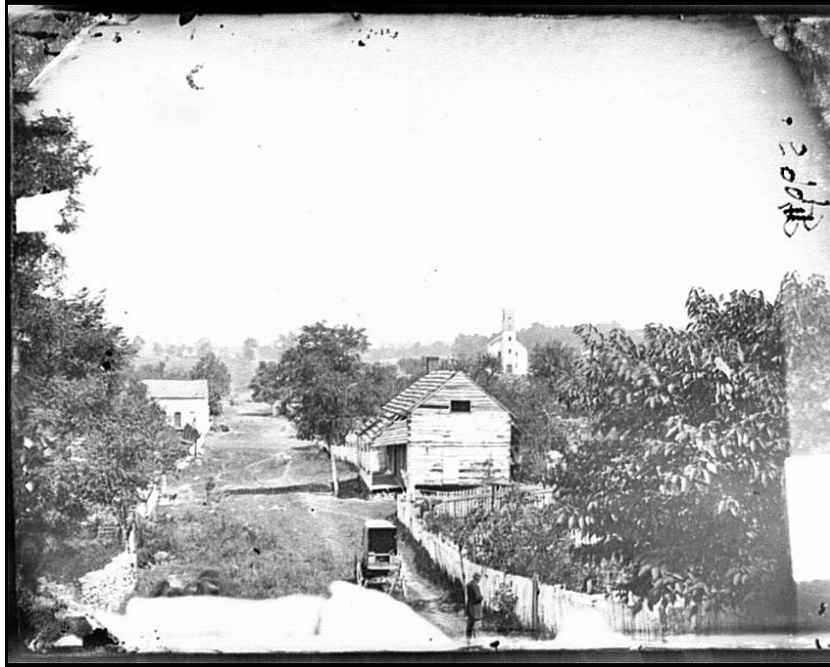
**Figure 1. A traditional frontier log structure in downtown Sharpsburg, MD. Source: Alexander Gardner, 1862.**

At this point in the development of the Mid-Atlantic colonies, log buildings were one of a number of construction options that were familiar to both English and German settlers.<sup>2</sup> The style of the Joseph Poffenberger house, and its log construction and simple floor plan, was not unusual (Figure 1). As immigrants from England and Germanic Europe made up the majority of the settlers in the region, it was their traditional architectural styles that were adapted early on to the novel New World conditions. Although there were many similarities between the two, there were important differences, ranging from room arrangements and chimney locations to decorative treatments and ornamentation. Over the course of the eighteenth century, the two traditions blended to create a loosely hybridized architectural vernacular.

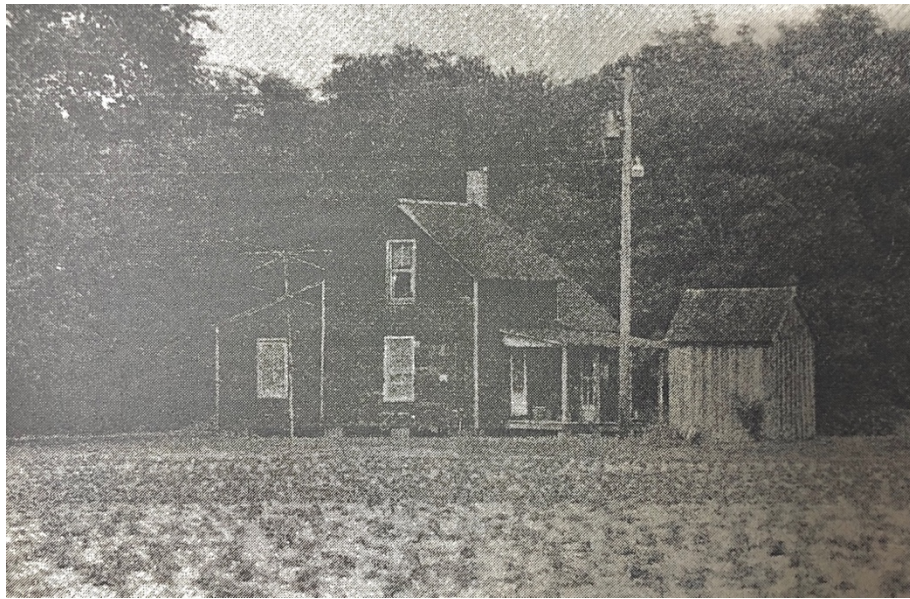
**Figure 11. Tenant house, c. 1900 in Northampton County, Virginia. Source: Lanier and Herman, 1997, 20.**

Although partitions made under one roof is most common, lean-tos or sheds were another option to create separate space (Figures 11 and 12). Lean-tos attached to the gable end or rear of a building were often unheated and meant for rough storage and sometimes for sleeping. These spaces usually had exposed framing and were rarely finished.<sup>18</sup> Open plan houses were regularly altered to keep up with evolving fashions and to improve privacy, and generally reflected the social and economic standing of the family.

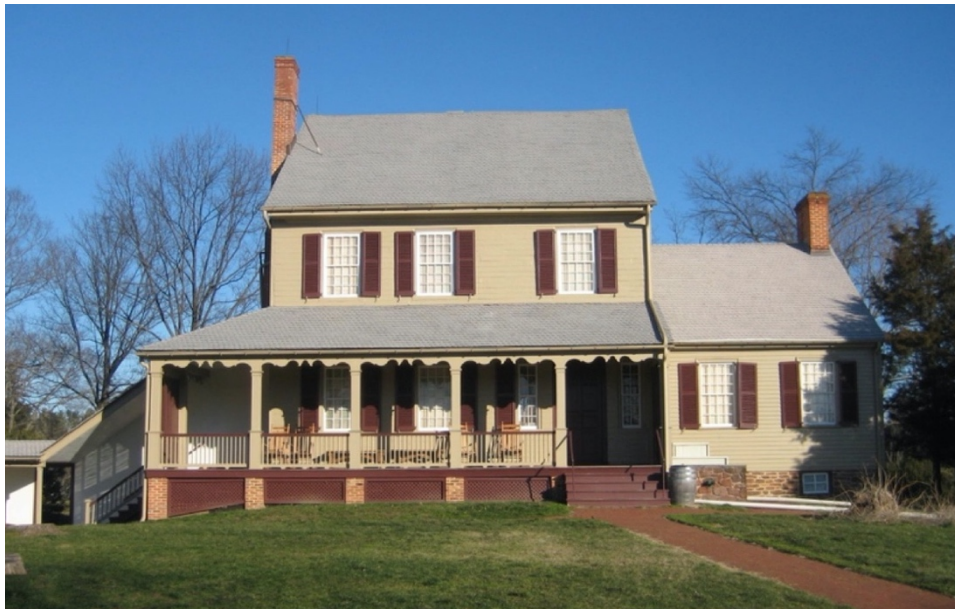
**Figure 14. Sully, side passage, double parlor (1795) with later wing. Source: Dennis J. Pogue, 2015.**

popular, but double pile, side-passage plans were also common, especially in urban settings.<sup>22</sup> The Sully plantation home of Richard Bland Lee, erected in 1795 in Fairfax County, Virginia, follows this design.<sup>23</sup> When adapted for commercial purposes, the business would be conducted in the front office with a formal dining room behind that, and upstairs was meant for formal entertainment, or private chambers. Several of the earliest high-style residences in Alexandria were constructed with this dual purpose in mind.<sup>24</sup>

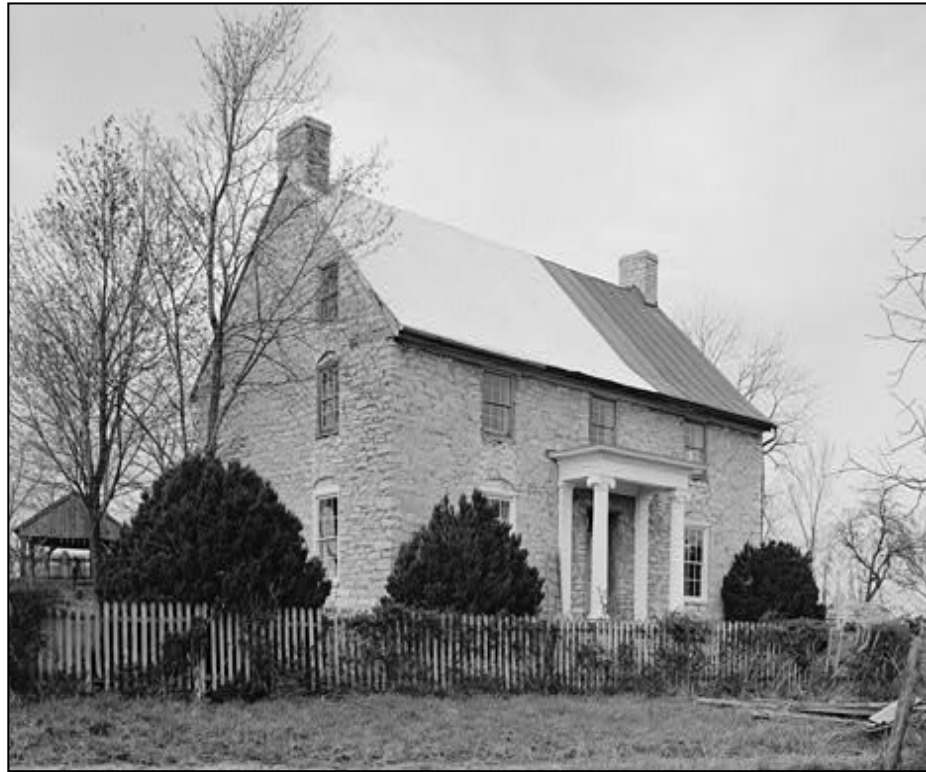
**Figure 20. Fort Bowman, 1771, Shenandoah County, Virginia, an example of a hybrid "German Georgian" façade.<sup>38</sup> Source: Historic American Building Survey.**

The final Germanic plan that can be identified in Schaefferstown are variants of the *durchgangigen* style, which translates literally as “through-hallway.” As with its English counterparts, the hallway acts as a center passage, which further insulates the private activities of the household from the intrusions of visitors. The *durchgangigen* plan also allowed greater specialization of room use and leant itself to more Georgian forms of external and internal symmetry. As in English center passage houses, the stairway to the rooms above was generally located in the hallway. The adoption of the *durchgangigen* meant that the house was substantial, and that the owners likely were aspiring to adopt Georgian ideals of privacy and symmetry, and

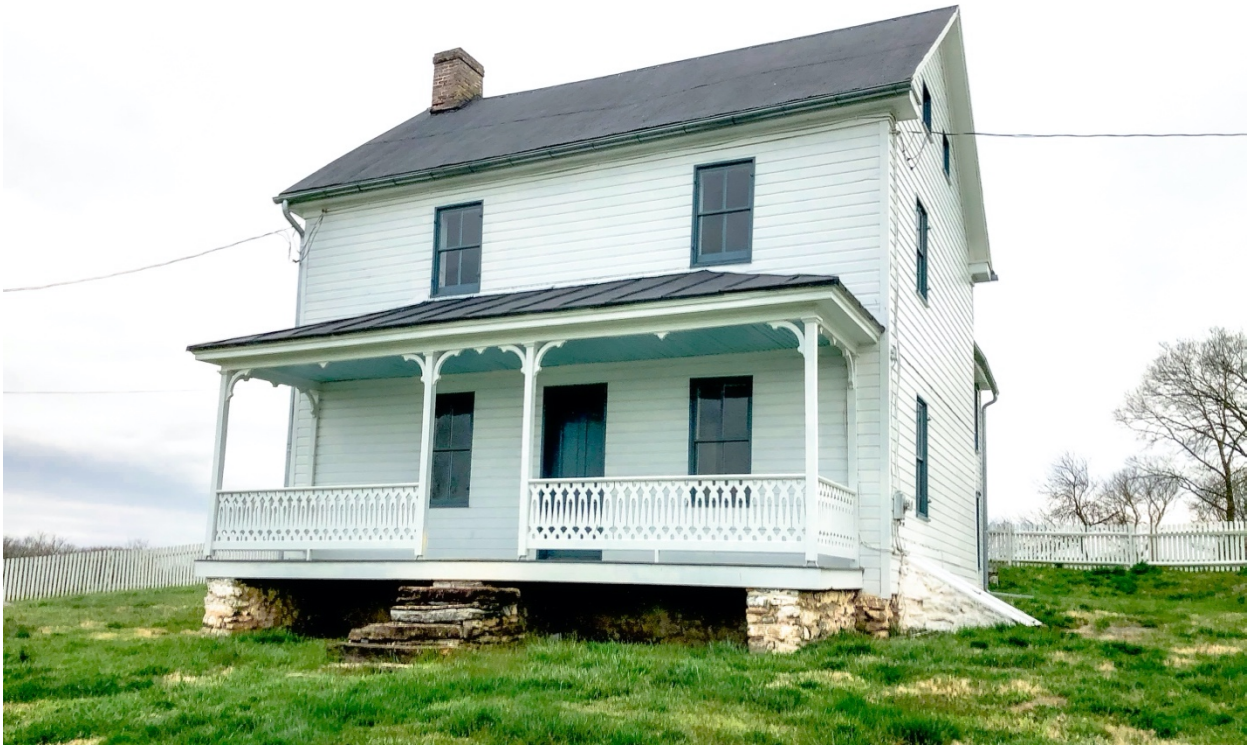
**Figure 24. South and east elevations of the Joseph Poffenberger House. Source: Sara Baum, 2020.**

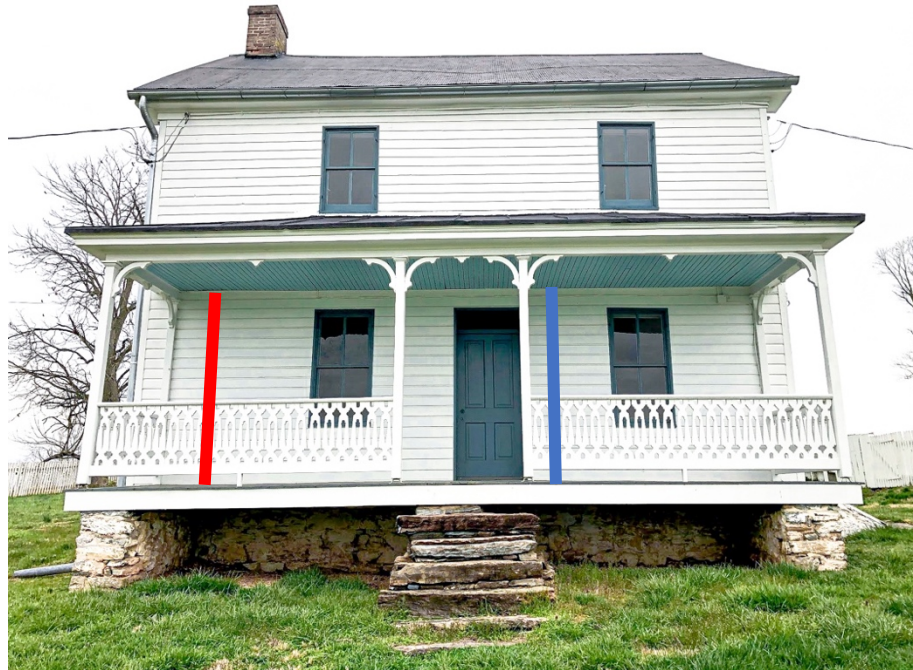
**Figure 25. South facade of Joseph Poffenberger House. The blue line indicates the approximate location of the parlor partition, and the red for the original stair. Source: Sara Baum, 2020.**

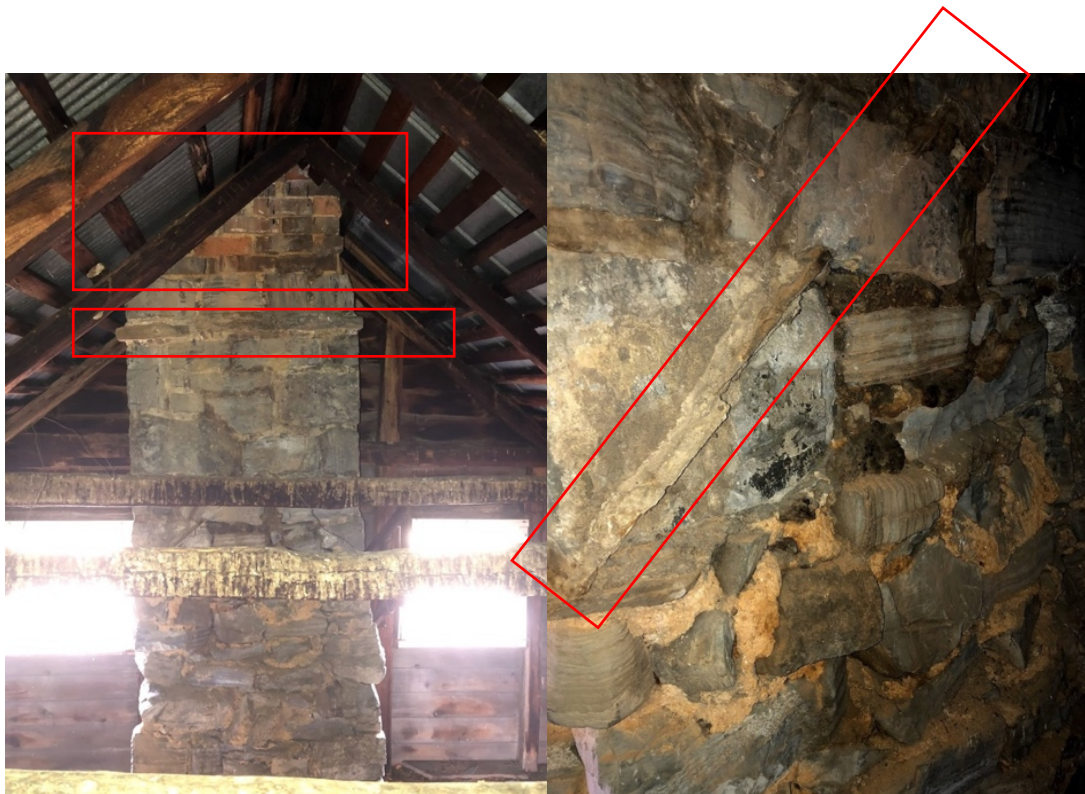
**Figure 28A and B. A. Stone chimney in the attic in the west gable, with the brick extension, and original stone cap. B. Remnant of mortar. Source: Sara Baum, 2020.**

The physical evidence for raising the roof consists of the addition of a brick stack on top of the original stone chimney, along with ghost marks indicting the original roofline, and changes made to the roof frame. The stone chimney terminates in a decorative, flared cap that does not extend beyond the ridgeline (Figure 28A and B). Below the cap are surviving remnants of mortar attached to the stone, which forms a steep angle, indicating the pitch of the original roof.

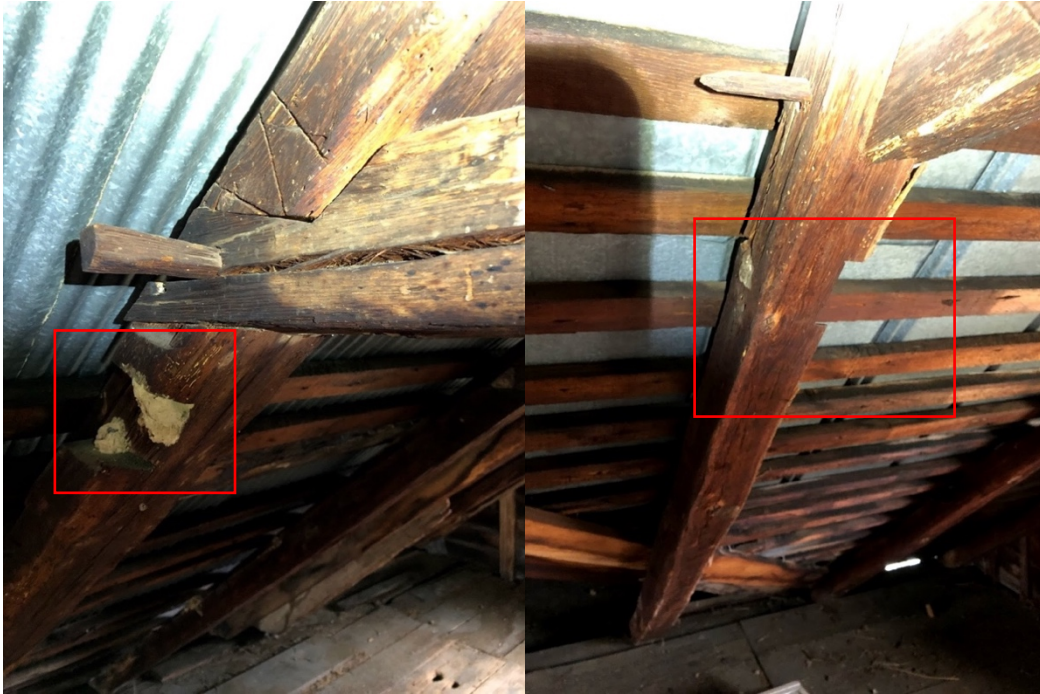
**Figure 29A and B. Details of a rafter and collar connection in the attic, showing empty collar joints. Source: Sara Baum, 2020.**

shortening the rafters and reattaching them at the peak, along with shortening and reattaching the collars.

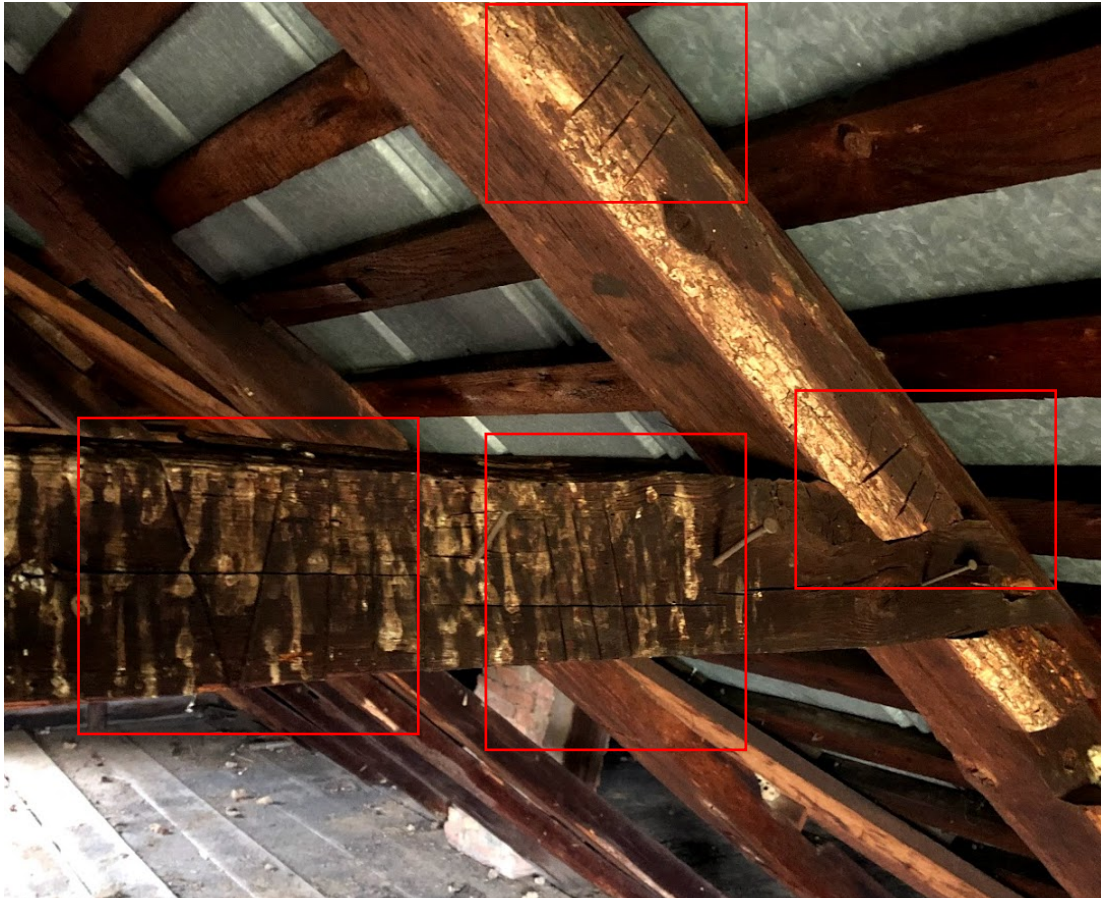
**Figure 30. Two sets of matching scribe marks on the collar and rafter, outlined in red. Source: Sara Baum, 2020.**

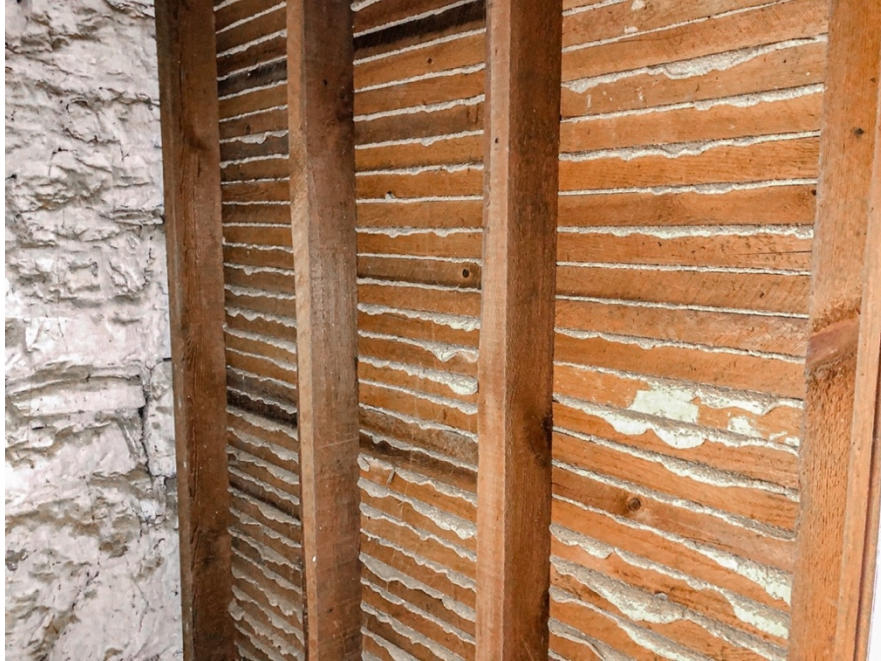
**Figure 34. Interior view of the closet left of the fireplace in the main floor hall. Note the dimensional balloon framing and circular sawn lathes and plaster. Source: Sara Baum, 2020.**

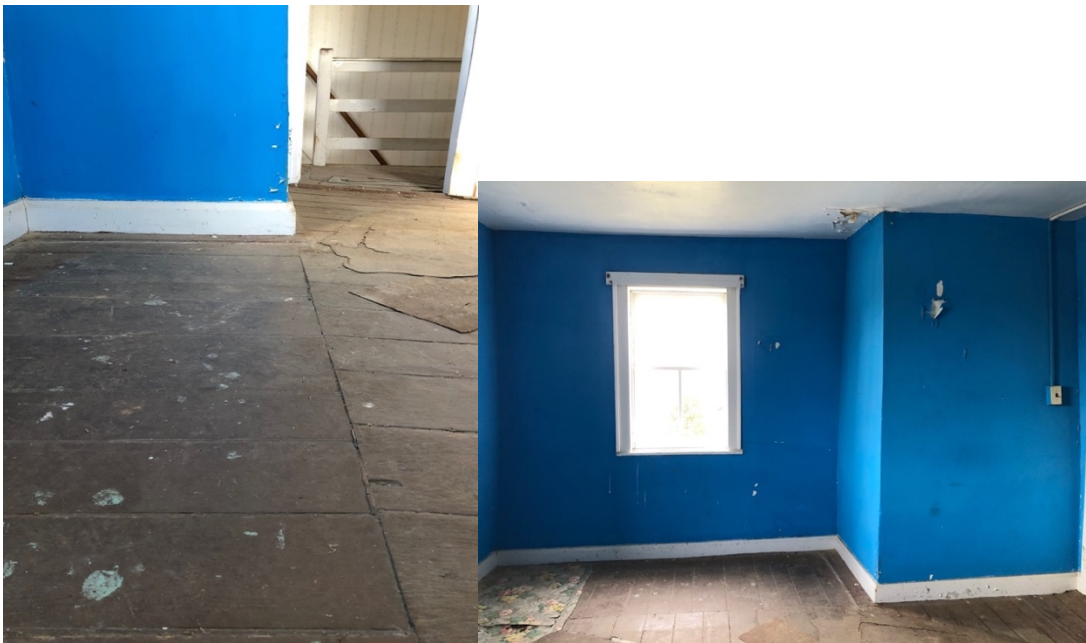
**Figure 35A and B. The patch in the floor indicating the location of the original stairway (A), extending from the chimney stack to the outer wall (B). Source: Sara Baum, 2020.**

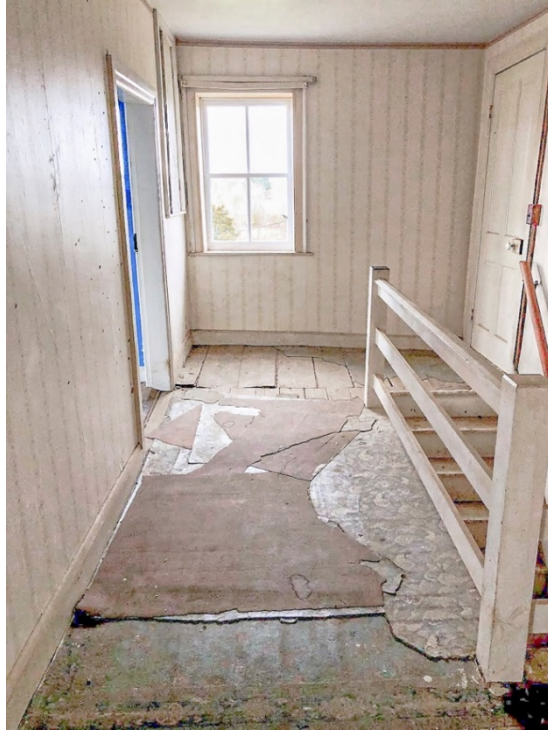
**Figure 36. The upper hallway, likely installed in Phase Three. Source: Sara Baum, 2020.**

The trim of the staircase against the north wall matches with that found in the rear ell, indicating that the stair was likely relocated in this phase, or underwent major renovations. Removing the original stairway, installing a more moderately pitched staircase, and creating an enclosed stair hall all would serve to allow greater privacy for the second floor chambers, which would complement the addition of the rear ell.

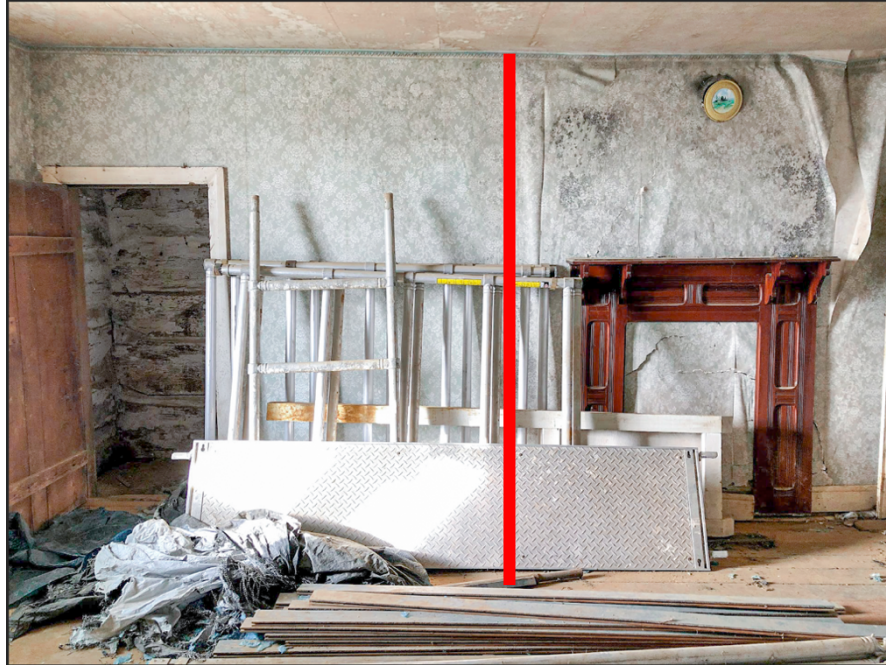
**Figure 37. West wall of the hall, showing the log walls with the closet and the applied faux mantel; the red line indicates the west side of the stone chimney. Source: Sara Baum, 2020.**

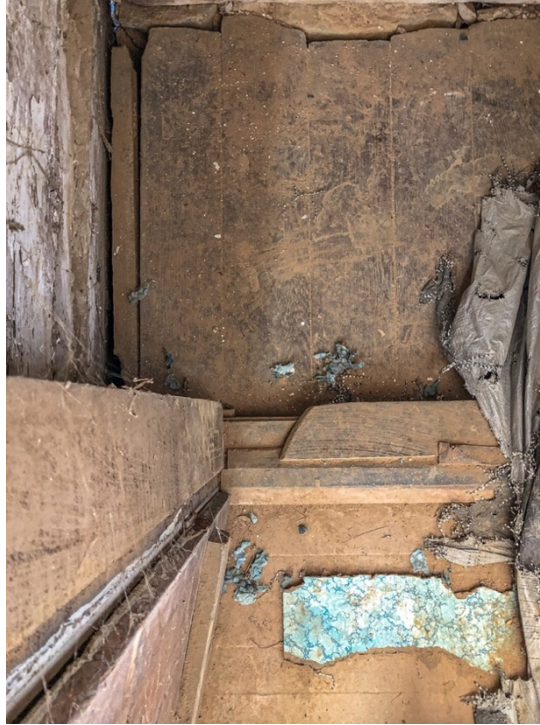
**Figure 38. Junction of the original floorboards visible in the closet with new flooring laid in the hall. Source: Sara Baum, 2020.**

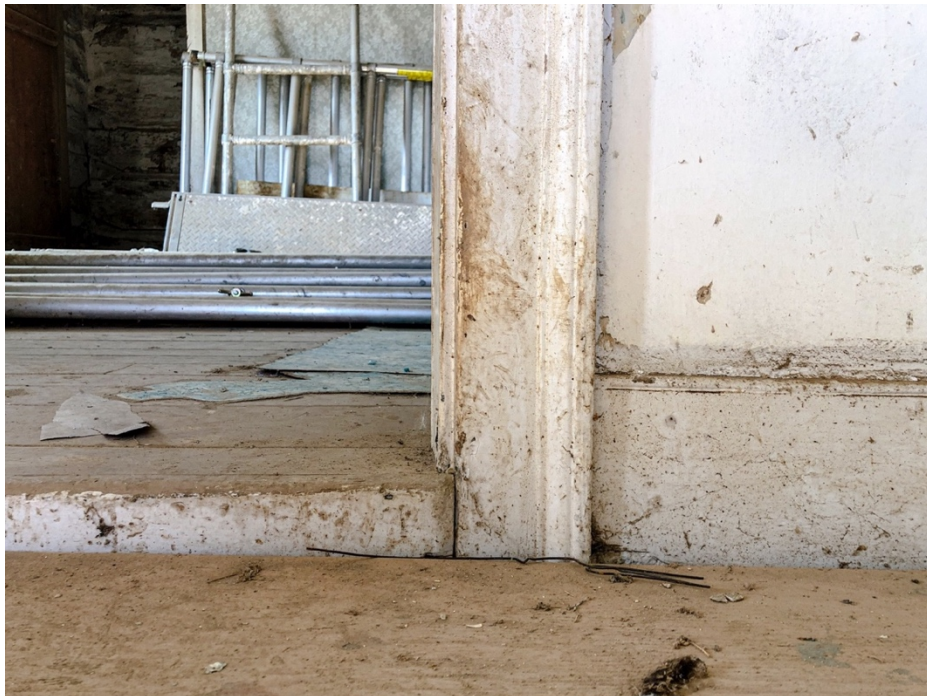
**Figure 39. Detail of the doorway threshold in the parlor, indicating the difference in height. Source: Sara Baum, 2020.**

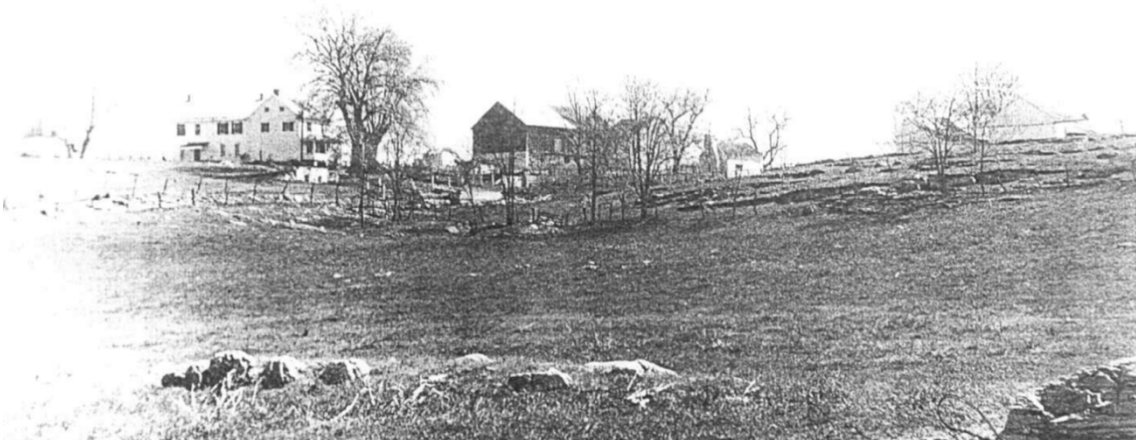
**Figure 41. Image c. 1896 indicates the latest date for construction of the addition. Source: Library of Congress.**
