## PERFORMANCE VERIFICATION STATEMENT for the Greenspan EC3000 Conductivity Sensor

<b>TECHNOLOGY TYPE:</b>	Coupled conductivity and temperature sensors with instrument based algorithms for estimation of salinity
<b>APPLICATION:</b>	In situ estimates of salinity for coastal moored and profiled deployments
<b>PARAMETERS EVALUATED:</b>	Response linearity, accuracy, precision and reliability
<b>TYPE OF EVALUATION:</b>	Laboratory and Field Performance Verification
<b>DATE OF EVALUATION:</b>	Testing conducted from May through October 2008
<b>EVALUATION PERSONNEL:</b>	S. Gilbert, K. Gundersen, T. Johengen, T. McKissack, M. McIntyre, A. Pinchuk, H. Purcell, C. Robertson, D. Schar, G.J. Smith, M. Tamburri and D. Wells.

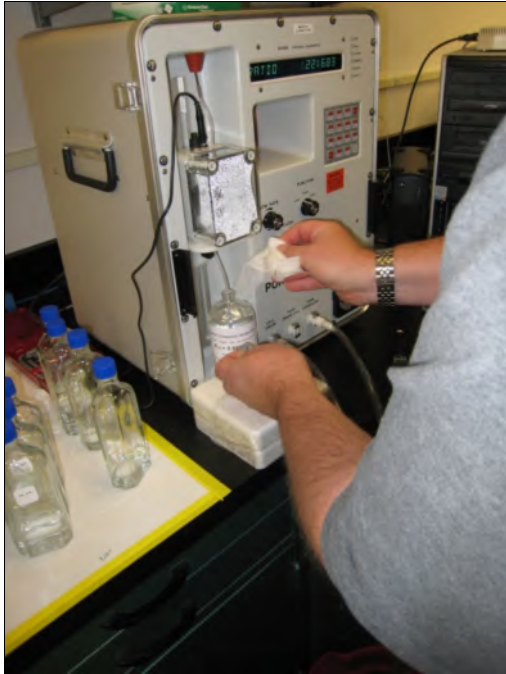
**Figure 1.** Analytical instrumentation (Portasal 8410A) used for laboratory analysis of salinity reference samples and one of the test baths and instrument racks used for the laboratory tests.

minutes prior to the start of reference sampling. The instrument was set to measure in situ conductivity and temperature using its own algorithms to derive a practical salinity estimate from these values at 1-minute intervals. Ten reference water samples were collected at sensor depth into sealed pre-rinsed glass salinity bottles at 3 minute intervals over 30 minutes. Each reference sample set was stored at room temperature and analyzed after 24 hours on the Portasal 8410A (Fig. 1).

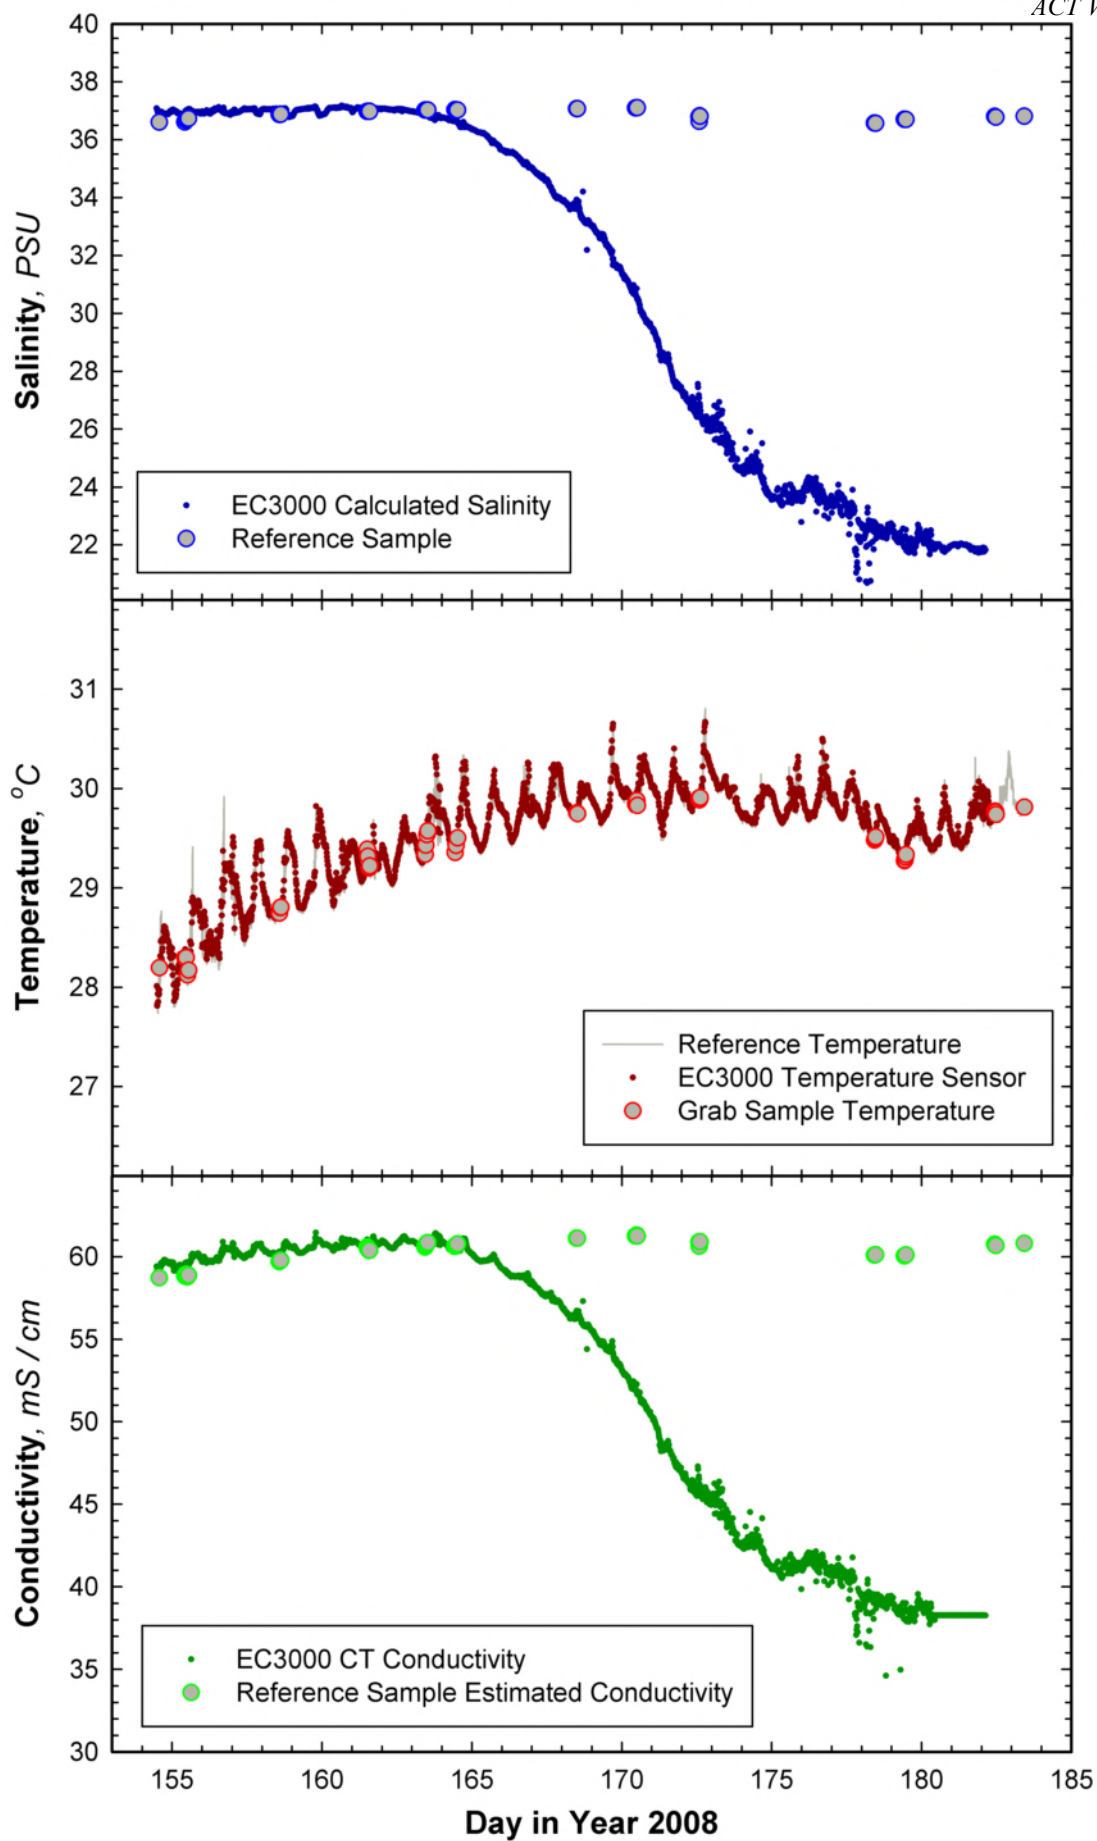
**Figure 7.** Time series of instrument measurements and corresponding reference samples acquired during USF field deployment.

Time series data of in situ measured conductivity and temperature, and derived salinity, for the FL field test were plotted against corresponding results from the laboratory analyzed reference samples and reference temperature logger (Fig. 7). Instrument measurements appeared to be impacted by fouling after approximately 10 days when a noticeable decrease in accuracy was observed and worsened over the last 20 days of the deployment test. The relative accuracy of the instrument measurements were depicted as numerical differences from the reference values and plotted over time (Fig. 8), but the data plotted was purposely limited by scale and therefore incomplete. The amount of offset in the salinity measurements was clearly related to performance of the conductivity cell, and the temperature sensor response was quite consistent throughout the deployment despite the presence of heavy biofouling. The mean offset in the salinity measurements over the first week of the deployment was 0.218 psu. To distinguish between biofouling impacts and potential instrument drift we compared measurement accuracy in pre- and post-exposure tests after the instrument was cleaned to remove any effects of biofouling using well mixed, reference sampled tanks (Fig 9). The agreement between instrument and reference sample values was actually slightly better in the post-deployment exposure, perhaps due a lower salinity of the test solution which better matched the calibration factors. The amount of fouling that development on the instrument is shown in figure 10 and the rate of fouling was documented with a time-series of photographs showing the accumulation on PVC tiles (Fig. 11).

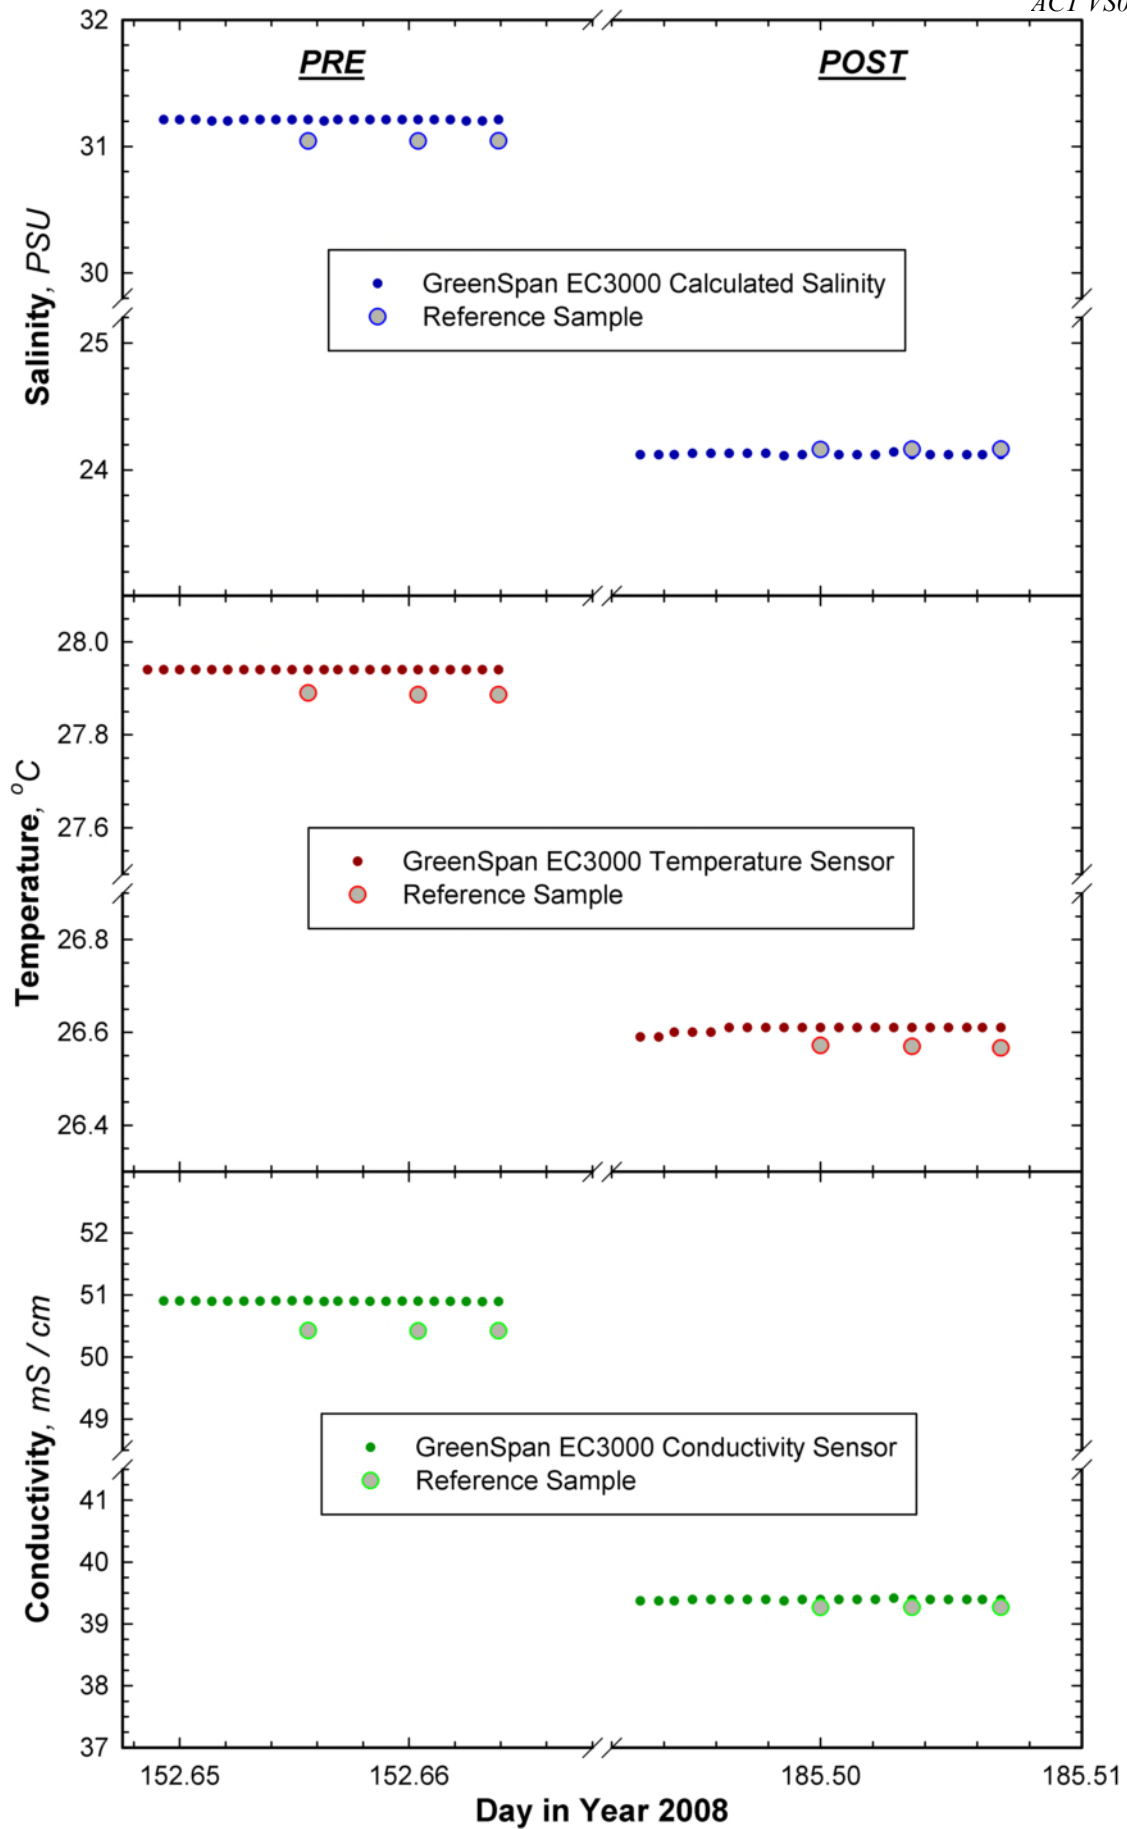
**Figure 9.** Pre- and Post-deployment reference checks in tanks of natural seawater at USF. Post-deployment tests conducted after cleaning instrument of all fouling material according to manufacturer's recommendations.

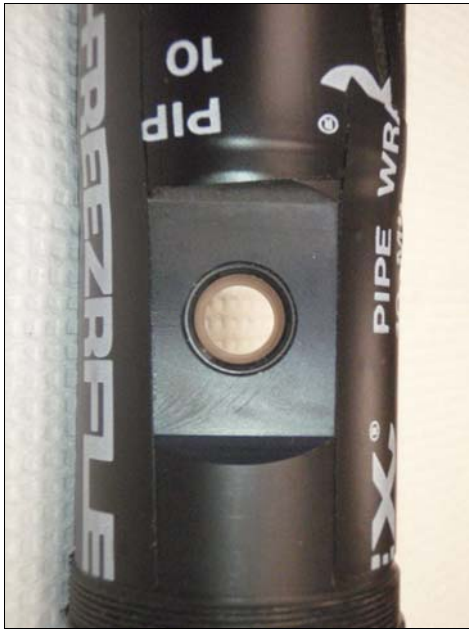
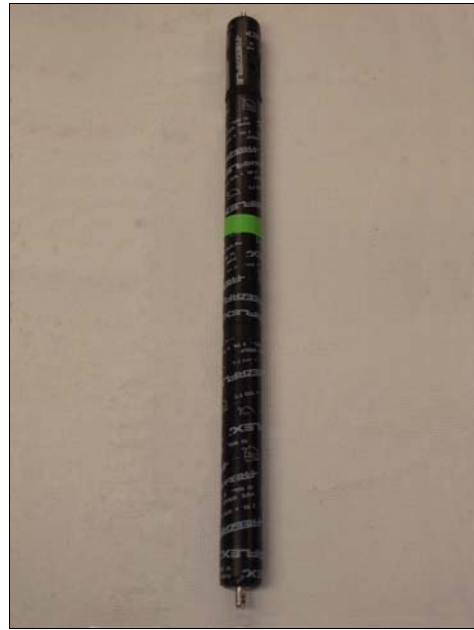
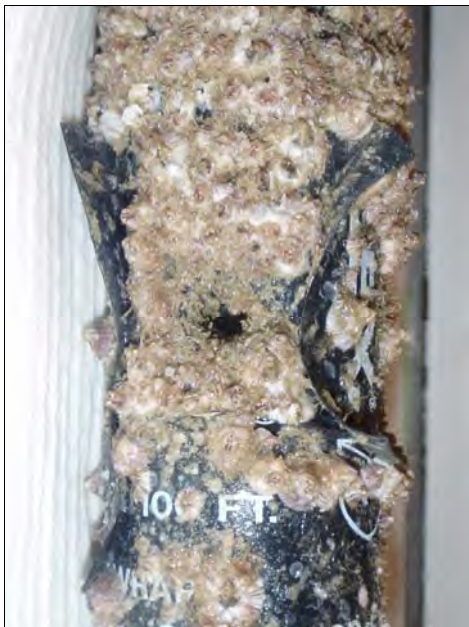
Before and after photos were taken of the instrument to examine the extent and possible impacts of bio-fouling (Fig. 10). A significant amount of hard, encrusting bio-fouling was evident across most of the instrument body by the end of the deployment, including directly within the conductivity cell.

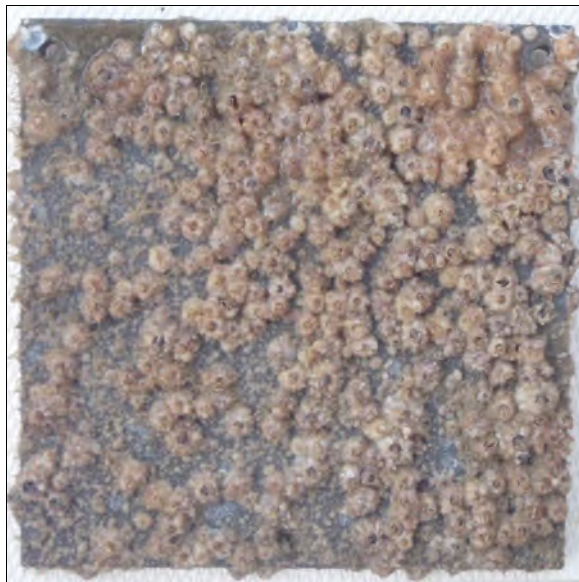
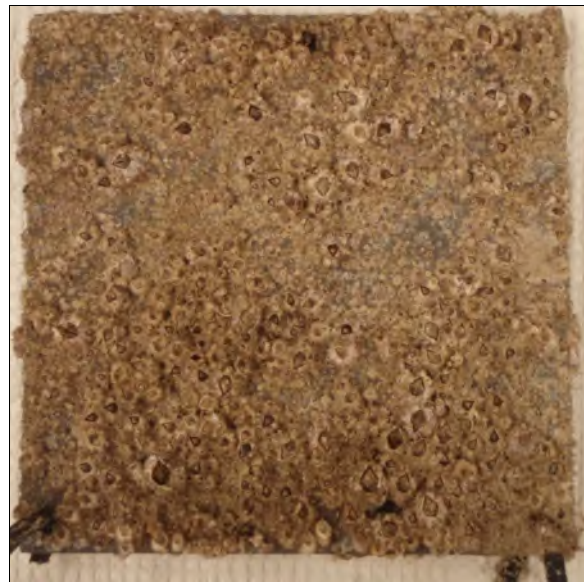
Bio-fouling plates were retrieved and photographed once each week throughout the deployment to help define the rate and extent of biofouling within the test environment (Fig. 11). By the third week of deployment there was an extensive amount of hard, encrusting biofouling at the Florida test site.

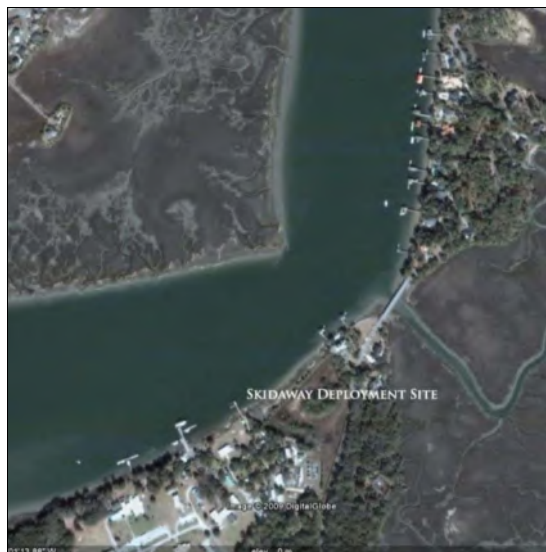
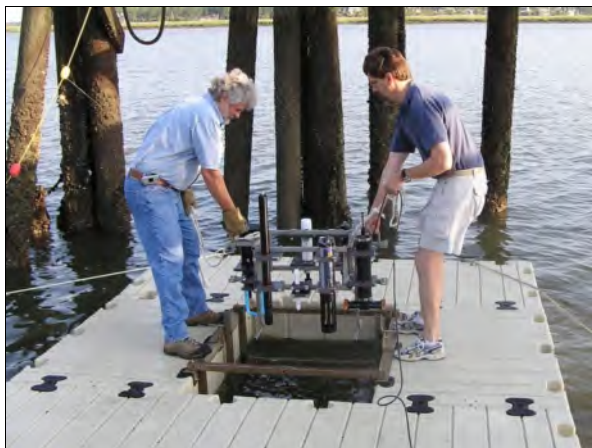
**Figure 12.** Site map and deployment arrangement for the field test conducted at Skidaway Island in Savannah, GA.

The mooring test in Georgia took place on a floating dock located on Skidaway Island on the Skidaway River (Fig. 12). The water depth of the test site was 2.3 m at minimum. The site exhibited a fairly large fluctuation in salinity, ranging from 26 – 33 PSU, and temperatures ranged from 28 – 31 °C.

SkIO Deployment Site off Skidaway Island

SkIO Easy Dock with Rack in Center

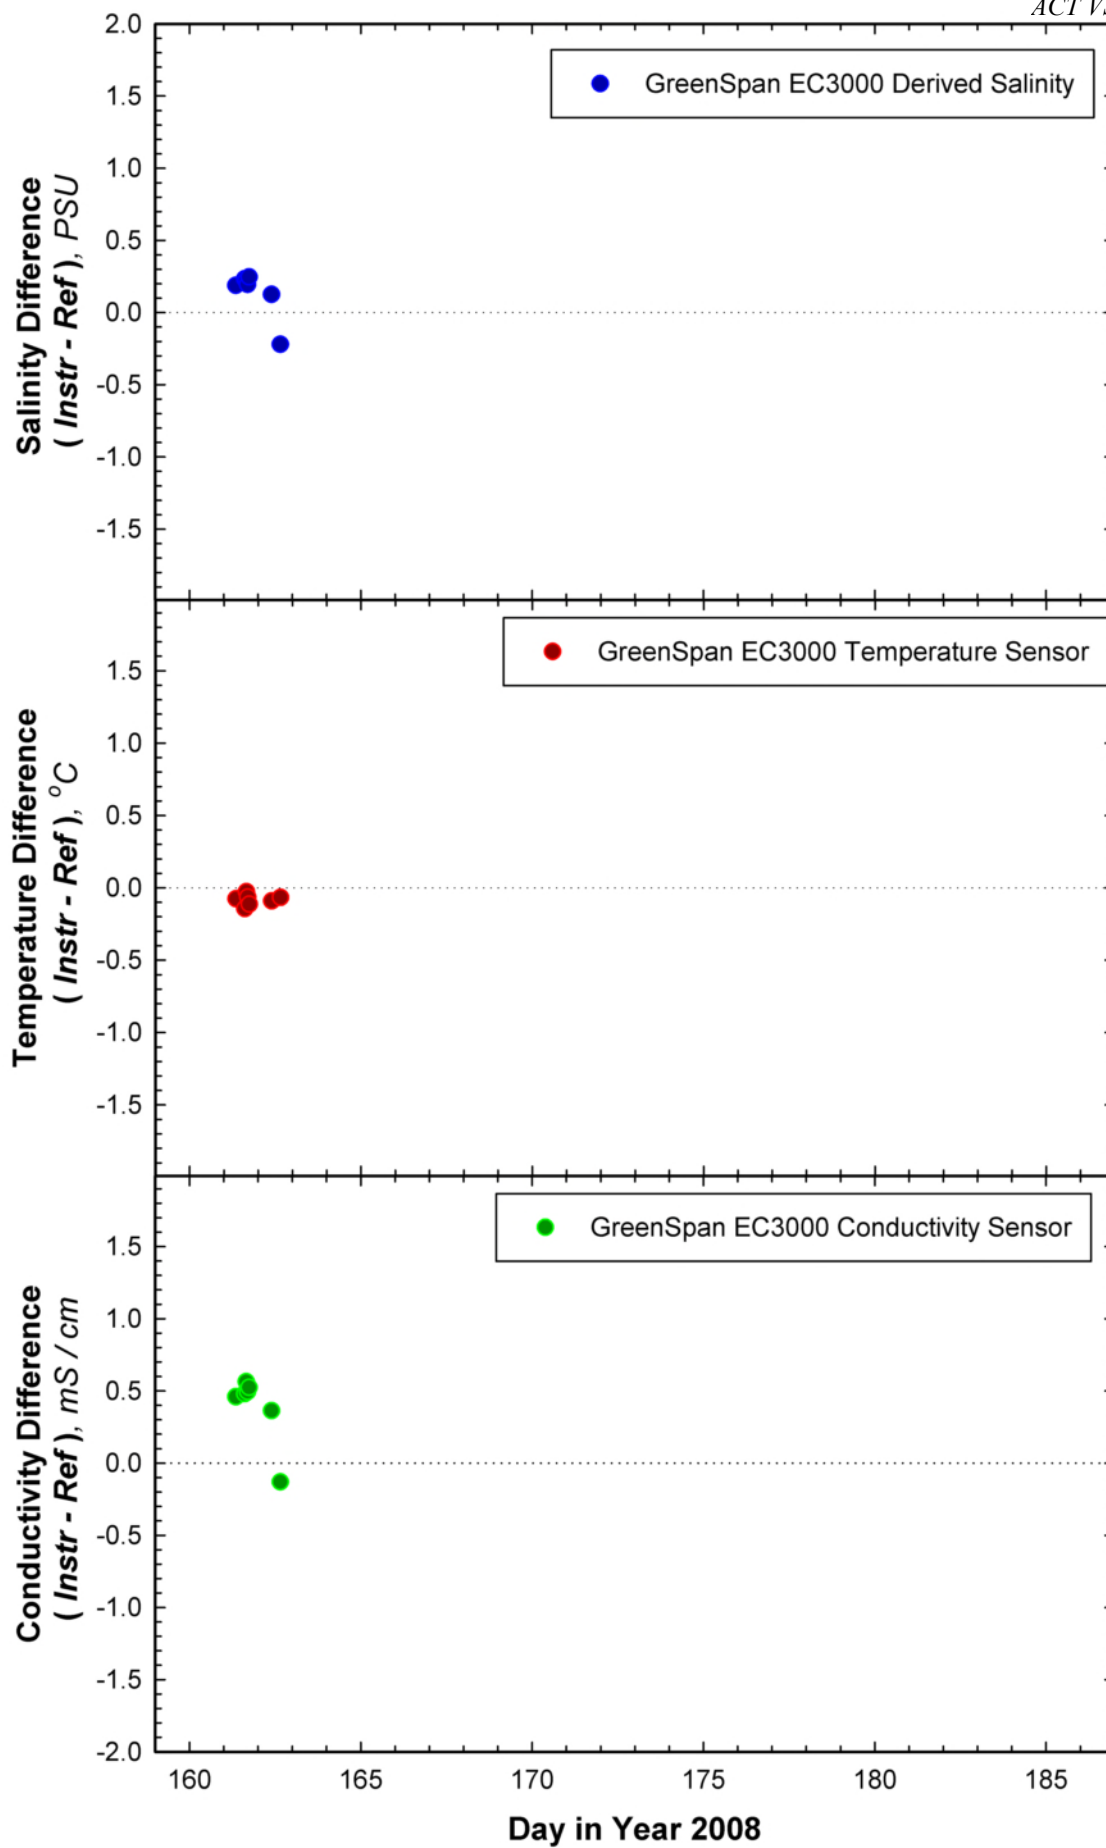
**Figure 14.** Assessment of relative accuracy of instrument time series measurements during the SKIO field deployment.

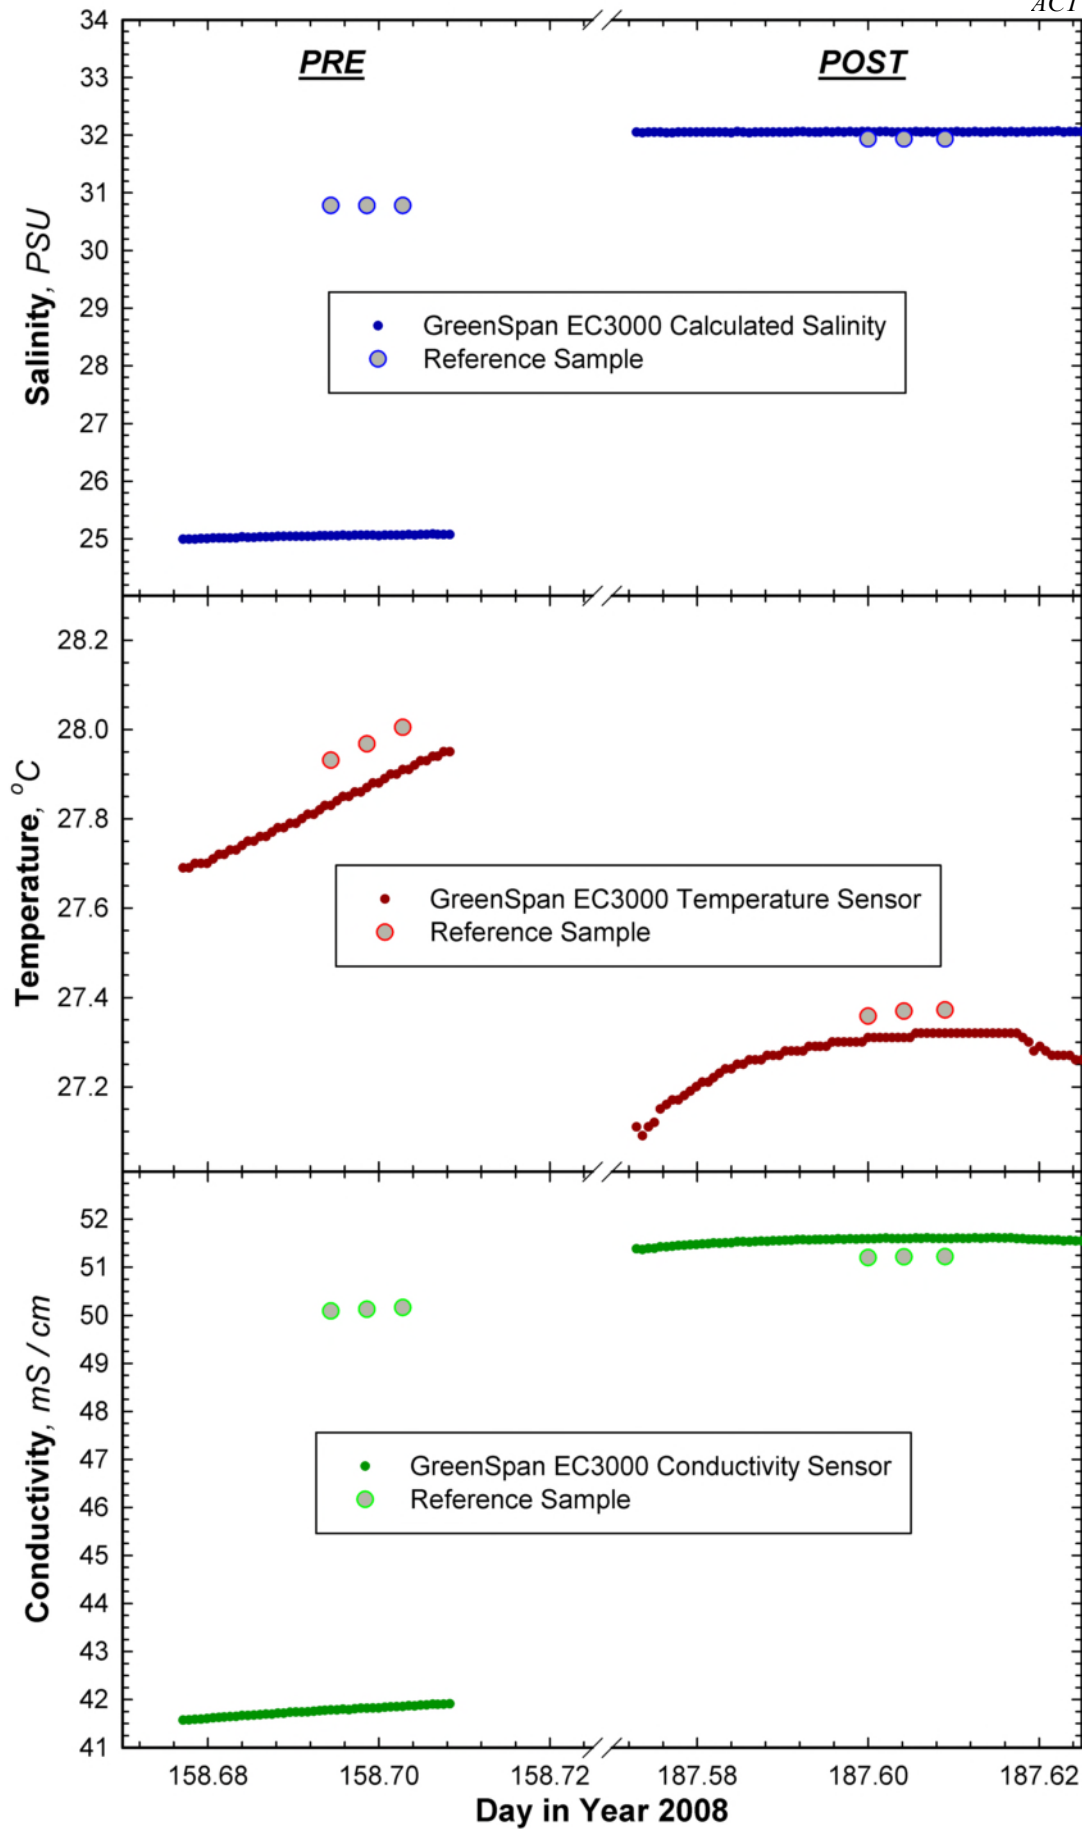
**Figure 15.** Pre- and Post-deployment reference checks in tanks of natural seawater at SkIO. Post-deployment tests conducted after cleaning instrument of all fouling material according to manufacturer's recommendations.

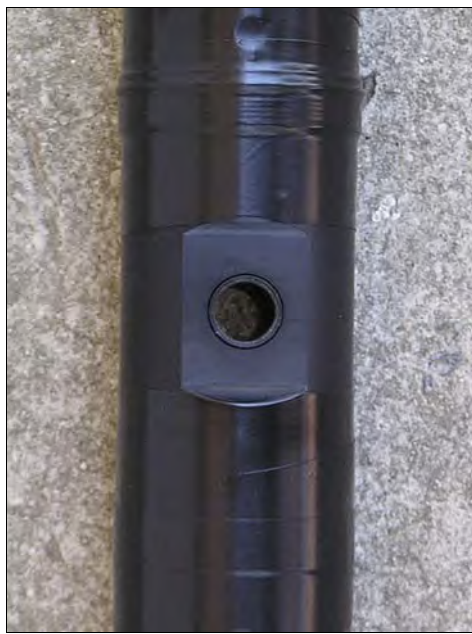
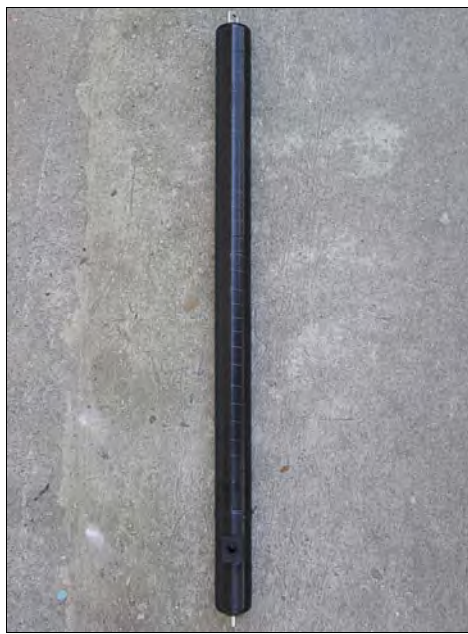
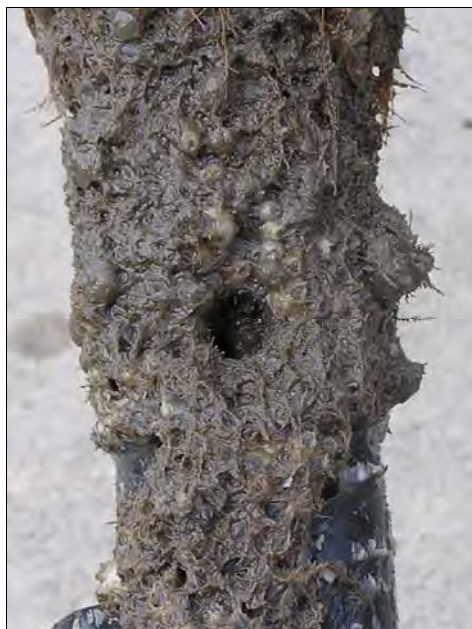
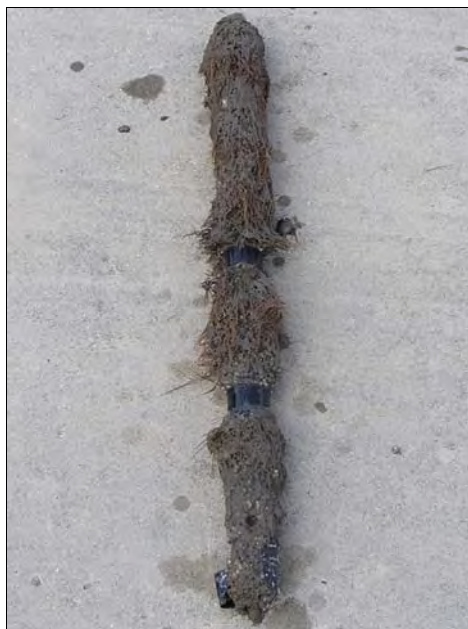
Before and after photos were taken of the instrument to examine the extent and possible impacts of bio-fouling (Fig. 16). A significant amount of soft (plant material) and hard (calcified) bio-fouling was evident across most of the instrument body by the end of the deployment including directly within the conductivity cell.

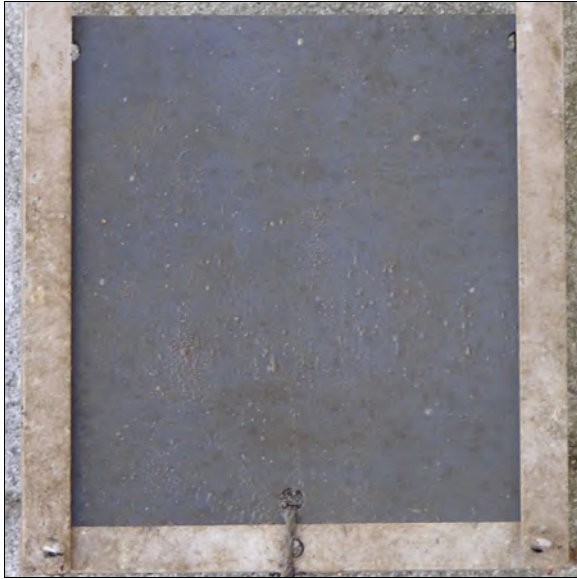
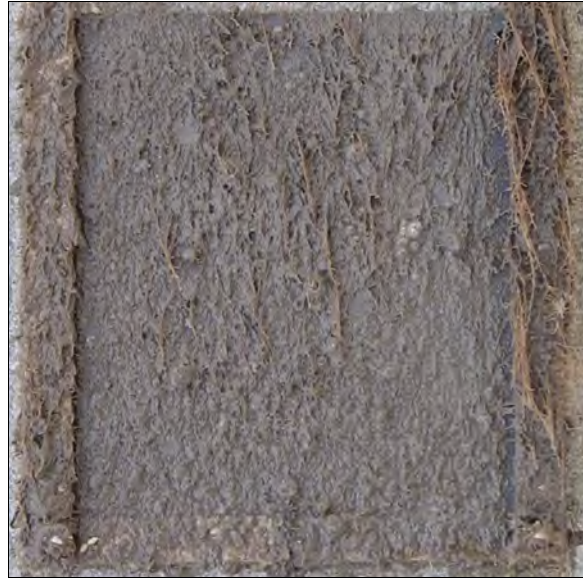
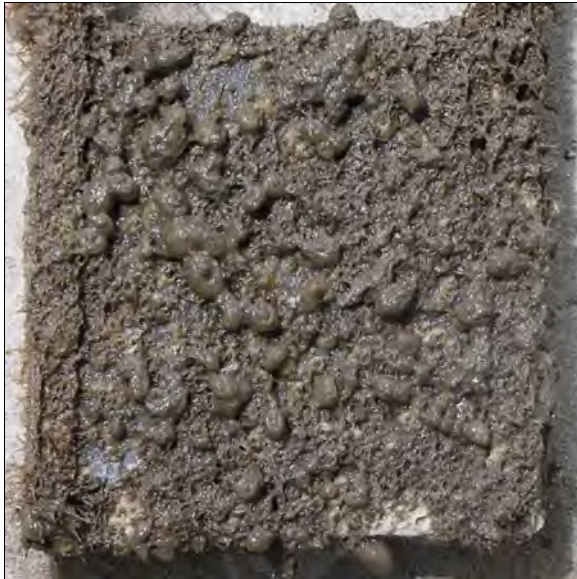
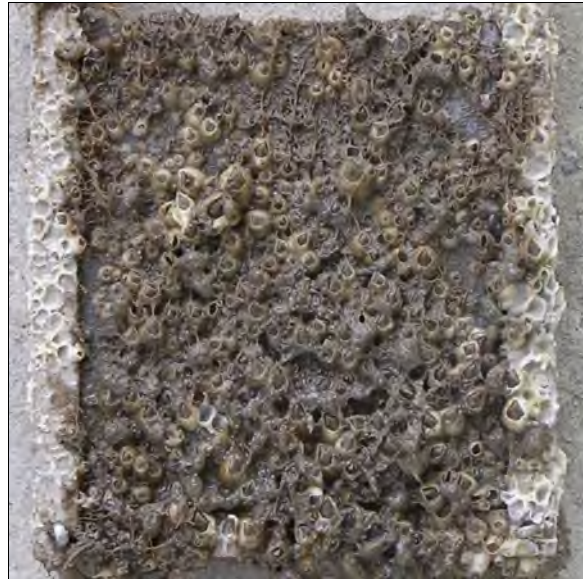
Bio-fouling plates were retrieved and photographed once each week throughout the deployment to help define the rate and extent of biofouling within the test environment (Fig. 17). Significant amounts of soft biofouling were evident by week 2 and progressed into heavy amounts of hard, encrusting biofouling at the Georgia test site.

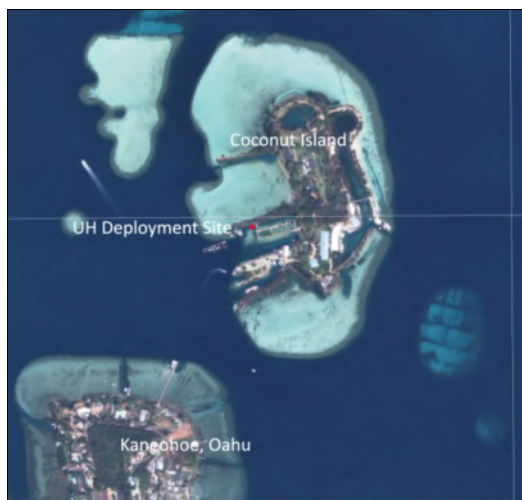
**Figure 18.** Site Photos from Field Deployment off Coconut Island, Kaneohe Bay, HI.

The mooring test in Kaneohe Bay took place on the fringing reef flat surrounding Coconut Island. The instruments were placed on a standing rack (Fig. 18) in a water depth of 3 meters with tidal variations typically less than 0.5 m at this site. During the deployment test, salinity values ranged from 33 to 35.5 and water temperatures from 26.1 to 29.6 °C.

Deployment Site on Coconut Island

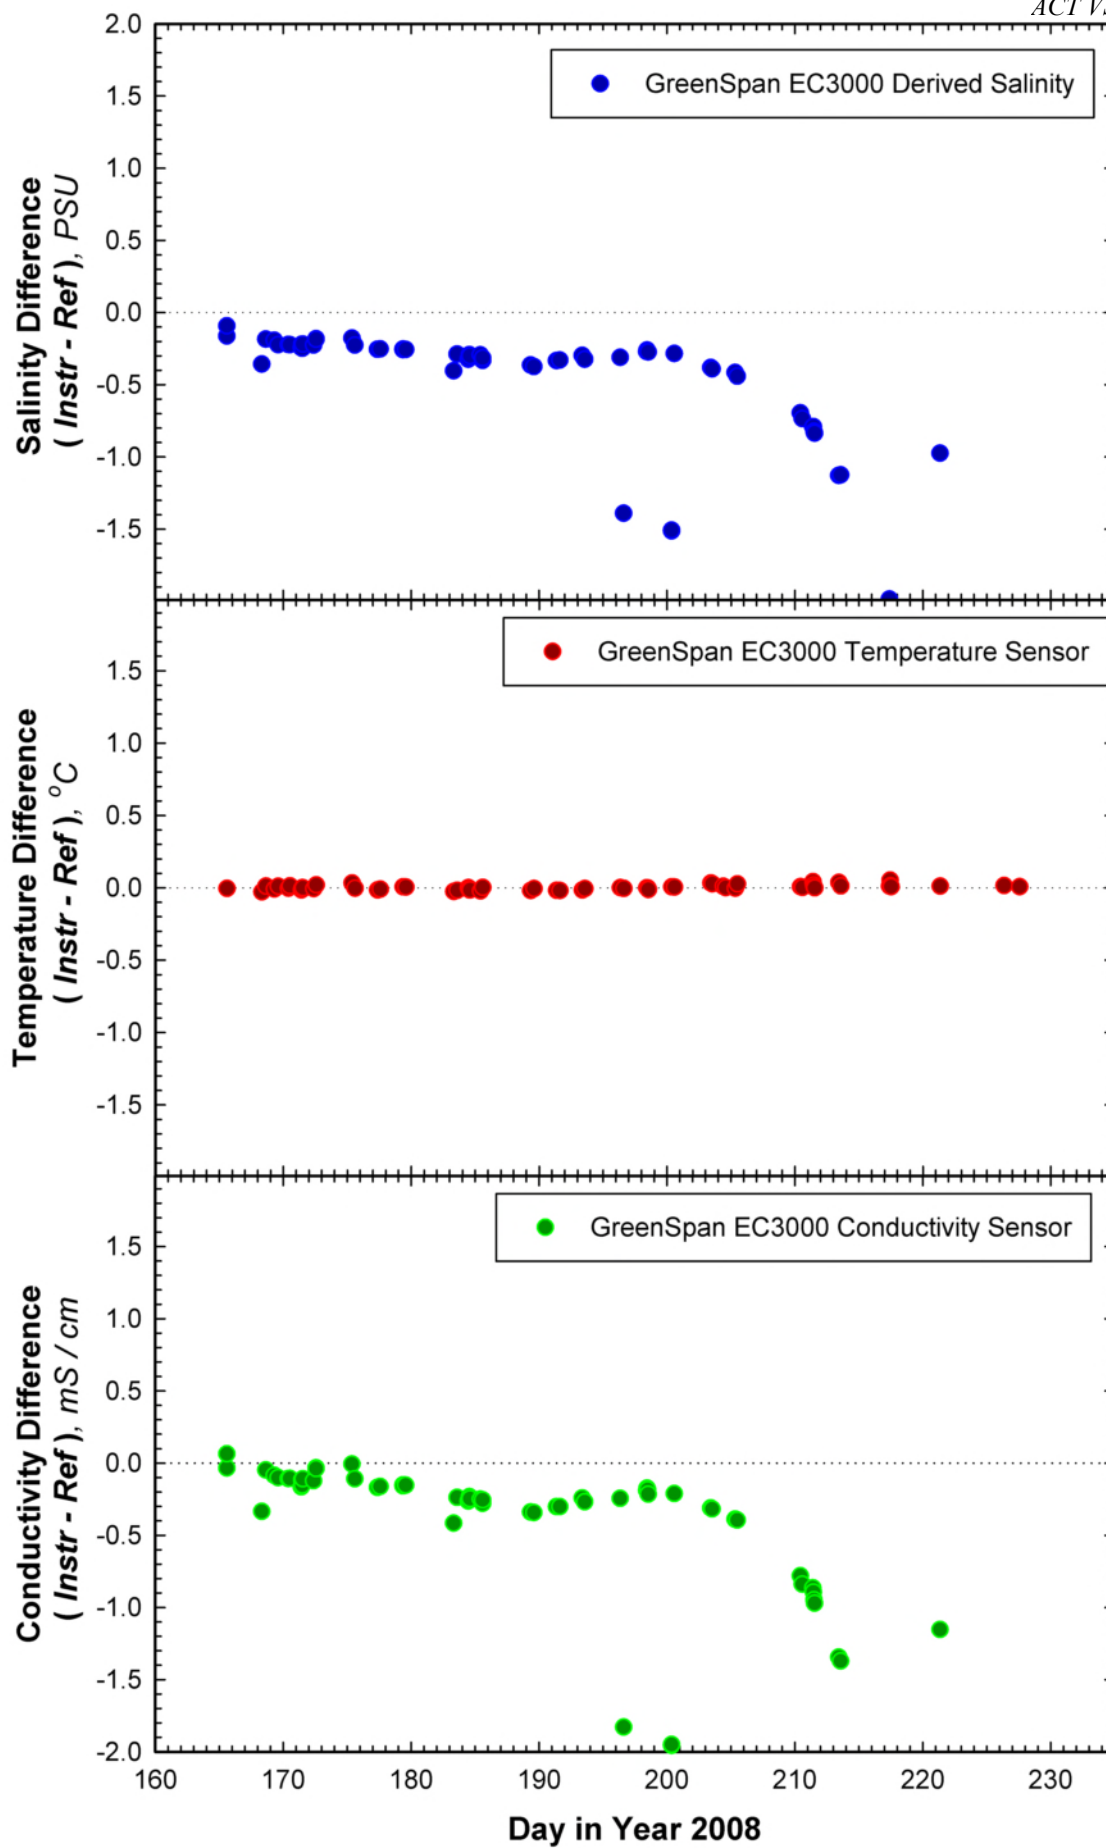
**Figure 20.** Assessment of relative accuracy of instrument time series measurements during the HI field deployment.

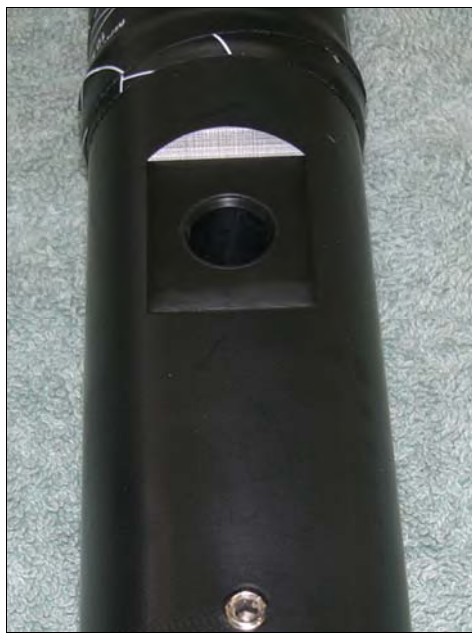
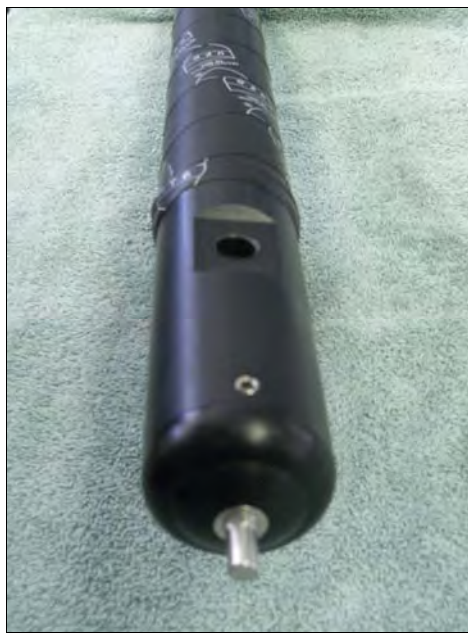
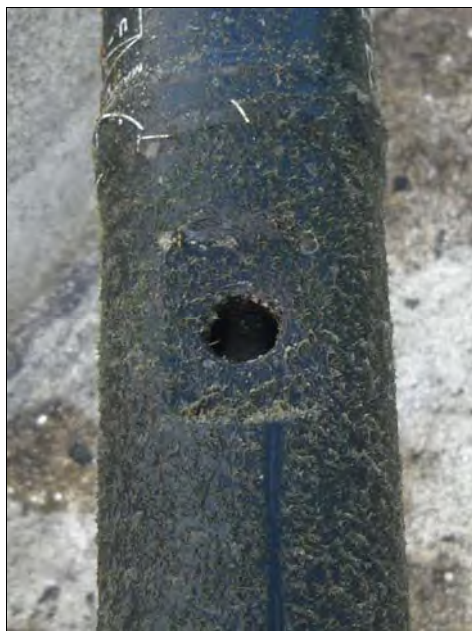
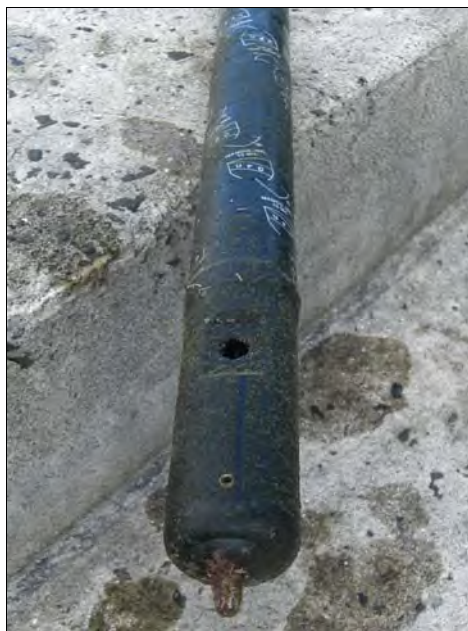
Before and after photos were taken of the instrument to examine the extent and possible impacts of bio-fouling (Fig. 22). The extent of bio-fouling was significantly less at this test site relative to FL or GA despite the longer deployment period and was mostly comprised of plant material and worm cases.

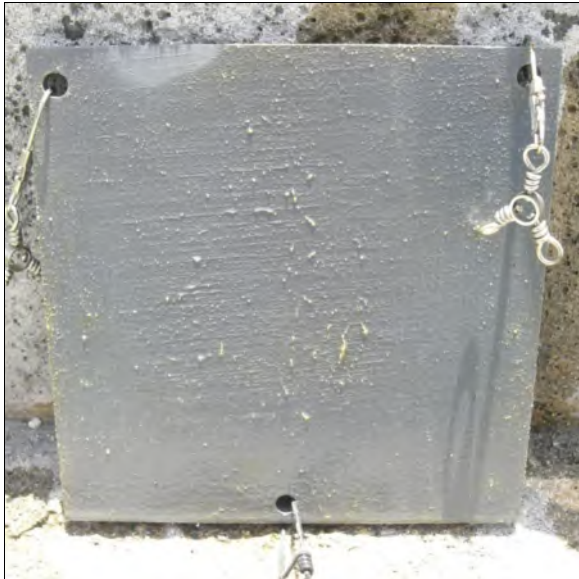
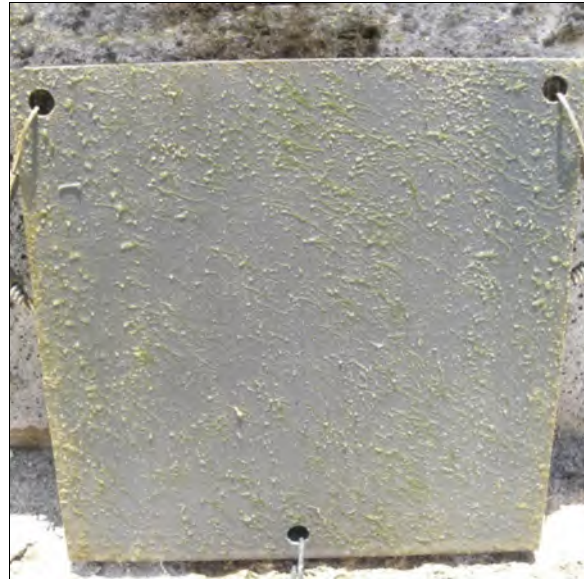
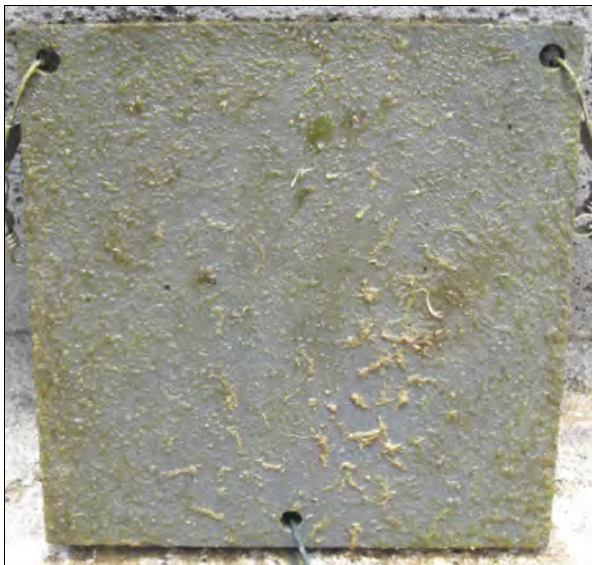
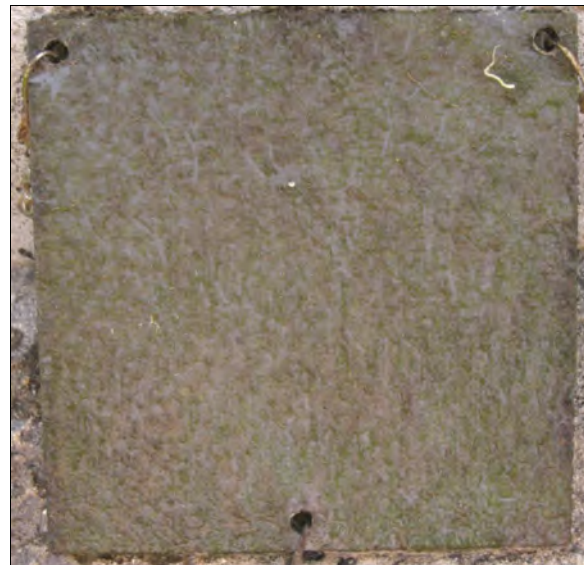
Bio-fouling plates were retrieved and photographed once each week throughout the deployment to help define the rate and extent of biofouling within the test environment. A subset of the plate photographs covering weeks 1, 2, 4, and 8 are shown in Figure 23. The extent of bio-fouling was significantly less at this test site relative to FL or GA despite the longer deployment period and was mostly comprised of plant material and worm cases.

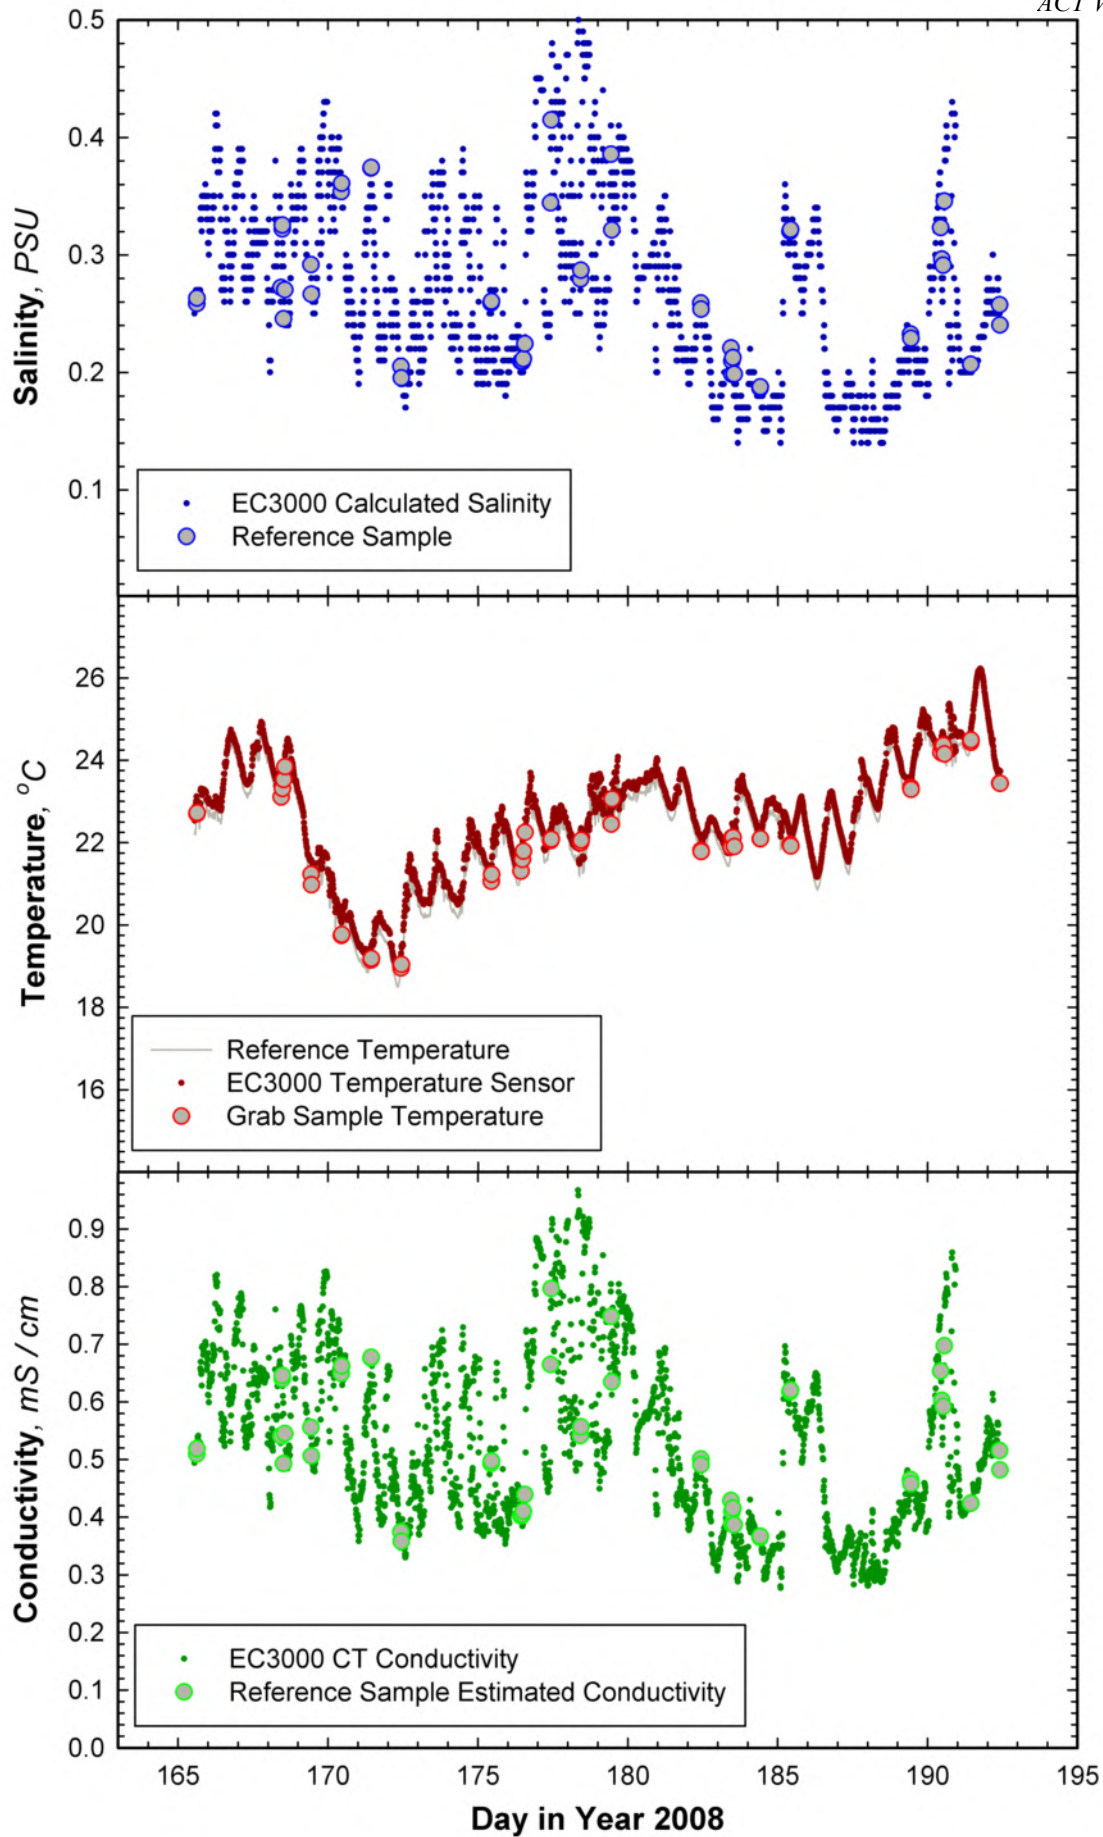
**Figure 25.** Time series of instrument measurements and corresponding reference samples acquired during the GL field deployment.

Time series data of in situ measured conductivity and temperature, and derived salinity, for the MI field test were plotted against corresponding results from the laboratory analyzed reference samples and reference temperature logger (Fig. 25). Instrument measurements closely tracked the sharp gradients in conductivity and temperature throughout the deployment. The relative accuracy of the instrument measurements were plotted over time (Fig. 26) and show little change in performance. The mean offset in the salinity measurements over the entire deployment was -0.0022 psu. The offset in temperature is somewhat higher at this site and averaged 0.2996 °C above the reference temperature logger. This offset was also observed in both the pre- and post-exposure tests in well mixed tanks so appears to be a calibration issue (Fig 27). In general, the agreement between instrument and reference sample values was very similar for the pre- and post-deployment tests. The amount of fouling that development on the instrument is shown in figure 28 and the rate of fouling was documented with a time-series of photographs showing the accumulation on PVC tiles (Fig. 29).
