## PERFORMANCE VERIFICATION STATEMENT for the Greenspan EC3000 Conductivity Sensor

<b>TECHNOLOGY TYPE:</b>	Coupled conductivity and temperature sensors with instrument based algorithms for estimation of salinity
<b>APPLICATION:</b>	In situ estimates of salinity for coastal moored and profiled deployments
<b>PARAMETERS EVALUATED:</b>	Response linearity, accuracy, precision and reliability
<b>TYPE OF EVALUATION:</b>	Laboratory and Field Performance Verification
<b>DATE OF EVALUATION:</b>	Testing conducted from May through October 2008
<b>EVALUATION PERSONNEL:</b>	S. Gilbert, K. Gundersen, T. Johengen, T. McKissack, M. McIntyre, A. Pinchuk, H. Purcell, C. Robertson, D. Schar, G.J. Smith, M. Tamburri and D. Wells.

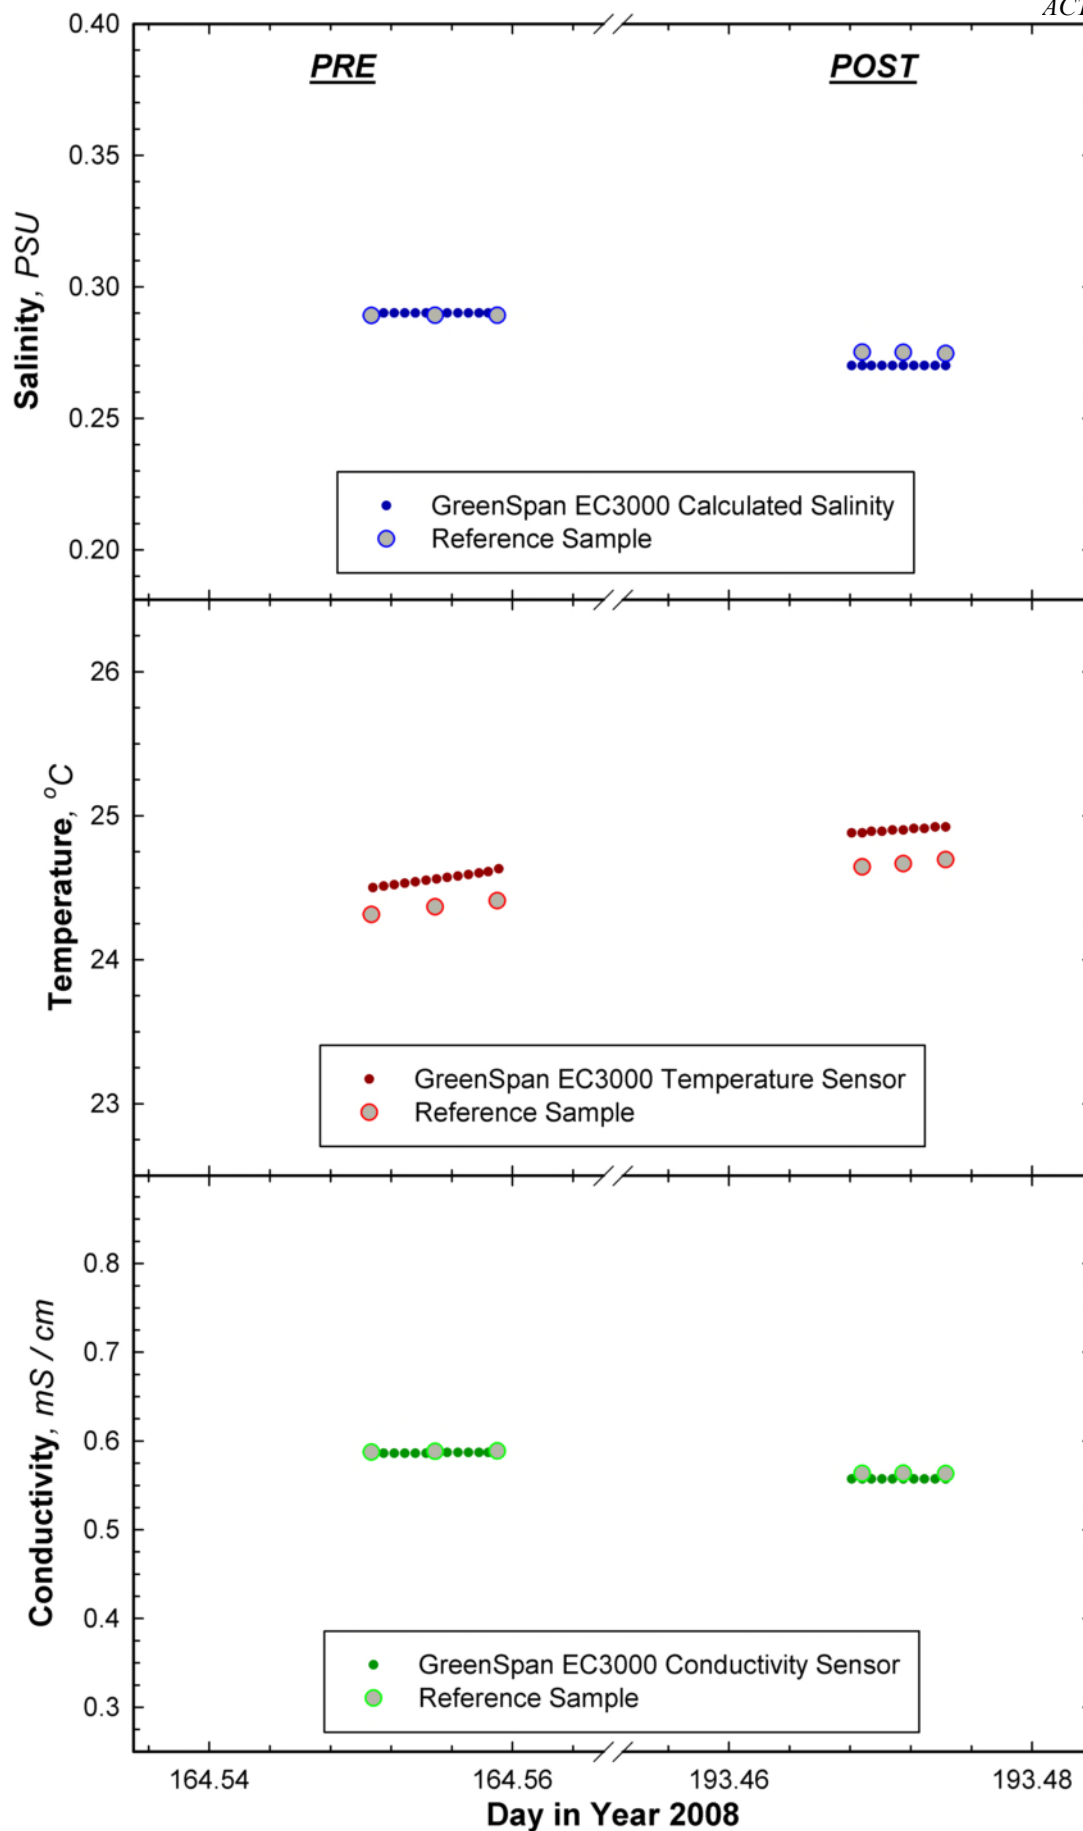
**Figure 27.** Pre- and Post-deployment reference checks in tanks of river water at GL. Post-deployment tests conducted after cleaning instrument of all fouling material according to manufacturer's recommendations.

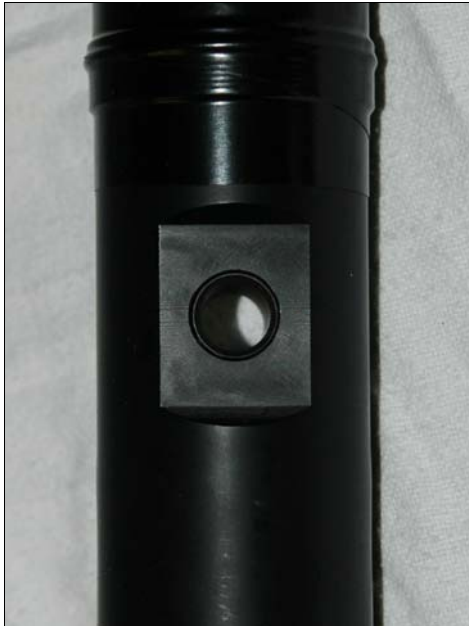
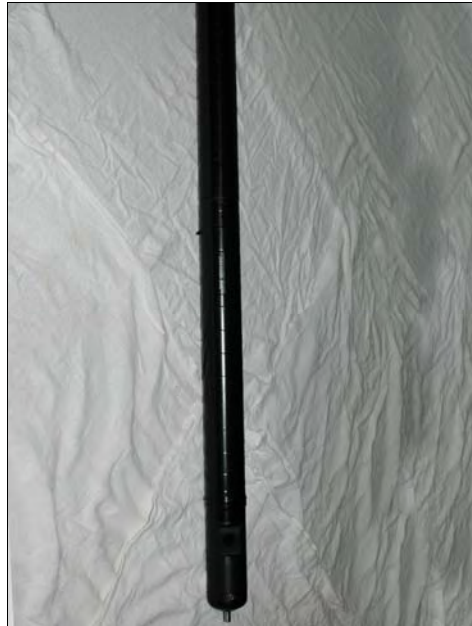
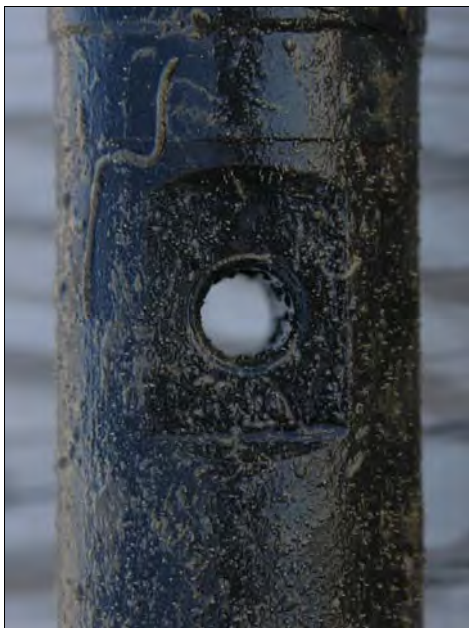
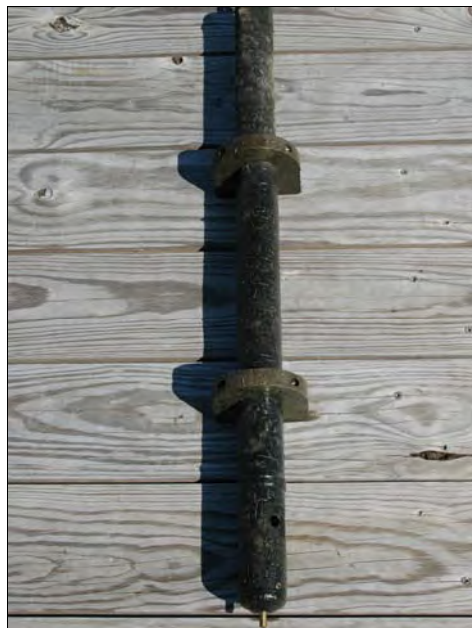
**Figure 28.** Greenspan EC3000 instrument photos from the Clinton River, MI test site before and after deployment

Before and after photos were taken of the instrument to examine the extent and possible impacts of bio-fouling (Fig. 28). The extent of bio-fouling was quite low at the MI test site and consisted of only soft plant material.

Prior to Deployment (Close-up)

Prior to Deployment (Full View)

After Deployment (Close-up)

After Deployment (Full View)

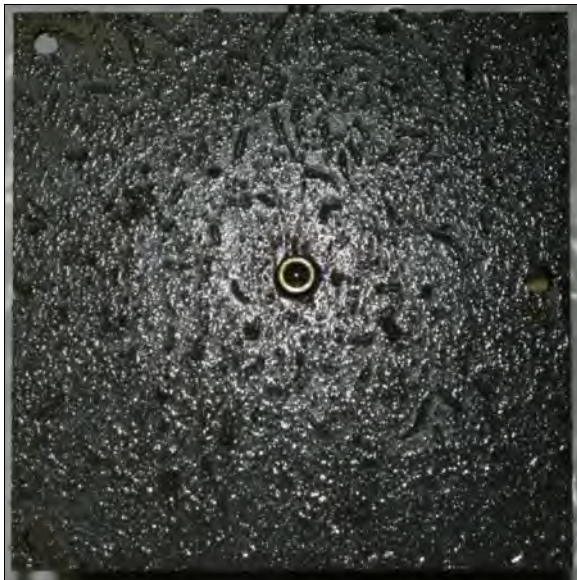
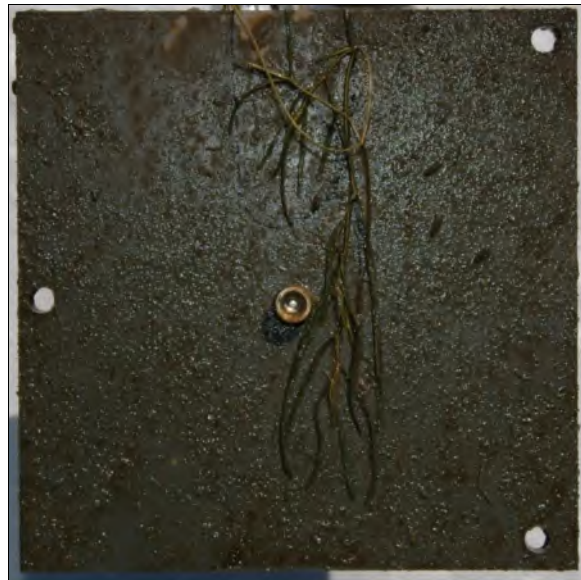
Bio-fouling plates were retrieved and photographed once each week throughout the deployment to help define the rate and extent of biofouling within the test environment (Fig. 29). Biofouling material was mostly comprised of plant material and developed rather quickly but did not appear to accumulate significantly once the original surface was covered.

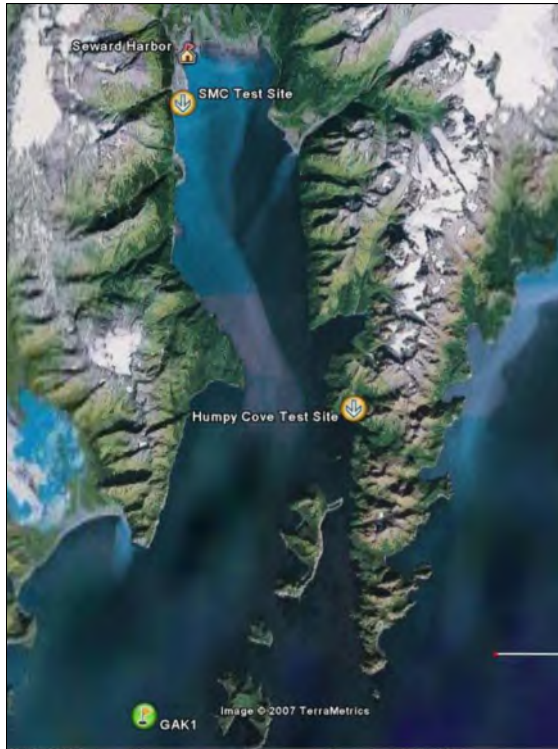
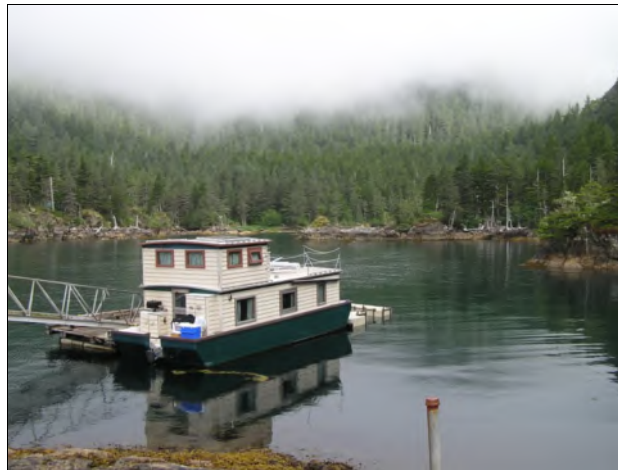
**Figure 30.** Site map and photo of the Alaska field test site located in Humpy Cove of Resurrection Bay near Seward, AK. The test instrument was deployed on a mooring frame attached to a floating dock.

The mooring test in Resurrection Bay took place within the inlet of Humpy Cove on a floating dock attached to the end of a small fixed pier (Fig 30). The water depth of the test site was 3 m.

Deployment Site in Resurrection Bay

Floating Dock location in Humpy Cove

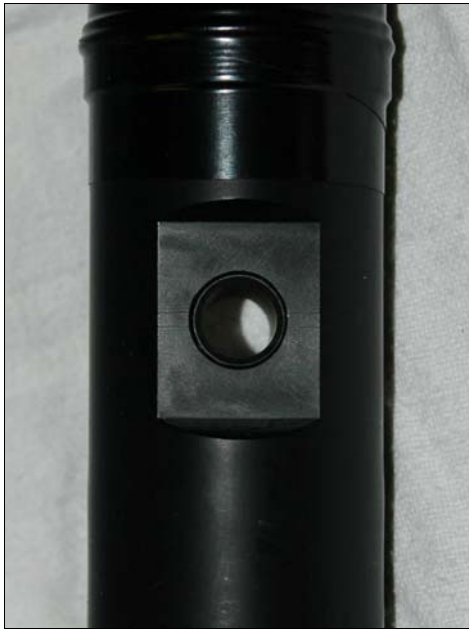
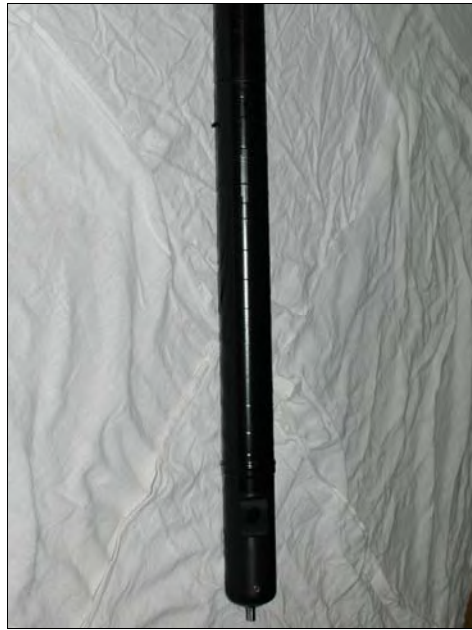
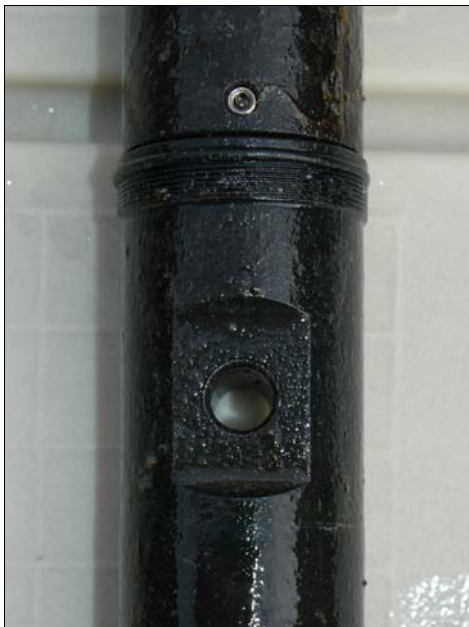
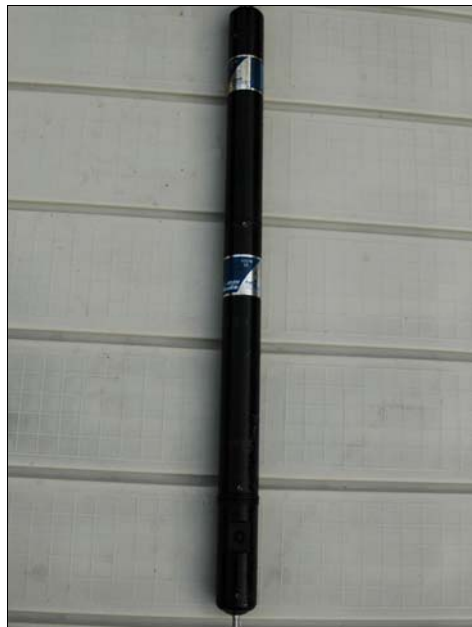
Before and after photos were taken of the instrument to examine the extent and possible impacts of bio-fouling (Fig. 34). The extent of bio-fouling at the AK test site was very small and the lowest of any of the five test sites. No hard fouling was observed.

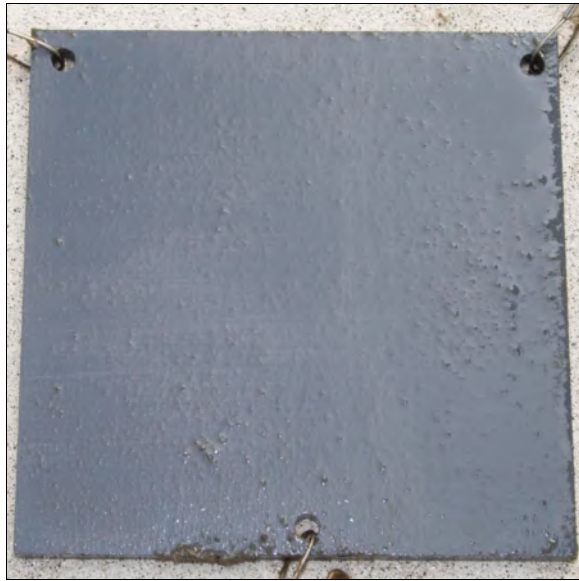
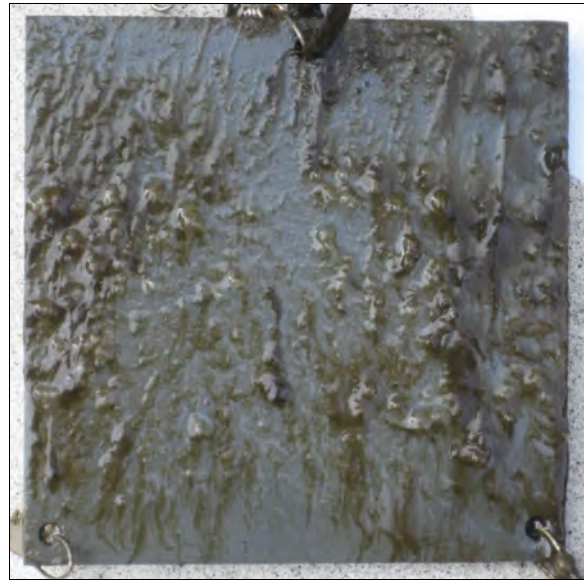
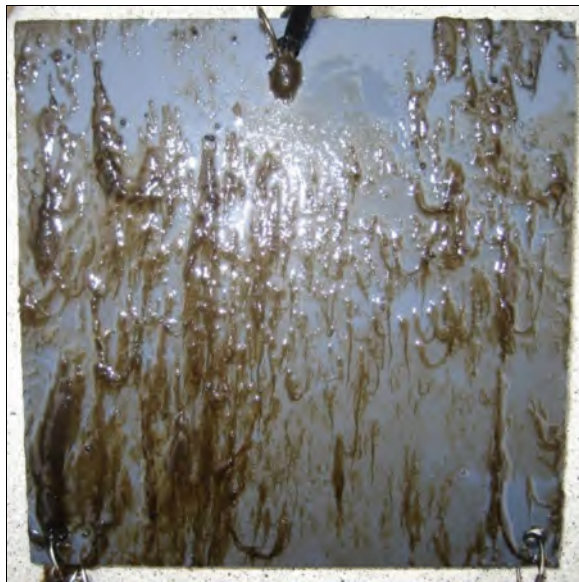
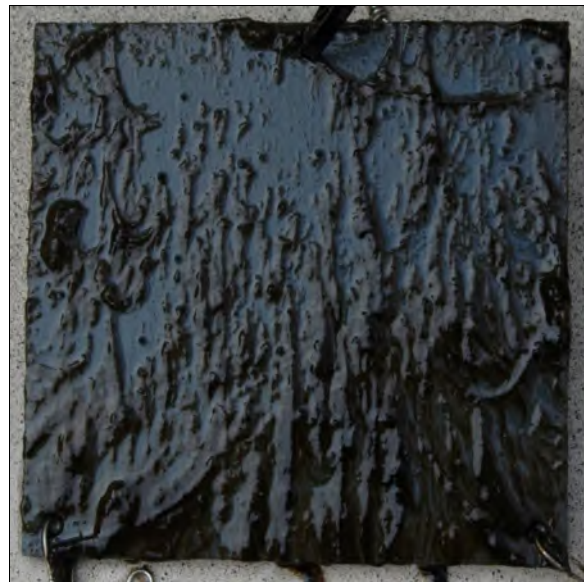
Bio-fouling plates were retrieved and photographed once each week throughout the deployment to help define the rate and extent of biofouling within the test environment (Fig. 35). Biofouling material was mostly comprised of plant material and had a slower but consistent rate of fouling until the surface was completely covered.

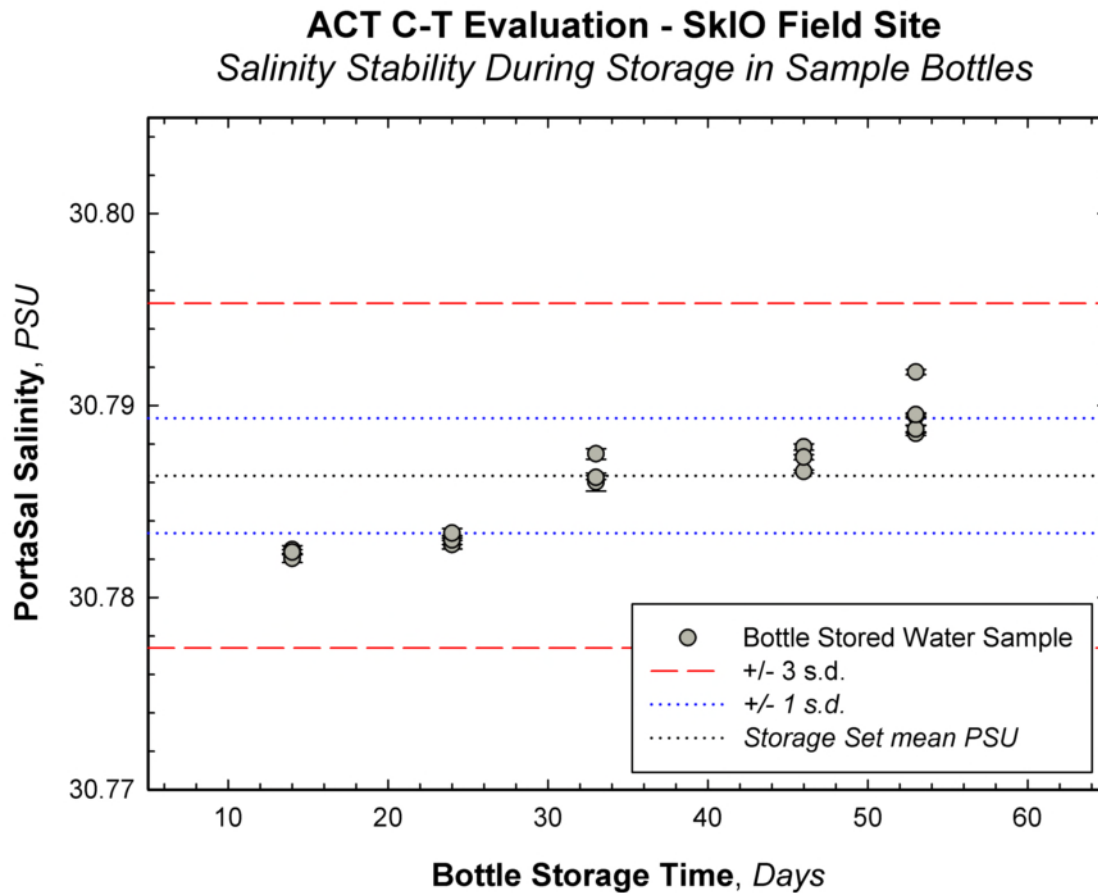
**Figure 38.** Assessment of drift in laboratory salinity measures associated with sample storage in field reference sample bottles. Sample bottles filled from single batch of test site surface water and subsets included in each sample shipment to MLML. Storage time reflects total time (days) since initial water collection.

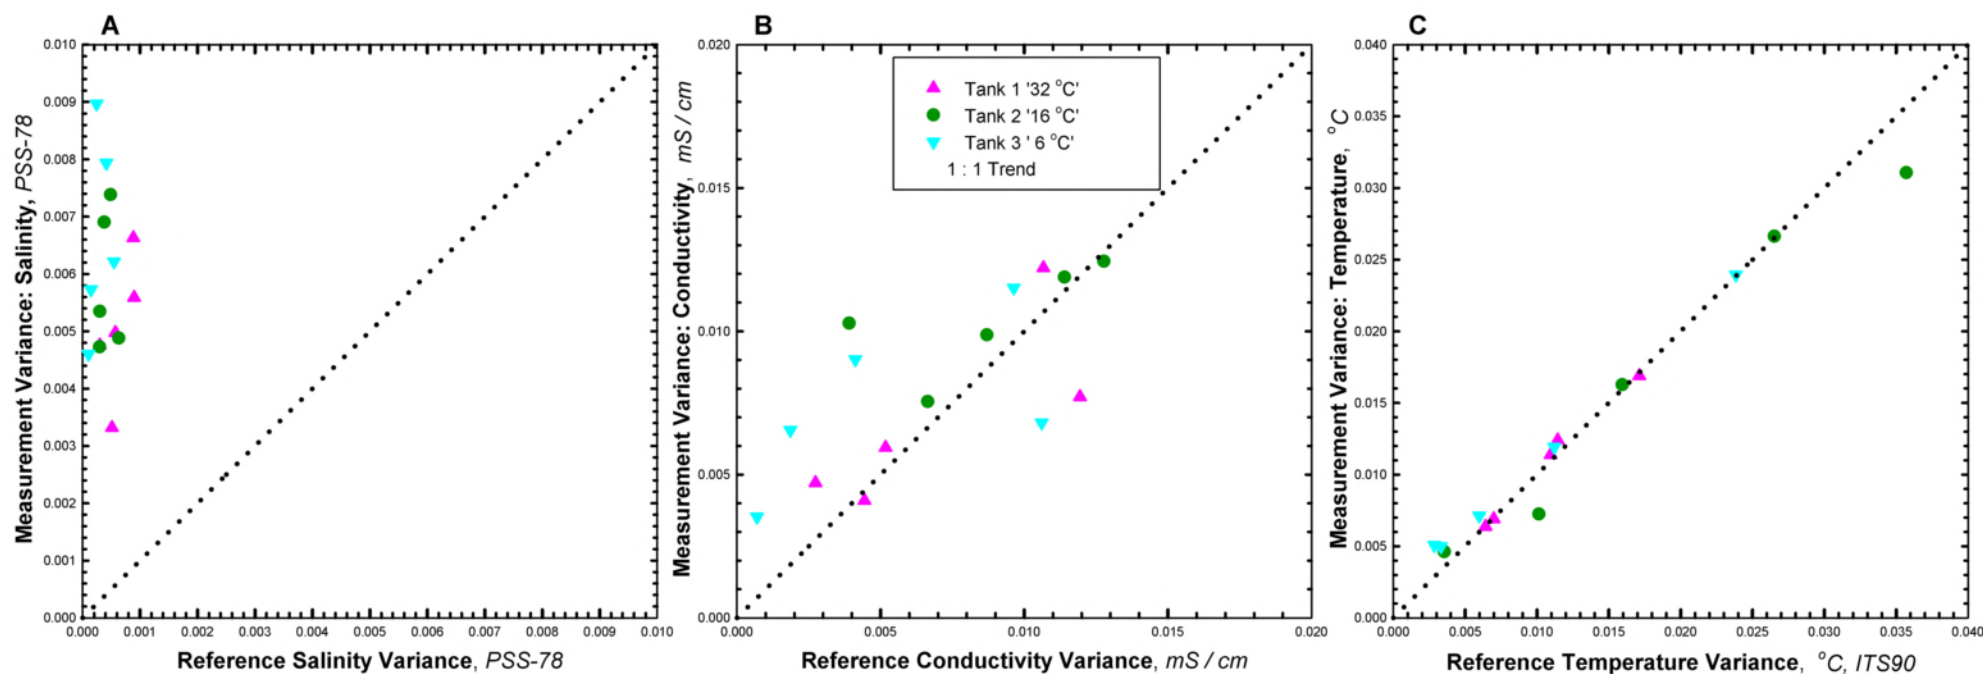
**Figure 4.** Evaluation of measurement variation of Greenspan Analytical's EC3000 conductivity and temperature sensor package achieved during the laboratory exposure trials plotted in **Fig. 3**. Instrument measurement variance is presented as the standard deviation from 30 consecutive instrument reads recorded during the 30 min reference sampling for each test exposure and plotted against the corresponding variation in the reference measure. The 1:1 correspondence line (dotted) is provided for comparison, with points below the line indicating lower and above higher-instrument measurement variation than obtained by our reference methods and test conditions. [A] Co-variation of derived salinity estimates; [B] Co-variation of in situ conductivity measurements; [C] Co-variation of instrument temperature measurements.
