**Phase II Archaeological Testing of the Hothouse Structure (18TA314), Talbot
County, Maryland
May 2012**

By
Beth Pruitt
Department of Anthropology
University of Maryland
College Park, MD 20742

Report Prepared for
Tilghman Family

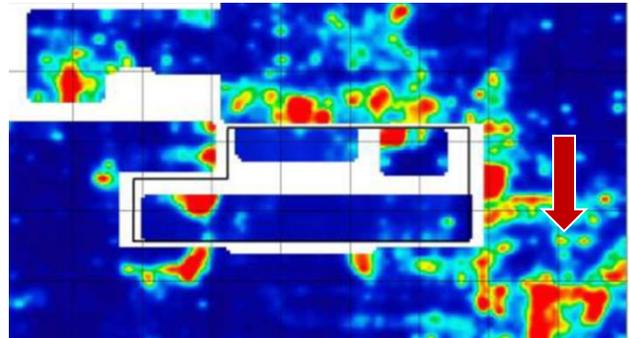
Figure 1: Ground penetrating radar showing an anomaly southeast of the standing Greenhouse at a depth of 1.49 feet.

Bryan Haley’s ground penetrating radar analysis reported in *A Geophysical Survey of Portions of the Wye House Grounds, Talbot County, Maryland* (Haley 2009) provided the location of a 16x16 ft. structure near the standing Greenhouse. Haley’s report shows the structure beginning to take shape at a depth of 1.14 feet and seems to solidify around a depth of 1.49 feet. It shows the northwest corner of the structure to be approximately 15 feet east and 10 feet south of the standing Greenhouse’s southeast corner.

On the landscape in the present day, there is a small ridge along the northern edge of this GPR anomaly on the ground surface, with a slight slope toward the south. It was on this basis that excavators decided on the location for two units to the southeast of the Greenhouse in an attempt to straddle the north wall and uncover the northwest corner.

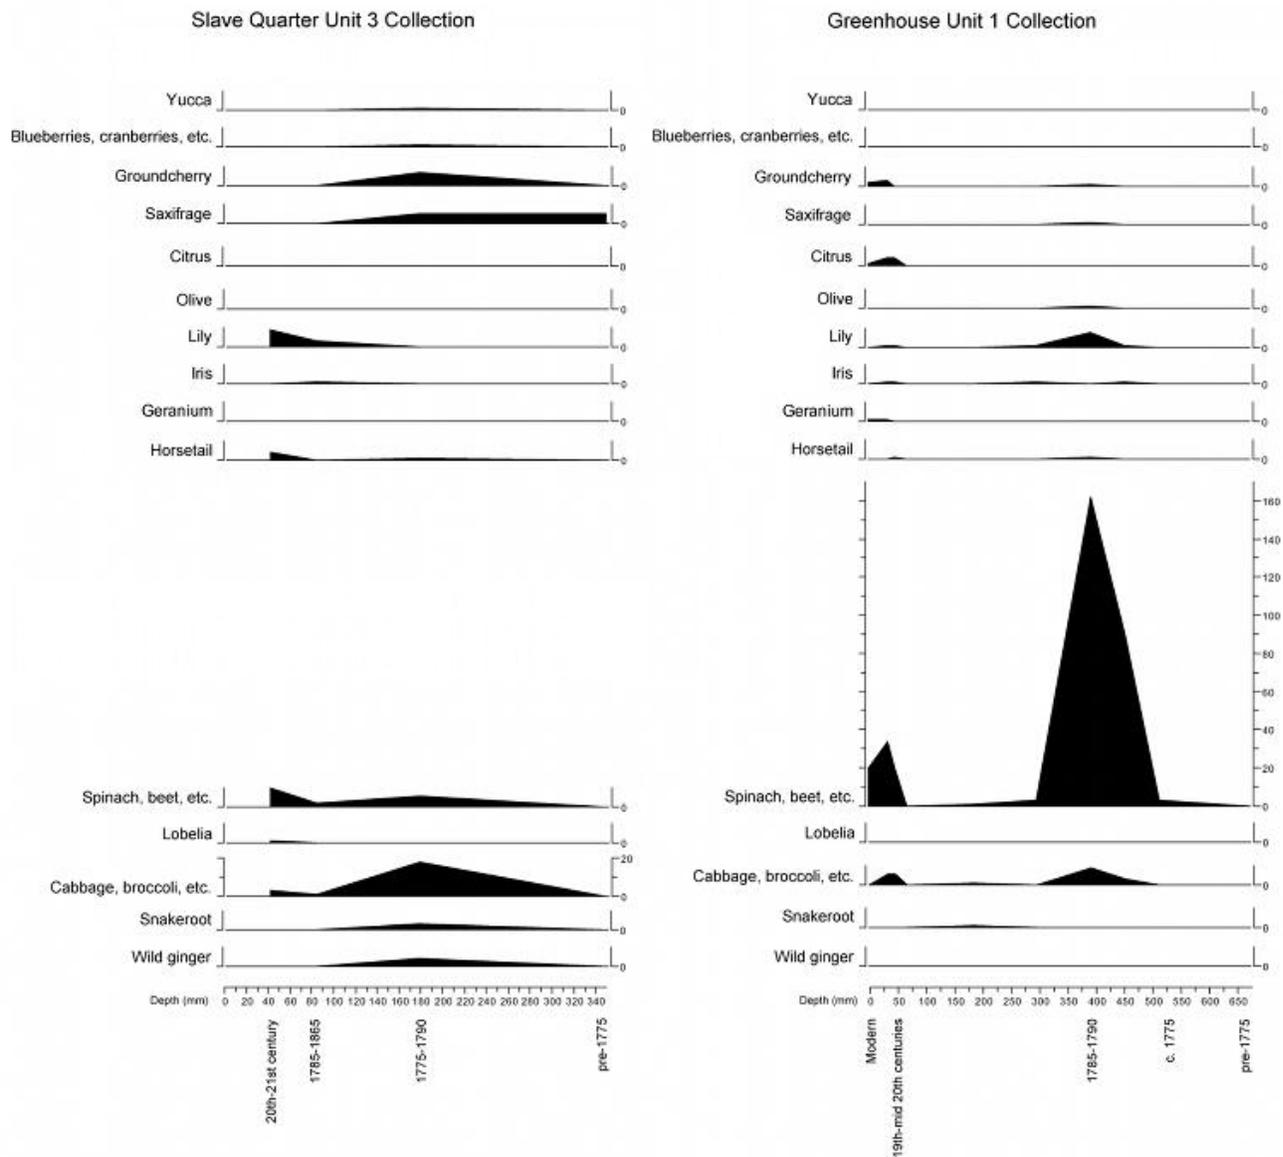
Figure 2: Selected pollen counts from the Greenhouse and attached slave quarter for comparison (reproduced from the data reported in Jacobucci and Trigg 2010).

These categories are not mutually exclusive, as many plants have multiple uses. Pollen remains of medicinal, practical, ornamental, and edible plants were found in both the Greenhouse and the slave quarter in varying quantities.

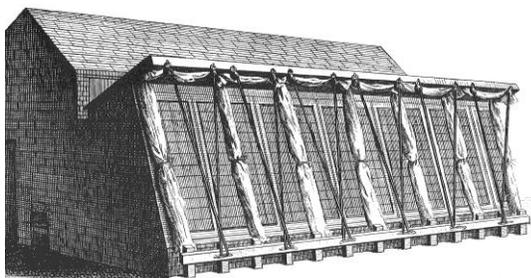
Figure 3: A hothouse heated by a furnace in the rear shed and a system of flues. Published in the *Dictionnaire Encyclopedie* (Diderot and d’Alembert 1760, reproduced in Woods and Warren 1988:58).

Hothouses are a structure similar to a greenhouse, but with the addition of an artificial heating element on top of the heat provided by the sun. Through the use of stoves, hot-beds, hypocausts, and warming pits, gardeners were able to achieve far higher temperatures and more closely regulate the climates inside the structures of hothouses. Along with greenhouses, hothouses became permanent and necessary fixtures of elite gardens. According to William Speechly, gardener and the author of *A Treatise on the Culture of the Pine*

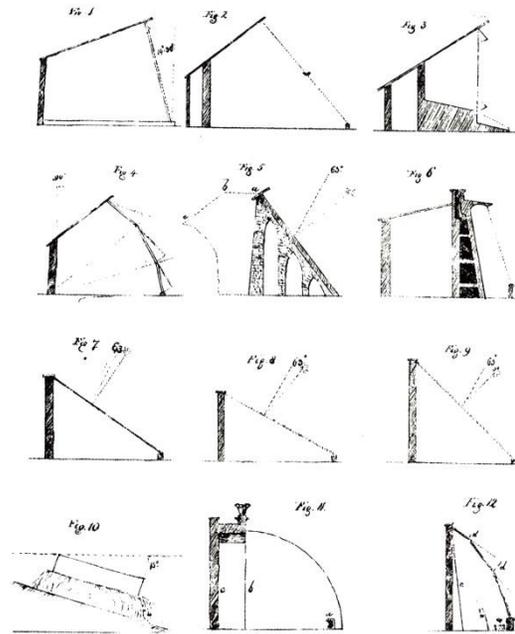
Figure 4: Comparisons of eighteenth and early nineteenth hothouse constructions and the angle of the glass frame (reproduced in Hix 1979:17).

Similar to greenhouses, hothouses in the eighteenth and nineteenth centuries mostly consisted of brick and glass frames. As scientific gardeners gradually understood the relationship between the construction and the sun for creating an artificial environment, they experimented in order to achieve optimal climates for temperamental tropical plants. Authors published advice on using the angle of the glass and position of the plants to provide higher temperatures to those that needed it (Hix 1974:16). The architect of the Hothouse at Wye may have followed similar advice, providing us with an idea of what the building may have looked like. A brick northern wall and a sloping glass frame may explain the slope of the present-day ground.

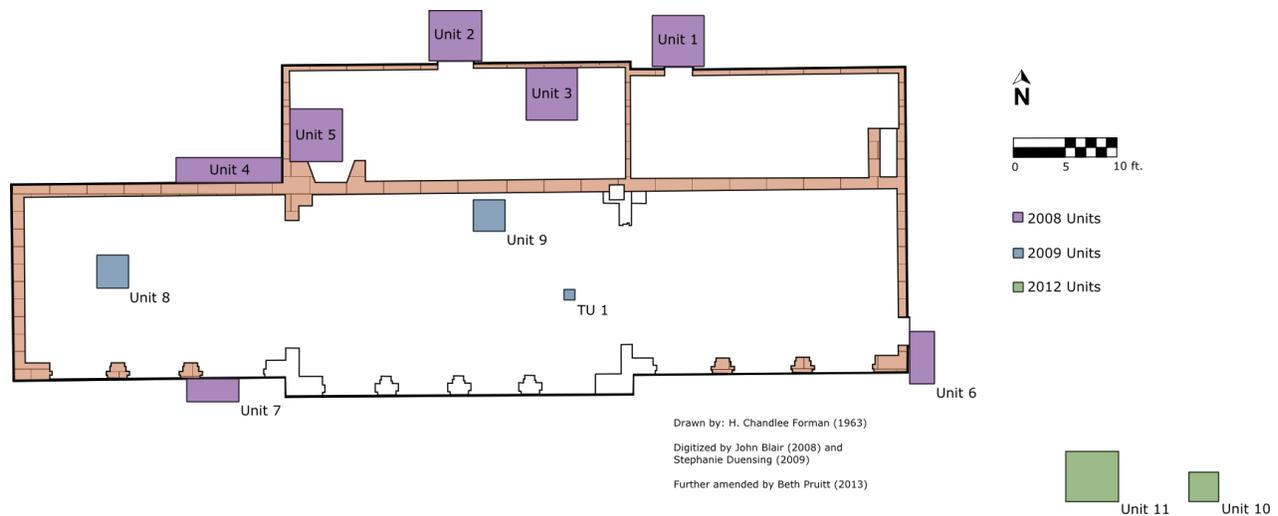
Figure 5: Schematic of the Greenhouse and the unit placements in the three years that Archaeology in Annapolis has excavated in or around the building.

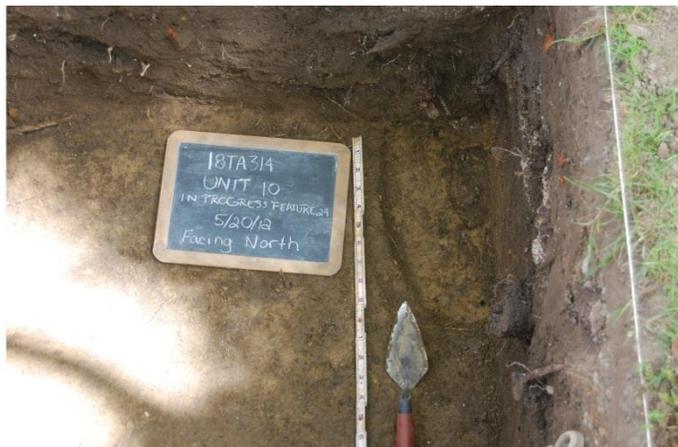
Figure 6: Posthole feature (F. 24) and Level G in progress in Unit 10.

Feature 24 is a posthole in the northeast corner of the unit, roughly underneath where the north wall of the Hothouse is suspected to have been. The soil consisted of a 10YR5/6 yellowish-brown clay. The top of Feature 24 was at 2.41 ftbd and the bottom was at 3.27

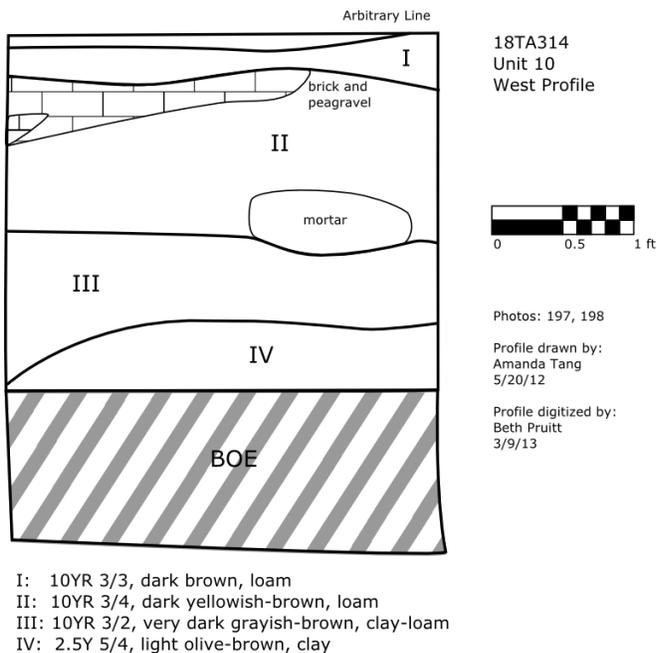
Figure 7: Unit 10 western profile wall, showing the layer of wall destruction.

The features of brick and mortar destruction found in Unit 10 in an east-west orientation suggest that this is the location of the north wall of the 16x16 ft. structure seen in the GPR report. Since much of the wall is no longer intact, it is likely that the building was destroyed and filled in when it was no longer in use in the mid-nineteenth century.

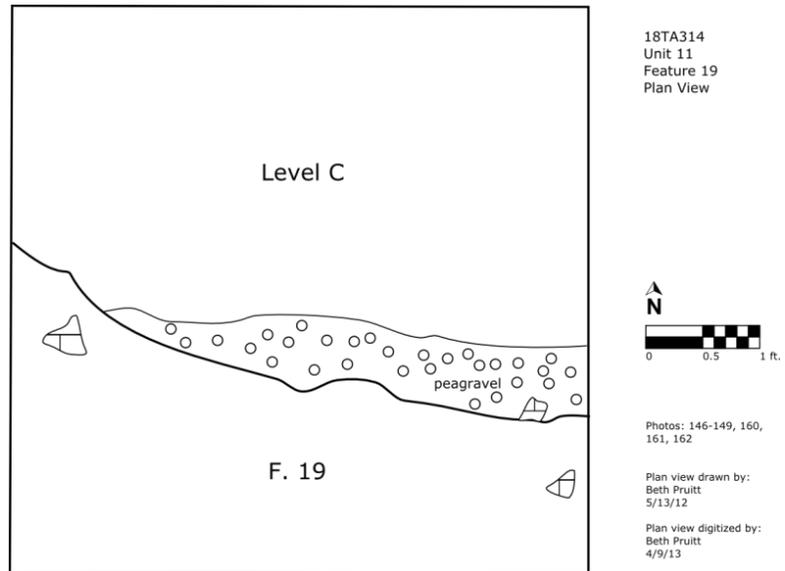
Figure 8: Plan view of the brick rubble feature (F. 19) in Unit 11, with a mixture of brick, mortar, and peagravel.

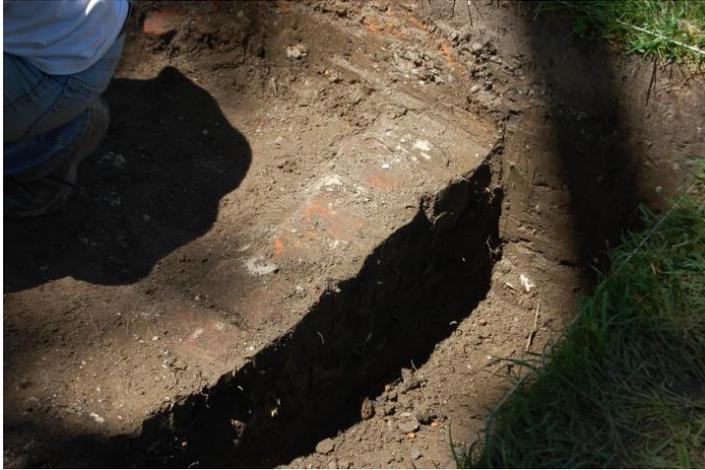
Figure 9: Intact hothouse wall segment (F. 21) in Unit 11.

Feature 21 is a nearly intact segment of a brick wall, likely part of the north wall of the Hothouse. The feature is oriented east to west, with five bricks laid side-by-side and mortar in between. The soil around the bricks consist of 10YR 2/2 very dark brown

loamy-clay. The top of Feature 21 was at 0.75 ftbd and ended at the top of Level E. Artifacts recovered from this feature included 5 pieces of brick, weighing 16.60 lbs. and 2 pieces of mortar, weighing 0.70 lbs.

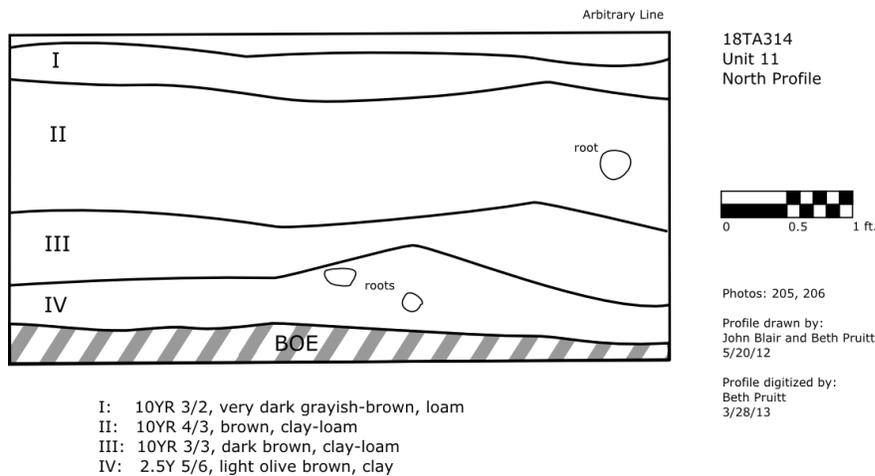
Figure 10: Unit 11 northern profile wall, outside of the hothouse structure.

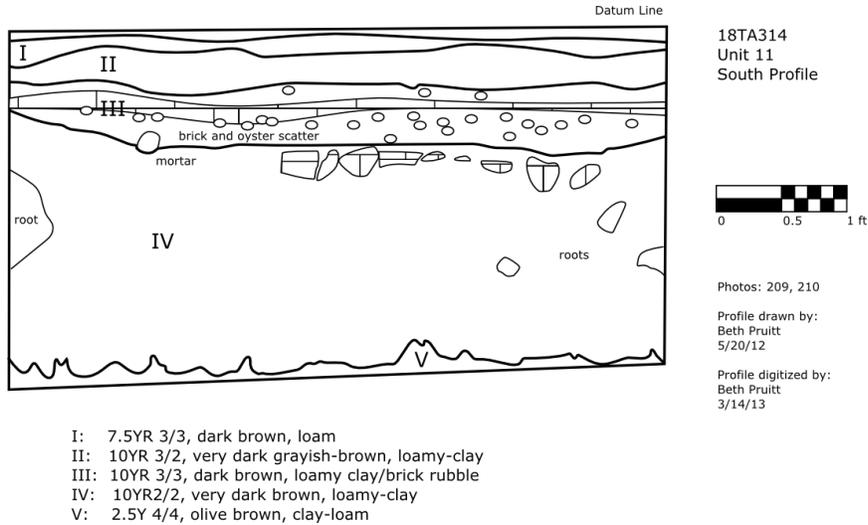
Figure 11: Unit 11 southern profile, showing the destruction inside of the hothouse structure.

Any layers of the hotbed laid for the Hothouse were not stratigraphically intact at the time of excavations, and have likely been churned up in the destruction of the building. Aside from the small patches of ash in Level D of Unit 10, there is little indication that the Hothouse was heated by a furnace or stove. The main artificial heating element appears at this time to be a hotbed.
