**Phase II Archaeological Testing on the Interior of the Wye
Greenhouse (18TA314), Talbot County, Maryland, 2009**

John E. Blair and Stephanie N. Duensing

Department of Anthropology

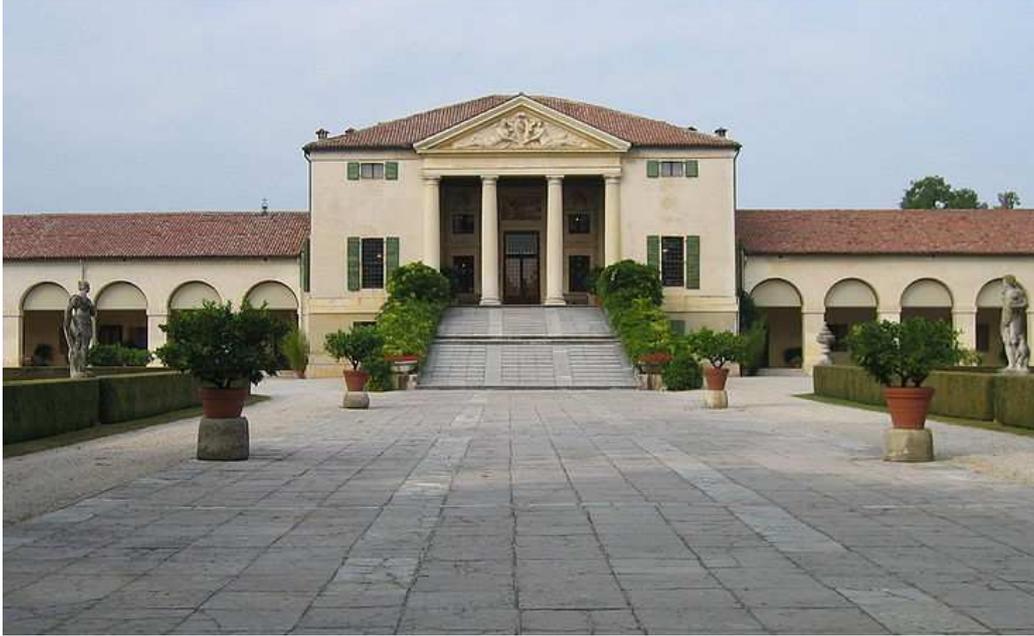
Figure 3 - Villa Emo, Italian villa in the Veneto near the village of Fanzolo de Vedelago. Photo obtained from http://upload.wikimedia.org/wikipedia/commons/2/26/Villa_Emo.jpg

Palladio is best known for his successful execution of a classical Italian villa. It is now believed that one of his villas provided the inspiration for the Greenhouse at Wye commissioned by Edward Lloyd IV between 1780 – 1790 (see Figure 4). Villa Emo (see Figure 3) was built between 1555 – 1565 for the Emo family and remained in the family until 2004 (Rybczynski, 2002:176). It is strikingly similar architecturally in many ways. One of the first things that grab the eye on both of these structures is the use of both the arch and the rectangle to draw the line of sight either out or up. Palladio uses the grand and dramatic portico to affect this in the Villa Emo, while at Wye, the function of the building demanded windows. Therefore, the negative space created with the use of the portico at the Villa Emo is elicited at Wye by the use of overly tall windows set into thinly spaced brick dividers. On the center block, the brick separating the windows

All of these similar architectural features indicate there was some strong connecting influence present. Yet there are other reasons that Villa Emo is a likely candidate for a contribution to the inspiration of the Wye Greenhouse. The depiction of the Villa Emo was published in 1570 in his famous book, *I Quattro Libri dell'Architettura* and translated in 1715 by Giacomo Leoni as *Palladio's Four Books of Architecture*. It is actually the most accurate real-life rendering of all the works Palladio published in his lifetime and then constructed. What is more, we know from the inventory taken at the time of the death of Edward Lloyd IV that there was a copy of Giacomo Leoni's translation at Wye (Wolf, 1969: 111-112).

In addition to the architectural similarities and the readily available access Lloyd had to the Palladian villa, there is the symbolically significant aspect of what the Villa Emo represented. The Villa Emo is framed by two colonnaded wings which originally housed agricultural activities, for this was a working villa like a number of the other designs by Palladio. Andrea Palladio emphasizes the usefulness of the lay-out in his treatise. He points out that the grain stores and work areas could be reached under cover, which was particularly important. Also, it was necessary for the Villa Emo's size to correspond to the returns obtained by good management. These returns must in fact have been considerable, for the side-wings of the building are unusually long, a visible symbol of prosperity (Wundram, 1993: 164). Professor of architecture at Texas Tech University, Urs Flueckiger, asserted in a paper submitted to the ACSA Annual Meeting in Salt Lake City, Utah that Villa Emo was the most perfectly executed example of an agricultural building. Lloyd's knowledge that this building was a conception of beauty and success in agriculture would be an incredibly symbolic and poignant statement indeed.

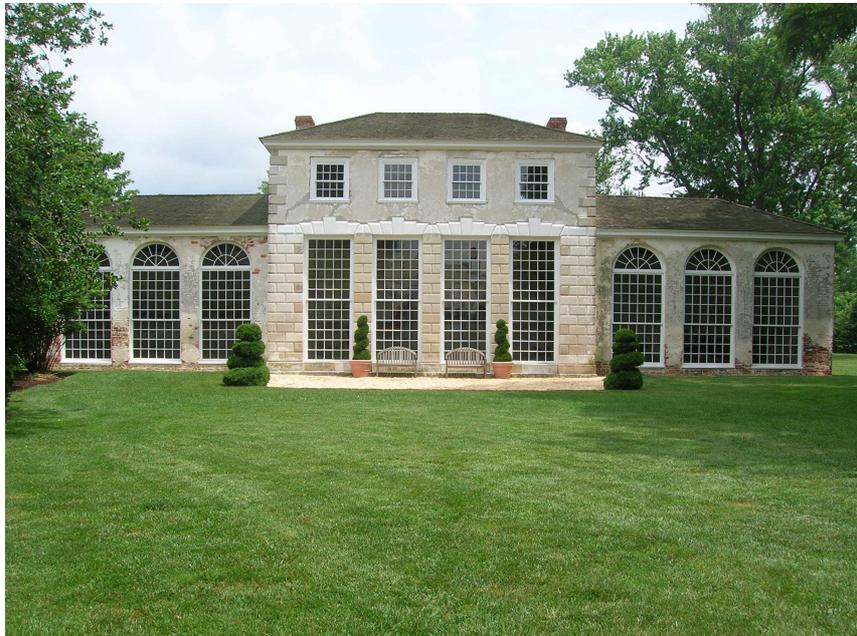
Figure 4 - Wye Greenhouse in Talbot County, Maryland, near the town of Easton. Photo by Stephanie Duensing

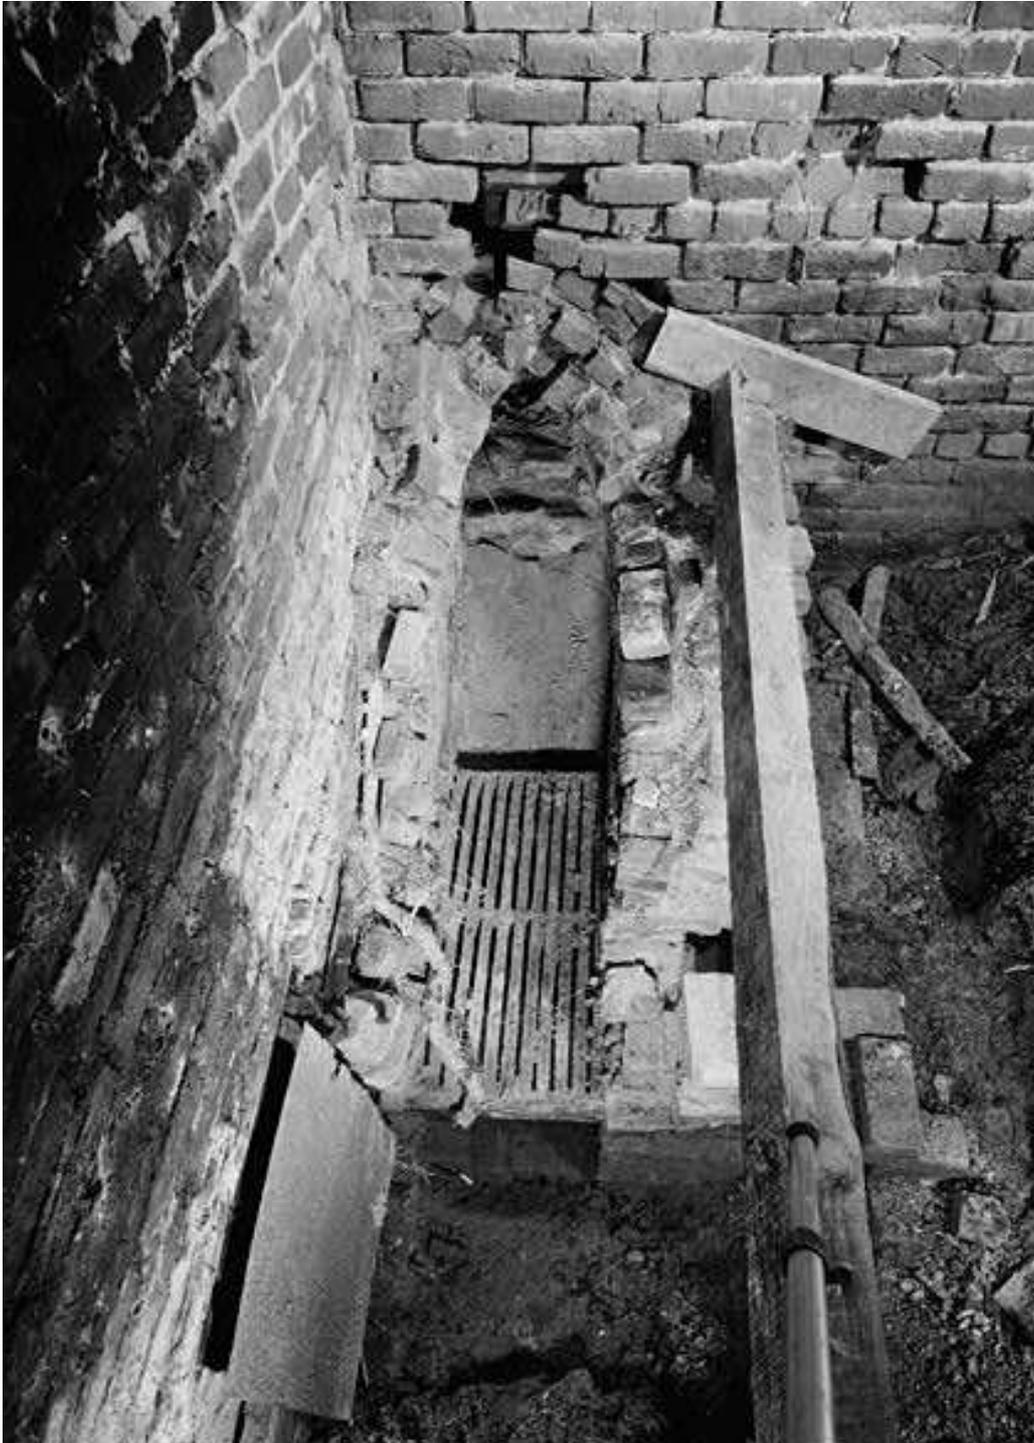
Figure 9 - Hypocaust furnace – Picture taken of the Wye Greenhouse furnace prior to its complete destruction. Photo circa 1963 for the *Historic American Buildings Survey* (HABS).

depicting the furnace's condition was taken by the *Historic American Buildings Survey* (HABS)(see Figure 9).

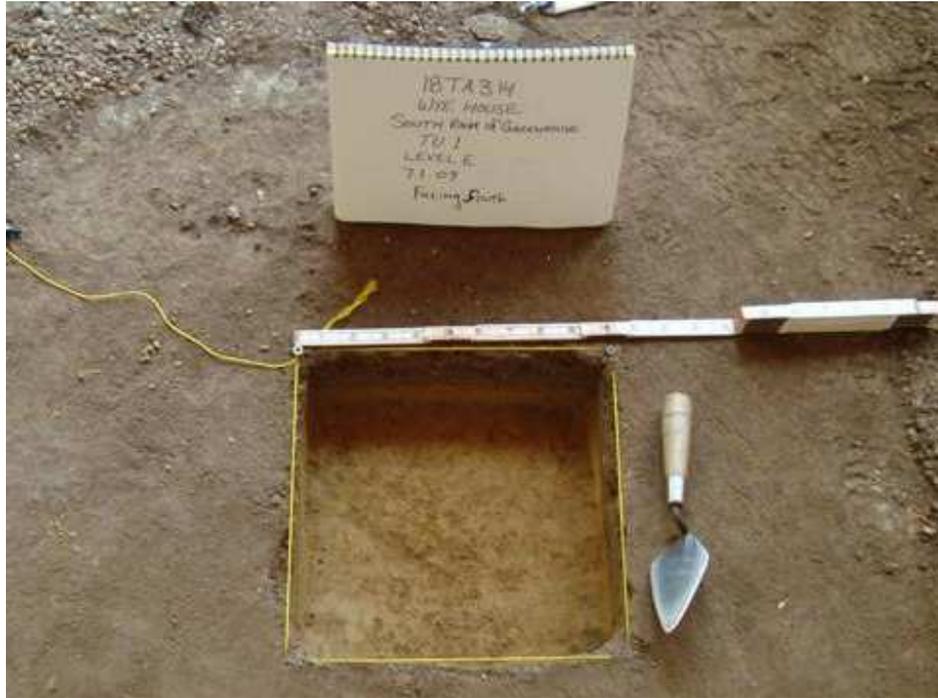
Figure 12 - (Test Unit 1) –Top of clay fill – The clay fill was placed into the interior of the Greenhouse to raise the grade to match the level of the hypocaust. Photo by Stephanie Duensing

The third stratum was a 1.25 ft deposit of clay fill (Figure 12). This fill lay over the original surface level of the Greenhouse, which was the fourth stratum. It was evident that this was the original surface due to the color and texture of the soil and the presence of architectural debris. This debris and other architectural refuse was scattered across the level in a manner characteristic of surface scatter. Below this surface was the fifth stratum, sterile of cultural material but contextually consistent in depth and attributes of the prehistoric stratum that has been found across the entire property. The sixth and final stratum was the sterile subsoil, which was sterile of all cultural material in all units.

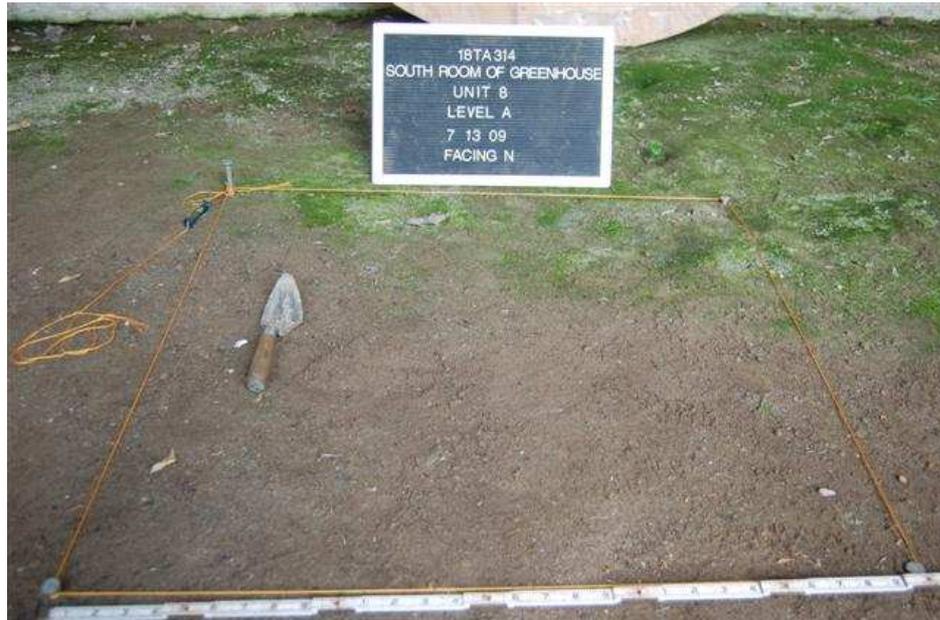
Figure 14 - (Unit 8) – Top of excavation – This unit was excavated in this location to figure out the stratigraphy of the western wing. Photo by John Blair

This test unit was placed so part of Level A was exposed to the moss that was growing on portions of the current floor of the Greenhouse in an attempt to see if the growth pattern was related to a presence/absence of material underground (Figure 14). The northwest corner of Unit 8, which also served as the datum for this unit, was placed 10 ft north of the interior south wall, and 7 ft east of the interior west wall (above the hypocaust). Unit 8 was 3 x 3 ft.

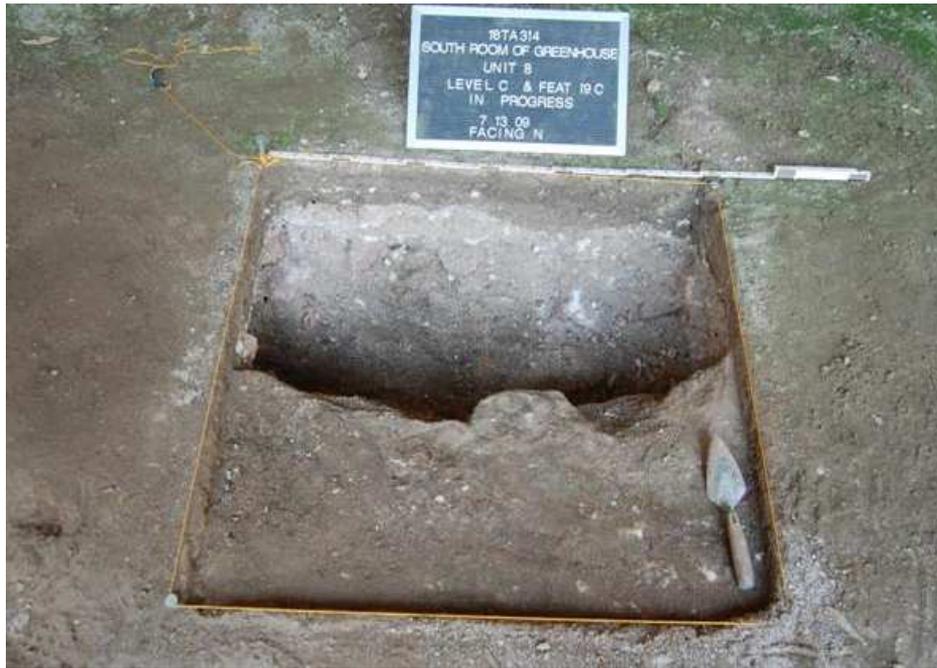
Figure 15 - (Unit 8) – Feature 19 – Feature 19 was a stratified brick and mortar fill feature. It was lined on the bottom with a thin layer of mortar and was capped with another layer of mortar. This fill was about two feet deep. The “bowl” shaped depression referred to above can be seen in the northeast portion of the wall. Photo by John Blair

At this time we began to focus on Feature 19. This feature was distinguished by a high concentration of mortar and brick pieces. After we began excavation we quickly saw that the feature boundary to the north was undercutting the area originally determined to be the northern portion of Level C. We named this Feature 19-A and removed it separately. Feature 19 contained three distinct layers or strata, and each was excavated separately. The uppermost layer, Feature 19-A, was only 0.05-0.1 ft deep on the west and east, but 0.5 ft in the middle, giving it a bowl shape (Figure 15).

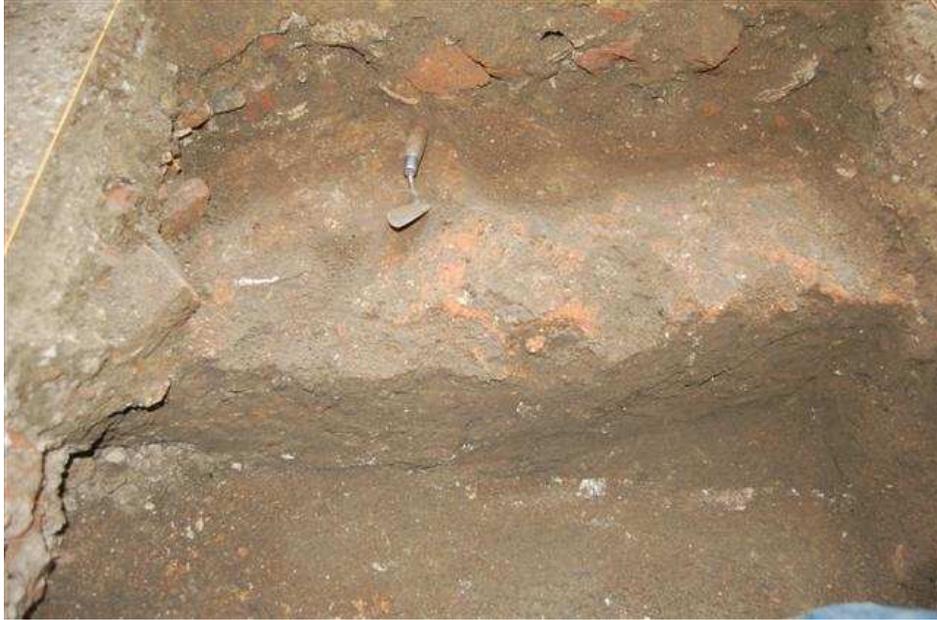
Figure 16 (Unit 8) – Feature 23 - Feature 23 was a thin brick surface. The bricks were so badly deteriorated that none of the brick were articulated. Photo by Stephanie Duensing

Feature 23 was found running under all of these levels and Feature 22, at an average depth of 1.0 ft. It was a thin, level, brick surface (Figure 16). This brick surface was badly deteriorated as a result of moisture. The surface was level and extended the entire length of Unit 8. There was every expectation that the feature would continue and reveal a structural wall or foundation, however, this was not the case. The feature was, in all, only 0.02 ft thick. This was not initially expected, but it appears to have been a tile floor or surface. The tiles, which would have originally been the same general thickness of the current pavers seen in the Greenhouse, appeared to have been dissolved beyond their original size from age and moisture. What we discovered was the compounded remains.

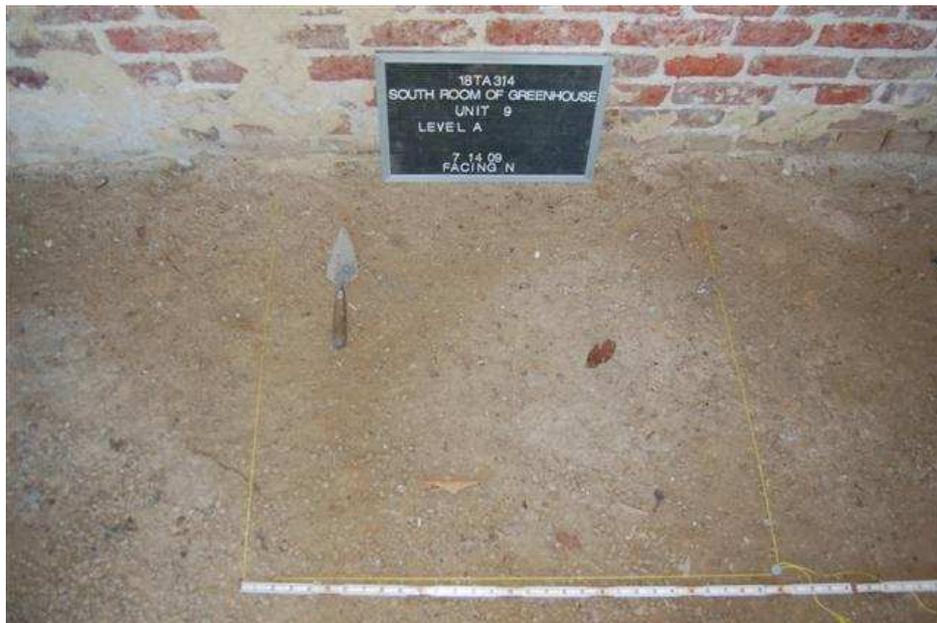
Figure 18 (Unit 9) – Top of Excavation - Unit 9 was placed against the northern wall of the South room for two reasons. One, so a builders' trench for the hypocaust could be excavated. Two, pollen gathers in greater numbers against walls. Photo by John Blair

The datum for Test Unit 9 (southeast corner) was placed 10 ft west and three feet south of the northeast truncated wall in the Greenhouse's main block. It was a 3 x 3 ft unit, abutted against the northern wall running parallel and perpendicular to it (Figure 18). This unit was placed here on the advisement of Dr. Heather Trigg from Fiske Center in an attempt to see if a higher density of pollen or botanical remains survived near the wall than had in the center of the room.
