Title of Thesis: BEHAVIORAL STUDY OF ULTRA HIGH PERFORMANCE CONCRETE GIRDERS.

Degree Candidate: Sayed Sameer, Master of Science, 2004

Thesis Submitted to the Faculty of the Graduate School of the  
University of Maryland, College Park in partial fulfillment  
of the requirements for the degree of  
Master of Science  
2004

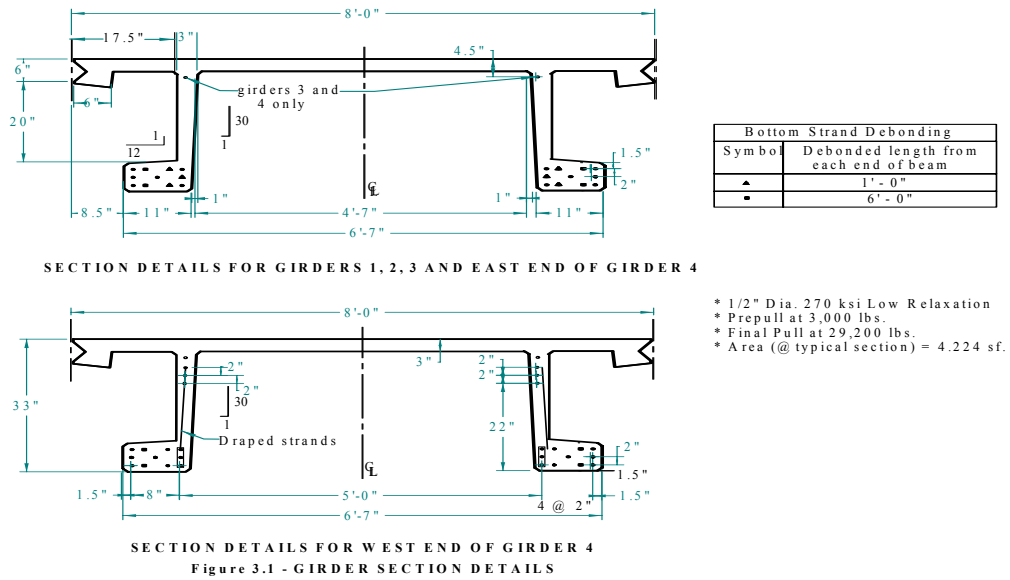
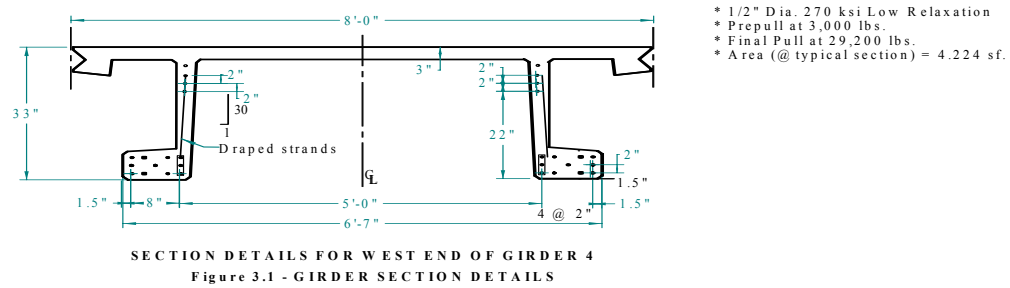
Figure 3.1 - GIRDER SECTION DETAILS

the web and the deck. In the west end of the fourth girder, the three interior strands have been draped in each bulb and the 12 in. debonds have been eliminated.

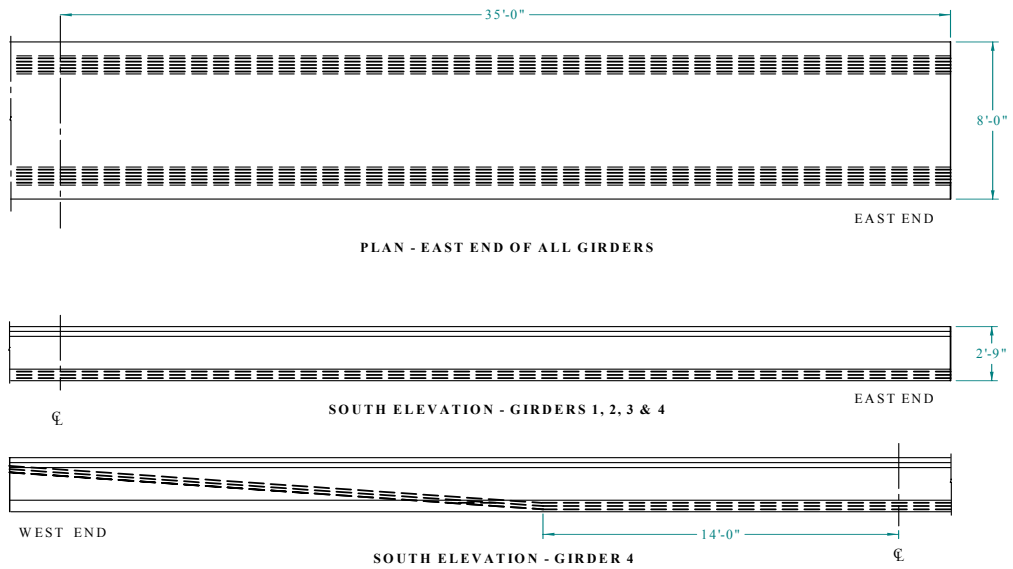
Figure 3.2 - GIRDER LONGITUDINAL DETAILS

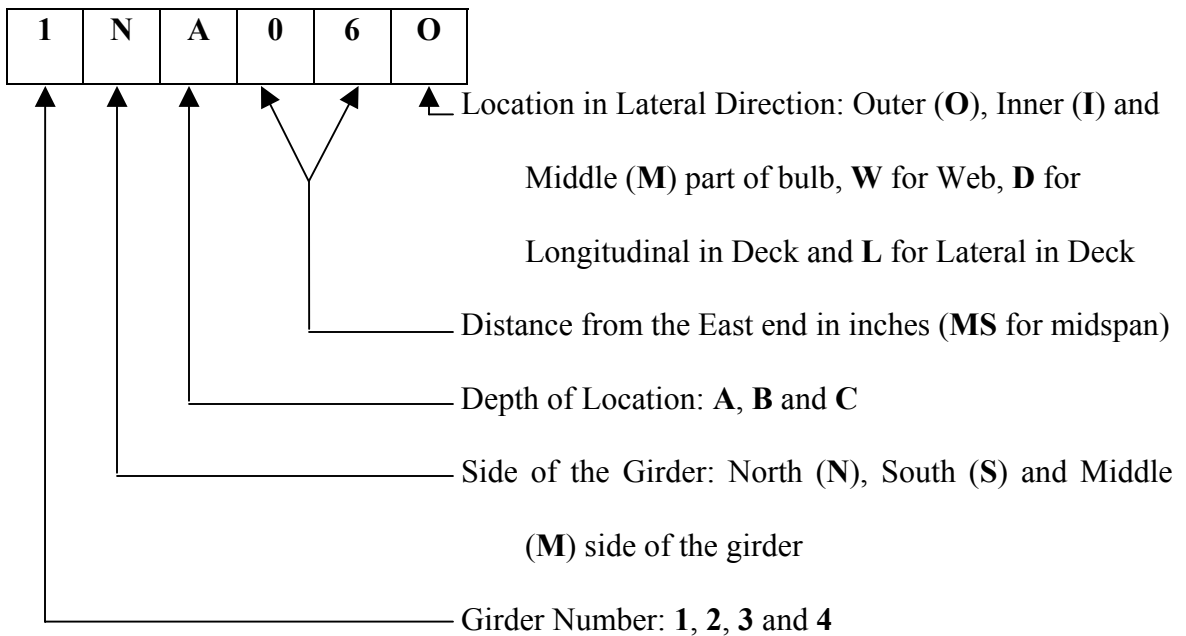
Figure 3.3 – Gage Identification Scheme

Each of the gages is labeled by an alphanumeric character string. This identifier contains six characters and indicates the gage's location within the girder. Figure 3.3 provides the description of the gage identifier.

replace the O. A gage in Girder 4 in the South side at depth B, at 3 in. from the end and in the web will be identified as 4SB03W. Gages placed longitudinally in the midspan bulb are identified as 1SAMSO for girder 1, 2NAMSO for girder 2, etc., whereas gages placed longitudinally in the midspan deck are identified as 1MCMSD for girder 1, etc. Those placed laterally in the midspan deck are identified as 1MCMSL for girder 1, and so on.

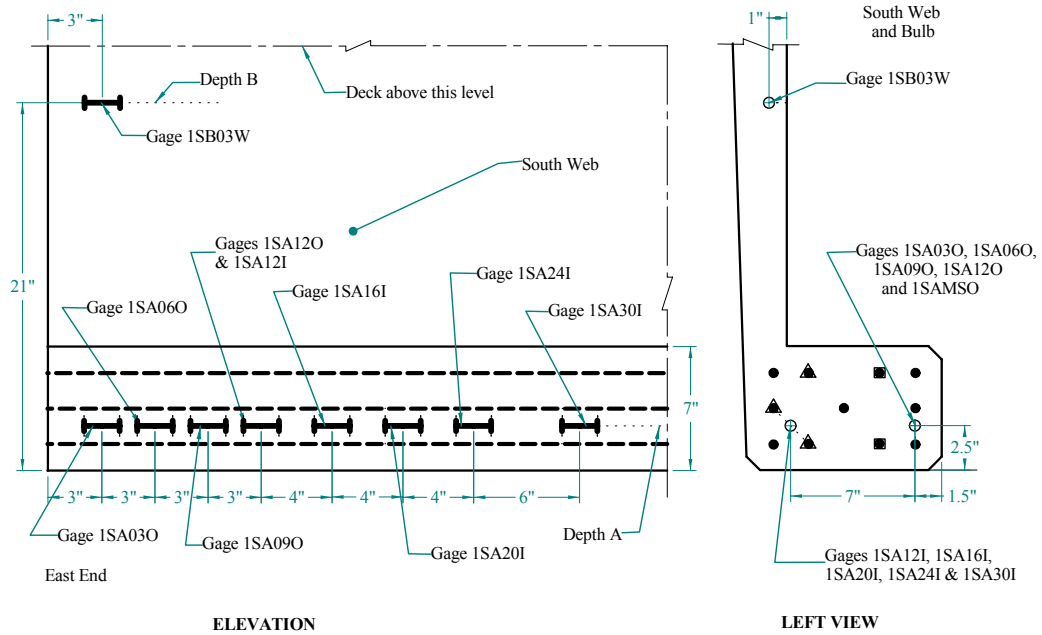
**INSTRUMENTATION PLAN FOR VIBRATING WIRE GAGES - GIRDER 1 AT SUPPORT**  
 Fig - 3.4

Thirteen vibration wire gages were cast into Girder 1. Nine of these were placed in the transfer region at the east end of the south bulb. From earlier estimates (*Steinberg E., Lubbers A., ISHPC 2003*), it was approximated that the transfer length should be in the range of 10 in. to 12 in. The three strands at the outer edge of the bulb are all fully bonded. Hence, as seen in Figure 3.4, the gages 1SA03O, 1SA06O, 1SA09O and 1SA12O provide the rate of transfer of the prestress of the non-debonded strands. The gages are installed in the concrete between the bottom two outer strands. The gages 1SA12I, 1SA16I, 1SA20I, 1SA24I and 1SA30I are located between strands that are debonded to 12 in. from the end of the girder. Ideally, the strain in the concrete near these gages should be a function of the strain due to the fully bonded strands and the strain due to the strands debonded to 12 in. and transferred thereafter. The purpose of these gages is to study the transfer behavior of the second set of strands, which are debonded to 12 in. The spacing between the gages has been increased and an extra gage (1SA12I) has been placed at 12 in. (effectively 0 in. of transfer) to record the strains in the concrete near the second set of strands due to the transfer of the fully bonded strands.

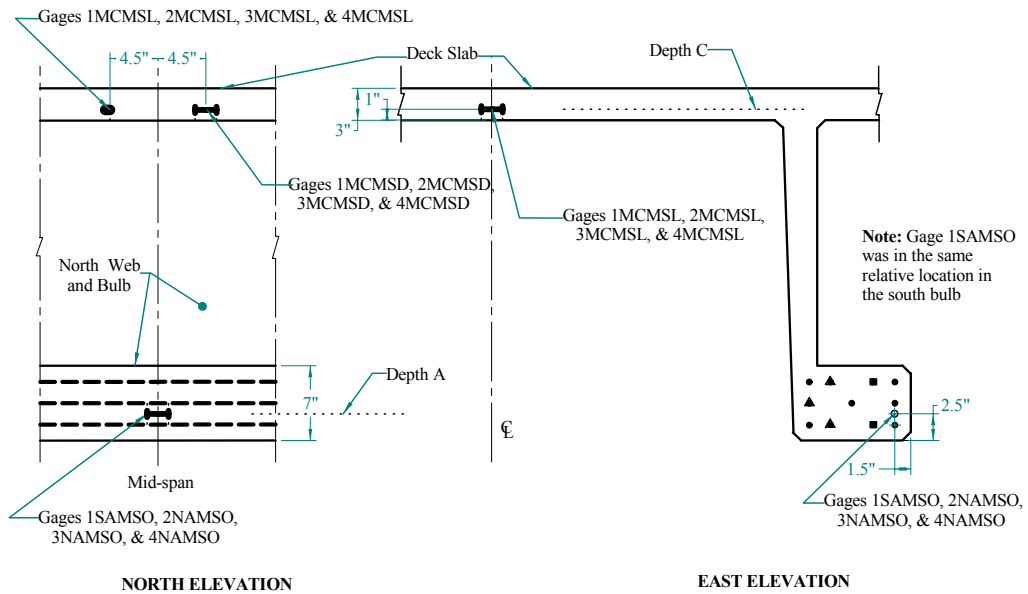
**INSTRUMENTATION PLAN FOR VIBRATING WIRE GAGES - GIRDER 1, 2, 3 & 4 AT MID-SPAN**  
 Fig - 3.5

The gage 1SA30I should provide an overall strain value after these two groups of strands have both transferred. Gage 1NB03W is cast into the web and is intended for a comparison between the strains at midspan and at the end at the level of the neutral axis. Three gages were cast into the girder near midspan. Gages 1SAMSO and 1MCMSD, as seen in figure 3.5, are primarily for the study of the flexural behavior of the girder at midspan. The 1SAMSO gage is in the same location in the girder cross-section as some of the transfer gages and thus can also be compared to those gages. The final gage in the first girder, 1MCMSL is for observation of the lateral strain behavior of the deck at the midspan.

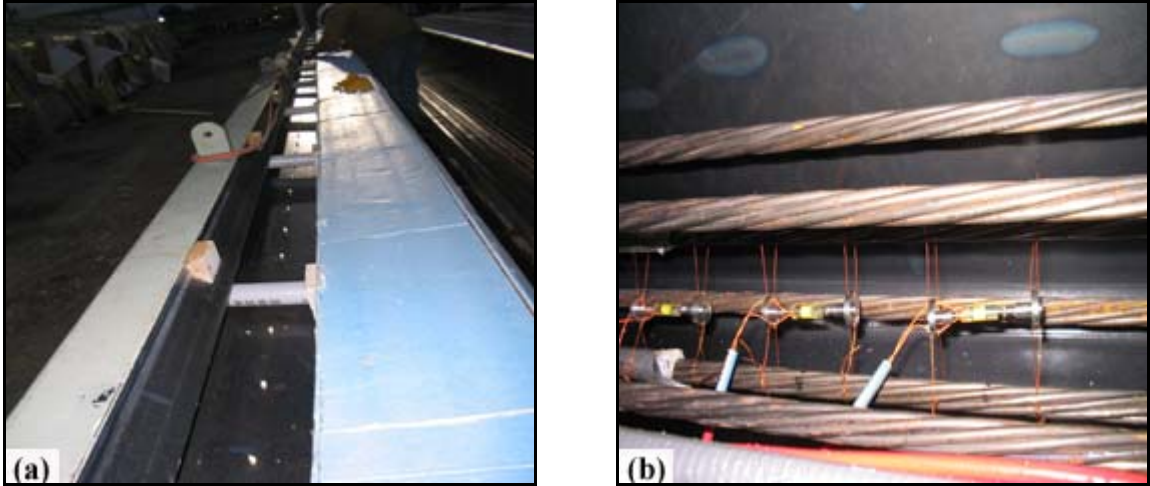
Figure 3.7 (a) Whittemore points and (b) Vibrating Wire Strain Gages

2MCMSL were kept at the same relative location, except that they were moved to the north bulb. Whittemore points were installed along the north side of this girder according to the same plan followed for the girder 1. Figure 3.7 (a) shows the Whittemore points for the underside of the overhang while figure 3.7 (b) shows the vibrating wire strain gages tied between the strands in the bulb.

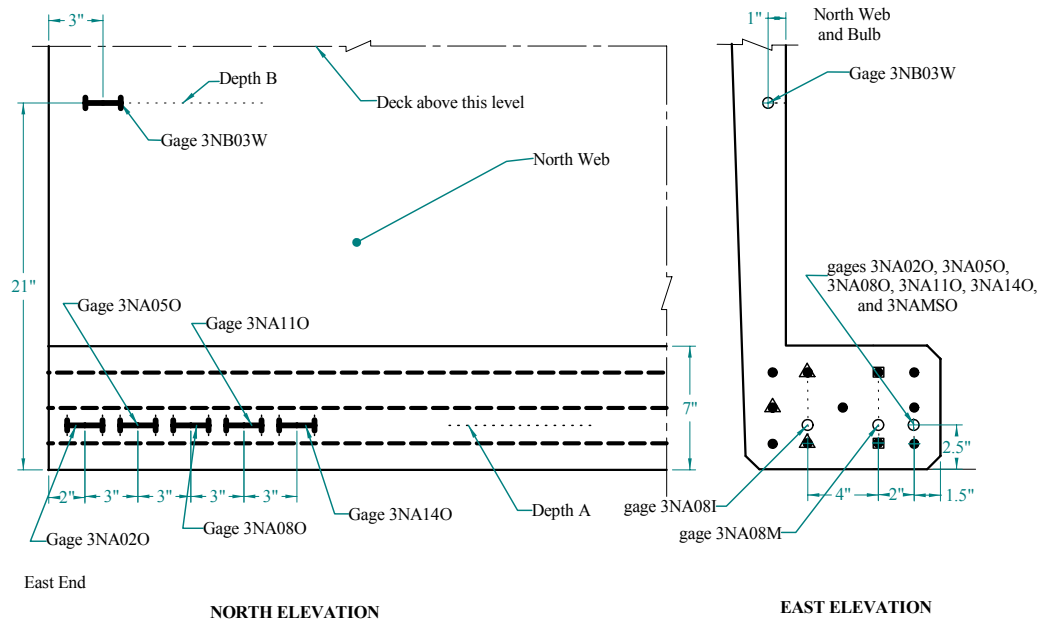
INSTRUMENTATION PLAN FOR VIBRATING WIRE GAGES - GIRDER 3 AT SUPPORT  
Fig - 3.8

The analysis of the data from girders 1 and 2 suggested some modifications for girders 3 and 4. The outer bulb transfer curve plotted for the first and second girders had transfer strain values at 3, 6, 9 and 12 inches. Hence, in order to more accurately determine the strand transfer behavior, gages 3NA02O, 3NA05O, 3NA08O, 3NA11O, and 3NA14 were installed as shown in Figure 3.8. Also from the data recorded for girders 1 and 2, it was observed that there was a lag between the strains in the inner and outer bulb at the same distance from the end of the girder. This was particularly evident between gages 1NA12O and 1NA12I or 2NA12O and 2NA12I. To better quantify the lag occurring laterally in the bulb, two gages, 3NA08M and 3NA08I, were installed along with gage 3NA08O. The midspan and web gages (3NB03W, 3NAMSO, 3MCMSD, and 3MCMSL) were again installed in this girder and are shown in figure 3.8. Whittemore points were not installed in this girder.

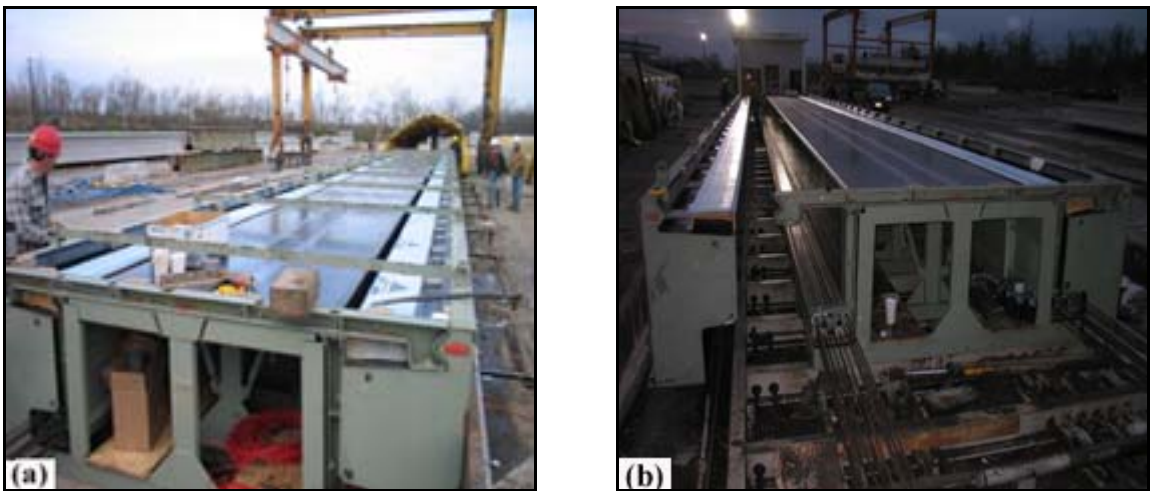
Figure 4.1 – Girder Formwork

supported the overhang and the outsides of the webs. The inside form consisted of a stationary center post and articulating arms supported from below by turnbuckles. The blackout on the underside of each overhang was formed from foam-covered plywood boxes. The east and the west end of the forms had blockouts with coil inserts at the deck level to provide a shear connection between the girder and the diaphragms. Blockouts were also placed at fixed intervals along the north and south edges of the deck to provide for the bolted and welded connections. Finally, two coil bolt inserts were specified for each lifting point. Figures 4.1(a) and 4.1(b) show the formwork for the girders.

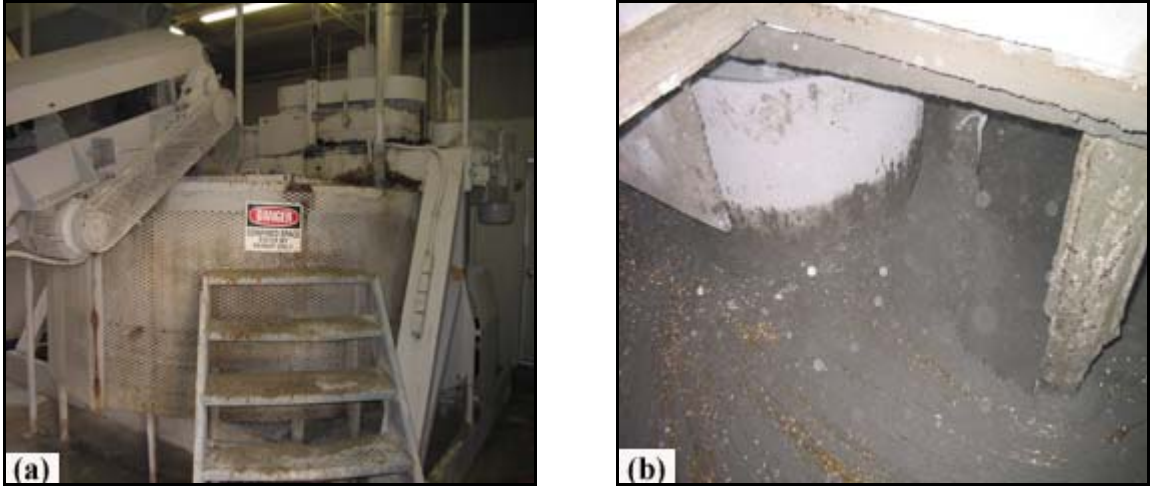
Figure 4.2 (a) Mixer and (b) UHPC being Mixed

Figure 4.2(a) shows the mixer used for the mixing of UHPC while Figure 4.2(b) shows the UHPC while it is being mixed.

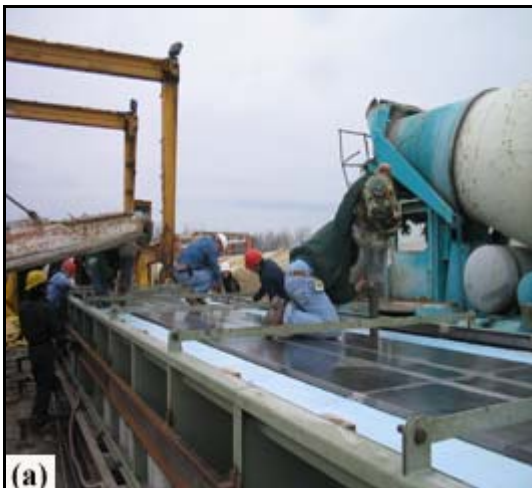
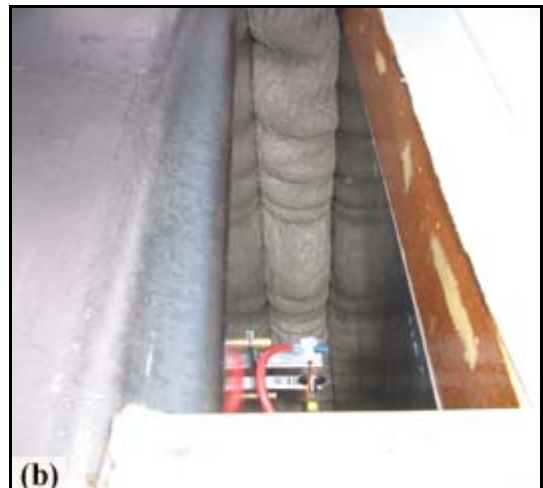
Figure 4.3 Placing UHPC

Plastic sheets were used to cover the deck as soon as it was cast and tents were placed over the girders to block the sunlight and dehydration.

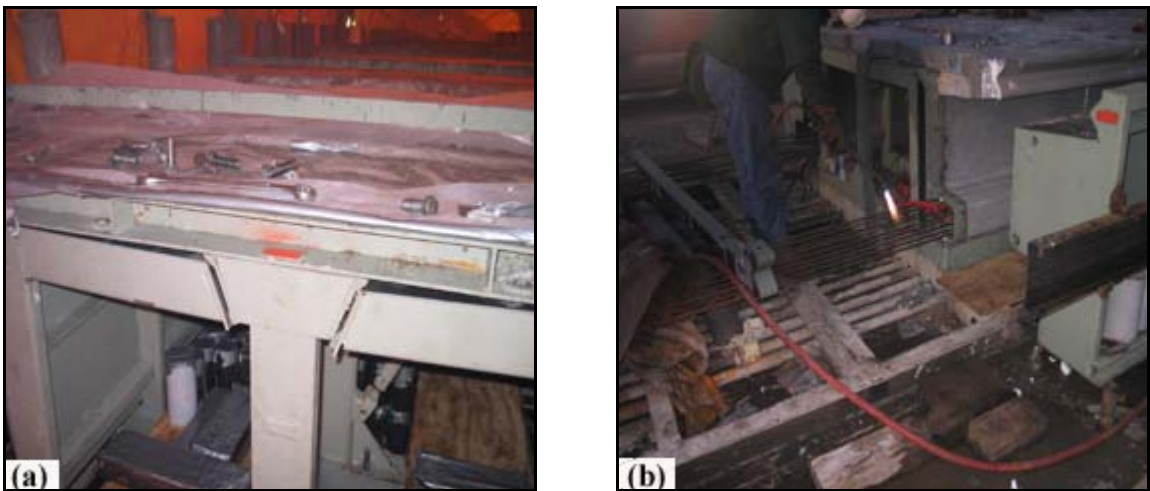
Figure 4.4 (a) Inner Forms Released and (b) Prestressing Strands being Cut.

penetration resistance as well as the temperature and shrinkage recorded by the gages showed a marked increase as the concrete began to set. The form elements providing restraint were gradually released as the setting progressed. First, the screws holding the Whittemore points and the chairs for the vibrating wire gages were released. Generally, the end and overhang blockouts were next, followed by the turnbuckles and inner forms. Lastly, the top and bottom clamps and outer forms were released. Figure 4.4(a) shows the inner forms after they were released and figure 4.4(b) shows the prestressing strands being cut.

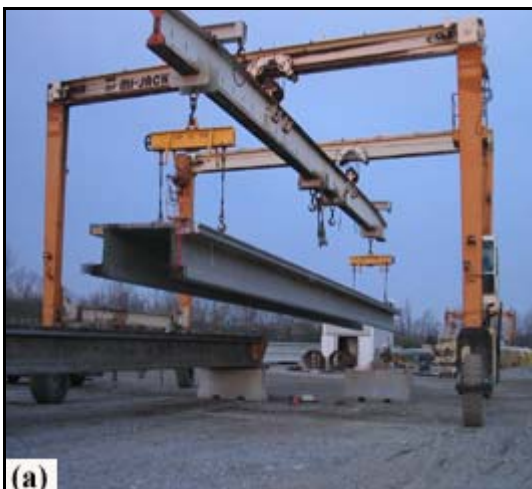
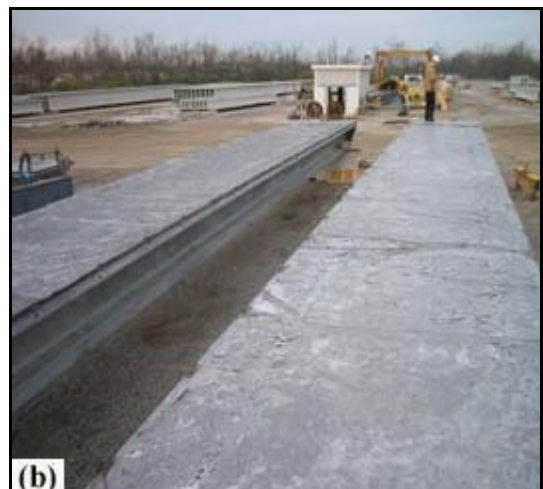
Figure 4.5 (a) Girder being Lifted and (b) Girder after it was Blocked.

After the strands in the girder bulb were cut, the girder was lifted out of the forms by means of the coil bolt lifting inserts with a mobile crane so that the casting bed would be free for the next girder. It was then blocked approximately 12 in. from each end. This blocking location allowed for the construction of the diaphragm formwork. Figure 4.5(a) shows the girders being lifted and figure 4.5(b) shows the girders after they are blocked.

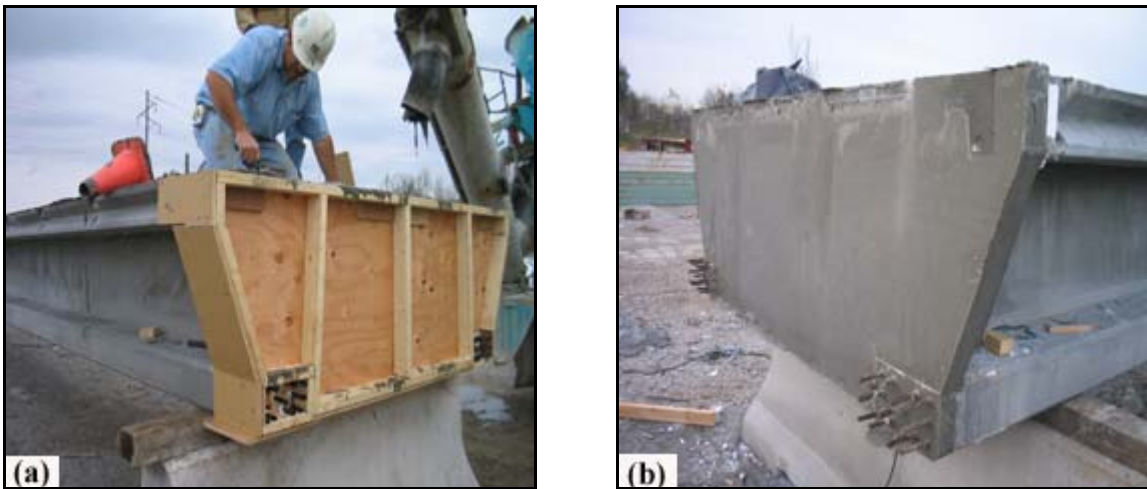
Figure 4.6 (a) Diaphragm being Cast and (b) Girder after Diaphragm Cast.

Diaphragms were cast onto each end of each girder through a secondary pour. In general, each girder casting included the casting of the previous girder's diaphragms. If environmental conditions warranted, the girders were draped in tarps and a portable propane heater was placed under them. This was to ensure that the diaphragms did not freeze before setting. Figure 4.6(a) shows the formwork and casting of a diaphragm while figure 4.6(b) shows the girder after the diaphragm was cast.

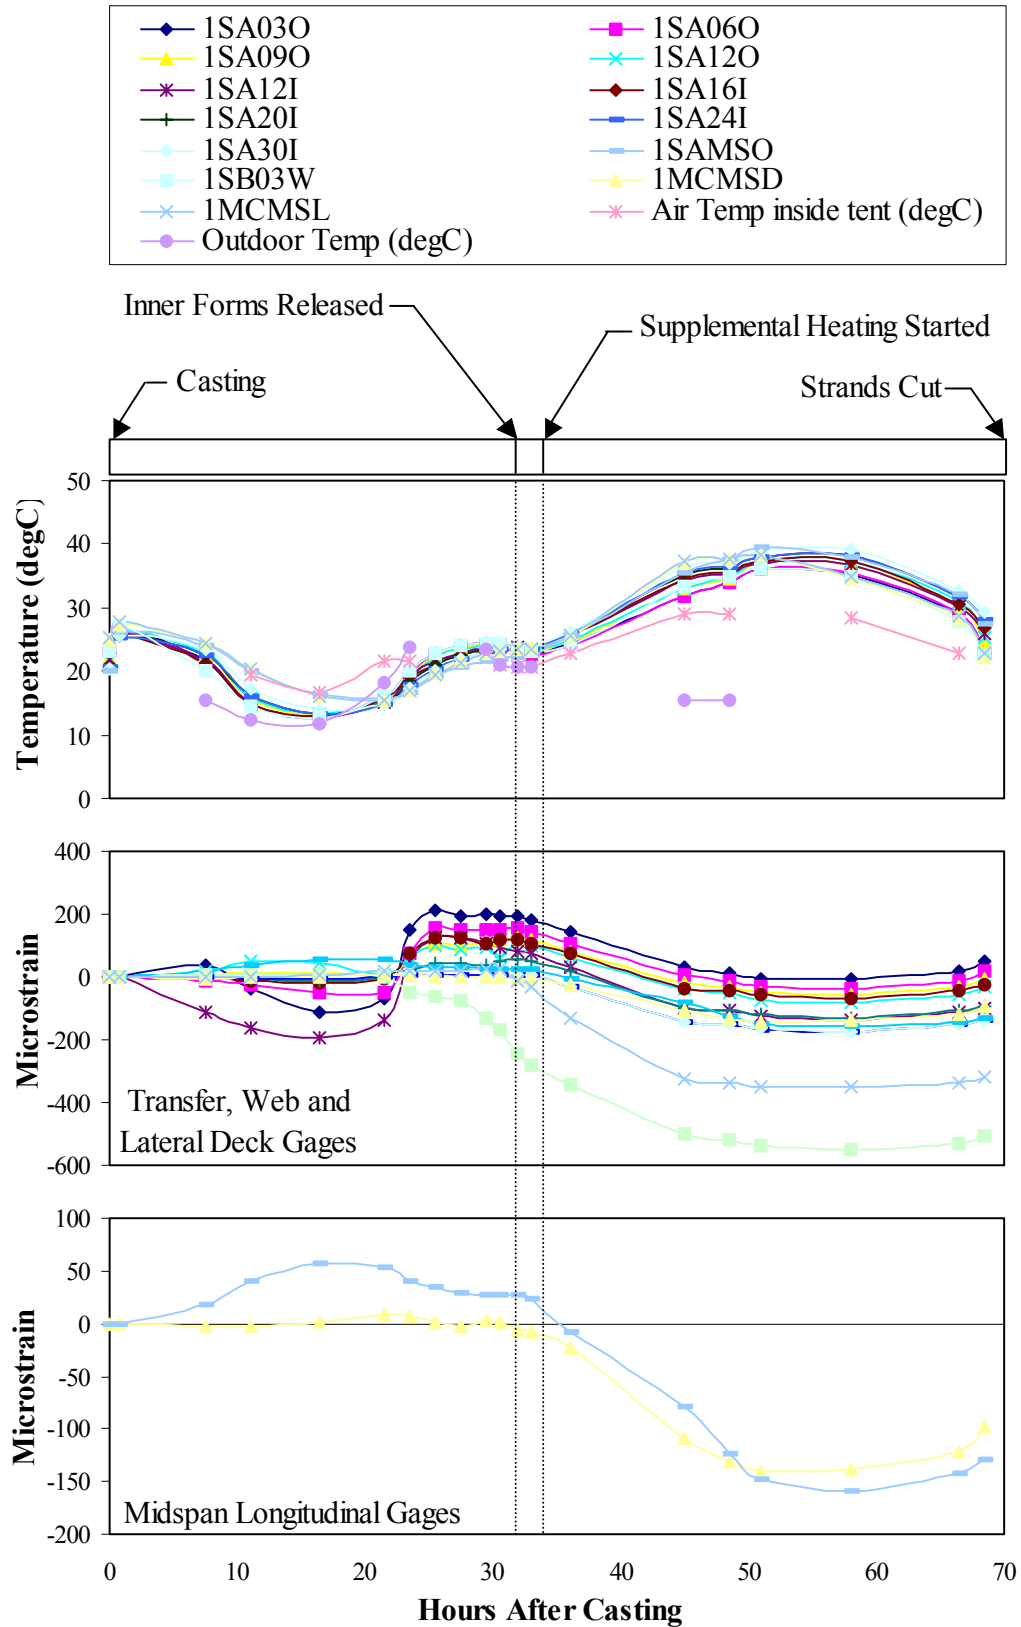
Figure 5.1 shows the shrinkage behavior and the temperature variations of concrete at different locations in Girder 1 as well as the temperature outside the girder from the cast time to the cutting of strands. The first 15 hours after the girder is cast show reduction in the temperature both inside and outside of the girder; however, it is not accompanied by any volumetric changes in the girder. The air temperature inside the tent is slightly higher than that shown by the gages inside the girder. By 20 hours after casting, the tent temperatures are showing a marked increase with the concrete seeming to exhibit volumetric expansion. The strains tend to increase at most locations and many of the gages, particularly the transfer gages, shift from being under compression or no strain to going into tension with 1SA03O showing the greatest variation. The shrinkage activity shows reduction with the distance inwards from the end of the girder, whereas the gages at midspan (i.e., 1SAMSO, 1MCMSD and 1MCMSL) show very little strain change. At

Figure 5.1 - Early Shrinkage Before Strands Cut, Girder 1

approximately 24 hours the welded connections and the overhang blockouts are released. The outdoor temperature rise slows down soon and within a couple of hours the temperature starts decreasing. The temperature inside the tent and the temperatures in the gages also show the same pattern but the temperatures in the gages do not decrease as sharply as the outdoor temperature. Lateral shrinkage cracks are observed in the surface of the deck at about 25 hours after casting. As soon as the cracks are observed, it can be seen that the temperature inside the girder also tends to fall down and the tensile strains suddenly relax and all the gages start showing either compressive strains or stabilizing. After 30 hours the end blockouts and the inner forms are released, but it doesn't seem to have much effect on shrinkage except that gage 1MCMSL, which after the release on the inner form is in an unrestrained location, shows faster shrinkage rate. Around this time the temperature in the girder starts reducing slightly until 34 hours, when high humidity supplementary heating is started. This heating expedites the shrinkage, with 11 microstrain/hr occurring in most transfer gages for the next 12 hours. After 45 hours the shrinkage behavior begins to subside and the volumetric changes become more closely tied to the internal temperature changes. At 46 hours the top and bottom clamps are removed and the side forms are broken loose.

Figure 5.1 shows that, apart from the first 15 hours, all gages except the lateral midspan deck and the longitudinal web gages are showing similar shrinkage behavior. These two gages are subject to more or less the same conditions as the other gages aside from the level of restraint provided by the formwork and strands. Gage 1MCMSL is the only lateral gage in the girder, and as such it is in a position that is either fully restrained or

fully unrestrained depending on the formwork. Gage 1MCMSL clearly shows the effect of this restraint as it exhibits approximately 25 microstrain/hour of shrinkage after the inner form is released while the always partially restrained gage 1MCMSD exhibits 7 microstrain/hour during the same timeframe. Gage 1SB03W is also restrained differently by being in the web very close to the end of the girder. Figure 5.1 clearly shows how this relatively unrestrained location can begin to shrink approximately 5 hours before the remainder of the gages show any shrinkage. The strain in the longitudinal midspan gages 1MCMSD and 1SAMSO are observed in the bottom plot in Figure 5.1. It can be seen that gage 1SAMSO shows larger variations in volumetric change as compared to the gage 1MCMSD. The gage 1SAMSO is embedded in the south bulb at midspan and is at the bottom and hence closer to the heating conduits. Thus this part of the girder gets more concentrated heating and shows larger shrinkage as compared to the deck gage.

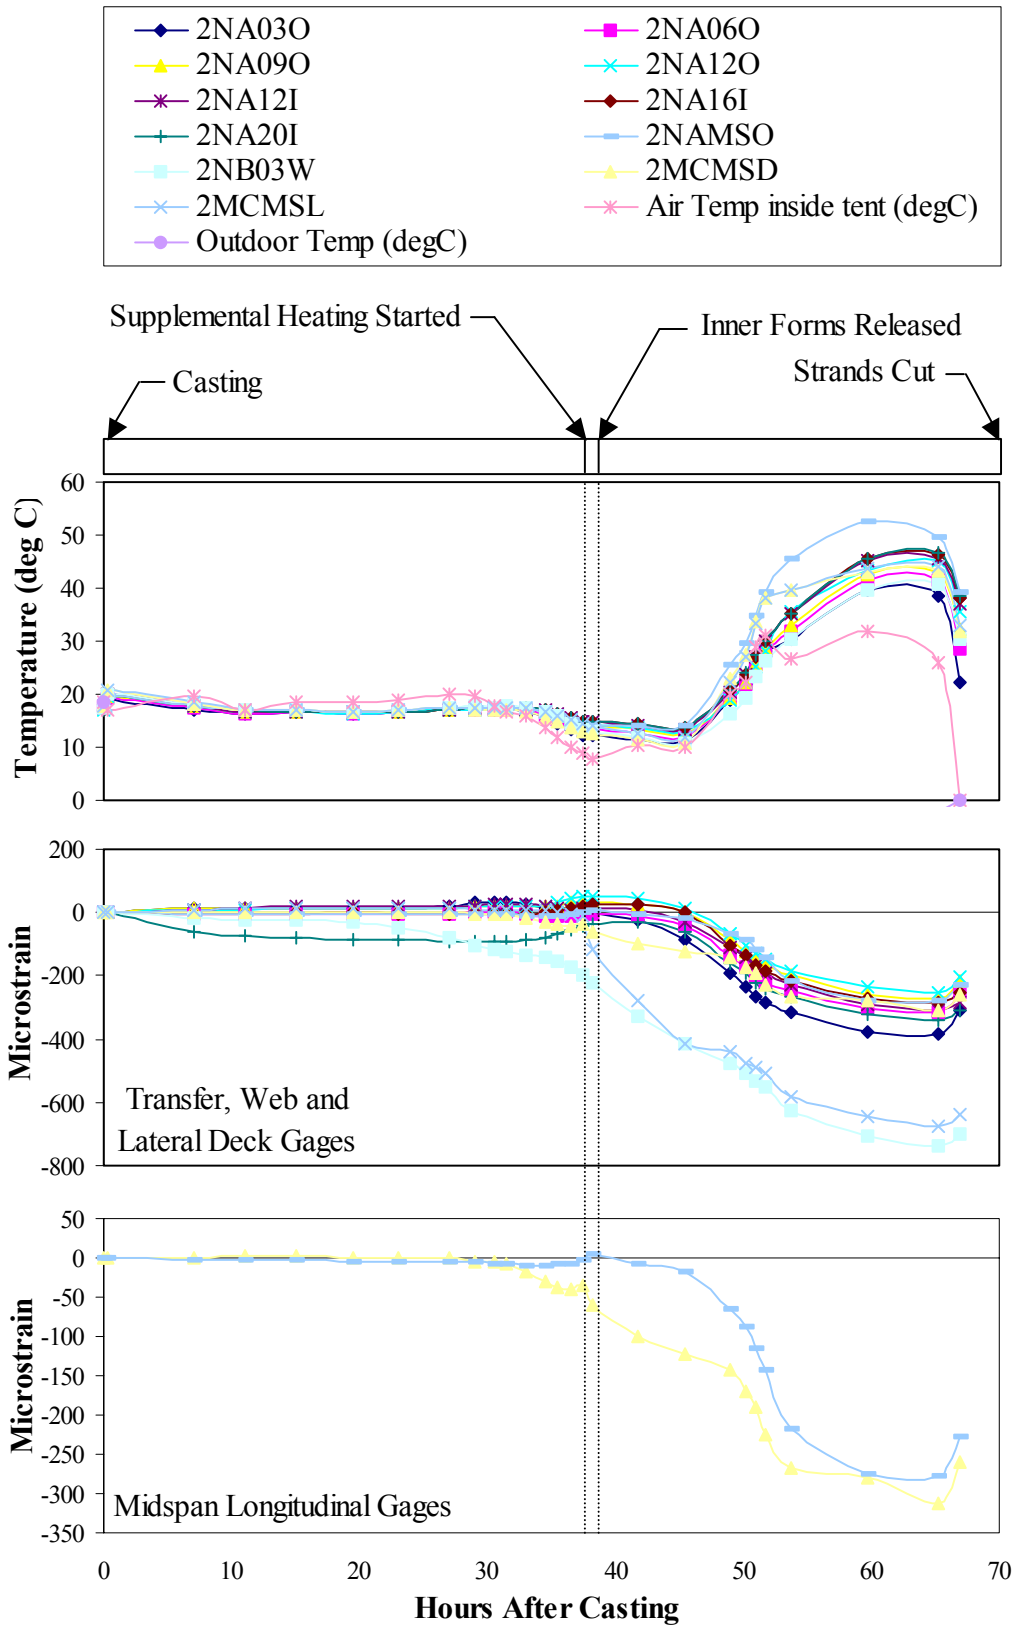
Figure 5.2 shows the shrinkage behavior and the temperature variations of concrete at different locations in Girder 2 as well as the temperature outside the girder from the cast time to the cutting of strands. There is a slight reduction in the concrete temperature in the first 10 hours after casting, after which the temperature remains almost constant for another 20 hours and the surrounding temperature (i.e., the temperature in the tent) also varies little and is the same as that observed inside the girder. By observing the behavior of the gages it can be seen that the concrete does not show any volumetric changes in the first 32 hours except at gage 2NB03W in the web near the end of the girder. The deck end and the overhang blockouts are released at around 30 hours. The temperature inside

Figure 5.2 - Early Shrinkage Before Strands Cut, Girder 2

the tent as well as inside the girder starts reducing after 30 hours. The concrete shows a slight expansion in most locations on the girder at this stage as is also seen in Girder 1. At about 38 hours the inner form is released and high humidity supplemental heating is started.

As was observed in Girder 1, the lateral gage in the deck shows immediate shrinkage as the restraint is removed. In fact, it shrinks at a rapid enough pace to quickly catch up to the web shrinkage gage, which had been showing shrinkage for the previous 15 hours. Gage 2NB03W exhibited 12 microstrain/hour shrinkage for 15 hours until the inner form was released, then it exhibited 26 microstrain/hour for an additional 15 hours. Comparatively, the lateral deck gage 2MCMSL exhibited 50 microstrain/hour for 8 hours before slowing to 20 microstrain/hour for another 8 hours. Figure 5.2 also shows that the transfer regime exhibited very little shrinkage until 5 hours after the form release when the temperature in the girder began to increase. Finally, note how the midspan bulb gage exhibits a significantly delayed shrinkage response as compared to the comparatively less restrained longitudinal midspan deck gage.

At 51 hours, the top and bottom clamps are removed and the side forms are broken loose. The supplemental high humidity heating is also reduced at the time. From here on, the temperature and strain plots of Figure 5.2 are almost mirror images of each other.

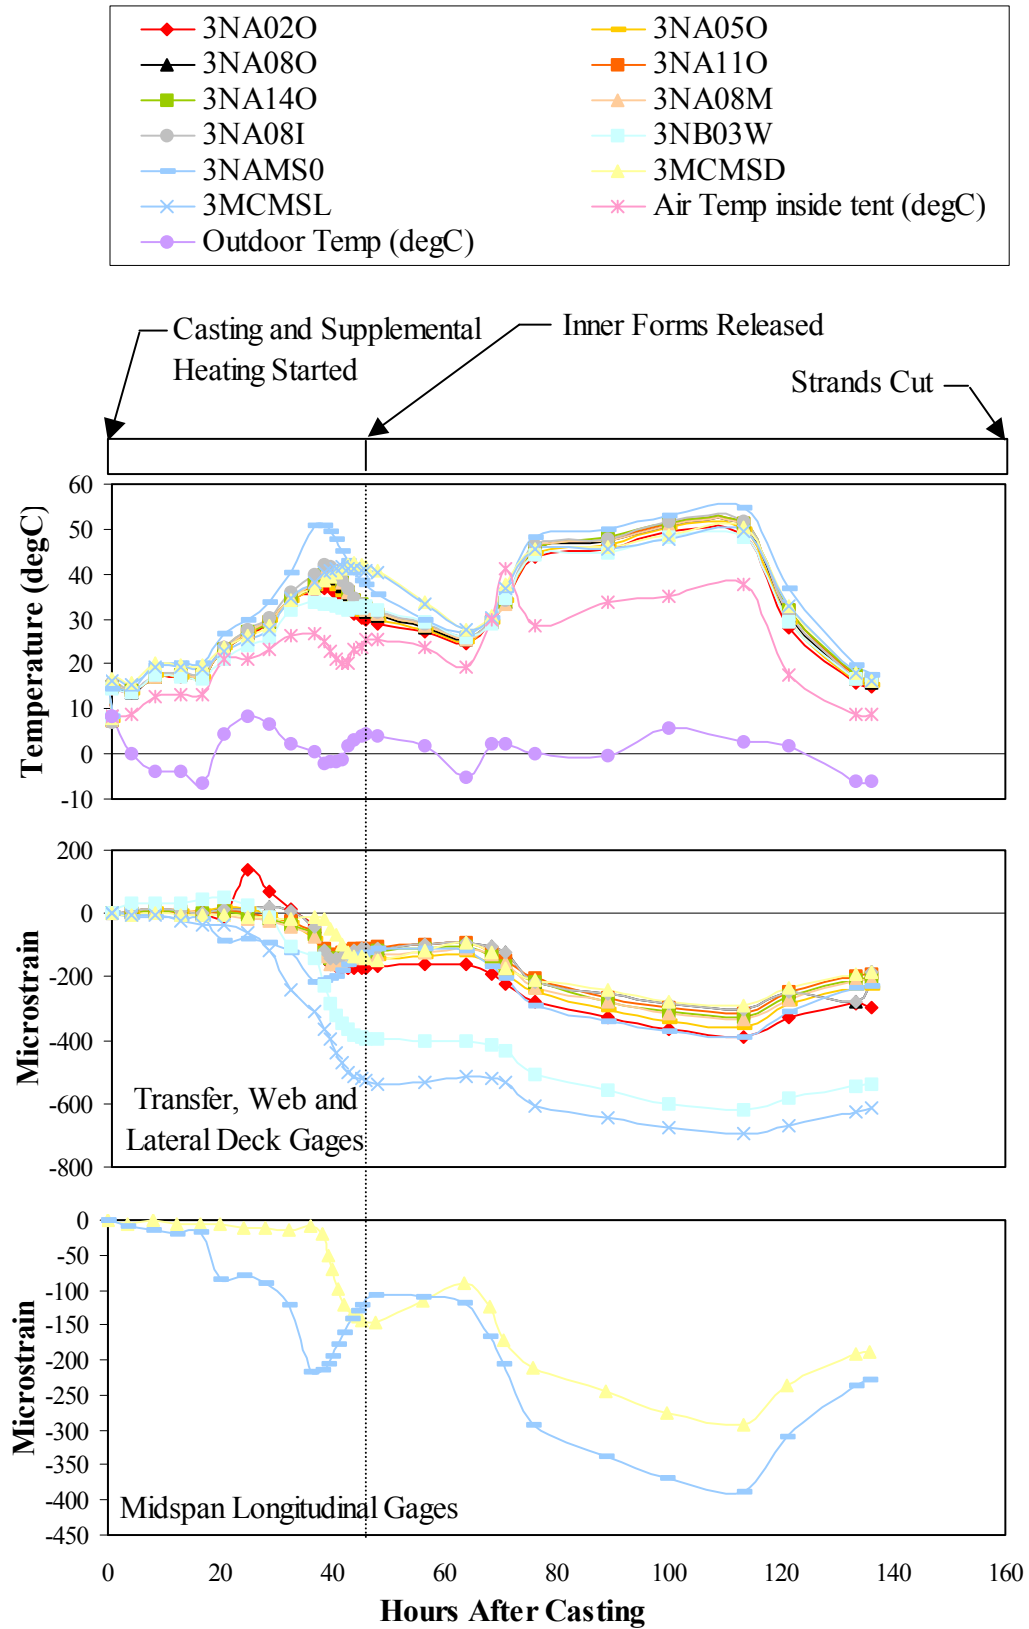
Girder 3 exhibits slightly different shrinkage behavior as compared to the first two girders. Their behaviors are more difficult to discern due to variations in the surrounding air temperature in the tent. Figure 5.3 shows the shrinkage behavior and temperature of concrete at different locations in Girder 3 from the cast time to the cutting of strands as well as the temperature variations in the tent and the ambient temperature. It can be seen that the concrete does not undergo much volumetric change in the first 20 hours. The outdoor temperature in this girder stays at around 0°C throughout and goes below zero during the early morning hours. The temperature inside the tent is kept much higher using low temperature steam right from the time the girder is cast. It can be seen in the temperature plots for Figures 5.1, 5.2 and 5.3 that the gage in the bulb at mid-span shows the highest temperature when the girders are subject to high humidity supplemental heating. This is due to a steam vent near the center of the girder. In Figure 5.3, it can be seen that the concrete near gage 3NAMS0 shows shrinkage much earlier than the other gages and the temperature plot also highlights the greater temperature it reaches due to continuous steam curing. After 20 hours the increase in the concrete temperature accelerates and the shrinkage activity also begins. The concrete reaches the maximum temperature of about 40°C (gage 3NAMS0 reaches 50°C) at 40 hours after casting. It can be seen that the air temperature in the tent is much lower at about 26°C. The welded connections, overhang blockouts, and end blockouts are released at around 40 hours and the supplemental heating is decreased at the same time.

Figure 5.3 - Early Shrinkage Before Strands Cut, Girder 3

The inner form is released at 45 hours; however, this does not seem to have a significant effect on the shrinkage behavior. The transfer region gages started to show shrinkage at 24 hours and the web gage showed shrinkage starting at 20 hours. The inner form was not released until 45 hours because penetration resistance testing indicated that the deck was not sufficiently strong. The primary reason for the differences in behavior compared to the earlier girders is related to the premix. This girder contained two different ages of premix, which were not evenly distributed between the two ready-mix placing trucks. This resulted in a faster setting mix being placed on the north side of the girder. Thus, the north side (where all the gages were located) began to shrink earlier while a significant part of the deck was showing no penetration resistance due to its slower setting. This allowed for virtually no lateral restraint in the deck and thus this shrinkage could occur unimpaired regardless of the release of the inner form. At around 64 hours the steaming temperature is increased and the concrete also shows rapid volume change (12 microstrain/hr). This girder has two shrinkage slopes that are linked by a zone during which slight expansion takes place. The zone of slight expansion coincides with the period of hiatus in the steaming being carried out on the girder. The steaming is again stopped at 70 hours and the temperature in the tent drops rapidly before the steaming is again started at 75 hours at a gradual rate. The concrete temperature continues to rise until 75 hours even though the steaming has been stopped and then the gain in temperature slows down to the rate of gradual steaming being carried out after 75 hours. The steaming is continued until 115 hours from casting and in this period the girder strains at approximately 3 microstrain/hr. The steaming is stopped at about 115 hours and the temperature in the girder and in the tent drops down rapidly due to the cold

As observed in all the girders, gages 3NB03W and 3MCMSL show much higher shrinkage rate (27 microstrain/hr) during initial shrinkage than the other gages (16 microstrain/hr), whereas the subsequent expansion and then shrinkage rates are almost equal.

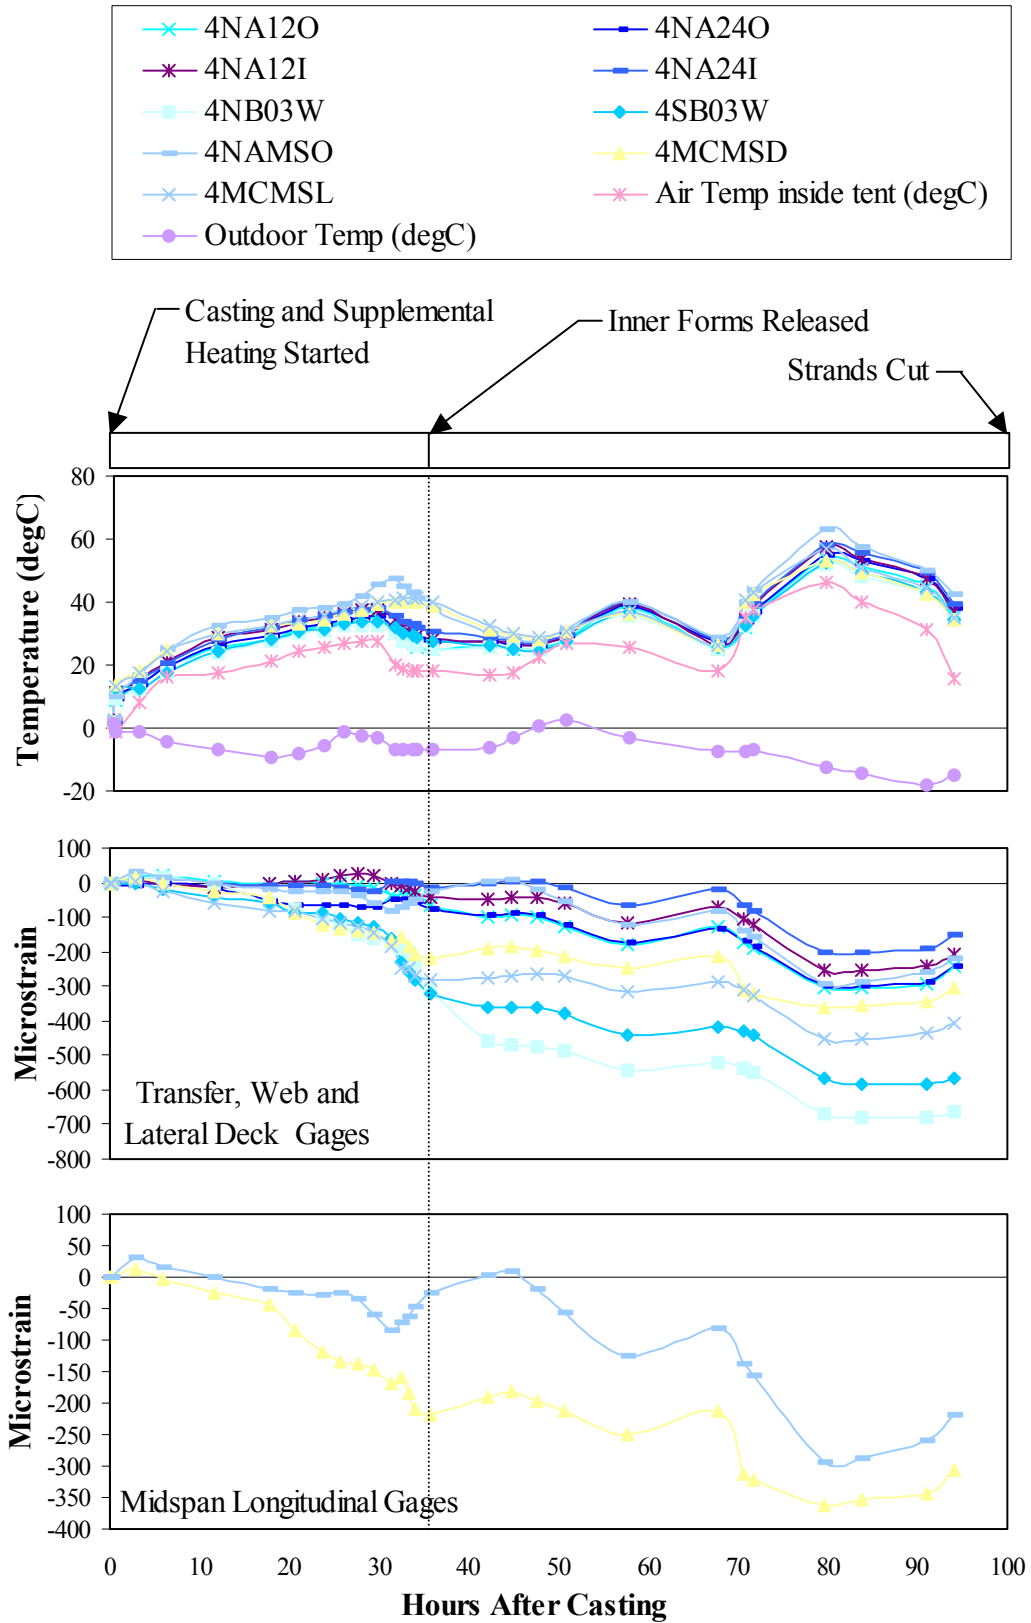
Figure 5.4 shows the shrinkage behavior of concrete and temperature variations at different locations in Girder 4 as well as the ambient temperatures outside and inside the tent from the cast time to the cutting of strands. This girder has also been cast in cold conditions as can be seen by the plot for outdoor temperature in Figure 5.4 and hence it has been subject to supplemental heating right from the time it was cast. It can be seen that the heating is continued for 30 hours and leads to an increase in the temperature of the girder concrete and that in the tent. Girder 4 shows slightly different behavior than the earlier girders. As seen in Figure 5.4, all the gages show almost the same small amount of strain in the first 15 hours, after which the gages in the bulb remain relatively constant while the gages in the webs and deck begin to show some shrinkage. At 30 hours the temperature inside the tent is reduced. At approximately the same time the gages outside the bulbs begin to show enhanced shrinkage. At 35 hours the inner form is released. In this girder, the form release had very little effect on the shrinkage behavior. It is likely that this again relates to the mix of different age premixes that were used in this girder.

Figure 5.4 - Early Shrinkage Before Strands Cut, Girder 4

For this casting, the different premixes were equally blended into each batch so the cast material was consistent. However, it seems likely that the differing set times of the premixes could have affected the setting enough to relieve some restraint and allow for the shrinkage before the inner form release. After 45 hours the outdoor temperature as well as the temperature inside the tent increase and the girder, after some time, also starts heating up. The concrete in all parts of the girder starts showing shrinkage at the rate of about 8 microstrain/hr for 10 hours. As in previous girders, the web gages show more shrinkage than the other gages in the earlier stages. Gage 4SB03W, installed in the south web to monitor the effect of using different batches of UHPC premix, shows the same shrinkage as 4NB03W in the earlier stages and then slightly less shrinkage in the later stages. As can be seen in the third plot of Figure 5.4, gage 4NAMS0 is more restrained and thus shows less shrinkage than gage 4MCMSD.

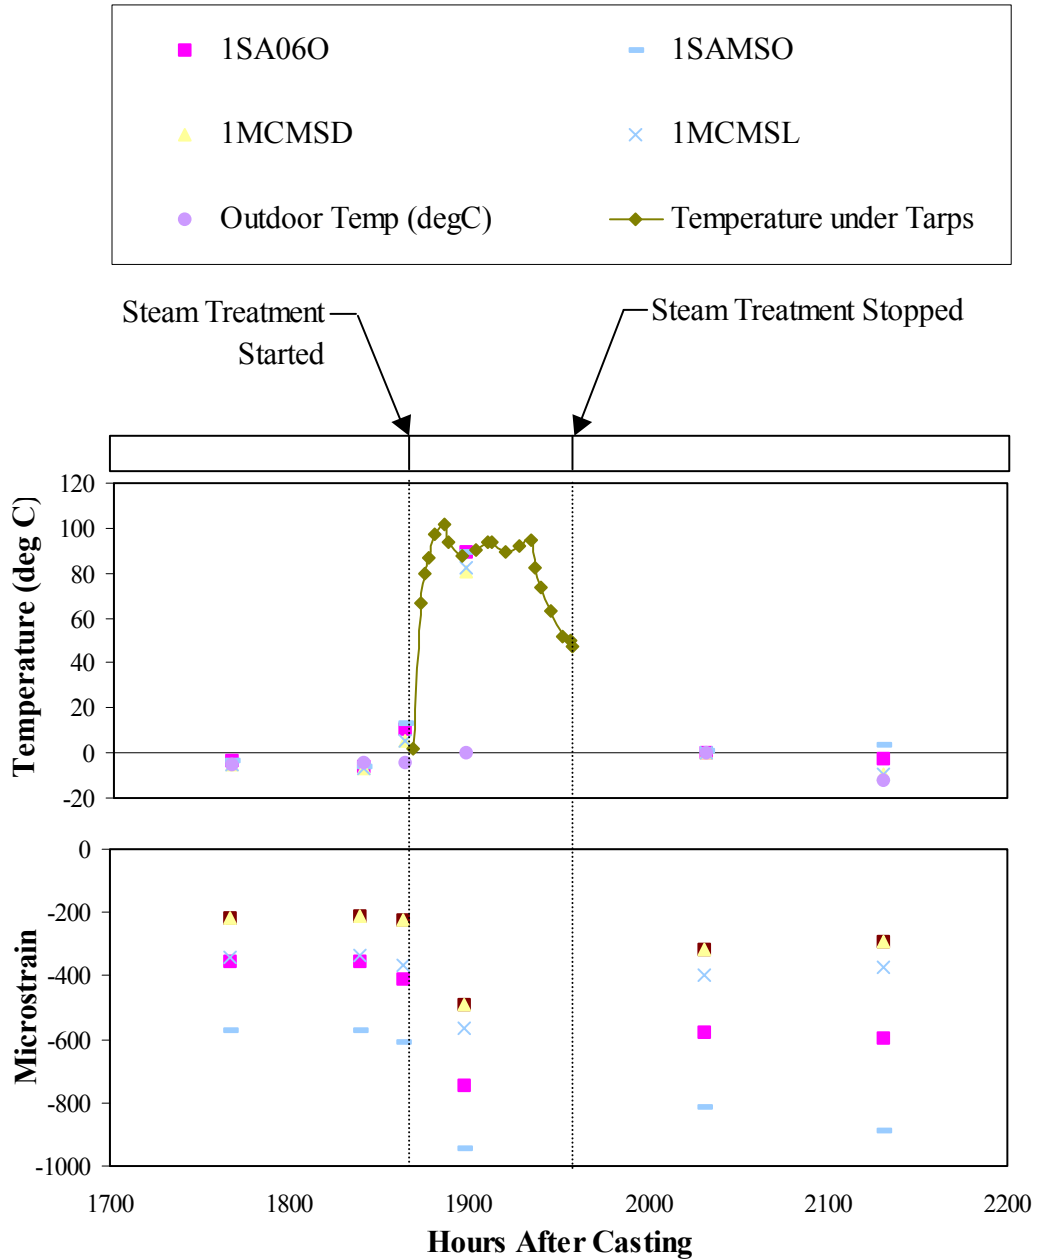
shrinkage from the steaming treatment, while the midspan deck longitudinal gage showed 98 microstrain of shrinkage.

**Figure 5.5 - Shrinkage Due to Steam Treatment, Girder 1**
