Title of Thesis: BEHAVIORAL STUDY OF ULTRA HIGH PERFORMANCE CONCRETE GIRDERS.

Degree Candidate: Sayed Sameer, Master of Science, 2004

Thesis Submitted to the Faculty of the Graduate School of the  
University of Maryland, College Park in partial fulfillment  
of the requirements for the degree of  
Master of Science  
2004

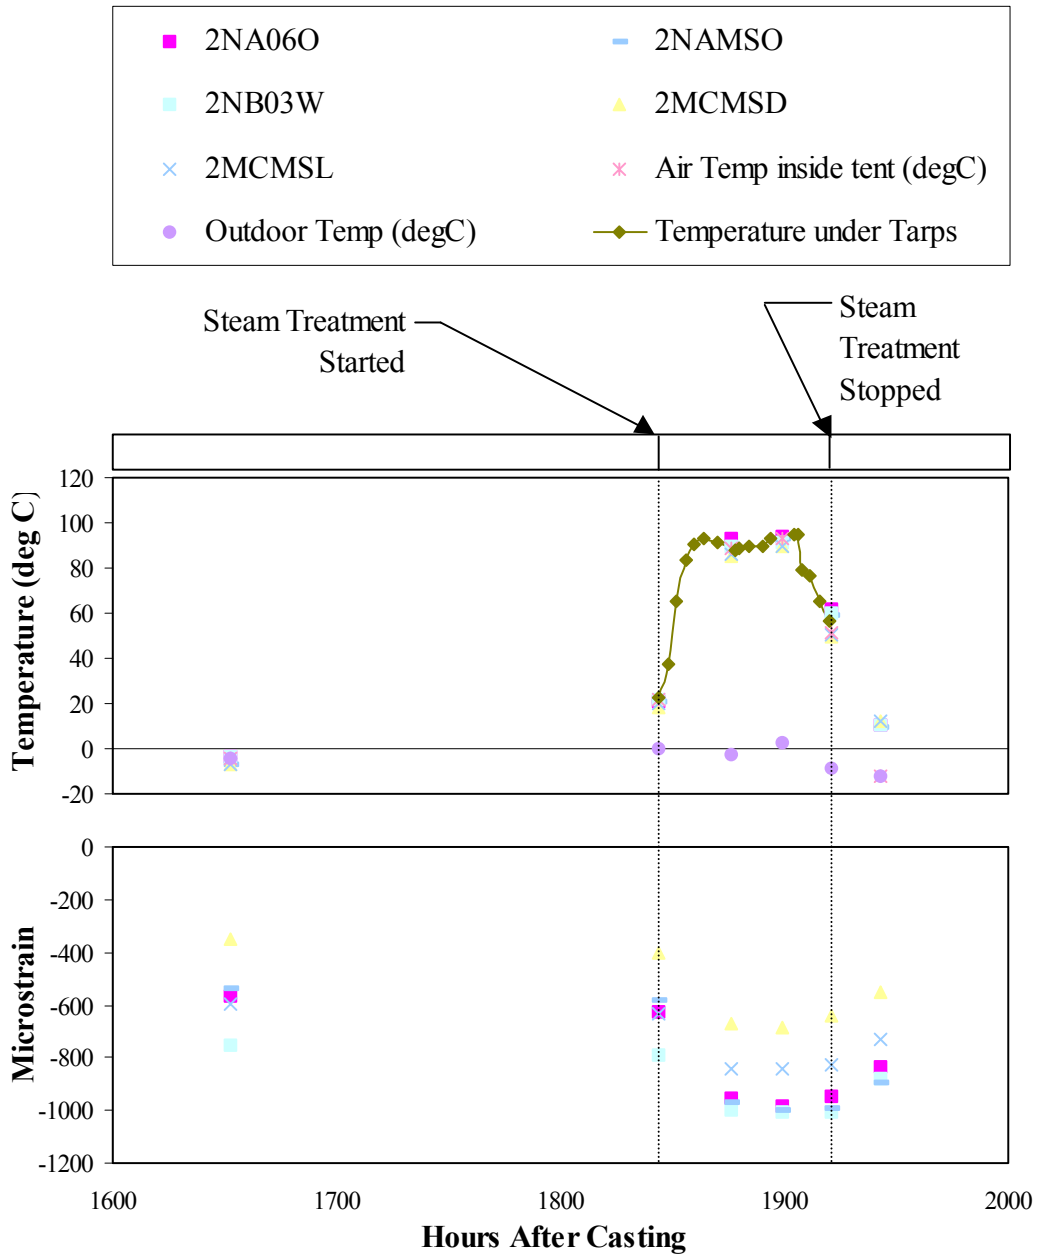
As seen in Figure 5.6, before the application of steam treatment to Girder 2, the shrinkage progressed at a negligible rate of 0.25 microstrain/hr. The girder was subjected to steam treatment 1845 hours (77 days) after being cast and the steaming was done for 72 hours.

Figure 5.6 - Shrinkage Due to Steam Treatment, Girder 2

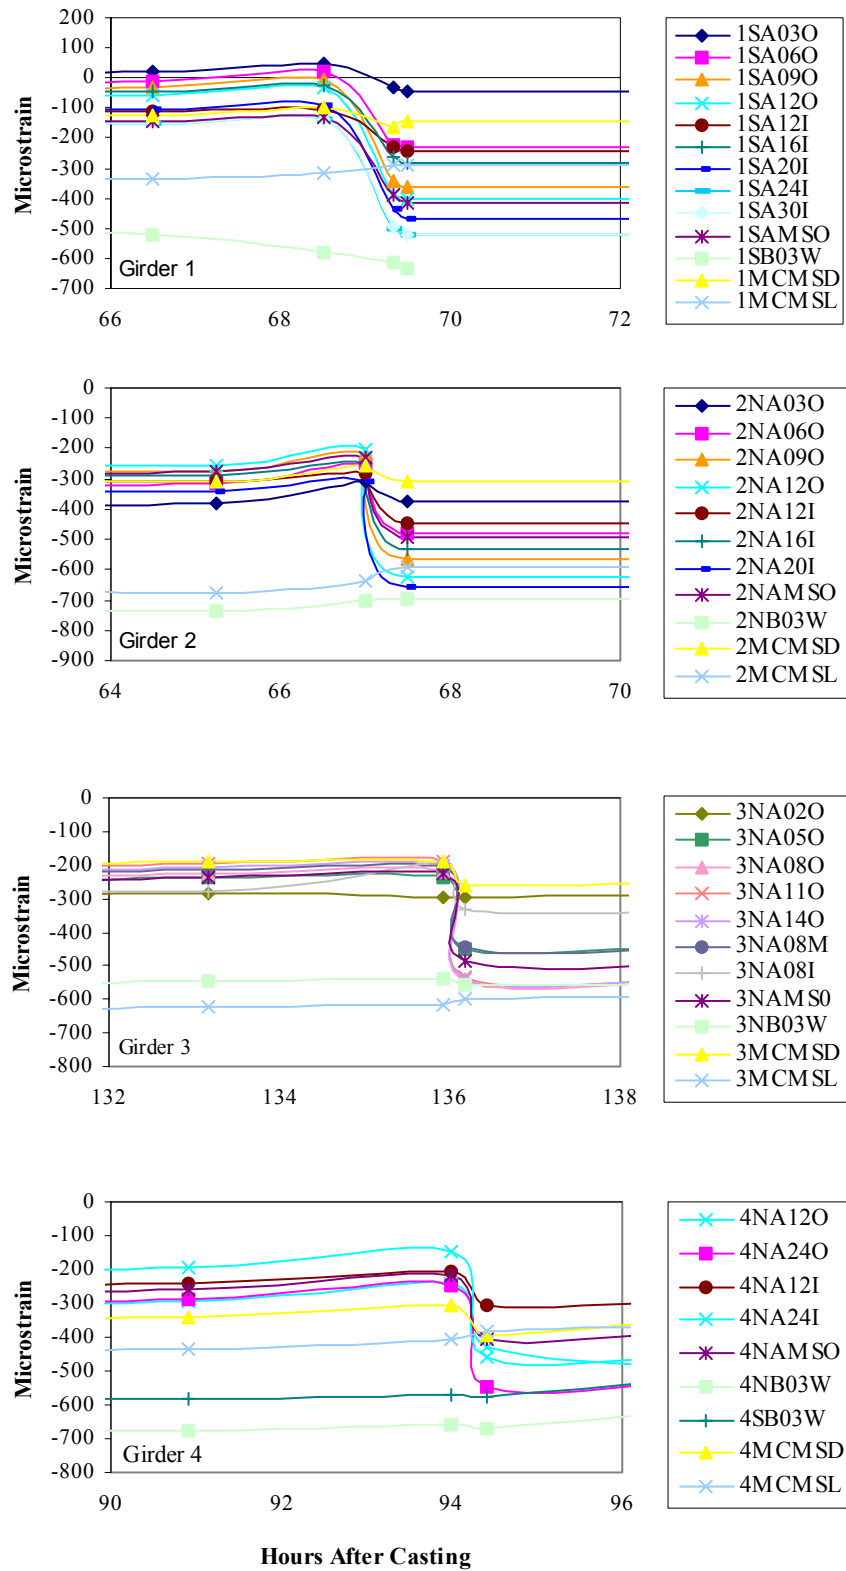
As stated in Chapter 4, low relaxation strands 0.5 in. in diameter were used for the prestressing. They were pulled based on force and elongation calculations with 19 in. and 21 in. as the specified minimum and maximum elongation of the strands. All strands were pulled to 29.2 kips of force. The prestressing was applied only after ascertaining that the UHPC had gained at least 10 ksi of compressive strength. The strands were cut symmetrically in both bulbs and simultaneously at each end. Figure 5.7 shows the strain values in all four girders at the time the strands were cut. The strains in all four girders are steady before the sudden drop in strains is observed in the plots for each of the girders. The actual drop in strains is more characteristic of the plot seen for Girder 3 but the slope of the drop looks variable for the girders due to different time intervals of data recorded after the strands were cut. All the gages placed longitudinally show increased compressive strains at the time of release of prestress. The two gages placed in the deck at midspan and the web gages are not near the strands in the girder. The web gage in the

**Figure 5.7 - Strain Profile During Application of Prestress**

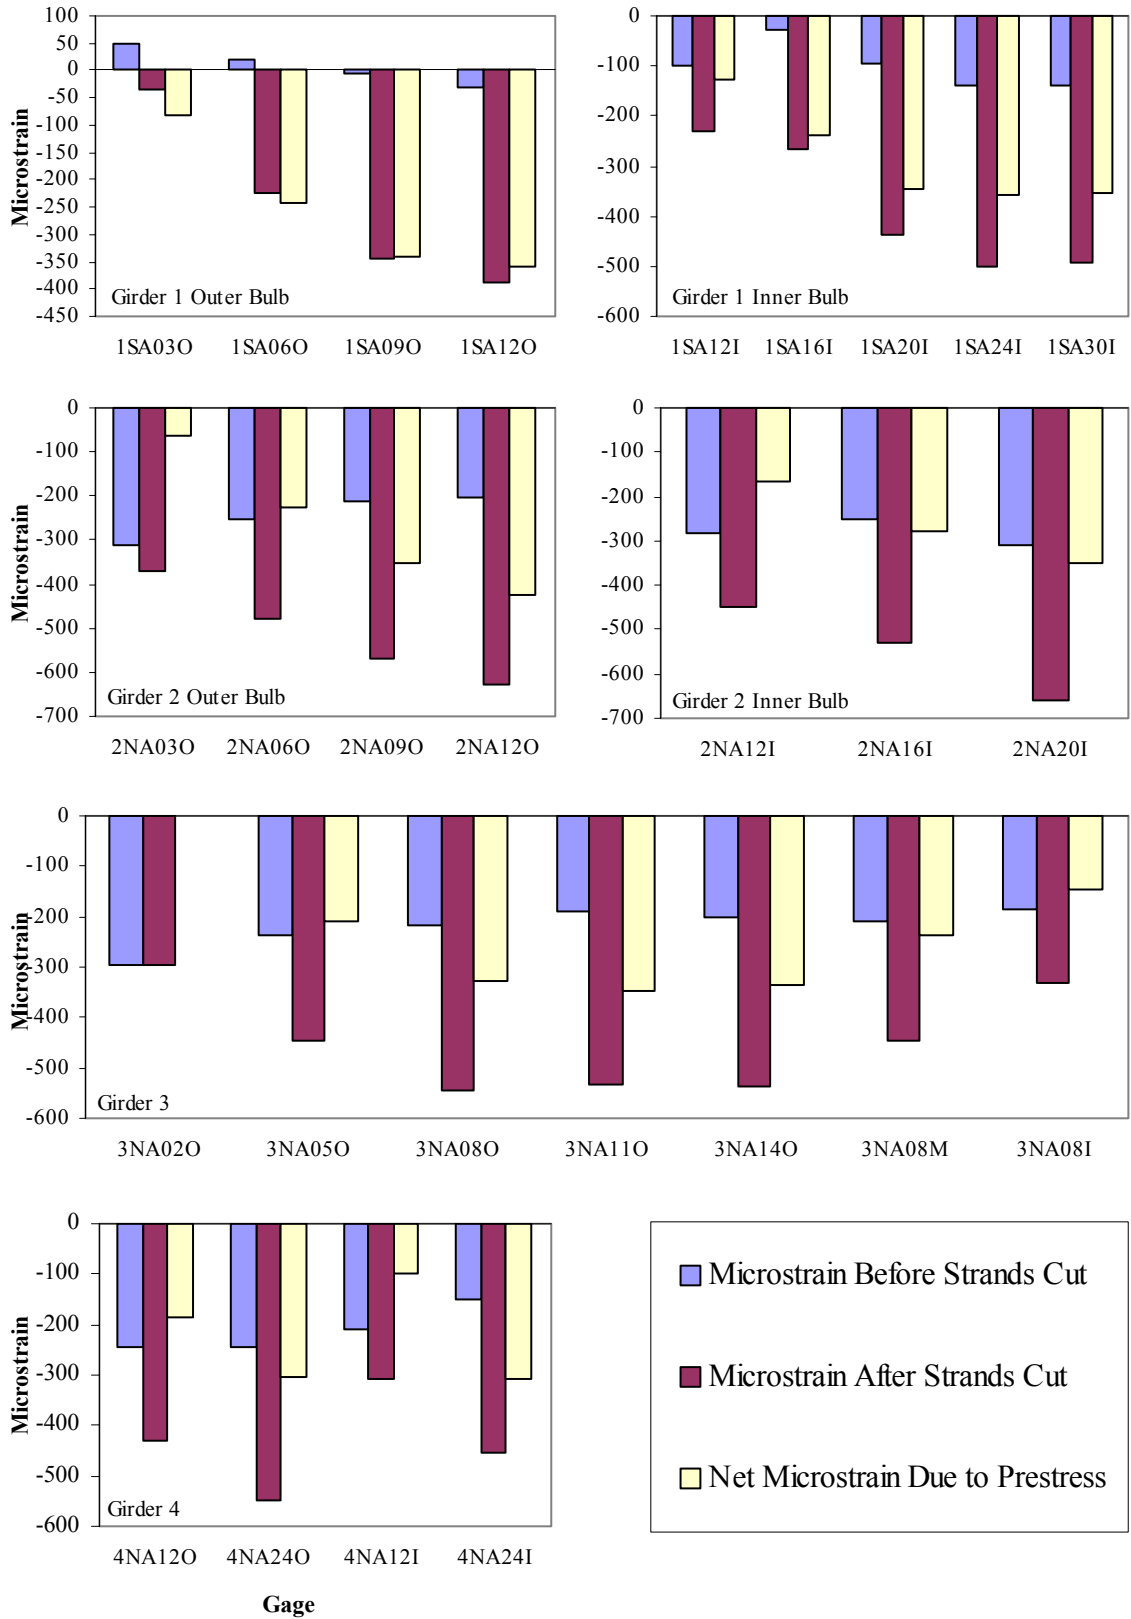
As per the prestressing pattern discussed in earlier chapters, the outer bulb had more strands that were not debonded as compared to those in the inner bulb. Collection of data was concentrated in the region of transfer of the first set of strands (not debonded) and the second set of strands (debonded up to 12 in. from support) in the first two girders. Hence, in Girders 1 and 2 the strain gages were located in the first 12 in. in the outer portion of the bulb and in the next 8 to 18 in. of the inner portion of the bulb. Girders 3 and 4 did not have a series of gages in the inner bulb for recording the transfer profile of the second set of strands. Figure 5.8 shows the strain readings before and after the prestressing strands were released and the net strain change in the bulb region as a result of the prestressing process. Shown are the separate plots created for the outer and inner bulbs for Girders 1 and 2, as there is a change in the strain pattern. The net increase in strain due to prestress shows increasing values up to 9 in, from the support after which the strain values show negligible increases suggesting that full transfer has been achieved at around 10 in. from the support.

Figure 5.8 - Strains Before and After Prestressing

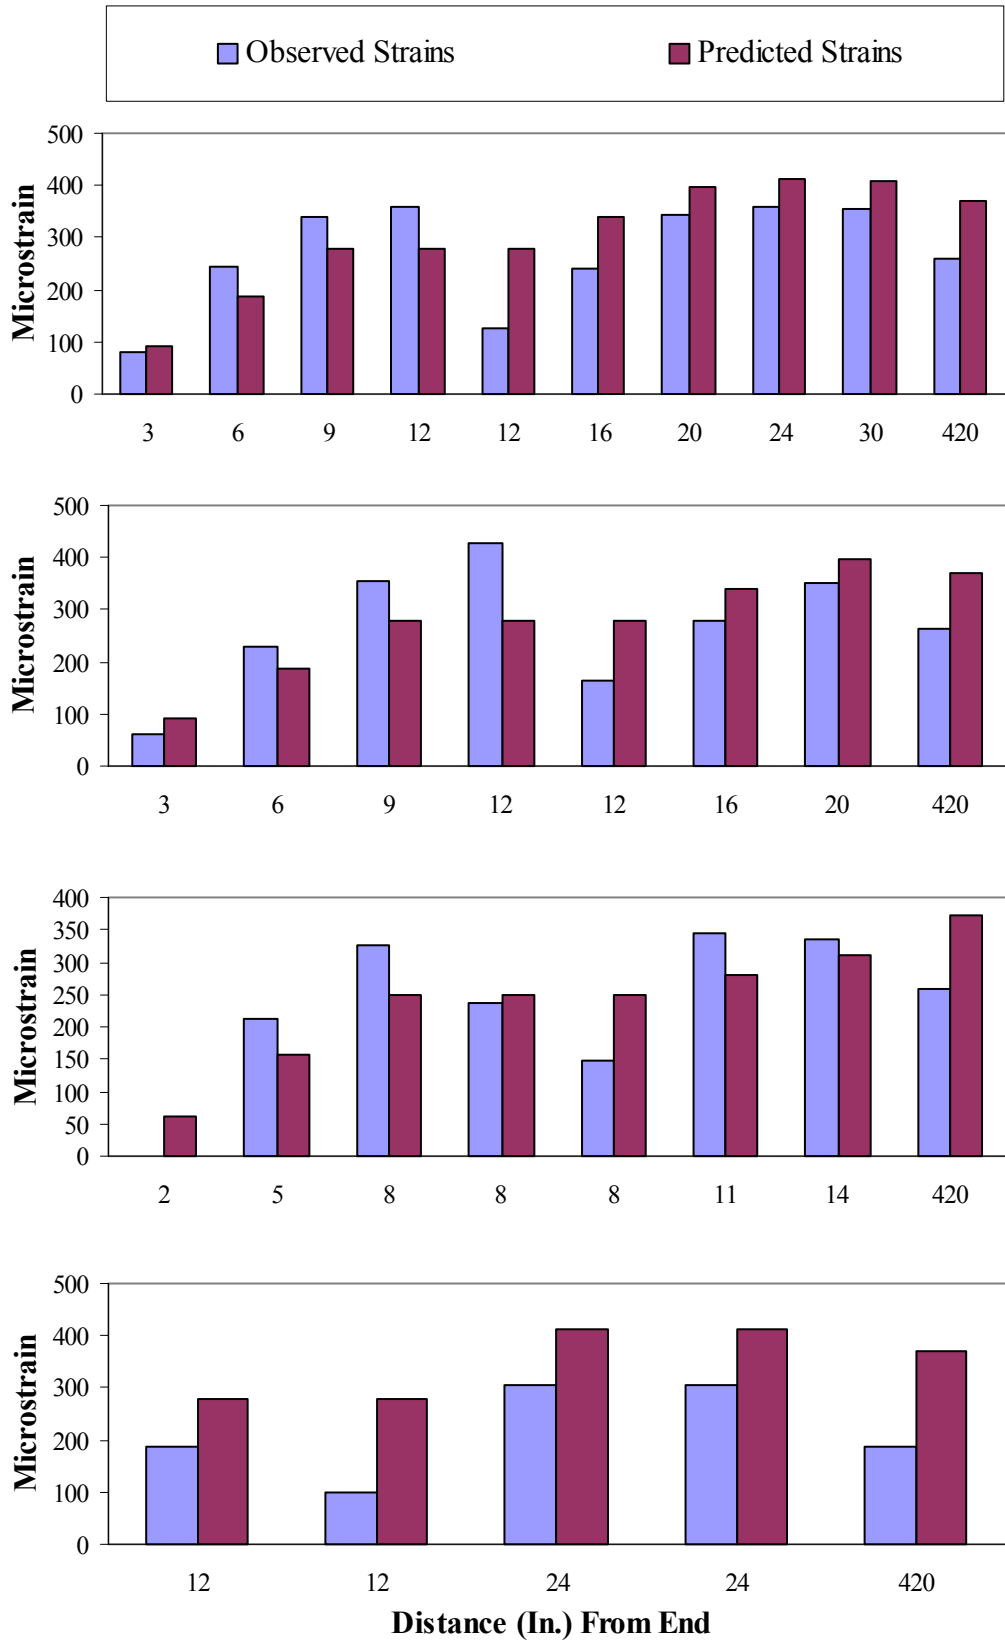
As it was known from earlier studies that the strands would completely transfer the prestress at about 10 in., analytical calculations were carried out for comparison with the strains observed in the girder. Figure 5.9 shows the comparison between the observed and the predicted strains. The predicted strains are a linear approximation that assumes that the prestress is transferred linearly up to complete transfer at 9 in. The plots for

**Figure 5.9 - Observed and Predicted Strains**

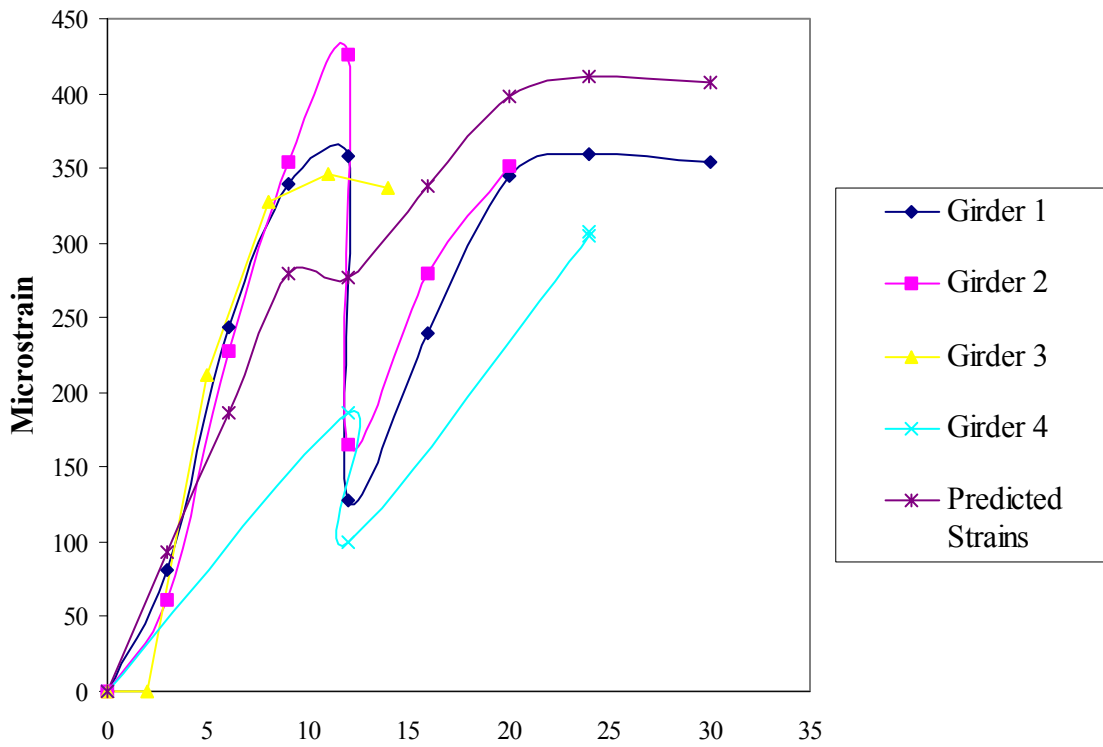
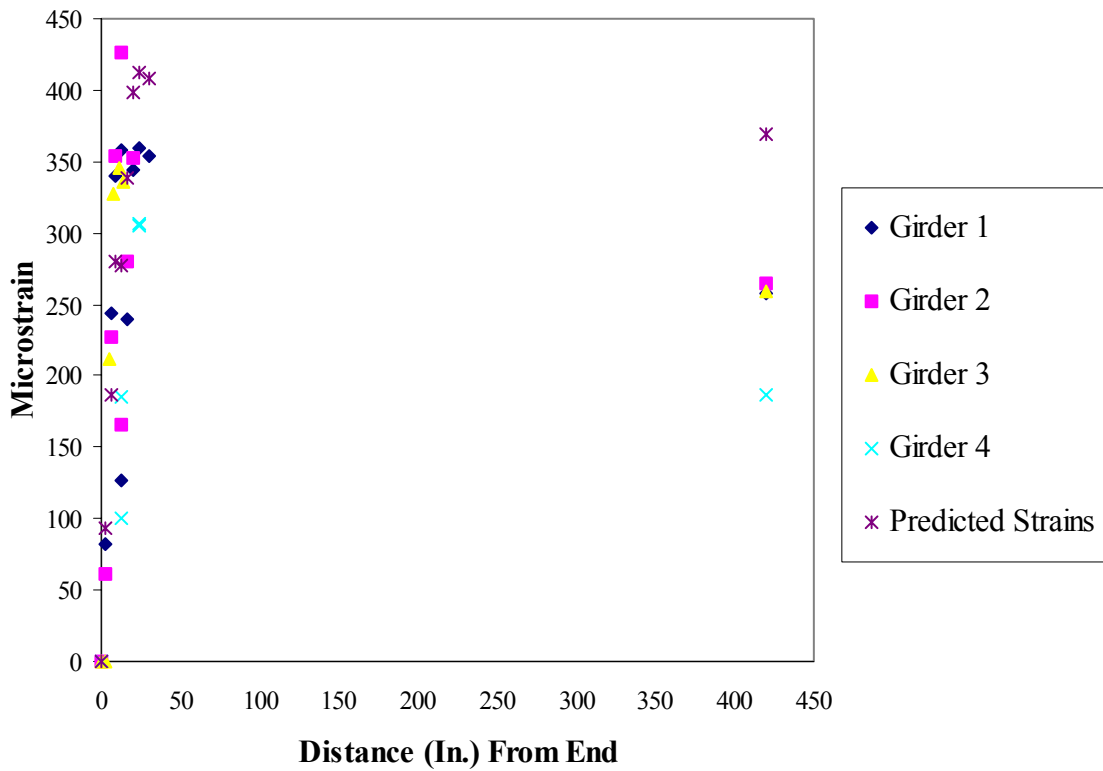
the strains at 8 in. in the middle and inner portions of the bulb are less than that at the outer portion. The plot for Girder 4 also shows another interesting observation: there is a difference in the strain values in the outer and inner bulbs at 12 in. (where only the 6 non-debonded strands in each bulb have transferred) but the strain values in the inner and outer bulbs at 24 in. (where the 6 non-debonded and the three strands debonded up to 12 in. have transferred) are almost the same with the inner bulb value being slightly higher. This may indicate that the strains transferred may have lateral variations in the transfer regions due to various debonding patterns. However, at a location, i.e., at 24 in., where prestress has already been transferred almost symmetrically throughout the section, the observed strains show little lateral variation at a particular longitudinal location. Another important observation is that the observed strains in all the girders, except Girder 4, are particularly higher than the predicted strains in the first 12 in., and the strains at 12 in. are higher than the predicted possible maximum strains. This may point to imperfect debonding since the higher strains may be due to prestress contributions from the debonded strands. Figure 5.10 shows the strain profile of all the gages in the bulbs regardless of whether they are in the outer portion or the inner portion of the bulb and with the predicted profile. The first plot shows only the gages in the transfer region whereas the second plot also shows the strains in the gages at midspan. Here the reduction in the strains at midspan can be clearly seen.

Figure 5.10 - Transfer Profile of All Bulb Gages

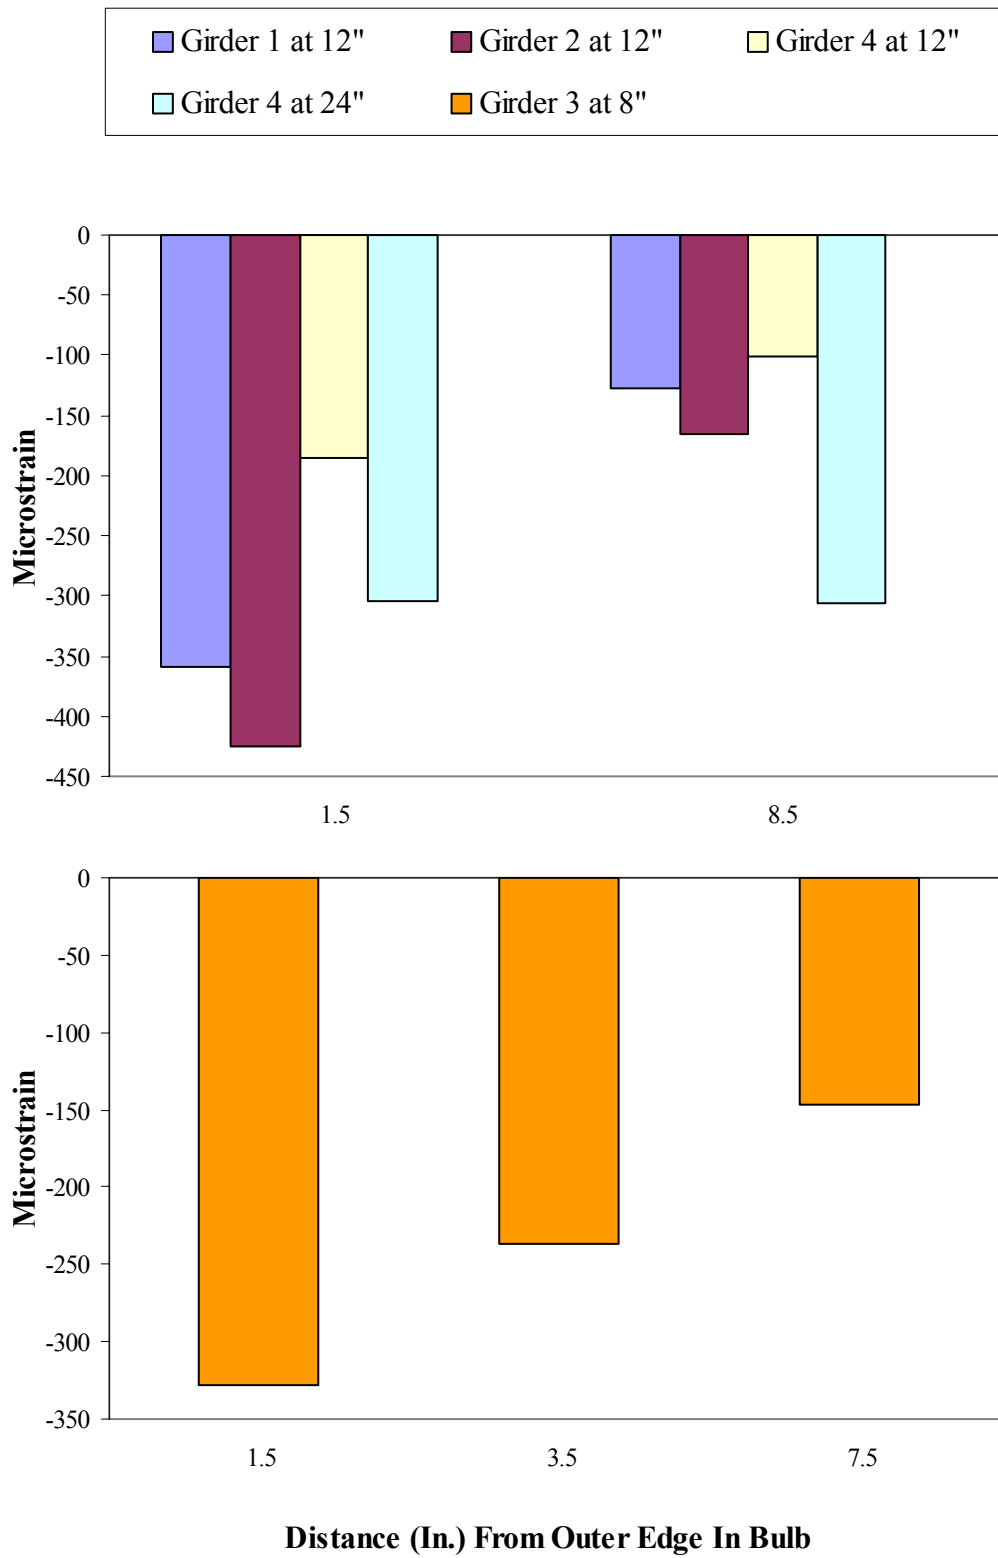
As has been pointed out before, the strains in the concrete section are not uniform and are concentrated more in the region near the strands and less going away from the strands. Figure 5.11 shows the comparison of the strains in gages placed to monitor the prestress transfer in the bulb at the same longitudinal distance from the support but at different locations in the bulb cross section. The gages are placed in the outer portion (1.5 in. from the outer edge) of the bulb and the inner portion (8.5 in. from the outer edge or 2.5 in. from the inner edge) of the bulb. The first plot is for outer and inner bulb gages at 12 in. for Girders 1, 2 and 4 and at 24 in. for Girder 4. At 12 in., the first set of strands, which are more concentrated in the outer portion of the bulb, have transferred whereas, at 24 in., the second set of strands have transferred and the effective prestressing force is slightly more concentrated in the inner region of the bulb. There is a sharp reduction in the strain values at 12 in. between the outer and the inner bulb gages for all the three girders under observation. The reduction in strains is 230 microstrains, 260 microstrains, and 85 microstrains for Girders 1, 2 and 4, respectively. The web provides restraint to the prestressing force in the bulb and the restraint is more in the inner bulb than in the outer bulb. Also, due to the eccentric loading in the bulb in the first 12 in. there is lateral bending in the bulb with the outer bulb being under more compression while the inner bulb has less compression. However, at 24 in. the strain values do not show reduction at the inner portion. Instead, the strain at the inner bulb is slightly higher than the outer bulb, which is consistent with the prestressing force being slightly more concentrated in the inner bulb at 24 in. The second plot in Figure 5.11 shows the prestress strain in the three gages placed in Girder 3 at 8 in. from the end.

**Figure 5.11 - Difference in Transfer Microstrain Across the Section  
- Girders 1, 2, 3 and 4**

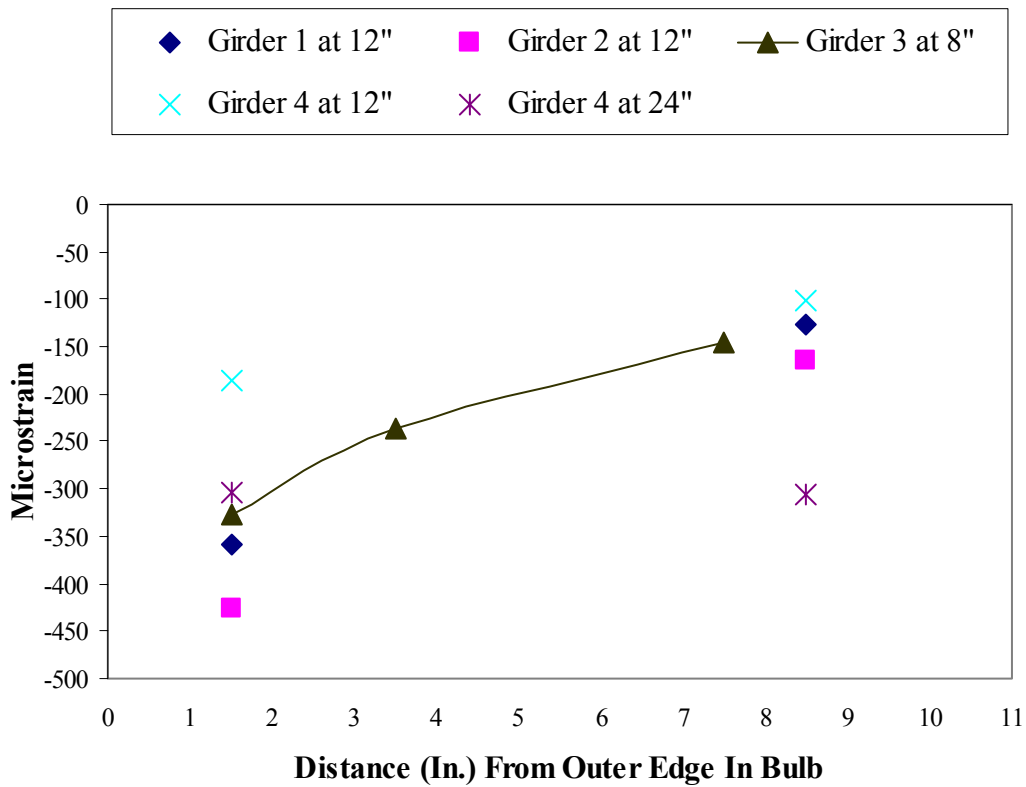
The gages 3NA08O, 3NA08M and 3NA08I are at 1.5 in., 3.5 in. and 7.5 in. from the outer edge in the cross section. We can see a 90 microstrains reduction between the outer and middle portion of the bulb and a further 90 microstrains reduction between the middle and the inner portion of the bulb. The fall in strain values across the section can be clearly observed. Figure 5.12, with an X-axis equal to 11 in. (width of the bulb), further elaborates the strain reduction in the cross section.

**Figure 5.12 - Difference in Transfer Microstrains Across The Section**

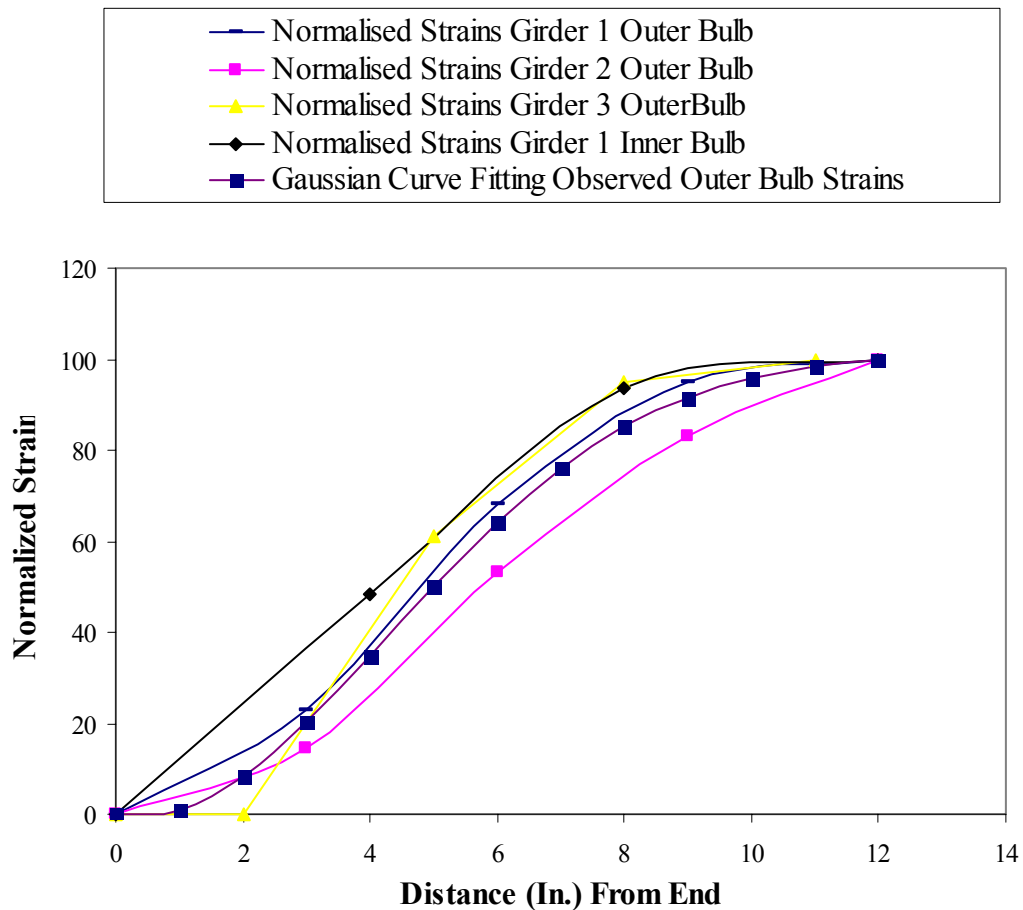
The transfer of prestress along the length of the strands follows a pattern that can be approximated by using normalized transfer strains. Strains have been normalized assuming a 100% transfer at 12 in. and the observed strain values at intermediate distances are expressed as a percentage of the strain at 12 in. Figure 5.13 shows the normalized strain plots for Girder 1 outer and inner bulb gages and Girder 2 and 3 outer bulb gages. The transfer pattern is quite similar except that seen for Girder 3 at gage 3NA02O, which shows no strain due to prestress. The fifth curve in the figure is the

**Figure 5.13 - Observed and Gaussian Normalized Curves**

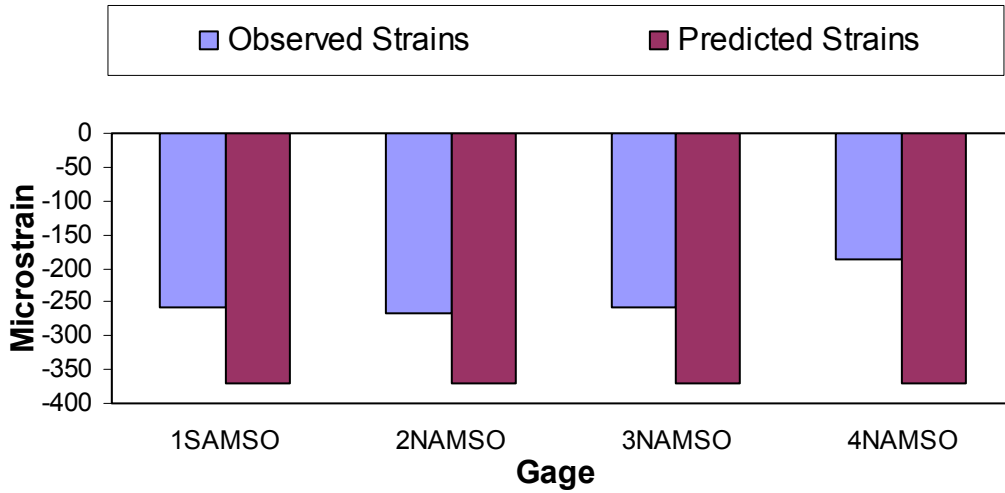
tension on the application of prestress. As observed in Figure 5.15, the midspan bulb gages do not show as much strain as analytical calculations suggest. The strains seen in the midspan bulb gage are about 110 microstrains lower than expected in Girders 1, 2, and 3 whereas they are about 185 microstrains lower than expected in Girder 4.

**Figure 5.15 - Observed and Predicted Prestress Strains at Midspan**

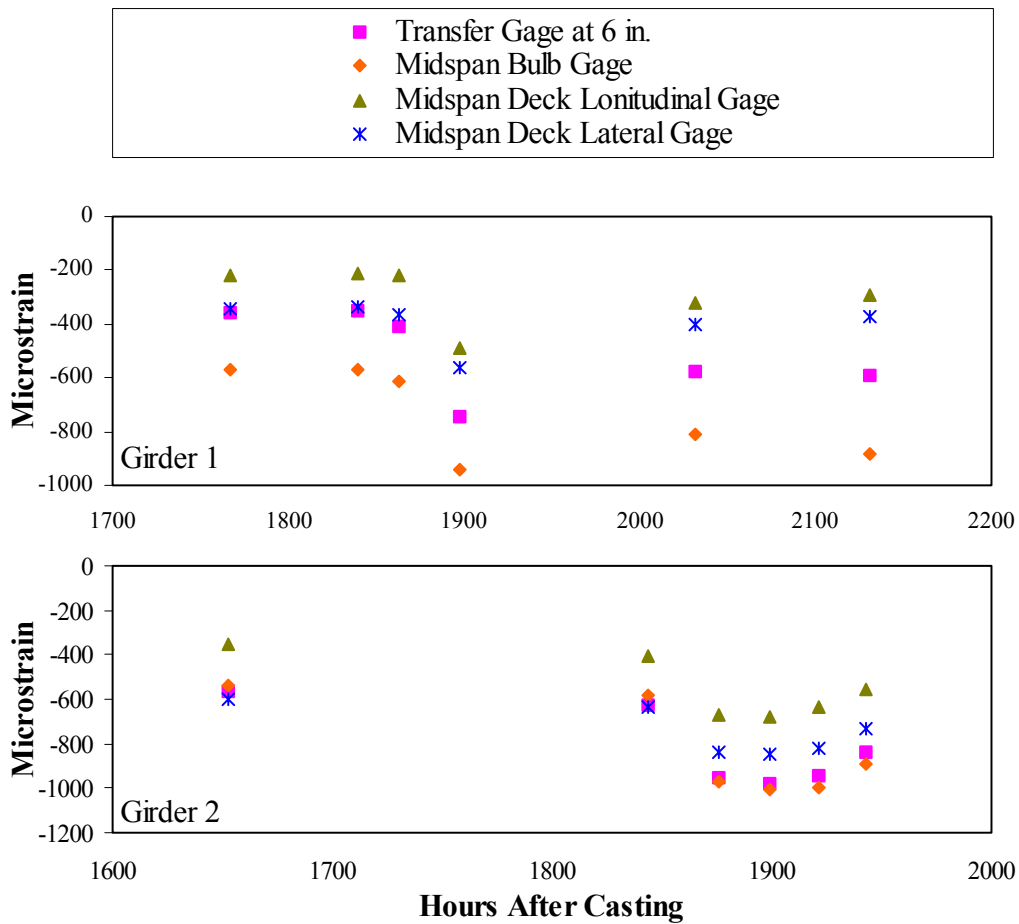
170 microstrains of shrinkage. In Girder 2 the shrinkage is more pronounced but the lesser shrinkage in the deck is evident as the lateral deck gage shows 97 microstrains of shrinkage and the longitudinal deck gage shows 153 microstrains of shrinkage compared to the midspan bulb gage which shows 308 microstrains and to the transfer gages, which show 250 microstrains of shrinkage.

Figure 5.16 - Strains at Midspan During Steam Treatment

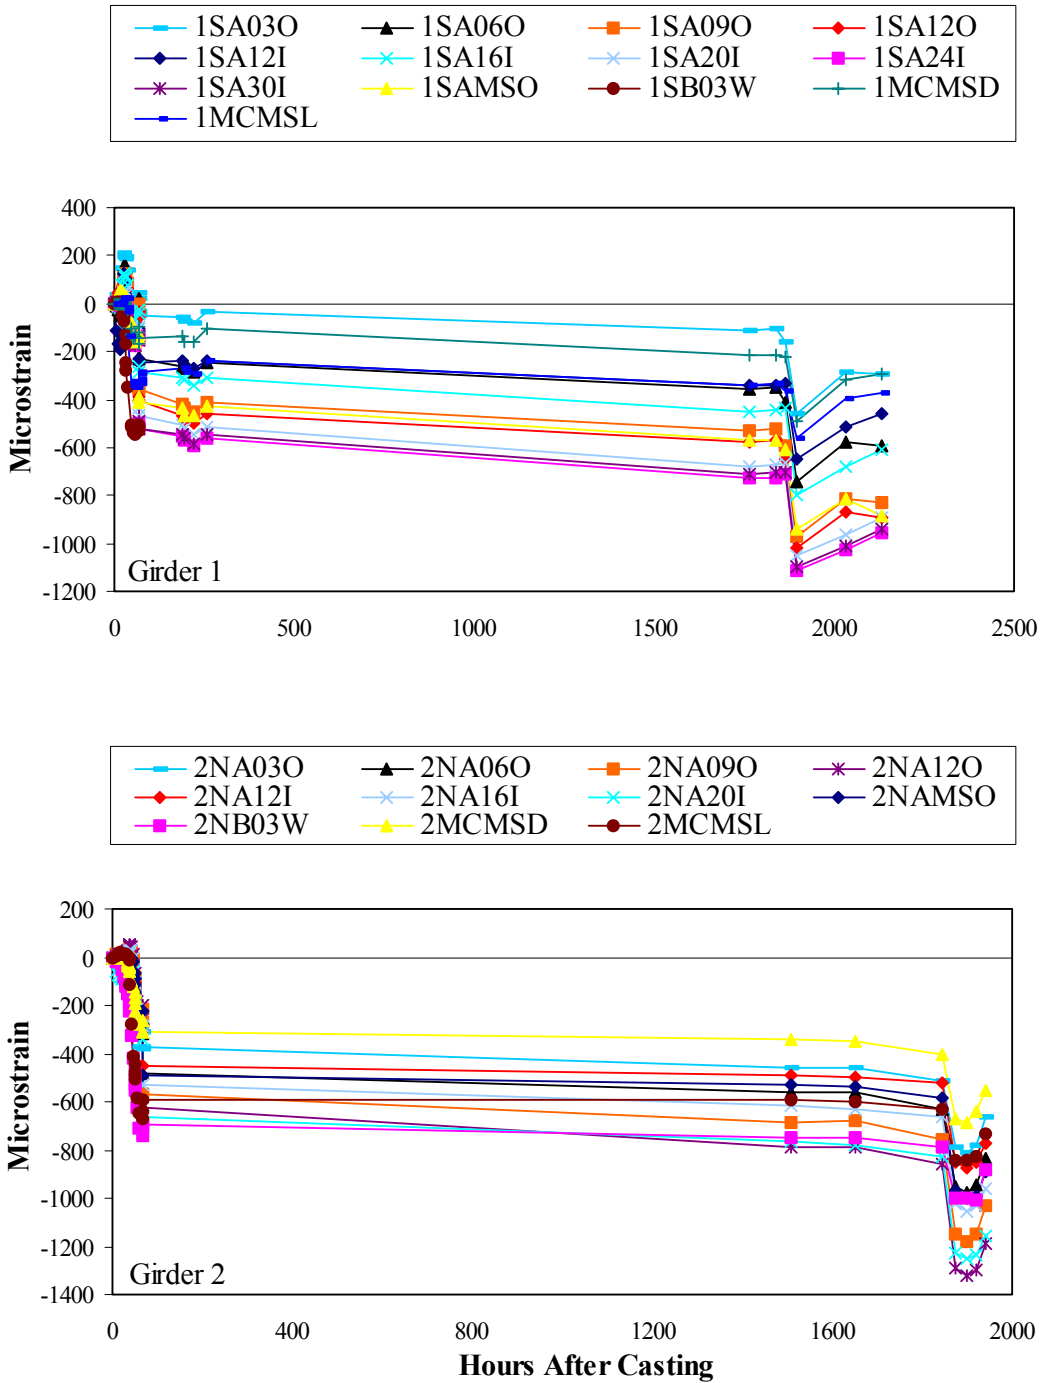
As soon as the strands are released, the girders were blocked in the yard. Girders 1 and 2 stayed blocked in the yard for long periods of time. During this stage, the forces acting on the girder were the self-weight and the prestress. Though most of the shrinkage occurs in the early stages after the concrete is cast, there is some residual shrinkage, which occurs at a very slow rate on a continuous basis over a large period of the concrete life. Figure 5.17 shows the strains in the girder during the period it was blocked in the yard with the prestressing force and self-weight acting on the girder. It can be seen from plots for Girders 1 and 2 that the compressive strains are increasing even though there is no increase in the forces acting on the girder. It can also be seen that there is a hiatus of almost 1500 hours in the plots for both the girders during which the strain values are not available and the strain profile has been assumed to be an almost straight line. Hence, it is very difficult to state the actual strain in that timeframe though there shouldn't be any jump as the conditions were more or less constant. However, it can be seen that the compressive strains have increased over that period. It can also be seen, particularly in Girder 2, that the gage in the web at the end shows very little increase in strain. The midspan deck lateral gage also does not show much increase in strain. The increase in strain was approximately 75 microstrain over a period of about 1500 hours in Girder 1, whereas the increase in Girder 2 was around 80 microstrain over a period of about 1600 hours.

Figure 5.17 - Strains After Application of Prestress

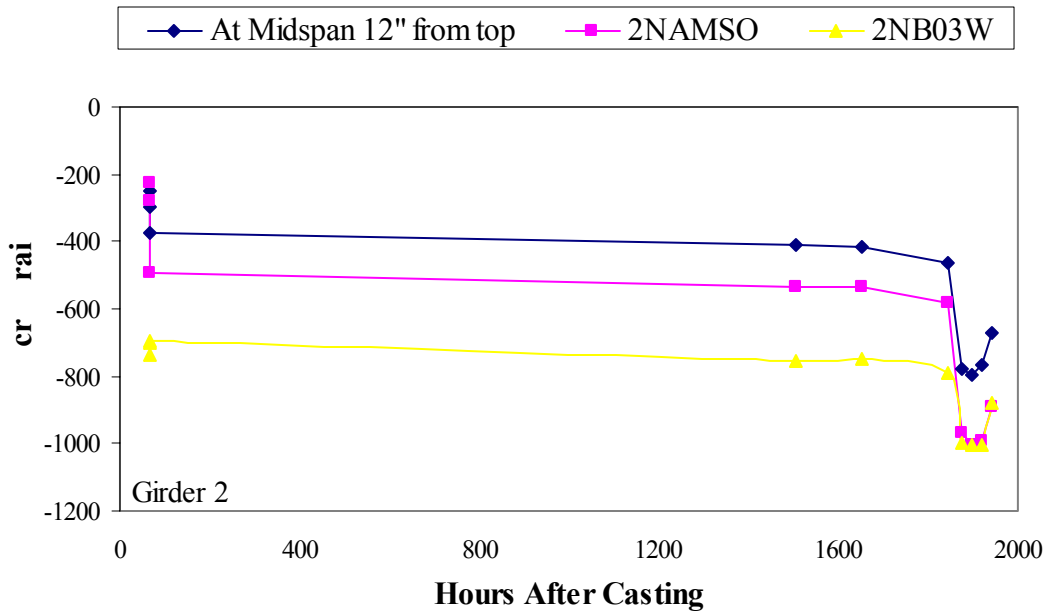
An approximate method of observing the creep strains is to compare the strains at locations not under the prestressing force and locations under prestressing force. In this section the strains along the bending neutral axis are discussed to get a closer idea of the creep acting on the girder. The web gage 3 in. from the east end of the girder has been placed at 12 in. from the top of the deck. This depth is approximately coincident with the bending neutral axis of the girder section. Hence, strains in this depth will be more or less an effect of the prestress. There are gages at midspan in the deck at the top and in the bulb at the bottom. The strain values in these gages have been interpolated to get the strain at 12 in. from the top at midspan. Figure 5.18 provides plots for strain at neutral axis at the end and at midspan, for Girder 2.

**Figure 5.18 - Strains along Neutral Axis and at Midspan in Bulb**
