Title of Dissertation: FAILURE MECHANISMS OF PEDIATRIC GROWING ROD CONSTRUCTS

Genevieve A-L. Hill, Doctor of Philosophy,
2017

FAILURE MECHANISMS OF PEDIATRIC GROWING ROD CONSTRUCTS

Dissertation submitted to the Faculty of the Graduate School of the
University of Maryland, College Park, in partial fulfillment
of the requirements for the degree of
Doctor of Philosophy
2017

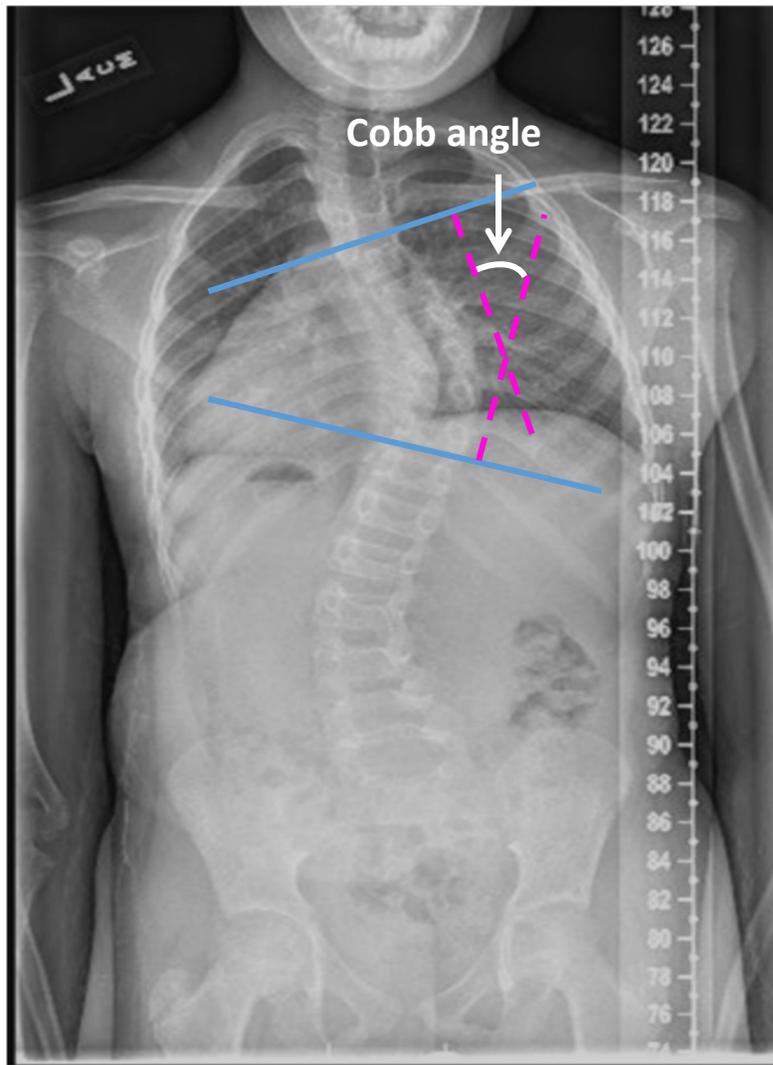
Figure 1: Measurement of Cobb angle on X-ray. Two lines (solid blue) are drawn parallel to the vertebrae at each end of a spinal curve. Two additional lines (dashed pink) are drawn perpendicular from the solid blue lines. The Cobb angle (white arc) is the angle at which the perpendicular lines (dashed pink) intersect.

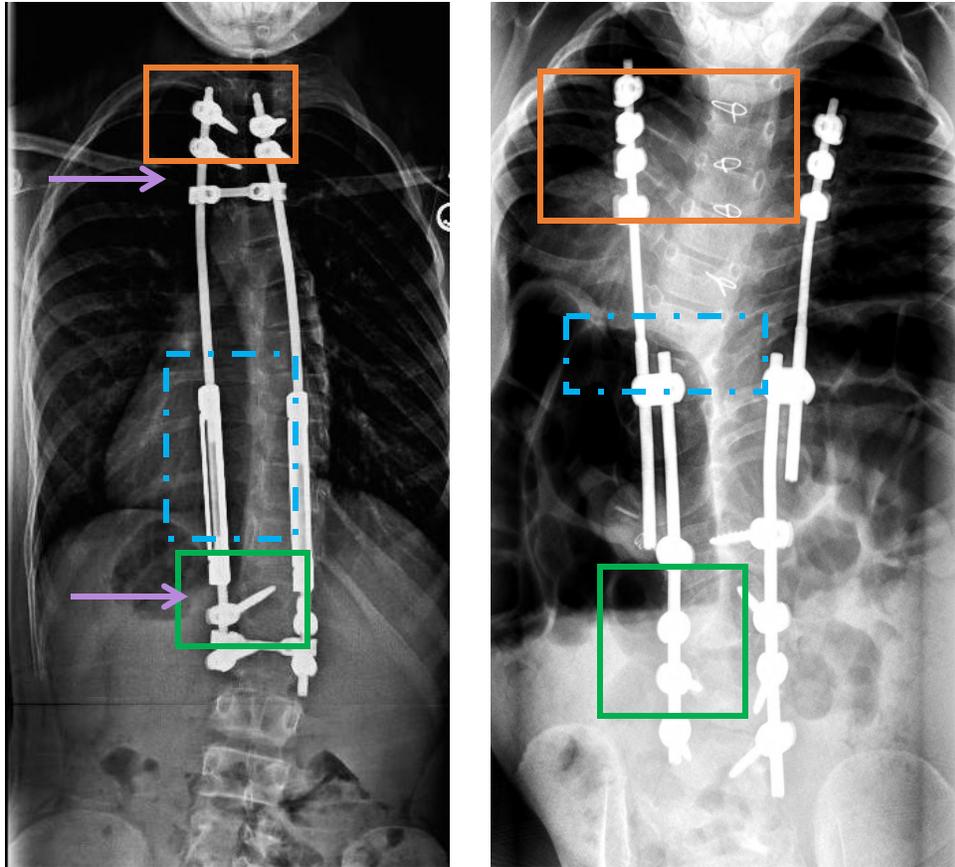
Figure 2: Types of implant components in growing rod constructs. Left: X-ray of a dual growing rod construct with spine-based fixation, tandem axial connector, and two optional crosslinks. Right: X-ray of a dual growing rod construct with rib-based fixation, side-by-side axial connectors, and no crosslinks. The superior anchor foundations are outlined in the orange boxes where the anchors (screws or hooks) are fixed to either the spine or ribs. The inferior anchor foundations are outlined in the green boxes where the anchors are fixed to the spine. The axial connectors are outlined in the blue, dashed boxes. The rods are cylindrical and run parallel to each other (not outlined or highlighted in the figure). Single rod constructs would only consist of one rod along one side of the spine. The optional crosslinks are identified by purple arrows. The axial connectors, anchors, and crosslinks come with set screws used to lock these components to the rod.

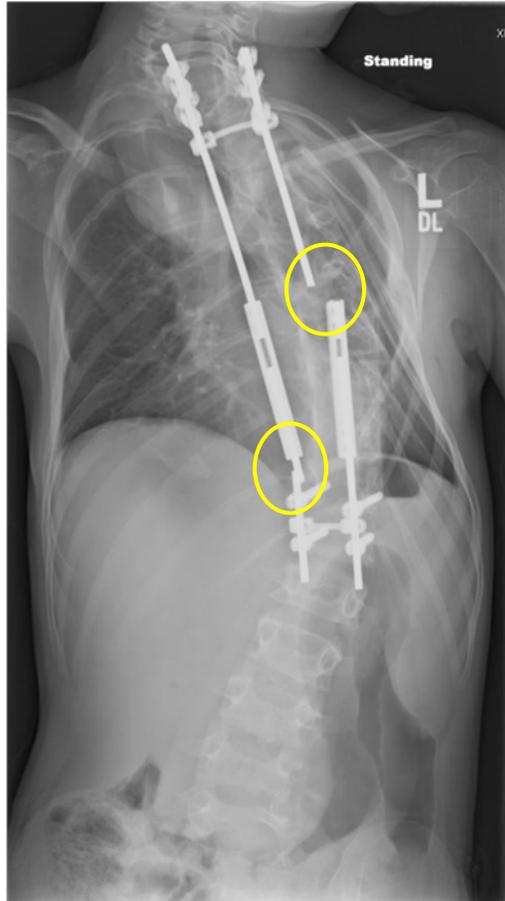
Figure 3: Example of rod fractures. Two rod fractures (yellow circles) in a pediatric growing rod construct as captured on X-ray.

Rod fracture (Figure 3) is one of the most common mechanical failures reported in the scientific literature with fracture rates ranging between 15% and 69%. This large range relates to the sample size used to collect rod fracture rates in each prior study. Prior studies involving smaller sample sizes (e.g., retrospective studies with less than 100 patients) typically reported higher percentages of rod fracture rates. Specifically, Bess et al reported 177 complications in 81 out of 140 patients (58%) where rod fracture occurred in 34/52 (65%) of patients [31]. Farooq et al followed 88 patients and found that implant complications included 31 rod fractures (35%) [23]. Sankar et al reported that 26 out of 36 patients (72%) had at least 1 major complication of which 18 were rod breakages (69%) [30]. Another study found 10 out of 16 patients (63%) experienced rod breakages of which 70% had multiple rod breakages [32]. Watanabe et al reported 119 complications in 50 out of 88 patients (57%) with 17 rod breakages [33]. Prior studies involving larger sample sizes (e.g., registry studies with several hundred patients) typically reported lower fracture rates. For example, Yang et al reported 86 rod fractures in 49 out of 327 patients (15%) with 16/49 patients (33%) having repeat fractures [34]. Rod fracture is an important focal point because it can be linked to pre-mature mechanical failure with direct

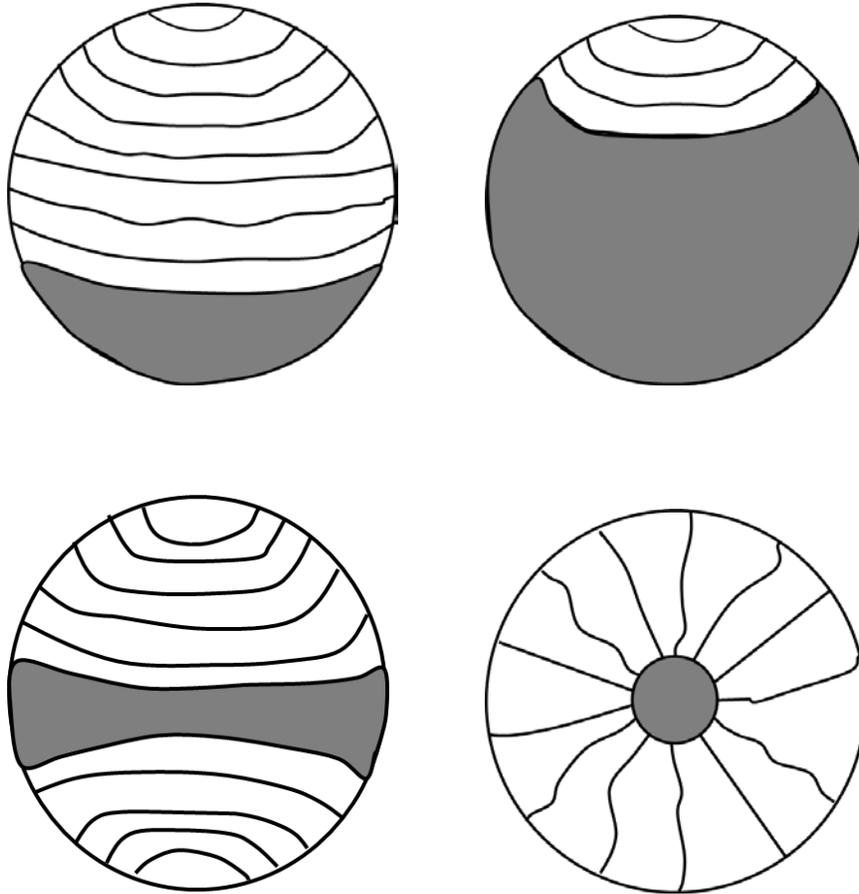
Figure 4: Examples of the surface topography of fractured components (cross sectional view) used to determine the failure mechanism. Note: pictorial representations only. Top left- bending under low nominal stress. Top right- bending under high nominal stress. Bottom left- reverse bending under low nominal stress. Bottom right- torsion under high or low nominal stress.

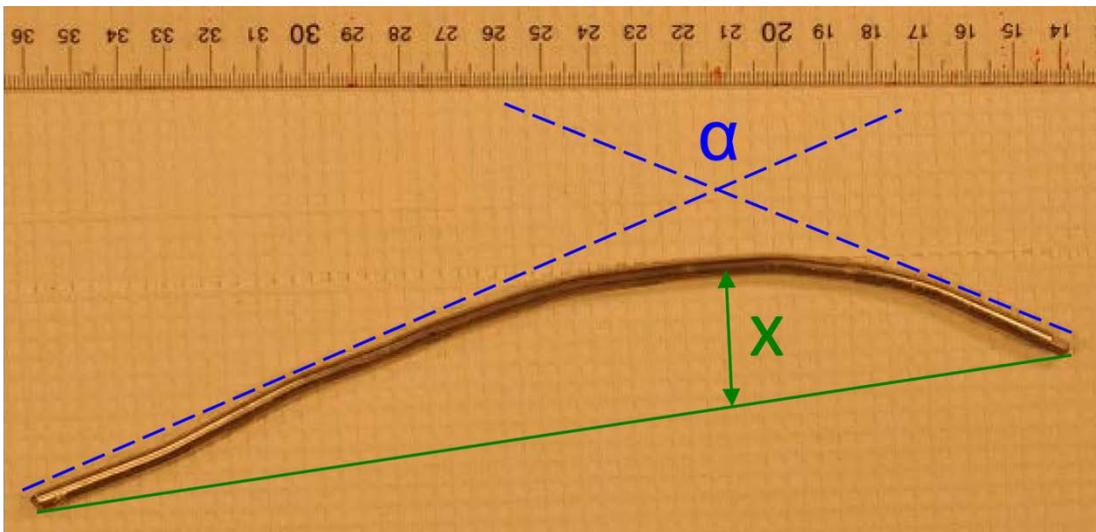
Figure 5: Rod Contouring Measurements. The rod sagittal angle (α) is the angle of intersection of the tangents to the outer edge of the rod (blue dashed lines) minus 180 degrees (example: 160 degree measurement is reported as 20 degree rod sagittal angle). Maximum deflection (x) is the distance of the line between the inner arc of the rod at α and the line connecting the ends of the rod (green solid lines). The background of each photograph was taken with a ruler and the scale was set in ImageJ prior to taking measurements.

All retrievals were analyzed per ASTM F561 *Standard Practice for Retrieval and Analysis of Medical Devices, and Associated Tissues and Fluid* [60] (Appendix 1). Non-destructive analyses included photographic documentation, dimensional analyses, and image analyses. Energy dispersive X-ray spectroscopy (JEOL USA JSM-6390LV, Peabody, MA) was utilized to reveal the material composition of implant components. Retrieved components were subjected to low magnification imaging using a digital optical microscope (Hirox-USA KH-7700, Hackensack, NJ) to identify areas of mechanical fracture, damage, and/or corrosion. Rod contouring (rod sagittal angle and maximum deflection) was measured using ImageJ software (National Institutes of Health, Bethesda, MD) (Figure 5) [61], and statistical analyses

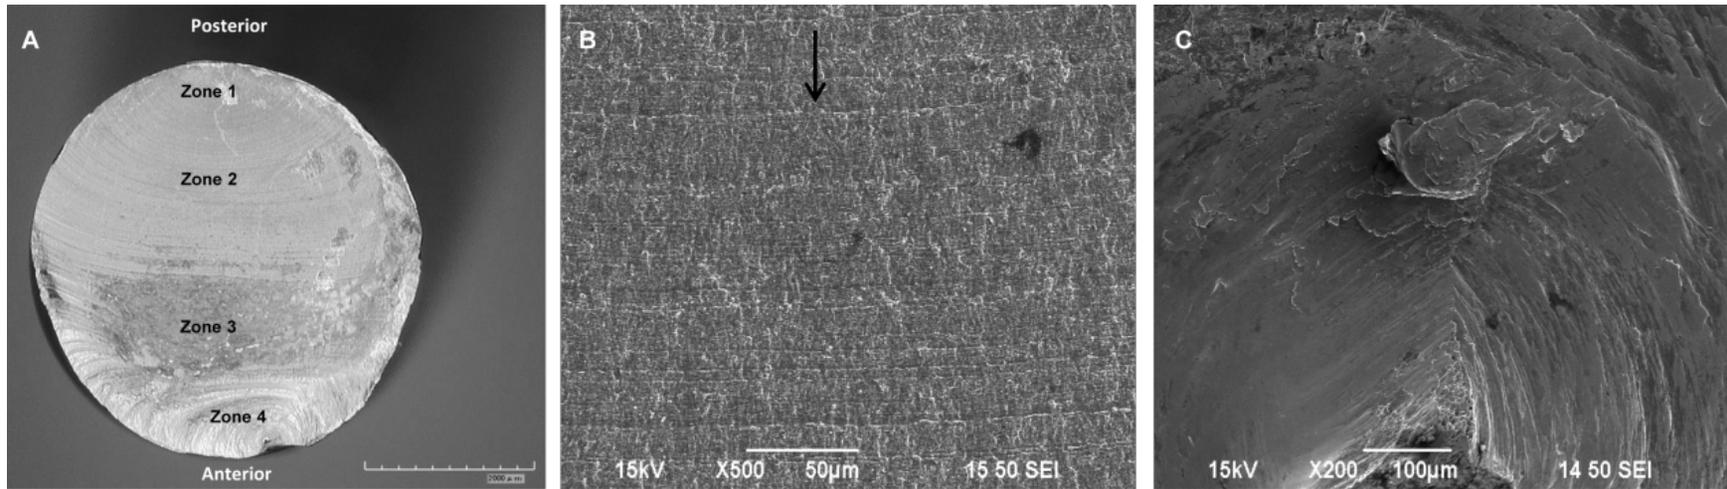
Figure 6: Failure Analysis of Rod Fracture Surfaces. a) Example of a fracture surface under a digital optical microscope (40x). The fractographic features determine each zone: Zone 1- the crack initiation site is located where the beachmarks (concentric semicircles) end; Zones 2 and 3- the fatigue propagation areas show signs of beachmarks and fatigue striations; and Zone 4- the final rupture area has a ductile, shear appearance. The posterior and anterior sides of the rod were identified. a) SEM image (500x) of Zones 2/3- fatigue propagation area. The arrow points to a fatigue striation in the direction of propagation. c) SEM image (200x) of Zone 4- final rupture area.

were performed on a per-rod basis. Components that exhibited mechanical fracture were subjected to high magnification imaging using a scanning electron microscope (SEM, JEOL USA JSM-6390LV). A failure analysis was conducted by examining the topography of the fracture surface to identify the crack initiation site (zone 1), crack propagation area (zones 2 and 3), and final rupture area (zone 4) as shown in Figure 6. The failure analysis involved identifying fractographic features (e.g., fatigue striations), which were then correlated with published failure mechanisms [37]. Both fracture surfaces of the rod were analyzed, when possible, to confirm the failure mechanism, especially when features were not visible due to burnishing. For rods that exhibited fatigue fracture, ImageJ was used to calculate the percent of the fracture surface that was consistent with fatigue propagation (zones 1-3).

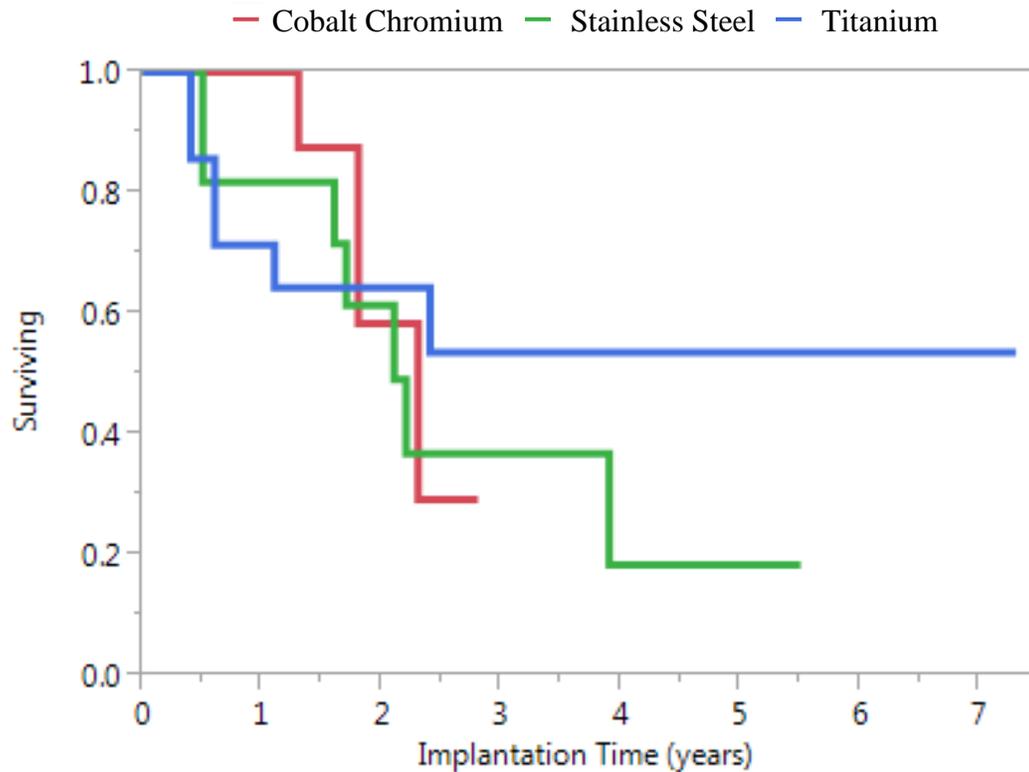
Figure 7: Survival Curve of Rod Material. Both the failed and intact groups were comprised of constructs of varying rod materials, but no significant difference was found in material versus implantation time (Cobalt Chromium- red line, Stainless Steel- green line, Titanium- blue line).

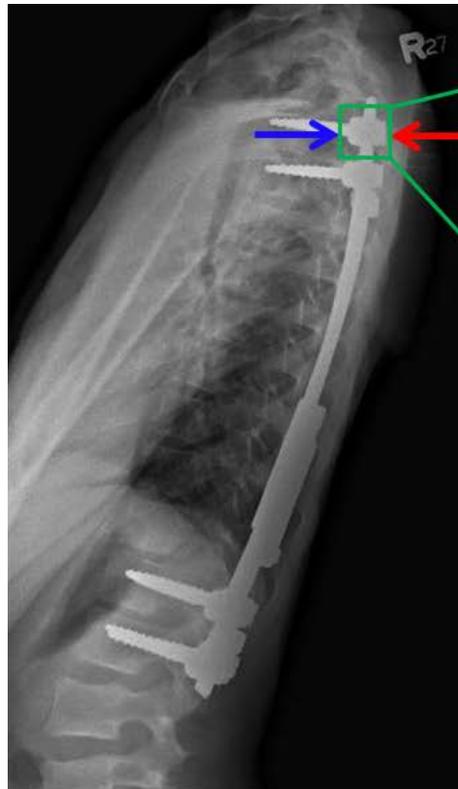
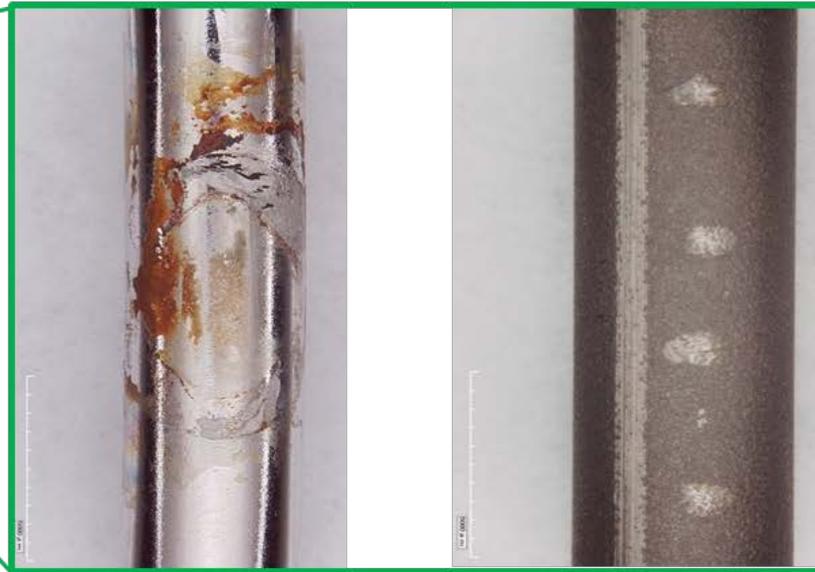
Lateral view on X-ray of growing rod construct

Anterior side of rod that interfaced with the screw saddle

Posterior side of rod (180 degrees from anterior side) that interfaced with the set screws

Figure 8: Determination of the orientation of retrieved rods. The anterior side (blue arrow) of the rod was determined by the presence of concentric oval shapes where the rod interfaced with the saddle of a polyaxial pedicle screw. 180 degrees from the anterior side was the posterior side of the rod. The posterior side (red arrow) of the rod was determined by the presence of small oblong shapes that come in pairs where the rod interfaced with set screws used to lock the rod to the screw housing.

experiences tension (also see Figure 8) [77]. Mechanics of materials principles were explored to help explain this finding as depicted in Figure 13. In this example, the spinal rod is analogous to a beam in bending. The stress of a beam in bending varies linearly from zero at the center (neutral axis) to maximum at the outer fiber of the beam. In other words, the beam in bending causes tensile stress on one side and compressive stress on the other side, starting from the neutral axis. Therefore, during flexion of the growing rod construct, the posterior side of the rod experienced tension and the anterior side experienced compression [81]. Based on principles of fracture mechanics, crack growth typically occurs under tensile stresses that pull the tip of crack open; during multiple fatigue cycles, this leads to final fracture. The proposed bench model allowed for the correct rod orientation so that the interconnecting components (screw or connector) interfaced with the posterior side of the rod that is experiencing tension, just as the rod would *in vivo*.

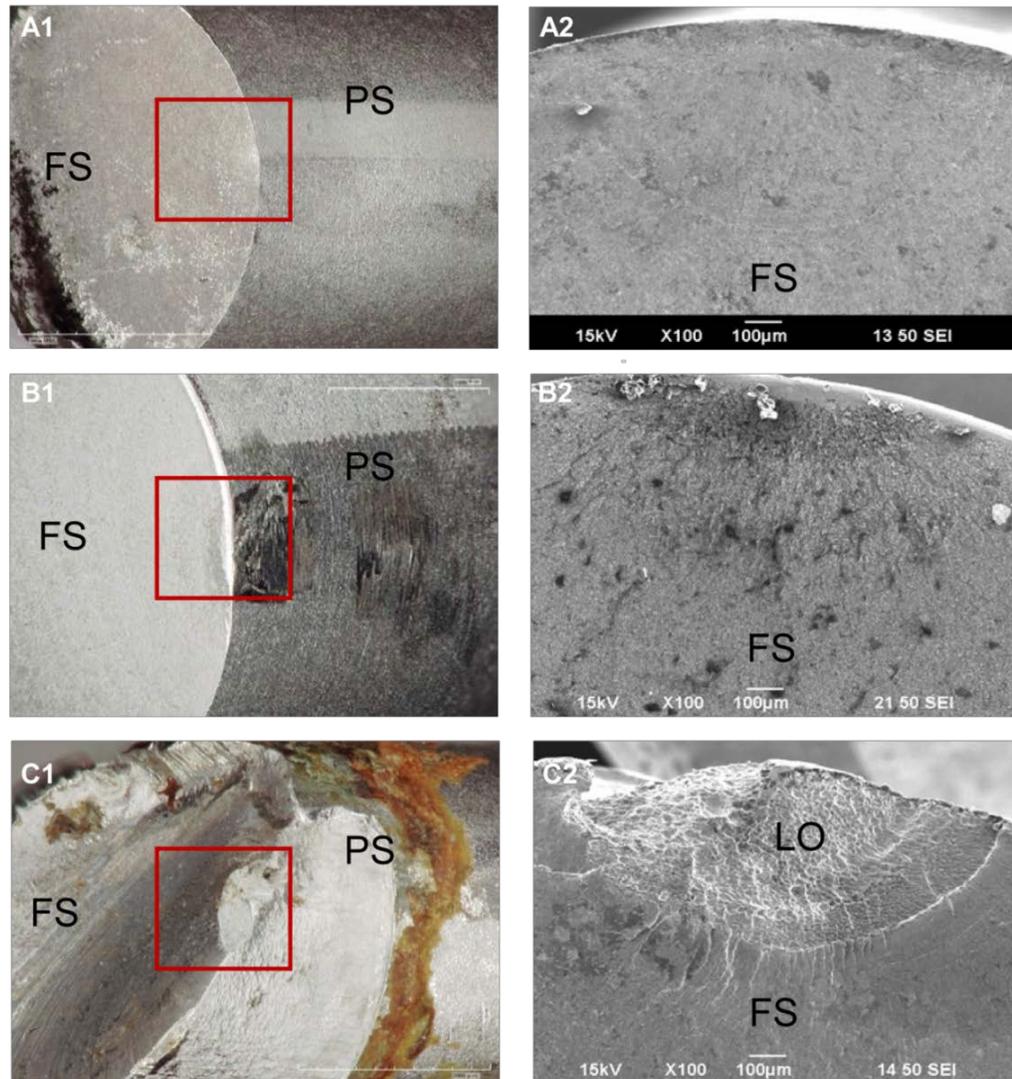
Figure 9: Failure Mechanism and Sub-Categories. a1 & a2) pure bending fatigue, b1 & b2) pure bending fatigue with stress concentration, and c1 & c2) pure bending fatigue with stress concentration and local overload (dimpled region denoted as “LO”). Images on left are an angled view of fracture surfaces (FS) with the crack initiation site on the posterior side (PS) of the rod in a red box under a digital optical microscope (60x) and images on right are SEM images (100x) of fracture surfaces (FS) at the crack initiation site (zone 1).

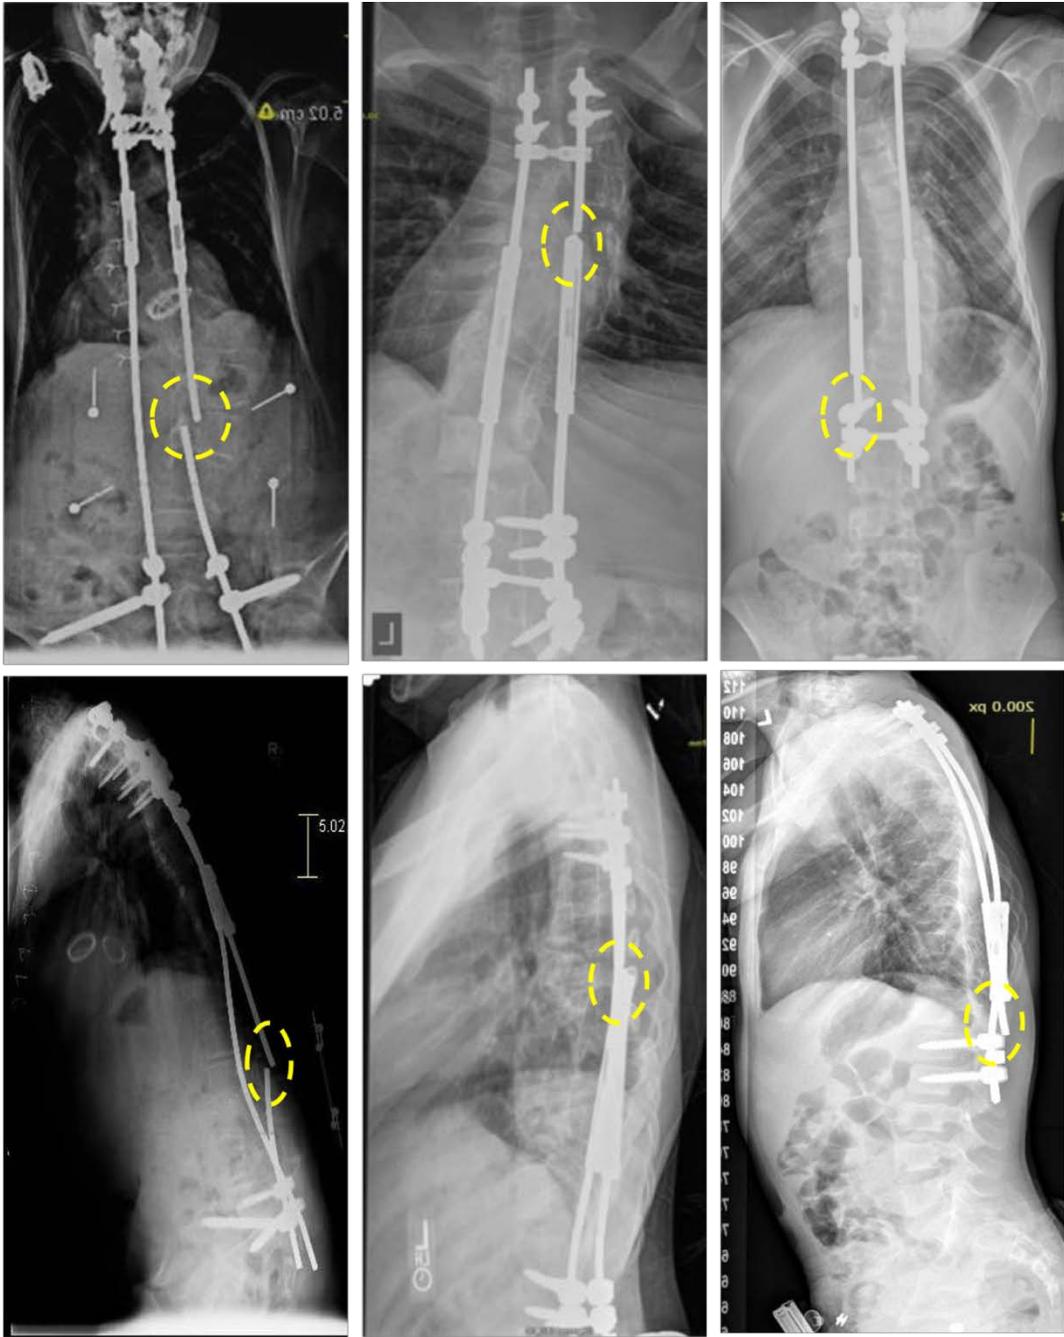
Figure 10: Representative Radiographs from Each Failure Location Category. Left to Right: Mid-Construct, Adjacent to Tandem Connector, and Adjacent to Distal Anchor Foundation. A-P Views on top row and Lateral Views on bottom row. Mid-Construct failures occurred in the middle of the construct with no interconnecting component in the vicinity of the rod fracture. Rod fractures adjacent to the tandem connector occurred just above and/or below the edge of the tandem connector. Rod fractures adjacent to the distal anchor foundation occurred just above the pedicle screws. All rod fractures are circled.

Of the 18 failed constructs, six constructs had fractured rod(s) above the axial connector, ten constructs had fractured rod(s) below the axial connector, one construct had one rod that fractured above the axial connector and a second rod that fractured below the axial connector, and one was unknown due to missing X-rays. Fracture occurred on the rod anchored to the concave side of the major spinal curve in 15/18 (83%) constructs (Figure 11). For patients that had two fractured rods within the same construct, the rod anchored to the concave side of the major curve failed first, which was elucidated by its smaller final rupture area.

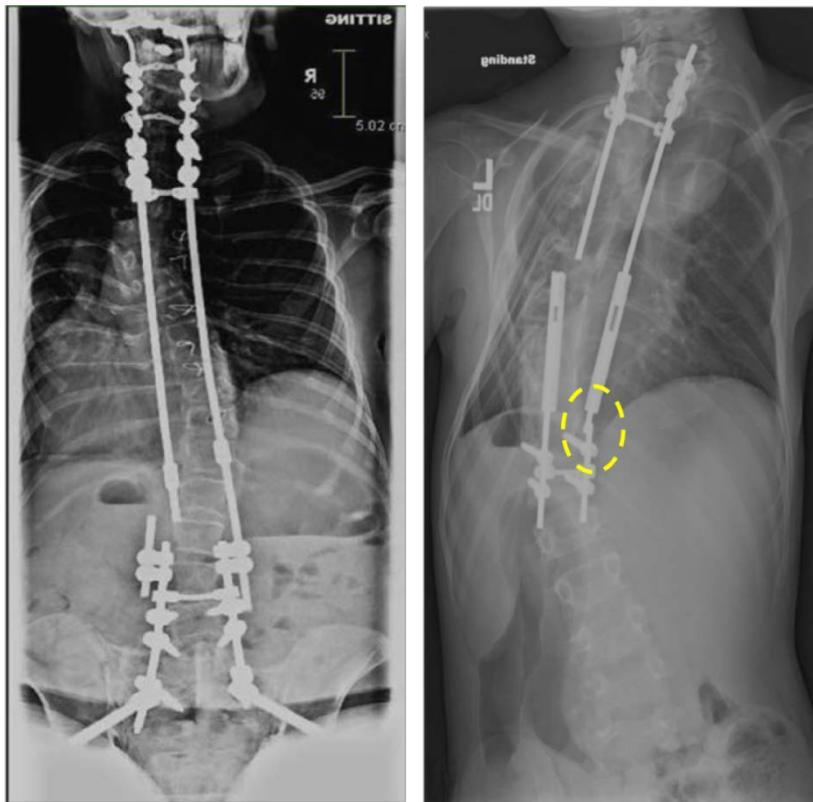
Figure 11: Radiographs Showing Fractures on the Rods Anchored to the Concave Side of the Major Spinal Curve. The circle shows the rod that fractured first in a construct with two fractured rods. The rod with a smaller final rupture area (zone 4) was determined to have failed first compared to the rod with a larger final rupture area that failed second.

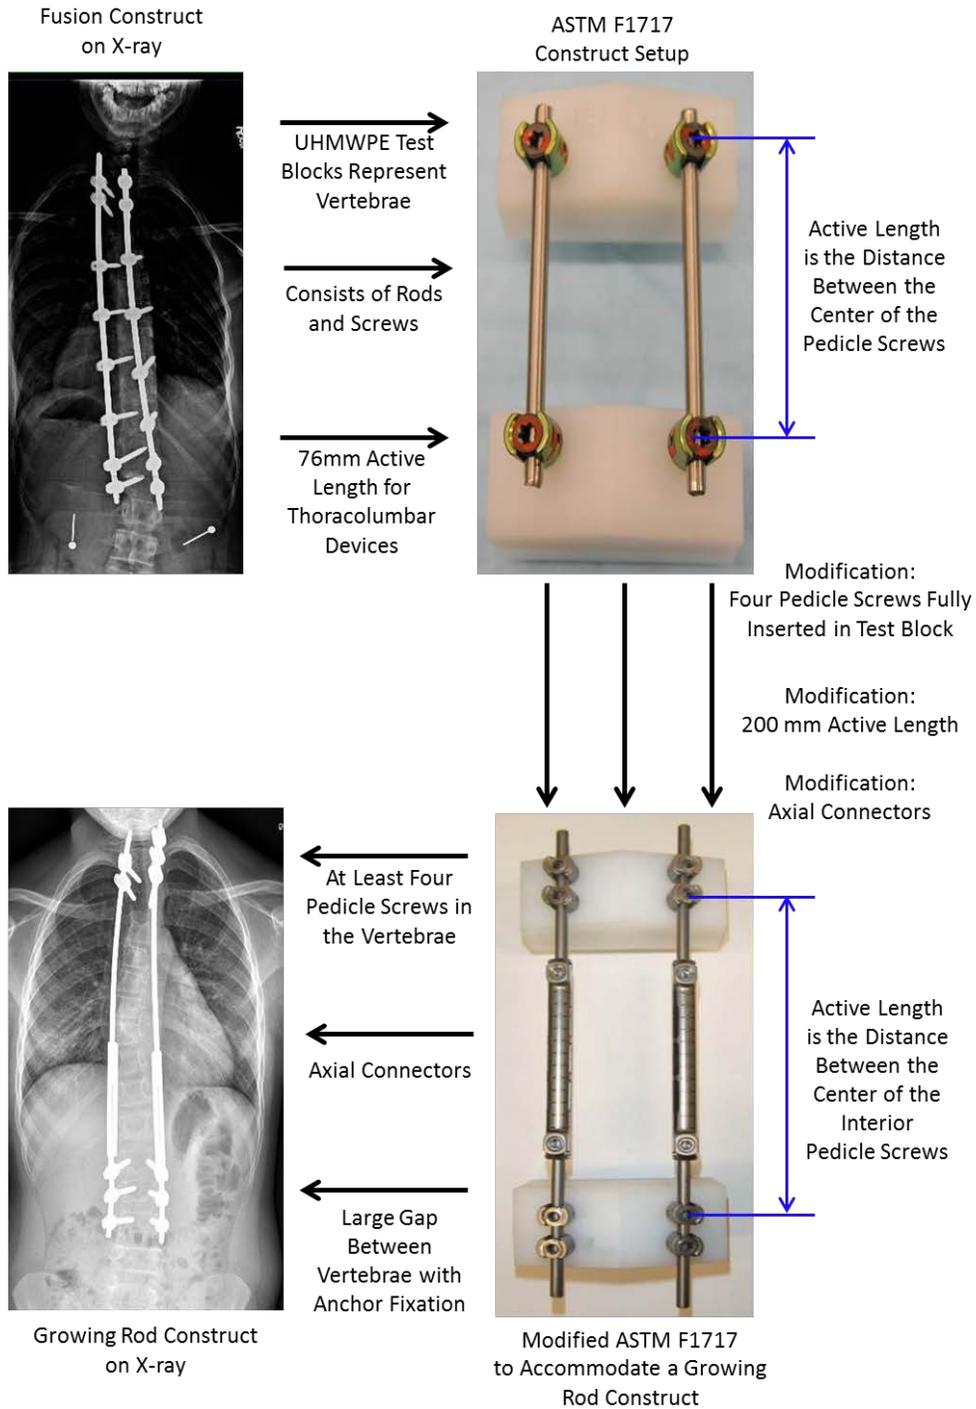
Figure 12: Progression from the ASTM 1717 test setup intended to assess fusion constructs to a test setup that was modified to accommodate a pediatric growing rod construct. The test blocks used in the modified setup can accommodate four pedicle screws at each end that are fully inserted into the block. The setup was modified with either tandem (pictured) or side-by-side connectors. The modified setup has an active length of at least 200 mm. Crosslinks may also be added to the construct configuration (not pictured).

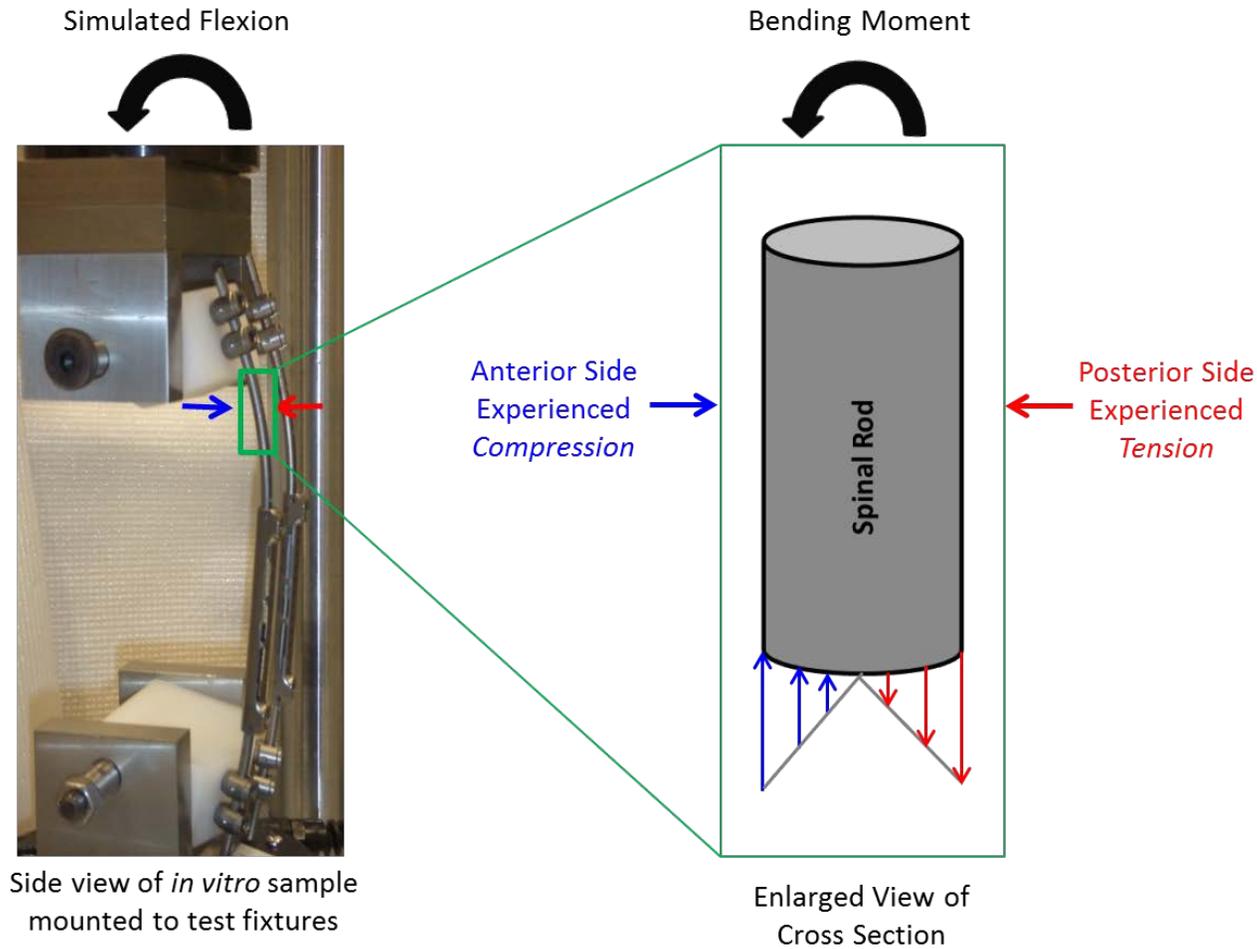
Figure 13: Stress experienced by a spinal rod under bending. The posterior (red arrows) and anterior sides (blue arrows) of a spinal rod experience different directions of stress during flexion motion. Note that the spinal rods were subjected to compression bending (via an offset axial load) in order to simulate spine flexion on the bench (black arrows). All rod fractures initiated on the posterior side of the rod experienced tensile stress; this is also the side of the rod where stress concentrations caused by interconnecting components (e.g., set screws) are located.

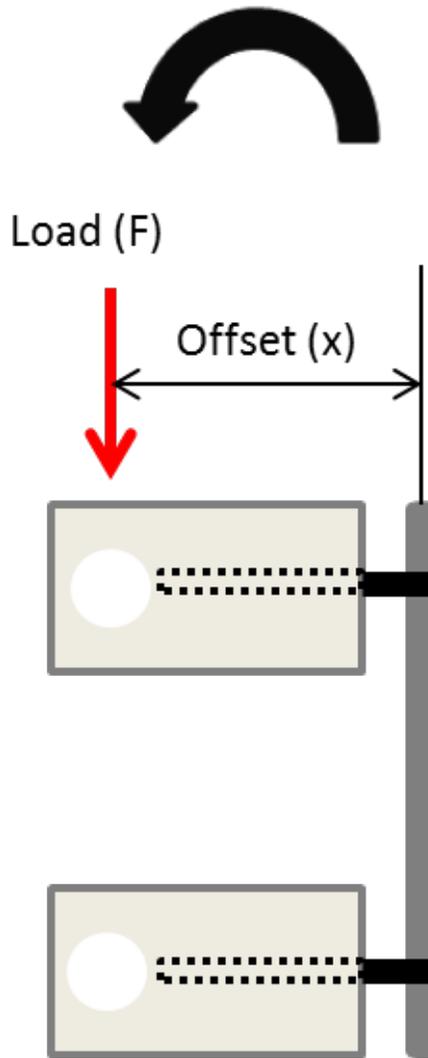
$$\text{Bending Moment} = F \cdot x$$

Figure 14: Side view of test setup showing a bending moment on the rod. The axial compressive load (F) is applied to the test blocks (beige rectangles) at an offset distance (x) away from the spinal rod (grey cylinder). Therefore, the rod is subjected to a bending moment ($F \cdot x$). The pedicle screws are screwed into the test blocks (dashed black boxes) with the screw housing (solid black rectangles) outside of the blocks connected to the spinal rod. Bolts are inserted through the white circles to attach the test blocks to the fixturing on the mechanical testing machine.

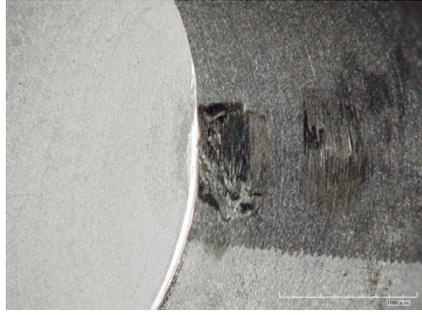
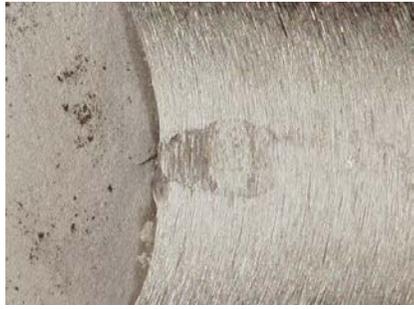
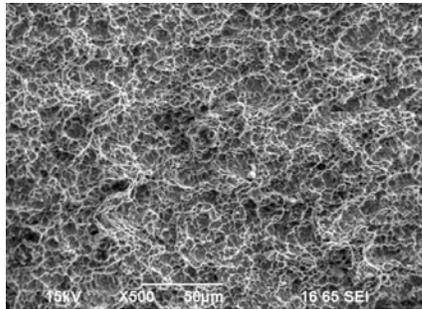
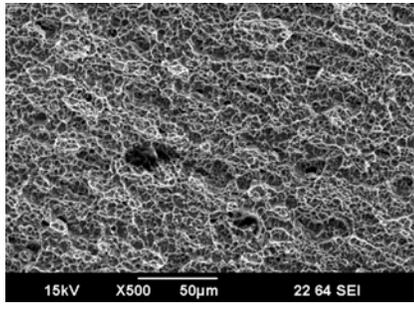
Retrieval	<i>in-vitro</i> Sample
<p>Angled view of the crack initiation site</p> <p>(showing an indentation caused by a set screw)</p>

<p>Fatigue propagation area</p>

Table 6: Comparison of a titanium alloy retrieval to a titanium alloy *in vitro* sample to demonstrate validation of the mechanical bench model. Both spinal rods show crack initiation at a stress concentration and surface topography consistent with bending fatigue.

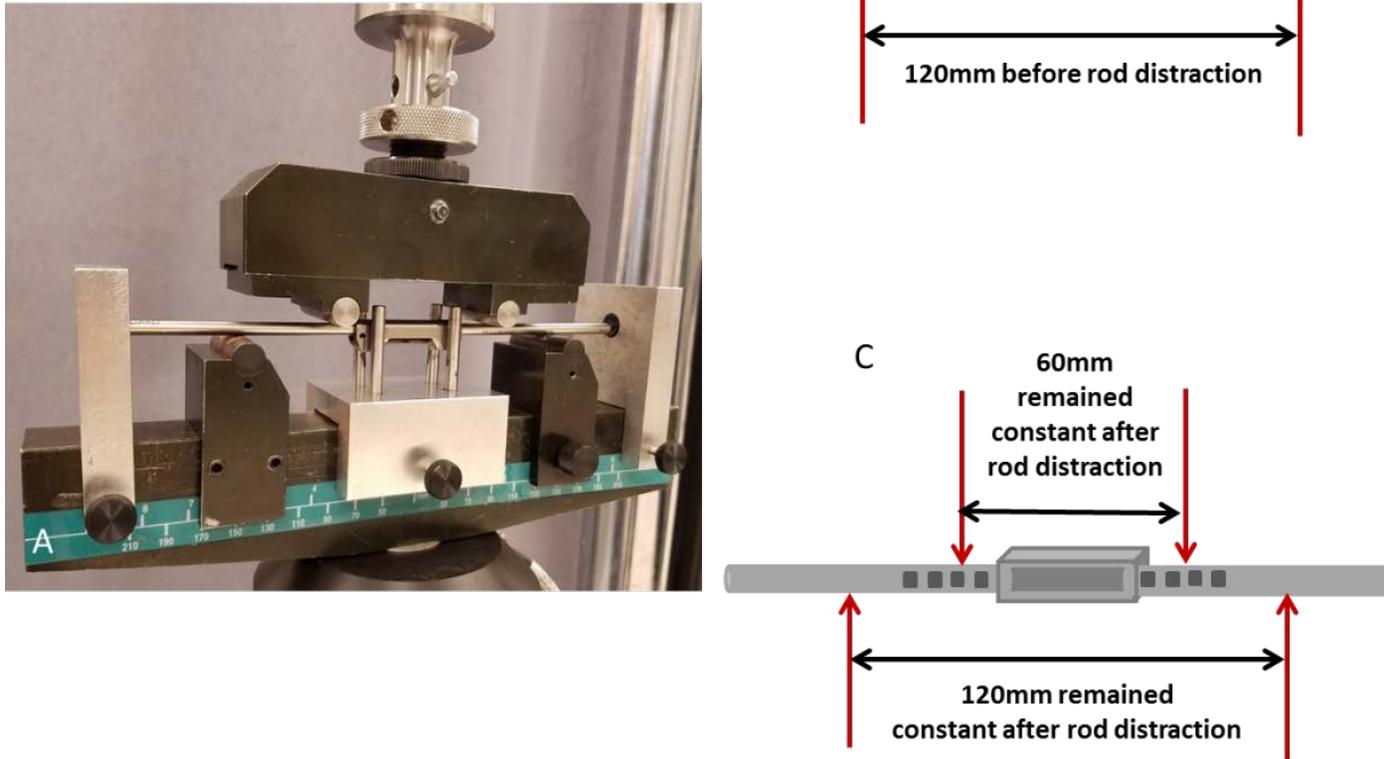
Figure 15: A secondary mechanical bench model. A) A 4-point bending test was used with custom fixtures to prevent rod rotation and translation. B) The specimen was subjected to a superior span of 60mm and an inferior span of 120mm. C) After rod distraction, prior indentations from the tandem connector set screws were exposed but the spans remained constant.

Both static and dynamic bending tests were performed using this model on a calibrated mechanical load frame and load cell. Static bending tests were performed at a displacement-controlled rate of 2mm/min to gather mechanical properties. It was determined that 95% of the yield load was necessary to induce rod fracture during dynamic testing. Therefore, a load-controlled rate fatigue test at 5Hz between 570N to 57N compressive loads ($R = 0.1$) was performed per a sinusoidal waveform until rod fracture occurred. The setup involved the use of stainless steel rollers that spanned 120mm on the inferior end and 60mm on the superior end (Figure 15B-C). Custom fixture accessories such as four stainless steel dowels and two end plates were added to prevent rod rotation and translation (Figure 15A). A shorter tandem connector (e.g., 40 mm) or side-by-side connector could be used in this model. The axial connector faced downwards so that the posterior side of the rod experiences tension.

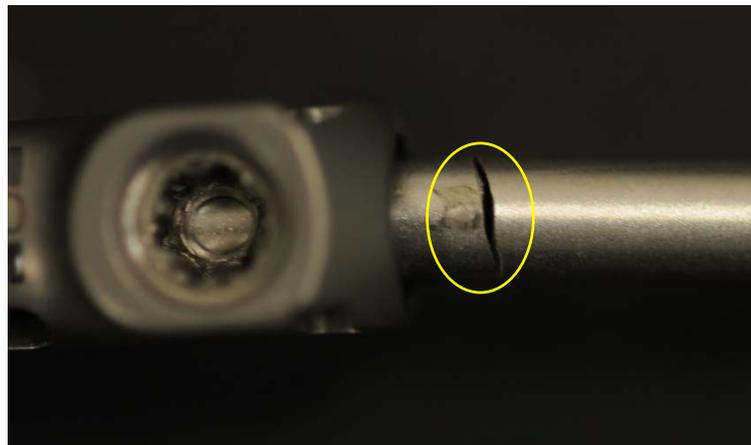
Figure 16: Rod fracture induced through a 4-point bending test. The fracture initiated on the posterior side of the rod, adjacent to a stress concentration (yellow circle) caused by an indentation made from a set screw, during a dynamic 4-point bending test.

fracture in all cases before 410,000 cycles, and the rods fractured adjacent to a prior indentation created by the tandem connectors' set screws. In four of six specimens in the experimental group, rod fractures occurred at the exposed indentation created initially, i.e., furthest from the tandem connector. The remaining two specimens experienced rod fracture closer to the tandem connector at the indentation created during subsequent distractions. Therefore, it was also concluded that the flexural bending test was an acceptable bench model to replicate bending fatigue failures of the rod.

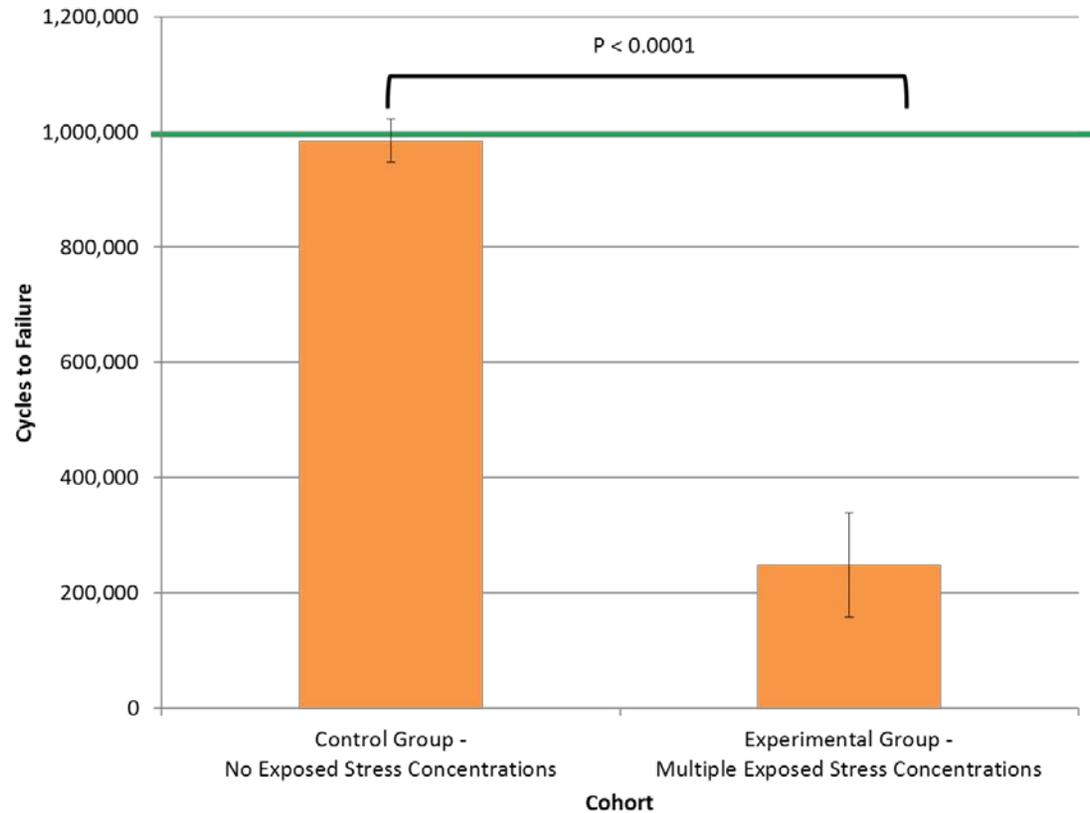
Figure 17: Results from dynamic 4-point bending testing. This small study was designed to examine the effects of exposed indentations on the rod and did not include a change in the length of the rod. The green line delineates runout at 1 million cycles. The control group showed significantly longer fatigue performance than the experimental group. Therefore, exposed stress concentrations on the posterior side of the rod experiencing tension significantly reduces the fatigue performance of the rod.

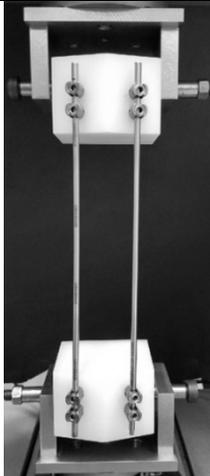
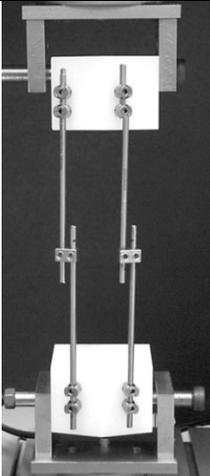
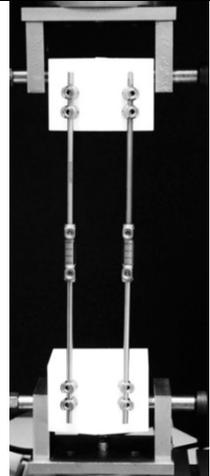
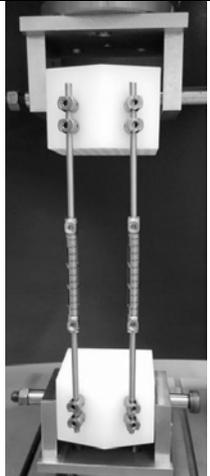
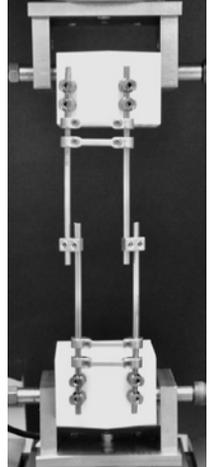
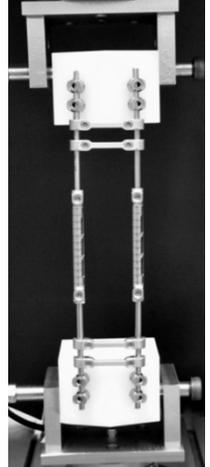
No Connectors- Rods Only	Side-by-Side Connectors	40 mm Tandem Connectors	80 mm Tandem Connectors
Construct configurations <u>without</u> crosslinks

Construct configurations <u>with</u> crosslinks	n/a

Table 7: Photographs of the six construct configurations. The top row displays the constructs without crosslinks: No Connectors- Rods Only, Side-by-Side Connectors, 40 mm Tandem Connectors, and 80 mm Tandem Connectors. The bottom row displays the constructs with crosslinks: Side-by-Side Connectors Plus 4 Crosslinks, and 80 mm Tandem Connectors Plus 4 Crosslinks. All construct configurations have an active length of 200mm and the axial connectors are placed in the center of the construct (note: constructs with side-by-side connectors have offset pedicle screws in the superior test blocks). Fixtures include steel U-frames with pins attached to UHMWPE test blocks with the load cell on the bottom

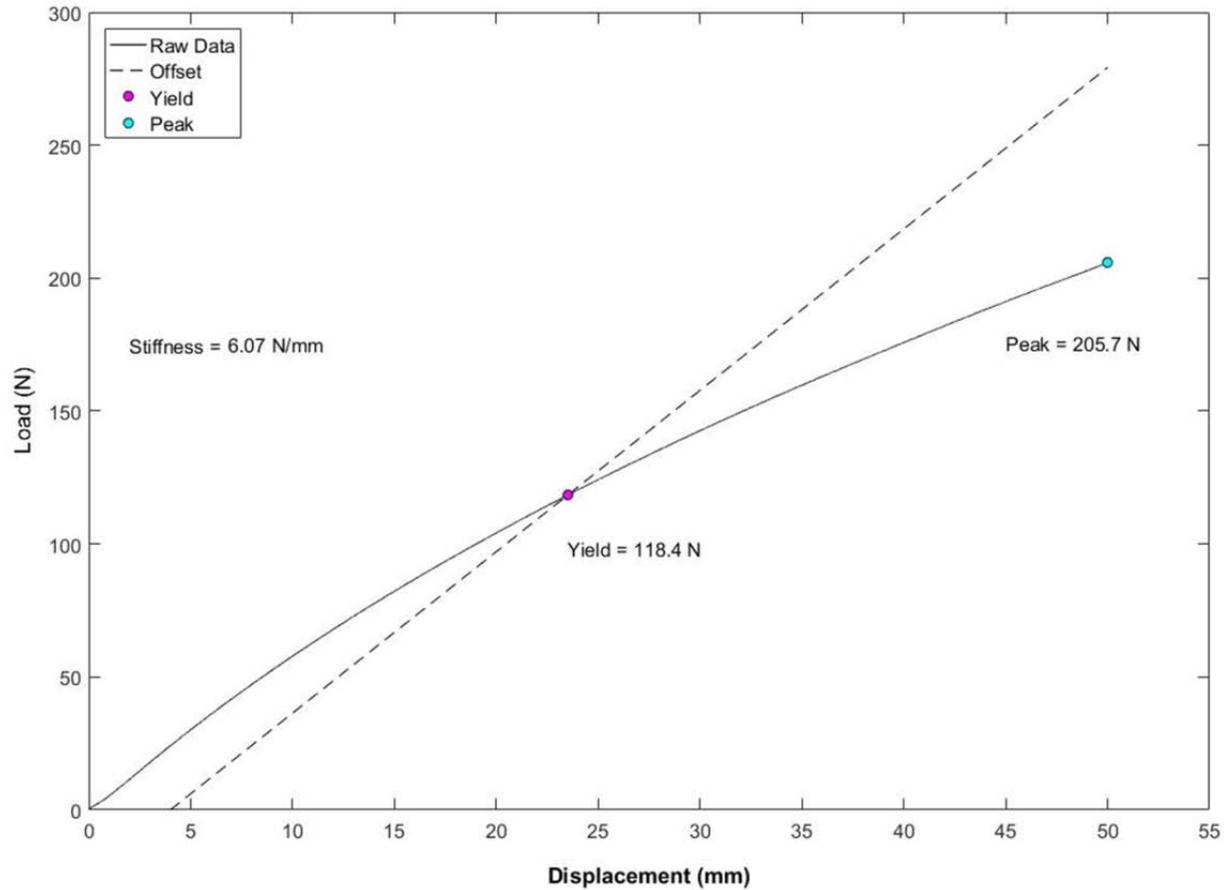
Figure 18: Sample load-displacement curve derived from MATLAB software for static compression bending tests. Stiffness was calculated using the 2% offset method. Yield load (pink circle) was the point where the offset (dashed line) intersected the curve (solid line). Peak load (blue circle) was based on the maximum load achieved at 50 mm total displacement.
