Title of Dissertation: FAILURE MECHANISMS OF PEDIATRIC GROWING ROD CONSTRUCTS

Genevieve A-L. Hill, Doctor of Philosophy,
2017

FAILURE MECHANISMS OF PEDIATRIC GROWING ROD CONSTRUCTS

Dissertation submitted to the Faculty of the Graduate School of the
University of Maryland, College Park, in partial fulfillment
of the requirements for the degree of
Doctor of Philosophy
2017

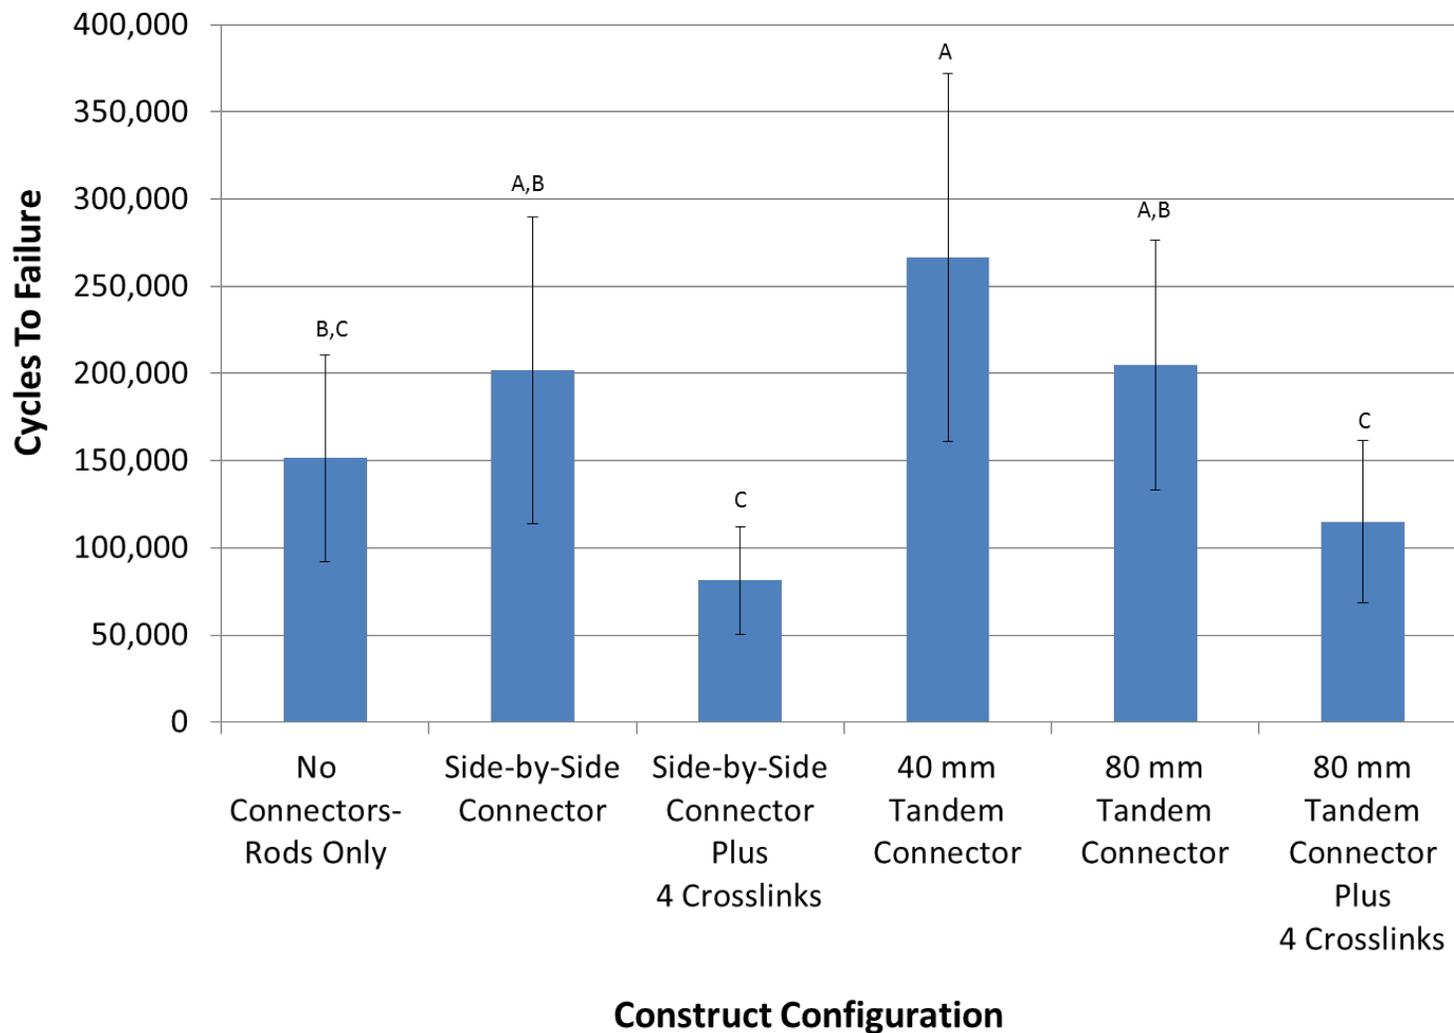
Figure 19: Fatigue performance for each construct configuration was captured through the number of cycles to failure during dynamic testing. All constructs were tested until rod fracture. Groups that do not share a letter are significantly different. Crosslinks significantly decreased the fatigue life of the constructs. Side-by-side and tandem connectors, regardless of length, have similar fatigue lives.

All dynamic constructs failed due to rod fracture, with fractures initiating on the posterior side of the rod. The fatigue results are displayed in Figure 19. The results showed that construct configurations with an axial connector alone (side-by-side, 40 mm tandem, and 80 mm tandem) had similar cycles to failure ($p > 0.07$). Interestingly, the cycles to failure for the construct configuration without connectors (rods only) was significantly different than that of the 40mm tandem connector configuration only ($p = 0.002$). The two construct configurations with crosslinks failed significantly earlier than their corresponding counterparts without crosslinks ($p < 0.015$). All four construct configurations without crosslinks experienced rod fracture adjacent to the pedicle screw while both construct configurations with crosslinks experienced rod fracture adjacent to the crosslink (Figure 20).

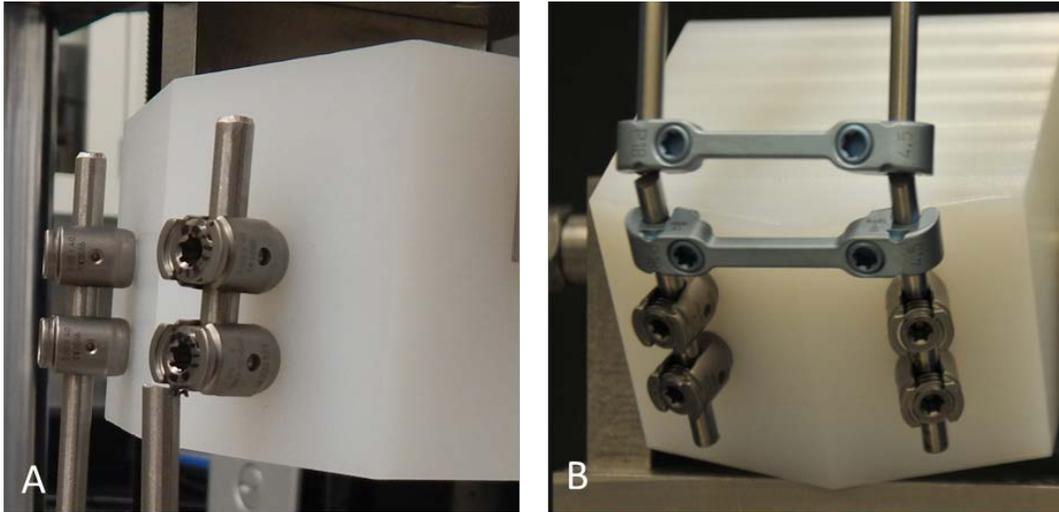
Figure 20: Examples of rod fracture after fatigue testing. The rods fractured adjacent to the pedicle screw (A) in four construct configurations. The remaining two construct configurations had crosslinks, and the location of rod fractures shifted adjacent to the crosslink (B). In all cases, fractures initiated on the posterior side of the rod adjacent to a stress concentration caused by either the pedicle screws or crosslinks.

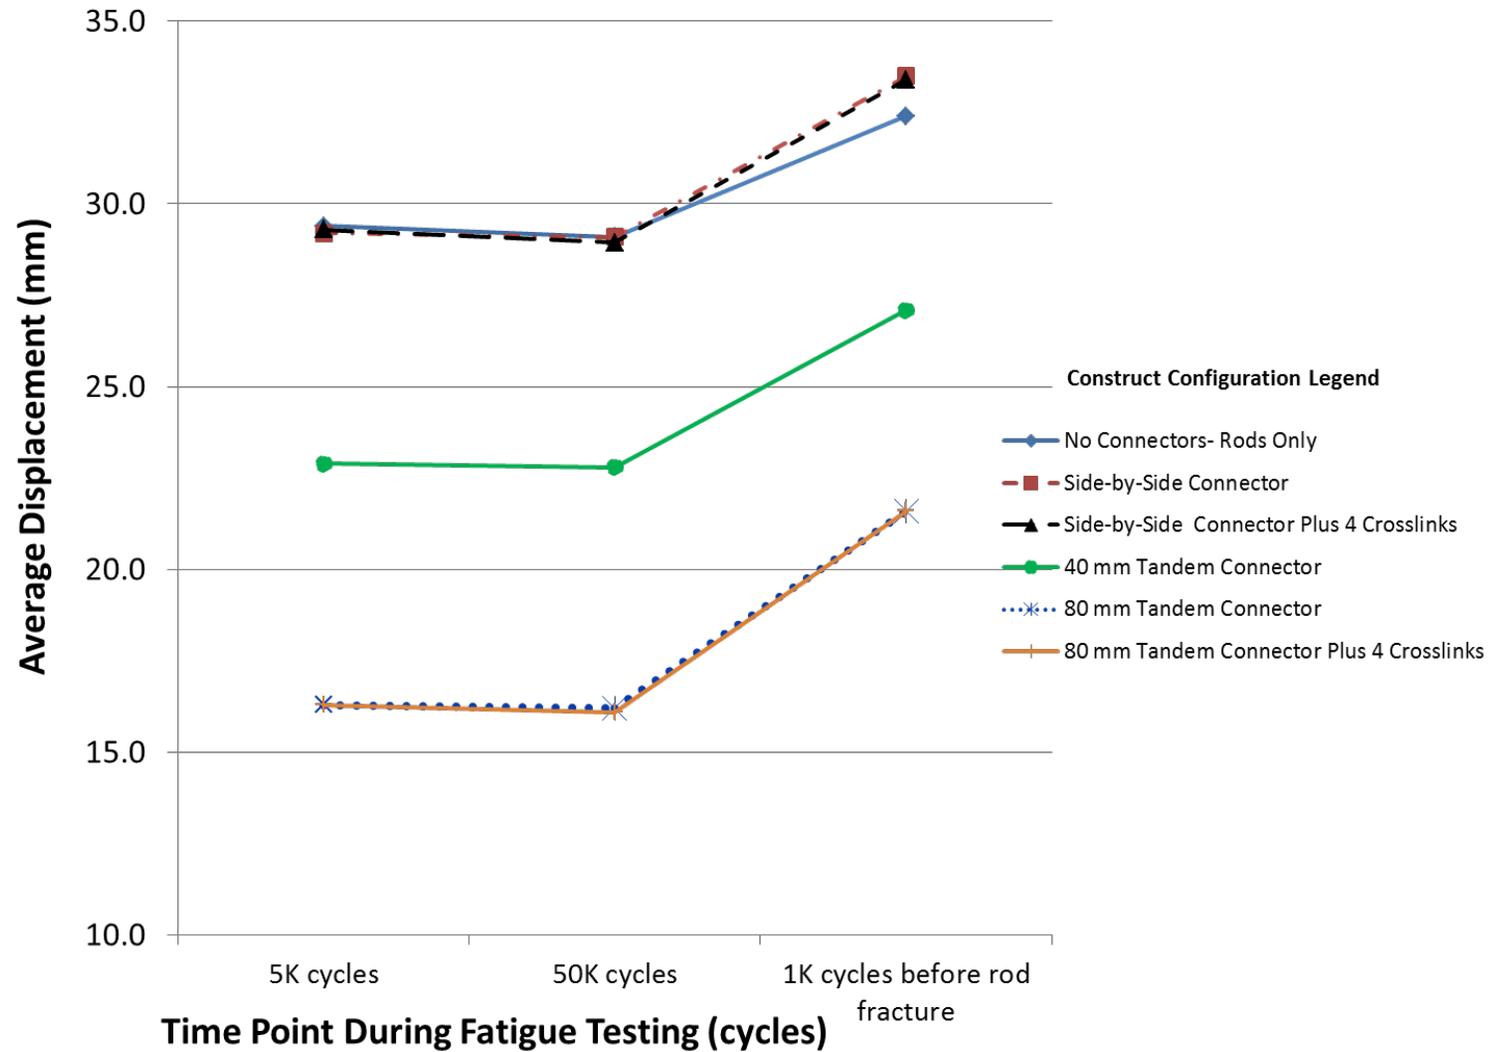
Figure 21: Graph showing displacement over time during fatigue testing. Displacement correlated to the type of axial connector, and the construct configurations with 80 mm tandem connectors (orange plus sign and blue star) allowed for the least amount of displacement. The groups with crosslinks (black triangle and orange plus sign) had similar displacements compared to their corresponding groups without crosslinks (red square and blue star, respectively).

The displacements during fatigue cycling varied based on the axial connector (Figure 21). All three of the construct configurations with tandem connectors (40 or 80 mm) experienced significantly lower displacements ($p < 0.001$) during fatigue testing at all time points as compared to groups that lacked a tandem connector (i.e., no connectors, side-by-side connectors with or without crosslinks). The two constructs with 80 mm tandem connectors exhibited significantly lower displacements than those present in configurations with 40mm tandem connectors ($p < 0.01$) and showed the lowest amount of displacement during fatigue testing overall. In general, the addition of crosslinks to the construct configuration did not alter the fatigue displacement as compared to its counterpart without crosslinks.

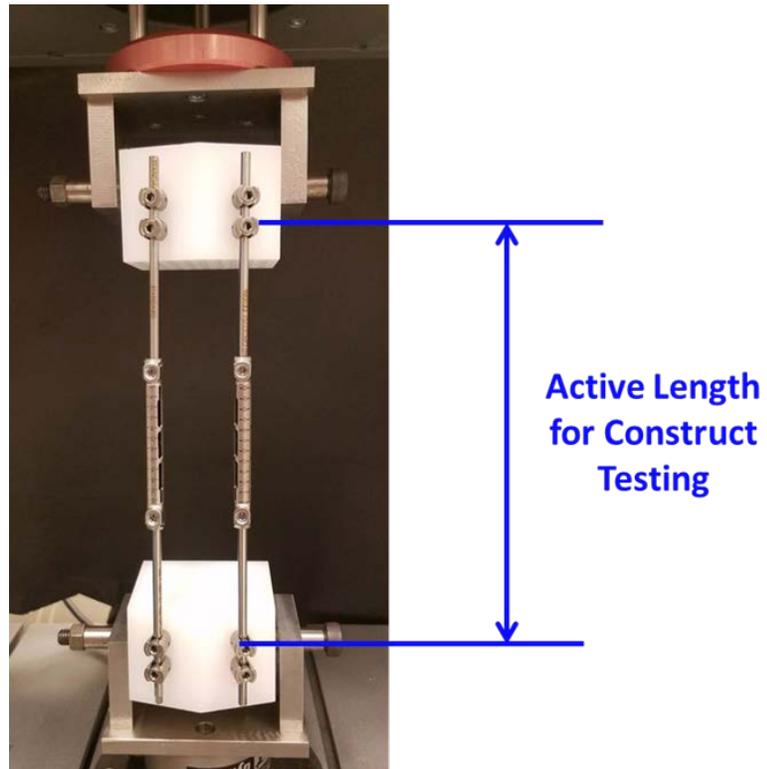
Figure 22: The test setup is based on ASTM F1717, modified to accommodate a pediatric growing rod construct. The active length of the construct was different for the groups described in Phases I-III.

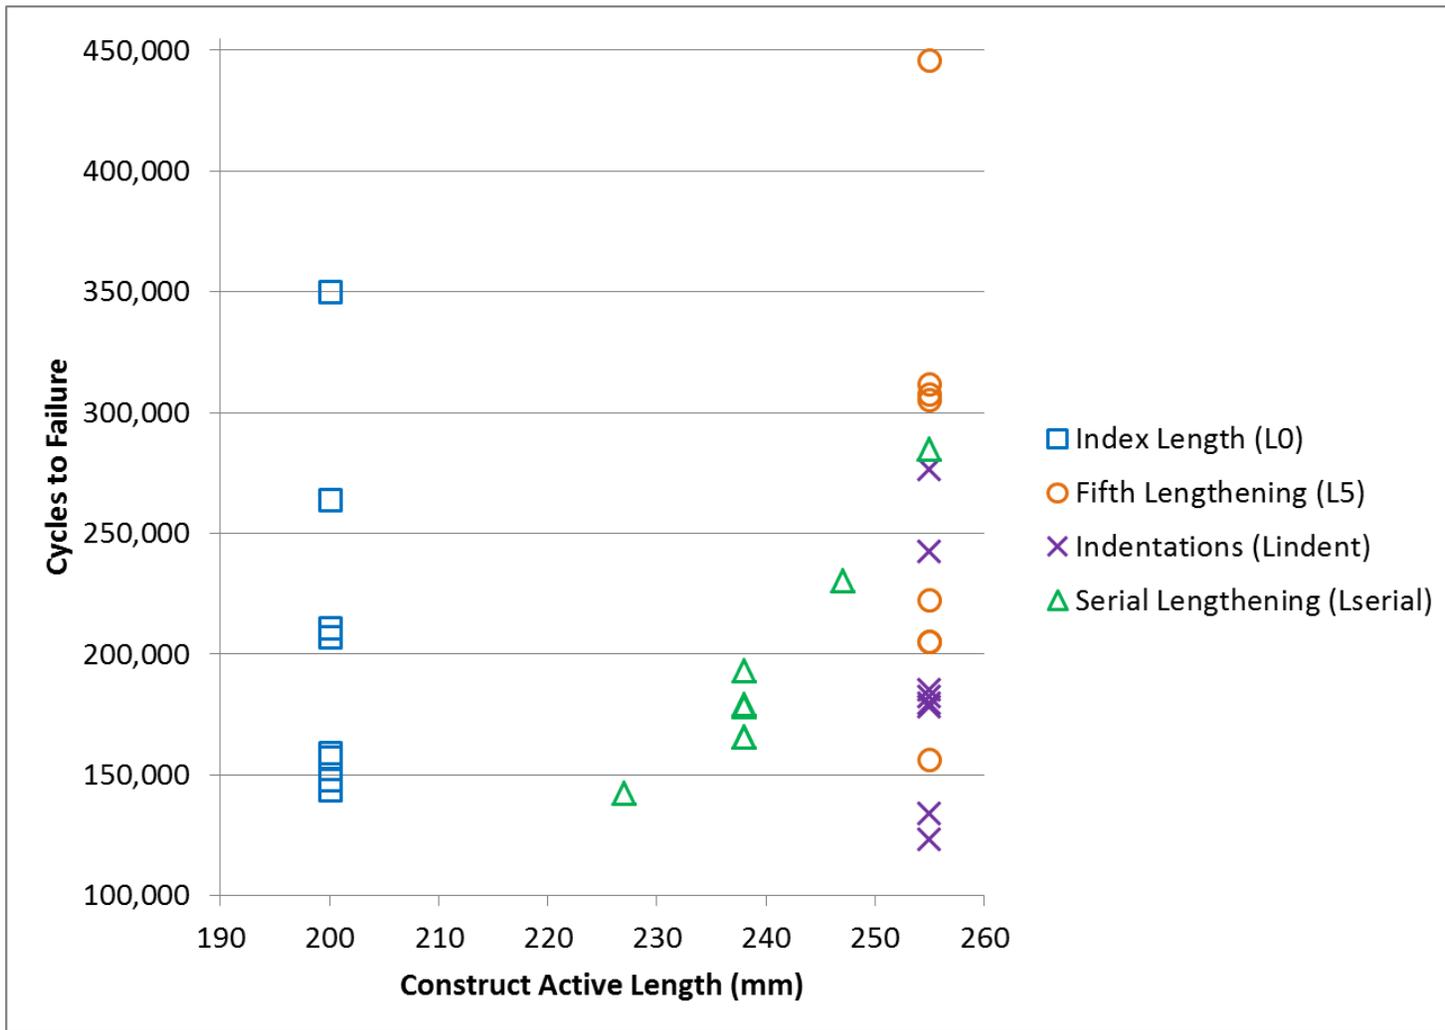
Figure 23: Results from dynamic compression bending. The index length group (blue square) has a 200mm active length based on rod lengths from our prior retrieval study. The fifth lengthening group (orange circle) has a 255mm active length and was included to evaluate lengthening alone without exposing indentations. The indentations group (purple X) has a 255mm active length and was included to evaluate indentations alone without lengthening. The serial lengthening group (green triangle) has an active length that changed every 50,000 cycles where indentations were exposed after each lengthening.

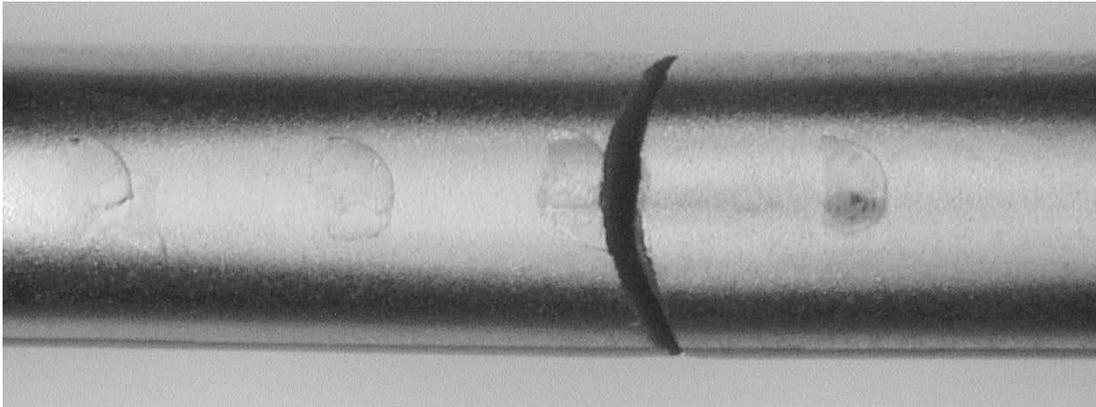
Figure 24: Photographs of an *in vitro* rod sample where the rod is lengthened to expose indentations made by set screws from the tandem connector. Rod fracture occurred in this location in 62.5% of samples in Phase III.

exposed indentation caused by the tandem connectors' set screws in 5/8 samples (Figure 24) or adjacent to a pedicle screw in 3/8 samples.
