Outdoor Education Center

# UNIVERSITY OF MARYLAND

## Arlington Echo Outdoor Education Center

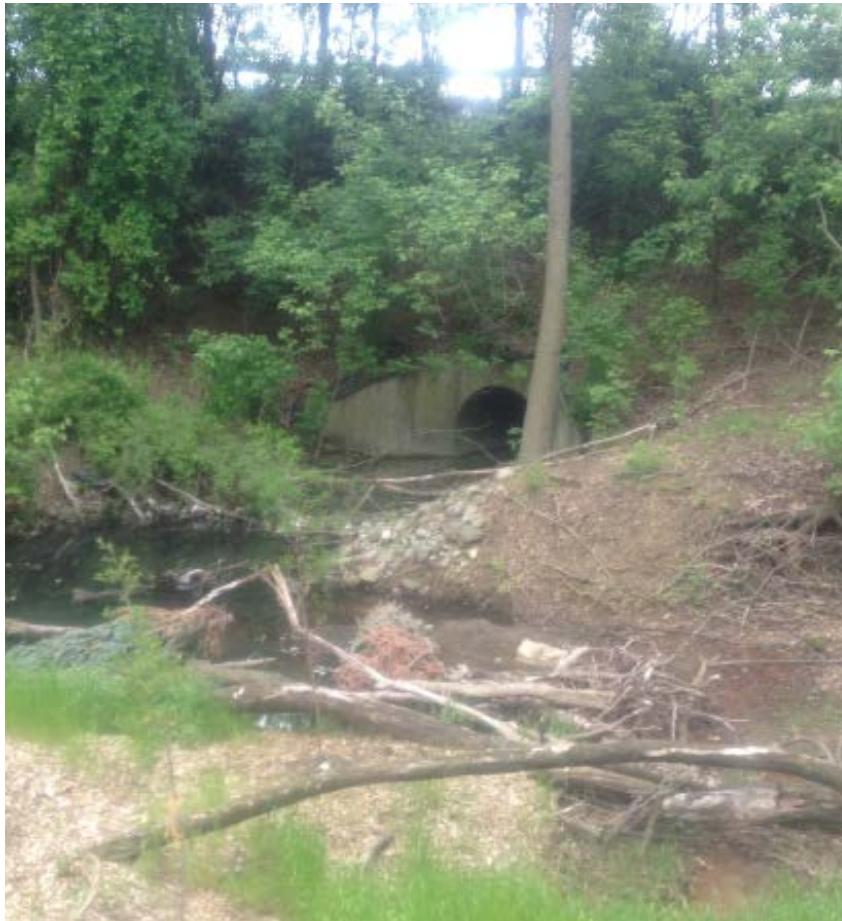
**Figure 3.** Site before restoration <http://ecosystemrestoration.com/arlington-echo/>

In 2009, work began on the site to restore natural habitats to the site. The restorations resulted in two bogs, native gardens, and a natural shoreline. Approximately 6,000 square feet of tidal wetlands and 250 linear feet of shoreline were created. The living shoreline stabilizes 250 linear feet of deteriorating bulkheads.

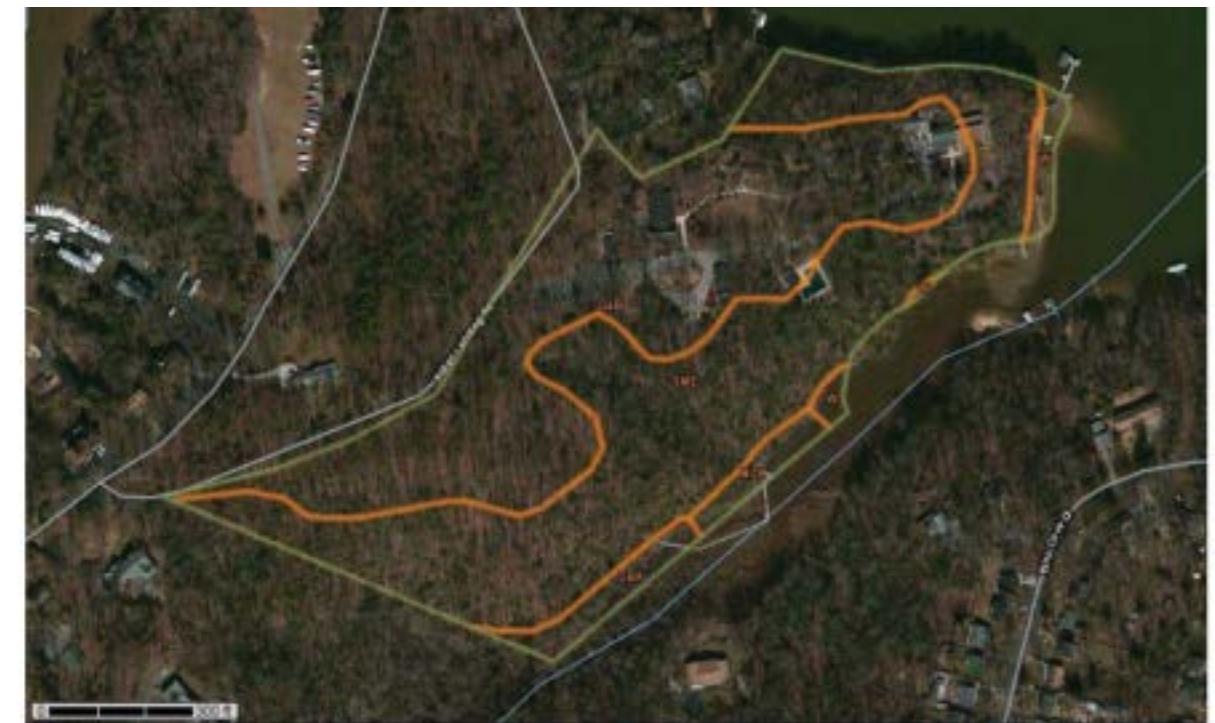
Figure 16. Soil Boundaries

Anne Arundel County, Maryland (MD003)			
Map Unit Symbol	Map Unit Name	Acres in AOI	Percent of AOI
GaB	Galestown loamy sand, 0 to 5 percent slopes	10.4	44.8%
MZA	Mispillion and Transquaking soils, 0 to 1 percent slopes, tidally flooded	0.5	2.0%
SME	Sassafras and Croom soils, 15 to 25 percent slopes	11.2	48.1%
W	Water	0.5	2.2%
ZBA	Zekiah and Issue soils, 0 to 2 percent slopes, frequently flooded	0.7	2.8%
Totals for Area of Interest		23.2	100.0%

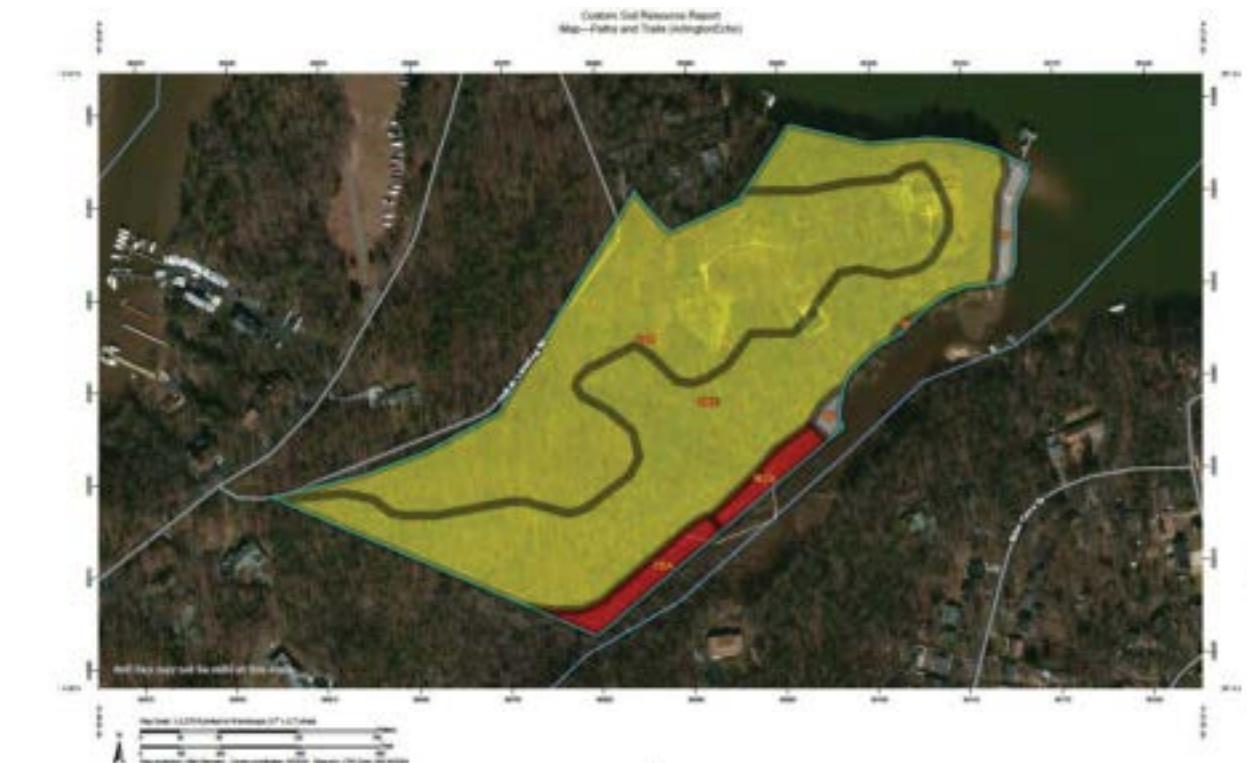
Figure 17. Trail Compatable Soils in Yellow

- Very limited for paths and trails
- Has a .37 K factor for Erosion
- Frequently flooded
- Hydrologic rating B/D
- High seedling mortality rate

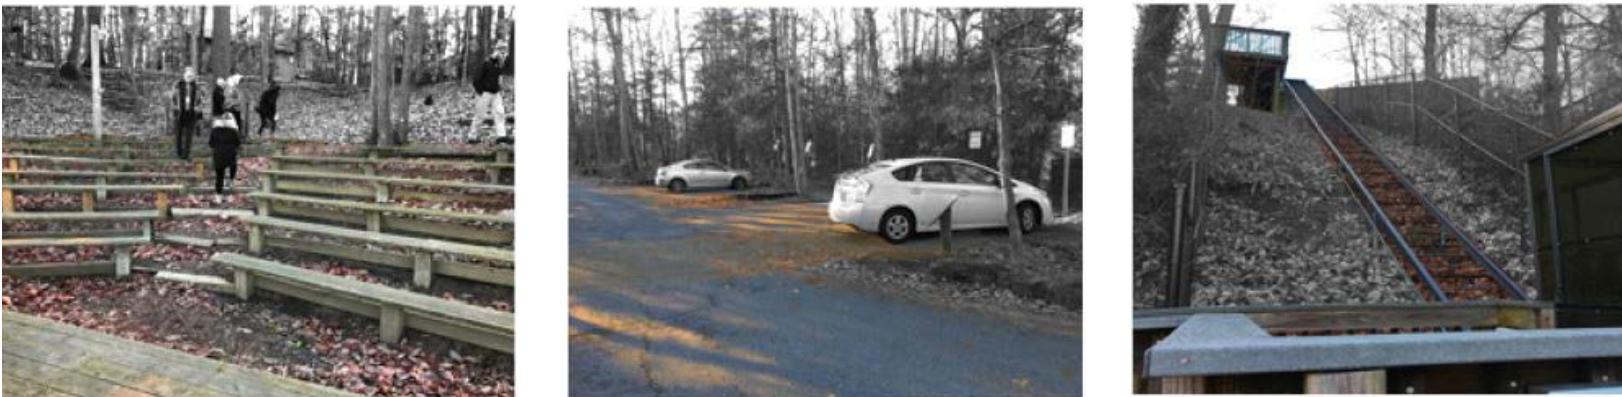
## Arlington Echo Site Map

- a. bus circle
- b. amphitheater
- c. parking spaces
- d. wheelchair lift
- e. trails

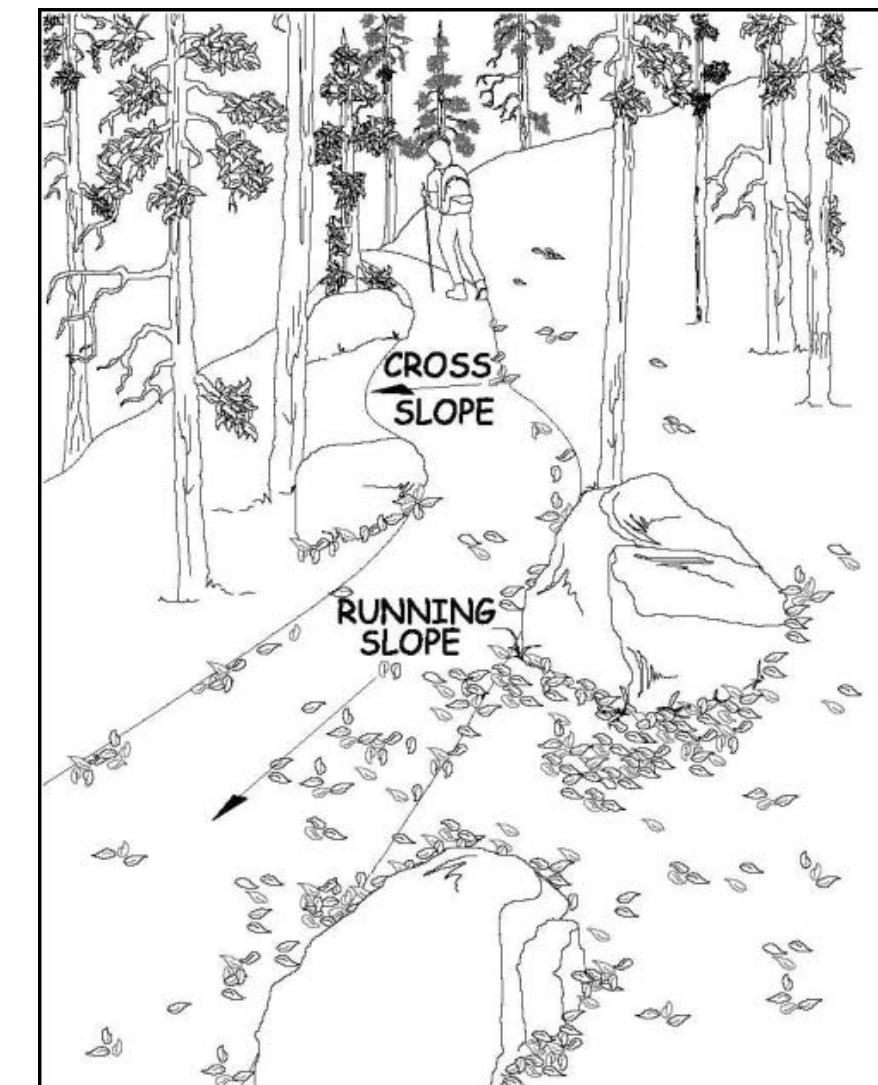
No more than 30% of the total length of the trail may have a running slope exceeding 1:12 (8.33%)  
The running slope may never exceed 1:8 (12%)  
Place resting intervals more frequently as the slope increases

Figure 8—The running slope is measured along a trail's length; the cross slope is measured across its width.

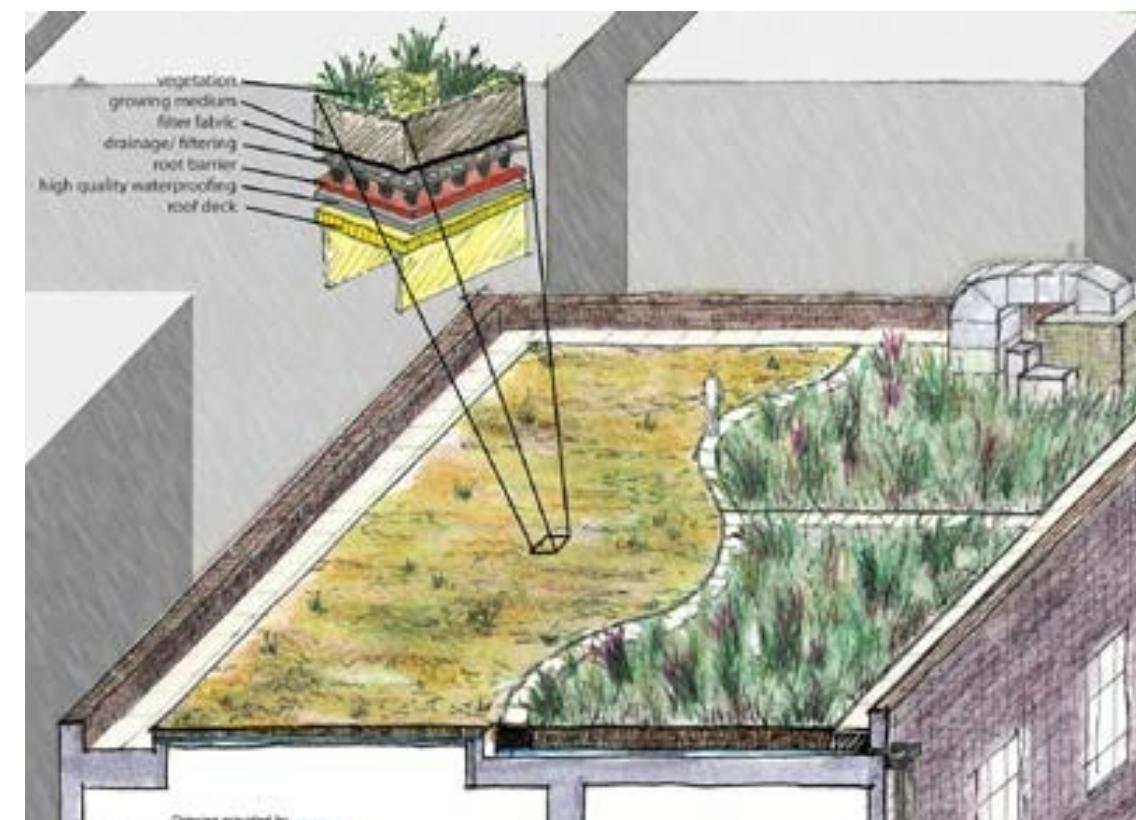
Figure 45. Green roof diagram

Access to the roof has to be guaranteed throughout the installation and for annual maintenance and service of the green roof.

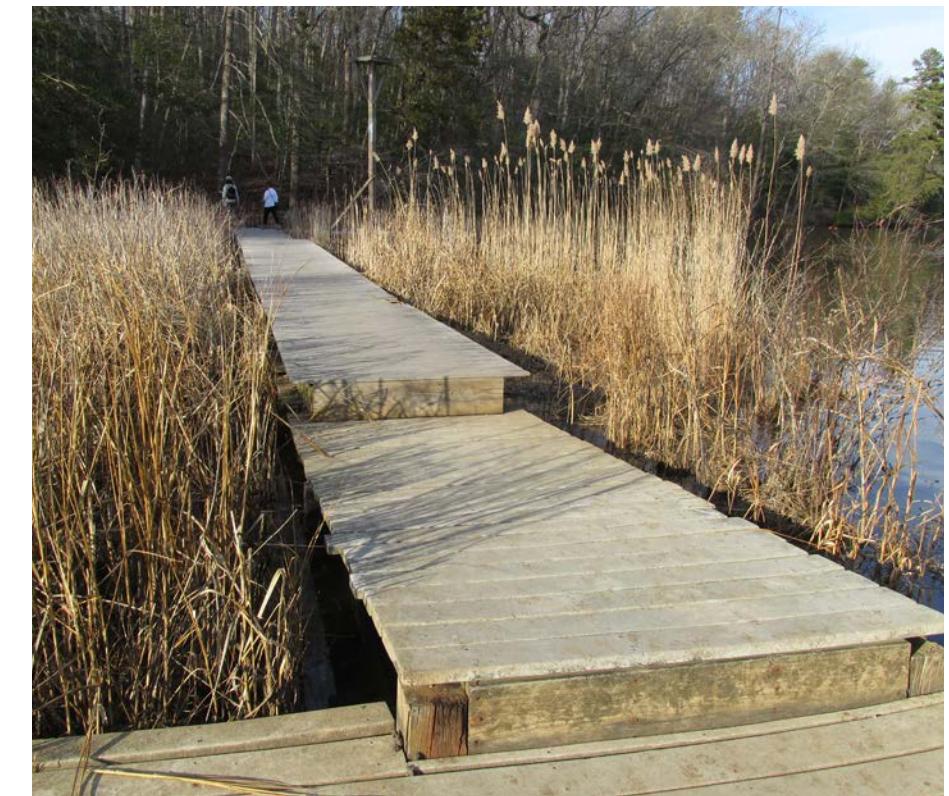
Figure 96. Existing non-ADA accessible boardwalk

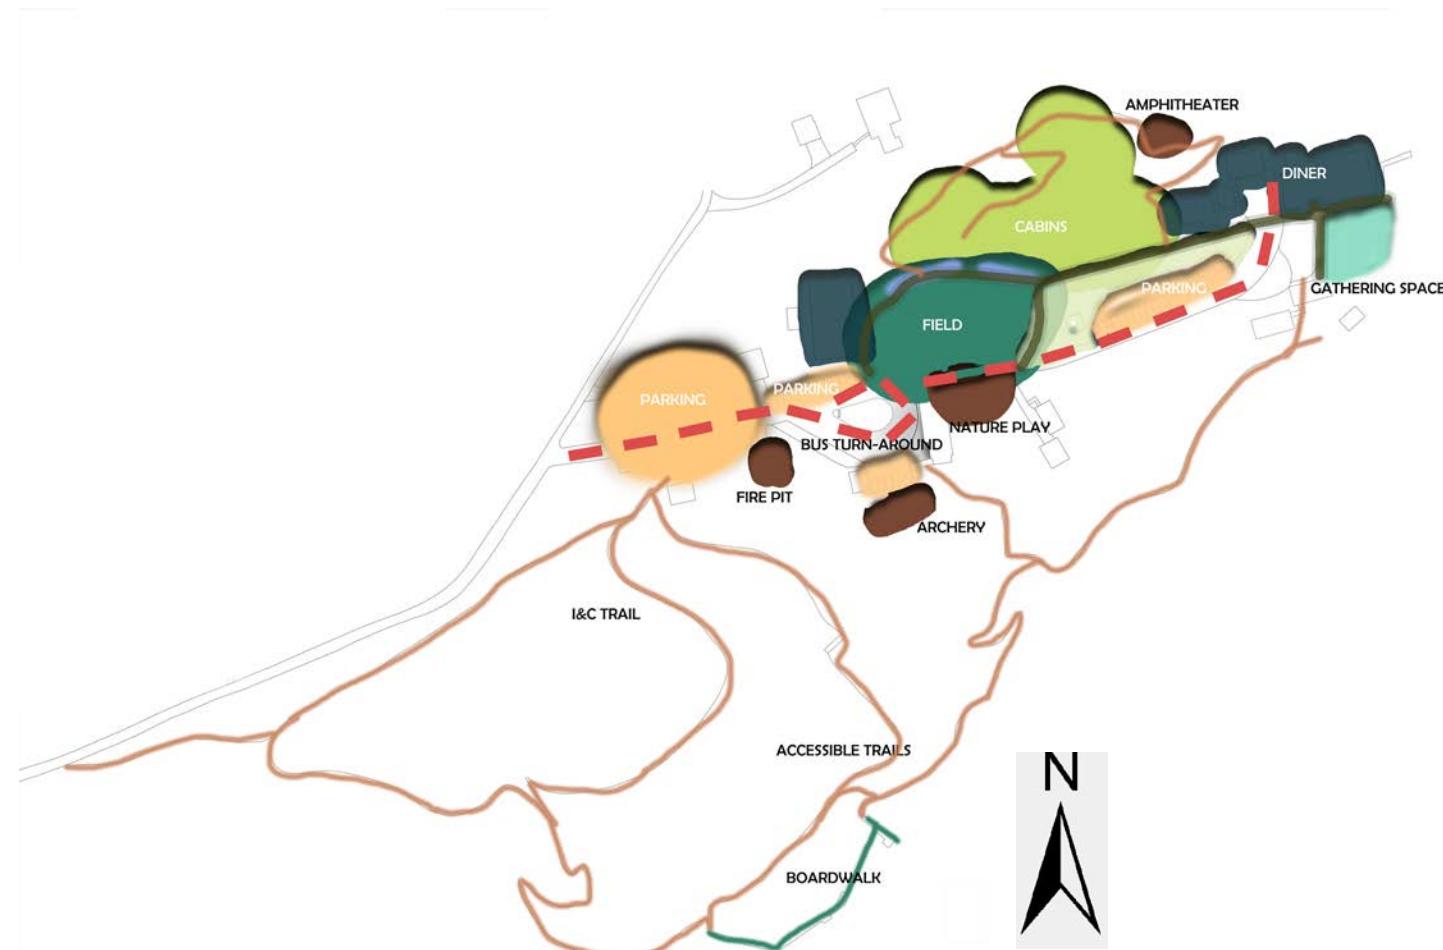
**Figure 101.** The functional diagram demonstrates the larger areas and defines the overarching

The functional diagram demonstrates the overall layout of the site. It gives a visual of where different areas such as recreation and trails are relative to the site. This diagram shows areas on the site that have been expanded or added. For example, the design implemented a larger parking lot in order to accommodate more vehicles. Several other parking spots were also integrated specifically made for employees only.

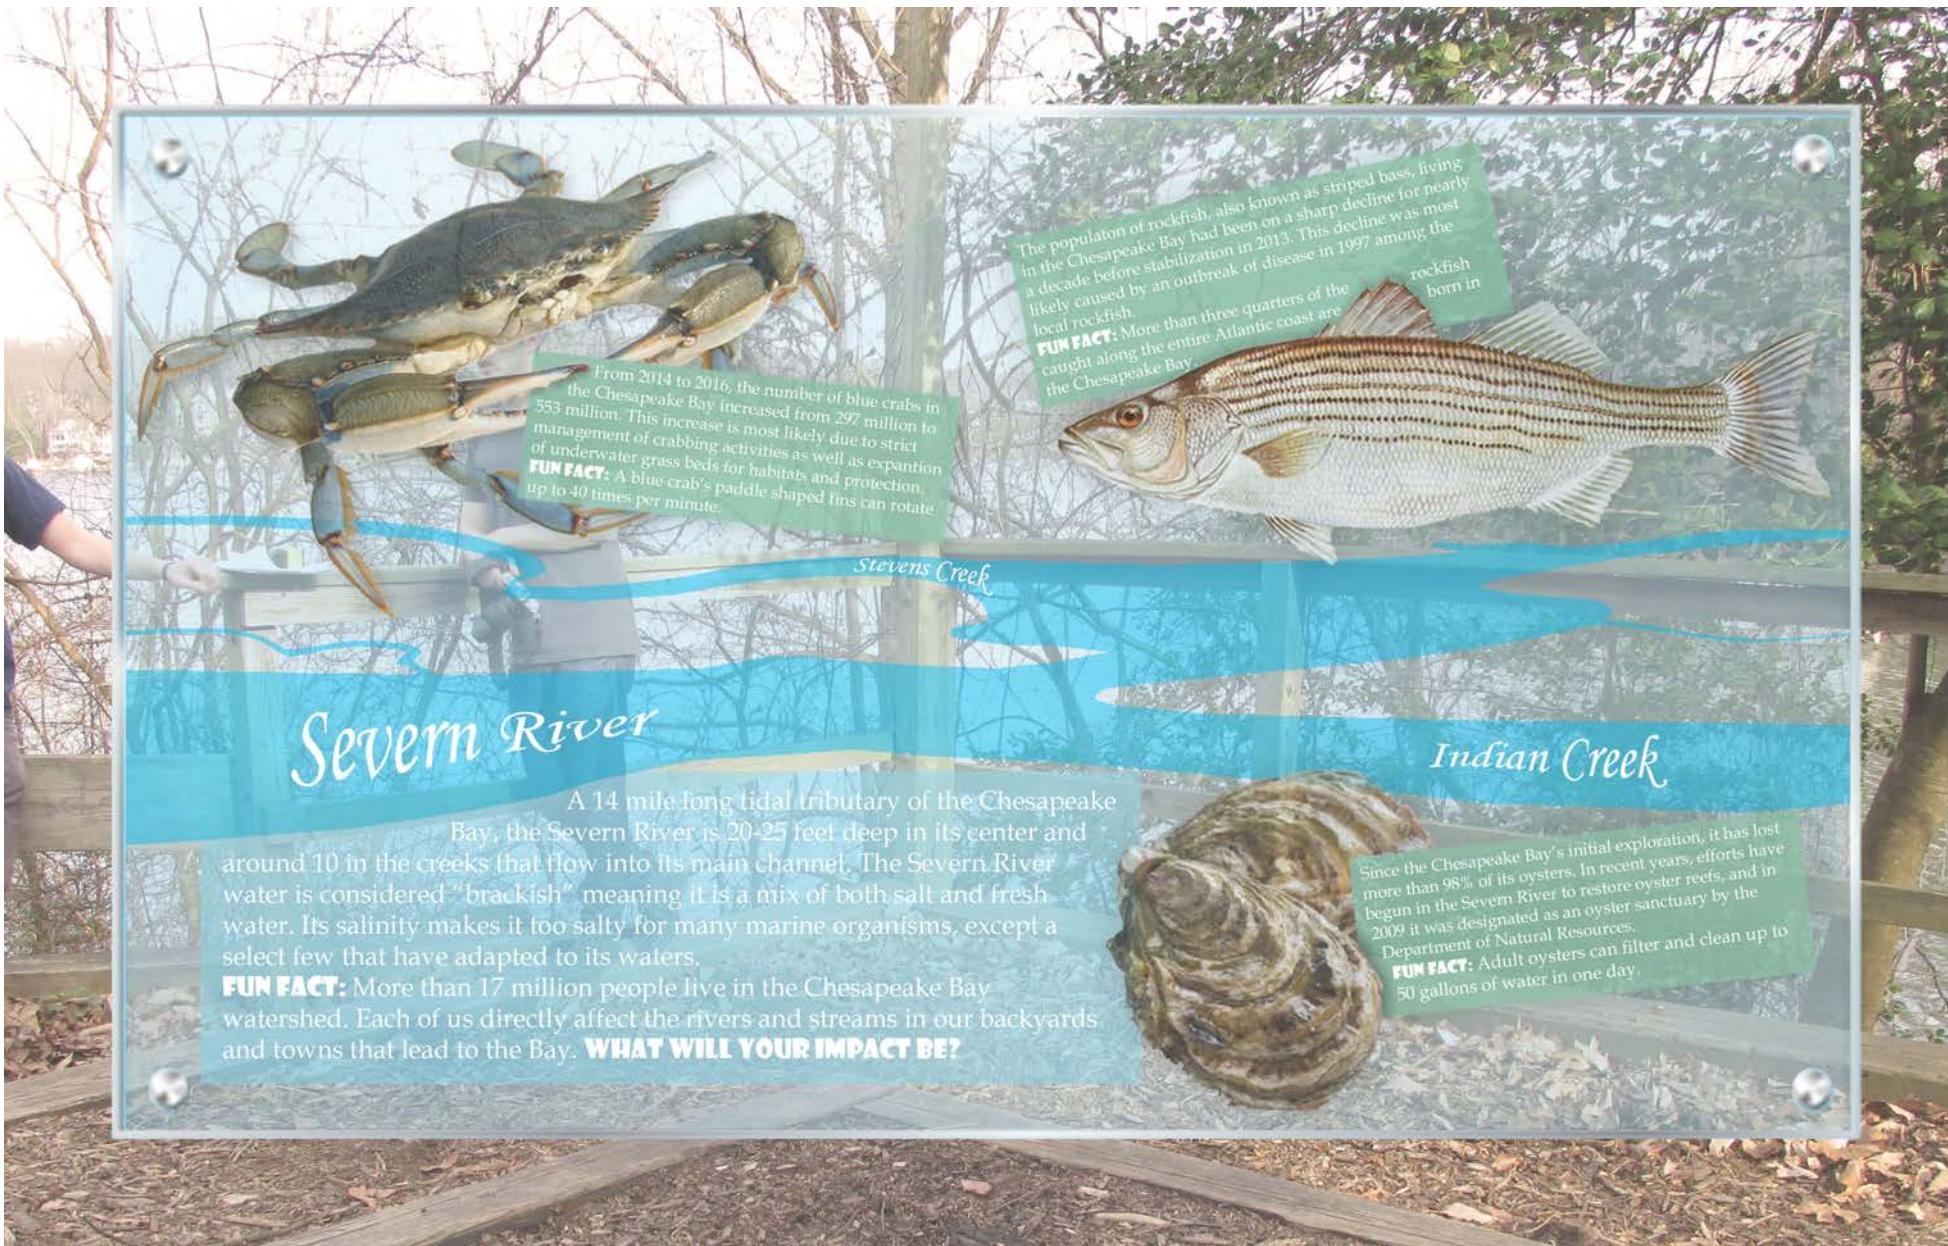
**Figure 113.** Educational signage depicting bodies of water around Arlington Echo and the organisms that inhabit them.

Made of glass, this particular educational sign allows its viewer to peer through its face and see the names of the rivers reflected on the bodies of water themselves.

In addition to general information about the Severn River, the major body of water surrounding Arlington Echo, it depicts a few of the native organisms that inhabit these rivers, as well as the im-

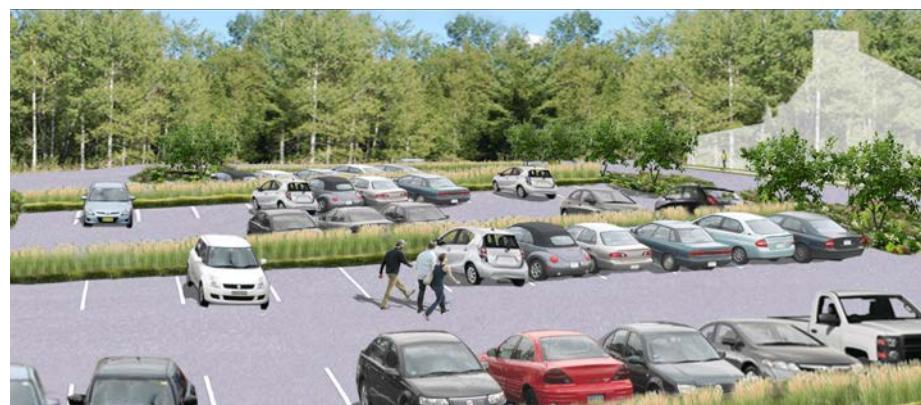
**Figure 114.** Expanded parking lot and Meadow. Created by Akira Shepherd

A meadow has been planted in the bioswales that divide the rows (Figure 114) and have several functions; screen parts of the cars, infiltrate and filter stormwater on site, expand the educational field, as well as enhancing wildlife on site through the native plantings.

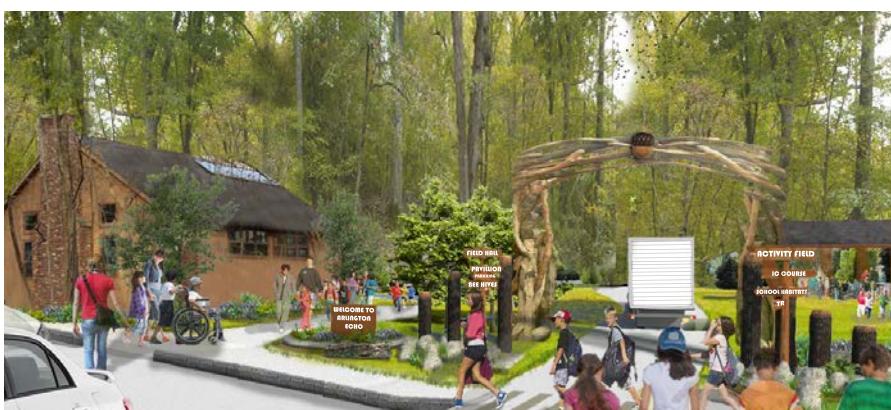
**Figure 118.** Entryway. Created by Blair Danies

(Figure 118) shows the entrance to the outdoor education center. An arch with an acorn symbol is the focal point, which invites visitors to enter into the nature center. The acorn has been given a central position, symbolizing the natural feel of the site and giving the outdoor education center a strong identity.

The entryway is an active space, meant to guide visitors in the right directions. Signage has therefore been provided in order to successfully do this.

The wooden arch, signs, and the acorn symbol are all made from the recycled wood taken from the trees that occupied the parking lot space.

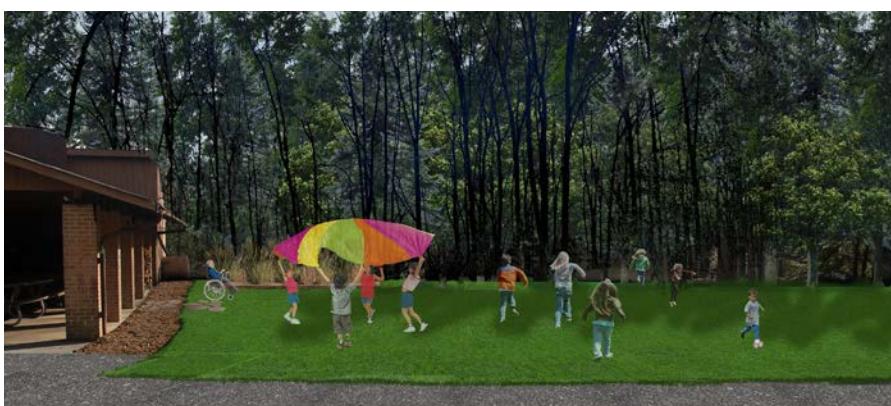
**Figure 115.** Additional Field. Created by Jenny Dibra

To accommodate for more play on green lush grass, an additional field has been implemented. This new field can be seen in (Figure 115). It is located in front of the orienteering pavilion, where the old bus drop-off used to be.

The lush grass field is lined by wood chips. This has been done to make the transition onto the field easier on the grass edges, and to visually unify the old field with the new. The wood chip edges also serve as a place to distribute damaged tree branches and materials that are found on the site.

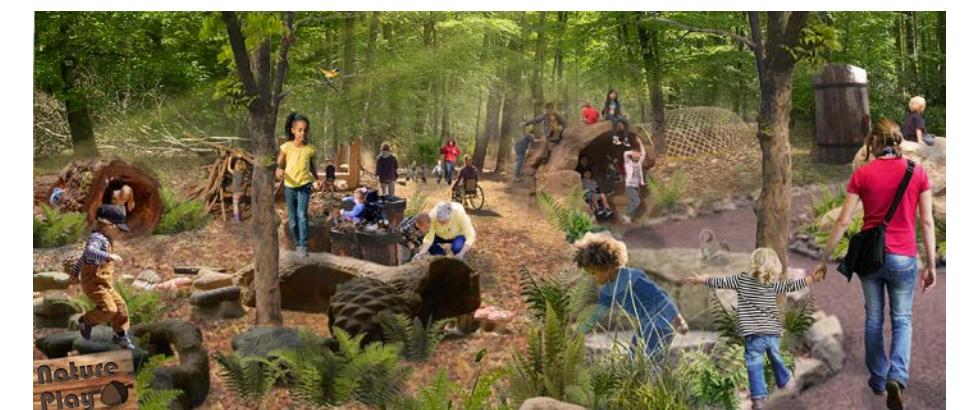
**Figure 116.** New Nature Play Space. Created by Sara Saernwald

the pool and the pavilion. It is a central location and has some slight elevations for enhanced natural play. The proximity to the Field Hall and access to the parking lot makes this an ideal place to spend time.

The nature play is targeted for children between ages 3 and 5, however, any age group is welcome. The nature play offers a range of play; from jumping on logs, climbing on stones, counting tree cones, and practicing building skills with sticks and branches. The area is adapted for ADA-usage.

The Nature play space can be seen in figure 116. The Initiative and Confidence Course (I & C Course) is located in the woods, to the right of the parking lot. New obstacles have been added in order to enhance the experience. Many of the obstacles are now also ADA friendly, which can be seen in (Figure 117). These include the creative spiderweb obstacle, and the exciting elevated ramp obstacle.

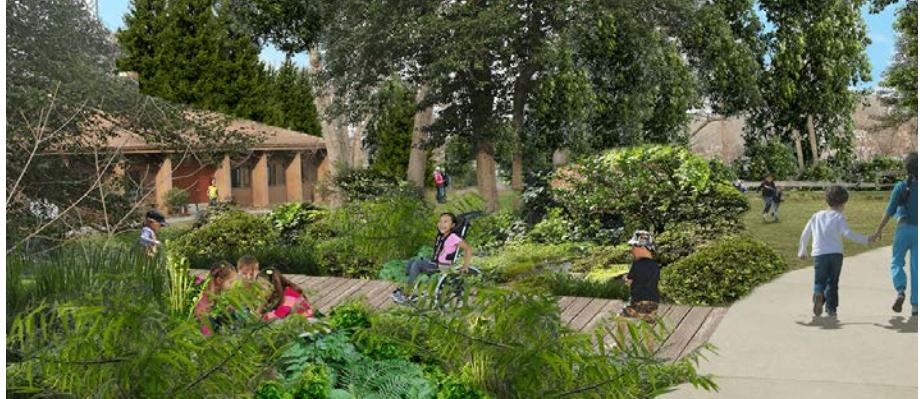
**Figure 119.** Expanded bog next to the Dining Hall. Created by Akira Shepherd

At the far northwest part of the educational center, the Resource Lab has been replaced by a net-zero building. A net-zero building uses energy that can be produced from clean, renewable resources.

The space between the Dining Hall and the new Resource Lab has been redesigned to unify the space with the net-zero building, and to emphasize opportunities for gathering, such as for informational meetings. The existing bog has been expanded and beautified and extends deeper in to the space. Its location and size has turned it into a visual focal point that can be seen from many places on the site.

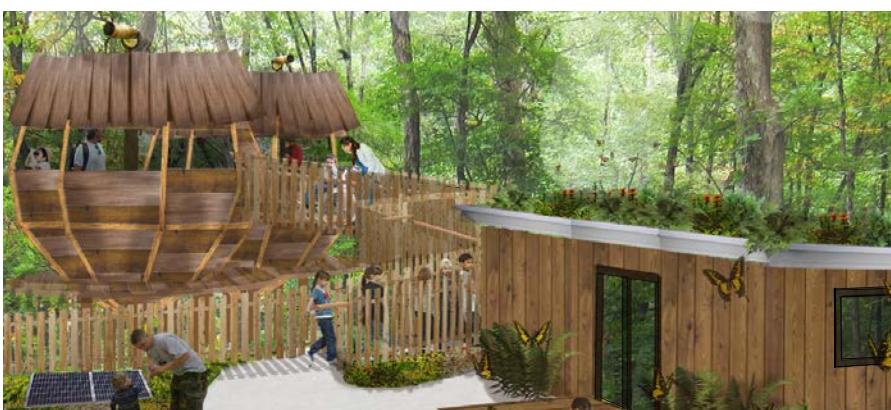
**Figure 120.** Tree-House. Created by Blair Danies

Behind the new net-zero Resource Lab, a tree-house has been installed in the lush tree canopies, (Figure 119). The tree-house is shaped like an acorn to emphasize the theme and identity of the outdoor center further. This shape adds interest to the experience when being inside the tree-house.

The tree house is accessed through an elevated walkway, from the flat area outside the Resource Lab. The Resource Lab has a green roof, as well as a small hut for adults to easily supervise the area.

The tree-house is supported by posts attached to the ground, and offers a breathtaking view. One can see birds, wildlife, and investigate the lush canopies of the different tree species. The amazing overview of the marsh along the Severn River can also be enjoyed.

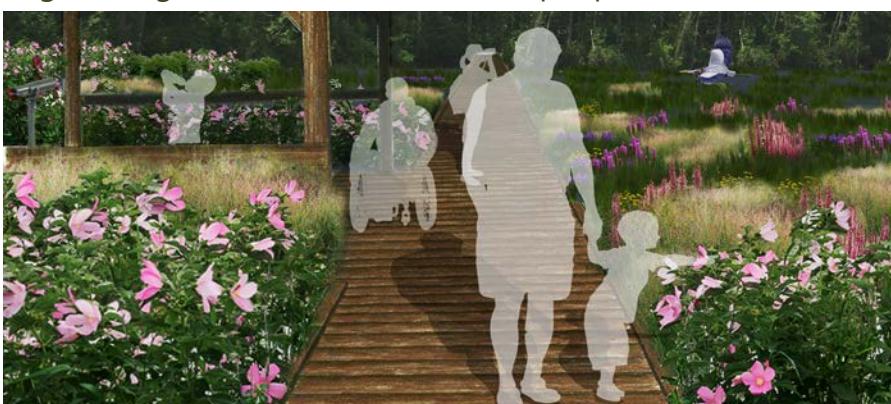
**Figure 121.** Improved Walkway and Marsh. Created by Devan Hare

The Marsh Observation Walkway (Figure 120) is located in the south, along the Indian Creek Cove. The walkway has been modified to fit ADA-accessibility standards, with curbs on each side for safety measures. Additional plants have been added for a richer experience and to contrast the grasses that now occupy most of the marsh.

A pavilion has been installed along the walkway to provide a place for resting and to protect from the sunlight during the warmer days. Seating is available under the pavilion, which is large enough to hold a class of 10-15 people.

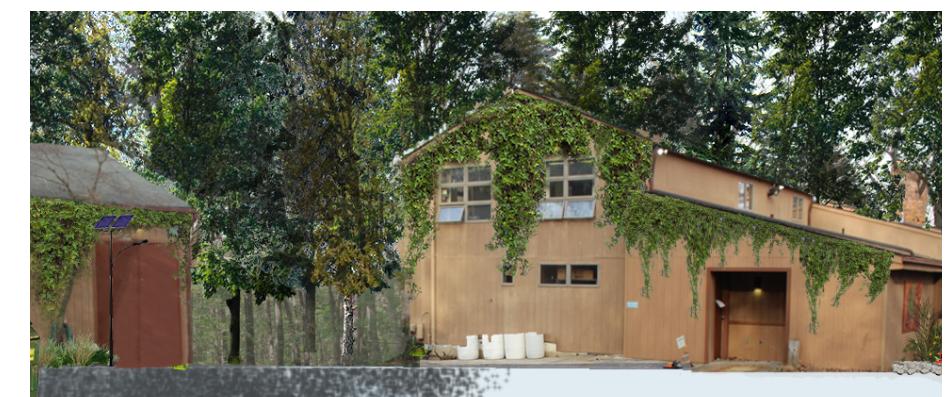
**Figure 122.** Hard-scape Activity Area/ Loading Area. Created by Jenny Dibra

The loading area next to the Dining Hall has been modified to serve as a hard-scape activity space. Lush vegetation has been planted around the edges to unify it with the nature (Figure 121). Flowers and vines beautifies the space and creates a lush enclosure.

Here, visitors can play sports and games on days when the field is occupied, or on days when the field is moist from a rainfall.

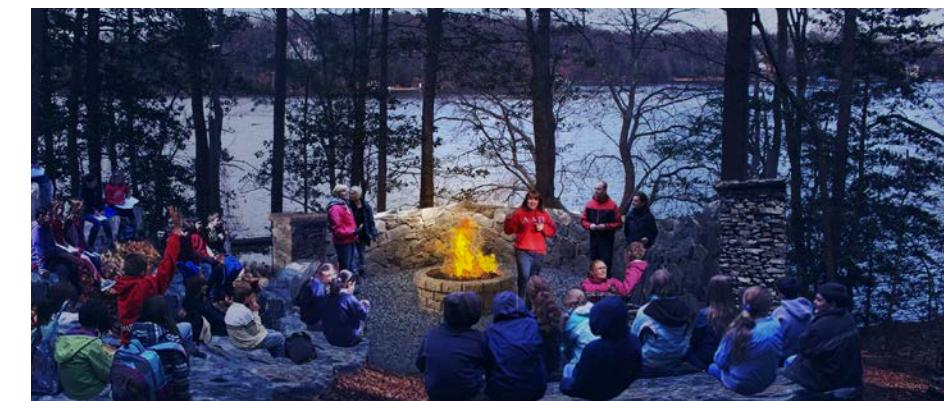
**Figure 123.** Amphitheater, North side. Created by Sara Saernwald

The amphitheater located on the north slope of the site has been modified to accommodate a fireplace (Figure 122). The fireplace is set on gravel with adequate space around it for safety. The trails that lead down to the amphitheater are ADA-accessible, allowing everyone an opportunity to take part of evening fun, grilling s'mores, and enjoying the beautiful view over the Severn River. A stone wall has been installed behind the fireplace for safety measures, and to protect against wind. The colors and rough surface of the stones also complement the view of the water.

The amphitheater can hold up to 106 people, and includes 4 landings to accommodate wheelchairs.

The seatings, which were previously wood, has been changed into stone, enhancing a more naturalistic feel of the space. The previous wood benches were also becoming damaged by rainfall and the lack of sun, which is not an issue for the stone seatings.

Accessible to all, this amphitheater uses stone seating to prevent moisture buildup and create a fluid seating area around the stage below.

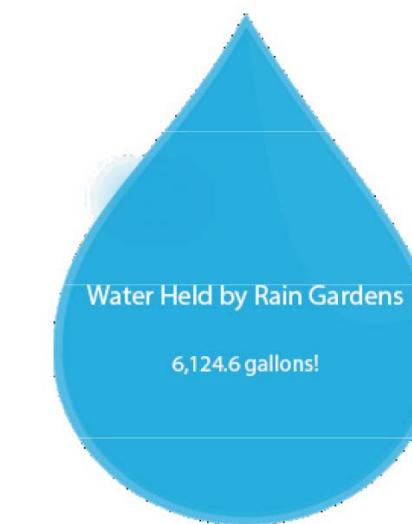
The rain drop illustration was used to depict the amount of water gathered by the rain gardens proposed in the main parking lot. An astounding 6,124.6 gallons of water can be retained during the first 2 inches of any rainfall event.
