Title of Thesis: EFFECT OF LONG-TERM AGING ON LEAD-FREE SOLDER AND SURFACE FINISH

EFFECT OF LONG-TERM AGING ON LEAD-FREE SOLDER (SAC405) AND  
SURFACE FINISH (PURE TIN)

Thesis submitted to the Faculty of the Graduate School of the  
University of Maryland, College Park, in partial fulfillment  
of the requirements for the degree of  
Master of Science  
2017

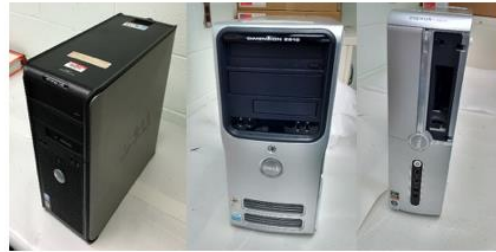
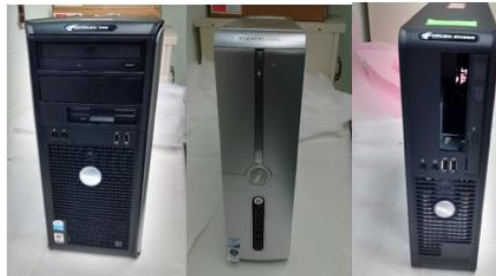
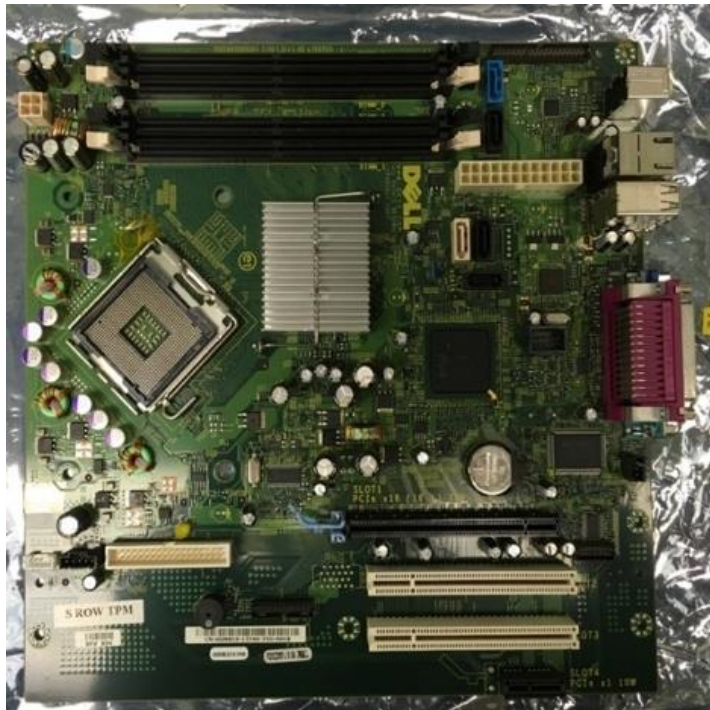
**Figure 1 (a) Used computers (with service tag) (b) Stored computer (bare motherboard)**

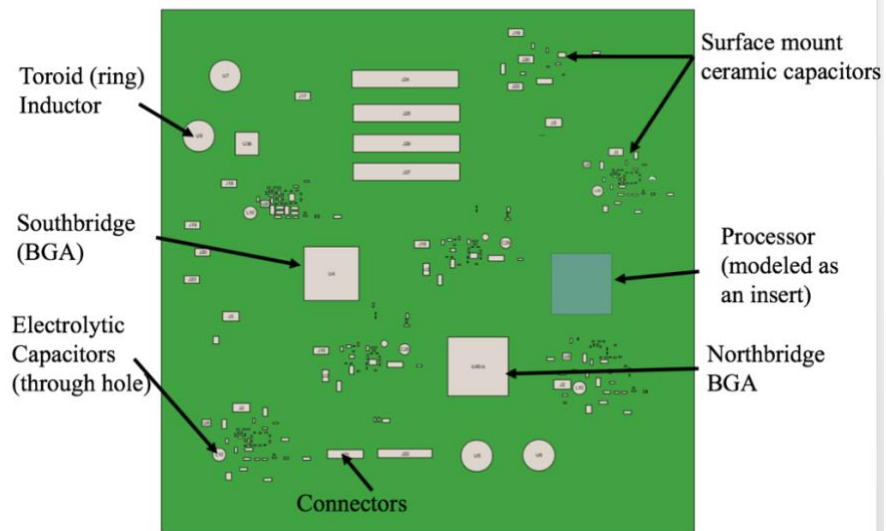
**Figure 4 CalcePWA Simulation Model of the Board with Components**

The CalcePWA analysis results indicate that the lead-free solder joints survived both the RT conditions for a period of ten years. The simulation result agrees with our system level evaluation, where the computer boards have not failed after being used and stored in RT for 10 years. The simulation results showed that the solder joints of Northbridge BGAs had the highest damage ratio (DR). The 0603 ceramic capacitors that were placed close to Northbridge were found to have the second highest DR. Physical examination of solder joints also showed no signs of degradation such as cracks or voids which matches with the low damage ratio accumulated in the simulation as shown in Table 2.

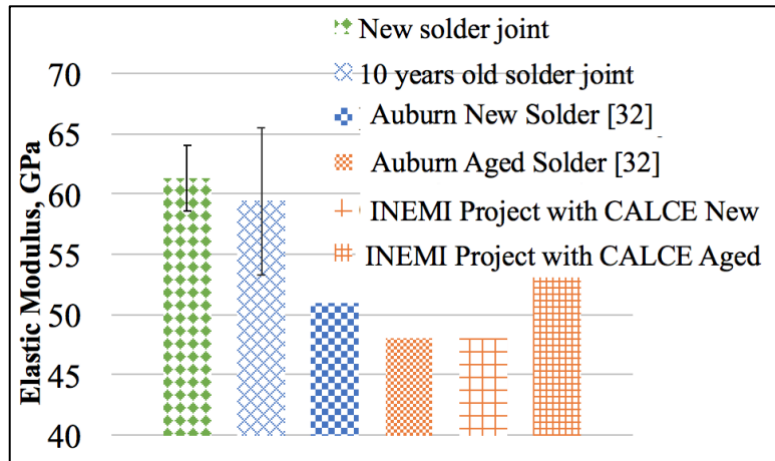
**Figure 7 Elastic Modulus of solder joints from our testing and literature reports**

The hardness and modulus are higher than typical values (40-50 GPa) reported in literature [31]. This could be due to the difference in the type of sample tested. Our study testing solder joint fillet, could have more grains than a solder bump which will result in constituting the effect of grain boundaries thereby increasing the overall modulus and hardness measured. In terms of aging effect, we find the modulus of SAC405 solder joint to decrease from 61 GPa to 59 GPa after ten years of aging. It is seen from the error bar that this drop may not necessarily indicate a change in modulus as it could be only a variation induced by measurement procedure. On the other hand, hardness was found to increase from 0.39 to 0.47 GPa which is similar in magnitude to the change reported in literature but is observed in the opposite direction. Hasnine et al. reported a decrease in hardness by 0.08 GPa after isothermal aging at 125 °C.

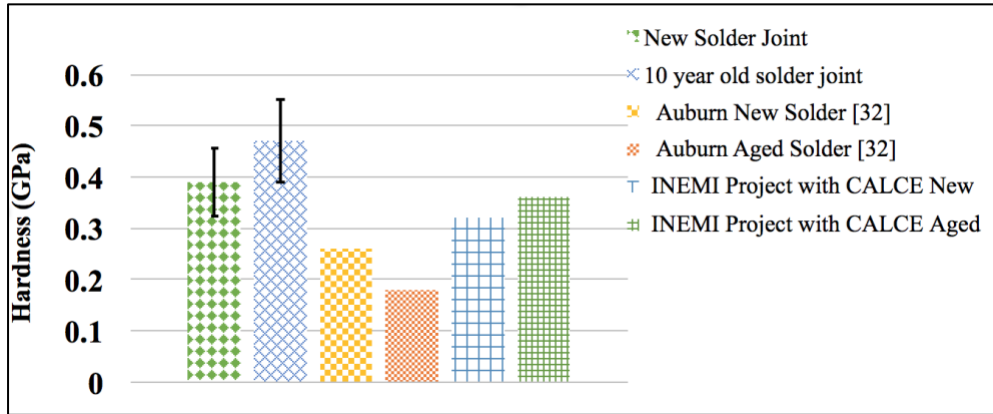
**Figure 8 Hardness of solder joints from our testing and literature reports**

On the other hand, the hardness was found to increase by 20% from 0.39 GPa to 0.47 GPa after 10 years of aging. This again is opposite of what has been reported in literature under elevated temperature aging conditions. The increase in hardness agrees with the creep test results of the solder joints where the aged solder joint crept lesser than the new solder joint. This is an indication of the presence of work hardening in the solder joints due to continuous power cycling over the ten years of usage.

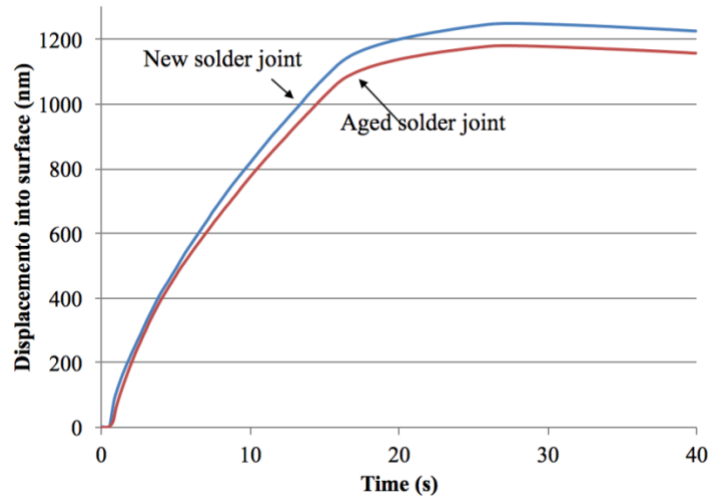
**Figure 9 Creep displacement of SAC405 solder joint under 10mN load**

The aged solder joint being harder than the new solder joint resists the deformation under indentation and hence shows lower displacement as compared to new solder joints. The creep data ascertains the presence of work/cyclic hardening effect on the solder joints. The hardening occurs due to initiation of multiple dislocation points over ten years of aging due to power cycling undergone by the solder joints. These dislocations points trap each other and prevent their relative motion leading to increase in hardness.

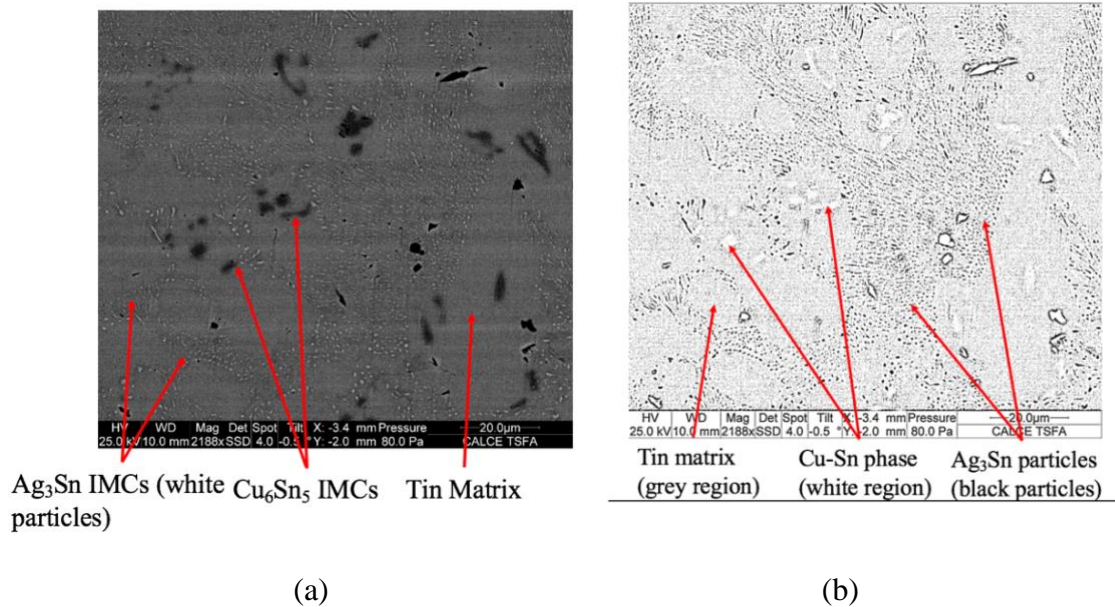
**Figure 10 (a) ESEM image and (b) Binary image of 10-year-old solder joint**

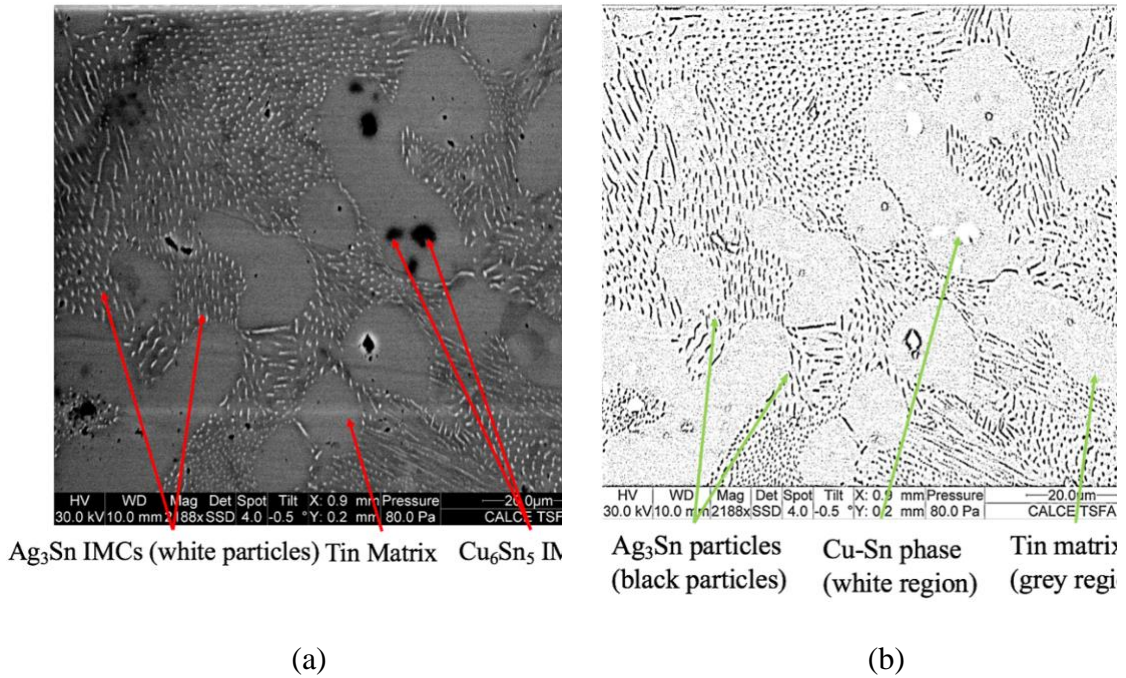
Figure 11 (a) ESEM image and (b) Binary image of new solder joint

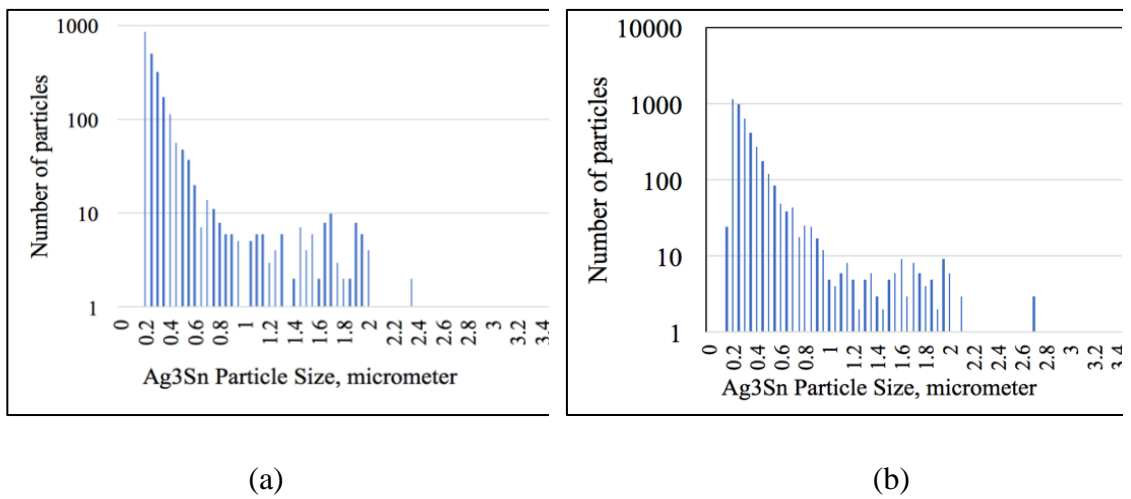
Figure 12 Ag<sub>3</sub>Sn IMC particle size distribution of (a) aged and (b) new solder joints

Following the f-test, the t-test was conducted and it yielded a p value of 0.4. Since it is more than 0.05 we accept the null hypothesis and ascertain that the aging did not change the microstructure. This finding differs from the literature reports where the  $\text{Ag}_3\text{Sn}$  particles have been observed to increase in size after aging at elevated temperatures.

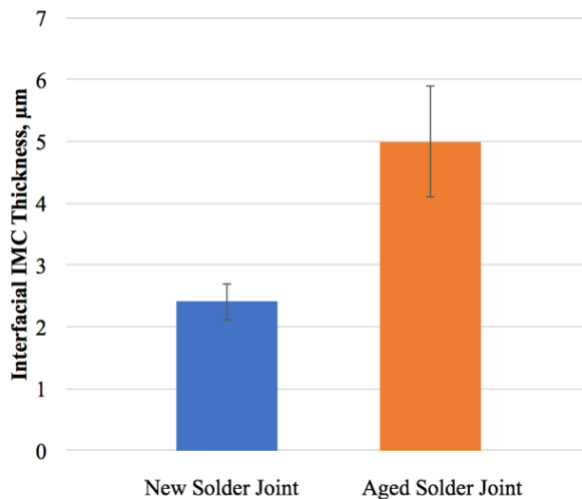
**Figure 13 Interfacial IMC Thickness Change**

Interfacial IMCs have a significant impact on the life of the solder joints as their brittle property causes crack initiation and propagation through them under high strain rate loads. It should be noted that the interfacial IMCs refer to the intermetallic formed during the reflow process between the copper pad and solder to form the assembly. This is different from the bulk solder IMCs that were discussed previously. Interfacial IMCs of SAC/Cu solder-pad assembly are generally comprised of  $\text{Cu}_3\text{Sn}$  and  $\text{Cu}_6\text{Sn}_5$  and grow in thickness over time. Due to the brittle nature of these IMCs, lower IMC thickness are generally preferred. Interfacial IMC thickness was measured in new and aged solder joints to characterize the effect of room temperature usage on solder joints. Interfacial IMCs of three solder joints each from new and aged boards were measured and compared. As shown in figure, the IMC thickness of new and aged solder joint were found to be 2.5 and 5  $\mu\text{m}$  respectively. This shows that the solder joint's vulnerability to drop loads increases with aging time.

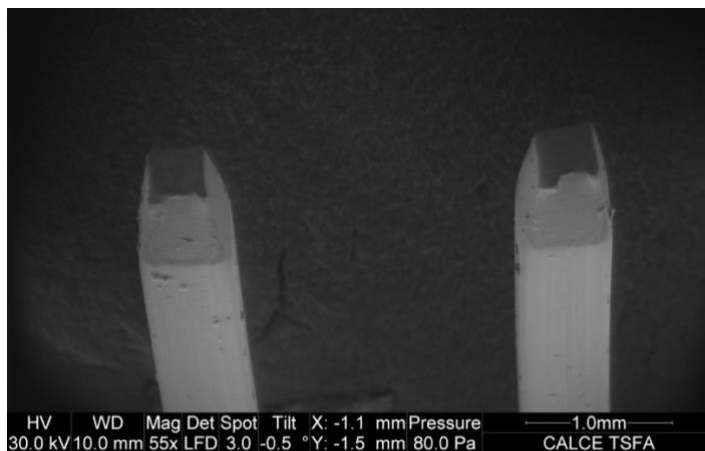
**Figure 16 ESEM Image of Connectors**

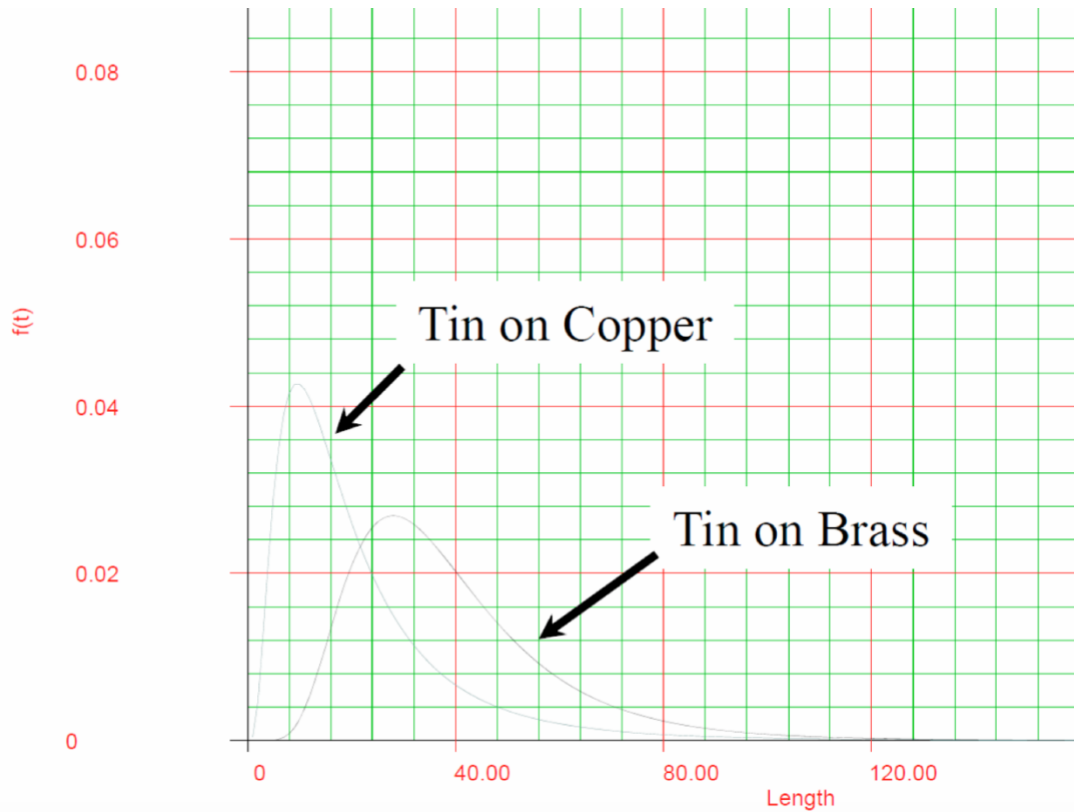
**Figure 18 Whisker Growth Distribution**

Figure 18 shows the distribution of whisker length collected by CALCE for tin coating on copper base and tin coating on brass base. The results from the CALCE Tin Whisker Risk Calculator are provided for each defined failure site in the defined system. For each site, the maximum simulated whisker length is provided along with the probability of failure for the failure site. At the bottom, the system reliability is presented.

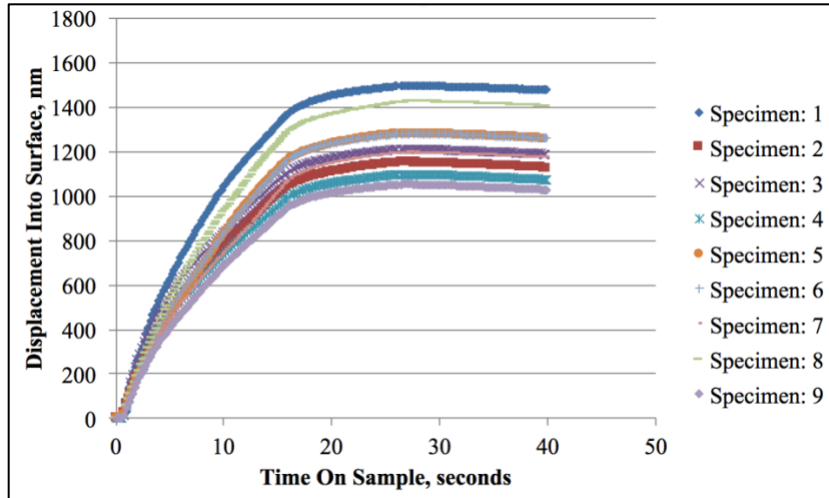
**Figure 22 Creep Displacement Curves of Aged Solder Joints**

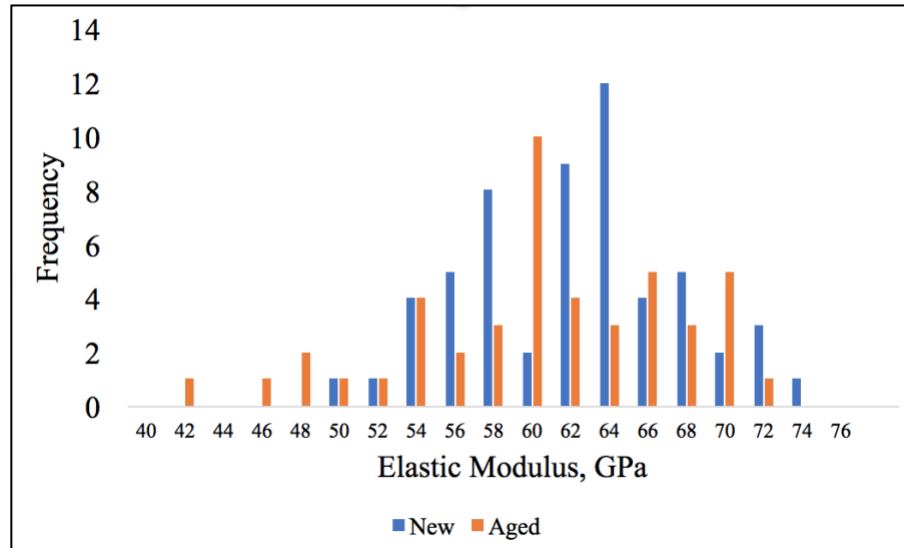
**Figure 23 Distribution of Elastic Modulus of New and Aged Solder Joint**

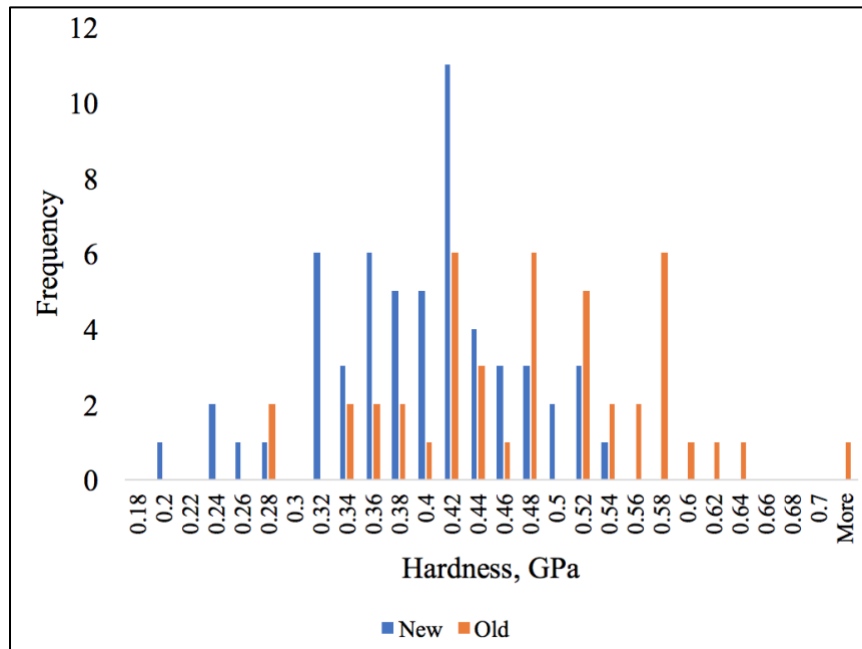
**Figure 24 Distribution of Hardness of New and Aged Solder Joint**
