Title of Thesis: **REGENERATIVE STORMWATER
CONVEYANCE: TECHNIQUES TO
WATERSHED STEWARDSHIP & TURNING
STORMWATER LIABILITIES INTO
AMENITIES**

Matthew R. Zerfas, Master of Landscape
Architecture, 2017

Thesis submitted to the Faculty of the Graduate School of the
University of Maryland, College Park, in partial fulfillment
of the requirements for the degree of
Master of Landscape
Architecture
2017

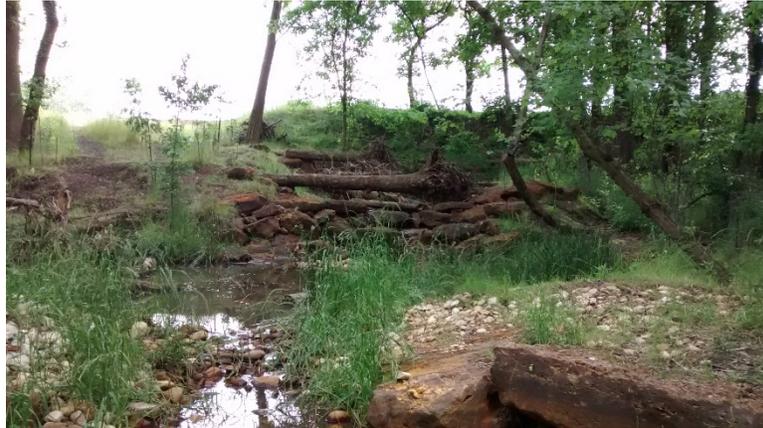
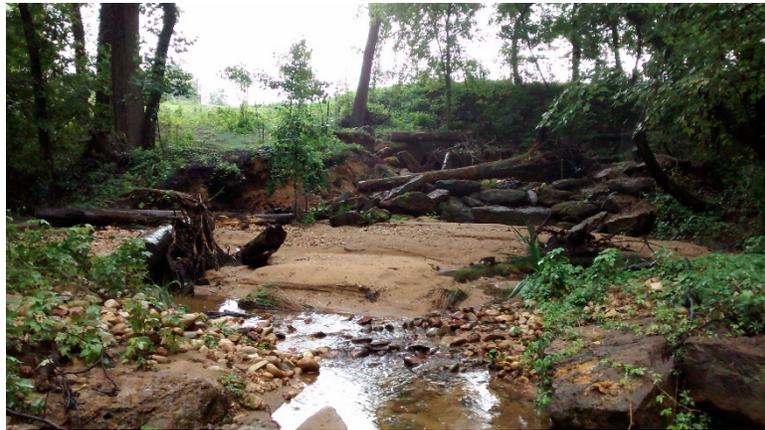
Figure 3.9: Before and after images of the first two sets of weirs and pools downstream of the pipe outfall

significantly. The first pool is nonexistent and the second pool was largely filled in by cobble and sand infiltration media as depicted in the before-after figure above.

The current understanding of what caused this blow out is overland flow of stormwater from the eastern side of the RSC (the left side of the weir in image 3.9), and it was *not* caused by flow from within the RSC channel.

Between August and September 2017 there was a partial blowout of the Briers Mill Run RSC. The second set of cascades (the one holding back the first pool after the outfall pipe) was blown out on the eastern bank. This blowout diminished the pooling area of the RSC

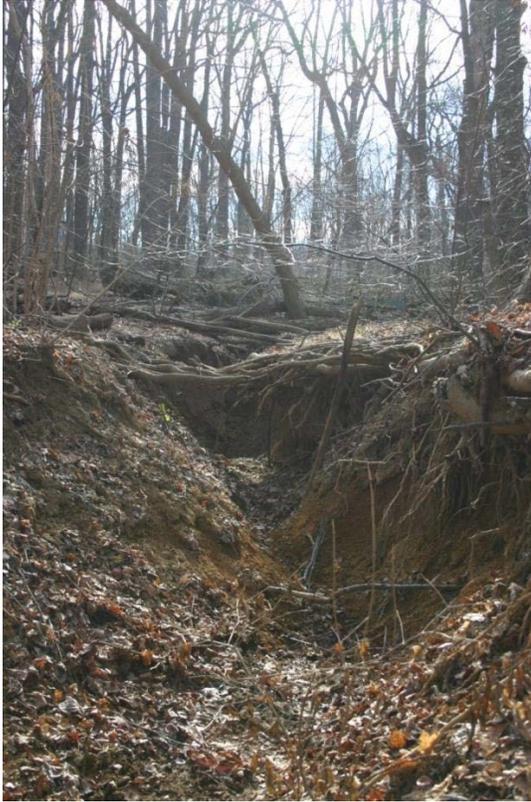
Figure 3.11: An image of channel degradation prior to construction of Bingham Run RSC

undercutting surrounding trees and other vegetation, and exposing utility lines, including sanitary sewer pipes (see figure 3.11). In addition, eroded soil from the banks had been carried downstream, damaging aquatic habitat. Instead of natural waterways characterized by step pools and surrounding vegetation, the headwater stream flowed in a severely eroded and deepened channel. The degradation of the headwater channel was linked to the significant increase in

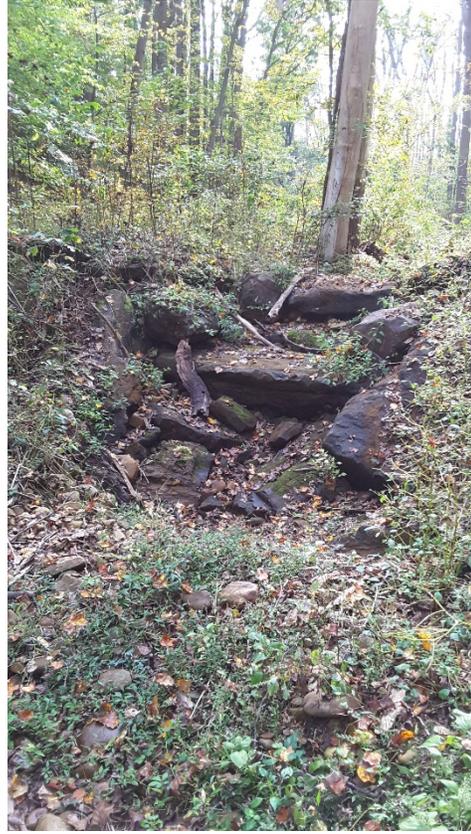
Figure 3.13: A photograph of an implemented weir dam at Bingham Run RSC

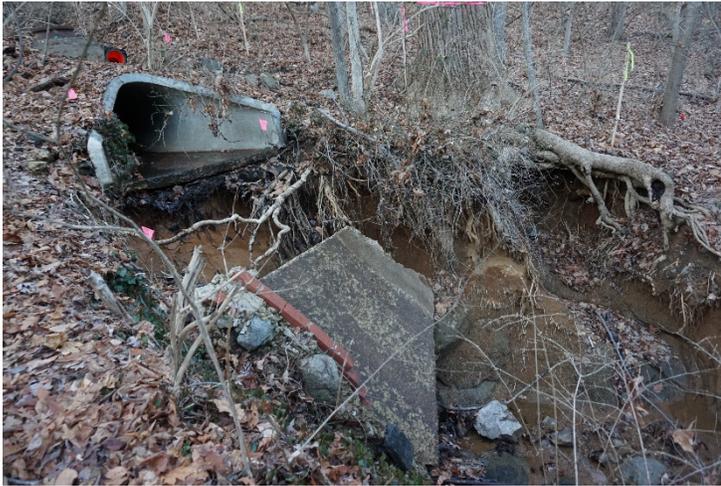
Figure 3.16: A photograph of a pipe outfall foundation failure at Linnean Gully (Used with the permission of Underwood & Associates)

Stormwater flows from the pipe outfall had led to an incised receiving channel. The substrate directly underneath the outfall had begun to undercut leading to the structural failure of the

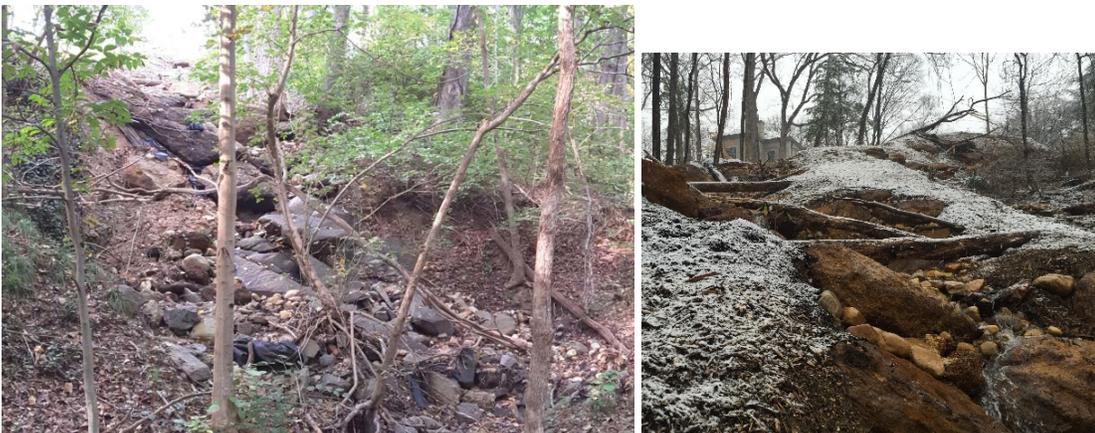
Figure 3.17: Images of Linnean Gully RSC post construction at the toe of the ridge (left) and (right) the RSC post construction near the middle of the ridge (Used with the permission of Underwood and Associates)

The site design is similar to the others in materials utilizing large sedimentary stones of between ≈ 500 lbs and 2 tons at the riffles (or cascades); in conjunction to utilizing downed trees and on site trees marked for removal as natural dams laid across the channel at varying intervals. The channel base is largely covered with high quartz content cobble which has partially been chosen for its aesthetic appeal (May, 2016) and likely to armor the bank against erosion, while providing for continued infiltration and resisting displacement during high flow events.

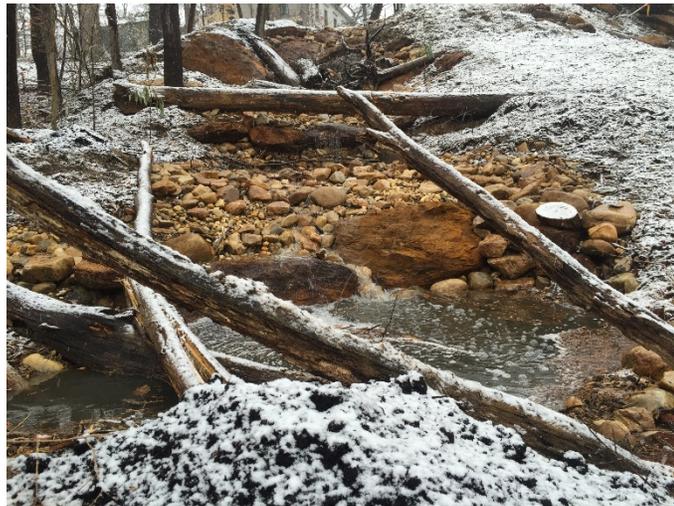
Figure 3.18: One small ponding area during a storm event (Used with the permission of Underwood and Associates)

While the ponding areas available are small, due to the high site gradient of the site; some small pools have been created (see figure 3.18) which further allow for infiltration treatment and settling of suspended solids; in conjunction with the typical highly hydraulically conductive sand and compost substrate utilized in RSCs while raising the channel height.

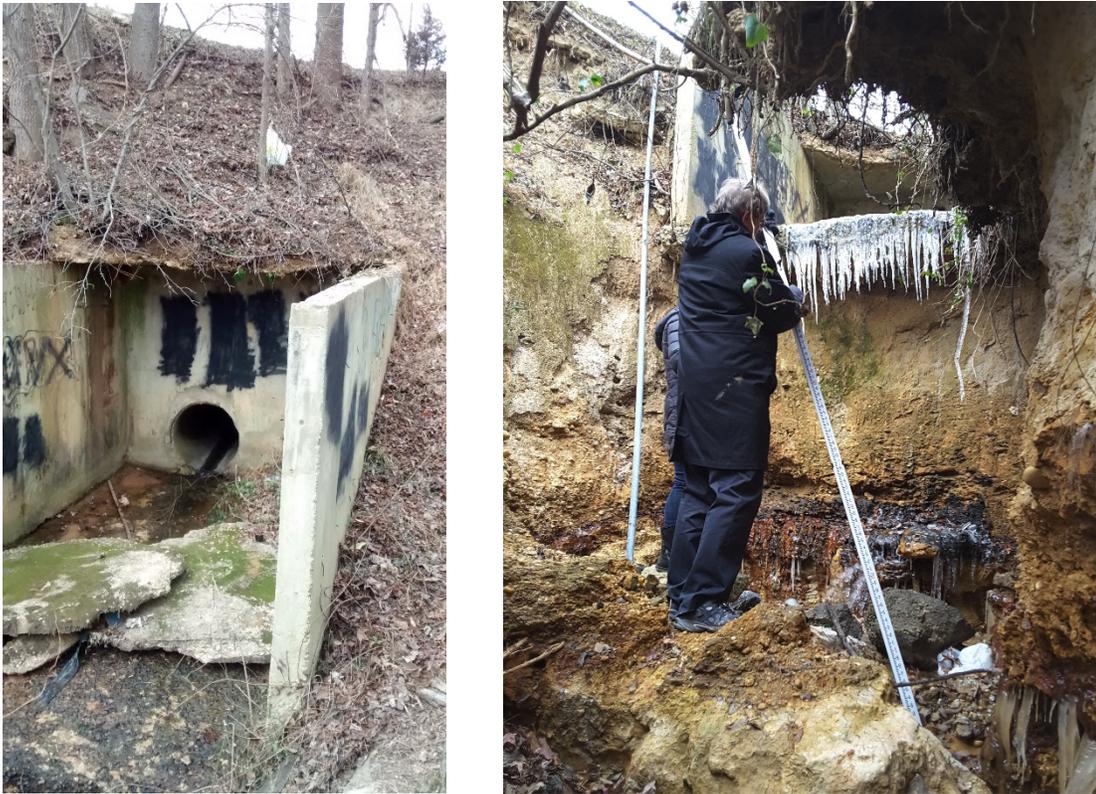
Figure 4.3: Images of the Outfield Channel Outfall, headwall and immediate channel

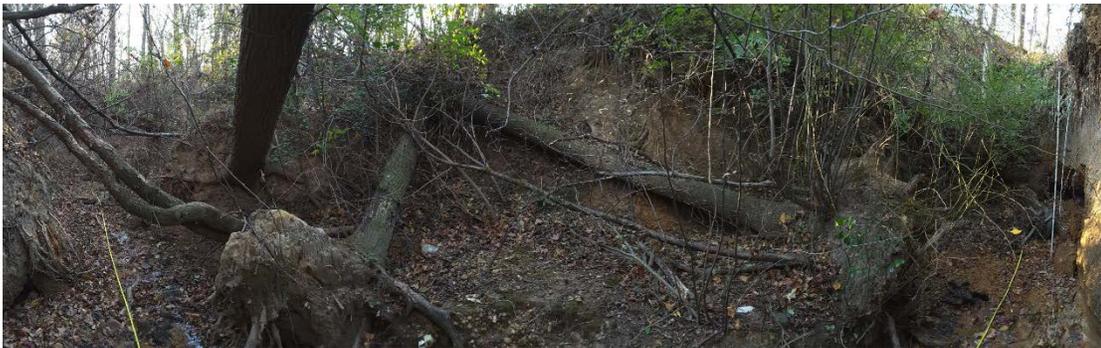
Figure 4.10: A panoramic view of several uprooted mature trees in the Outfield Channel near the stormwater pipe outfall.

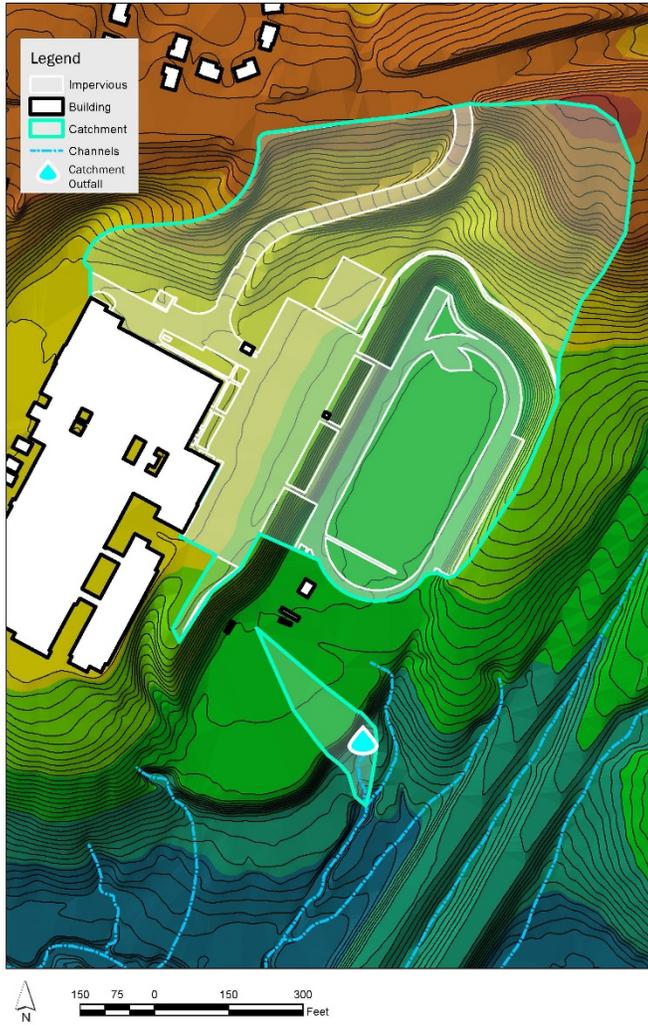
Figure 4.15: A topographic map of the catchment with 2ft contour lines (brown represents the highest elevation while blue denotes the lowest elevation)

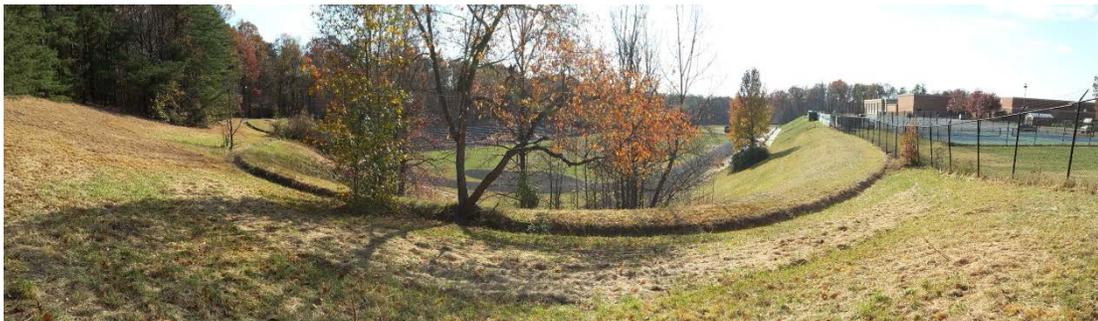
Figure 4.16: A panoramic photo from the top of the ridge on the northwestern side of the football field (Particularly of note: is a concrete drainage ditch around the entire northern extent of the field)

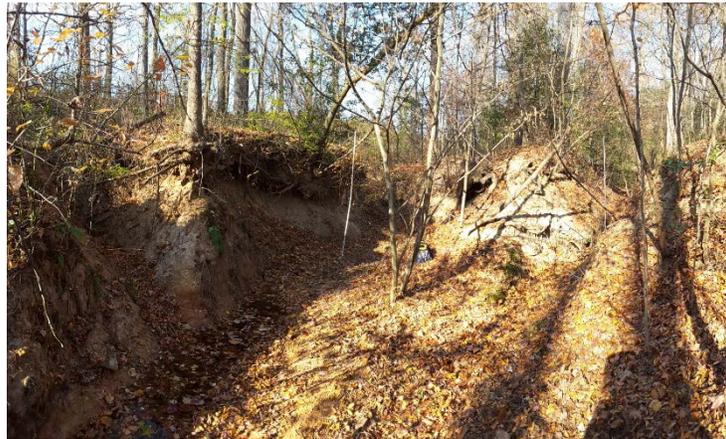
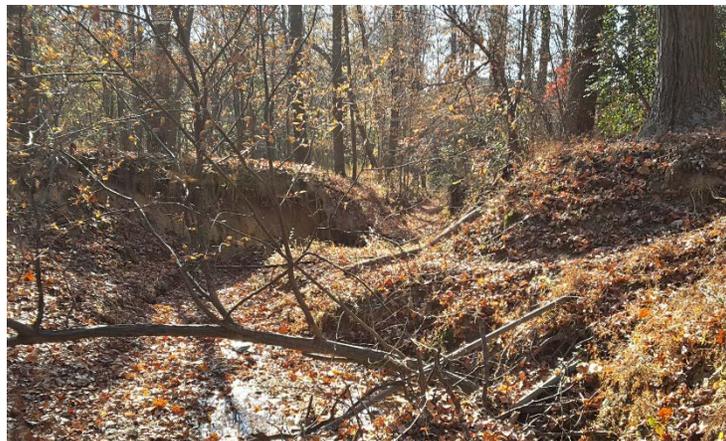
Figure 4.18: Top: A northward view of a highly eroded area just south of the Outfield Channel, and another area of active erosion in the receiving channel (bottom)

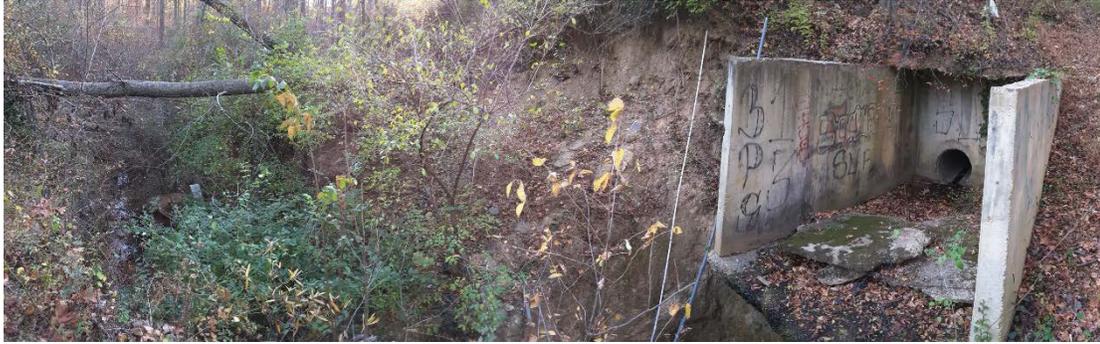
Figure 4.19: A southward panoramic view of the outfall pipe depicting the level of erosion on the southern bank of the Outfield Channel (for reference: the white pole in the center is 20' in length).

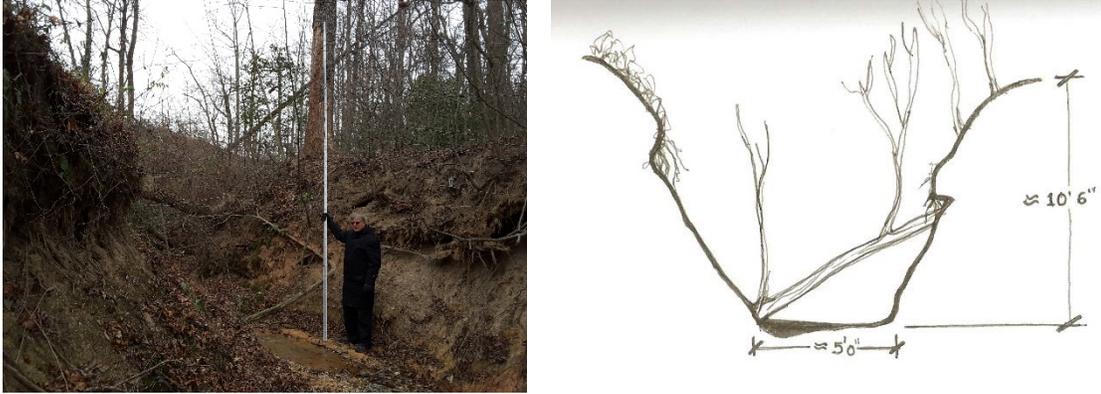
Figure 5.3: Left: an image of the second vertical measure of station point 1+25, and the subsequent cross section (right)

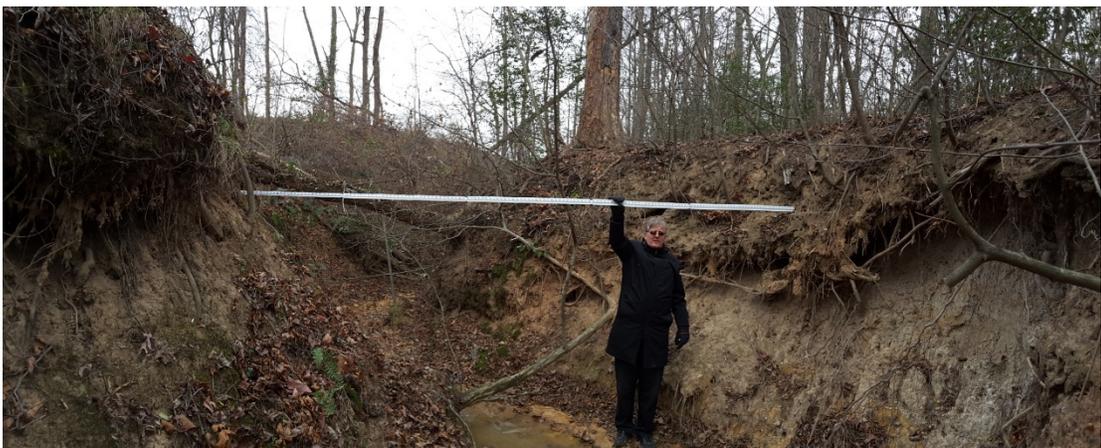
Figure 5.4: A photograph of a horizontal channel measurement at station point 1+25
