Title of Dissertation: AN ANALYTICAL AND EXPERIMENTAL INVESTIGATION OF FILAMENT FORMATION IN GLASS/EPOXY COMPOSITES.

AN ANALYTICAL AND EXPERIMENTAL INVESTIGATION OF FILAMENT
FORMATION IN GLASS/EPOXY COMPOSITES

Dissertation submitted to the Faculty of the Graduate School of the
University of Maryland, College Park, in partial fulfillment
of the requirements for the degree of
Doctor of Philosophy
2005

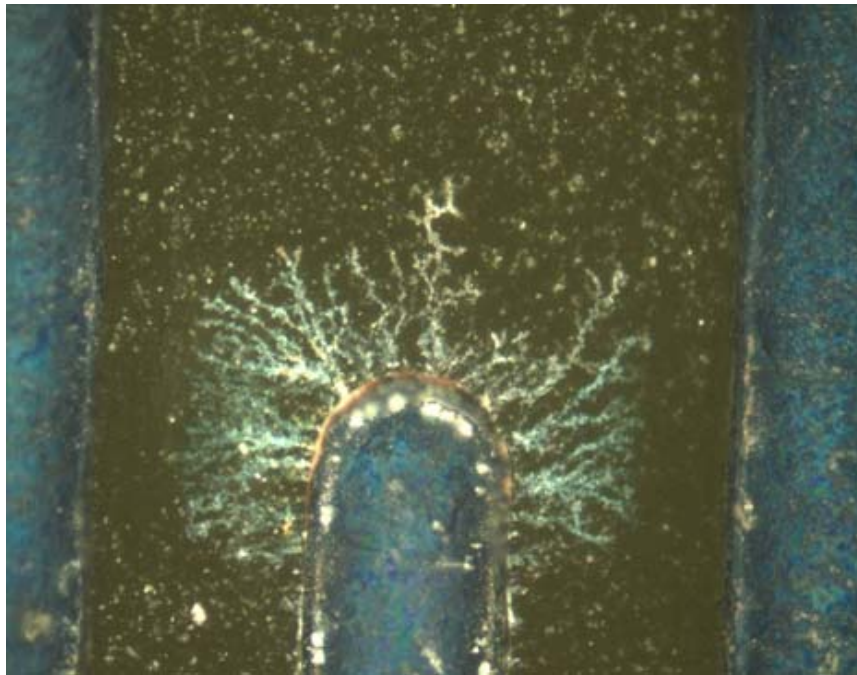
Figure 1. Dendritic growth is shown branching from a cathodic finger of a comb structure on the surface of a PWB.

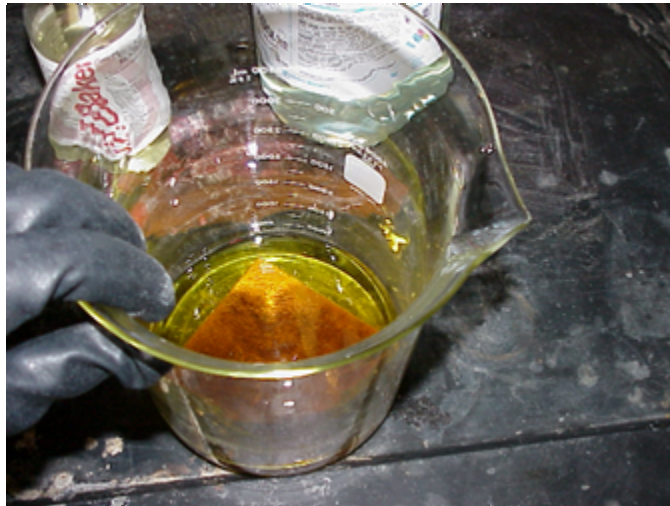
Figure 13. Placing the copper cladded laminates in a chemical solution of concentrated hydrochloric and nitric acid (aqua regia), for about 10 to 15 minutes, effectively removes all exposed copper from the surfaces. This is done in a fume hood, using the appropriate protection necessary for working with hazardous chemicals.

performed in a fume hood, using the appropriate protection as necessary for working with hazardous chemicals (see Figure 13).

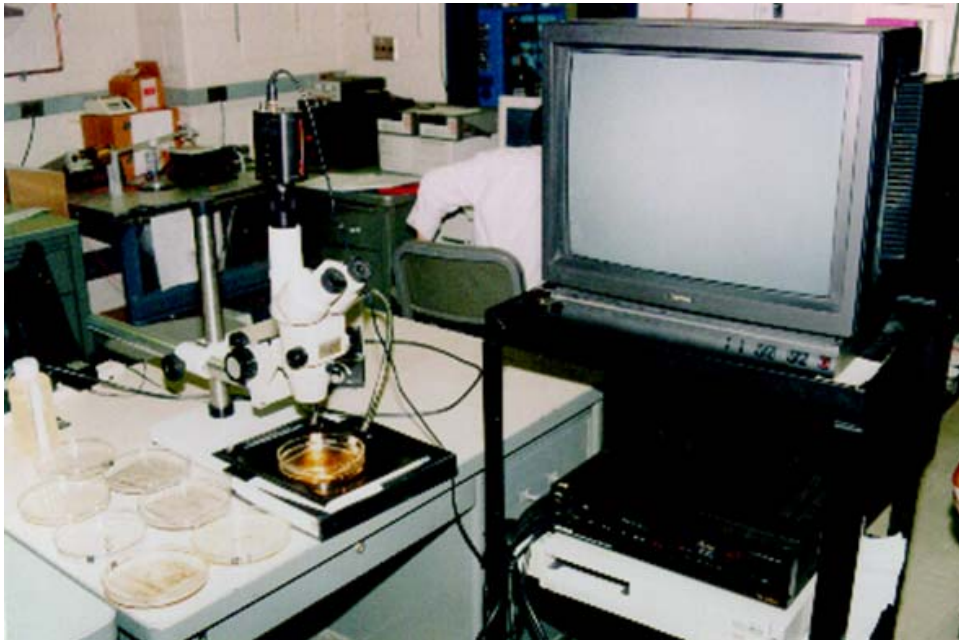
Figure 16. A change in the refractive properties is evident through an optical microscope by a bright white line. In some cases, a hollow fiber could be detected without using a microscope. The light source is positioned so that light enters the edge of the fabric perpendicular to the fibers being observed.

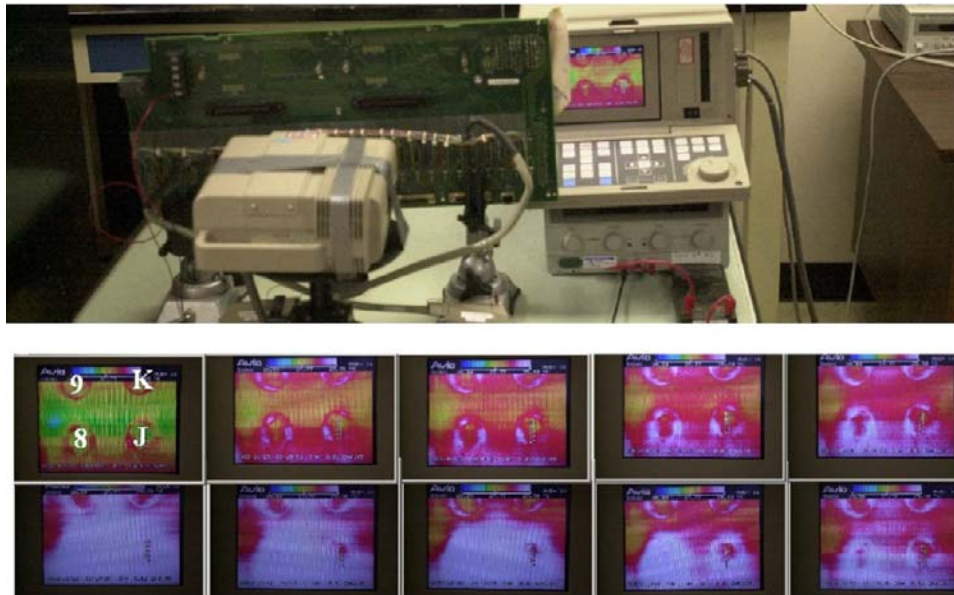
Figure 26. The photo at the top shows the thermal imaging equipment, while the photo at the bottom shows a sequential series of snapshots (clockwise starting at top left) as the power is turned on, identifying the shorted area.

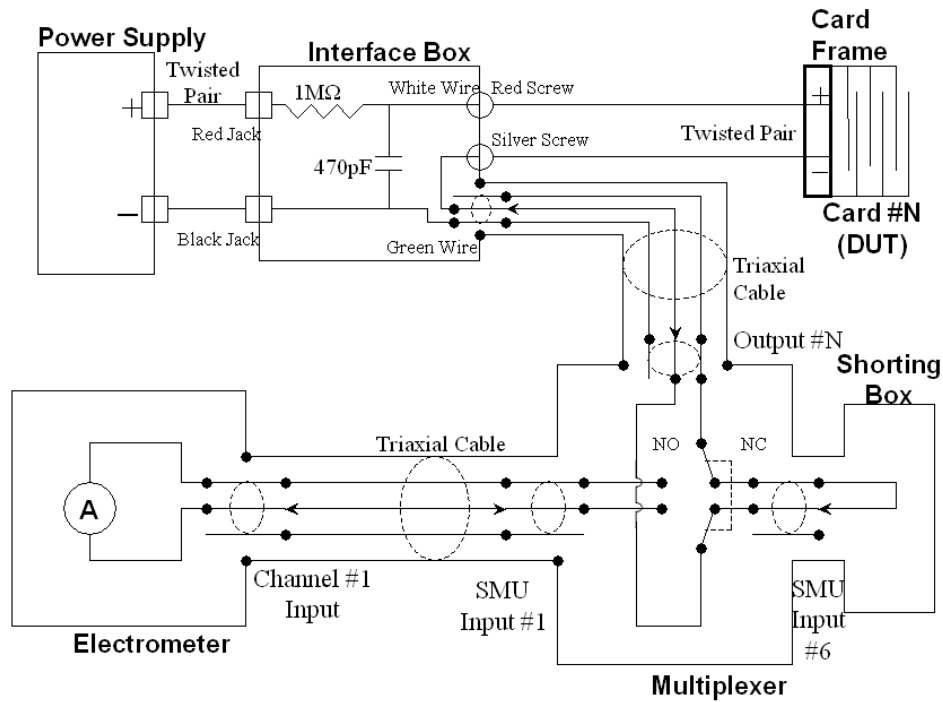
Figure 38. Schematic of the electrical circuitry used for monitoring the insulation resistance

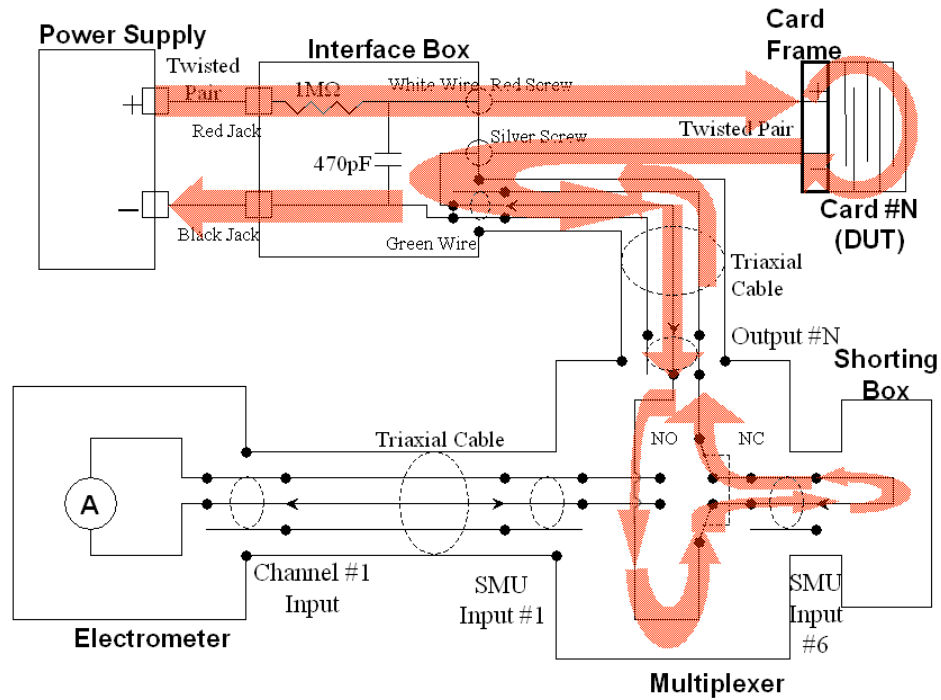
Figure 39. The normal current path is shown in red, going through a shorting box.

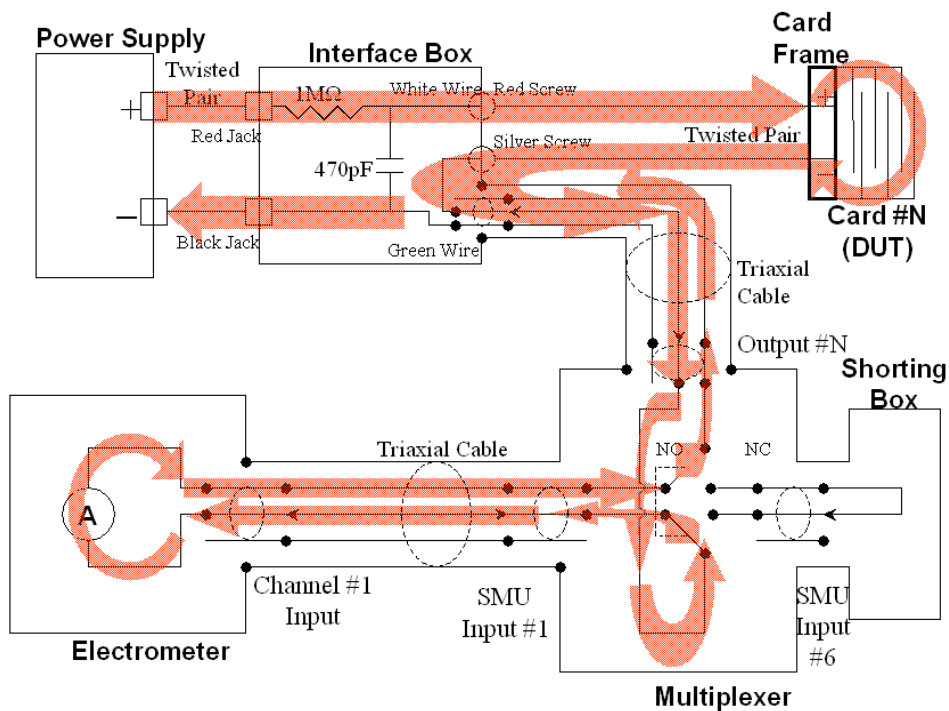
Figure 40. The current path, shown in red, obtained by “opening” the shorting box, and allowing the current to flow through the electrometer, was used when a device was being tested.

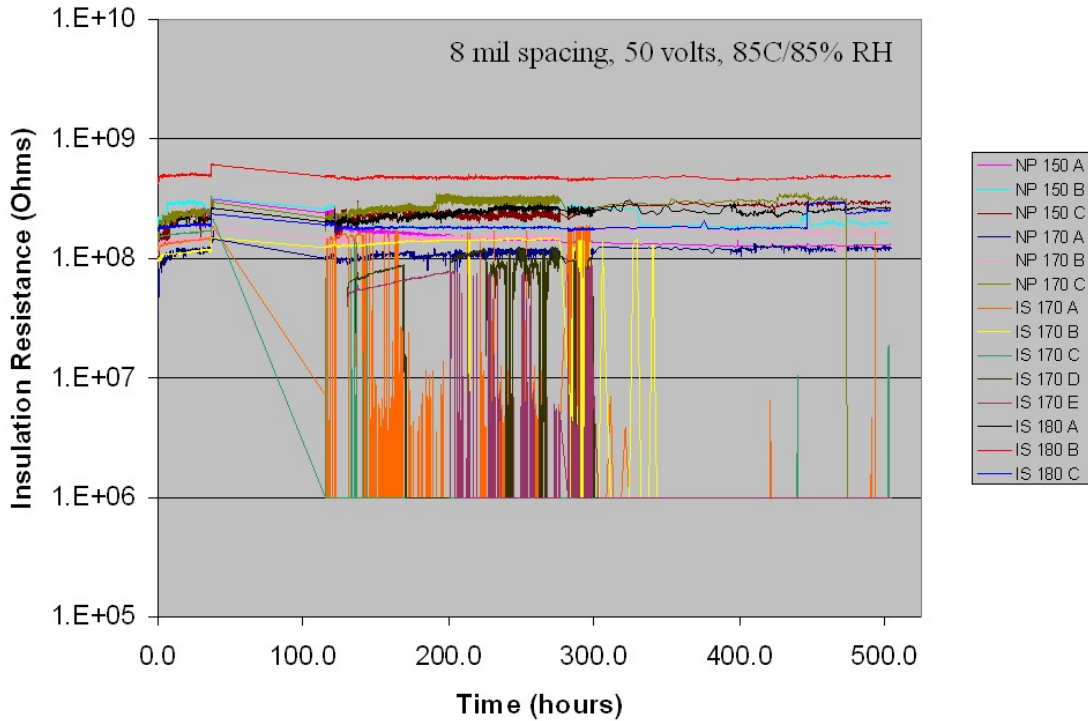
Figure 46. This plot shows the internal resistance of the PTH-planes in the powered samples. Isola samples, IS 70A and IS 70C, failed between 30 and 130 hours. The missing data section, seen as straight lines, was due to a power outage.

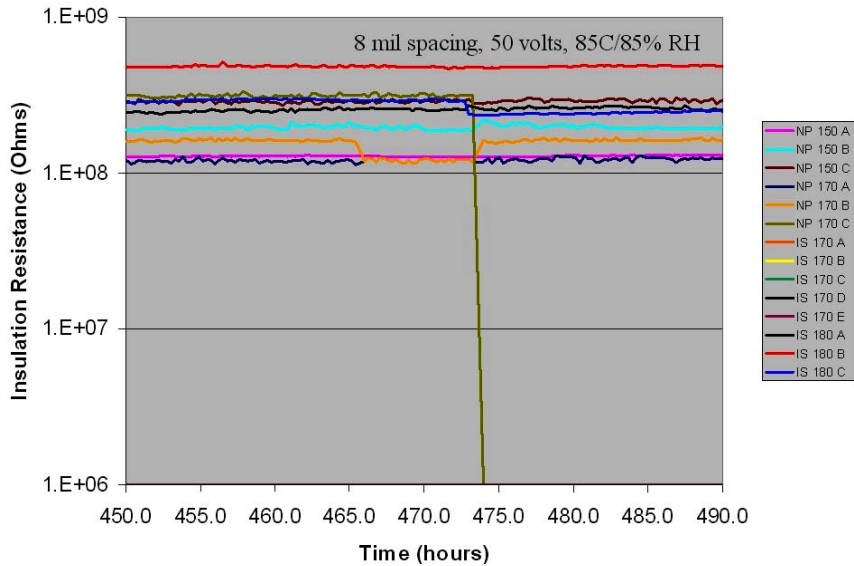
Figure 48. Close to the end of the 50-volt testing of the PTH-plane circuitry, 8 surviving samples can be seen above the lines above 1E8 ohms.

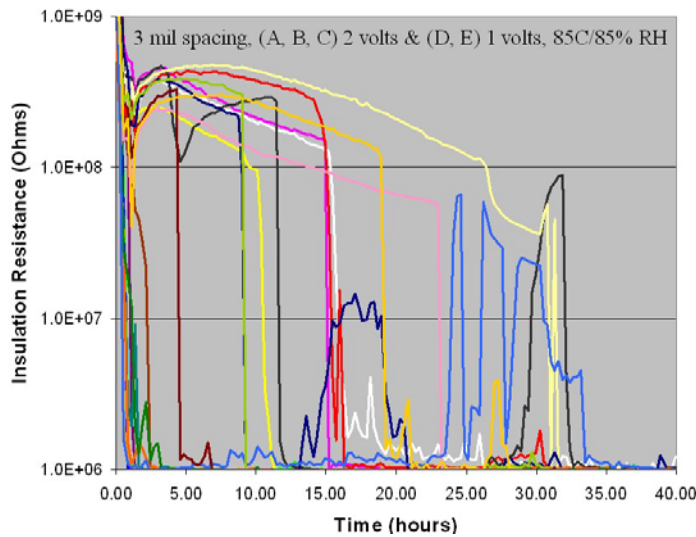
Figure 50. This plot shows the insulation resistance for the PTH-PTH XG samples up to 40 hours, at which time all had failed.

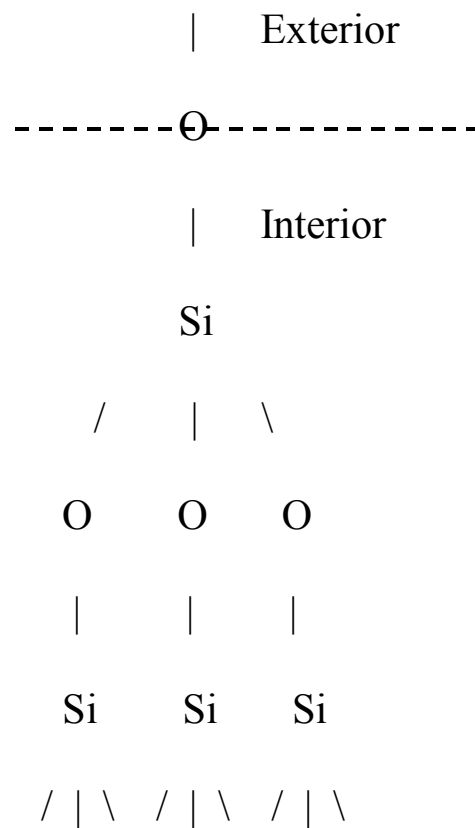
Figure 69. Schematic showing each dangling bond attached to a hydrogen atom.
