A COMPARATIVE STUDY OF CREMONA
FARM'S ANTEBELLUM TOBACCO
BARNs AND OUTBUILDINGS AS
RESOURCES IN REGIONAL CONTEXT

Michael Christopher Bryan, Master of Historic
Preservation, 2021

Final Project submitted to the Faculty of the Graduate School of the University of
Maryland, College Park, in partial fulfillment of the requirements for the degree of
Master of Historic Preservation
2021

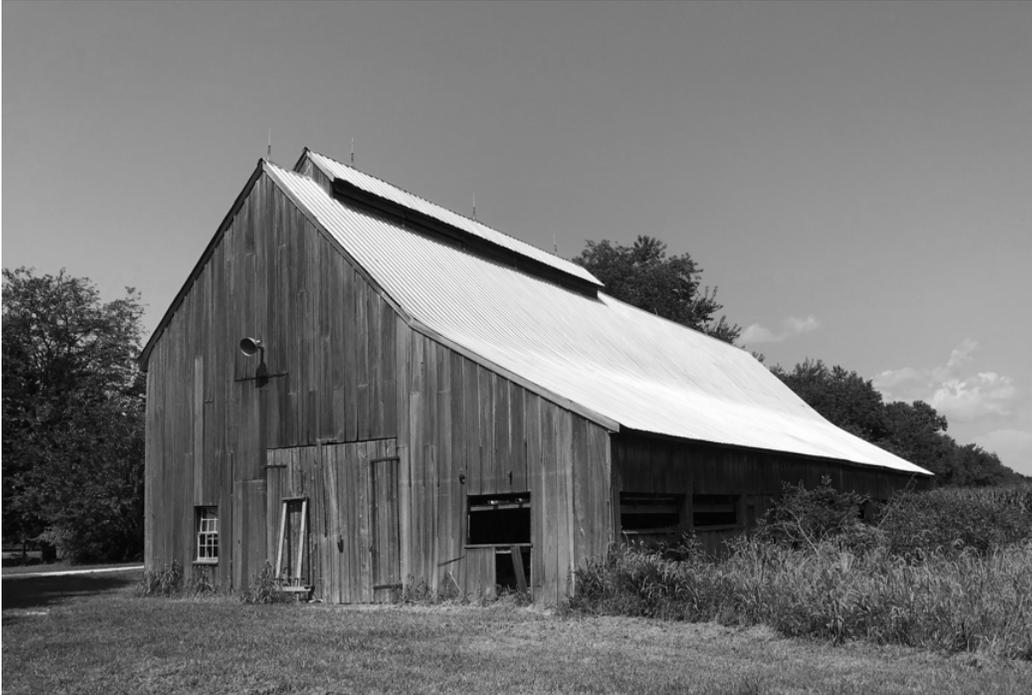
Figure 2. Cremona Barn 1, Southwest Elevation; the original portion of the barn is one-half of the gable-roofed section on the left.

Tobacco Barn Number 1 (Figures 2 and 3), dendrochronology dated to 1832, sits south of the Cremona's spine road and east of a spur road leading south, across Great Manor Creek, to the De La Brooke property. The structure has 24'-wide gabled ends on the east and west elevations. The north and south elevations of the original

barn measure 48'. Vertical board and batten siding clads the current exterior. A one-story shed extends along the south elevation.³³

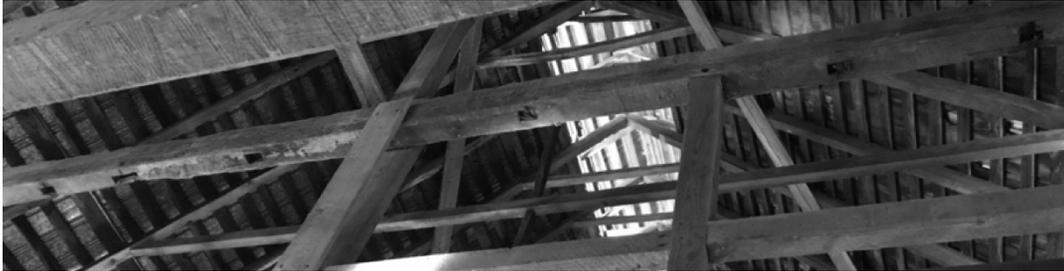
Figure 4. Cremona Barn 1, Ghost Mortises for Studs and Door Posts on East Girt.

at some point, and the east wall framing under the girt was removed. Nevertheless, mortise holes remain in the original girt (Figure 4), betraying the original framing pattern on that wall, which included an eight-foot-wide double door. While not

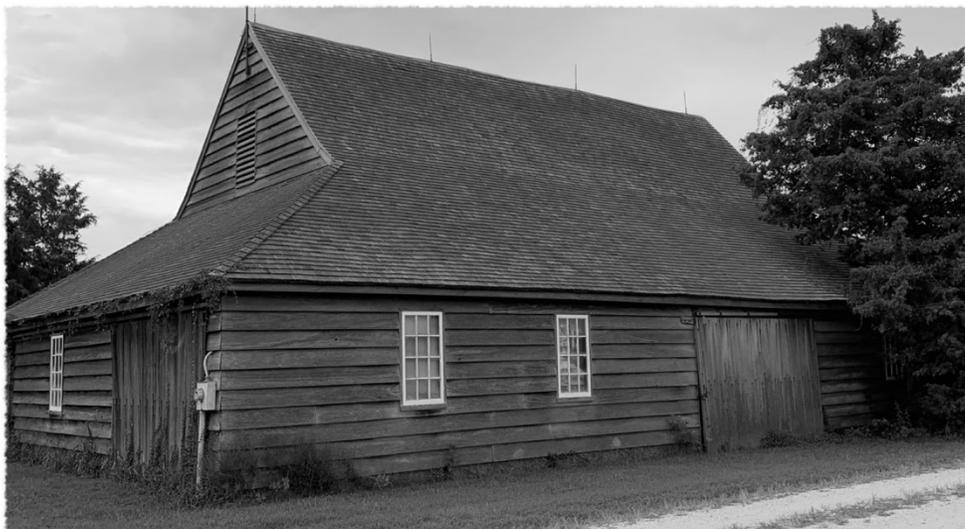
Figure 5. Cremona Barn 2, Northwest Elevation; the original gable-roofed section is now surrounded on all sides by later sheds.

The Cremona Tobacco Barn Number Two (Figures 5 and 6), dendrochronology dated to 1826, resembles Barn Number 1 in many ways. The structure is oriented with its shorter gabled ends to the east and west. It contains a coaxial plan with openings on every elevation. This barn currently contains sheds on every elevation creating a gable over hipped roof. As originally configured, the barn

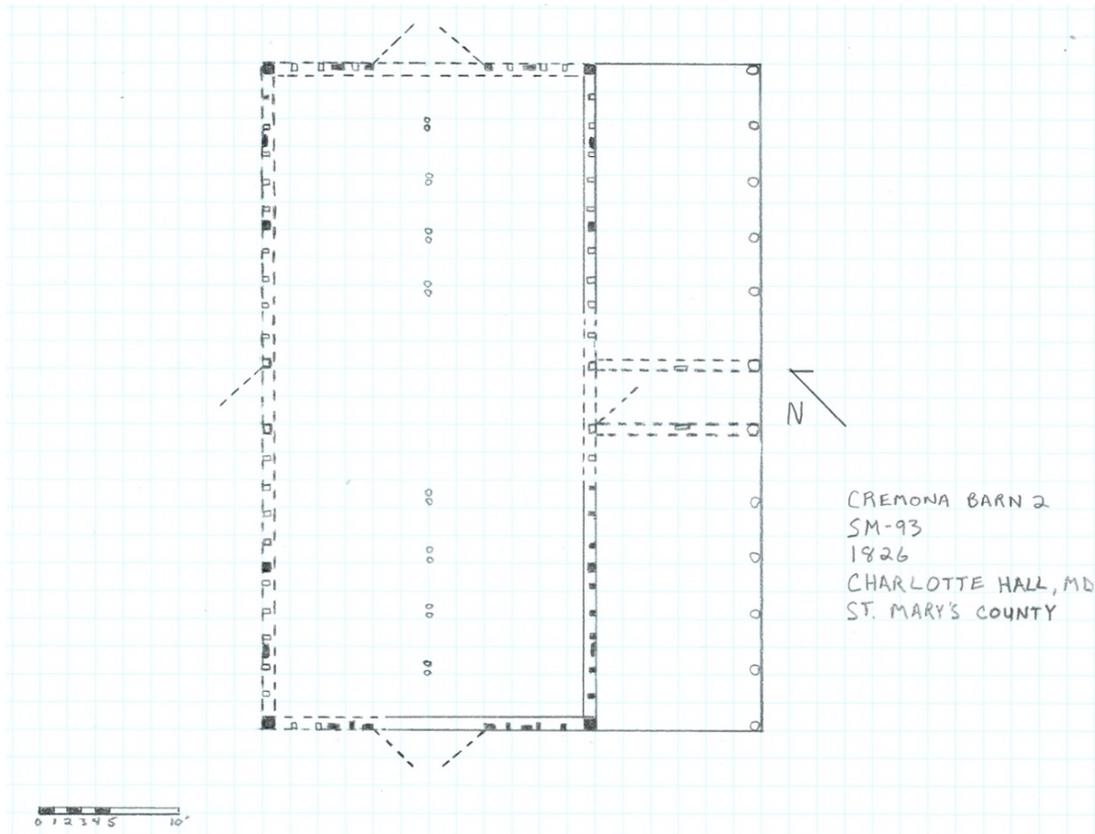
Figure 6. Cremona Barn 2, Plan View.

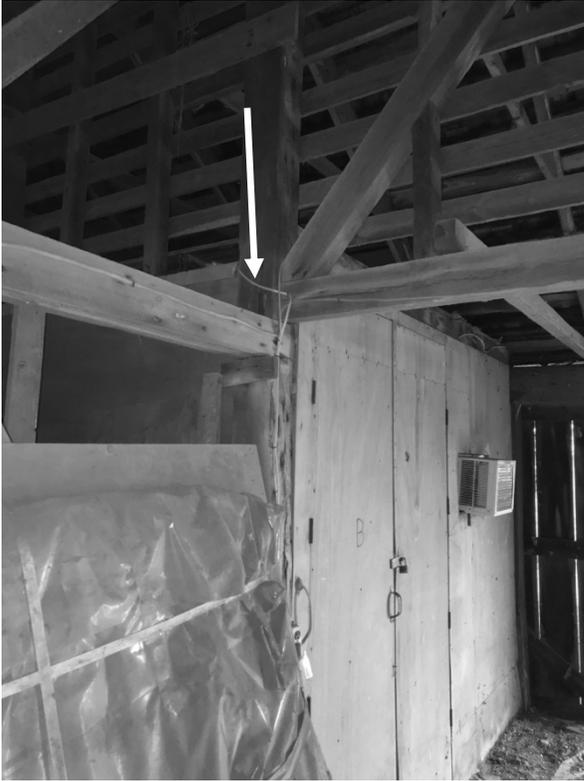
Figure 7. Cremona Barn 2, Ghost Mortise for Transverse Rail.

lower on the posts and are shorter (Figure 7). There is also no evidence of an original transverse sill across the barn despite the 48' length of this barn; however, some of the sills that might have revealed this have been replaced. These lower shallow mortises likely held horizontal rails for additional tobacco hanging capacity and provided added stability between the two long walls in lieu of an intermediate sill within the barn.

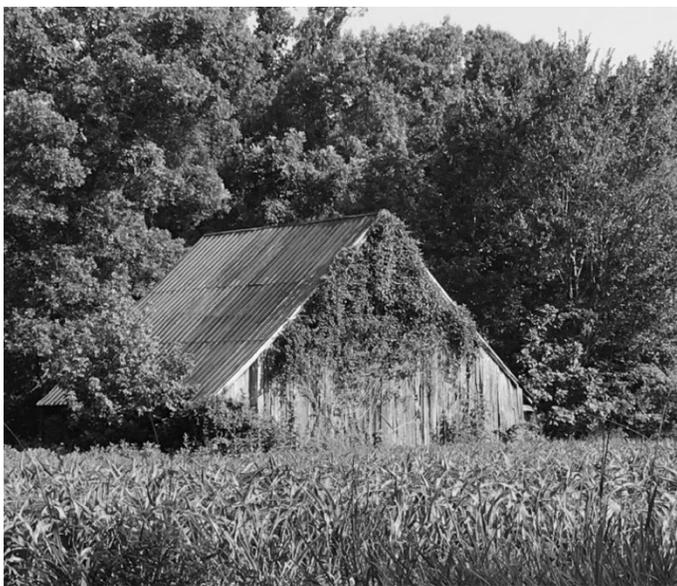
Figure 10. De La Brooke Barn, Southeast Elevation.

The De La Brooke Barn (SM-411) stands on what was once an adjacent property to Cremona and is now part of the Cremona property. The barn (Figures 10 and 11) is dendrochronology dated to 1797, with a footprint measuring 32' x 20' and a short span of 13'4" to the top of the plate. The barn is organized into four, eight-foot bays and four-foot rooms. Breaking with the traditional expectation, this barn contains double doors on the gable ends and contained single, off-center doors on the long elevations. These single doors were next to a single transverse intermediate sill

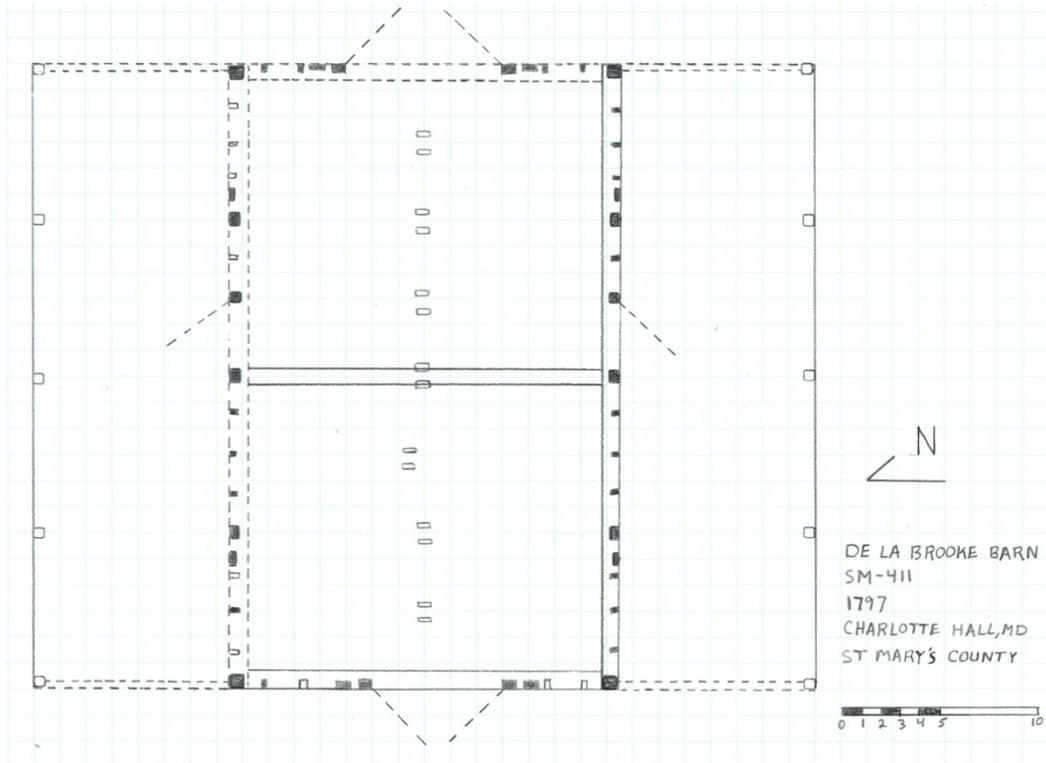
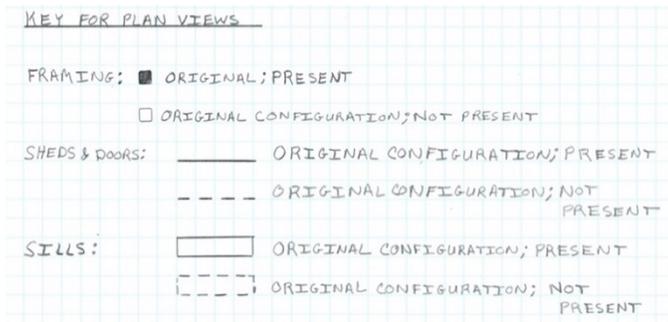
Figure 11. De La Brooke Barn, Plan View.

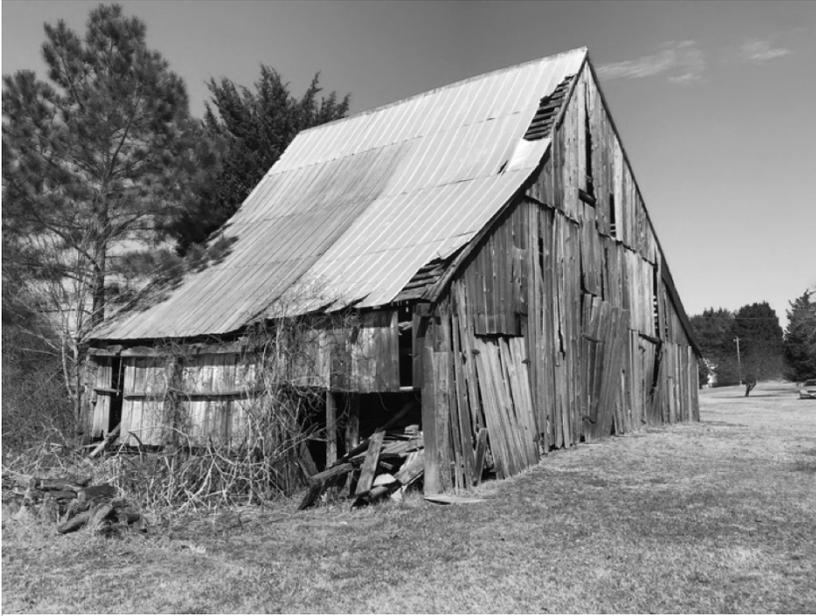
Figure 13. Buckler Barn, Southeast Elevation

The **Buckler Barn** (CT-1090) in Huntingtown (Figures 13 and 14) is small with an uncommon footprint at 18' x 28'. The barn is relatively short, as well, at only 15' 6" to the top of the plate; it is taller than De La Brooke, yet shorter than the 17'

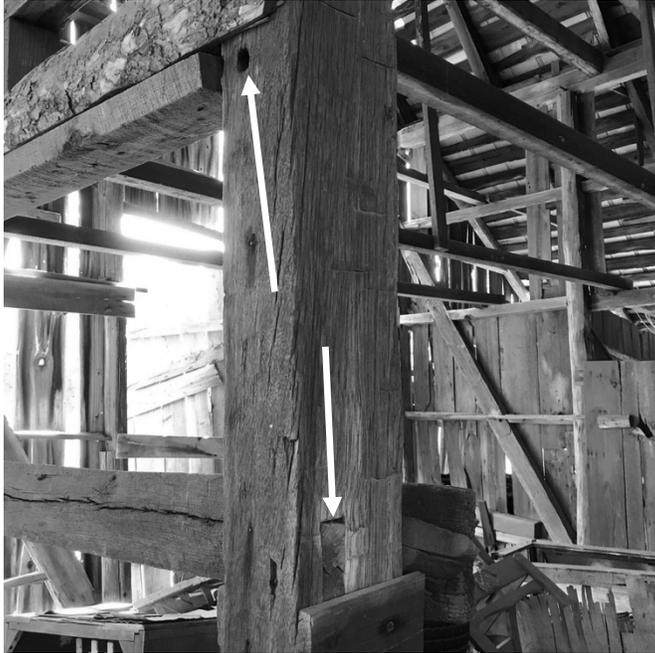
Figure 15. Buckler Barn, Used Pintle on North Wall Door Post and Mortise for Siding with Remnant of Tenon.

Centered single doors open on the gable ends, while off-center double doorframes open on the long walls. The double door frame on the north wall, away from the shed, contains used pintle holes, suggesting that a door once existed there. This doorframe also includes mortises for a rail to hang vertical siding. These mortises retain the tenon of a rail (Figure 15). Therefore, this wall was also sided at one time. The double door frame facing the south shed contains pintle holes that appear to have been unused. The apparently unused pintle holes, combined with the presence of siding on the wall facing the shed seem to quash the idea of this shed

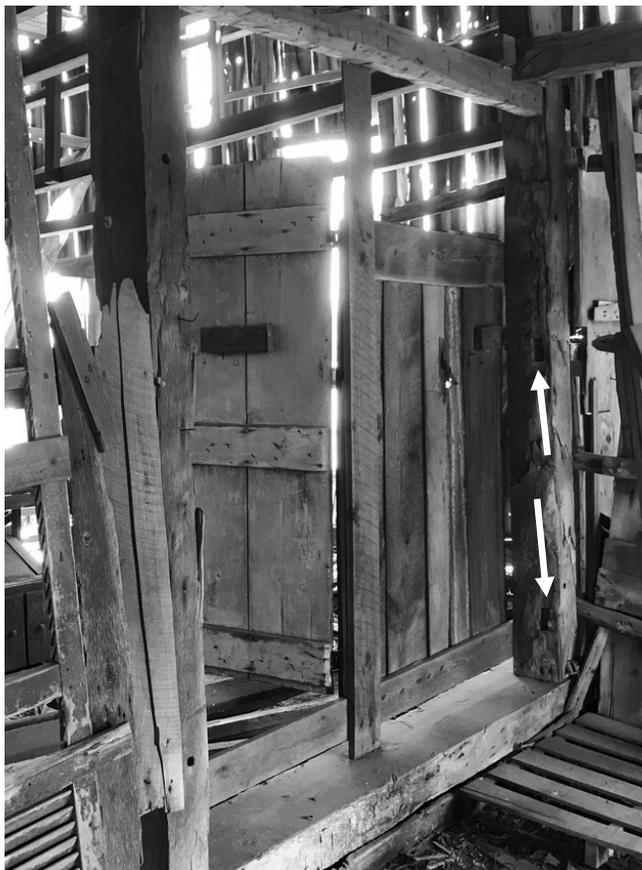
Figure 16. Buckler Barn South Doorframe from Shed Showing Riven Siding and ghost mortises on Door Post for Nailers Rails Across the Doorway.

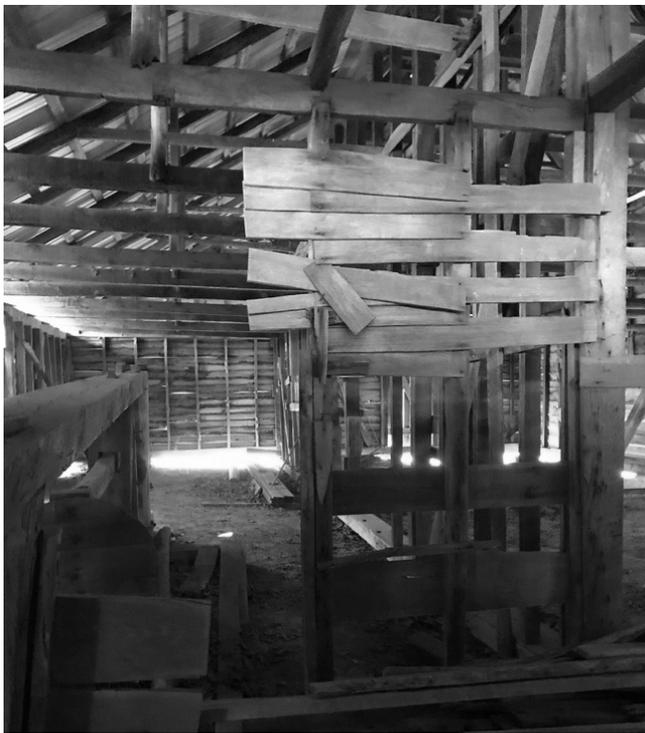
Figure 18. Plumer-Cranford Barn, View of Riven Clapboard Siding on Partition Between East and South Sheds.

Access between these sheds appears to have been limited. A riven clapboard sided partition (Figure 18) exists between these sheds, which is currently partial. No door framing exists, and it is presumed that this was once a complete wall. The eastern shed had no access to the core barn itself, which was sided on the adjacent wall. Prior investigators suspected this shed was used for stabling cattle or horses.⁴⁴

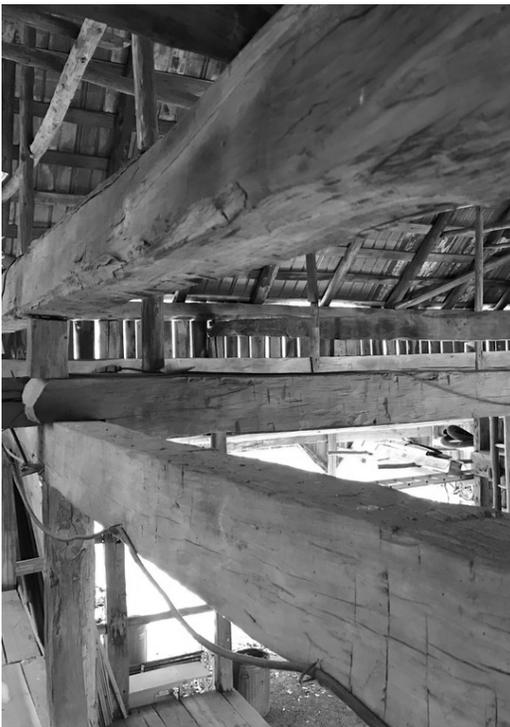
Figure 20. Half Pone Barn, Double Joist Framing Over Eastern Intermediate Sill Posts.

The bracing is irregular as well. The corner brace on the northeast corner, extending to the west, does not attach to the northeast corner post at all. It descends from the first post to the east of the corner post and appears to provide questionable structural support. It is typical for braces to descend from posts on the long elevations to the intermediate sills. That is not the case in this barn, which contains a pair of posts that ascend from each of the two outboard intermediate sills. The purpose for

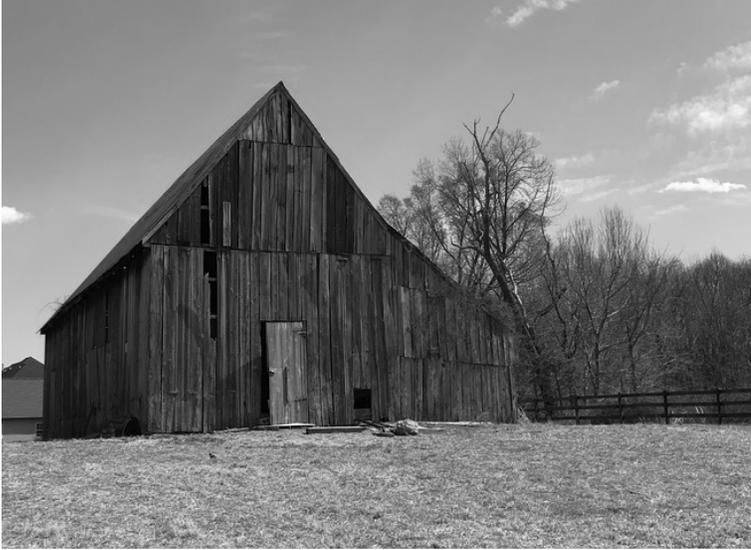
Figure 21. Vieley Barn, West Elevation.

The **Vieley Barn** (Figures 21 and 22) in Huntingtown appears to have no MIHP record. Presumably, it has not been investigated or recorded before. As such, this description includes a few additional details without being exhaustive. This barn measures 40' x 24' and is oriented on an east-west axis, and measures 15' 3" to the top of the plate. Originally, continuous sills rested on stone piers with posts forming five eight-foot bays. A single intermediate sill with braces connects the north and

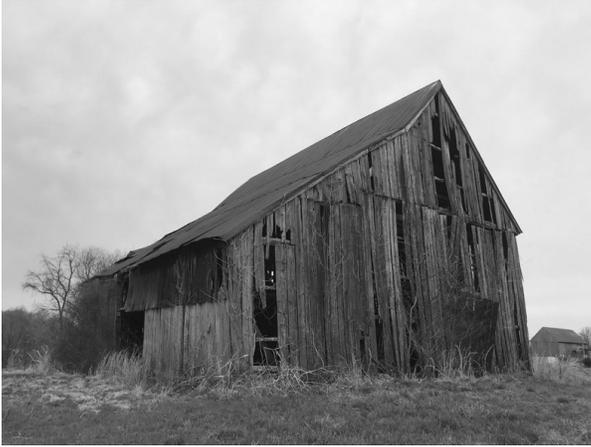
Figure 23. Trott Barn D, Southeast Elevation.

Trott Barn D (CT-1104) in Dunkirk (Figures 23 and 24) is almost a match of the Vieley Barn. The structure measures 40' x 24' and is oriented on an east-west axis. The bay, door, and shed configuration matches the Vieley Barn. There are

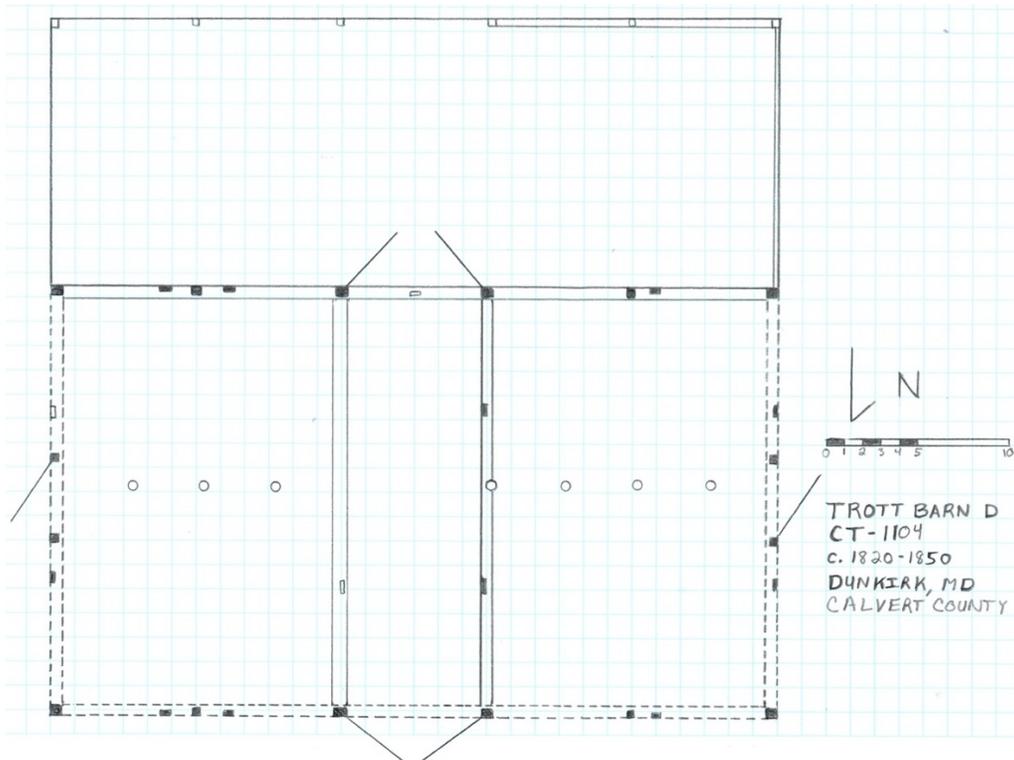
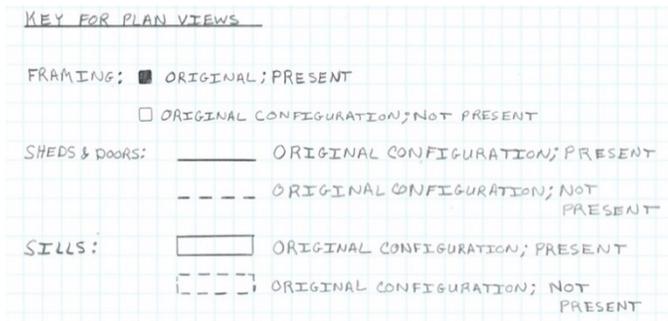
Figure 24. Trott Barn D, Plan View

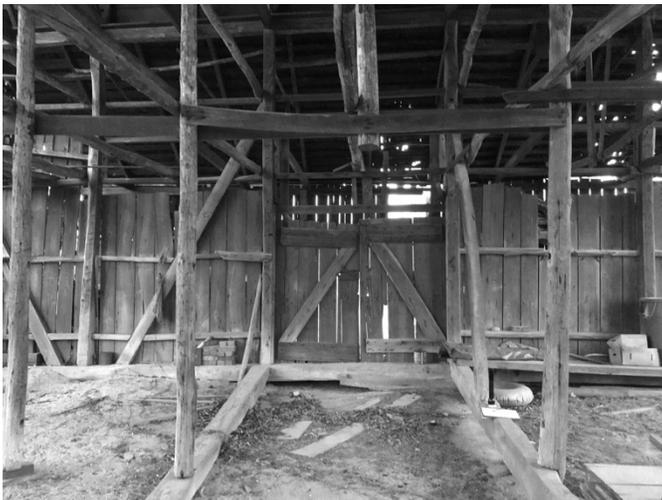
Figure 25. Trott Barn D, Center Aisle facing South and Showing both Intermediate Sills and Double Doors to Shed.

three appreciable differences in the main barn. One difference is that Trott Barn D measures 16' 3 1/2" to the top of the plate, one foot taller than Vieley. The Vieley Barn also has down braces attaching to the corner posts only, while down braces on Trott Barn D descend from both the corner posts and the principal posts. One brace in that pattern was never installed. The final difference is that the Vieley Barn contains one intermediate sill, while the Trott Barn D contains two intermediate sills that flank the center bay (Figure 25). The Trott Barn D intermediate sill to the west of the center bay stands on its side, 10 inches tall by 5 1/2 inches wide. It attaches to two down braces.

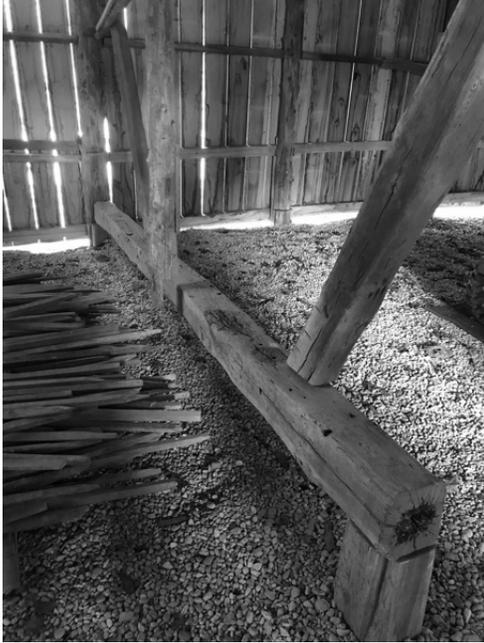
Figure 27. Dawson Barn, Intermediate Sill with Earthfast Posts.

Above the plate, the common rafters are spaced at two-foot intervals and rest on a flat false plate. A single row of round tier poles descends below the roof peak at four-foot intervals. This barn, also suspected to have been raised between 1820 and 1840, may be a good example of a builder trying to provide easier access to the barn by using post-in-ground rather than a continuous sill, reminiscent of the Allstan

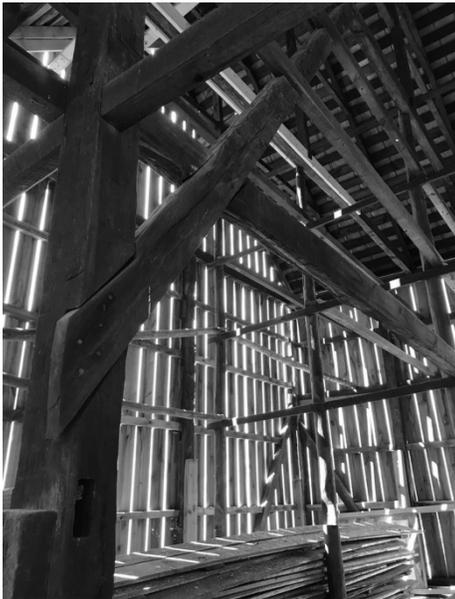
Figure 29. Hallowing Pt. Barn A, Upbrace Connecting to Post.

The barn contains no intermediate sills, but it does contain a brace (Figure 29) that is half-dovetailed and nailed into the post on the western side of the southern wall's central bay and rises to the joist above. Single doors existed on each gable end and on the north long elevation. The doors on the gable ends are now missing and

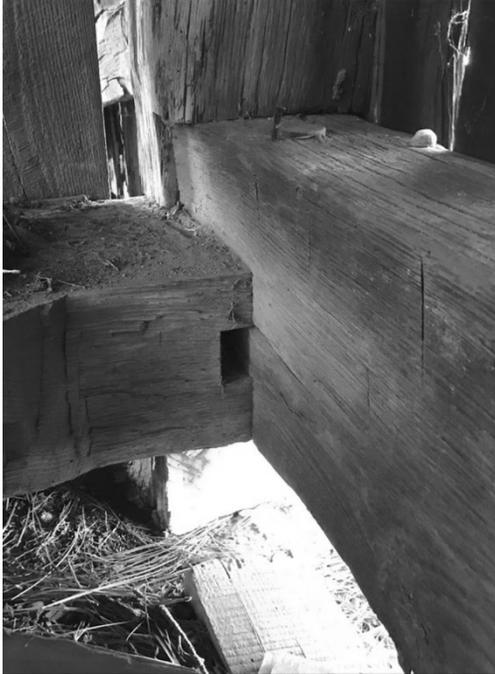
Figure 30. Buckler Barn, Southwest Corner Post, showing the mortise in the side wall sill, with a peg through the end sill, and the lapped corner post.

Examples of highly unusual joinery were discovered in four Calvert county barns. These joints occurred where gable and long wall sills connect with corner posts, and sometimes where sills, intermediate sills, and posts connect. In some of the barns, a similar joint condition was found at the intersection of the plate/principal post or plate/corner post/girt. Typically, the connections in these locations are standard mortise and tenon or lapped joints, both of which would be pegged. In this case, the shorter sill -- either the gable or intermediate -- was laid on its side so that it is tall and narrow. The shorter sill joins the side wall sill, which is the same dimensions but oriented so that it is short and wide. The short sill is lapped over the long sill with a tenon cut

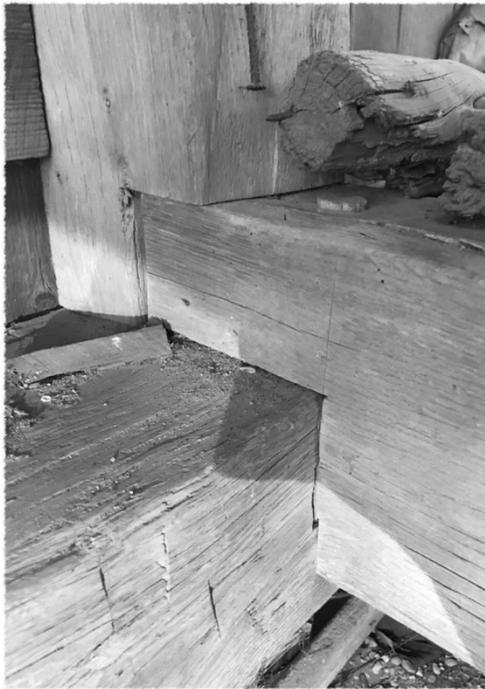
Figure 31. Trott Barn D, Southwest Door Post, showing intermediate sill lapped and tenoned into side wall sill.

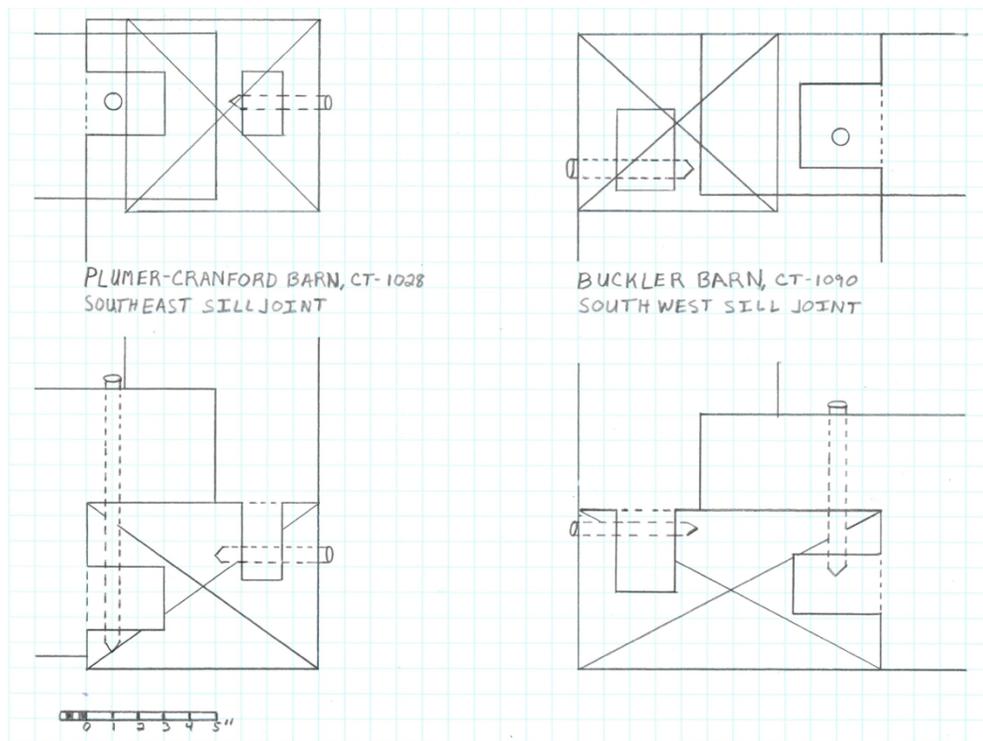
Figure 32. Plumer-Cranford and Buckler Barn Clenched Joints, in plan and section; edges of sills, posts, and pegs not visible to the eye rendered as dashed lines.

below the lapped portion of the sill. The tenon is inserted into a mortise in the long sill. The whole joint is pegged through the top of the lapped portion of the short sill. The post is lapped around the short sill and tenoned into the top of the long sill, which is pegged in place through the back of the joint. The Buckler, Plumer-Cranford, and Trott Barn D barns (Figures 30-32) all contain this clenched joint. The Vieley Barn has the same joint, but is not double pegged, as it is missing the peg through the top of the sills. The Vieley Barn also has a unique variation of this joint at the plate level, where the tenon and the lapped portion of the post extend nearly a foot beyond the top of the plate, resembling rabbit ears (Figure 33).

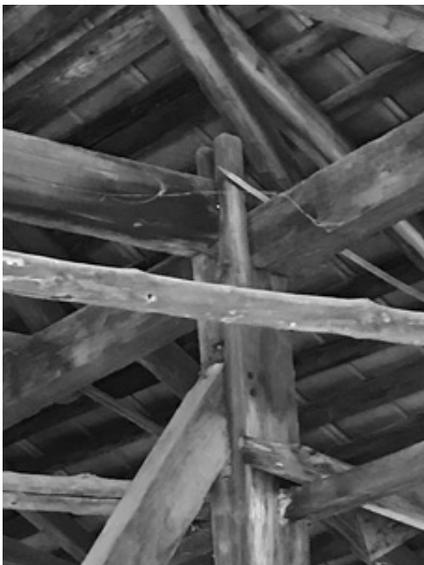
Figure 33. Vieley Barn Clenched Joint at Plate with "Rabbit Ears."

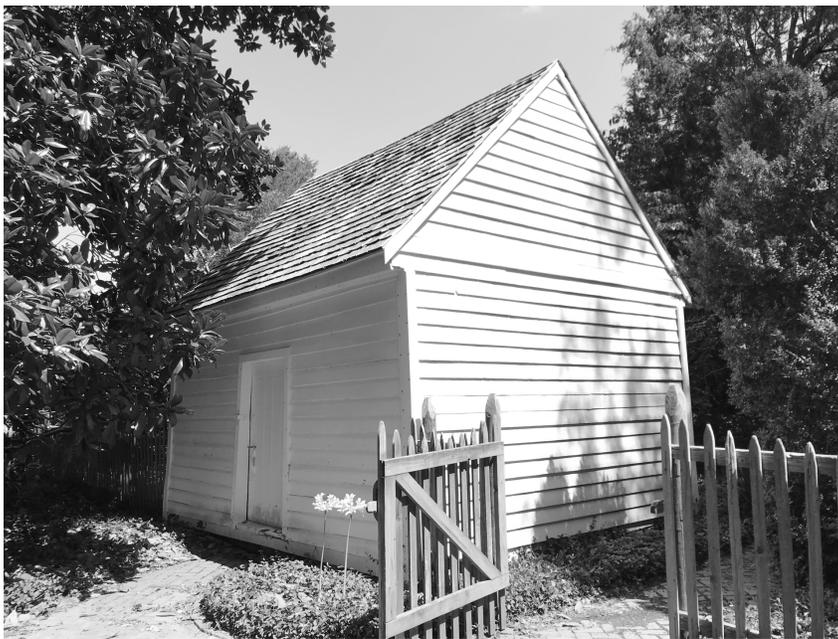
Figure 34. Cremona Meat House, Northwest Elevation.

Cremona's meat house (Figure 34), dendrochronology dated to 1830, is a single-story, side-gabled frame building, resting on a brick foundation. Rectangular rather than square at 14' by 16', the building is large compared to the regional pattern for Chesapeake meat houses. The building is sheathed with wooden weatherboards. The north façade contains a centered single bay with what appears to be an original

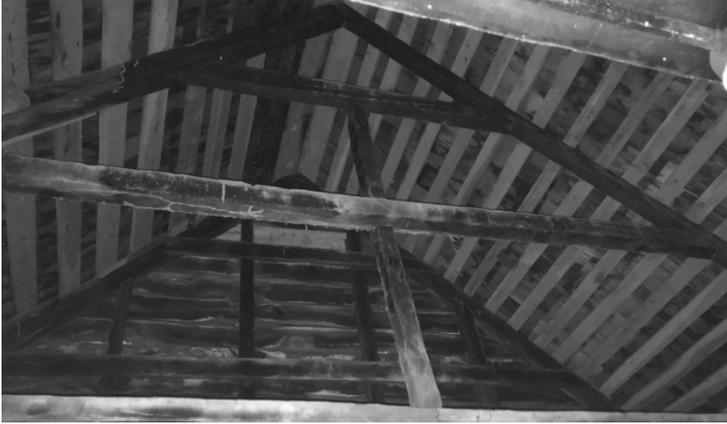
Figure 35. Cremona Meat House, Collars on Roof Framing for Hanging Meat.

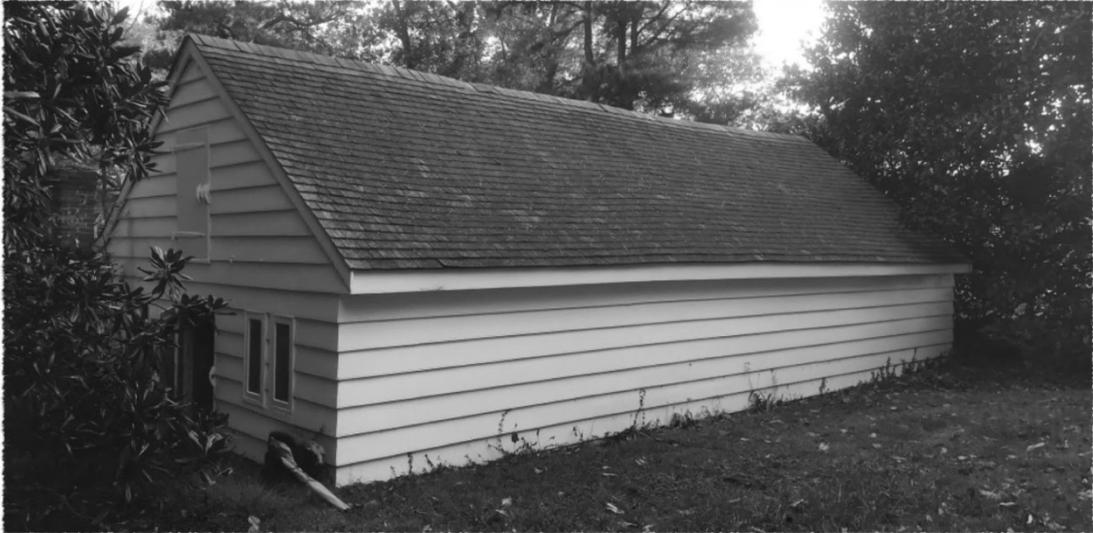
Figure 36. Cremona Livestock Barn, Northeast Elevation; the siding was renewed in the 1930s, and a low shed was added running along the south wall.

A front-gabled livestock barn at Cremona (Figure 36), dendrochronology dated to 1831, demonstrates the same early 19th-century construction techniques, such as pegged mortise and tenon joints, as the tobacco barns and meat house. The lumber is hewn and more roughly dimensioned than the other structures, as is expected in such a structure. Posts for the stalls, which are hewn into a round dimension are joined into hewn joists overhead. The structure's foundation utilizes earthfast posts, which Orlando Ridout V suggested was generally the case for livestock barns, given the available evidence. While cows and pigs often roamed freely in the Chesapeake region, especially until the end of the 18th century, these structures were often used for fattening pigs before slaughter and for affording better conditions for milking cows. Given the low height of this structure, it is more likely that it housed these

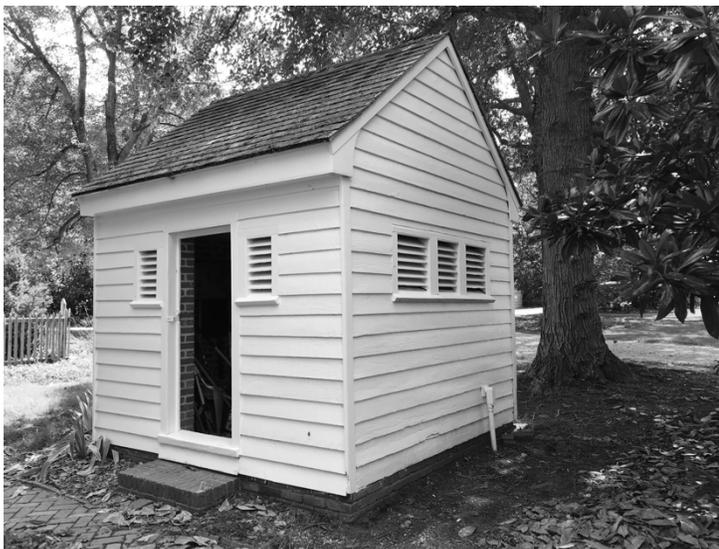
A presumed dairy (Figure 37) is located between the meat house and the kitchen wing of the manor house. This relative positioning was typical. Like the meat house, this smaller, square (10.3' x 10.3') structure is side-gabled, this time with an east façade. These dimensions fit neatly within the range of comparable structures in the 1798 Federal Direct Tax for St. Mary's County. External appearances suggest that this building's integrity is largely lost. Indeed, it appears to be a modern structure, as the interior walls are covered in brick and the ceiling is covered in concrete.

Floorboards cover the ground, and it currently used for tool storage.

Figure 37. Suspected Dairy, Northeast Elevation.

A few details indicate that the building likely dates to the Thomas period, however. First, a narrow gap between the door and the edge of the interior brickwork reveals a hewn doorframe. This gap extends overhead,

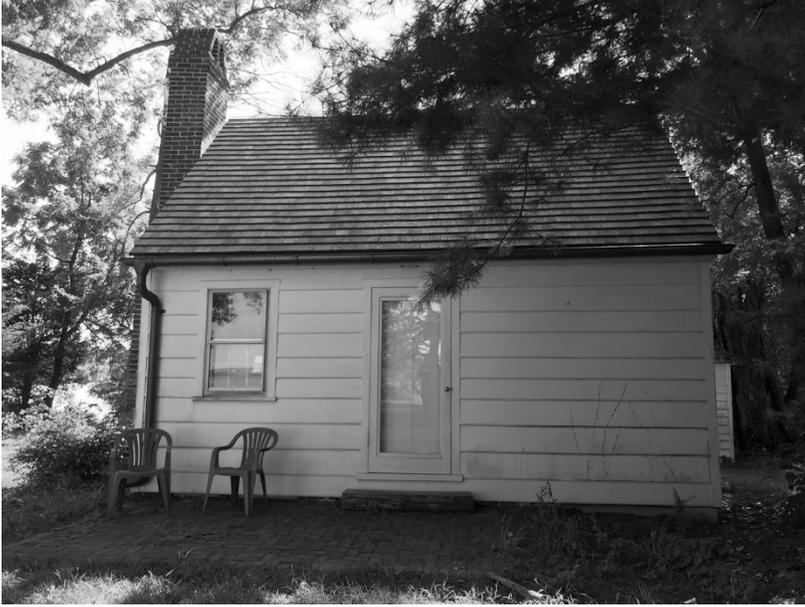
Sam's Cabin (Figure 38), a framed structure, has long been suspected as a slave quarter. It, too, possesses the side-gabled style of the meat house and the dairy, but is much farther removed from the Manor House, which was common. Its two-bay east façade contains a small window and a door. An exterior brick chimney rises

Figure 38. Sam's Cabin, East façade.

along the south elevation. Its name comes from a former occupant, Sam Dotson, who lived in the structure after emancipation, but who also had been enslaved on the property. The structure, which is currently occupied, does not offer sufficient access to investigate further. However, an archaeological investigation of the surrounding yards conducted in 2015 recovered domestic refuse generally dating to the second half of the 19th and the early 20th centuries.⁵³

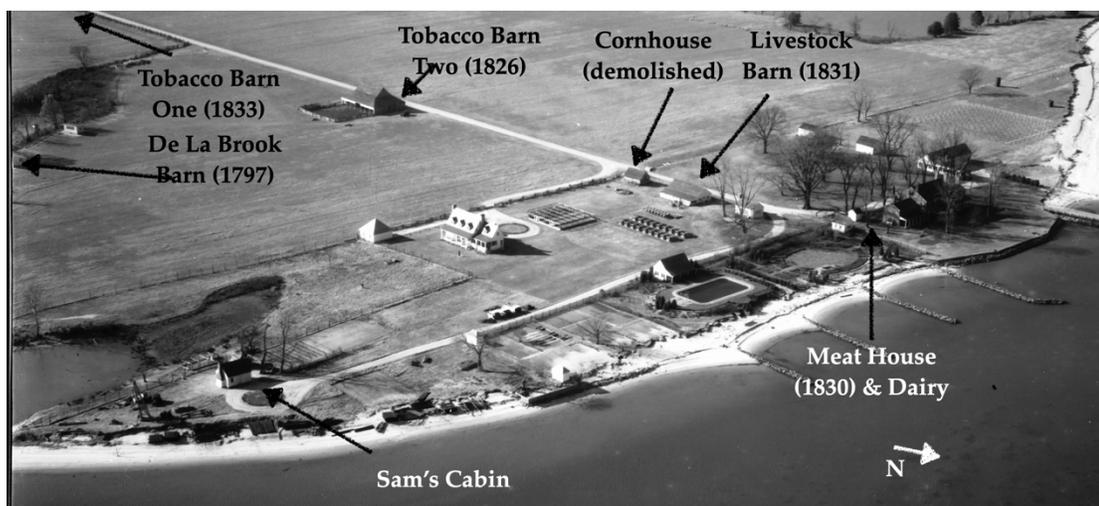
Farther afield (Figure 42) from the domestic core sits Cremona's livestock barn. Its activities began the transition to the agricultural, with applications relative to

the fields, yet it could supply the activities of the dairy and possibly the meat house. As such, this was a transitional structure, hierarchically. The same was true for the next structure, the cornhouse, which is demolished but clearly identified in photographs from the 1930s. It was nearest to the fields and more agricultural in nature. While its contents could still supply activities in the kitchen or possibly the livestock barn, it would have benefitted Thomas to shorten the transit distance from field to storage. Beyond the cornhouse, amidst the fields, Tobacco Barns 2 and 1 stand. Wholly agricultural, they are fully disconnected from the operation of the Manor. This functional hierarchy became a widespread, standard practice amongst the class of landowners in the Chesapeake Tidewater region who had sufficient means to push work tasks out of the home. At its heart this hierarchical relationship was driven by the nature of the tasks and is demonstrated clearly at Cremona.

Figure 42. 1933 Aerial, Cremona Archives; depicting Thomas era structures within the burgeoning Colonial Revival landscape created by the Davidsons.
