National Register of Historic Places Registration Form

Historic name: Ohio & Erie Canal Southern Descent Historic District (Discontiguous)

Ohio & Erie Canal Southern Descent Historic
District

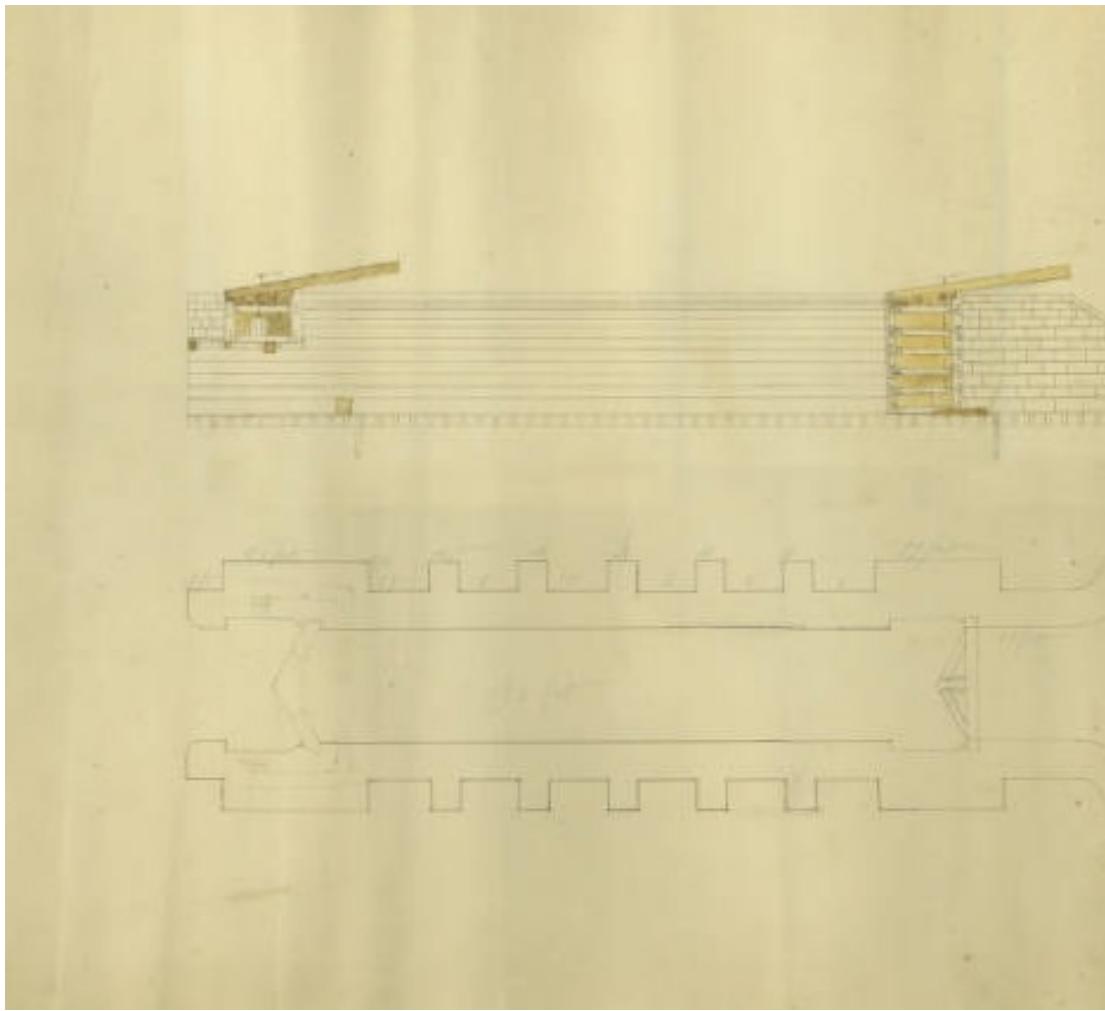
Figure # 2

Drawing of an Ohio and Erie Canal lock in section (above) and plan (below).

The lift locks were the most numerous and among the most complicated of the O&E Canal’s features. Their function was to raise and lower boats to compensate for changes in grade of the adjacent ground level, and their basic principles had been worked out in Europe and Britain by the early 18th century. Locks on all the Ohio canals were similar in design but varied somewhat in details and dimensions. Each lock was constructed on a foundation of closely-spaced heavy squared timbers between which clay puddling was placed. The timbers were perpendicular to the axis of the lock and then floored with heavy wood planks. This provided a solid foundation upon which the lock walls and associated features such as the tumble were built. The internal portions of the walls typically were built of large stone rubble, while the visible exterior stone was always dressed and finished, often with hammered margins or beveled top edges. The dry-laid finish stones were carefully dressed to seal out water as much as possible; the wood lock floor and the supporting timbers were intended to remain constantly wet to avoid dry rot; but the puddling helped to avoid too much water loss through the floor. Dimensions varied, but typical lock chamber measurements were not less than about 15 by 90 feet. (**Figure #2**)

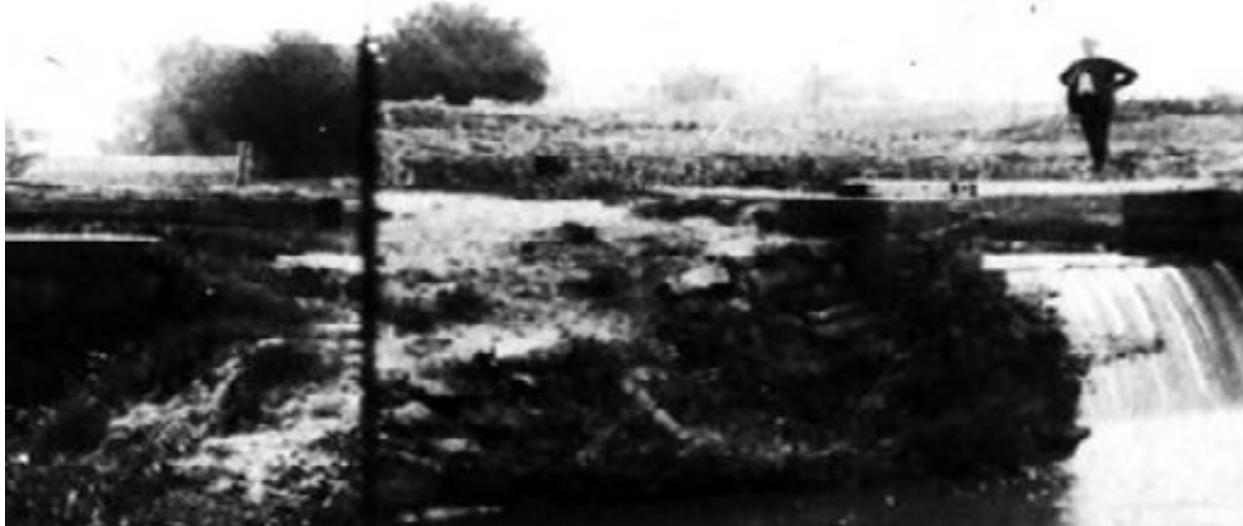
Figure # 3

Historic photo of Lock # 8 (Bibler's Lock) near the village of
Baltimore, Ohio.

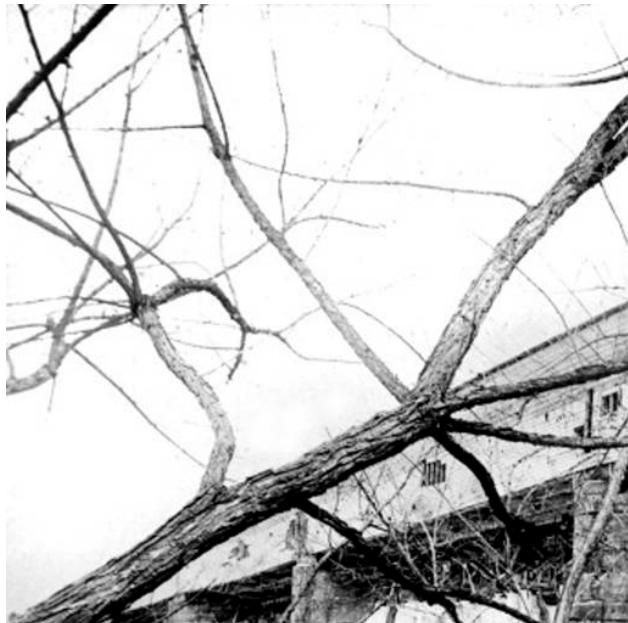
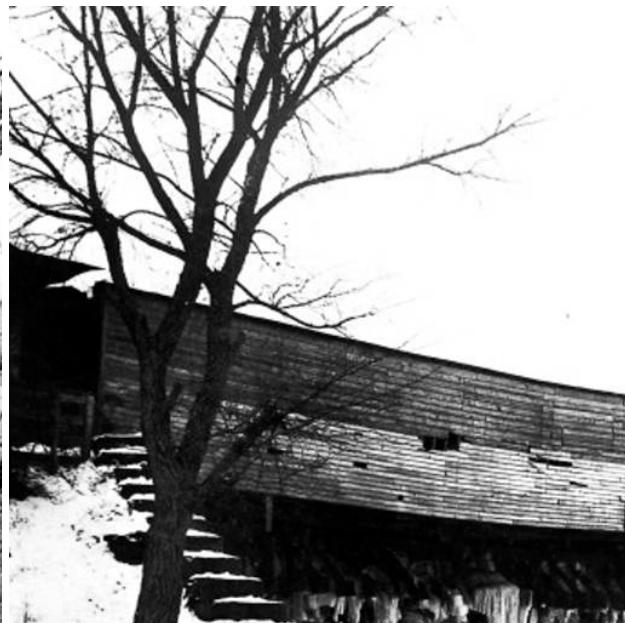
Figures # 7, 8

Two historic photos from 1896 showing the aqueduct over the Scioto River at Circleville, Ohio.

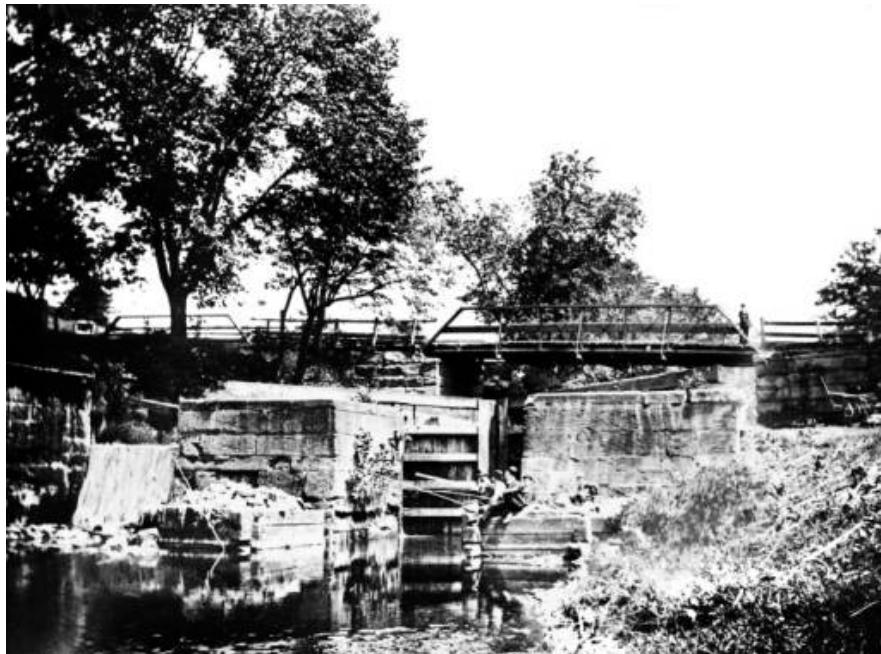
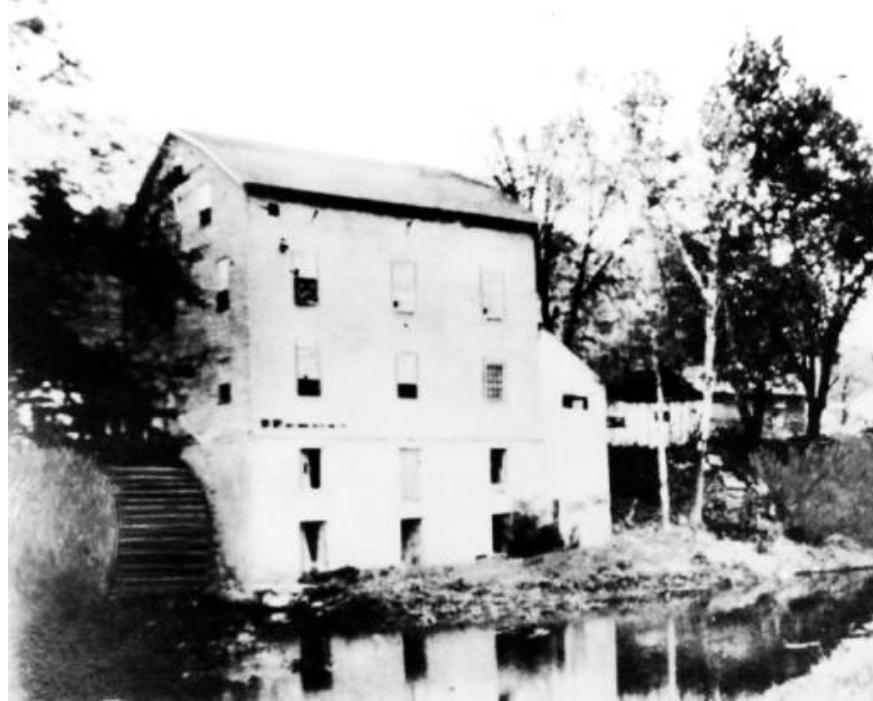
Figures # 9, 10

Two historic views of West Portsmouth c. 1900. The top is a photo of Lock #50 and the lower of a mill there powered by water from the canal.

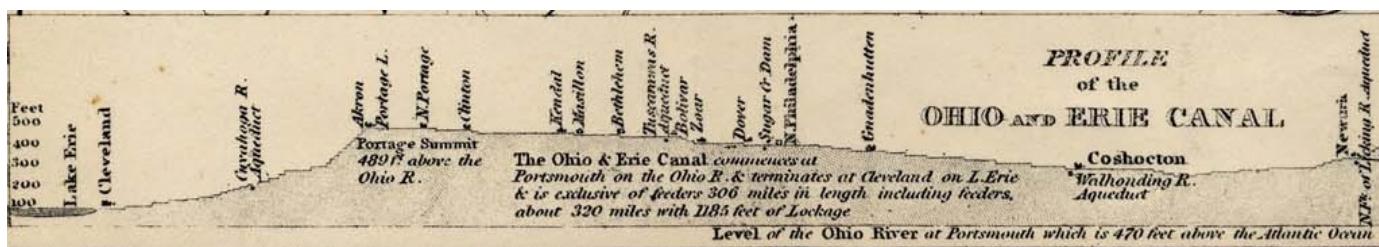
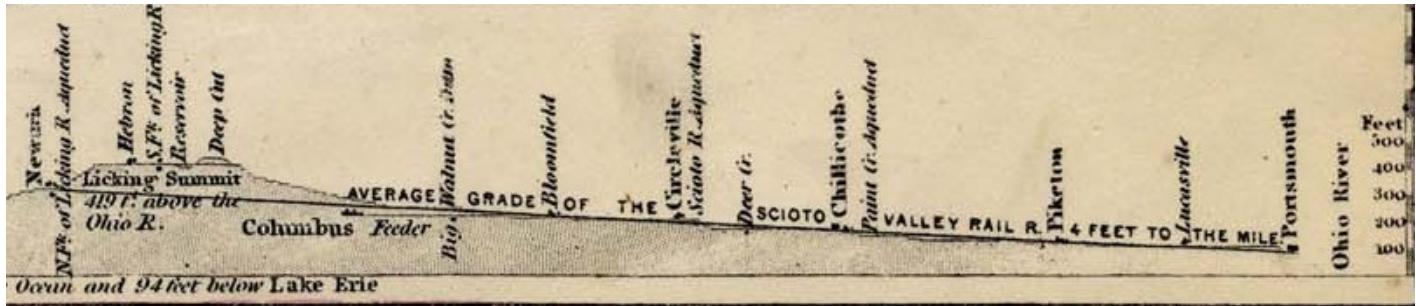
Figures 11, 12, 13

An 1850 drawing illustrating the profile of the Ohio and Erie Canal from Lake Erie to the Ohio River (top); northern section of the canal (middle); and the southern descent from the Licking Summit in Licking County to the Ohio River at Portsmouth (bottom). Canal features of the southern descent are the subject of this nomination.

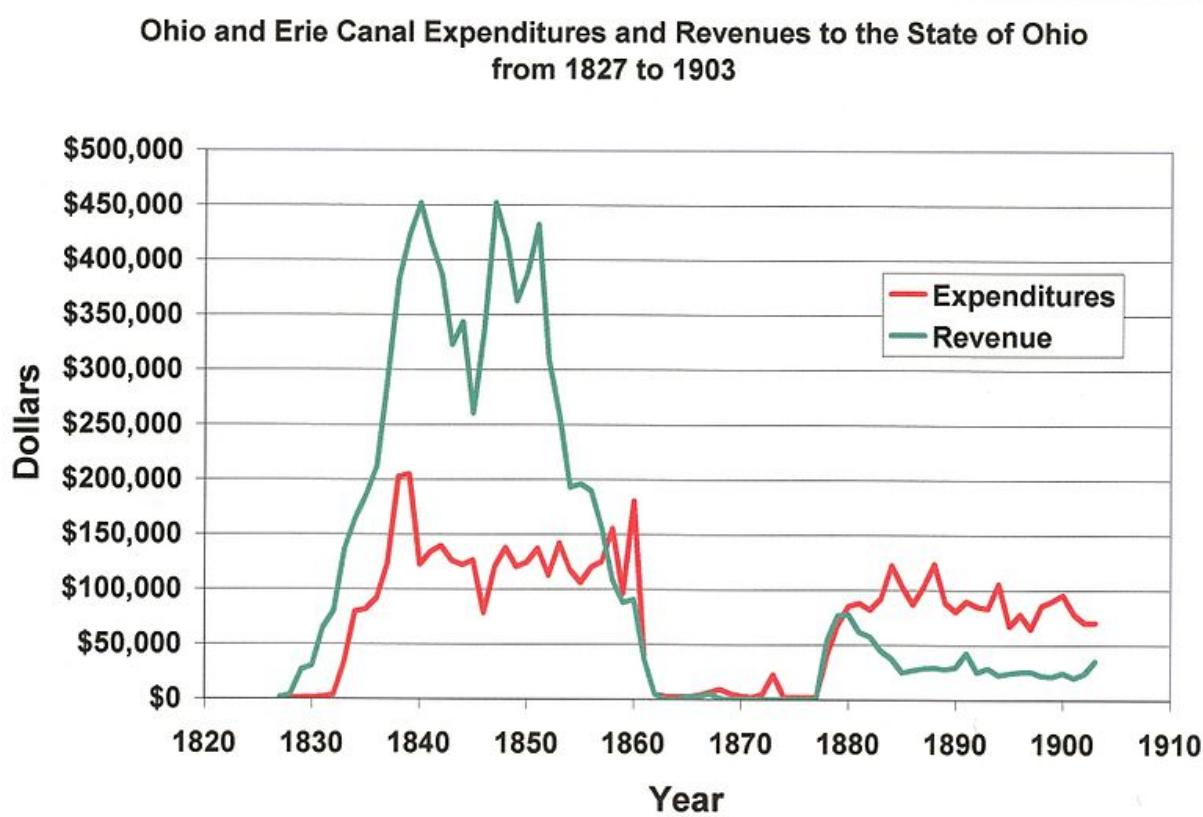
Figure # 14

Ohio & Erie Canal Expenditures and Revenues to the State of Ohio, 1827-1903.

boat tolls (**Figure 14**). As Figure #14 shows, from an overall perspective the O&E Canal covered its costs quite well, even in earlier years when revenues plunged for various reasons. During the lease to private interests between 1861 and 1879, of course, there was no revenue, but apparently the state had to step in and do considerable repair work once it reclaimed the canal. From then on until final abandonment in 1913, the revenue and expense figures reflected the increasing effect of railroad competition, but also the fact that income from water sales and water power leases was part of the revenue picture even as boat tolls continued to slide.

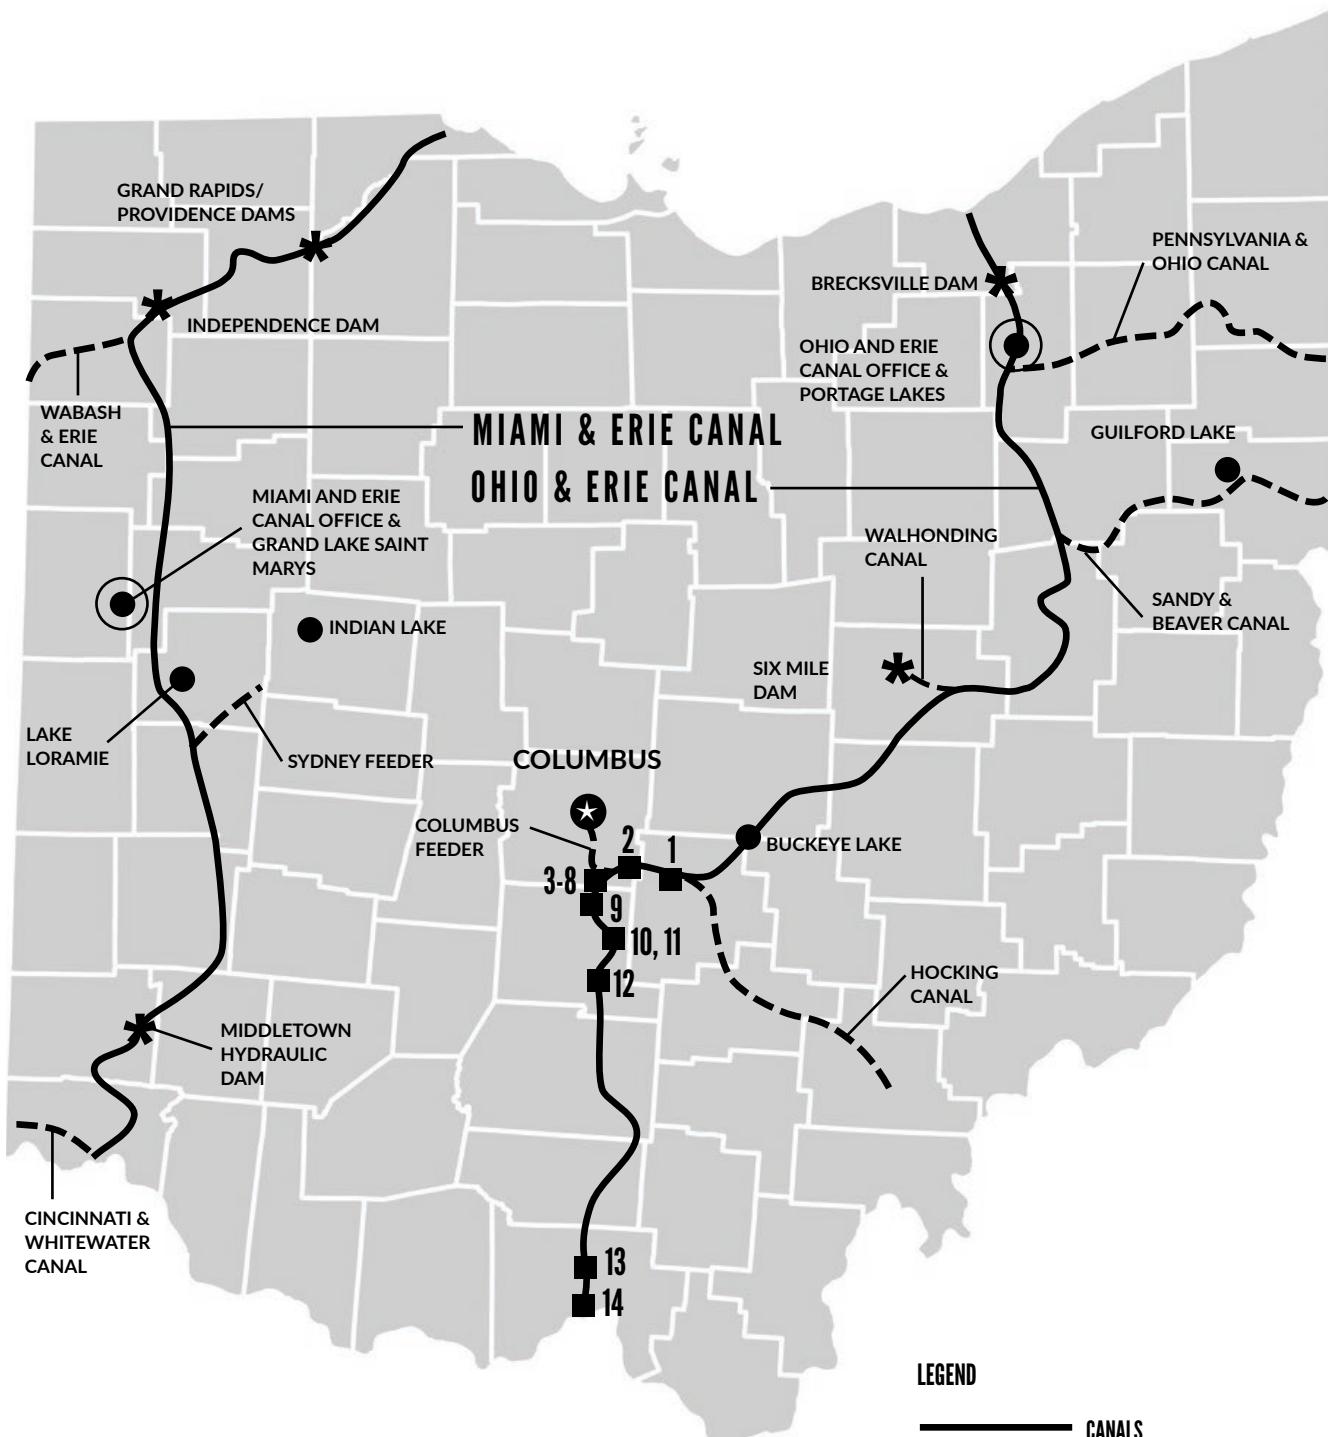
LEGEND

- CANALS
- - - FEEDER CANALS
- CANAL RESERVOIRS
- * LOW DAMS
- () OPERATING FACILITIES
- [] FEATURE LOCATION
