Compton Bassett

Balancing Preservation and Change A Cultural Landscape Report

UNIVERSITY OF MARYLAND
SCHOOL OF ARCHITECTURE, PLANNING, & PRESERVATION
GRADUATE PROGRAM IN HISTORIC PRESERVATION
STUDIO | FALL 2012

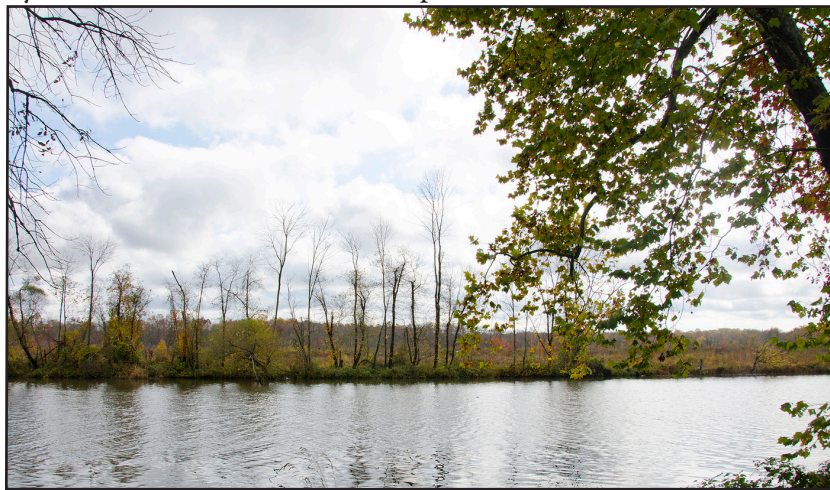
The Patuxent River forms the eastern boundary of the property and separates eastern Prince George's County from western Anne Arundel County. The Patuxent River feeds into the Chesapeake Bay and is the largest river located entirely within the State of Maryland. The Patuxent River flows from the Piedmont region of Maryland into the Chesapeake Bay, which is approximately fifty miles downstream from Compton Bassett.

Above: The Patuxent River, a defining feature of Compton Bassett's landscape, as it appears from the Compton Bassett river landing.

Despite recent efforts by the Natural and Historical Resources Division of M-NCPPC (NHRD), the river's ecosystem remains in poor condition. Many invasive species have been removed or

culled, and NHRD has replanted native wild rice species along the river's banks, improving the river's ecosystem. Erosion remains a significant problem and has likely resulted from a combination of damaging historical agricultural practices and modern development. State and county level reports have continued to evaluate the river's conditions in order to implement restoration and protection plans to manage this important resource.

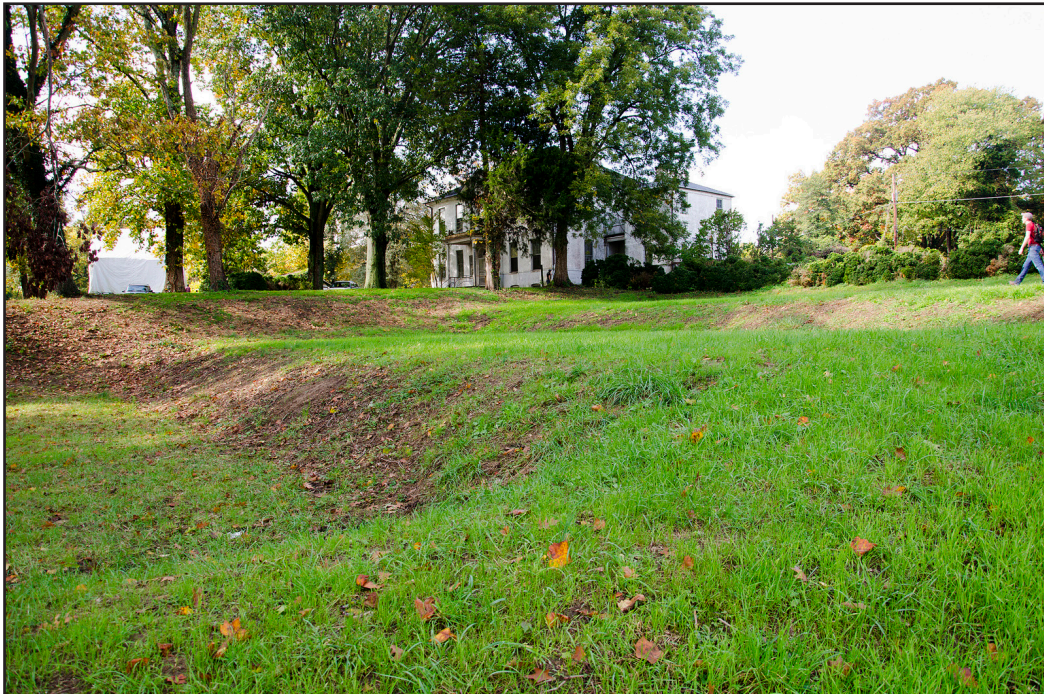
The site also contains two collections of terraces, which again reflect how inhabitants have altered the topography. To the east of the Main House there is a multilevel terraced garden. There are also several terraces south of the Chapel which may date to an even earlier period of construction. Both collections of terraces are in excellent condition, remaining well defined, and lacking any significant erosion, and do not require immediate maintenance.

Above: Terraces located to the north of the Main House.

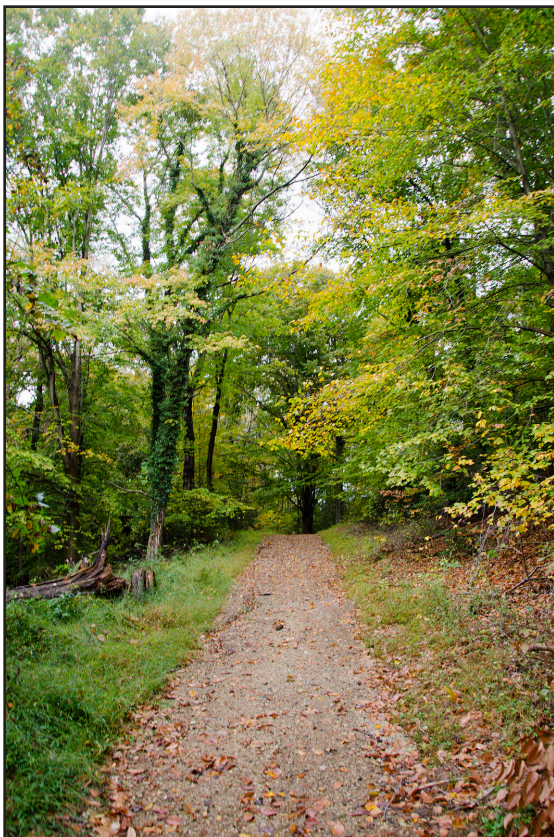
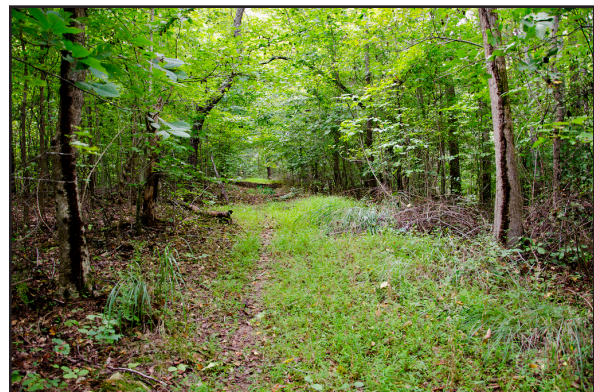
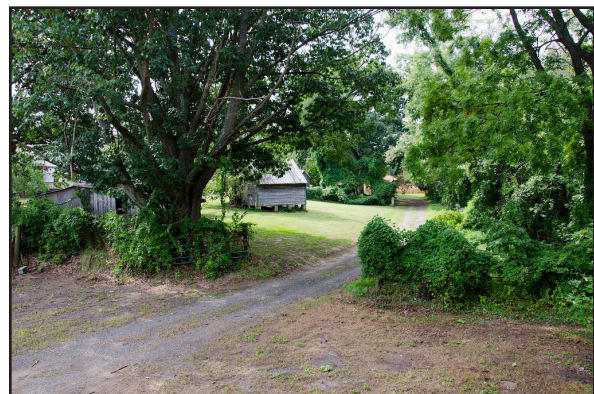
The current main entrance to the site extends from north to south, joining Old Marlboro Pike with the North-South Farm Road. This entryway curves behind the Dairy and Smokehouse towards the Main House, eventually terminating in a circle in front of the Main House. This road is still in use today.

Left: Road to the river. Top Right: Portion of the North-South Farm Road in the northern panhandle. Bottom Right: Portion of the North-South Farm Road, which forms part of the contemporarily used road system within the property.

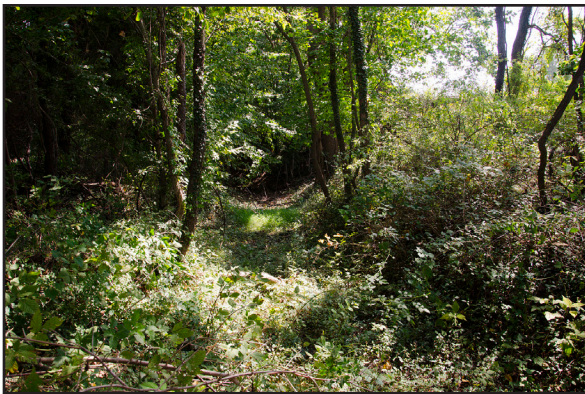
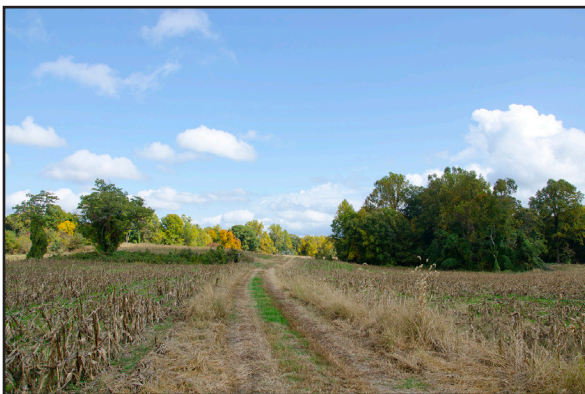
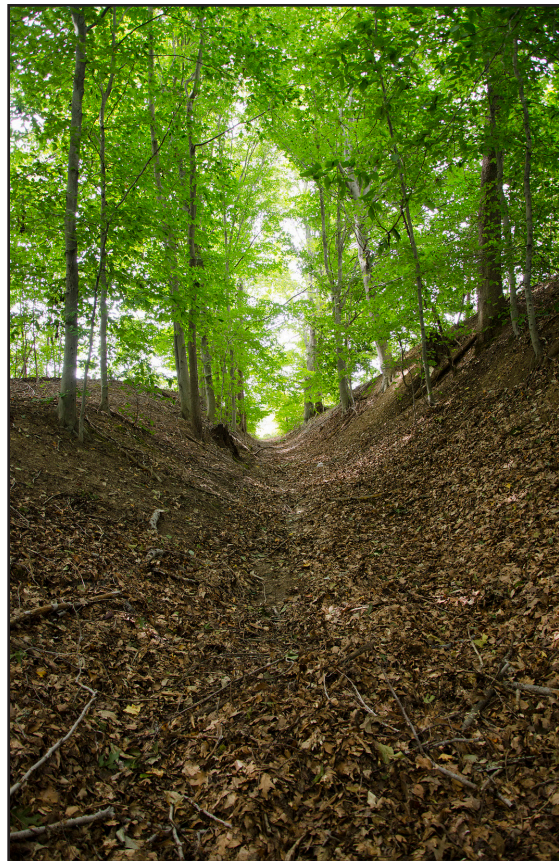
The Road to the River forks off from the North-South Farm Road and heads southeast towards the river. This path passes through the agricultural fields and near the Horse Barn, before entering into forested area and declining steeply towards the river. The path ends at what is believed to be the historic river landing. This path is well maintained and clearly articulated through the woods on a moderate downward slope.

Top Left: Remains of the historic entrance to Compton Bassett. Bottom Left: Portion of the North-South Farm Road cutting through the fields. Right: Portion of the North-South Farm Road in the northern portion of the property.

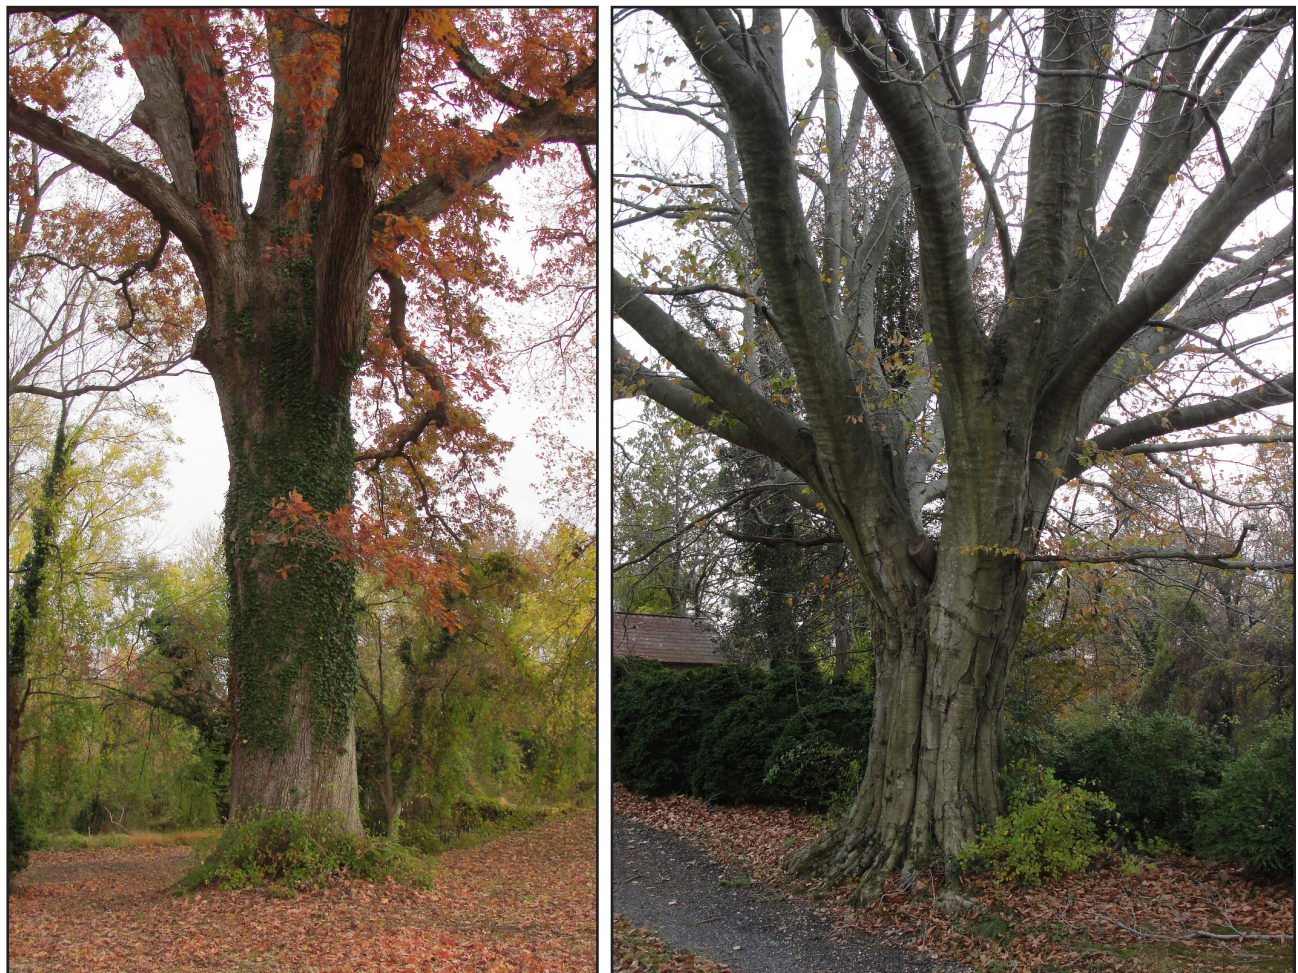
The Compton Bassett site includes a number of trees within the formal plantation plan of the landscape (Figure 13). The land in the vicinity of the Main House and farm outbuildings contains the oldest known surviving trees within the contemporary legal boundaries of the property. The oldest tree, a 320 year old White Oak located behind the Dairy would have been present since the late seventeenth century and would have been large enough to provide shade to the Dairy by the late eighteenth century. The second oldest tree is an American Beech located near the Concrete Garage and is approximately 298 years old. Two Red Oaks, both just under 200 years old, frame the view of the front of the Main House. Additionally, there are two large tree stumps—sixty and sixty-eight inches in diameter—located near the Chapel. Although difficult to date, the age of similarly sized trees likely of the same species suggests that these trees were over 300 years old when they were cut down. M-NCPPC removed these trees approximately three years ago as a means of removing the foliage and limbs overhanging the Chapel.

Left: The c. 320 year old White Oak near the Dairy. Right: The c. 298 year old American Beech located near the Concrete Garage.

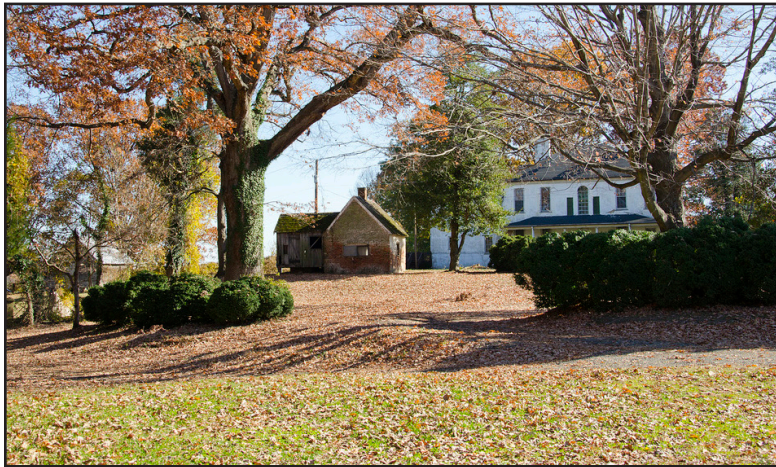
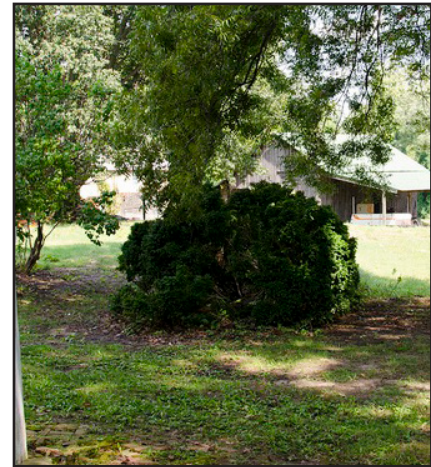
Aside from trees, one of the most noticeable vegetative elements of the landscape is the collections of boxwood which are part of the formal plantation design (Figure 14). These features represent the introduction of a non-native plant species onto the site, and were probably planted and renewed at various times through the life of the site. There are several boxwood plantings located near the Main House: one collection sits in the center of the circular driveway in front of the façade of the Main House, while another collection is located between the Dairy and Smokehouse. A line of boxwood also extends at the top of the terraces north of the Main House;

Left: Boxwood in rear of the Main House that form important decorative landscape elements.
Right: Collection of boxwood near the Main House.

additional boxwood plantings are located at the bottom of the former terraced gardens. Several rows of boxwood are located along various sections of the current main entrance and North-South Farm Road: these fragments suggest that a longer line of boxwood may have once extended along portions of these roads. Boxwood also provide boundaries for the cemetery. The boxwood that remain are generally in good condition, although an overgrowth of other vegetation within them has damaged the health of the boxwood surrounding the cemetery.

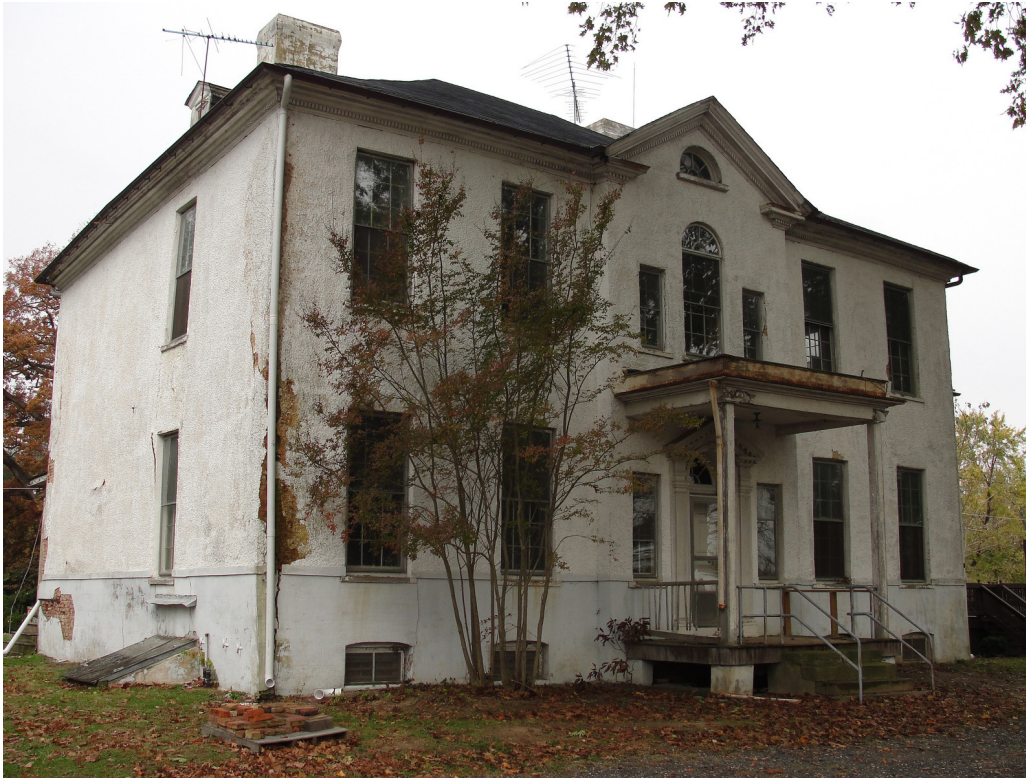
The Main House on the Compton Bassett property is a large two-story brick dwelling laid in Flemish bond and covered in cream colored pebble-dash stucco. Constructed c. 1783, this Federal style house replaced an earlier post-in-ground structure. The house is five bays wide, two piles deep, and features a two-story kitchen addition on the northeast elevation that was built in 1928. The remnants of a brick foundation beneath the kitchen addition suggestion that an earlier addition or ell of some sort may have existed prior to the current one. The hipped roof is pierced by two interior end chimneys aligned with the second and fourth bays. The roof of the Main House is covered with asphalt shingles and the kitchen addition roof is covered with slate. The original block of the house measures approximately 50 feet by 40 feet and is positioned with the façade of the house facing southeast towards the Patuxent River. The central bay of the façade projects outward from the main plane of the house and is capped by a triangular pediment that interrupts the cornice line and features a fan light detail. In 1940, a large porch with a low-pitched hipped roof was added to the rear elevation of the house. During the same period a small porch with a flat roof was added to the façade spanning only the width of the projecting central bay. The basement level of the house is distinguished by a decorative water table, under which the stucco has been finished smoothly and scored to give the effect of large blocks of stone. The bricks below the water table were laid in English bond, rather than Flemish bond, suggesting that this lower portion has always been covered by a decorative treatment.

Above: Façade of the Main House.

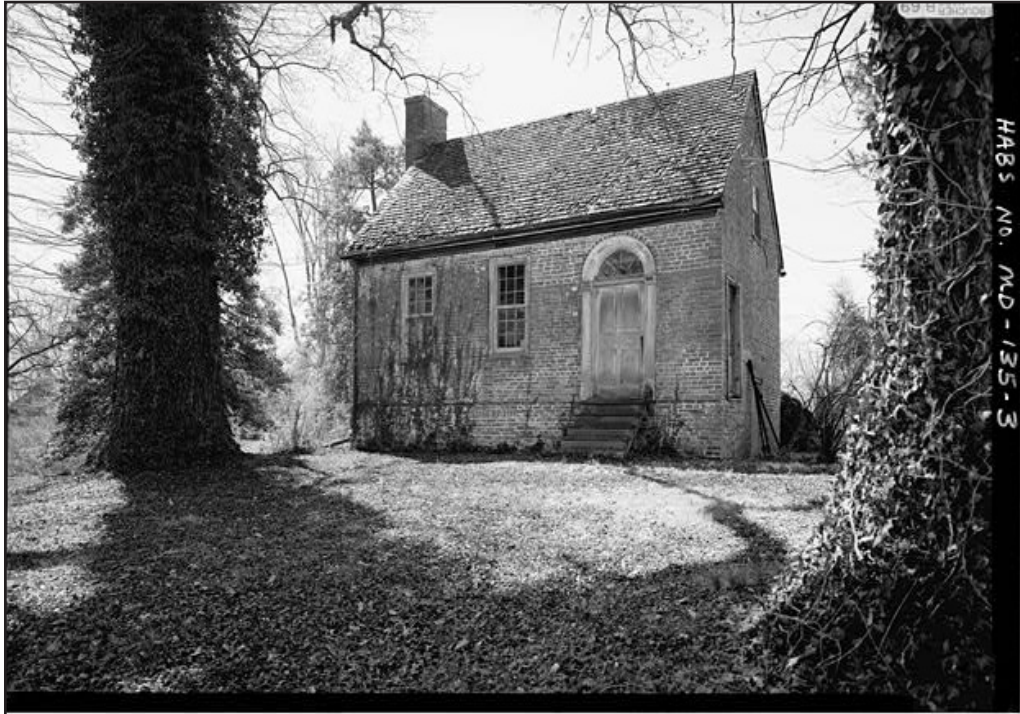
One of the most unique structures found on the Compton Bassett estate is an Roman Catholic chapel. The Chapel is located to the south of the Main House and is positioned on an east-west axis. The Chapel is three bays wide, one and a half stories in height, one pile deep, and includes both a finished garret and cellar space with a brick herringbone floor. The building measures approximately 26 feet wide by 18 feet deep. The Chapel is constructed of structural brick laid in a variety of bonds and features randomly placed glazed headers; the differing brick bonds are indicative of multiple build periods and later repairs made to the building. An exterior gable end chimney anchors the southeastern gable end of the building. The northern elevation, which features the entryway and serves as the façade of the building, is three bays wide with windows in the left and center bays. The door is located in the right-hand bay and is crowned by a four-light fanlight. The entryway to the cellar is located on the northwestern gable end, opposite the chimney. The Chapel's roof is covered with wooden shake shingles. Riven lath and early cut nails are visible in the stairwell walls leading to the garret, which differ from the sawn lath found throughout parts of the main floor and garret.

The Chapel has a number of structural and maintenance issues. The roof has failed completely and as a result the entire structure is now covered by a large white tarp in an attempt to prevent additional deterioration. While it is effective in keeping out water, the tarp is potentially causing

Above: Early twentieth century Historic American Buildings Survey photograph of the Chapel.

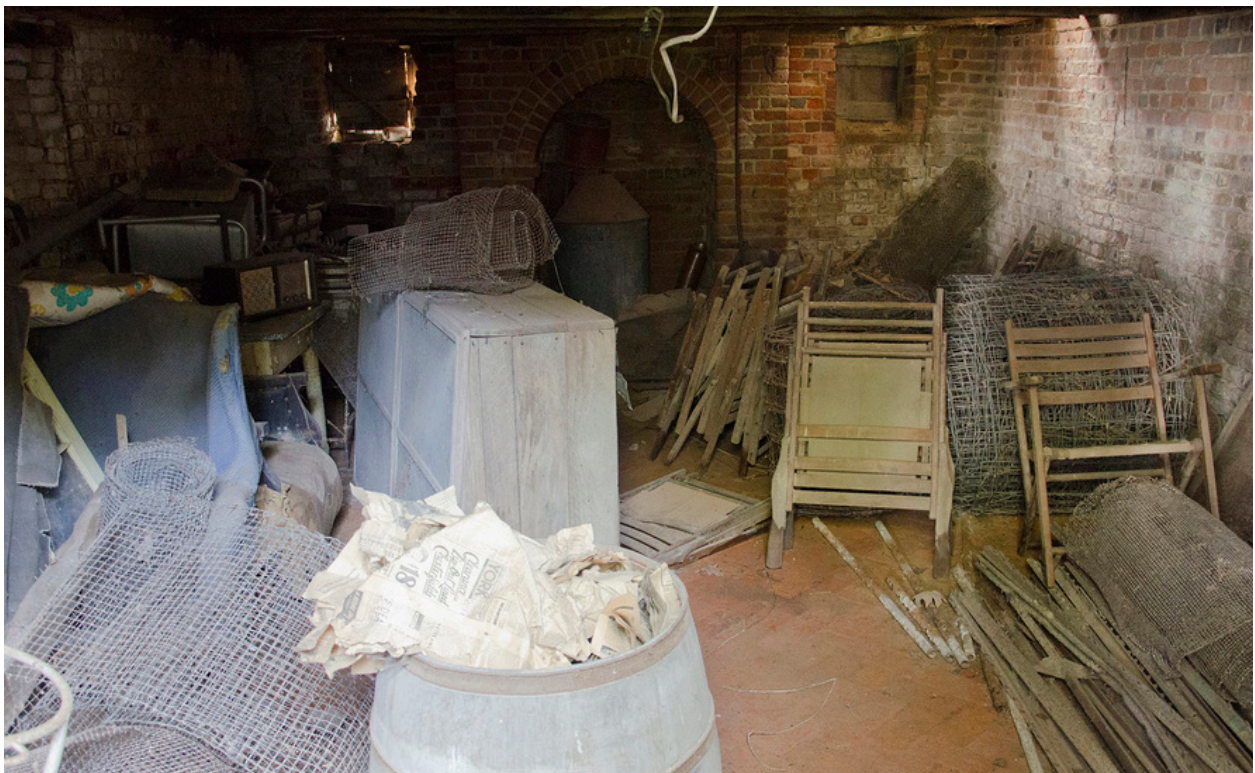
Above: Chapel cellar as it appears today.

further harm by trapping moisture inside the building and making the structure support the substantial weight of the tarp itself. The failures in the roof have in turn caused the floor and ceiling of the Chapel to fall through in multiple places. Additionally, a boxwood hedge along the southern elevation was planted too close to the chapel and had grown too large. The plants which has recently been removed were holding moisture against the building that resulted in damage to the foundation and brickwork.

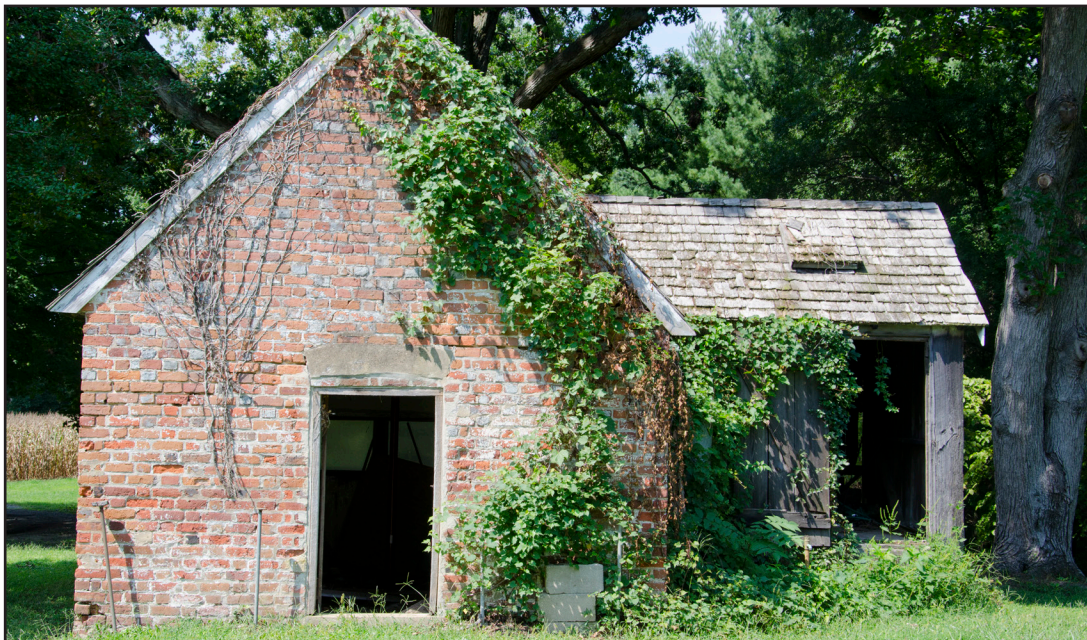
Above: The Dairy in rear of the Main House with wood addition to the structure.

The Dairy has several structural issues. A brick repointing job using improper mortar was completed at an earlier date and has damaged many of the structure's historic bricks. The damaged chimney also requires repair, or possible removal, so that the metal jack can be removed from the interior. Lastly, the wooden addition is in poor condition, and a decision must be made about whether or not to retain it.

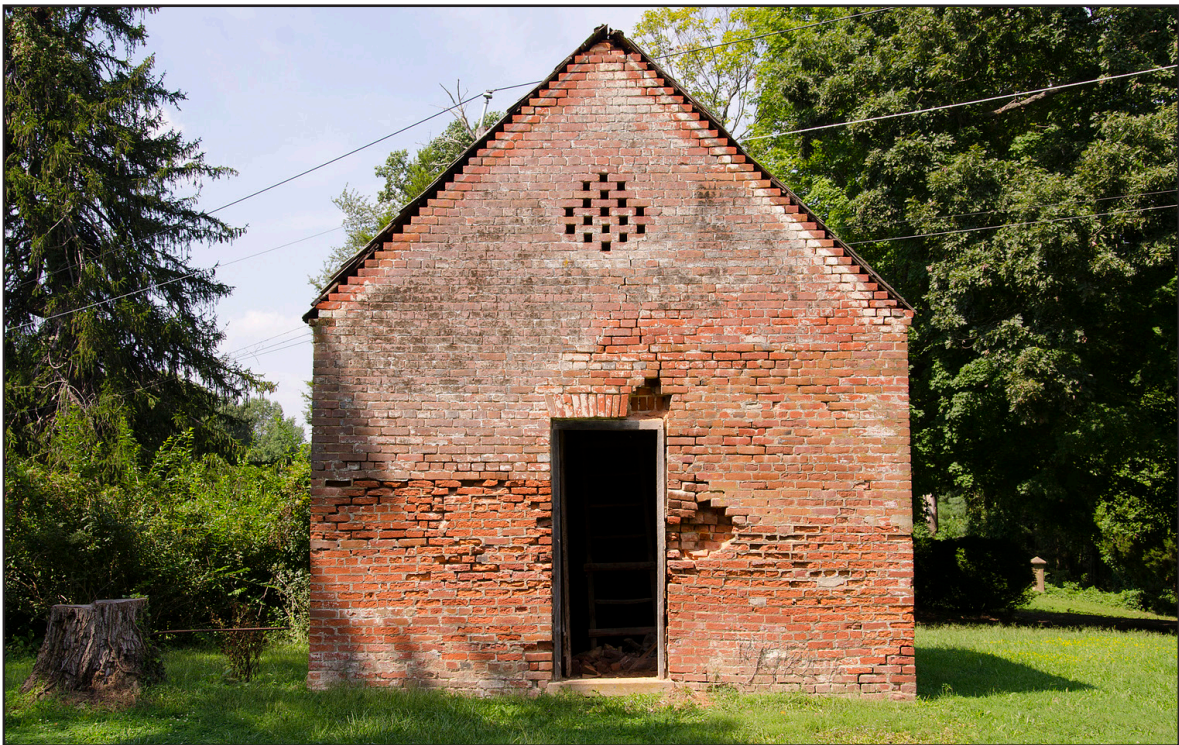
The Smokehouse is in poor condition and in danger of further deterioration or collapse. The brickwork was repointed using a Portland cement based mortar during the twentieth century, and

Above: Façade of the Smokehouse located behind the Main House at Compton Bassett.

this inappropriate mortar has caused significant brick spalling; the August 25, 2011 earthquake furthered this deterioration. Countless bricks have fallen out of their bond or have deteriorated completely into powder. While the wood framing supporting the roof appears to be in good condition, further investigation is needed to be certain.

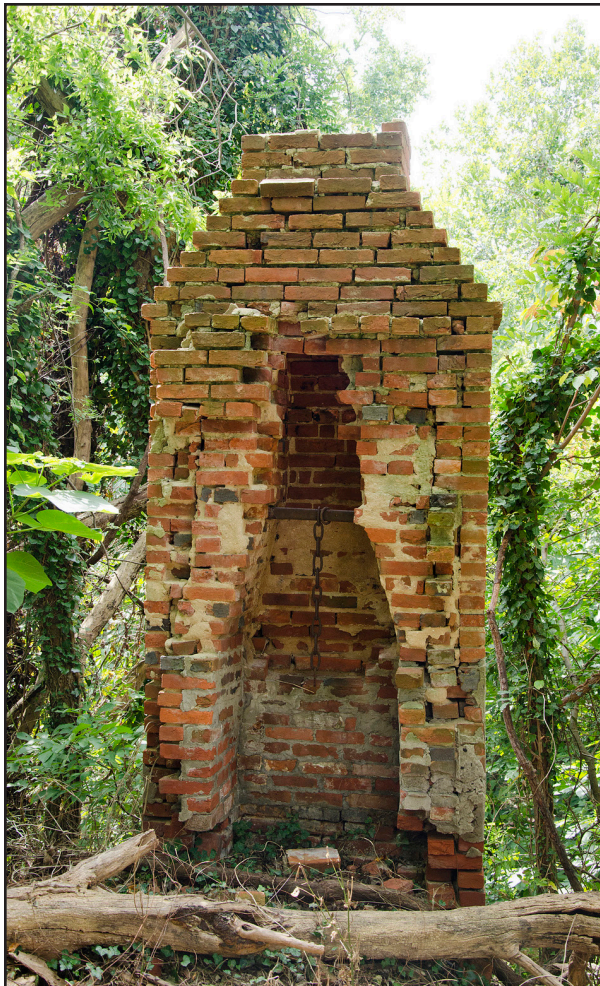
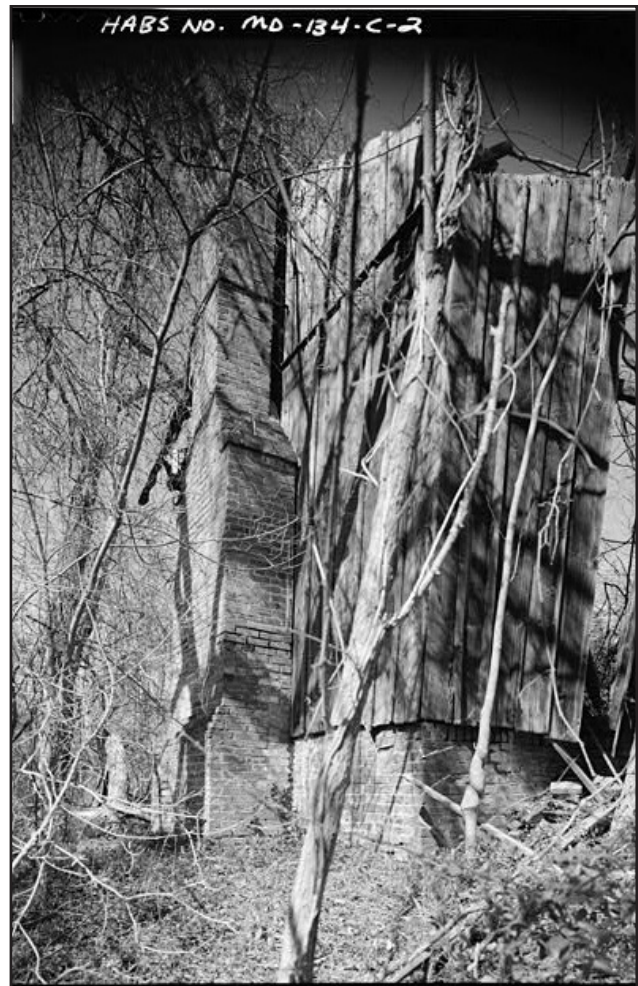
Northeast of the Chapel there are the ruins of a structure believed to have been a tenant house of wood and masonry construction. All that remains of this structure are the base of a brick chimney, which stands approximately 10 feet tall, and the remnants of the structure's brick foundation. An iron crane and cooking pot chain are still present in the chimney. Judging from the bricks that comprise the chimney, and the bricks scattered around the site, the structure appears to have been constructed in the mid-to-late nineteenth century. The decorative brick belt course on the chimney suggests that it may be the dilapidated board-and-batten tenant house visible in a HABS photograph from the 1930s. The site is overgrown with brush, but appears to be in stable condition.

Left: Tenant House Ruins behind Chapel. Right: A twentieth century Historic American Buildings Survey image, which may show the more complete tenant house now evidenced only by a chimney.

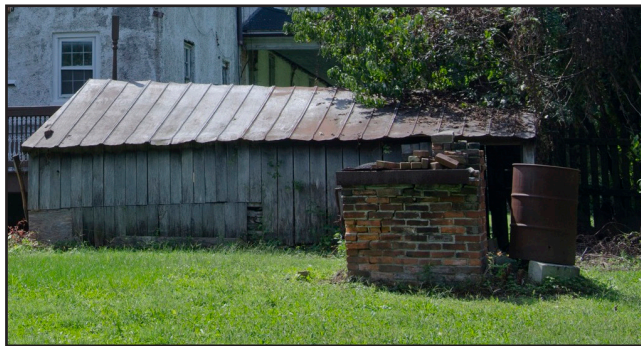
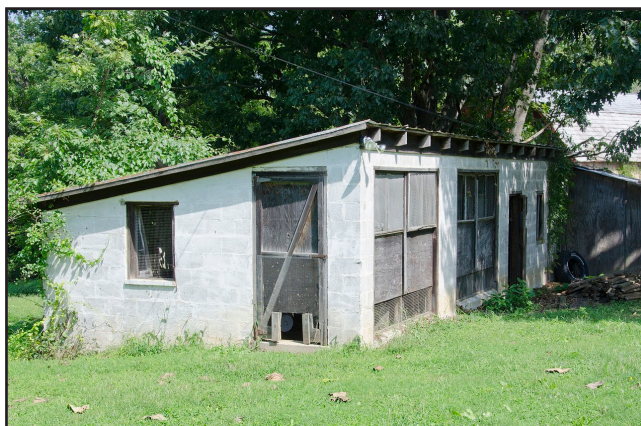
Located approximately 30 feet to the west of the Chicken Coop is a wooden shed, which stands approximately 2 feet above the ground on a system of brick piers. The shed measures 18 feet by 19 feet, is clad in wooden clapboard siding, and is covered by a standing seam metal roof; this shed was constructed in the twentieth century. Other than minor cosmetic repairs, the Wooden Shed appears to be in excellent condition. Branches from a nearby tree are encroaching on the shed and could potentially damage the structure if left unaddressed.

Top Left: The shed located near the kitchen addition of the Main House.

Bottom Left: Chicken Coop located within the Agricultural Complex.

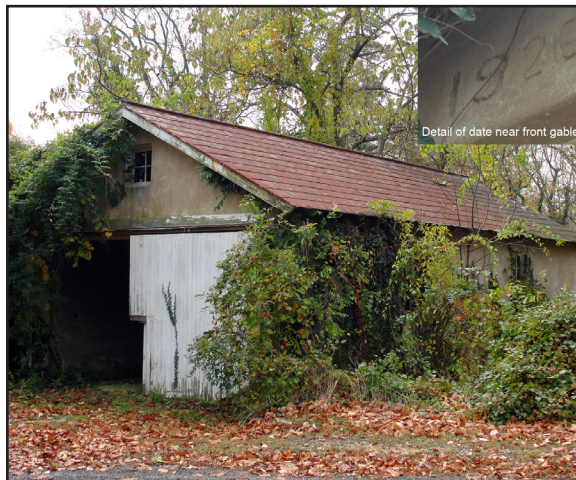
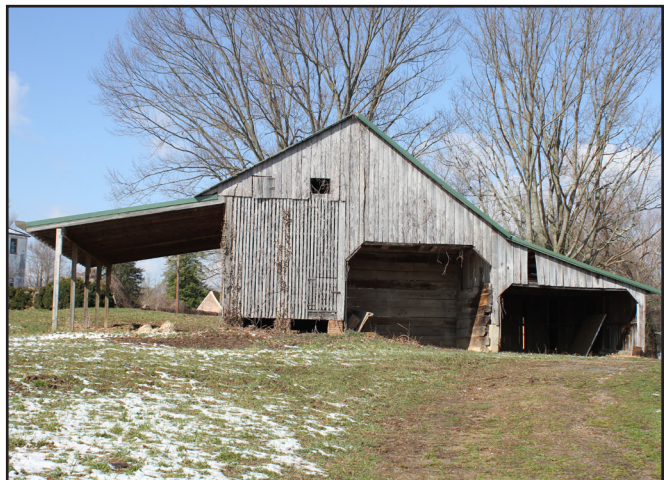
The International Barn is a wooden barn located to the northeast of the Main House. A 1946 International flatbed truck was formerly parked within this barn, giving rise to the structure’s name and providing evidence of the kinds of artifacts used on the farm throughout the twentieth century. The barn exhibits multiple periods of construction: it appears that the central portion of the barn, which seems to have functioned as a corn crib, was constructed first, possibly standing alone as an independent structure. The section features widely spaced vertical slats indicative of a corncrib. Presently, this initial section, along with the later additions, has now been incorporated into barn as it exists presently. A shed addition extends off of the northern elevation while a shed addition carport is positioned on the southern elevation of the building. This barn is in excellent condition and appears to need little work.

Left: The twentieth century Concrete Garage located near the Chapel. Photographic inset reveals the date, 1926, inscribed in the building, likely the date of construction. Right: A wooden barn, referred to as the International Barn, located among the agricultural buildings.

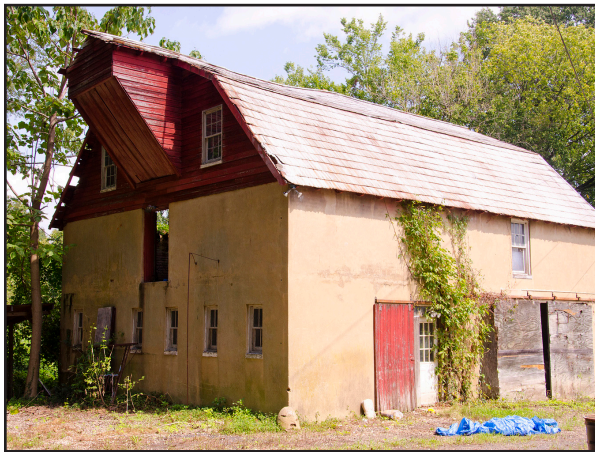
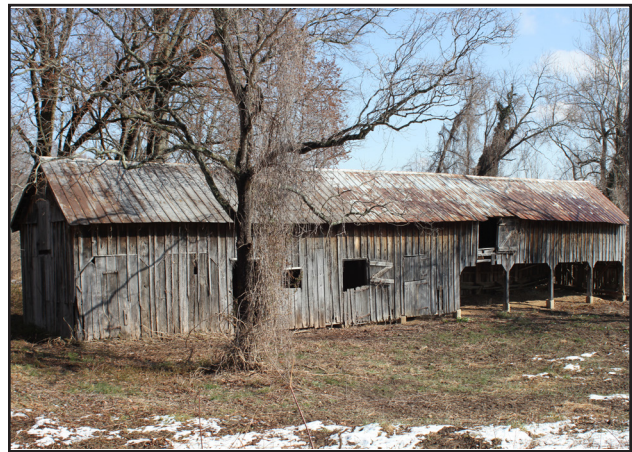
The Long Barn is a narrow, wooden barn located east of the Gambrel-Roofed Barn. It is of twentieth century construction, framed entirely in wood, and measures approximately 88 feet long by 15 feet deep. The Long Barn is covered by a gable roof with standing seam metal roofing; the barn itself is clad in vertical board and batten siding. The barn is divided into a multiple sections, including a portion at the eastern end where the front of the barn is open, similar to a carport. The Long Barn appears to be structurally sound, but it is almost entirely covered in vines and undergrowth. If these vines remain unaddressed they will begin to deteriorate the Long Barn and could potentially cause structural issues by trapping moisture against the building and adding weight to the structure.

Left: Gambrel-Roofed Barn located among the collection of twentieth-century agricultural buildings.
Right: The Long Barn located among the site's agricultural building.

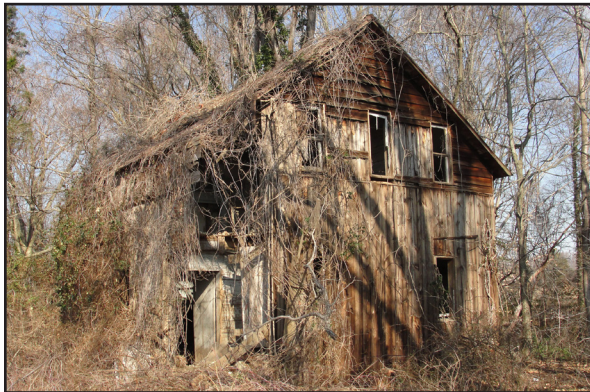
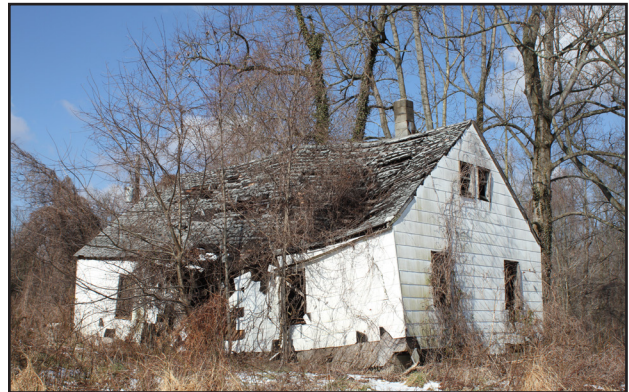
East of the Long Barn exists the remains of another tenant house. This structure dates to the twentieth century and is in ruinous condition. The house measures approximately 40 feet wide by 24 feet deep, features a standard gable roof with 3-tab asphalt shingles, and is clad in asbestos siding. The tenant house is in ruinous condition. The roof has fallen through in multiple areas and the rear of the building is entirely open to the elements. If left in place the structure will soon collapse, spreading asbestos siding dust into the immediate environment.

Left: Brick Nogging Tenant House. Right: Asbestos Siding Tenant House.

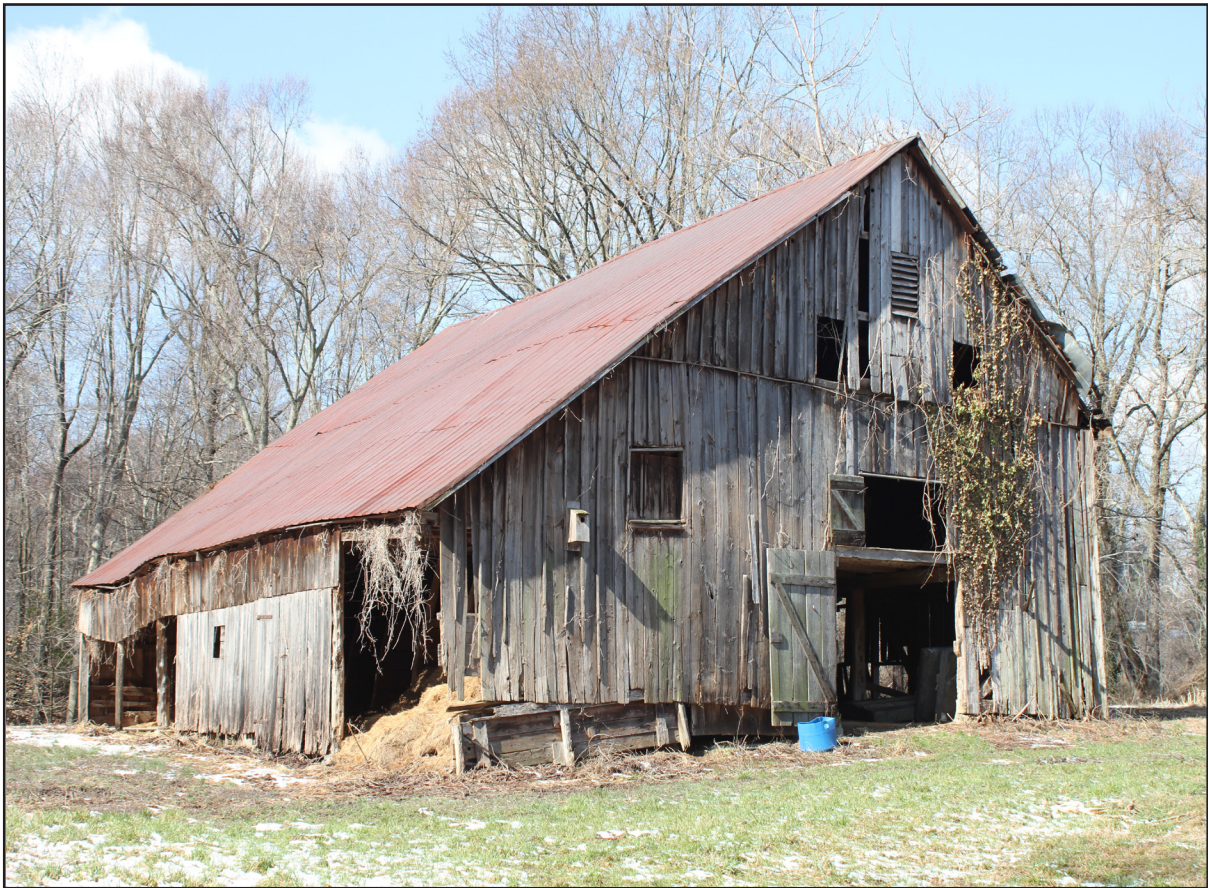
The Horse Barn exhibits evidence of multiple periods of construction. Hand-hewn framing timbers featuring mortise-and-tenon joints were likely reused from an earlier structure on the property. Both cut nails dating to the nineteenth century and wire nails dating to the twentieth century are found throughout the barn. Most interestingly, wrought nails, possibly dating to the eighteenth century, are present in one of the hayloft doors. This door also features wrought strap hinges, again possibly dating to the eighteenth century. As with the hand hewn framing members, this door was possibly salvaged and repurposed from an earlier structure. These building elements suggest that the Horse Barn was constructed in the nineteenth century, possibly using materials salvaged from earlier structures.

Despite some issues that require immediate attention, the Horse Barn is in good condition. In addition to the partially collapsed northern wall, powderpost beetle holes are visible in certain framing members; however, these holes might date to an earlier infestation.

Above: Horse Barn located on the road leading to the Patuxent River.

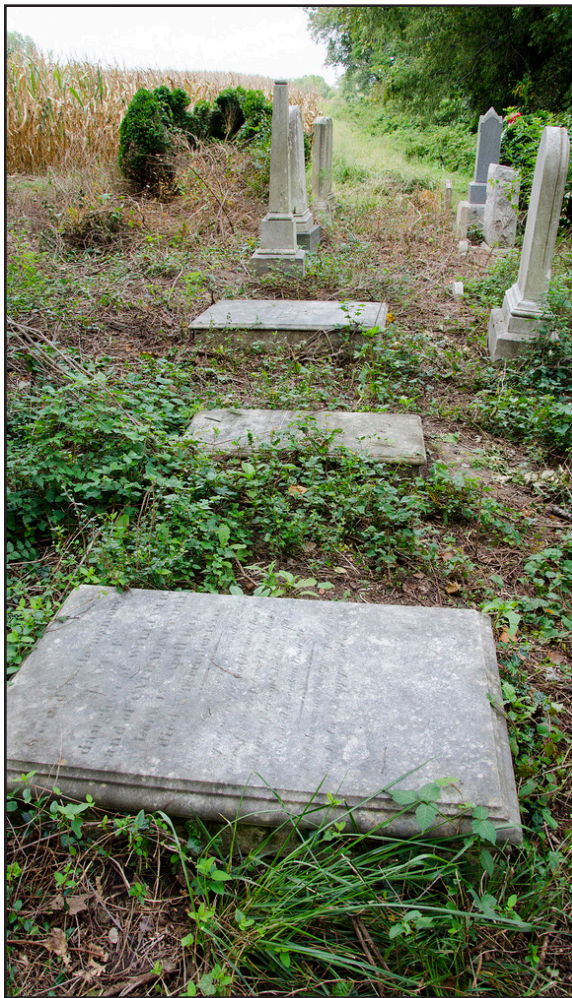
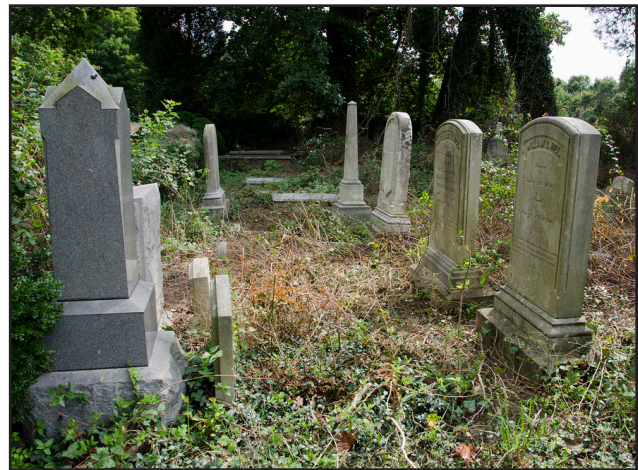
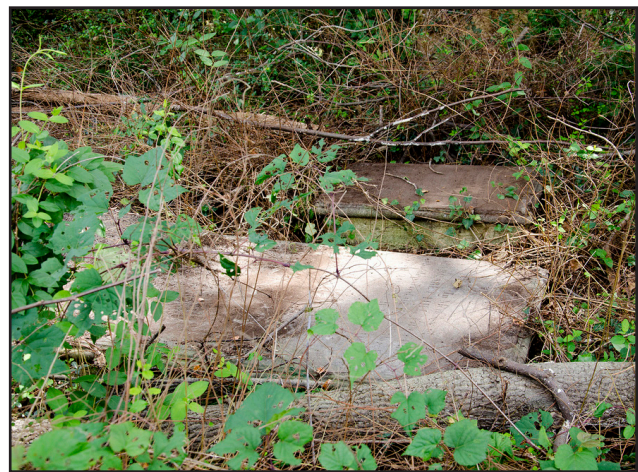
The cemetery contains several broken headstones and is in poor condition. In recent years, the undergrowth was left to grow freely and consumed nearly the entire cemetery; several trees had fallen and seriously damaged headstones. M-NCPPC grounds keepers have removed much of this undergrowth, however, the cemetery still remains slightly overgrown and need further maintenance. The broken headstones and grave shafts risk further deterioration if left unaddressed.

Above: Various images of the Hill Family Cemetery located on the Compton Bassett site.

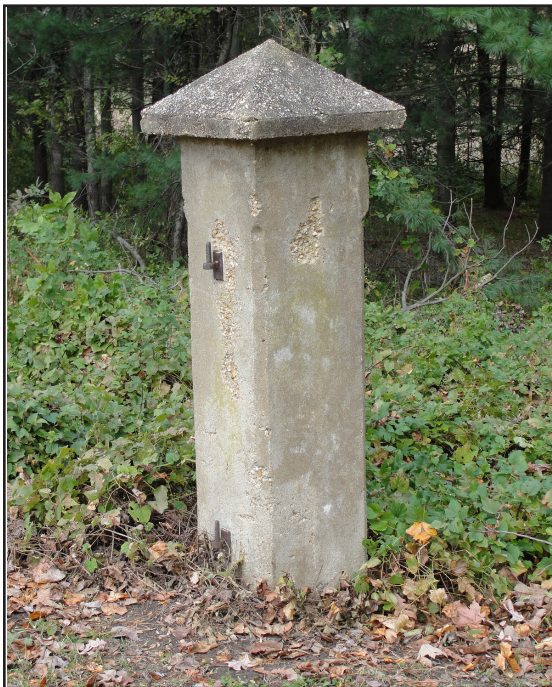
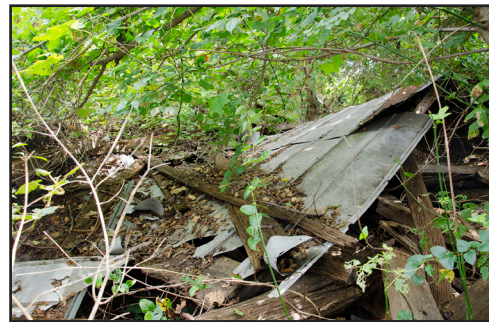
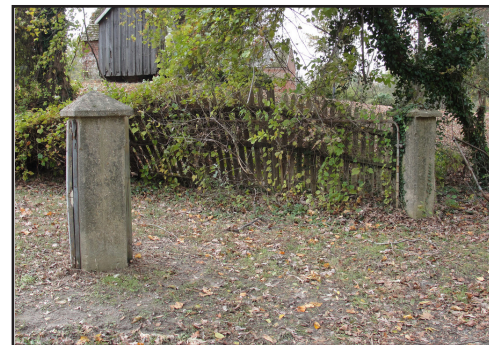
Three gateposts remain on the site. The first post is oriented in relation to the historic entryway to the plantation. An additional set of matching posts stands approximately 100 yards further along the farm road near the Agricultural Complex. These posts are of poured concrete construction and likely date to the twentieth century. The posts are in good condition.

Ruins of an early twentieth century tobacco barn sit on the opposite side of the historic entryway from the Hill Family Cemetery. This barn appears to have been constructed using salvaged building materials from an earlier outbuilding, evidenced by the hand-hewn timbers with mortise-and-tenon joints and the late nineteenth century bricks comprising the foundation. Vines and undergrowth largely obscure these ruins.

Left: Entryway gatepost. Top Right: Tobacco Barn ruins. Bottom Right: Other gateposts.

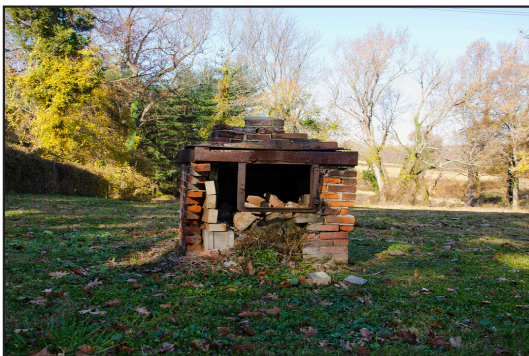
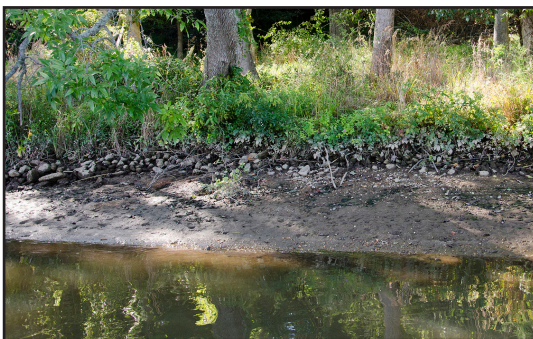
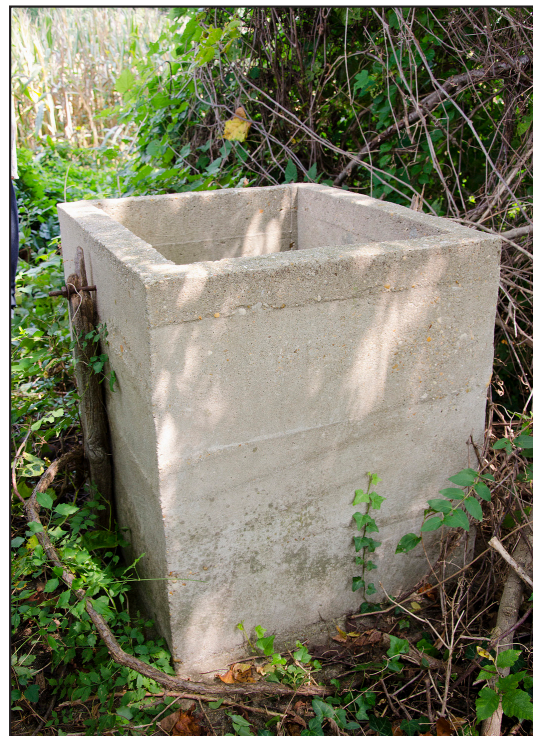
A small brick fire pit or barbecue measuring approximately 3 feet by 3 feet square, and approximately 4 feet in height is located in the side yard of the Main House near the Agricultural Complex. This structure appears to have functioned as a cooking facility. The date of construction is twentieth century, although it is comprised of bricks reused from an earlier date. The feature is charred with soot and suffers from deteriorating brickwork and masonry.

A hand dug well lined with handmade bricks is located approximately 300 feet west of the Main House along the historic entryway to the site. It has been capped with a twentieth century concrete cover with a raised portion featuring an access hole in the top. This cover allows for well access and use but keeps the well free of debris. This well does not exhibit obvious evidence of deterioration.

Top Left: Brick Fire Pit. Bottom Left: River Landing. Right: Cement cover on the hand-dug well near the historic entryway to the property.

Due east from the Main House, located immediately on the banks of the Patuxent River, there is what is likely the historic river landing for the Compton Bassett property. The flat topography found in this area appears to have been kept cleared, leveled, and maintained in order to allow for river access. Stones were placed along the shore in this area in order to prevent erosion; the bank appears to be in stable condition at this time. Following M-NCPPC's acquisition of the property the plant life in the area has been allowed to grow more freely and now presents problems for visitors to the river landing. In addition to this, multiple chairs, concrete blocks, and an old barbecue grill lay in the grass near the river landing.

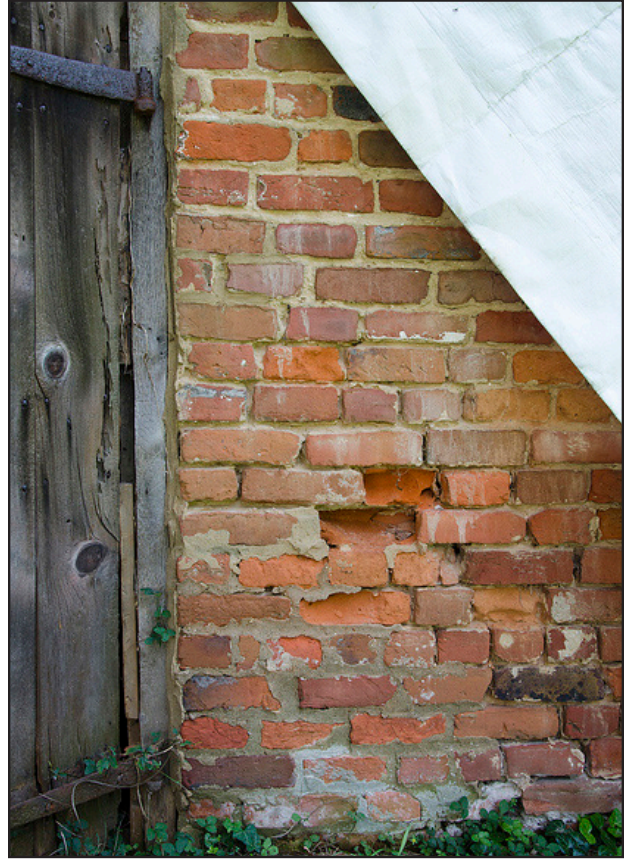
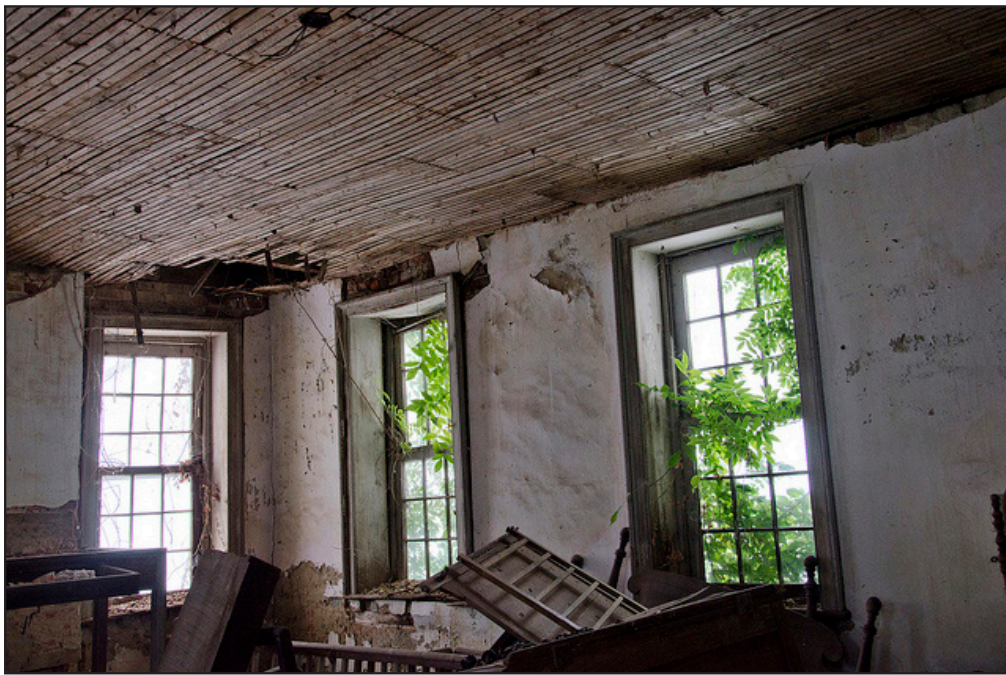
Top Left: Severely deteriorated masonry in the Main House. Top Right: Damaged brickwork on the Chapel.
Bottom: The poor structural condition of the Chapel's interior.
