Compton Bassett

Balancing Preservation and Change A Cultural Landscape Report

UNIVERSITY OF MARYLAND
SCHOOL OF ARCHITECTURE, PLANNING, & PRESERVATION
GRADUATE PROGRAM IN HISTORIC PRESERVATION
STUDIO | FALL 2012

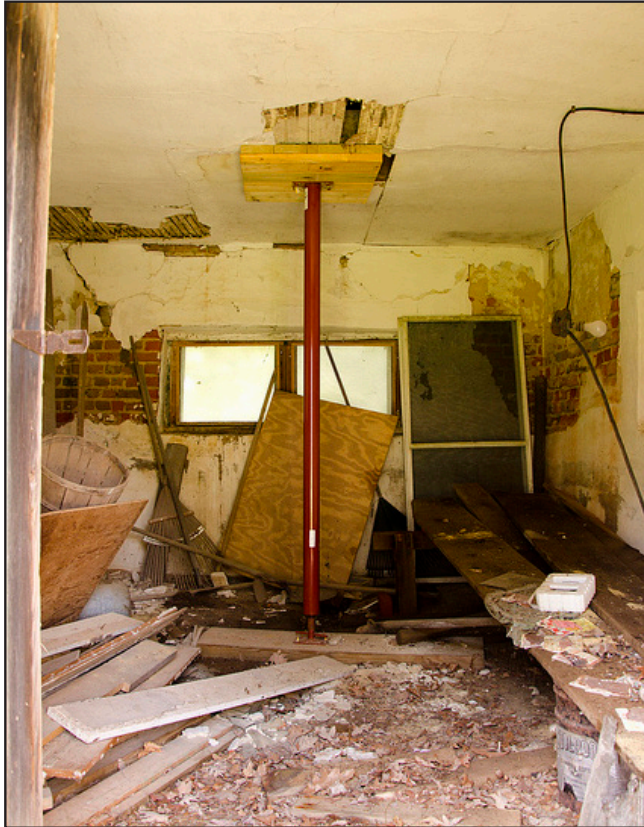
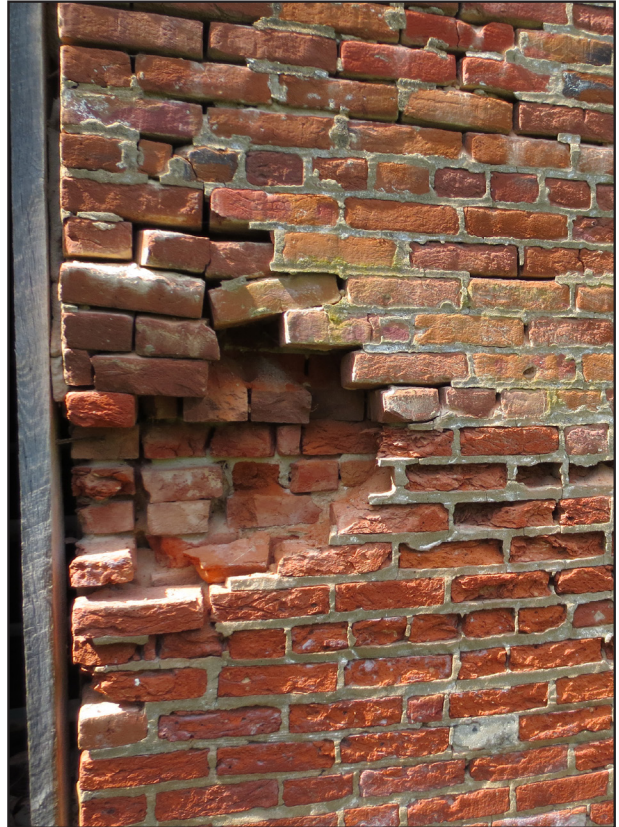
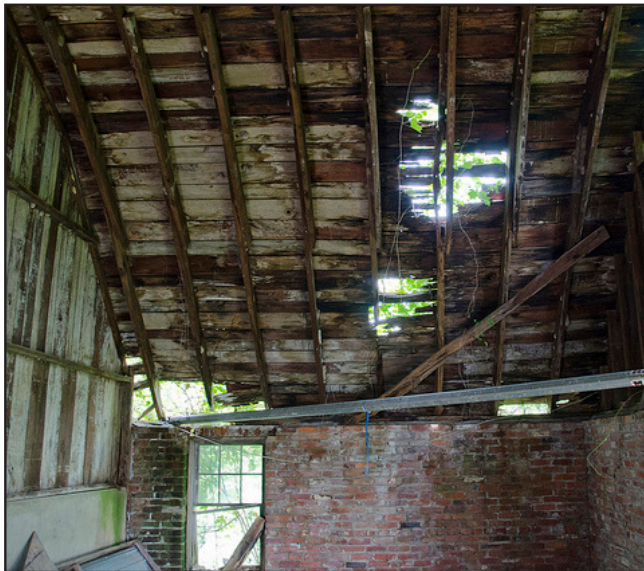
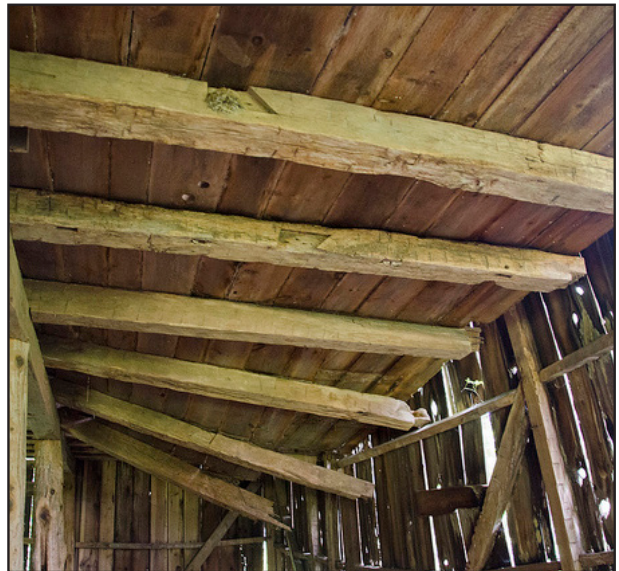
Top Left: The temporary jack supporting the Dairy's chimney. Top Right: The damaged masonry on the Smokehouse.
 Bottom Left: The damaged roof of the Gambrel-Roofed Barn. Bottom Right: Damage to the second floor of the
 Horse Barn, which requires stabilization.
