Title of Final Project: RECONSIDERING THE ROULETTE BARN

Tabitha Mary Gold, Master of Historic
Preservation, 2023

The Roulette Farm's iconic bank barn is currently underutilized and endangered. The National Park Service has assigned a narrow period of significance to the property and barn, tying its significance solely to the American Civil War and overlooking its broader history as a center of agricultural production. The structure had fallen into disrepair before being repaired with modern building materials, and is missing key features of its original construction. The barn's untapped potential warrants structural repairs, a full restoration to its original condition, and a rethinking of its interpretive uses. This analysis develops a preservation plan to assess the history, significance, and condition of the Roulette Barn. The plan also considers the barn's construction methods, addresses its historic integrity and how the barn's narrow period of significance and interpretation methods have impacted historic integrity, suggests new interpretive possibilities, and recommends necessary repairs and maintenance requirements that would lead to the restoration of the structure. Expa

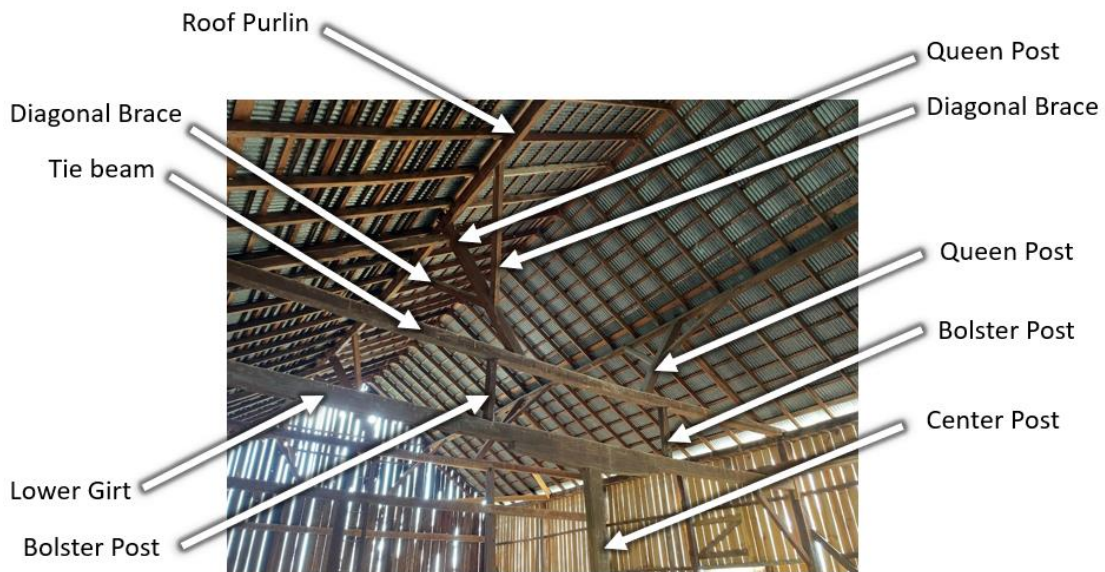
Figure 10. Bolster Posts Connecting Tie Beam (Tabitha Gold, 2022).

Construction in German-settled areas typically utilized a distinct heavy roof framing system.⁶¹ The wood was built into heavy trusses including principal and common rafters, and heavy frames consisting of purlins supported by posts as shown in Figures 10 & 11.

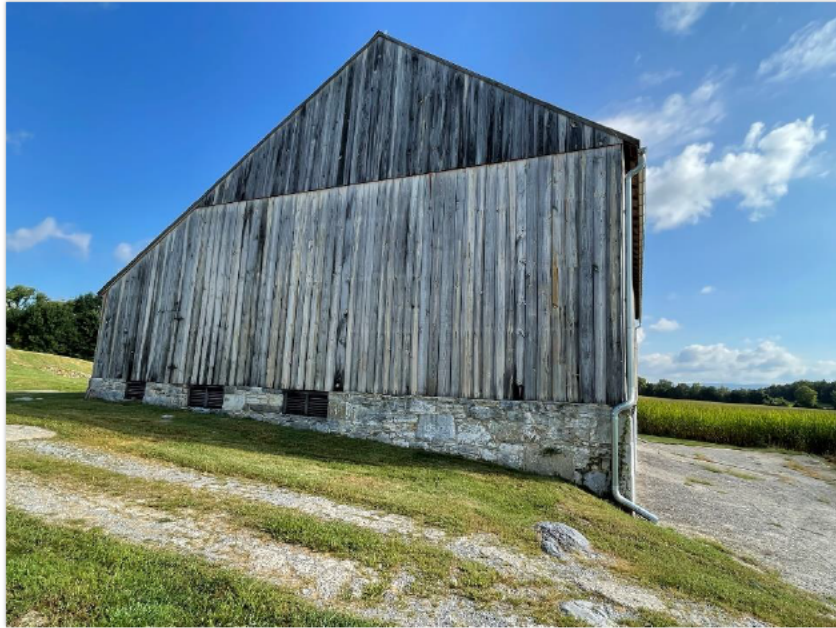
Figure 14. Roulette Barn, west gable end. (Tabitha Gold 2022).

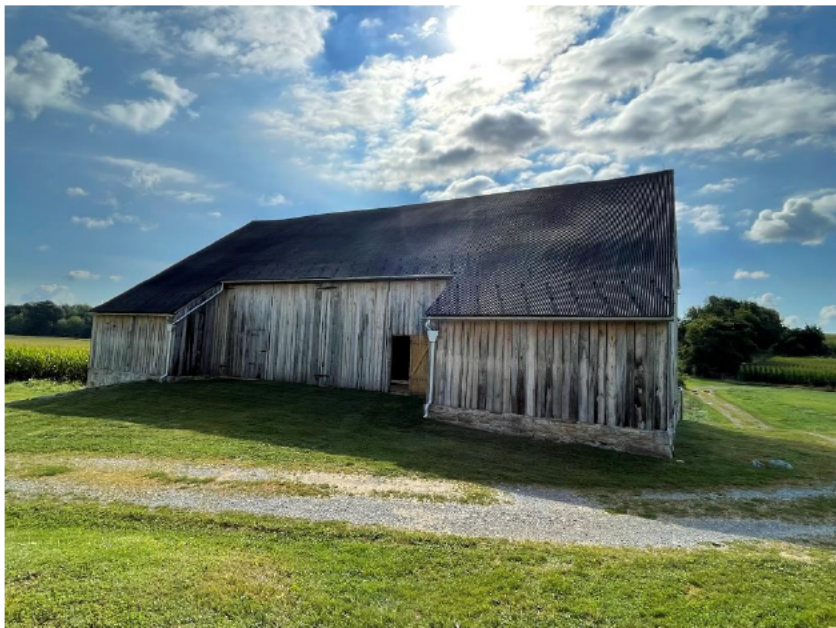
Figure 15. Roulette Barn, bank side showing outsheds. (Tabitha Gold 2022).

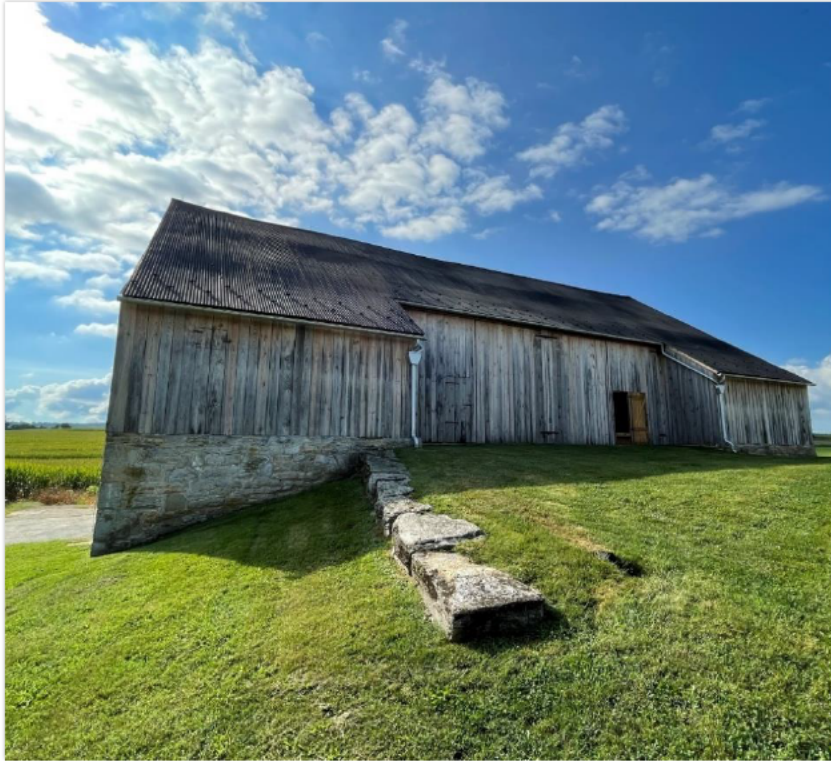
Figure 16. Roulette Barn, bank side showing earthen ramp and outsheds. (Tabitha Gold 2022).

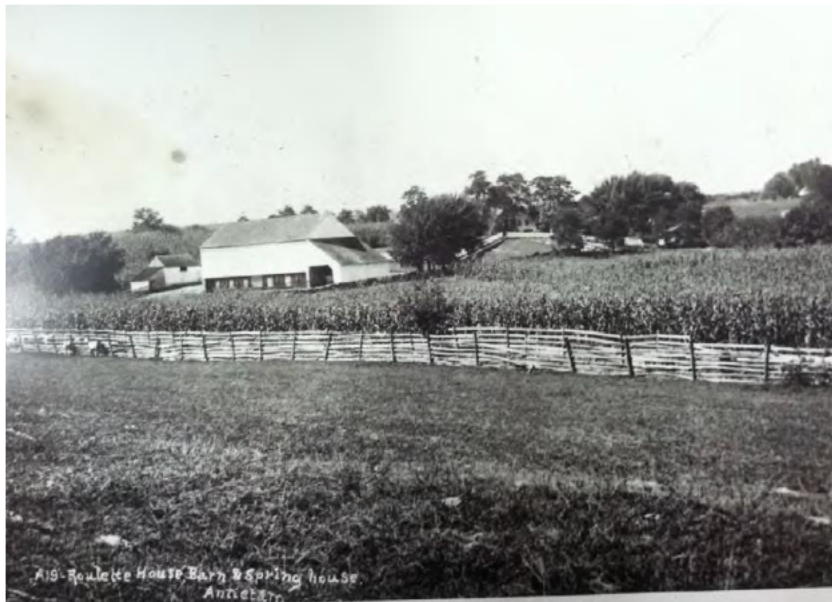
Figure 17. Roulette Barn ca. 1890. (Antietam National Battlefield archives, Battlefield Farms Box. Historic Structures Report, NPS).

Dendrochronology performed as part of the HSR done by the National Park Service dated the Roulette Barn to ca. 1855, though the HSR speculates that, based on varying wood species of different ages identified, some older than 1855, the barn may have been reconstructed from an existing barn at the former Miller farm.¹⁰² The Roulette family's decision to construct a bank barn was likely influenced by the Pennsylvania Bank Barn style that was popular in the area at this time. Figures 14, 15, & 16, below, show the exterior of the Roulette Barn. Figure 17 shows the Roulette Barn ca. 1890.

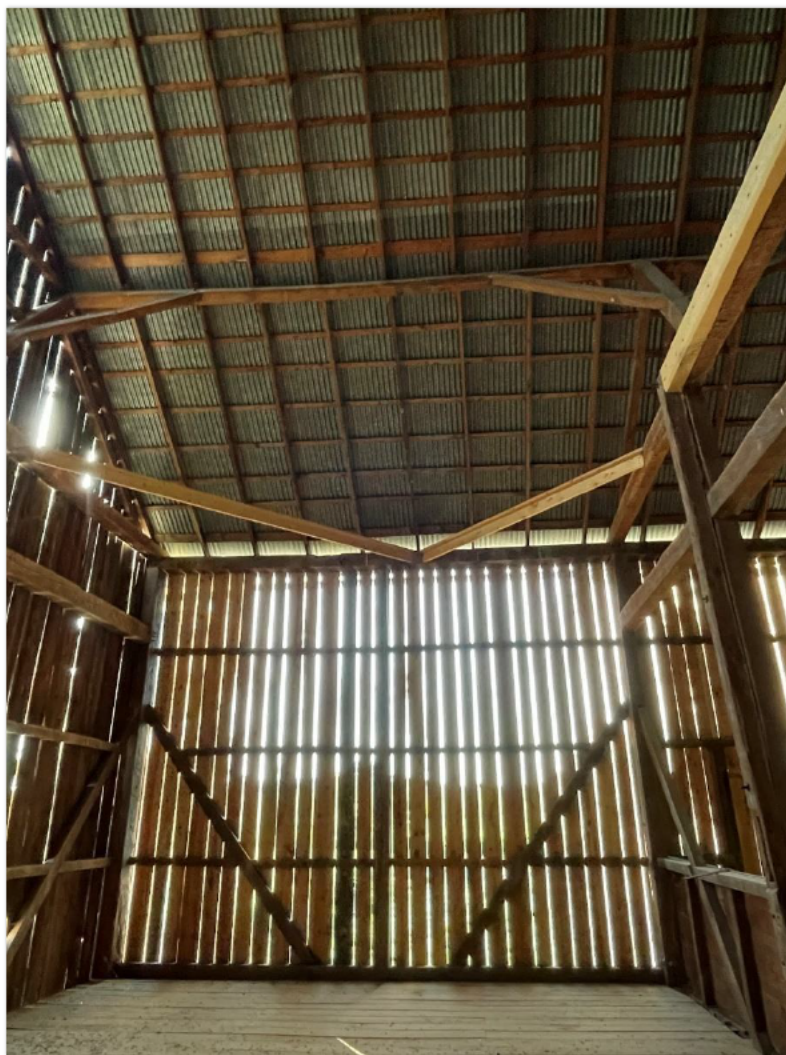
Figure 18. Roulette Barn down braces connecting from corner post to sill. (Tabitha Gold 2022).

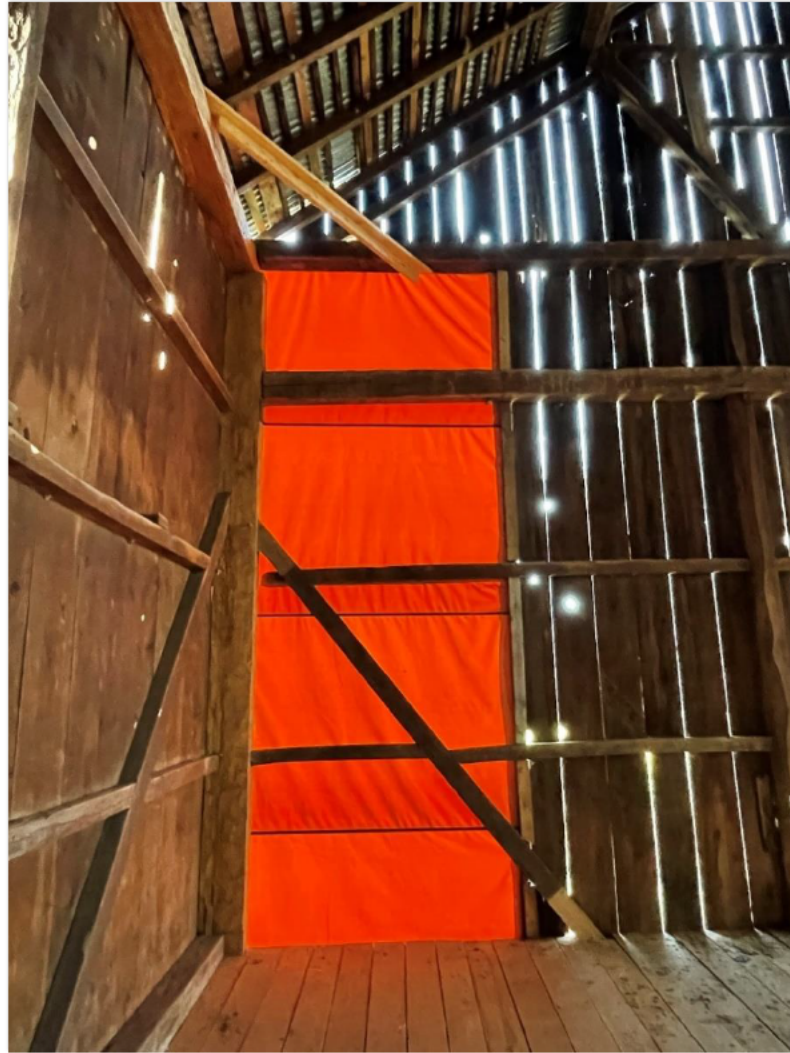
Figure 19. Roulette Barn, down braces on east gable wall. (Tabitha Gold, 2022).

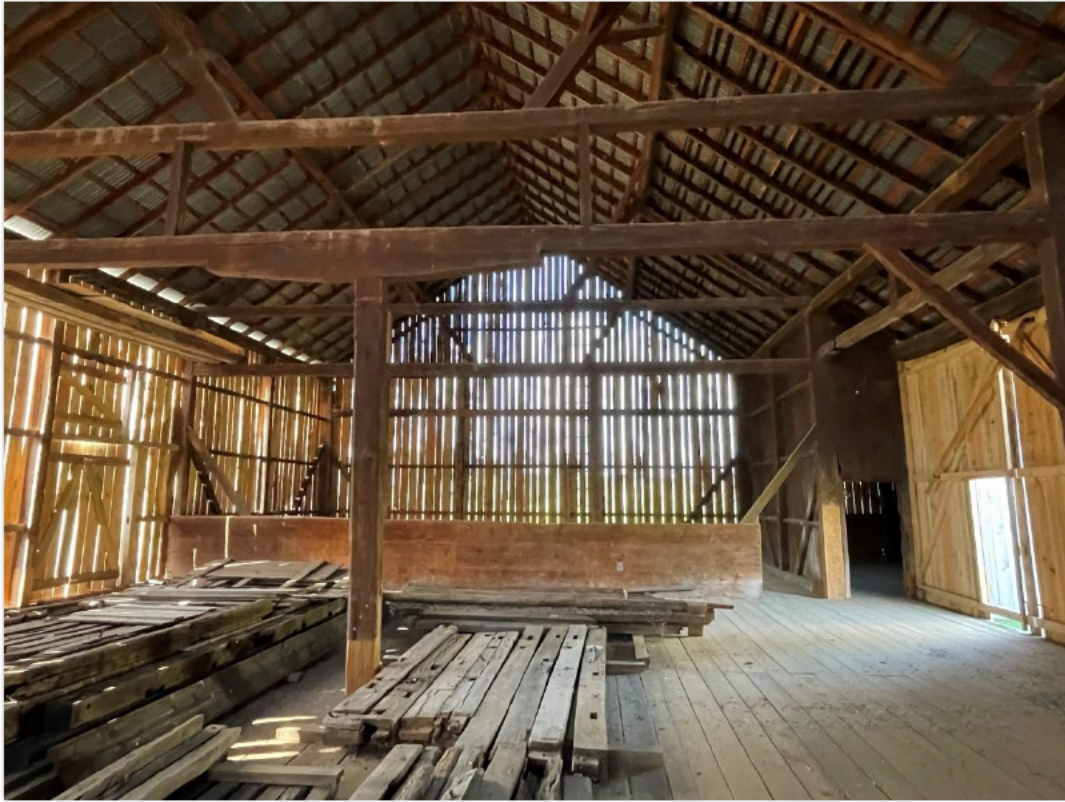
Figure 20. Roulette Barn, main section of the upper level. (Tabitha Gold 2022).

Figure 20 shows the current makeup of the upper level. The rafters are a variation of historic and modern framing members. Modern 2"x6" replacements were installed sometime before NPS ownership. The sloping roof members are lapped at the mid-point with the modern and historic materials and are supported by the lower end with a roof plate. A plywood member connects the rafters with the nailer strips

for the metal roof. The roof members above the barn's outshed granary roof are made of smaller purlins and what appear to be historic rafters.

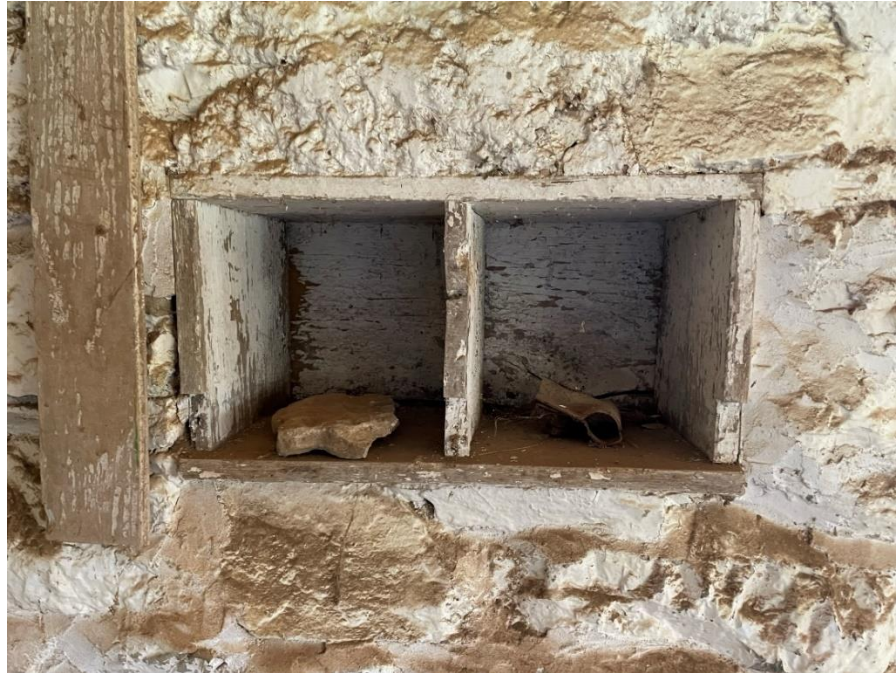
Figure 24. Roulette Barn, Northeast Foundation Wall Interior View Cubby Shelving. (Tabitha Gold, 2022).

The barn has a fieldstone foundation that supports the timber frame. The limestone wall foundations are believed to be original to the construction of the barn ca. 1855. The width of the foundation walls is approximately 2'-2" thick and the limestone is laid in a randomly coursed pattern with lime mortar. The foundation includes ventilation windows and small cubby shelving shown in Figures 24 and 25.

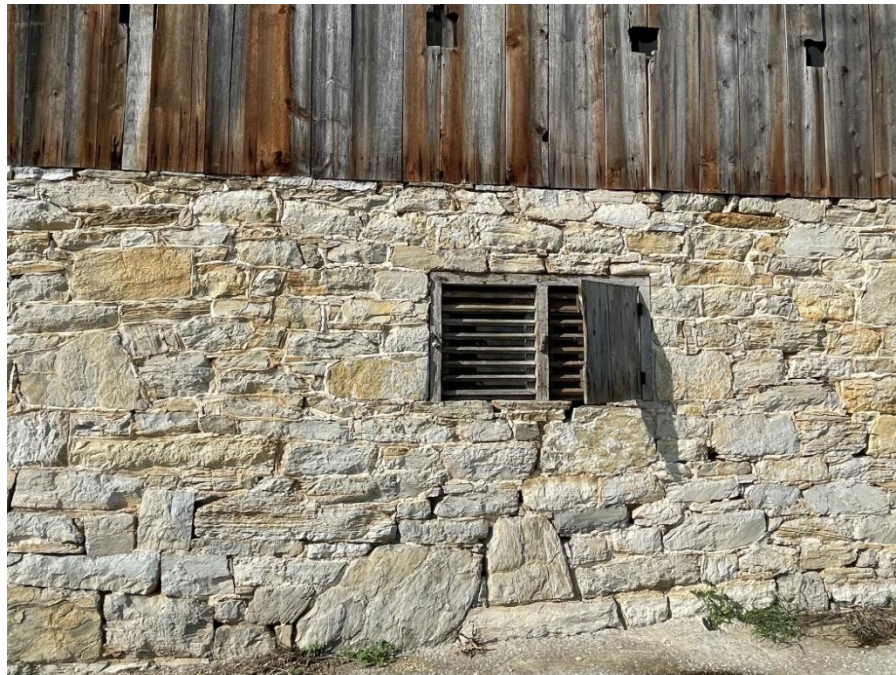
Figure 25. Roulette Barn, Ventilation Windows on Northeast Foundation Wall. View from Exterior. (Tabitha Gold, 2022).

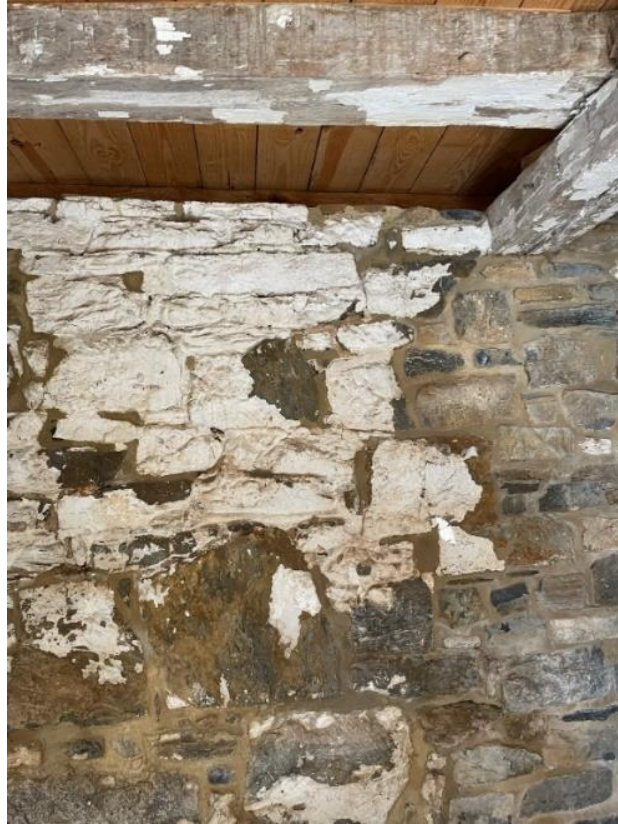
Figure 26. Roulette Barn, Whitewash remnants on stone foundation wall (Tabitha Gold, 2022).

The foundation of the Roulette Barn also has remnants of whitewash on the interior of the foundation wall shown in Figure 26.

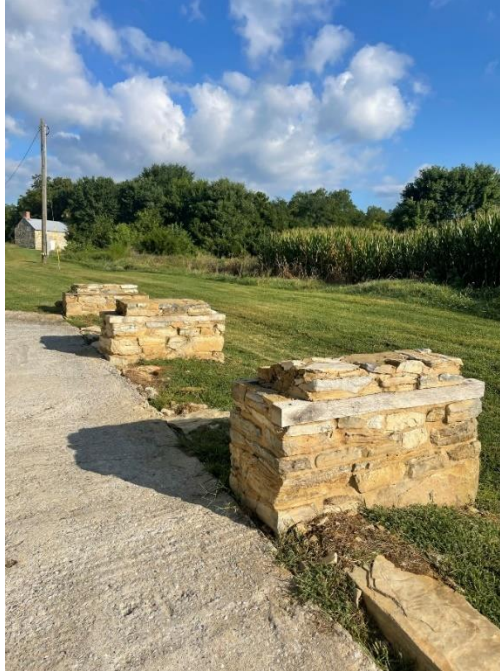
Figure 27. Roulette Barn, corn crib/wagon shed piers. (Tabitha Gold, 2022).

The corn crib has four limestone piers that are approximately 5'-1" wide by 2'-2" deep. The pattern of the limestone piers is also randomly coursed with lime mortar similar to the main foundation of the barn. The corn crib piers are at an unknown depth. Figure 27 shows the piers in their current state.

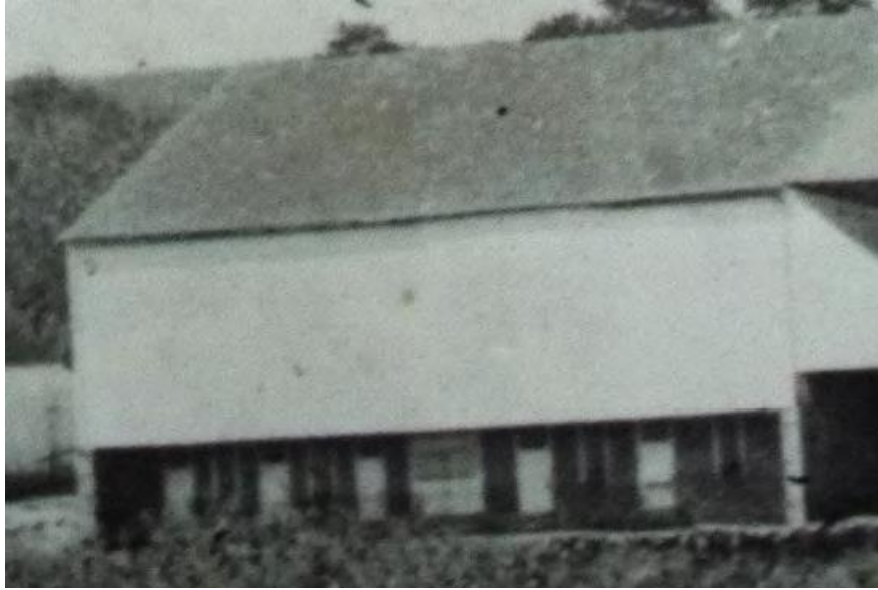
Figure 29. Original Forebay Wall in ca. 1890 photograph. (Antietam National Archives, Farm Box. Cited from Roulette Barn HSR).

The original wall under the forebay (shown previously in Figure 29, page 53) was removed by the Millers sometime in the 1950's.¹²⁶ A new wall made of concrete blocks was constructed 7'-0" forward of the original location flush with the outside edge of the forebay. The CMU wall is unpainted and has nine windows (Figures 39 & 40). When the forebay wall on the lower level was removed, 7" hollow metal poles were added to support the summer beam shown in Figure 41.

The forebay wall should be rebuilt with a wood wall below to match the appearance in the 1890's photo of the Roulette barn (Figure 29, page 53). The forebay wall should be located at approximately 7'-0" from the present CMU wall beneath the front summer beam. The installation of the CMU wall flush with the forebay side was likely intended to modernize and enclose the space of the barn for the later dairy operation, not support the cantilever. The gap in the wall seen in the top left corner of Figure 42 shows the location of the original forebay wall, while Figure 43 shows an exterior view of the intersection of the CMU wall and limestone foundation.

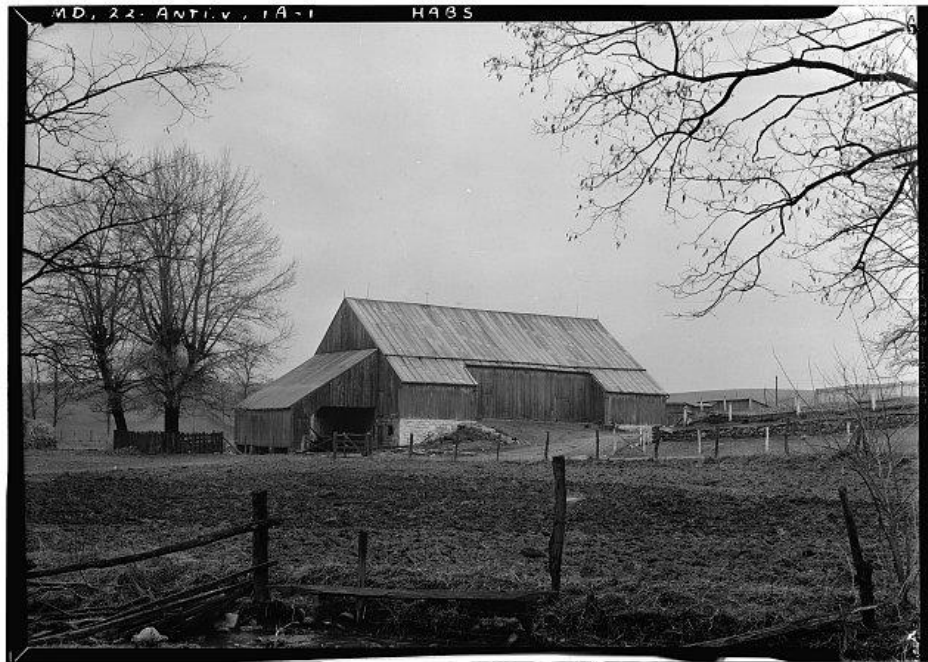
Figure 30. Roulette Farm, Barn, Sharpsburg, Washington County, MD. (Waterman, Thomas T., creator Historic American Buildings Survey, Thomas T. Waterman, Photographer 1940).

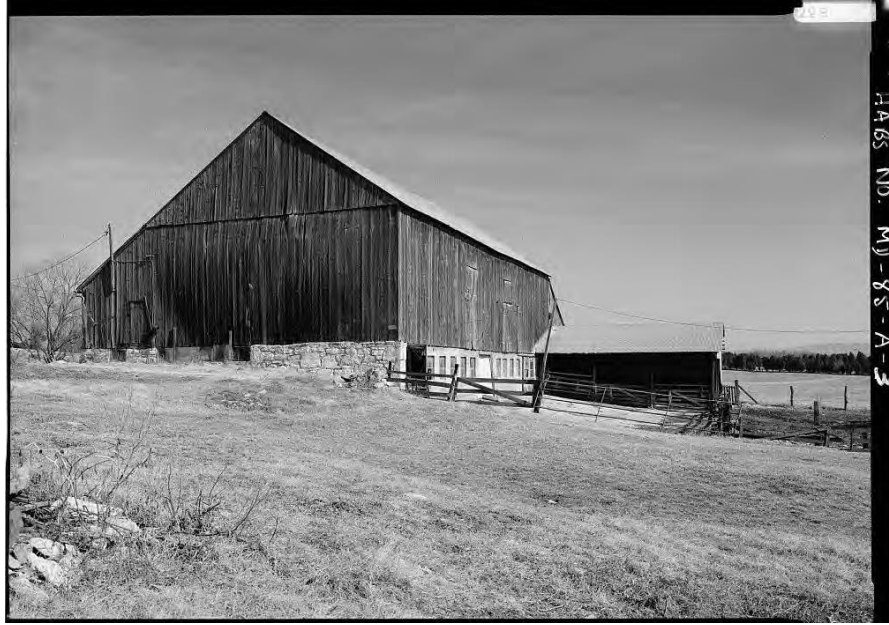
Throughout its life the Roulette Barn has been damaged, repaired with modern building materials, and lost key features of its early configuration. The barn was constructed ca. 1855 and has undergone multiple cycles of repair and modification.¹¹⁵ The construction date of the corn crib and wagon shed is ca. 1863, and the barn appears to have been whitewashed by the time of an 1890 photograph (Figure 29).¹¹⁶ A 1940 HABS photograph shows the corn crib and wagon shed and the structure is no longer whitewashed (Figure 30).¹¹⁷ A 1989 HABS photograph shows the addition of a concrete-block wall under the forebay side of the barn (Figure 31).¹¹⁸

Figure 31. Perspective view of south end and east (rear) – 1989 Roulette Farm, Barn, Sharpsburg, Washington County, MD. (Boucher, Jack E., creator Historic American Buildings Survey).

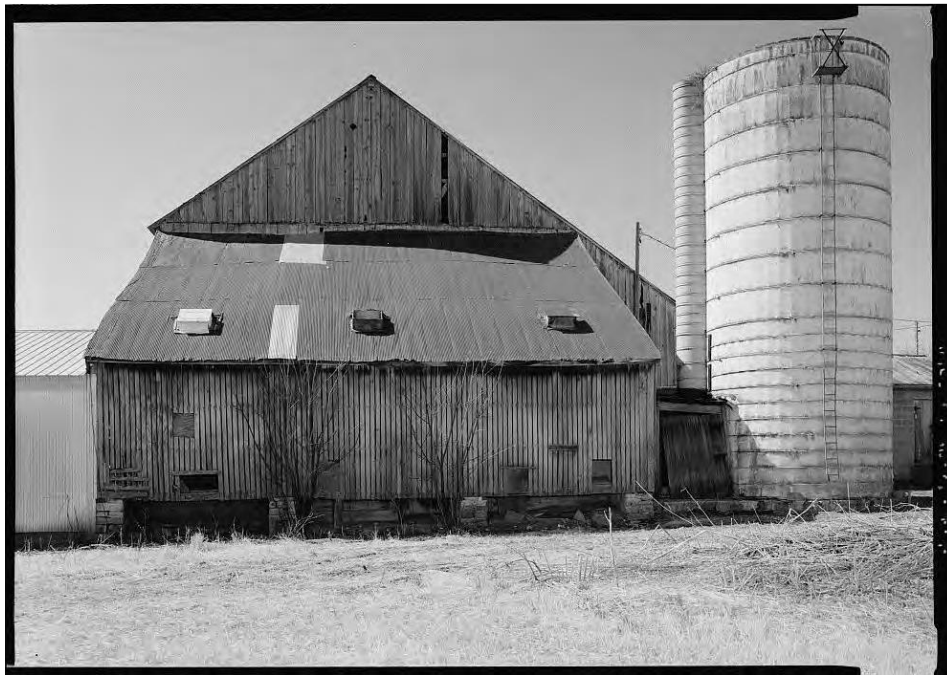
Figure 32. North elevation with addition and silo in foreground – 2004 Roulette Farm, Barn, Sharpsburg, Washington County, MD. (Boucher, Jack E., creator Historic American Buildings Survey).

A 2004 HABS photo of the east elevation (Figure 32) shows the corn crib and roof intact.¹¹⁹ The overall form of the Roulette Barn stayed consistent, however, the modifications over time have resulted in a significant loss of integrity to the barns vernacular origin.

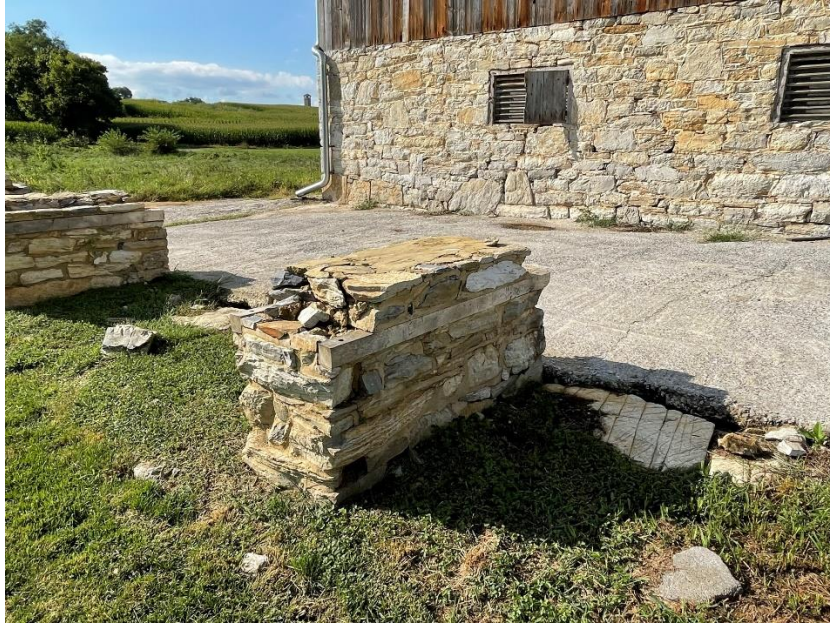
The corn crib and wagon shed were dismantled, and salvageable pieces were tagged and placed in the center of the barn for storage. The siding that was salvaged from the corn crib appeared to be different sizes than the vertical wood siding on the main section of the barn. The documentation performed by HPTC in the Historic Structures Report includes measurements of the corn crib before it was taken down. The remains of the corn crib foundation piers are shown in Figure 33.

Figure 33. Roulette Barn, Corn crib/wagon shed stone pier. (Tabitha Gold, 2022).

In order to start the process of reconstructing the corn crib, new sills need to be installed in the existing stone foundations. The top sections of the piers need to be reappointed with stone and mortar before new wood framing can be installed.

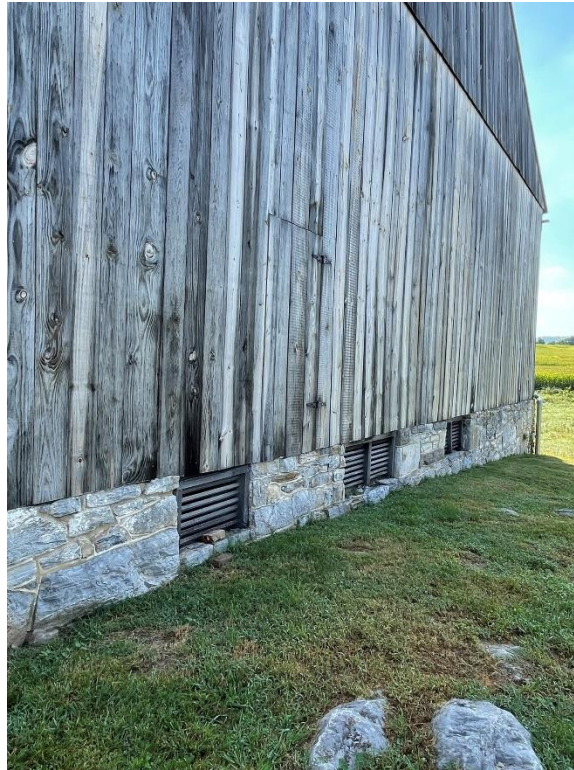
Figure 36. Roulette Barn, Foundation Walls With Vents. (Tabitha Gold. 2022).

mortared with Portland cement. Areas where modifications have been done on the interior of the barn can be easily identified as locations without whitewash. The 2'-0" thick limestone wall foundation can be seen in Figure 36. Some sections have been patched and the mortar was reappointed with compatible lime mortar in 2004.¹²⁵

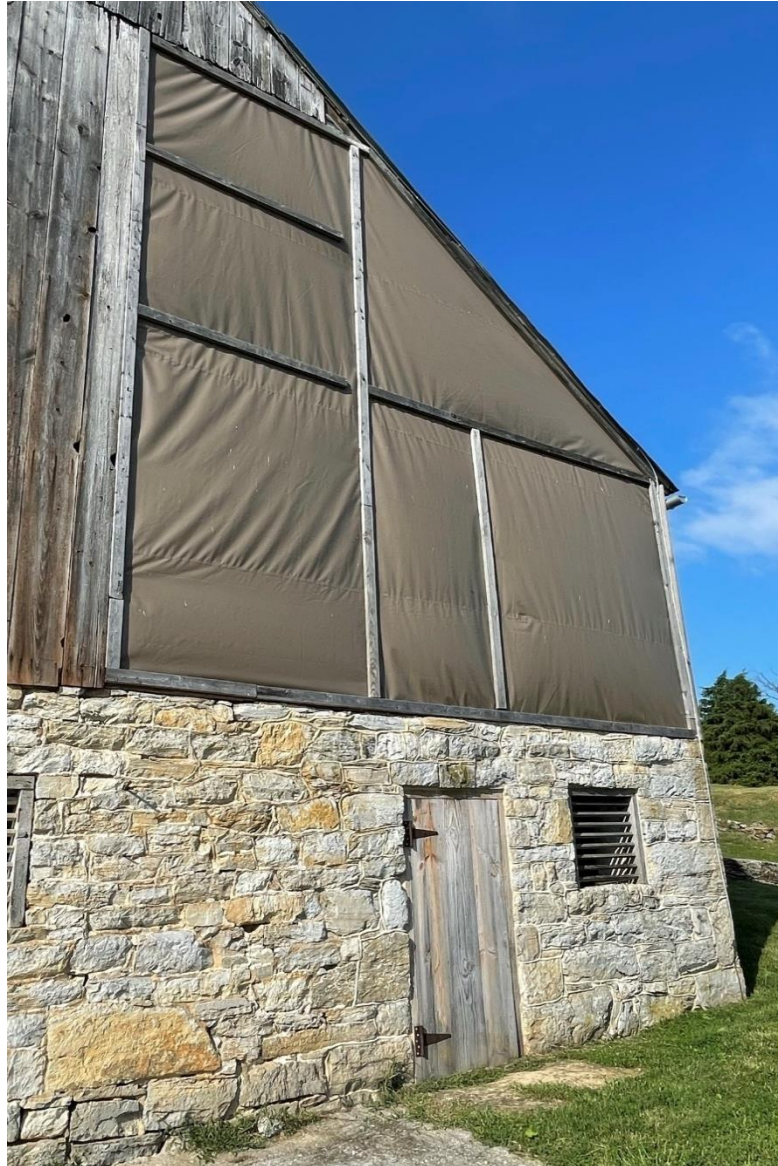
Figure 37. East gable side of the Roulette Barn. (Tabitha Gold, 2022).

task for a complete replacement due to the deterioration of the wood. Pieces of the timber that were salvageable were documented and are currently in the main level of the barn cataloged and in storage. As shown in Figures 37 and 38, the east gable wall, where the corn crib had previously been located, has vertical siding that is severely weathered and exhibiting signs of rot.

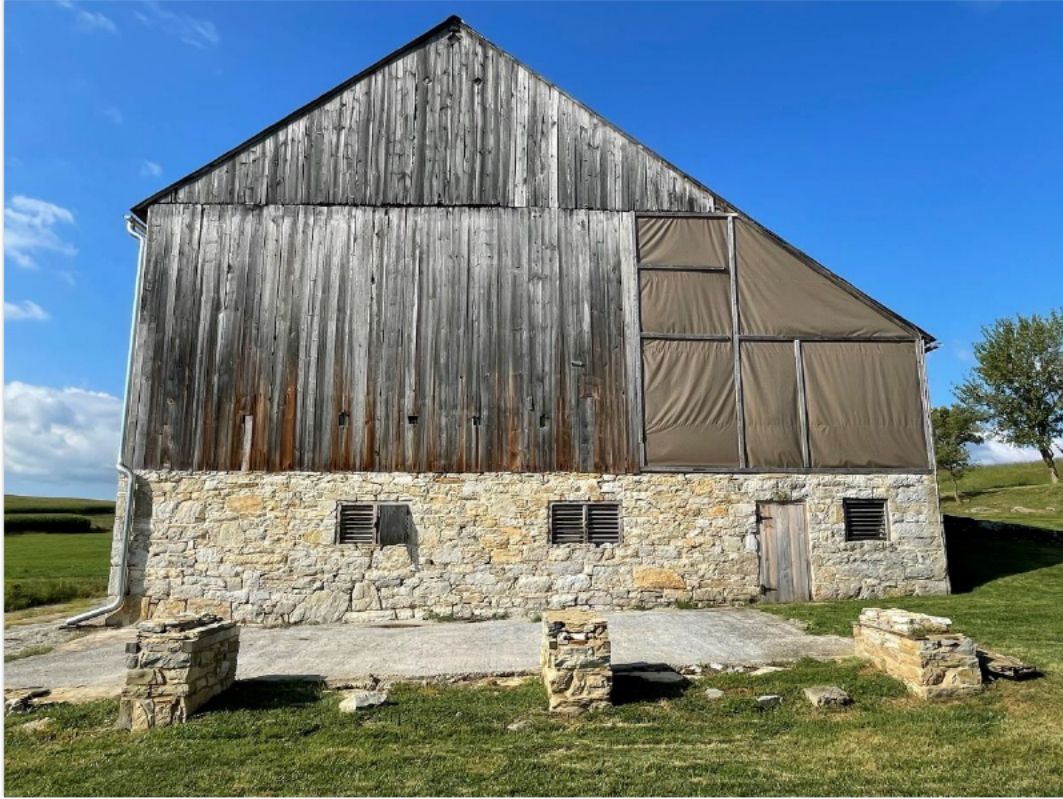
Figure 38. Corn crib/wagon shed stone piers. (Tabitha Gold, 2022).

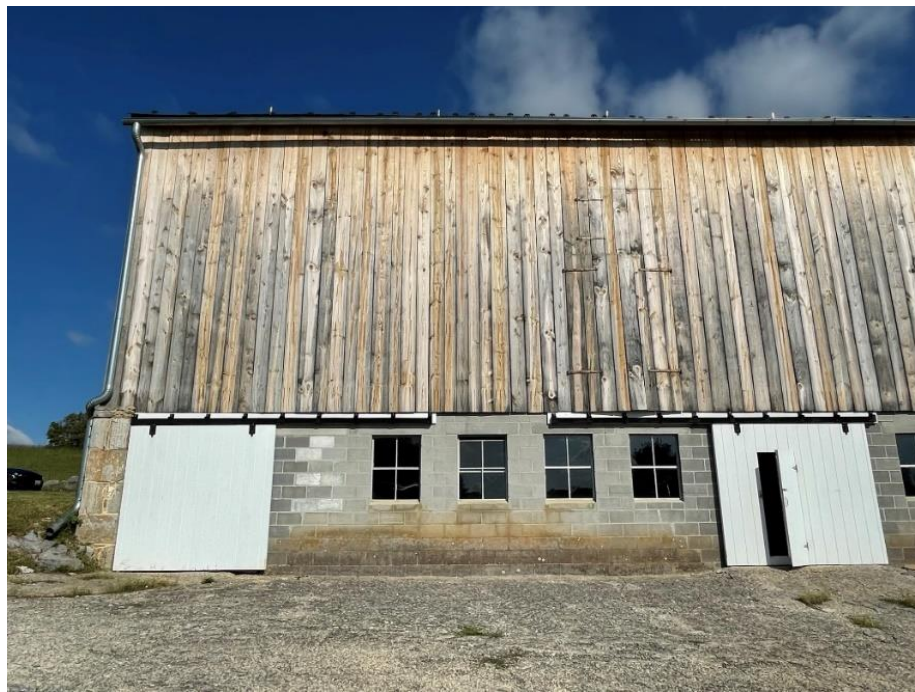
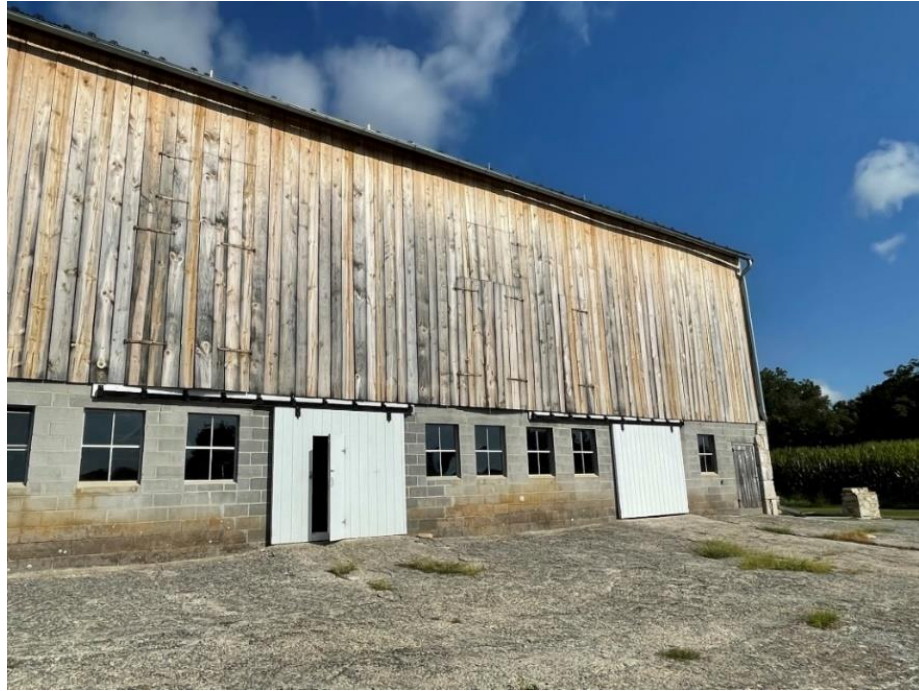
Figure 39. Roulette Barn, View of South Wall. (Tabitha Gold, 2022).

Figure 40. Roulette Barn, View of South Wall. (Tabitha Gold, 2022).

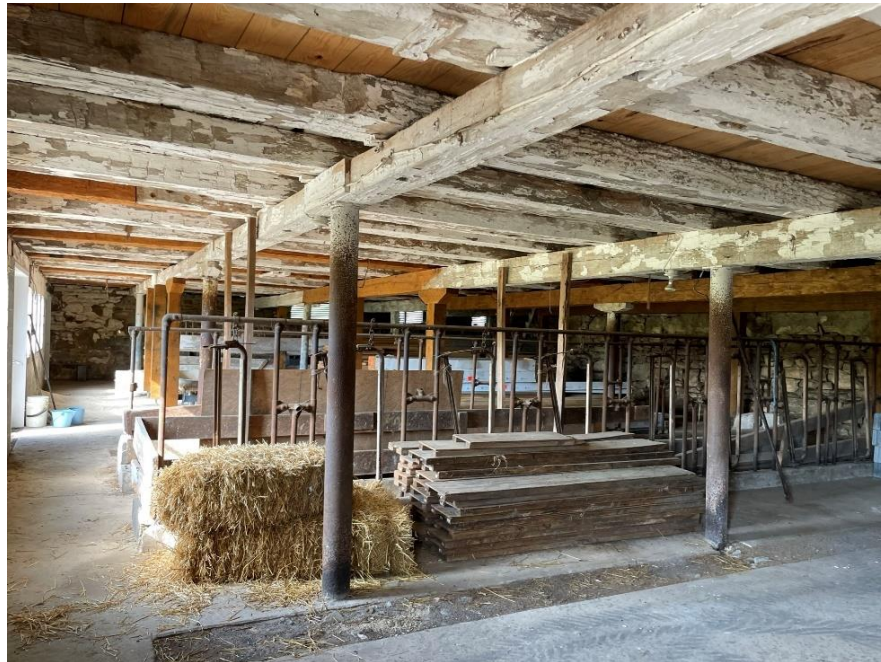
Figure 41. Hollow metal poles added ca 1950's by the Roulette Family. (Tabitha Gold, 2022).

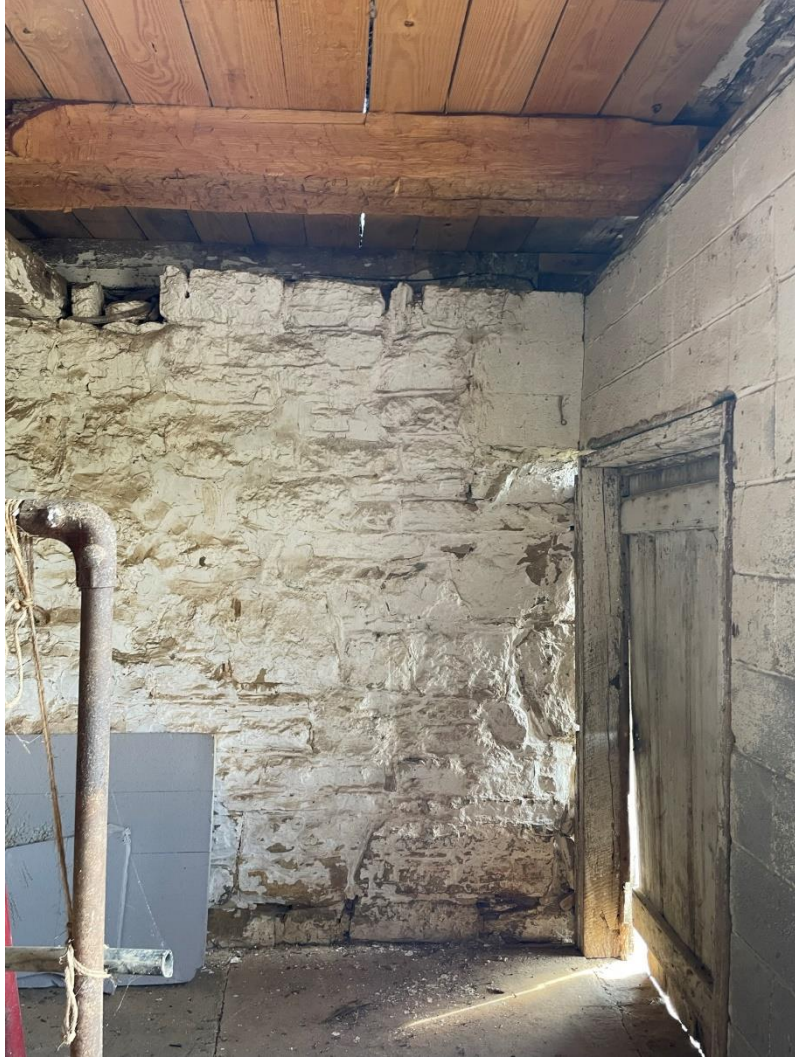
Figure 42. Viewpoint of CMU wall intersecting with limestone foundation wall (Tabitha Gold 2022).

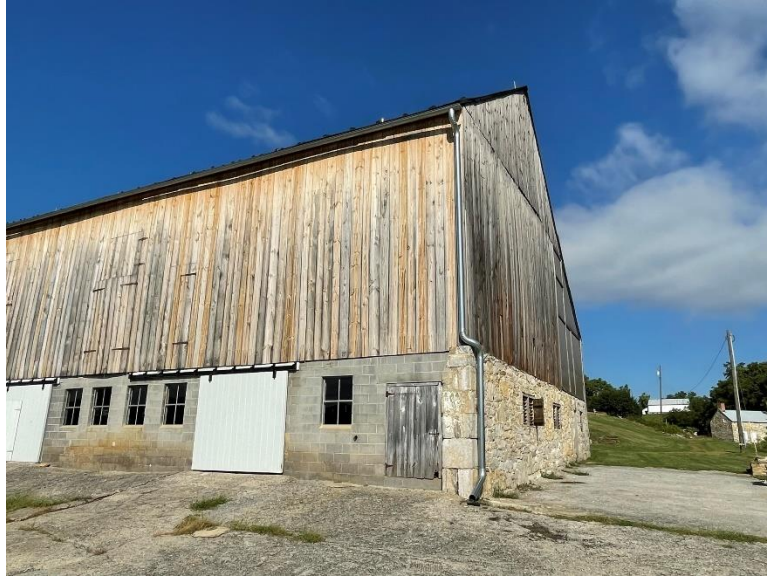
Figure 43. Exterior showing CMU wall intersecting with limestone foundation wall (Tabitha Gold, 2022).

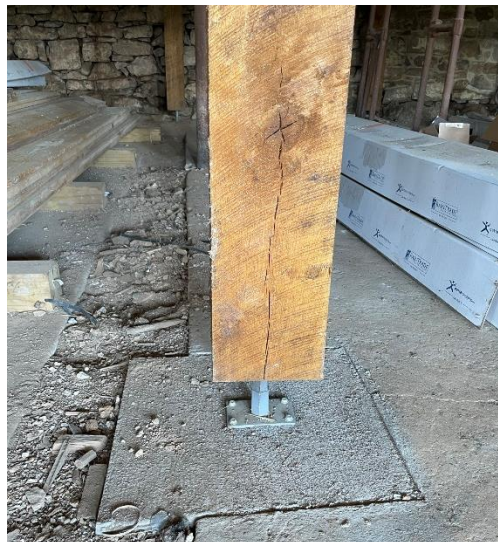
Figure 44. Post replacement under the summer beam on the lower lever (Tabitha Gold, 2022).

The cantilever will extend approximately 7'-0" when the CMU wall is removed. A historically appropriate wall, preferably made from white oak timbers, shall be constructed on the lower level. Currently wood posts were installed in the HPTC 2018 repair project to support the summer beam (Figure 44).

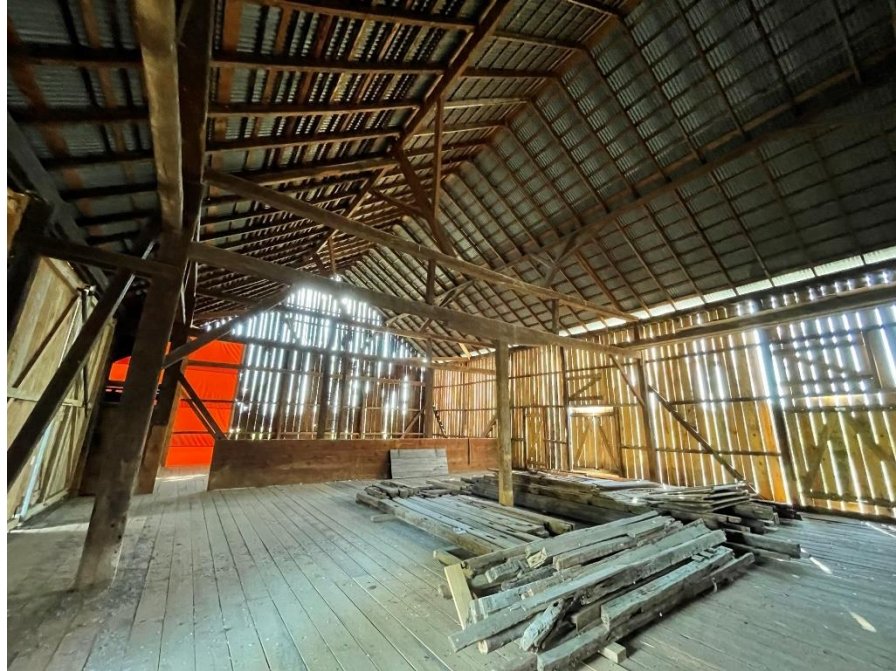
Figure 45. Roulette Barn, Salvaged corn crib members stored in the main area of the barn (Tabitha Gold, 2022).

Some wood members of the corn crib have been salvaged and stored in the Roulette Barn (Figure 45).

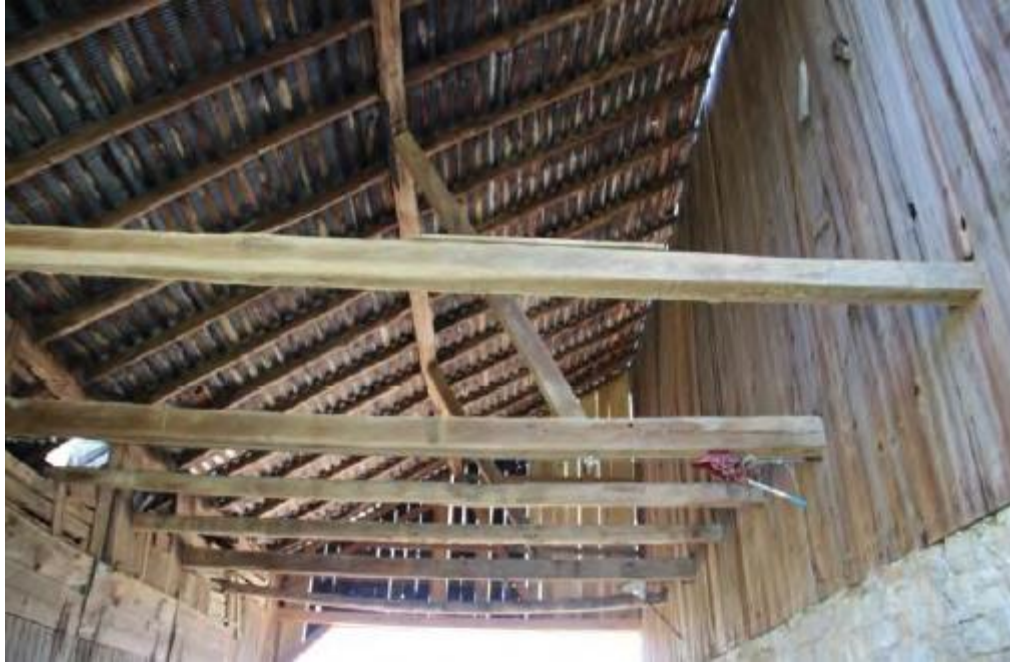
The corn crib was divided into three bays separated by posts. The north and south walls were connected by large tie beams at each corner post. The posts on the west side of the corn crib supported a roof plate that was 7" wide and 8" deep. The posts on the east side of the corn crib supported a roof plate that was 5" wide and 8" deep.

Figure 46. Photo of the corn crib and wagon shed in 2012 before the removal (HSR Rebecca Cybularz).

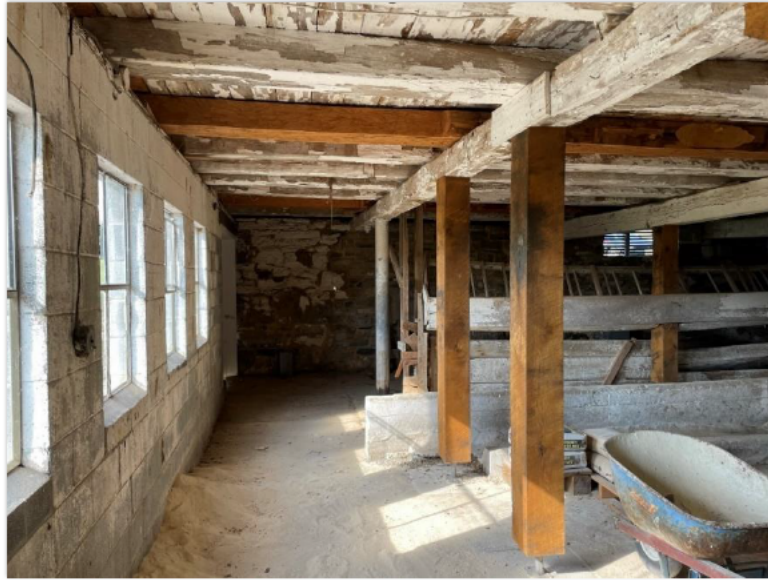
Figure 49. Post and beam replacements previously performed by NPS in the 2018 repair project (Tabitha Gold, 2022).

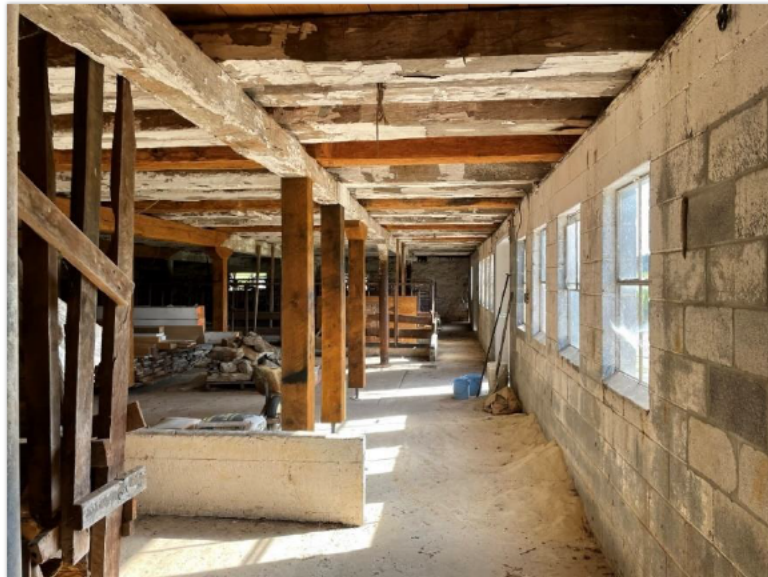
Figure 50. Post and Beam replacements near CMU wall (Tabitha Gold, 2022).
