Arc failure of Southwire Romex Simpull non-metallic sheathed 14/2 American wire gauge (AWG) with ground cable due to external heat was examined. This type of cable was selected due to its widespread use in residential building wiring. This research is motivated by the fact that currently there are no widely accepted methods or models used to predict electric arc failure in cables exposed to thermal conditions or to determine whether an arc failure event was the cause or result of a fire. A variety of tests were performed at various temperatures to learn more about the arc failure of these cables. The cables were exposed to precise temperatures with a steady heating rate in a convection oven in order to best attempt to eliminate heat transfer through the cable. In order to explore the effect current may have on the time to arc failure of the cable, experiments at different temperatures were performed in both loaded and unloaded scenarios. During many of these tests, voltage and current measurements were collected during an arcing event. As part of the process of exploring the events leading up to arc failure, electrical resistance tests of the cable's insulation components were exam

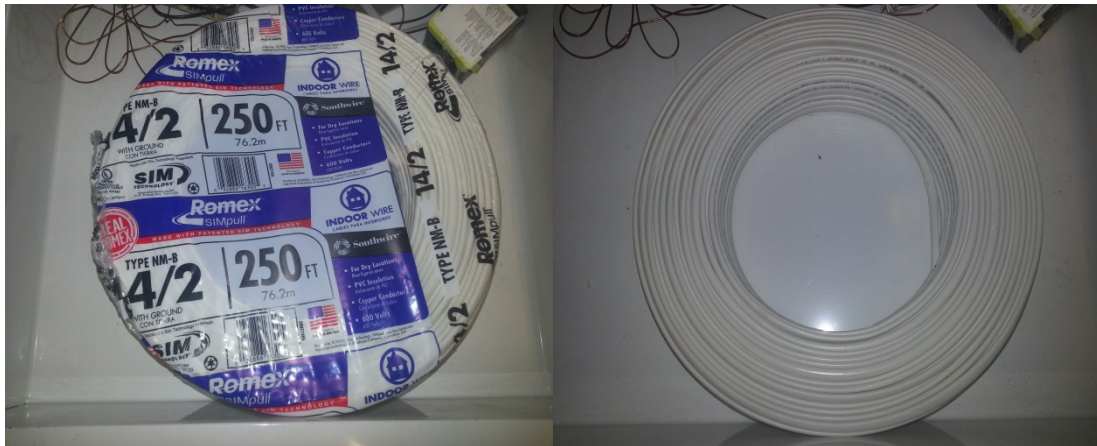
The cable type selected in this study is commonly used in residential branch circuit wiring and is readily available. The specific type of cable used was 14/2 AWG (1.63 mm diameter copper wire) with ground Southwire Romex Simpull non-metallic sheathed cable. A 250' roll of this cable is shown in Figure 1.

Figure 1: Southwire Romex Simpull non-metallic sheathed 14/2 with ground cable

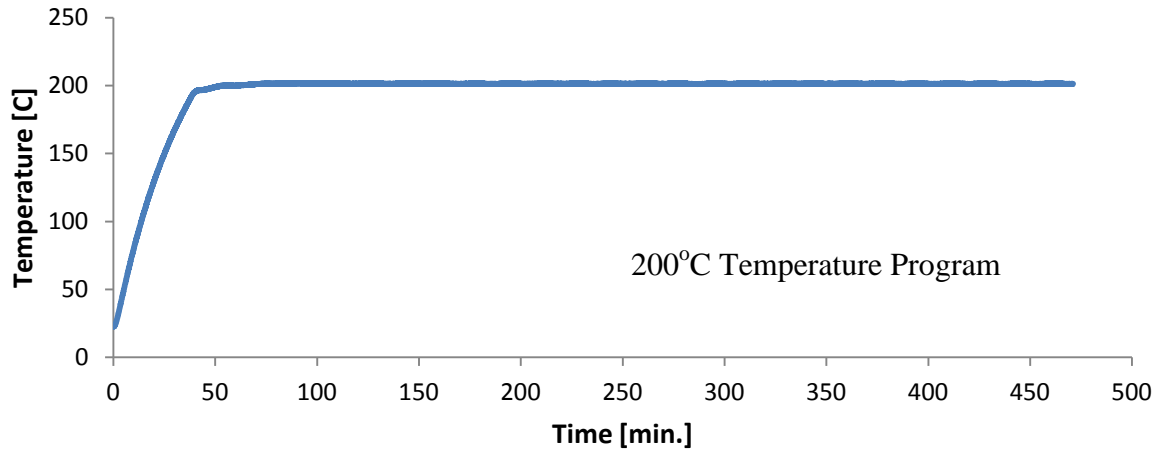
main temperatures used were 200°C, 210°C, and 230°C. These temperatures were chosen due to the fact that full tests could be run within one day. The temperature ramps used were that of the maximum capacity of the oven at each given temperature. In other words, this was the fastest the oven could reach each given temperature. Overall, however, the ramps are relatively slow which allows for even heating throughout the cable. The corresponding oven temperature programs can be seen in Figure 3.

Figure 3: Oven Temperature Programs

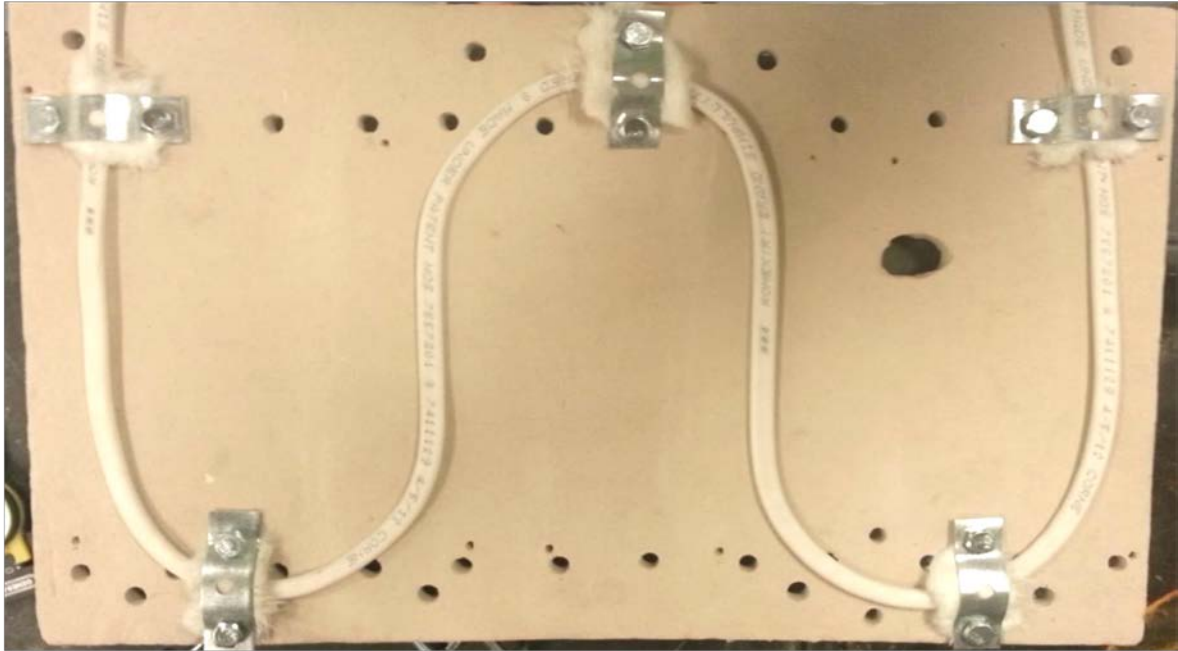
Figure 5: Cable Mold

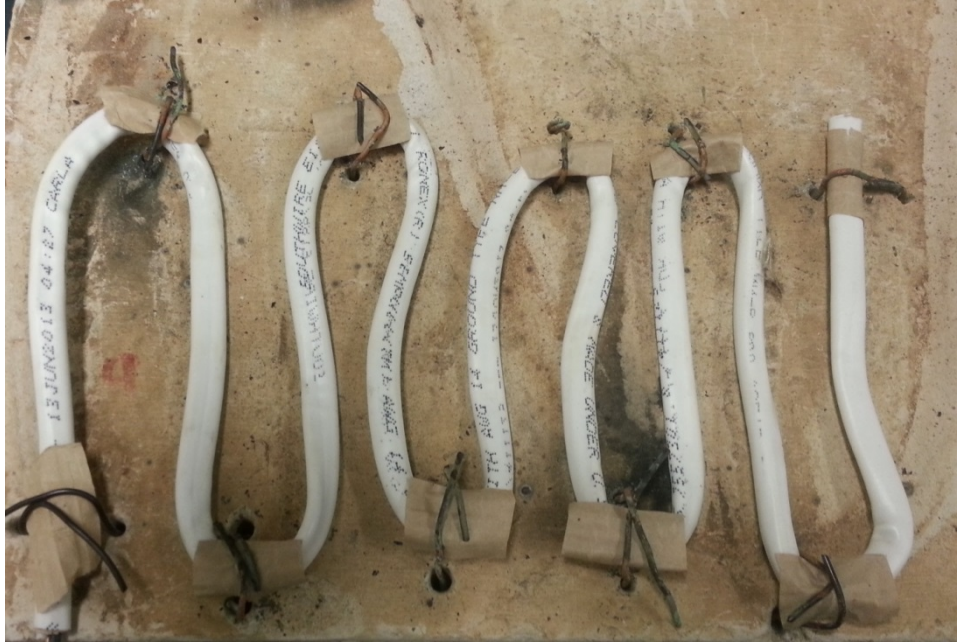
In order to examine the possible effects of the geometry of the cable set up, a different cable arrangement was explored. In this set of experiments, sharp bends were introduced in the geometry of the cable set up as seen in Figure 6. The cable length was 50” just as it was in previous cable tests, but now bent sharply. This allowed the researchers to examine how an increase in mechanical stress on the cable may have an impact on the time to arc failure. It was hypothesized that sharp bends in the cable could cause the cable to be more susceptible to an electrical arc across the insulation components due to the mechanical stress on the insulation coupled with the thermal degradation of the insulation. Specifically, damaging the structure of the ground paper sheathing was hypothesized to play a role in the time to arc failure. The sharp bends were explored in order to see if a difference in orientation and contact between the PVC insulation and the paper would have an effect on the time to arc failure of the cable.

Figure 6: Sharp Bend Testing. Note: Brown paper pieces used for insulation from fasteners

The results from the 200°C sharp bend tests are compared to the 200°C energized, unloaded test results in Table 3 and show that there was not a significant impact on the time to arc failure due to the sharp bending of the cable. There is an increase in time to failure for the sharp bends set up over the original set up, however this falls within two standard deviations of the mean of the time to failure of the original set up so was determined to be negligible.

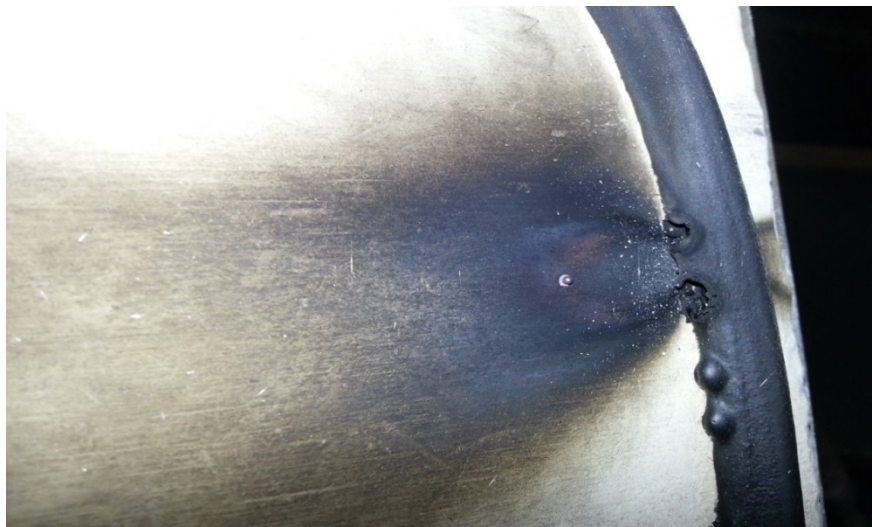
The time to arc failure was recorded at the first visual sign of arcing event (sparking). Many times this coincided with a blown fuse in the circuit, but occasionally several short, sputtering arcing events occurred before the fuse in the circuit blew. Figure 11 shows an example of a cable post-electric arc event. The cable has undergone significant charring and as result of the arc event, molten copper was ejected from the side of the cable in the form of sparks. In the figure, ruptures in the side of the cable are obvious. A small piece of solidified molten copper is highlighted in the photo and additional photos can be found in the Appendix.

Figure 11: Cable Arc Aftermath

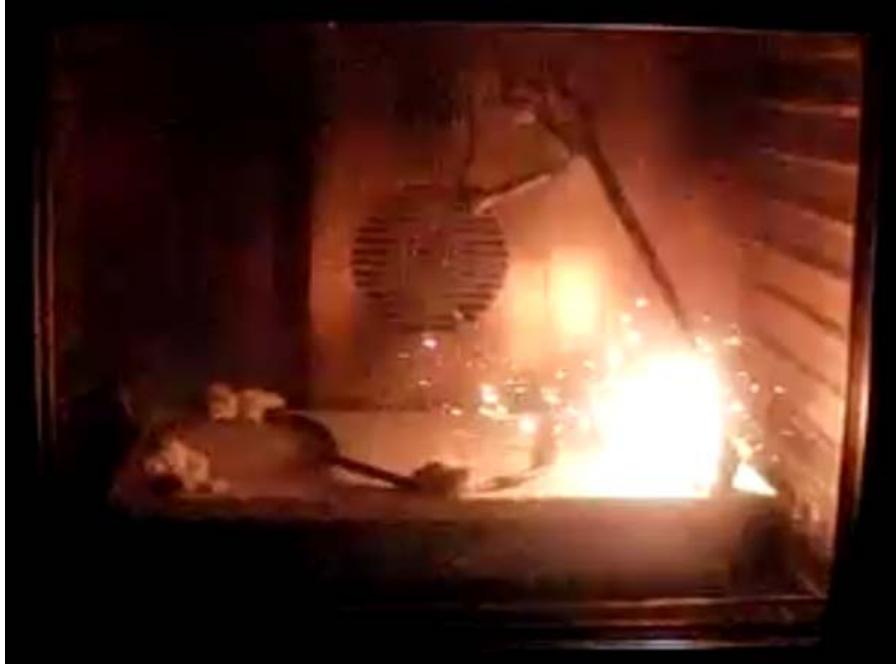
When the arcing event occurred, a loud humming sound erupted and sparks begin to be ejected from the cable. At this point, in most cases, the fuse will have blown and the circuit was shut down manually past the fuse. Throughout the entirety of this study, the 20 Amp fuse failed prior to activation of the 15 Amp circuit breaker. Several types of circuit breakers were experimented with throughout testing, but no circuit breaker activation occurred. The arcing event finished either when the fuse was blown or when the wires were broken due to the immense amount of energy from the event. Either way, the circuit was now open and the test concluded. The arcing event melts the copper in the wires and emits sparks in the form of molten copper. Figure 14 is a snapshot of a high speed video of an arcing event at 230° C. Additional photographs are available in the Appendix.

Figure 14: Arcing Event

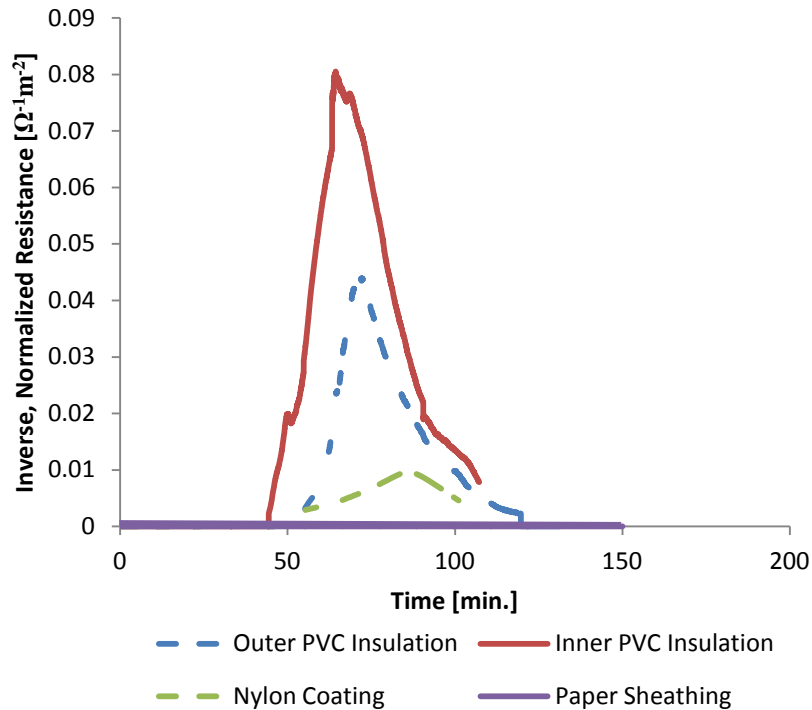
From the resistance drop testing for each of the insulation components, an inverse, normalized resistance was determined from the resistance measurements and the surface area of the samples used in the experiments. Therefore, the inverse, normalized resistance measurements are reported in units of $\Omega^{-1}\text{m}^{-2}$. Examples of this for the outer PVC insulation, inner PVC insulation, nylon coating, and paper sheathing are shown in Figure 22.

Figure 22: 230°C Insulation Component Inverse, Normalized Resistance

During the exposure, the paper sheathing did not show any measurable drop in resistance for up to 150 minutes. The times in Table 6 are noticeably less than the average time to resistance drop in the entire cable of 72 minutes that shown in Table 1.

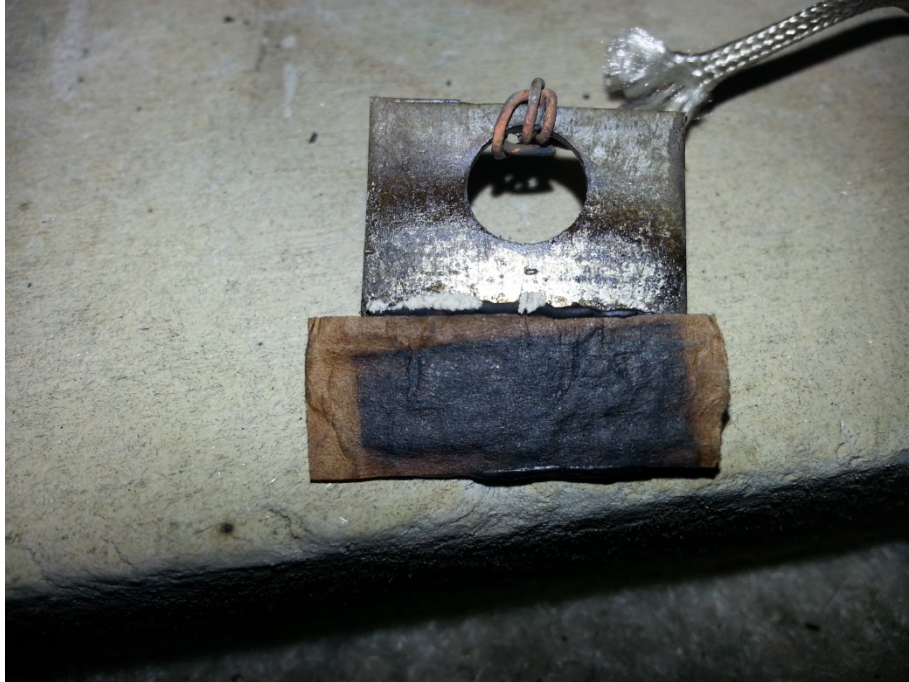
Figure 23: PVC-Paper Component Post Resistance Testing (Top Plate Removed for Picture)

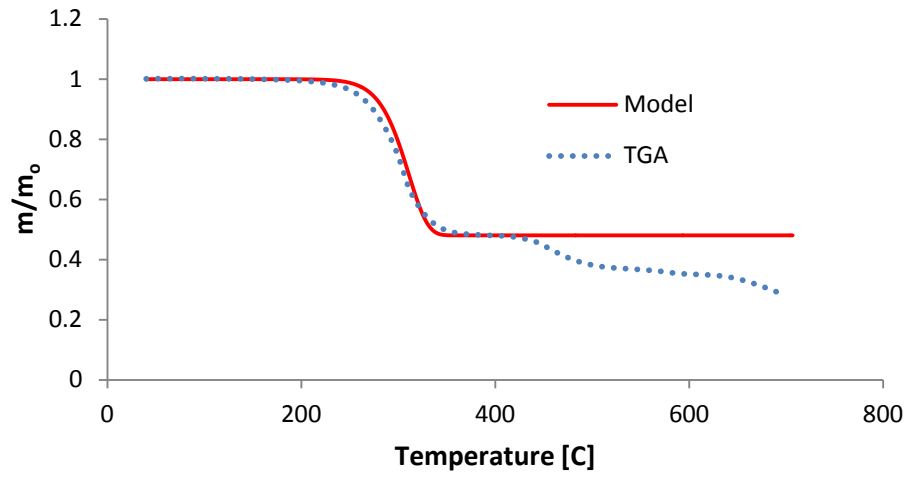
The Arrhenius parameters that were determined based on the results from the TGA testing were now used in an additional modeling approach. These parameters were then used to model the state of each insulation component based on the conditions within the testing oven. Simulations were conducted for each insulation component at each of the three main testing temperatures (200°C, 210°C, 230°C). The temperature profile of the oven tests were prescribed in the model and the end of the simulation was set to be the experimental average time to arcing failure for full cable tests at each respective testing temperature. For example, ThermaKin simulations used to model the 200°C oven temperature experiments had a prescribed temperature program to match that of the 200°C oven temperature profile and ended after 498.5 minutes for each insulation component. 498.5 minutes is the average time to arc failure for the 200°C energized, unloaded cable experiments; the average time to arc failure for these experiments can be found in Table 2. The energized, unloaded experimental time to failures were then used to begin the development of a predictive model. At the end of the oven-replicating simulations, the mass concentration of char and virgin solid of each insulation component was noted. The mass of the gas given off from the material during thermal decomposition had a negligible effect on the overall mass of the material because it was expected to leave the material. The mass concentration findings are described as a critical degree of degradation that exists at the time of arc failure and are listed in Table 11. The critical degrees of degradation calculated to exist at the average time to arc failure for each temperature profile in the model produced particularly consistent results. The consistency of these results brings confidence to the inputs and determined failure criteria for electrical arc failure. The definition of critical degree of degradation is listed below.

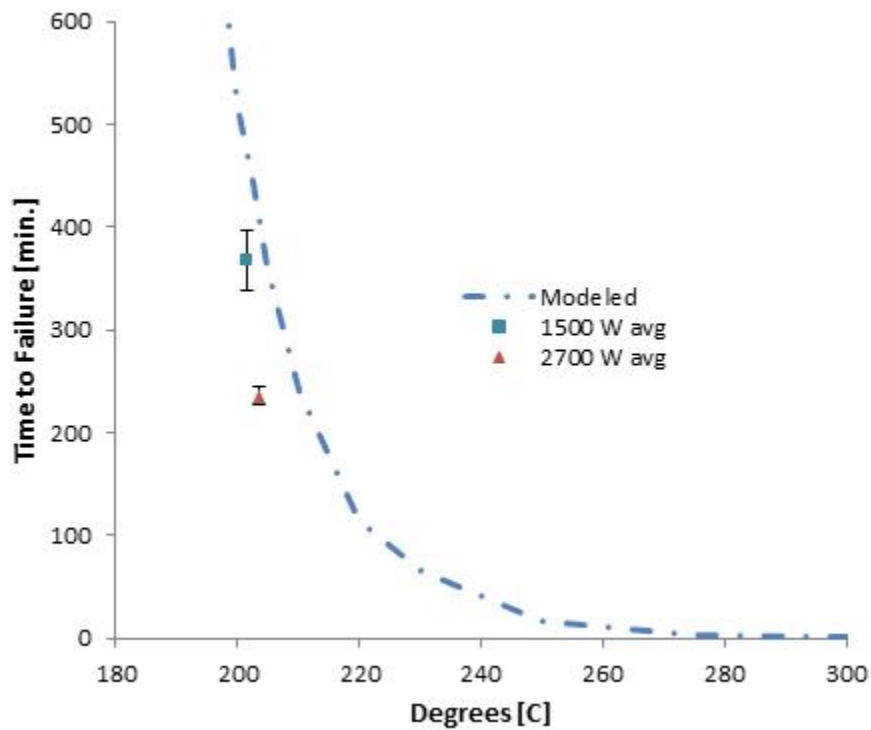
As previously mentioned, an additional increase in internal cable temperature was seen when a load was introduced to the cable. Therefore, it was hypothesized that the increase in cable temperature caused the decrease in time to arc failure in the different 200°C load scenarios as shown in Table 4. Furthermore, the increased cable temperatures of the loaded scenarios were inputted into the model previously used to represent the unloaded scenarios (in which the environmental temperature and cable temperature were found to be relatively equal throughout the experiment). The temperatures used for input for the loaded scenarios were average steady-state cable temperatures calculated after the cable reached the prescribed oven atmospheric temperature and up until arc failure. The temperatures are those listed in Table 5. Figure 42 shows the previously developed model along with the time to arc failure predicted by the model for the load scenarios. The model slightly over-predicts the time to failure for the energized and loaded cable scenarios. One reason for this may be because the temperature measurements were taken just underneath the outer PVC insulation. It is assumed that closer to the actual current flow in the interior of the cable, there is a higher temperature. Therefore, if the temperatures from the middle of the cable were able to be obtained and used to compare with the modeled prediction, a closer agreement would exist. However, in an attempt to cause as little disruption to the cable geometry as possible, taking temperature measurements at the center of the cable was not feasible.

Figure 42: Model, Loaded Experimental Time to Failure Predictions

Figure 43: Correct Model, Loaded Experimental Time to Failure Predictions

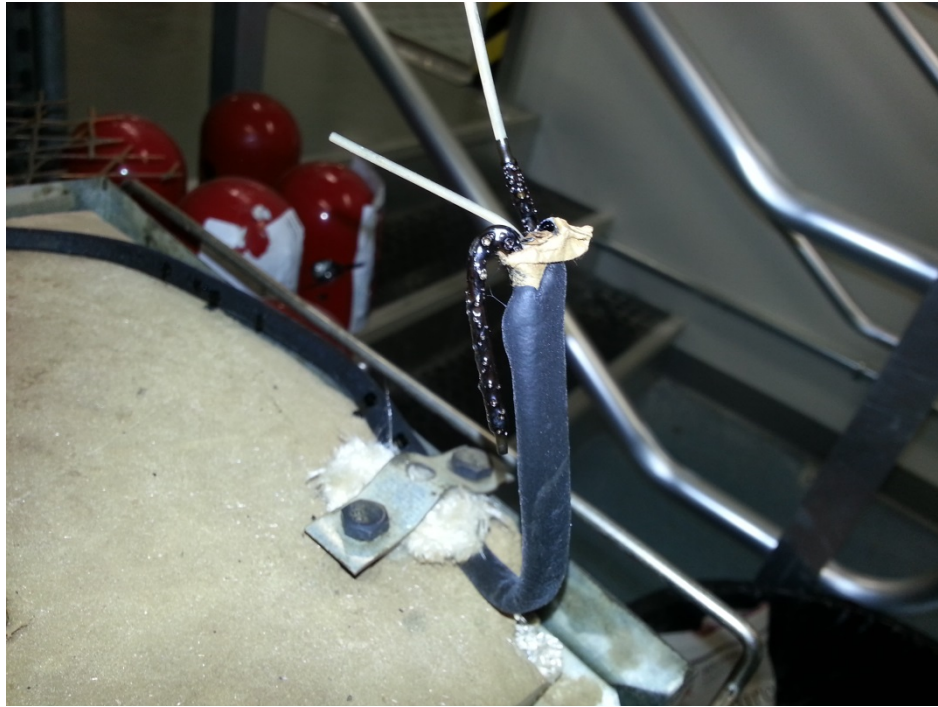
Figure 43: Bubbled, Cracked Inner Insulation (Post Exposure)

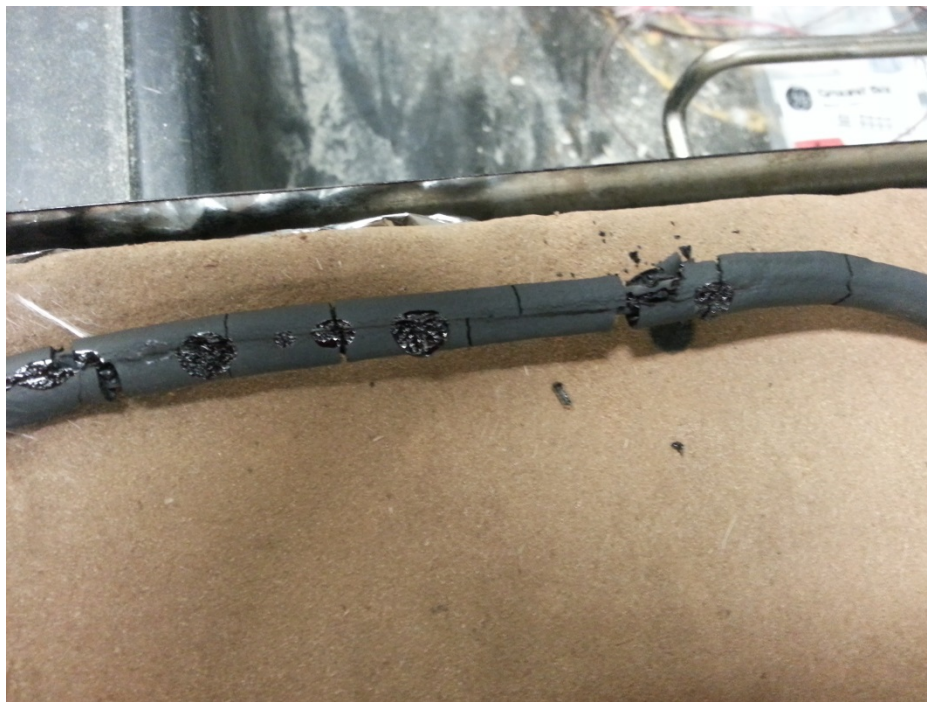
Figure 44: Bubbled, Cracked Outer Insulation (Post Exposure)

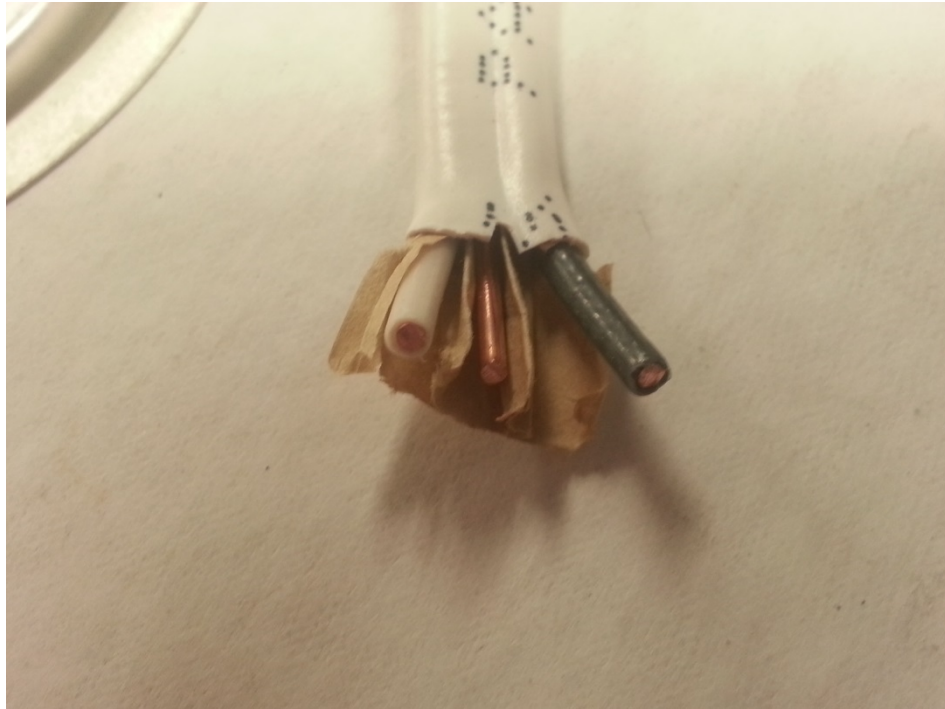
Figure 45: Interior Cable Structure

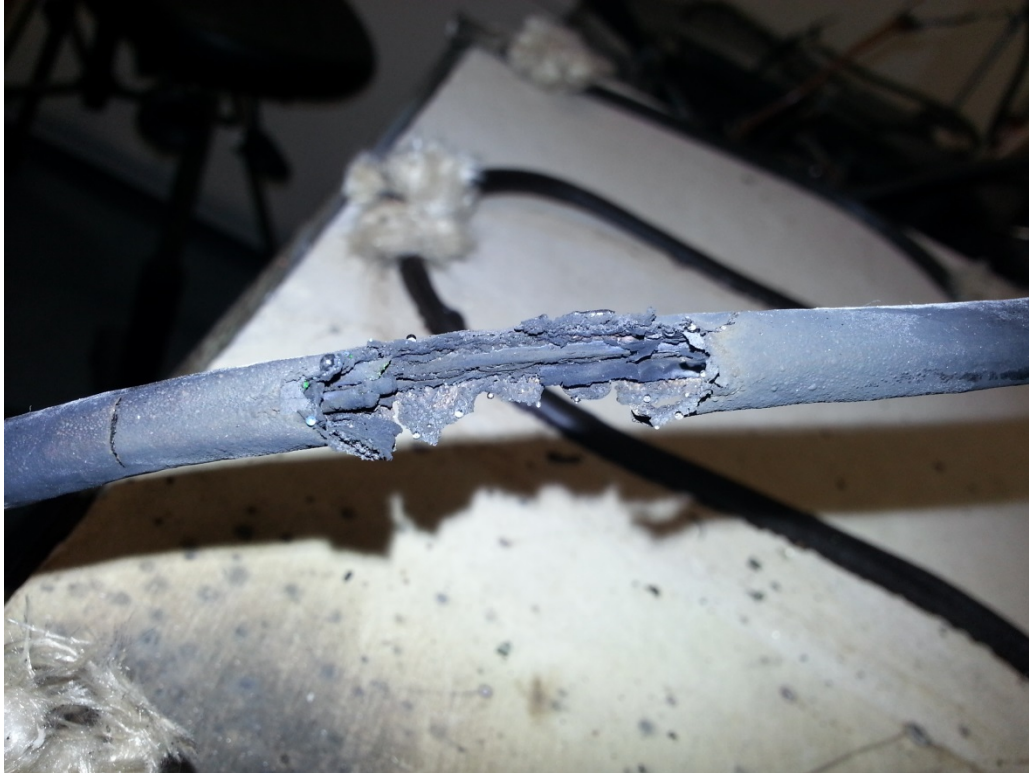
Figure 47: Post Arc Failure (Destroyed hot and ground wires)

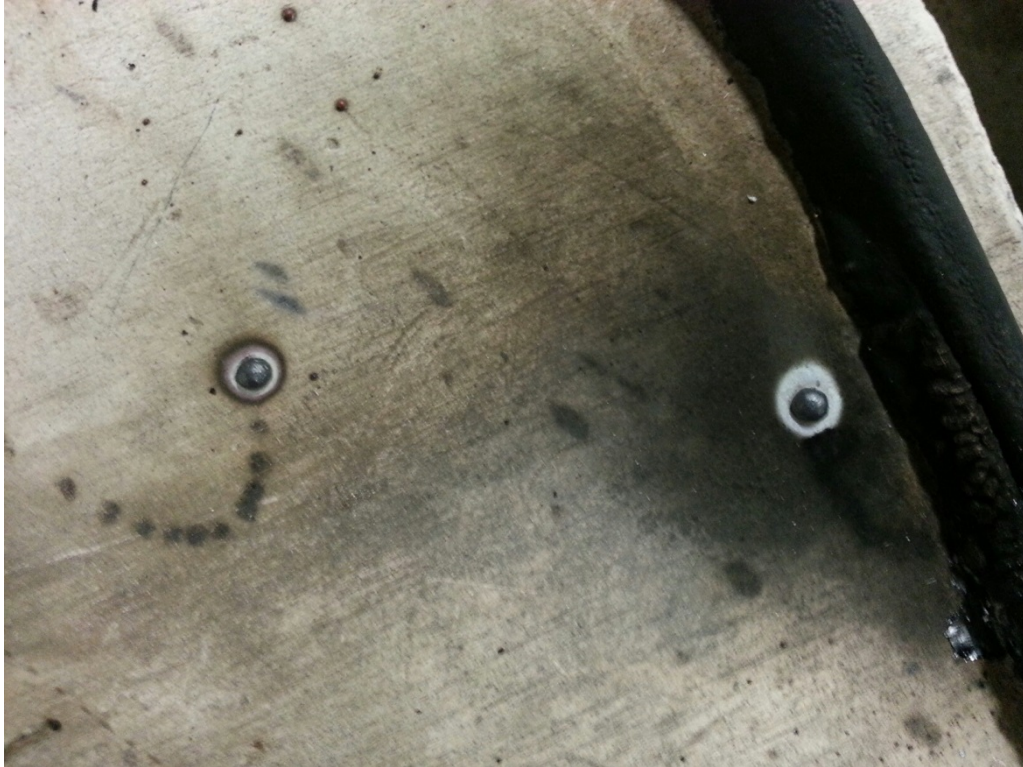
Figure 49: Copper Beads Ejected From Cable During Arc Failure
