Title of Thesis: ANALYSIS OF UNDERVENTILATED  
COMPARTMENT FIRES

Andrew John Wolfe, Master of Science, 2009

# ANALYSIS OF LIMITED VENTILATION COMPARTMENT FIRES

Thesis submitted to the Faculty of the Graduate School of the  
University of Maryland, College Park in partial fulfillment  
of the requirements for the degree of  
Master of Science  
2009

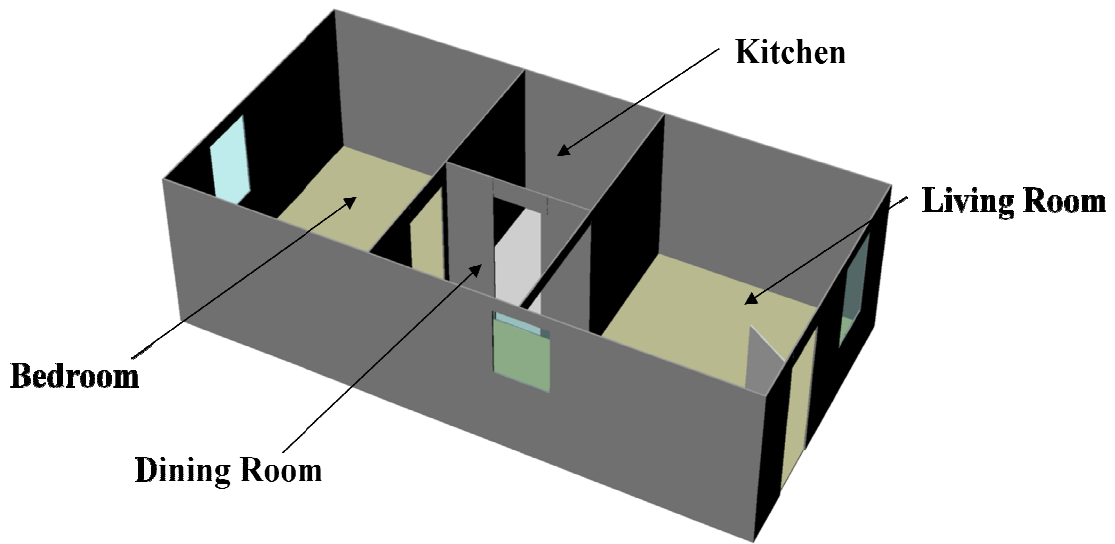
Figure 1-1. General Schematic of Enclosure

The objectives of this research were achieved by way of full scale experiments. The experiments were performed within an instrumented, four room, apartment style enclosure with an area of 41.8 m<sup>2</sup> (450 ft<sup>2</sup>). Figure 1-1 shows a general schematic of the test enclosure. A total of fifteen full-scale experiments were performed. The enclosure and instrumentation of the enclosure were in general accordance to ASTM 603-07, “Guide for Room Fire Experiments” (ASTM E 603-07, 2007).

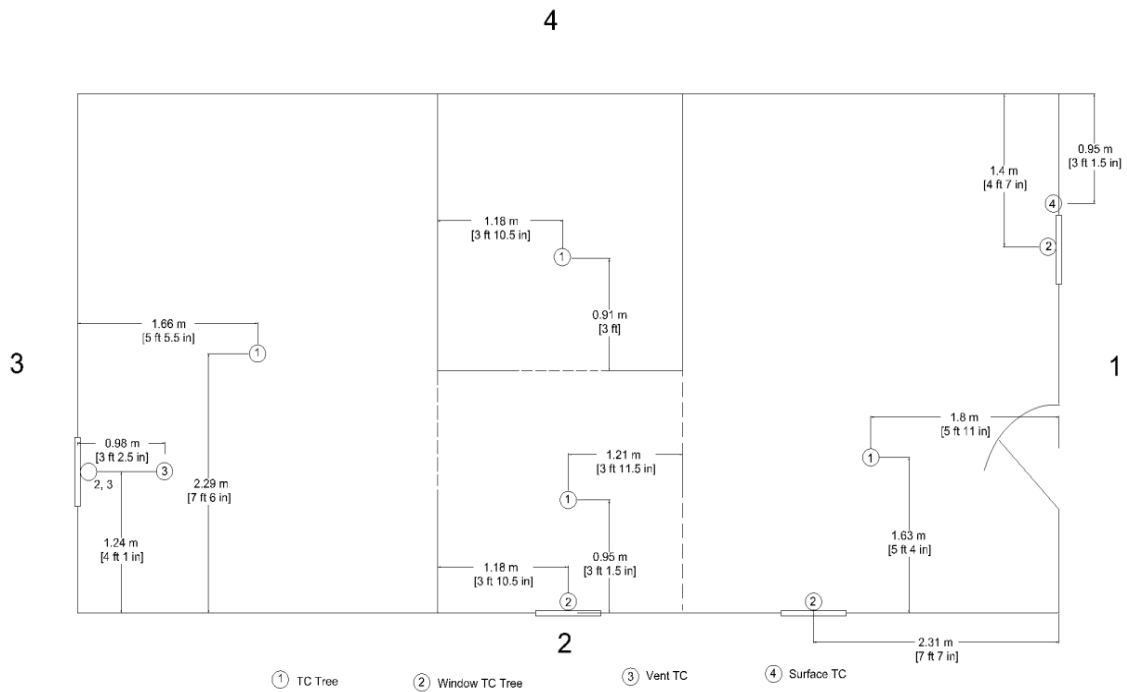
Figure 4-1: TC Locations

Thermocouples (TCs) were used to characterize the thermal environment within the enclosure. Locations of TCs can be found in Figure 4-1.

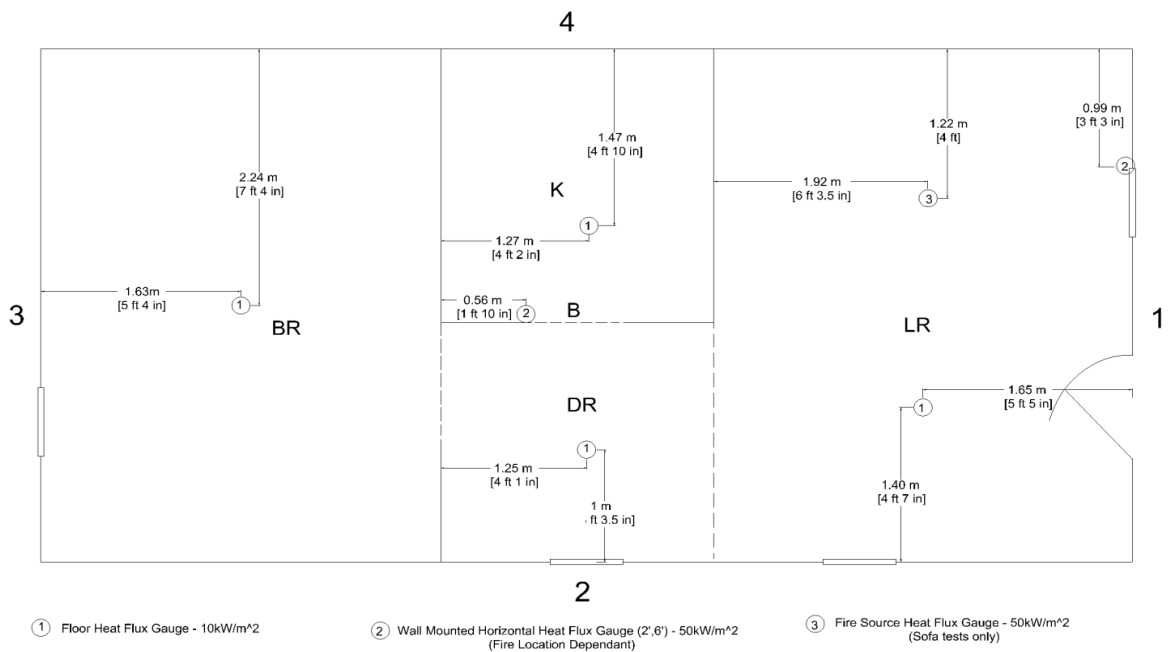
Figure 4-5: Heat Flux Transducer Locations

were used. A 0-25 kW/m<sup>2</sup> transducer (model #64-2.5-36-21640) was used for all floor level locations. A 0-50 kW/m<sup>2</sup> transducer (model #64-5SB-36-21640) was used for wall-mounted and fire locations. Locations of all heat flux transducers can be found in Figure 4-5.

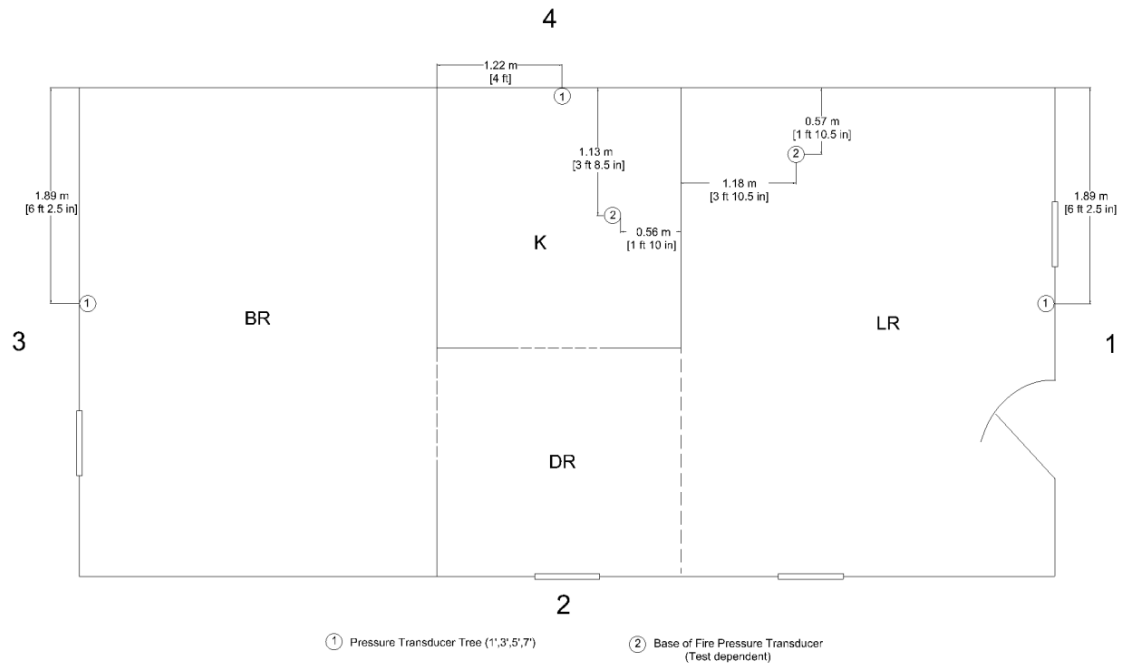
Figure 4-6: Pressure Transducer Locations

Pressure transducers were used to determine pressure differentials between the enclosure and ambient conditions. A total of thirteen pressure ports were used throughout the enclosure. Twelve of the ports were located at elevations of 0.31 m (1 ft), 0.91 m (3 ft), 1.52 m (5 ft), and 2.13 m (7 ft) in the LR, DR, and K. The final port was located on the floor near the base of the fuel source. The pressure ports were 0.31 m (1 ft) lengths of 0.006 m (0.25 in) diameter copper tubing, which protruded 0.03 m (1 in) into the enclosure. The copper ports were connected to the transducers by 0.006 m (0.25 in) diameter polyethylene tubing. Locations of these ports can be seen in Figure 4-6. The second pressure port of the transducer was connected to a section of polyethylene tubing that was mounted to the exterior of the enclosure at the same elevation to yield the pressure difference between the interior and exterior of the enclosure. The transducers used were MKS Instrument, Model 220DD-00001B2B transducers, with a range of 0-133.32 Pa.

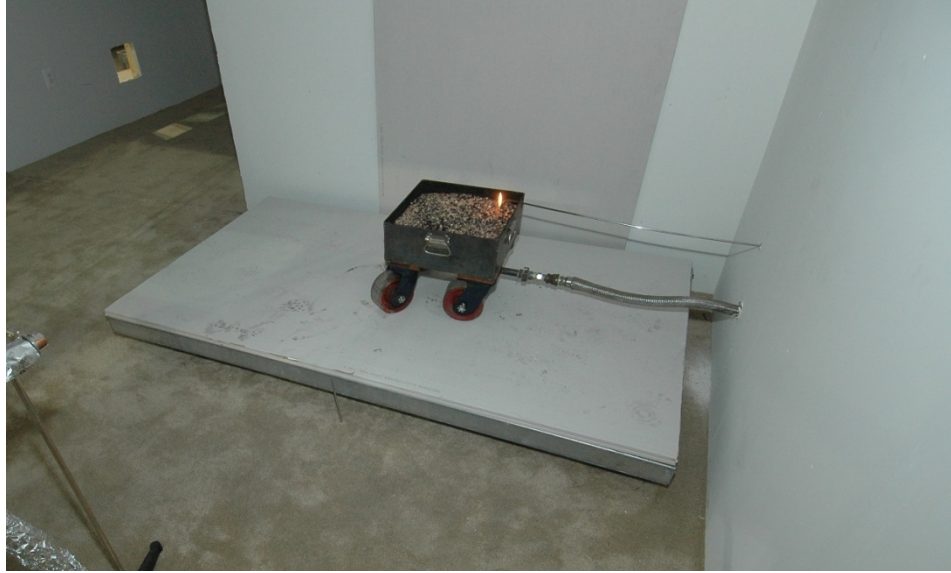
Figure 5-6. Burner placement for tests B1 and B2

Burner tests were performed inside the enclosure to check the operation of instrumentation and to determine baseline fire behavior inside the enclosure for a well-characterized source. The fire in these tests was provided by a 0.41 m (16 in) by 0.41 m (16 in) sand burner with natural gas fuel. The fire size was 125 kW and was controlled by an Alicat Scientific Model MCR-1000S2PM-D mass flow controller that was in-line with the natural gas supply line. The uncertainty of the flow controller was  $\pm 0.8\%$  of the reading. Ignition of the burner was achieved by a propane pilot flame. The pilot was ignited with the natural gas mass flow controller secured. After the pilot was ignited and the compartment sealed, the mass flow controller was turned on and the 125 kW flame was verified. The burner was placed in the LR where the sofa would be placed during fire tests (see Figure 5-6). The burner was turned off after 10 minutes, and the test was ended 2 minutes later, for a total duration of 12 minutes. Two burner tests were performed. One test (B1) was performed with no ventilation, the other with full open window ventilation (test B2).

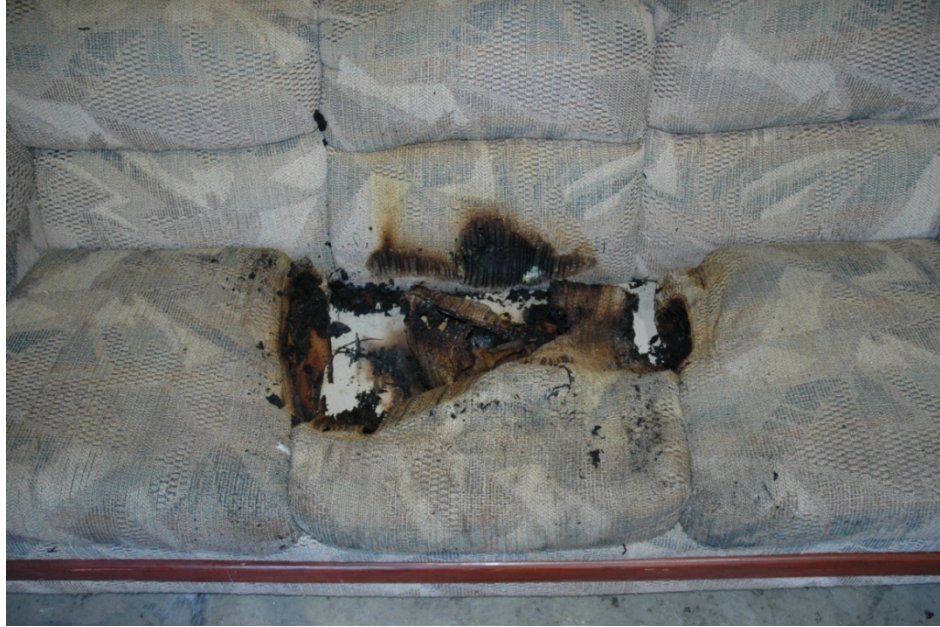
Figure 5-21. Test SM4 damage

The temperatures in this test did not rise above 29°C. During the test, there was no measurable change in oxygen or CO<sub>2</sub> concentrations. CO concentrations reached a maximum of 0.075%. This test was run chronologically between two cabinet tests, and due to this, the load cell was installed in the kitchen. Therefore, the cushions were removed and weighted before and after the test using the scale from test SM1 to determine the total mass loss over the duration of the test. The original mass of the bottom seat cushions was 5.63 kg. The total mass loss was 1.09 kg, approximately 19% of the total mass. Mass lost from the attached seat cushions was not measurable; however, the mass lost appeared to be negligible compared to the mass lost from the bottom seat cushions (see Figure 5-21). Approximately half of the center cushion was completely consumed. Charring and some consumption of material were present on the sides of the outer cushions and back of the sofa.

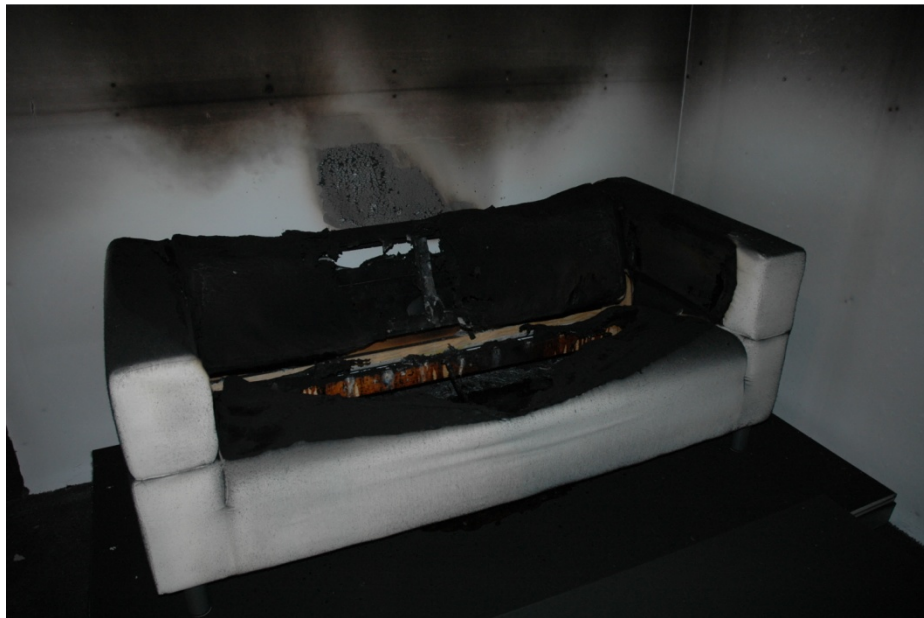
Figure 5-23. Test S1 damage

Data from this test is presented in Figure 5-24. The peak temperature reached during this test was 286°C in the living room. The oxygen concentration at 2.41 m (7 ft 11 in) dropped to a minimum value of 13.6%. The peak CO concentration was 0.4%. The peak CO<sub>2</sub> concentration was 4.5%. The initial mass of the sofa was 49.77 kg. During the test, the total mass loss was 5.80 kg, approximately 12% of the initial mass. The maximum heat release rate calculated during this test was 353 kW. The fire burned away a section of the seat and back approximately 3 ft wide. The remainder of the seat and back were heavily charred but still intact (see Figure 5-23).

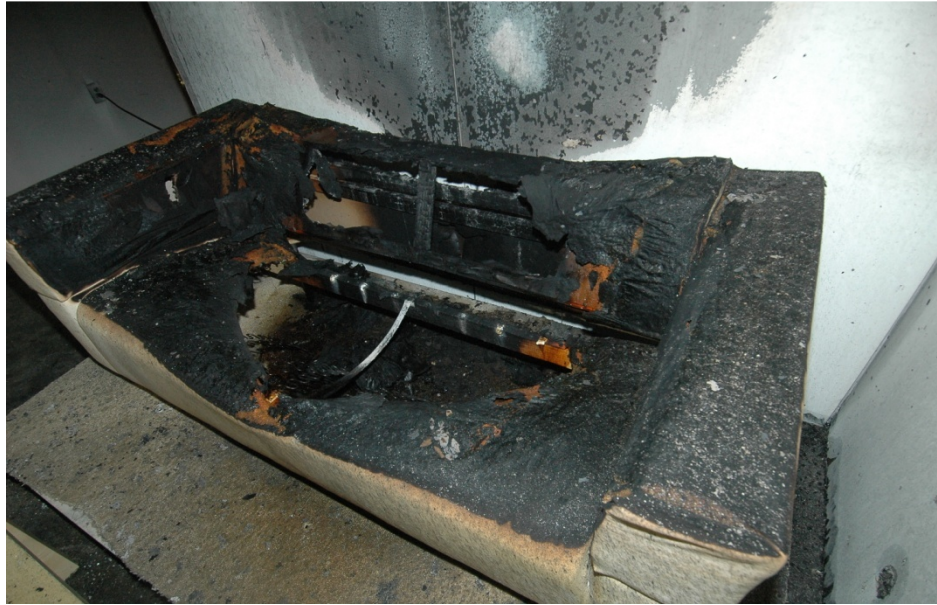
Figure 5-25. Test S2 damage

the fire was made due to rapidly increasing temperatures and flaming across the ceiling which was visible through the wall 1 window. A majority of the material was burned away on the sofa seat, back and interior of the armrests (see Figure 5-25).

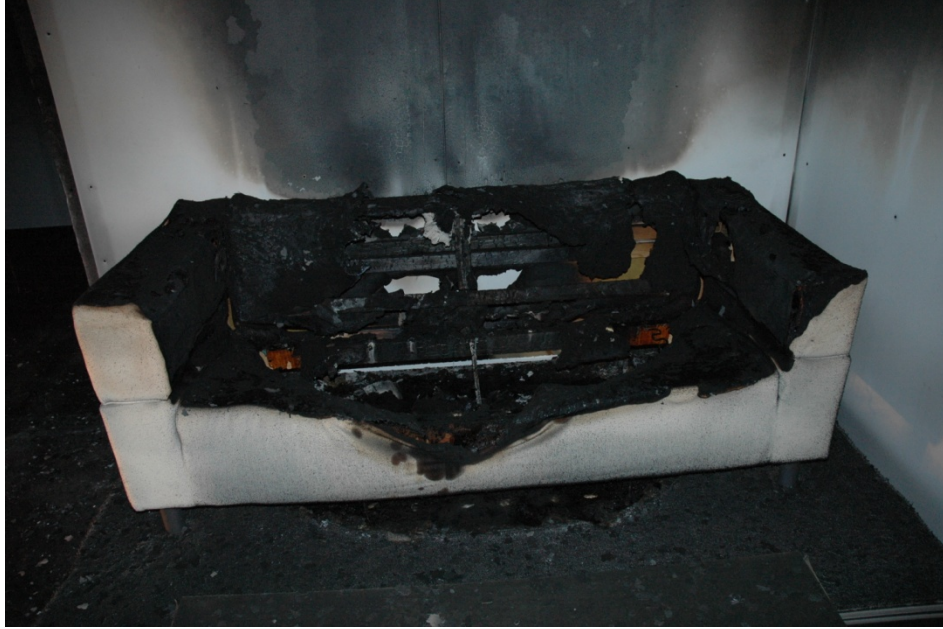
Figure 5-27. Test S3 damage

The data from this test is presented in Figure 5-28. The peak temperature reached during this test was 630°C. Oxygen concentration at 2.41 m (7 ft 11 in) dropped to a minimum value of 3.4%. The peak CO concentration was 5.5%. The peak CO<sub>2</sub> concentration was 14.3%. The initial mass of the sofa was 49.80 kg. During the test, the total mass loss was 6.75 kg, approximately 14% of the initial mass. The maximum heat release rate calculated during this test was 862 kW. A majority of the material was burned away on the sofa seat, back and interior of the armrests. Also, the center of the front portion had begun to burn away and the wooden frame had begun to char along the back of the sofa (see Figure 5-27).

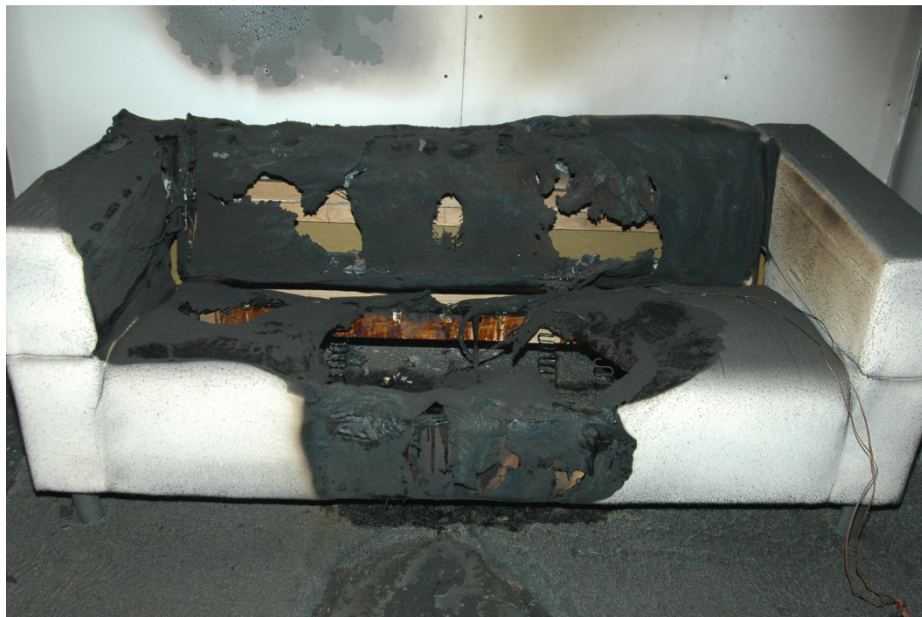
Figure 5-29. Test S4 damage

The data from this test is displayed in Figure 5-30. The peak temperature reached during this test was 345°C. Oxygen concentration at 2.41 m (7 ft 11 in) dropped to a minimum value of 16.3%. The peak CO concentration was 0.3%. The peak CO<sub>2</sub> concentration was 3.7%. The initial mass of the sofa was 49.45 kg. During the test, the total mass loss was 3.99 kg, approximately 8% of the initial mass. The maximum heat release rate calculated during this test was 300 kW. The front face and center of the couch where the gasoline had been poured were burned away. The remainder of the seat and back were charred, but not burned away. The most severe charring occurred on the side of the sofa closest to the dining room, and only the inner armrest on that side of the sofa was charred, with the other armrest relatively unchanged aside from soot deposition (see Figure 5-29).

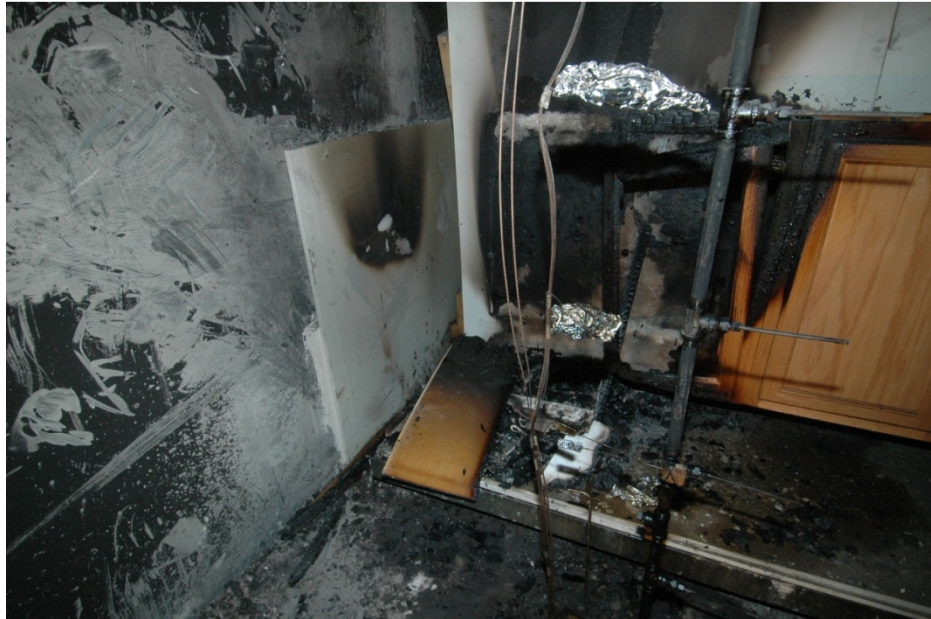
Figure 5-33. Test CL1 damage – low cabinets with no ventilation

The data for this test is presented in Figure 5-34. The peak temperature reached during this test was 806°C. Oxygen concentration at 2.41 m (7 ft 11 in) dropped to a minimum value of 1.4%. The peak CO concentration was 1.8%. The peak CO<sub>2</sub> concentration was 17.2%. The initial mass of the cabinets was 53.84 kg. During the test, the total mass loss was 30.42 kg, approximately 57% of the initial mass. The maximum heat release rate calculated during this test was 599 kW. The entire first cabinet was consumed, as well as all of the second cabinet except the right side and some of the front

frame. There was some charring to the front face of the third cabinet and little damage fourth cabinet

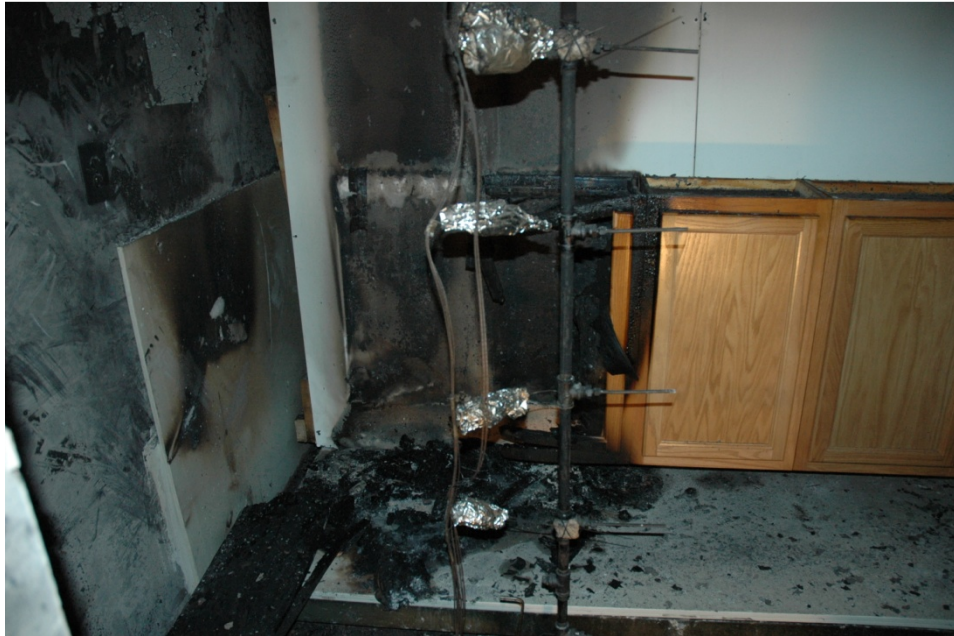
Figure 5-35. Test CL2 damage – low cabinets with half open window

The data for this test is presented in Figure 5-36. The peak temperature reached during this test was 785°C. Oxygen concentration at 2.41 m (7 ft 11 in) dropped to a minimum value of 2.5%. The peak CO concentration was 2.2%. The peak CO<sub>2</sub> concentration was 17.1%. The initial mass of the cabinets was 53.66 kg. During the test, the total mass loss was 30.95 kg, approximately 58% of the initial mass. The maximum heat release rate observed during this test was 595 kW. The majority of the first and second cabinets were completely consumed. Additionally, there was charring present on

the top and left side of the front face of cabinet three. There was little damage to the fourth cabinet (see Figure 5-35).

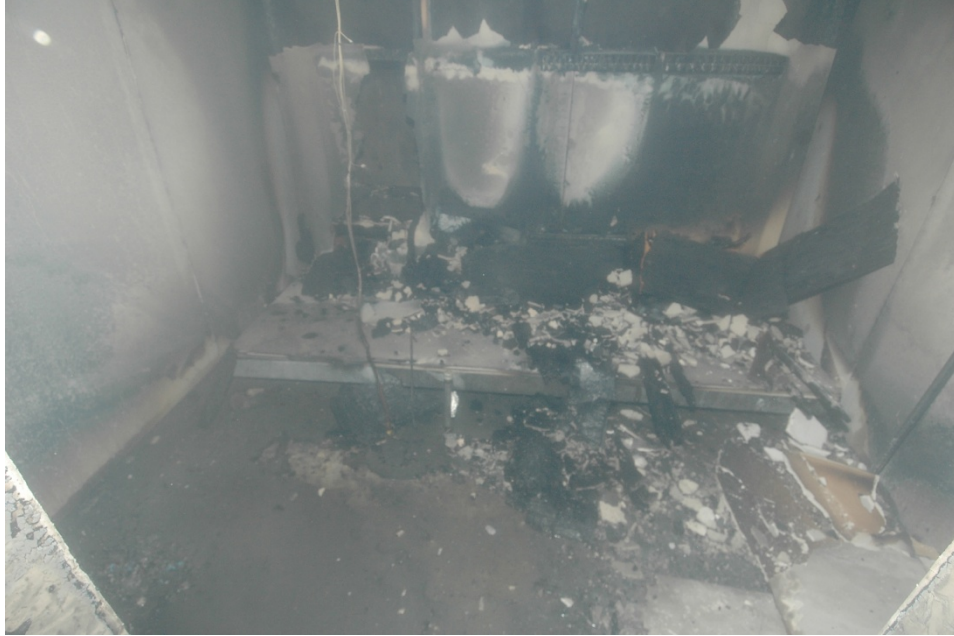
Figure 5-37. Test CL3 damage – Low Cabinets with Open Door

The data for this test is presented in Figure 5-38. The peak temperature reached during this test was 727°C. Oxygen concentration at 2.41 m (7 ft 11 in) dropped to a minimum value of 5.8%. The peak CO concentration was 0.5%. The peak CO<sub>2</sub> concentration was 13.0%. The initial mass of the cabinets was 53.41 kg. During the test, the total mass loss was 49.87 kg, approximately 93% of the initial mass. The maximum heat release rate calculated during this test was 984 kW. Due to falling debris, the heat

release rate data had a few false readings, most notably at 19.05 and 27.50 minutes. The majority of all of the cabinets were consumed during this test (see Figure 5-37).

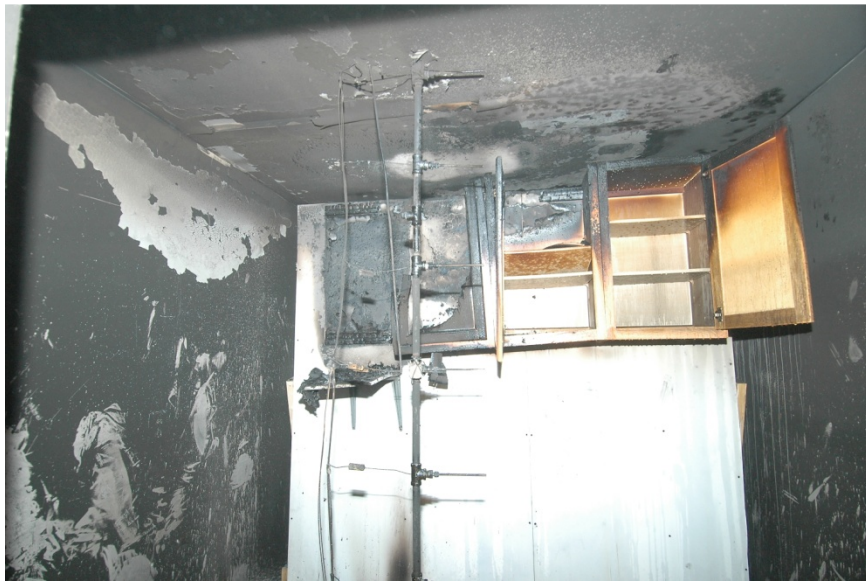
Figure 5-41. Test CH1 damage – high cabinets with no ventilation

consumed. In addition, the top half of the third cabinet was consumed and there was substantial charring both inside and out. There was also some charring on the top of the fourth cabinet (see Figure 5-41).

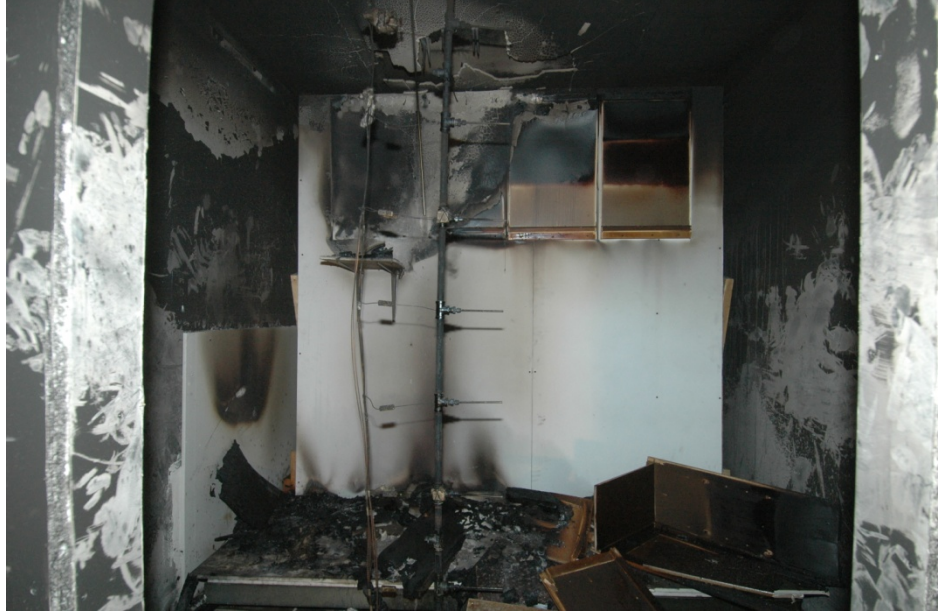
Figure 5-43. Test CH2 damage – high cabinets with half open window

The top frame of the fourth cabinet was consumed, and there was severe charring throughout the rest of the cabinet (see Figure 5-43).

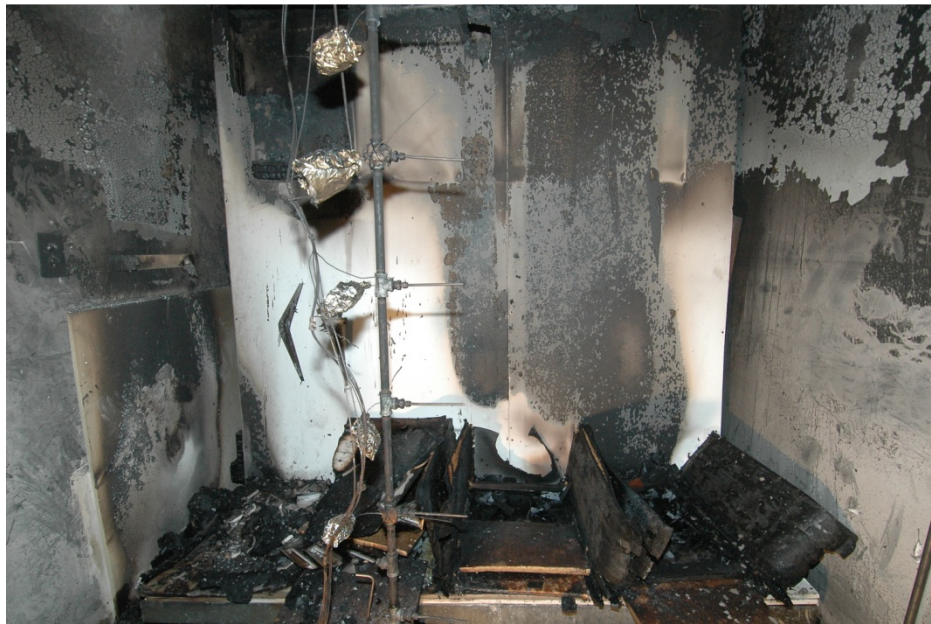
Figure 5-45. Test CH3 damage – high cabinets with no bedroom window

The data for this test is presented in Figure 5-46. The peak temperature reached during this test was 718° C. Oxygen concentration at 2.41 m (7 ft 11 in) dropped to a minimum value of 5.1%. The peak CO concentration reached was 1.6%. The peak CO<sub>2</sub> concentration was 13.1%. The initial mass of the cabinets was 54.07 kg. During the test, the total mass loss was 29.75 kg, approximately 55% of the initial mass. The maximum heat release rate calculated during this test was 469 kW. The first cabinet and the majority of the second cabinet were consumed during the test. The frame of the third and fourth cabinets remained mostly intact, but had substantial charring throughout (see

Figure 5-45). After the cabinets fell at about 30 minutes, the fire started to grow on the floor as the cabinets had fallen from a vitiated upper layer to the lower layer with higher oxygen concentrations. All analyses in this study only consider events up until the time when the cabinets fell so as to consider the effects of the cabinets being high in the space. The fact that the third and fourth cabinets fell early in their involvement was an artifact of the test installation. Due to prior test damage to the wood studs of the false wall that the cabinets were installed to, the screws prematurely pulled out of the studs during the CH3 fire.

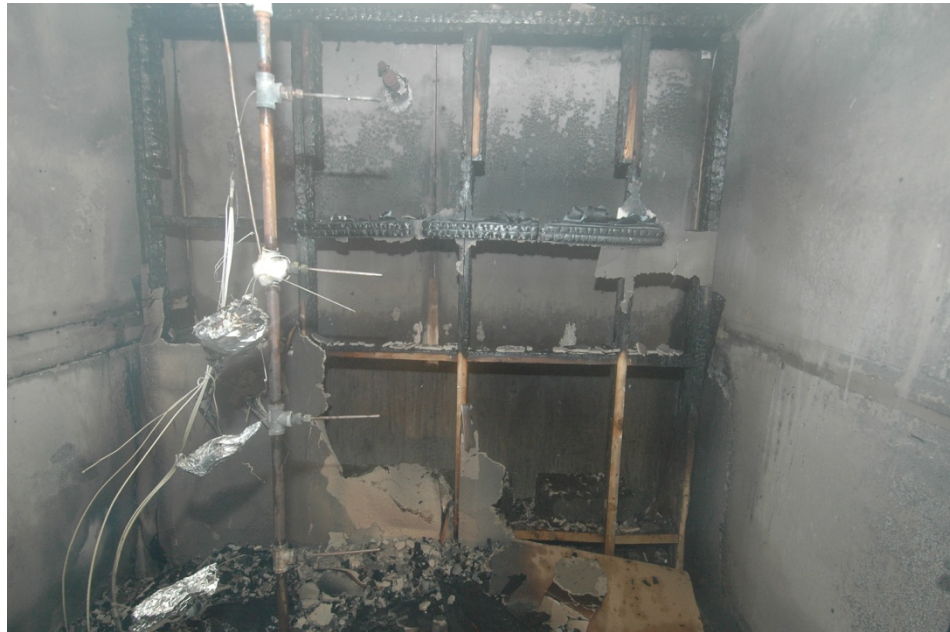
Figure 5-47. Test CH4 damage – high cabinets open door

this test was 1.1 MW. Due to falling debris, the heat release rate data has several false readings, most notably at 19.8, 26.17, 27.02, and 31 minutes. The majority of the cabinets were consumed; the rest, with most of the GWB from the false wall, were left on the base of the load cell stand (see Figure 5-47).

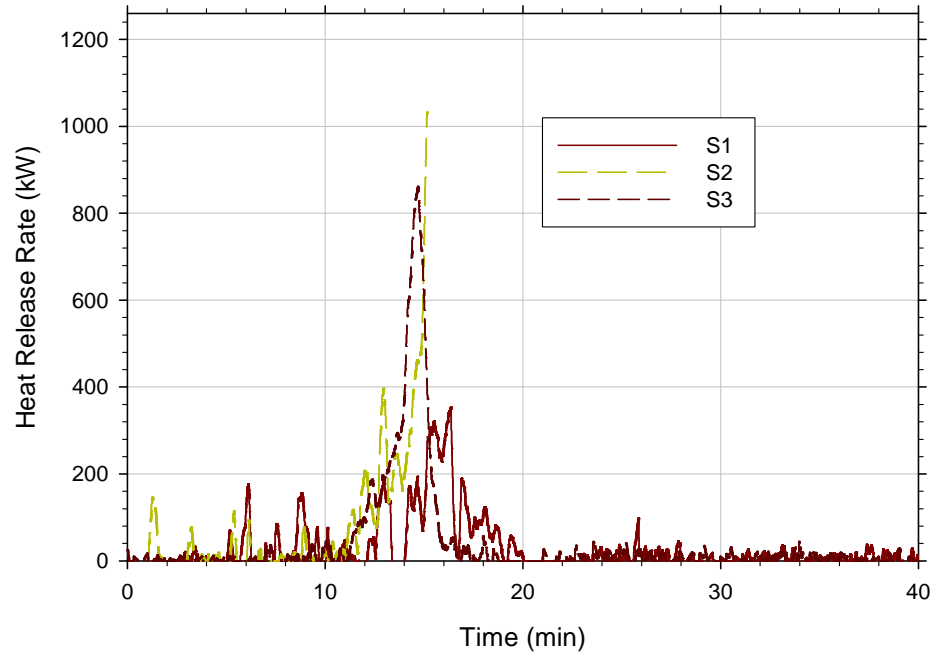
Figure 6-1. Initial HRR development for sofa fires

For cabinet fires, the critical ventilation size lies between the half open window and open door scenario, since the half open window test became vitiated and the open door did not. The critical vent size for cabinets can be inferred to be larger than the sofa, due to the fact that the change from no ventilation to half open window ventilation had a more pronounced effect on heat release rate in the sofa fires than it did on cabinet fires.

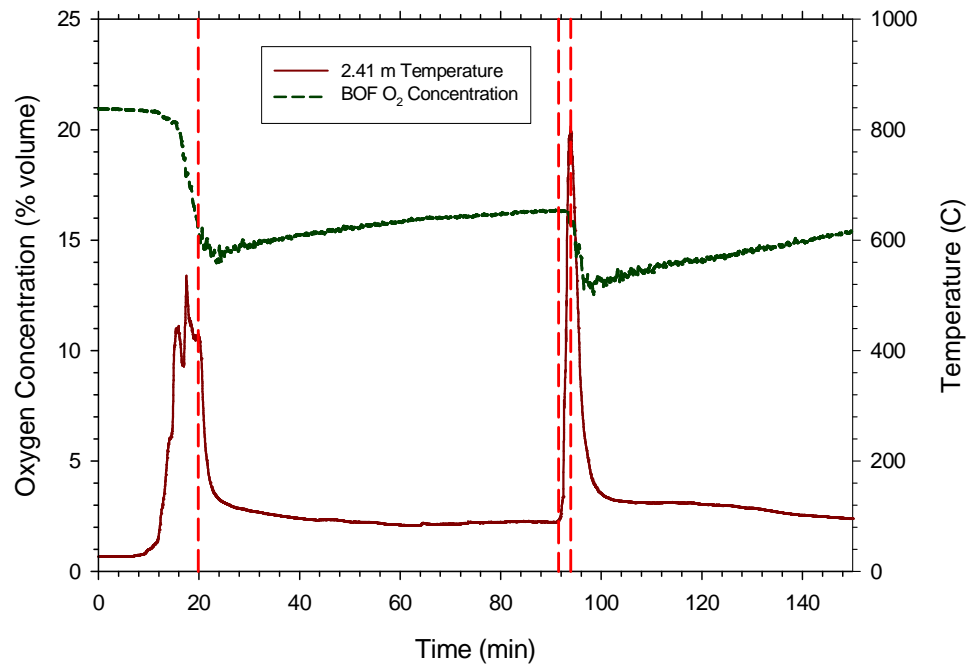
Figure 6-5. Temperature method of determining LOI for test CL1

suppressed. Figure 6-5 shows the temperature and base of fire oxygen time histories for test CL1. The vertical lines show where the temperature data sharply changed and the oxygen was evaluated. Using these concentrations, an approximate LOI was determined for each test. Tests CL3, CH3, and CH4 were not included because there was not a significant decline in burning before the tests were ended; these fires were deemed not to have been suppressed due to vitiation.

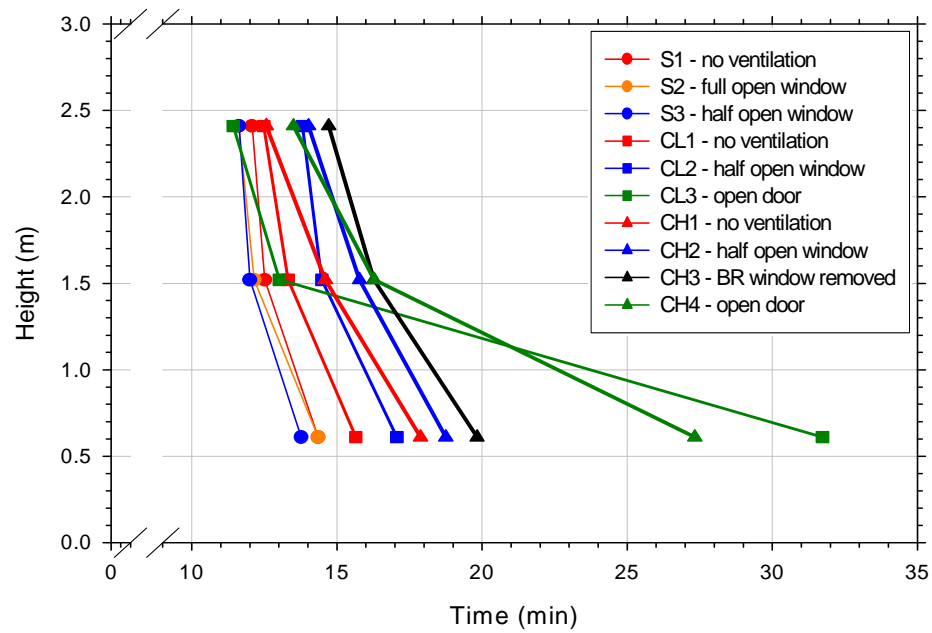
Figure 6-6. Time to 0.43 optical density per meter at sample elevations in the living room for all tests

Figure 6-6 and Figure 6-7 show graphical comparisons of when the tests reached the target optical density at each sample elevation in the living room and bedroom. It can be seen from these figures that for each fuel source, the difference between ventilations is generally only on the order of approximately two minutes. Even across all of the fuel sources, the target optical density is generally reached within five minutes, particularly at the high elevation. Test CL3 and CH4 were low and high cabinet tests with open door ventilation. The open door caused the layer height to remain higher in the living room for a longer period of time; that is why the smoke level did not decrease to  $0.43 \text{ m}^{-1}$  at the 0.6 m height until much later compared to the other tests. There is also a general trend that the sofa reached the target first, then the lower cabinets, then the upper cabinets. This trend is consistent with the relative fire developments as shown in the heat release rate data.

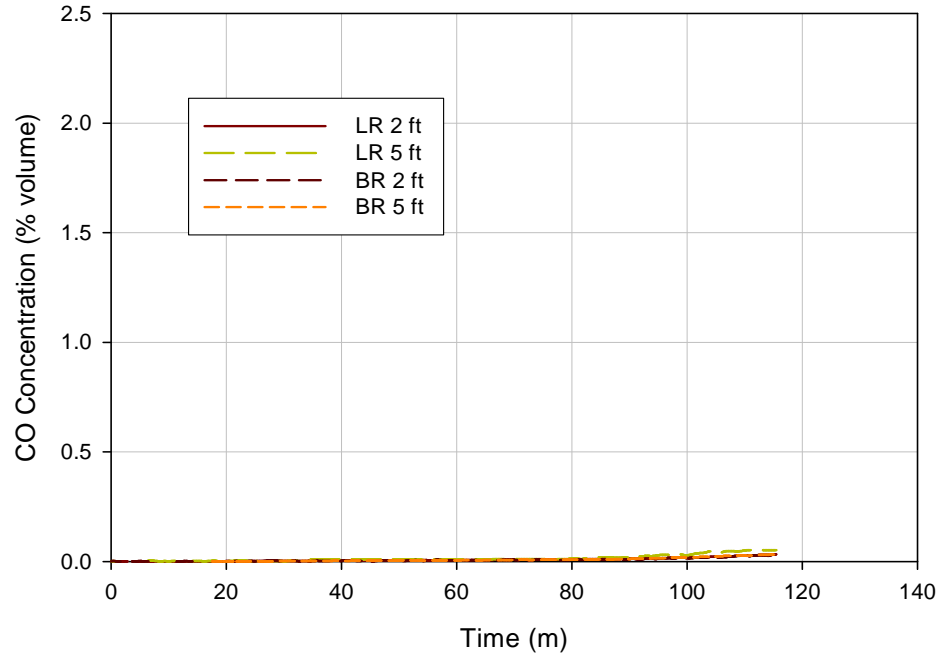
Figure 7-2. Test SM4 (smoldering sofa, no ventilation) CO concentrations

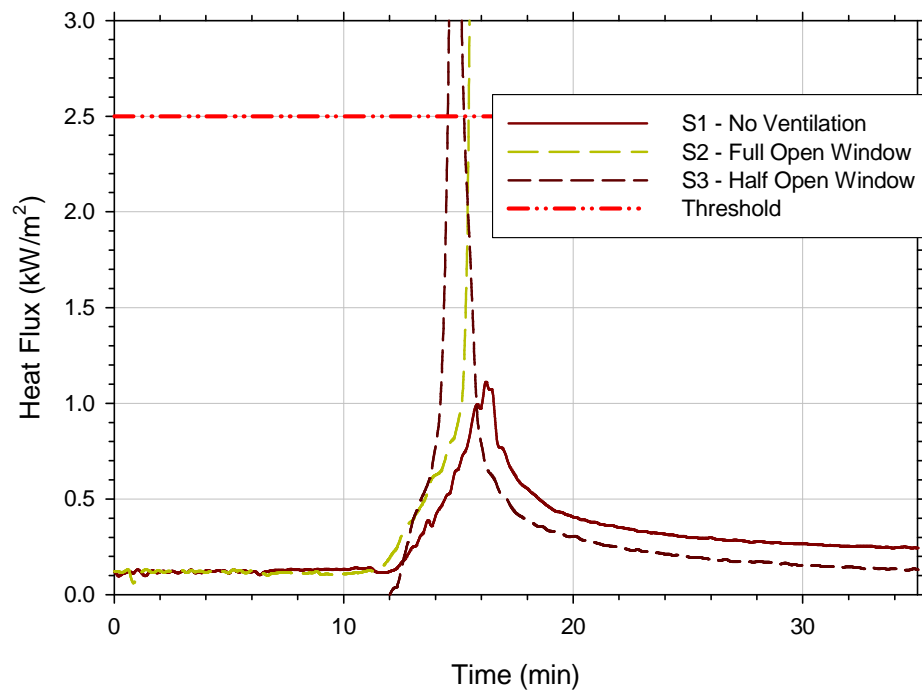
Figure 7-16. Heat flux for sofa tests at floor level in the living room

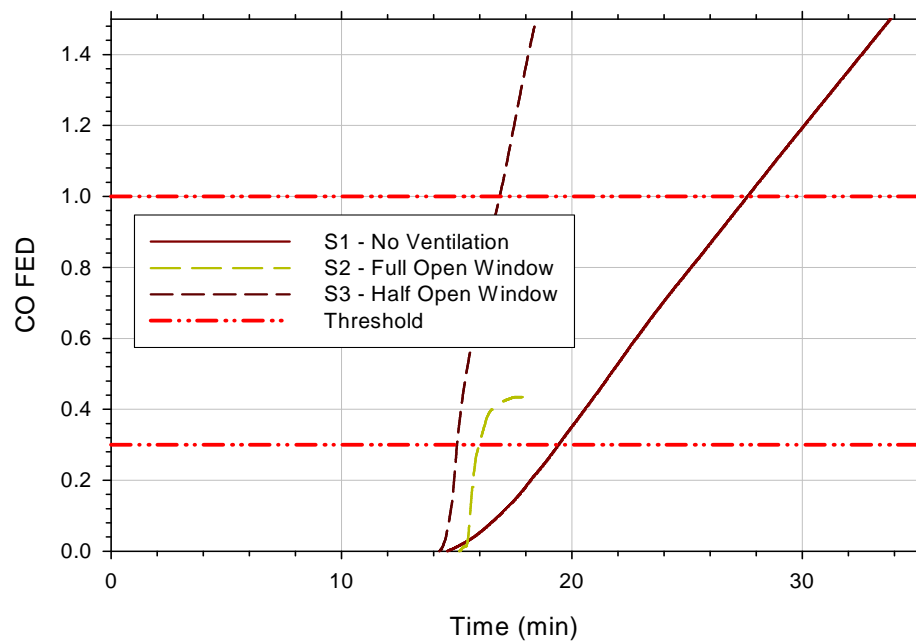
Figure 7-17. CO FED for sofa tests at 1.52 m (5 ft) in the living room.

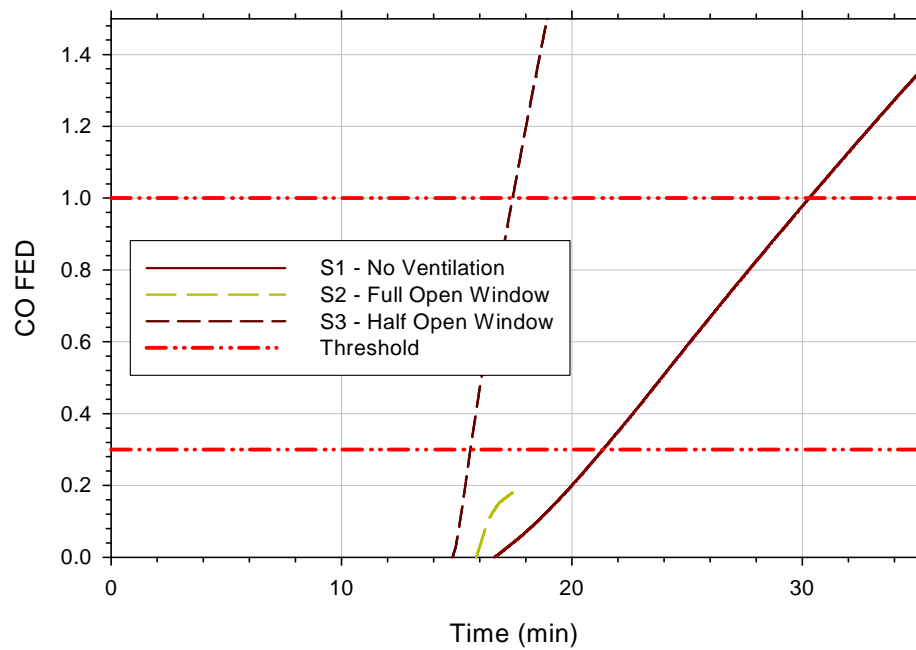
Figure 7-18. CO FED for sofa tests at 1.52 m (5 ft) in the bedroom

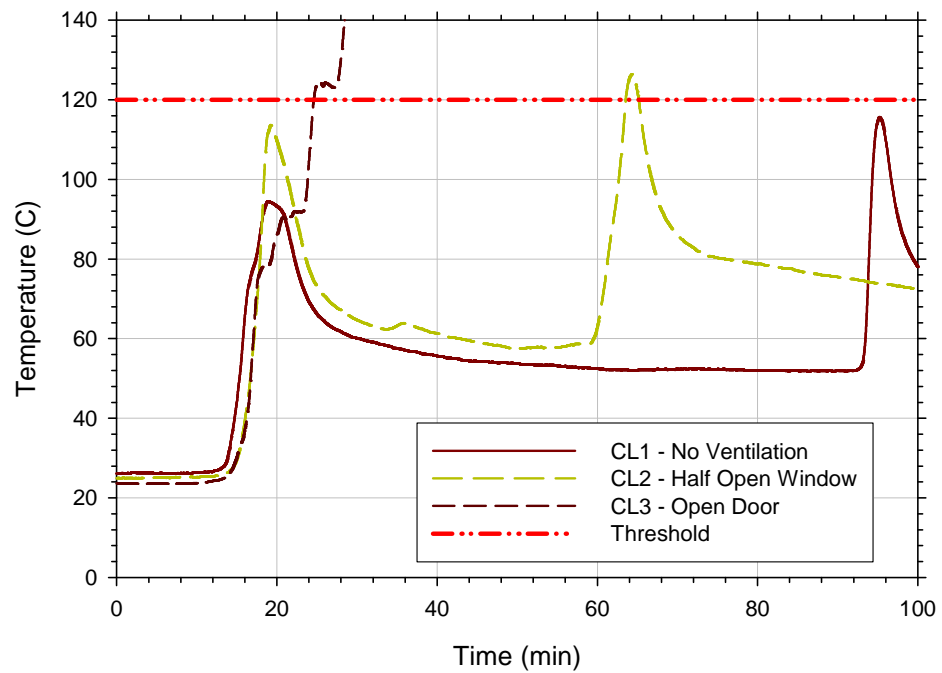
Figure 7-20. Temperature for low cabinet tests at 1.52 m (5 ft) in the bedroom

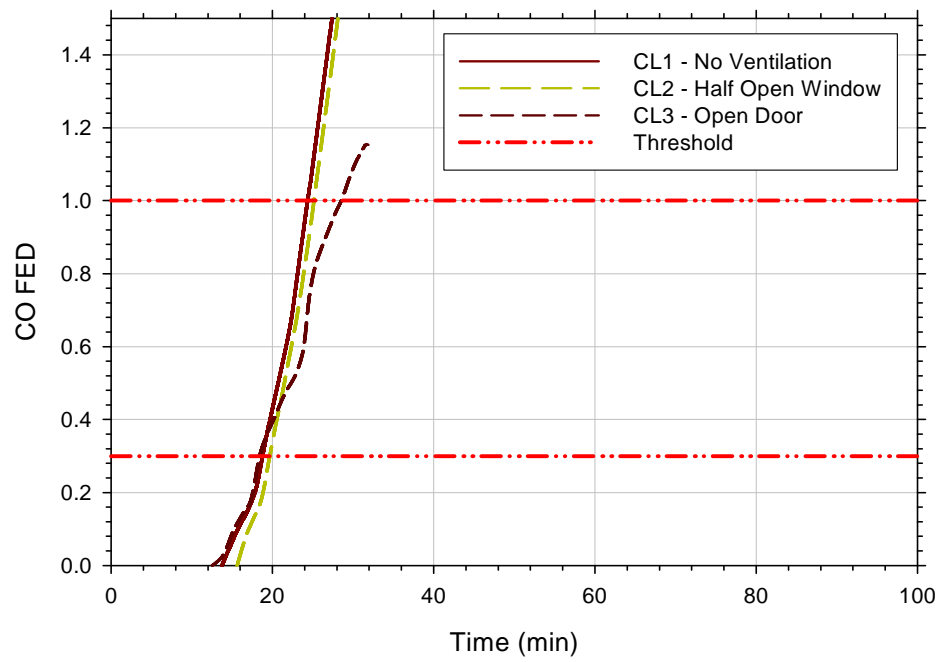
Figure 7-21. CO FED for low cabinet tests at 1.52 m (5 ft) in the living room

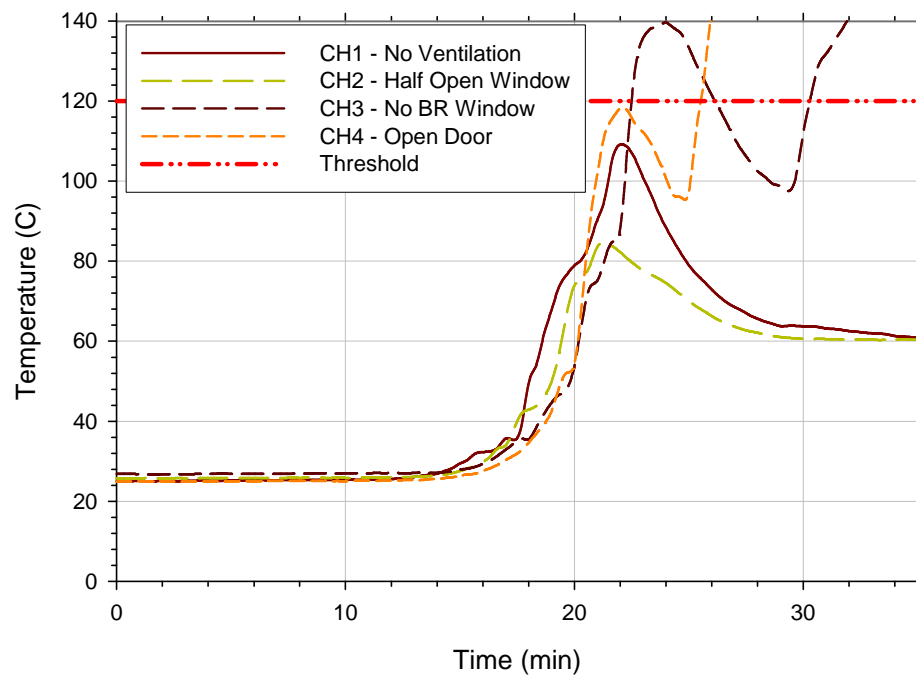
Figure 7-23. Temperature for high cabinet fires at 1.52 m (5 ft) in the living room

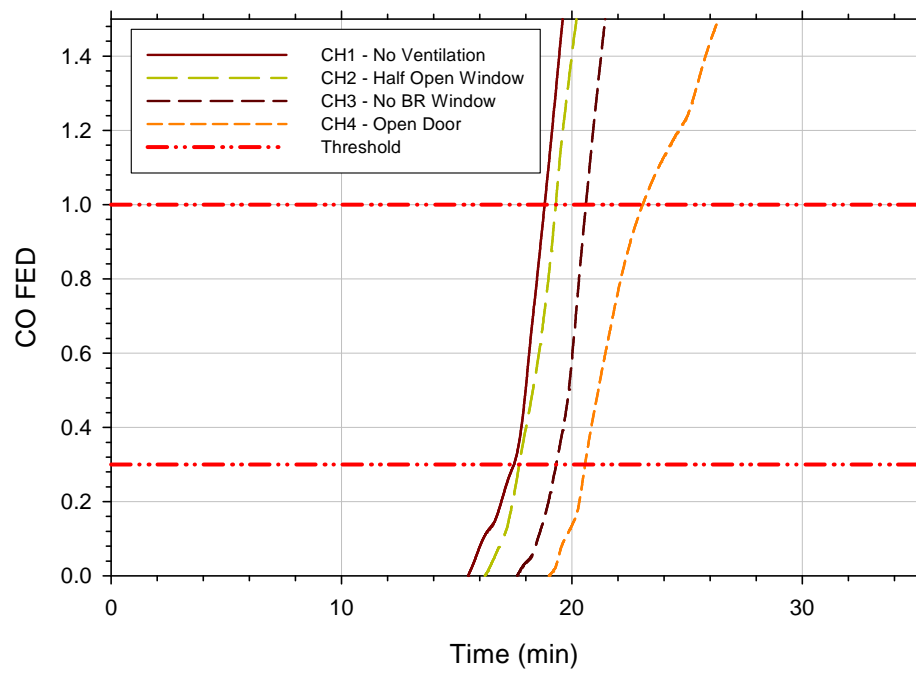
Figure 7-27. CO FED for high cabinet tests at 1.52 m (5 ft) in the living room

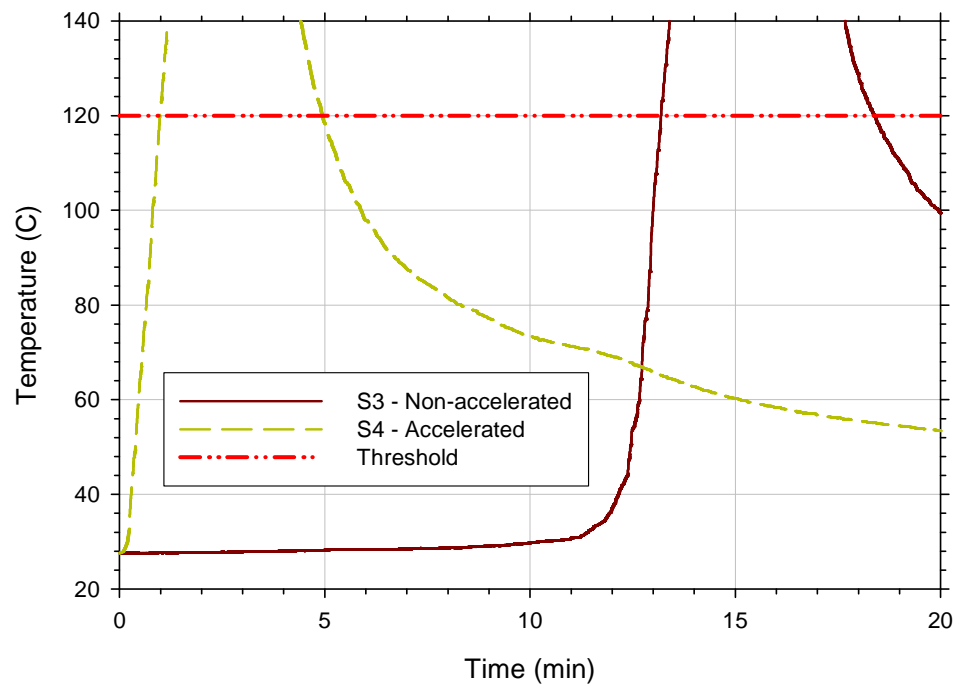
Figure 7-29. Temperature comparison for flaming class A ignition (S3) and accelerated (S4) sofa fires at 1.52 m (5 ft) in the living room

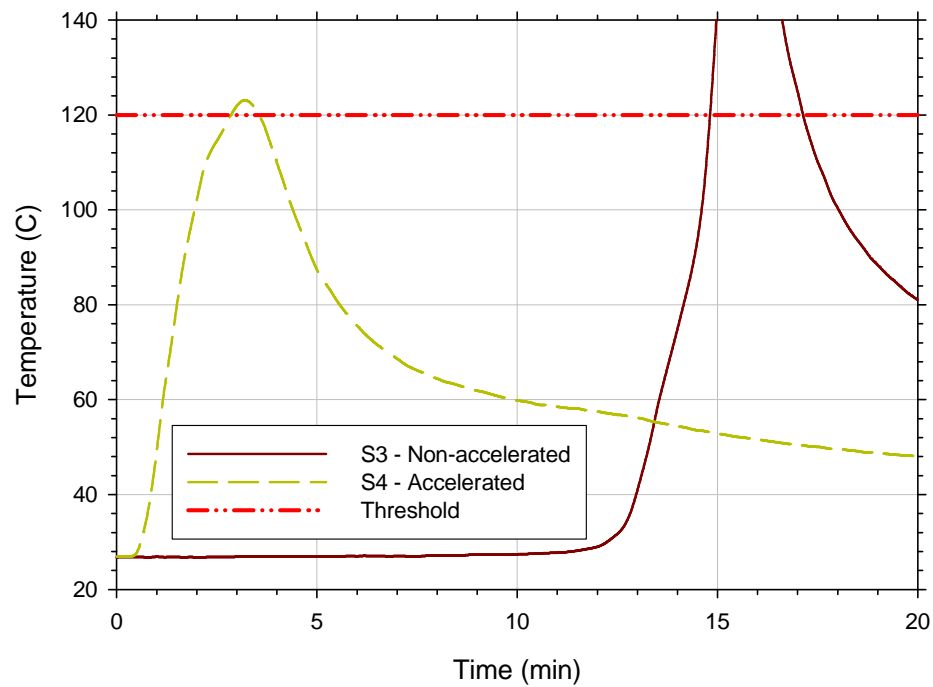
Figure 7-30. Temperature comparison for flaming class A ignition (S3) and accelerated (S4) sofa fires at 1.52 m (5 ft) in the bedroom
