Title of Thesis: ANALYSIS OF UNDERVENTILATED  
COMPARTMENT FIRES

Andrew John Wolfe, Master of Science, 2009

# ANALYSIS OF LIMITED VENTILATION COMPARTMENT FIRES

Thesis submitted to the Faculty of the Graduate School of the  
University of Maryland, College Park in partial fulfillment  
of the requirements for the degree of  
Master of Science  
2009

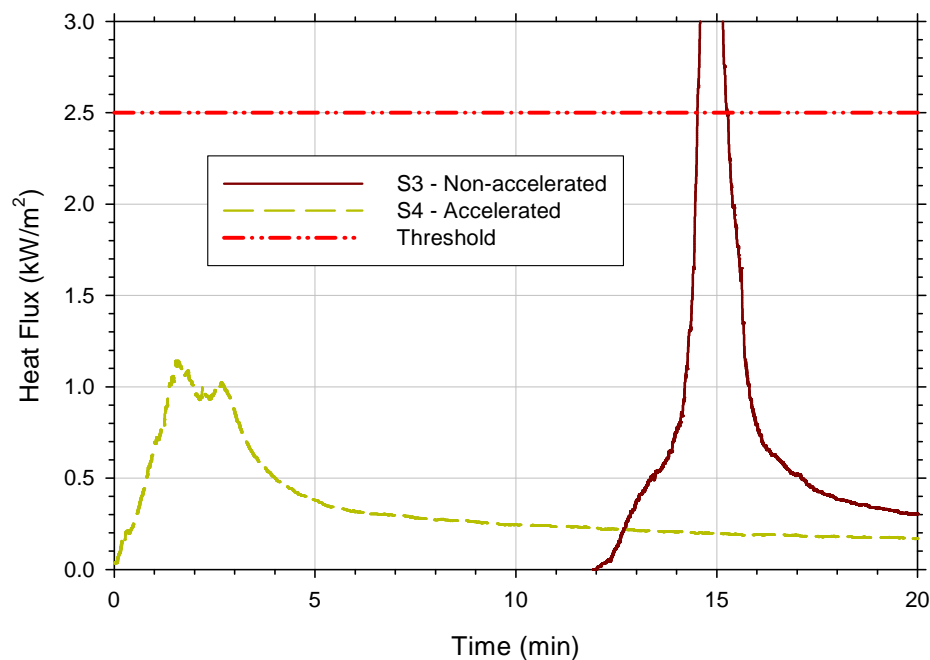
Figure 7-31. Heat flux comparison for class A and accelerated fires in the living room

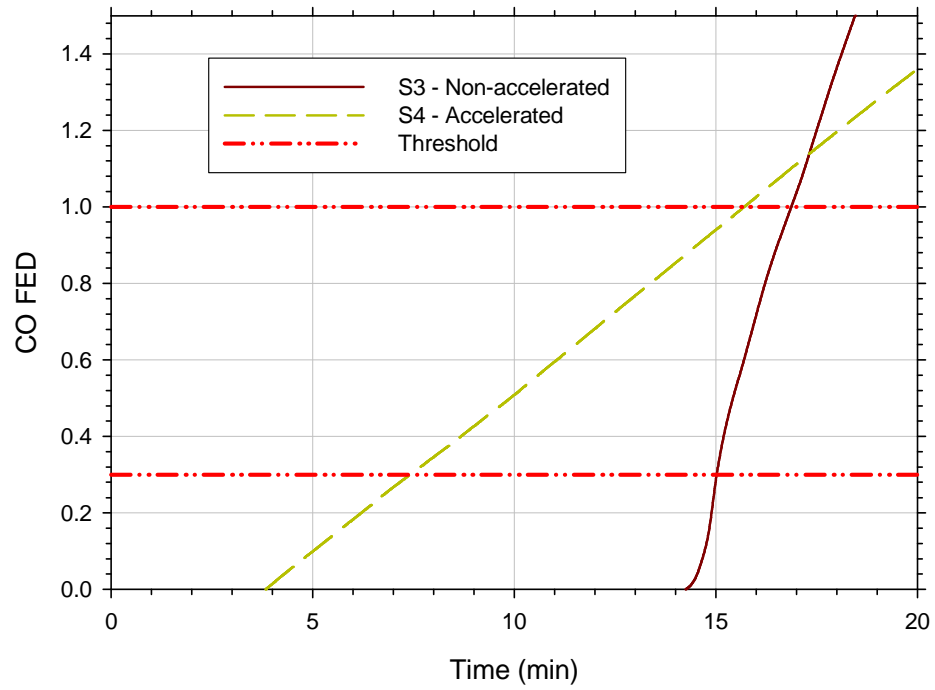
Figure 7-32. CO FED comparison of class A and accelerated fires at 1.52 m (5 ft) in the living room.

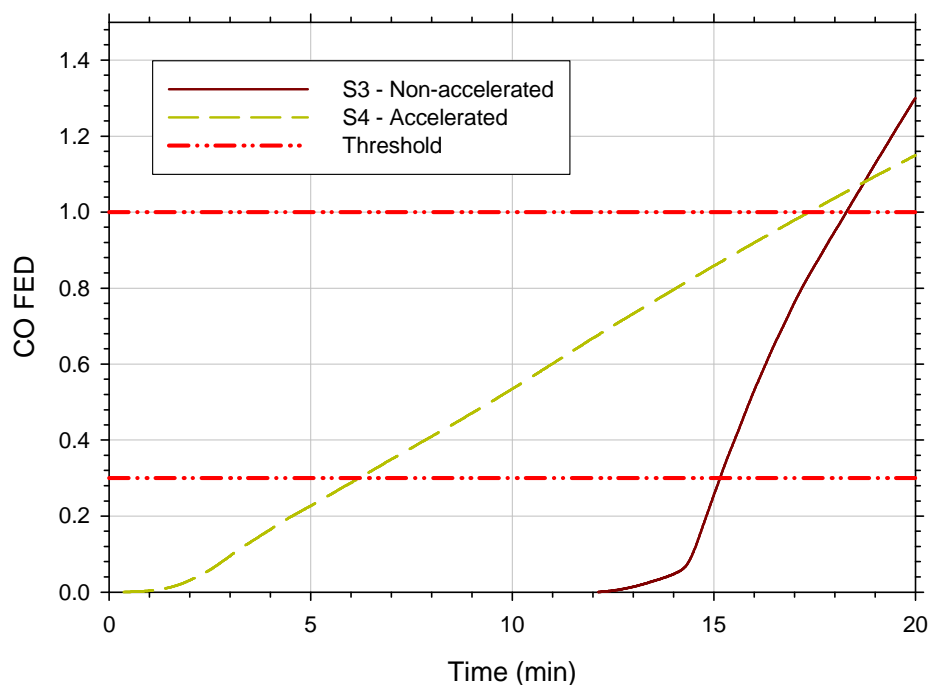
Figure 7-33. CO FED comparison of class A and accelerated fires at 1.52 m (5 ft) in the dining room.

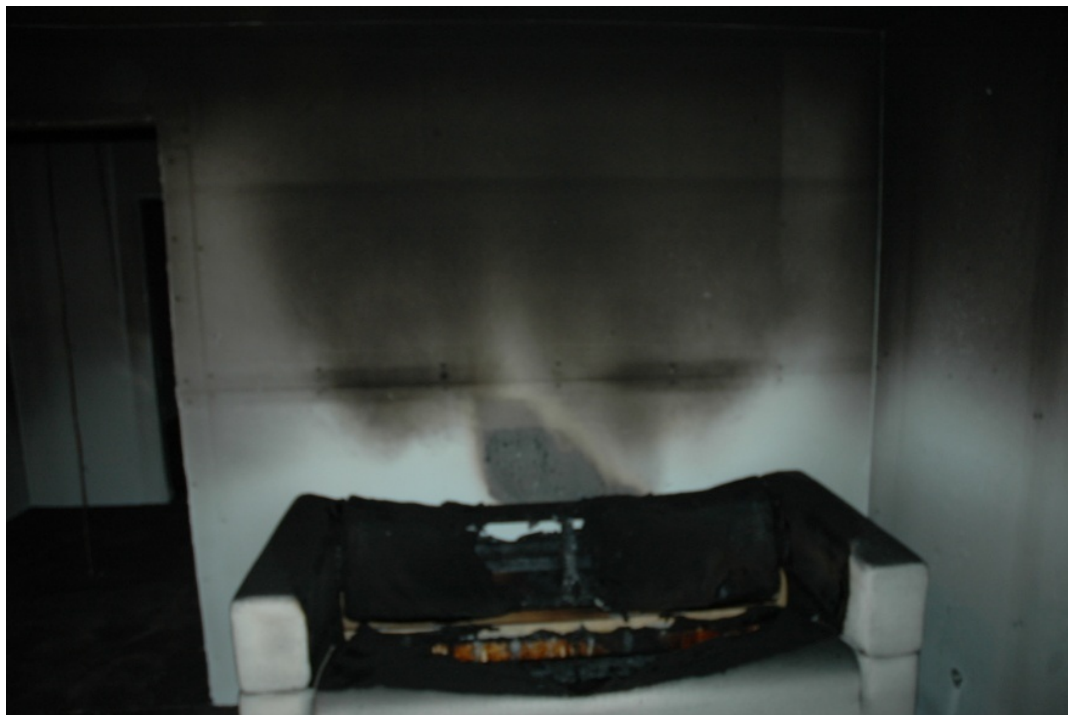
Figure 8-1. Fire pattern from test S1 (no ventilation)

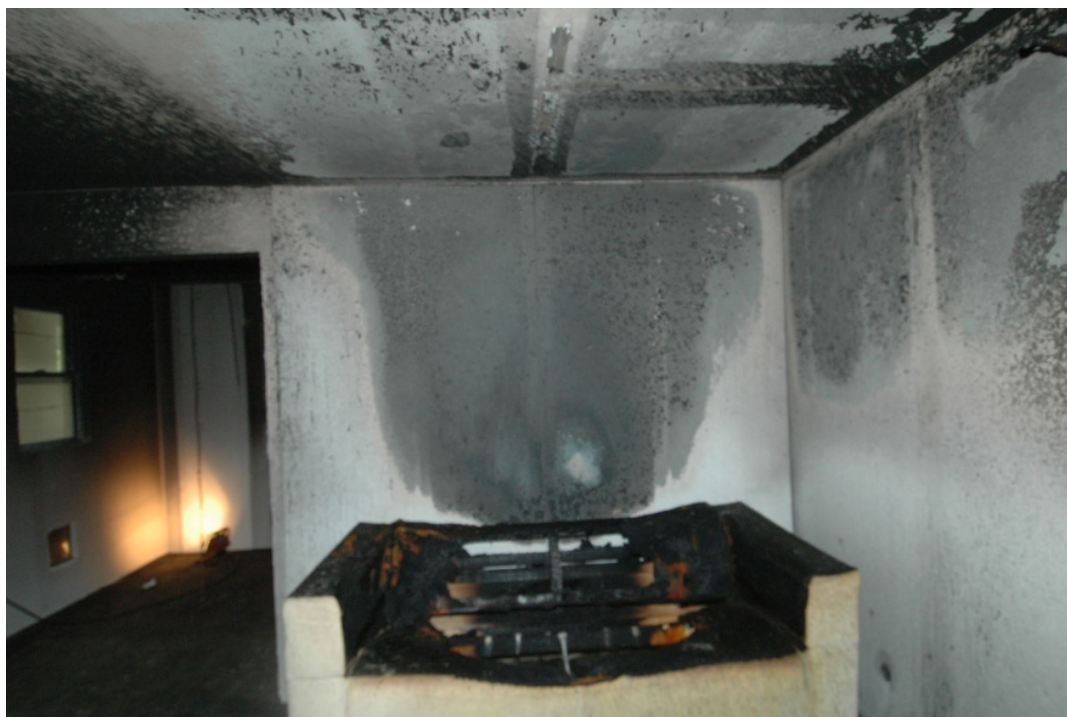
Figure 8-5. Fire pattern from test S2 (full open window)

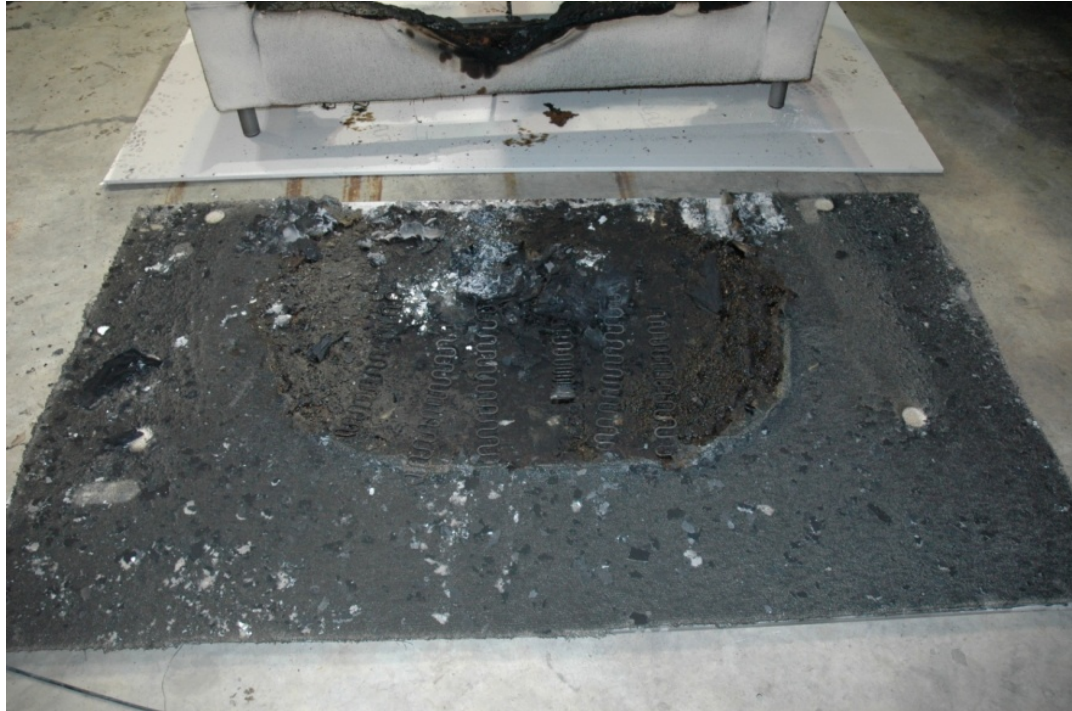
Figure 8-6. Burn pattern under sofa common to all accidental tests.

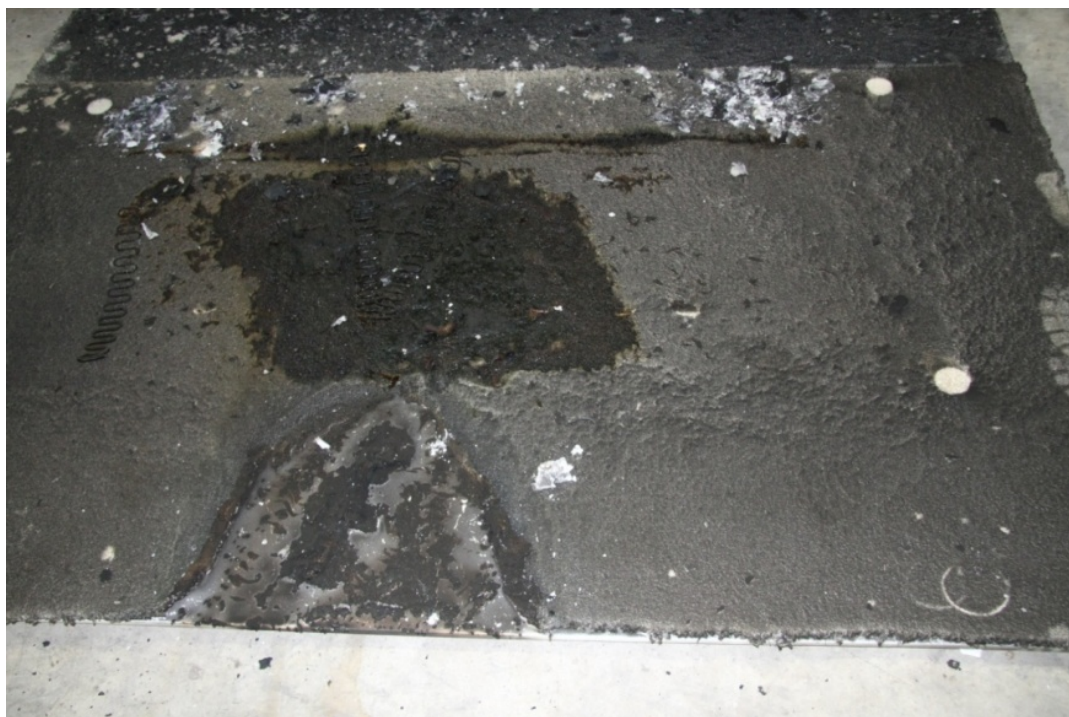
Figure 8-7. Burn pattern under and in front of sofa during accelerated test

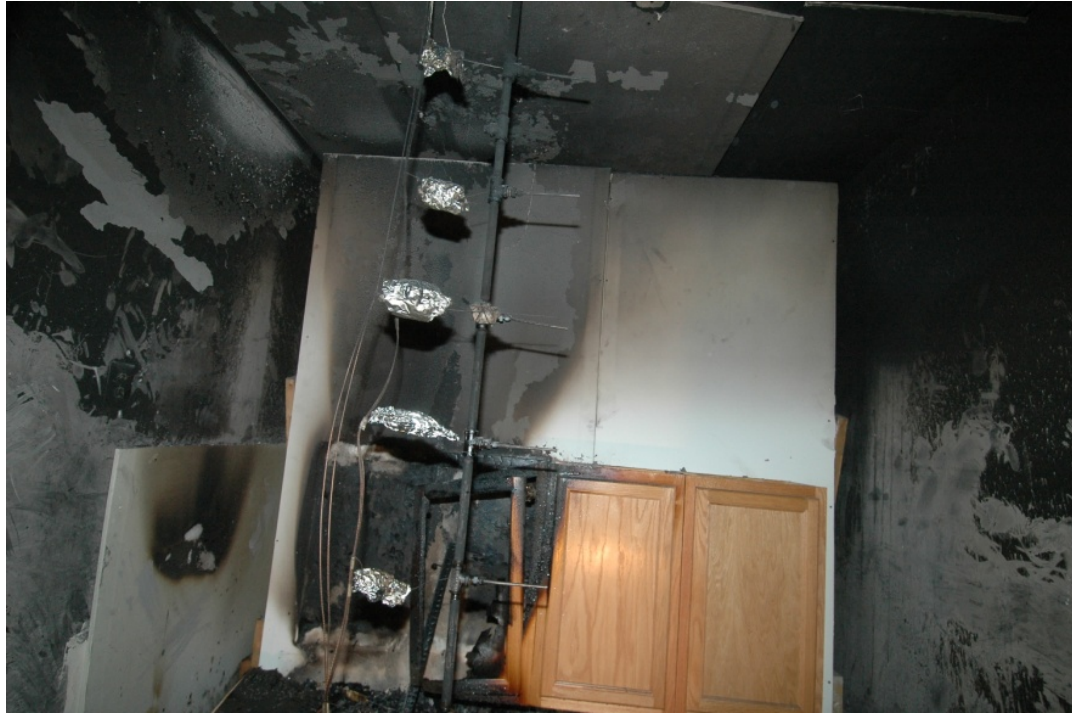
Figure 8-8. Fire pattern from test CL1 (no ventilation)

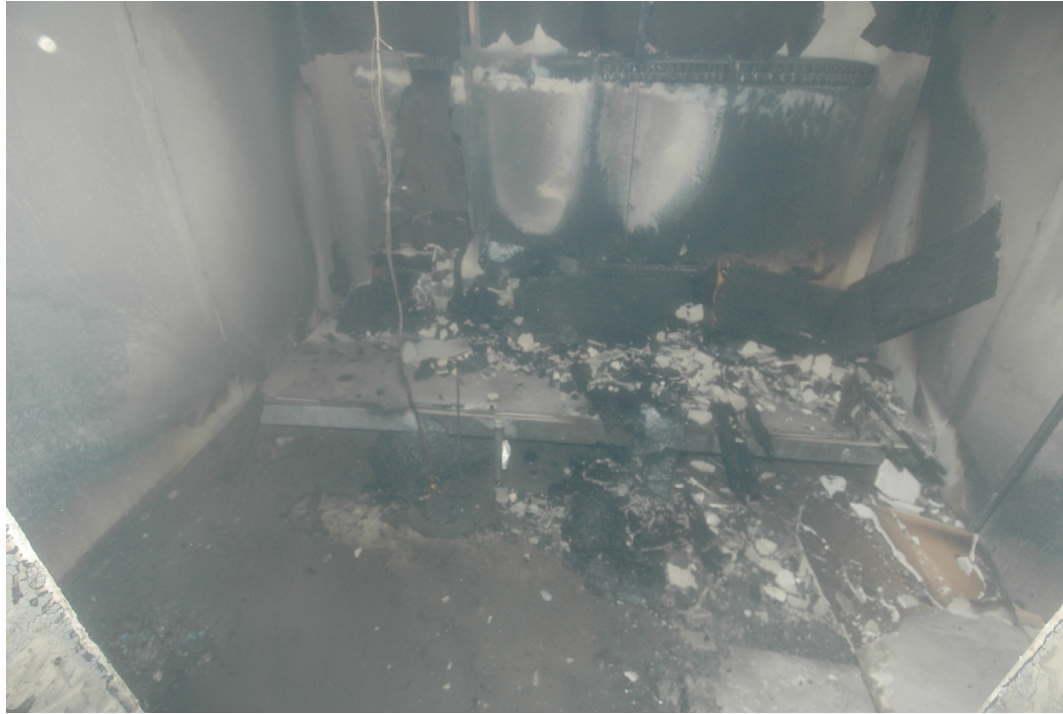
Figure 8-10. Fire pattern from test CL3 (open door)

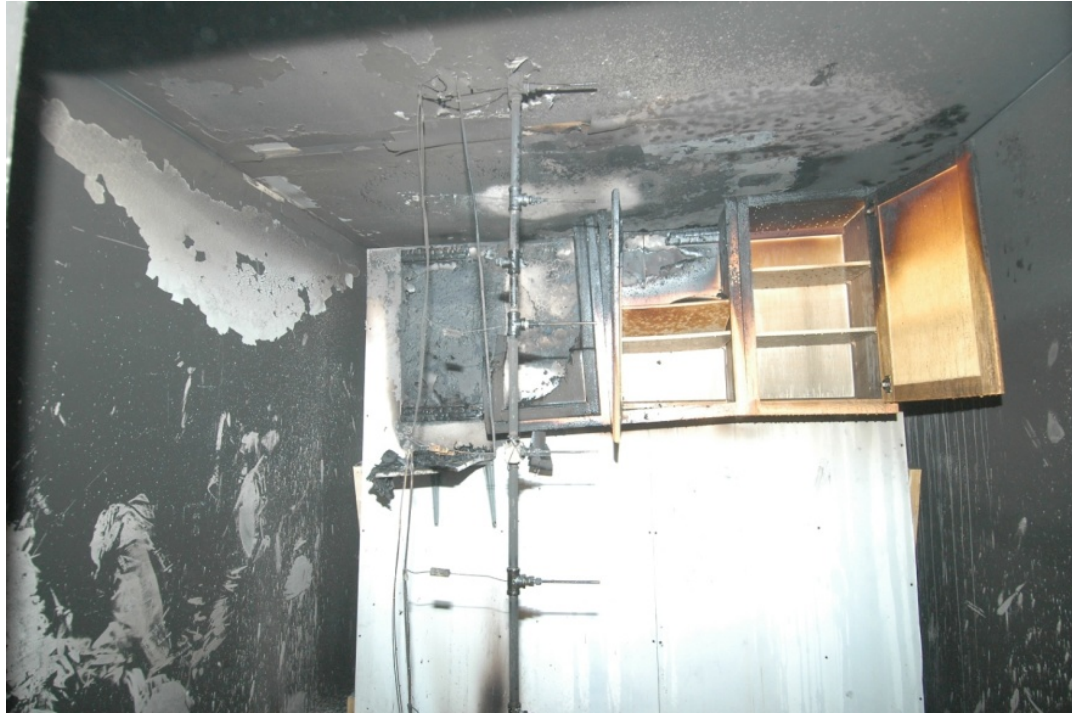
Figure 8-11. Fire pattern from test CH1 (no ventilation)

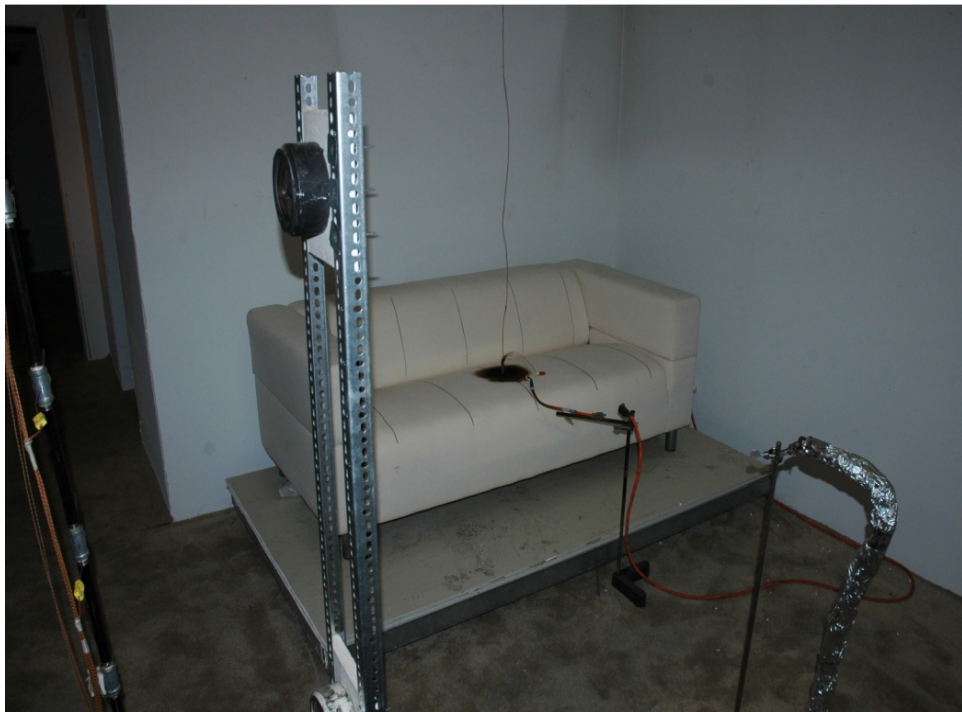
Figure 8-38. After smoldering sofa test (SM2 – no ventilation) (note: this photo actually portrays the scene darker than observed on site due to the lighting in the space when the photo was taken.)

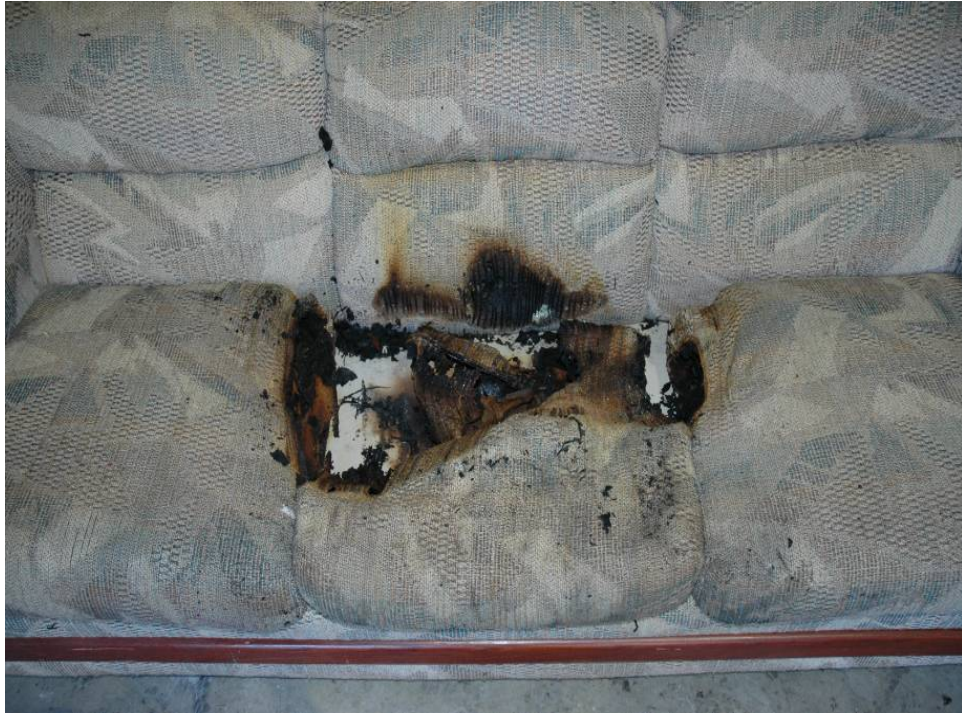
Figure 8-39. Damage to sofa after smoldering test (SM4 – no ventilation)

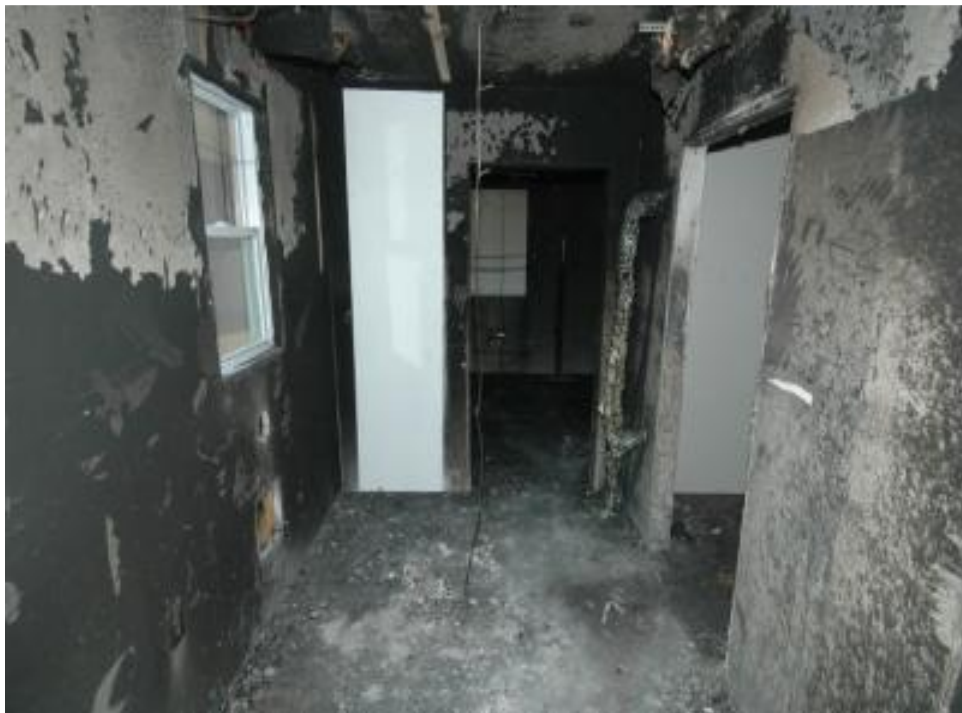
Figure 8-40. Soot deposition on GWB target after smoldering sofa test (SM4 – no ventilation)
