Seismic signature of turbulence during the 2017 Oroville Dam spillway erosion crisis (Supplemental Materials)

Goodling, Prestegaard, and Lekic (2018)

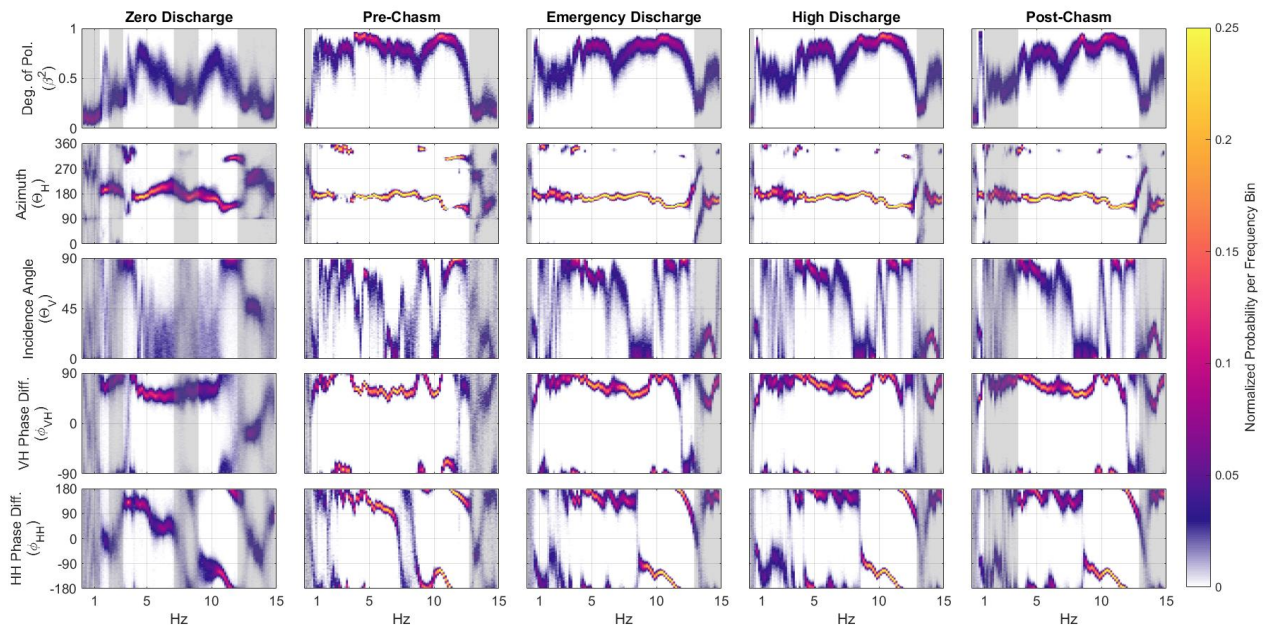
Figure S1- The four polarization attributes and degree of polarization (β^2) for the five time periods of interest. Grey shading indicates frequencies at which the polarization attributes are not interpretable ($\beta^2 < 0.5$). The Azimuth (θ_H) and vertical-horizontal phase difference (ϕ_{vh}) are shown in Figure 7 of the main text.

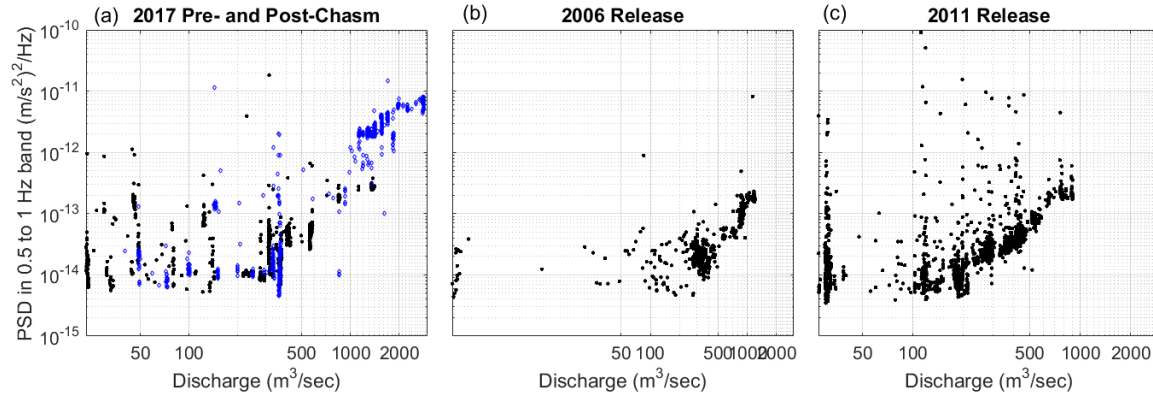
Figure S2- The hourly relationship between dominant eigenvector power and discharge has an apparent break in slope at approximately 200 cubic meters per second of discharge. We interpret this to be the threshold for which the seismometer is sensitive to flood control spillway discharge, and complete the scaling analysis in the main text only for hours with discharge greater than 200 cubic meters per second.

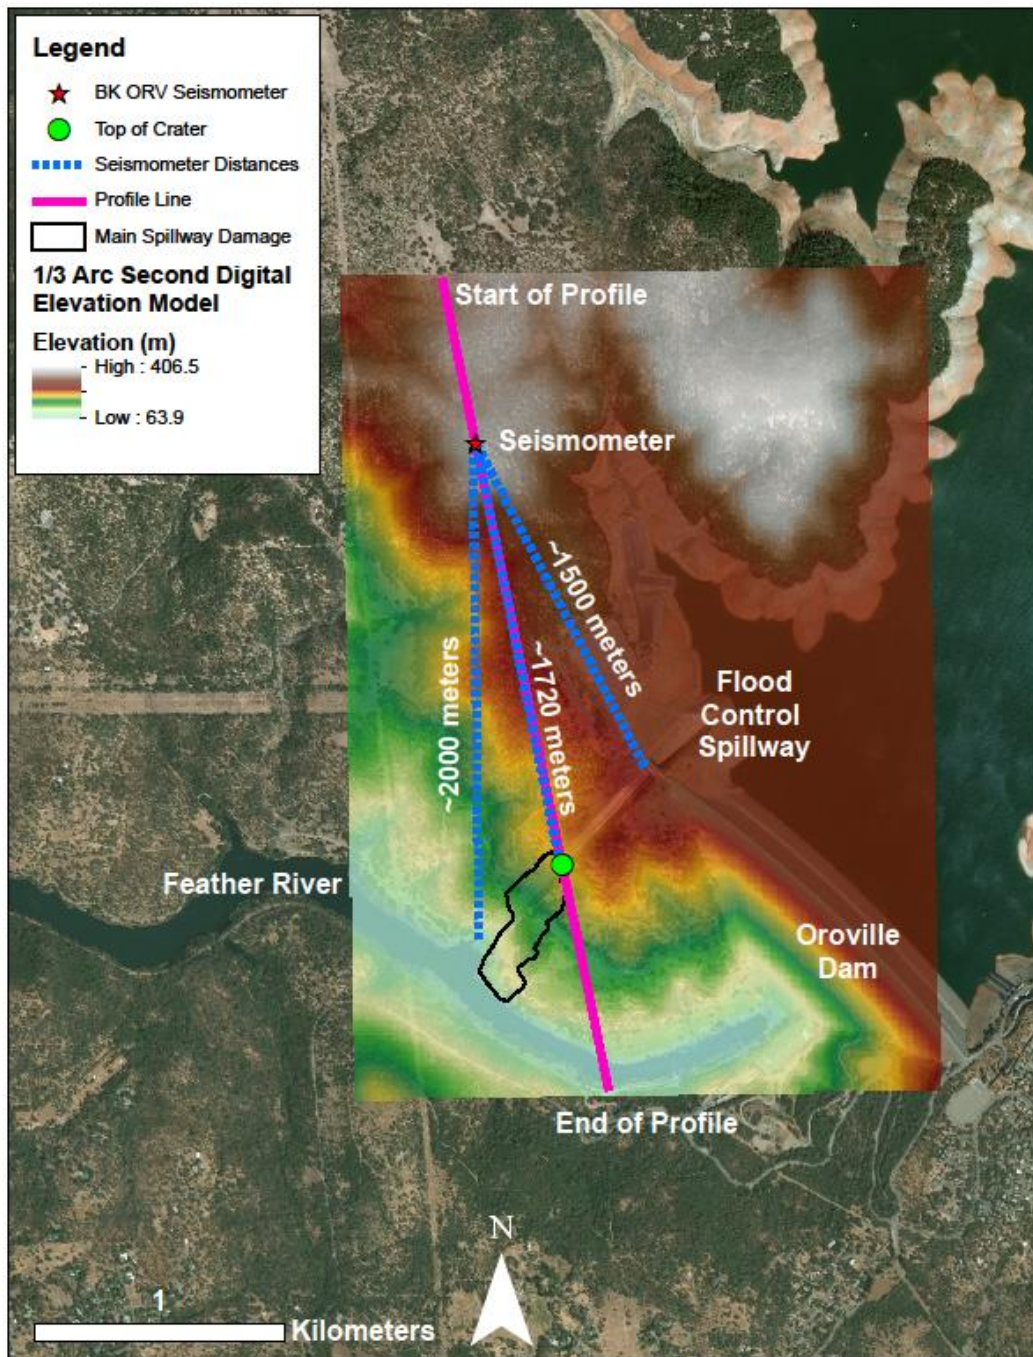
Figure S3- The hillside topography extracted for the SPECfem2D simulation. If the entire length of the flood control spillway is considered an ambient seismic source, then the seismic waves travel a range of approximately 500 meters to the seismometer. In our simulation, we simplify this by simulating five sources spaced 100 meter apart along a profile line to the middle of the flood control spillway.

Topographic model domain for the SPECFEM2D simulation was created by extracting the elevation profile along a transect extending through the BK ORV seismometer and the center of the Oroville Dam Spillway. To create the model domain, 1000 meters were added to the lowest elevation, so that the model boundary did not interfere with the topography.

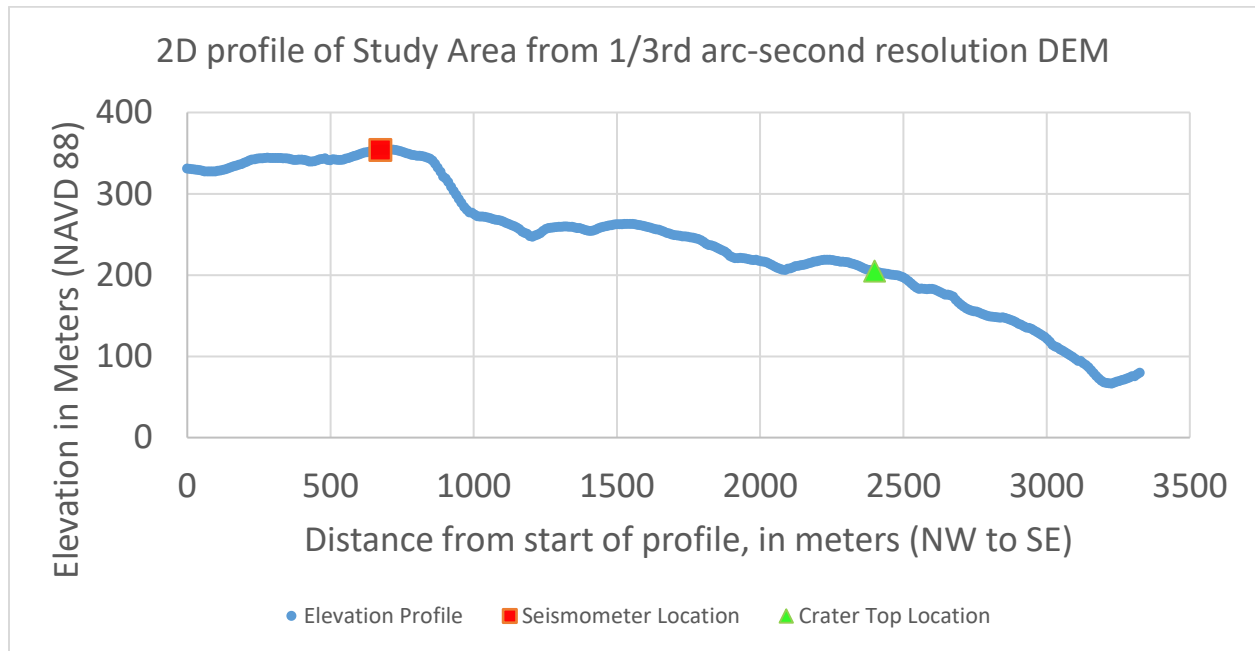
Figure S4- The elevation profile extracted for the SPECFEM2D simulation.

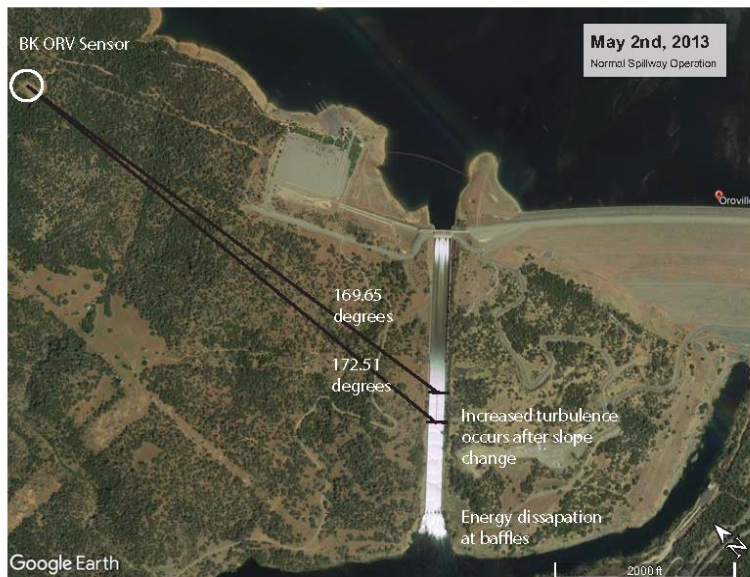
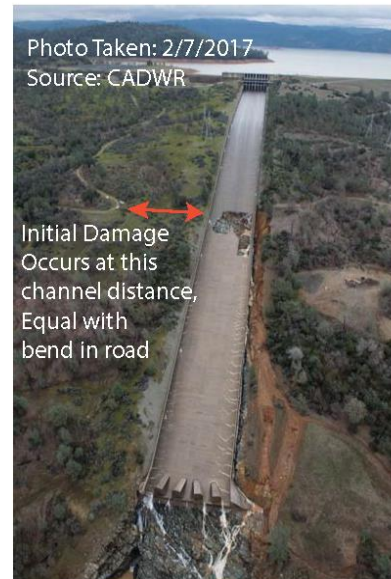
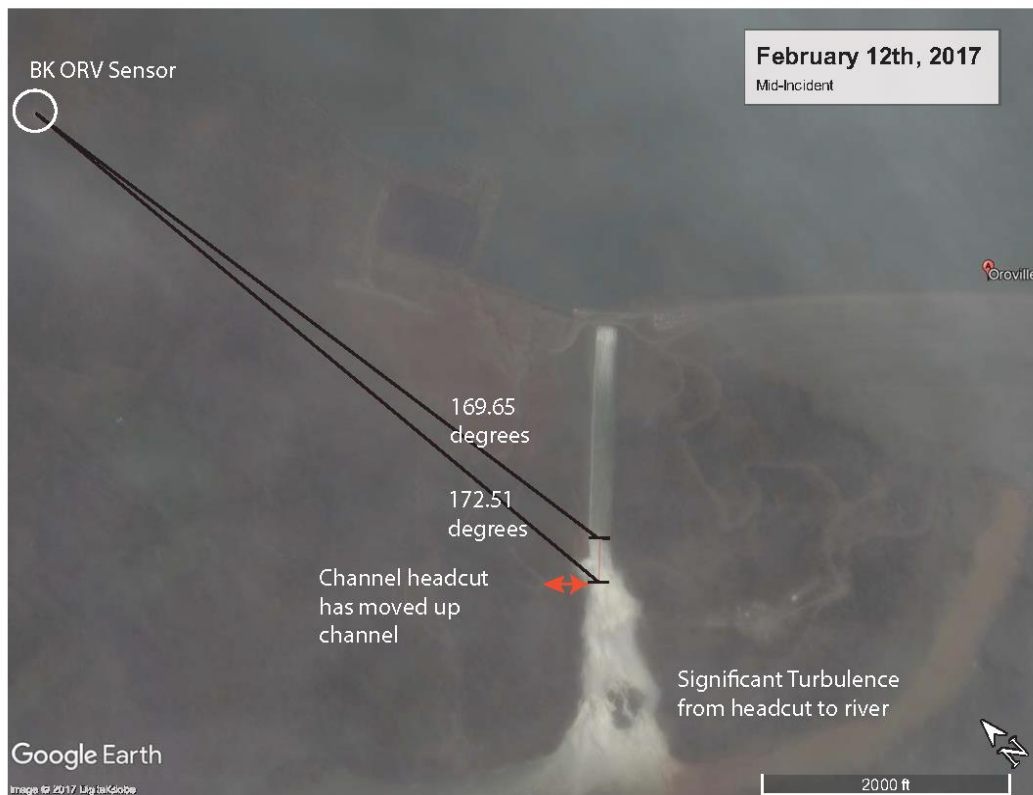
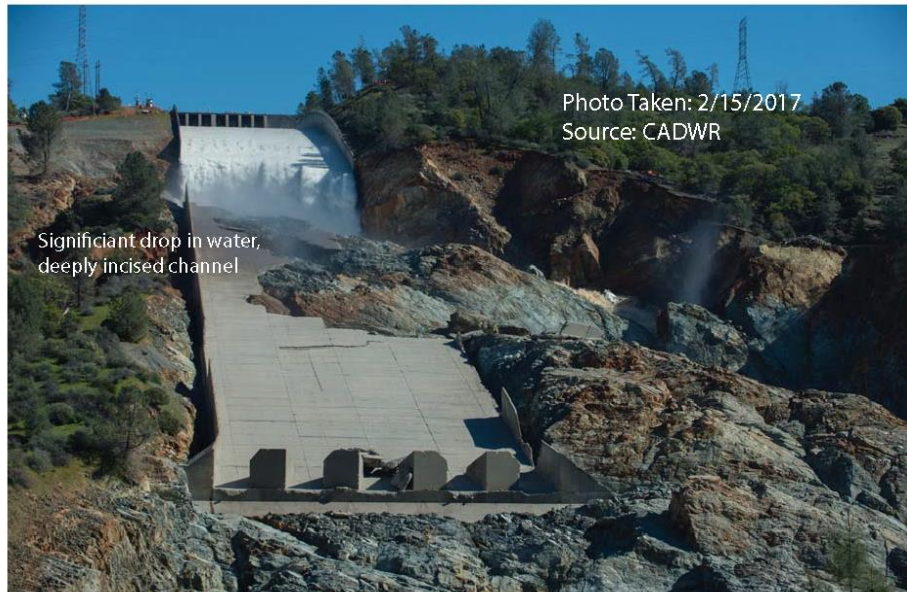
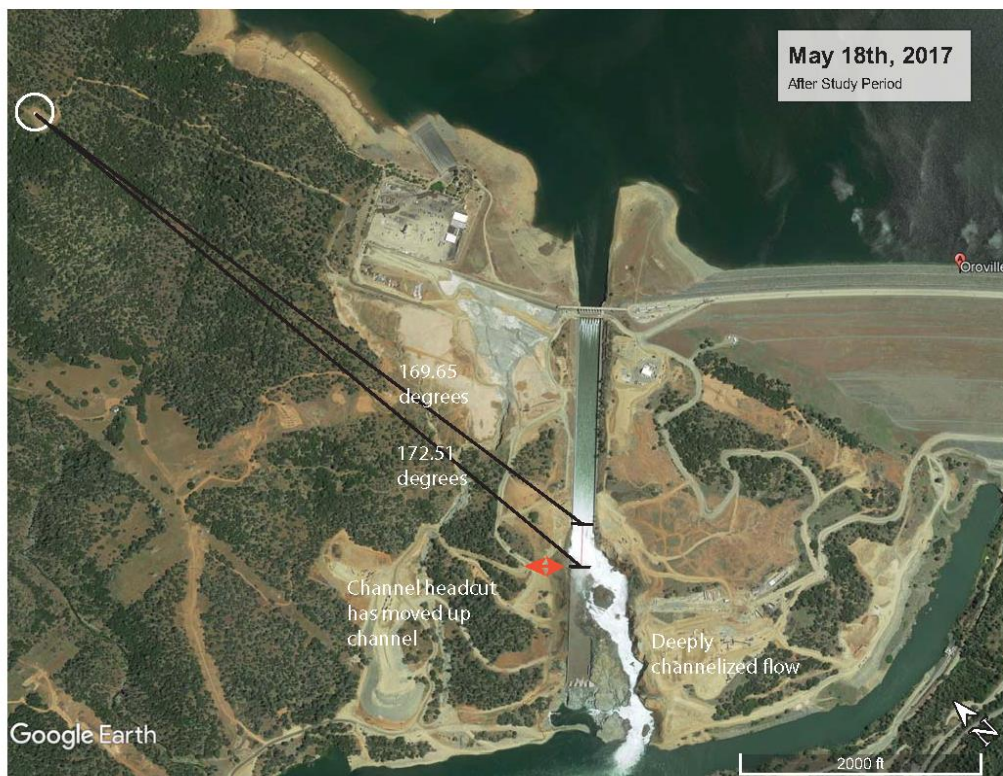
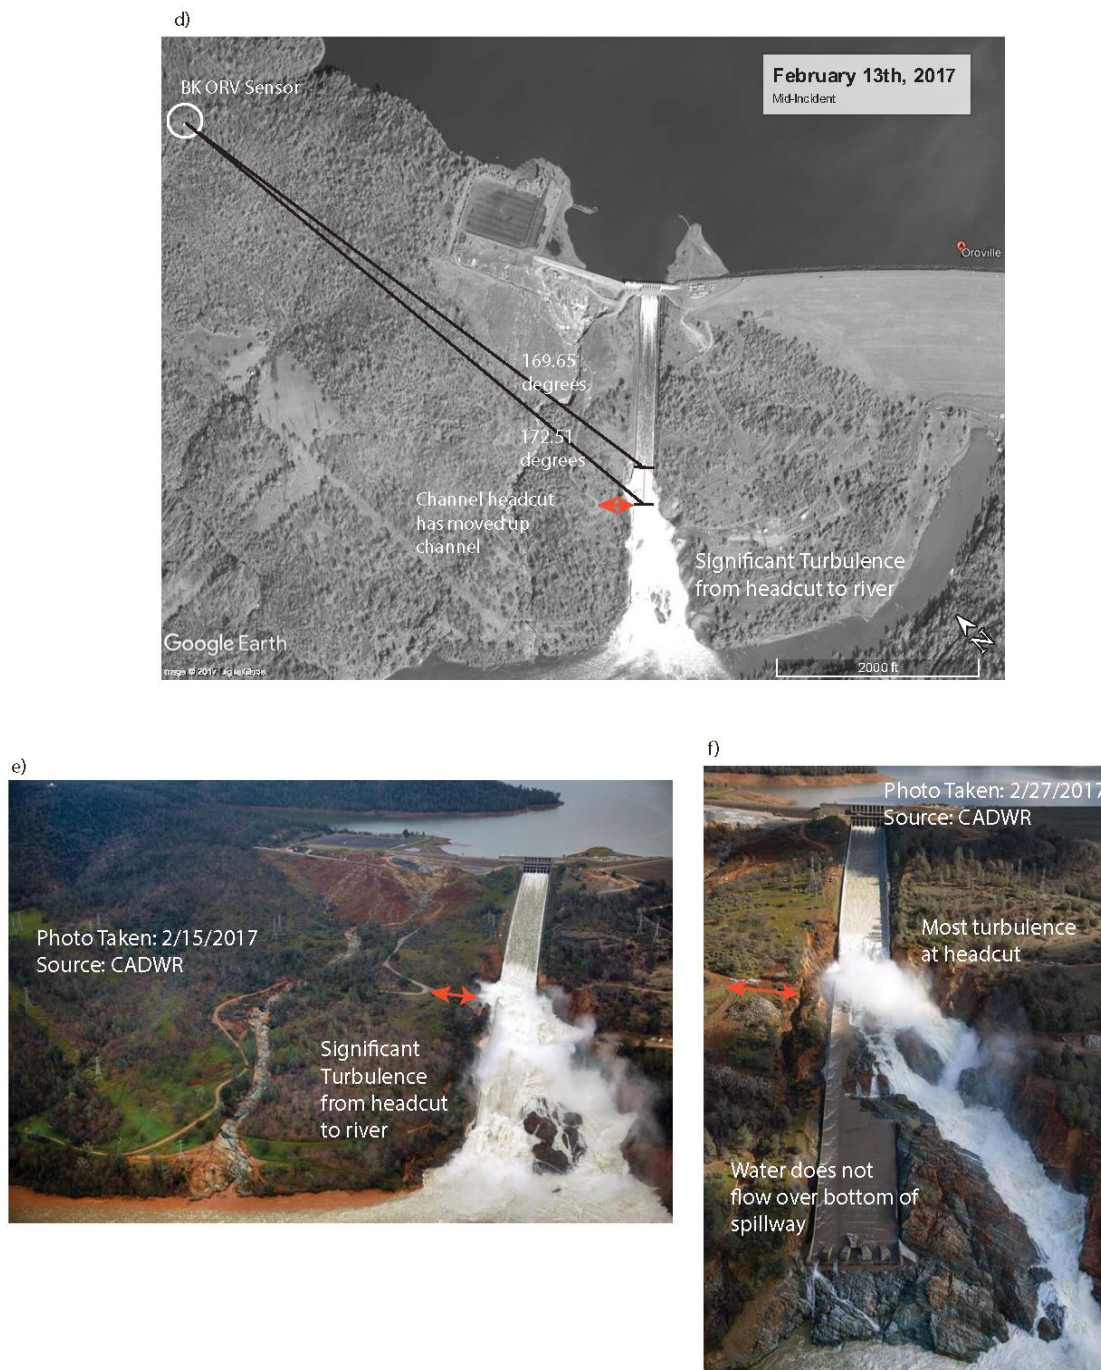
Figure S5 (a-f)- Aerial photographs collected during the time period of interest showing the evolution of the spillway erosion damage.

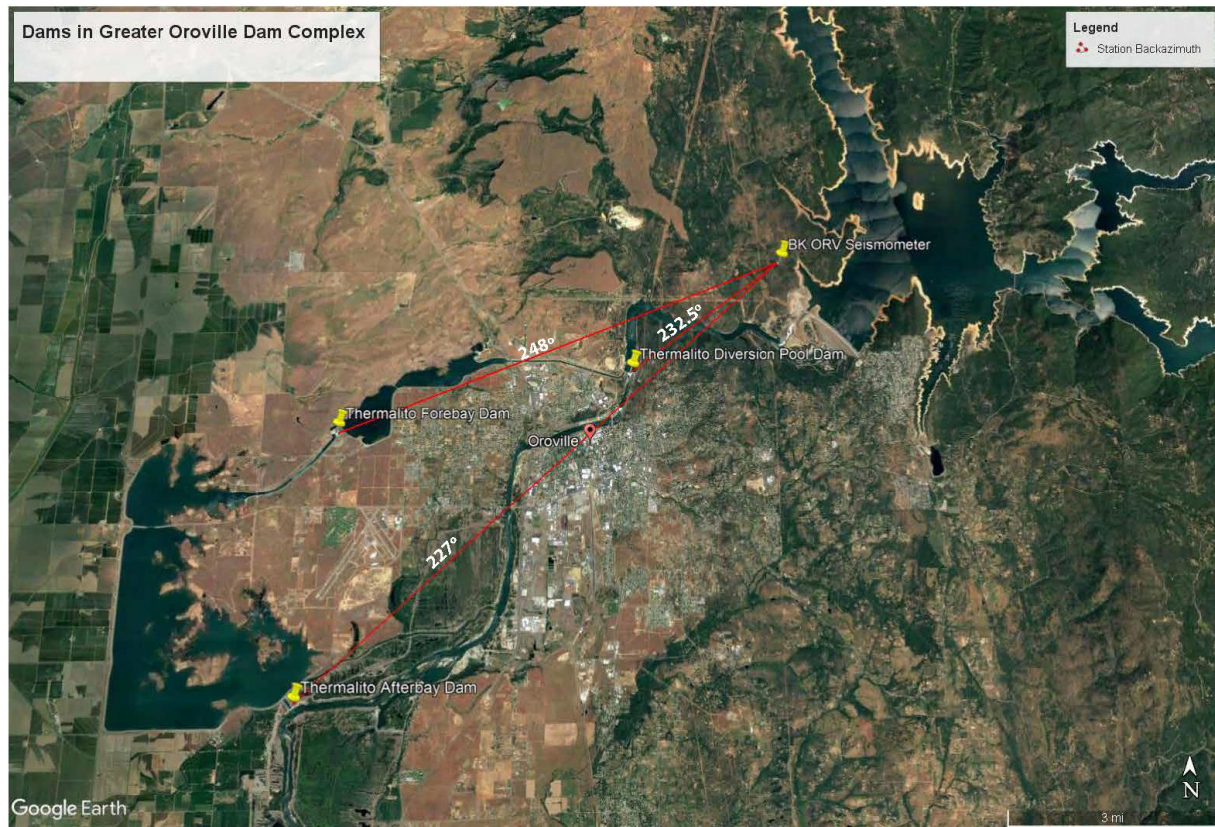
Figure S6- Three other dams- Thermalito Forebay Dam, Thermalito Diversion Pool Dam, and Thermalito Afterbay Dam- are a part of the Oroville Dam Complex and are at backazimuths of 248°, 232.5°, and 227°, respectively. The town of Oroville, California is located between station backazimuths of approximately 248° and 217°.
