# **Sotterley: The Search for Access**

**University of Maryland  
Masters Program  
Historic Preservation  
Final Project Fall 2008**

The focus of this paper will be Sotterley Plantation in southern Maryland, a site operated as an historic house museum and outdoor educational and recreational public facility. Barriers to both physical and programmatic access will be identified and recommendations will be given for better incorporation of accessible use. Sotterley faces challenges similar to any historic site- how can the defining characteristics that make it so unique be protected while at the same time providing a fair opportunity for those with disabilities to experience it?

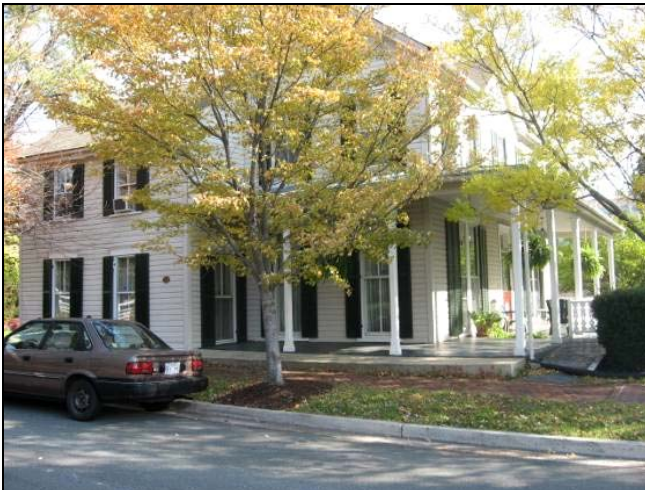
An example of a poorly planned access solution can be seen in downtown Rockville, Maryland. Figures 7 and 8 show the impracticality of the ramp on the side entrance of the Jenkins/Miller/McFarland House. While the ramp itself appears to be compatible with the design of the building, objects like a gutter downspout and furniture have been improperly placed and obstruct the access route. The design efforts have been overshadowed by the impossible use of the ramp for anyone requiring assistance. Proper maintenance of access features is as vital to users as the design and placement of the feature.

Figure 7. Exterior ramp at Jenkins/Miller/McFarland House, Rockville, Maryland (Photos by author).

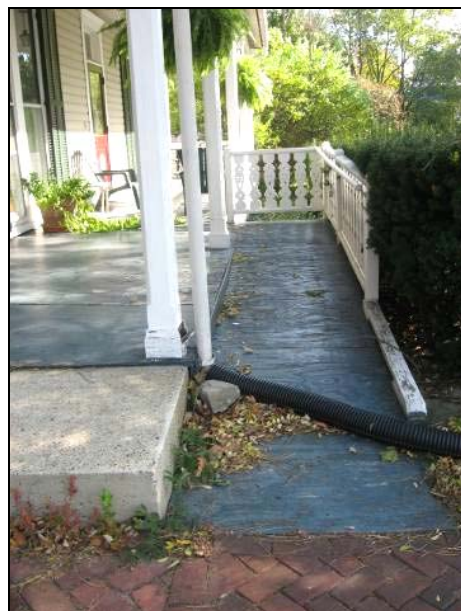
Figure 8. Ramp provides limited accessibility due to poor maintenance.

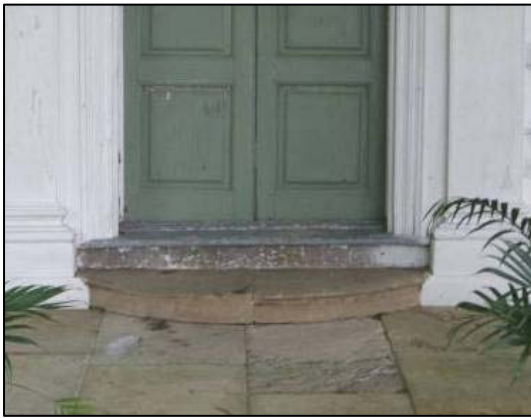
As shown in Table 2, the main house has several major barriers that prevent total access to the interior and limited access to the exterior. Barriers include elevated thresholds to the entrances, level changes between rooms on the first floor, narrow doorways, and discontinuous and narrow pathways surrounding the building. The only rooms in the main house currently open to visitors are the West wing, the drawing room, the stair hall, Madam Bowles room, and the dining room. The second floor does not present an access issue at this time as it is not included in the regular tour. However, if it is opened to visitors in the future it must be reconsidered in the study for overall access.

Figure 10. East elevation entrance (Photos by author).

Given the significance of the main house to the site and the irreplaceable nature of the entrances and doorways, only non-structural changes are recommended for interior access. Temporary ramps could be installed on the west elevation entrances.

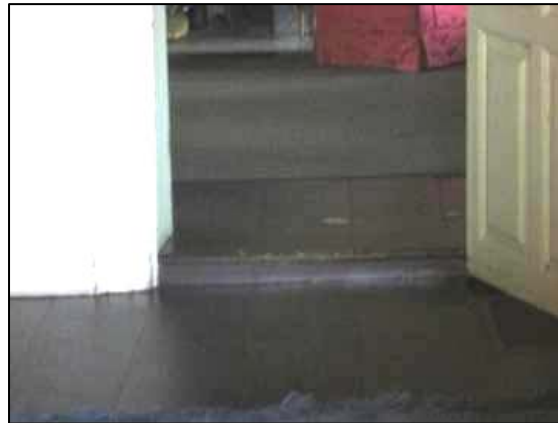
Figure 11. Interior threshold.

Once inside, beveled or ramped thresholds could be fixed to the entryways in order to level floor changes. Narrow wheelchairs and walkers (supplied by Historic Sotterley, Inc.) would allow for non-mobile visitors to navigate the narrower passages. Alternatives to be discussed in Section 5 should also be considered for ways to allow visitors to visually view the interior if physical experience is not feasible.

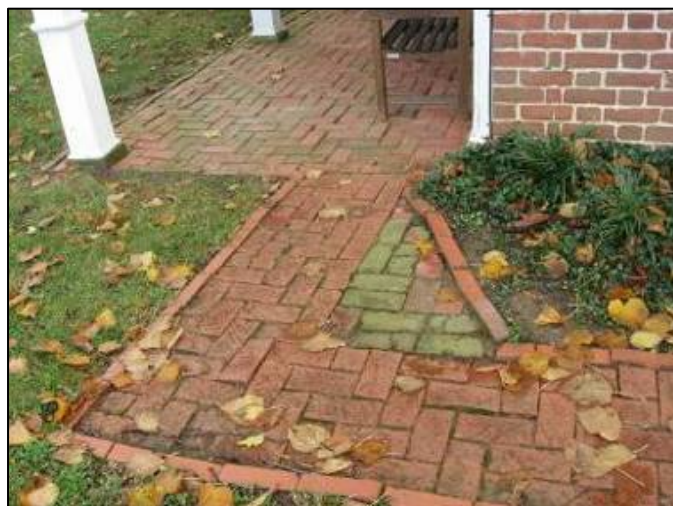
Figure 12. West elevation pathway, main house.

The pathways surrounding the building could be improved to allow for easier movement around the main house. At present, the pathways are composed of brick and stone pavers. Portions on the west elevation are too narrow for access purposes and have become loose and uneven.

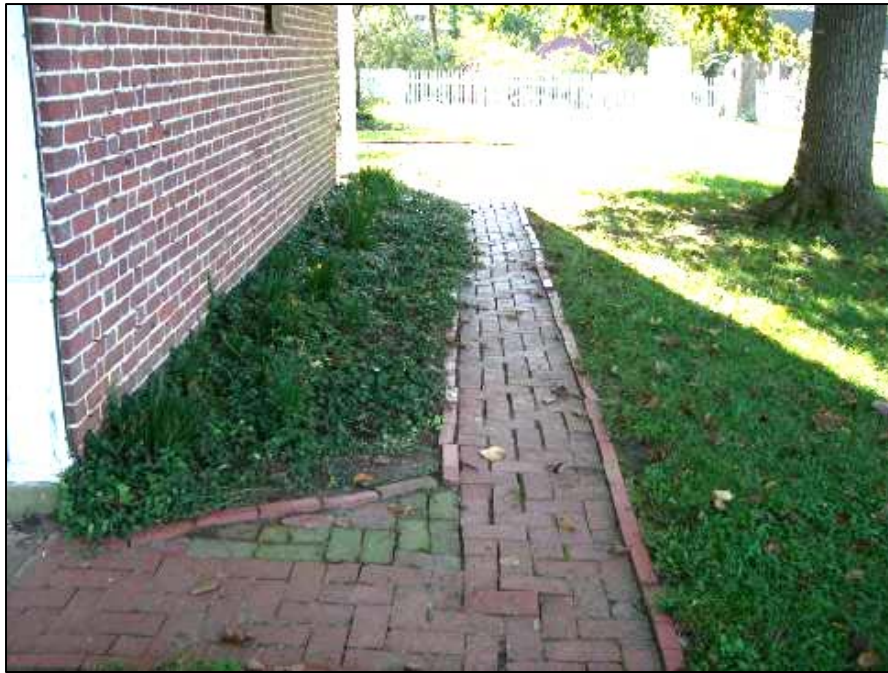
Figure 14. West elevation pathway, main house (Photo by author).

compatible with the pathways throughout the property. Interpretive panels around the exterior or a docent-led guide for visitors who can't access the interior could be provided to enhance the experience.

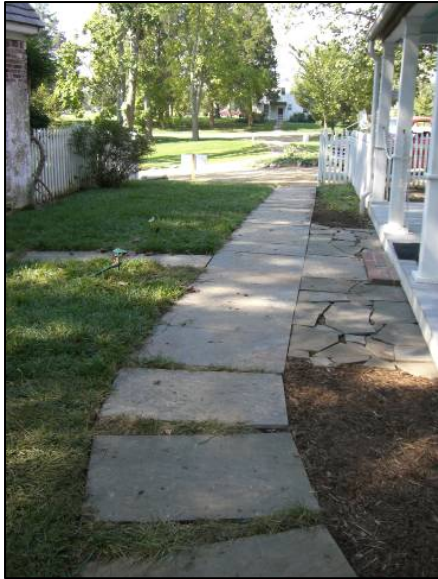
Figure 15. South elevation pathway, main house (Photos by author).

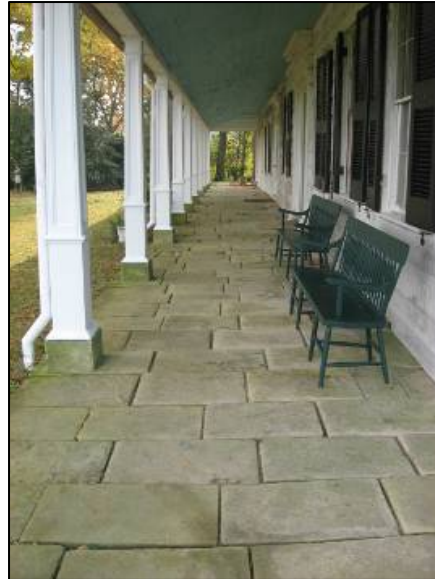
Figure 16. East elevation entrance and pathway, main house.

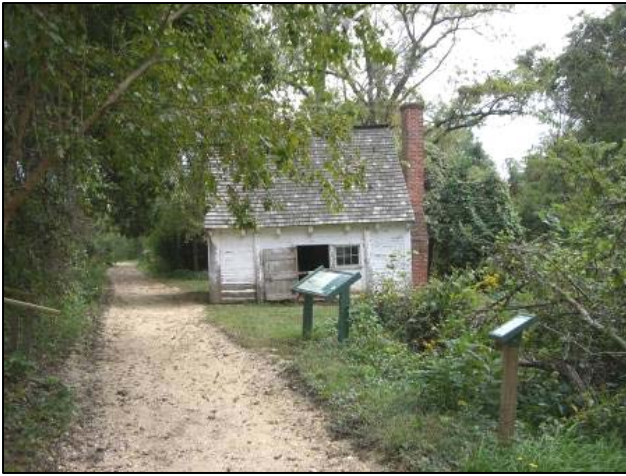
history of the cabin and the road on which it sits. The largest barrier to accessing the cabin is the dirt and gravel rollway road.

Figure 17. Slave cabin and interpretive panels along Rollway Road (Photos by author).

Given the high significance of the structure, the road, and the visual setting, no major improvements or alterations are recommended for this site. One minor suggestion would be to extend the trailhead of the rollway road to the bathrooms. This portion of the property has already been altered with the construction of the bathrooms and extending the pathway would allow visitors with movement and sight challenges an easier route.

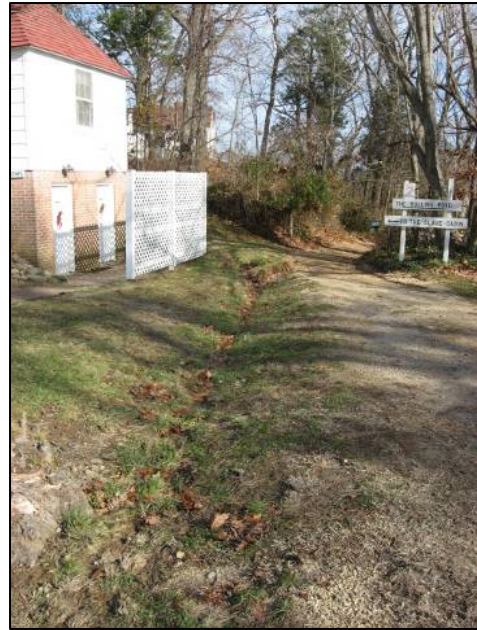
Figure 18. Trailhead of Rollway Road, with gift shop restrooms to left.

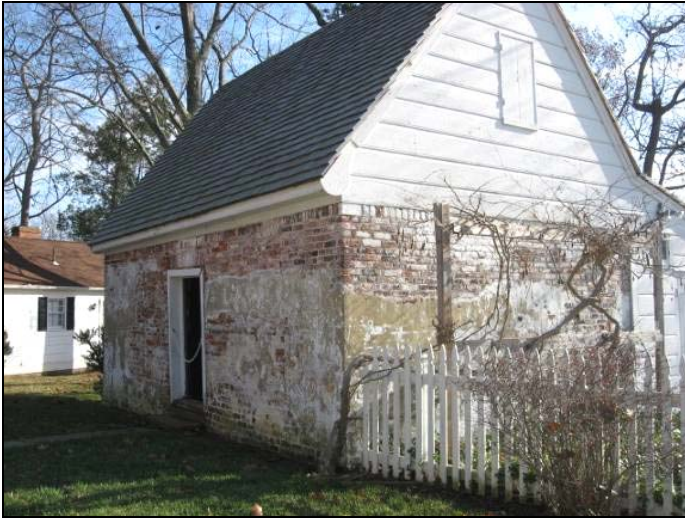
Figure 19. Exterior view of smokehouse (Photos by author).

Improving the pathway to the entrance of the smokehouse would be the only necessary alteration. Similar to the slave cabin, access for visitors is restricted to the exterior, which eliminates the challenge of altering the elevated entrance. By constructing a more solid walkway and displaying informative panels, complete access could be achieved.

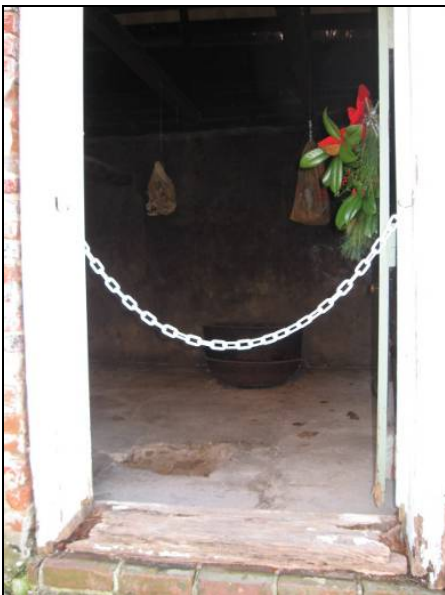
Figure 20. Interior view of smokehouse.

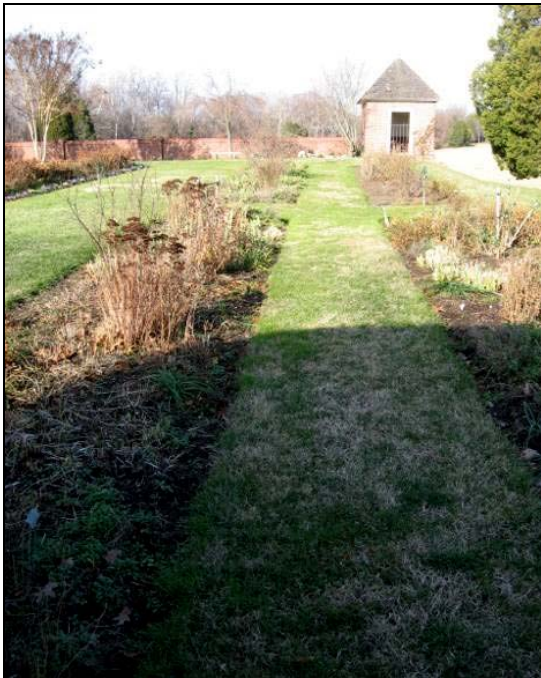
Figure 21. Looking north to privy, from main house (Photos by author).

Providing interpretive panels and a clearly-designated pathway would be the best possible option for allowing access to the privy. As visitors are not regularly allowed inside the structure, all visitors could benefit from a narrative panel and solid ground for circulation. Paving would not be recommended for the pathway, as the garden is a grass surface only. But short cut grass and appropriate drainage would accommodate most users. Another alternative for the pathway leading to the privy (and other clearly-defined walkways throughout the garden) would be to utilize technology like Grasspave. Discussed further in Section 5, Grasspave provides a more solid surface and looks and performs the same as standard grass.

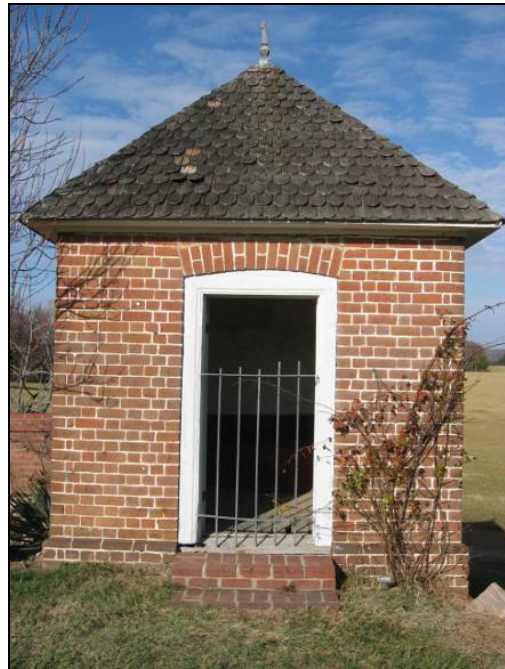
Figure 22. Front elevation of privy.

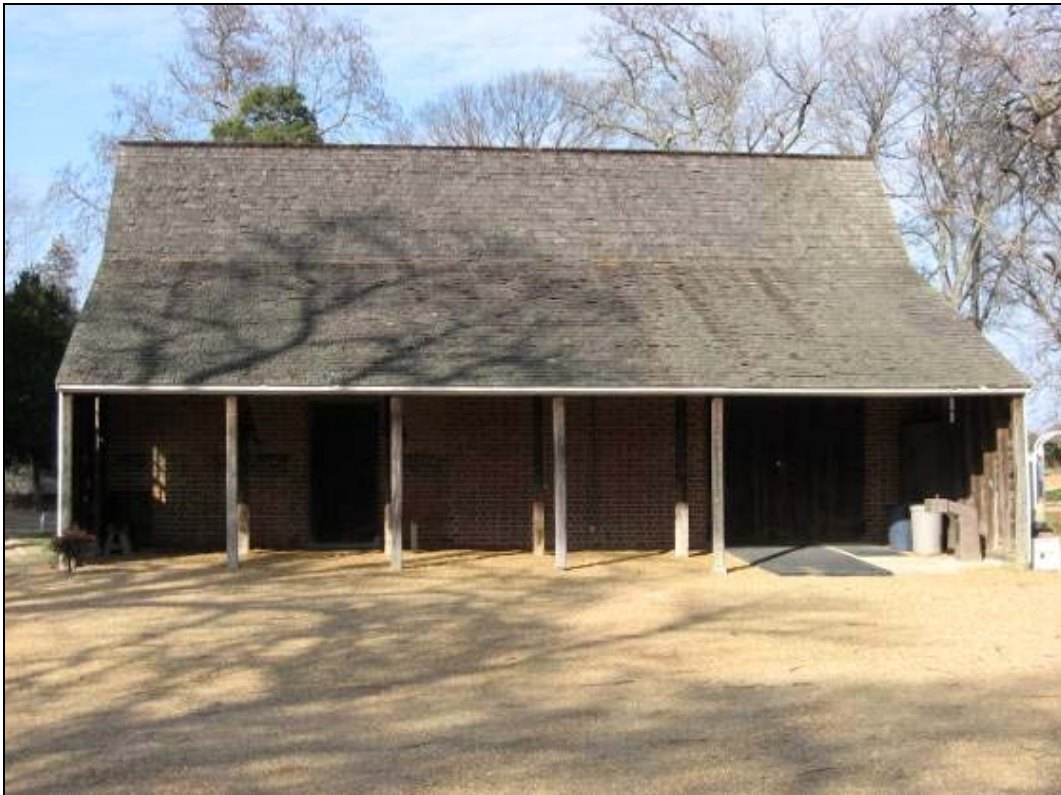
Figure 23. Custom warehouse (Photo by author).

The warehouse currently serves as an exhibit space and lecture room. Built in the 18th century, the building was altered in the 1910's and 1930's<sup>19</sup> and now has a ramped entrance on the south elevation. One of four buildings on-site with a ramp, the warehouse could provide a useful space for accessible events and displays. However, the gravel walk leading to the warehouse entrance is difficult to maneuver and there is a lack of signage indicating the accessibility of the building. These are relatively small and inexpensive improvements that can help to enhance the use of the building. As part of a long term goal, Historic Sotterley, Inc. may want to consider moving the gift shop services to the warehouse. It is one of the closest buildings to the parking lot, is a close distance to the bathrooms in the sheep barn, and already has a ramp in place.

Lastly it is recommended that all existing accessible (or partially-accessible) space be utilized to the greatest degree possible. This includes the following buildings at Sotterley- custom warehouse, corn crib, sheep barn, and Knott farmhouse.

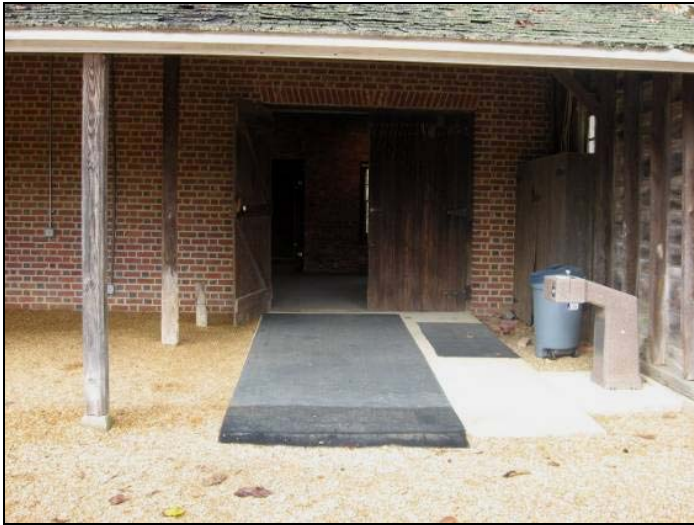
Figure 24. Exterior ramp to Custom warehouse (Photo by author).

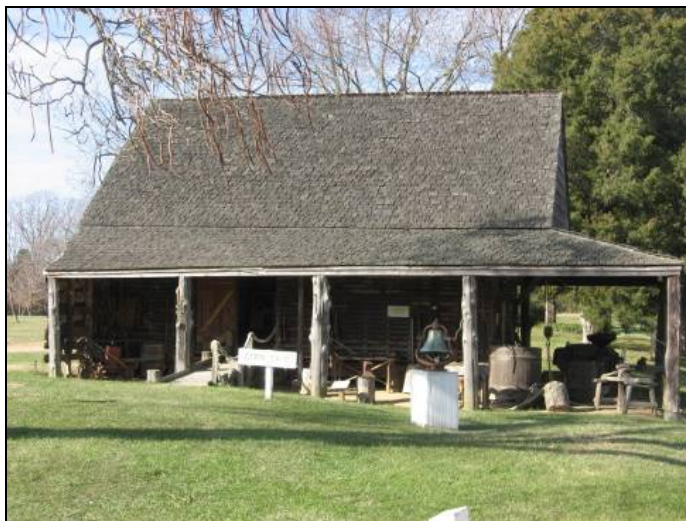
Figure 25. Corn crib (Photo by author).

Similar to the warehouse, and situated adjacent to the parking lot, the corn crib has a ramp on the south elevation. The building is also used as exhibit space. The largest obstacle to access is the lack of a continuous route from the lot to the ramp. This all but eliminates the usefulness of the ramp, as one would have to cross a grassy open space before reaching it. Again, this is an easy adjustment to make to provide complete access.

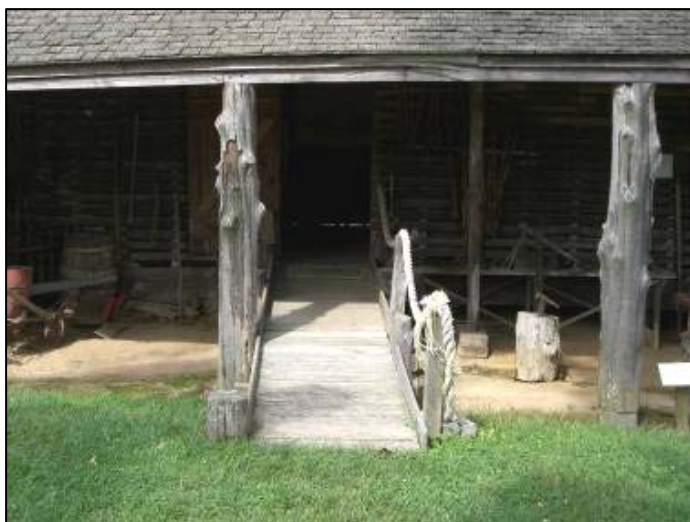
Figure 26. Exterior ramp to corn crib (Photo by author).

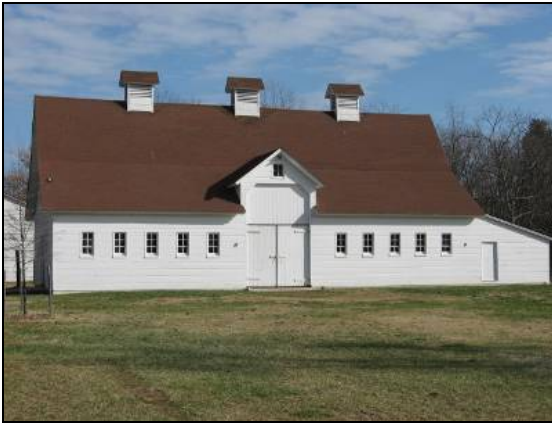
Figure 27. Sheep barn (Photos by author).

The sheep barn on the south end of the property provides the greatest opportunity for accessible space. A large, single level building, it has newer bathrooms (some with grab bars, others that can be easily modified), a ramped entrance, and unused parking in the rear. The only obstacles to access at the barn are the lack of a solid circulation route from the current parking lot and the absence of signage directing visitors. Corrections to both barriers could be addressed when improvements are made to overall site circulation and signage. The possible uses for the barn include exhibit space, lecture hall, programmed events, performances, rental space, and visitor services. With just a few minor improvements, the building could serve a variety of functions while at the same time providing full access.

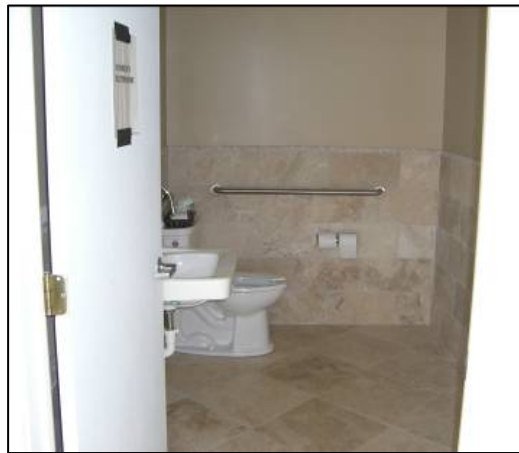
Figure 29. Restroom facilities with grab bar.

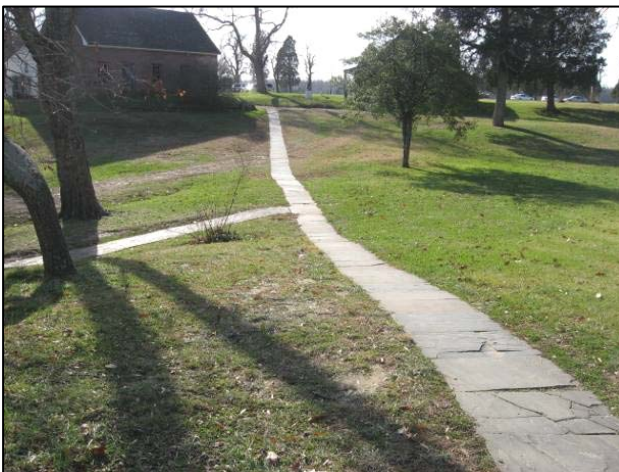
An assessment of the overall site identifies the pathways and parking lot as major access barriers. The parking lot is located approximately 150 feet from the gift shop, which is the starting point for all tours. The path of travel from the lot to the gift shop

descends down a steep hill and back up to the entrance. The route would be challenging for a visitor with even the slightest difficulty walking steeper slopes. The other option would be to follow the gravel road to the main house and take a set of stairs down to the gift shop, a route twice as long as Figure 30. Pathway from parking lot to gift shop (Photo by author).

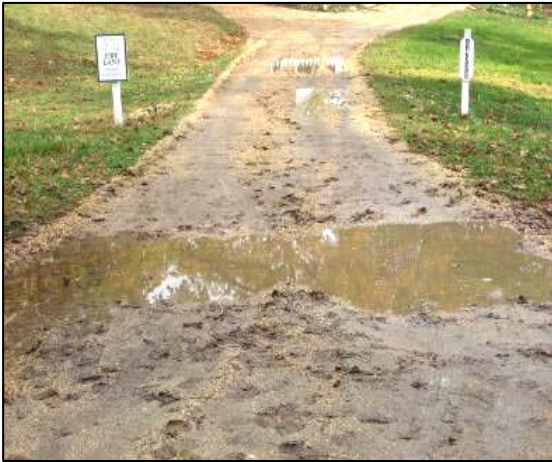
the previous one. The pathway to the house and most of the outbuildings is a mix of loose gravel, dirt and grass. This presents a particular issue after a rain event, as the property drains poorly and the pathways and parking lot become muddy.

Figure 31. Poor site drainage (Photos by author).

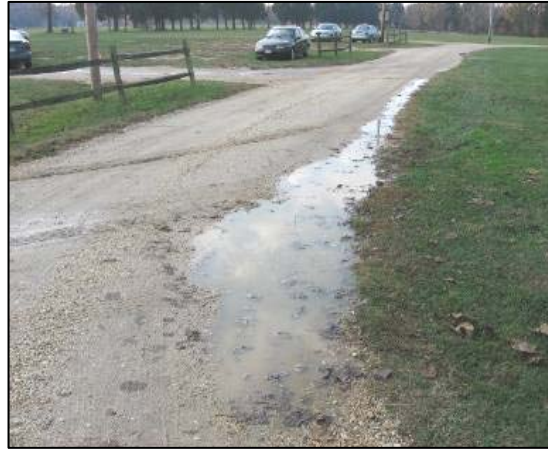
Figure 32. Poor site drainage.

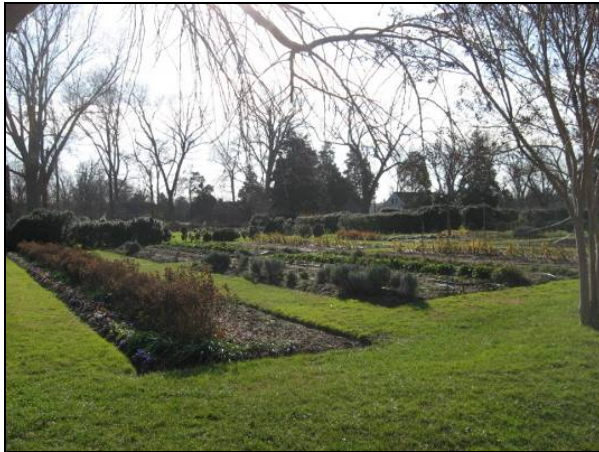
Figure 33. Colonial Revival garden  
(Photos by author).

The Colonial Revival garden presents a particular obstacle because it lacks pathways of stable material. Visitors are permitted to walk through the garden on its grassy surface. This would be a challenge to anyone that requires harder footing to move comfortably or must travel with a wheelchair, walker or stroller. As suggested previously with the privy, using a surface treatment such as Grasspave on clearly-marked pathways through the garden would give visitors a solid, stable surface to travel with the same aesthetic and function as regular grass.

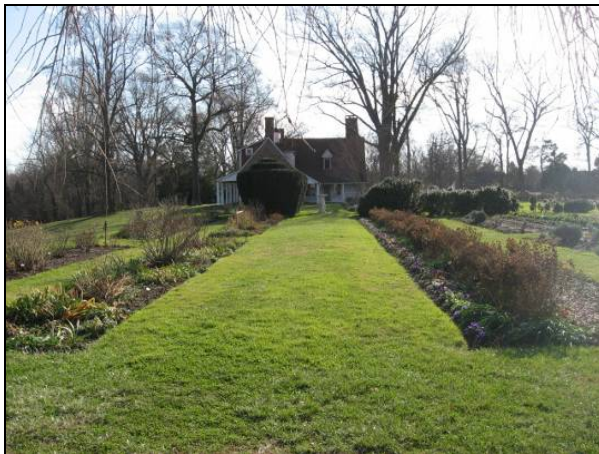
Figure 34. Grass pathway through garden.

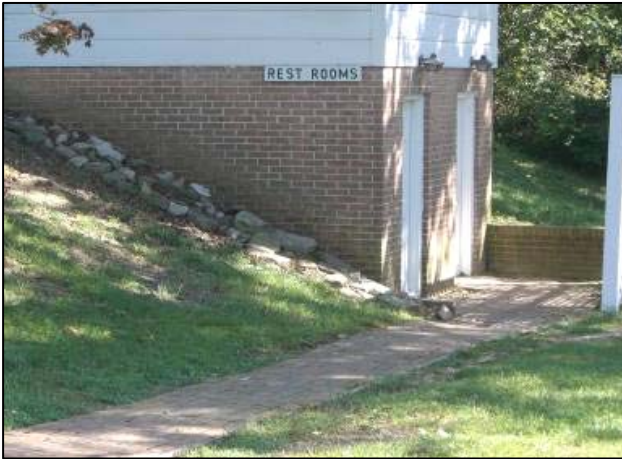
The next issue is the restroom facilities. There are restrooms on the basement level of the gift shop, but they are outdated and difficult to reach. Newer bathrooms in the sheep barn are not currently ADA or UFAS accessible but could be easily modified. These facilities are unmarked however and quite a distance (approximately ¼ mile) from the historic core.

Figure 35. Gift shop restroom facilities. (Photos by author).

The next set of access modifications would be improved restroom facilities at both the gift shop and sheep barn. The restrooms are noncontributing features to the site and can be fully altered according to access standards. Other service features that could be modified or constructed to code include benches, picnic tables, water fountains, handrails, and trash cans.

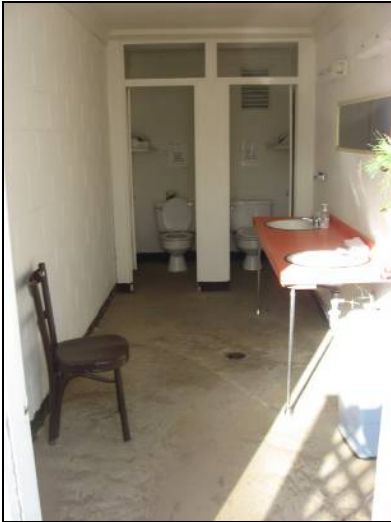
Figure 36. Gift shop restroom facilities.

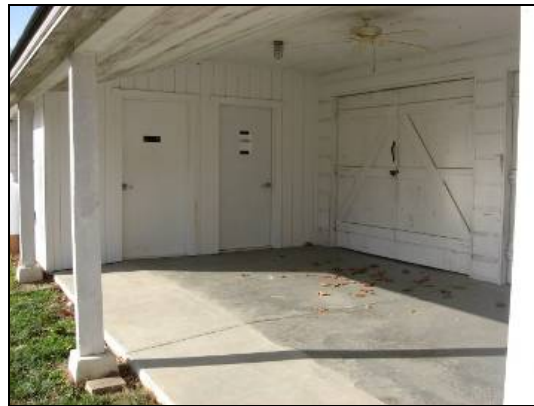
Figure 37. Sheep barn restroom facilities.

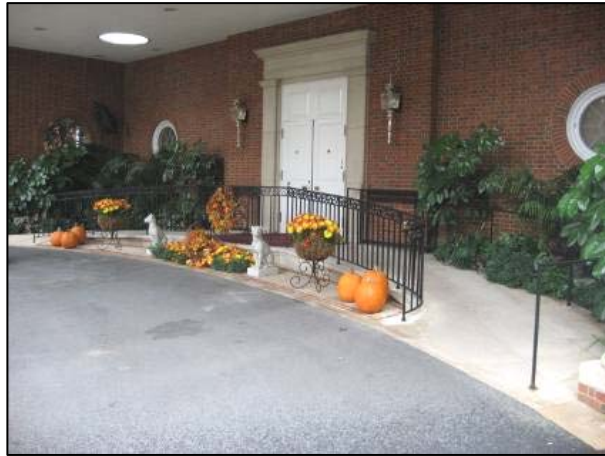
Figure 40. Ramp entrance to mansion.

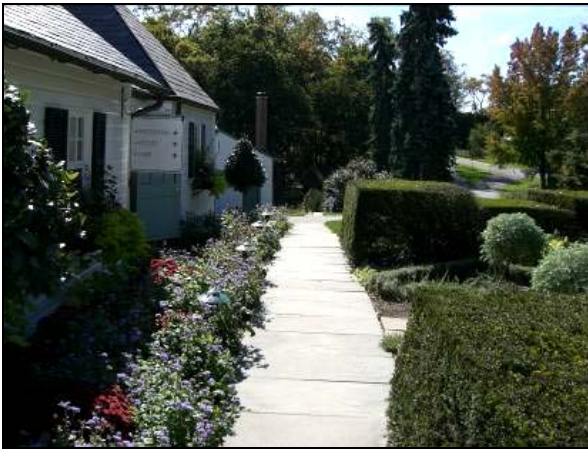
Like Sotterley, Ladew Gardens is a preservation easement property held by the Maryland Historical Trust and has a range of buildings, structures, and landscapes to consider when making access decisions. The approach they have taken is to provide minimal access to the manor house, but full access to the gardens and accessory buildings. Golf cart tours of the garden are available by appointment for visitors with impairments. Walkways around the buildings are solid surface and signage directs guests to accessible bathrooms and entrances. Parking spaces for cars and vans are provided near the visitor building and manor house.

Figure 43. Signage and pathway (Photos by author).

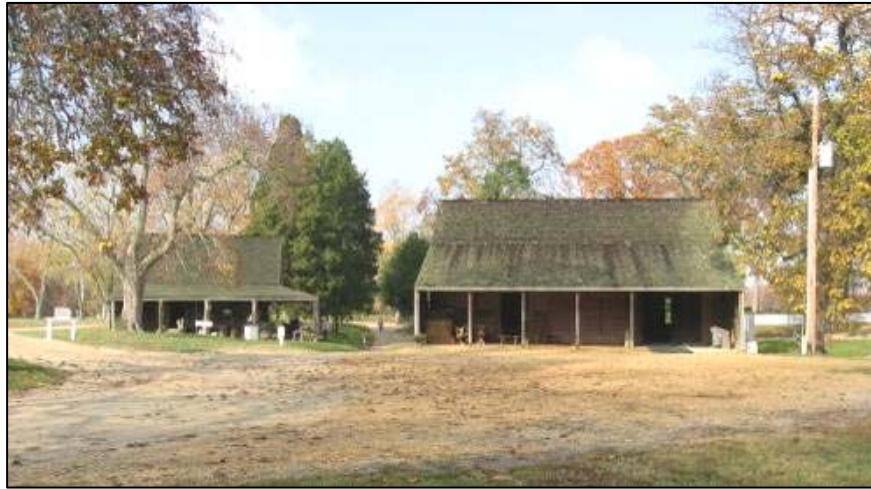
Figure 48. Corn crib and Custom warehouse (Photos by author).

These buildings should be advertised on the website as providing (to some degree) for physical access needs and programs should be listed with date and time of event. Programs may include, but are limited to, exhibits, lectures, performances, fund-raising events, holiday events, and private parties. In addition, Historic Sotterley, Inc.

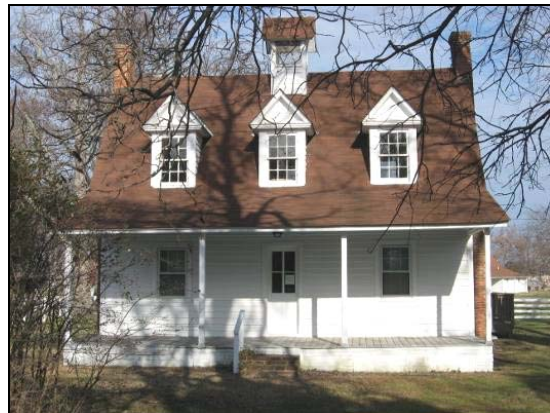
Figure 50. Knott farmhouse (education building).

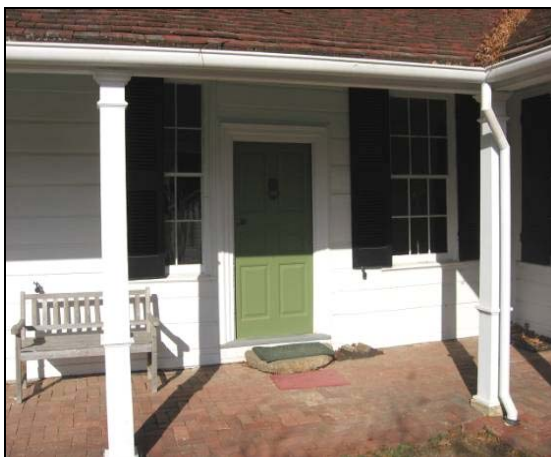
Figure 51. West wing, west elevation entrance (Photos by author).

To get visitors with movement challenges (wheelchairs, walkers, etc.) inside the house, a ramp could be placed at the door to the West wing (entrance point for all visitors) with an exit ramp at the dining room (east or west elevation). The exterior doors are approximately 36-38" in width, which would accommodate most wheelchairs and walkers. Narrow models could be provided by staff if further study shows that passageways and doors on the interior are too narrow for most assistive equipment (doorways must be at least 32" in width).<sup>26</sup>

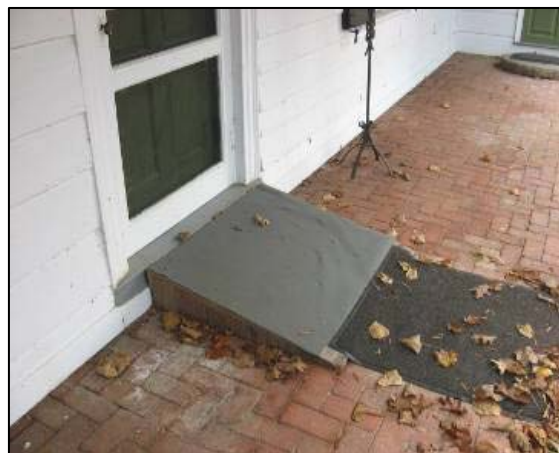
Figure 52. Example of temporary ramp, dining room entrance.

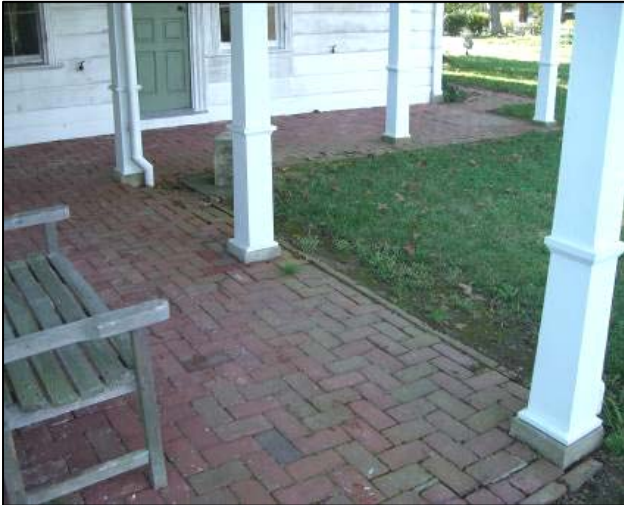
Figure 55. Pathways requiring minimal improvements  
(Photos by author).

constructed of an appropriate material for access (stone, brick, concrete) they should be widened (if necessary), fixed in place, and maintained to avoid loose or missing material. Pathways that require only minimal modifications include those surrounding the main house and smokehouse.

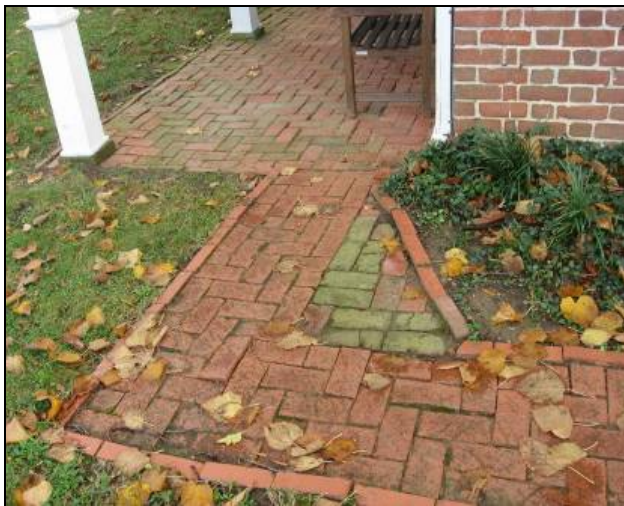
Figure 56. Pathways requiring minimal improvements.

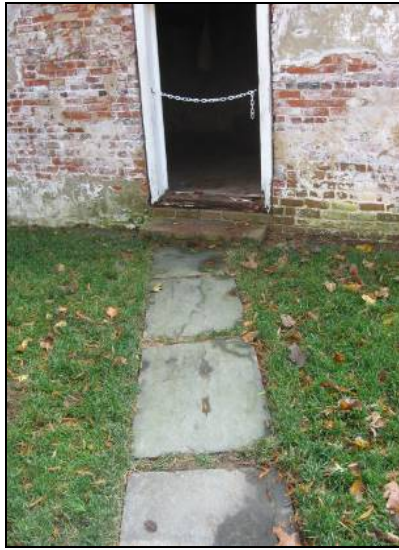
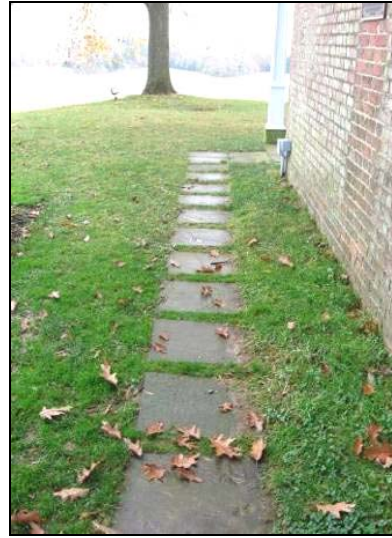
Figures 57-58. Pathways requiring minimal improvements (Photos by author).

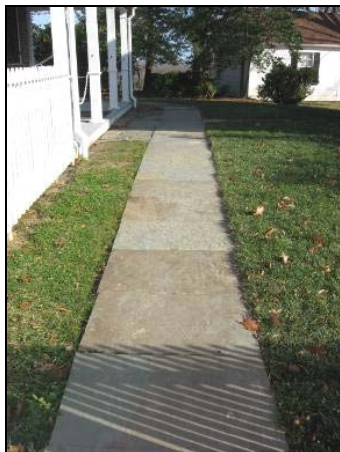
- Pros- fits in with current paving around main house, solid surface when maintained
- Cons- requires regular maintenance for stable, non-slip surface, material can be costly

Figure 59. Stone paving (Photo by author).

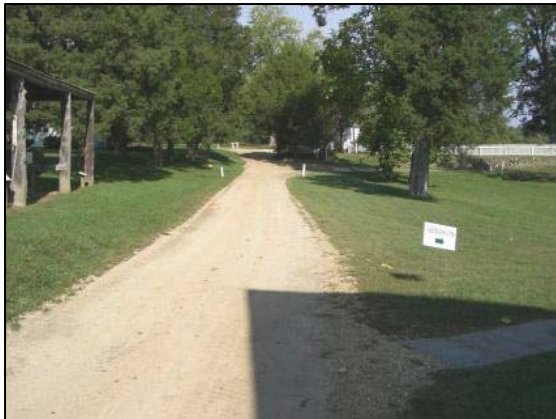
Figure 66. Main pathway from parking lot to main house (Photos by author).

The pathways on-site that would require new surface material include the main route from the parking lot to the main house, the road from the lot to the custom warehouse and sheep barn, the path to the Spinning cottage, and the entry court.

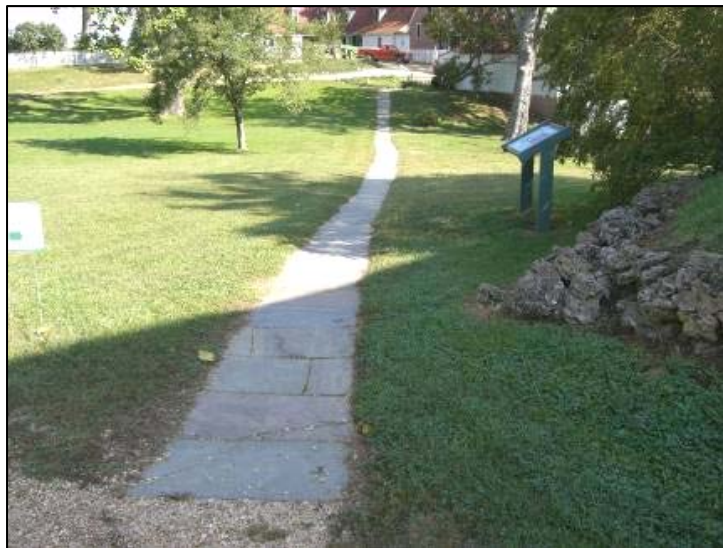
Figure 71. Pathway from parking lot to gift shop.

The path from the lot to the gift shop can be maintained with its current stone pavers, but consideration should be given to re-grading the walk in order to decrease the slope. The brick walk to the gift shop restrooms would need only to be widened and maintained. The rollway road, as mentioned previously, should be maintained as is, with the trailhead extended to connect with the brick pathway near the restrooms.

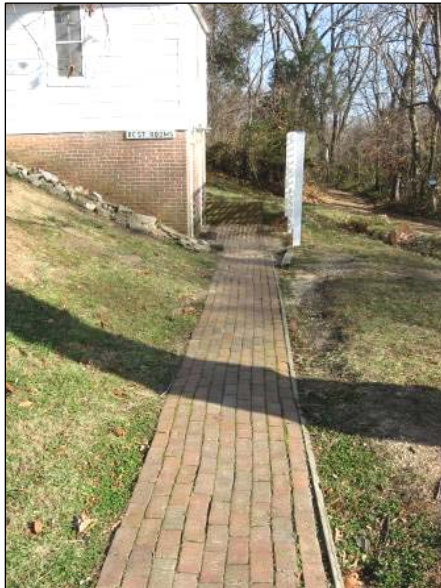
Figure 72. Pathway to gift shop restrooms  
(Photos by author).

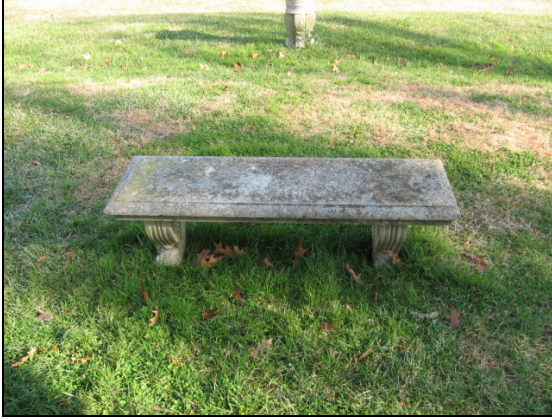
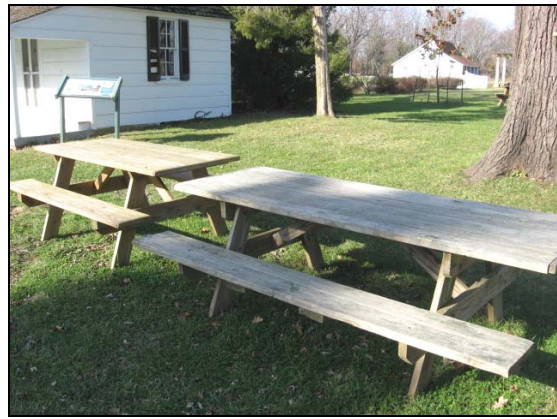
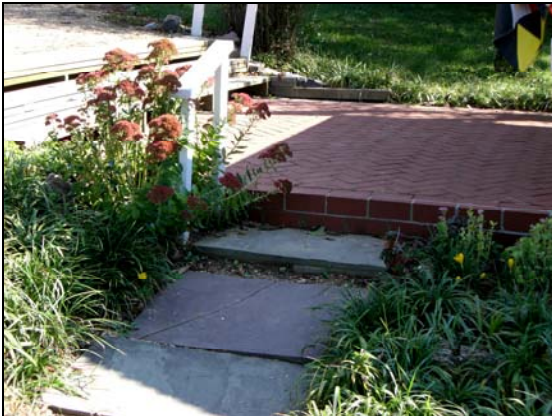
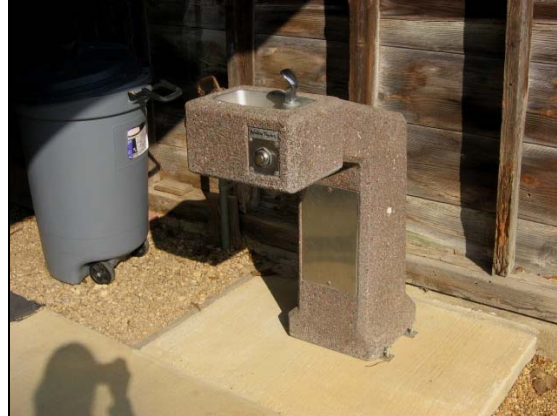
Figure 74. Bench (Photos by author).

Figure 75. Picnic tables.

Figure 76. Handrails.

Figure 77. Trash can and water fountain.

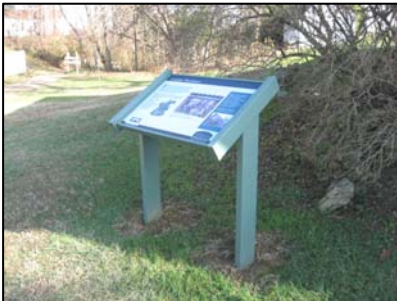
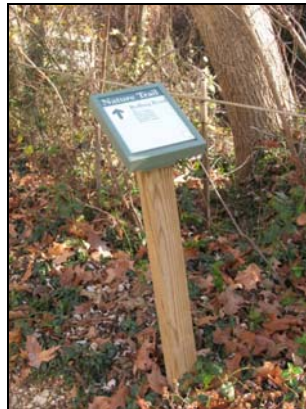
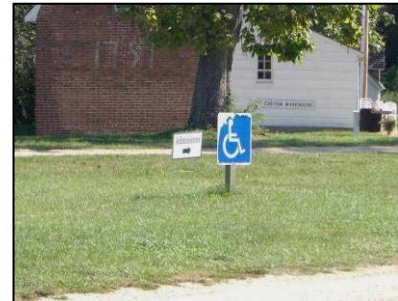
Figures 83-85. Examples of signage throughout Sotterley (Photos by author).

When assessing barriers in visitor services, one of the first priorities is signage. There are less than ten interpretive panels throughout the site and only several signs directing visitors to the restrooms, gift shop, and slave cabin. Signs should show universal symbols for access and should be standardized with a non-glare finish and a dark background and white font or white background and dark font. They should be placed in a location that can be easily viewed by all visitors and should be maintained (painted or replaced) regularly.
