Title of Thesis: PERFORMANCE OF REPAIRED  
REINFORCED CONCRETE COLUMNS  
UNDER AXIAL LOADING

PERFORMANCE OF REPAIRED CONCRETE COLUMNS UNDER AXIAL  
LOADING

Thesis submitted to the Faculty of the Graduate School of the  
University of Maryland, College Park, in partial fulfillment  
of the requirements for the degree of  
Master of Science  
2020

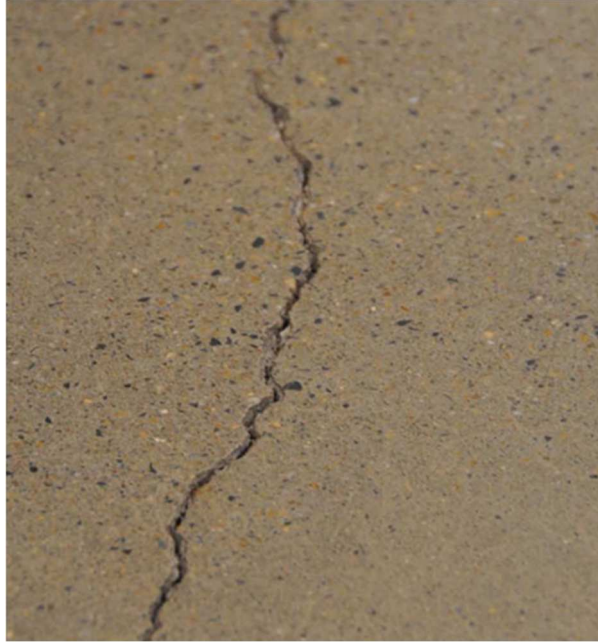
Plastic shrinkage cracks can be identified by their unique appearance related to their formation. As explained above, this process occurs when the concrete is still plastic; the rupture of the semi-hardened cement matrix causes smooth edges along the cracks. Such cracks remain shallow as the surface tension is generally not sufficient to create significant stresses in the deeper sections of the concrete; also, the crack penetration is stopped by the presence of the aggregates limiting the extension through the matrix. While plastic shrinkage cracks are commonly observed in structural slabs and are a more significant concern in such applications, they can cause issues in column/beam repair applications where the surfaces of the repaired areas are exposed to elements during curing. While gravity-fed epoxy applications are efficient in filling such cracks, a low-pressure epoxy injection may be necessary for vertical or overhead cracks (at the soffits of slabs). In many cases, such cracks do not pose a structural problem and are simply sealed to prevent corrosion.

*Figure 1-5 Plastic Shrinkage Cracking at a Slab on Grade*

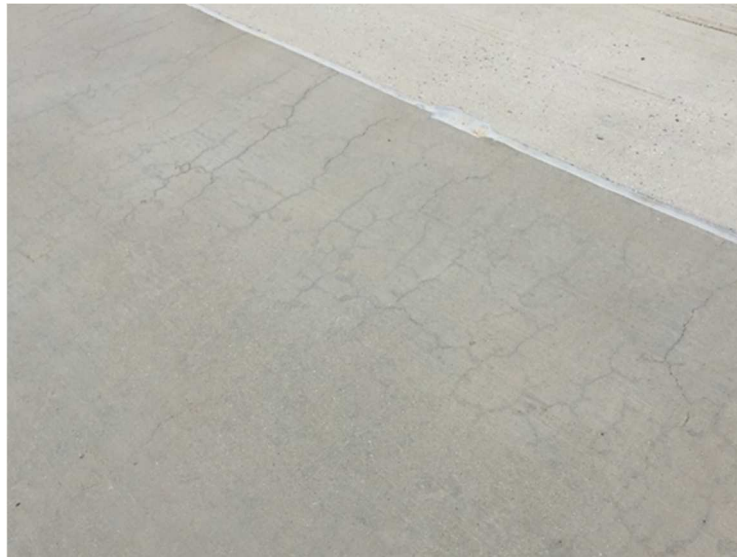
Drying shrinkage cracks often present themselves in a random or spiderweb shaped pattern in slabs and vertical wall surfaces. ACI 224.1R (2012) provides information related to the assessment, evaluation, and repair of such cracks by various methods.

*Figure 1-6-Drying Shrinkage Cracks at a Precast Double-Tee*

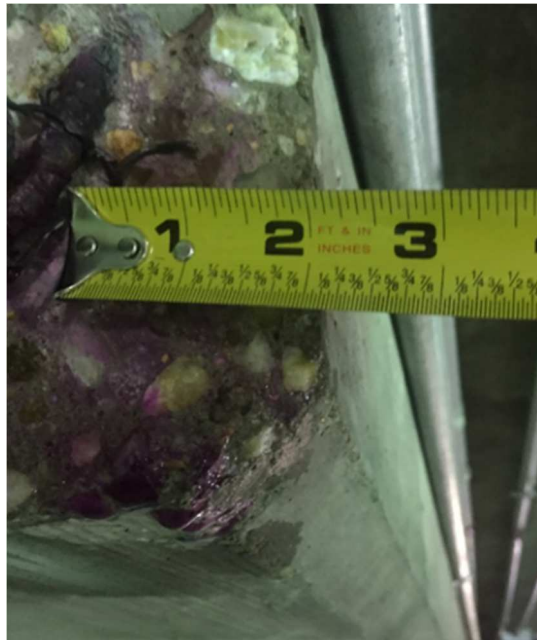
A lesser considered but as important issue carbonation of concrete. Carbonation occurs due to penetration of  $\text{CO}_2$  into concrete and formation of carbonic acid, which causes corrosion of embedded reinforcement. According to the National Precast Concrete Association, 0.039 inches of carbonation per year is expected (*Hanson, 2015*). Carbonation beyond this rate is considered to be a sign of low density, which would indicate concrete being susceptible to chemical attack and chloride intrusion. Also, the depth of carbonation penetration can help to determine the age of structures when if a correlation between the density and carbonation can be made for the concrete being investigated.

*Figure 1-8-Depth of Carbonation at a Beam*

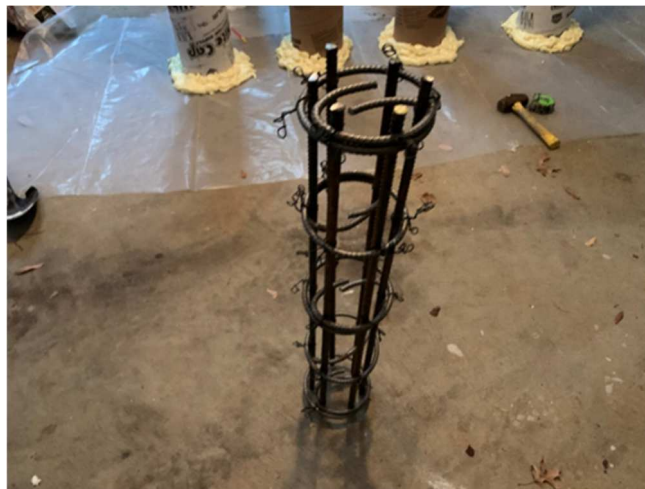
*Figure 3-1-Column Rebar Cage*

ACI 318 (2014)'s detailing guidelines followed for the column samples to avoid local buckling of the rebar; thus, (6) vertical #4 bars were placed around #3 circular column ties (with standard hooks) which were hooked to alternating vertical bars to prevent cracks from forming at the surface of the columns during the load test. A regular weight, commercially available bag mix with  $\frac{3}{4}$ " aggregate was chosen due to its low-cost and availability as opposed to a higher strength and self-consolidating mix. As seen in **Figures 3-2 and 3-3** below, partial and full depth concrete repairs were performed at the side of the column where the vertical bars were extended to the horizontal face of the columns to prevent potential issues with cracks/fissures at the which could have occurred chipping the opposite end with more concrete cover. During the demolition of the concrete, at sections of the columns where the aggregate became loose or the concrete fractured beyond the 6"x12" areas, repairs were extended to such areas to ensure that no loose concrete was left within the section of the concrete being repaired. Total repair areas are summarized in **Table 1** below.

To comply with the detailing requirements, #3 rebar ties with alternating hooks were placed at max. 8" o.c. at full height of the columns (except for the ends where the first tie was placed 3" from the ends), as shown in **Figure 1-1** below and **Figure 3-1**.

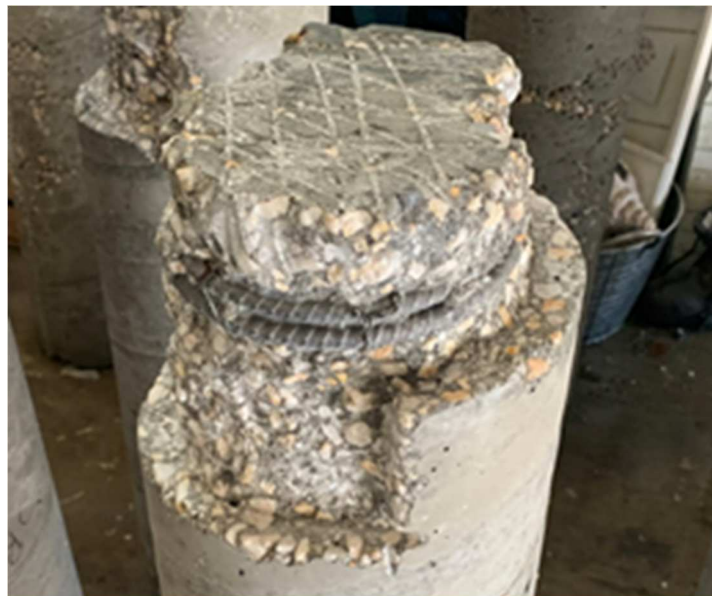
*Figure 3-2-Demolition at Sample SR3*

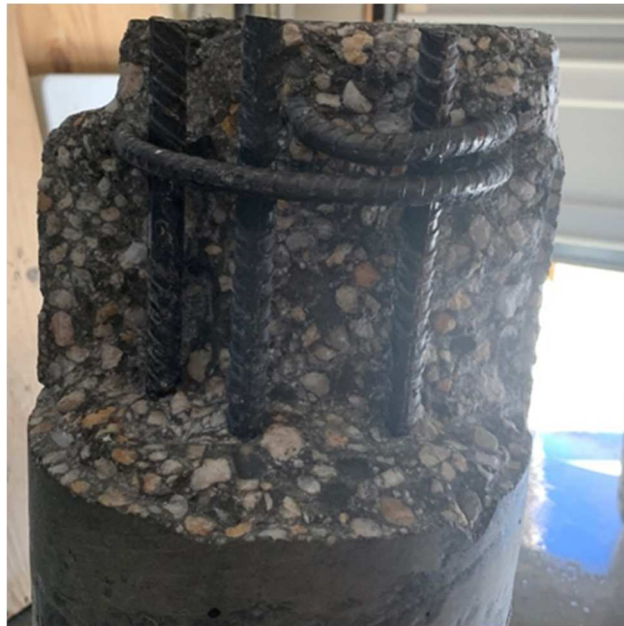
*Figure 3-3-Demolition at Sample DR2*

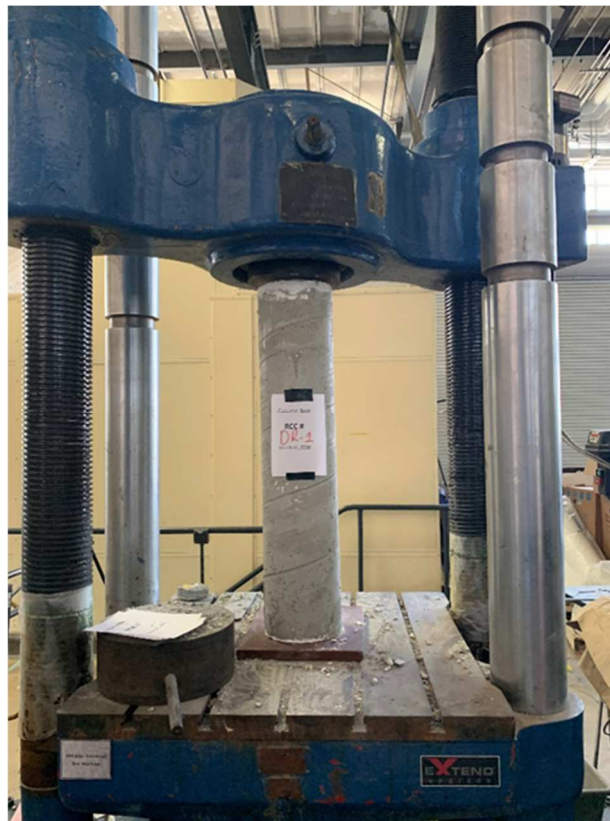
Axial load testing was performed with a 400-kip capacity universal load testing machine, as seen in **Figure 3-4** below. Since the load testing equipment was capable of inducing moment to the column, top and bottom surfaces of the column samples were flattened to prevent accidental eccentricities.

*Figure 3-4- Axial Load Testing Equipment*

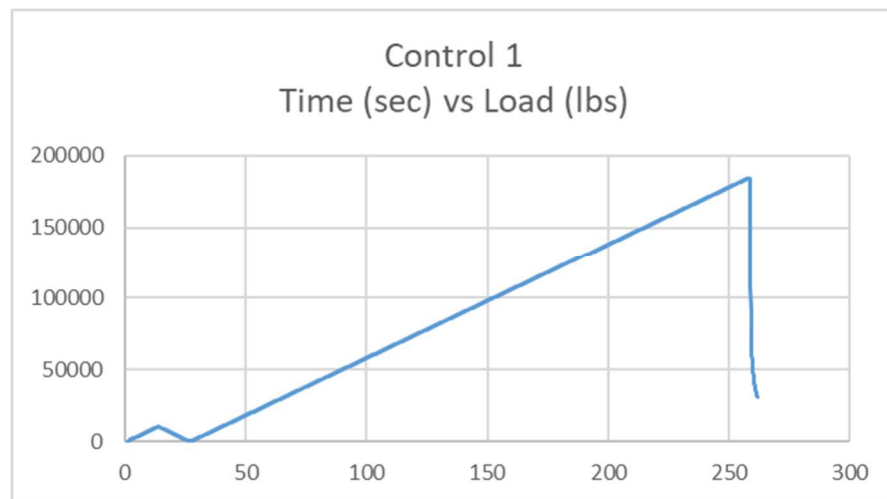
Figure 3-5-Test Results for all Columns

As seen above, all columns behaved similarly and, with the exception of SR3, obtained maximum load and deformation values were close to each other. Based on the obtained results, the following are the maximum and average load, compressive stress, deformation and modulus of elasticity:

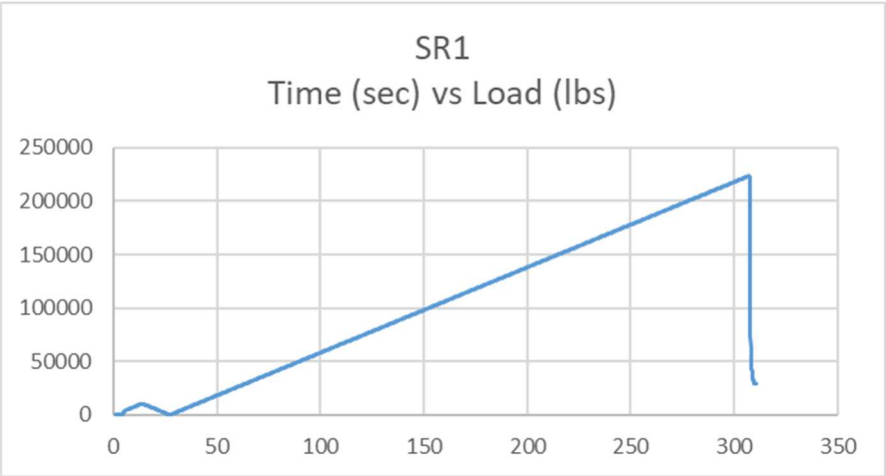
After the columns were secured to the testing machine, and it was ensured that the sample was centered to avoid eccentric loading, axial loading was applied in 2 stages. During stage 1 or “preloading stage,” columns were loaded up to 10,000 lbs and then unloaded to allow the columns to engage the entire column section. Following the preloading stage, columns were loaded to failure. The figures below contain the results of the load testing at each column:

Results of the load tests yield very close axial capacity values and are revealing. It can be seen that the capacity of the columns which underwent shallow repairs is almost identical to control columns. Also, the capacity of the columns, which underwent deep repairs, increased by approximately 3%. The increase in the capacity of the deep repairs is relatively small and discussed in the following chapter. The relationship between the compressive load, along with load vs. displacement values are as follows:

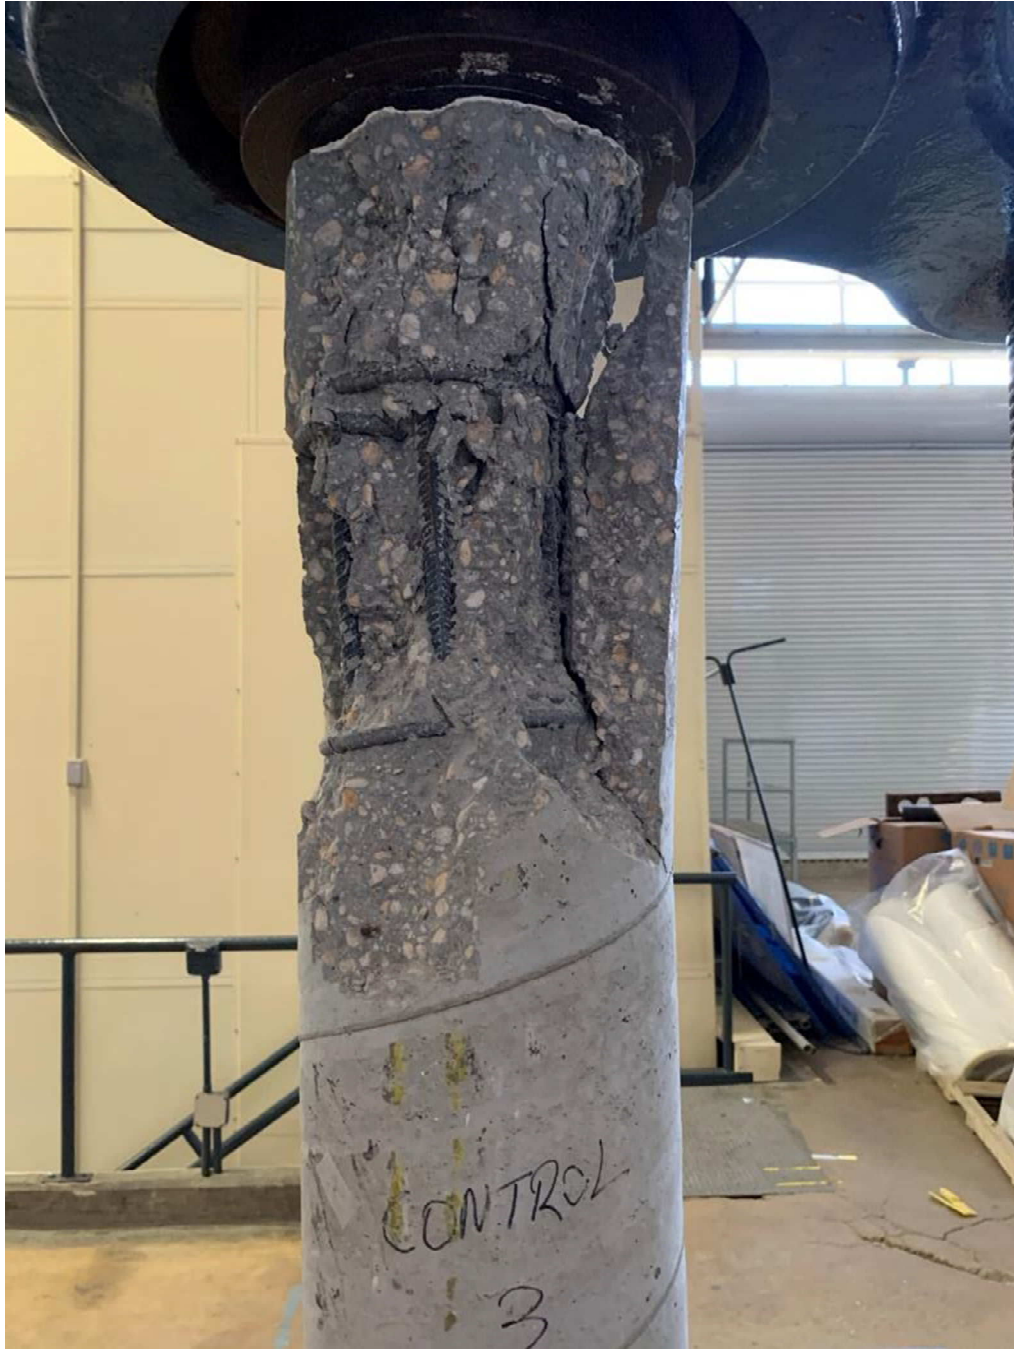
At all column samples except for sample SR3, a distinctive V-shaped compressive cone failure pattern was observed when the columns were tested. At all columns, the failure initiated at the ends of the columns where the rebar was not extended to the surface. The following are the photographs of the columns after failure:

*Figure 3-7-Control 3 after the Load Test*

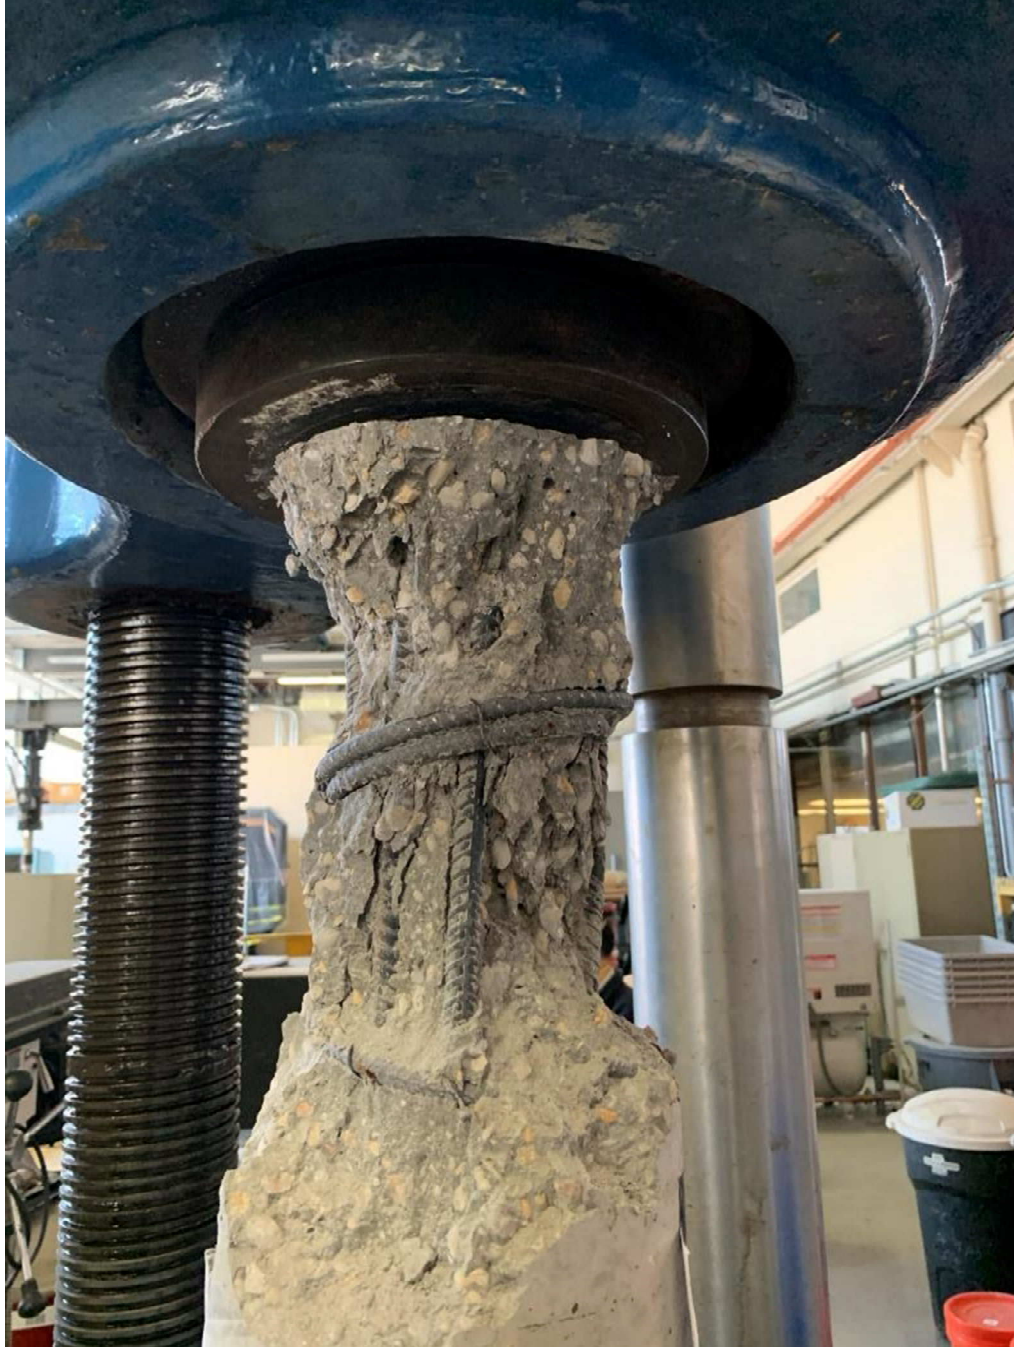
*Figure 3-8-Control 2 after Load Test*

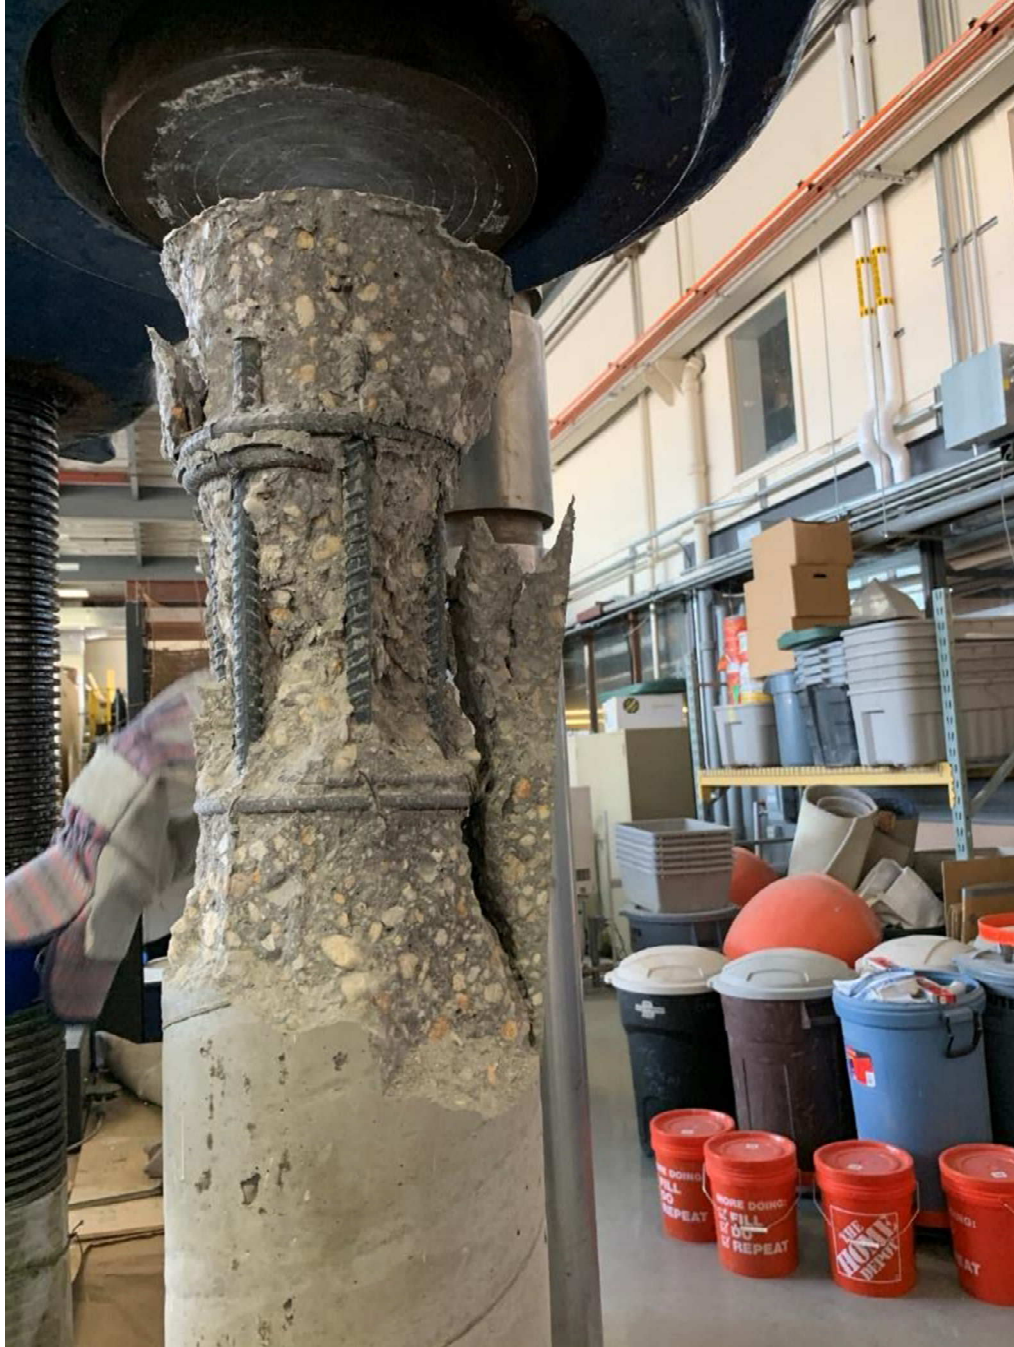
*Figure 3-9-Control 1 after the Load Test*

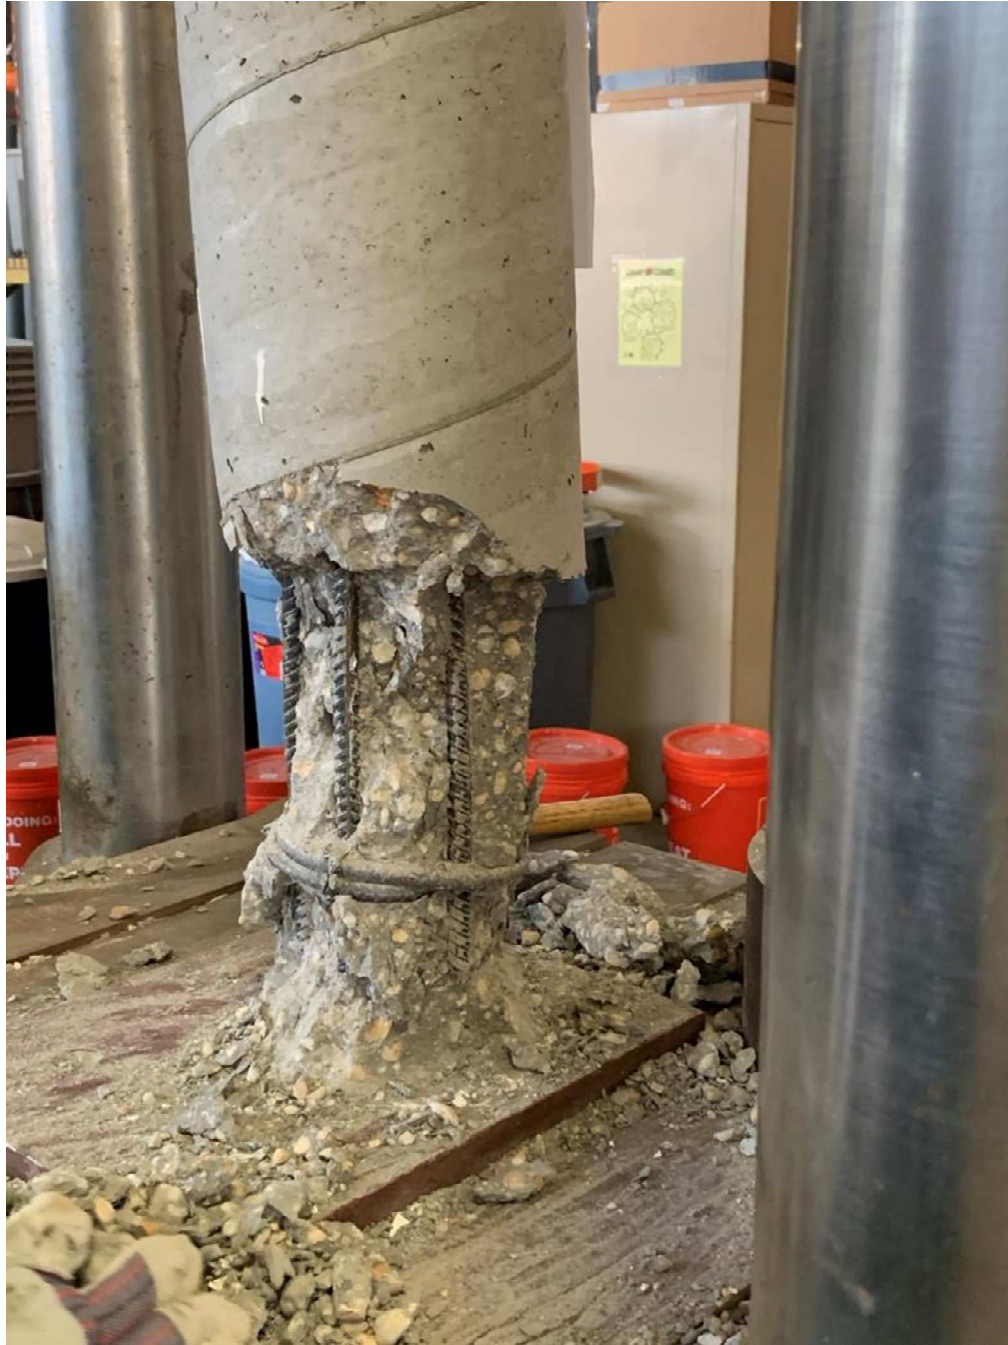
*Figure 3-10-DR3 after the Load Test*

Except for column sample DR3, none of the repaired columns exhibited any cracks or debonding. In the case of sample DR3, cracking and spalling was noted was observed around the patch which started to propagate through the unrepaired section of the column as seen in **Figure 3-16** below:

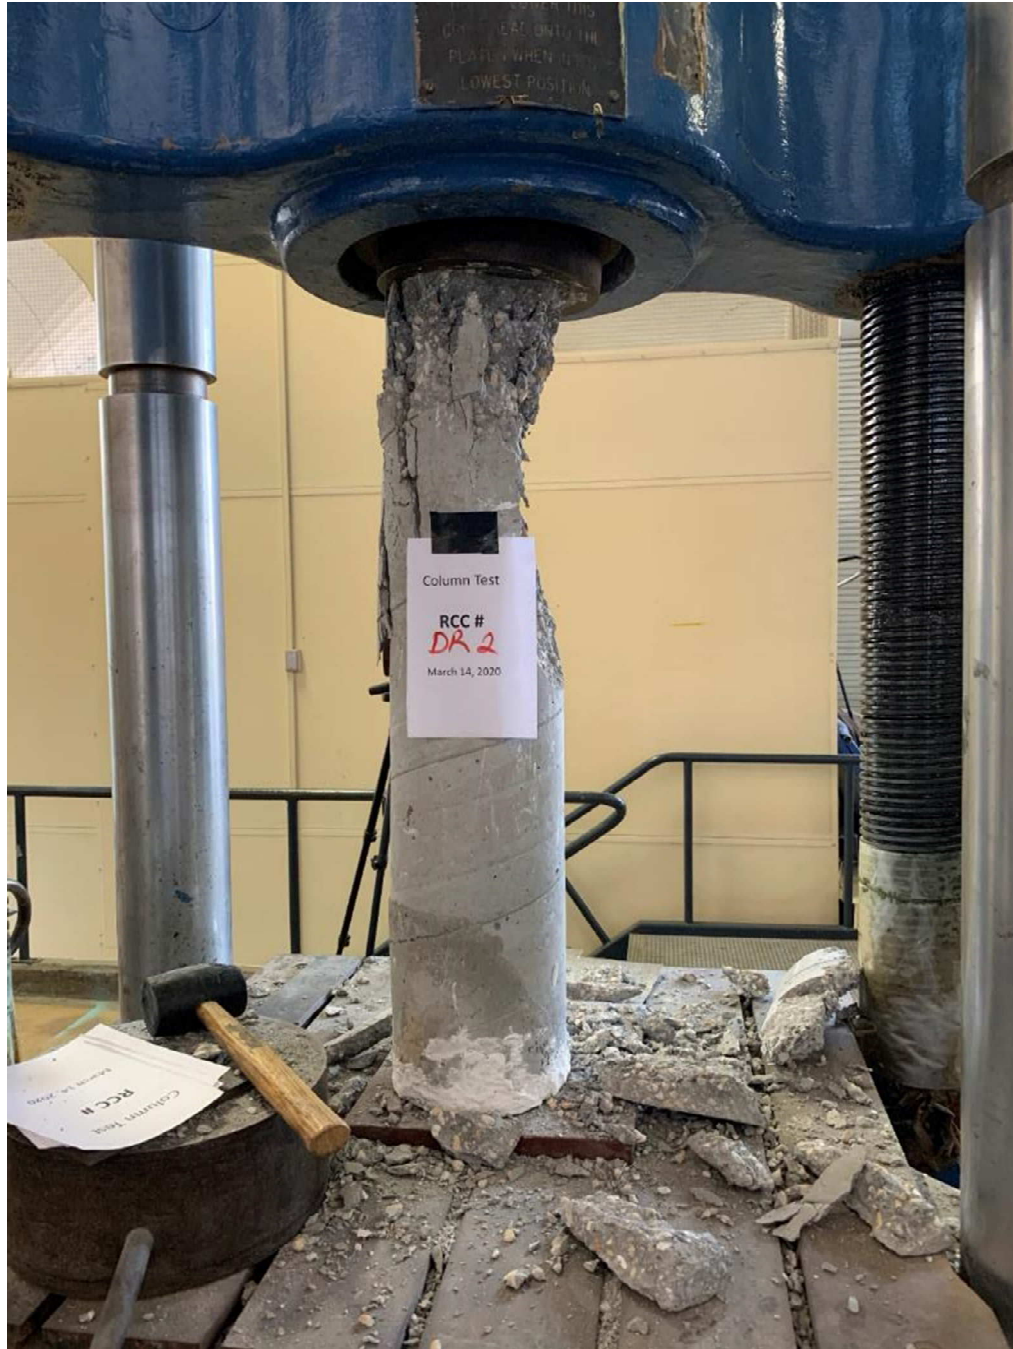
*Figure 3-11-DR2 after the Load Test*

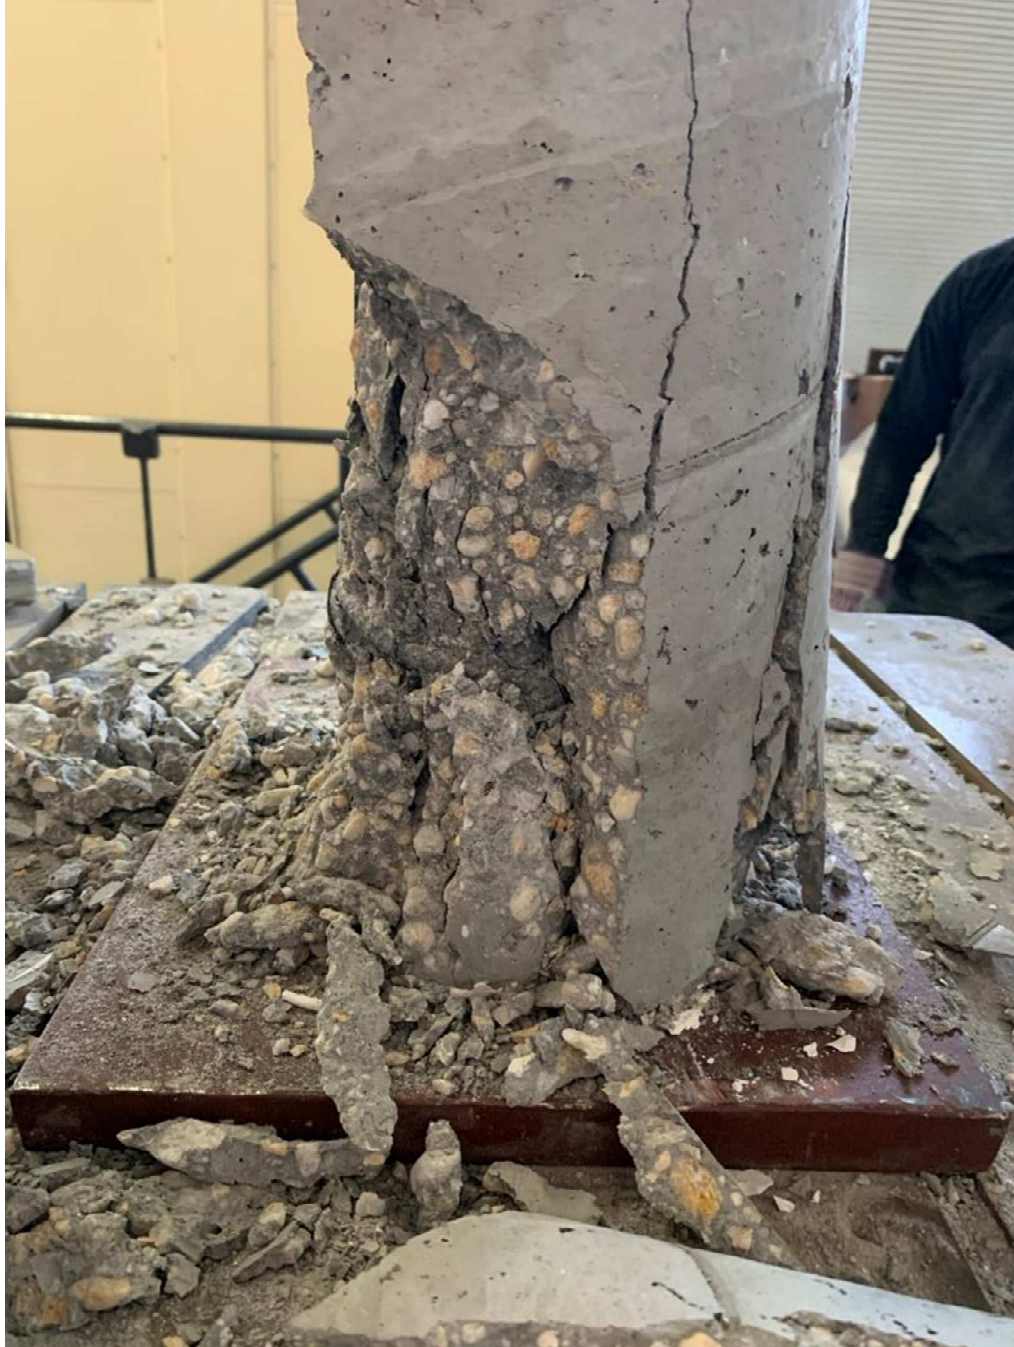
*Figure 3-12-DR1 after the Load Test*

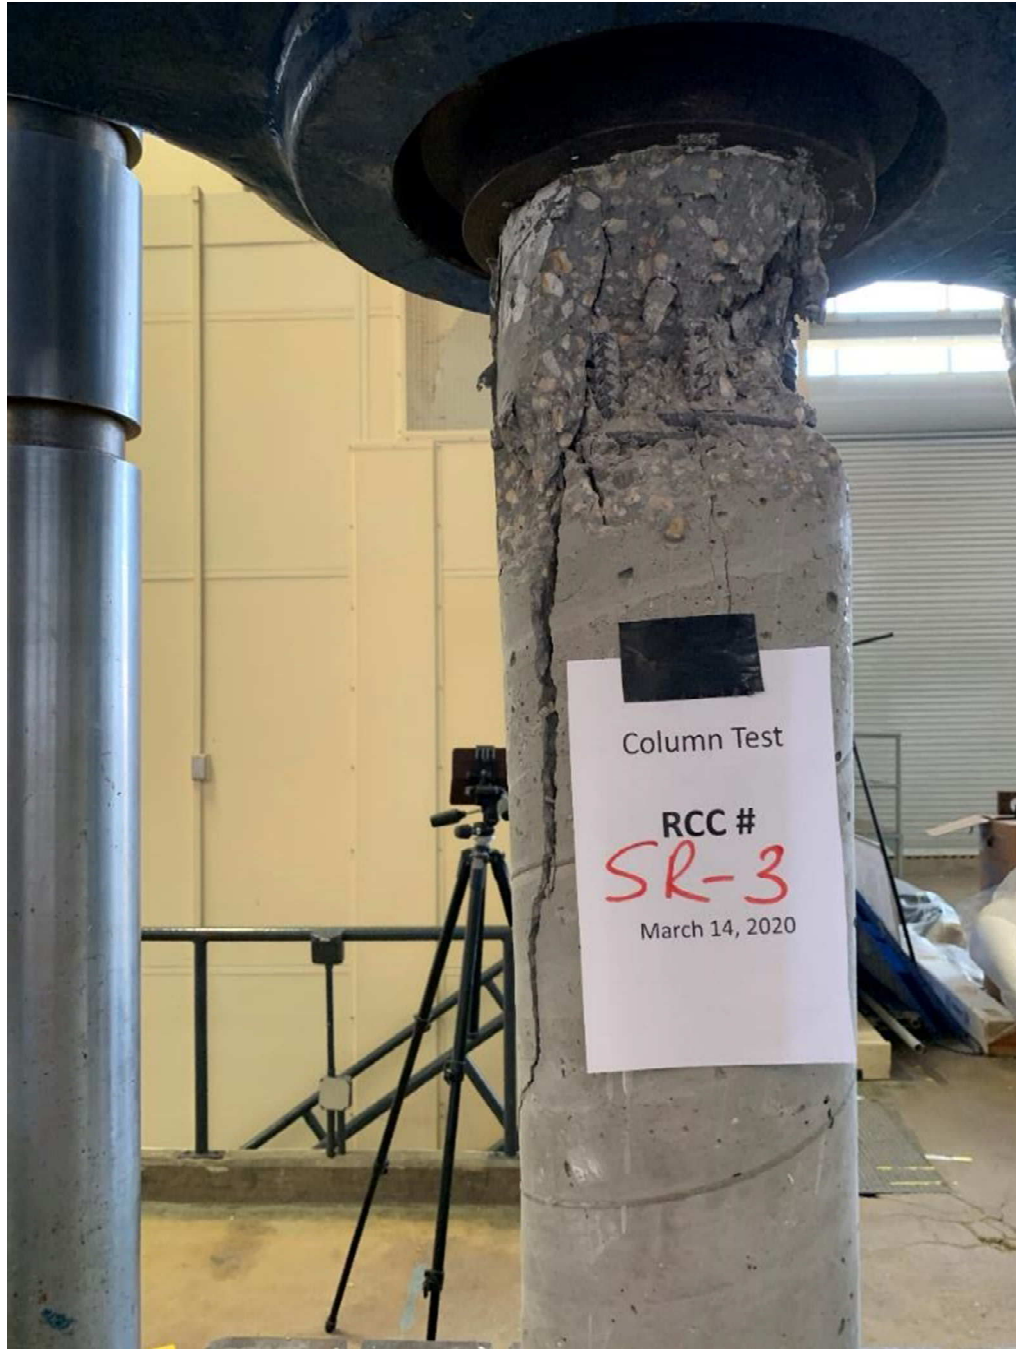
*Figure 3-13-SR3 after the Load Test*

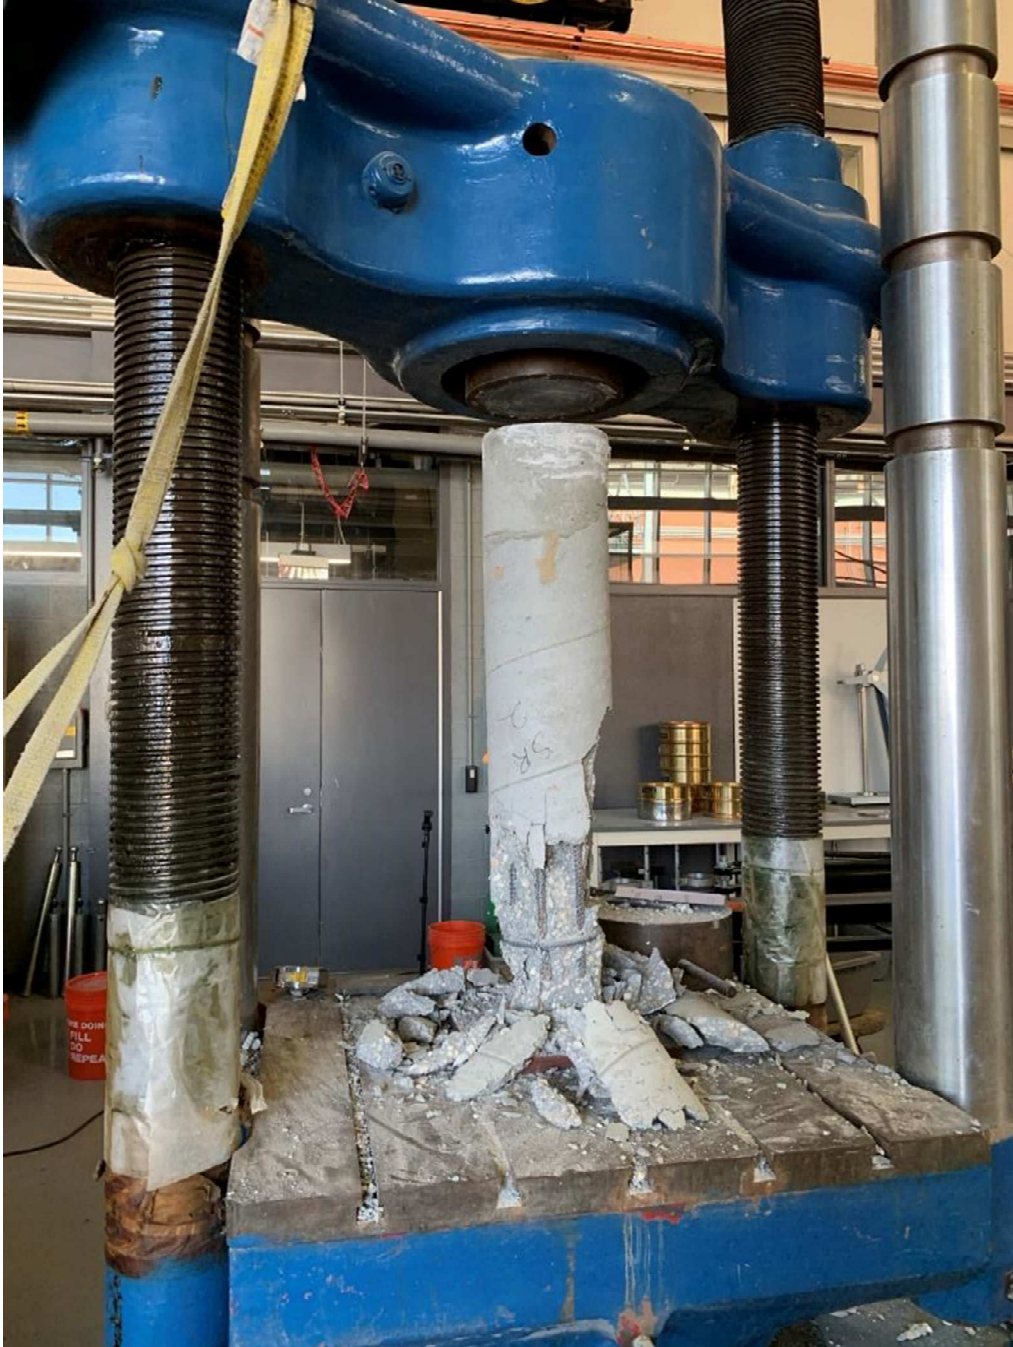
*Figure 3-14-SR2 after the Load Test*

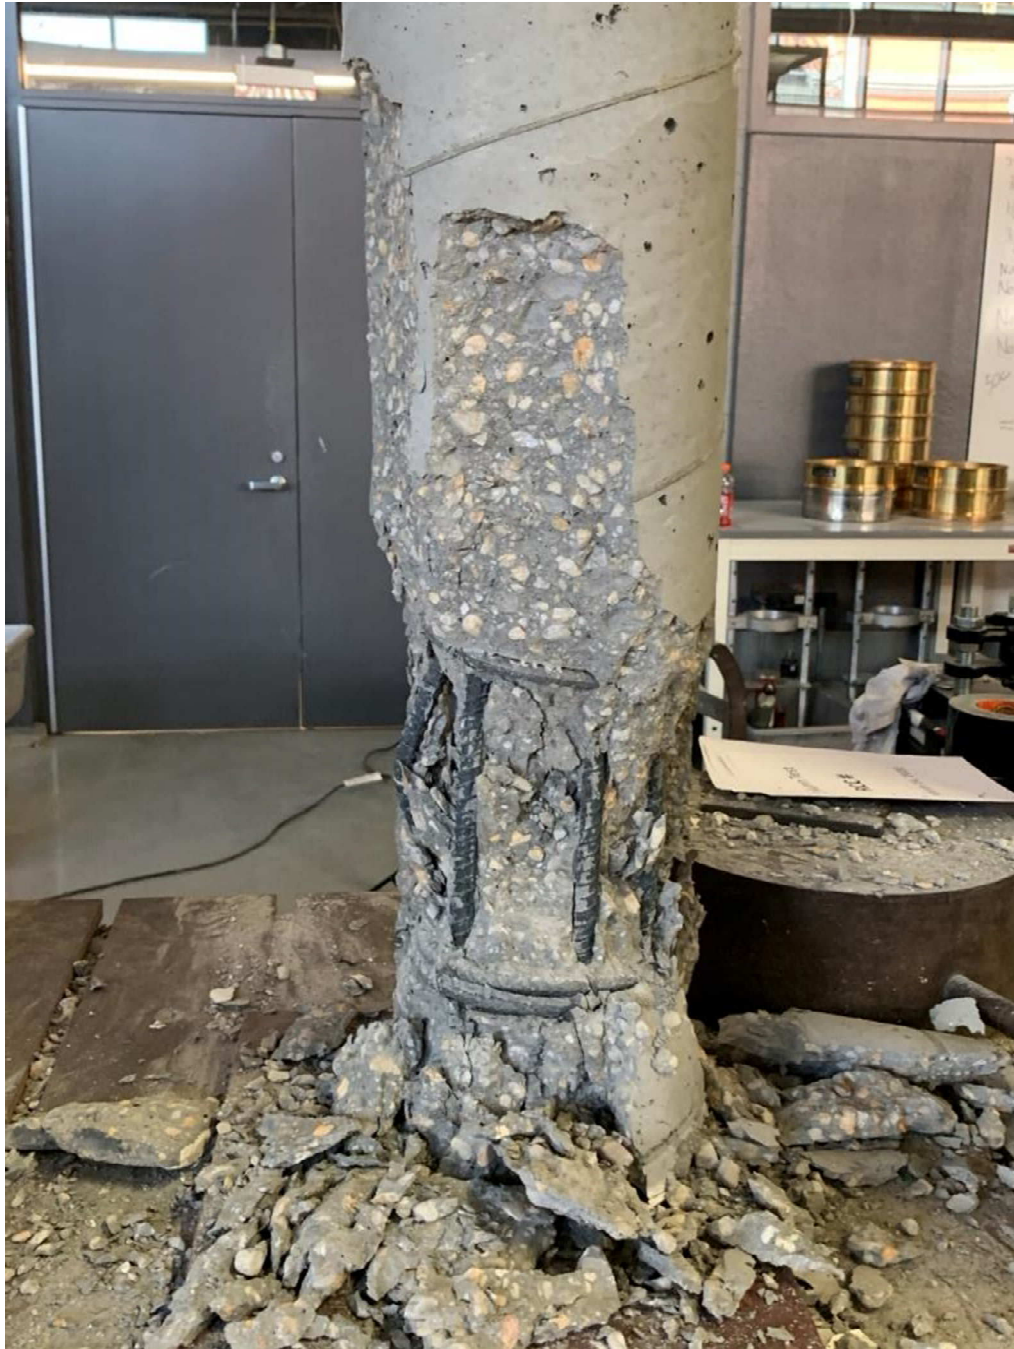
*Figure 3-15-SR1 after the Load Test*

The highest capacity was obtained from sample SR1 with 223.44 kips, where the vertical rebars started to buckle due to bearing over the concrete section at failure. No other issues related to vertical rebar or column ties were noted at the remainder of the samples. Lowest capacity was obtained from sample SR3, where the most partial depth repairs were performed. In terms of total repair volume, most repairs were performed at column DR1, which exhibited the second highest compressive capacity with 205.7 kips.

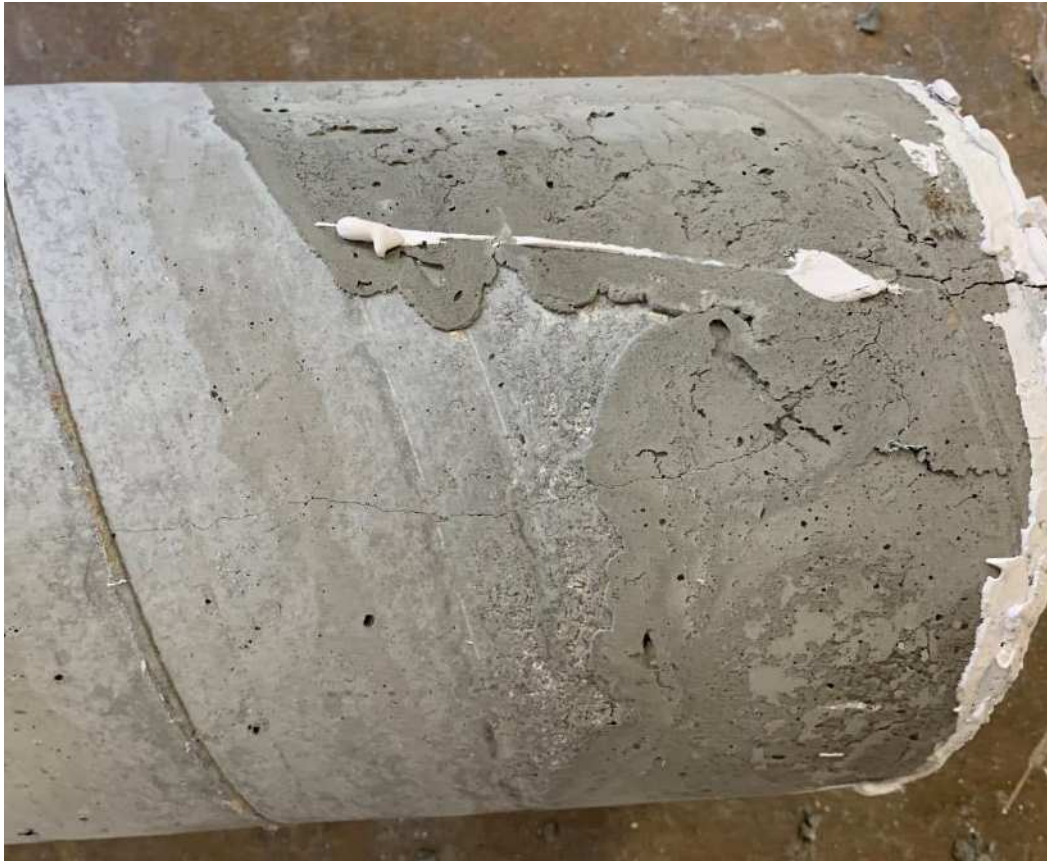
*Figure 3-16-Sample DR3 with cracks at the Unrepaired Side*
