Geomorphology of the Maryland Lower Piedmont

SITE ANALYSIS: Geomorphology

SITE ANALYSIS: Interior Land Uses

SITE ANALYSIS: Aquatic Habitat

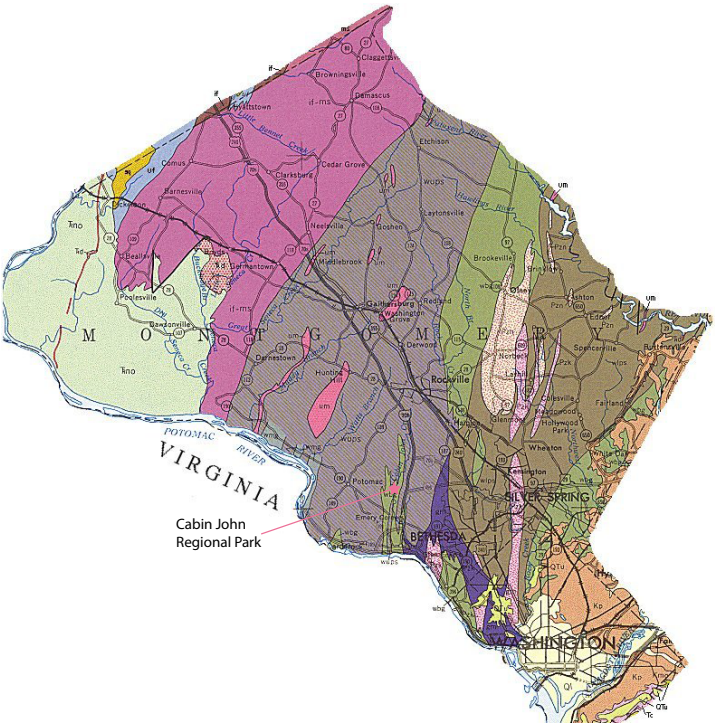
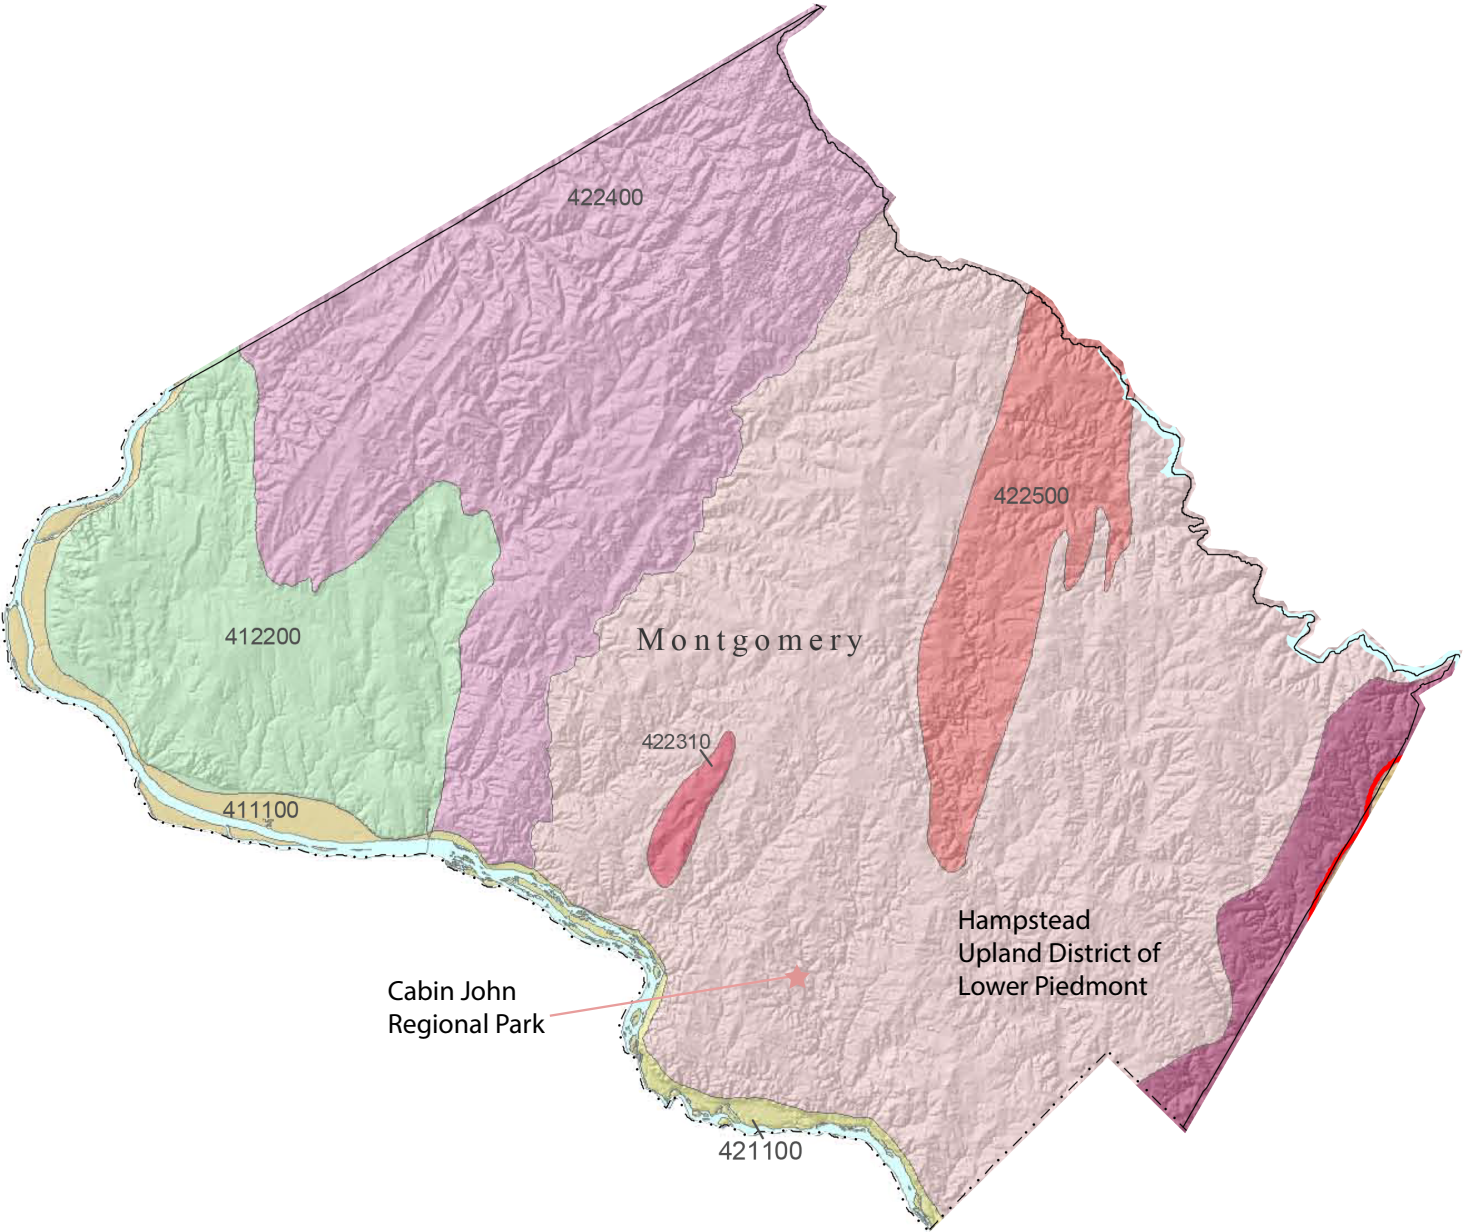
Figure 3. Geologic Map of Montgomery County (left)
Geologic map of Montgomery County based on the Maryland Geologic Survey from 1968. The gray area in the center of the county represents the Upper Pelitic Schist formation; the green area by the Cabin John Regional Park area represents Boulder Gneiss, the Paleozoic intrusive formation.

Figure 2. Physiographic Map of Montgomery County (above)
Clip of Montgomery County from Physiographic Map of Maryland produced by the Maryland Department of Natural Resources and Maryland Geological Survey. The red star shows the approximate location of Cabin John Regional Park within the Hampstead Upland District of the Piedmont Plateau.

The specific part of the Piedmont physiographic province that Cabin John Regional Park lies within is the Hampstead Upland District. This region is characterized by a combination of upland areas and steep-walled gorges. The uplands can be hilly or gently rolling and are interrupted by streams that lie within areas that have weathered differently to produce steep valleys. This type of Piedmont district is common and representative of about half of Montgomery County.

There is an area of Paleozoic igneous bedrock located near Cabin John Regional Park that may affect the topography of the area. This later intrusion was likely formed from magma underground that reached into the area and cooled slowly in place. These rocks include gabbro and serpentinite and may weather differently than the surrounding Precambrian bedrock, resulting in the upland and valley topography described above.

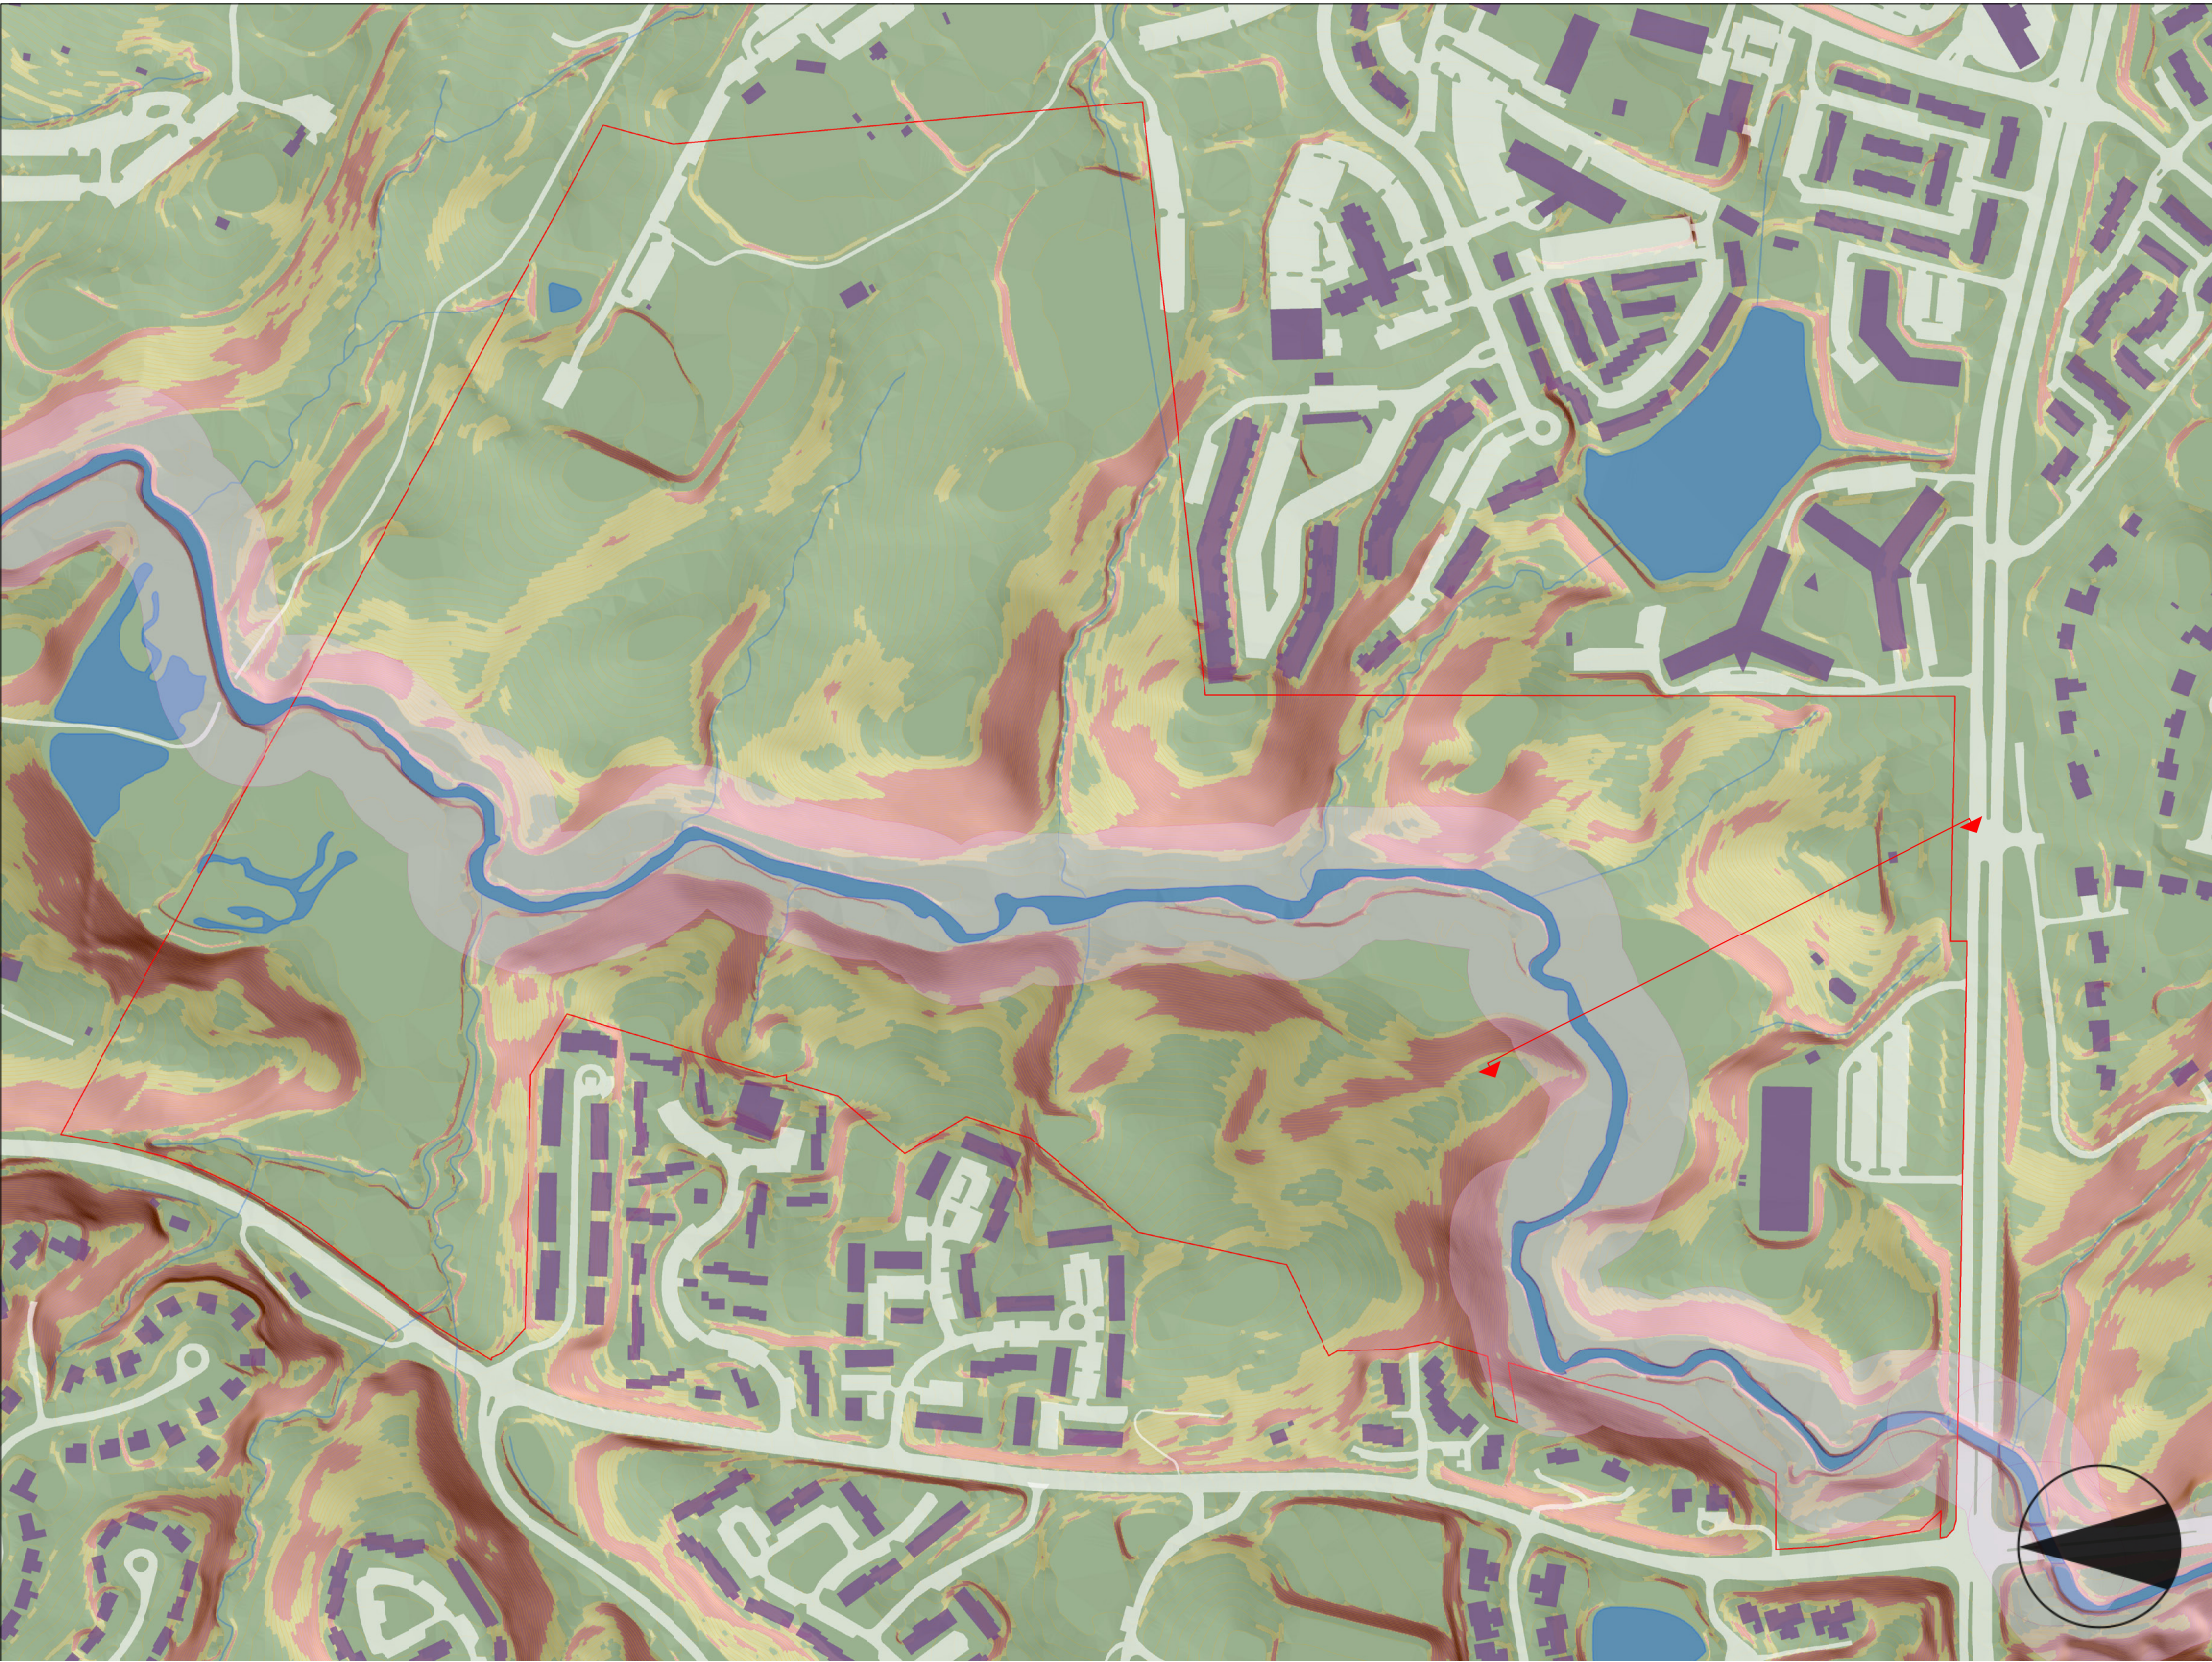
Figure 2. Slope Gradients
Sources: Montgomery County Planning Data

This portion of the Cabin John Creek runs along the bottom of a deep gorge with many steep slopes. All along the sides of the floodplain are slopes with a 25% incline or greater. As per the Montgomery County Environmental Guidelines, a 150 foot buffer must be created along both sides of the stream bed. All areas within the buffer cannot be constructed on except for bike paths and trails where they are necessary to the function of the park, and nature center.

The section cut below shows the slope profile from the frontal area, across the small plateau behind the picnic shelter and down to the floodplain. There is an 80 ft difference in altitude between the plateau and the floodplain with a majority of slopes at a 15-25% Grade.

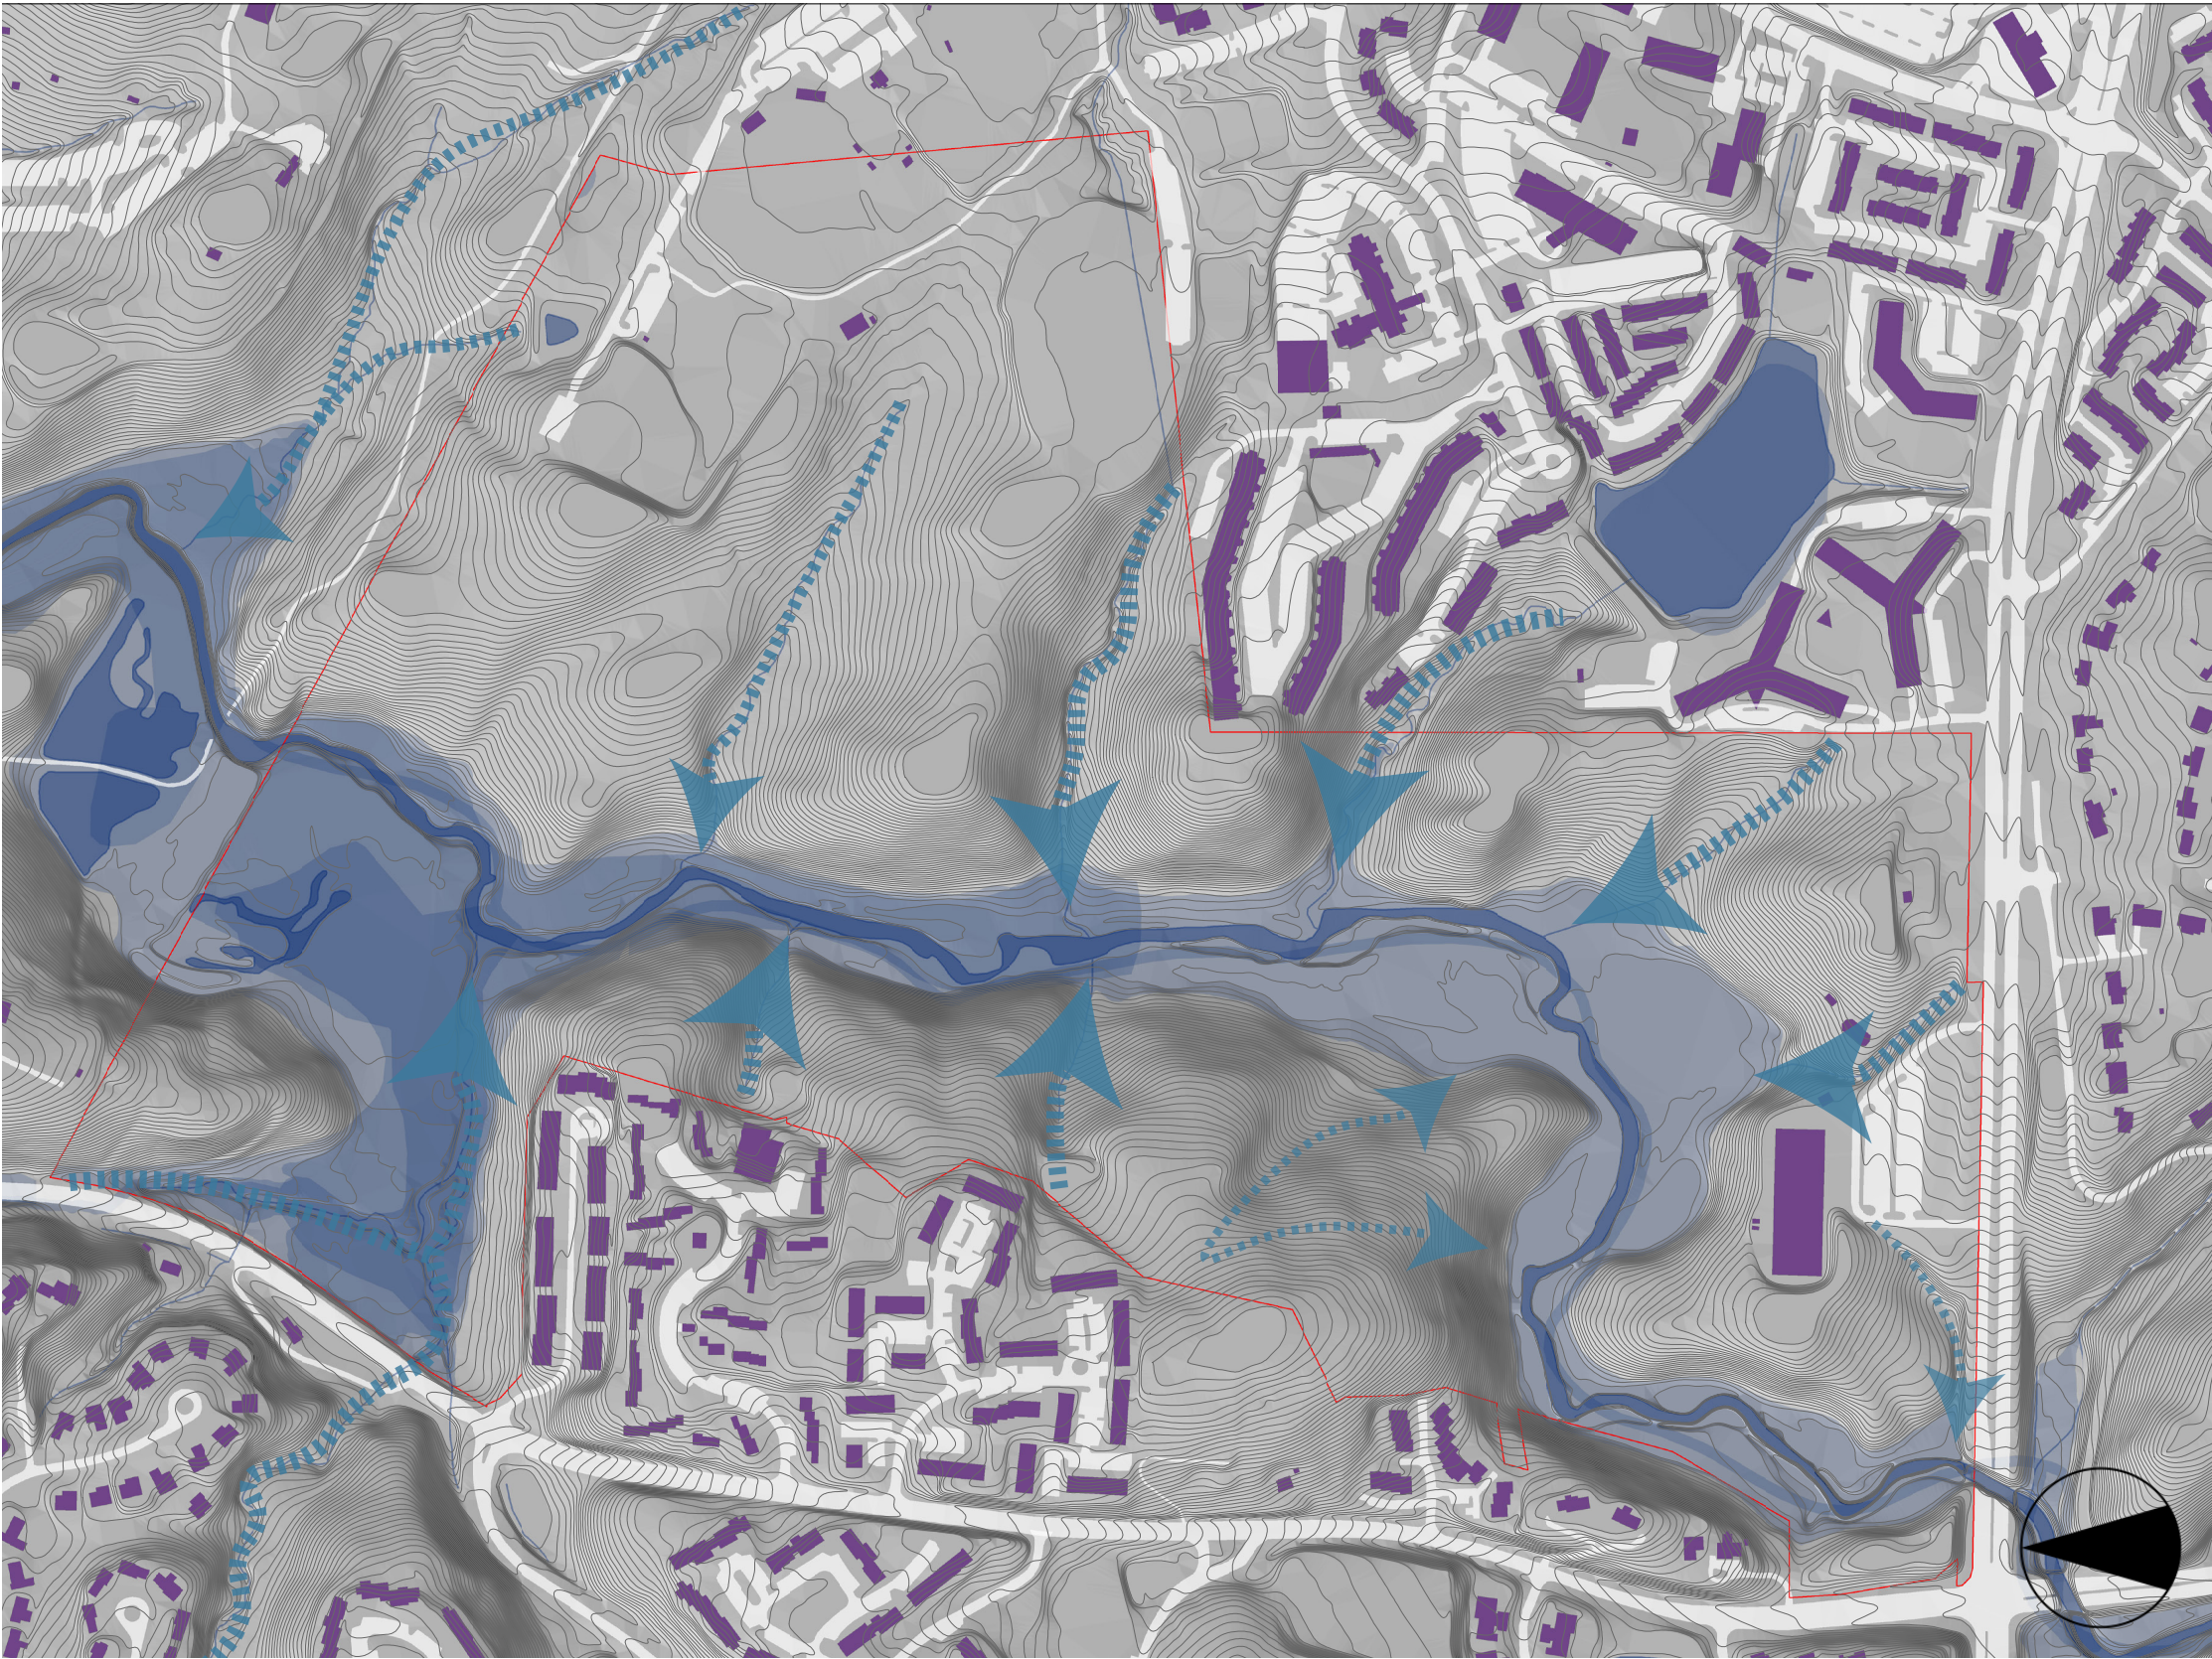
Figure 2. Site Drainage
Sources: Montgomery County Planning Data; National Wetlands Inventory

The gorge is flanked by heavy development on both sides. Large swaths of impermeable surfaces including, roads, parking, and buildings generate a large amount of stormwater runoff. As the water runs rapidly into the creek down a series of drainage ditches, it creates significant erosion, which could lead to a greater sediment load on the creek. The amount of water flowing through the drainage channels makes them excellent candidates as locations for stormwater management features, such as an RSC (Regenerative Stormwater Conveyance). These could help to slow down the water, allowing it to release sediment and other solid contaminants, as well as infiltrate into the ground before flowing into the lake. Channels draining from heavily developed areas are the best suited as they tend to carry more stormwater, as well as more contaminants.

The map shows that the best draining soil in the gorge is in the southern portion, while the northern portion is made up somewhat to poorly drained soils. This is partially caused by the presence of wetlands.

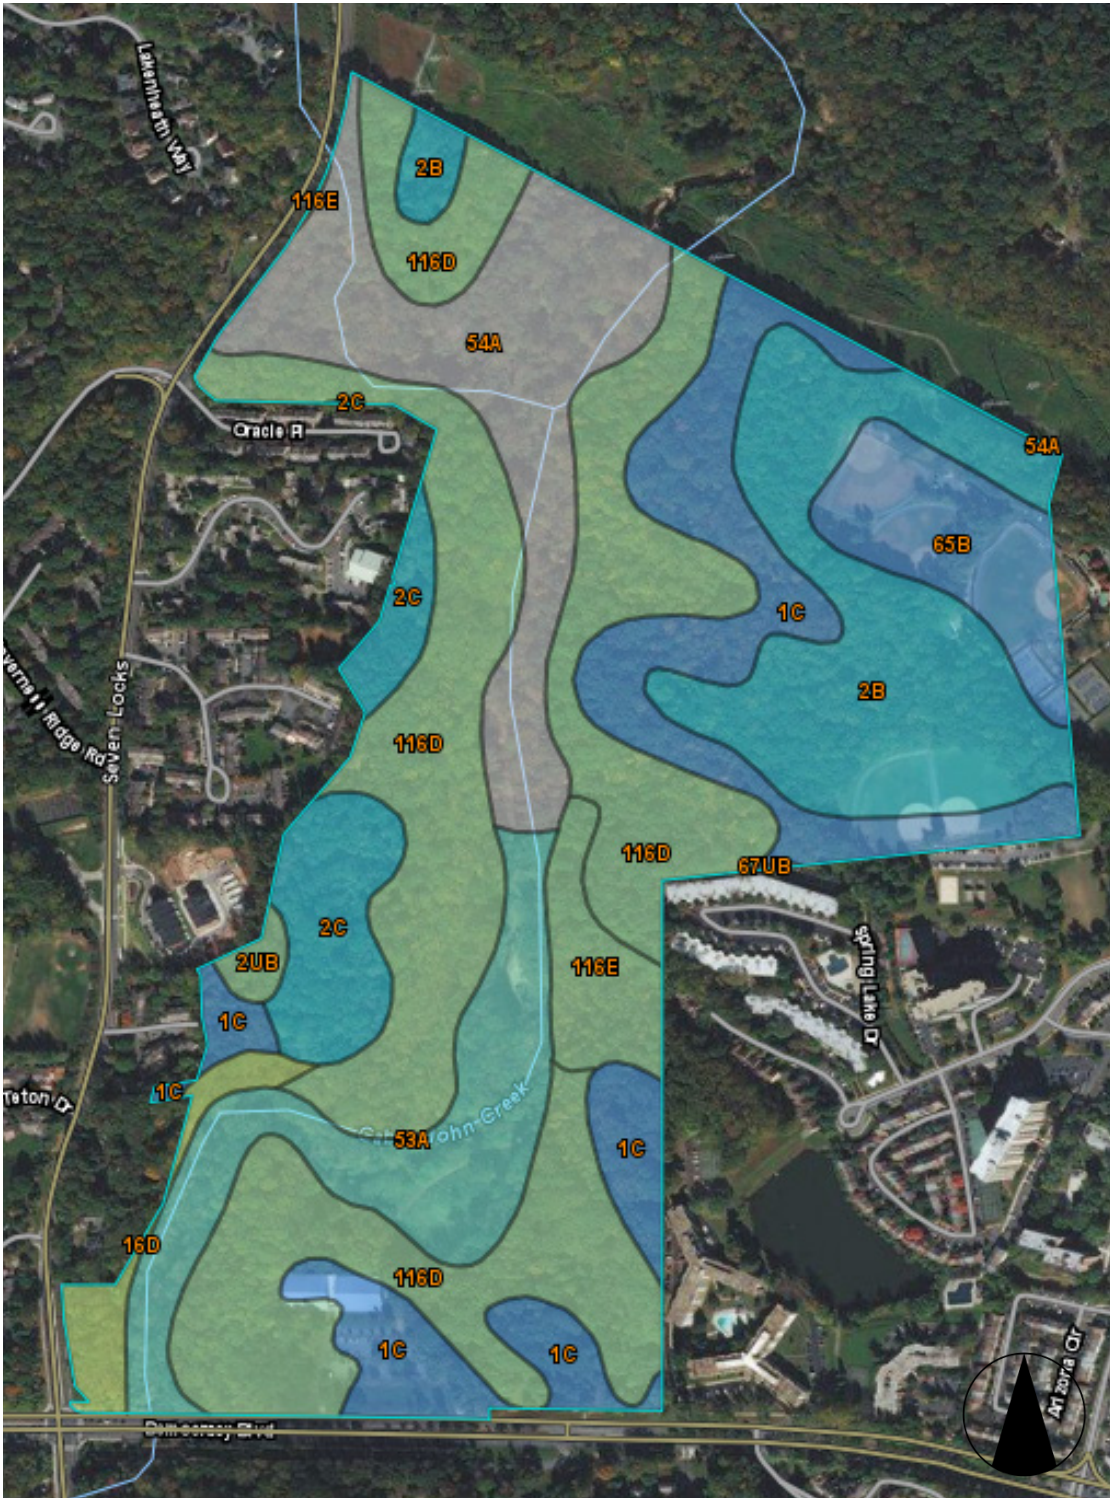
The K factor indicates the susceptibility of the soil to sheet and rill erosion. Values of K range from 0.02 to 0.69. Other factors being equal, the higher the value, the more susceptible the soil is to sheet and rill erosion by water.

Figure 3. Factor K
Sources: USDA Web Soil Survey

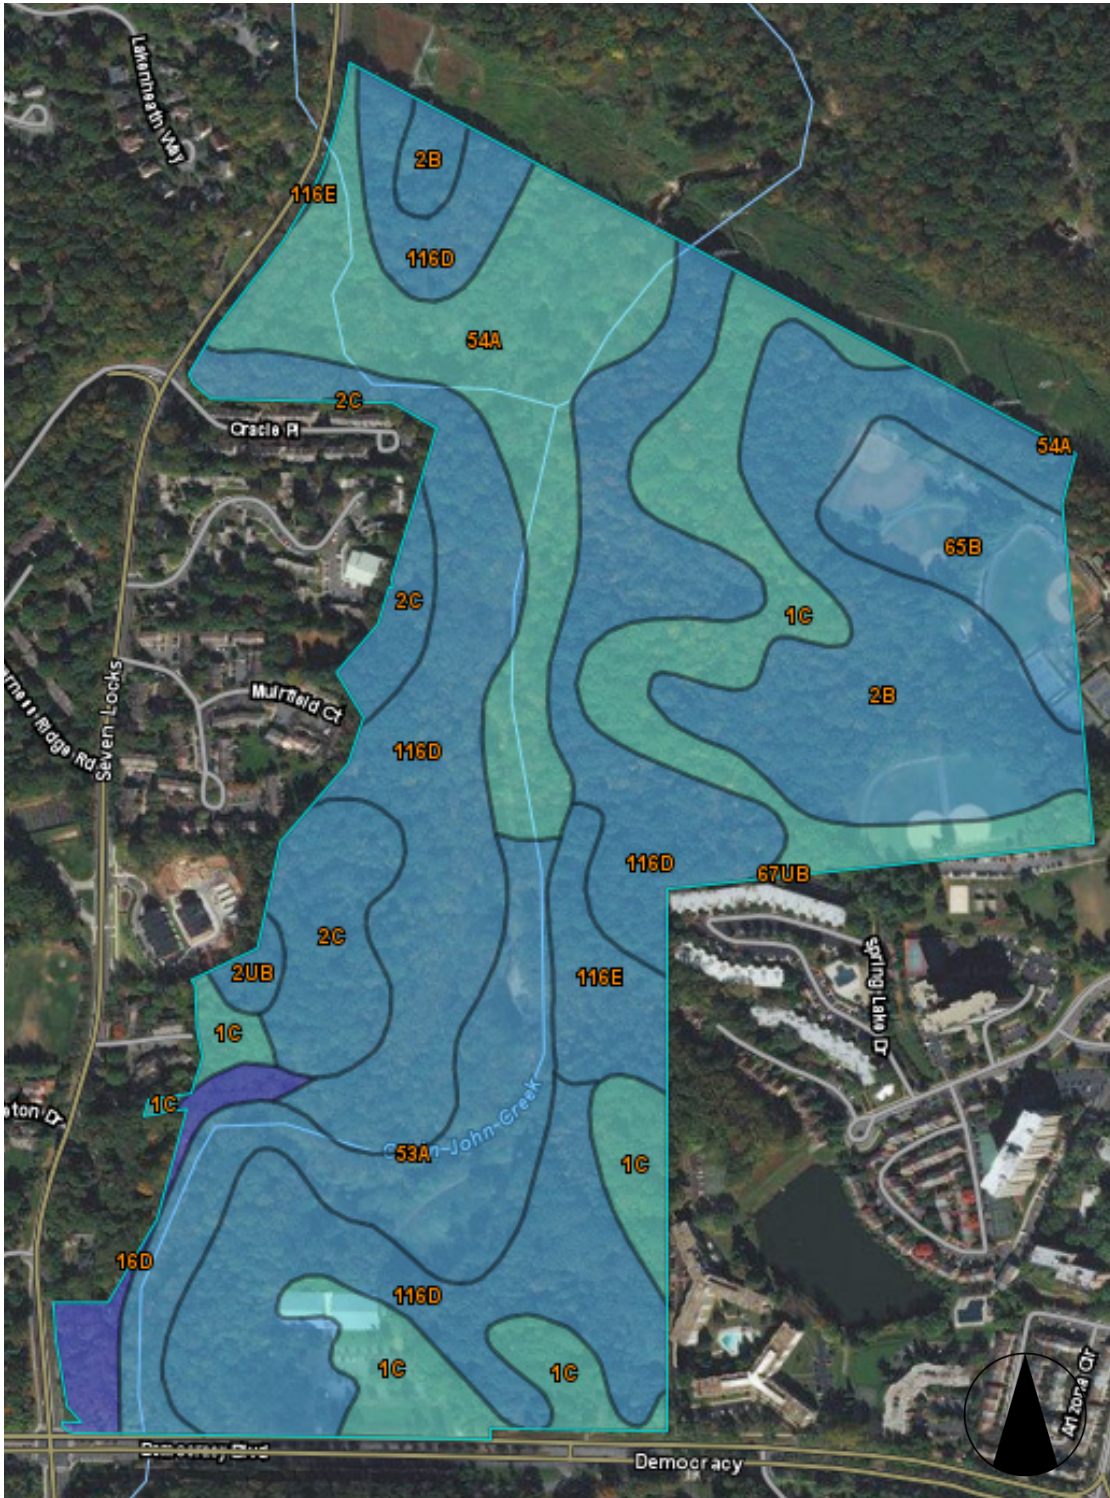
Wind erodibility groups (WEG) consists of soils that have similar properties affecting their susceptibility to wind erosion in cultivated areas. The soils assigned to group 1 are the most susceptible, and those assigned to group 8 are the least susceptible.

Figure 4. Wind Erodibility Group
Sources: USDA Web Soil Survey

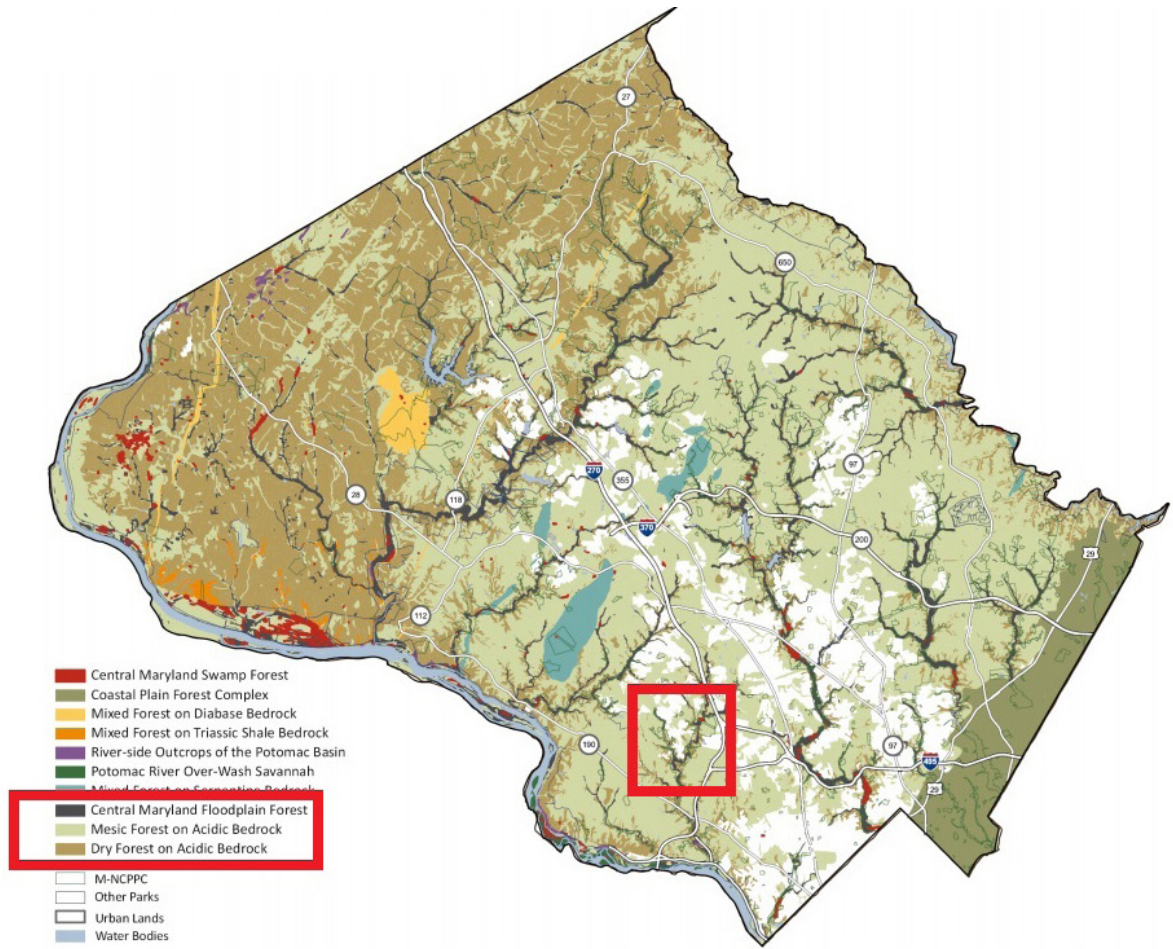
Figure 5. Major Terrestrial Natural Communities
Cabin John Creek, Montgomery County, MD

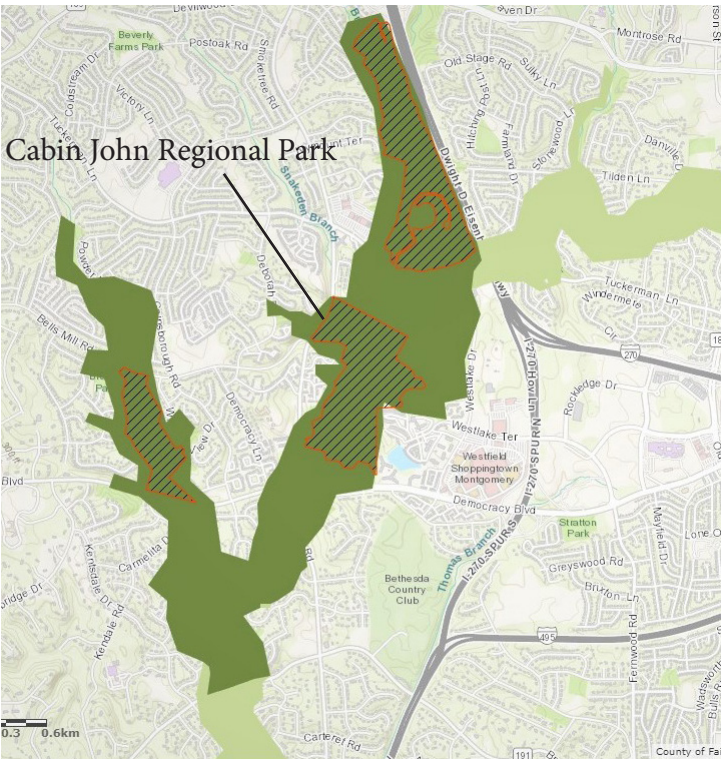
Figure 7. Maryland Green Print Program Mapping
Detail for the Cabin John Regional Park area

Maryland has carefully identified and protected areas that will contribute to the long term goals of open, continuous corridors of forest for wildlife habitat. Ecosystems that are along streambeds are some of the easiest and best to include in the corridor system because these areas are protected from development by their inclusion in the “critical habitats”. These critical habitats include streams and stream bed buffers, 100 year floodplains, steep slopes, areas of known endangered species and wetlands.

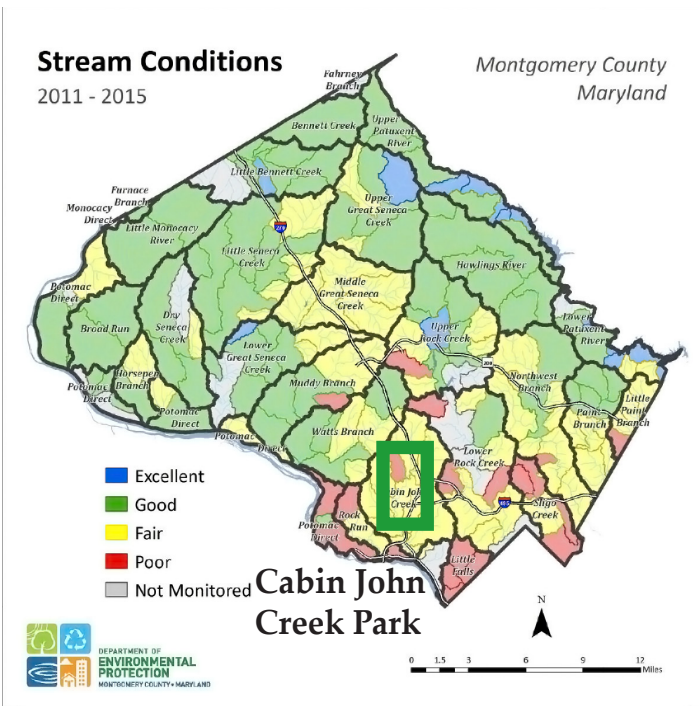
Figure 2. Montgomery County Stream Conditions

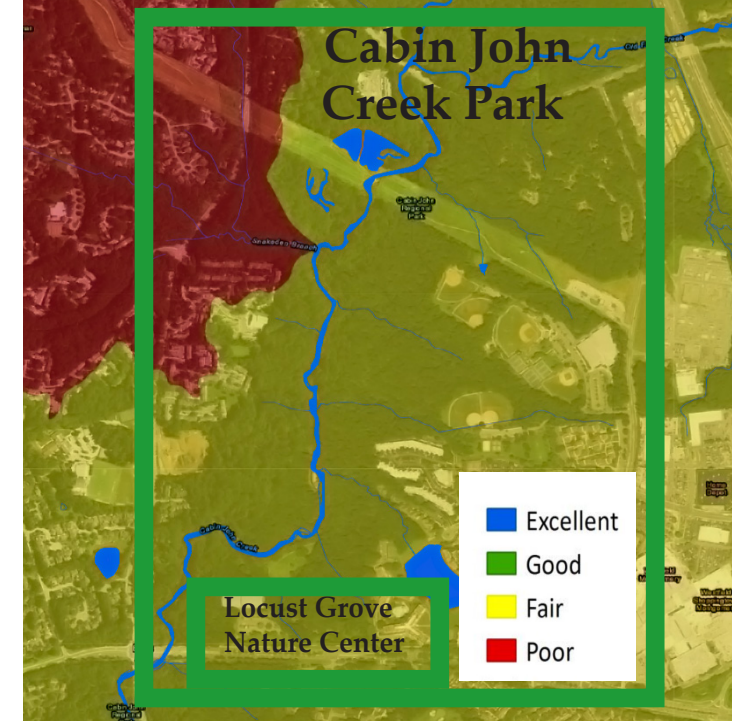
Figure 3. Cabin John Creek Park Stream Conditions

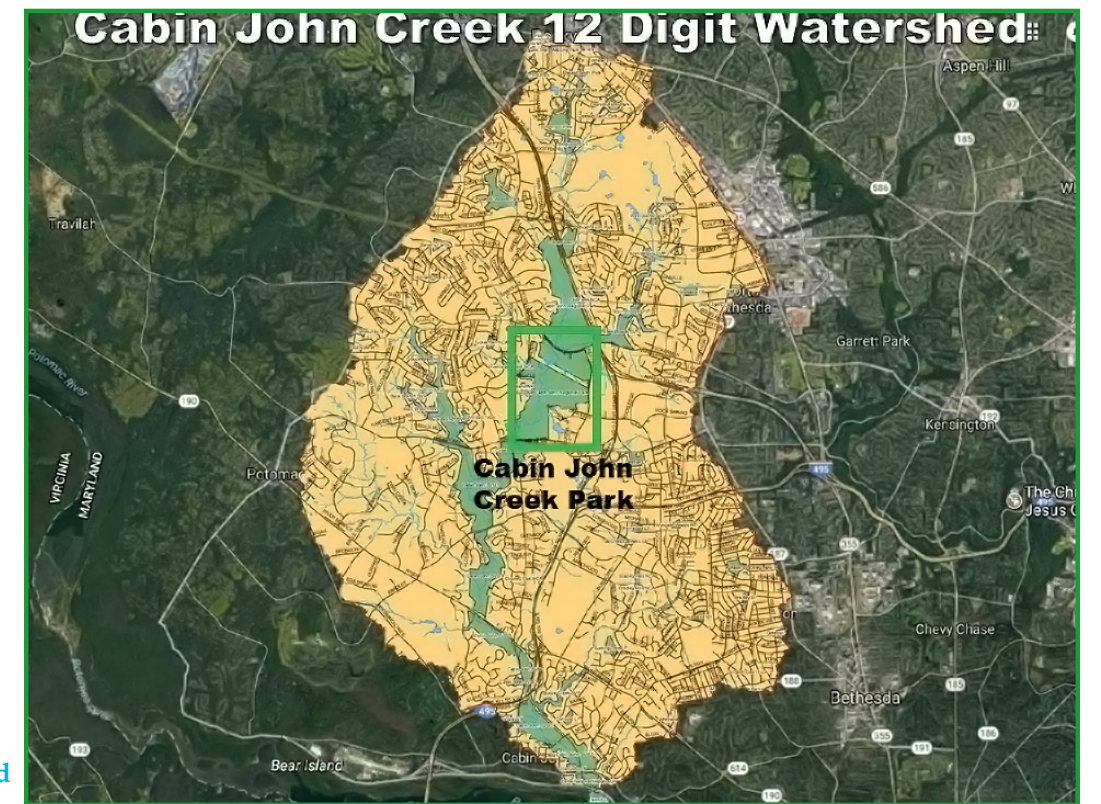
Figure 4. Cabin John 12-Digit Watershed

The Cabin John Watershed is located in an densely-developed portion of Montgomery County, Maryland, just northwest of Washington, DC. The main-stem headwaters of Cabin John Creek originate in the city of Rockville and the mouth flows into the Potomac River between the towns of Cabin John and Glen Echo.

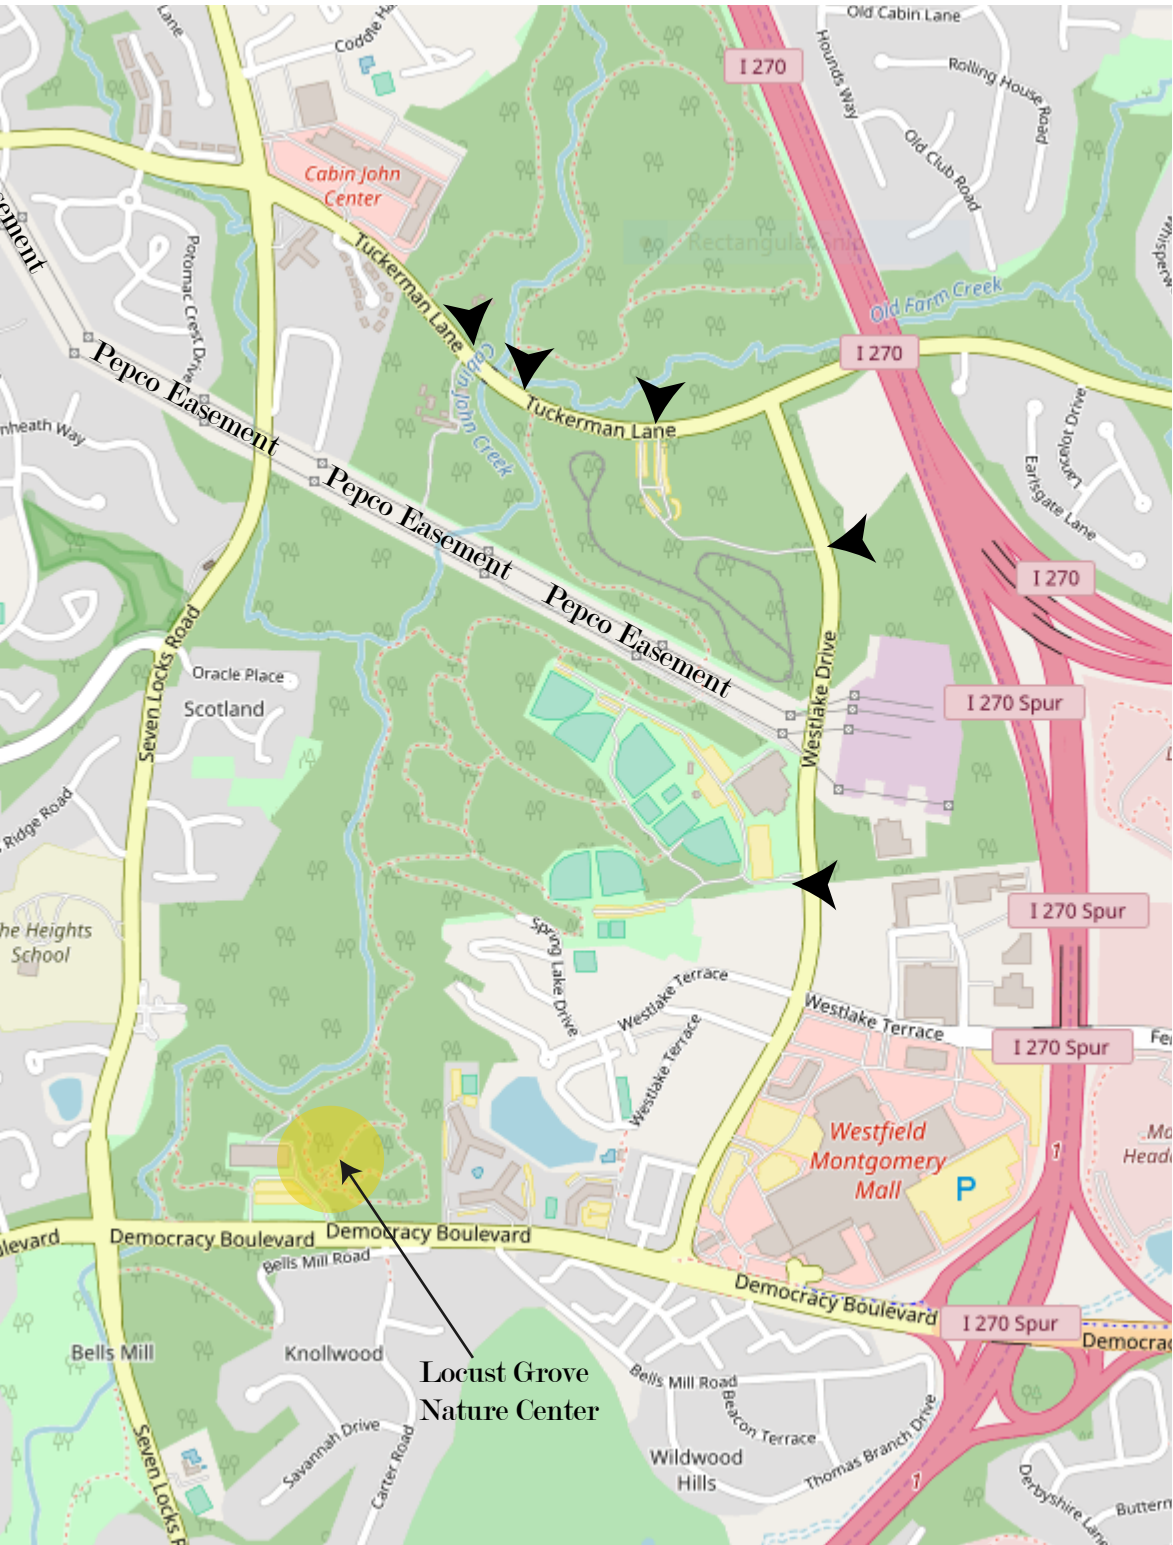
Figure 1. Major roads and access points around Cabin John
Five local streets surround Cabin John Regional Park, Democracy Blvd, Westlake Terrace, Westlake Drive, Seven Locks Road, and Tuckerman Lane. Access points from motorway I-270.

Locust Grove Nature Center is easily accessed from I-270 and several major roads. The Cabin John Creek flows along the trails of Cabin John Regional Park.

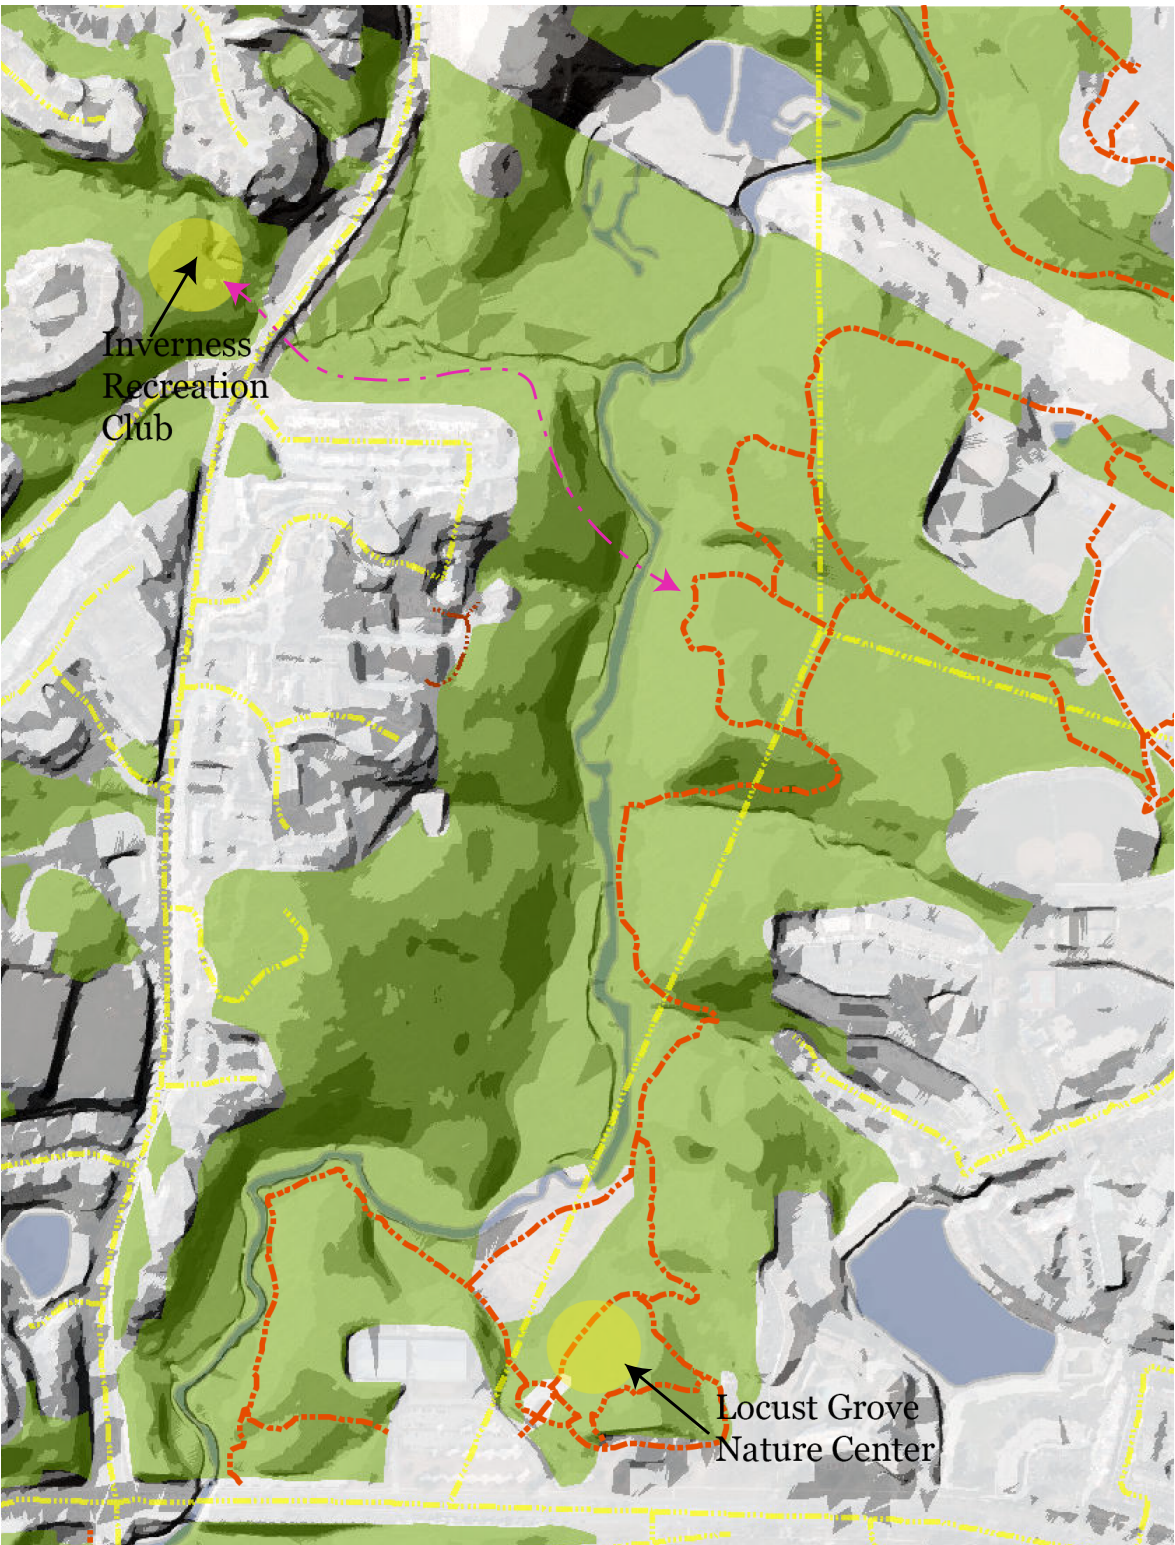
Figure 2. Existing and Proposed Trails
Bike and nature trails around the whole of Cabin John Regional Park. Also, proposed trail that extends towards the Inverness Recreation Club.

Cabin John and has 5 existing trails and pedestrian made trails close to Pepco's easement. A new nature trail can be created from the Inverness Recreation Club that would connect to the Pine Ridge existing trail. Cabin John has 5 existing parking lots connections and 1 parking lot that is shared with the Pauline Betz Addie Tennis Center.
