Geomorphology of the Maryland Lower Piedmont

SITE ANALYSIS: Geomorphology

SITE ANALYSIS: Interior Land Uses

SITE ANALYSIS: Aquatic Habitat

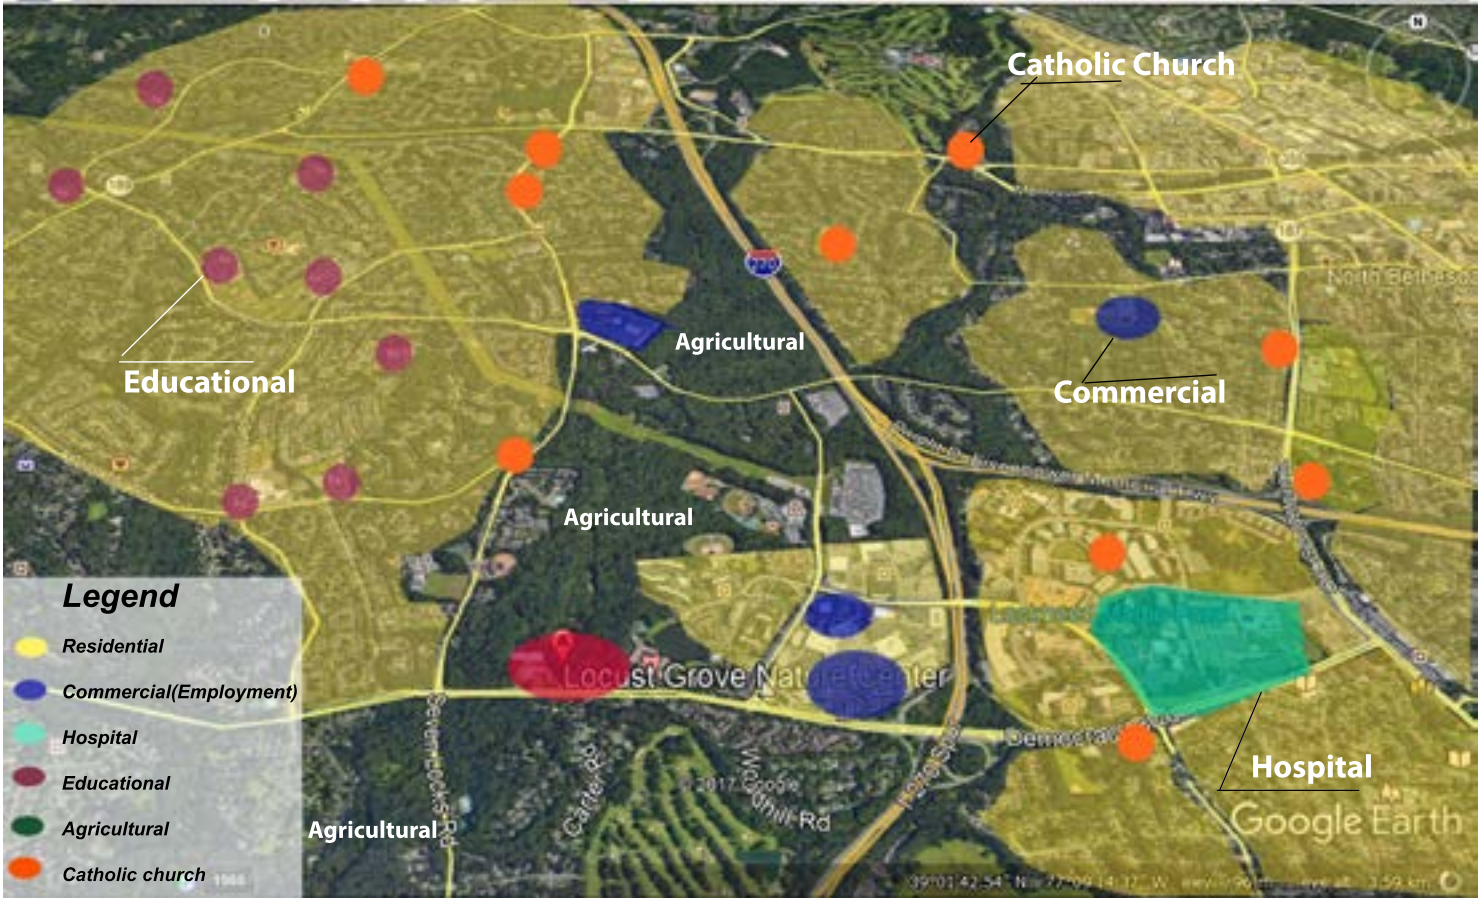
Figure1. Neighbourhood Land use

The land use around the nature center is included the Agriculture, Hospital Rural Residential, Residential detached, Residential Multi unit, educational, Commercial and Catholic church.
