Title of Document: EVALUATING THE SUSCEPTIBILITY OF ELECTRONIC COMPONENTS ASSEMBLED WITH LEADED SOLDER TO FLEXURAL FAILURES, WITH HIGH RATE CONSIDERATIONS.

Dissertation submitted to the Faculty of the Graduate School of the
University of Maryland, College Park, in partial fulfillment
of the requirements for the degree of
Doctor of Philosophy
2008

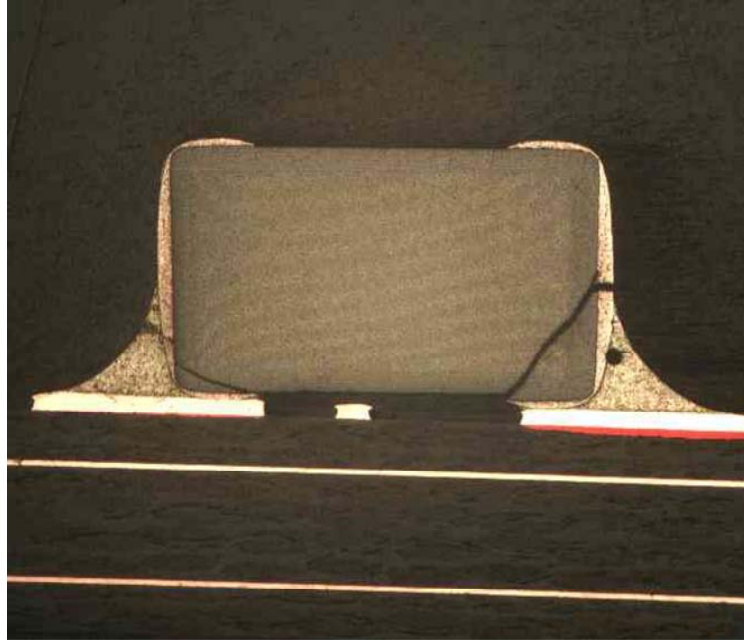
Figure 3.2: Cross section of size 1206 Kemet MLCC, illustrating flex cracking.

The behavior of MLCC devices when subjected to low to medium rate bending (PWB strain rate $< 0.1/s$) has been well documented in the literature. The failure mechanism resulting from these loading criteria has been observed to be a diagonal crack in the lower portion of the ceramic near the solder attach (see Figure

3.2). This is the only observed failure mechanism identified in the literature for MLCCs subjected to bending loads.

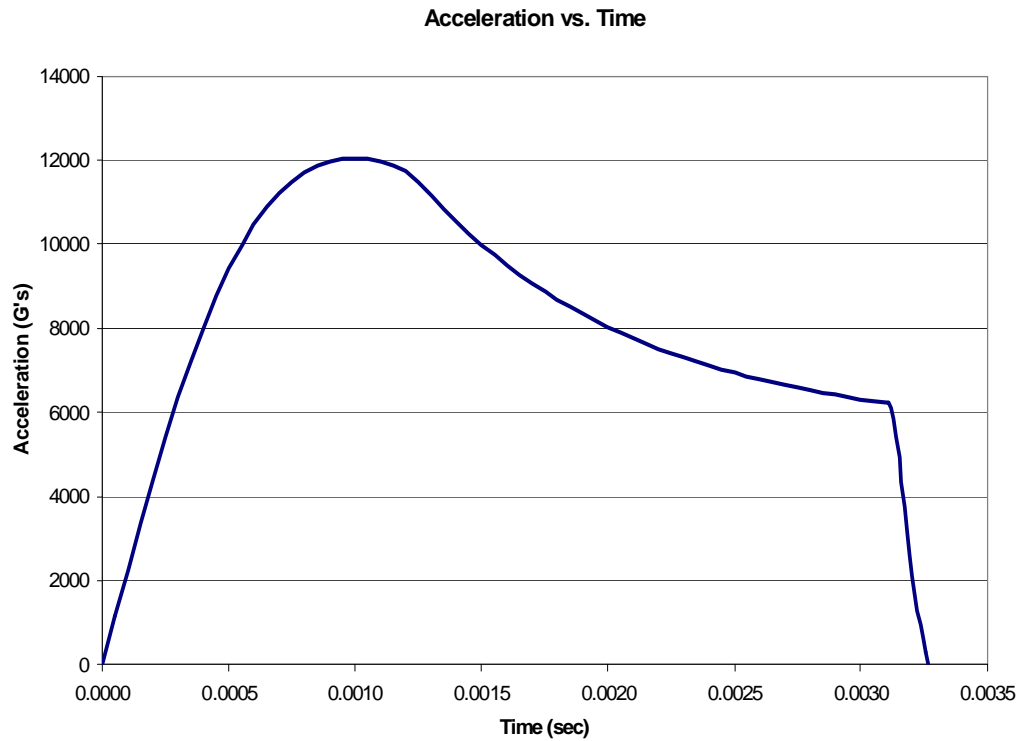
Figure 3.8: Acceleration profile (calculated) of 12kG air gun trial.

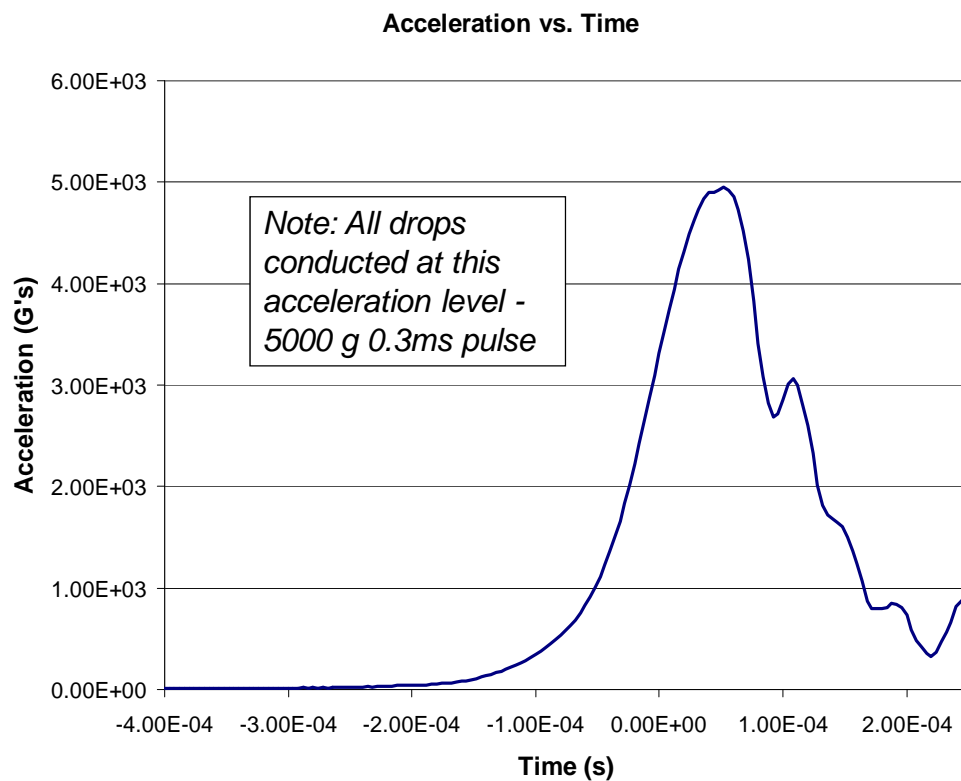
Figure 3.9: Acceleration profile for drop tower tests.

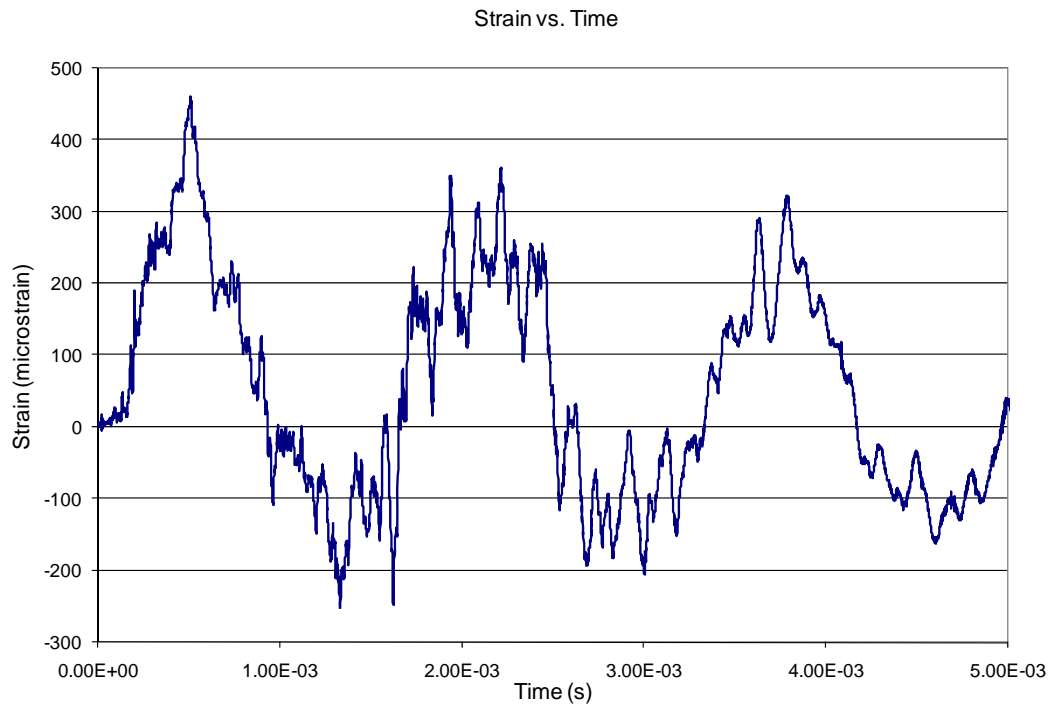
Figure 3.10: Strain response at board edge for full diaphragm condition.

located at the outer edge of the board for the fixed center support condition. This strain plot shows the same amount of time as Figure 3.10 for the simple diaphragm support condition. However, the number of strain cycles achieved in this time is higher, resulting in a higher strain rate for the fixed center support case. This higher strain rate is a result of the structure being stiffened by the inclusion of the center support.

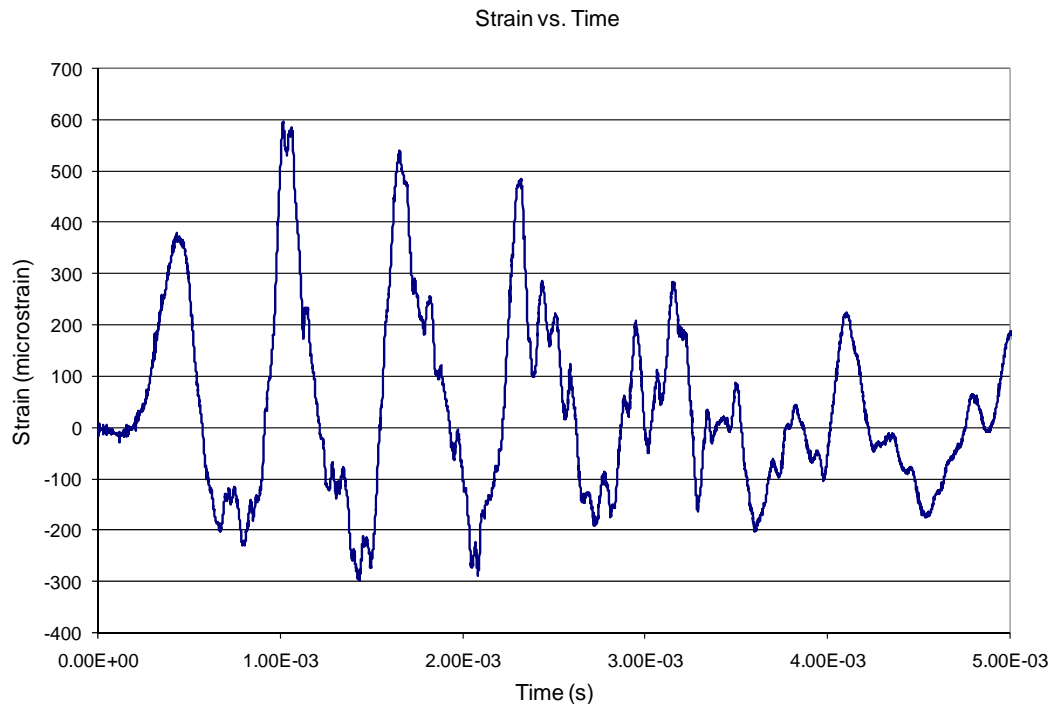
Figure 3.11: Strain response at board edge for fixed center condition.

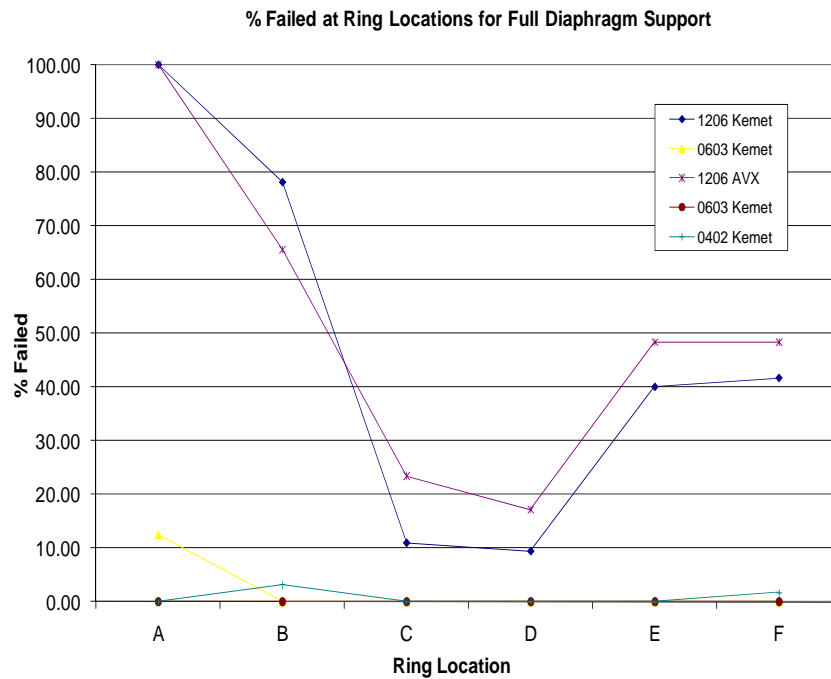
Figure 3.12: Failed components per ring location for diaphragm support.

The maximum strain that each ring of components on the test board experienced varied, with the maximum strain at each ring location summarized in Table 3.3. The percentage of failed components at each ring location also varied. Figure 3.12 and Figure 3.13 plot the percentage of components failed at each ring

location for each of the experimental trials conducted in the free diaphragm and center clamped support conditions, respectively. Based on this plot it is evident that

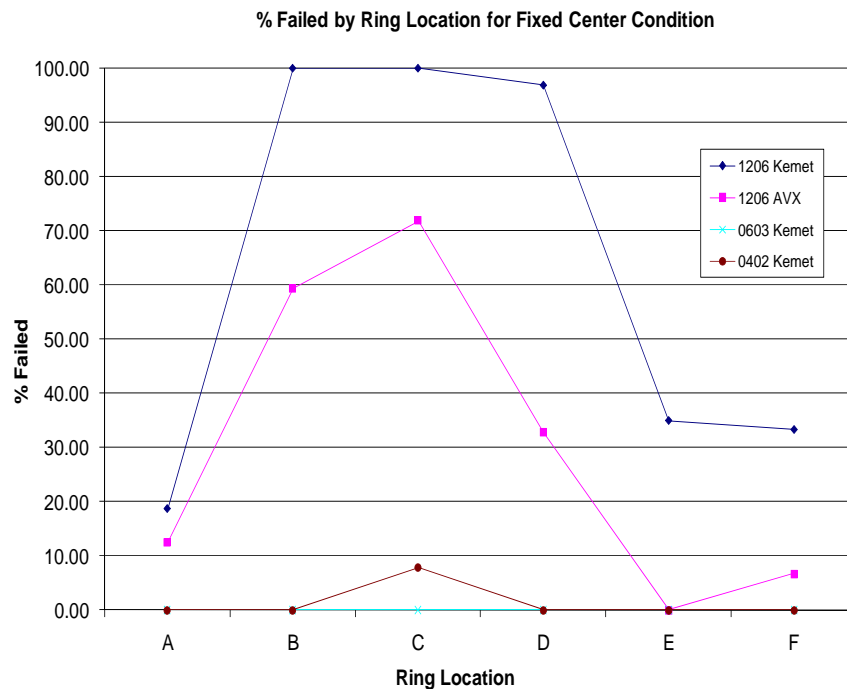
Figure 3.13: Failed components per ring location for fixed center support.

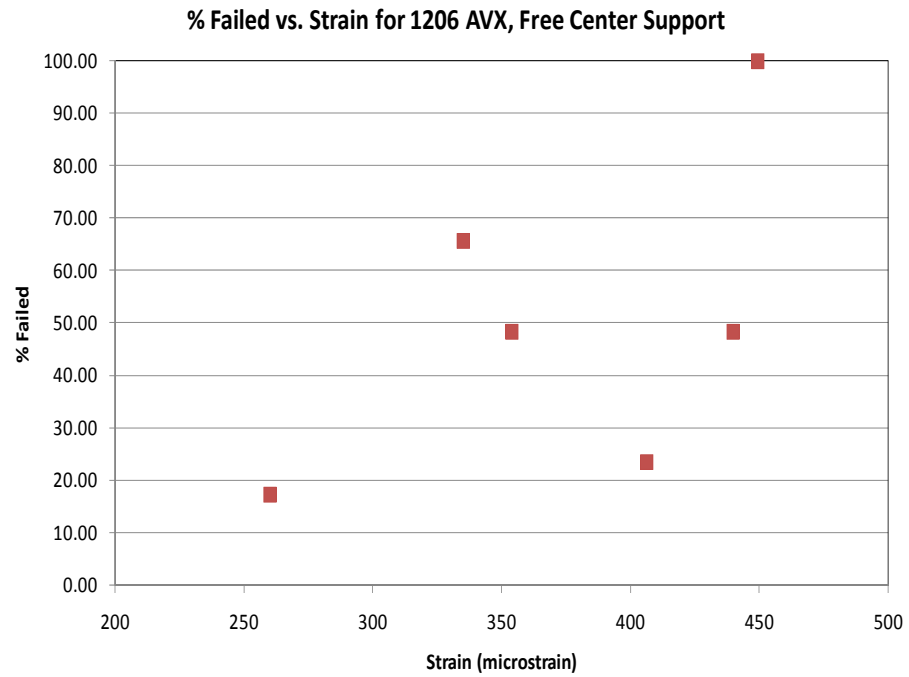
Figure 3.14: Percent failed vs. strain for 1206 AVX, free center.

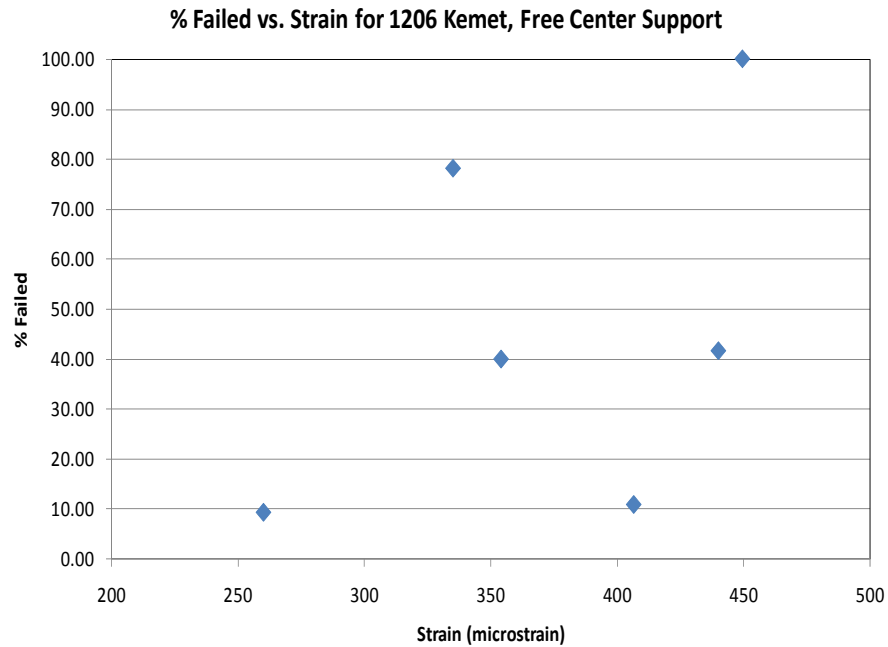
Figure 3.15: Percent failed vs. strain for 1206 Kemet, free center.

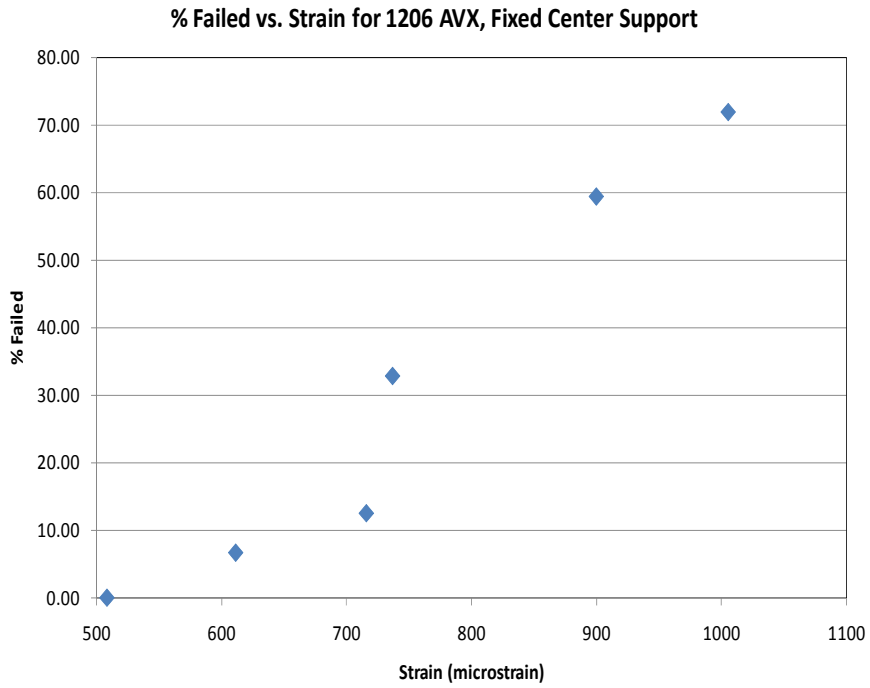
Figure 3.16: Percent failed vs. strain for 1206 AVX, fixed center.

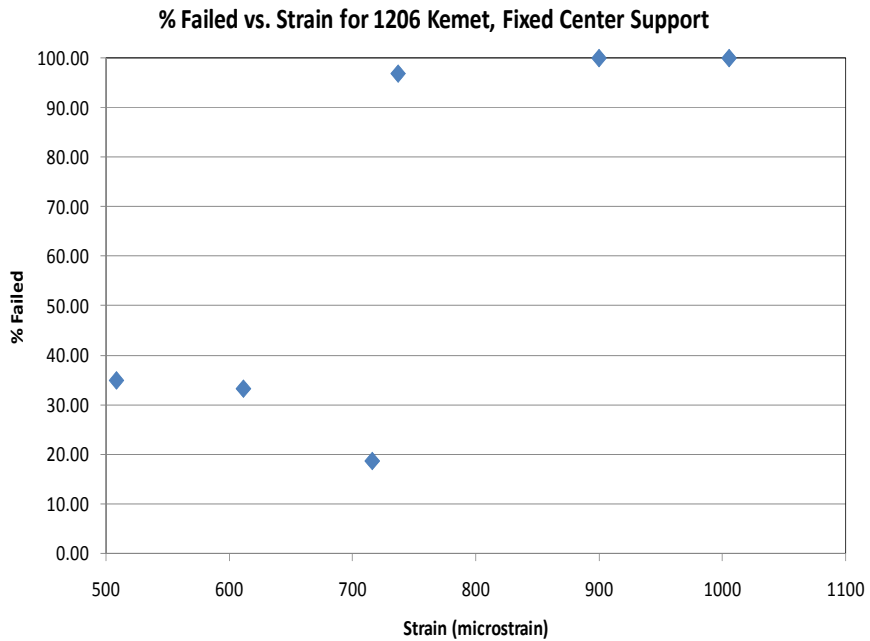
Figure 3.17: Percent failed vs. strain for 1206 Kemet, fixed center.

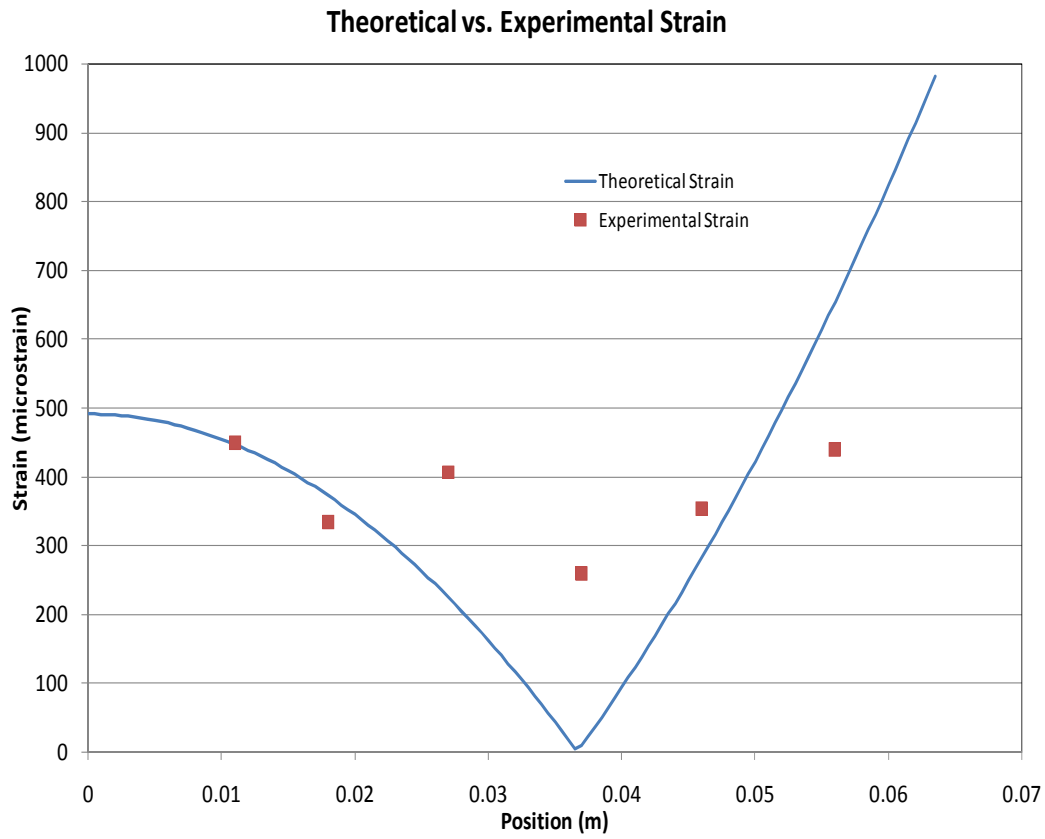
Figure 3.18: Theoretical strain distribution vs. experimental results.

The uniform pressure load p_0 was adjusted to result in a strain profile that reasonably approximated the maximum strains recorded at each ring location for the high rate drop experiments. The resulting calculated maximum strain distribution was assumed to approximate that of the fundamental mode in the dynamic experiment. The calculated strain distribution is plotted in Figure 3.18 along with the experimentally derived data. The theoretical strain at each of the component ring locations on the board was calculated and then plotted versus the percentage of failed components at

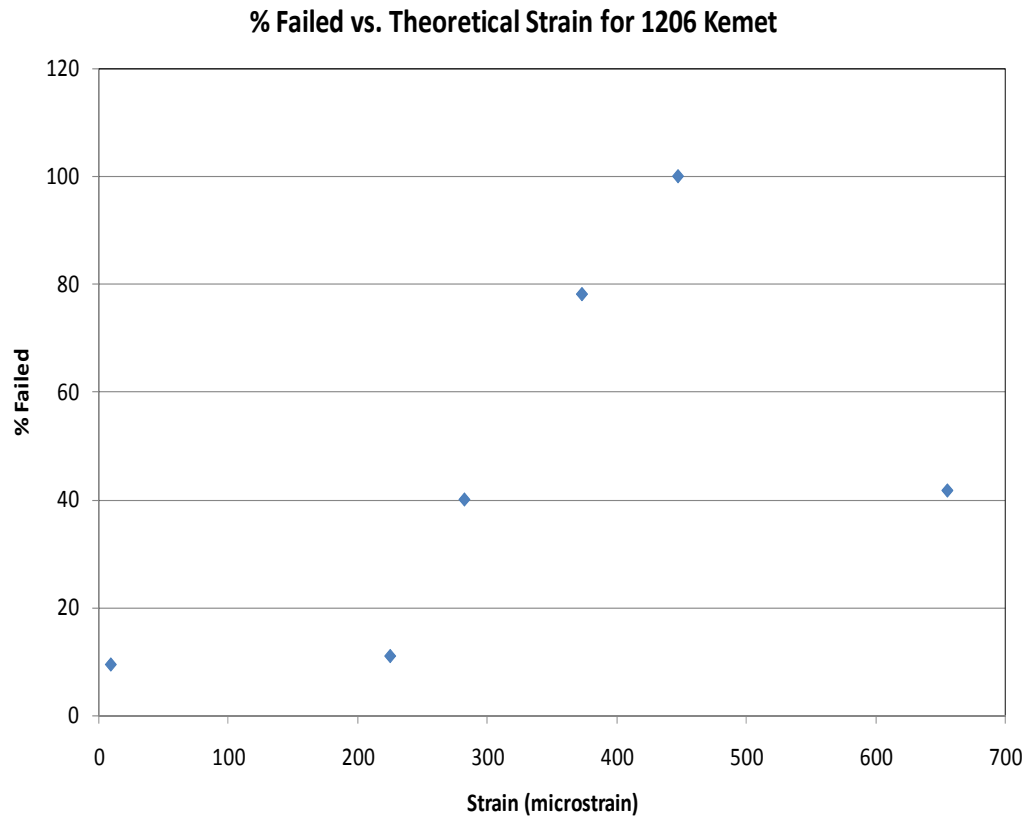
Figure 3.19: Percent failed vs. theoretical strain for 1206 Kemet

that location. These plots are shown in Figures 3.19 and 3.20. These plots show the percentage of failed components increasing more consistently with increasing strain. This is due to the strain data representing the fundamental mode of the board, which is a better determinant of the strain that the components at a given ring location on the board will see. The experimental strain data was gathered along a single board radius, and is prone to localized maximum strain values due to the influence of higher order modes. The outlier on each of these figures is the last data point, which occurs at roughly $650 \mu\epsilon$ on both plots. This data point represents the strain at the outer edge of the board, which is at the clamped boundary condition. The fact that these values do not fall as expected on the plot can be attributed to the inability of the theoretical result to accurately predict the strain at the boundary condition. These plots also

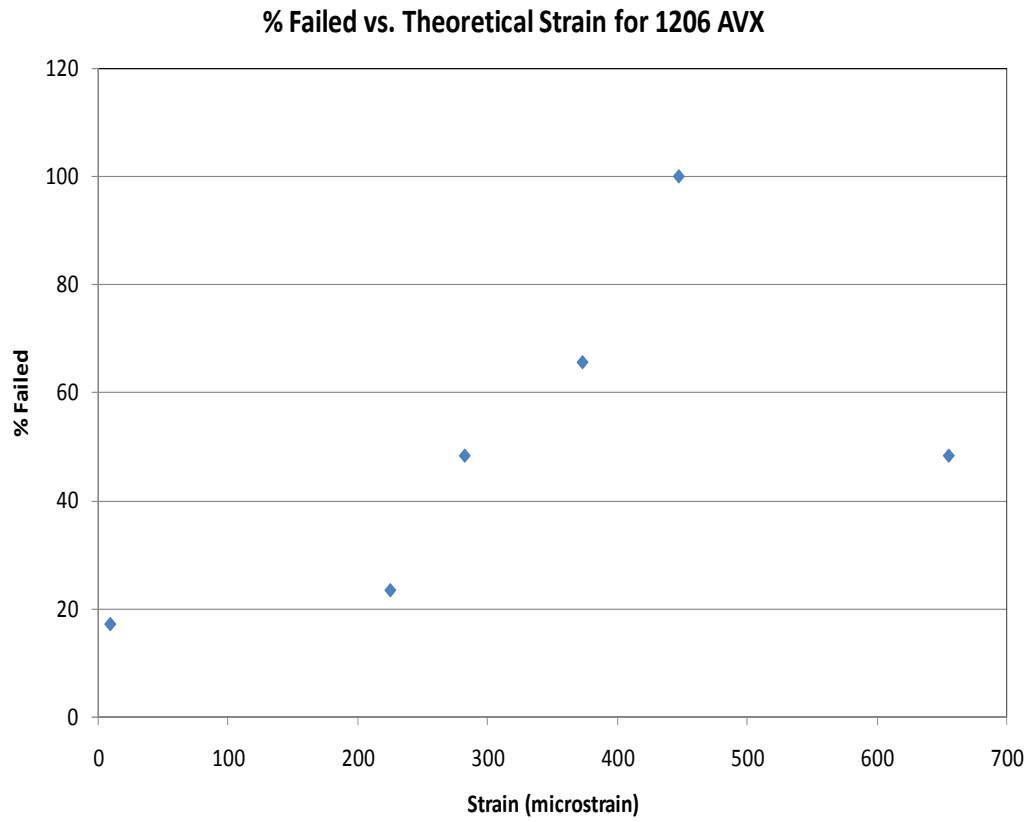
Figure 3.20: Percent failed vs. theoretical strain for 1206 AVX

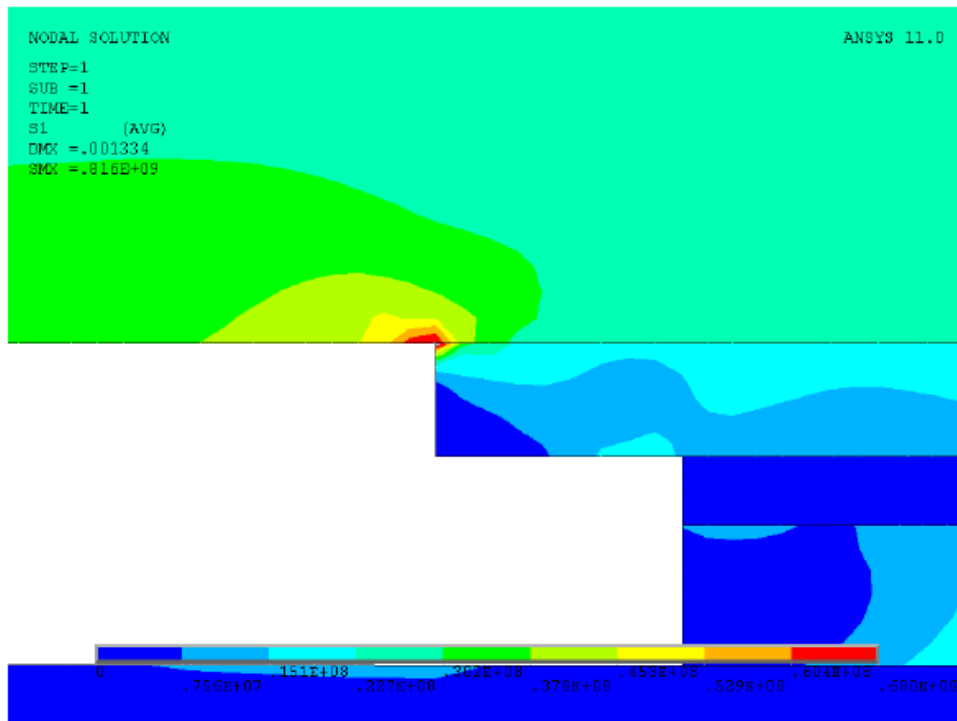
Figure 3.28: Magnified view of critical stress region, double sided case.

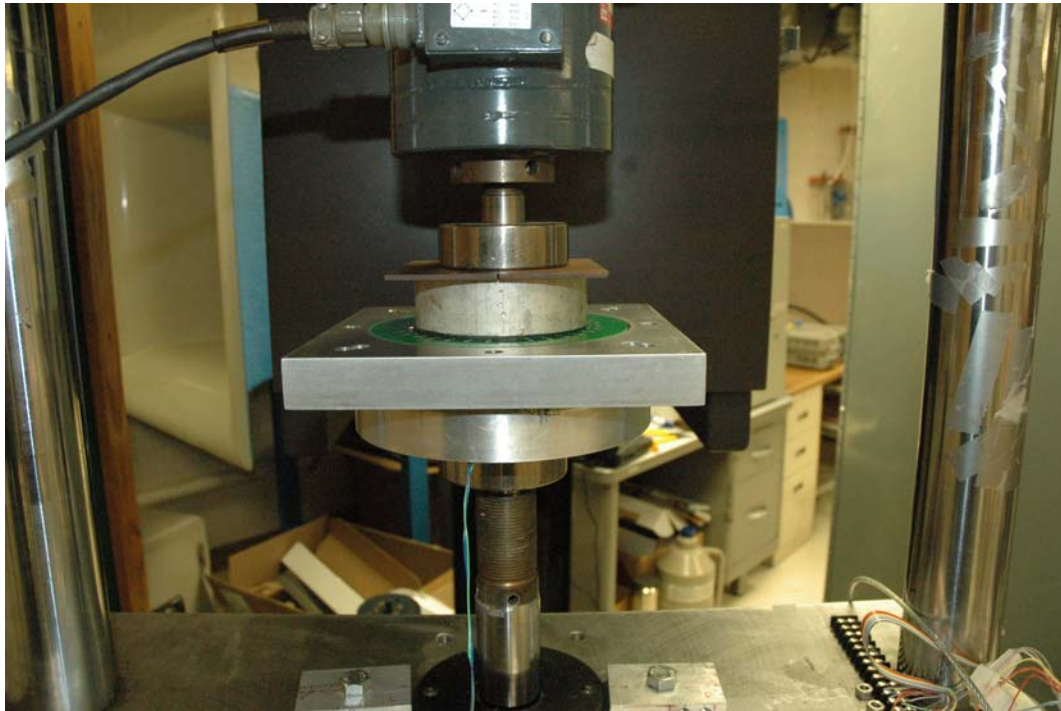
Figure 3.29: MTS bending test setup with round test board.

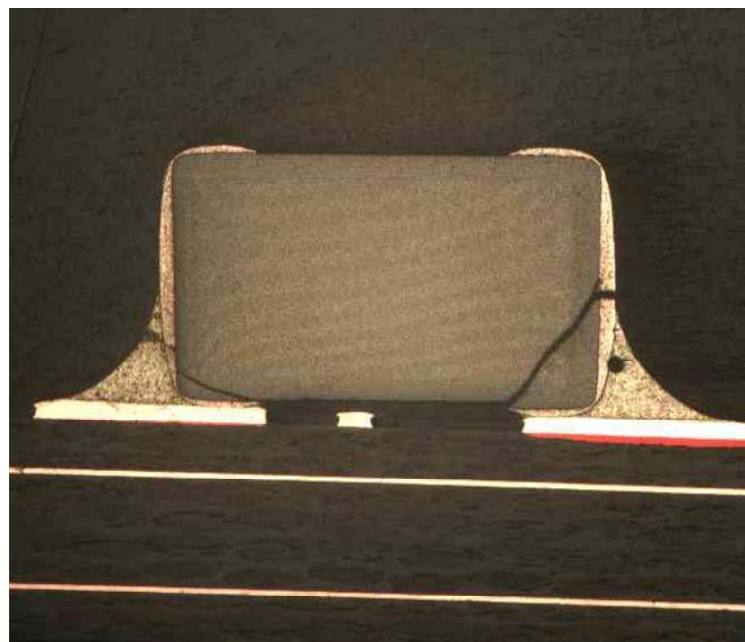
Figure 4.4: Cross section of 1206 Kemet MLCC, with visible flex cracking.

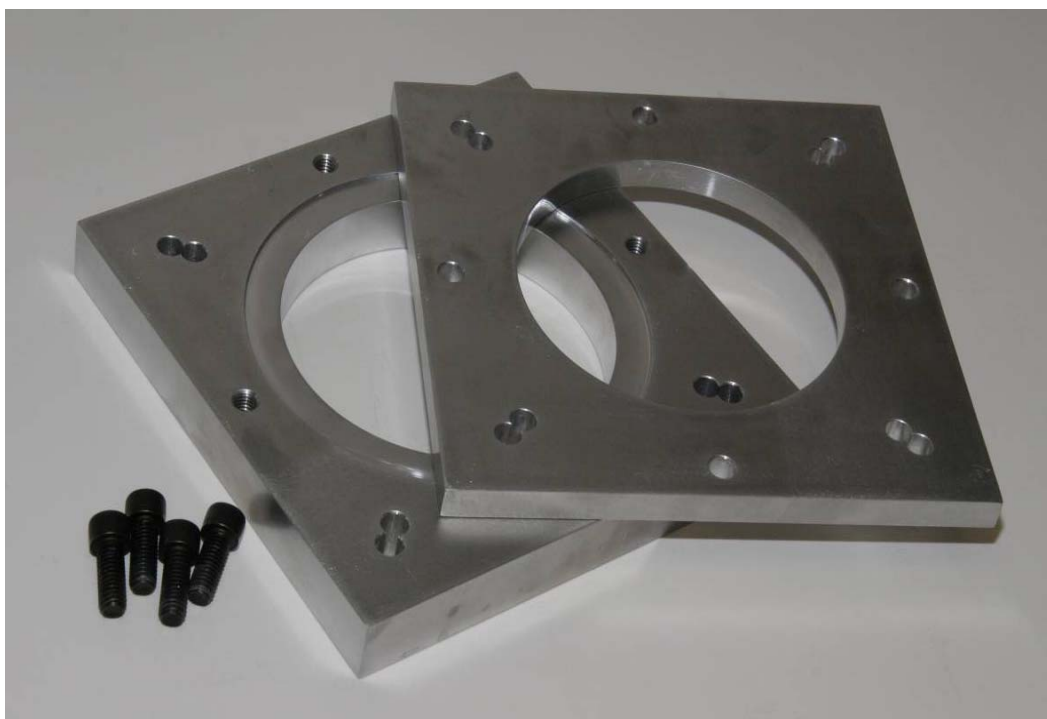
Figure 4.6: Drop tower test fixture.
