**The Archaeology and Restoration  
of the  
William Paca Garden, Annapolis, Maryland:  
1966-1990**

University of Maryland  
Master of Applied Anthropology  
Internship Report

Jason Shellenhamer

March 26, 2004

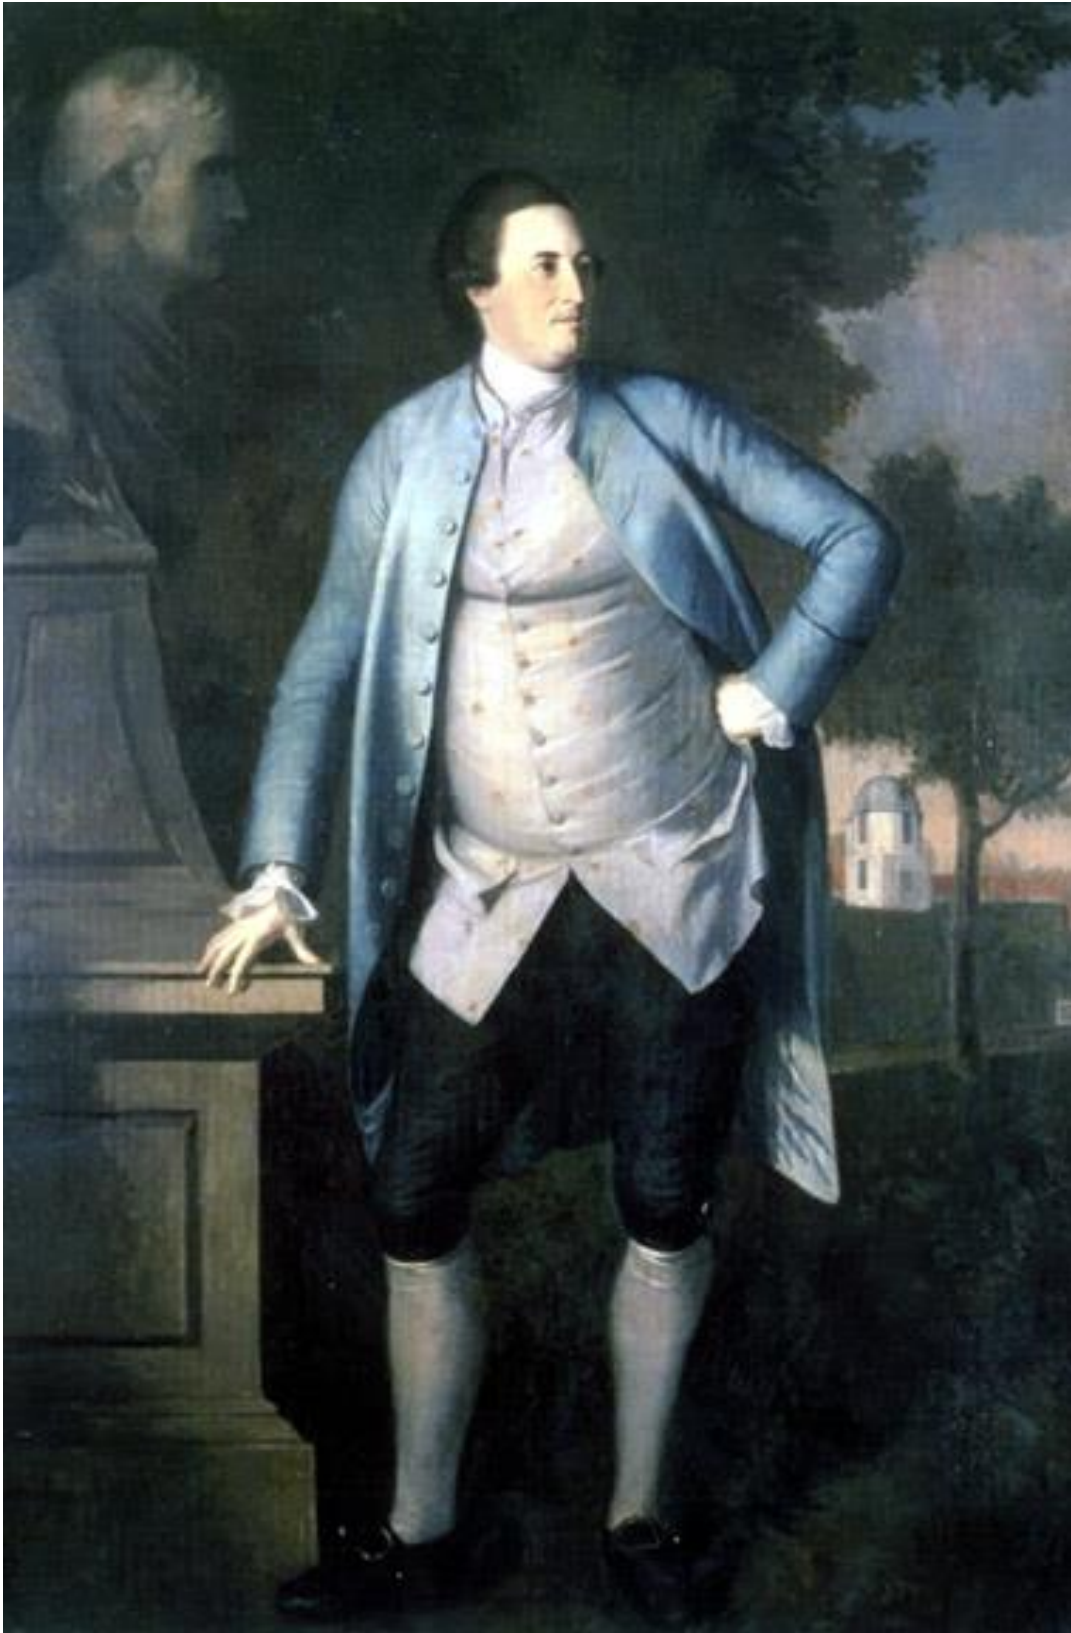
**Figure 1.1** Charles Willson Peale's portrait of William Paca standing at his garden. (South 1967)

summerhouse in the center rear of the garden, a one story brick structure with a pyramid roof to the right of the pavilion, a slotted brick wall behind the two structures running along King George Street, and finally a small pond located just in front of the pavilion. The Peale painting identifies several of the garden's outbuildings, but fails to provide any detailed information about the landscape of the garden aside from the pond and pavilion.

Years before the construction of Carvel Hall Hotel, two paintings, one in 1772 and another in 1884, were created of the historic garden. Charles Willson Peale, a renowned painter, was hired by William Paca to paint his portrait in 1772 (Figure 1.1). The painting depicts Paca standing along a wall with his Annapolis garden in the background. While Paca is the focus of the portrait, a number of garden features can be identified as well:

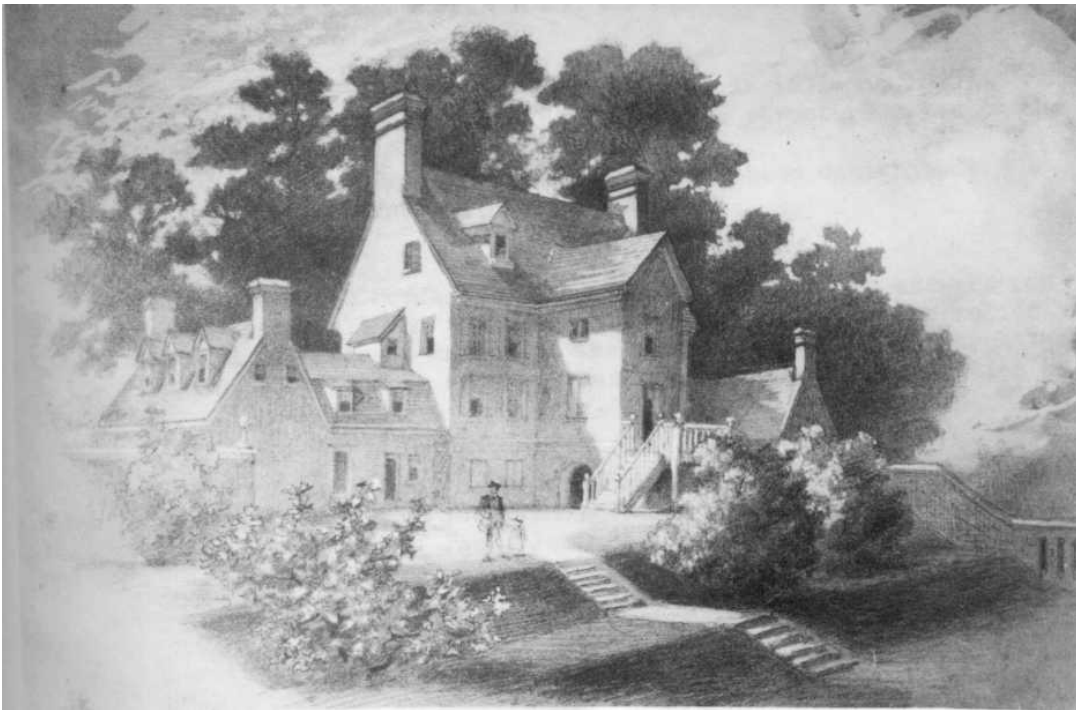
**Figure 1.2** Frank B. Mayer's 1884 sketch of the William Paca Garden ( South 1967).

two falls and three terraces are shown extending toward King George Street with a central pathway originating at the upper terrace directly across from the southeast hyphen and bisecting the garden. While the portrait was created in the late 19<sup>th</sup> century, little

American artist Frank B. Mayer, created a second painting of the garden in 1884 (Figure 1.2). The painting depicts the upper garden elevation as well as the rear of the house. In the Mayer sketch one can identify a slotted brick wall along the southwest portion of the garden, identical to the wall depicted in the Peale portrait. In addition,

1884 sketch of the rear of the William Paca House. The section of the brick wall located in the southwestern side of the garden was found in test trenches one and two.

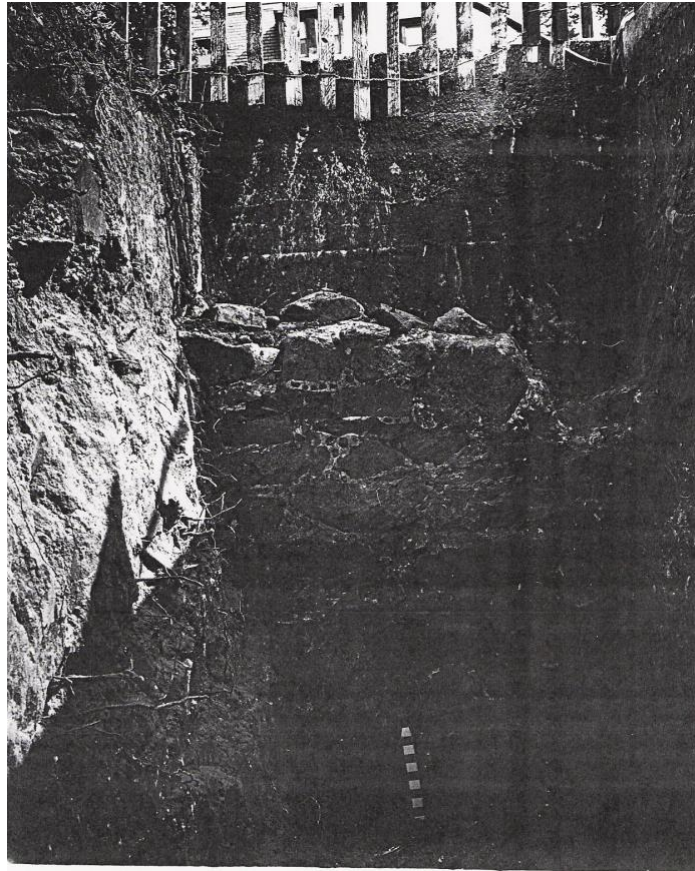
**Figure 2.2** Photograph of the southwestern portion of the garden wall, discovered by Bruce Powell in 1966 (Powell 1966).

The top of the wall was 0.8 feet below the 1966 surface, while the base of the wall was 6.2 feet below the surface (Figure 2.2). The base of the wall consisted of stone typically found in use throughout Annapolis (Powell 1966). The foundation of the section of wall was laid in irregular courses; however, at a depth above 3.5 feet, the inside face of the wall became more carefully aligned suggesting this area of the wall was visible during the period of Paca's use of the garden. Unfortunately, Bruce Powell could not confirm

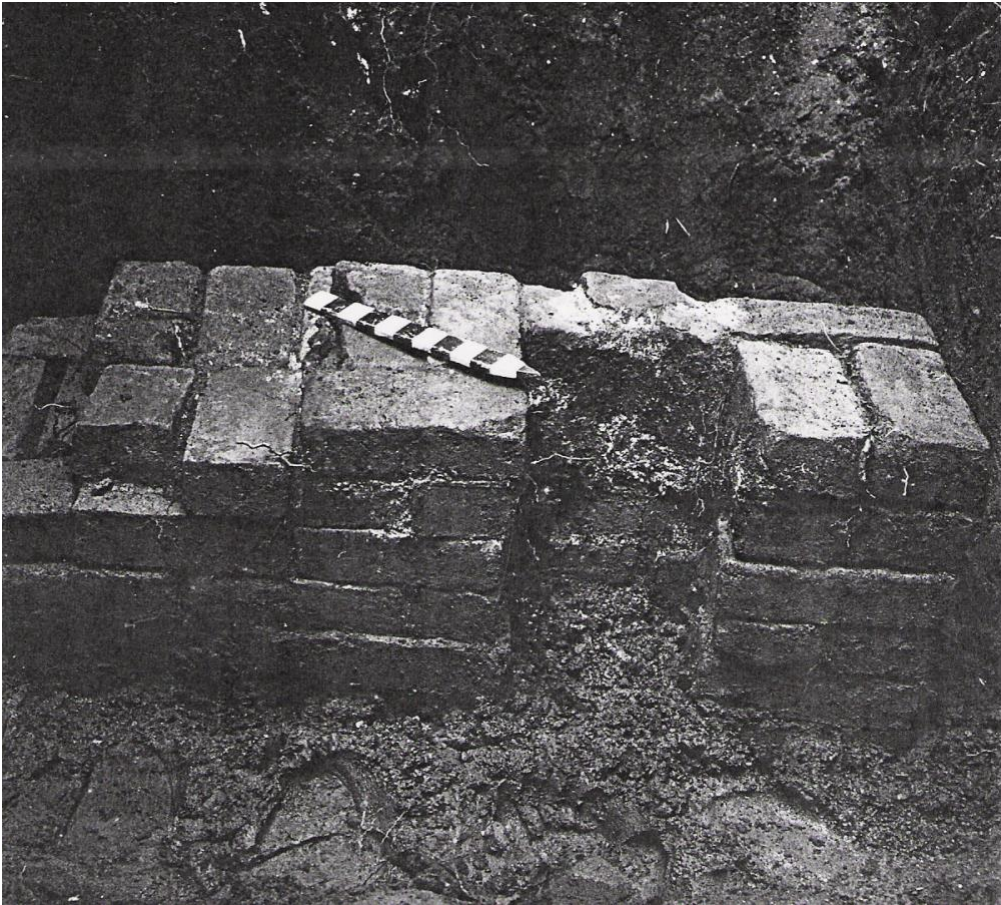
**Figure 2.3** Photograph of Powell's structure 2. Located in test trench 5 (Figure 2.1), this feature was photographed looking south toward the William Paca House. In later excavations structure 2 is determined to be a portion of the original summerhouse (Powell 1966).

Powell found a third structure located in test trench five (Figure 2.1). According to Powell, the feature (structure 2) was of unknown use, measuring 3 feet 9 inches long by 1 foot 10.5 inches wide (Figure 2.3). The bricks that made up the structure were large, measuring 9 by 4 by 2  $\frac{3}{4}$  inches. They were laid in a common bond with a poor clay mortar mixture. In the northwest corner, the feature was seven courses high but in the other areas the feature only measured 5-6 courses. In the northern side of the structure a semicircular hole extended from the top to the bottom of the feature. At the top of the hole a coating of mortar surrounded the opening, giving the hole its circular shape.

According to Powell, there was no indication in the hole or in the surrounding soils as to what the hole may have held. No remains of wood were observed, nor were there any signs of metal (Powell 1966). Powell never came to any final interpretation or any reasonable explanation for this structure. Powell did, however, offer some suggestions: a flagpole base, a gate foundation, a pump, or drain housing.

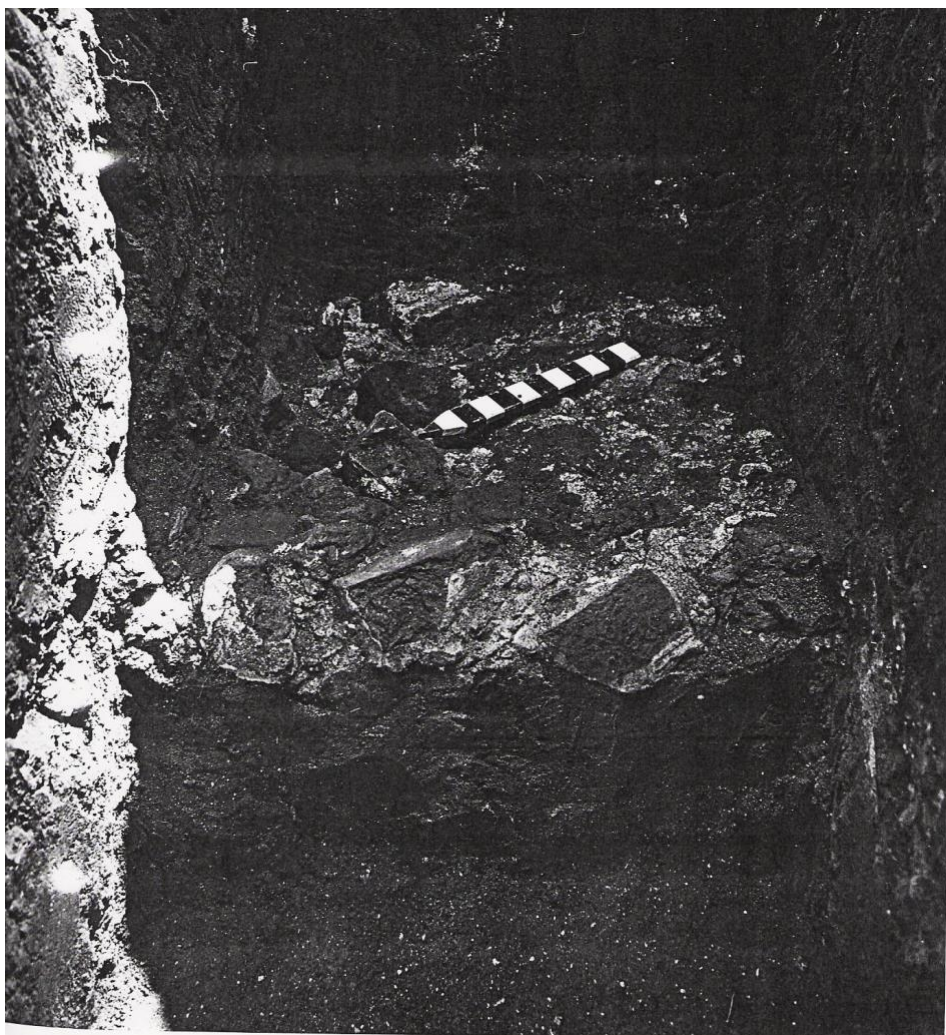
**Figure 2.4** The fourth structure Powell discovered during his excavation of the William Paca Garden, also located in test trench 5 (Figure 2.1), Powell was unable to determine its purpose (Powell 1966).

The final structure (Figure 2.4) located by the Powell excavations was also found in test trench five. The structure was a line of unbonded brick, two rows wide and one course deep. It was found crossing test trench five in an east-west direction at a depth 7.5 feet below the surface. Because of the depth of the structure, Powell identified it as being associated with the historic Paca period of the garden. Unfortunately, as with the previous structure, Powell was unable to offer any interpretations as to the purpose of the feature.

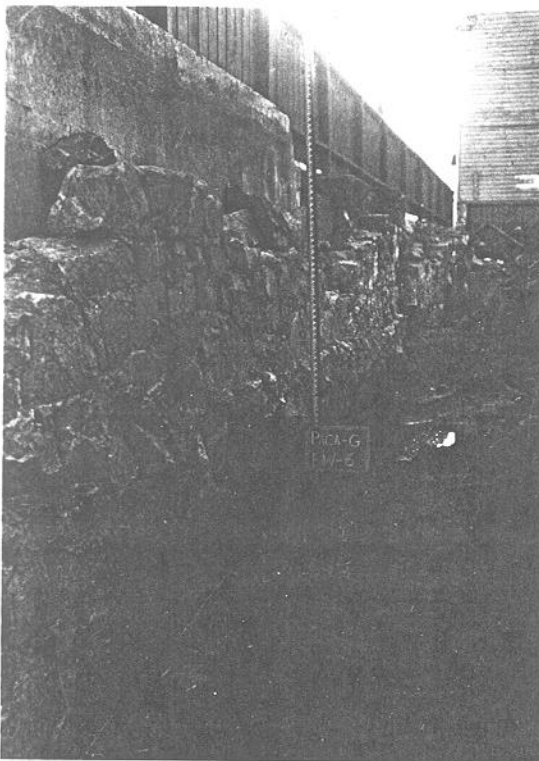
**Figure 3.2** shows exposed section of the north wall looking east (Figure 3.5 #1). Unearthed during the Little excavations (Little 1967).

During the excavation of the garden, Little uncovered several portions of the historic garden wall (Figure 3.2), similar to those found by Bruce Powell a year earlier. Little found the original walls consisted of a stone foundation with brick courses laid on top. Along the eastern side of the garden, Little found that the base of the wall was not at a constant elevation. The southern most portion of the excavated wall was found at an elevation of roughly 11 feet above sea level.

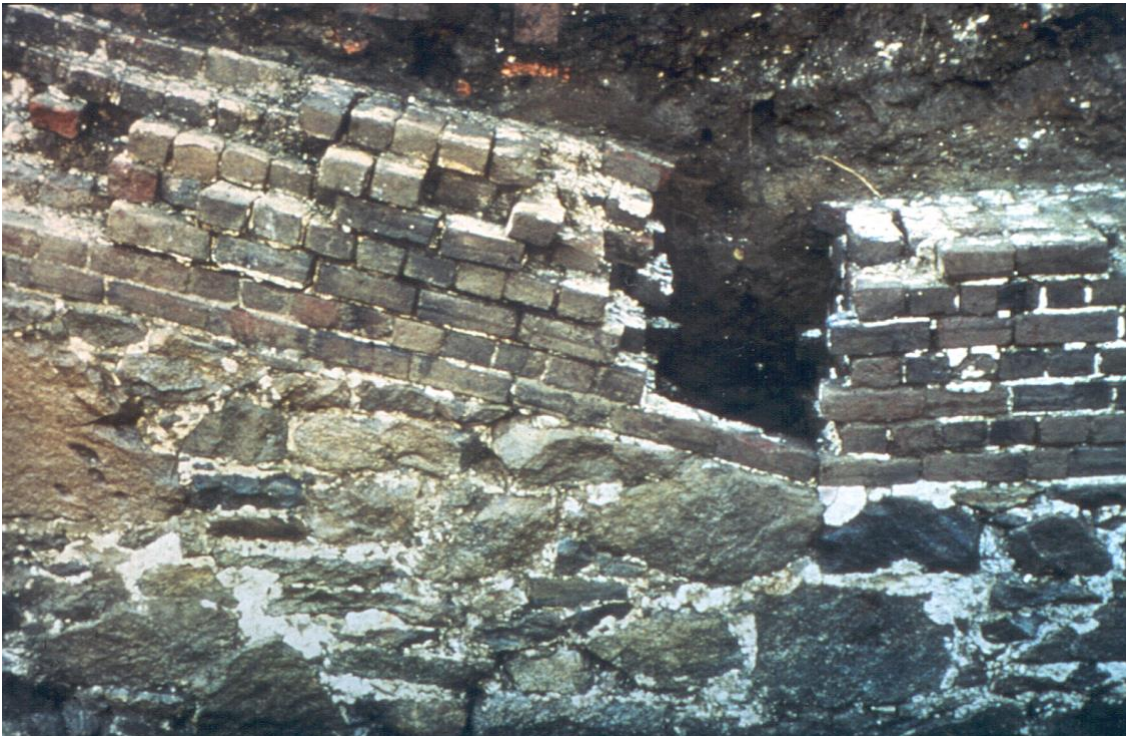
**Figure 3.4** shows a portion of the west garden wall excavated by Glenn Little during the 1967 field season. The photograph shows the wall's fieldstone and mortar base sloping down toward King George Street. Atop the fieldstone, brick courses were laid to correspond with the terracing of the garden surface (Little 1967)

wall's base measuring 11 feet above sea level. The feature was found to grade downward an additional 6 feet to the north where it became level at an elevation of 5 feet above sea level. From this information, Glenn Little concluded that the wall represented a single sloping fall measuring about 15-16 feet from top to bottom. This evidence further suggested to Little that the wall was constructed to correspond with the change in the garden topography (Figure 3.4).

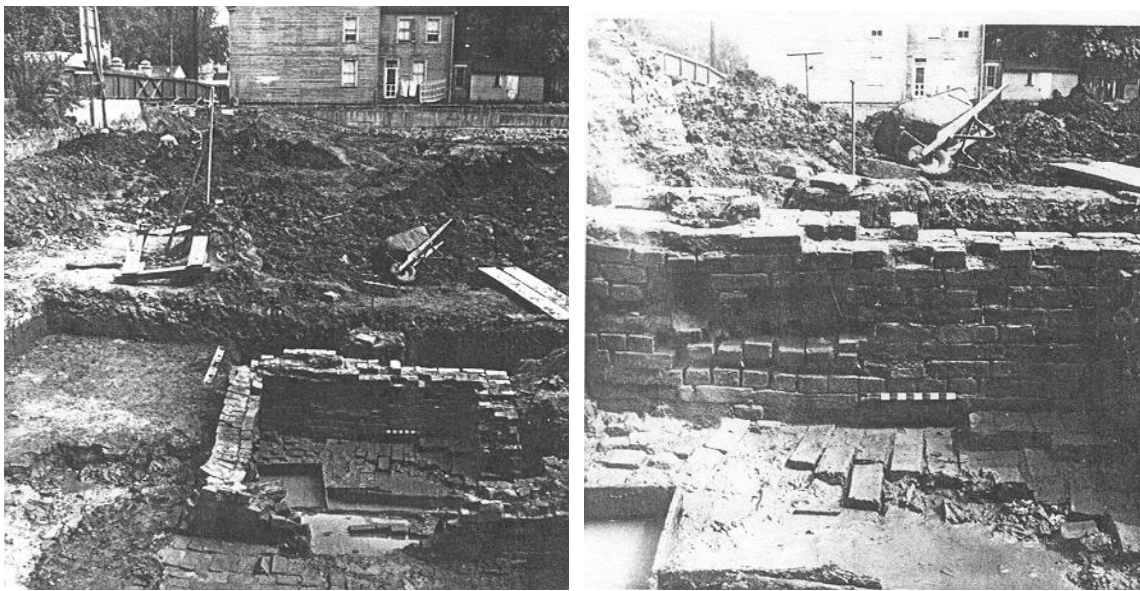
**Figure 3.10** Two views of Glenn Little's excavation of the springhouse. To the left is a view of the springhouse from the west garden wall. Looking at the base of the structure's west wall, one can see the center area is void of brick with a fieldstone step exposed. The photograph to the right is a close up of the east interior wall of the springhouse. In both photographs, the brick floors and wall are present as well as the 19<sup>th</sup> century collecting basin and trough (Little 1968).

top of the brick floor (Figure 3.10). The trough and basin were made of wooden boards. Wooden stakes were found along the exterior of the trough and basin serving as the boards' support (Figure 3.11).

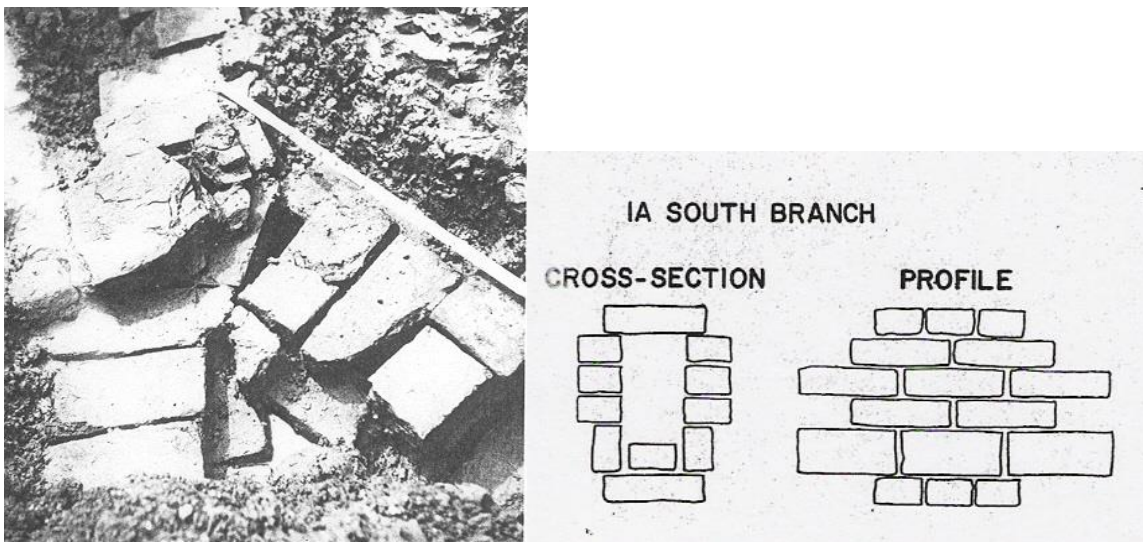
**Figure 3.12** Left, a photograph of the brick drains discovered during Glenn Little's excavation within the fourth fall of the William Paca Garden. The photograph shows a single drain at the top which forks into two directions. Right, Glenn Little's drawing of the drain showing both a cross-section and a profile (Little 1974).

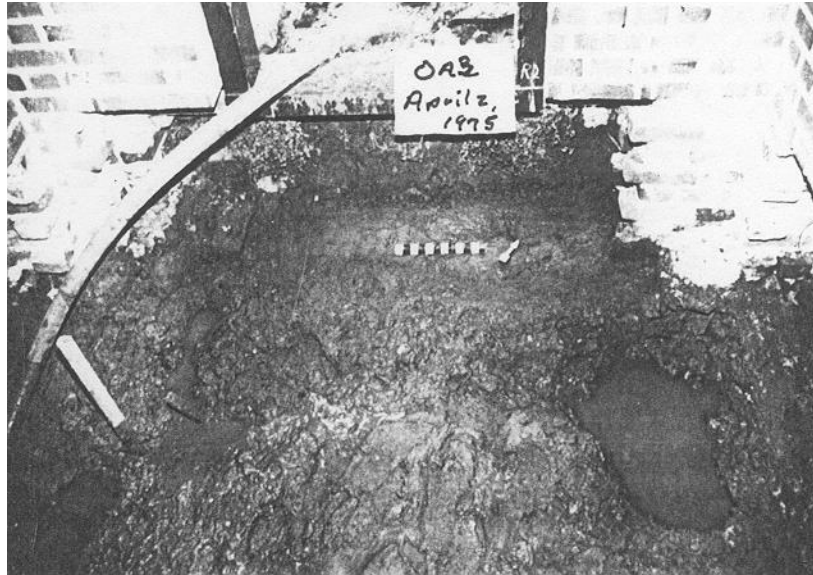
**Figure 4.1** A photograph of the fill placed within the springhouse following the conclusion of Glenn Little's excavations in 1968 (Orr and Orr 1975).

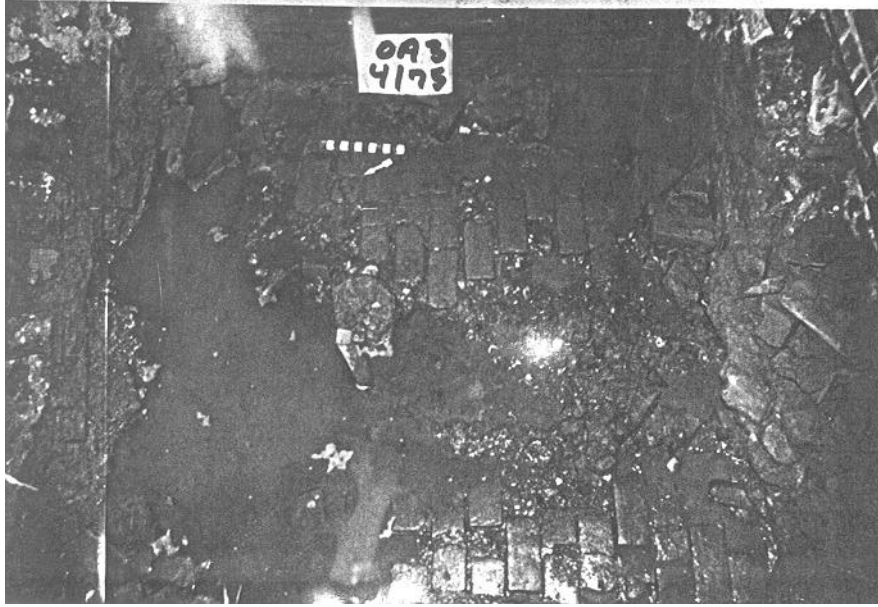
**Figure 4.2** Photograph of the springhouse floor following the removal of the fill zone (Orr and Orr 1975).

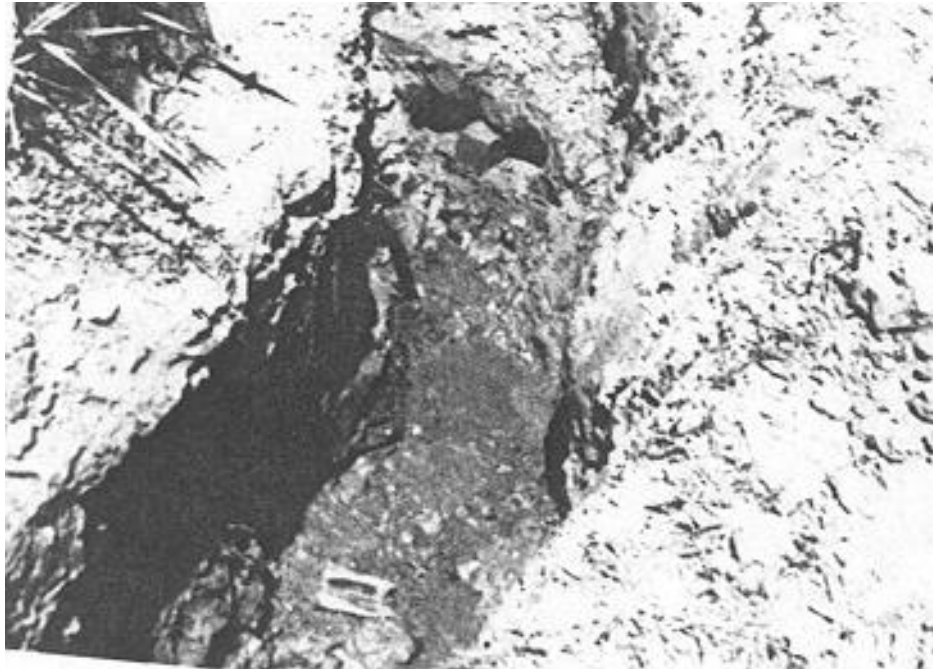
**Figure 4.3** Photograph of the northeast springhouse drain. The photograph was taken from the exterior of the structure (Orr and Orr 1975).

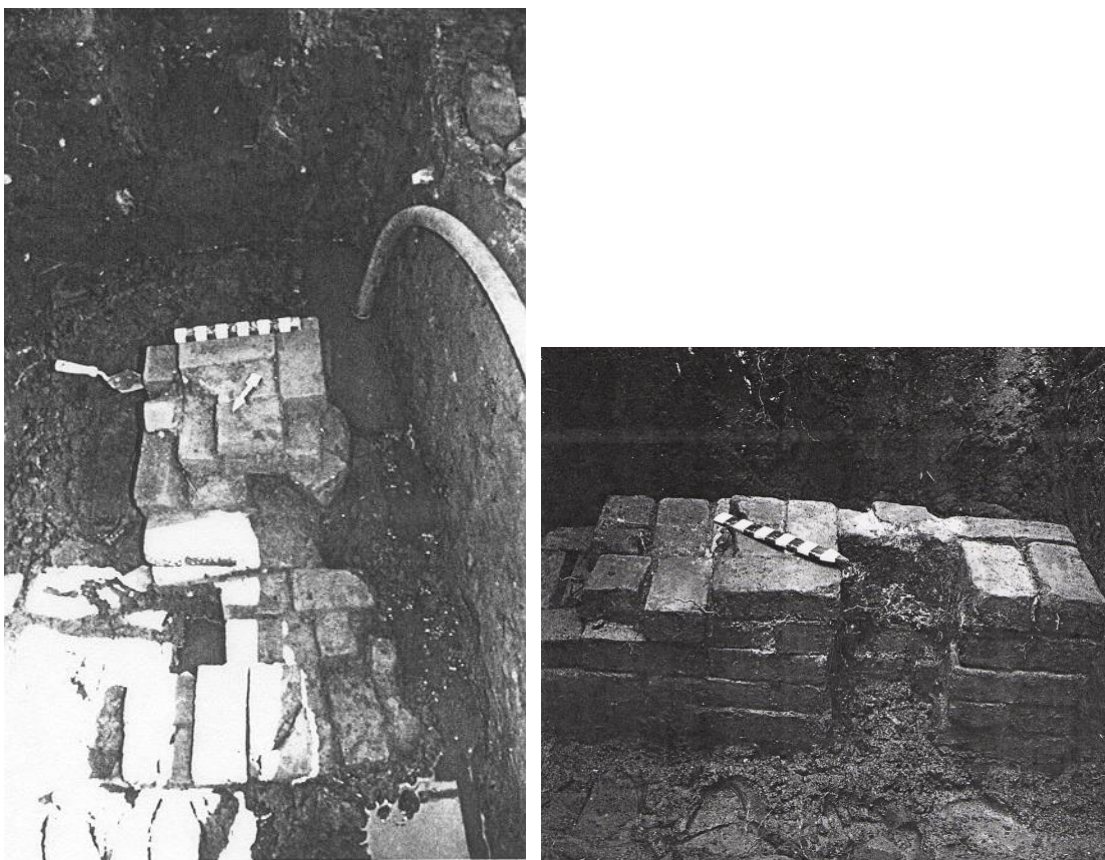
**Figure 4.5** **Left:** Photograph of Kenneth and Ronald Orr's excavation of Bruce Powell's Structure 2. The photograph was taken from the west side of the structure, facing east. **Right:** A photograph of the original excavation of Structure 2 by Bruce Powell. The photograph was taken from the structure's north side facing south (Orr and Orr 1975).

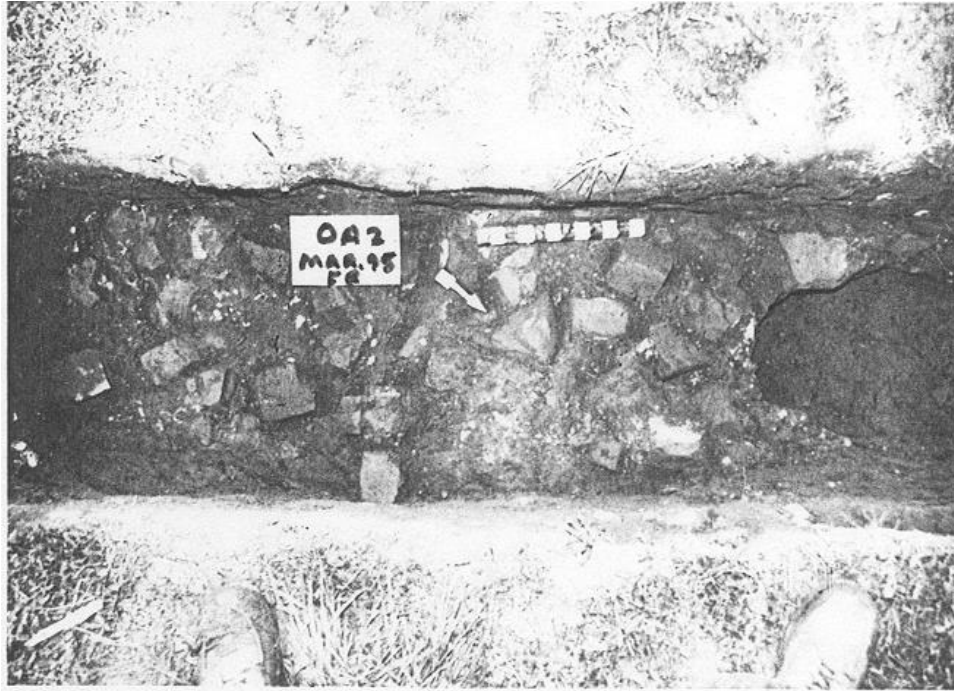
**Figure 4.6** Photograph of Feature B, located adjacent to Powell's brick Structure 2. The photograph was taken just north of Feature B, facing south towards the William Paca House (Orr and Orr 1975).

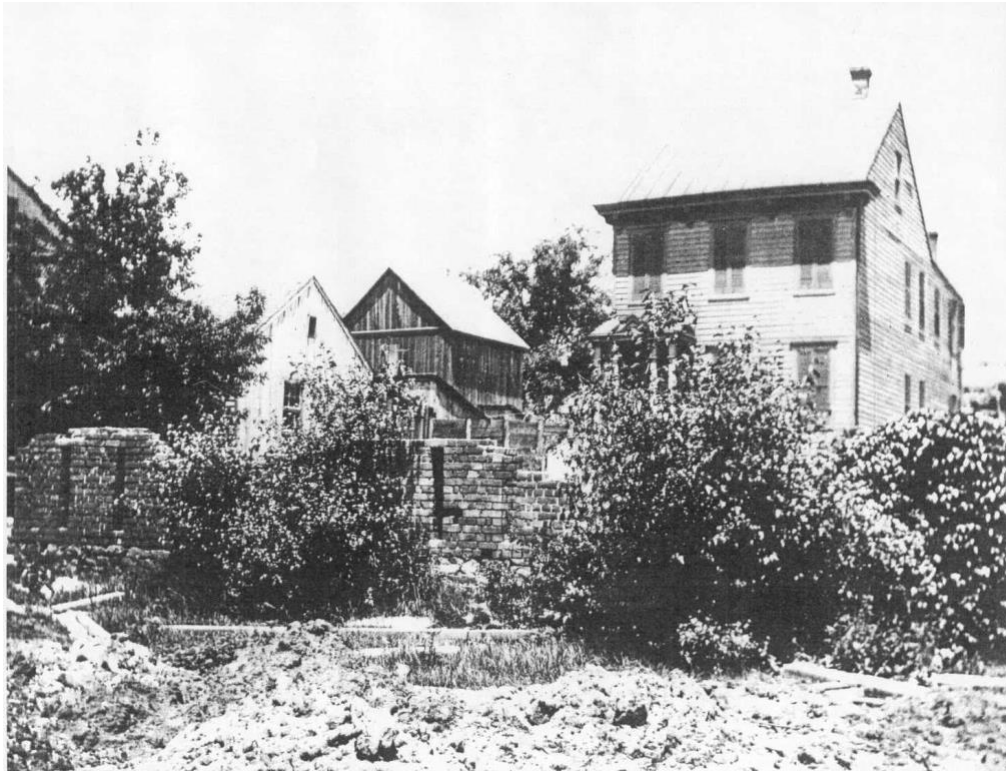
**Figure 5.1** Photograph of the remaining portion of the Paca Garden wall located between the Paca and Brice houses.

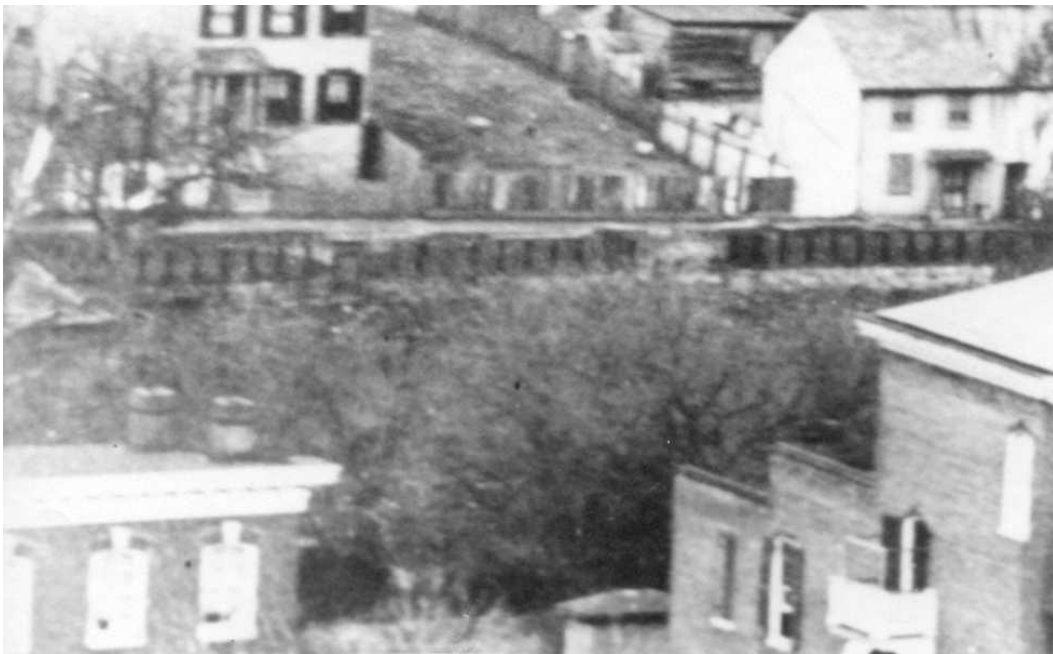
**Figure 5.2** A close up of the photograph taken from the State House. The picture shows slots clearly existed in the walls. In addition a gate is visible near the center of the wall. Glenn Little found evidence of the gate during his excavation in 1967-68 (South 1967).

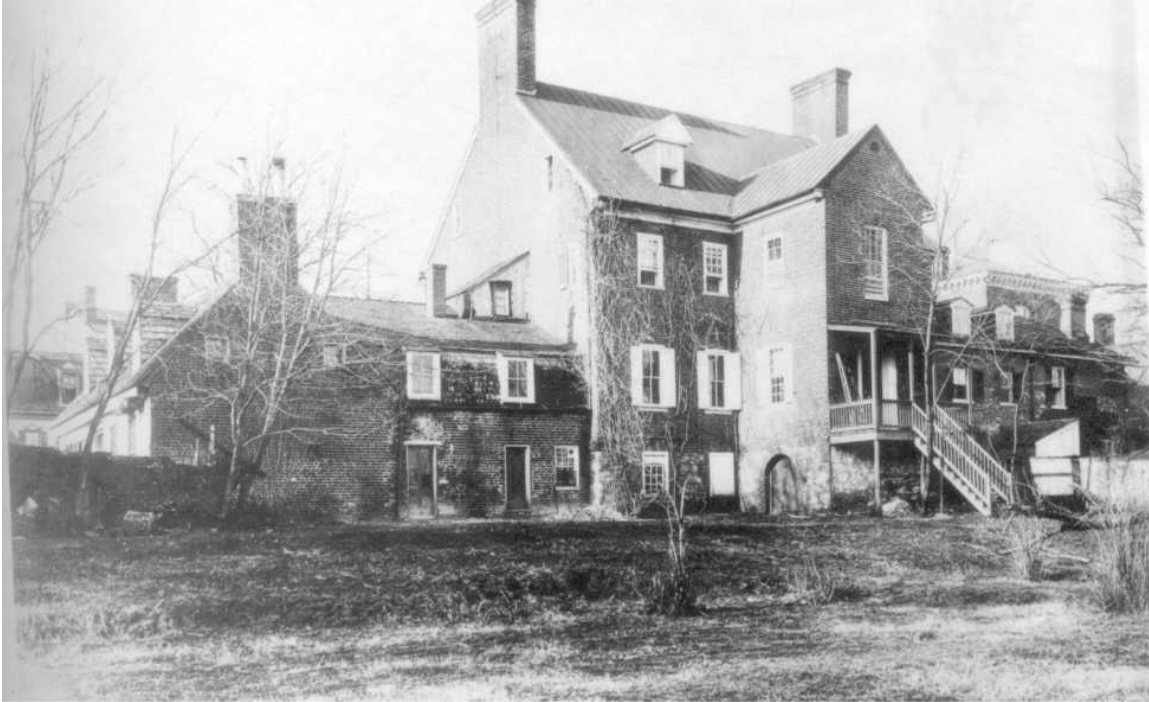
**Figure 5.3** A photograph of the Paca garden's first terrace and fall. The photograph was taken prior to construction of the Carvel Hall Hotel.

The parterres designed by Laurance Brigham for the terraces occupying the upper garden are conjectural (Wright 1973). Brigham's decision to include parterres was based on their being typical for the period. Both the archaeology conducted in the garden as well as the historical documentation fail to suggest that Paca once had parterres on either side of the central walk. In addition both the 1884 Mayer drawing and the 19<sup>th</sup> century photograph show the terrace to be bare.

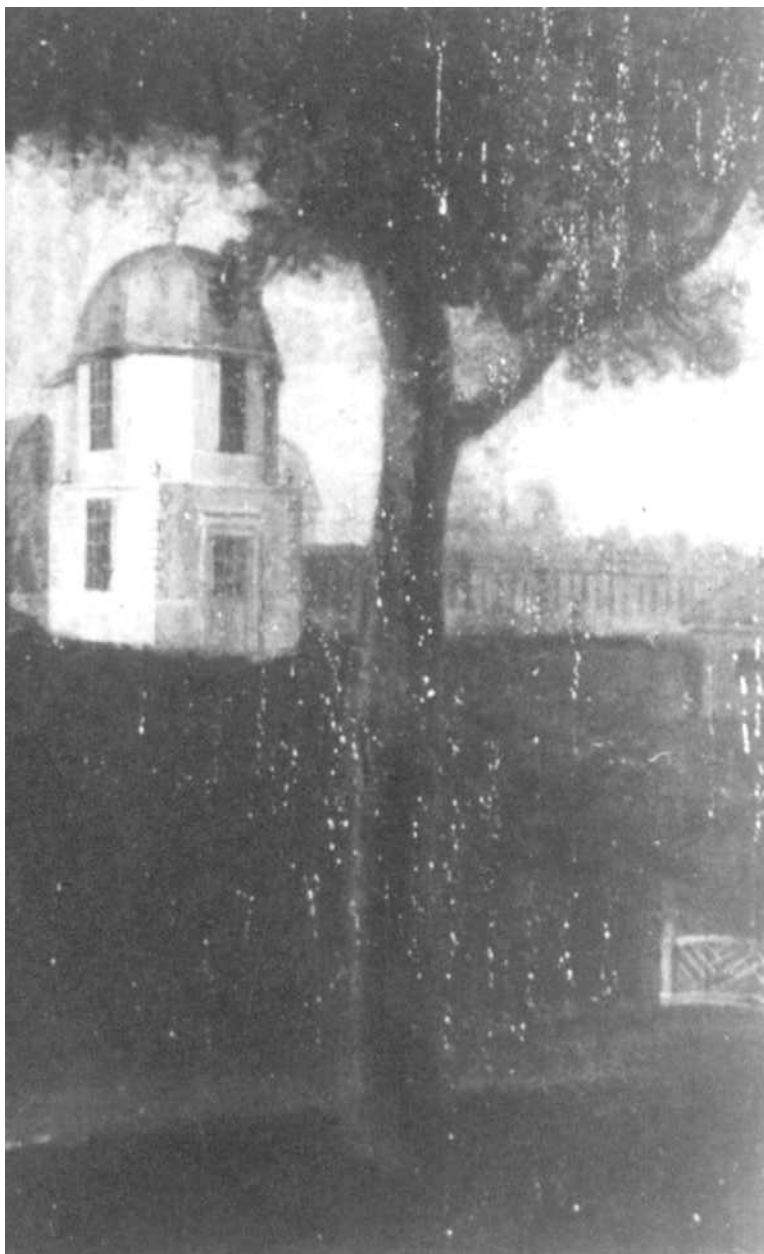
**Figure 5.6** A close up of the Charles Willson Peale portrait of William Paca. Along the right edge of the picture the small brick structure is clearly visible. Also looking directly to the right of the summerhouse, part of the north garden wall is visible. Looking closely at the wall, small slots can be seen (South 1967).

Little of the original foundation of the structure remained through to the 20<sup>th</sup> century. As a result, Bullock based his design of the summerhouse on the Peale portrait (Figure 5.6). The building was restored as a two-story structure with an octagonal roof. The restored structure also included a statue of the god Mercury as to correspond with the Peale painting. The placement of Mercury was further supported by 18<sup>th</sup> century literature. Batty Langley suggests in his book, *New Principles in Gardening* (1728):

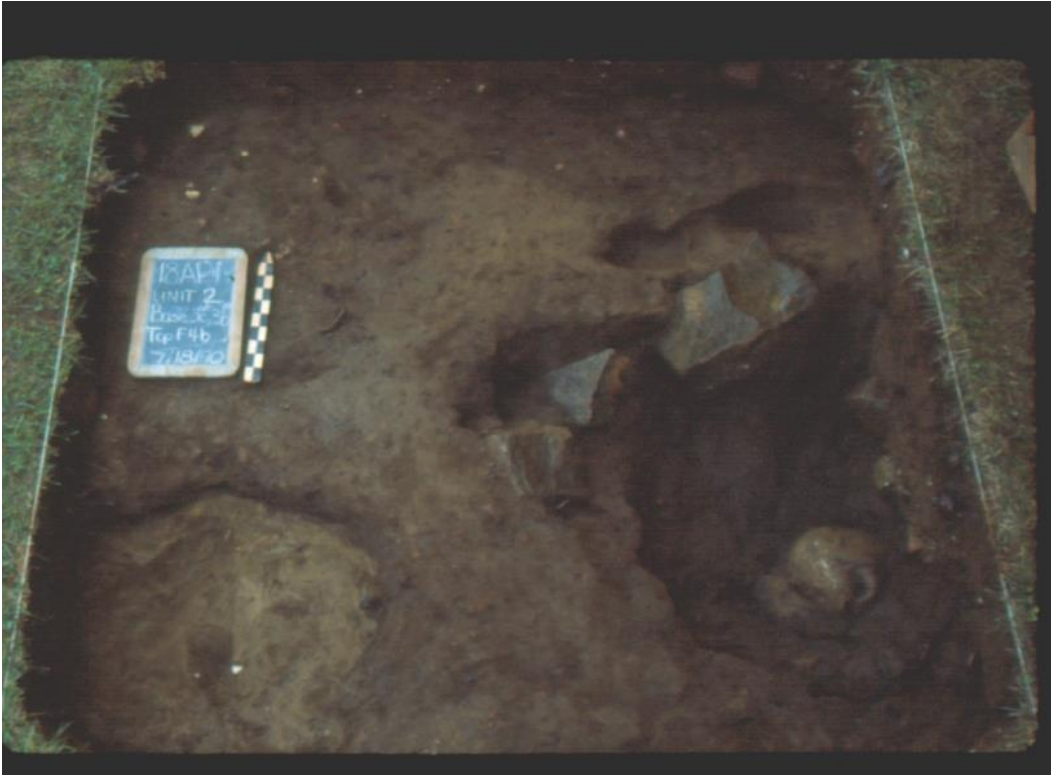
**Figure 7.3** A plan view photograph of the 19<sup>th</sup> century surface level that was exposed during the excavation of test Unit 2. The photograph shows evidence of a planting feature (southwest corner) as well as granite and mortar building materials along the eastern side of the unit (Galke 1990).

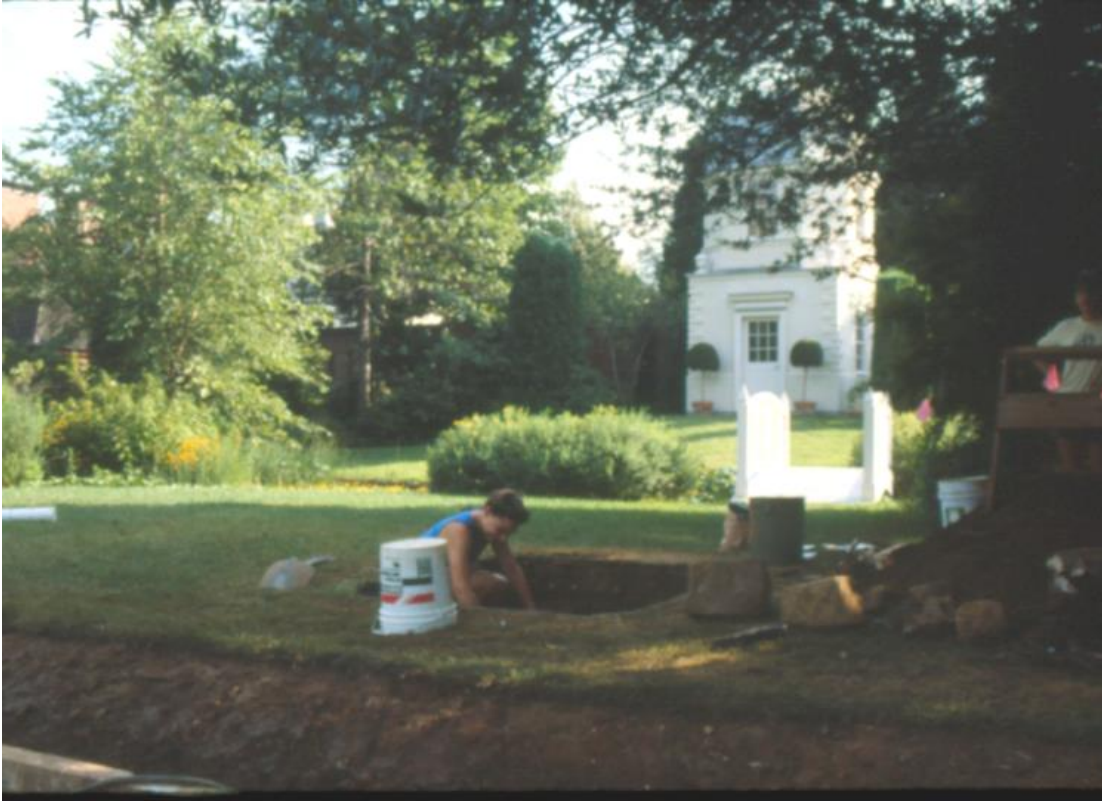
**Figure 7.4** A photograph of field school students excavating test Unit 2. Beyond the excavation, to the north, the restored summerhouse and Chippendale bridge are visible (Galke 1990).

Galke identified a third stratigraphic level dating to the late 18<sup>th</sup> or early 19<sup>th</sup> century. Evidence for this level was only found during the excavation of Unit 2 (Figure 7.4). Within the stratum only a handful of artifacts was discovered which were used in dating the soil level. Tin-glazed earthenware and blue-on-white porcelain were among the findings in the stratum. Unlike the previous level, no features were found in the stratum to indicate a living surface of any kind (Galke 1990).
