# **Reintegrating Public History & Environmental Education:**

## **Preservation and Interpretation of the Ruin at Java Plantation, Edgewater, Maryland**

**January M. Ruck  
HISP 700  
University of Maryland  
School of Architecture, Planning and Preservation  
Spring 2008**

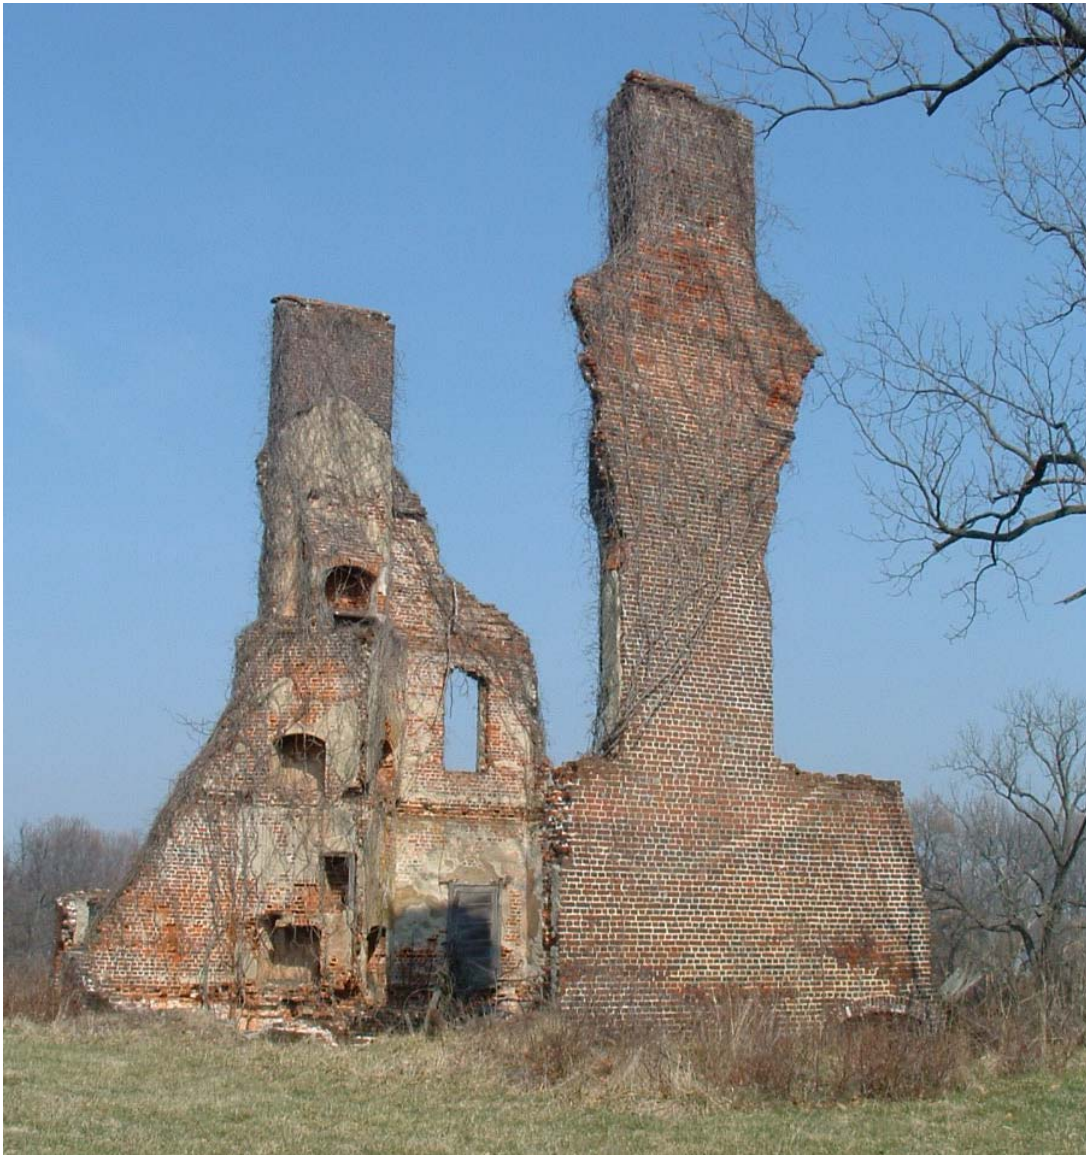
Figure 3. Current conditions of Java Plantation ruin (Photo by J. Ruck, March 2008).

its Georgian features, the mansion did not include a water table or belt course, which would have been common for a house of the style.<sup>18</sup> The mansion was struck by lightning and fire burned the structure in 1890.<sup>19</sup> The building was partially reconstructed, including only the main center block, west hyphen and west wing, using the fire-damaged brick in 1890.<sup>20</sup> The building was abandoned as a dwelling in 1923 and, since that time, deterioration has been dramatically swift, with photographic documentation chronicling the structure's ruination over time (Figures 2 and 3).

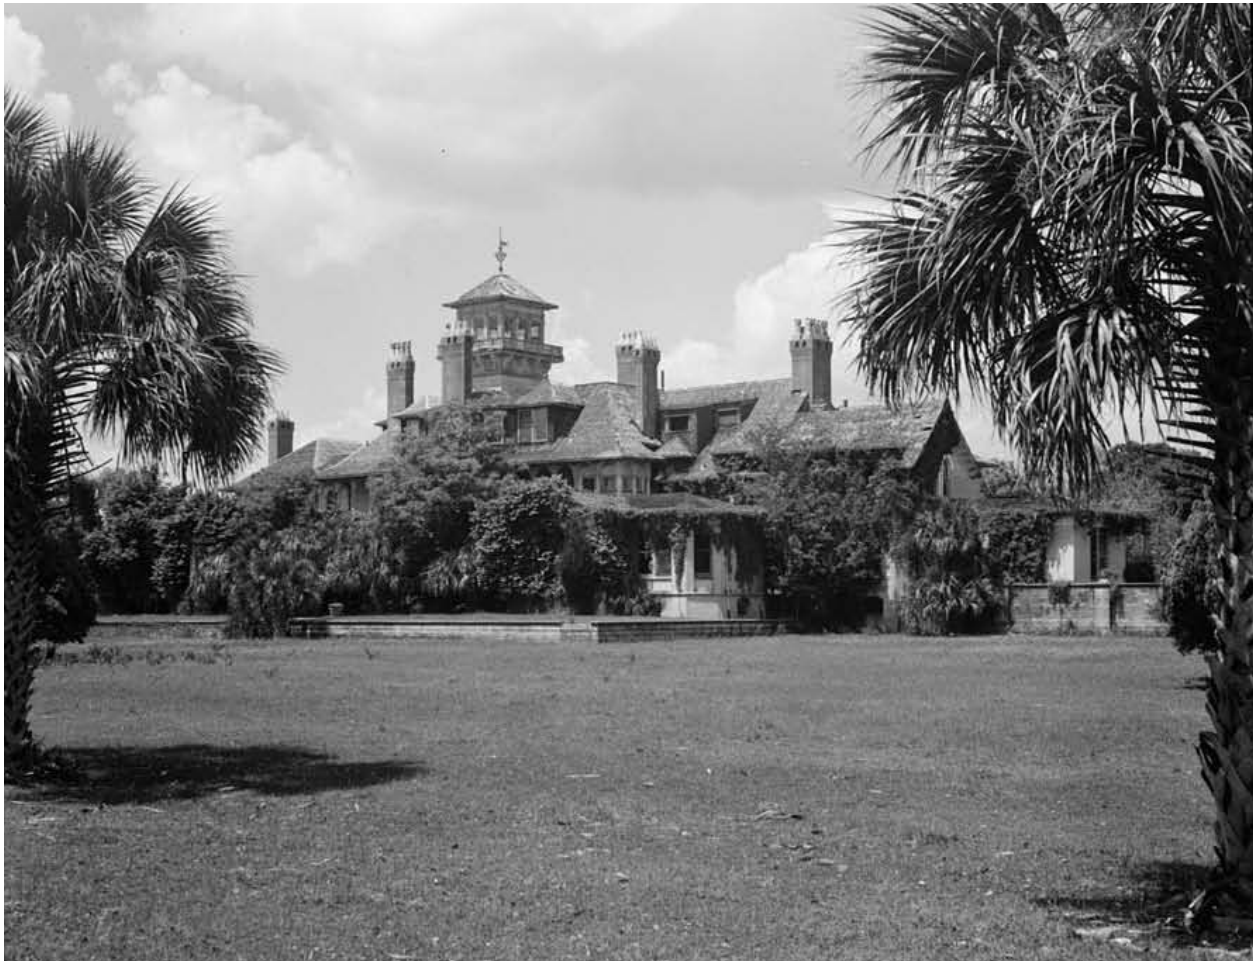
Figure 19. Front and north side elevations of Dungeness Mansion prior to ruination (Photo by Philip E. Gardner for the Historic American Buildings Survey, 1958; Available from the Library of Congress at <http://hdl.loc.gov/loc.pnp/hhh.ga0298>; Accessed May 2008).

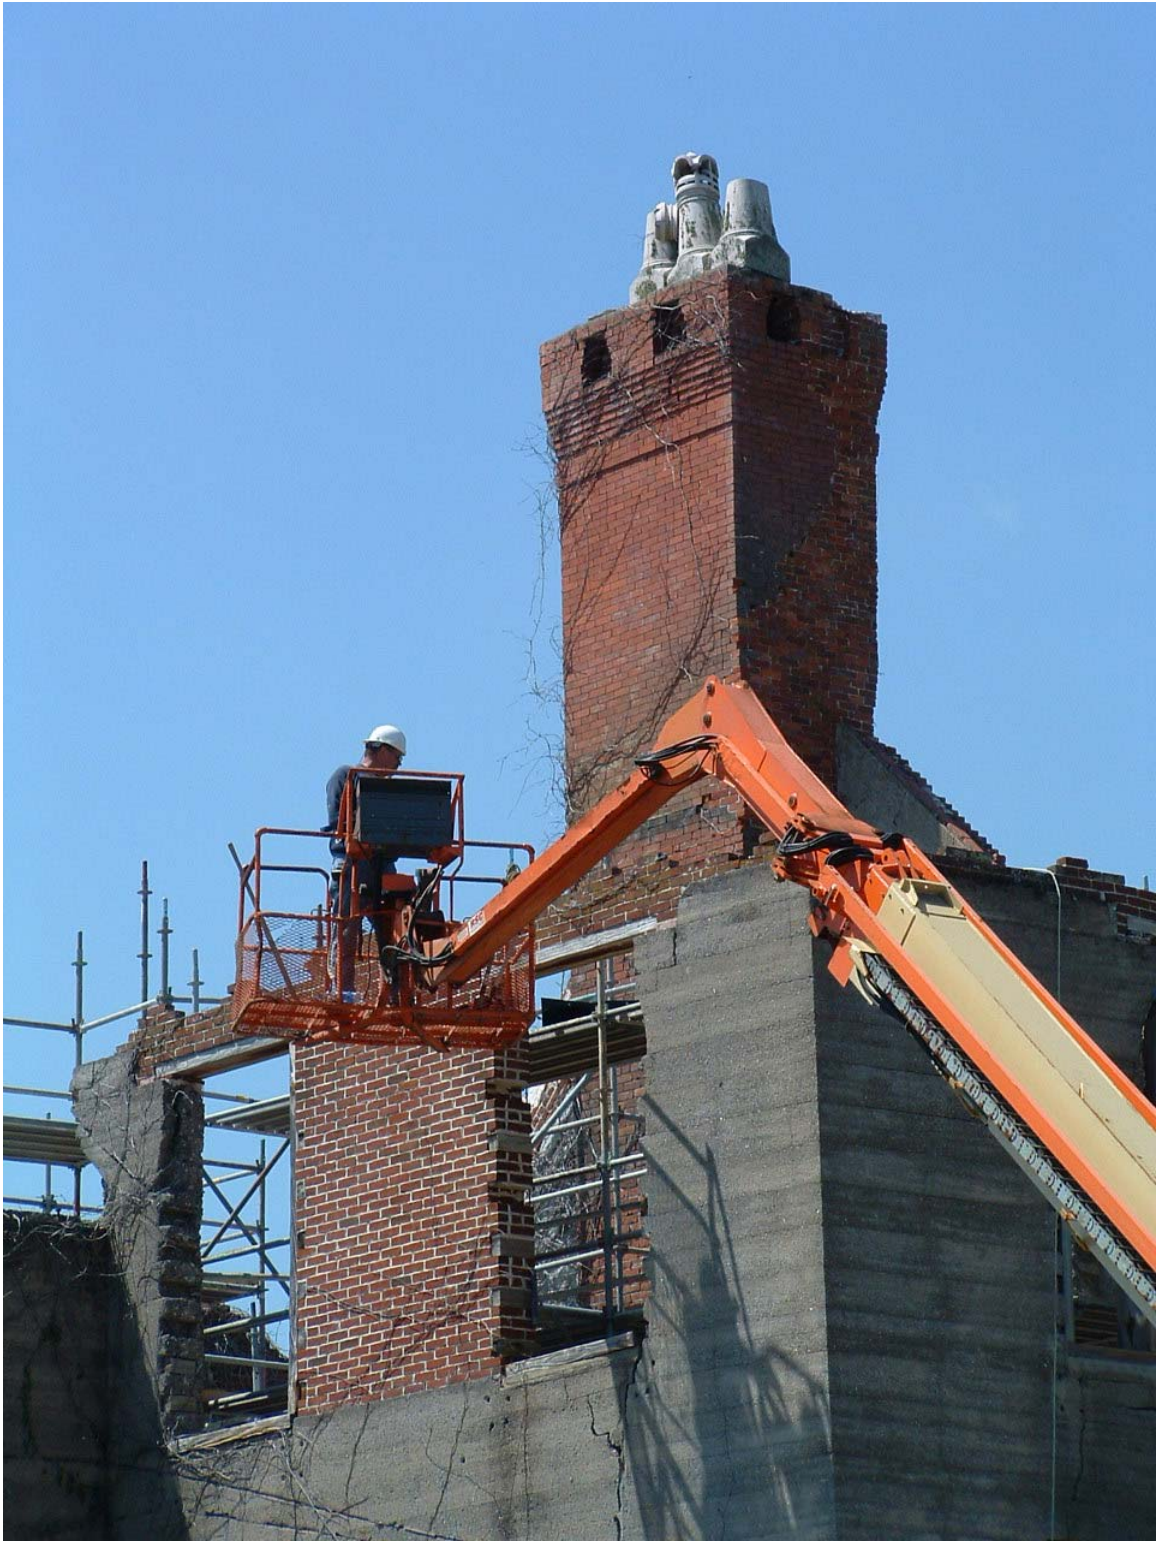
Implementation of the preferred stabilization treatment – stabilization of only the most intact portion of the Dungeness Ruin – is on-going (Figure 20) and completion of the projected is projected for August 2008. The procedure has been governed strictly, and excerpts from the “Dungeness Ruins Stabilization, Cumberland Island National Seashore, Project Manual, January 2006,” including specification “Section 04911 – Brick Masonry Repair and Replacement” and “Section 04916 – Repointing with Cement Lime Mortar,” are attached to this report as *Appendix B*. These construction documents provide guidance for technical standards appropriate for the treatment of the ruin at Java Plantation.

Figure 20. Brick and mortar conservation treatment at Dungeness Mansion ruins, Cumberland Island, Georgia (Photo by J. Ruck, March 2008).

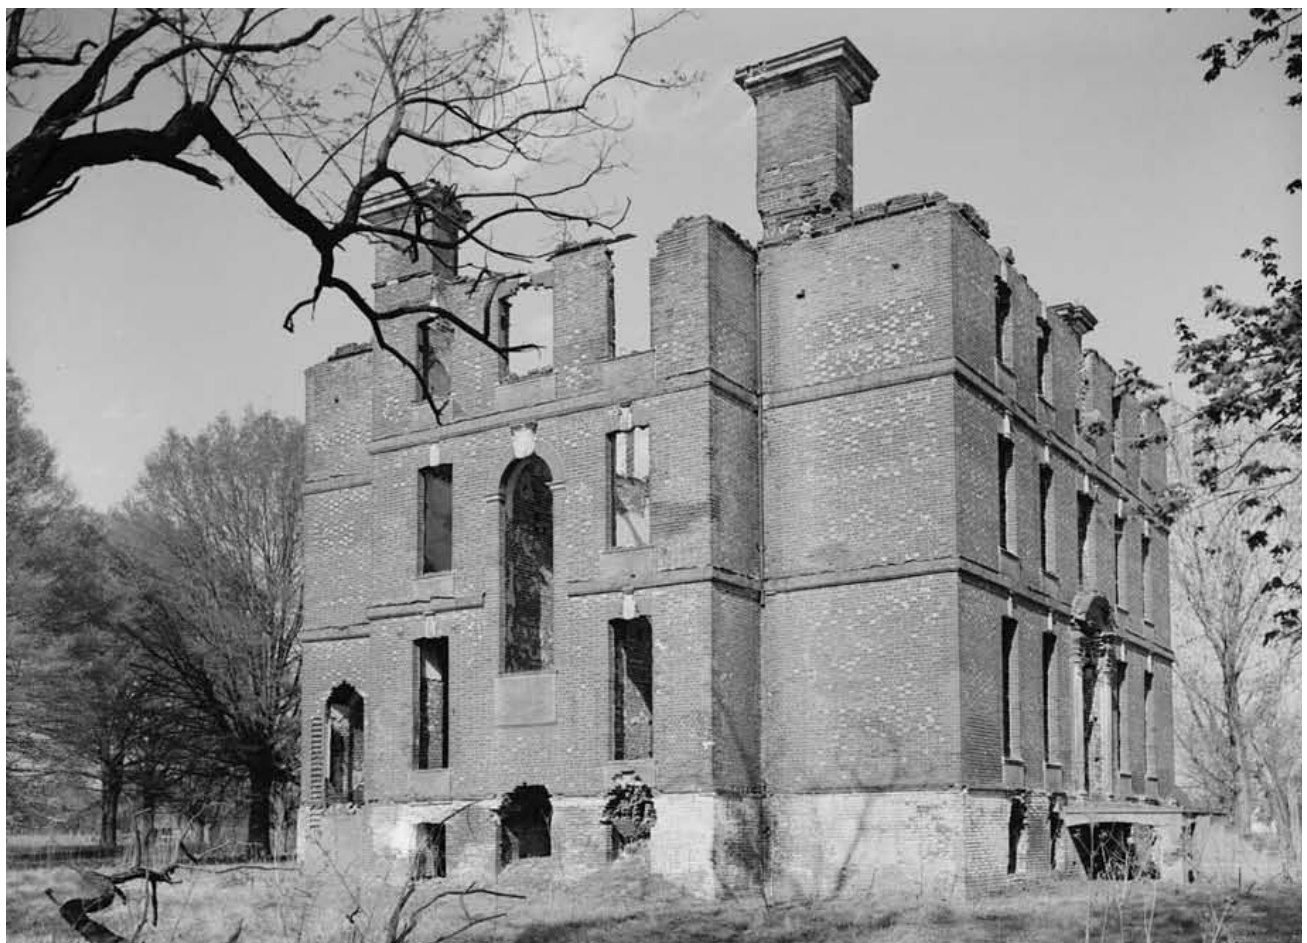
Figure 21. Photographic documentation of the Rosewell ruins; Created for the Historic American Buildings Survey at an unknown date (Available from the Library of Congress at <http://hdl.loc.gov/loc.pnp/hhh.va0475>; Accessed May 2008).

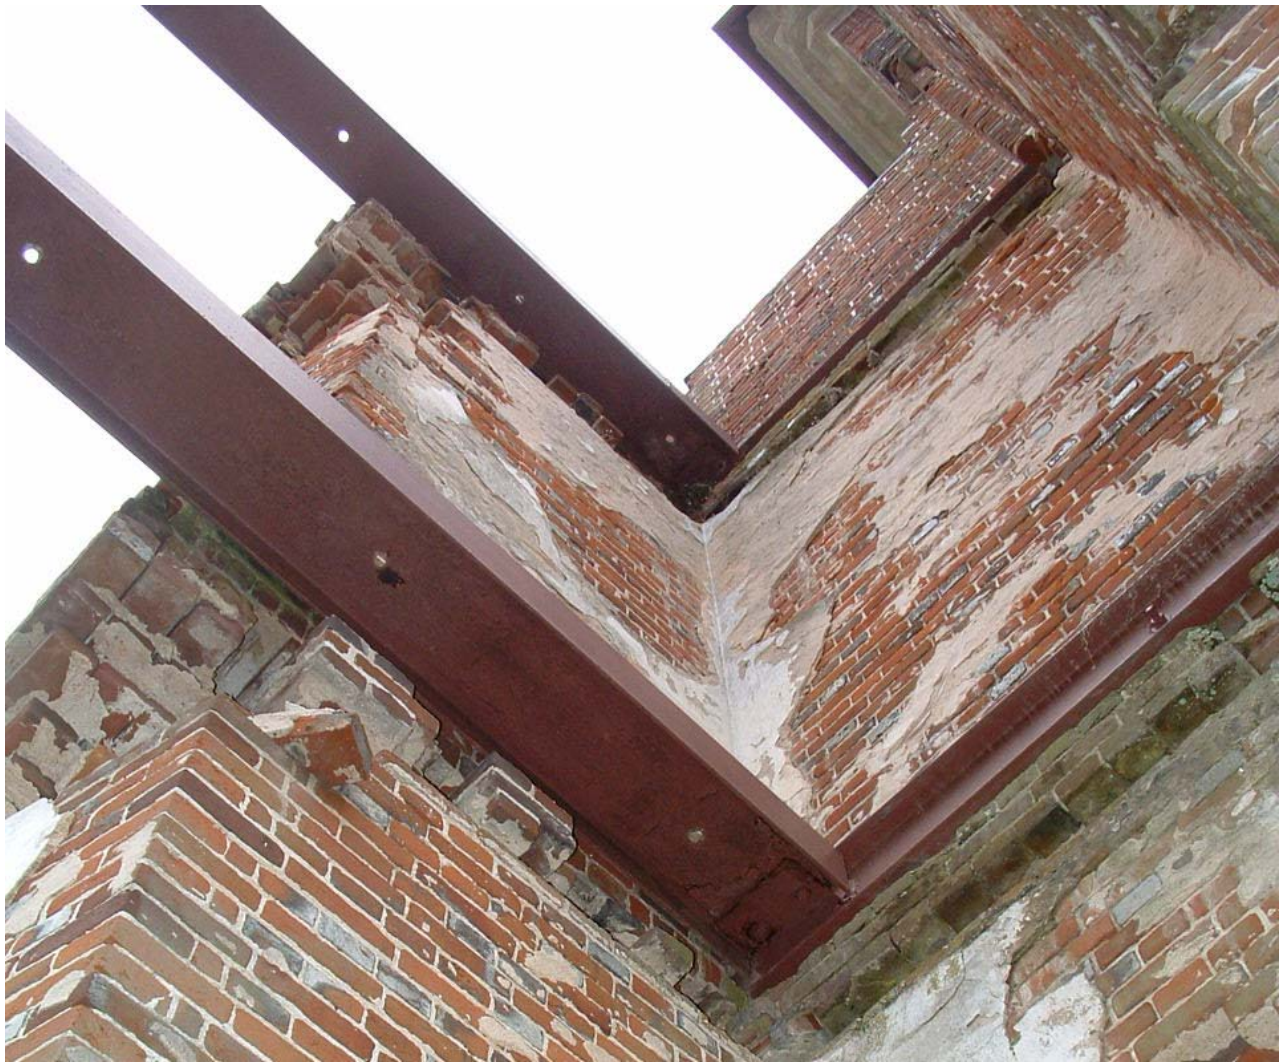
Figure 22. Steel structural reinforcement utilized for stabilization of Rosewell ruins in Gloucester, Virginia (Photo by J. Ruck, April 2008).

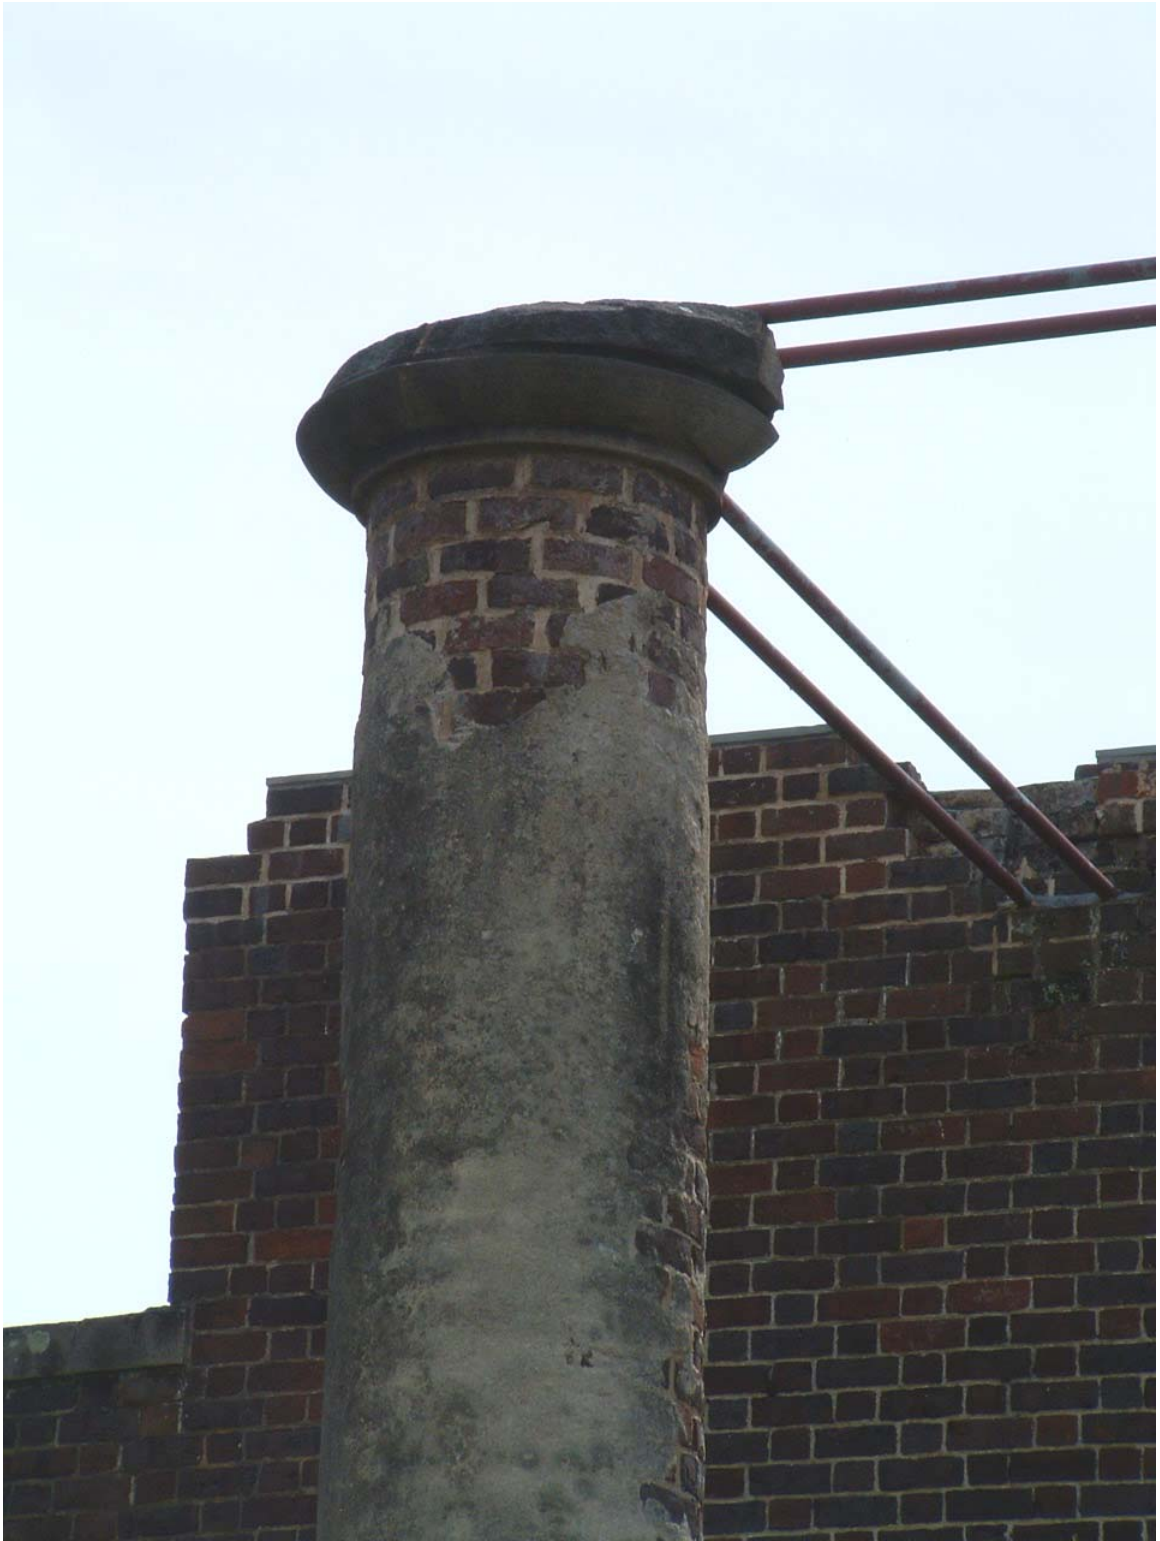
Figure 25. Column of the Old Governor's Mansion at Barboursville Vineyards, with steel reinforcement (Photo by J. Ruck, April 2008).
