Title of Thesis: THE ST. FRANCIS DAM COLLAPSE AND  
ITS IMPACT ON THE CONSTRUCTION OF  
THE HOOVER DAM

Thomas M. McMullen, Master of Science, 2004

Thesis Directed By: Director of Project Management Program, Dr.  
John Cable, Civil Engineering

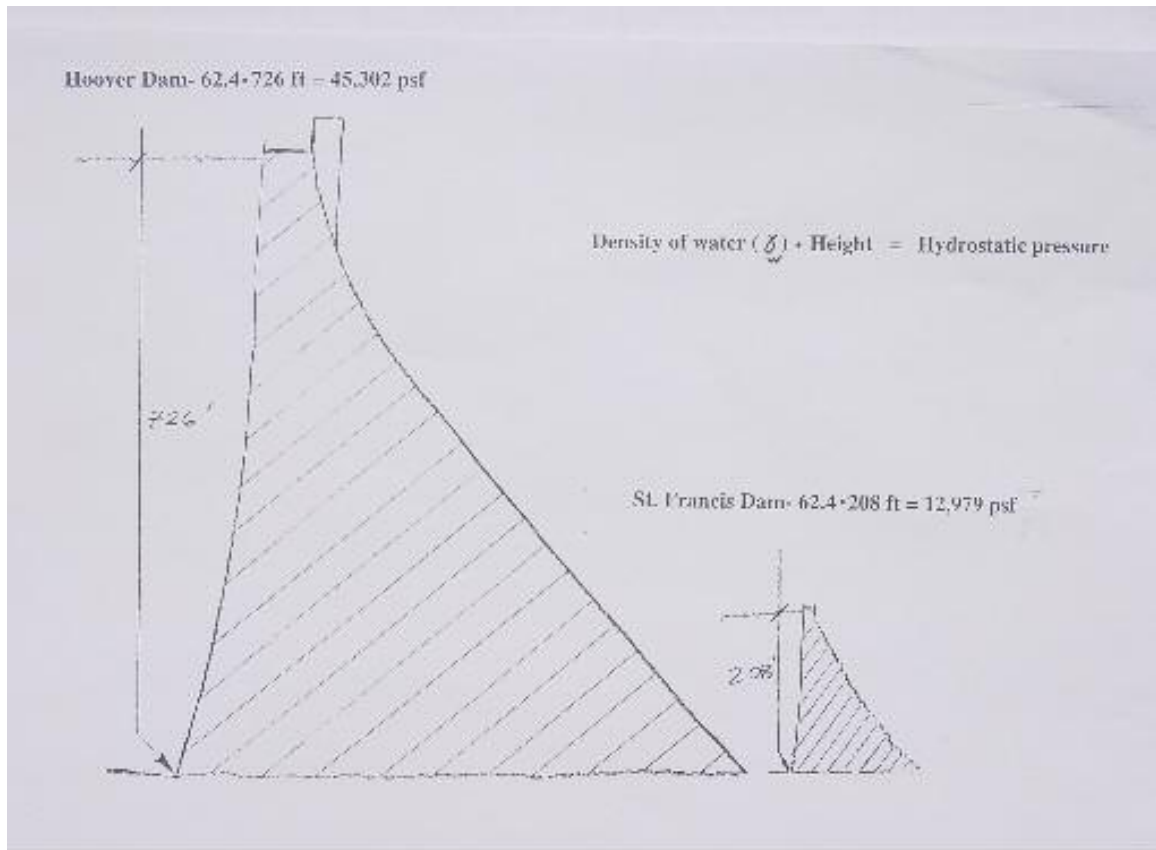
Scale drawings of Hoover Dam and St. Francis Dam with calculations for hydrostatic pressure present at lowest upstream point of structures.

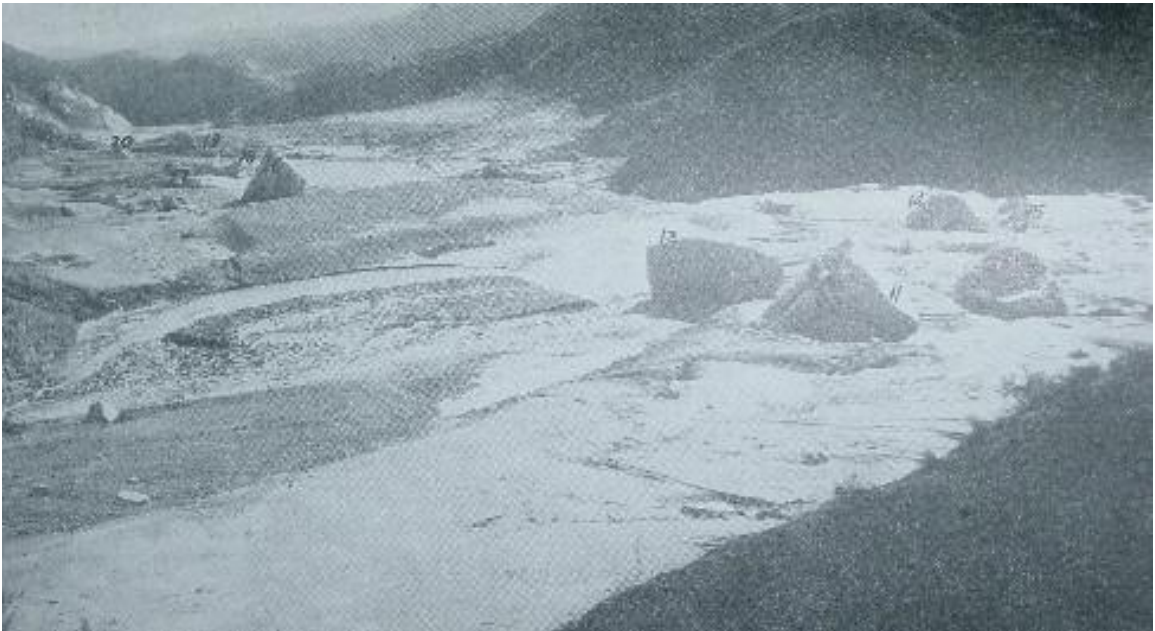
Plate 2 Location of St. Francis Dam fragments after the collapse.

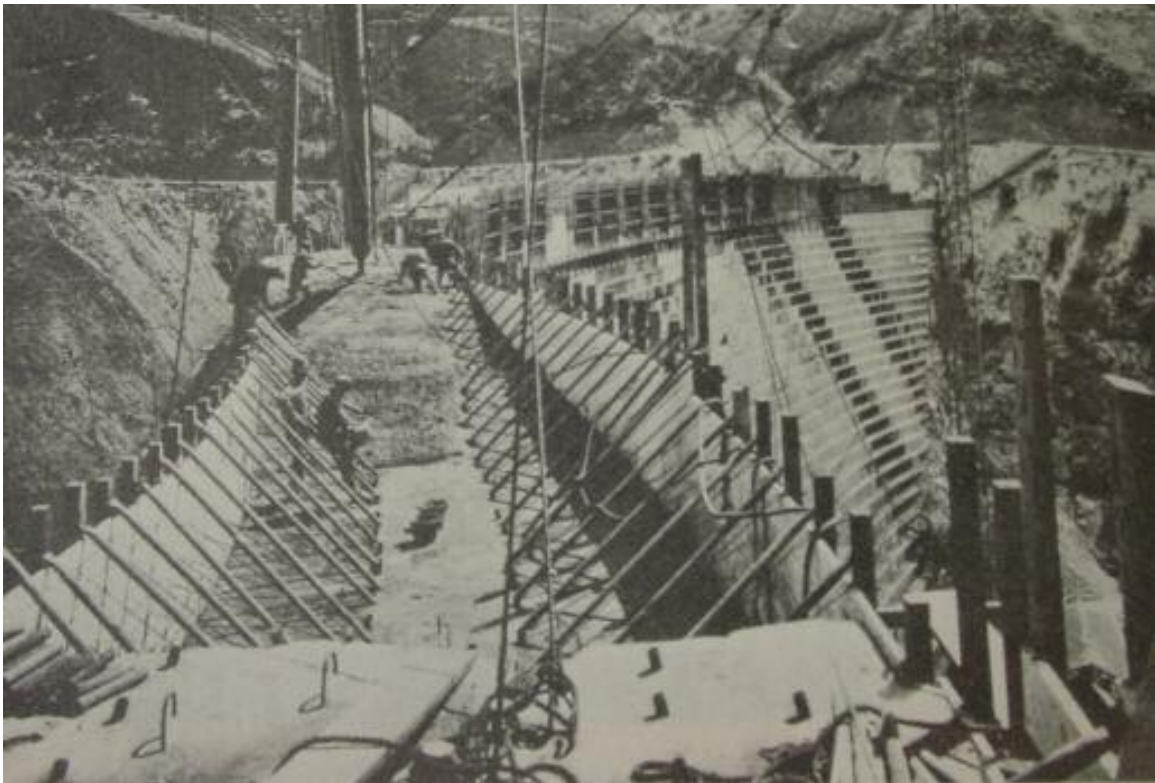
Plate 6 Concrete pour for the St Francis Dam.

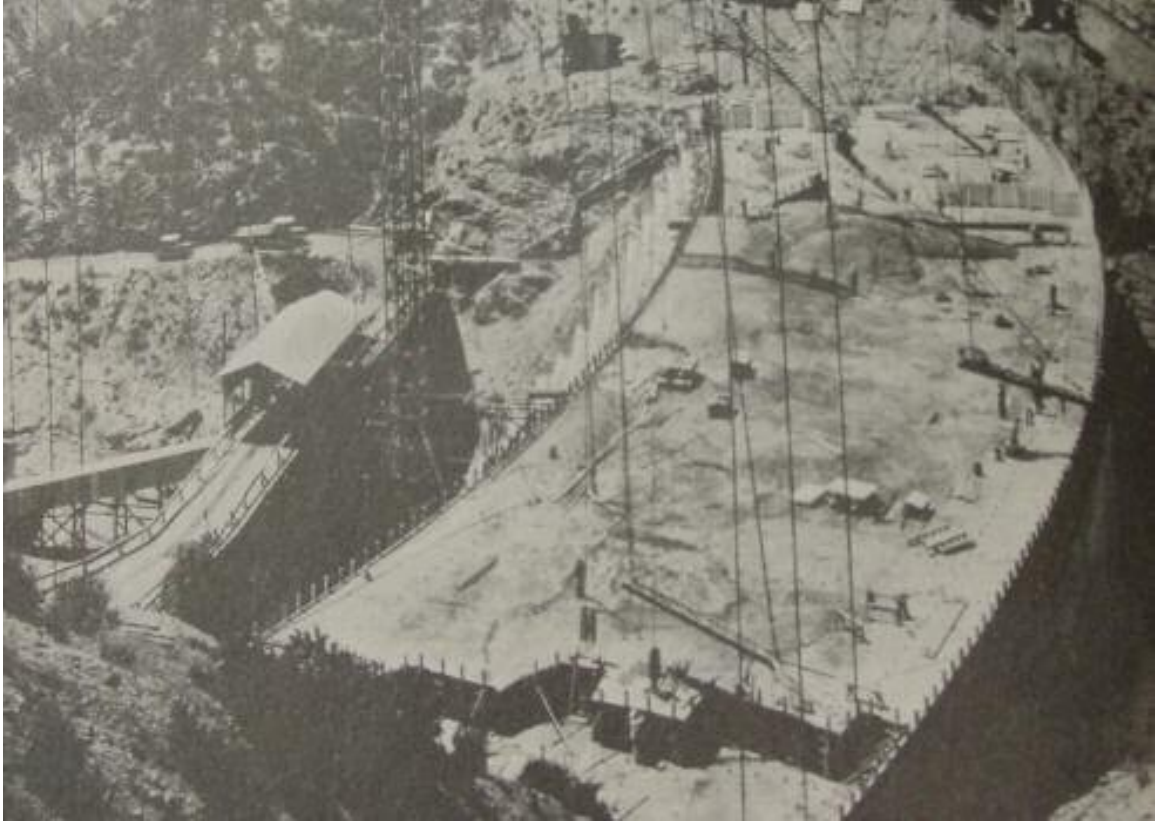
Plate 7 Early view of St. Francis Dam showing, “hummocks”.

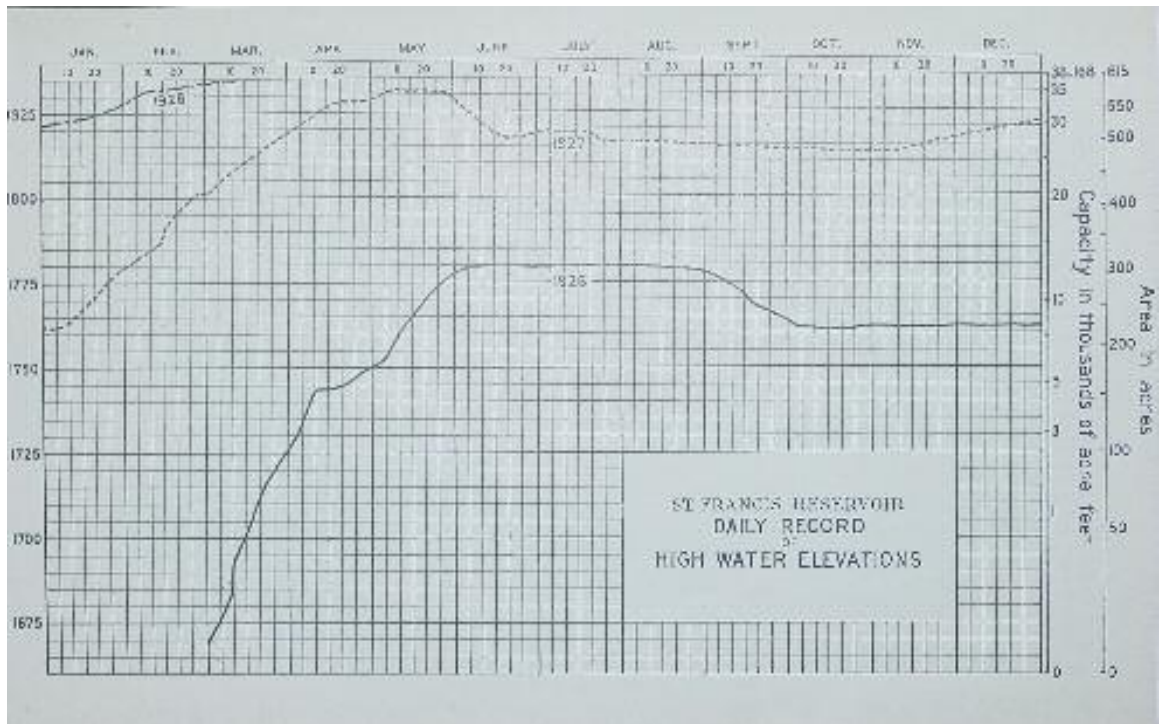
Plate 8 Graph showing water levels in the St. Francis dam on March 12, 1928.

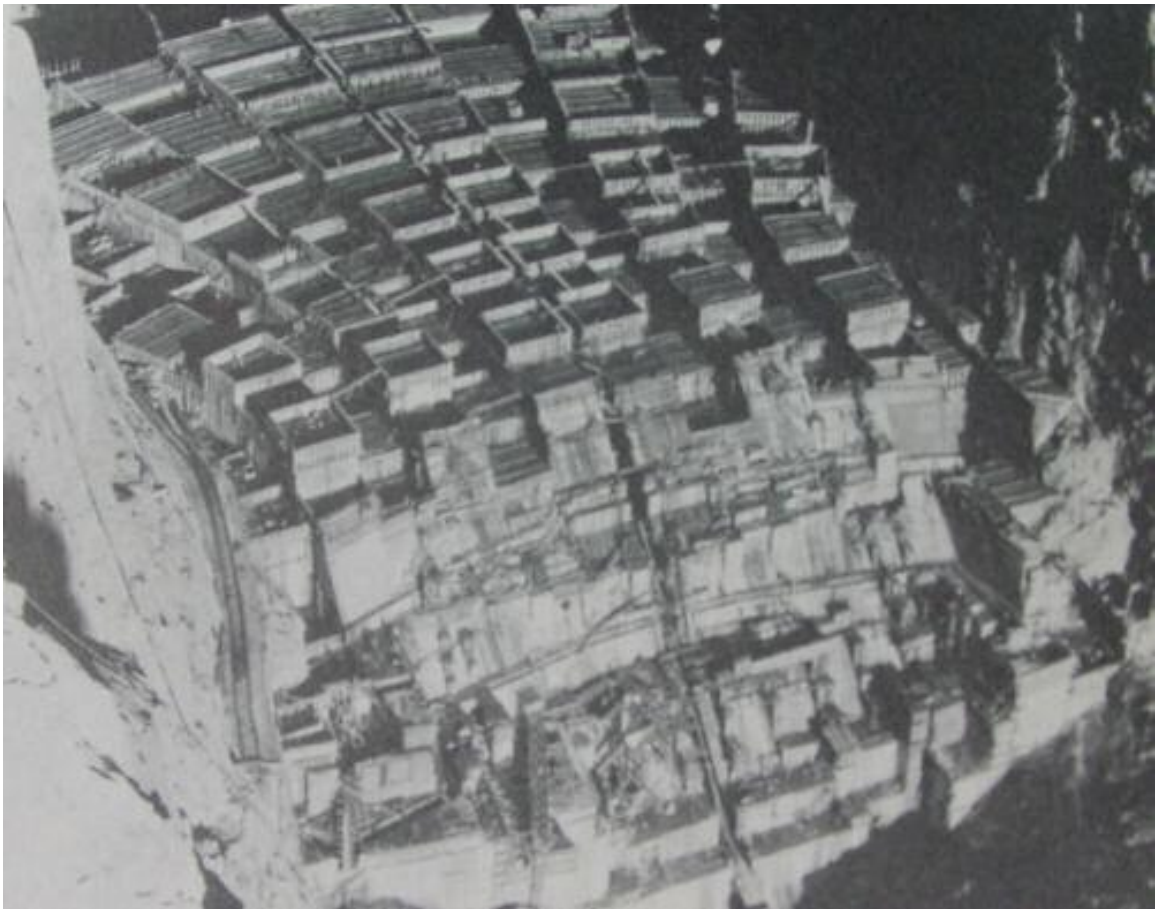
As seen in Plate 11, page 60,<sup>49</sup> pouring in blocks no more than five foot deep gave the Hoover Dam a different look than the pour did for the St. Francis Dam. Although both these dams were built in similar climates with arched-gravity designs, the way the concrete cooled in the St. Francis Dam (in large concrete pours with hummocks to provide tie-in between pours) likely contributed to its sudden break-up after one side

Plate11 Hoover Dam under construction.

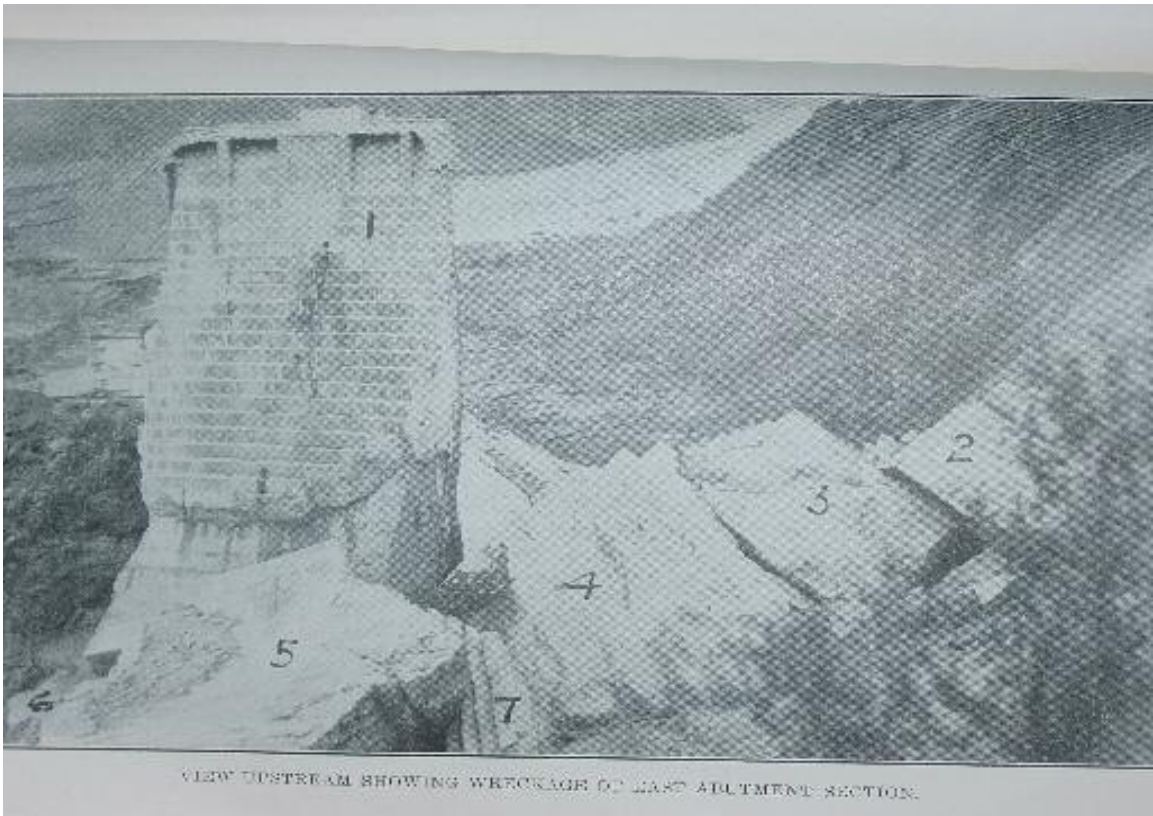
wall of the canyon collapsed. Plate 12, page 61 shows the pieces of the St. Francis Dam spread at its base after the disaster.<sup>50</sup>

Plate 12 St Francis Dam after collapse.

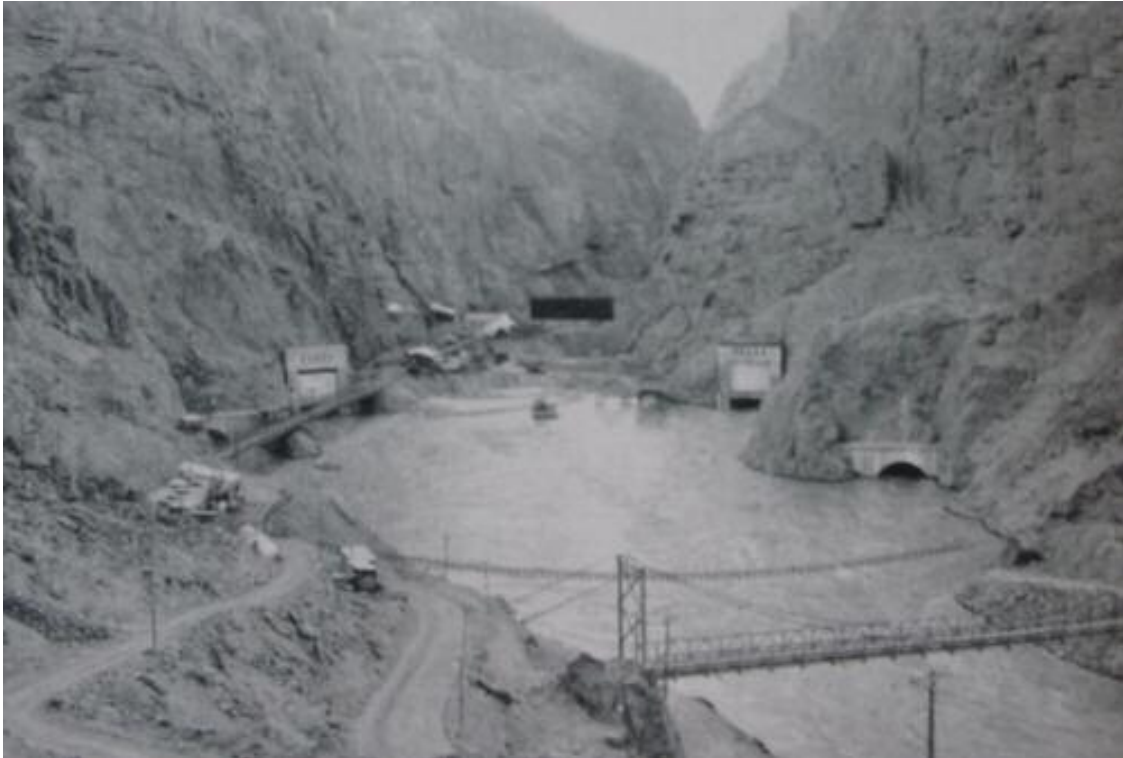
In addition to the restriction on the speed of pouring concrete, the Hoover Dam was designed with honeycombed one inch diameter piping through which river water and then ice cold refrigerated water was pumped until the concrete cooled and stopped shrinking (see Plates 13 and 14, pages 61 and 62). Grout was then used to fill the gaps between the blocks and gaps at the surfaces where the canyon walls and the blocks met. The network of pipes that the water was circulated through was also filled with grout, making the finished dam monolithic in look even though it consisted of many parts.<sup>51</sup> The volcanic tuff composition of the Black Canyon walls allowed the grout tie-in to work incredibly well for the Hoover Dam construction. A cut removed from the junction of the Hoover Dam and the canyon wall on the west side in the 1990s showed how well the slow cooling and grouting worked. Even under microscopic examination, the seam between the Dam and the canyon walls had disappeared and the chemical curing of the concrete has perfectly joined the concrete to the canyon wall. Conversely, the conglomerate rock and mica schist in the side walls of the San Francisquito Canyon would have prevented Mr. Mulholland from ever using grout to adequately tie the St. Francis Dam to the walls of the canyon.

Plate 14 Three hundred foot long cooling plant (black building) located on lower coffer dam.

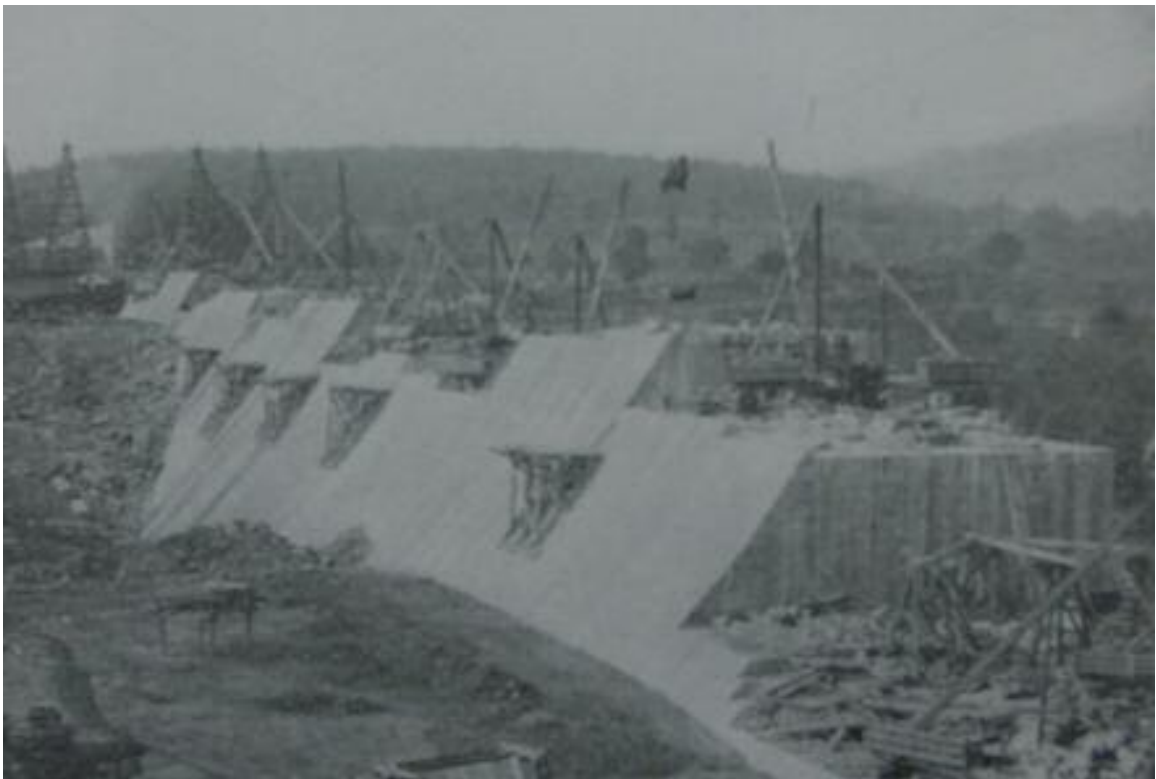
In Smith's book, pictures of the Olive Bridge Dam (Plate 15, page 62)<sup>53</sup> show a dam under construction as early as 1910 with contraction joints and vertical steps. These features were both missing in the construction of the St. Francis Dam.<sup>54</sup> Contraction "cracks" did exist in the St. Francis Dam. Two of those cracks extended vertically through the Dam, one was 58 feet to the west of the outlet gates and another approximately the same distance to the east. Incredulously, these cracks had been packed with oakum and grouted after the Dam was completed; on Plate 16, page 63<sup>55</sup> the cracks are visible in the completed Dam from the downstream side. Not surprisingly, the cracks match perfectly the outline of the standing monolith after the failure<sup>56</sup> (see Plate 17, page 63).<sup>57</sup> Several other cracks occurred in the completed St. Francis Dam. One of these further to the east end of the Dam opened in late December 1927. Another crack

Plate 15 Olive Bridge Dam construction circa 1910.

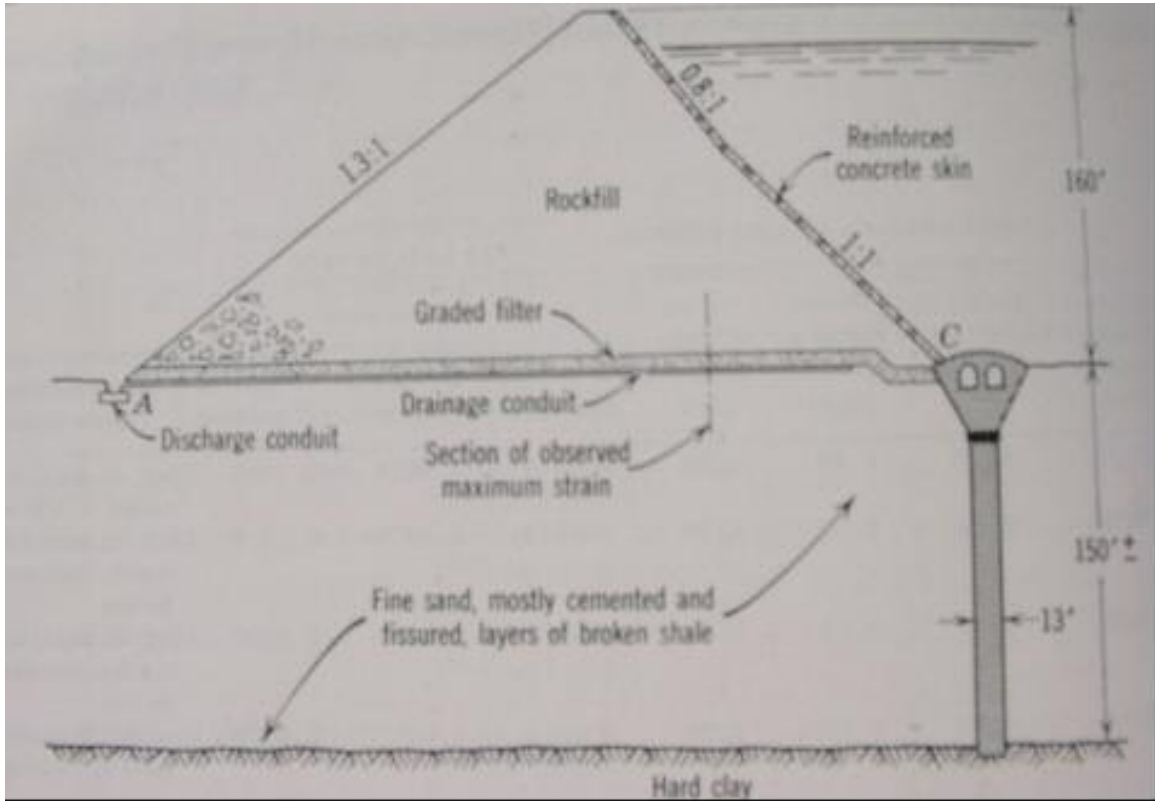
grouted and the same result would be accomplished. Early in 1912, the Portland (Oregon) Railway, Light and Power Company built a dam in the western U.S. which included a cut-off wall over 60 feet deep created by pressure grouting. Five hundred and fifty five holes, 2 3/8" in diameter and over 60 feet deep were drilled and then grouted up to 200 psi to create a cut-off wall and seal the dam's foundation (see Plate 18, page 64).<sup>62</sup>

Plate 18 Example of generic cut-off trench under a dam.

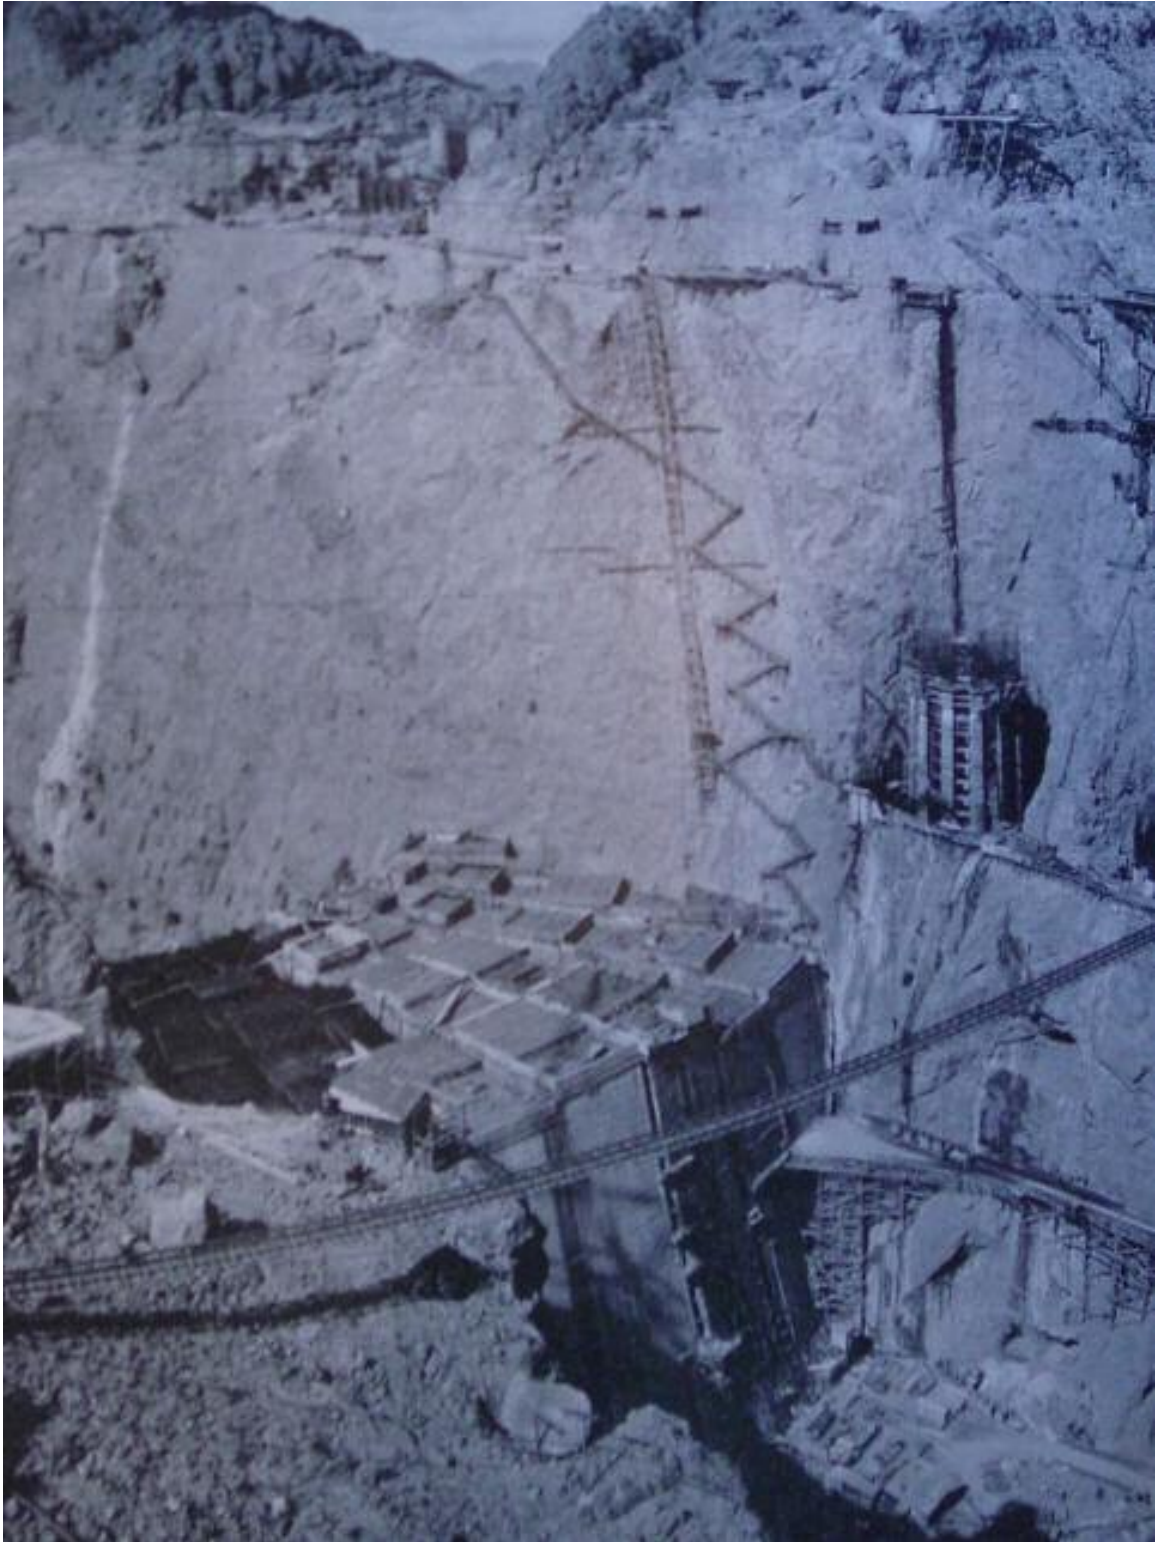
The west abutment can be seen on Plate 22, page 67.<sup>79</sup>

Plate 22 View of Hoover Dam west abutment.
