Title of Document: CHARACTERIZATION OF DELAYED
ETTRINGITE FORMATION IN MARYLAND
BRIDGES

Micah Shalom Ceary, Ph.D., 2007

CHARACTERIZATION OF DELAYED ETTRINGITE FORMATION IN
MARYLAND BRIDGES

Dissertation submitted to the Faculty of the Graduate School of the
University of Maryland, College Park, in partial fulfillment
of the requirements for the degree of
Doctorate of Philosophy
2007

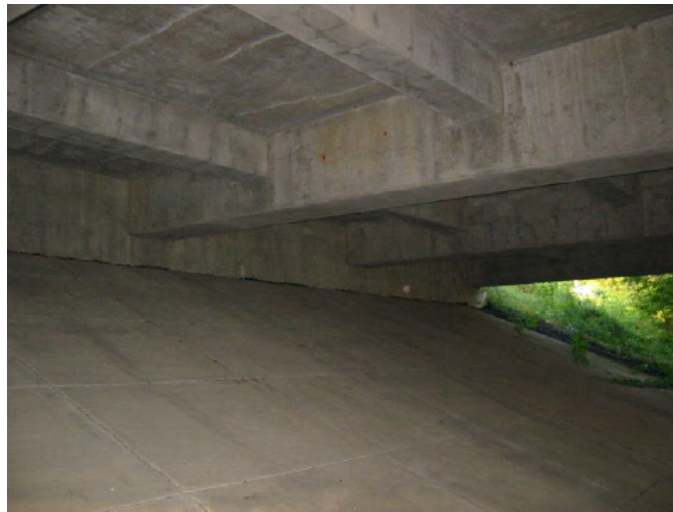
Figure 3.4: Test Location (2203201 – US 13 NB over MD 346)

Bridge 2203201 is a three span structure built in 1972, with 32 foot end spans supported by cast-in-place concrete girders and 76 foot center span carried by steel beams. Testing was performed on the center concrete girder of the south end span, see Figure 3.4. The concrete girders exhibited minor map cracking (hairline cracks), see Figure 3.5 for a close-up of the side of the girder.

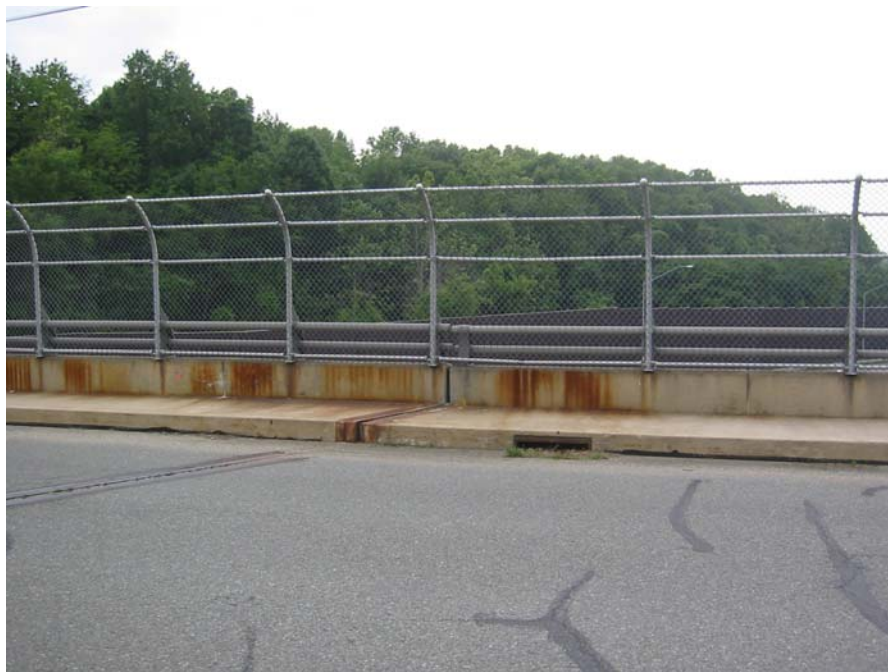
Figure 3.7: General Test Location (1511300 - Greentree Rd over I-495)

Greentree Road bridge over I-495 (Capital Beltway) is a four span steel beam structure built in 1962 with 40 foot northern end span, 2 – 74 foot center spans, and a 48 foot southern end span. The roadway width for Greentree Road is 30 feet with sidewalks on both sides, and testing was conducted on the inside face of the west parapet wall on the span over I-495 Outer Loop. The parapet and sidewalk show heavy rusting possibly due to previous fencing and exhibit minor to severe map cracking throughout with occasional locations of efflorescence, see Figures 3.7 and 3.8 for the general test location and Figure 3.9 for a close-up.

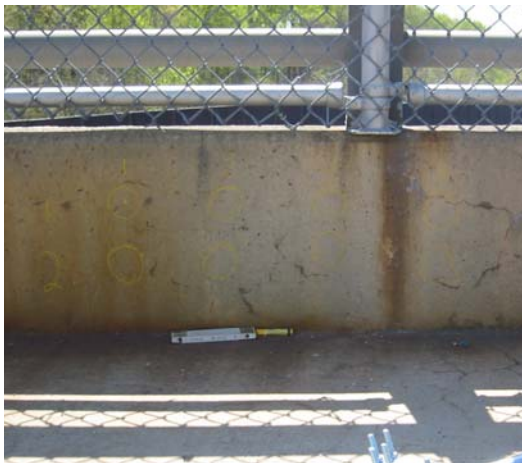
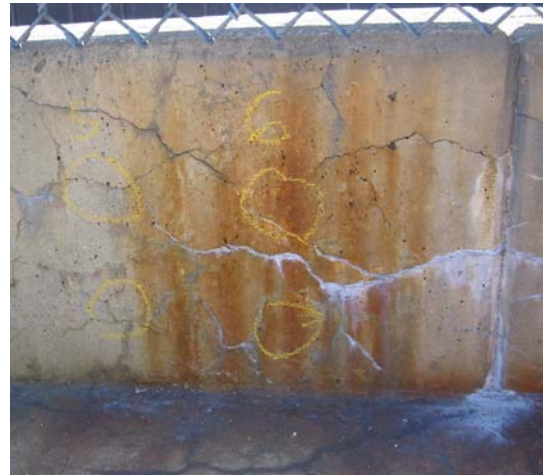
Figure 3.9: Greentree Rd over I-495 (1511300)

Two locations were identified for testing, a “clean” location which is a baseline reference location with as little map cracking as possible and a “dirty” location which exhibits heavy map cracking. This step is preformed for all bridges were possible. Some bridges exhibited a more uniform distribution of cracking which made the clean location must harder to select. Bridge 1511300 exhibited drastic difference between the clean and dirty locations.

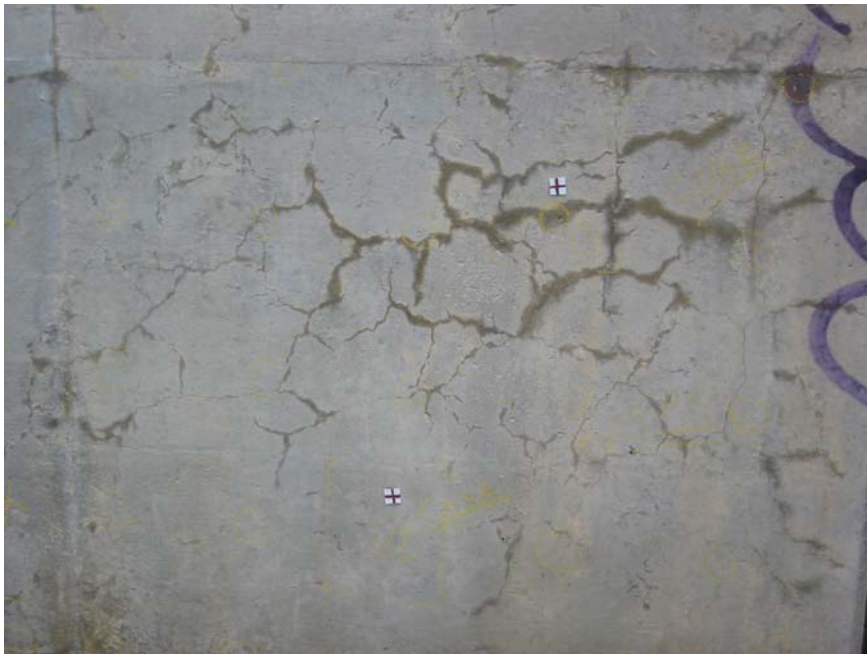
Figure 3.12: Test Location (1600400 - US 1 over Paint Branch)

Bridge 1600400 is a two span steel girder structure built in 1980 with a roadway width of 68 feet not including sidewalks along both sides, and 2 -80 foot spans; see Figure 3.10 for general testing location and Figure 3.11 for bridge elevation. The test was preformed on the northwest wingwall, which exhibited moist map cracking throughout the wingwall see Figure 3.12.

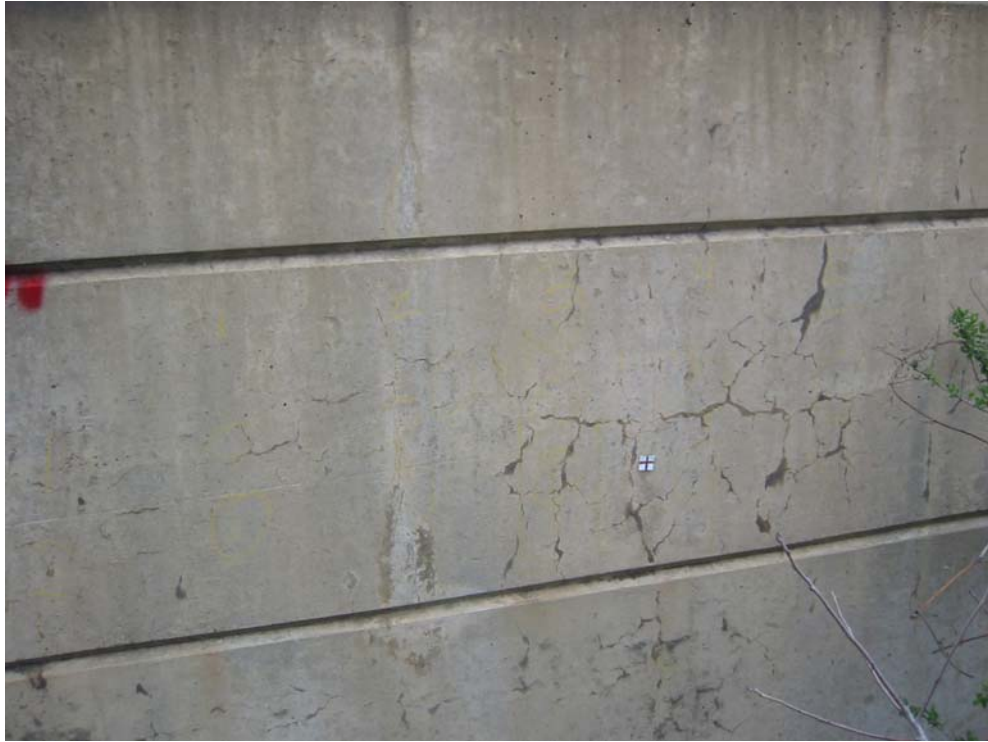
Figure 3.14: Test Location (1620003 – MD 198 over I-95)

Bridge 1620003 is a four span steel girder structure over I-95 built in 1971 and has a roadway width of 52 feet, with a 57 foot northern end span, a 137 foot northern center span, a 157 foot southern center span, and a 105 foot southern end, see Figure 3.13. The test was preformed on the exterior side of the southwest parapet wall above the southwest wingwall, see Figure 3.14. The parapet and wingwall exhibited moist map cracking at random locations throughout the wingwall and parapet. A thorough visual inspection of the exterior side of the south parapet wall for map cracking was not possible due to the heavy traffic volume on I-95.

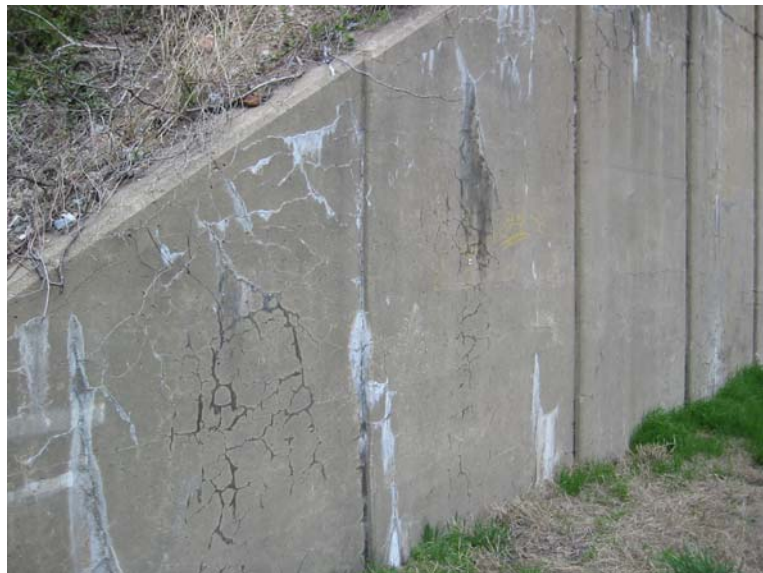
Figure 3.16: Test Location (0311100 - CSX Transportation over I-695)

CSX Transportation bridge over I-695 (Baltimore Beltway) is a two span steel girder structure built in 1957 with 2 - 75 foot spans and a roadway width for CSX Transportation of 57 feet and 4 inches, see Figure 3.15. Testing was conducted on the northwest wingwall. The wingwall exhibits minor to severe map cracking throughout with occasional locations of efflorescence, see Figure 3.16.

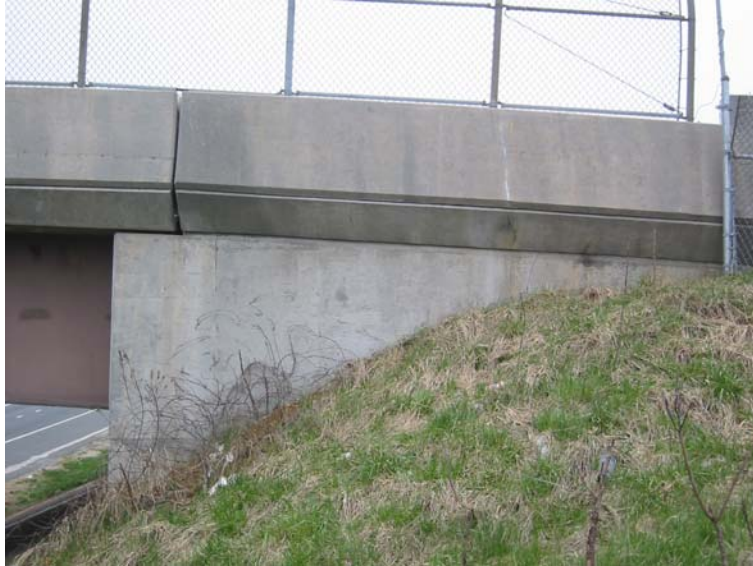
Figure 3.18: Test Location (0314200 - Old Court Rd over I-695)

Old Court Road bridge over I-695 (Baltimore Beltway) is a two span steel girder structure built in 1983, with a 137 foot eastern span, a 161 foot western span, and a roadway width for Old Court Road of 50 feet wide not including sidewalks on both sides, see Figure 3.17. Testing was conducted on the outside face of the north parapet wall over the northwest wingwall. The parapet wall exhibits minor map cracking in scattered locations, see Figures 3.18 and 3.19.

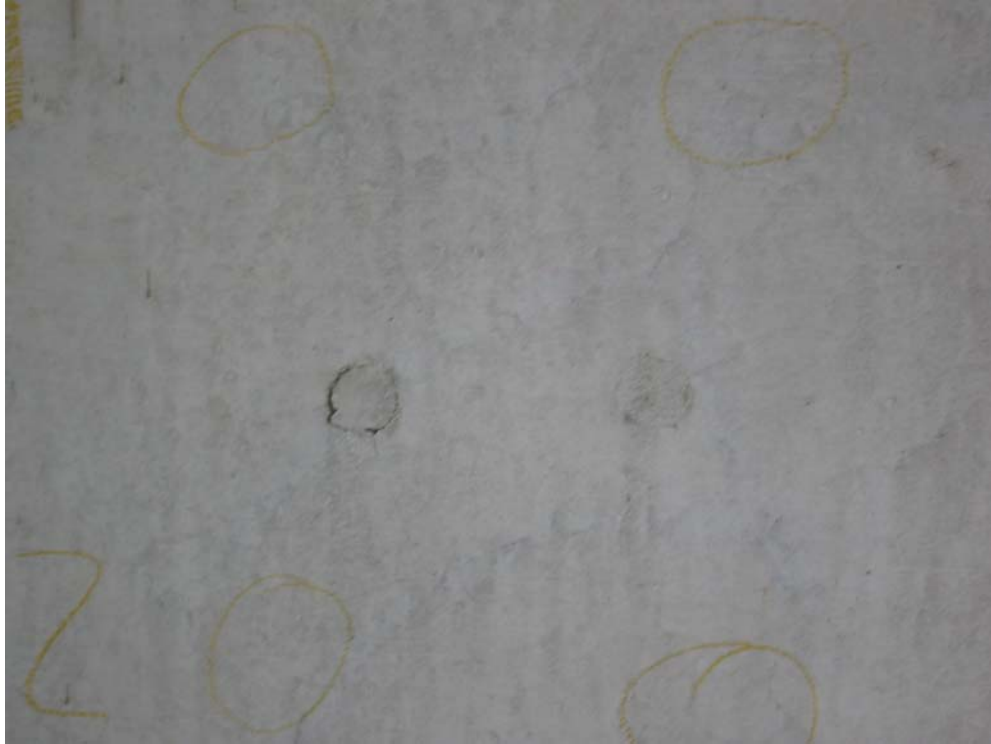
Figure 3.21: I-795 over Franklin Blvd. (0333402)

Bridge 0333402 is a two span steel girder structure built in 1985, with a 73 foot northern span, a 90 foot southern span, and a roadway width for I-795 of 50 feet wide, see Figure 3.20. Testing was conducted on the south side of the median pier. The pier exhibits minor map cracking in scattered locations and has been epoxy coated, see Figure 3.21.

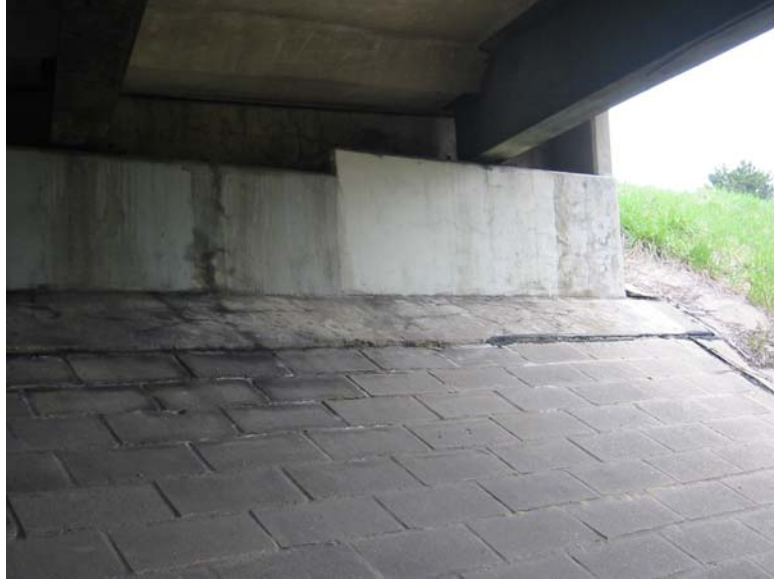
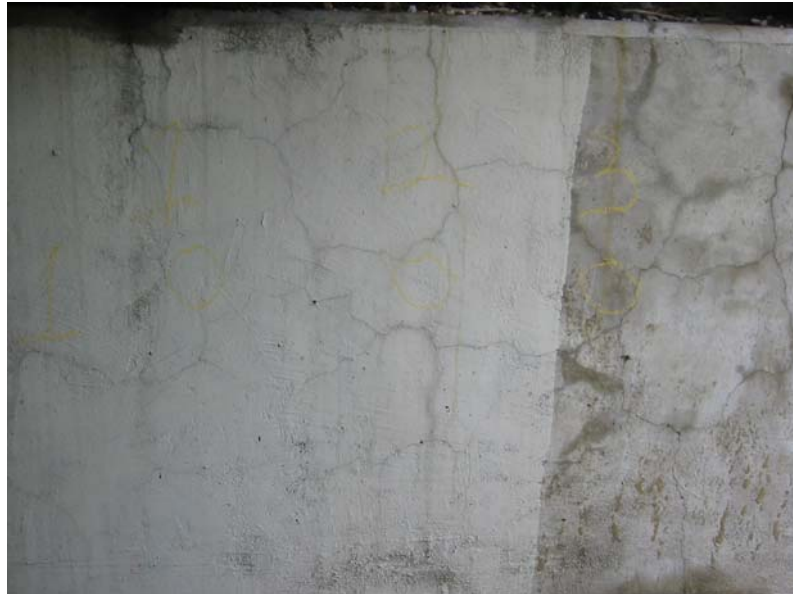
Bridge 0208303 is a four span steel beam structure built in 1985, with 33 feet end spans, 44 feet center spans, and a roadway width for MD 100 of 30 feet wide. Testing was conducted on the west abutment. The abutment exhibits minor map cracking in scattered locations and has been partially epoxy coated, see Figures 3.22 and 3.23.

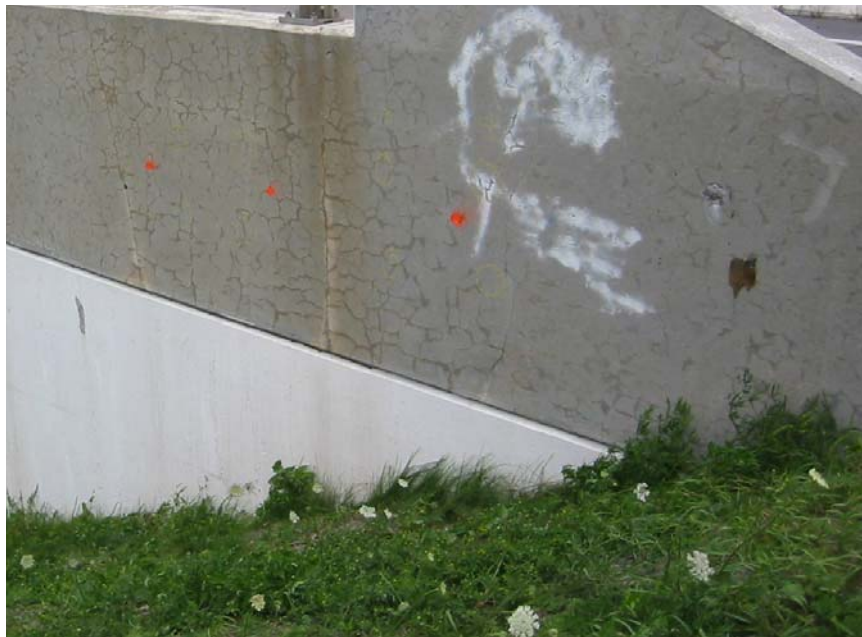
Figure 3.27: Test Location (1102100 - US 219 over Deep Creek Lake)

US 219 over Deep Creek Lake is a three span steel girder structure built in 1987, with 210 feet end spans, 260 foot center span, and a roadway width for US 219 of 40 feet wide, see Figure 3.26. Testing was conducted on the northwest wingwall. The wingwall exhibits minor map cracking throughout, see Figure 3.27.

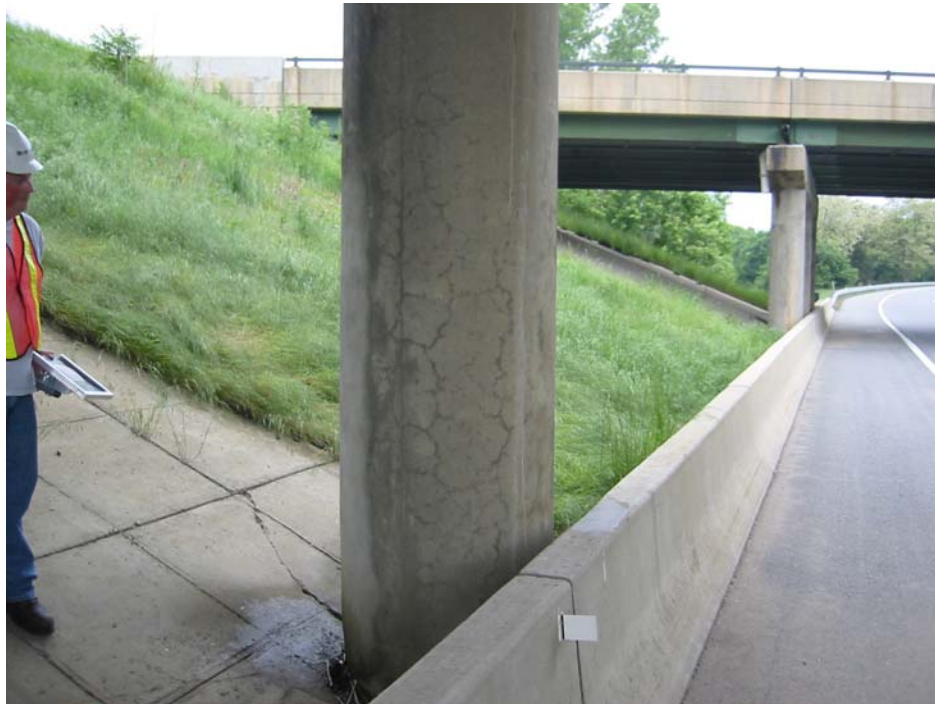
Figure 3.28: Test Location (2111504 - I-70 WB over MD 632)

I-70 westbound bridge over MD 632 is a four span steel beam structure built in 1966 with a 38 foot eastern end span, 2 – 47 foot center spans, a 41 foot western end span, and a roadway width for I-70 WB of 40 feet. Testing was conducted on the eastern pier. The dirty location was on the southern column, and the clean location was on the center column. The southern column exhibits minor map cracking throughout, see Figure 3.28.

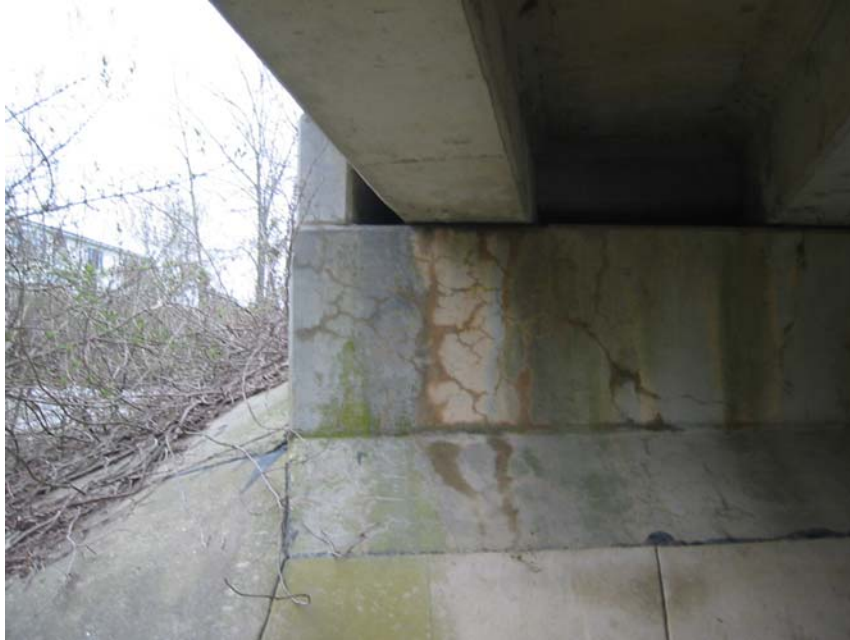
Figure 3.30: Test Location (0605800 – Ladiesburg Road over Little Pipe Creek)

Bridge 0605800 is a three span concrete girder structure built in 1965, with 3 - 35 foot spans and a roadway width for Ladiesburg Road of 24 feet wide, see Figure 3.29. Testing was conducted on the south abutment. The abutment exhibits minor map cracking in scattered locations, see Figure 3.30.

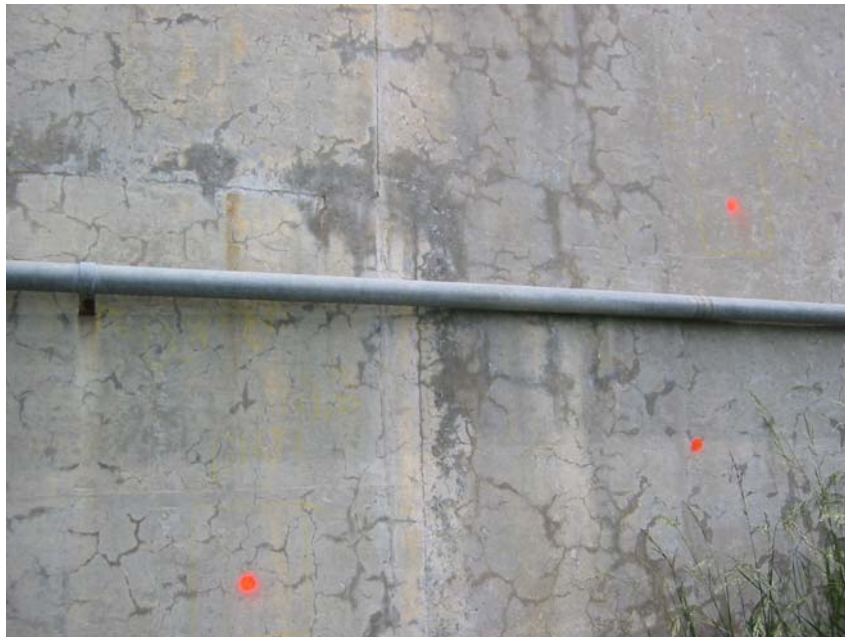
Figure 3.32: Test Location (1311000 - MD 32 EB over US 1)

MD 32 EB bridge over US 1 is a two span steel girder structure built in 1983, with a 111 foot eastern span, a 107 foot western span, and a roadway width for MD 32 EB of 43 feet, see Figure 3.31. Testing was conducted on the southeast wingwall, which exhibited minor map cracking throughout, see Figure 3.32.

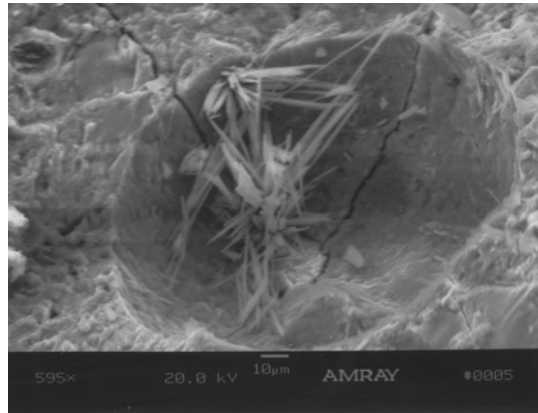
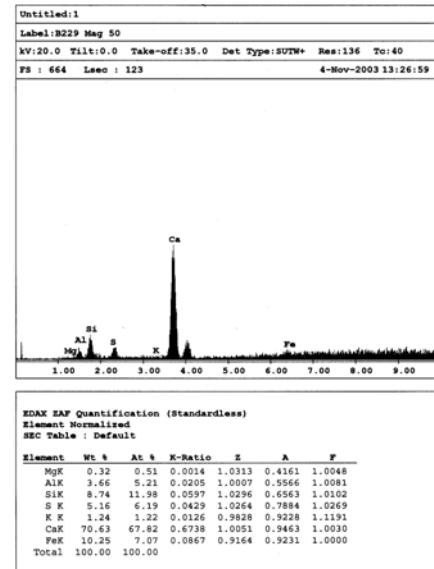
Figure 4.1: Sample Images from SEM and EDAX

(a) Ettringite Crystals in Void – SEM

(b) Analysis of Ettringite Crystals
in Void – EDAX

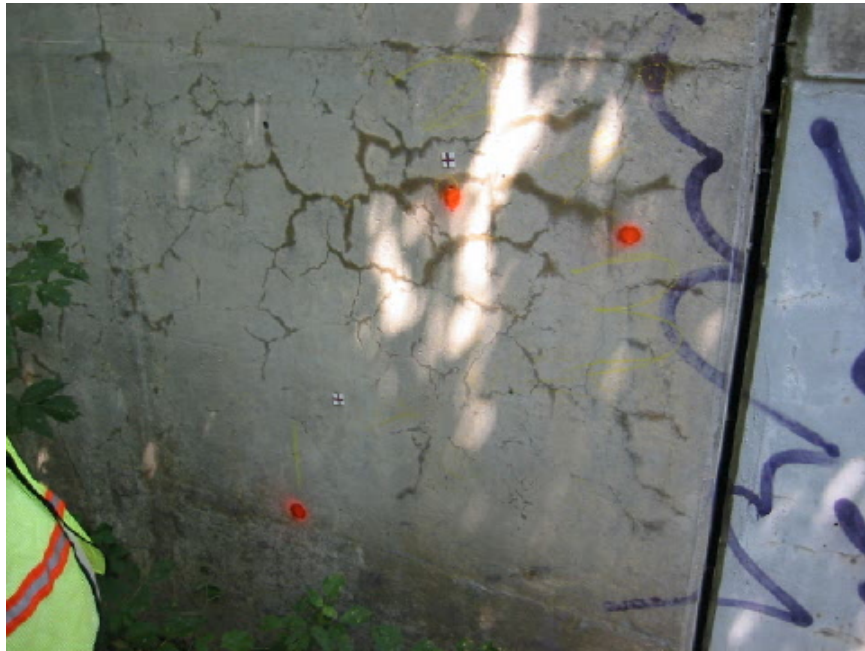
Figure 4.8: Coring Locations (1600400 – US 1 over Paint Branch)

All 3 cores exhibit ettringite formations throughout the samples. Most voids contain ettringite formations. See Figures 4.9 and 4.10. Energy Dispersive Analysis X-ray (EDAX) verifies the elemental composition of the crystal formations by showing the distinct aluminum, sulfur, and calcium pattern. The ettringite formations appear to be hexagonal prismatic morphology in voids and tightly-packed ettringite formation in cracks and on the fractured surface. The three cores do not vary considerably in the type of ettringite formations or in the prevalence of ettringite formations in the samples.

The UV light ASR test confirms the presence of ASR gel in the wingwall.

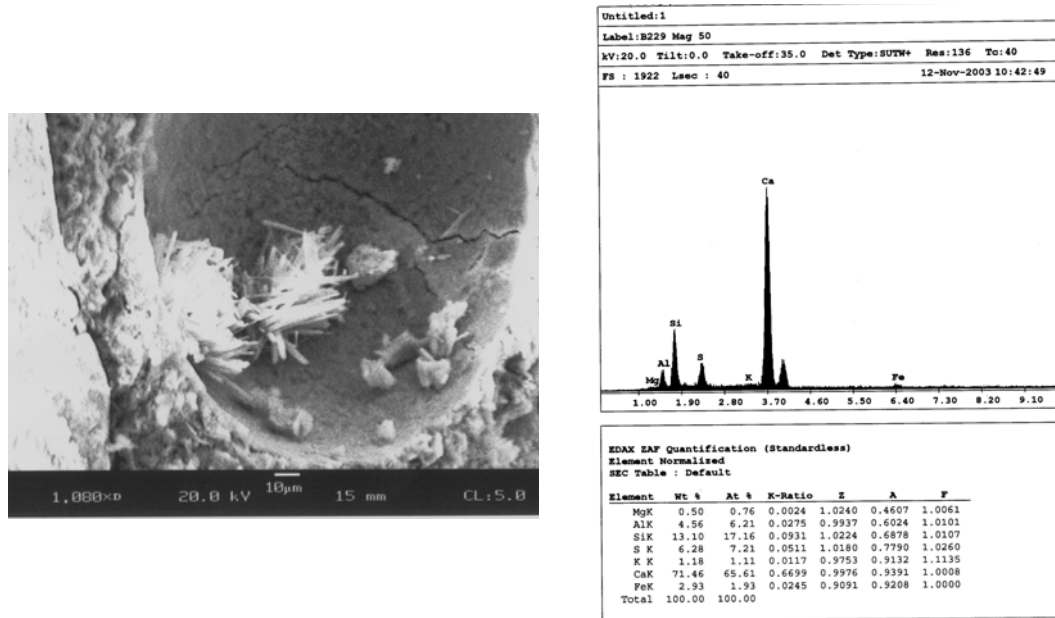
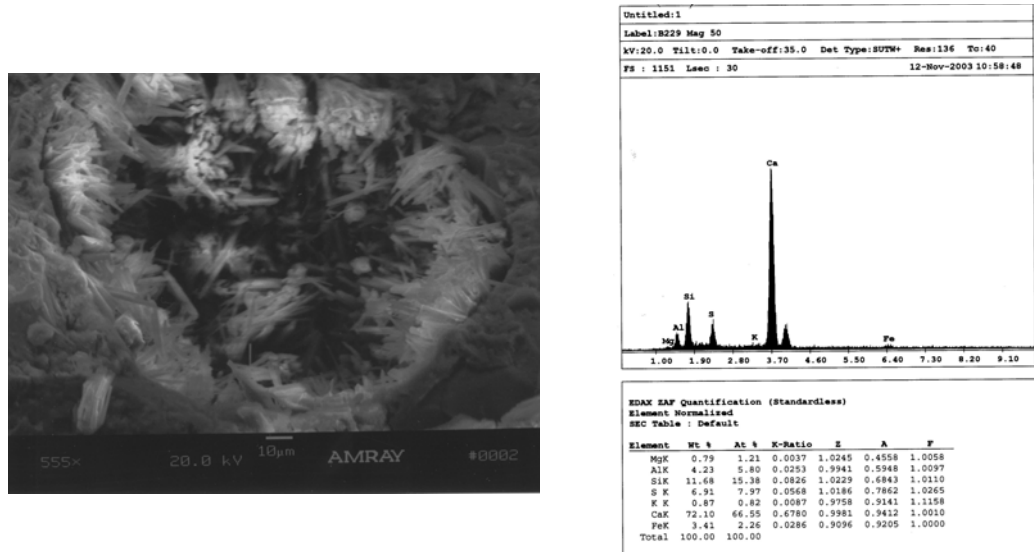
Figure 4.9: US 1 over Paint Branch (1600400)

(a) Ettringite in Void with
Microcracking in the Background

(b) Analysis of Crystals in (a)

(c) Ettringite in Void

(d) Analysis of Whole Picture (c)

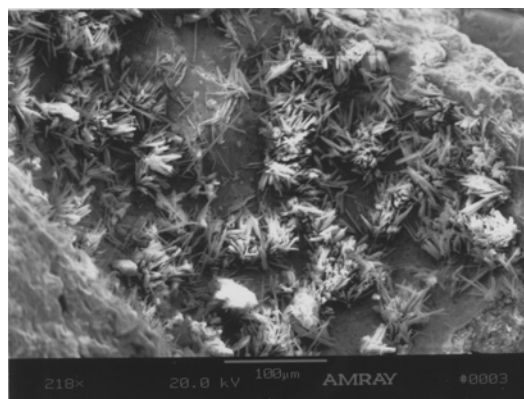
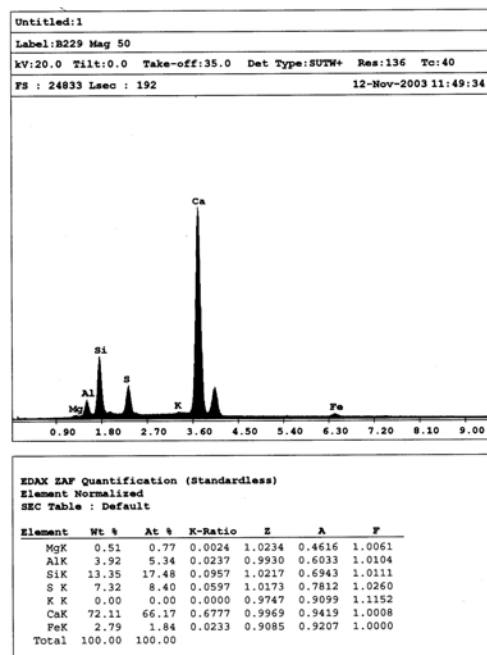
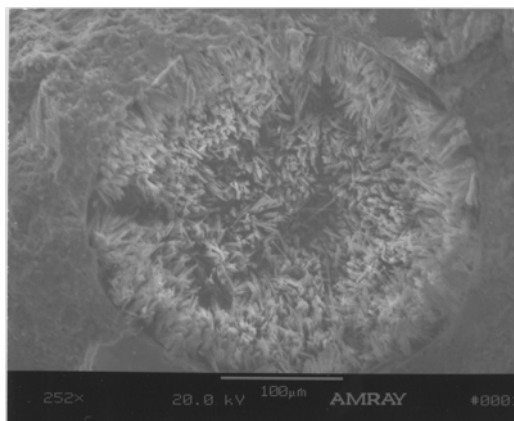
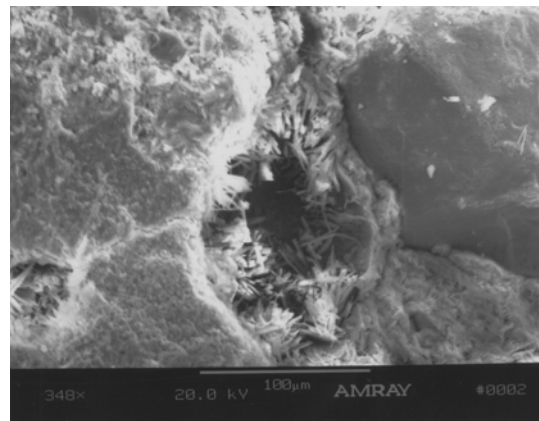
Figure 4.10: US 1 over Paint Branch (1600400)

(a) Ettringite in Void

(b) Analysis of Whole Picture (a)

(c) Ettringite in Void

(d) Ettringite in Voids and Along
Aggregate

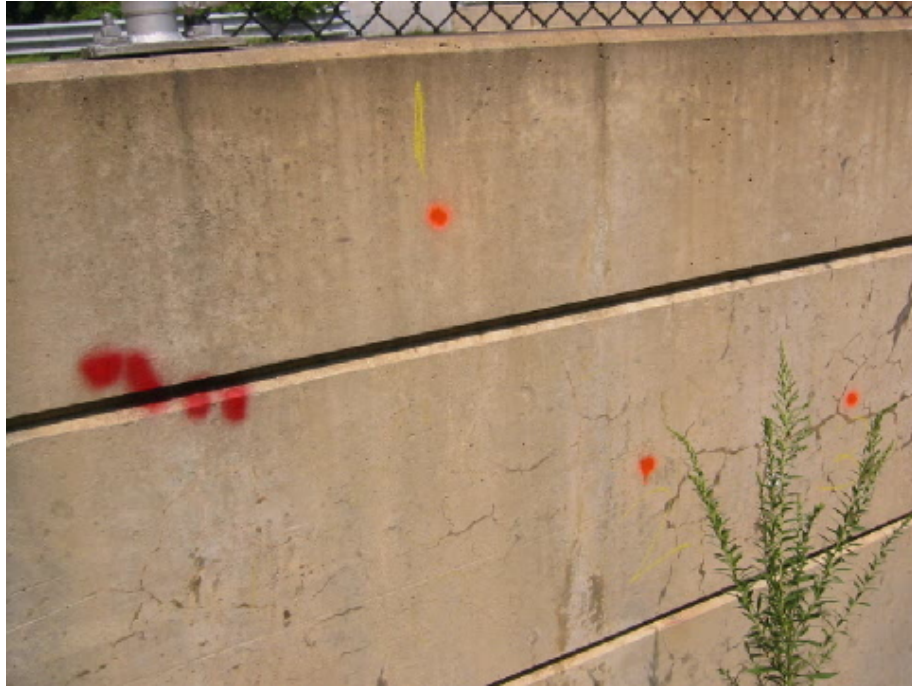
Figure 4.11: Coring Locations (1620003 – MD198 over I-95)

Three cores were taken from the southwest wingwall; see Figure 4.11 for locations.

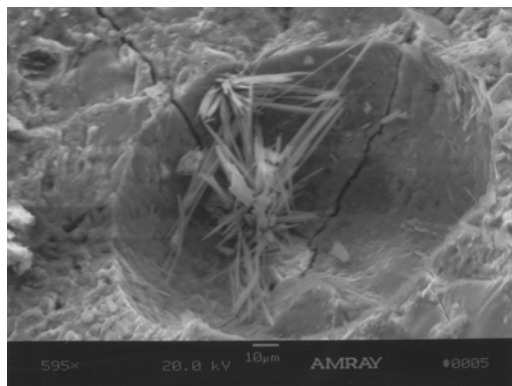
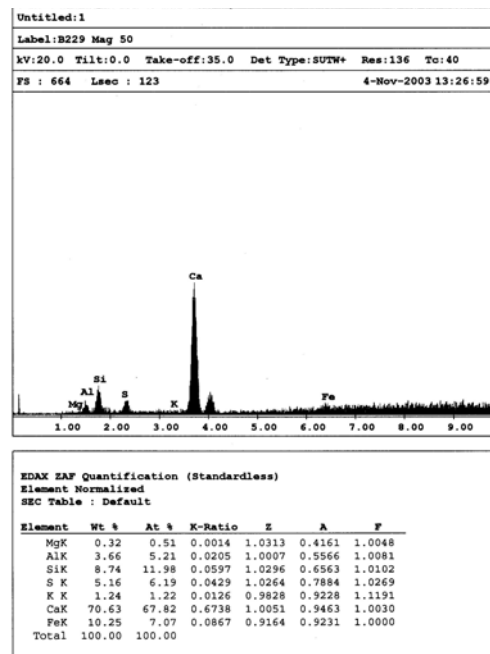
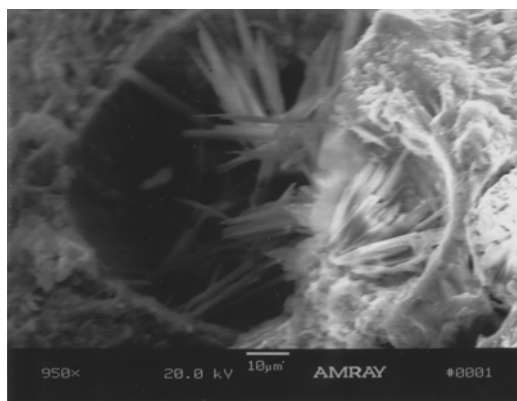
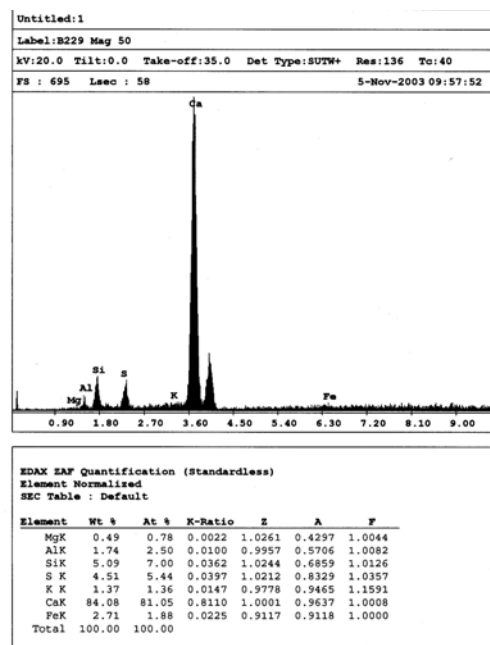
Figure 4.12: MD198 over I-95 (1620003)

All three cores exhibit ettringite formations throughout the samples, and two different types of ettringite formations were observed in these cores. In Figure 4.12, the ettringite formations appear to be hexagonal prismatic in morphology. In Figures 4.13 and 4.14, the ettringite formations appear to be shorter in length and much closer together, and the morphology will be identified as tightly-packed ettringite or tightly-packed DEF throughout this report. These formations were observed in cracks, on the surface of the sample, and filling voids. In both cases, EDAX verifies the elemental composition of the crystal formations by showing the distinct aluminum, sulfur, and calcium pattern. In Figure 4.14, EDAX analysis shows the ettringite is in a crack

(a) Ettringite in Void with Microcracking
in the Background

(b) Analysis of Crystals in (a)

(c) Ettringite in Void

(d) Analysis of Crystals in (c)

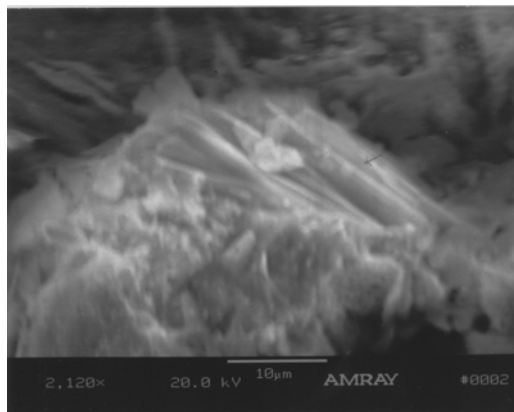
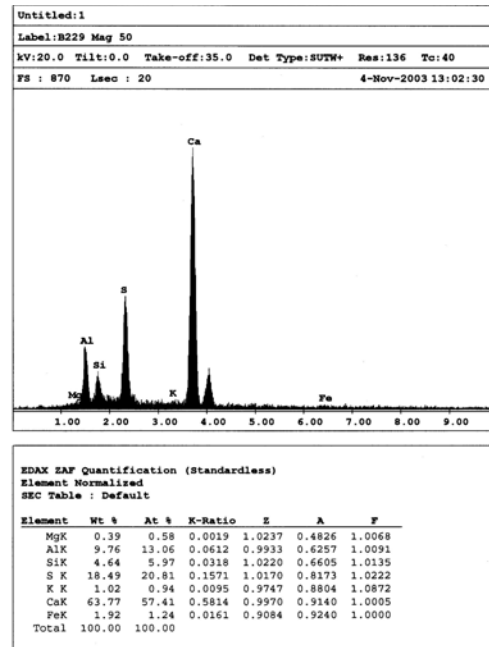
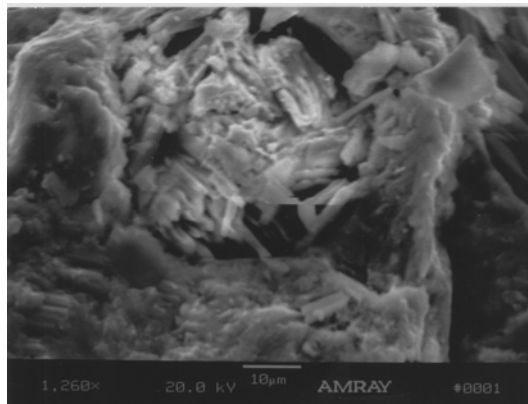
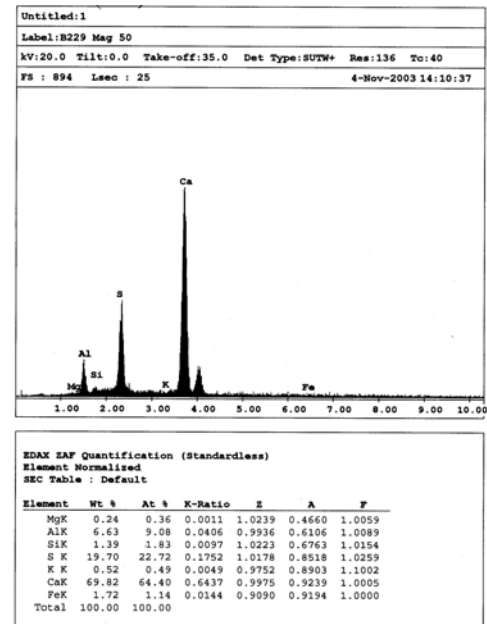
Figure 4.13: MD198 over I-95 (1620003)

(a) Ettringite on Surface of the Sample

(b) Analysis of Whole Picture (a)

(c) Ettringite Filling Void

(d) Analysis of Ettringite

Filling Void (c)

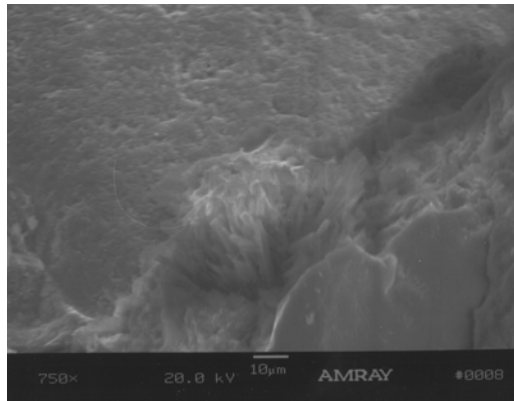
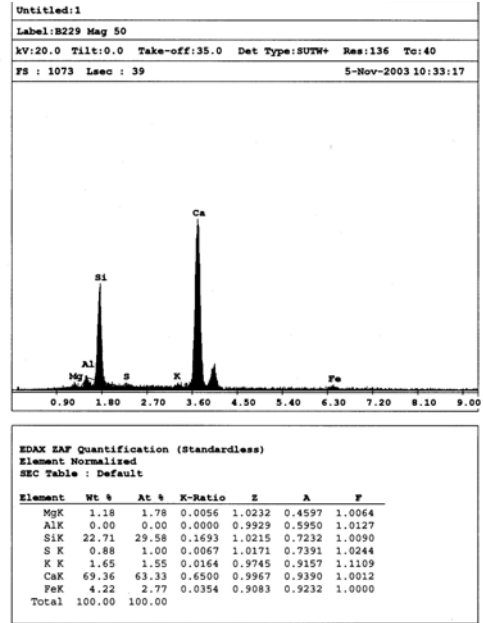
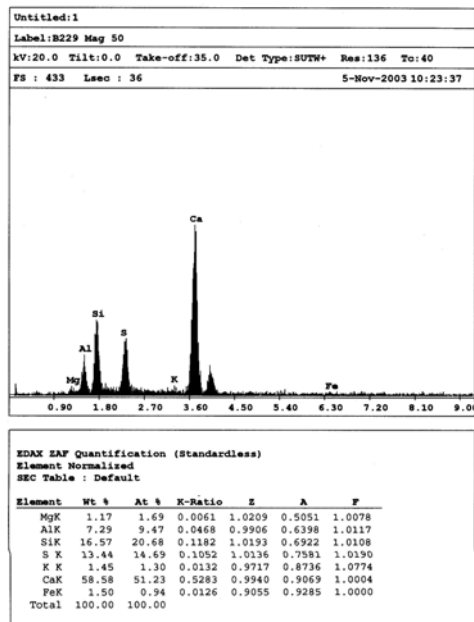
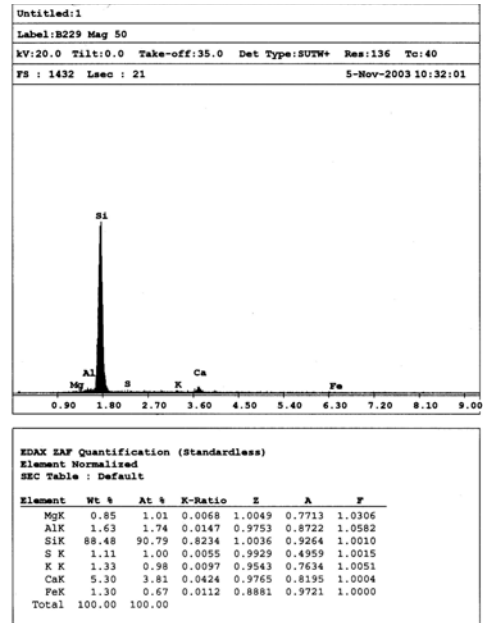
Figure 4.14: MD198 over I-95 (1620003)

between a sand particle and the cement paste. The three cores do not vary considerably in the type of ettringite formations or in the prevalence of ettringite formations in the samples.

(a) Ettringite Filling Crack Between
Sand Grain and Cement Paste

(b) Analysis of Cement Paste –
Top Left of Photo (a)

(c) Analysis of Ettringite Crystals –
Middle of Photo (a)

(d) Analysis of Sand Grain –
Bottom Right of Photo (a)

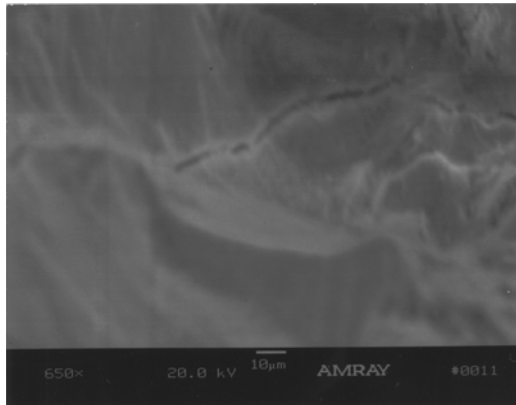
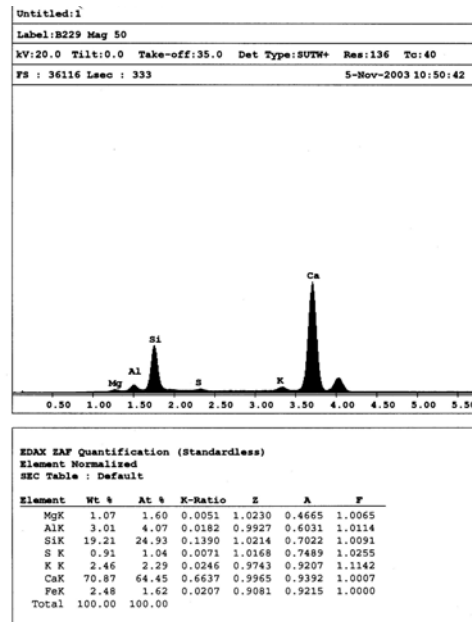
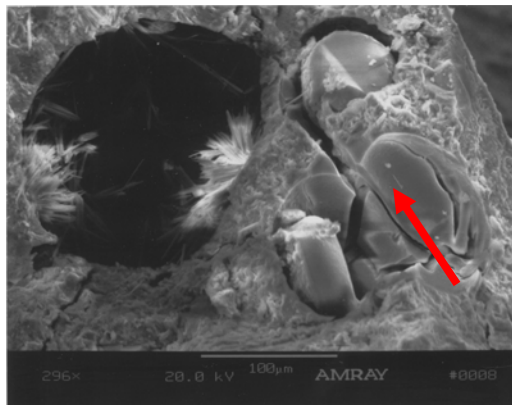
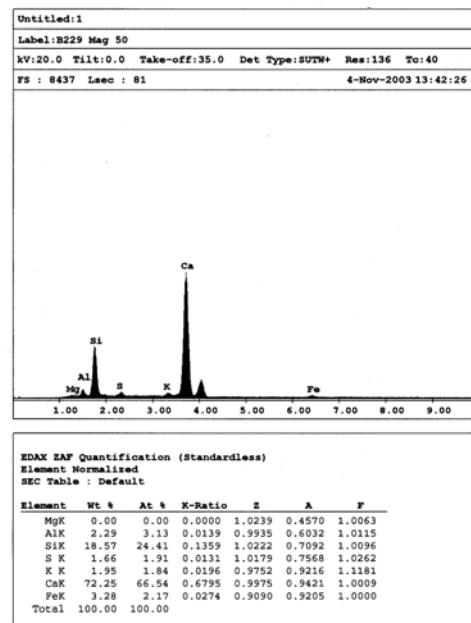
Figure 4.15: MD 198 over I-95 (1620003)

The UV light ASR test confirms the presence of ASR gel in the wingwall. Two of the three cores appeared to contain ASR gel as observed with the SEM, see Figure 4.15. In both cases, EDAX verifies the elemental composition of the gel by showing the distinct silicon and potassium pattern. For ASR gel, the silicon peak is very high when compared to the potassium peak.

(a) ASR Gel

(b) Analysis of Whole Picture (a)

(c) Ettringite in Void (Left) and ASR Gel (Right)

(d) Analysis of ASR gel (c)

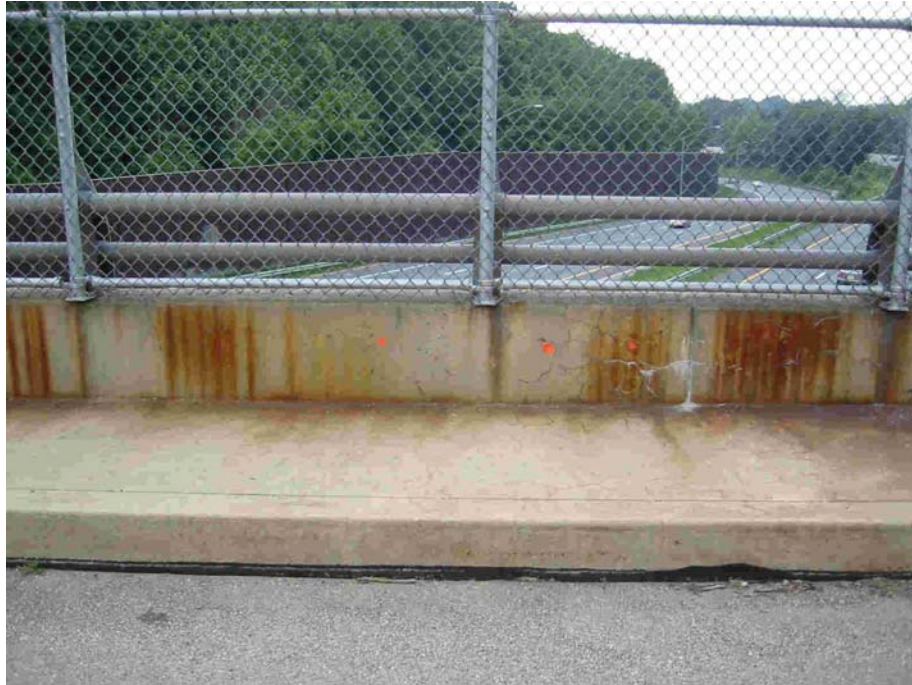
Figure 4.16: Coring Locations (1511300 – Greentree Rd over I-495)

Three cores were taken from the inside face of the west parapet; see Figures 4.16 and 4.17 for locations.

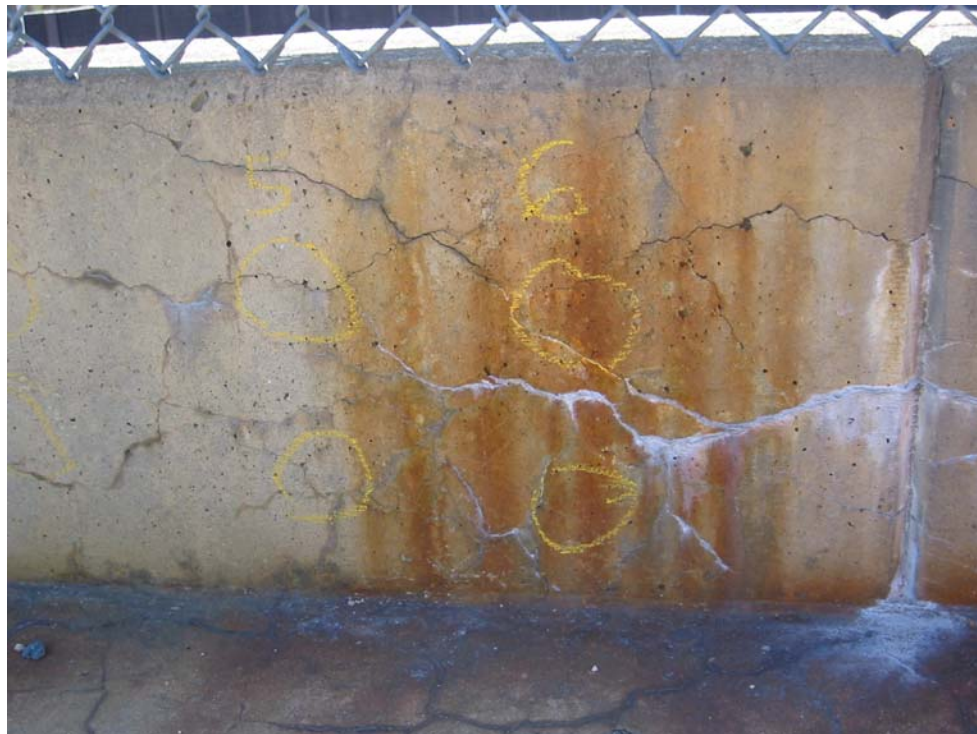
Figure 4.17: Right Coring Location (1511300 – Greentree Rd over I-495)

All three cores exhibit ettringite formations throughout the samples, and two different types of ettringite formations were observed in these cores. In Figure 4.18, the ettringite formations appear to be hexagonal prismatic in morphology, with tightly-packed ettringite formations in Figures 4.19 and 4.20. The tightly-packed ettringite formations were observed in cracks, on the surface of the sample, covering an aggregate, and filling voids. The right core, in the location of greatest distress as observed from the surface, exhibited significantly more tightly-packed DEF than any other core in this study. See Figure 4.17 for close-up of the right core location. The

cracks around the coring location are of measurable width using typical bridge inspection equipment. In both types of ettringite formations, EDAX verifies the elemental composition of the crystal formations by showing the distinct aluminum, sulfur, and calcium pattern. The three cores vary considerably in the type of ettringite formations with the tightly-packed ettringite being observed in the right and center cores and hexagonal prismatic ettringite formations being observed in the center and left cores. The prevalence of ettringite formations in the samples also varied and decreased from right to left with the location exhibiting more damage on the surface having more ettringite formations and the location with the least damage on the surface having less ettringite formations.

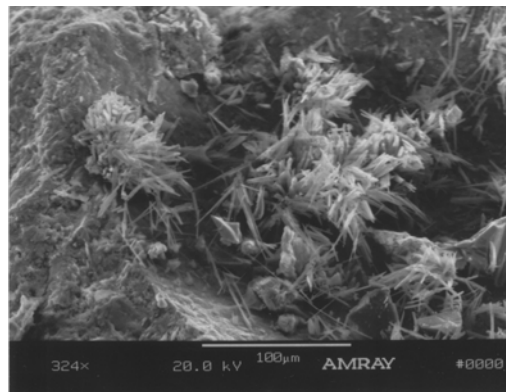
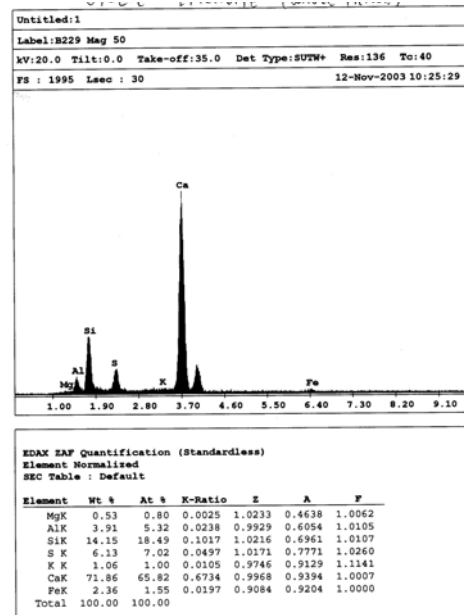
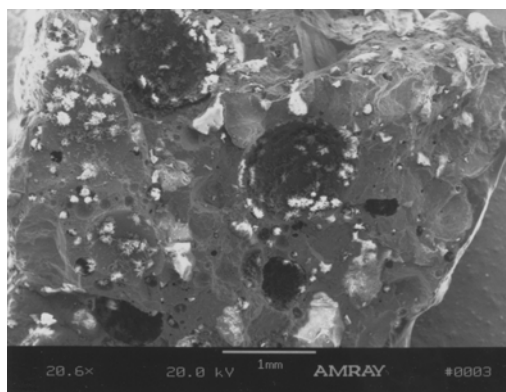
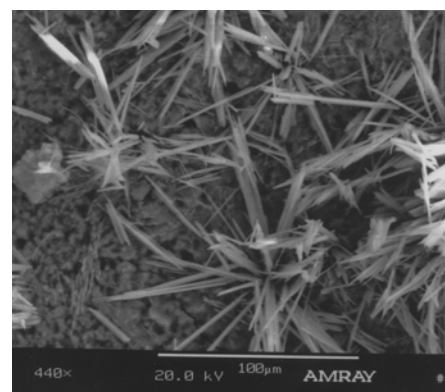
Figure 4.18: Greentree Rd over I-495 (1511300)

(a) Ettringite in Void

(b) Analysis of Whole Picture (a)

(c) Ettringite in Voids and on the Sample
Surface (Low Magnification)

(d) Crystals in a Void from
Picture (c)

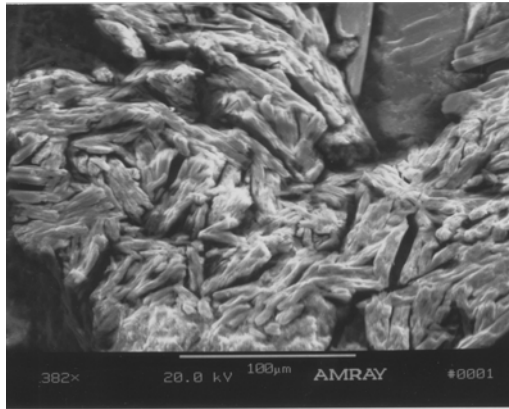
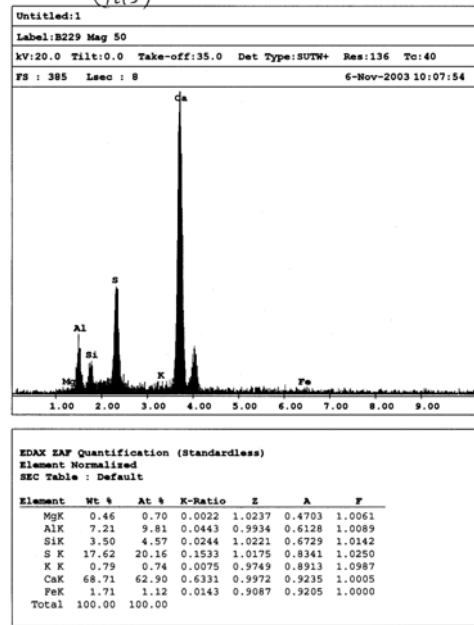
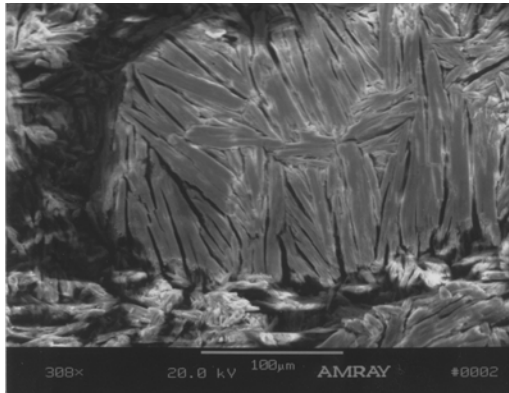
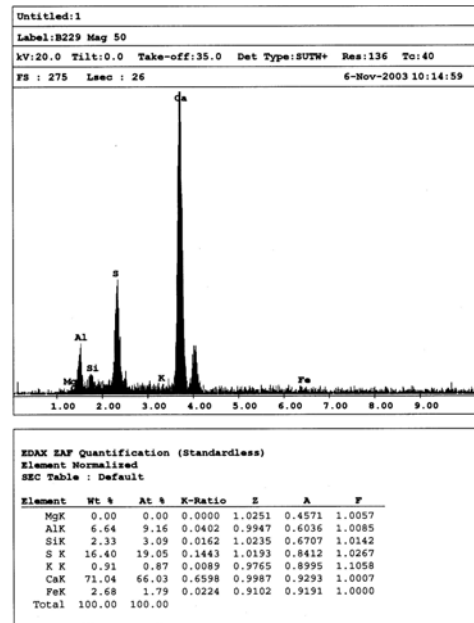
Figure 4.19: Greentree Rd over I-495 (1511300)

(a) Tightly-Packed Ettringite on Surface of the Sample

(b) Ettringite Mass in Picture (a)

(c) Ettringite Filling Void

(d) Analysis of Ettringite Filling Void (c)
