Title of Document: CHARACTERIZATION OF DELAYED
ETTRINGITE FORMATION IN MARYLAND
BRIDGES

Micah Shalom Ceary, Ph.D., 2007

CHARACTERIZATION OF DELAYED ETTRINGITE FORMATION IN
MARYLAND BRIDGES

Dissertation submitted to the Faculty of the Graduate School of the
University of Maryland, College Park, in partial fulfillment
of the requirements for the degree of
Doctorate of Philosophy
2007

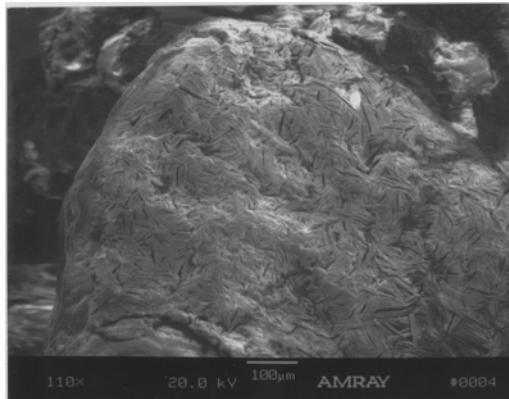
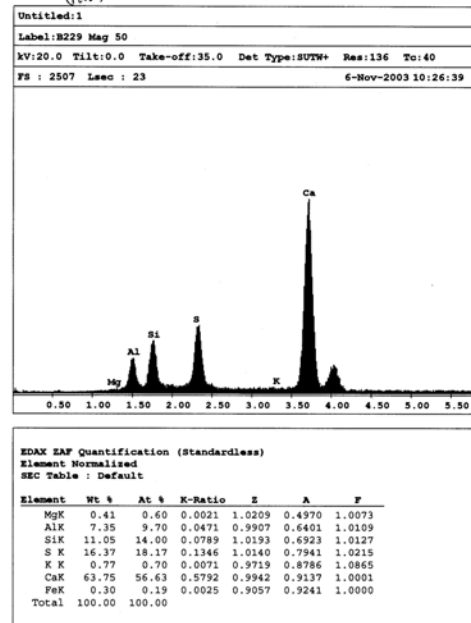
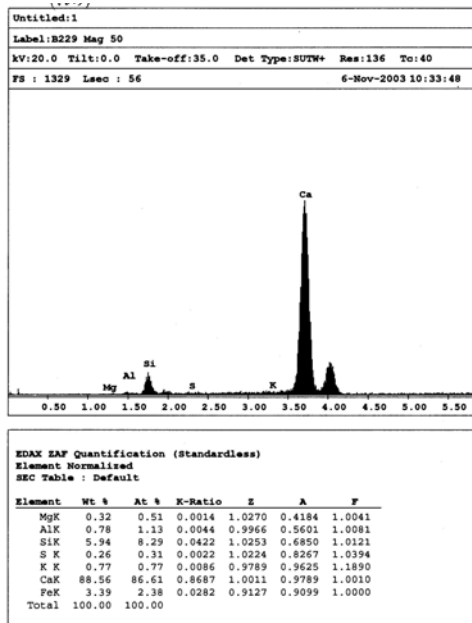
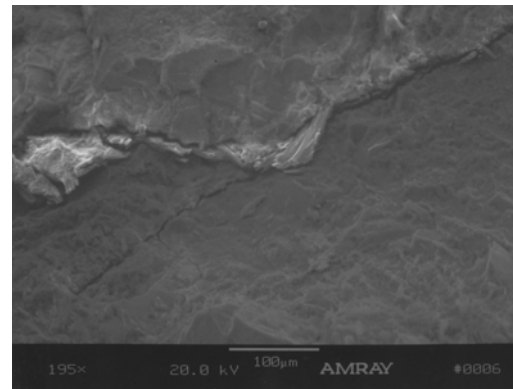
Figure 4.20: Greentree Rd over I-495 (1511300)

All three cores exhibit ettringite formations throughout the samples, and two different types of ettringite formations were observed in these cores. In Figure 4.18, the ettringite formations appear to be hexagonal prismatic in morphology, with tightly-packed ettringite formations in Figures 4.19 and 4.20. The tightly-packed ettringite formations were observed in cracks, on the surface of the sample, covering an aggregate, and filling voids. The right core, in the location of greatest distress as observed from the surface, exhibited significantly more tightly-packed DEF than any other core in this study. See Figure 4.17 for close-up of the right core location. The

(a) Tightly-Packed Ettringite on Surface of the Aggregate

(b) Analysis of Whole Picture (a)

(c) Analysis of Aggregate Underneath Ettringite in Picture (a)

(d) Ettringite in Crack

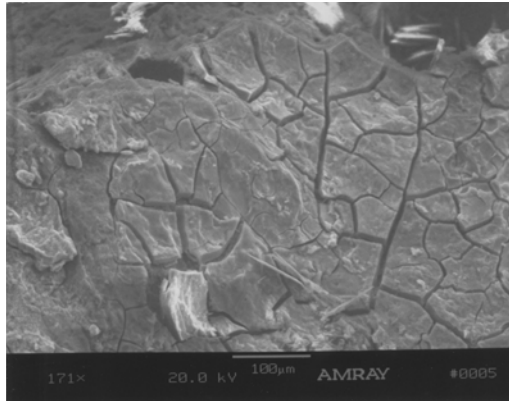
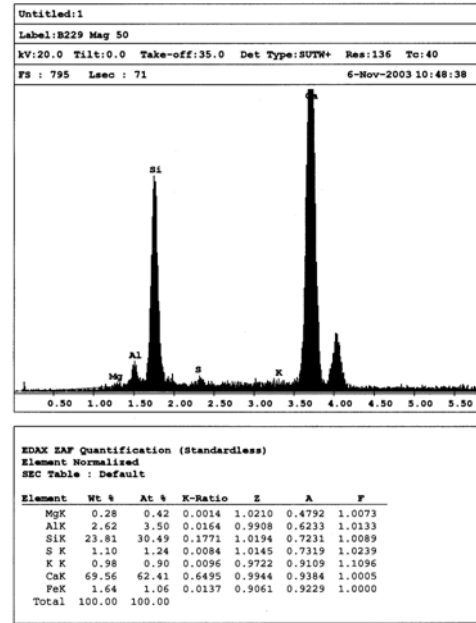
Figure 4.21: Greentree Rd over I-495 (1511300)

The UV light ASR test confirms the presence of ASR gel in the parapet. One possible location of ASR gel, as observed with the SEM, is shown in Figure 4.21.

(a) Possible ASR Gel

(b) Analysis of Possible ASR Gel

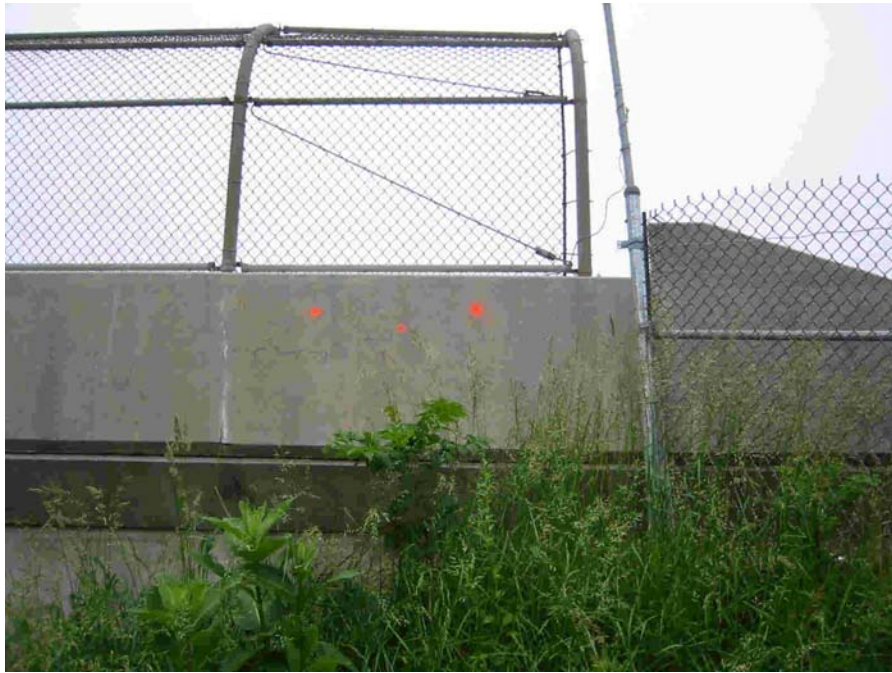
Figure 4.22: Coring Locations (0314200 – Old Court Rd over I-695)

Three cores were taken from the parapet above the northwest wingwall; see Figure 4.22 for locations.

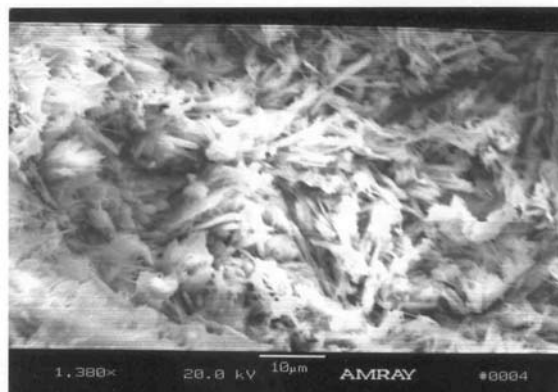
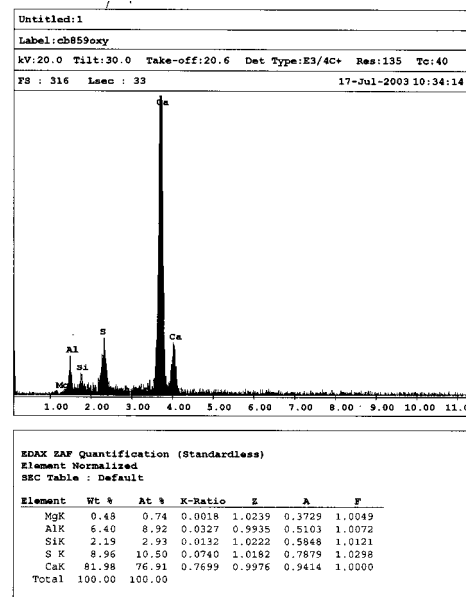
Figure 4.23: Old Court Rd over I-695 (0314200)

All three cores exhibit ettringite formations throughout the samples, and two different types of ettringite formations were observed in these cores. In Figure 4.23, the ettringite formations appear to be hexagonal prismatic in morphology, but in Figures 4.24 (a) and (b), the ettringite formations appear to have needle-like crystal morphology and are smaller than typically observed. The ettringite formations have developed in holes in the cement paste and on the fractured surface. In both types of ettringite formations, EDAX verifies the elemental composition of the crystal formations by showing the distinct aluminum, sulfur, and calcium pattern. The right

(a) Ettringite on the Surface

(b) Analysis of Whole Picture (a)

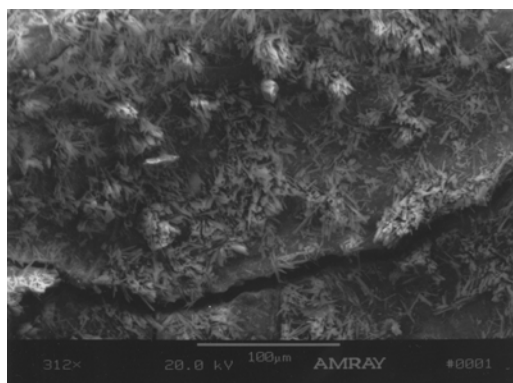
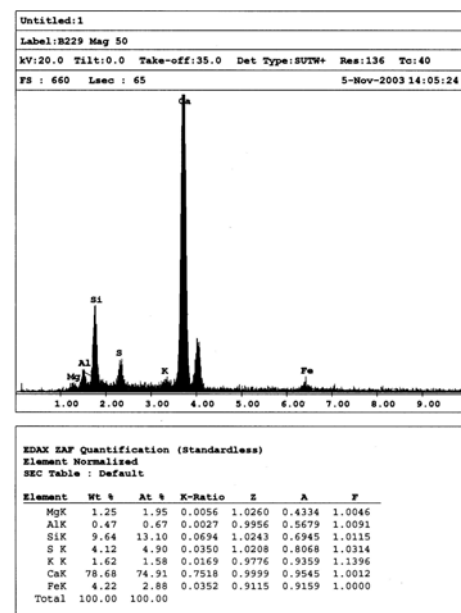
(c) Ettringite on the Surface of an
Aggregate (Top) and Cement Paste
(Below)

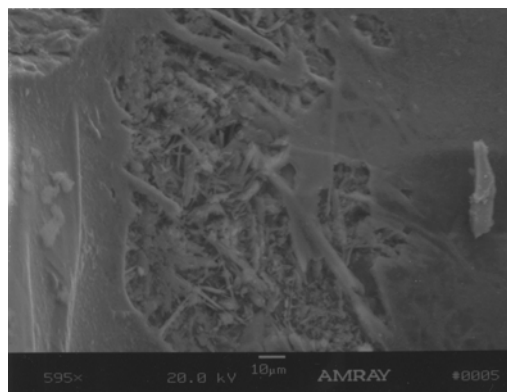
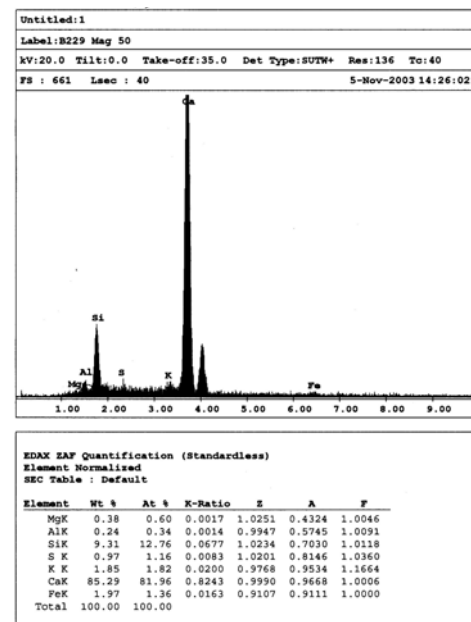
(a) Ettringite in Hole in Cement Paste

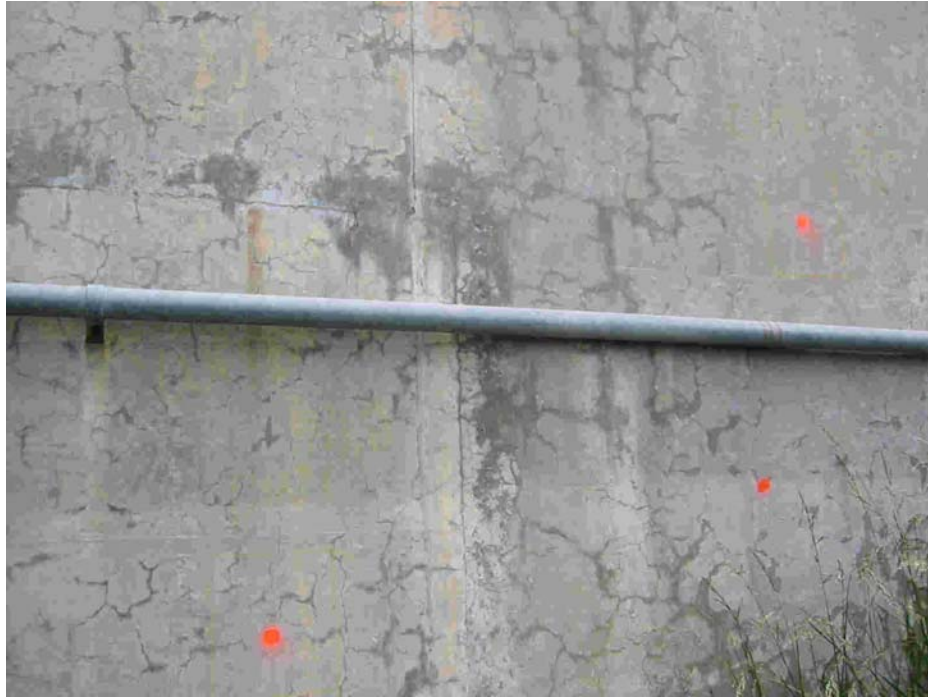
Figure 4.25: Coring Locations (1311000 – MD 32 EB over US 1)

Three cores were taken from the southeast wingwall; see Figure 4.25 for locations.

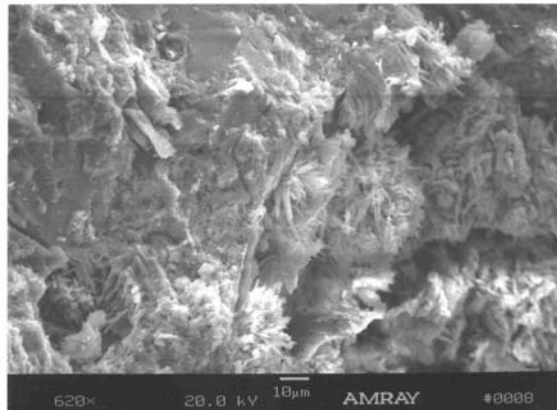
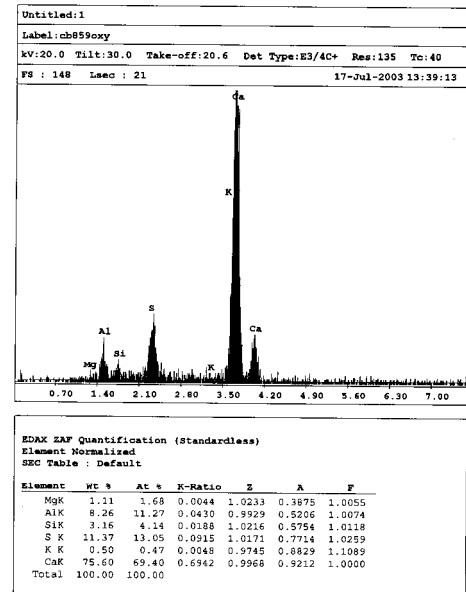
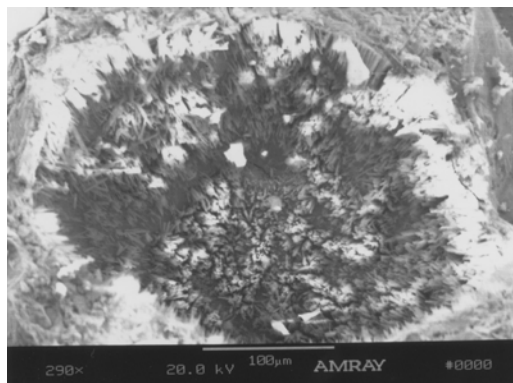
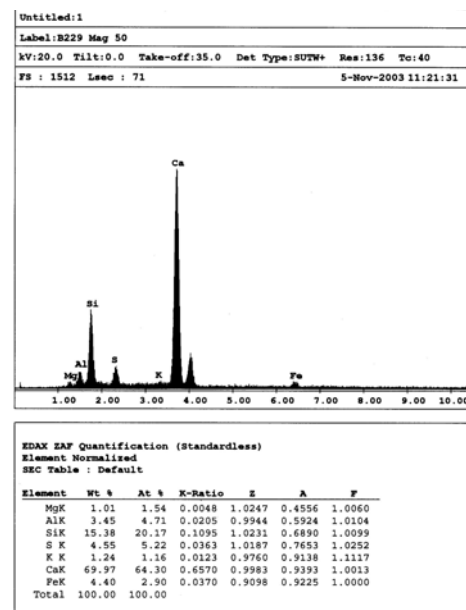
Figure 4.26: MD 32 EB over US 1 (1311000)

All three cores exhibit ettringite formations throughout the samples, and three different types of ettringite formations were observed in these cores. First, in Figure 4.26 (a) and (b), the ettringite formations appear to be needle-like short crystals found on the fractured surface. Second, in Figures 4.26 (c), 4.26 (d), 4.27 (a), and 4.27 (b), the ettringite formations appear to be hexagonal prismatic in morphology. Third, in Figure 4.27 (c) and (d), tightly-packed ettringite is filling and lining voids. EDAX verifies the elemental composition of the crystal formations by showing the distinct aluminum, sulfur, and calcium pattern. The three cores do not vary considerably in

the type of ettringite formations or in the prevalence of ettringite formations in the samples.

(a) Ettringite on the Surface

(c) Ettringite in Void

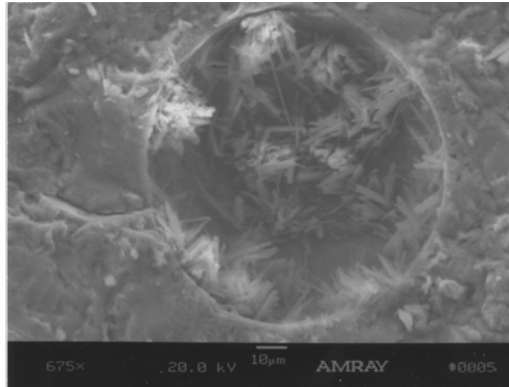
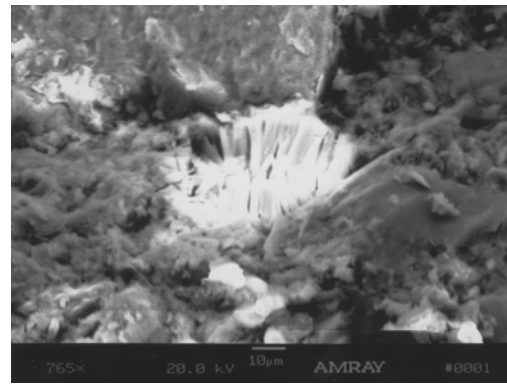
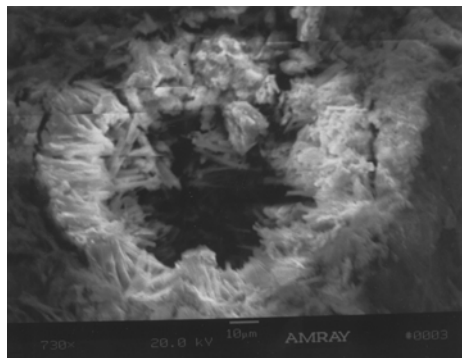
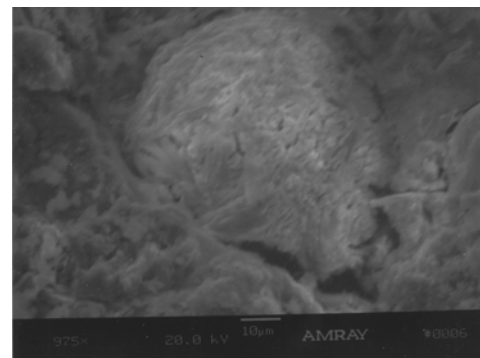
Figure 4.27: MD 32 EB over US 1 (1311000)

(a) Ettringite in Void

**(b) Ettringite in Between Aggregate
(Top) and Cement Paste (Bottom)**

(c) Tightly-Packed Ettringite – 1

(d) Tightly-Packed Ettringite – 2

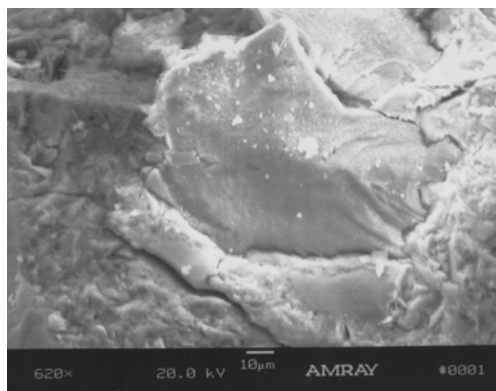
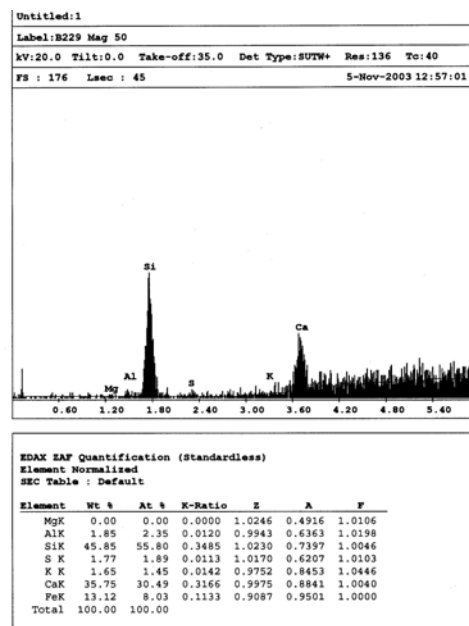
Figure 4.28: MD 32 EB over US 1 (1311000)

The UV light ASR test confirms the presence of ASR gel in the wingwall. See Figures 4.28 (a) and (b) for ASR gel and analysis report. EDAX verifies the elemental composition of the gel by showing the distinct silicon and potassium pattern.

(a) Possible ASR Gel

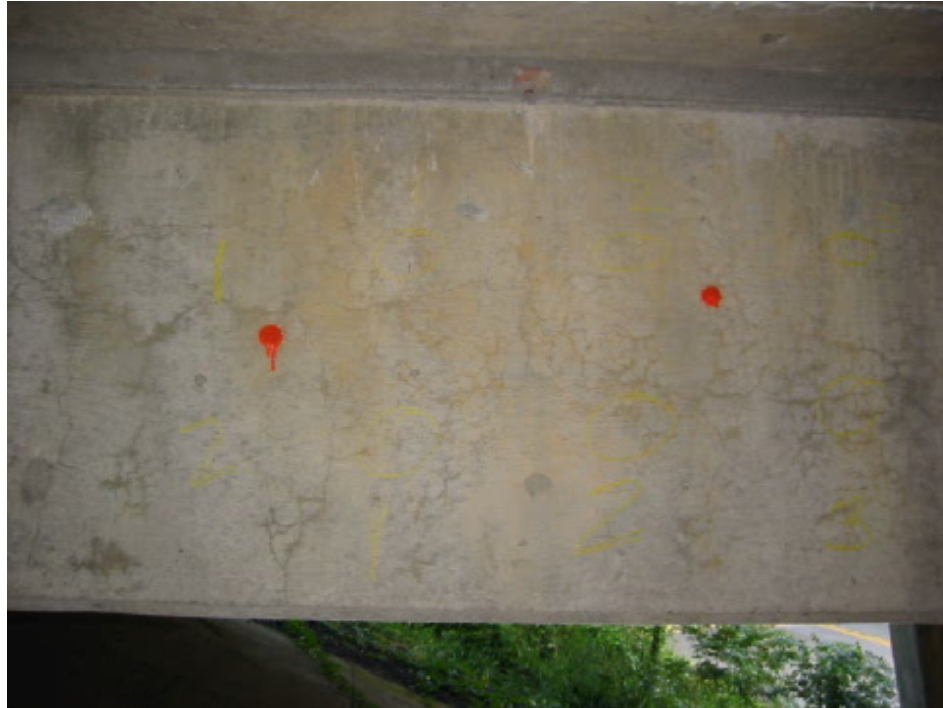
Figure 4.29: Coring Locations (2203201 – US 13 NB over MD 346)

Two cores were taken from the center beam of the southernmost span; see Figure 4.29 for locations.

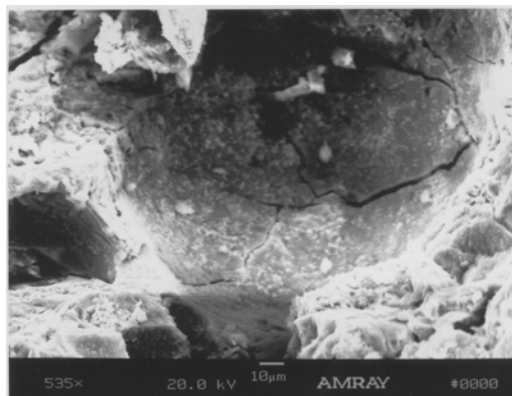
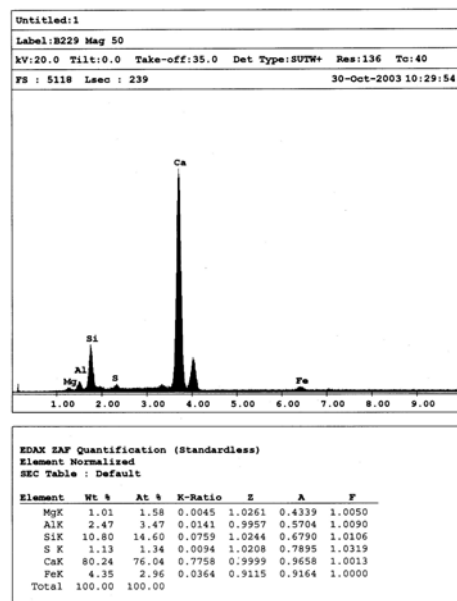
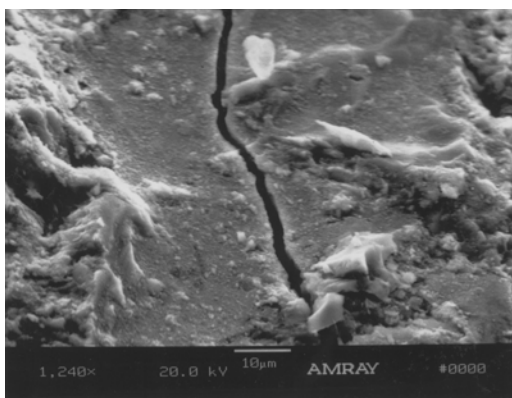
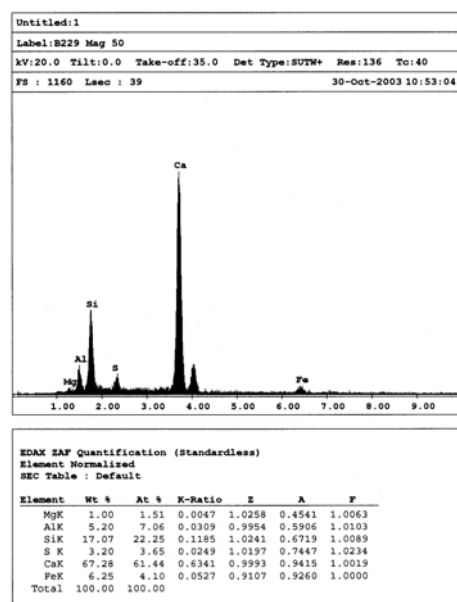
Figure 4.30: US 13 NB over MD 346 (2203201)

The left core did not exhibit signs of either DEF or ASR gel, but the cement paste had extensive microcracking on the surface and in the voids, see Figure 4.30. The right core exhibited ettringite formations, which were unlike any form observed prior. Even at a high magnification, not shown here, a lamellar material appeared to cover the void surface, see Figure 4.31. EDAX verifies the elemental composition of the lamellar material as ettringite by showing the distinct aluminum, sulfur, and calcium pattern. No signs of ASR gel were observed in either core, using the SEM or the UV light test.

(a) Microcracking in the Void

(c) Microcracking on the Surface

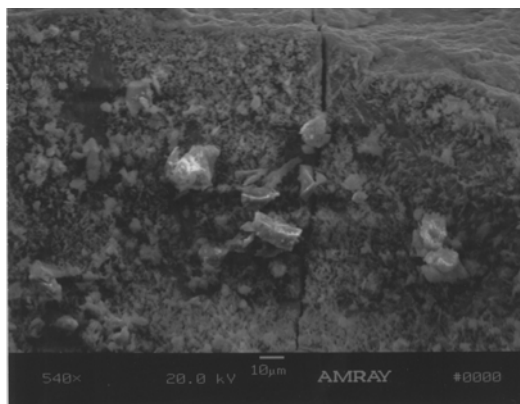
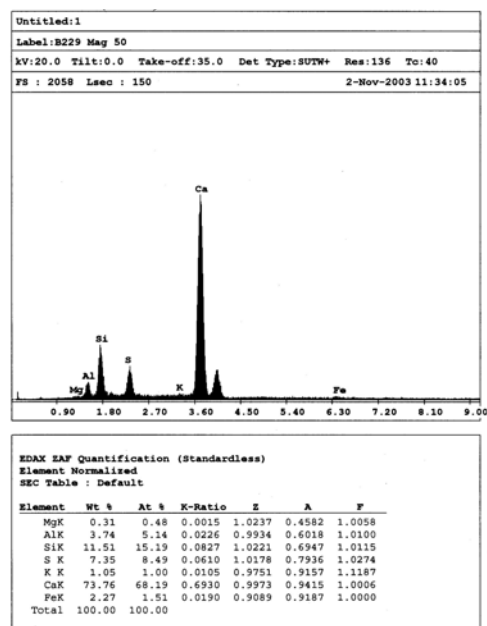
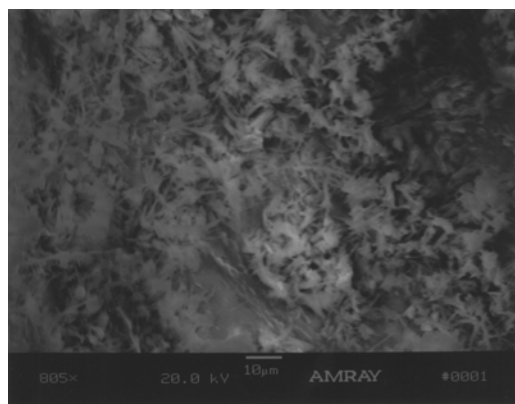
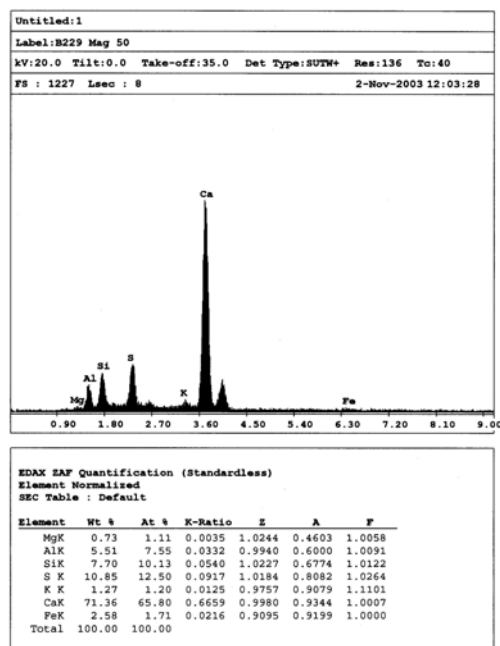
(a) Ettringite in a Void

(c) Ettringite in a Void

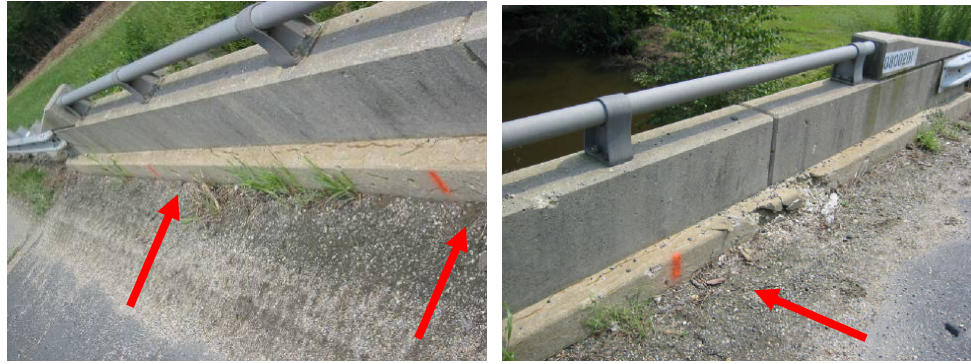
Figure 4.32: Coring Locations (0800201 – MD 5 NB over Zekiah Swamp)

Three cores were taken from the inside face of the east parapet; see Figure 4.32 for locations.

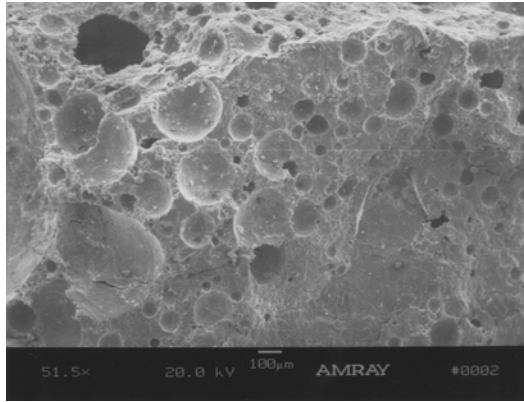
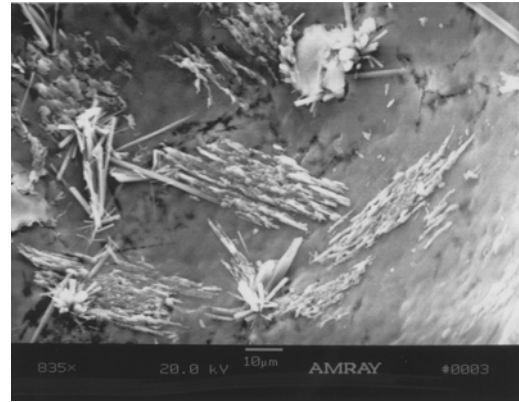
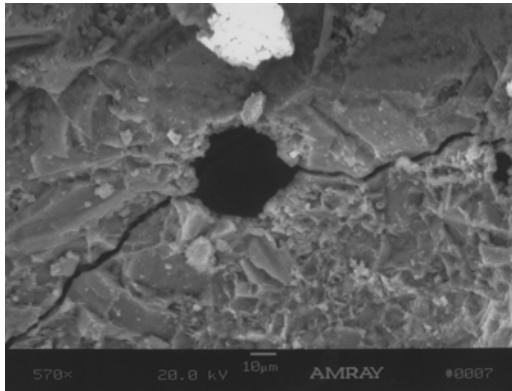
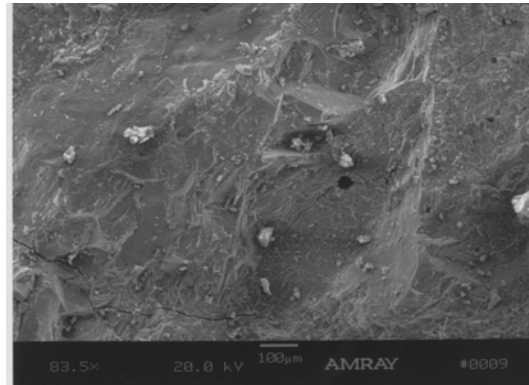
Figure 4.33: MD 5 NB over Zekiah Swamp (0800201)

The leftmost core in the left image from Figure 4.32 exhibited no signs of DEF, see Figure 4.33 for typical images, but the right and center cores exhibited ettringite formations. In Figure 4.34, the ettringite formations appear to be hexagonal prismatic in morphology. EDAX verifies the elemental composition of the crystal formations by showing the distinct aluminum, sulfur, and calcium pattern.

(a) Numerous Empty Voids

(b) Typical Void with Calcium Hydroxide

(c) Void with Crack

(d) Void with Crack

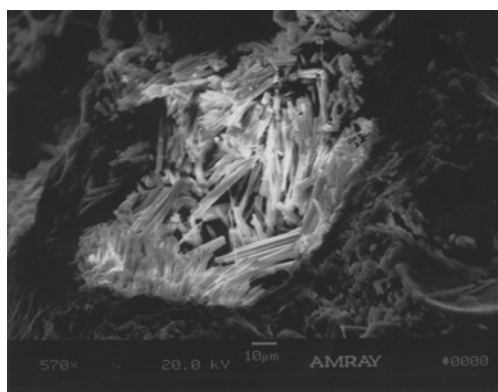
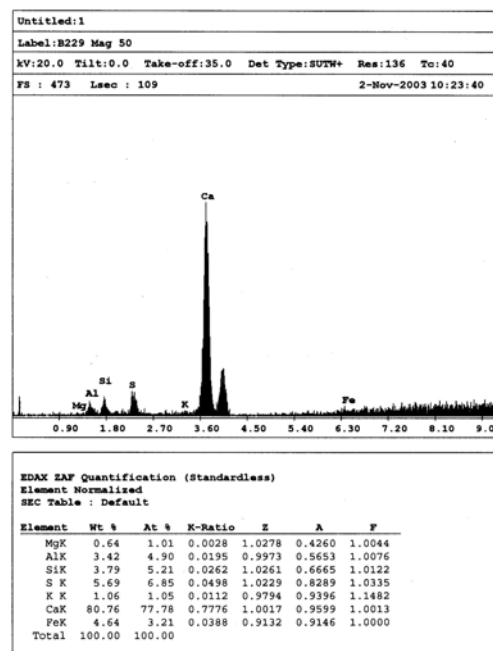
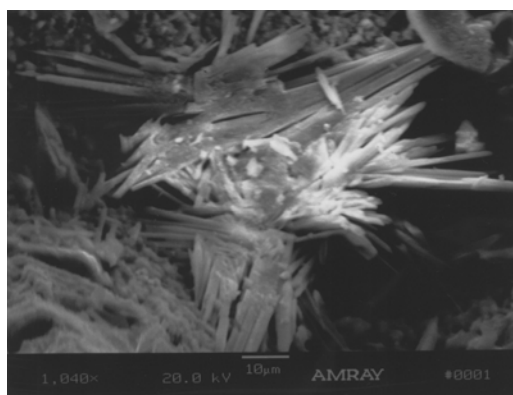
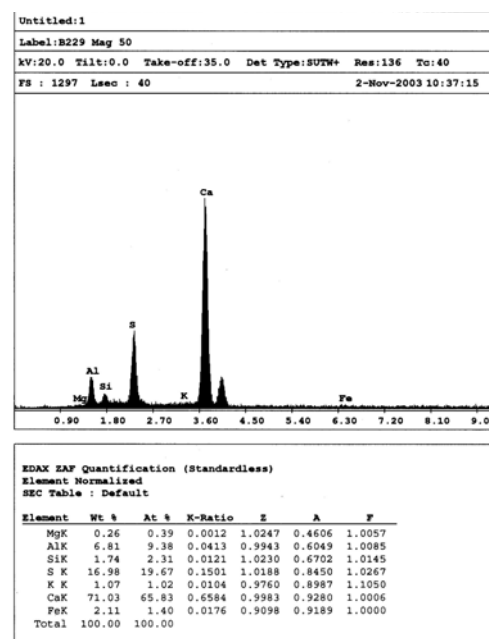
Figure 4.34: MD 5 NB over Zekiah Swamp (0800201)

(a) Ettringite in Void

(c) Ettringite on the Surface

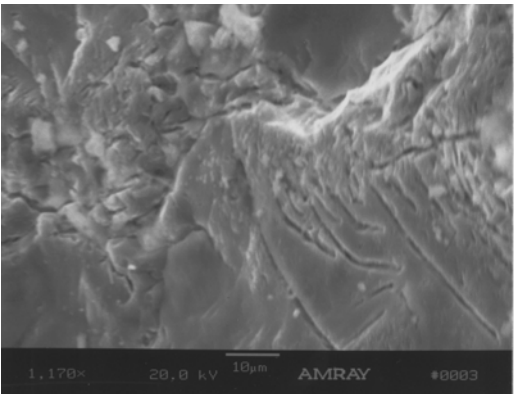
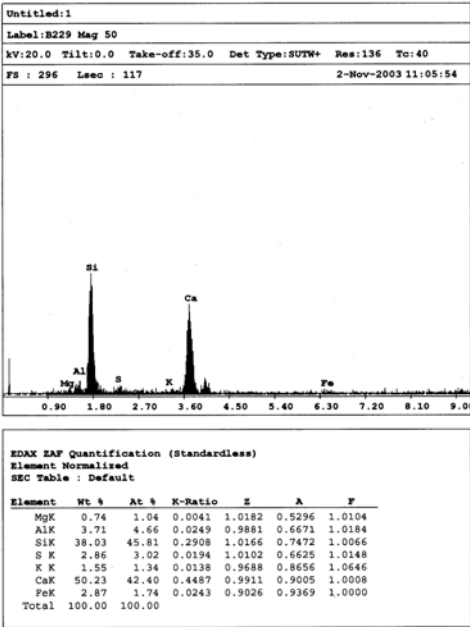
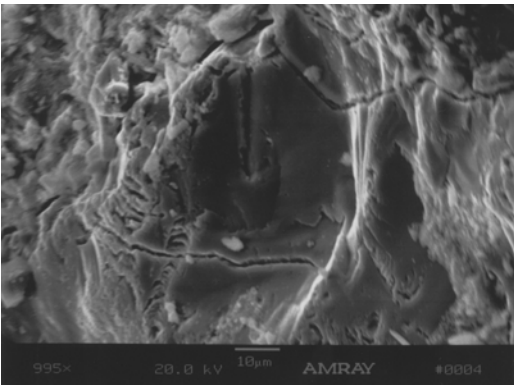
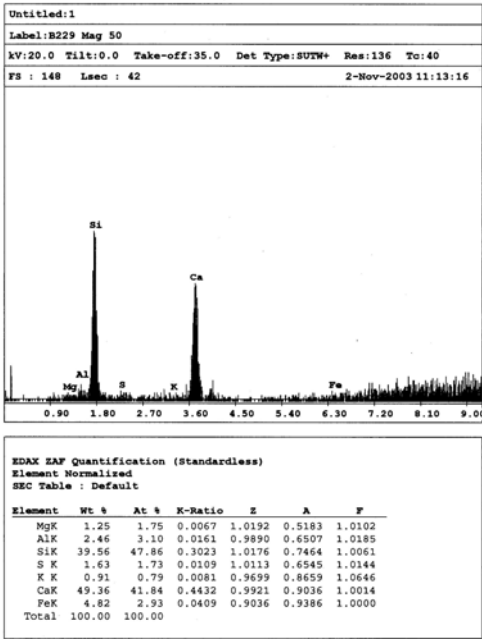
Figure 4.35: MD 5 NB over Zekiah Swamp (0800201)

The UV light ASR test confirms the presence of ASR gel in the wingwall. The right core contains possible locations of ASR gel as observed with the SEM, see Figure 4.35. EDAX verifies the elemental composition of the gel by showing the distinct silicon and potassium pattern for Figures 4.35 (a) and (b) with a potassium percentage by weight of 1.55, but the pattern is not as pronounced for Figures 4.35 (c) and (d) with a potassium percentage by weight of 0.91.

(a) Possible ASR Gel

(c) Possible ASR Gel

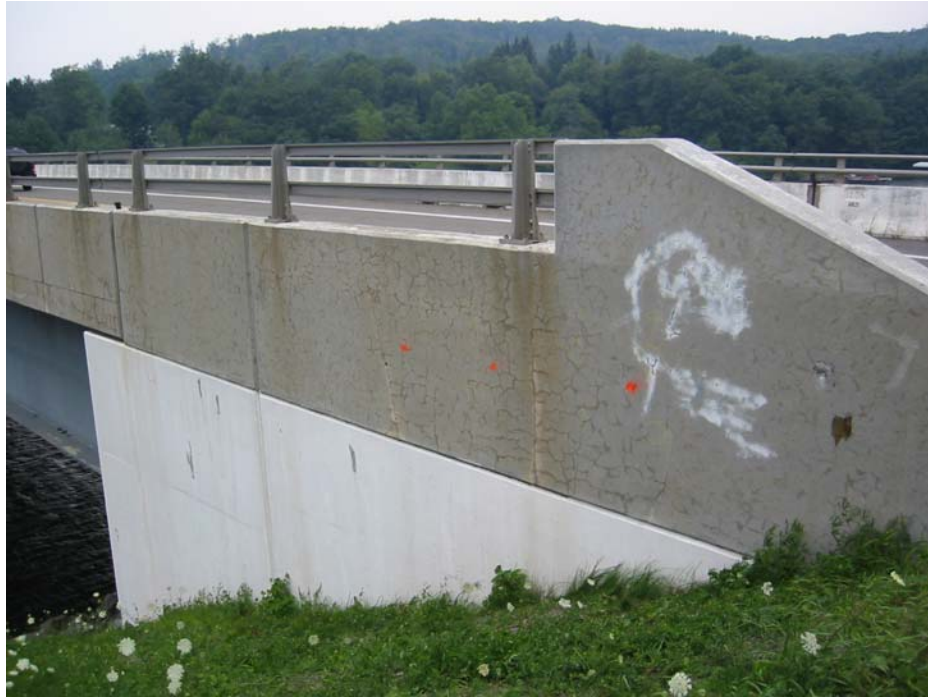
Figure 4.36: Coring Locations (1102100 – US 219 over Deep Creek Lake)

Three cores were taken from the northwest wingwall; see Figure 4.36 for locations.

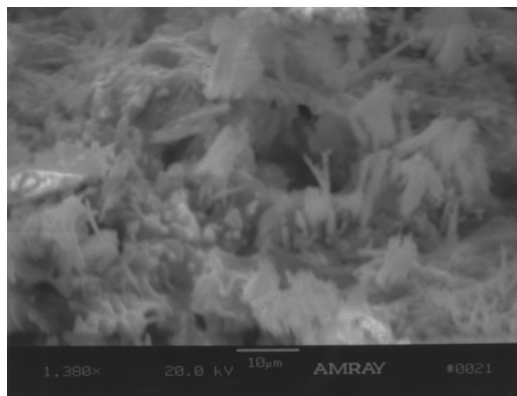
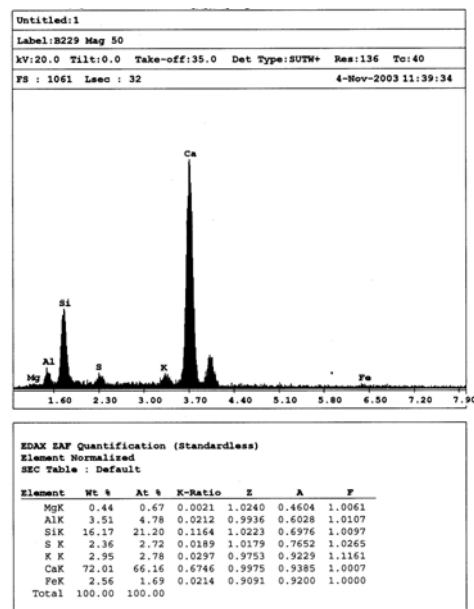
Figure 4.37: US 219 over Deep Creek Lake (1102100)

All three cores exhibited ettringite formations throughout the samples, and two different types of ettringite formations were observed in these cores. In Figure 4.37 (a) and (b), the ettringite formations appear to be needle-like short crystals found on the fractured surface, and in Figures 4.37 (c) and (d), the ettringite formations appear to be hexagonal prismatic in morphology. EDAX verified the elemental composition of the crystal formations by showing the distinct aluminum, sulfur, and calcium pattern. The three cores do not vary considerably in the type of ettringite formations or in the prevalence of ettringite formations in the samples.

(a) Ettringite on the Surface

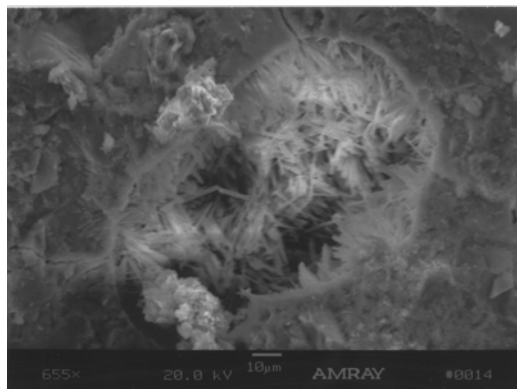
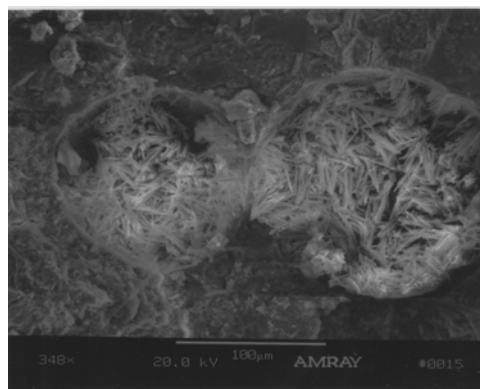
(c) Ettringite in Void

(d) Ettringite in Void

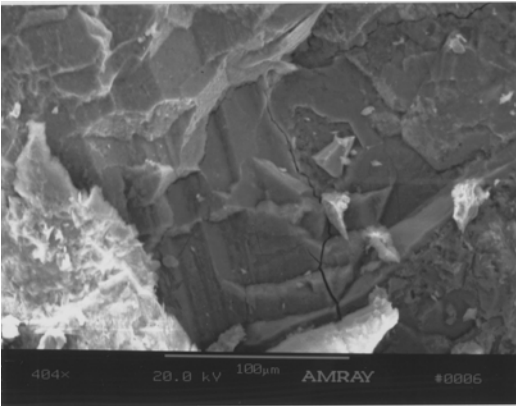
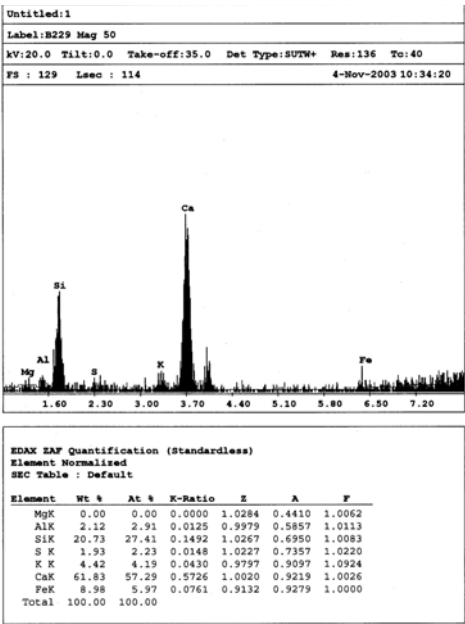
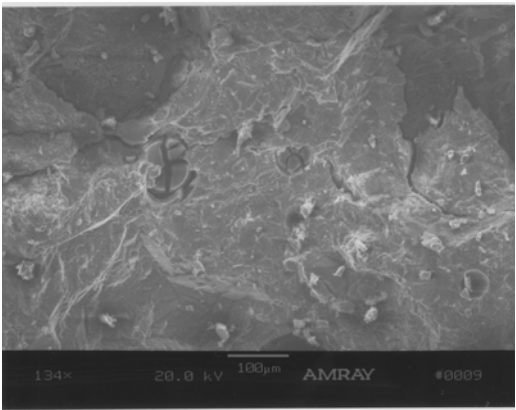
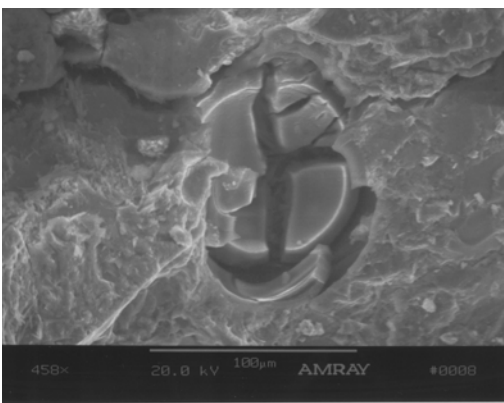
Figure 4.38: US 219 over Deep Creek Lake (1102100)

The UV light ASR test confirmed the presence of ASR gel in the wingwall. The left core contains possible locations of ASR gel as observed with the SEM, see Figure 4.38. EDAX verified the elemental composition of the gel by showing the distinct silicon and potassium pattern.

(a) Possible ASR Gel

(b) Analysis of Possible ASR Gel

(c) Possible ASR Gel with Cracking

(d) Possible ASR Gel – Close-up of
Picture (c)

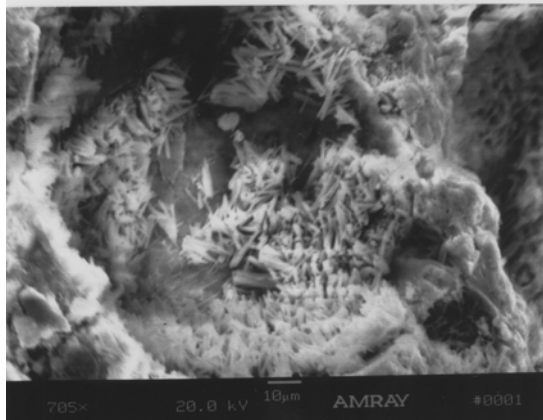
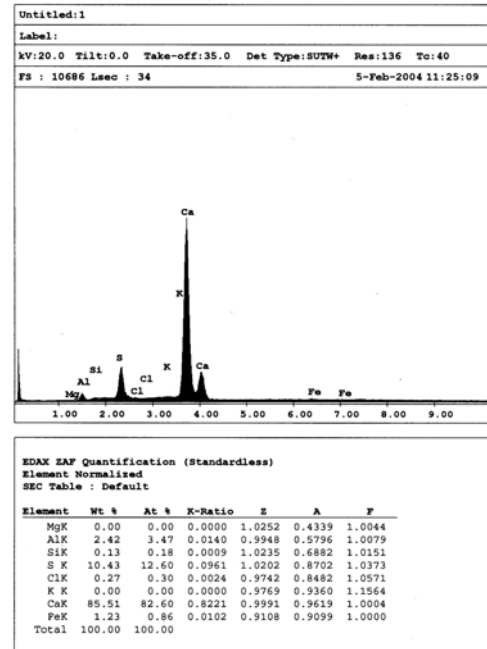
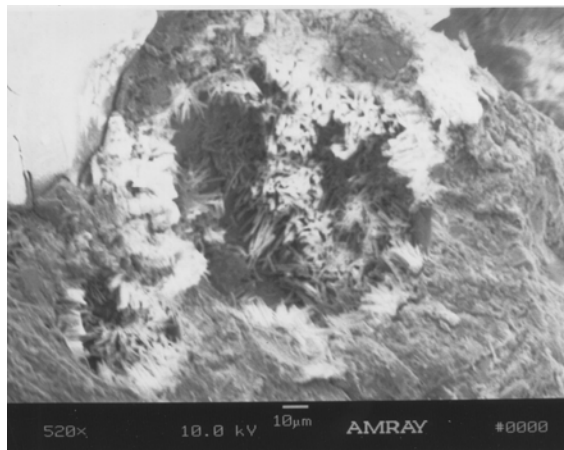
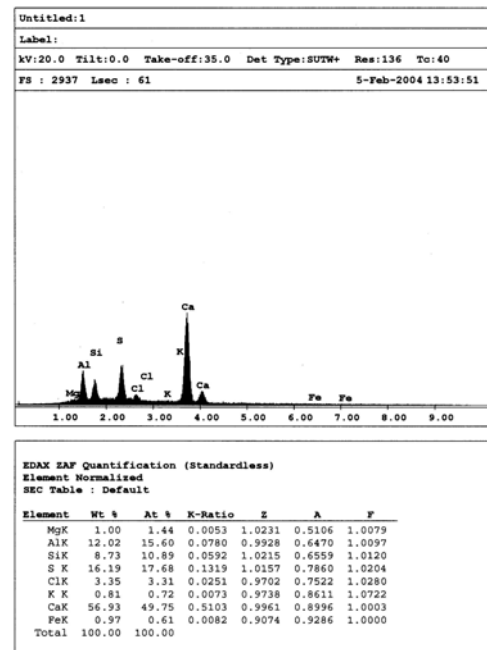
Figure 4.40: US 29 over Middle Patuxent River (1301302)

All three cores exhibited ettringite formations throughout the samples, but the samples only contained hexagonal prismatic DEF in voids. The amount of DEF found in the voids was minimal compared to bridges with map cracking, see Figure 4.40.

(a) Ettringite in Voids

(c) Ettringite in Voids

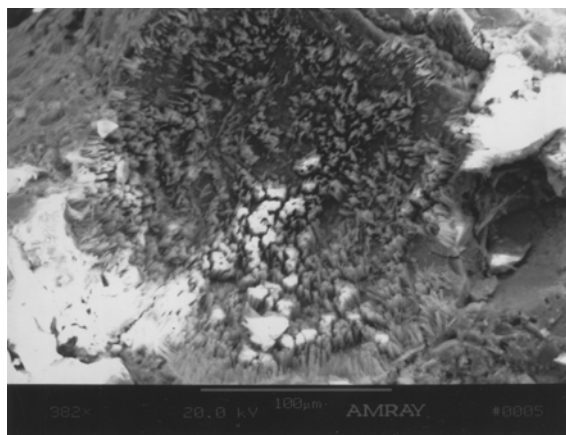
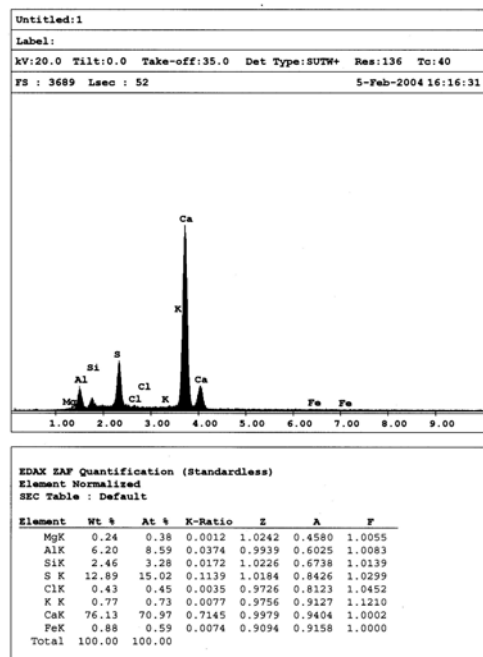
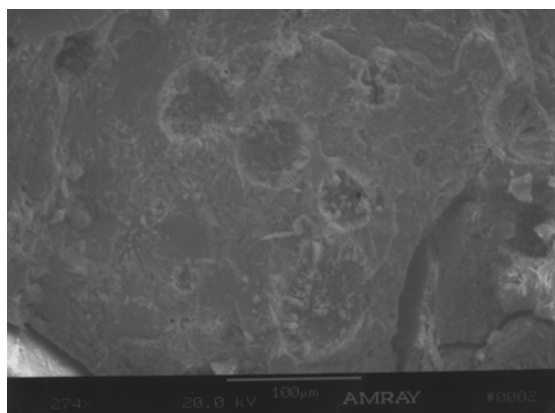
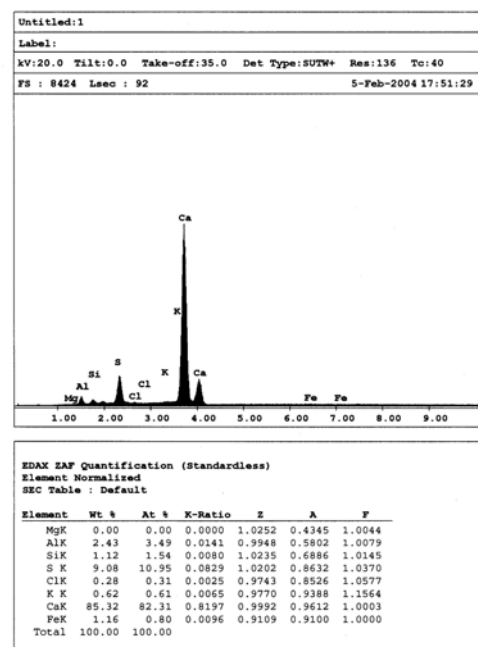
Figure 4.42: I-795 over Cockeys Mill Road (0333702)

All three cores exhibited ettringite formations throughout the samples, but the samples only contained hexagonal prismatic DEF in voids. The amount of DEF found in the voids was minimal compared to bridges with map cracking, and the DEF was found mixed in with calcium hydroxide crystals, see Figure 4.42.

(a) Ettringite in Voids

(c) Ettringite in Voids

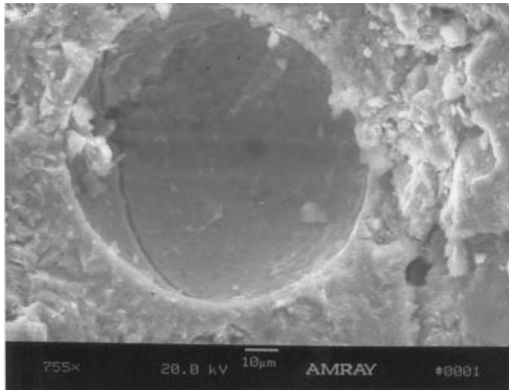
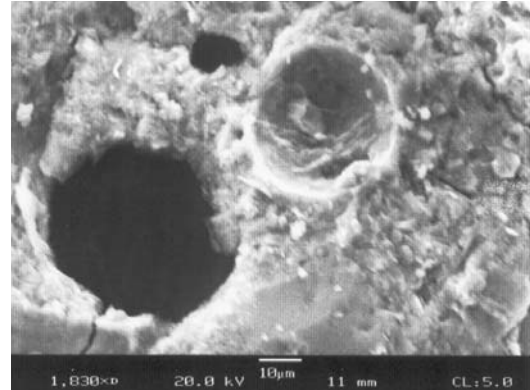
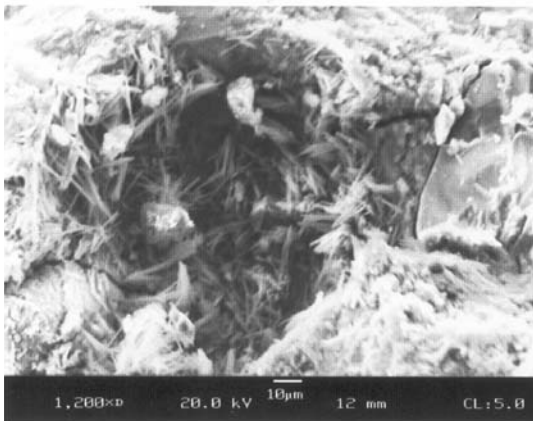
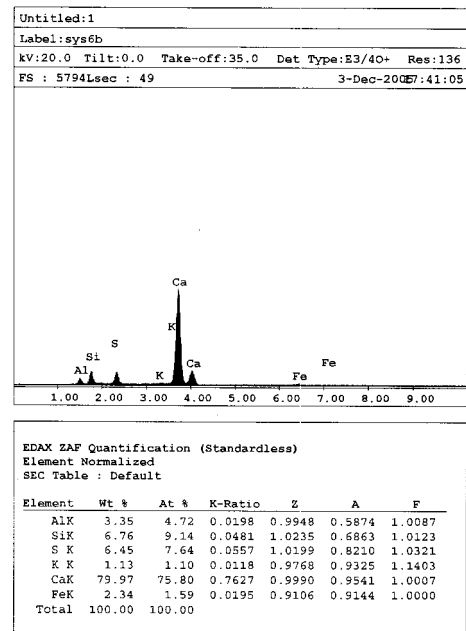
Figure 5.7: MD 77 over Hunting Creek (1005000)

Two of the three cores examined contained no ettringite formations. The third core contained long ettringite crystals mixed in with calcium hydroxide Ca(OH)_2 . The DEF fills much less than 5% of the voids. See Figure 5.7. Energy Dispersive Analysis X-ray (EDAX) verifies the elemental composition of the crystal formations by showing the distinct aluminum, sulfur, and calcium pattern with very high levels of calcium from the Ca(OH)_2 . The bridge contained little to no ettringite in the cores sampled, see Figure 5.8 for typical core results.

(a) Empty Void with Microcracking in the Background

(b) Empty Voids

(c) Calcium Hydroxide and Ettringite in Void

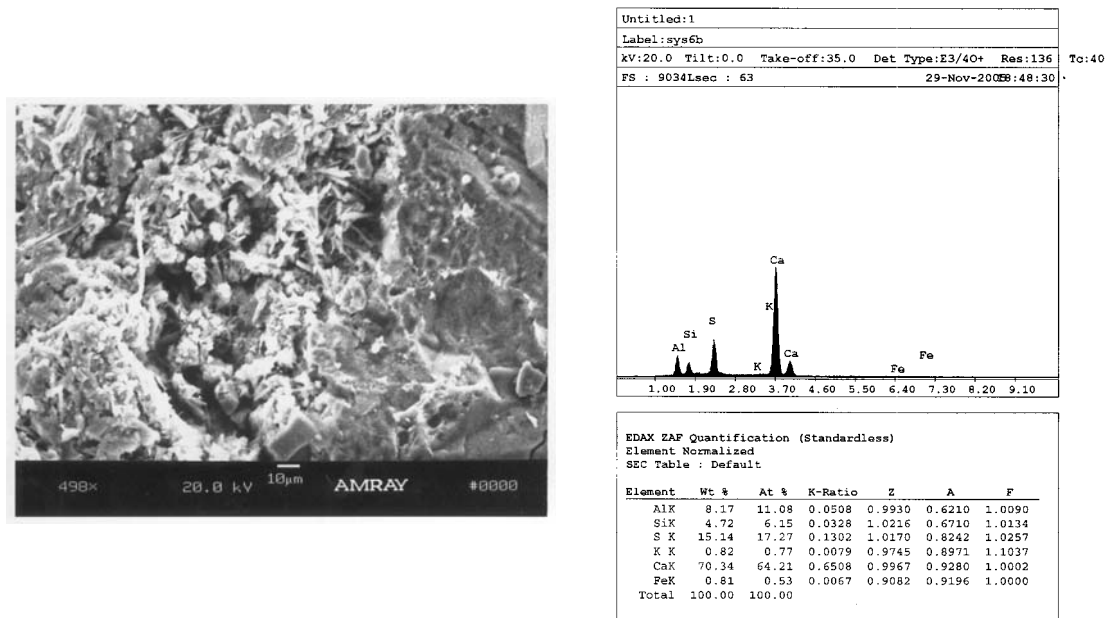
Figure 5.10: US 15 SB over Fishing Creek (1011100) - 1

One of the three cores examined contained no ettringite formations. The other two cores contained long ettringite crystals mixed in with calcium hydroxide Ca(OH)_2 in some locations. The DEF fills much less than 5% of the voids. See Figures 5.10 and 5.11. Energy Dispersive Analysis X-ray (EDAX) verifies the elemental composition of the crystal formations by showing the distinct aluminum, sulfur, and calcium pattern in general. Figure 5.11 (b) has very high levels of calcium indicating the DEF is mixed with Ca(OH)_2 . The bridge contained little to no ettringite in the cores sampled, see Figure 5.12 for typical core results.

(a) Ettringite in Void (b) Analysis of Ettringite in (a)

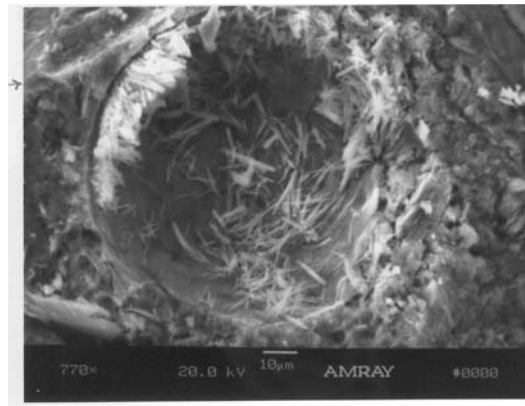
(a) Ettringite in Void

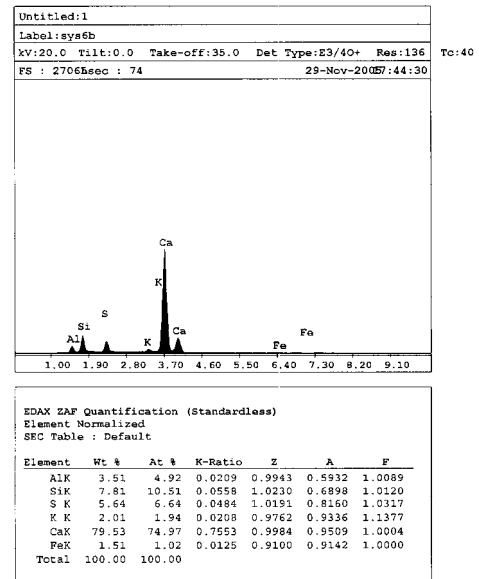
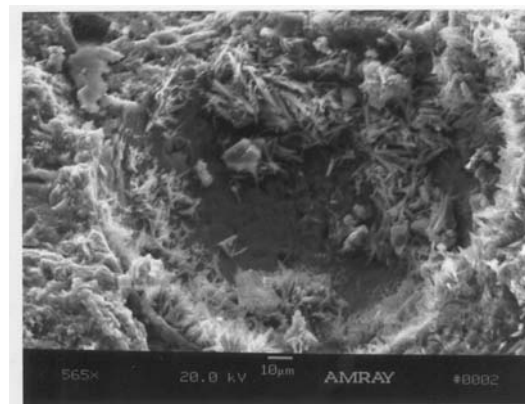
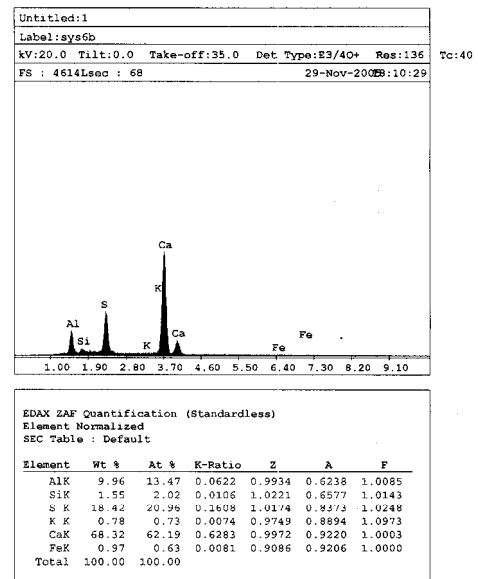
Figure 5.11: US 15 SB over Fishing Creek (1011100) - 2

(b) Analysis of Crystals in (a)

(c) Ettringite in Void

(d) Analysis of Crystals in (c)
