Title of Document: CHARACTERIZATION OF DELAYED
ETTRINGITE FORMATION IN MARYLAND
BRIDGES

Micah Shalom Ceary, Ph.D., 2007

CHARACTERIZATION OF DELAYED ETTRINGITE FORMATION IN
MARYLAND BRIDGES

Dissertation submitted to the Faculty of the Graduate School of the
University of Maryland, College Park, in partial fulfillment
of the requirements for the degree of
Doctorate of Philosophy
2007

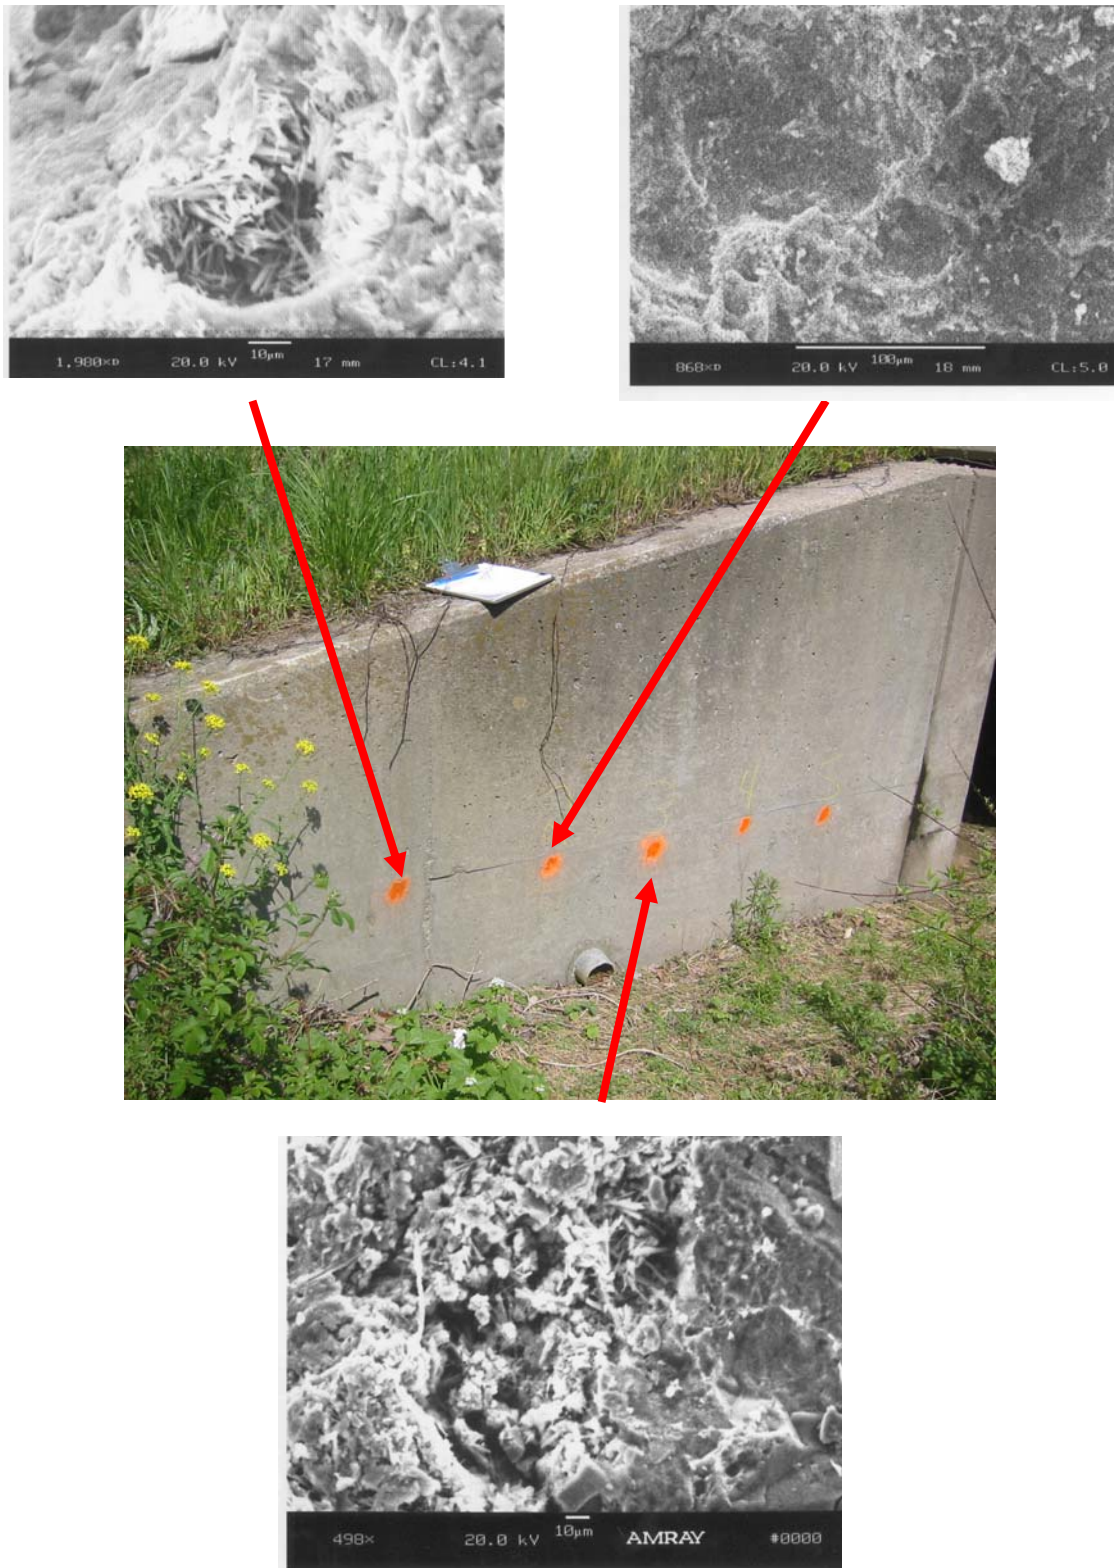
Figure 5.12: Ettringite Spatial Distribution
(1011100 – US 15 SB over Fishing Creek)

One of the three cores examined contained no ettringite formations. The other two cores contained long ettringite crystals mixed in with calcium hydroxide Ca(OH)_2 in some locations. The DEF fills much less than 5% of the voids. See Figures 5.10 and 5.11. Energy Dispersive Analysis X-ray (EDAX) verifies the elemental composition of the crystal formations by showing the distinct aluminum, sulfur, and calcium pattern in general. Figure 5.11 (b) has very high levels of calcium indicating the DEF is mixed with Ca(OH)_2 . The bridge contained little to no ettringite in the cores sampled, see Figure 5.12 for typical core results.

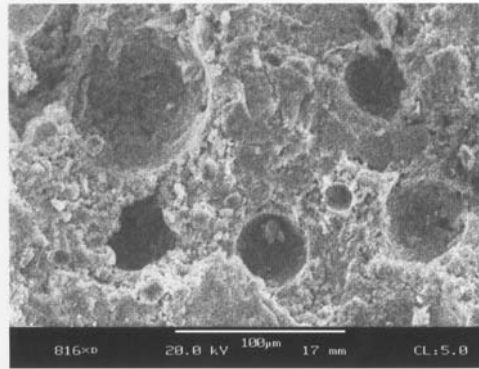
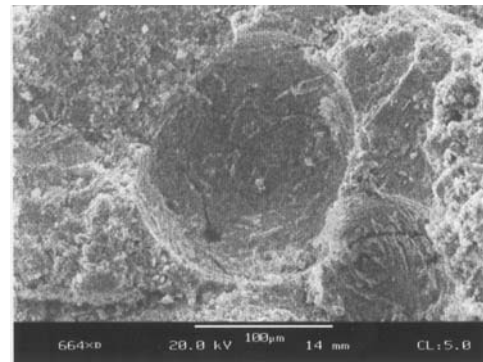
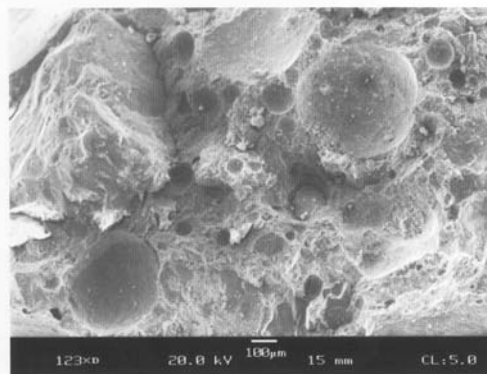
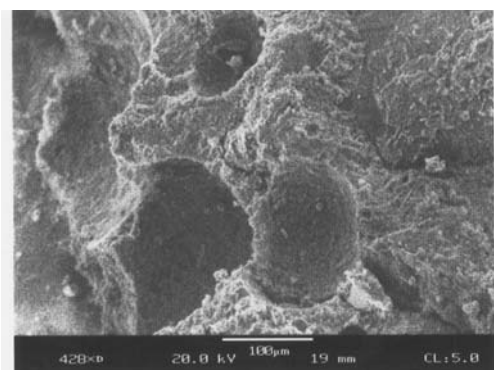
Figure 5.14: I-95 X SB over I-495 OL (1612300) - 1

Two of the three cores examined contained no ettringite formations. The other core contained long ettringite crystals. The DEF fills greater than 50% of the small voids or lines the larger voids with long crystals that occupy approximately 5% of the void. See Figures 5.14 and 5.15. Energy Dispersive Analysis X-ray (EDAX) verifies the elemental composition of the crystal formations by showing the distinct aluminum, sulfur, and calcium pattern in general. The bridge contained long DEF crystal that fills greater than 50% of the voids to no ettringite in the cores sampled, see Figure 5.16 for typical core results.

(a) Empty Voids

(b) Empty Voids

(c) Empty Voids

(d) Empty Voids

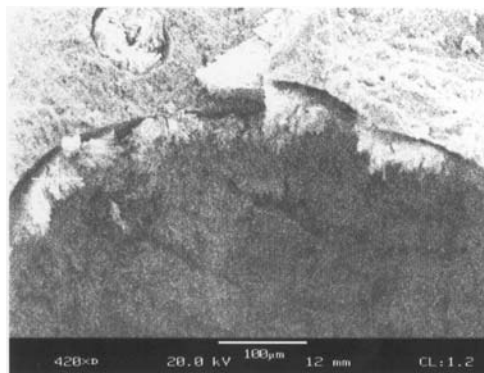
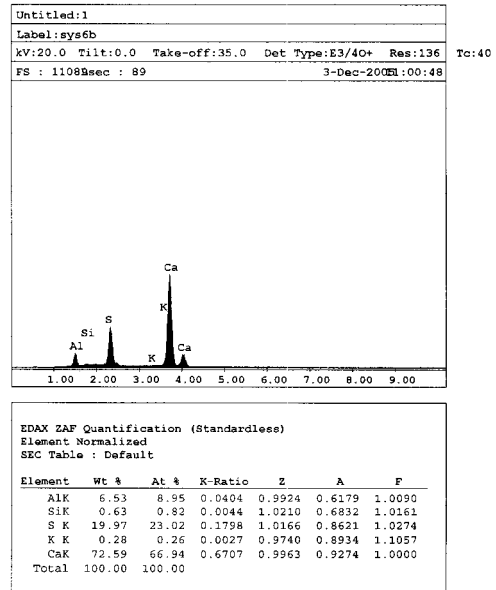
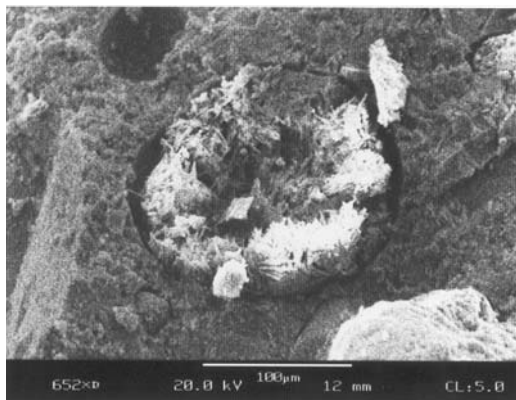
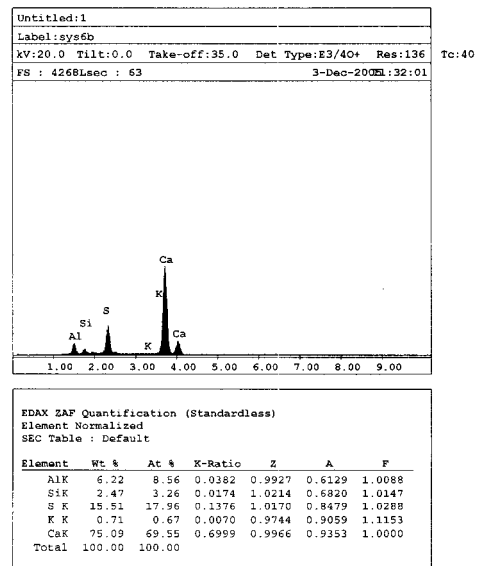
Figure 5.15: I-95 X SB over I-495 OL (1612300) - 2

(a) Long Ettringite Crystals
Lining Voids

(b) Analysis of Ettringite in (a)

(c) Ettringite in Void

(d) Analysis of Ettringite in (c)

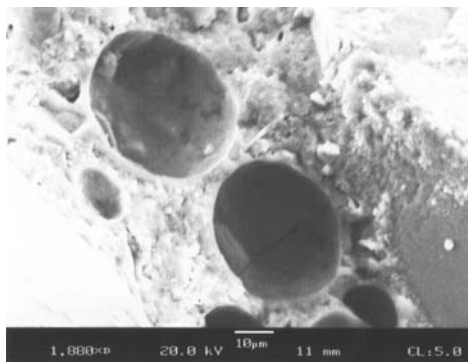
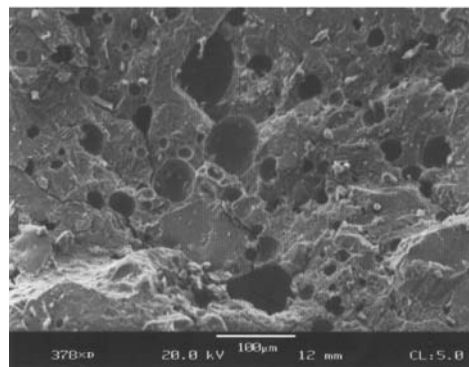
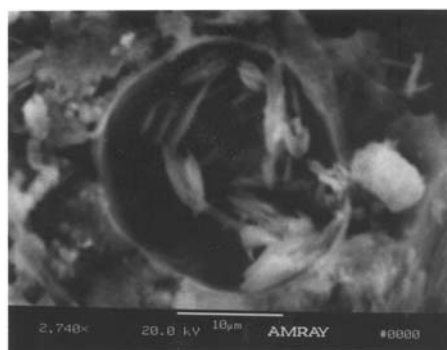
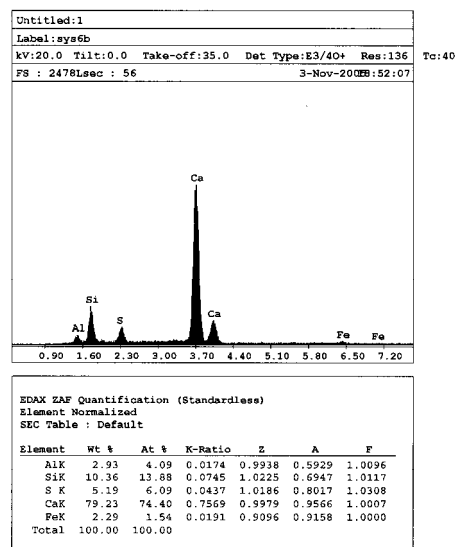
Figure 5.18: MD 10 SB over MD 177 (0217202)

One of the three cores examined contained no ettringite formations. The other two cores contained long ettringite crystals mixed in with calcium hydroxide Ca(OH)_2 in some locations. The DEF fills much less than 5% of the voids. See Figure 5.18.

(a) Empty Voids

(b) Empty Voids

(c) Ettringite in Void

(d) Analysis of Ettringite in (c)

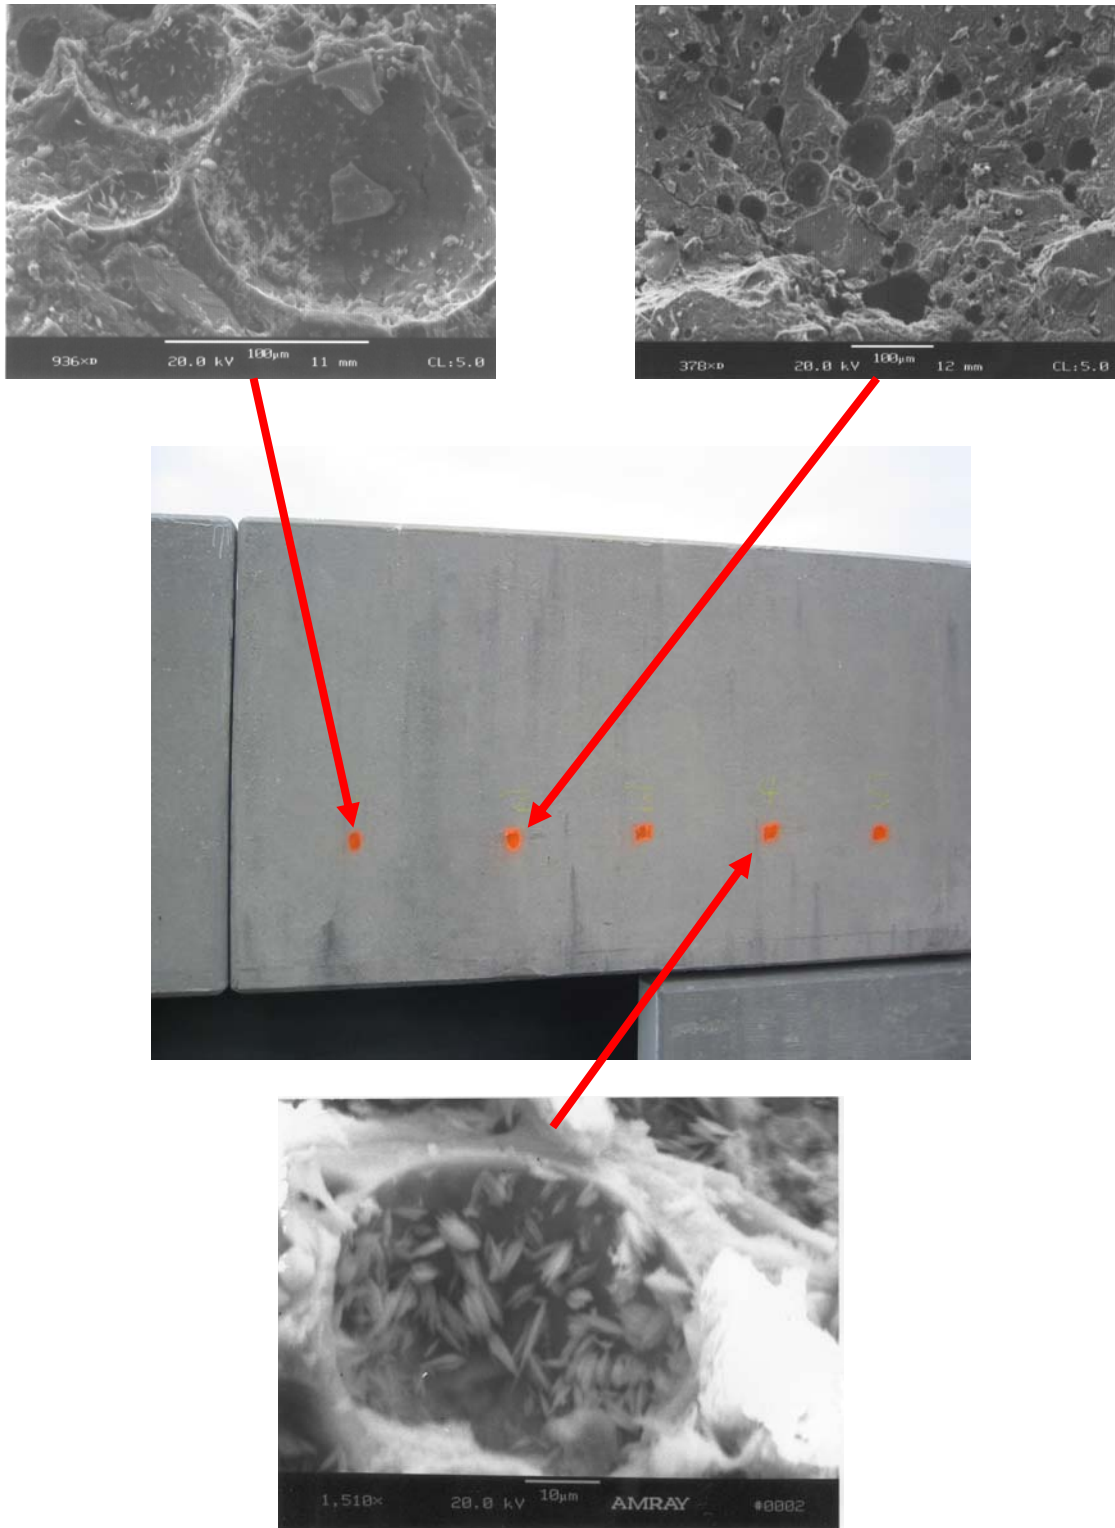
Figure 5.19: Ettringite Spatial Distribution
(0217202 – MD 10 SB over MD 177)

Energy Dispersive Analysis X-ray (EDAX) verifies the elemental composition of the crystal formations by showing the distinct aluminum, sulfur, and calcium pattern in general. The bridge contained little to no ettringite in the cores sampled, see Figure 5.19 for typical core results.

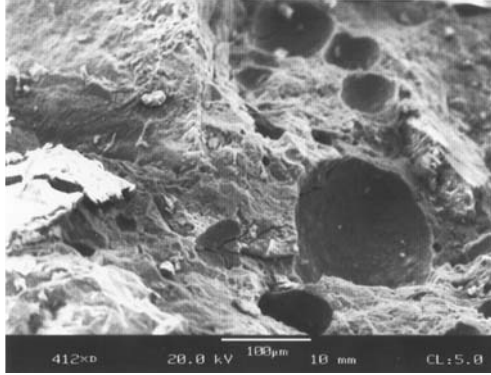
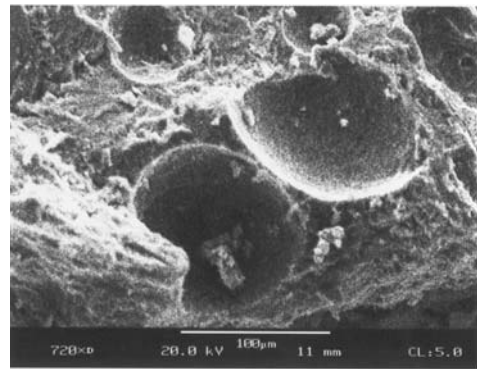
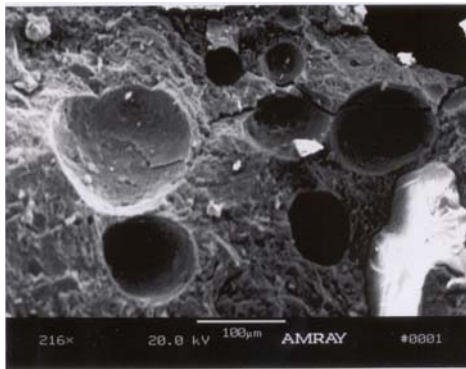
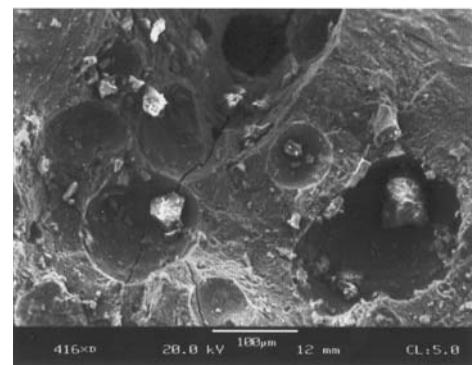
Figure 5.21: Queenstown Road over MD 100 (0219000)

All three of the cores examined contained no ettringite formations. See Figure 5.21. The bridge contained no ettringite in the cores sampled, see Figure 5.22 for typical core results.

(a) Empty Voids

(b) Empty Voids

(c) Empty Voids

(d) Empty Voids

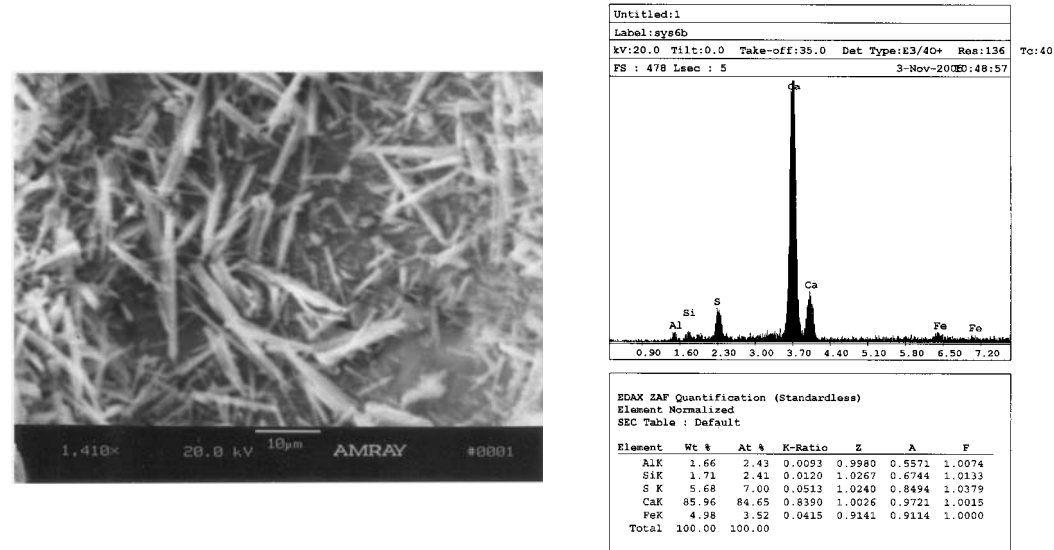
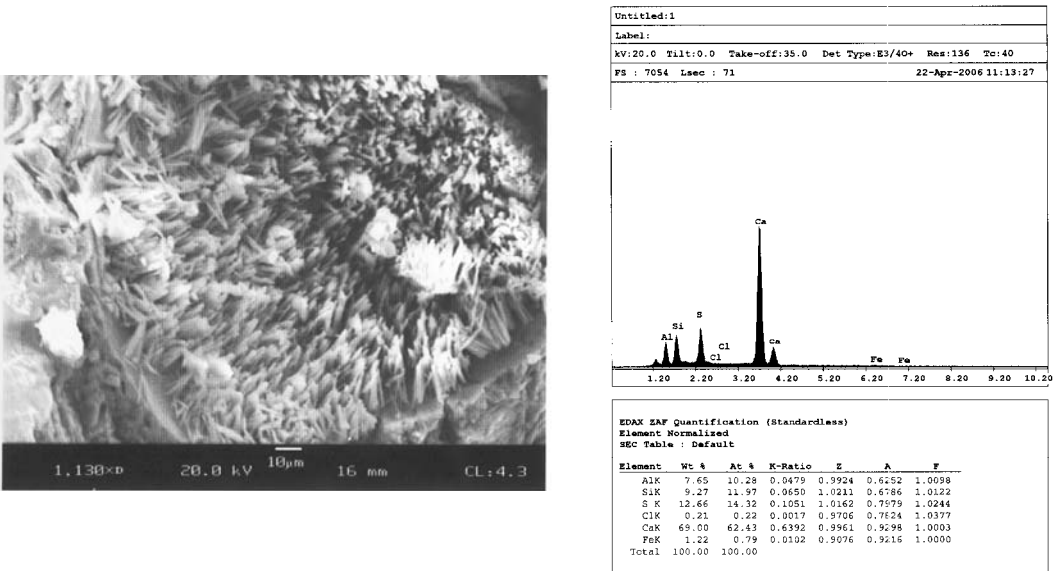
Figure 5.24: MD 77 over Double Pipe Creek (1005600) - 1

All three of the cores examined contained ettringite formations. The cores contained long ettringite crystals that fills anywhere from much less than 5% to greater than 50% of the voids. See Figures 5.23 and 5.24. Energy Dispersive Analysis X-ray (EDAX) verifies the elemental composition of the crystal formations by showing the distinct aluminum, sulfur, and calcium pattern in general. The bridge contained long DEF crystal that fills anywhere from much less than 5% to greater than 50% of the voids in the cores sampled, see Figure 5.25 for typical core results.

(a) Ettringite in Voids

(b) Analysis of Ettringite in (a)

(c) Ettringite in Void

(d) Analysis of Ettringite in (c)

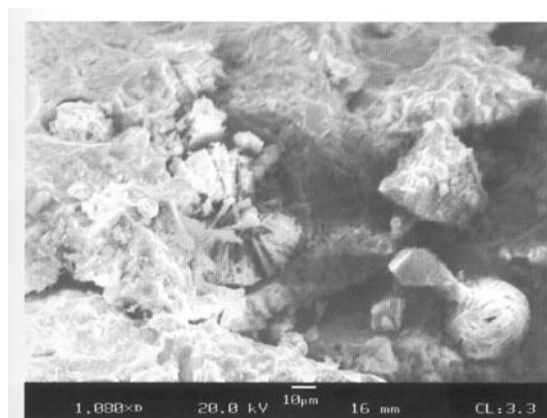
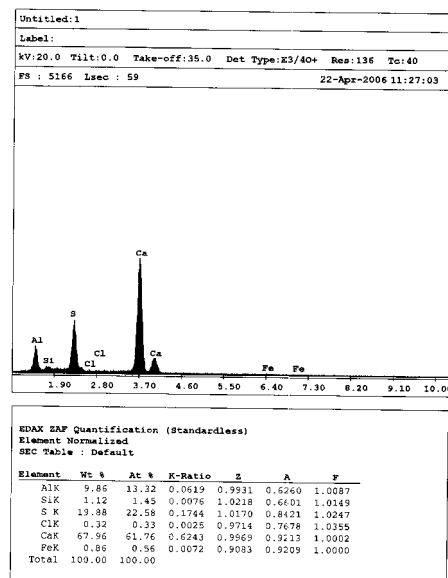
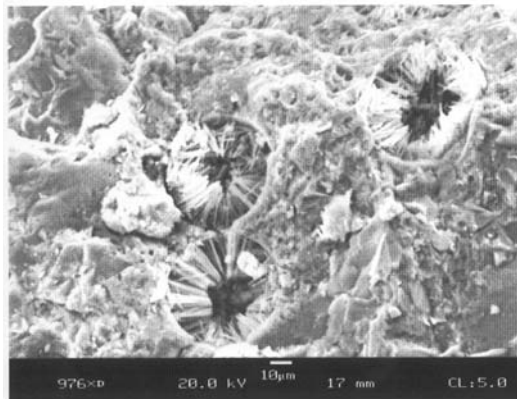
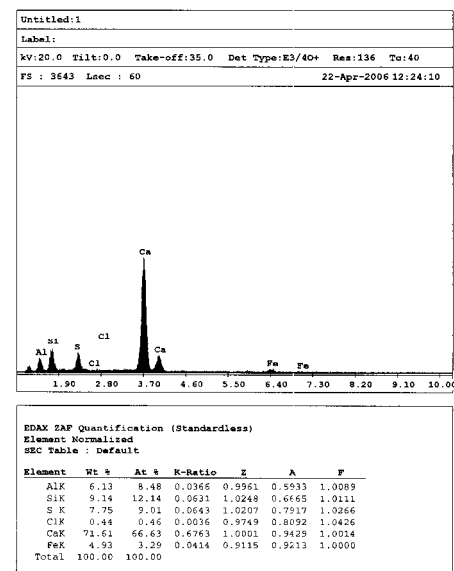
Figure 5.25: MD 77 over Double Pipe Creek (1005600) - 2

(a) Ettringite in Void

(b) Analysis of Ettringite in (a)

(c) Ettringite in Void

(d) Analysis of Ettringite in (c)

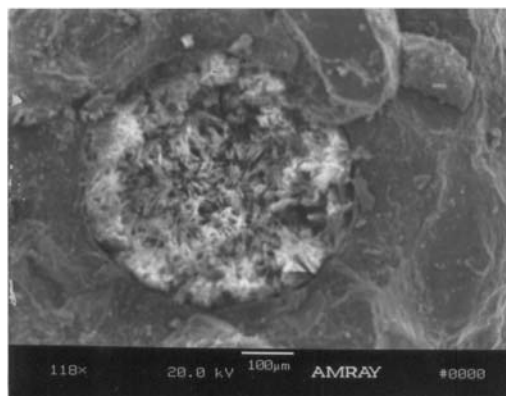
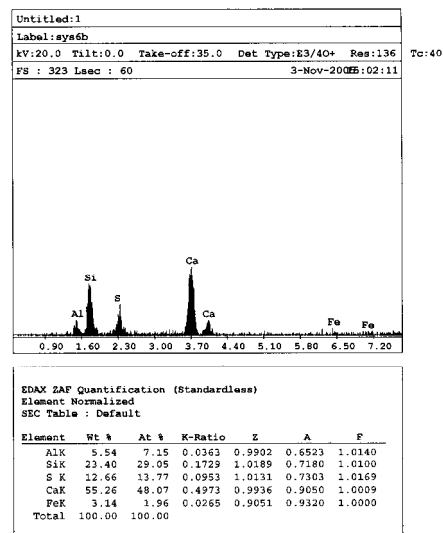
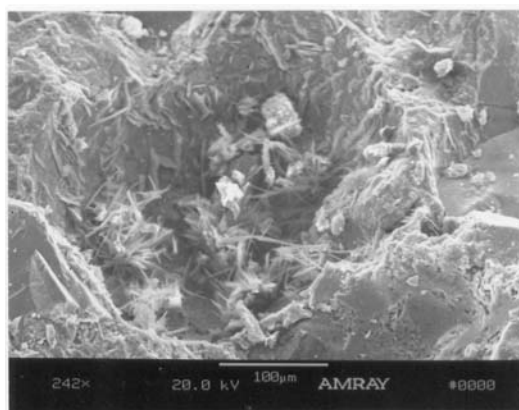
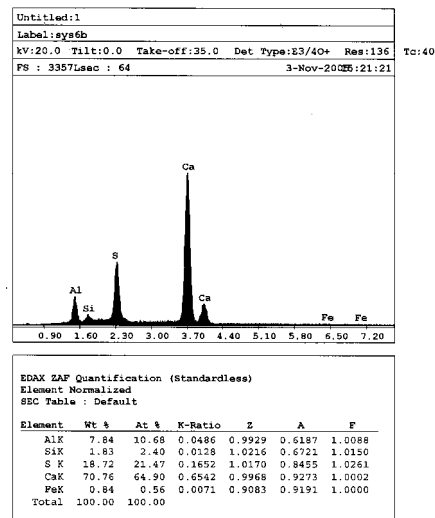
Figure 5.28: MD 100 WB over MD 174 (0208304) - 1

Two of the three cores examined contained no ettringite formations. The other one cores contained long ettringite crystals, which filled the voids from much less than 5% to greater than 5% but less than 50% of the voids. See Figures 5.28 and 5.29. Energy Dispersive Analysis X-ray (EDAX) verifies the elemental composition of the crystal formations by showing the distinct aluminum, sulfur, and calcium pattern in general. The bridge contained long DEF crystal that fills less than 50% of the voids to no ettringite in the cores sampled; see Figure 5.30 for typical core results.

(a) Ettringite in Void

(b) Analysis of Ettringite in (a)

(c) Ettringite in Void

(d) Analysis of Ettringite in (c)

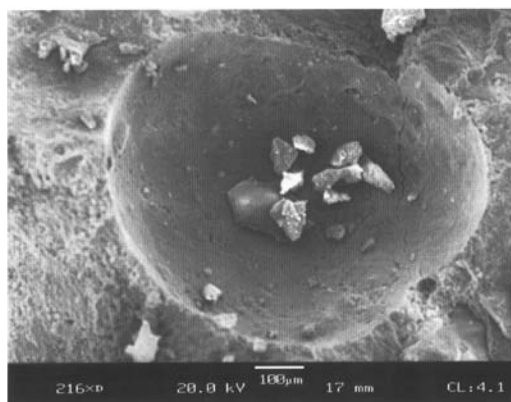
(a) Empty Void

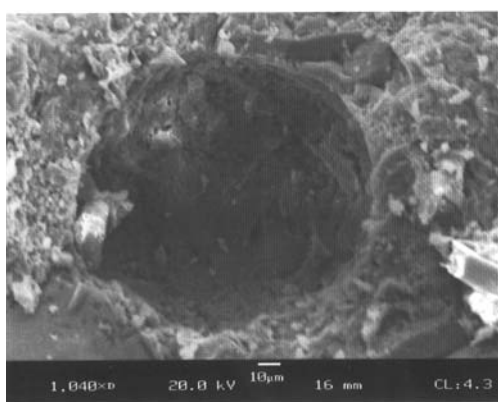
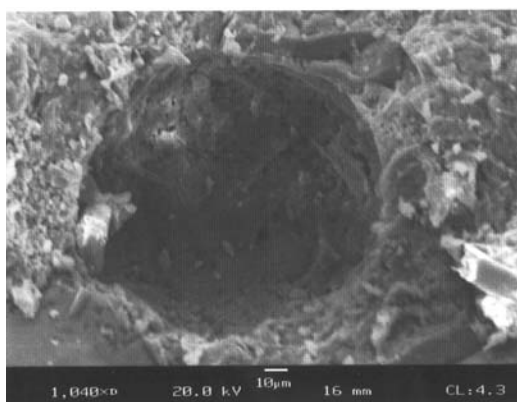
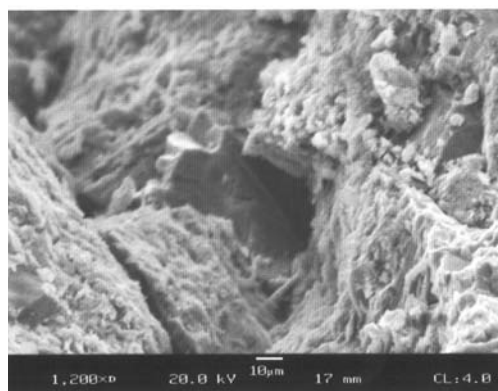
Figure 5.29: MD 100 WB over MD 174 (0208304) - 2

(b) Empty Void

(c) Empty Void

(d) Empty Void

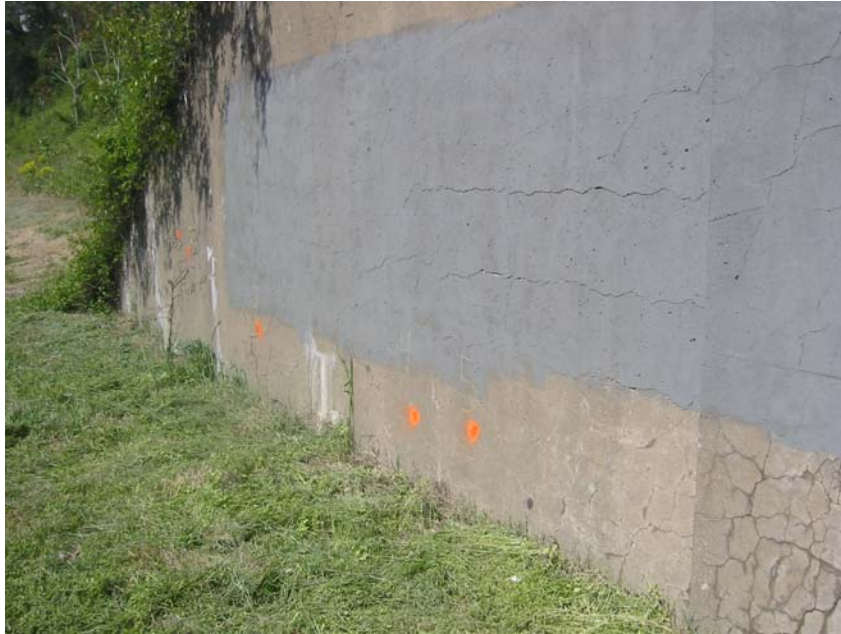
Figure 5.31: Coring Locations (0311100 – CSX Transportation over I-695)

Three cores were taken from the inside face of the northwest wingwall; see Figure 5.31 for locations.

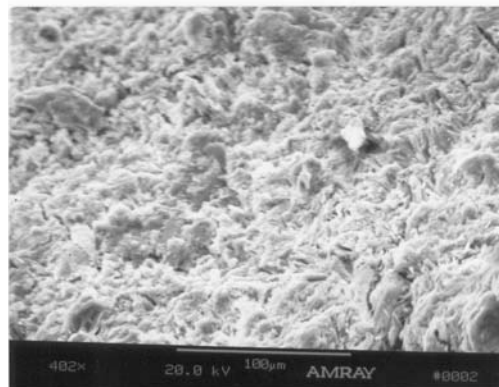
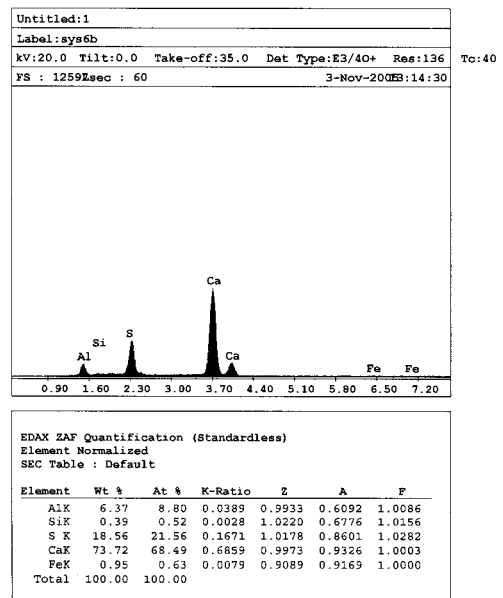
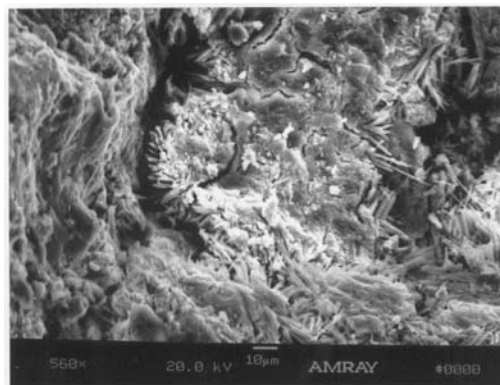
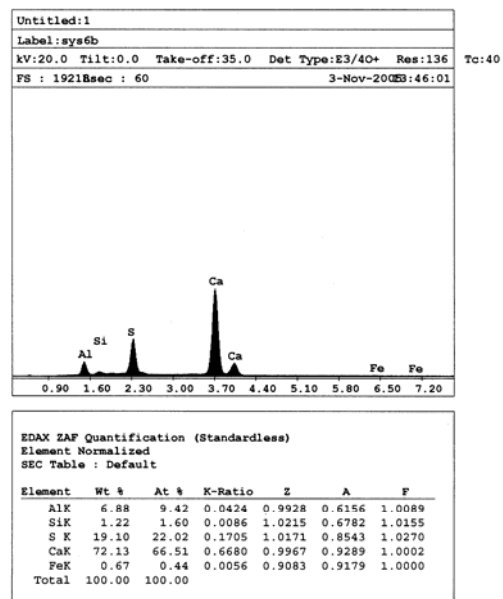
Figure 5.32: CSX Transportation over I-695 (0311100) - 1

All three of the cores examined contained significant ettringite formations. The majority of the DEF observed was in laminar formations found on the sample surface. The ettringite of the surface would have been in a crack along which the concrete cracked in the sample preparation work. Occasionally voids were found with long ettringite crystals that filled anywhere from much less than 5% to greater than 50% of the voids. See Figures 5.32, 5.33, and 5.34. Energy Dispersive Analysis X-ray (EDAX) verifies the elemental composition of the crystal formations by showing the distinct aluminum, sulfur, and calcium pattern in general. The bridge contained significant quantities of laminar ettringite with occasional void containing long DEF

(a) Laminar Ettringite on Surface

(b) Analysis of Ettringite in (a)

(c) Laminar Ettringite on Surface

(d) Analysis of Ettringite in (c)

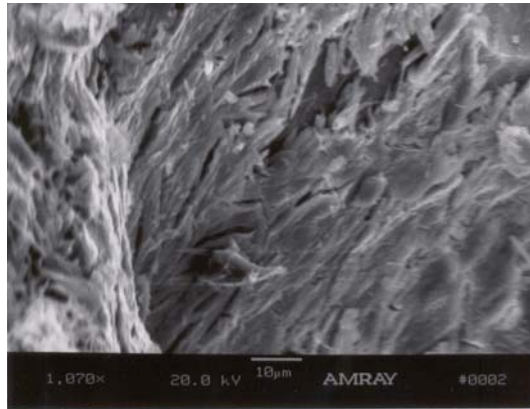
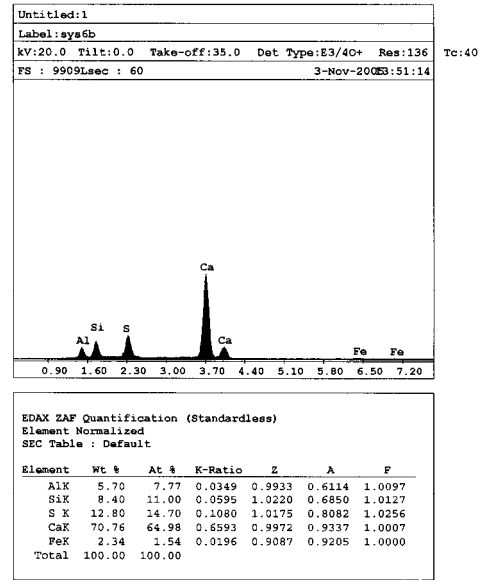
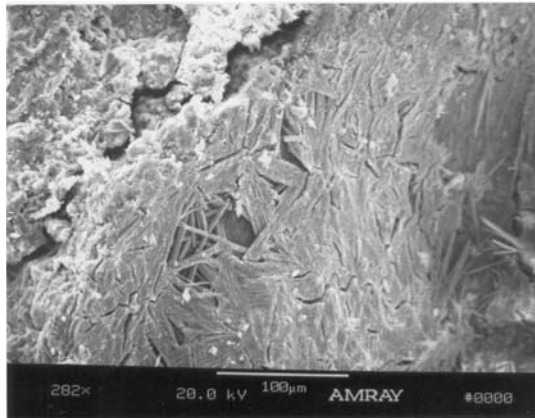
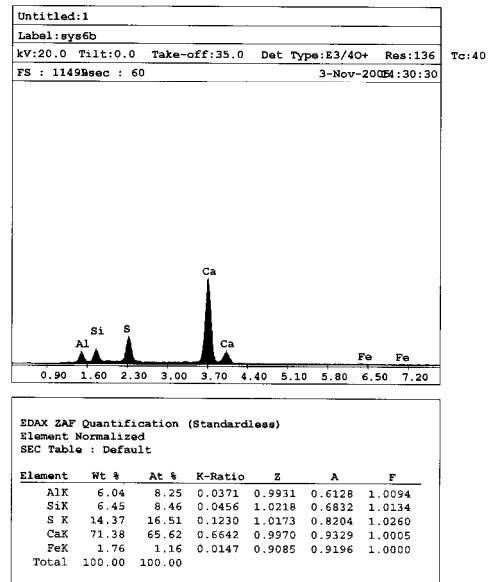
Figure 5.33: CSX Transportation over I-695 (0311100) - 2

(a) Laminar Ettringite ofnSurface

(b) Analysis of Ettringite in (a)

(c) Laminar Ettringite on Surface

(d) Analysis of Ettringite in (c)

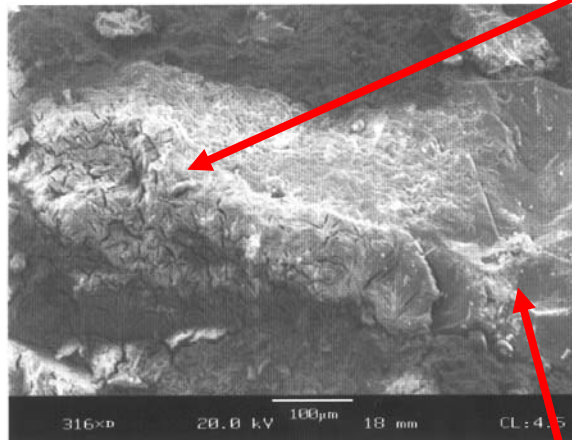
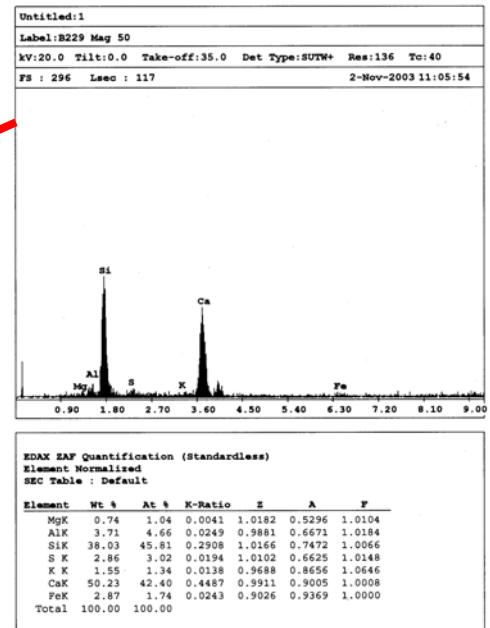
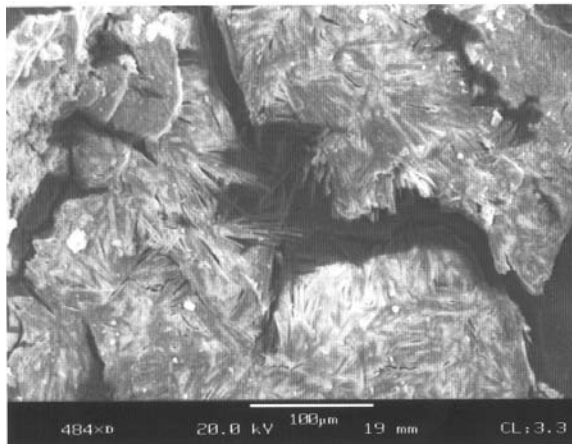
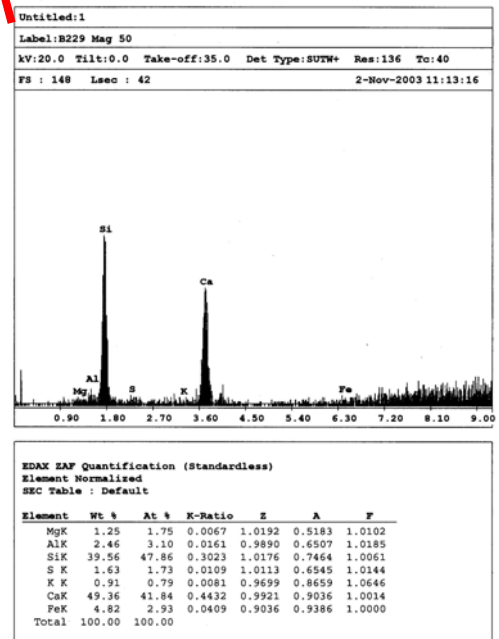
Figure 5.34: CSX Transportation over I-695 (0311100) - 3

(a) Laminar Ettringite on Aggregate

(b) Analysis of Ettringite in (a)

(c) Close-up of Laminar Ettringite on Surface

(d) Analysis of Aggregate in (a)

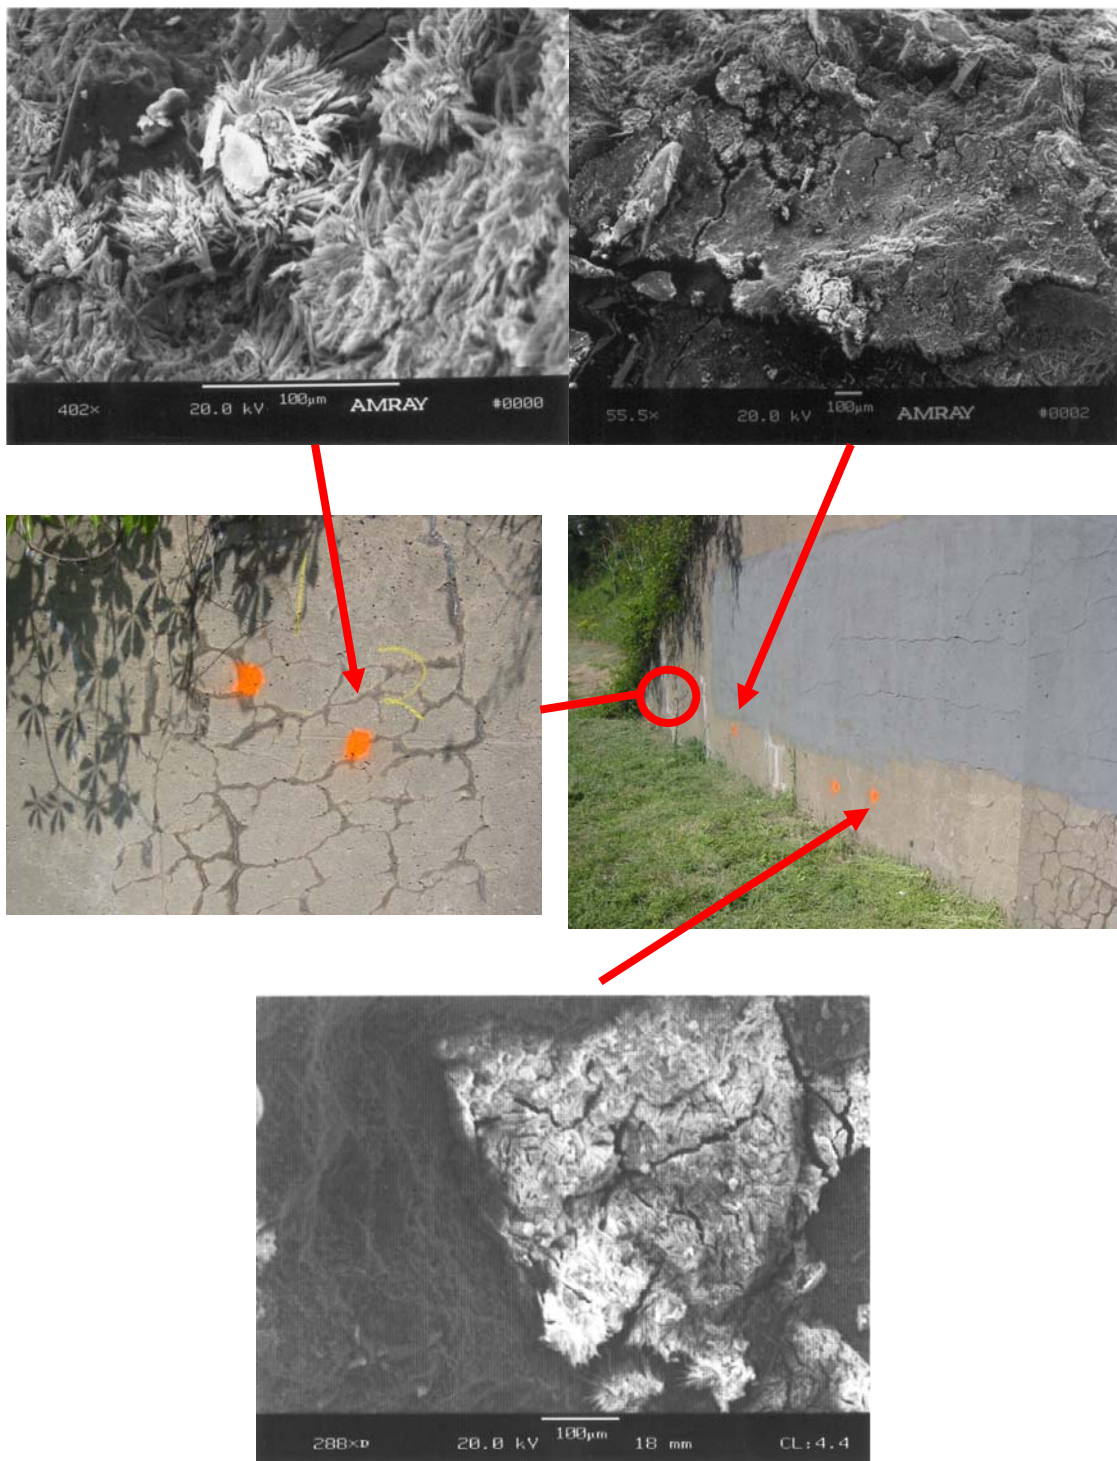
**Figure 5.35: Ettringite Spatial Distribution
(0311100 – CSX Transportation over I-695)**

crystal that fills anywhere from much less than 5% to greater than 50% of the voids in the cores sampled, see Figure 5.35 for typical core results.

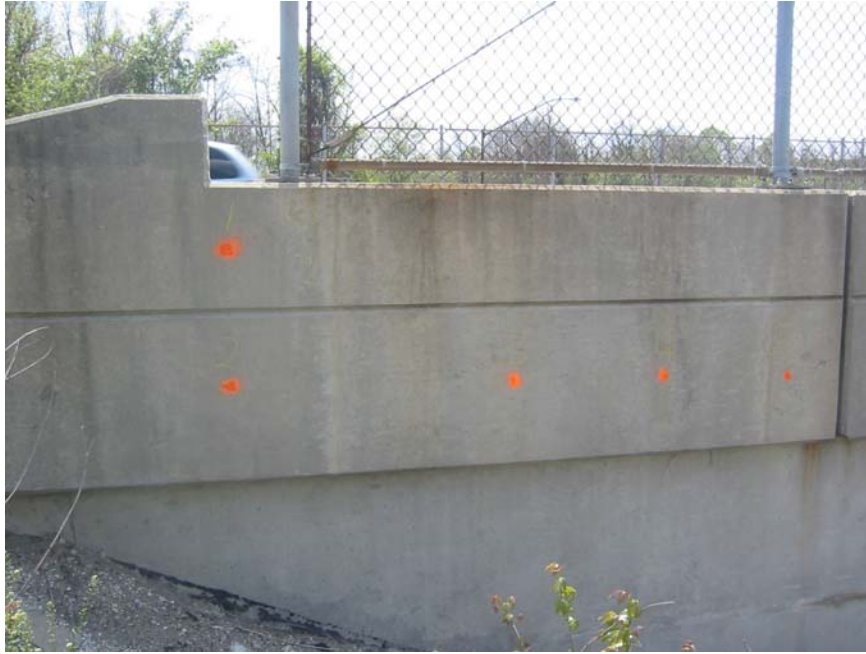
Figure 5.36: Coring Locations (1308603 – MD 175 EB over US 29)

Three cores were taken from the outside face of the north parapet above the northeast wingwall; see Figure 5.36 for locations.

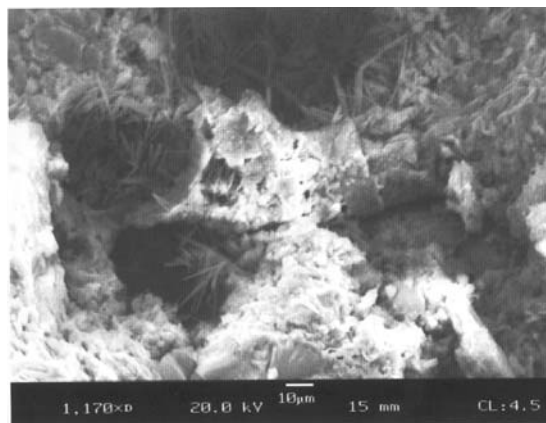
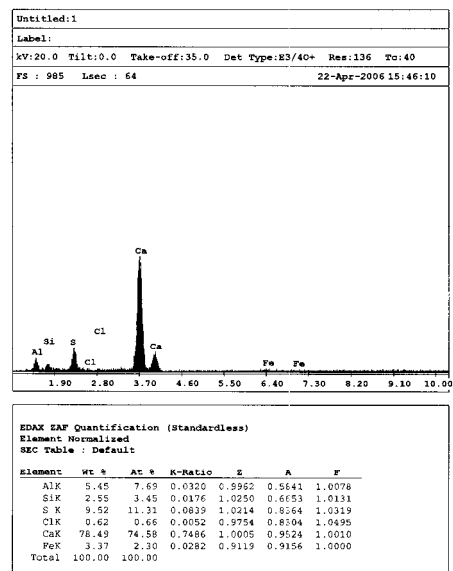
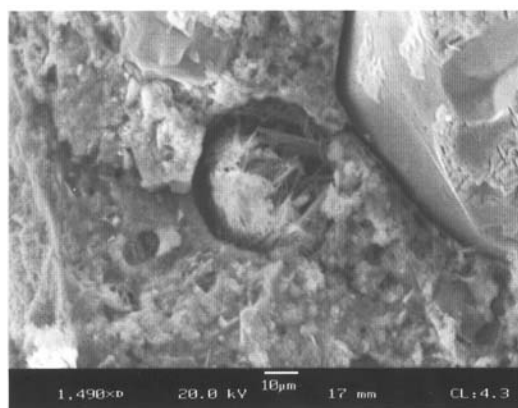
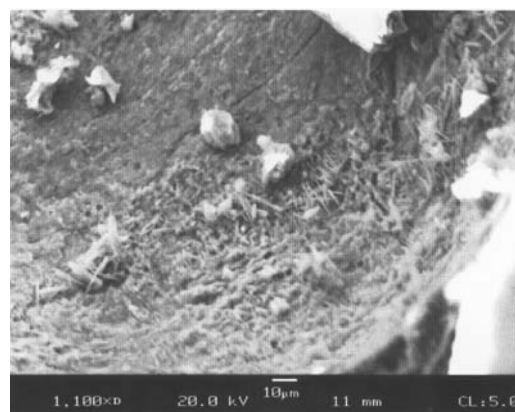
Figure 5.37: MD 175 EB over US 29 (1308603) - 1

One of the three cores examined contained no ettringite formations. The other two cores contained long ettringite crystals. The DEF fills much less than 5% to between 5% and 50% of the voids. See Figures 5.37 and 5.38. Energy Dispersive Analysis X-ray (EDAX) verifies the elemental composition of the crystal formations by showing the distinct aluminum, sulfur, and calcium pattern in general. The bridge contained little to no ettringite in the cores sampled, see Figure 5.39 for typical core results.

(a) Ettringite in Voids

(b) Analysis of Ettringite in (a)

(c) Ettringite in Void

(d) Ettringite in Void

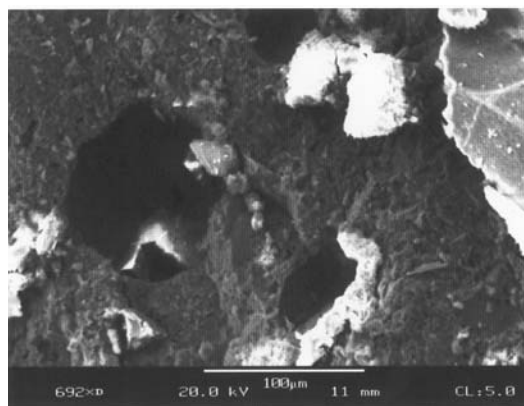
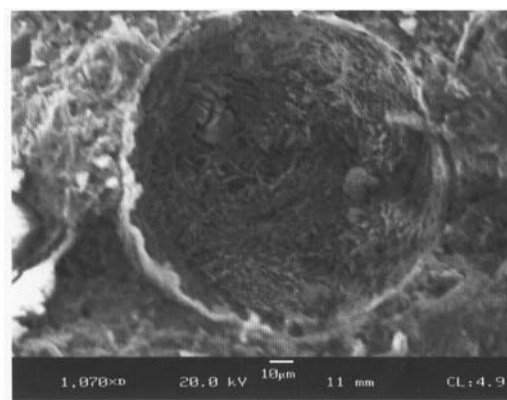
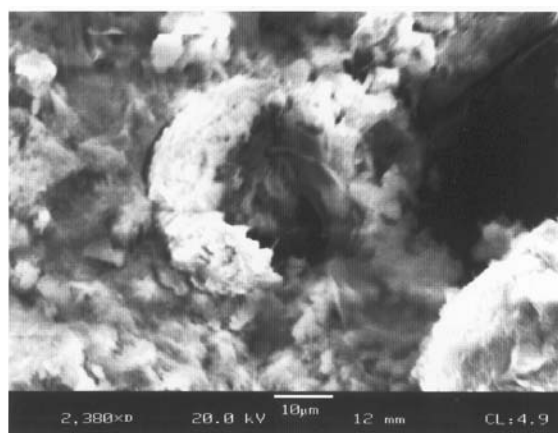
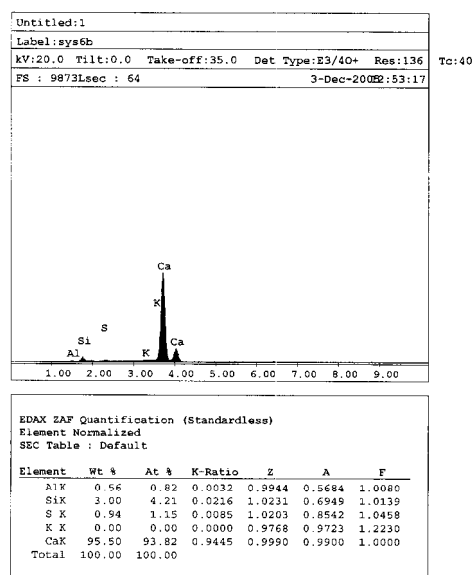
Figure 5.38: MD 175 EB over US 29 (1308603) - 2

(a) Empty Voids

(b) Void with Calcium Hydroxide

(c) Void with Calcium Hydroxide

(d) Analysis of Crystals in (c)

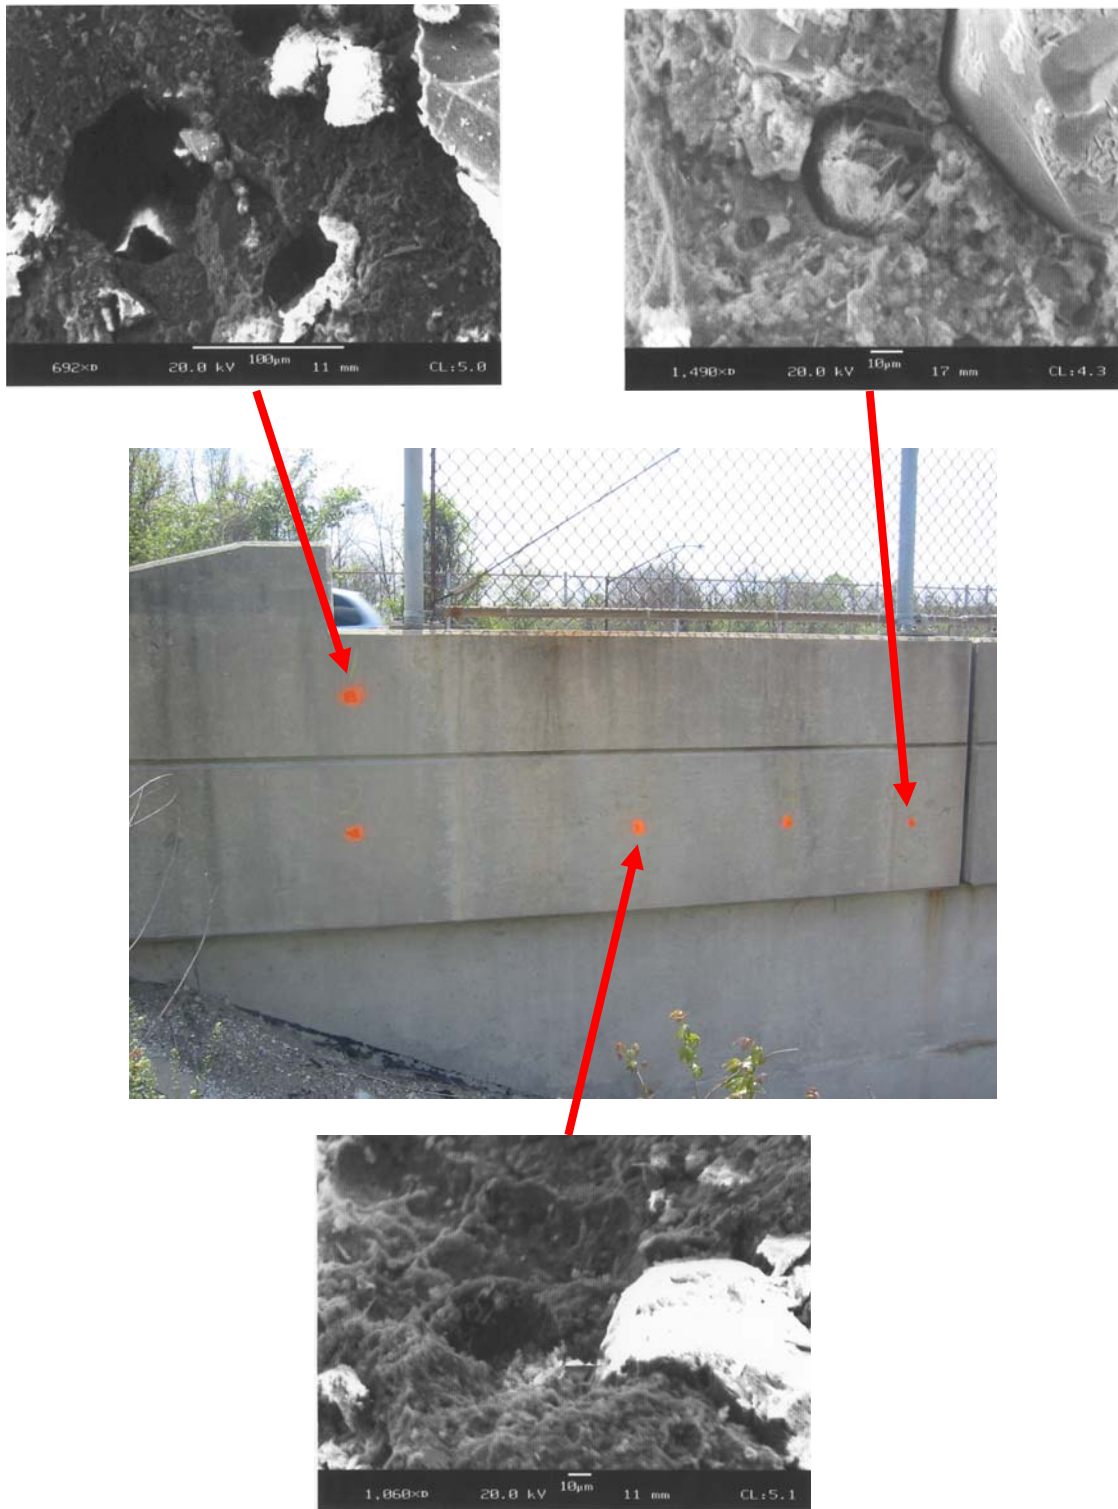
Figure 5.39: Ettringite Spatial Distribution
(1308603 – MD 175 EB over US 29)

In addition to the SEM and EDAX analysis, a large sample of the fractured cores was taken for ASR testing. The UV light ASR test indicates no presence of ASR gel in the parapet.

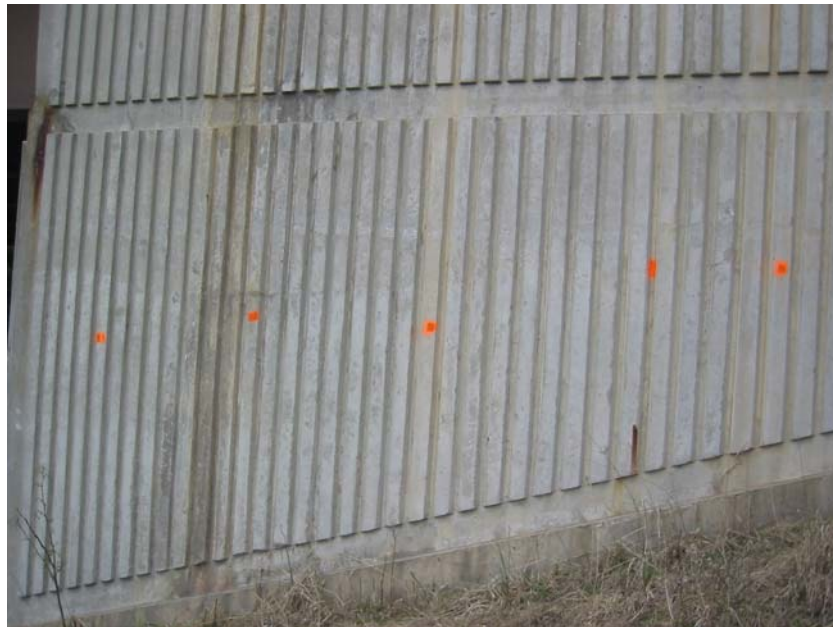
Figure 5.40: Coring Locations (MD 140 SB over I-795 Ramp 'T' & 'G')

Three cores were taken from the northeast wingwall; see Figure 5.40 for locations.
