Title of Document: CHARACTERIZATION OF DELAYED
ETTRINGITE FORMATION IN MARYLAND
BRIDGES

Micah Shalom Ceary, Ph.D., 2007

CHARACTERIZATION OF DELAYED ETTRINGITE FORMATION IN
MARYLAND BRIDGES

Dissertation submitted to the Faculty of the Graduate School of the
University of Maryland, College Park, in partial fulfillment
of the requirements for the degree of
Doctorate of Philosophy
2007

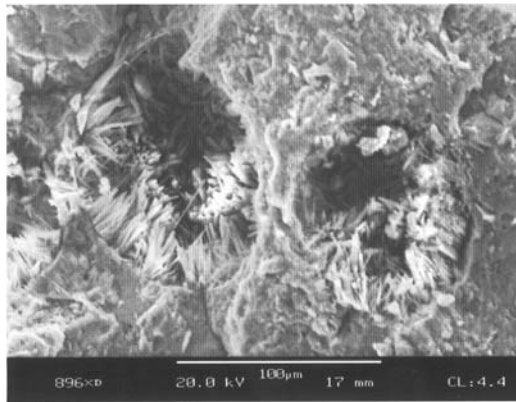
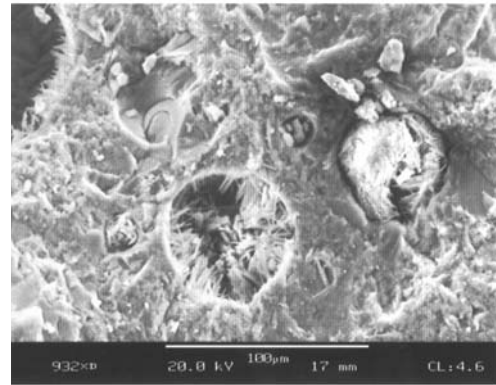
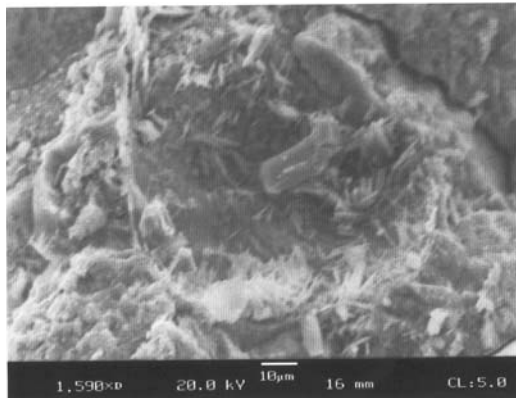
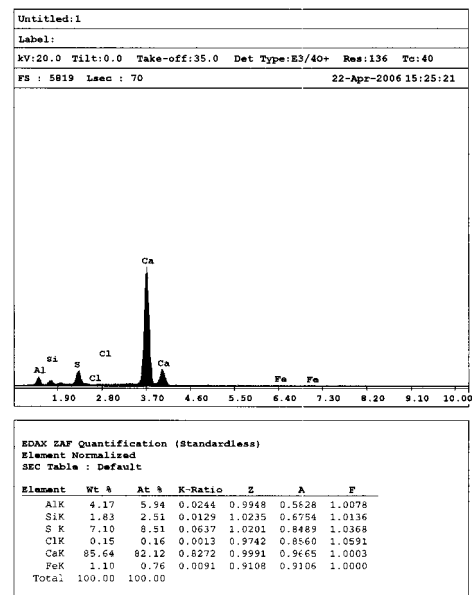
Figure 5.41: MD 140 SB over I-795 Ramp 'I' & 'G' (0333900) - 1

All three of the cores examined contained ettringite formations. The DEF exhibited long crystals morphology, which filled anywhere from much less than 5% to greater than 50% of the voids. See Figures 5.41 and 5.42. Energy Dispersive Analysis X-ray (EDAX) verifies the elemental composition of the crystal formations by showing the distinct aluminum, sulfur, and calcium pattern in general. The bridge contained little to no ettringite in the cores sampled, see Figure 5.43 for typical core results.

(a) Ettringite in Voids

(b) Ettringite in Voids

(c) Ettringite in Voids

(d) Analysis of (c)

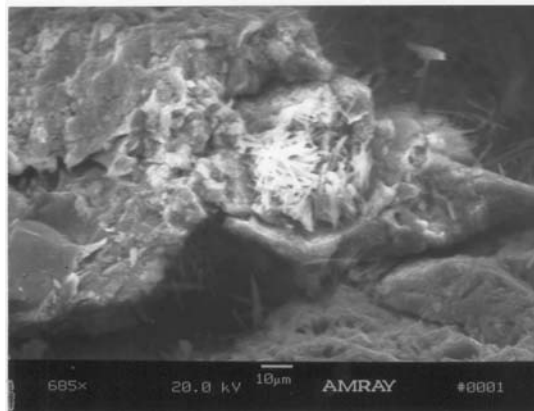
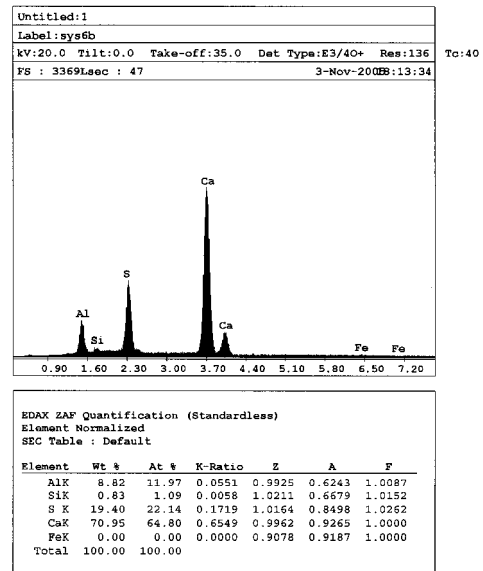
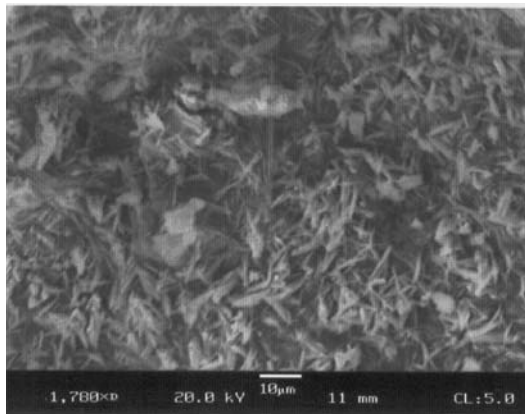
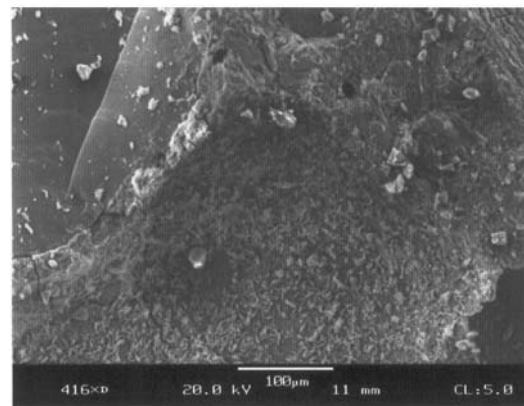
Figure 5.42: MD 140 SB over I-795 Ramp 'I' & 'G' (0333900) - 2

(a) Ettringite in Voids

(b) Analysis of Ettringite in (a)

(c) Ettringite in Voids

(d) Ettringite in Voids

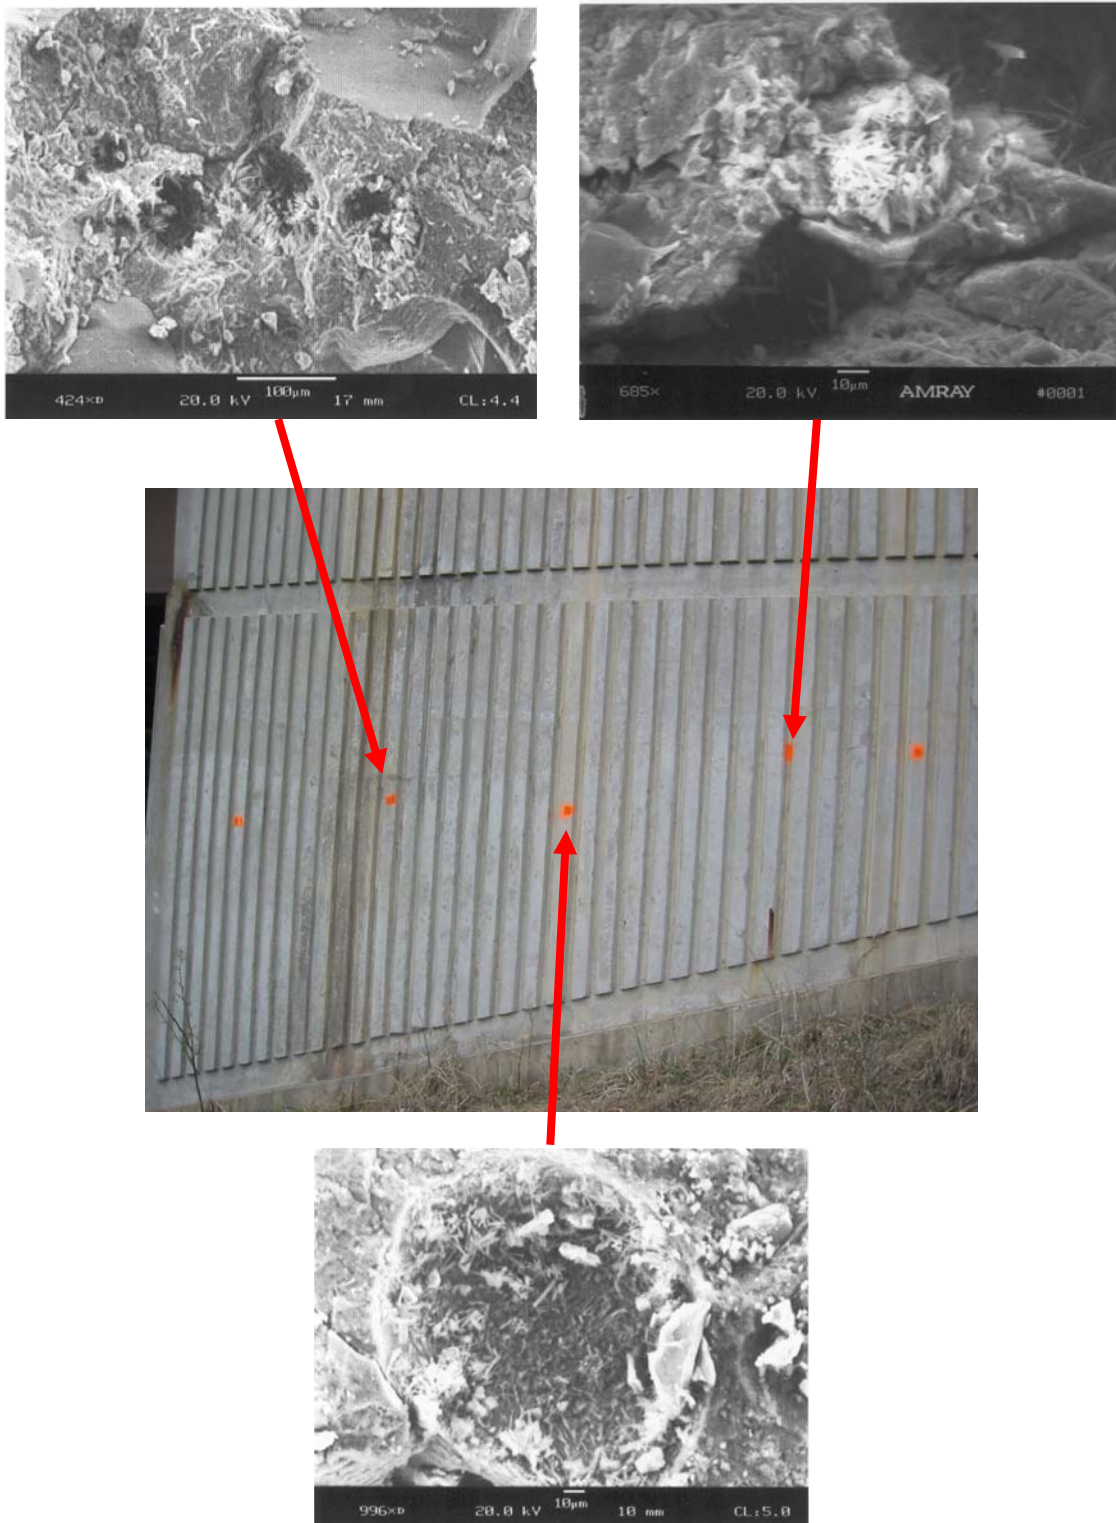
Figure 5.43: Ettringite Spatial Distribution
(MD 140 SB over I-795 Ramp 'T' & 'G')

In addition to the SEM and EDAX analysis, a large sample of the fractured cores was taken for ASR testing. The UV light ASR test indicates no presence of ASR gel in the wingwall.

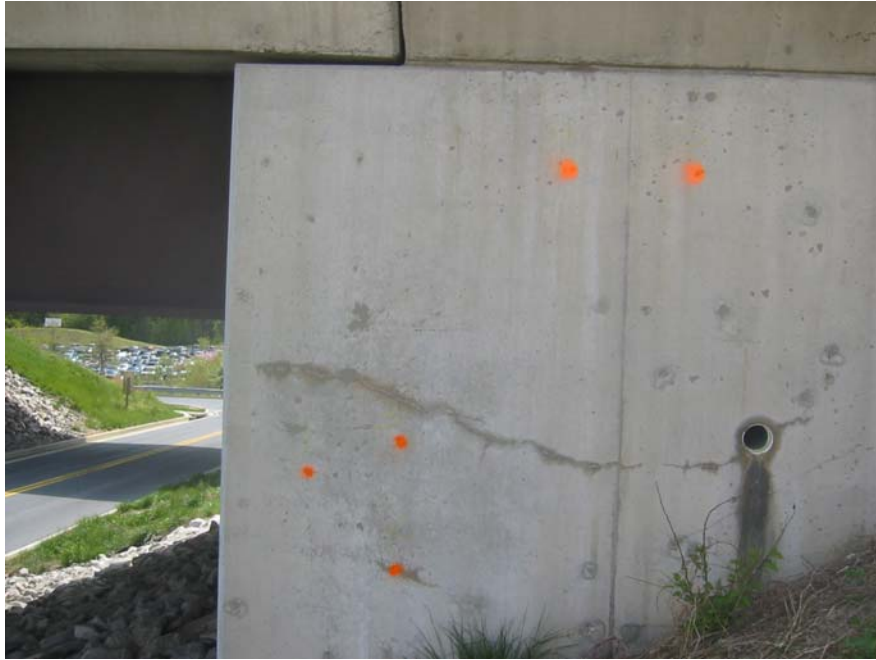
Figure 5.44: Coring Locations (MD 100 WB over Dorsey Station Road)

Three cores were taken from the outside face of the west parapet above the northwest wingwall; see Figure 5.44 for locations.

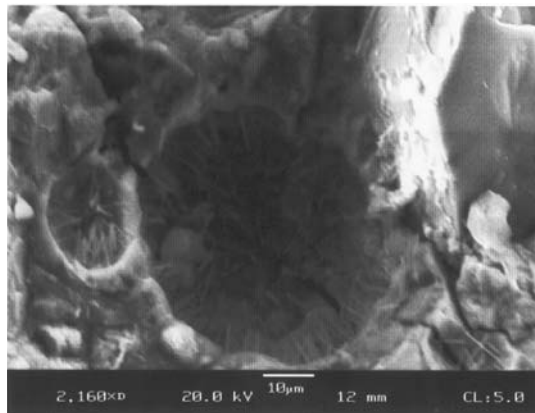
Figure 5.45: MD 100 WB over Dorsey Station Road (1315004)

Two of the three cores examined contained no ettringite formations. The other one cores contained long ettringite crystals, which filled much less than 5% of the voids. See Figure 5.45. Energy Dispersive Analysis X-ray (EDAX) verifies the elemental composition of the crystal formations by showing the distinct aluminum, sulfur, and calcium pattern in general. The bridge contained long DEF crystal that fills much less than 5% of the voids to no ettringite in the cores sampled; see Figure 5.46 for typical core results.

(a) Ettringite in Voids

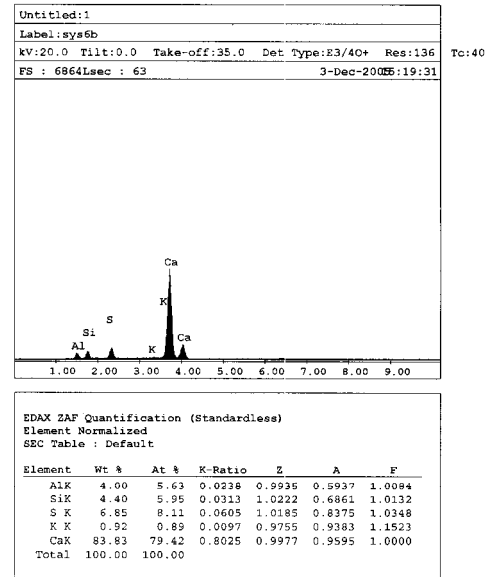
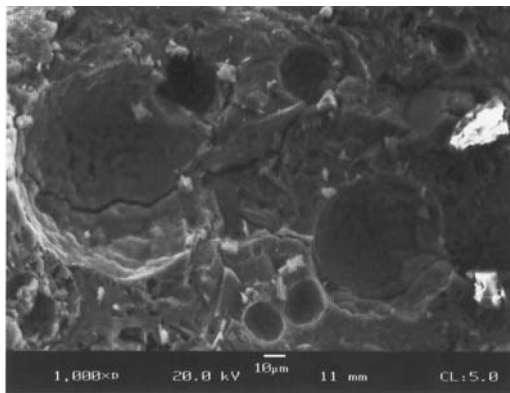
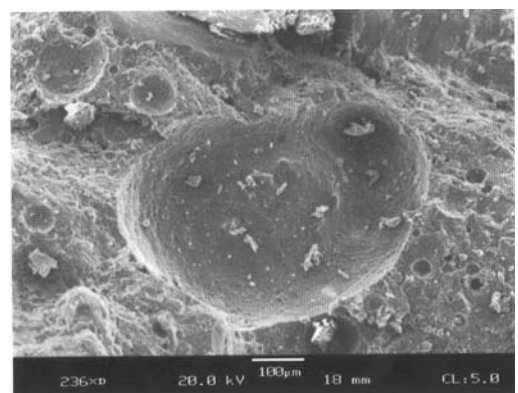
(b) Analysis of (a)

(c) Empty Voids

(d) Empty Void

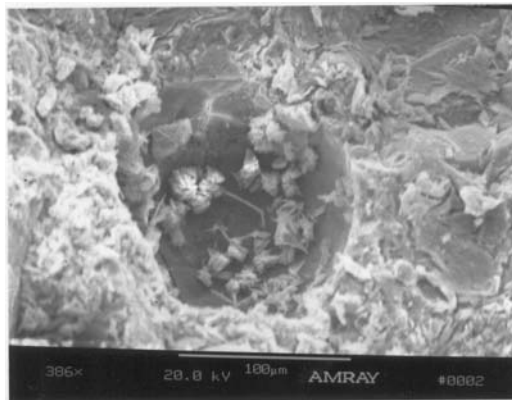
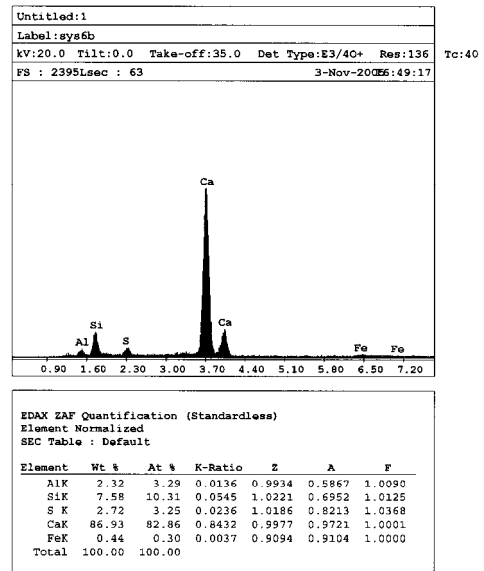
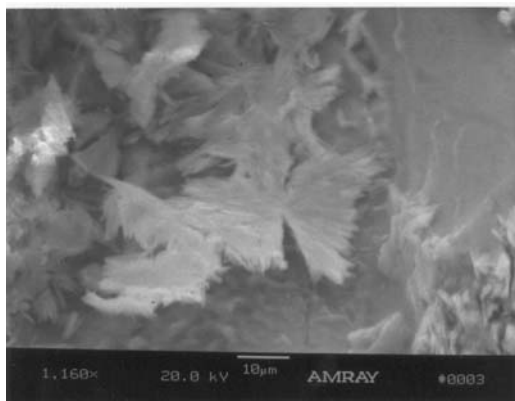
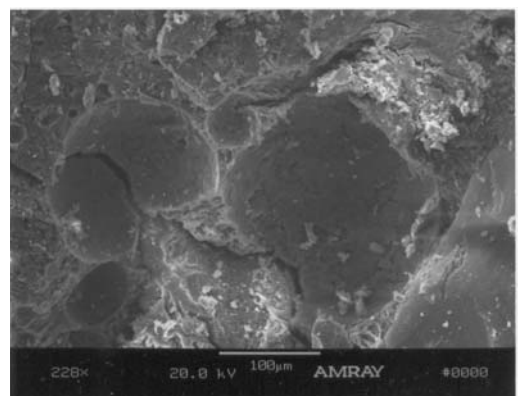
Figure 5.48: MD 32 over River Road & Patapsco River (1315700) - 1

Two of the three cores examined contained no ettringite formations. The other one cores contained laminar ettringite formations on the sample surface and long ettringite crystals that filled much less than 5% of the voids. See Figures 5.48 and 5.49. Energy Dispersive Analysis X-ray (EDAX) verifies the elemental composition of the crystal formations by showing the distinct aluminum, sulfur, and calcium pattern in general. The bridge typically exhibited no ettringite, but the core from an area where moisture mapping cracking is developing exhibited both long DEF crystal that fills less than 5% of the voids and laminar ettringite; see Figure 5.50 for typical core results.

(a) Laminar Ettringite of Surface

(b) Analysis of (a)

(c) Laminar Ettringite of Surface

(d) Empty Voids

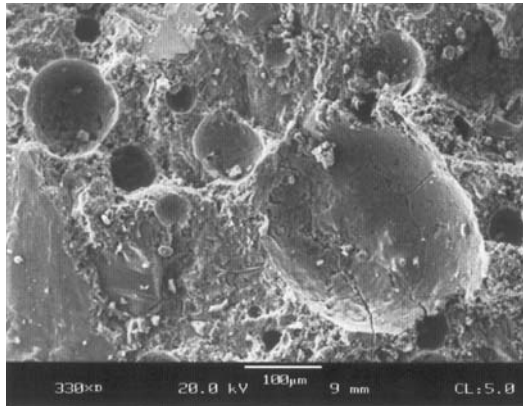
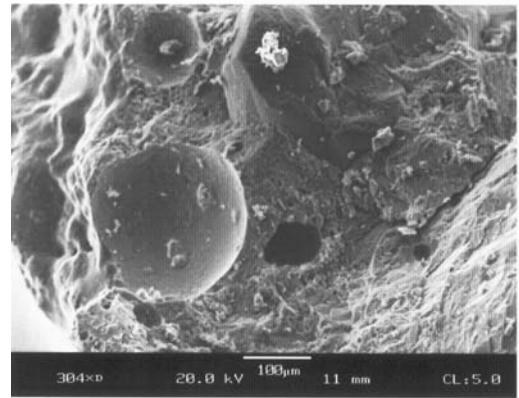
Figure 5.49: MD 32 over River Road & Patapsco River (1315700) - 2

(a) Empty Voids

(b) Empty Voids

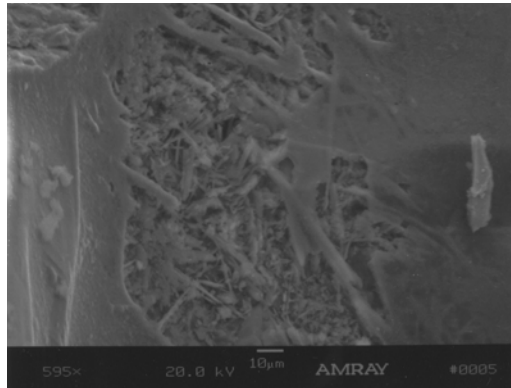
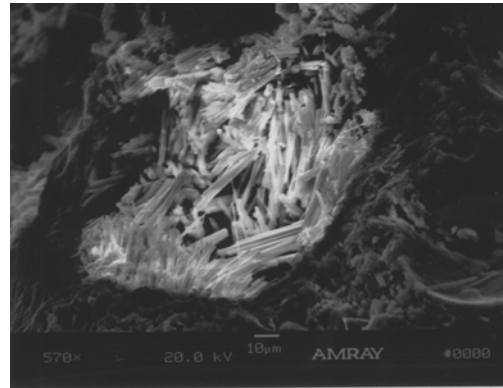
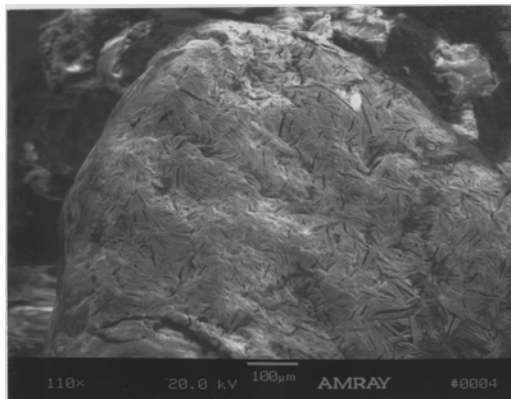
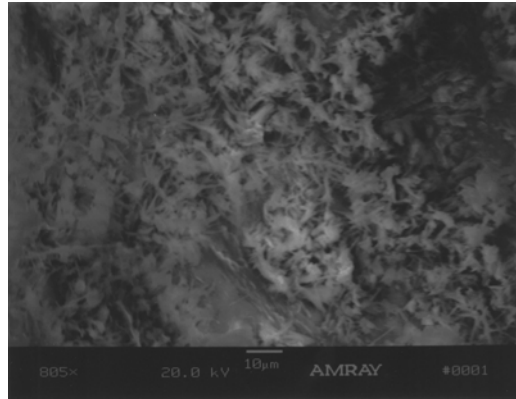
Figure 6.2: Ettringite Formations

In the course of analyzing the core samples throughout the study, four different forms of DEF were observed in samples from the field, see Figure 6.2. The possibility of ettringite existing in different forms has been speculated by some researchers, but this topic is still highly debated. The four different types of ettringite formations observed are: needle-like crystals, hexagonal prismatic crystals, a tightly-packed ettringite formations, and a lamellar material.

(a) Needle-like Ettringite Crystals

**(b) Hexagonal Prismatic
Ettringite Crystals**

(c) Tightly-Packed Ettringite

(d) Lamellar Ettringite

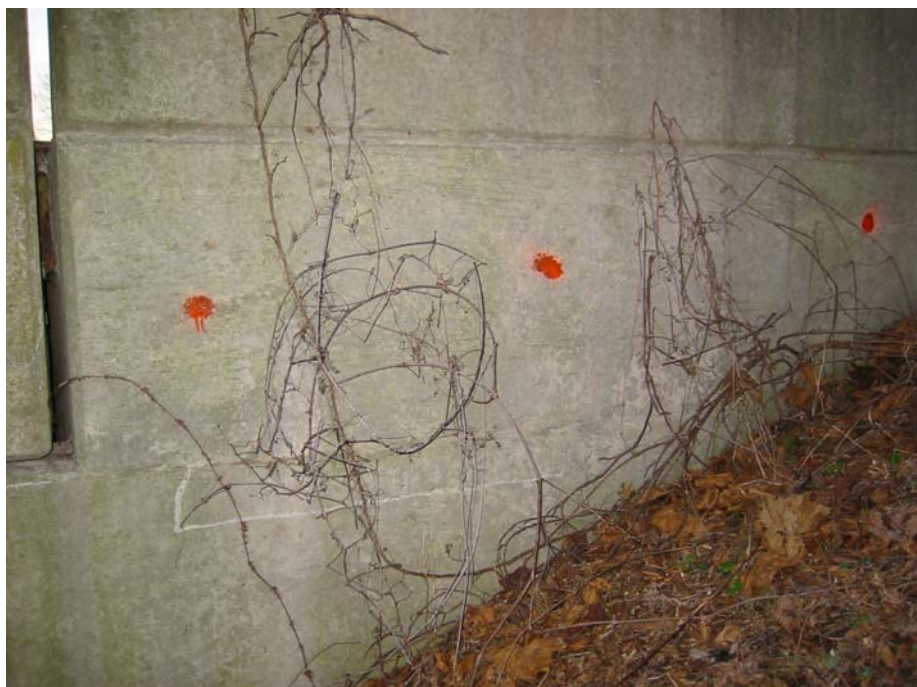
Figure 6.3: Sampled Area (1301302 – US 29 SB over Middle Patuxent River)

Control Bridge 1301302, US 29 SB over Middle Patuxent River, did not exhibit map cracking on the southwest wingwall where the cores were taken, see Figure 6.3. The SEM results show ettringite crystal growth in the voids, see Figure 6.4. The crystals were hexagonal prismatic which grew in unrestrained spaces, and are not necessarily considered evidence of deleterious expansion since the crystals were free to expand.

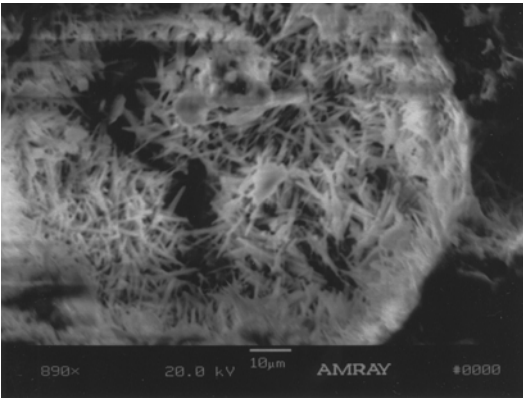
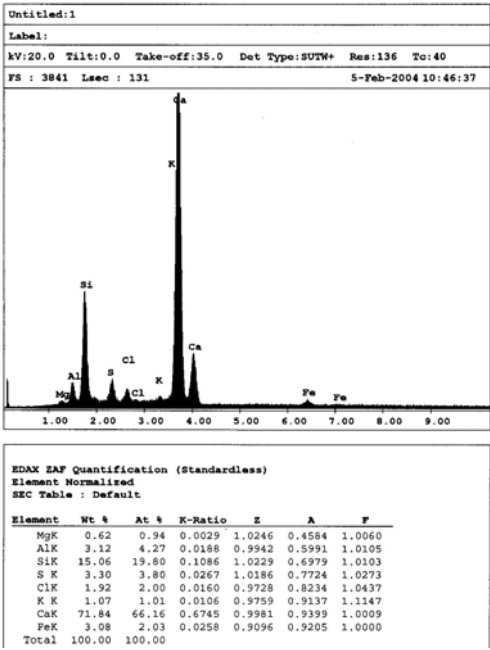
Figure 6.4: Typical Voids (1301302 – US 29 SB over Middle Patuxent River)

(a) Ettringite in Void

(b) Analysis of Whole Picture (a)

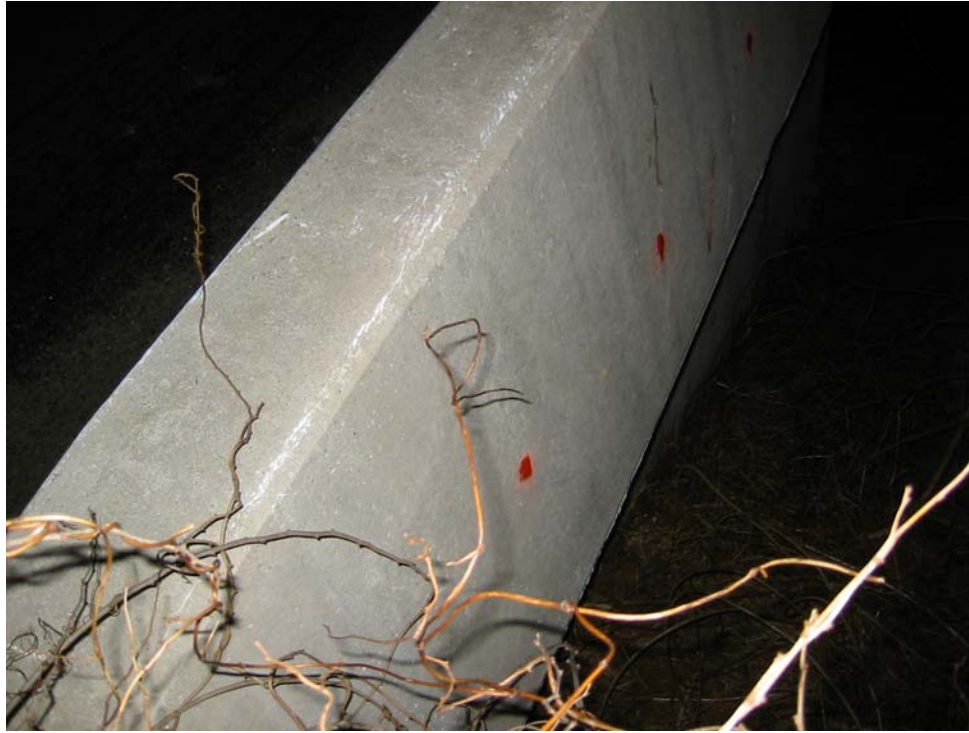
Figure 6.5: Sampled Area (0333702 – I-795 SB over Cockeys Mill Road)

Control Bridge 0333702, I-795 SB over Cockeys Mill Road, did not exhibit map cracking on the northwest wingwall where the cores were taken, see Figure 6.5. The SEM results show ettringite crystal growth and a location of ASR gel in the voids, see Figure 6.6. The crystals were hexagonal prismatic which grow in unrestrained spaces, and are not necessarily considered evidence of deleterious expansion since the crystals are free to expand. The ettringite is mixed heavily with calcium hydroxide (CaOH_2), which makes distinguishing between the calcium hydroxide and the ettringite formations difficult. In Figure 6.6 (a), both formations are readily visible. ASR gel was observed in a void, and though ASR gel was observed with the SEM, the ultraviolet ASR test indicated that ASR gel was not present in large quantities. The ASR gel quantity is insignificant, probably because of very limited supply of reactive aggregate.

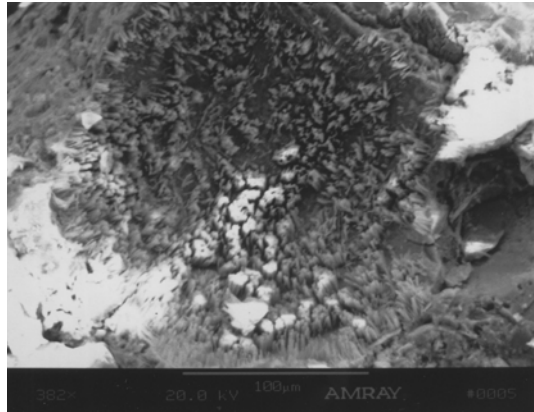
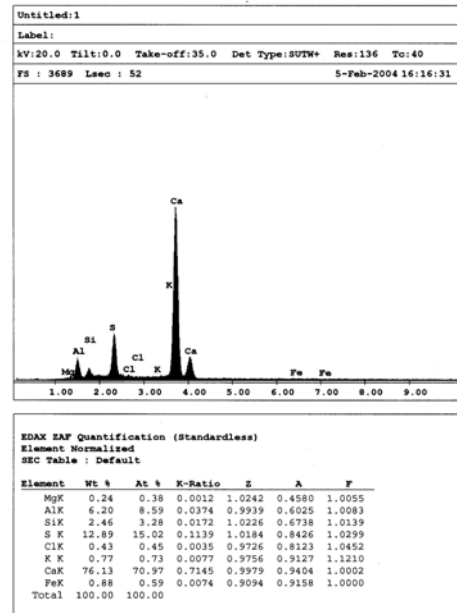
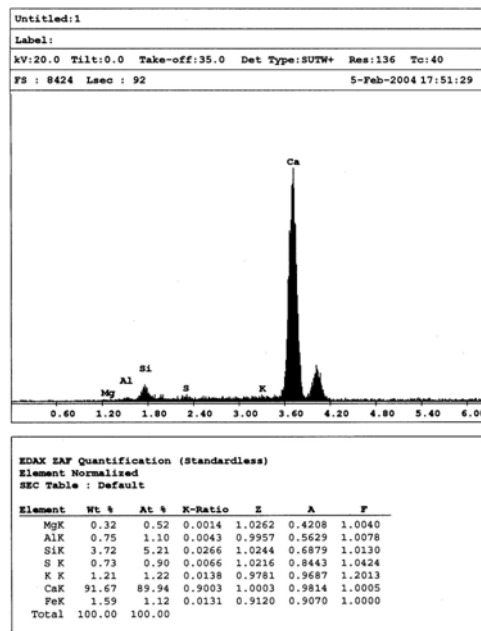
Figure 6.6: Typical Voids (0333702 – I-795 SB over Cockeys Mill Road)

(a) Ettringite in Void

(b) Analysis of DEF Crystals in(a)

(c) Analysis of Calcium Hydroxide Crystals in(a)

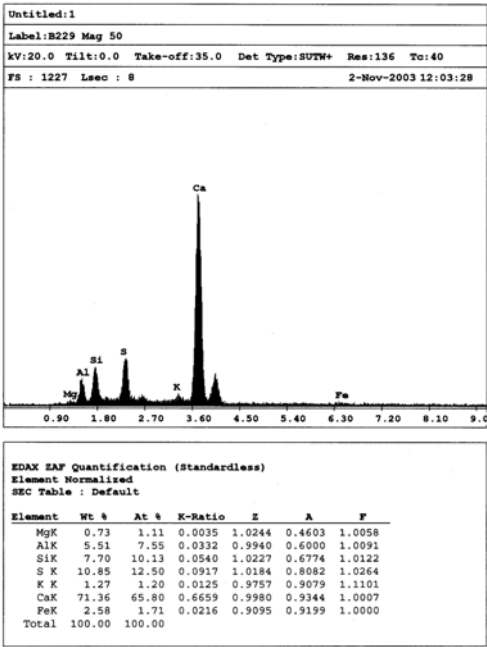
Figure 6.10: Typical Voids (2203201 - US 13 NB over MD 346)

Bridge 2203201 (US 13 NB over MD 346) exhibited map cracking in localized areas, see Figure 6.9. The SEM results show ettringite crystal growth in the voids, see Figure 6.10. DEF in the voids was lamellar.

(b) Analysis of (a)

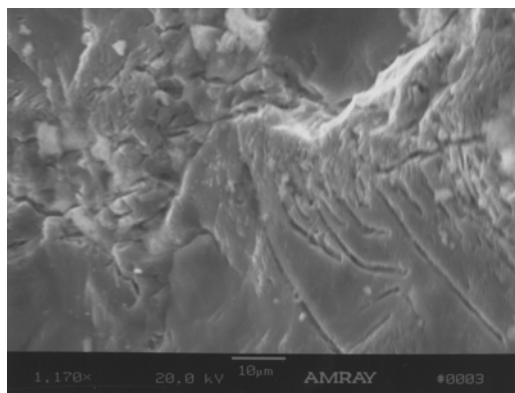
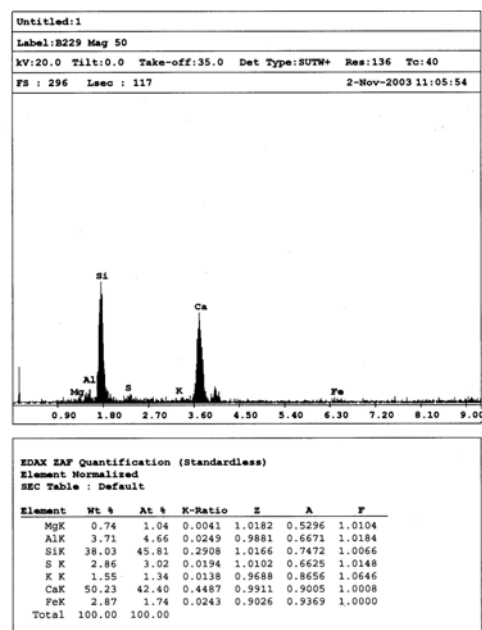
Figure 6.14: Typical ASR Gel (0800201 - MD 5 NB over Zekiah Swamp)

Bridge 0800201 (MD 5 NB over Zekiah Swamp), Bridge 1600400 (US 1 over Paint Branch), and Bridge 1620003 (MD198 over I-95) exhibit localized areas of map cracking. The areas typically have numerous cracks with uncracked concrete in adjacent areas, see Figures 6.11 to 6.13. ASR gel was located with the scanning electron microscope (SEM) and identified using an energy dispersive x-ray analysis (EDAX). An ultraviolet light test was also used to determine if ASR gel was prevalent in the core. All bridges contained ASR gel as determined by the SEM and ultraviolet light test, see Figure 6.14 for typical ASR gel location. In addition to ASR gel, DEF was found in each bridge, and the various forms of morphology included hexagonal prismatic and tightly packed formations, see Figures 6.15 and 6.16.

(a) ASR Gel

(b) Analysis of ASR Gel (a)

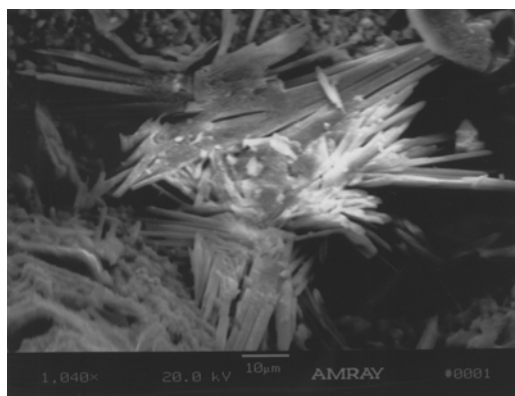
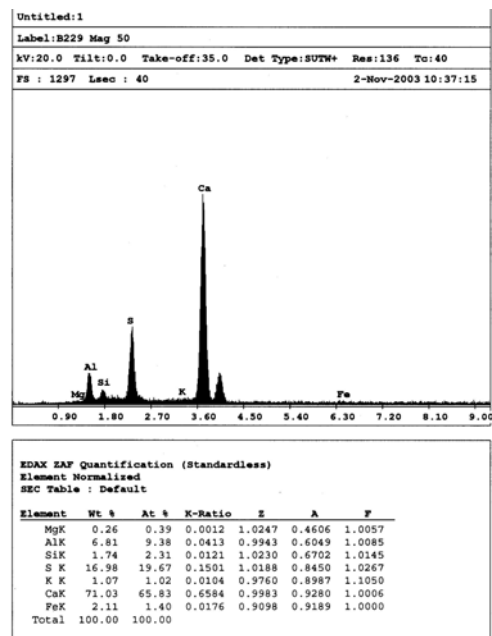
Figure 6.15: Ettringite (0800201 - MD 5 NB over Zekiah Swamp)

(a) Ettringite on the Surface

(b) Analysis of Ettringite in (a)

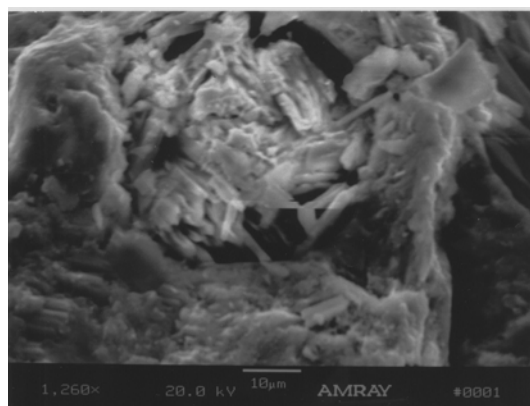
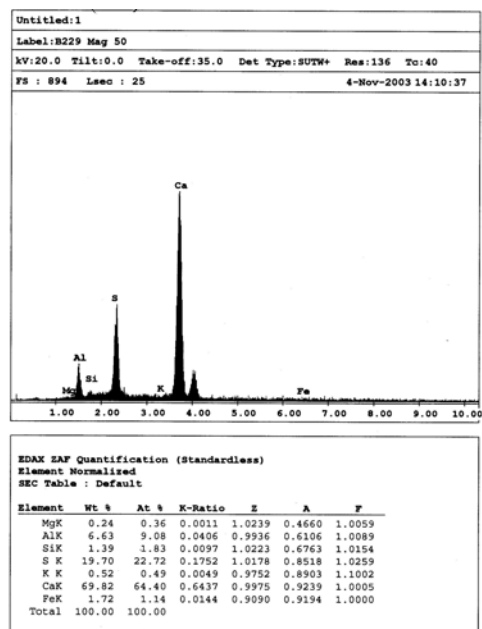
(a) Ettringite Filling Void

(b) Analysis of Ettringite
Filling Void (a)

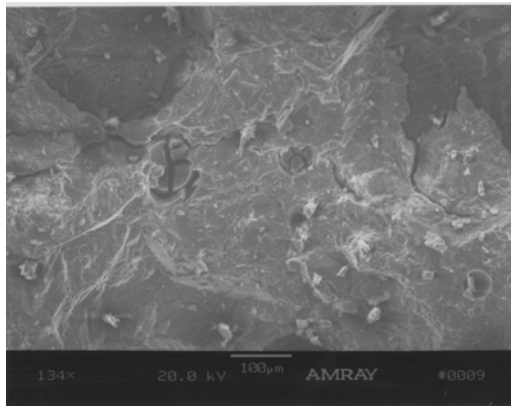
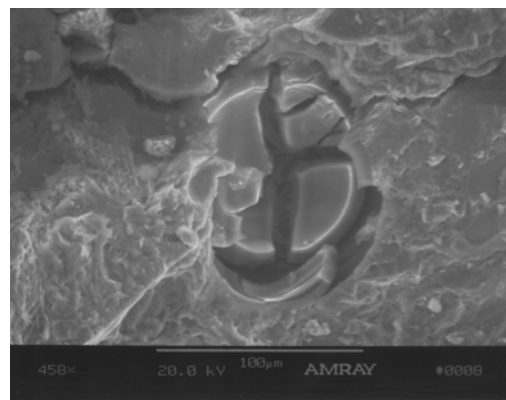
Figure 6.20: ASR Gel (1102100 - US 219 over Deep Creek Lake)

Bridge 1102100 (US 219 over Deep Creek Lake), Bridge 1311000 (MD 32 EB CD over US 1), and Bridge 1511300 (Greentree Road over I-495) exhibited map cracking covering the entire surface of the affected concrete element, see Figures 6.17 to 6.19. Using the scanning electron microscope (SEM) and energy dispersive x-ray analysis (EDAX), ASR gel was observed in all bridges. Furthermore, an ultraviolet light test was used to determine if ASR gel was prevalent in large quantities in the core, see Figure 6.20 for typical ASR gel location. In addition to ASR gel, DEF were found in each bridge, and the various forms of morphology included hexagonal prismatic and tightly packed formations, see Figures 6.21 to 6.23.

(a) ASR Gel with Cracking

(b) ASR Gel – Close-up of (a)

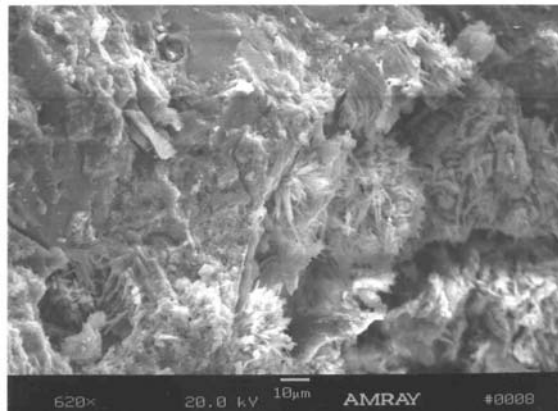
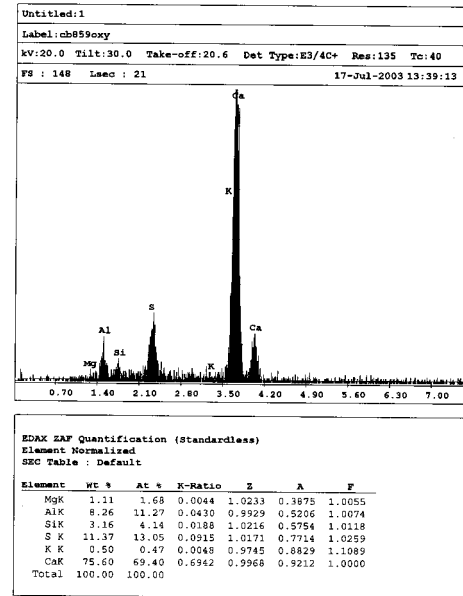
Figure 6.21: Hexagonal Prismatic Ettringite (1311000 - MD 32 EB CD over US 1)

(a) Ettringite on the Surface

(b) Analysis of Whole Picture (a)

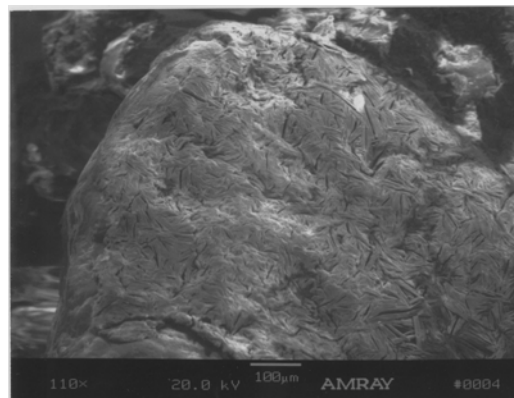
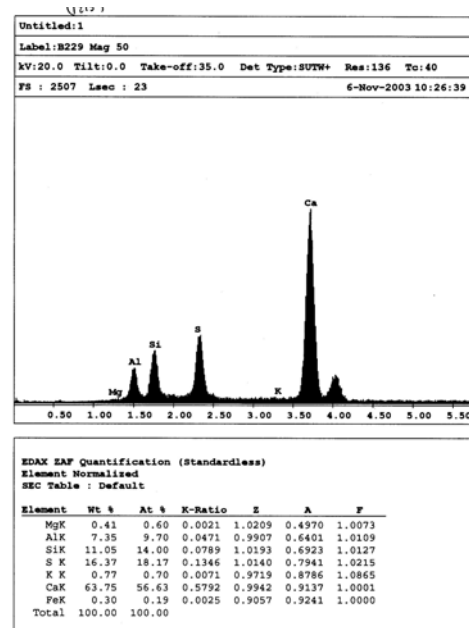
Figure 6.22: Tightly Packed Ettringite (1511300 - Greentree Rd over I-495)

(a) Ettringite Mass on Surface of the Aggregate

(b) Analysis of Whole Picture (a)

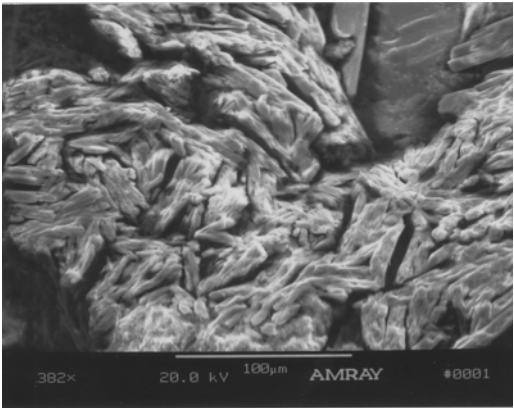
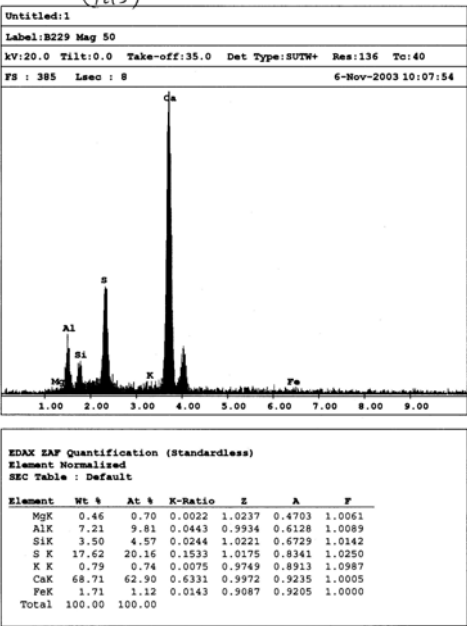
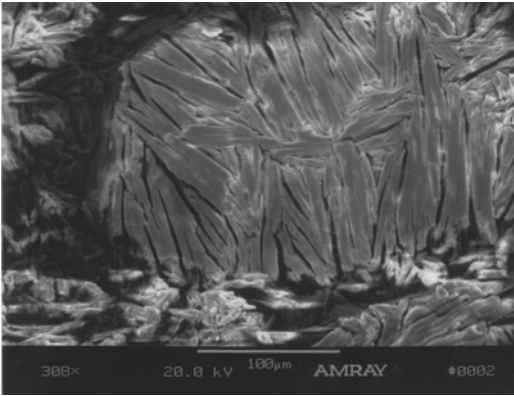
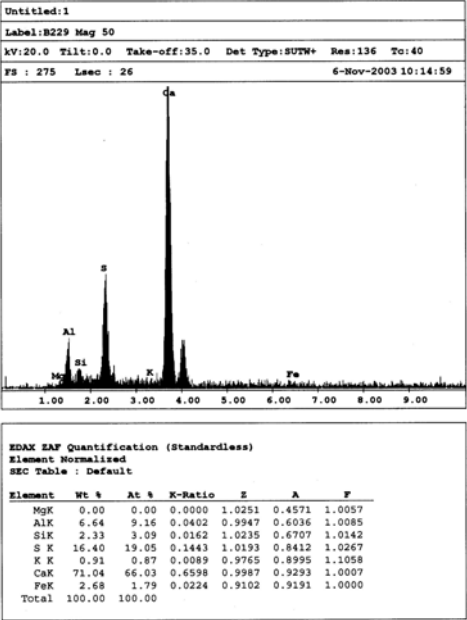
Figure 6.23: Tightly Packed Ettringite (1511300 - Greentree Rd over I-495)

(a) Ettringite Mass on Surface of the Sample

(b) Ettringite Mass in (a)

(c) Ettringite Filling Void

(d) Analysis of Ettringite in (c)

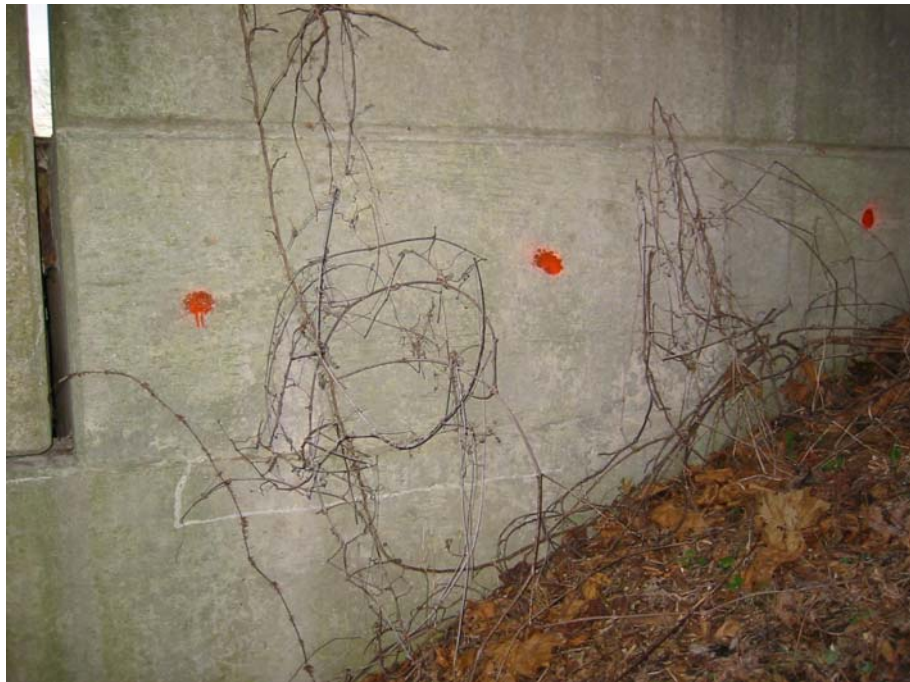
Figure 6.24: No Moist Map Cracking

In addition to differences in morphology, differences were noticed in the distribution of moist map cracking on the concrete surface. Three distinct patterns were observed which include no moist map cracking, localized moist map cracking, and widespread moist map cracking, see Figures 6.24 to 6.26. Further testing should investigate the significance of widespread versus localized moist map cracking.

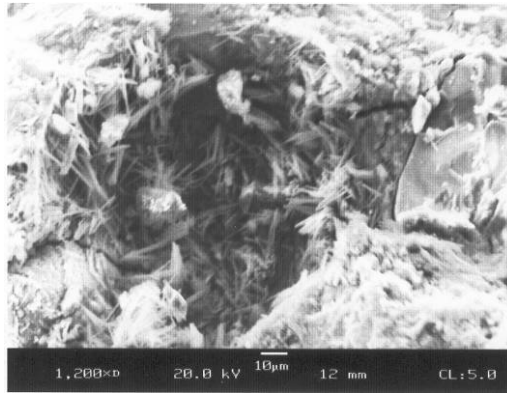
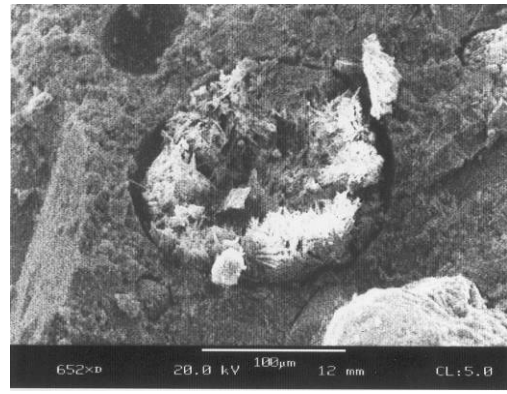
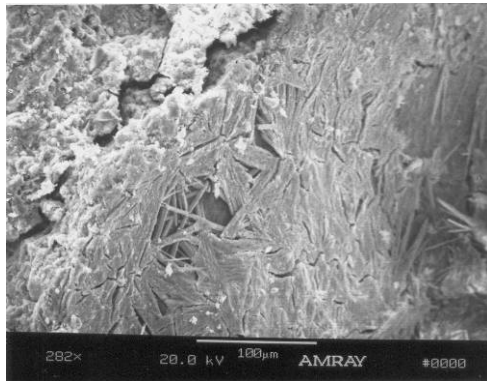
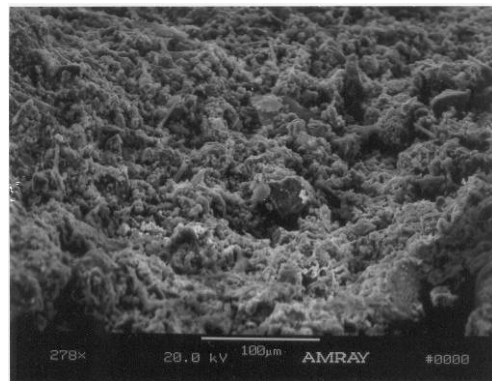
Figure 6.28: Ettringite Formations

In the course of analyzing the core samples from the phase 2 bridges, similar ettringite morphologies were observed, see Figure 6.28. Field studies conducted in the US, Canada, France, and Germany has documented similar ettringite morphologies as identified in phase 1 bridges (Gress 1997, Stark and Bollman 1997, Lawrence et al. 1999, Cody et al. 2001, Amde et al. 2004, and Divet, Pavoine, and Clement 2006). Of

**(a) Sparse Hexagonal Prismatic
Ettringite Crystals**

**(b) Hexagonal Prismatic
Ettringite Crystals**

(c) Tightly-Packed Ettringite

(d) Lamellar Ettringite

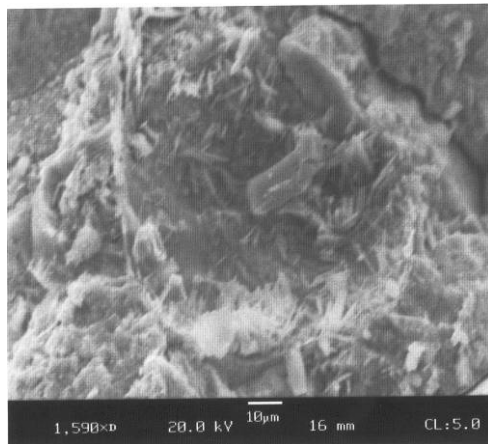
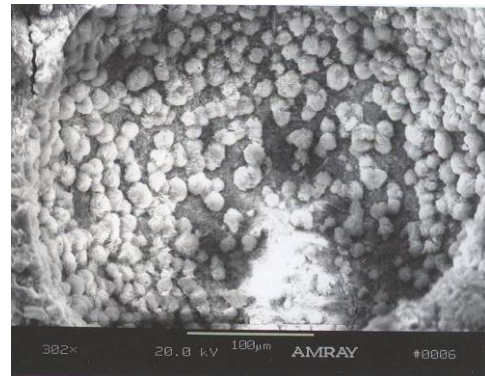
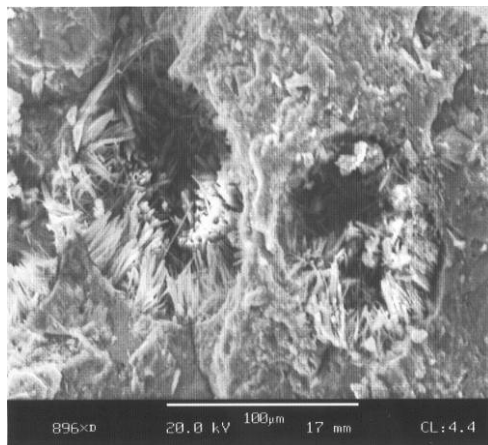
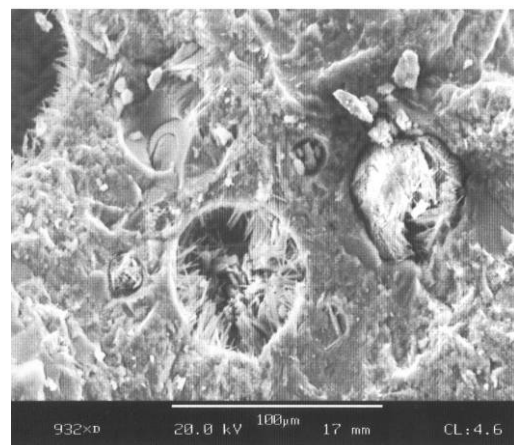
Figure 6.30: Ettringite Formations - 1

See Figure 6.30 and 6.31 for samples of the morphology types. The results show that most samples had no DEF (37 of 72) or occasional long needle ettringite crystals in voids (20 of 72), which totals 57 of the 72 samples analyzed. This suggest the normal condition of concrete, and show that occasional long needle ettringite crystals in voids is not indicative of ettringite that leads to DEF related damage. Furthermore, two (2) morphologies observed in laboratory or other field studies were not observed in this survey. This could suggest possible transition phases observed during early ettringite development. The bundles / balls are readily observed in laboratory testing at early stages in the development of DEF. The bundles / balls may progress into a different morphology. If this is the case, it would explain the absence of bundles / balls in the field samples that are between 3 and 50 years old. The other morphology that was not observed was lamellar ettringite in voids. This morphology was observed in phase 1

(a) Long Needles in Voids (<<5%)

(b) Bundles / Balls in Voids

**(c) Long Needles in Voids
(5%-50%)**

(d) Long Needles in Voids (>50%)

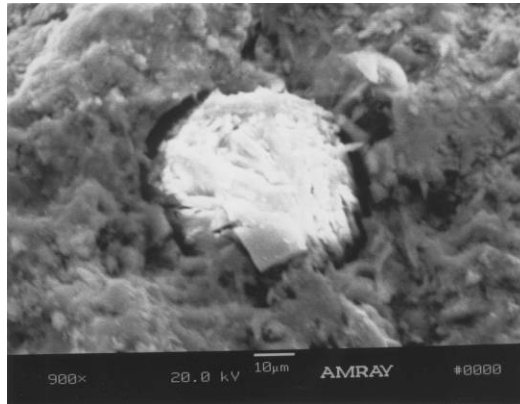
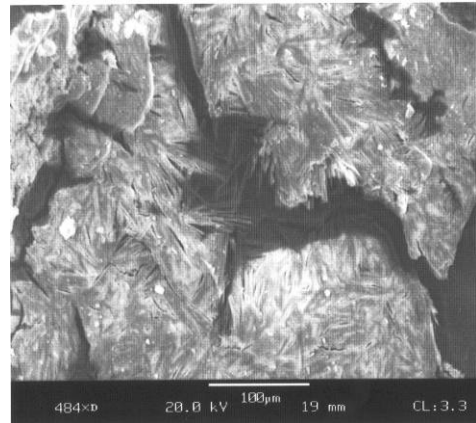
Figure 6.31: Ettringite Formations – 2

(a) Lamellar Formations in Voids

(b) Lamellar Formations on the Sample's Fractured Surface

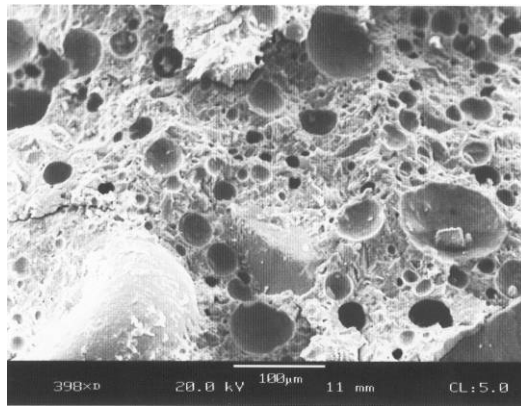
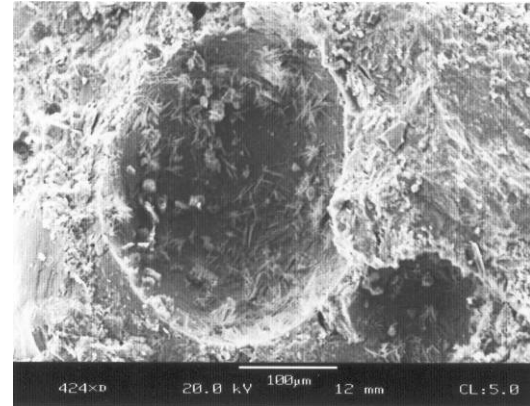
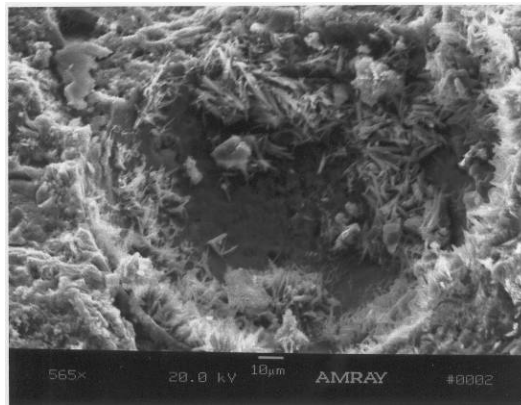
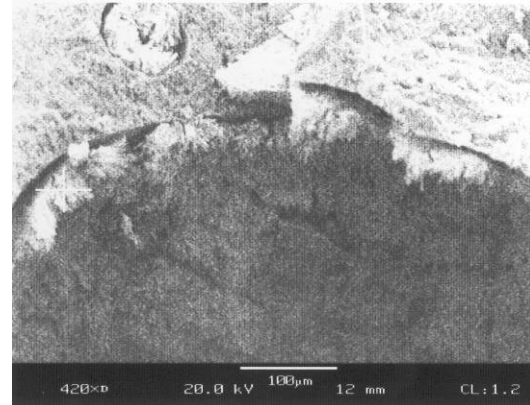
Figure 6.32: Quantification Classification - 1

(a) No DEF
Empty Voids

(b) Minor (Noted as DEF-)
Typical Voids

(c) Moderate (Noted as DEF)
Typical Void

(d) Heavy (Noted as DEF+)
Typically Lining Large Voids or
Partially Filling Small Voids

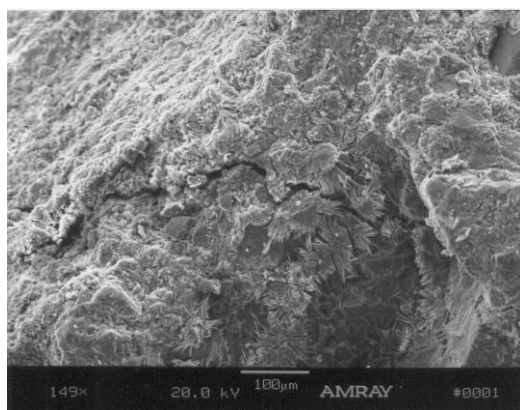
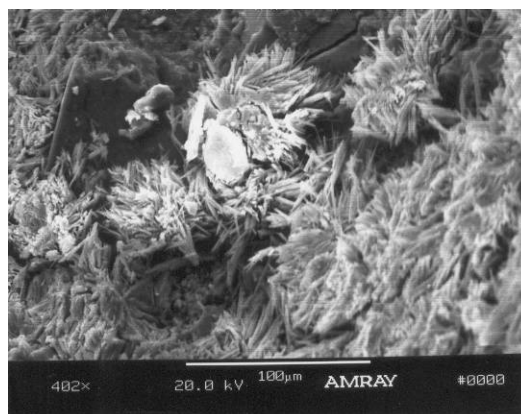
Figure 6.33: Quantification Classification - 2

(a) Severe (Noted as DEF++)
Typical Lamellar on Sample's
Fractured Surface

(b) Severe (Noted as DEF++)
Close-up View

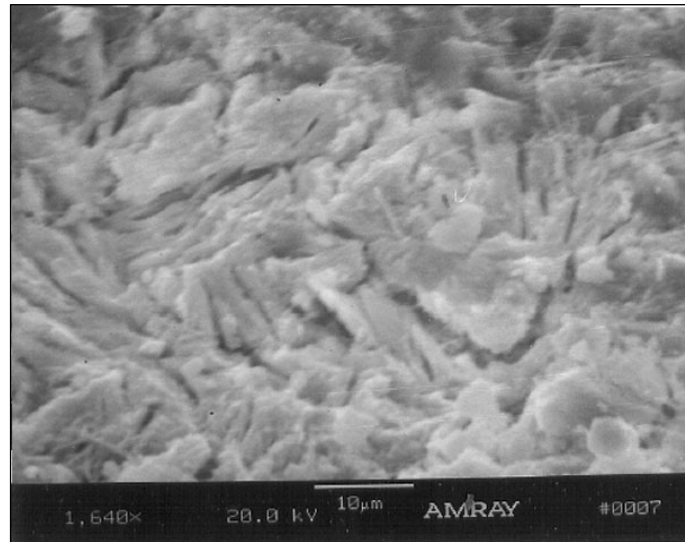
Future testing should apply the mitigation products prior to the 45 days used in this study. The SEM work at 45 days found lamellar ettringite, which the field portion of this research showed as significant in the deterioration of the concrete matrix. Deterioration of the concrete matrix will results in significant loss of concrete strength.

Figure 7.11 – Lamellar Ettringite in Control Prism (Set No. 1) at Day 45.
SEM Sample of Exterior Region of Prism
Ca-S-Al Ratio (Wt %) = 79.03 – 10.57 – 4.79

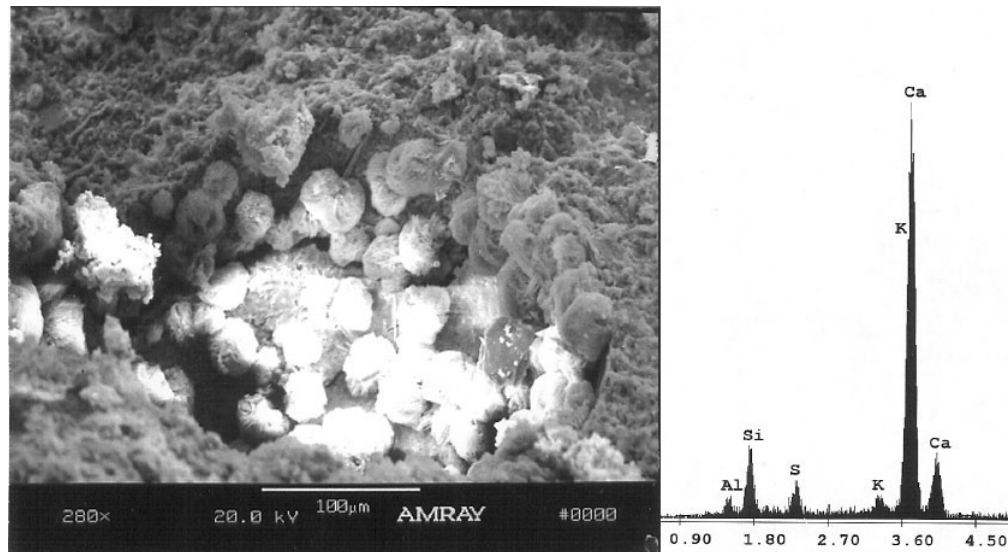
Figure 7.12 – Spherical Ettringite Balls in ChimneySaver (Set No. 2) at Day 90.
SEM Sample of Exterior Region of Prism
Ca-S-Al Ratio (Wt %) = 77.46 – 3.73 – 1.79

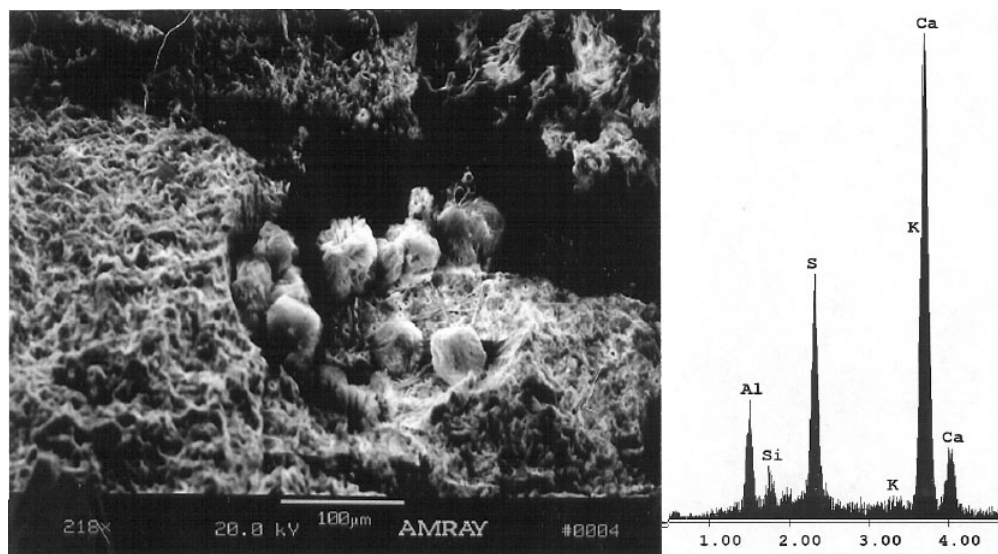
**Figure 7.13 – Spherical Ettringite Balls in Noveon Good-Rite K572 (Set No. 3) at Day 90. SEM sample of Exterior Region of Prism.
Ca-S-Al Ratio (Wt %) = 69.09 – 21.76 – 10.72**
