# THE EFFECTS OF ENVIRONMENTAL STRESSES ON THE RELIABILITY OF FLEXIBLE AND STANDARD TERMINATION MULTILAYER CERAMIC CAPACITORS

Thesis submitted to the faculty of the Graduate School of the University of Maryland, College Park, in partial fulfillment of the requirements for the degree of Master of Science,

May 2009

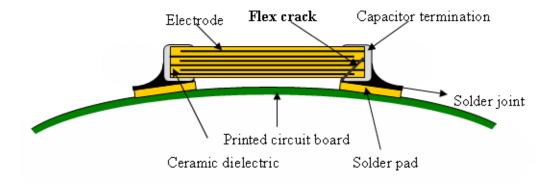
Figure 2: Flex cracking of a capacitor due to printed circuit board bending [4]

"Flex" cracking has been a major problem since the inception of MLCCs. This occurs when stress is applied to the printed circuit board (PCB) upon which the capacitor is mounted. This stress is transmitted through the circuit board, and into the MLCC. If this stress exceeds the strength of the ceramic dielectric in the capacitor a crack can form. An illustration demonstrating flex cracking is shown in Figure 2.

Flex cracks typically have the same origin. They start at the end of the termination on the board side of the capacitor and propagate up into the dielectric and electrode layers. Various factors, such as ceramic dielectric type, capacitor dimensions and the solder fillet shape can influence cracking of the capacitor. A photo of a flex crack is shown in Figure 3.

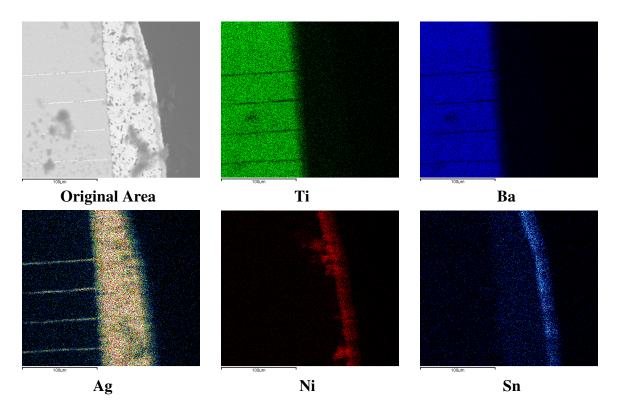
Figure 5: EDS map of standard termination capacitor.

An electron dispersive spectroscopy (EDS) map is shown in Figure 5. From this mapping it is evident that the electrodes are made of silver, while the ceramic is barium titanate. One point of note is that the electrodes shown are only showing silver, when in fact they are silver palladium. The palladium is therefore believed to be in a very low concentration.

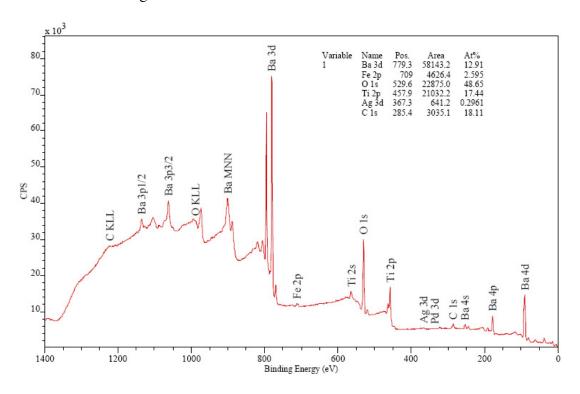
Figure 20: XPS Results for standard termination dielectric

X-ray Photoelectron Spectroscopy (XPS) was employed to determine the failures from the storage tested capacitors. It was believed that there may be a material difference between the ceramic used in the standard termination MLCCs and the flexible termination MLCCs due to differences in the color of the ceramic, as well as the differing failure rates. XPS demonstrated that there was no difference in the material composition of the two dielectrics. Both sets of capacitors had barium titanate dielectric with iron as a dopant. Measurements were taken of regions on the surface of the capacitors and also in a region inside the capacitors. An example of the spectrum for the standard termination dielectric is shown in Figure 20.

To measure the inner dielectric of the capacitors it was necessary to break the capacitors. In breaking the capacitors it was found that the flexible termination capacitors experienced a clean break with a flat shear plane. The standard termination capacitors were much more brittle and would disintegrate rather than having a clean shear plane. It is hypothesized that the difference in the dielectric is not a material difference, but rather a grain size difference. Due to the high sintering temperature used in the manufacturing process it is not possible to determine the grain size used in each of the capacitor types.

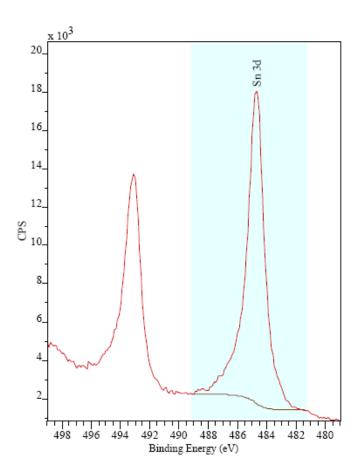
Figure 26: XPS results for pure tin (termination area without oxidation)

XPS was used to analyze the material and it was found to be caused by tin oxide. The metallization coating the standard and flexible terminations is the same, both nickel coated with tin, however this problem is solely on the flexible termination capacitors, which indicates that the silver filled polymer is having some effect on the tin coating of the end termination. The XPS results for an area without the oxidation (pure tin) are shown in Figure 26, while the results for the oxidized tin are shown in Figure 27.
