Title of Document: HISTORIC STRUCTURE INVESTIGATION:
THE COLLINS HOUSE, BLOOMFIELD,
NEW JERSEY

Francesca Evans, Master of Historic
Preservation, 2022

The Collins House in the Township of Bloomfield, New Jersey, is in the process of being rehabilitated with the intent for the building to become one of the visitor centers along the state-wide Morris Canal Greenway. Despite the building's National Register Nomination form and a cultural resources survey carried out in 1982, there is a lack of detailed documentation of the Collins House to guide future interpretation of the site and ensure that character defining features are preserved and retained.

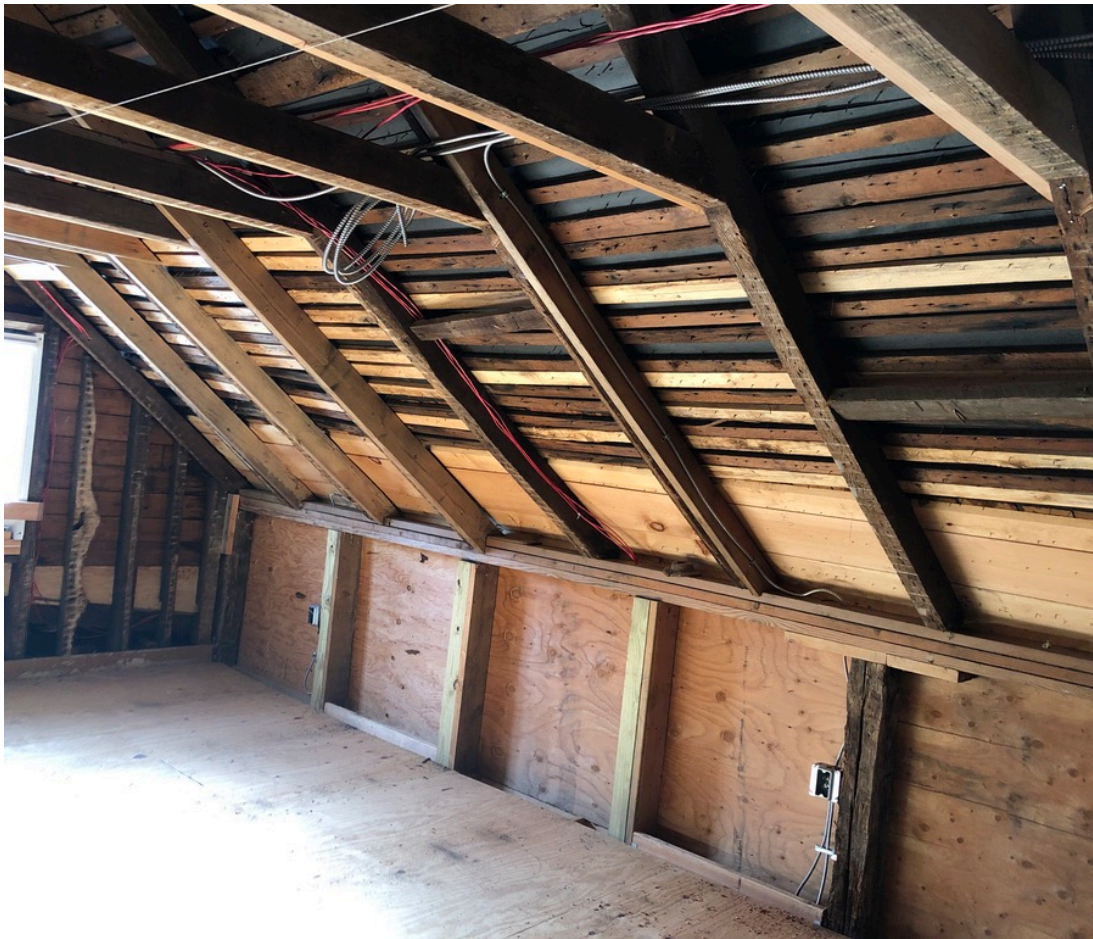
Despite the few anchor-bents in Phase Two, it can still be considered an East Jersey Cottage because of the extension of the vertical posts about three feet in the half-story above (Figure 20). The knee wall extension in the half-story and the side-hall floor plan with front and back parlors, along with the hybrid combination of Dutch and English framing techniques, all lend support to the Collins House's identity as an East Jersey Cottage house type.

Figure 20. Knee wall extension in the west wall of Phase One. (Source: Francesca Evans, 2022)

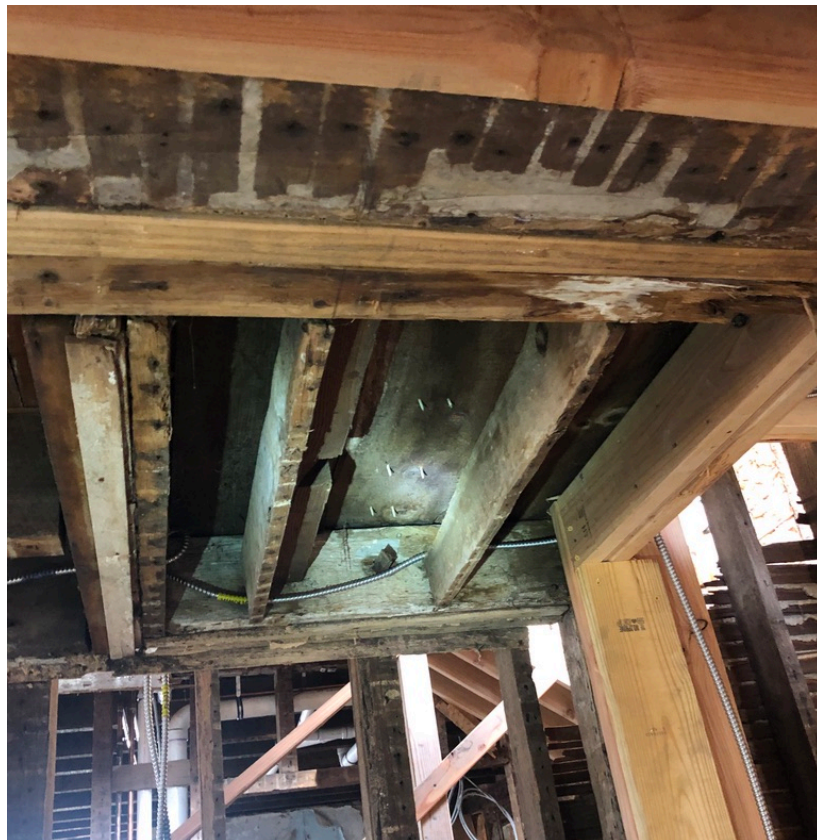
suggesting a doorway into the main living area of Phase One. While ceiling joists in Phase One run east to west in this section of the house, there is a 3' long ceiling joist, most likely the header for the stair opening, in the northeast corner running north to south, suggesting the existence of a small, framed opening which provided access to the garret in the half-story (Figure 25). This area would have been quite a narrow width for a bed chamber, and it would have also been odd for the stairway or ladder to the garret to be placed within that room. Therefore, the partitioned area was most likely an unheated side-hall entry with stairs leading to the garret and a doorway leading to the main hall of the dwelling.

Figure 25. Framing evidence of a small opening providing access to the garret in the half-story. (Source: Francesca Evans, 2022)

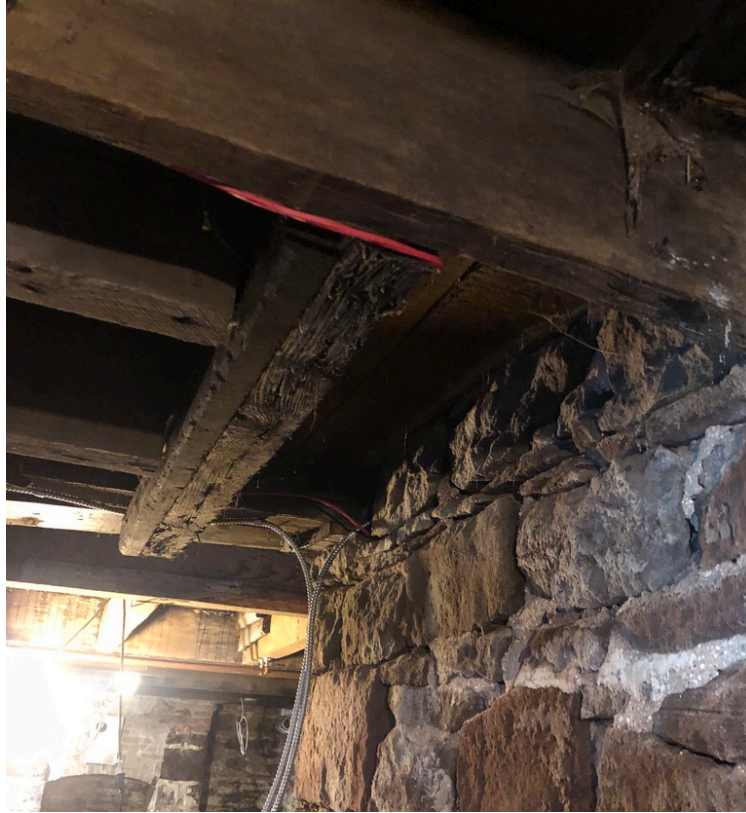
There is physical evidence indicating that the bulkhead was originally located on the rear of the house directly across the cellar from where it is located now. Framing in the northeast corner of the cellar under Phase One may indicate where the original bulkhead was located (Figure 27). The timber running perpendicular to the ceiling joists may have once acted as a header for a stair opening to the cellar; as the timber is quite close to the east wall, if it was a header for a stair opening those stairs would have provided access to the cellar from the exterior of the house, rather than the interior. The current bulkhead does not have any sort of joist acting as a header for the opening, as it might have been difficult to add since it was not part of the original construction of Phase One. The bulkhead was most likely moved because of the addition of Phase Four (located on the east elevation of Phase One), which would have provided a strong impetus to go to the trouble of making major modifications to the foundation of the building.

Figure 27. Timber in northeast corner of the cellar under Phase One that may have acted as a header for the stair opening of the original bulkhead. (Source: Francesca Evans, 2022)

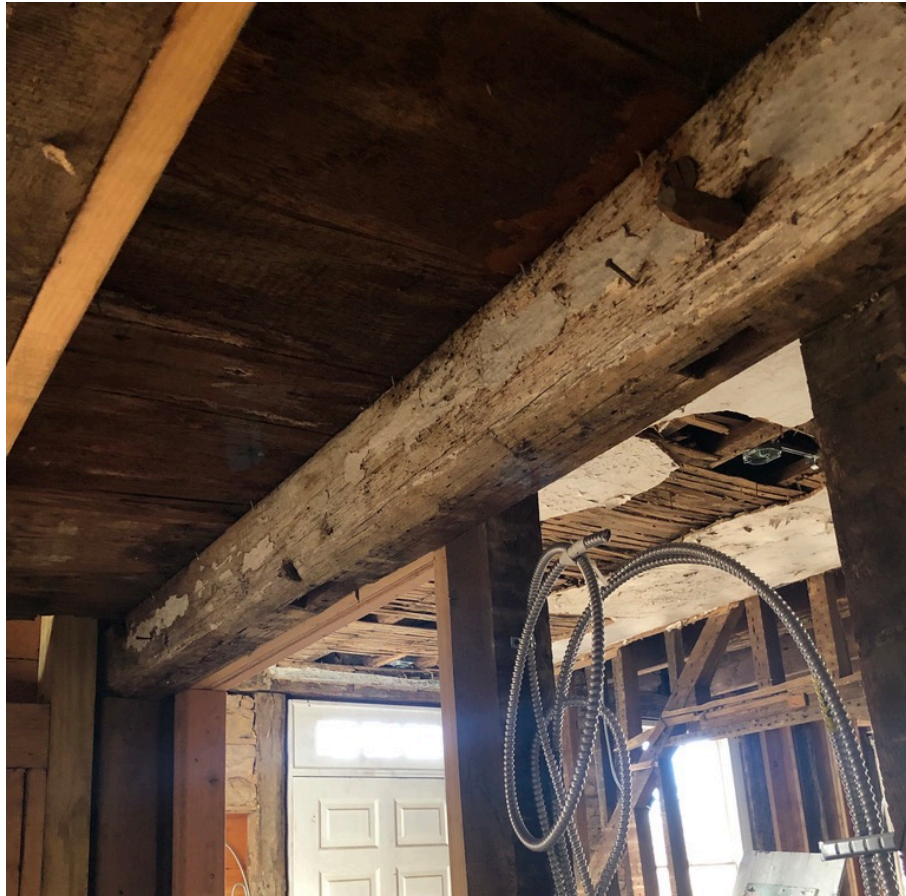
north and south walls (Figure 28). While the chamfered edges of the bents indicate that they were originally exposed, it is odd that they and the floorboards in the ceiling were not painted (Figure 29).

Figure 28. White paint on the northernmost anchor-bent in Phase One. (Source: Francesca Evans, 2022)

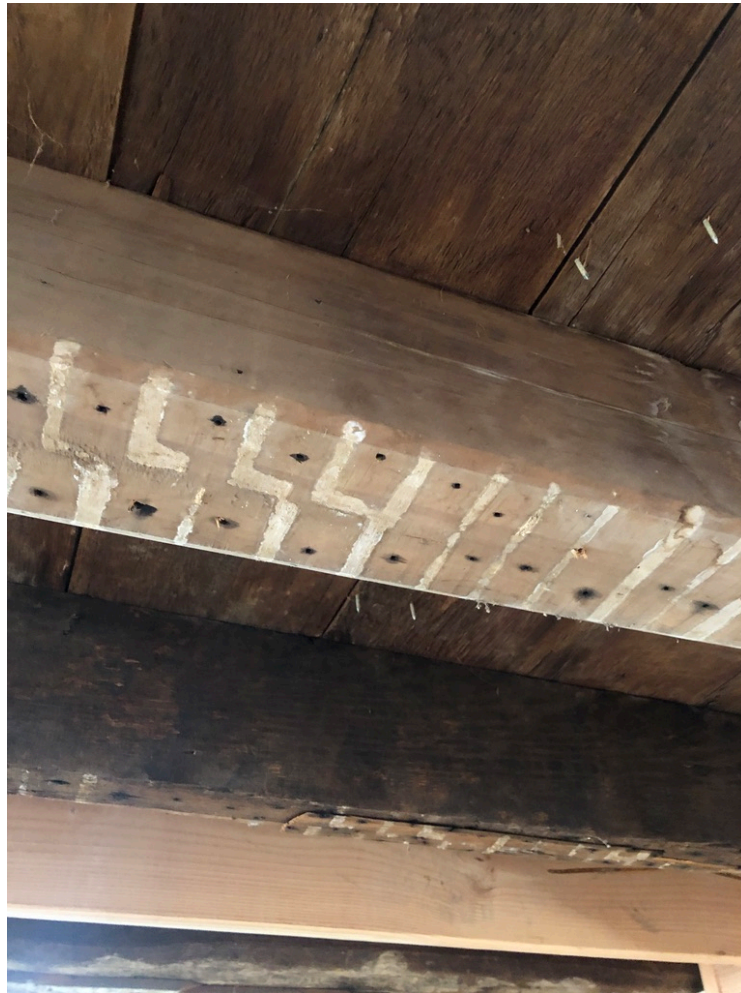
Figure 29. Chamfered edge on one of the planed anchor-bents. (Source: Francesca Evans, 2022)

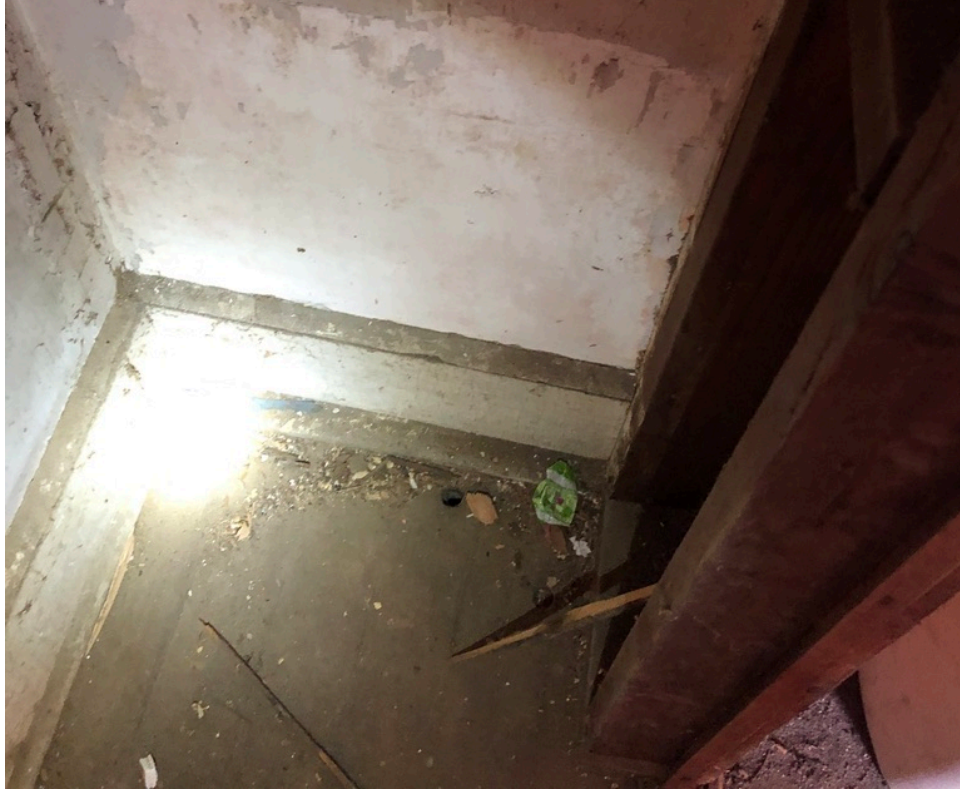
Figure 30. Tongue and groove floorboards and trim in the closet. These floorboards run east to west while the original flooring runs north to south. (Source: Francesca Evans, 2022)

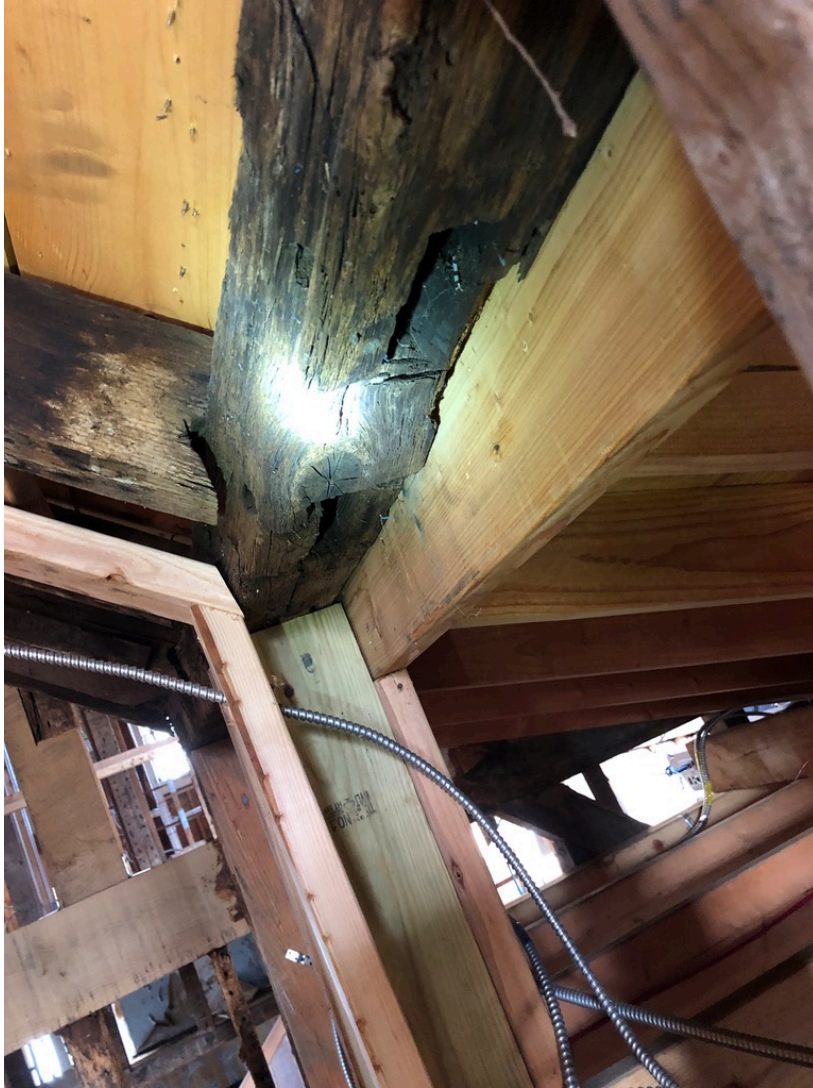
and were mortise and tenoned into the intermediate plate below. However more than half of the top plate was replaced during the recent roof replacement so only seven remain, five of which are empty. The spacing of the seven total mortises varies from as few as 7-½” to 26” (Figure 31). These timbers could have been removed then due to their deteriorated condition, or when the Phase Four addition was appended to the east elevation. While the rafters are half-lapped and secured with a peg, the collar beams are attached using nails. Flat baseboard identical to that found in Phase Two remains along the south wall and the floorboards (visible from the southeast corner on the first floor) are tongue and groove. Ghost marks, along with photographic evidence, indicate that the attic was plastered at one point in time, however when this occurred cannot be accurately determined (Figure 32).

Figure 31. Two empty mortises with peg holes in the top plate of the east wall. (Source: Francesca Evans, 2022)

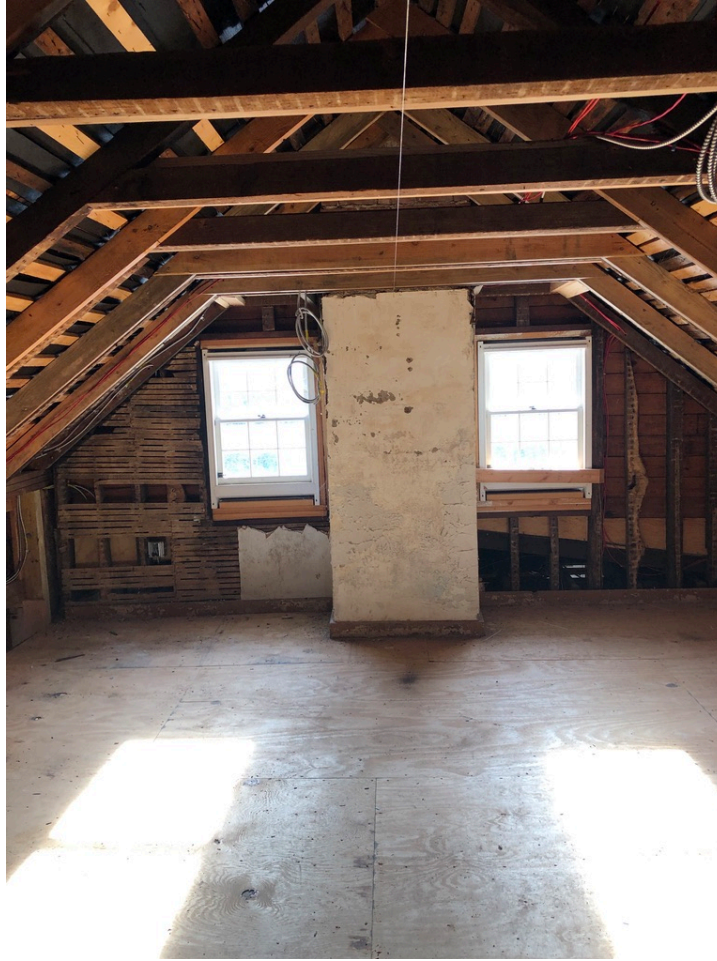
Figure 32. Half-story of the original dwelling facing south. (Source: Francesca Evans, 2022)

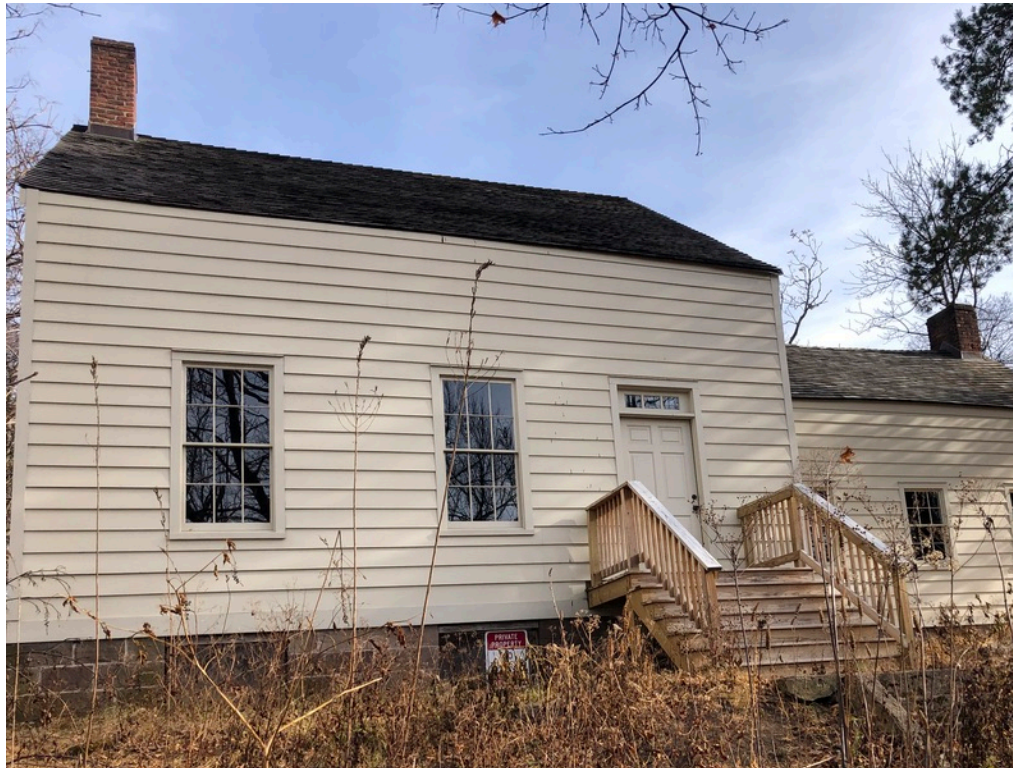
Figure 33. West façade of Phase Two. (Source: Francesca Evans, 2022)

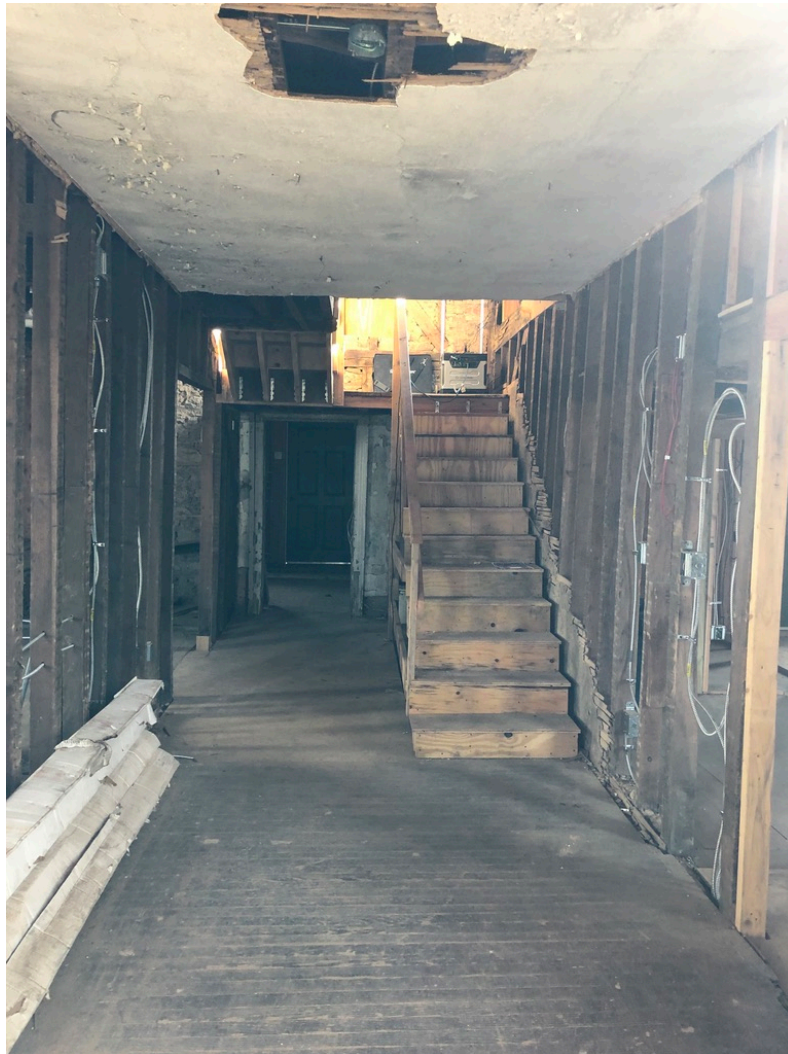
Figure 37. Side hall in the c. 1820 section facing east. The narrow tongue and groove floorboards run north to south in the same direction as the floor joists in the cellar below the hall. When examining the flooring underneath the staircase, it appears as though the original flooring in the hall ran east to west. (Source: Francesca Evans, 2022)

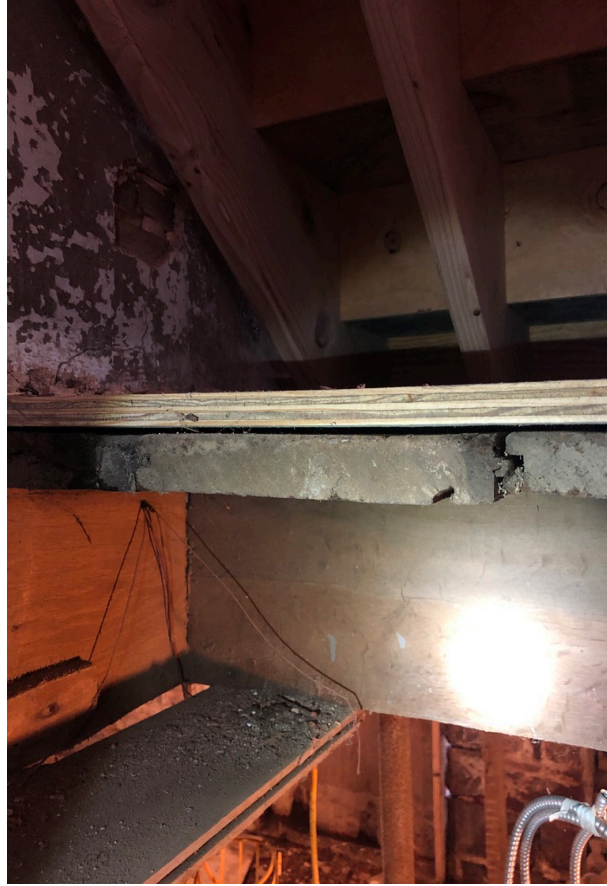
Figure 38. Image of the flooring that remains underneath the staircase. Note the north-south direction of the joists which run throughout the side hall and the east-west direction of the flooring. This flooring runs underneath the current flooring in the stair hall and is much wider as seen in Figure 37. (Source: Francesca Evans, 2022)

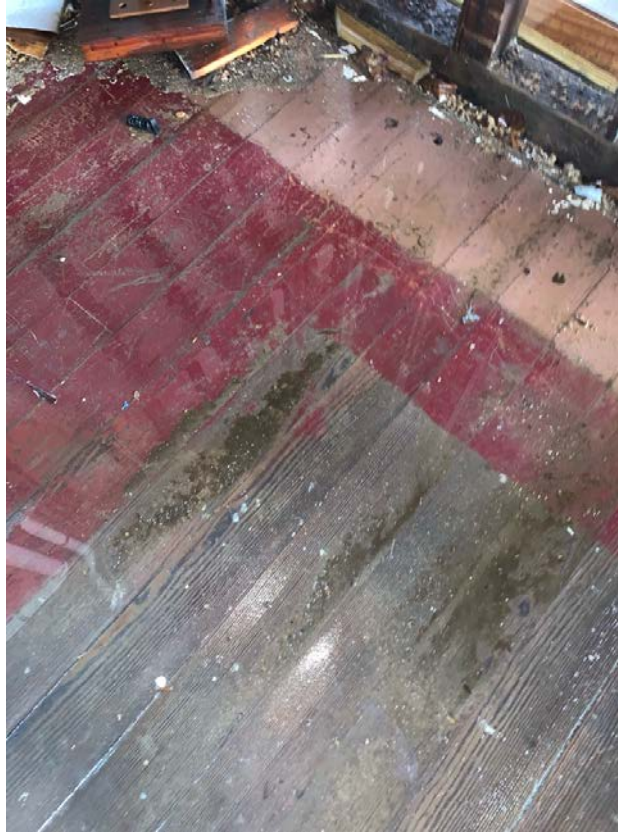
west parlor shows evidence of a band of red paint around the edges of the room, while the east parlor flooring is painted with two different colors—pink and red—that create a rectangle of unfinished flooring in the center of the room (Figure 39). The center of the floor in either room does not appear to have been painted; a canvas cloth could have been tacked down in the unfinished area or it may have been covered by a carpet. It is most likely that the floors in the east and west parlors were painted during the nineteenth century as painted floors became a popular trend during the eighteenth century that continued through the next century. To gain a more complete understanding of the first story flooring throughout Phase Two and see what lies beneath what is there now would require the removal of plywood or the utilization of destructive investigation techniques. Neither option was feasible for this study, therefore observations were made based on what was visible at the time of the investigation.

Figure 39. Image of the painted flooring in the east parlor. Note how it is wider than the flooring used in the hall, which is the same flooring that is also found in the west parlor. (Source: Francesca Evans, 2022)

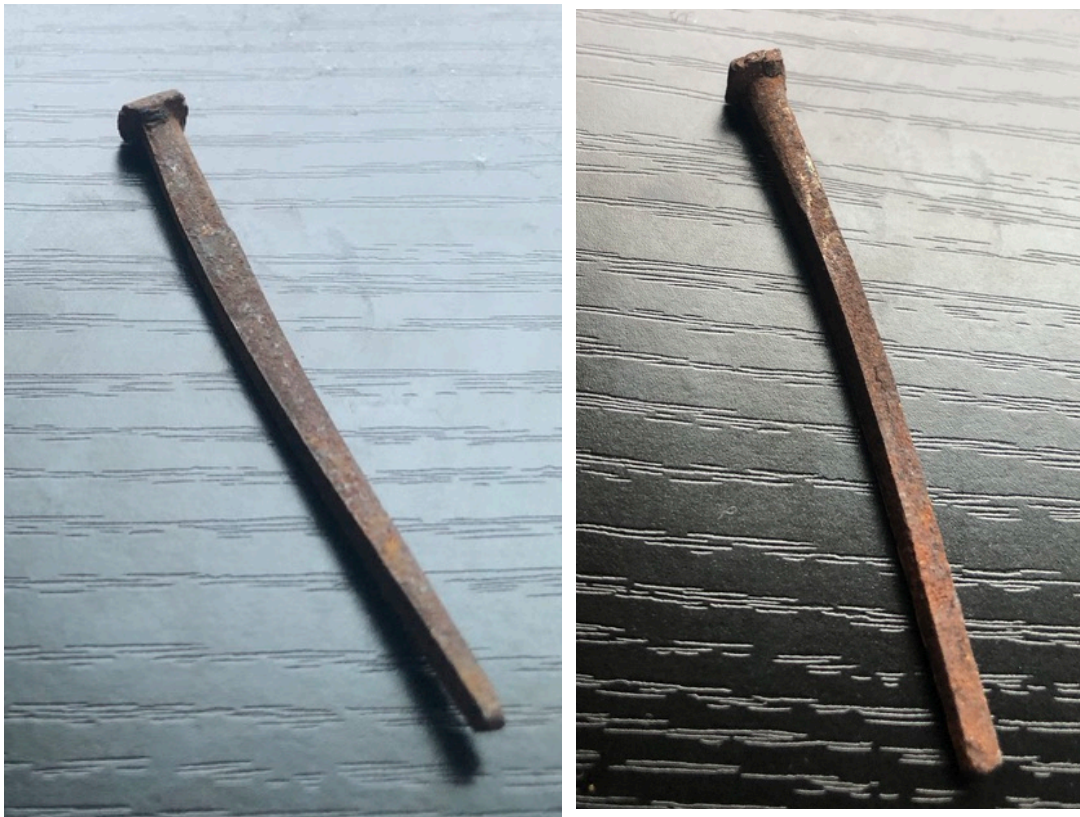
Figure 43. Face and side of a nail found in the half-story of Phase Two, indicating that the nail was side-pinched. (Source: Francesca Evans, 2022)

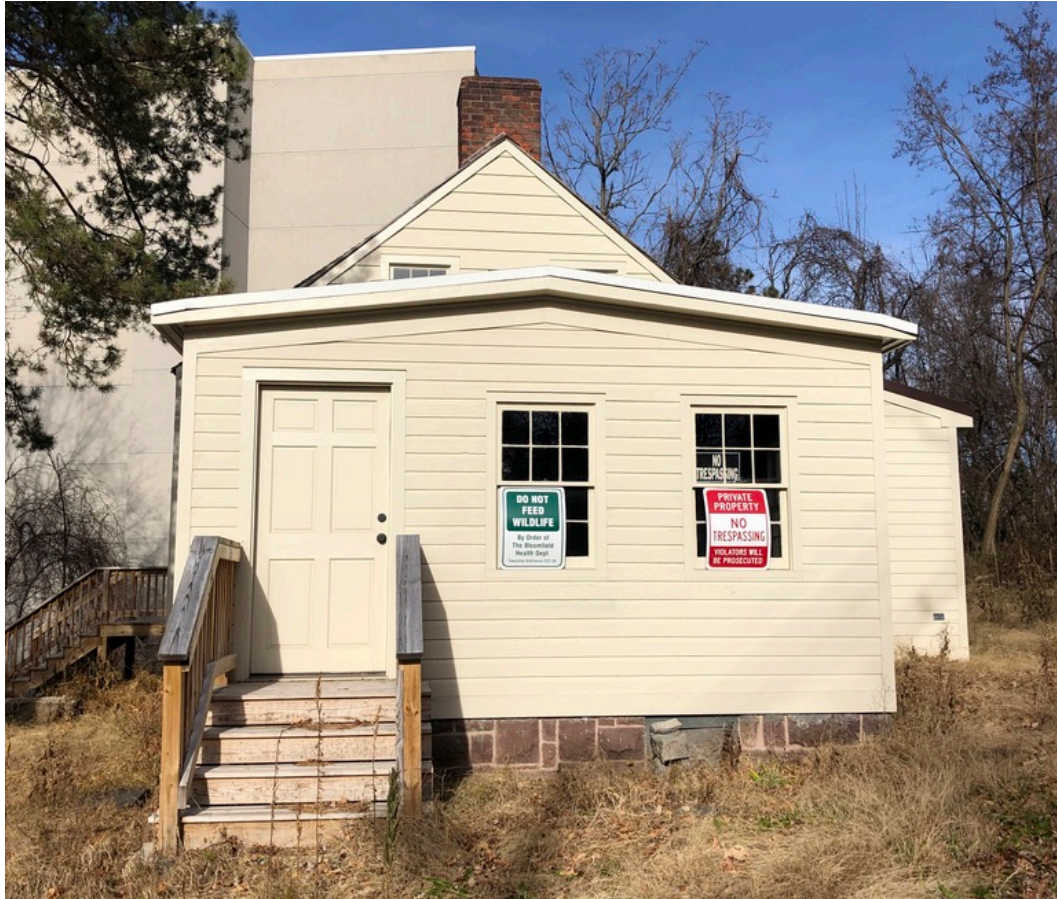
physical appearance of the addition suggests that this section of the building was constructed after the house was bequeathed to Jane Collins, upon her husband Isaac's death in 1841. The Phase Two addition used similar construction methods and retains the same roof pitch and materials (foundation and siding) as the original dwelling while this section is markedly different (Figure 45).

Figure 45. South façade of the Phase Three addition. Note the difference in appearance from Phases One and Two, especially the one-story height, low roof pitch, foundation appearance, and German drop siding. (Source: Francesca Evans, 2022)

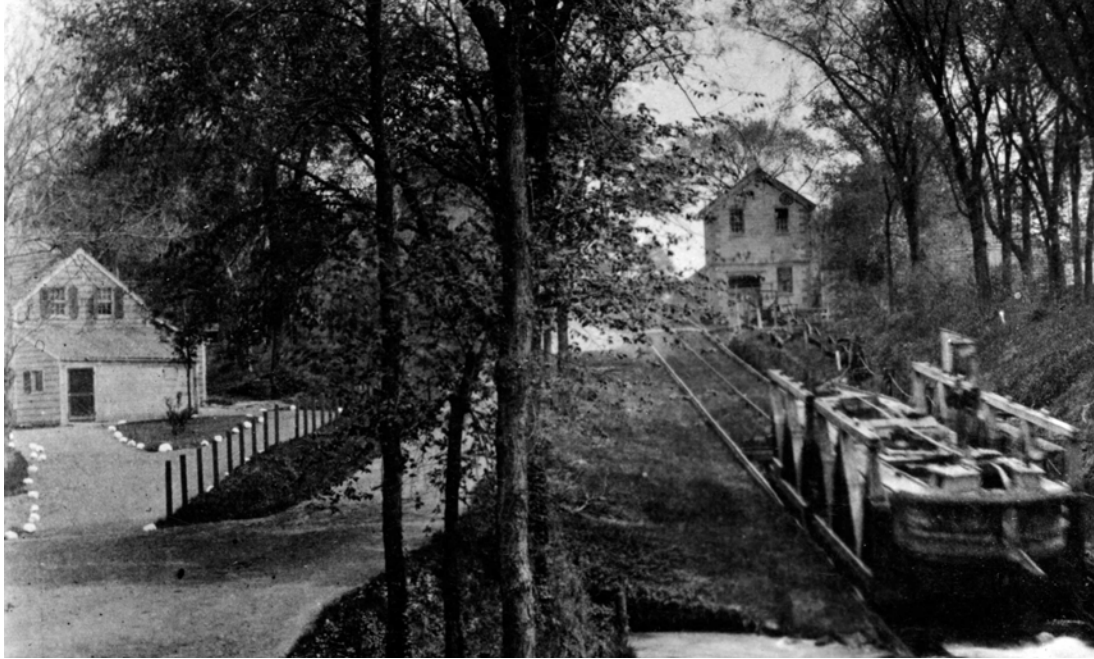
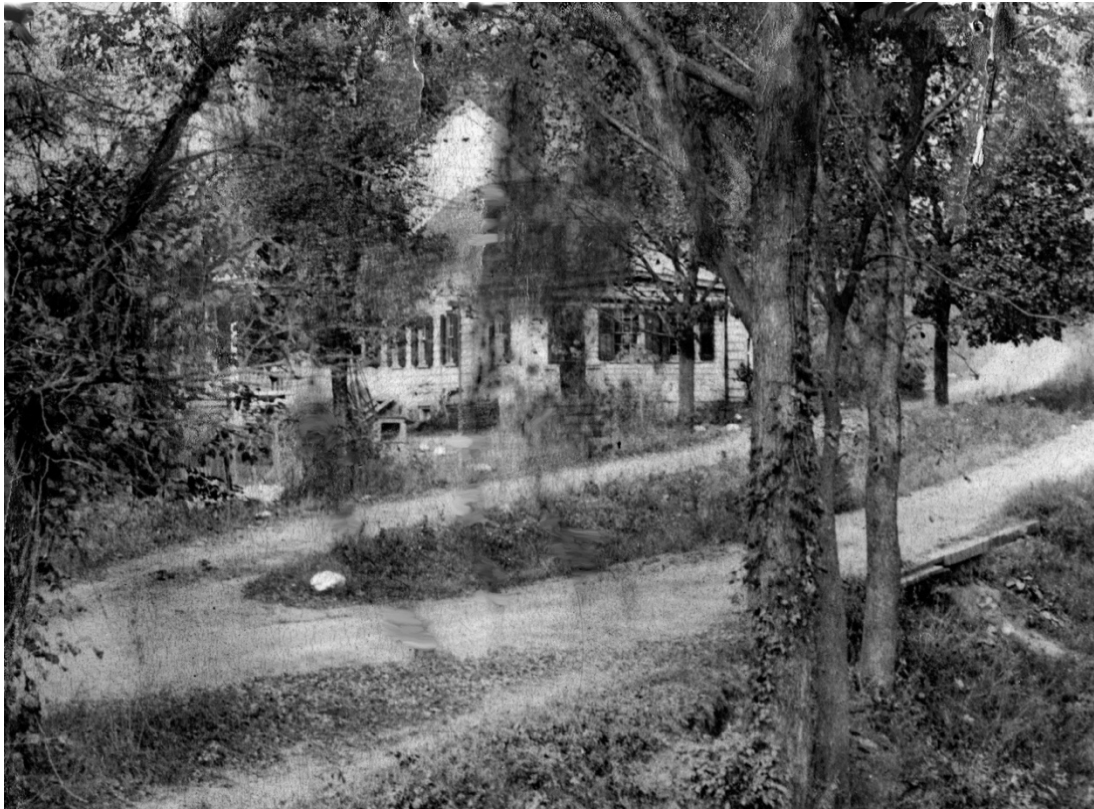
Upon close inspection of the picture, Phase Three was originally a one-story shed addition, a form that makes more sense given the period when the addition was built. However, there is no physical evidence in the framing to confirm what can be seen in the photograph; the vertical framing members that abut the half-story on the south elevation of Phase One contain notches that rise ½” on each vertical member from the eaves of each side of the roof toward the chimney. Had the notches been original to the shed roof, the indentations would have been located at the same height on each vertical timber. That Phase Three shared the same form as the Phase Four additions also lends support to this report’s observation that Phases Three and Four were constructed concurrently. The original addition contains two small windows on the west elevation and a single door on the south façade. No entry steps are discernable from the photograph and the foundation of the addition is not visible. A later historic photograph, taken from about the same vantage point, shows the marked changes to Phase Three which comprise its appearance today.

Figure 46. The top image shows the original shed form of the Phase Three addition. The lower image shows Phase Three after being converted from a shed form to a one-story structure with a low-pitch gable roof. (Source: Bloomfield Historical Society)

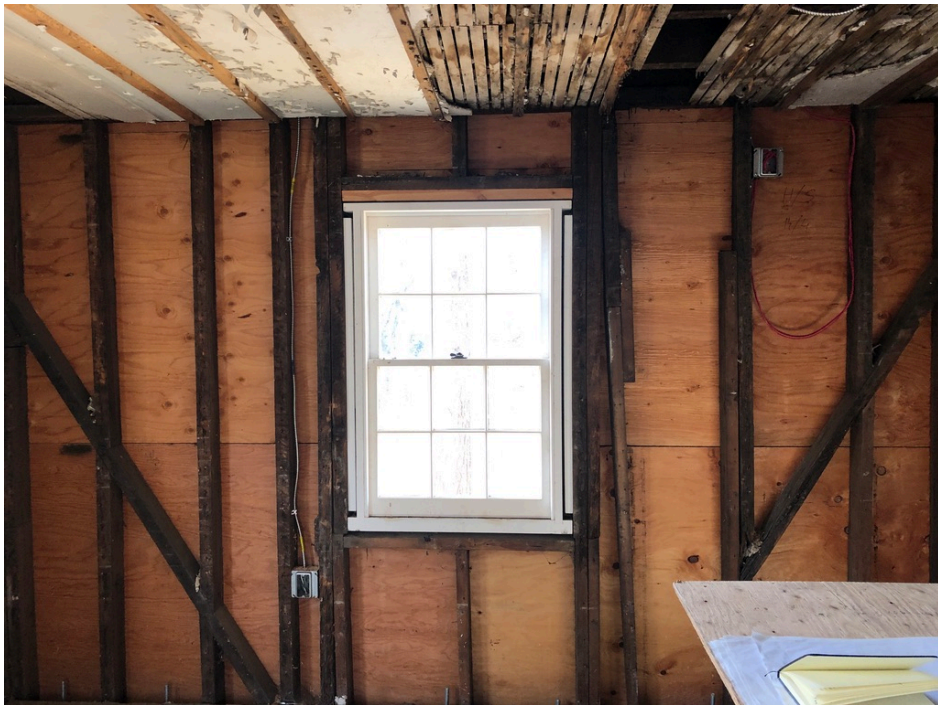
The current one-story addition, despite its adoption of a gable roof, is much different in appearance from Phases One and Two, with a low-pitch asphalt-clad roof, eaves on all exposed sides, and is of balloon frame construction rather than the timber framing of the first two phases (Figure 47). Foregoing the use of large timbers interlocked with mortise and tenon joints and secured with wooden pegs, the balloon framing of this section relies on wire nails to secure each piece of sash-sawn and circular-sawn lumber and four corner braces that have been “let in” to the studs so that they are flush with the wall surface. The flooring is narrow tongue and groove (2- $\frac{3}{4}$ ” wide) running east to west and is laid over top of wider tongue and groove flooring running north to south, like that found in Phases One and Two.

Figure 47. West wall of the Phase Three addition which was built using balloon frame construction. (Source: Francesca Evans, 2022)

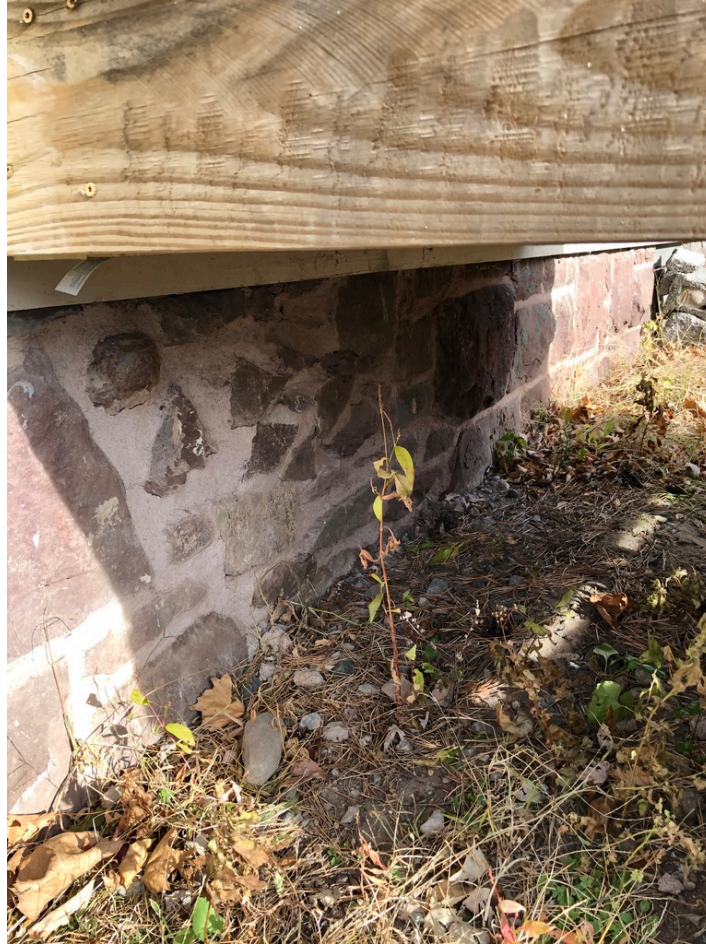
Like each section of the Collins House, this one-story addition has new 6-over-6 wooden windows and a new six-paneled door, along with a new entryway leading up to the door which have all been added as part of rehabilitation efforts. Foundation evidence suggests that there was an entry stoop about three feet in width in the same location as the entryway is today (Figure 48). These entry steps were most likely constructed when Phase Three was converted from a shed addition to a one-story structure with a low-pitch gable roof. These steps were probably removed when the doorway was eliminated before being added back during the recent exterior rehabilitation.

Figure 48. Evidence in the Phase Three foundation of a three-foot wide entry step, most likely added when Phase Three was converted to a gable roof. (Source: Francesca Evans, 2022)

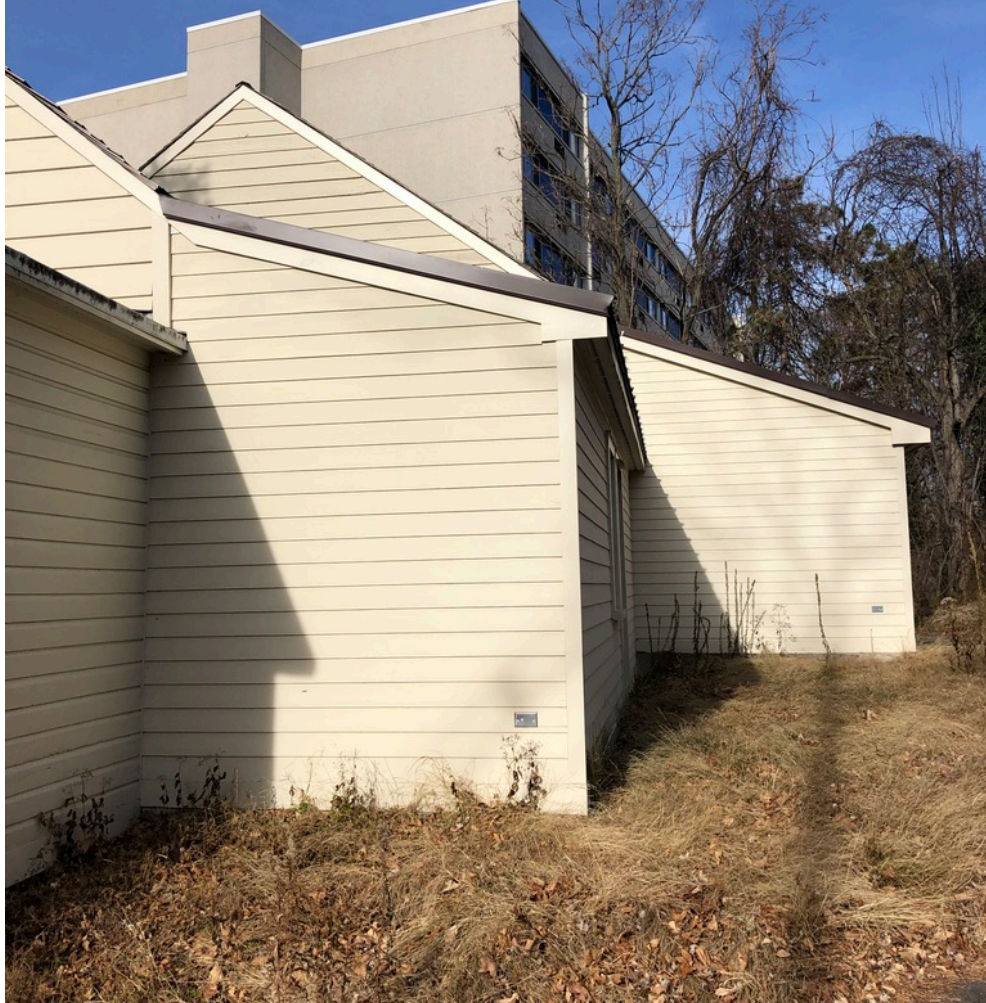
When solely examining physical evidence, it is difficult to date these two shed additions as they were reconstructed during the exterior rehabilitation of the Collins House. The National Register nomination notes that these two additions feature the same “novelty siding” as that of the third phase addition, which suggests that “construction was either concurrent or of similar timing.”⁸⁴ While evidence from maps supports this theory, it is difficult to find this connection while examining the rehabilitated exterior today, especially as Phase Three no longer exhibits its original shed form. In addition, both sheds of Phase Four now feature clapboards like those on the original dwelling and Phase Two section, only narrower in width, and not the same siding as that of Phase Three (Figure 52). The National Register nomination also notes that these two additions were balloon framed; while extant physical evidence could not definitively confirm this, the rear addition on the original dwelling does show evidence where a diagonal brace was “let in” similar to the braces in Phase Three (Figure 53).

Figure 52. Phase Four additions. Note the difference in siding from Phase Three and the narrower clapboards used than those seen on Phases One and Two. (Source: Francesca Evans, 2022)

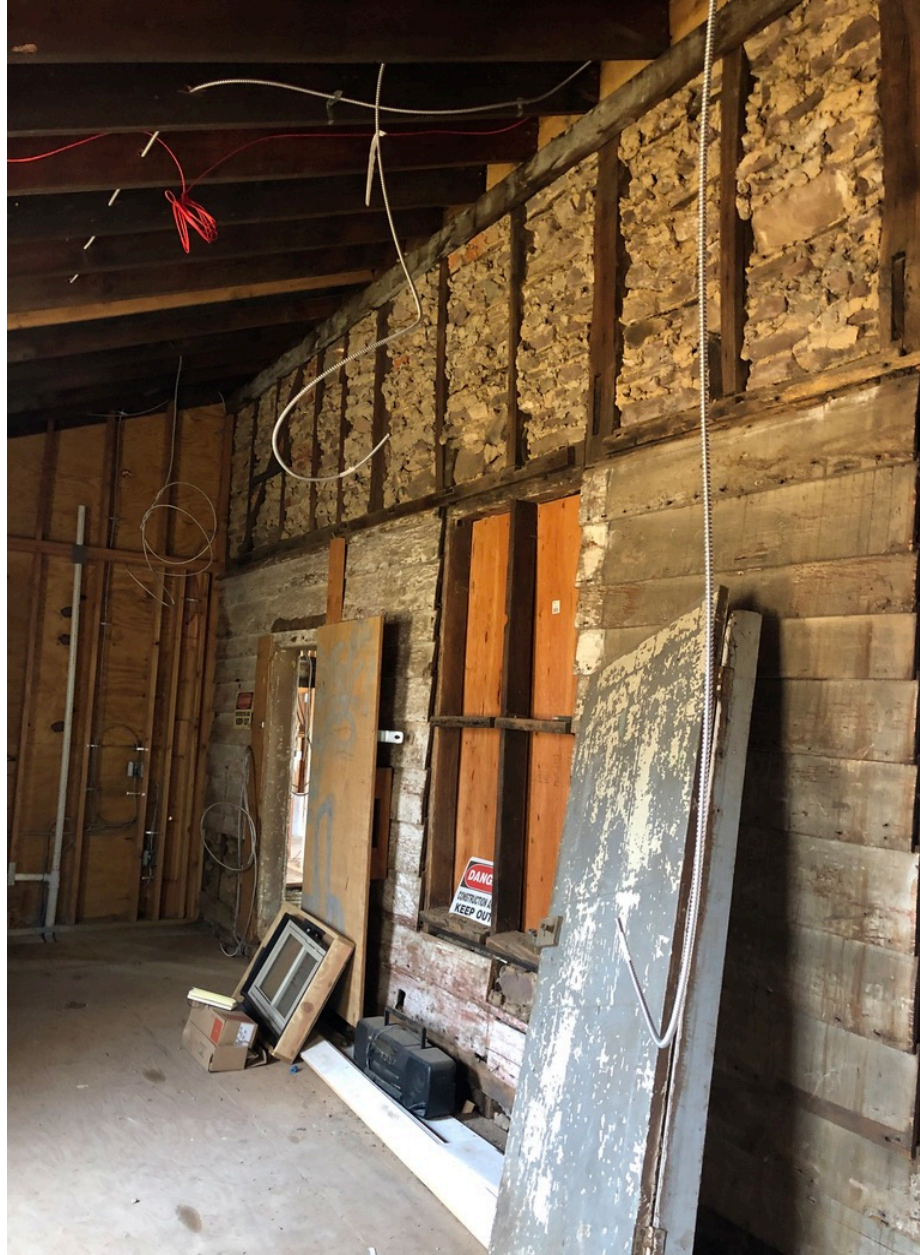
While the fourth phase addition to the rear of Phase One has almost entirely new framing, the fourth phase addition appended to the rear of the Phase Two section, while also mostly modern, is more telling as the original Phase Two exterior east wall remains largely intact. It is interesting to note that the west wall of the shed addition on this section of the building contains one of the original window openings (the other was converted into a door) and the clapboard siding that covers the rest of Phase Two (Figure 54). Documentary evidence before the exterior rehabilitation of the

building began shows that this wall had been covered over with plaster, however, it is unclear why the siding was not removed when this addition was constructed. The extant siding provides the potential for a greater understanding of the building's construction because covering the exterior wall in plaster prevented original building materials from being removed, including nails which could help confirm the period of construction for the Phase Two section.

Figure 54. Interior of the Phase Four addition appended to the east of the Phase Two addition. Documentary evidence shows that the original clapboard siding and window were covered over with plaster at some point. (Source: Francesca Evans, 2022)

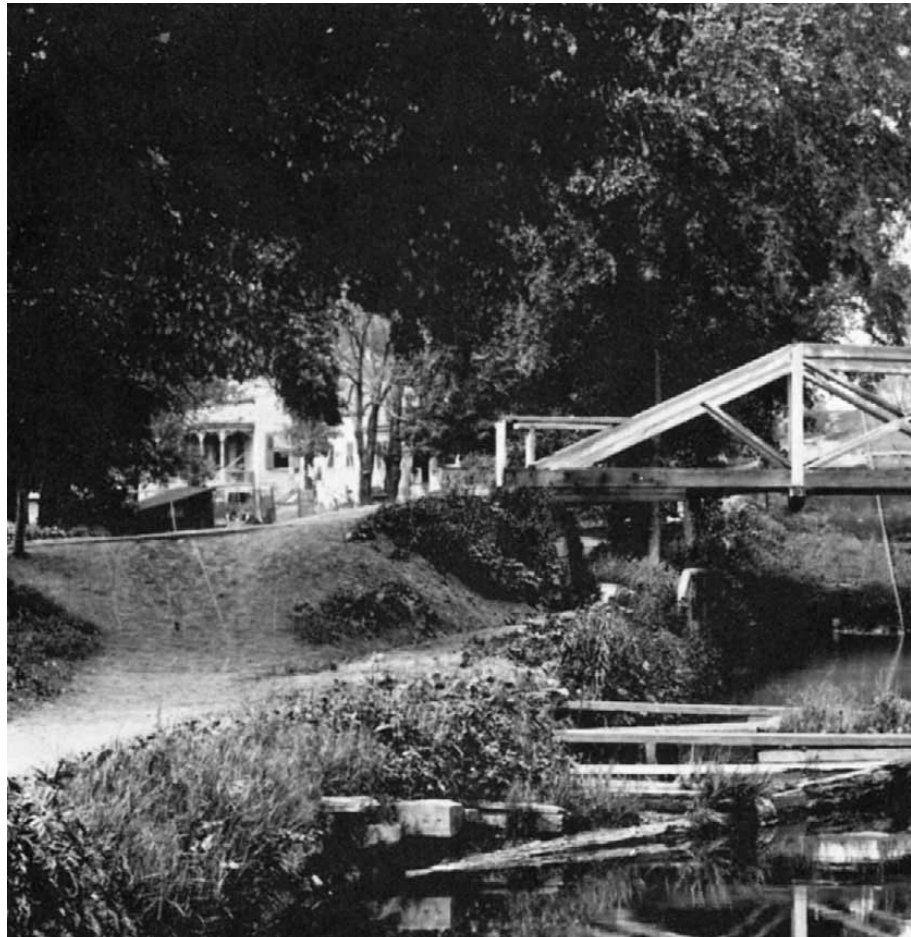
Figure 57. Image showing full-width porch on Collins House with Victorian detailing.
(Source: Bloomfield Historical Society)

Physical evidence in the foundation indicates that the original entry into the Phase Two section of the house was in the third, southernmost bay, and spanned approximately six feet in width. A 1907 Sanborn Map first documents the full-length porch, but it is unclear how old that porch was, as there are no remaining physical materials or fasteners, such as nails, to aid in dating its construction. The existence of the porch is not reflected in Thomas Hughes' 1856 map of Bloomfield or E.

One project currently being considered at the Collins House includes the construction of a porch or front stoop on the west façade of the Phase Two addition. Currently a temporary set of stairs has been built to provide access from the west side of the building as the full-width porch had deteriorated beyond repair by 2010. The National Register nomination notes that the porch was in the Greek Revival style, with unelaborated square columns, a simple guardrail, wooden balusters, and a hipped
