Title of Final Project: JOHN TYLER'S WOOD BURN:  
A PRESERVATION PLAN

William Valentine White IV, Master of Historic  
Preservation, 2023.

JOHN TYLER'S WOODBURN: A PRESERVATION PLAN

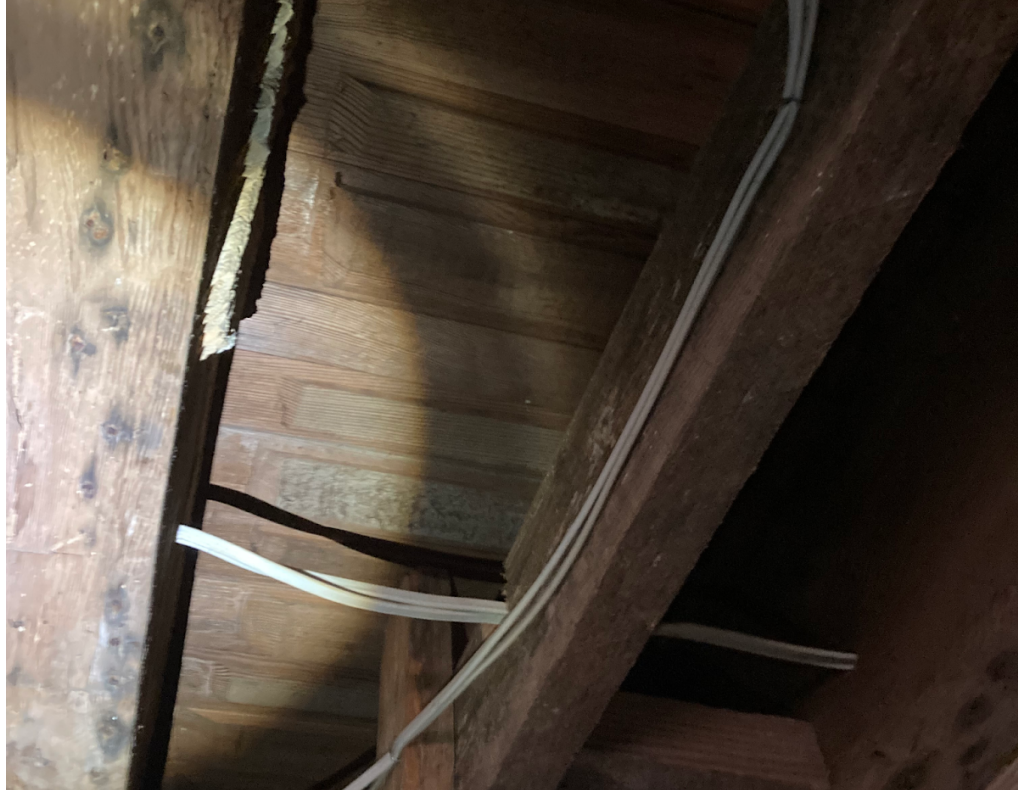
The ceiling of the basement is unfinished and provides a view into the system supporting the first floor. Elements from the 1970s restoration can be seen as steel I-beams running across the ceiling supporting the wooden floor joists (Figure 3.8). The tongue and groove flooring for the first floor can be seen in between the joists

Figure 3.8. Image of one of the I-beams added in the 1970s (Photo by author, 2022).

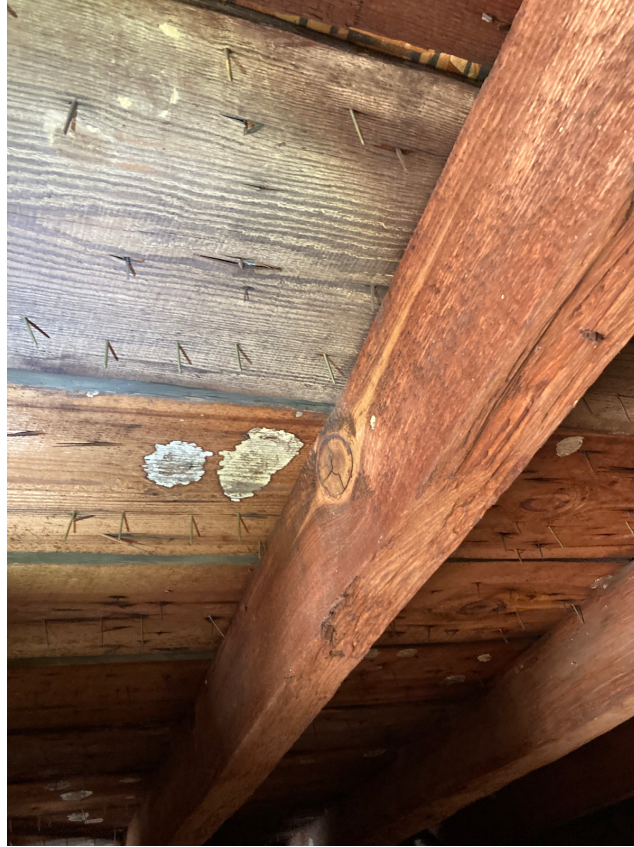
The rafters and collar beams are mainly pit sawn with a few circular saw marks on the south wall likely part of 1970s restoration (Figure 3.30). The roofing decking is wide sash sawn lumber with visible cut nails. On top of the decking are sheets of plywood with wire nails for the asphalt roofing currently on the house (Figure 3.31).

Figure 3.31. Cut and wire nails in attic decking  
(Photo by author, 2022).

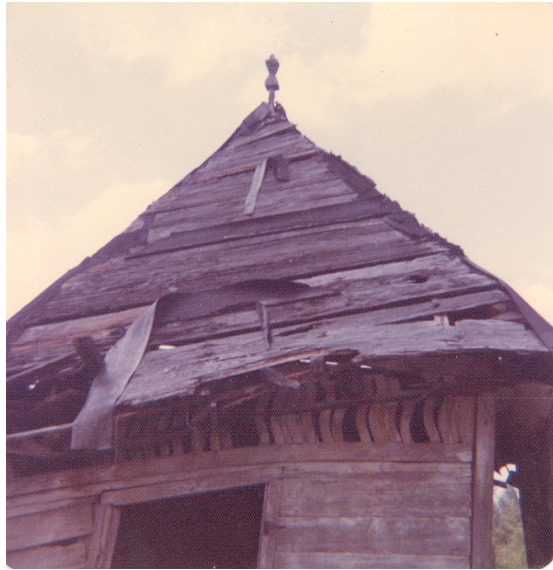
According to the 1977 survey, the dairy was originally built between 1813-1815 during the construction of the main house.<sup>48</sup> Unfortunately, by the time the Neticks purchased the property, the dairy was in very poor condition (largely collapsed) and had to be rebuilt (Figure 3.35). Currently, the dairy looks much like it would have originally appeared in 1813 when Tyler lived on the property. Measuring 12' 9" by 12' 9" it is clad in beaded weatherboard, had a pyramidal roof, and cyma

Figure 3.35. Dairy in the 1970s  
(Source: Tyler Family Collection).

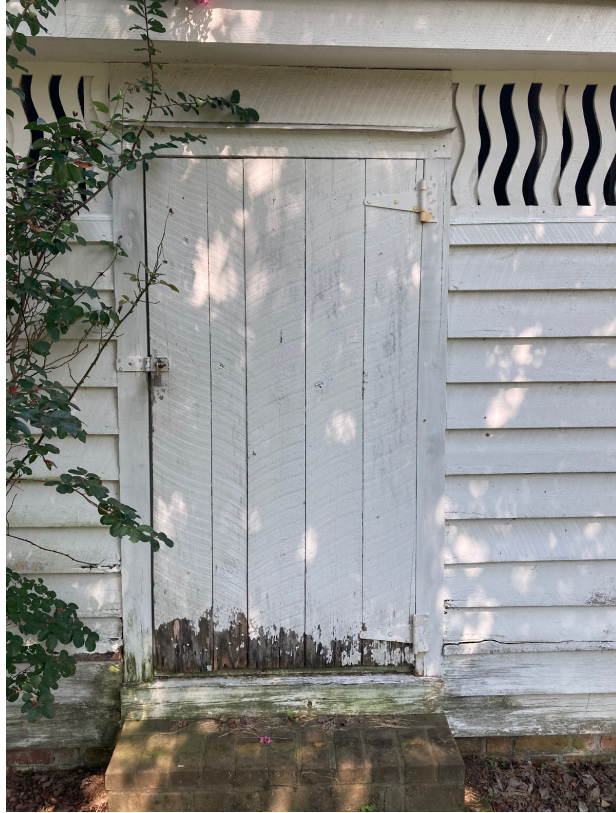
While looking similar to how the dairy would have looked in 1815, the structure has modern elements that indicate it is a reconstruction. All of the framing members have circular saw marks (Figure 3.37). The asphalt shingles on the roof are the same as on the main house with wire nails and were likely also added around the mid- to late 2000s. The cyma reversa vent grilles on the front are made from plywood. The door to the dairy is also made from circular sawn wood with modern hinges and screws (Figure 3.38).

Figure 3.38. Dairy Door  
(Photo by author, 2022).

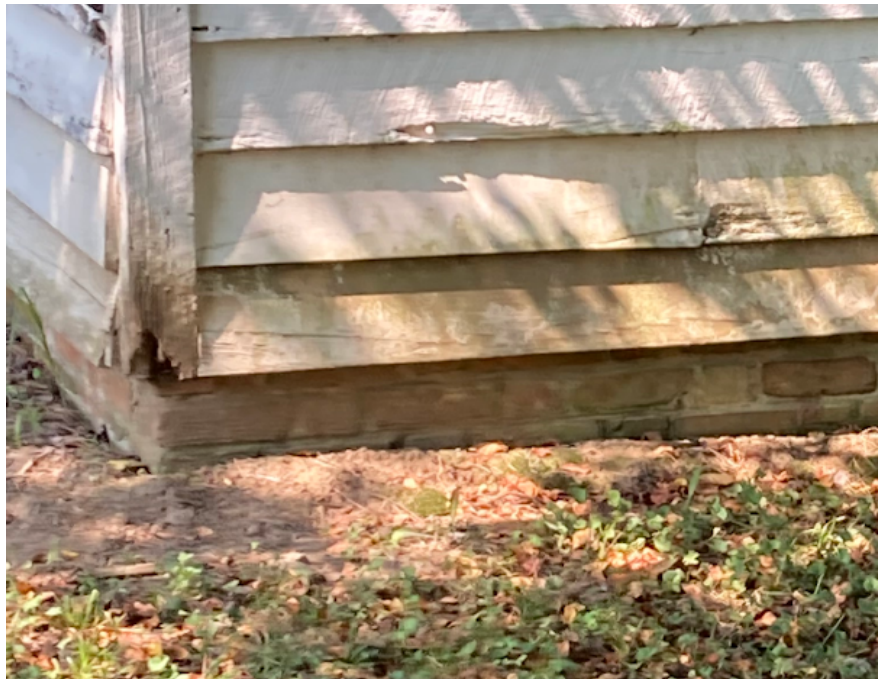
When examining the brick foundation of the smokehouse it appears it was fully rebuilt using Portland cement mortar (Figure 3.42). The dairy, despite being labeled as collapsed in the 1970s, appears to have its original brick foundation (Figure 3.43). The smokehouse has concrete blocks (CMU) as a foundation with Flemish bond brick above. These same bricks match similar ones found in the main house that were likely used during the restoration. This suggests that both the smokehouse and dairy are fully reconstructed, with the dairy still having its original foundation.

Figure 3.43. Dairy foundation  
(Photo by author, 2022).

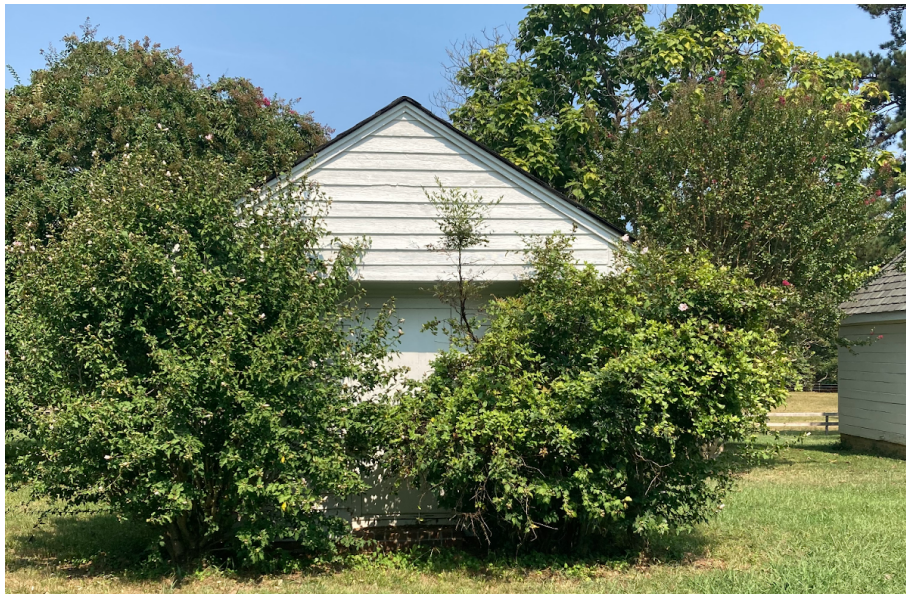
Located directly behind the main house, the storehouse measures 12' 3" by 12' 4" and is clad in weatherboard on a brick foundation with a molded brick cap and a gable roof with asphalt shingles (Figure 3.44). A single wooden door with modern hinges provides access to the structure; the storehouse has two six-over-six double-hung sash windows, one on its west side and one on its east side. According to the 1977 survey, the structure is listed as being from the mid-nineteenth century and is likely timber framed.<sup>50</sup> The interior walls are finished with plaster (Figure 3.45). Circular saw marks are visible on the exterior including several of the weatherboard with wire-cut nail heads. On the rear of the structure, a single concrete slab abuts the brick foundation. It appears that the slab was put there to buttress the wall (Figure 3.46).

Figure 3.44. Storehouse  
(Photo by the author, 2022).

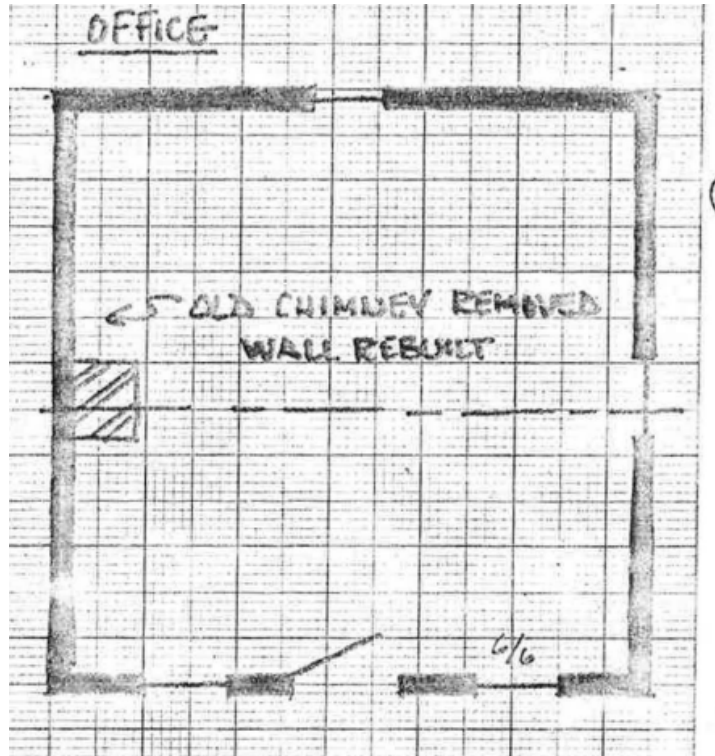
Figure 3.48. Sketch of Office from 1977 Survey  
(Source: Virginia Department of Historic Resources).

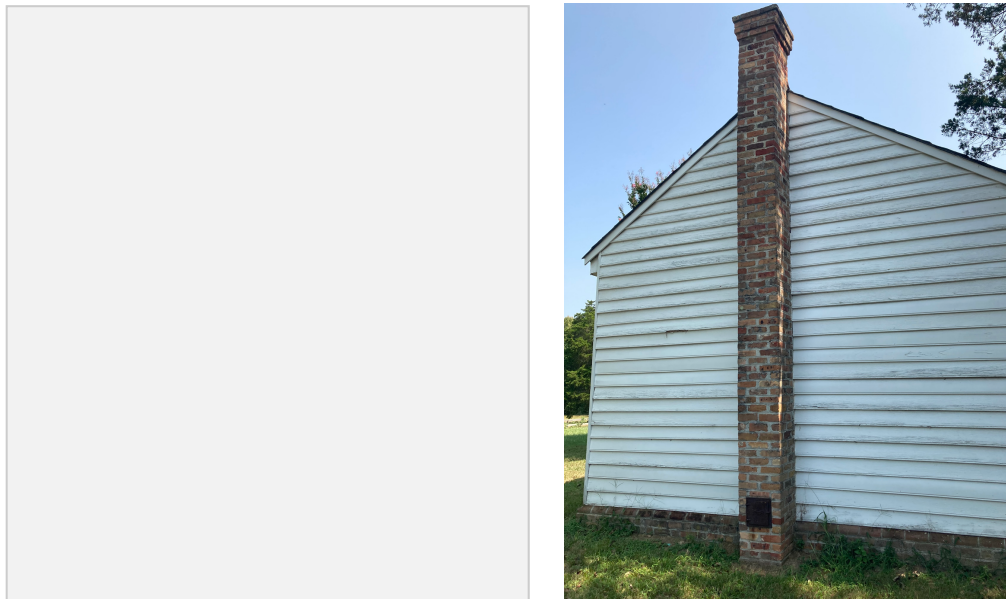
Figure 3.49 (left) East side of Office, (right) West side of Office  
(Photos by author, 2022).

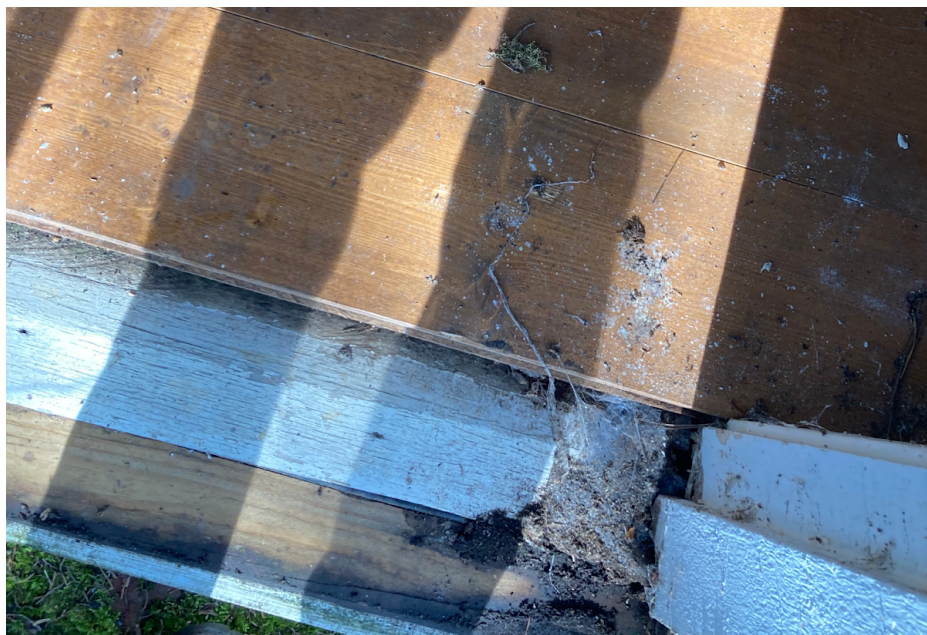
Like the storehouse, the interior has plaster with no visible view of the framework, but likely based on its suggested date of construction is a timber-framed structure. The office is a single open room with a stove pipe opening on the west wall. The room is lined with a flat baseboard and crown molding. The floor is made up of tongue-and-groove, however, it appears to be on top of the original flooring. When looking at the door sill, the floor can be seen over lapping the threshold (Figure 3.50).

Figure 3.50. Tongue and groove flooring visible on door sill  
Photo by author.

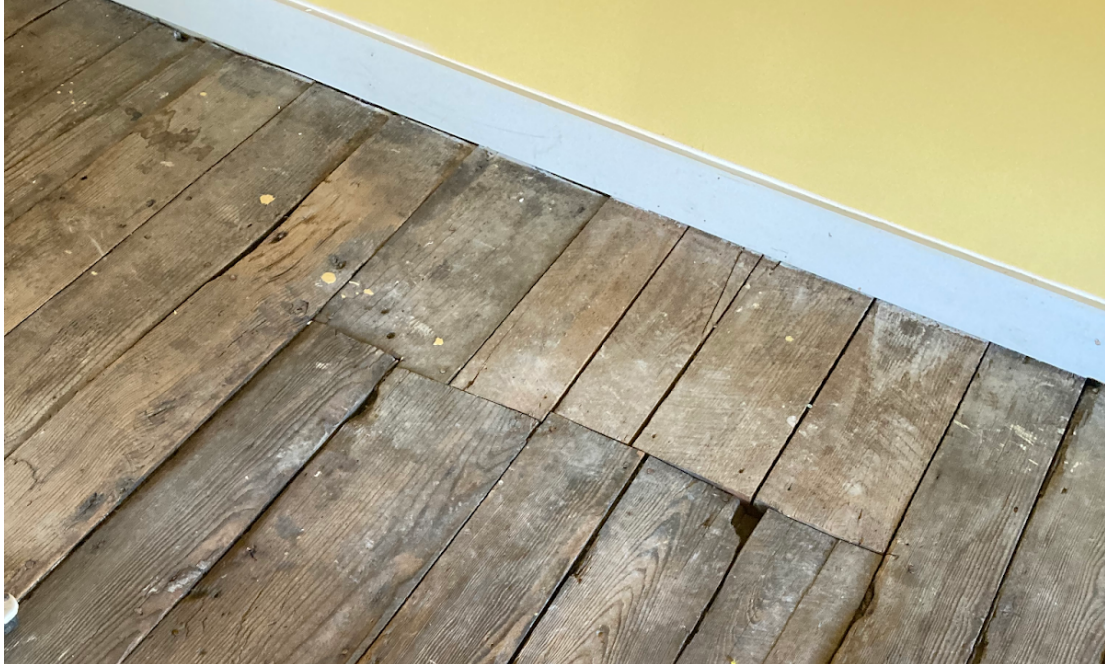
The attic space has been modified into a bedroom with a section in the northwest corner walled off for a bathroom. This upstairs was likely originally used as the living area for enslaved persons who worked in the kitchen (Figure 3.52). Due to remodeling, the first floor and basement flooring and walls could not be properly studied. These ongoing modifications will be discussed in the following chapter.

Figure 3.52. Attic in kitchen with repairs of circular sawn lumber.  
(Photo by author, 2022).

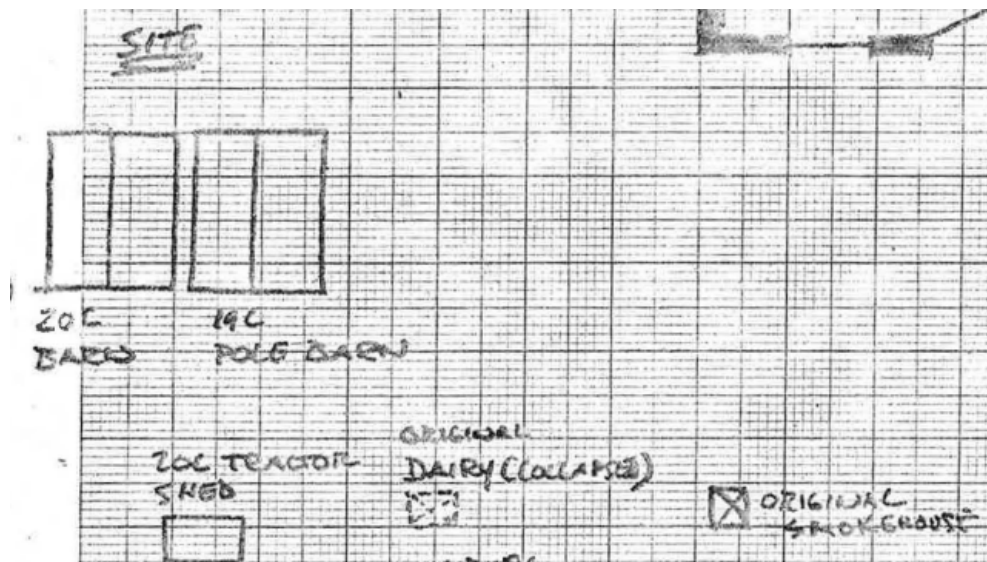
Figure 3.54. Survey with two barns marked on the map, 1977 (Source: Virginia Department of Historic Resources).

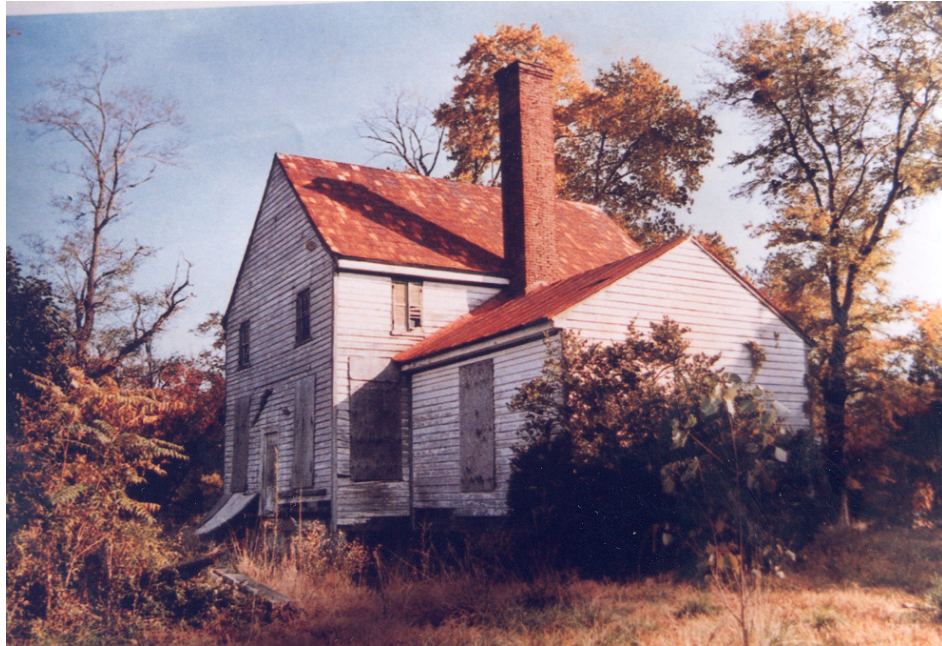
When the Neticks purchased Woodburn in 1971 it was in need of massive restoration work. This work included repairing foundation as the basement was repeatedly flooded with several feet of water damaging the original foundation. Despite several photographs from the 1970s both before and during the restoration, few images help to fully illustrate the level of repair that was needed. In 1971, an Architectural Survey Form was done by the Virginia Historic Landmarks Commission, which included a sketch of the landscape and structures on the property along with a rough drawing of the floor plan of the house. In 1977, the Society of Architectural Historians Architecture Resources Archive (SAHARA) collected several images of the main house before its renovation. While helpful the archive only had images of the front of the house, the smokehouse, and three rooms on the first floor of the main house. These rooms were the entry hall, dining room, and ballroom. Despite the SAHARA images and the Architectural Survey report no photographs or sketches of the basement, second floor, or attic space. Due to a lack of documentation, aspects of their condition during the 1970s will be inferred based on analyzing the condition of the property based on the known photographs, the various sketches, and notes about the property collected by the Virginia Department of Historic Resources and what the owner remembered being told about the property by the Neticks (Figure 4.0 and 4.1).

Figure 4.0. The rear of Woodburn, 1970s  
(Source: Tyler Family Collection).

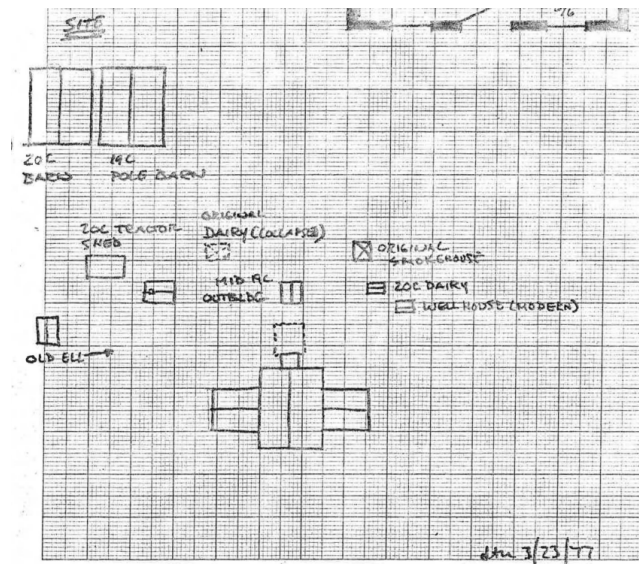
Figure 4.1. Sketched map of Woodburn, 1977. (From Left to Right and top to bottom) of 20th-century Barn and 19th-century Pole Barn in the upper left corner, 20th-century tractor shed [Removed], original Dairy labeled as collapsed, small outbuilding, an original smokehouse, “Zoe Diary” a 20th century dairy [removed], and a modern well house. “Old Ell” is the original kitchen which had been moved. The arrow is pointing to the outlined square connecting to the main house. Before being connected to the house in the 19th century it was originally located on the east side of the house (Source: Virginia Department of Historic Resources).

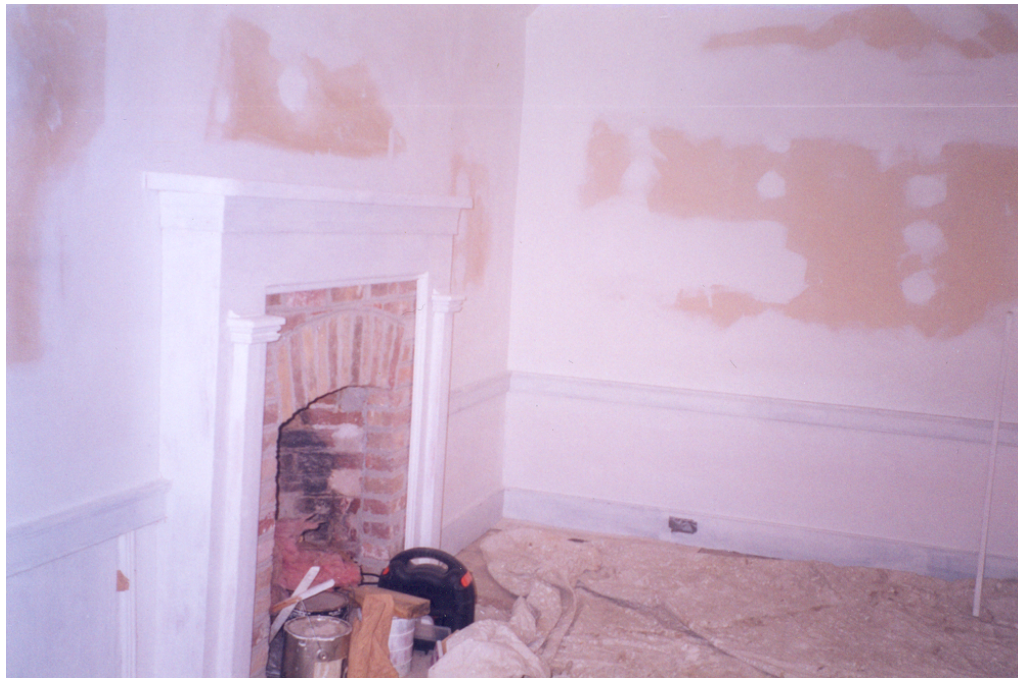
Photographs of the restoration from the early 1980s show that the fireplaces upstairs were likely restored in the late 1970s to earlier 1980s after the foundation and chimney were repaired. Based on photographs from the late 1970s and early 1980s, it appears that most of the interior restoration began during this period(Figure 4.3). The ballroom was converted back to its earlier appearance, as the 1977 survey shows a wall on the east side of the room creating two small rooms labeled as a bath and closet.

Figure 4.3. East bedroom during restoration, 1980s  
(Source: Tyler Family Collection).

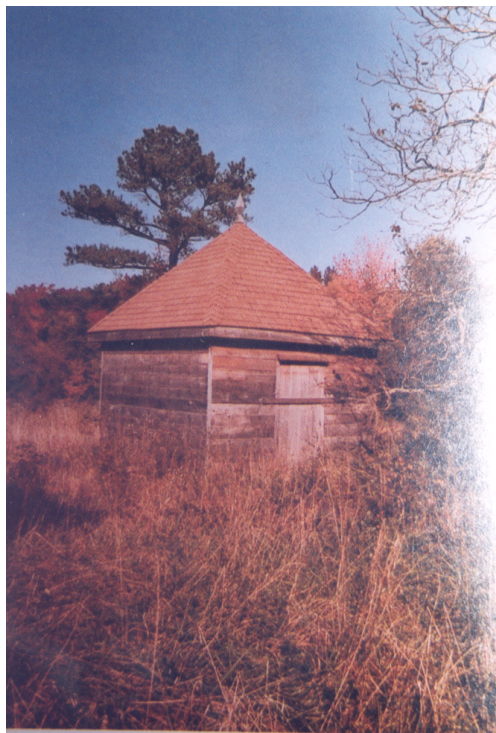
Along with the main house, all of the outbuildings were restored. As mentioned previously in Chapter 3, the smokehouse and dairy are largely full reconstructions. Figure 4.5 shows the smokehouse during the 1970s restoration and Figure 4.6 shows the restored dairy. The kitchen, once connected to the back of the house with a breezeway, was relocated to the west side of the central area between 1971 and 1977. This is based on the kitchen appearing in the 1971 survey attached to

Figure 4.5. Smokehouse during the restoration  
(Source: Tyler Family Collection).

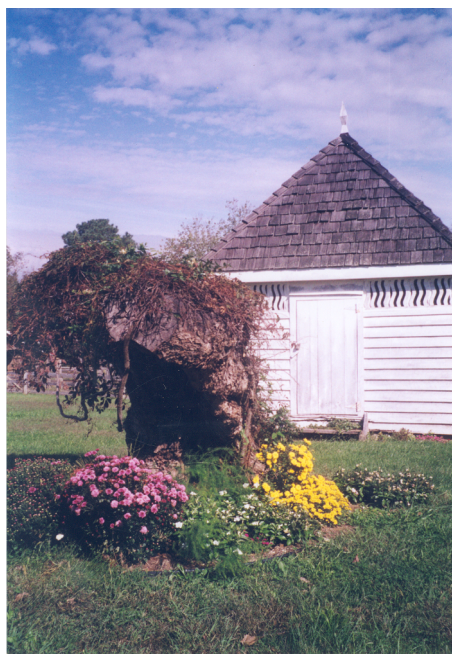
Figure 4.6. Dairy Restored, ca. 1980s  
(Source: Tyler Family Collection).

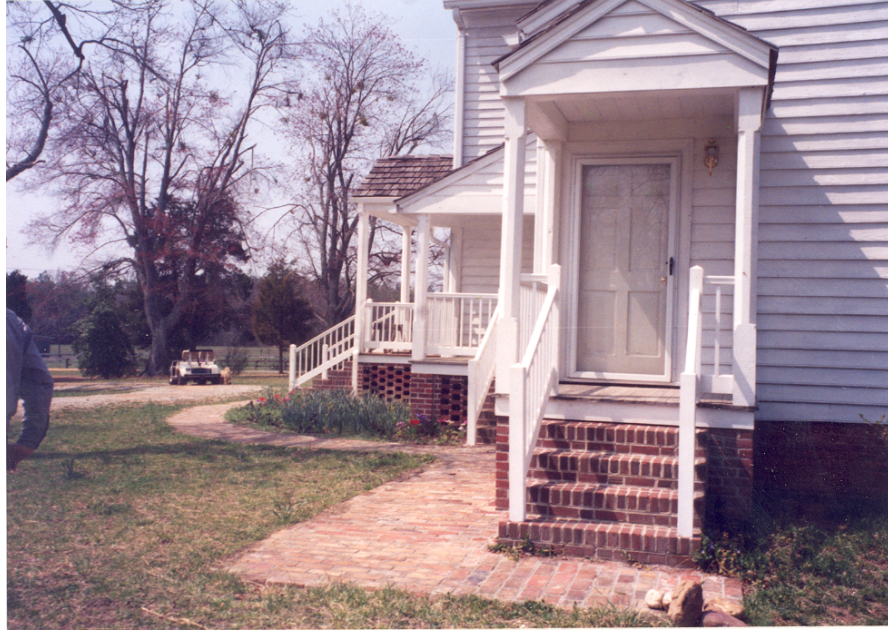
the back of the house and mentioned as being removed in 1977, suggesting that the building was moved between 1971-1977. Little information from the surveys from the 1970s discusses or mentions the landscape work done on the property. Based on the photographs several trees were removed and the circular drive was restored (Figure 4.7).

Figure 4.7. Side of Woodburn with circular drive restored, ca. 1980s  
(Source: Tyler Family Collection).

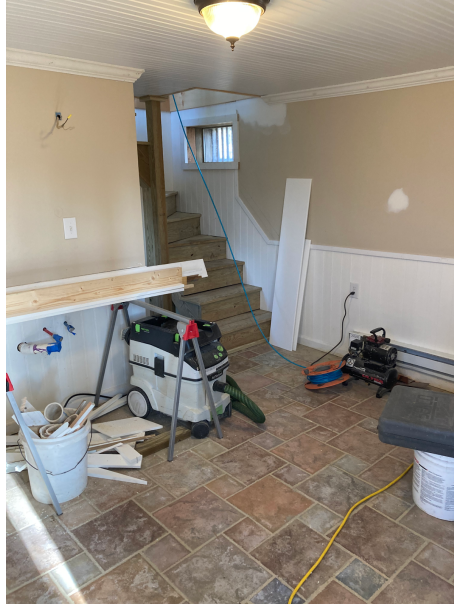
fireplace, and crown and baseboard molding with the ceiling clad with beadboard (Figure 4.13). The English basement is in the process of being modified into a kitchen area and bathroom. Modern tile flooring has been installed on the floor, along with drywall, beadboard ceiling, crown and baseboard molding along with vertical wainscoting. A section on the west side of the basement has been modified with plumbing for a toilet, sink, and shower.

Figure 4.14 - Kitchen basement remodeling  
(Photo by author,2022).
