AN ANALYSIS OF VEHICLE FIRES AND  
POTENTIAL METHODS TO REDUCE THEIR  
SEVERITY THROUGH MORE STRINGENT  
MATERIAL STANDARDS

Evan A. Patronik, Master of Science in  
Fire Protection Engineering, 2008

Thesis submitted to the Faculty of the Graduate School of the  
University of Maryland, College Park, in partial fulfillment  
of the requirements for the degree of  
Master of Science  
2008

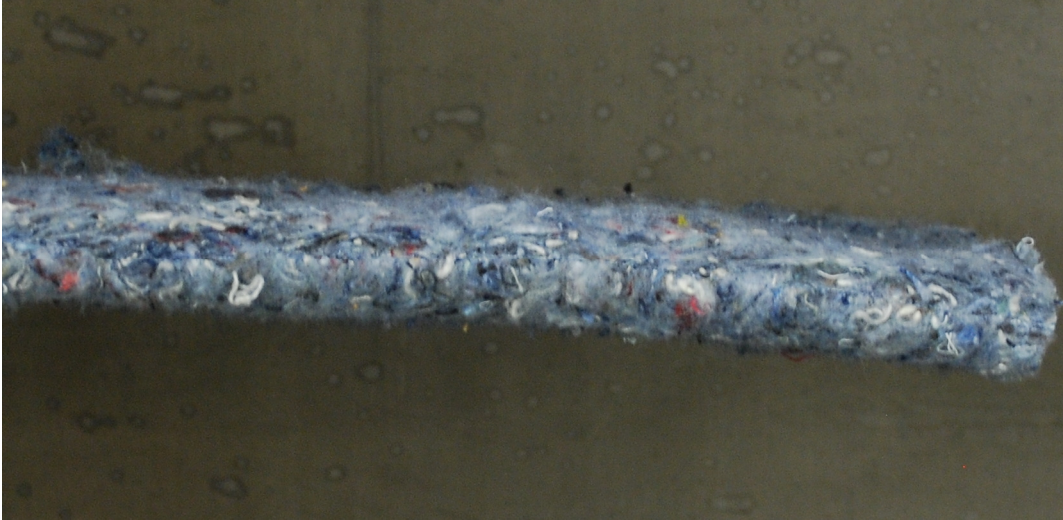
liquid, the material is forced to absorb the retardant throughout its volume, increasing its fire resistant qualities. Figure 2.1 shows a side view of the FR Material insulation.

**Figure 2.1. FR Material side view**

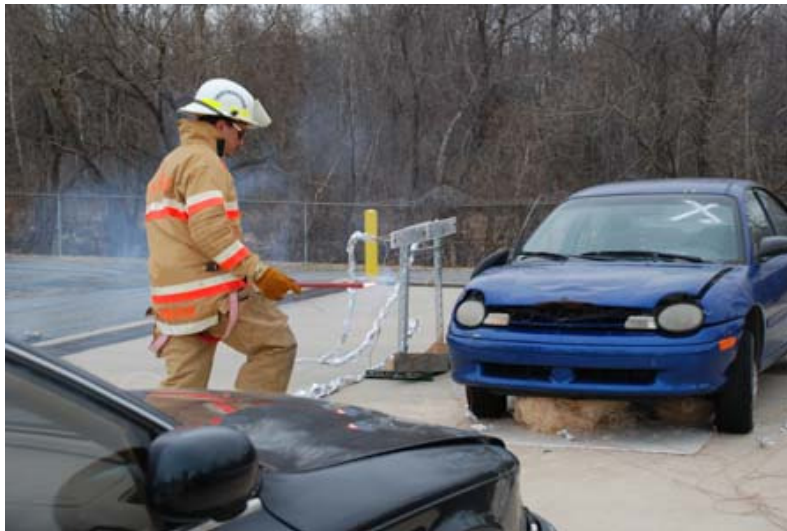
The large-scale insulation test burns were completed at the Maryland Fire and Rescue Institute (MFRI) in College Park, MD. Two vehicles provided by MFRI were used in the test burns. One vehicle was an early 1990's Dodge Neon (small four door sedan) and the other was a 1990's Infiniti J30 (mid-size four door sedan). As shown in Figure 3.1, the two vehicles were positioned facing each other raised on concrete cinder blocks.

**Figure 3.1. Vehicle orientation**

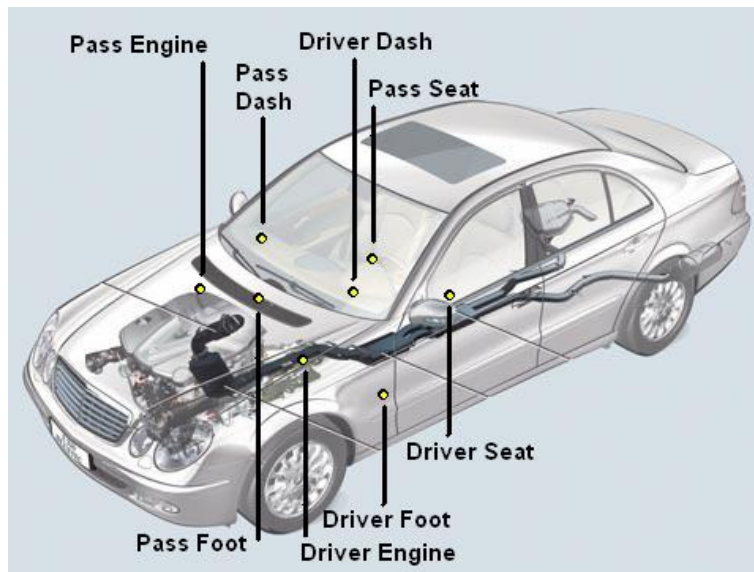
- Two (2) on the right and left sides of the engine compartment within a foot of the firewall at approximately the level of occupant feet;
- Two (2) just above the dashboard several inches from the windshield along the centerline of the front driver and passenger's bodies;
- Two (2) in the foot wells of the front driver and passenger seats; these thermocouples were placed between the carpeting and the firewall insulation
- Two (2) in the front driver and passenger's seats at waist level

**Figure 3.2. Diagram of thermocouple locations**

\*See Figure 3.2 for a diagram of these locations

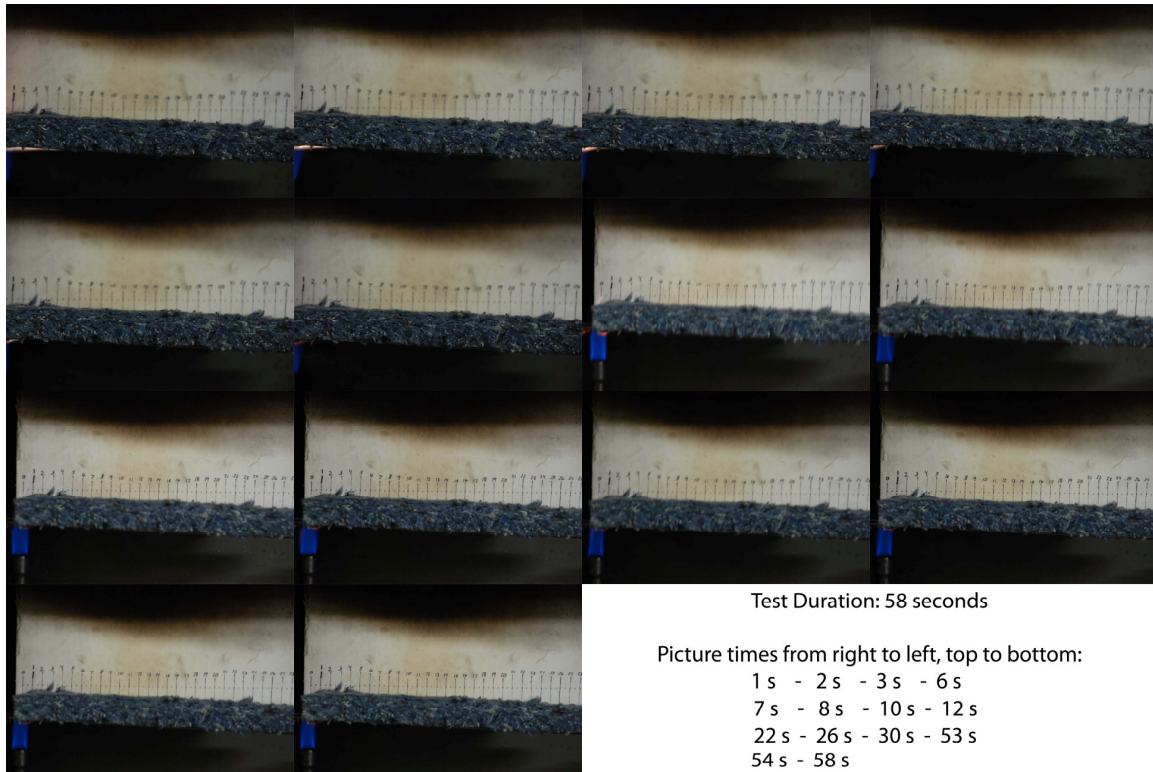
**Figure 4.1. Photographs of FR Material horizontal flame spread test**

Each line on the white background along the length of the sample in the photographs is 1 cm. In the lower right corner of the figure, the total test duration and time elapsed for each picture [moving left to right and top to bottom] is listed. As shown, no flame spread occurred for the duration of the test, resulting in an approximate flame spread velocity of at most 5 mm/s.

Negligible flame spread occurred along the length of the insulation for the duration of the test. Figure 4.1 shows time lapse photographs of the FR Material test.

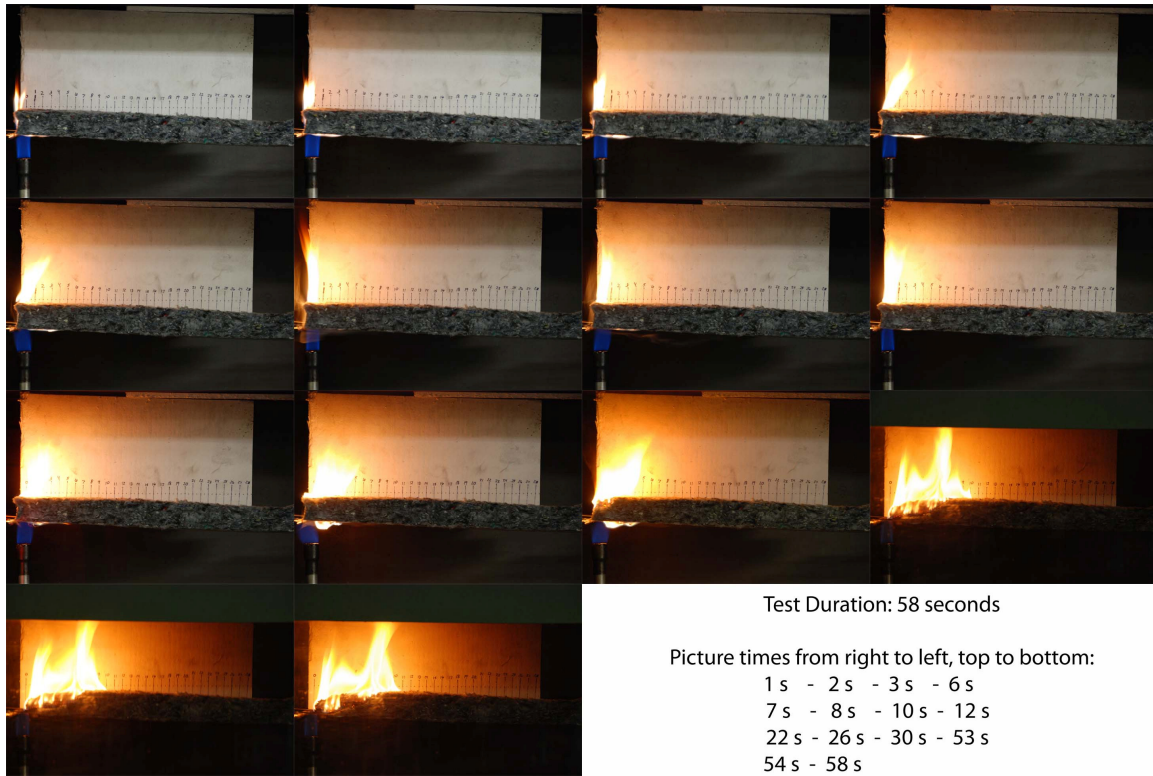
**Figure 4.2. Photographs of Current Material horizontal flame spread test**

Each line on the white background along the length of the sample in the photographs is 1 cm. In the bottom right corner of the figure, the total test duration and time elapsed for each picture [moving left to right and top to bottom] is listed. As shown, flame spread was minimal in the first 12 seconds of the test, with significant flame spread occurring at 26 s and beyond. By the end of the test at 58 seconds, flames had spread more than the maximum distance of 102 mm allowed by the FMVSS 302 standard. Figure 4.3 is a larger image of the last photograph in the progression allowing a better view of the distance propagated by the flames.

The Current Material showed flame spread that was faster than the FR Material. Figure 4.2 contains time lapse photographs of the Current Material test.

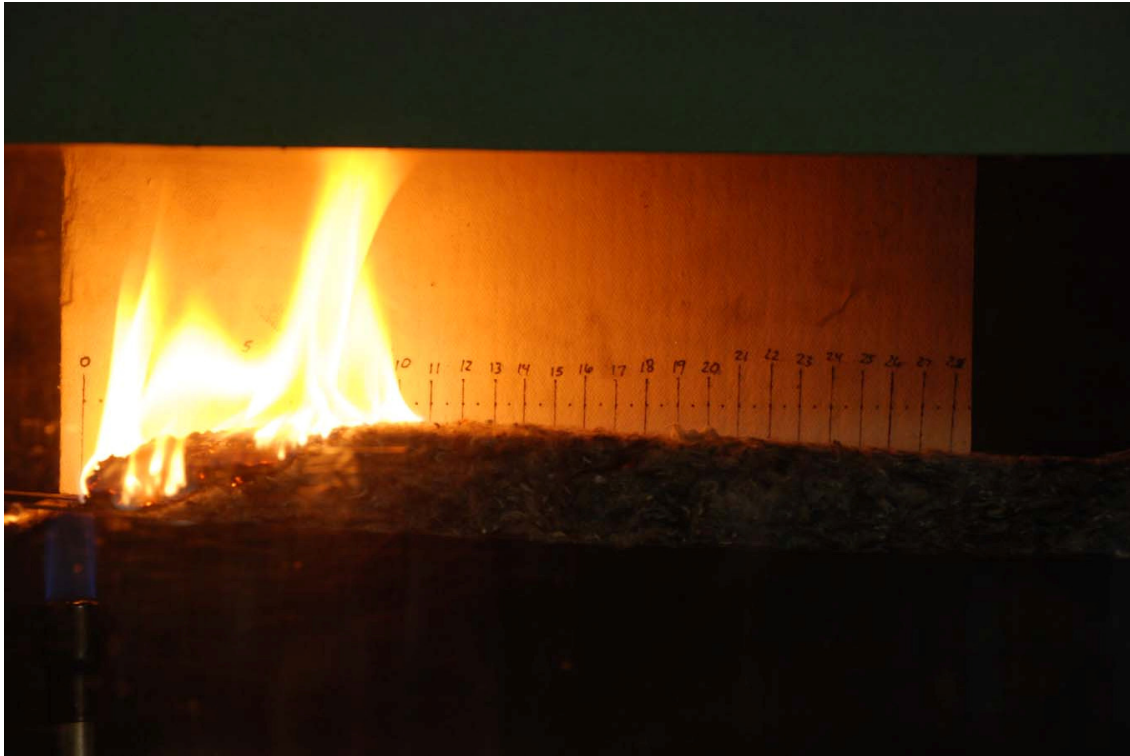
**Figure 4.3. Flame spread at 58 s into Current Material test**

The FMVSS 302 standard states that flames must not spread with a velocity more than 102 mm per minute [1.7 mm/s]; in the Current Material test, by 58 seconds the flames had spread 110 mm, resulting in a flame spread velocity of 1.89 mm/s. This value is greater than the accepted maximum by the standard, but these tests are not official FMVSS 302 test set-ups so judgments in terms of FMVSS 302 cannot be made.

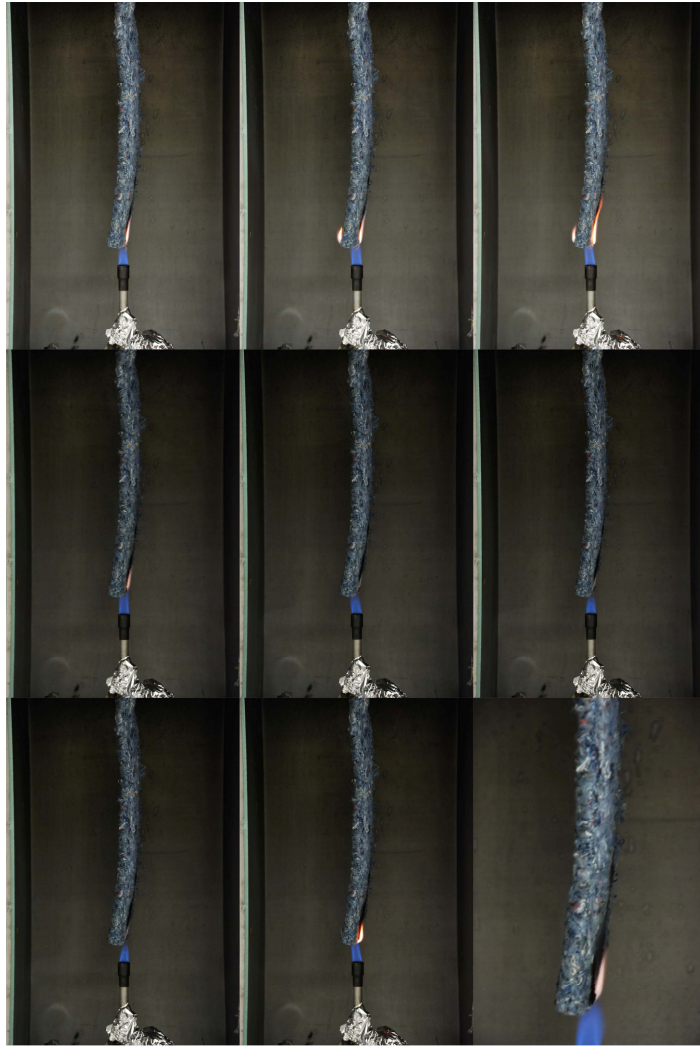
Charring could be seen on the portions of the sample upon which the flame, or sometimes the very beginning of the hot plume, impinged, but beyond the flame no visible damage occurred. The material was resistant to flame spread, even in the vertical orientation.

**Figure 4.4. Photographs of FR Material vertical flame spread test**

In the bottom of the figure, the total test duration and time elapsed for each picture (moving left to right and top to bottom) is listed. After 71 seconds of flame impingement, the material still had yet to exhibit any signs of flame spread. Even after

These results are shown in the photographs in Figure 4.4.

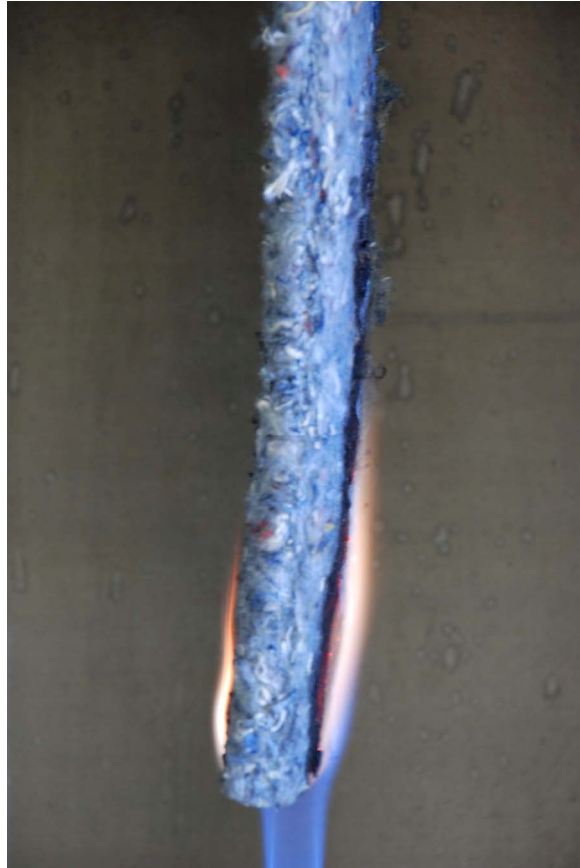
increasing the flame height to almost 3 times its initial height by adjusting the flow of methane to the burner, flame spread did not occur. More charring over a larger area did take place, but only due to the increased size of the ignition source. In Figure 4.5, a photograph of the increased flame size with no flame spread is shown.

**Figure 4.5. Photograph of FR Material vertical flame spread test with increased flame size**

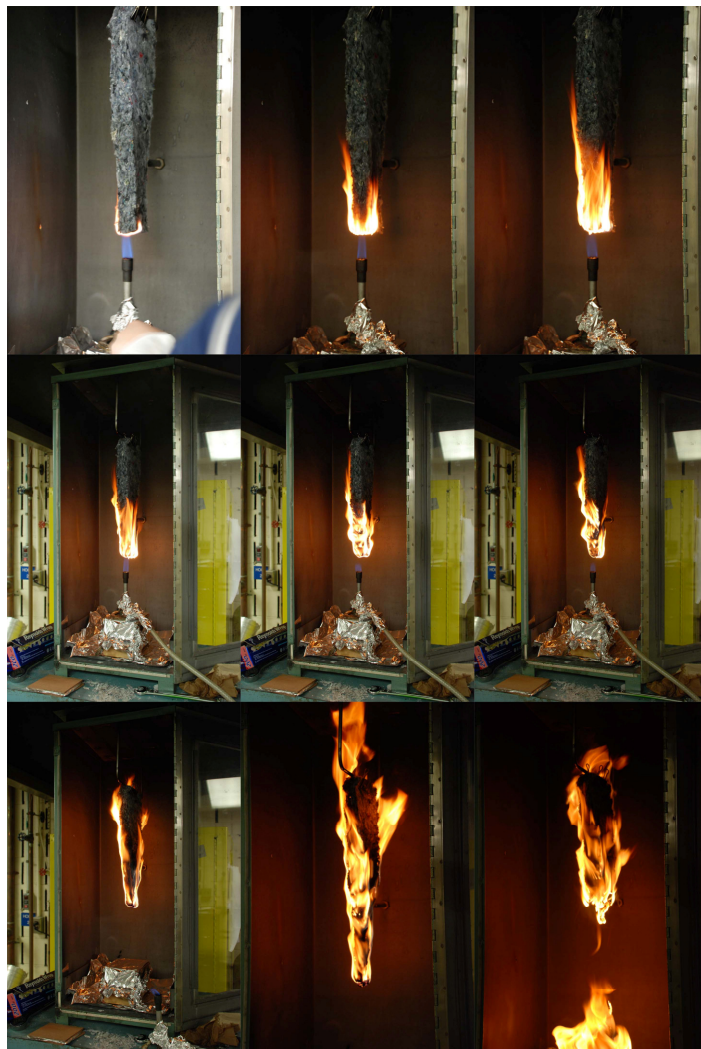
The Current Material sample ignited quickly and propagated flames upward along the sample. Once ignited, the flames grew larger and accelerated up the height of the sample.

**Figure 4.6. Photographs of FR Material vertical flame spread test**

In the bottom of the figure, the total test duration and time elapsed for each picture (moving left to right and top to bottom) is listed. After 5 seconds, the sample has clearly ignited and flame spread has begun. By the 33 second mark, the entire sample has become involved and by 37 seconds the sample is no longer able to support its own weight, resulting in the separation of the burning material into multiple parts; NFPA 556 requires that materials not have this characteristic of flaming drips or the separation of flaming parts. In other runs of this same test with the Current Material sample, full sample involvement sometimes occurred in as little as 15 seconds. In the vertical modified-FMVSS 302 test, the Current Material sample did not perform well. Even without a comparison to the FR Material sample, it is evident that the Current Material lacks fire retardancy for use in the vertical orientation.

These results are shown in the photographs in Figure 4.6.

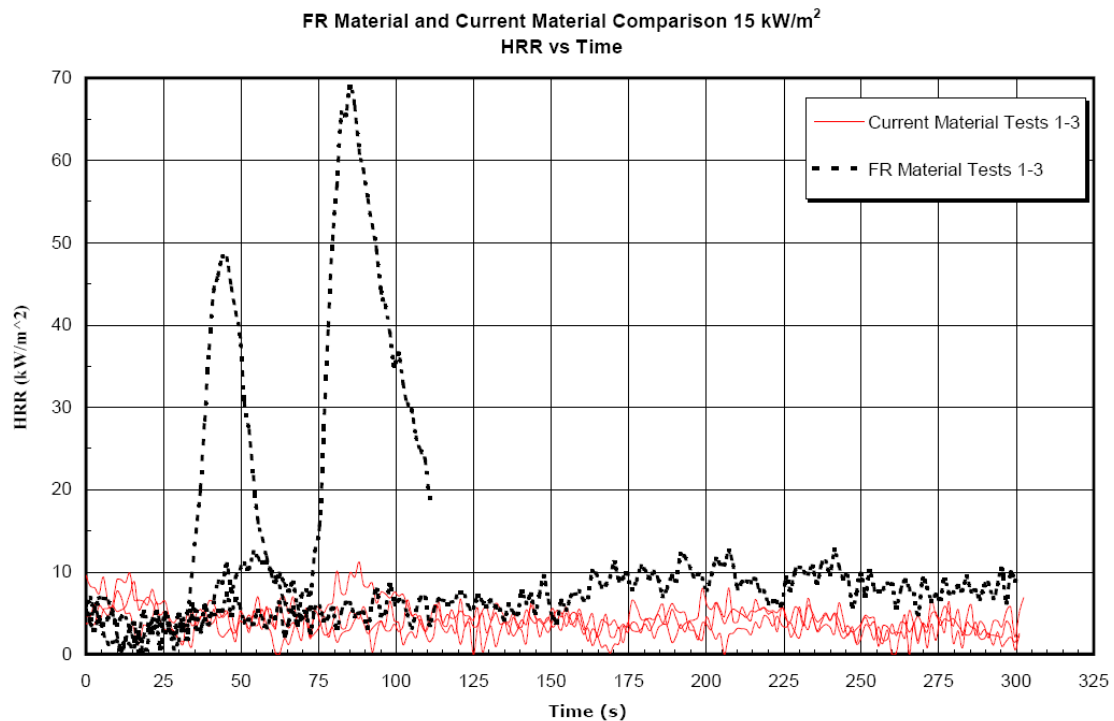
The HRR results from the three tests for each sample at an incident heat flux of 15 kW/m<sup>2</sup> are presented in Figure 4.7. The two FR Material HRR curves that spike are due to ignition during those two tests, while the other four curves represent tests in which ignition did not occur. The sample of FR Material that did not ignite has a comparable HRR pattern to the non-ignition Current Material samples. These tests indicate that the FR Material material appears to have a lower critical heat flux for ignition than the Current Material.

**Figure 4.7. HRR at 15 kW/m<sup>2</sup> for both samples**

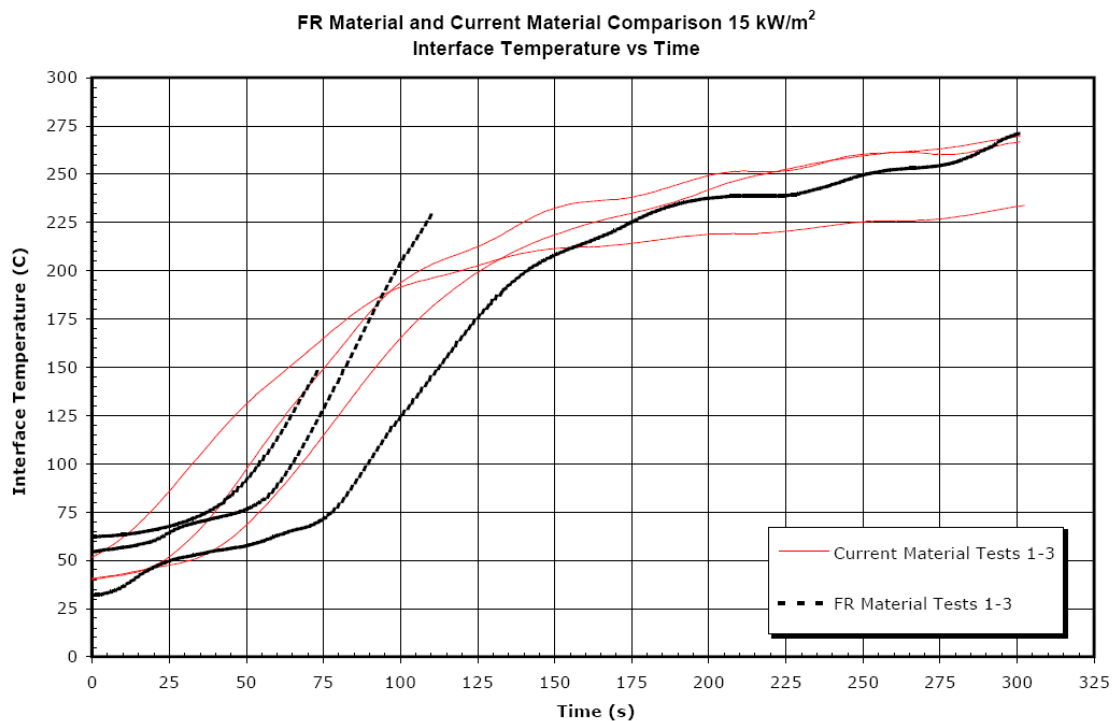
The interface temperature results from the three tests for each sample at an incident heat flux of  $15 \text{ kW/m}^2$  are presented in Figure 4.8. The two plots with steeper temperature increases are from the two FR Material tests in which ignition occurred. The two samples have similar insulation qualities, with the FR Material samples peaking at a slightly higher temperature due to ignition.

**Figure 4.8. Interface temperatures at  $15 \text{ kW/m}^2$  for both samples**

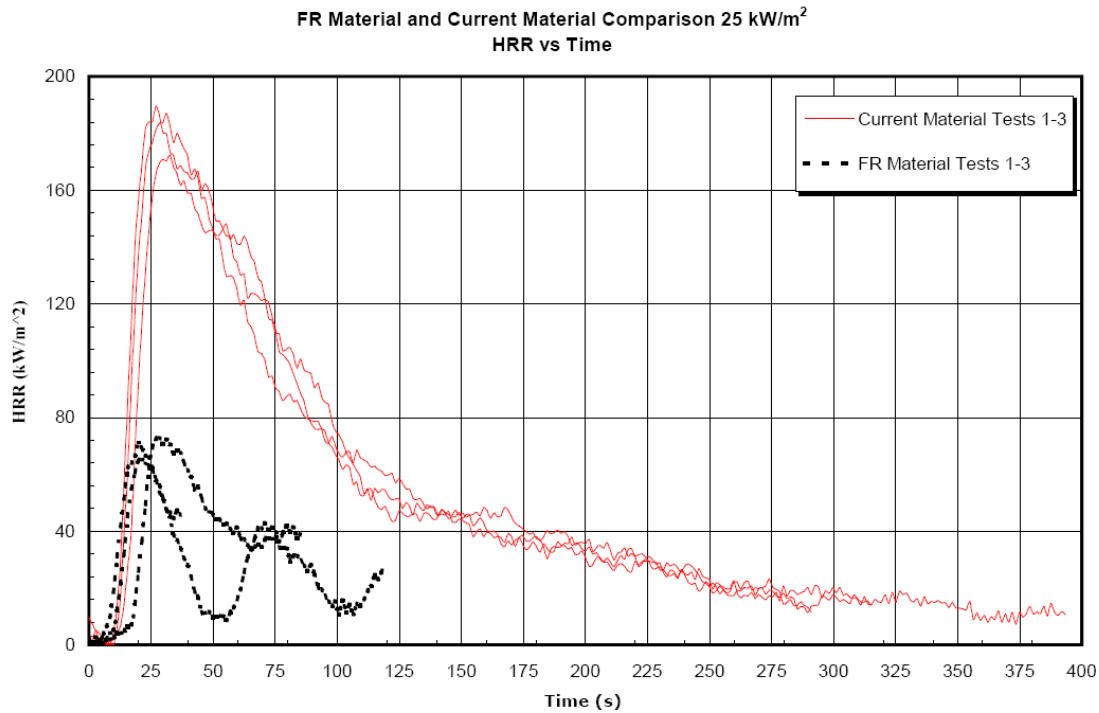
The HRR results from the three tests for each sample at an incident heat flux of 25 kW/m<sup>2</sup> are presented in Figure 4.9. The curves from the two samples share similar shape, indicating somewhat similar ignition and burning while their peak heat release rates differ. The peak heat release rate from the FR Material samples is approximately 72 kW/m<sup>2</sup> while the Current Material samples have peak heat release rates of approximately 180 kW/m<sup>2</sup>.

**Figure 4.9. HRR at 25 kW/m<sup>2</sup> for both samples**

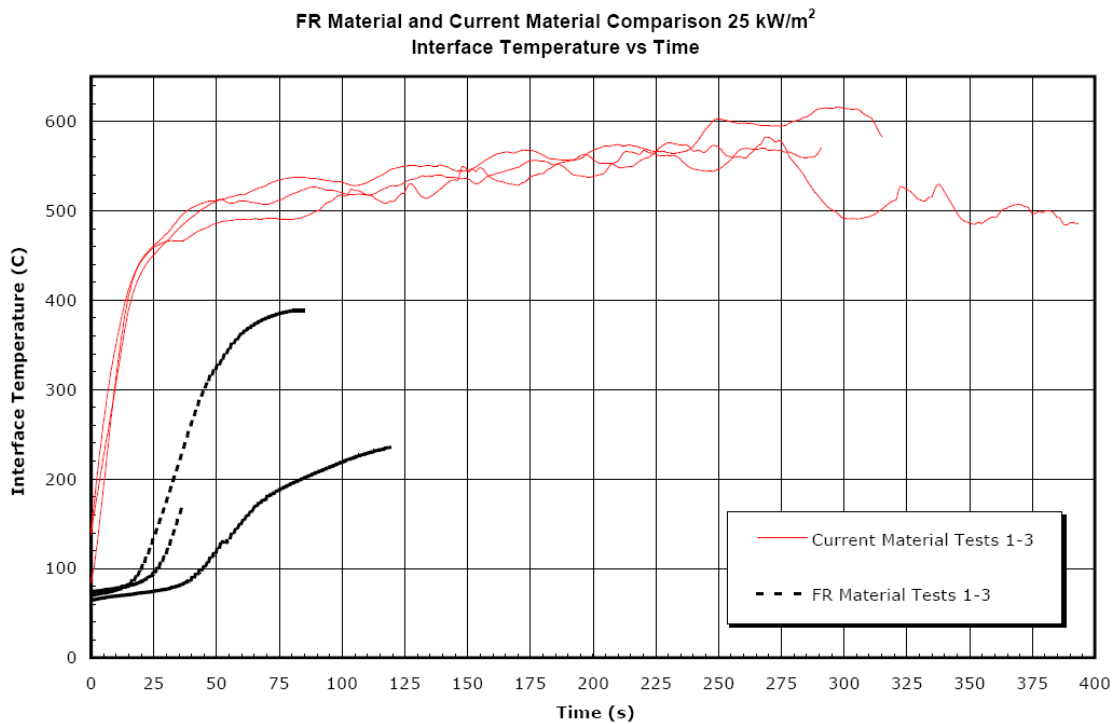
The interface temperature results from the three tests for each sample at an incident heat flux of 25 kW/m<sup>2</sup> are presented in Figure 4.10. Tests were stopped once the samples self-extinguished, accounting for the shortened time measurements of the FR Material tests. Although a complete comparison can not be made, it appears as though the FR Material exhibits better insulative properties than the Current Material within the first 110 seconds.

**Figure 4.10. Interface temperatures at 25 kW/m<sup>2</sup> for both samples**

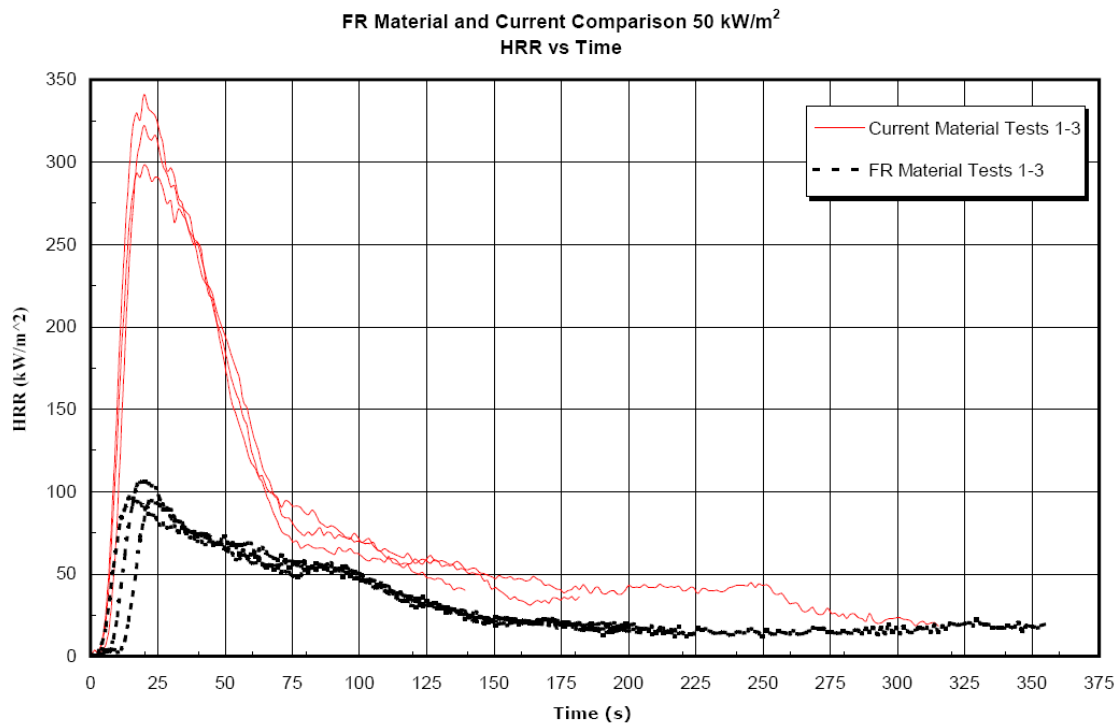
The cumulative HRR results from the three tests for each sample at an incident heat flux of  $50 \text{ kW/m}^2$  are presented in Figure 4.11. The curves from the two samples share similar shape, indicating somewhat similar ignition times while their peak heat release rates differ. The peak heat release rate from the FR Material samples is approximately  $100 \text{ kW/m}^2$  while the Current Material samples have peak heat release rates of approximately  $310 \text{ kW/m}^2$ .

**Figure 4.11. HRR at  $50 \text{ kW/m}^2$  for both samples**

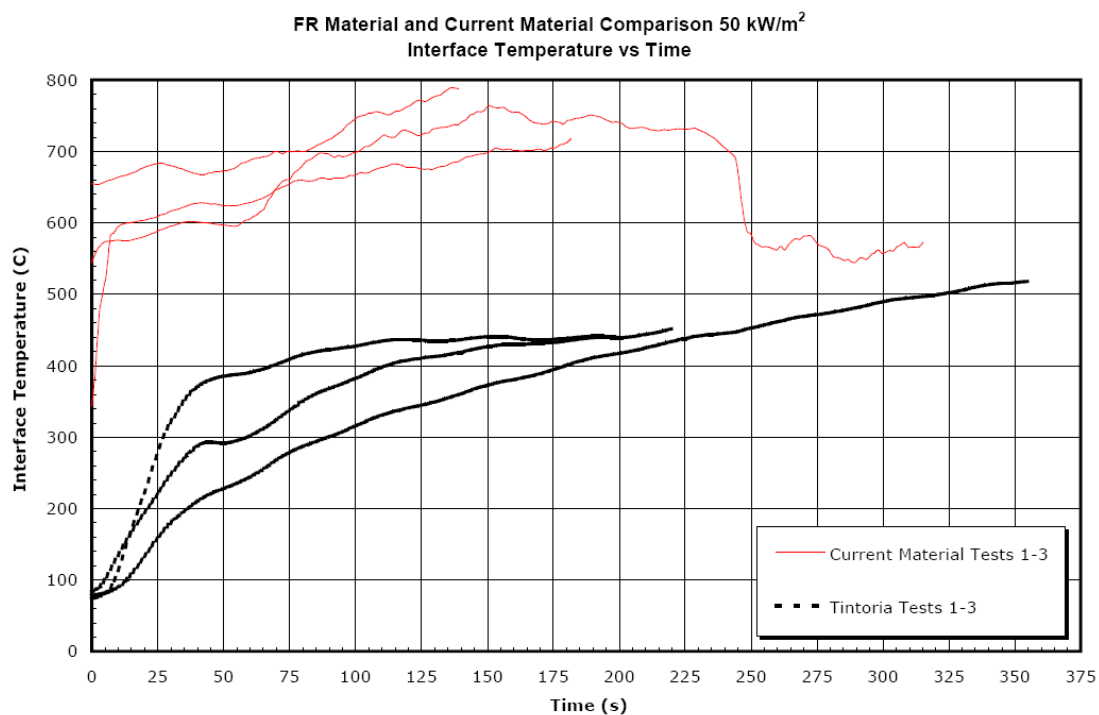
The interface temperature results from the three tests for each sample at an incident heat flux of  $50 \text{ kW/m}^2$  are presented in Figure 4.12. From the figure, the FR Material samples prevented considerable heat from penetrating to the steel backing 40 seconds longer than the Current Material samples. Additionally, the FR Material samples keep the peak temperature of the steel backing at almost  $300^\circ\text{C}$  less than the Current Material samples.

**Figure 4.12. Interface temperatures at  $50 \text{ kW/m}^2$  for both samples**

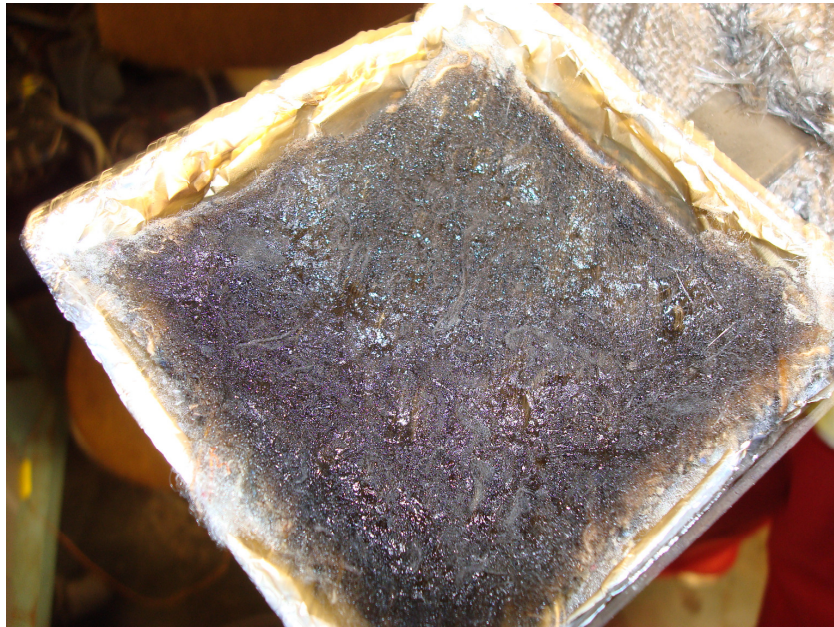
The Current Material samples, when ignited, would burn until most of the material had burnt away; upon extinction of the flame, very little of the samples remained. Figures 4.13, 4.14, and 4.15 show the extent of this degradation as the incident heat flux is increased.

**Figure 4.13. Current Material after 15 kW/m<sup>2</sup>**

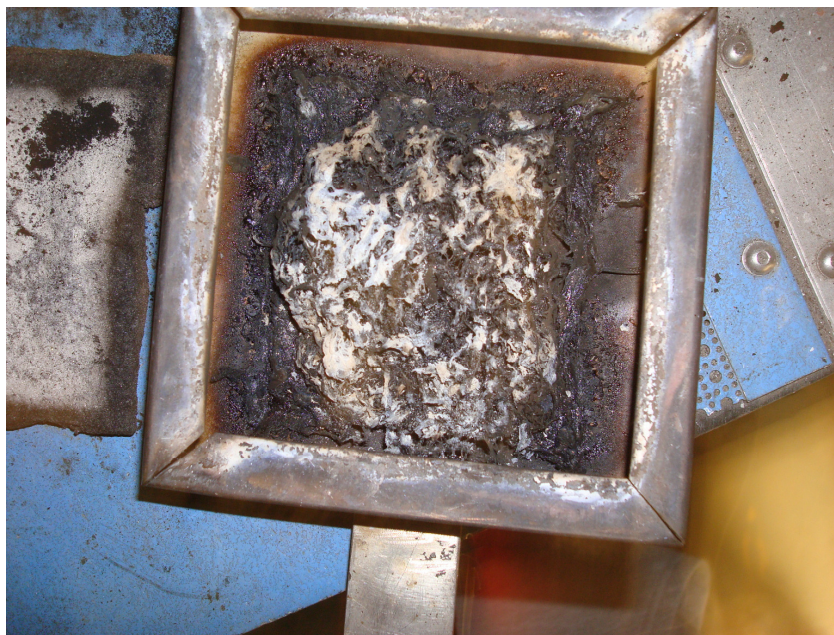
**Figure 4.14. Current Material after 25 kW/m<sup>2</sup>**

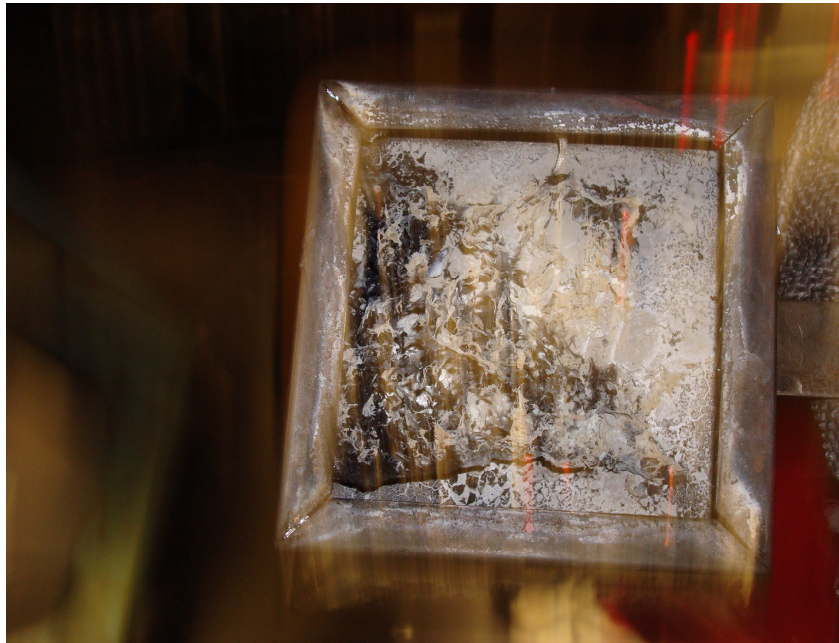
**Figure 4.15. Current Material after 50 kW/m<sup>2</sup>**

The high interface temperatures in the Current Material samples can be partially attributed to this mass loss. In Figure 4.15, the white area in the upper right triangle is the steel underneath the sample. In this case, very little of the sample remains after the burn. The FR Material samples charred on the surface, and depending upon the length of burn, would sometimes char lower into the sample, but the material would maintain shape and integrity. Figures 4.16, 4.17, and 4.18 show the charring in the FR Material samples as the incident heat flux is increased.

There are clear differences between the Current Material sample remains in Figure 4.15 and the FR Material sample remains in Figure 4.18. Though the FR Material has been affected by the incident heat and ignition, it retains more of its mass and thus retains more of its insulative qualities.

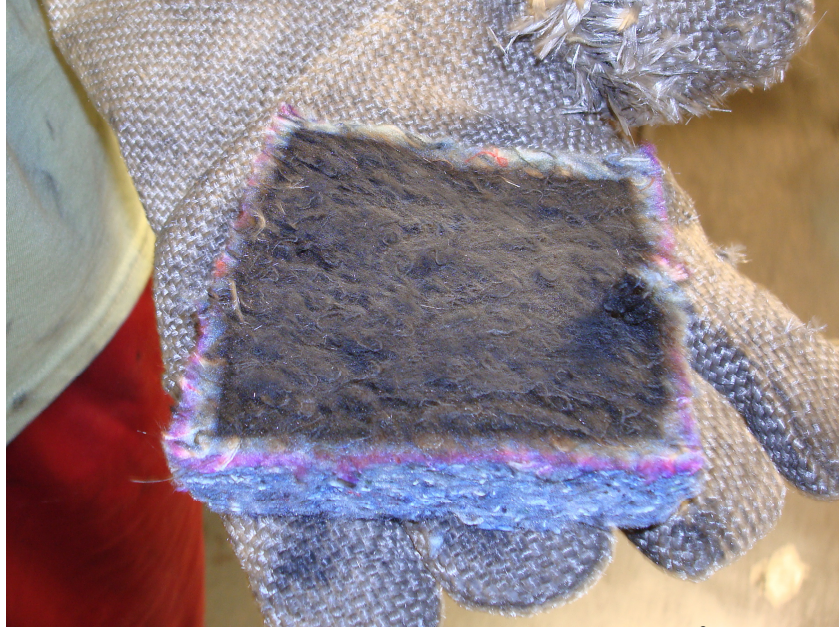
**Figure 4.16. FR Material after 15 kW/m<sup>2</sup>**

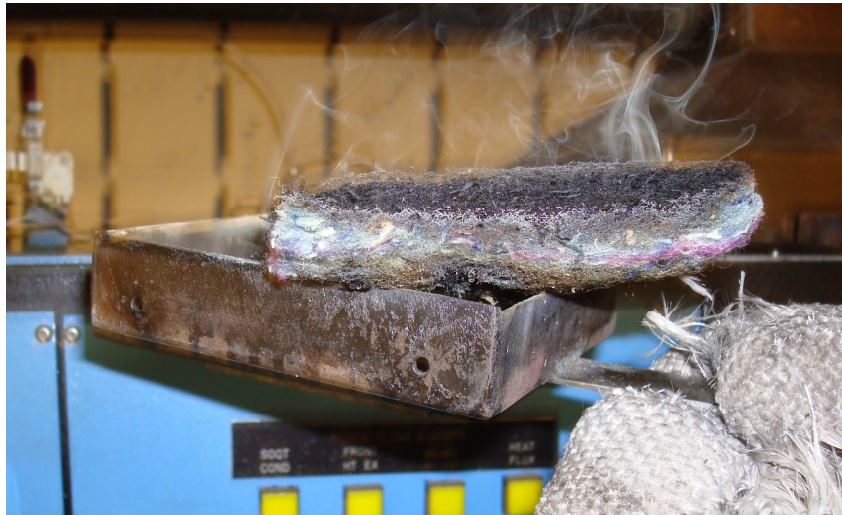
**Figure 4.17. FR Material after 25 kW/m<sup>2</sup>**

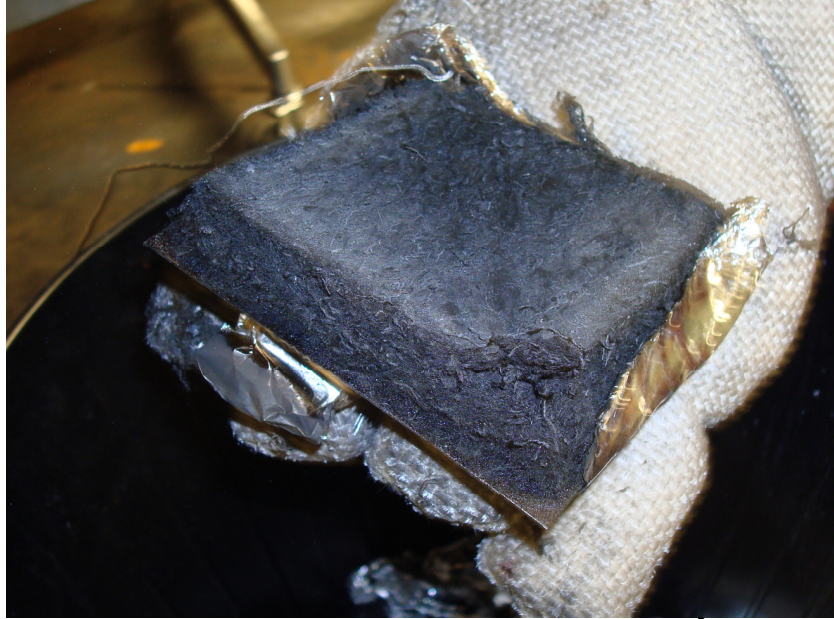
**Figure 4.18. FR Material after 50 kW/m<sup>2</sup>**

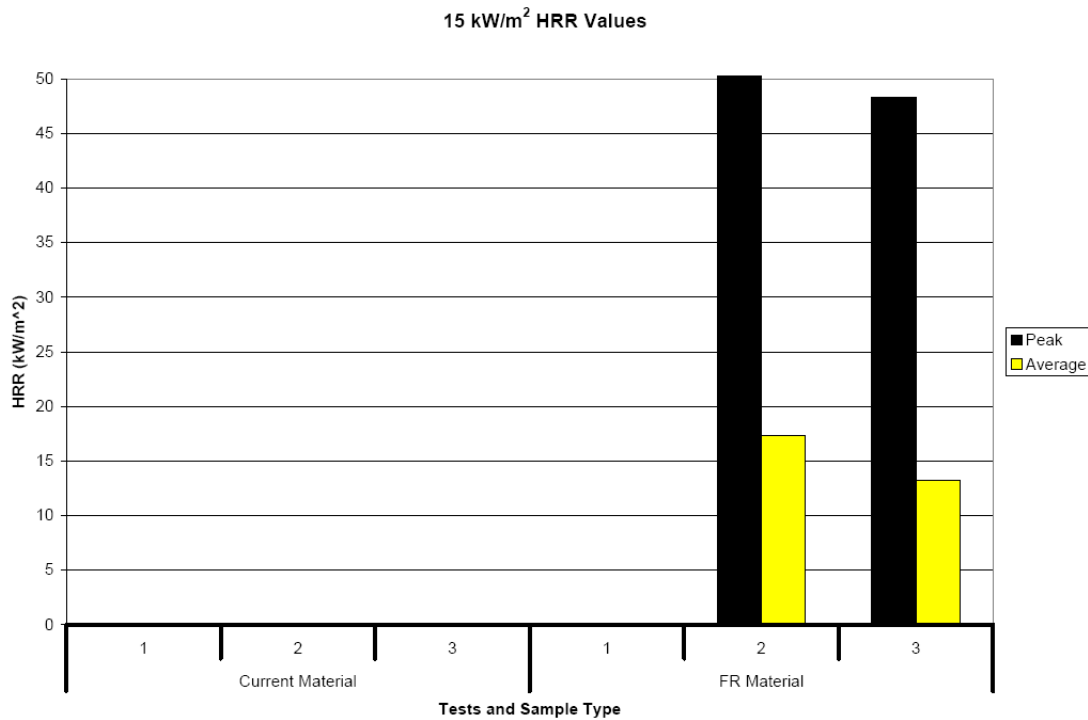
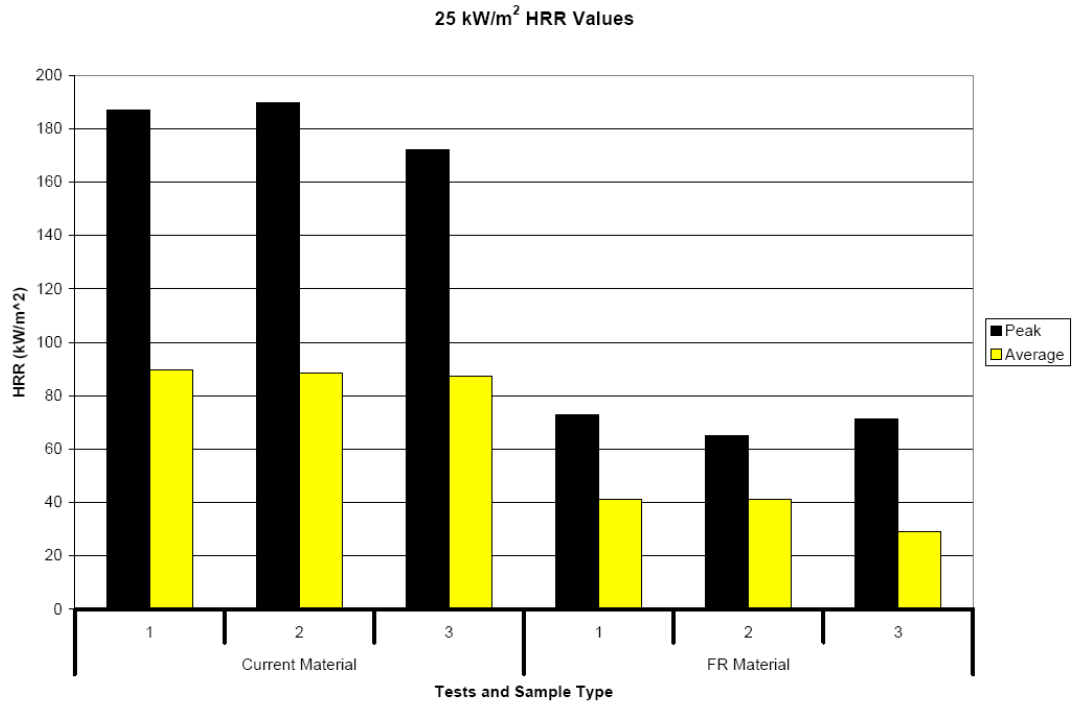
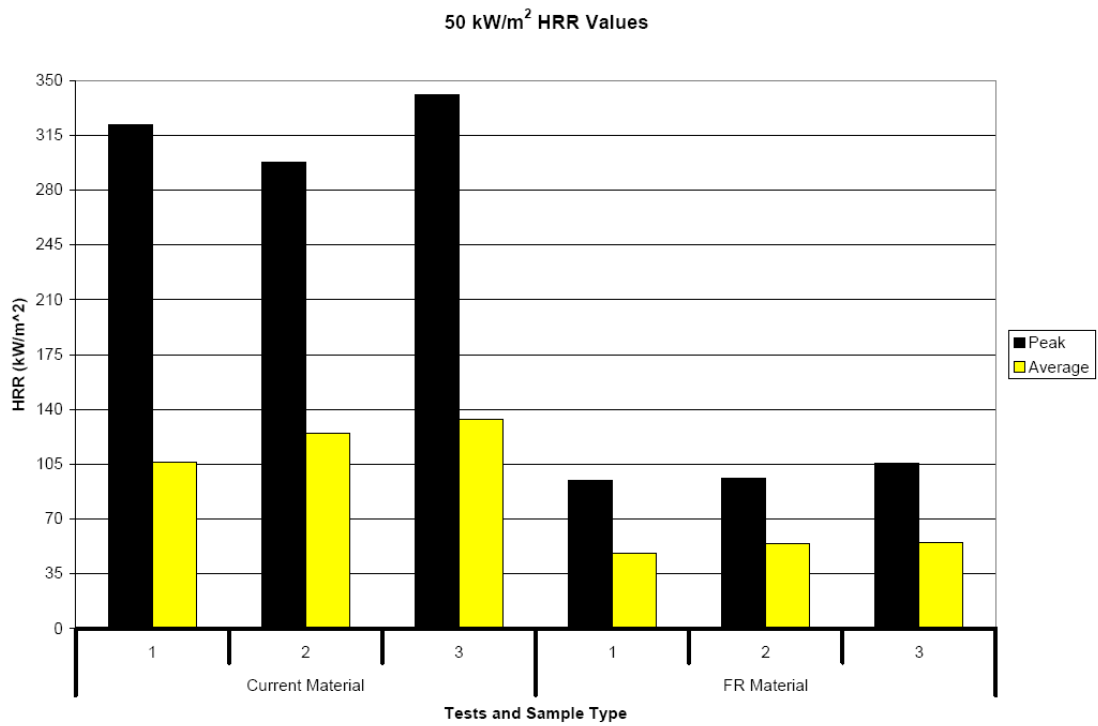
had HRR's of less than half that of the Current Material; it was found that the peak HRR of the Current Material was an average of 2.36 times higher than the FR Material samples and the average HRR was an average of 1.25 times higher. Figures 4.19, 4.20, and 4.21 give a graphical representation of this data for a better comparison of magnitude.

**Figure 4.19. Side-by-side Comparison of 15 kW/m<sup>2</sup> HRR Values**

**Figure 4.20. Side-by-side Comparison of 25 Kw/m<sup>2</sup> HRR Values**

**Figure 4.21. Side-by-side Comparison of 50 kW/m<sup>2</sup> HRR Values**

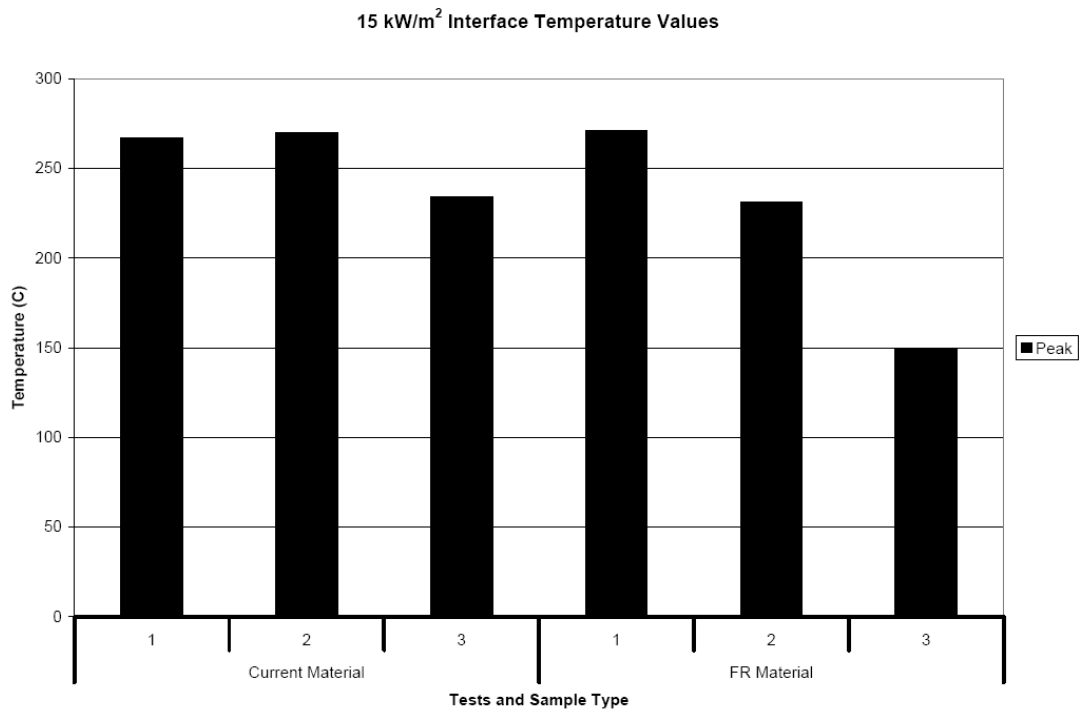
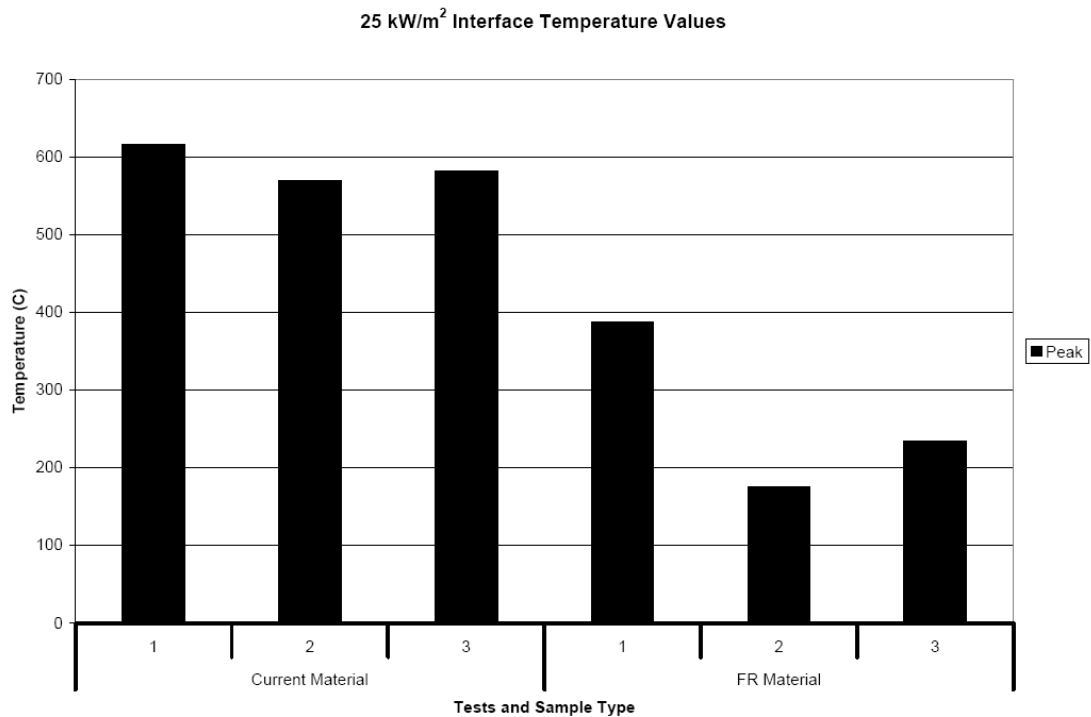
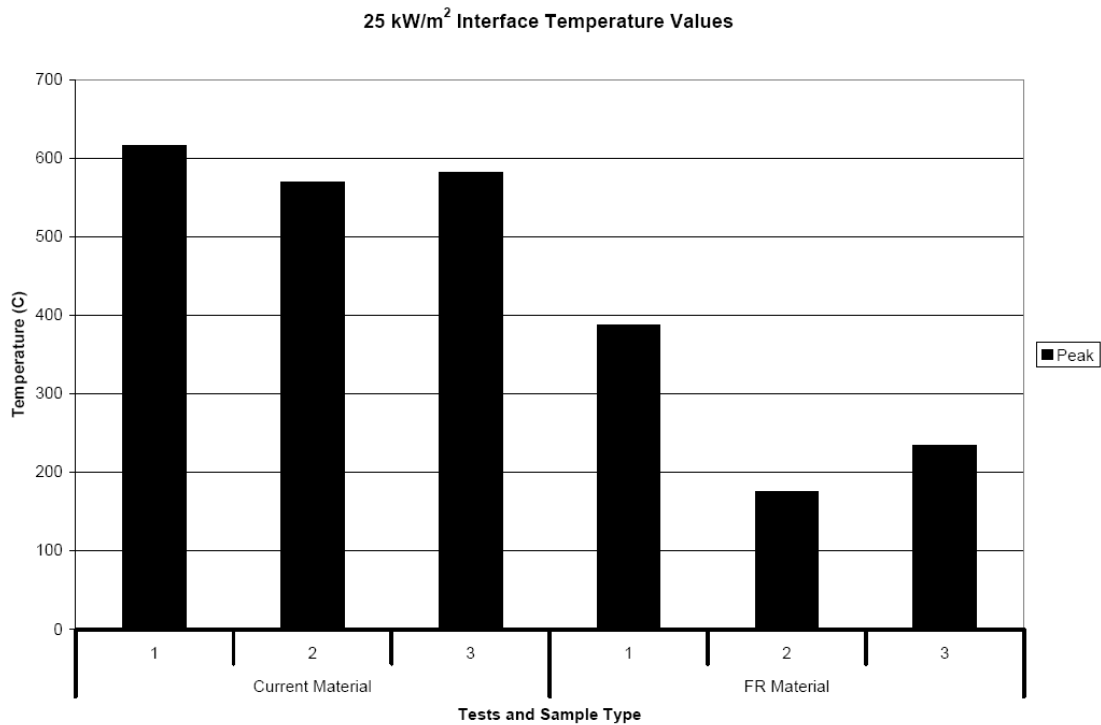
Figures 4.22, 4.23, and 4.24 give a graphical representation of this data for a better comparison of magnitude.

**Figure 4.22. Side-by-side Comparison of 15 kW/m<sup>2</sup> Interface Temperatures**

**Figure 4.23. Side-by-side Comparison of 25 kW/m<sup>2</sup> Interface Temperatures**

**Figure 4.24. Side-by-side Comparison of 50 kW/m<sup>2</sup> Interface Temperatures**

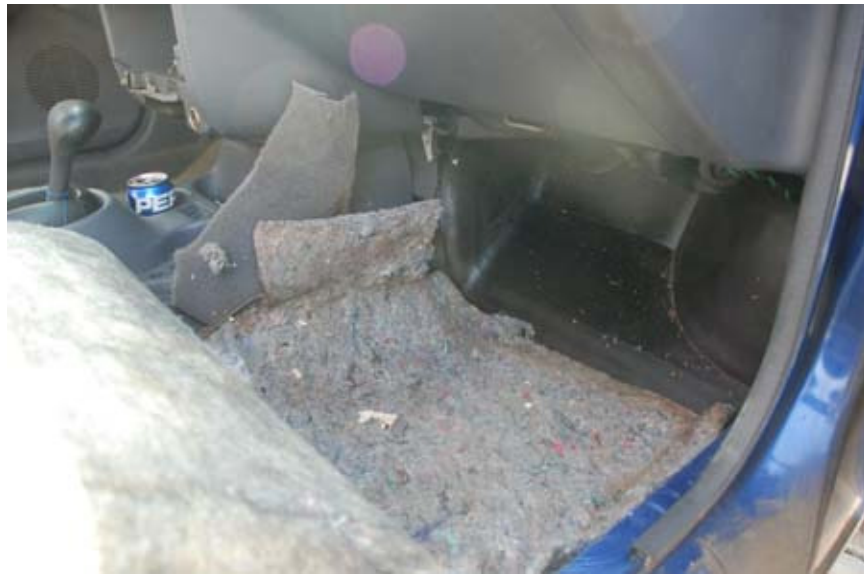
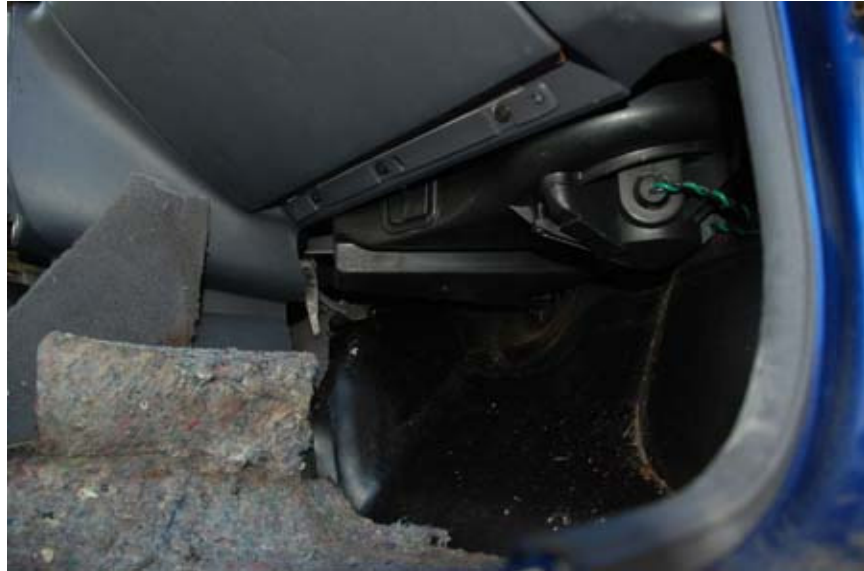
During the insulation replacement process, it was observed that little insulation was actually used in the firewall. Figures 4.24 and 4.25 from the Dodge Neon show that the insulation does not reach the top of the carpeting in the footwell; it was initially believed that the insulation reached all the way behind the dashboard. This fact will be taken into consideration when analyzing the results. Additionally, in the Infiniti, there was very little firewall insulation, at least of any sort similar to the insulation of FR Material and Current Material; a dense, yellow foam was used instead. The FR Material insulation was installed under the material (the foam was glued securely to the carpeting and could not be removed) and in dashboard areas.

**Figure 4.25. Current Material pre-removal of old insulation**
